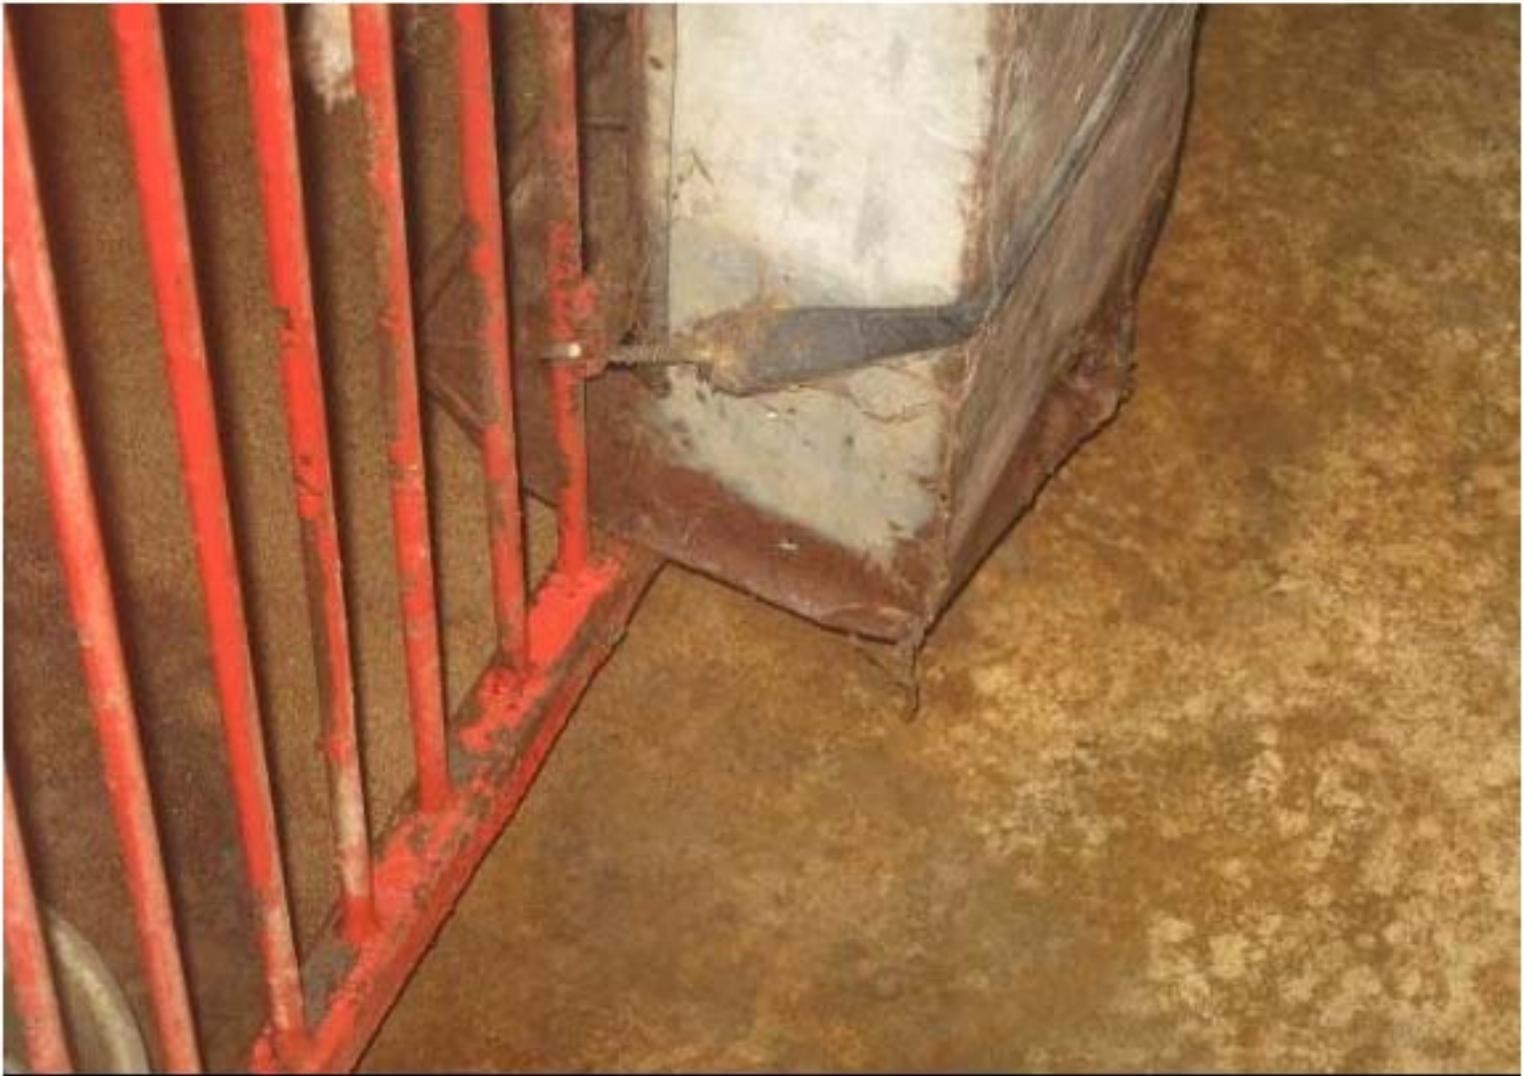
CFR: 3.1 (c) (1) (ii)

Photographer:	Randall Wagner (ACI)	Legal Name:	Registration:	42-A-1253
Photo Taken:	Thu, Sep 23, '10	DAVE RUTER		
Inspection:	280100021210681			
Description:	The tin framing and chain link fence are exposing and sharp edge and protruding sharp points.

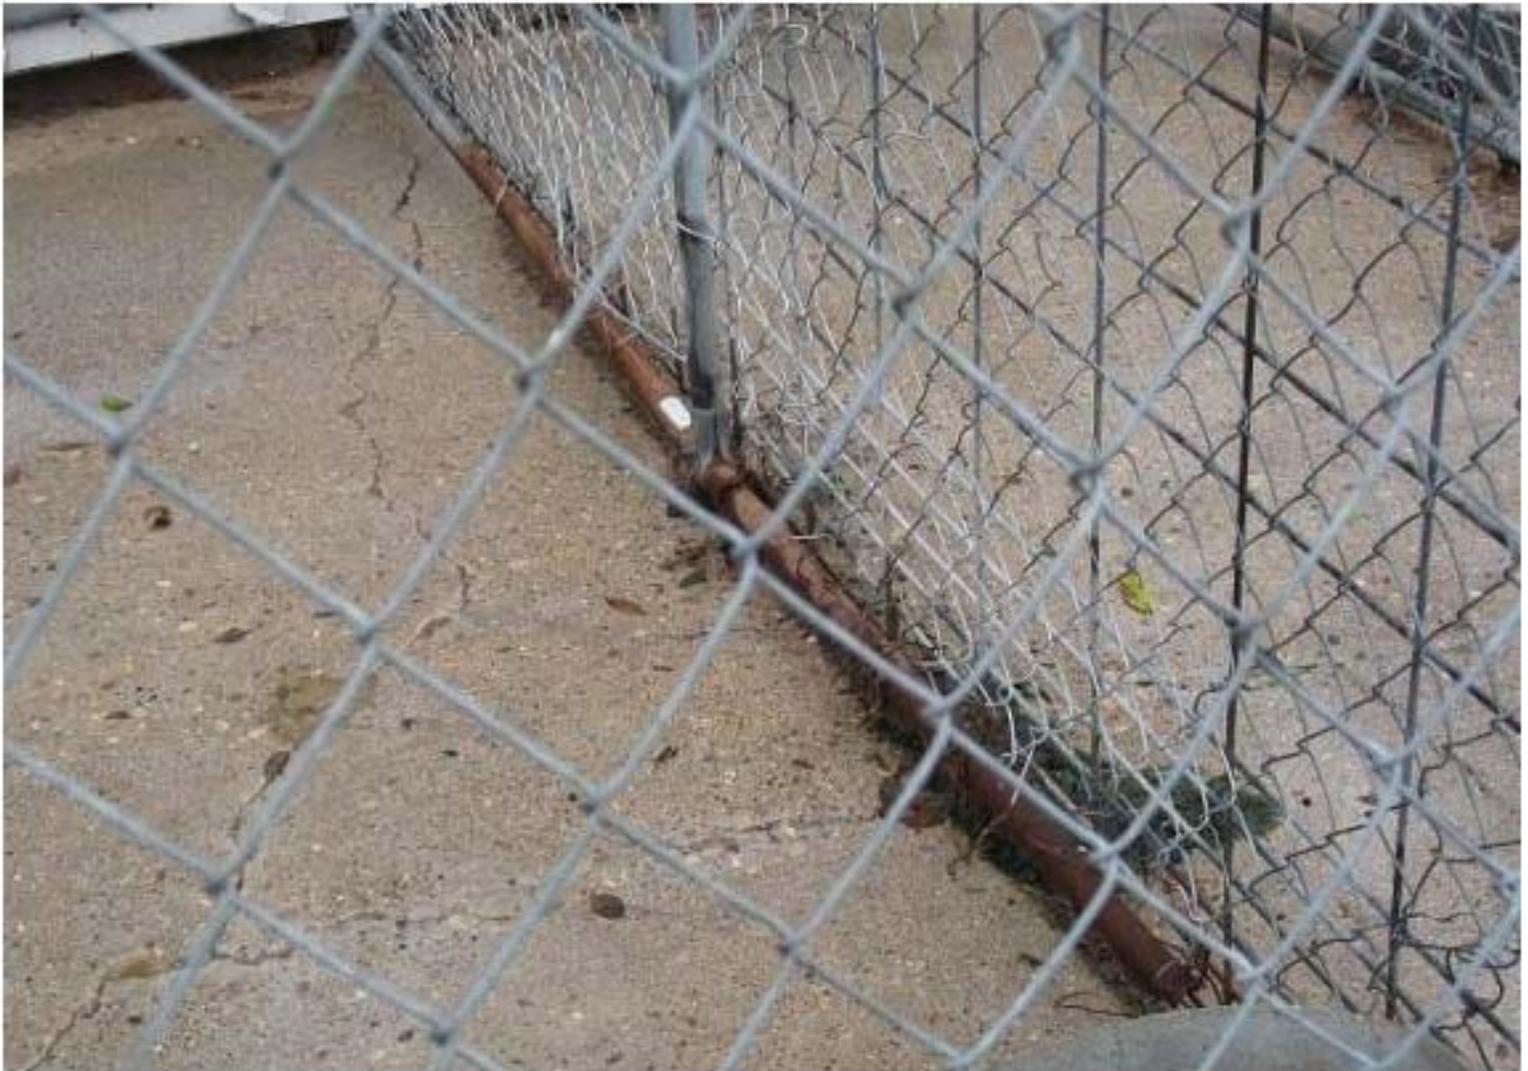
CFR: 3.1 (c) (1) (i)

Photographer:	Randall Wagner (ACI)	Legal Name:	Registration:	42-A-1253
Photo Taken:	Thu, Sep 23, '10	DAVE RUTER		
Inspection:	280100021210681			
Description:	The bottom of the metal feeder is excessively rusty and flaking. The structural integrity is affected from the rust.

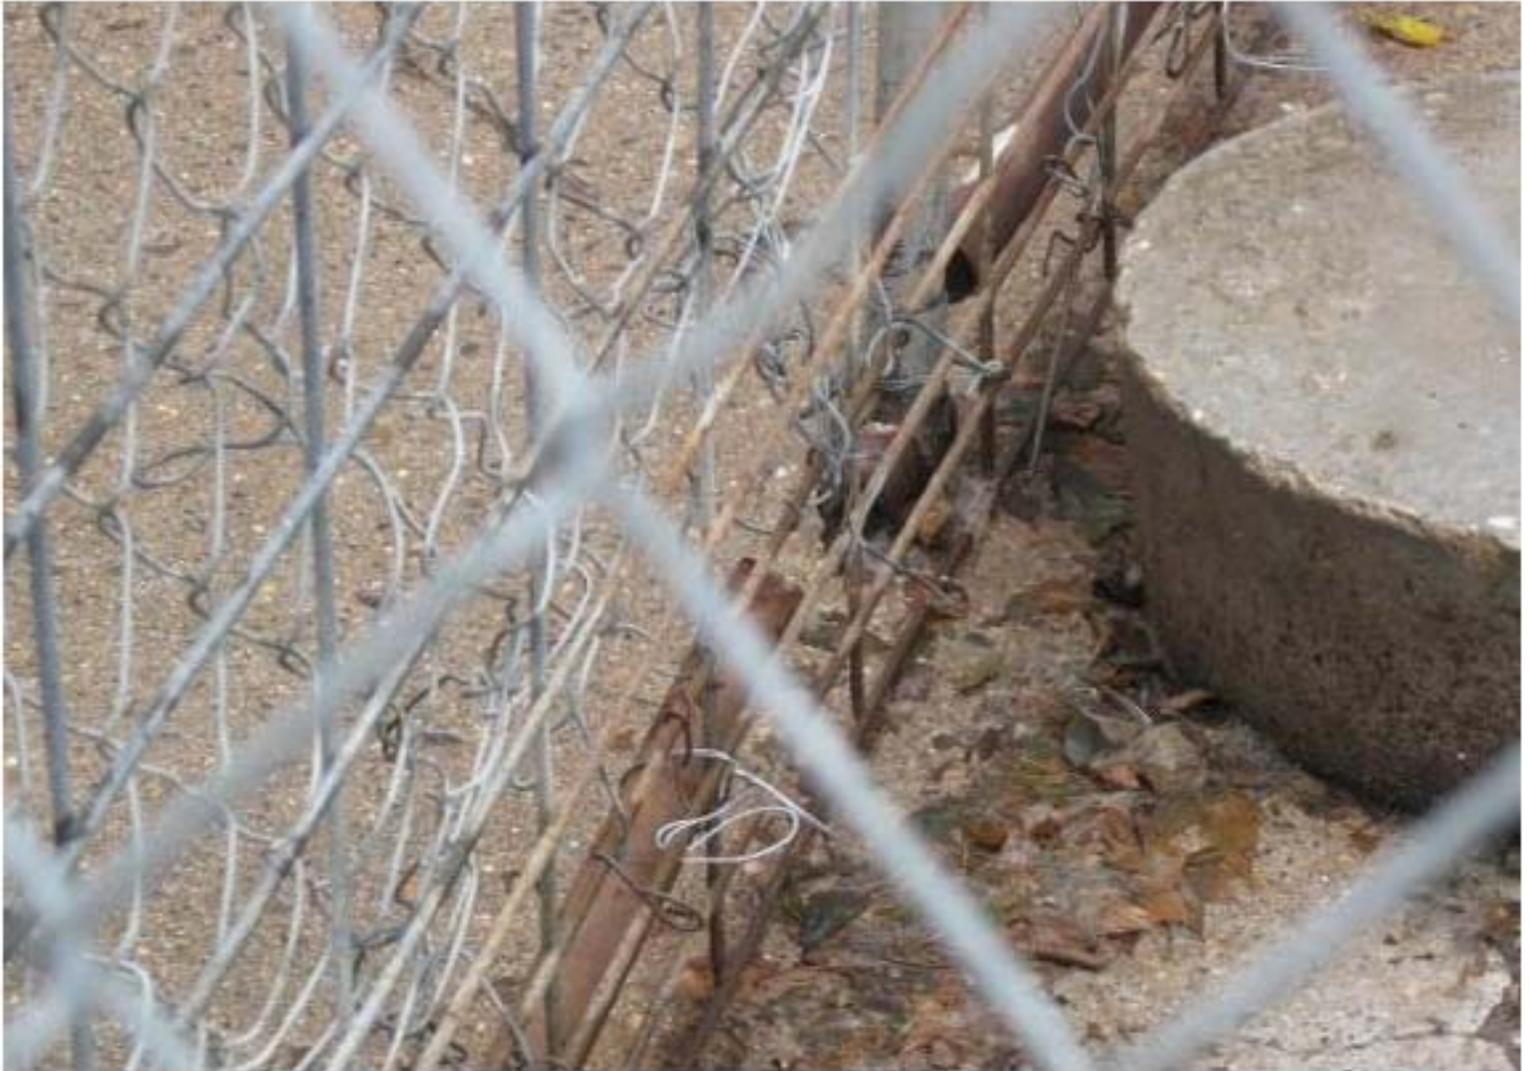
CFR: 3.1 (c) (1) (i)

Photographer:	Randall Wagner (ACI)	Legal Name:	Registration:	42-A-1253
Photo Taken:	Thu, Sep 23, '10	DAVE RUTER		
Inspection:	280100021210681			
Description:	The bottom metal pipe framing surface is excessively rusty and flaking. The pipe is rusted through in areas affecting the structural strength.

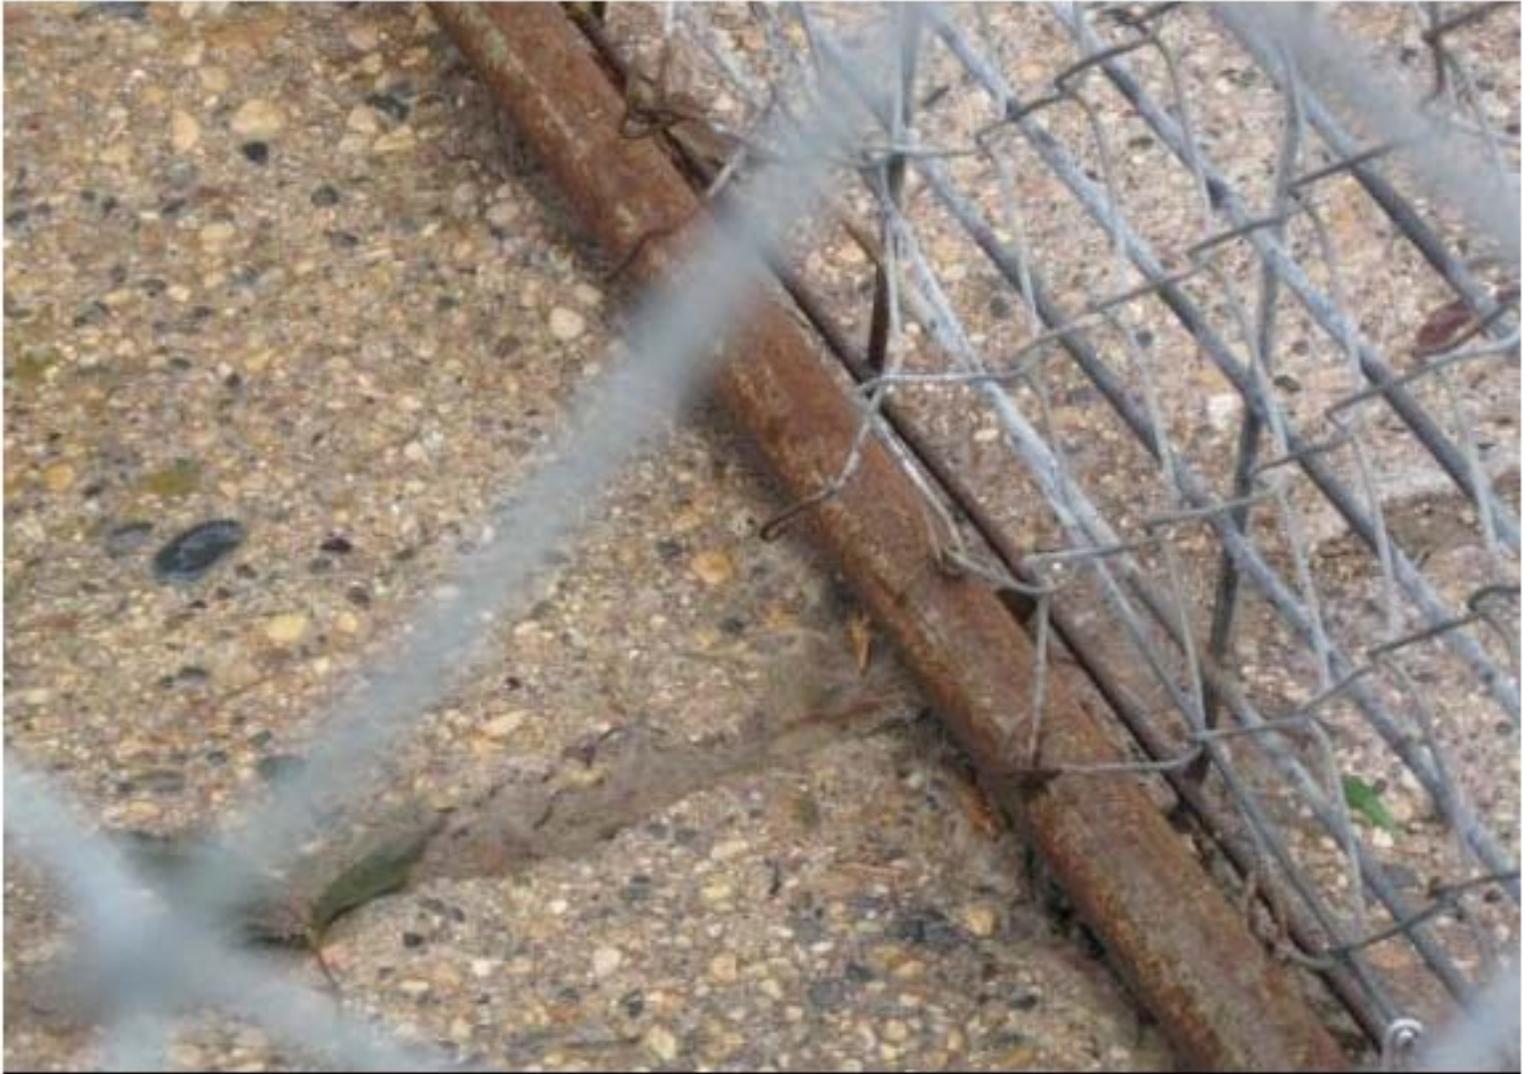
CFR: 3.1 (c) (1) (ii)

Photographer:	Randall Wagner (ACI)	Legal Name:	Registration:	42-A-1253
Photo Taken:	Thu, Sep 23, '10	DAVE RUTER		
Inspection:	280100021210681			
Description:	The sharp points protruding from the chain link fencing.

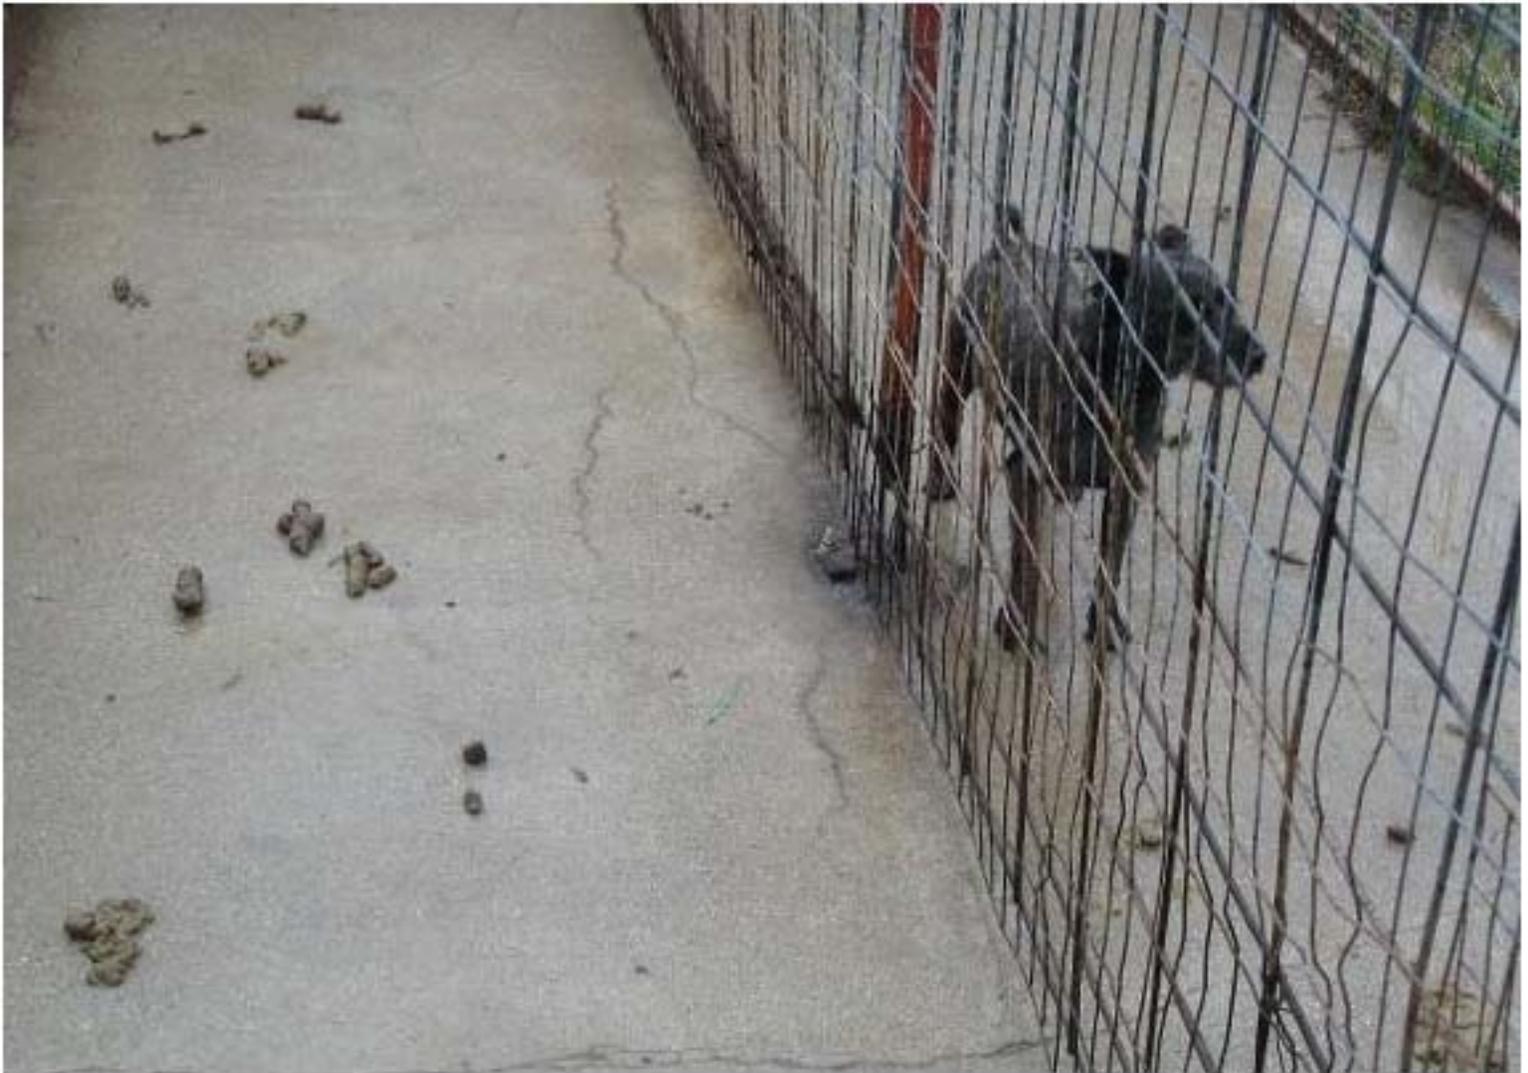
CFR: 3.1 (c) (1) (i)

Photographer:	Randall Wagner (ACI)	Legal Name:	Registration:	42-A-1253
Photo Taken:	Thu, Sep 23, '10	DAVE RUTER		
Inspection:	280100021210681			
Description:	The metal pipe framing surface is excessively rusty and flaking.

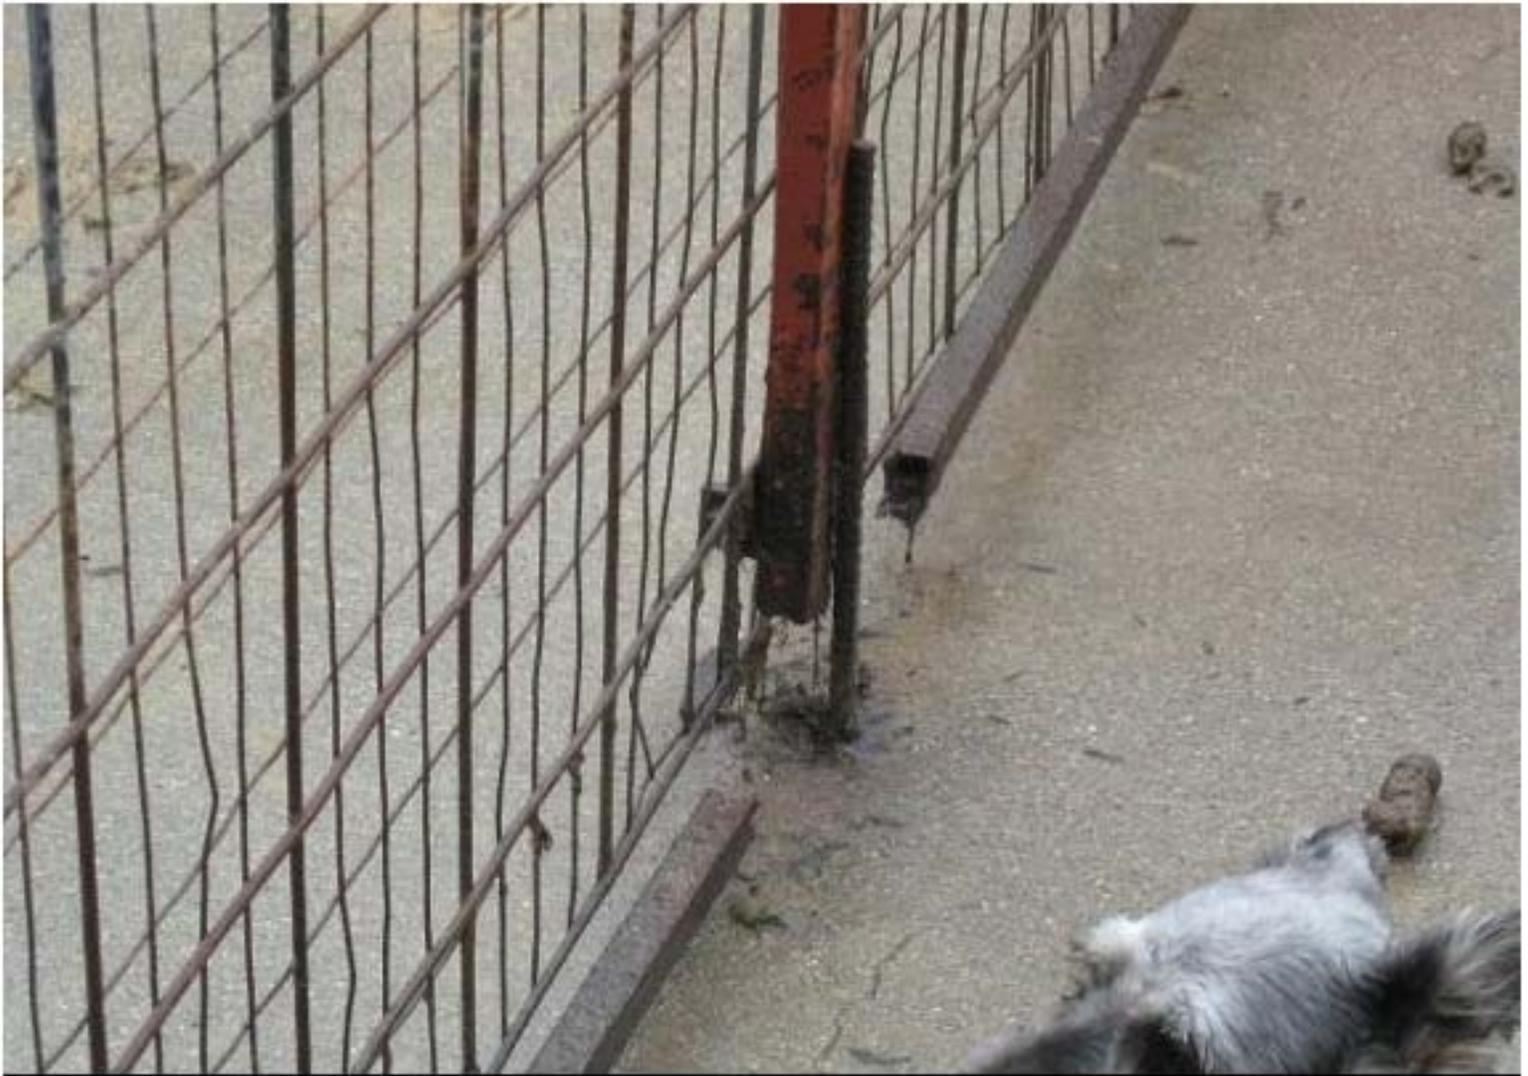
CFR: 3.1 (c) (1) (i)

Photographer:	Randall Wagner (ACI)	Legal Name:	Registration:	42-A-1253
Photo Taken:	Thu, Sep 23, '10	DAVE RUTER		
Inspection:	280100021210681			
Description:	The metal pipe framing and 2 X 4 wire are excessively rusty and flaking. The wire is coming apart and the pipe rusted through.

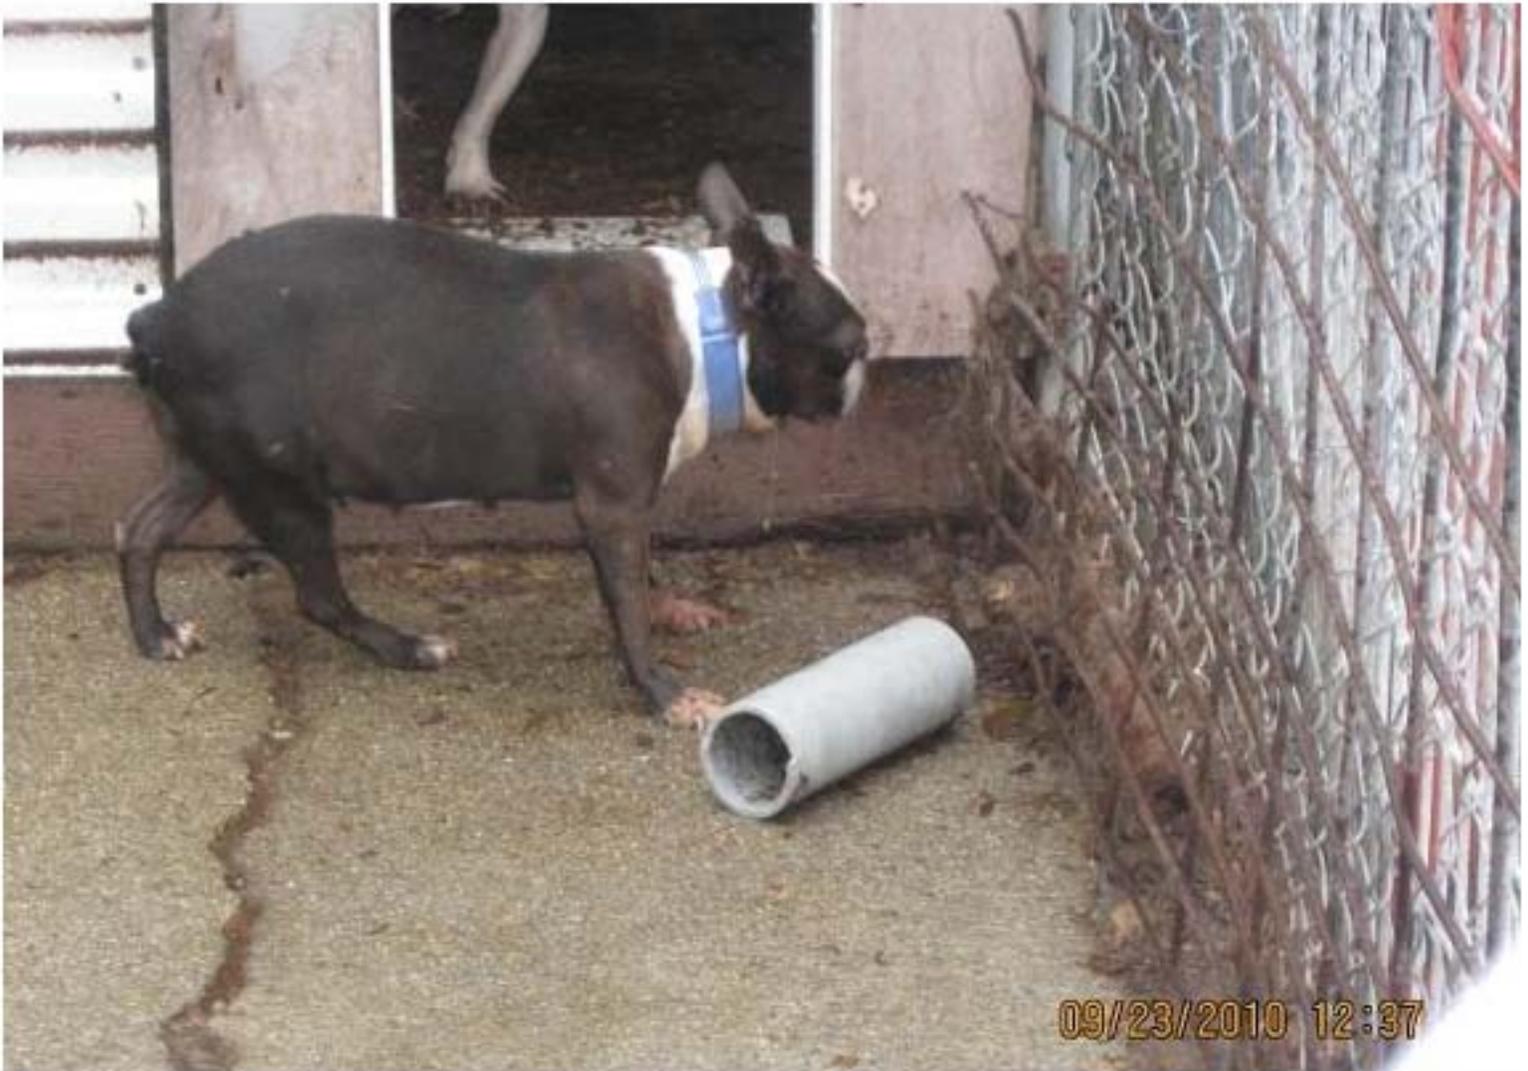
CFR: 3.1 (c) (1) (i)

Photographer:	Randall Wagner (ACI)	Legal Name:	Registration:	42-A-1253
Photo Taken:	Thu, Sep 23, '10	DAVE RUTER		
Inspection:	280100021210681			
Description:	The metal pipe support structural strength is affected from the excessive rusting. The metal bar is rusted off or coming apart.

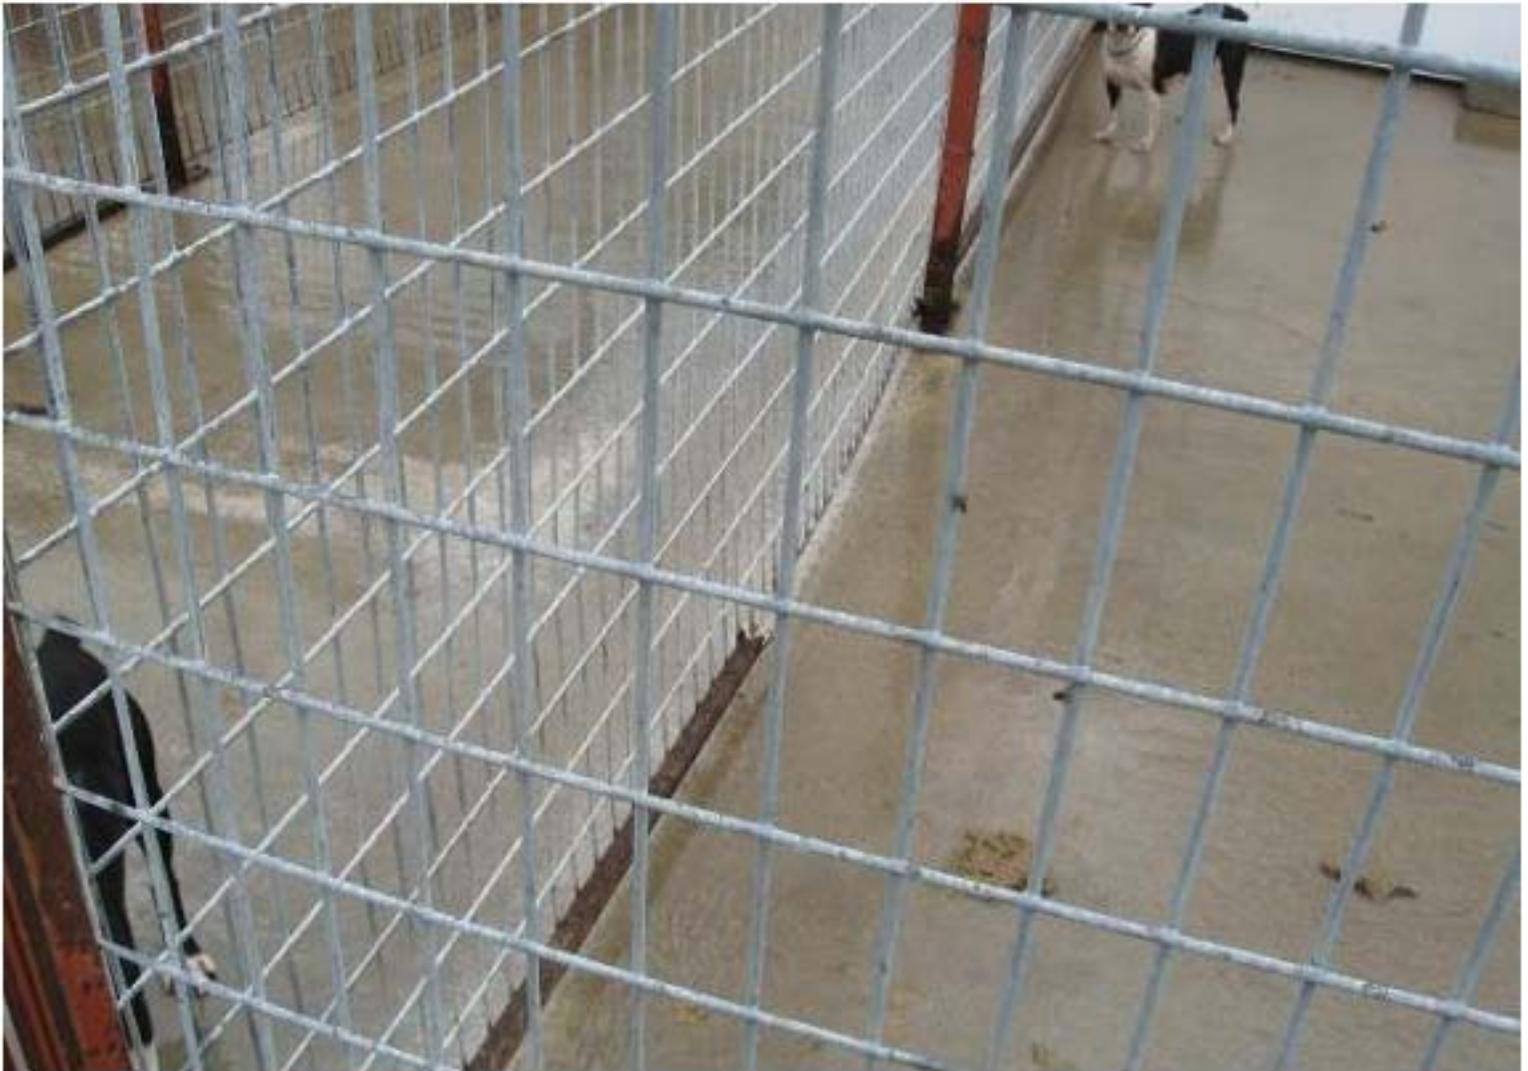
CFR: 3.1 (c) (1) (i)

Photographer:	Randall Wagner (ACI)	Legal Name:	Registration:	42-A-1253
Photo Taken:	Thu, Sep 23, '10	DAVE RUTER		
Inspection:	280100021210681			
Description:	The bottom of the metal door is excessively rusting and flaking.

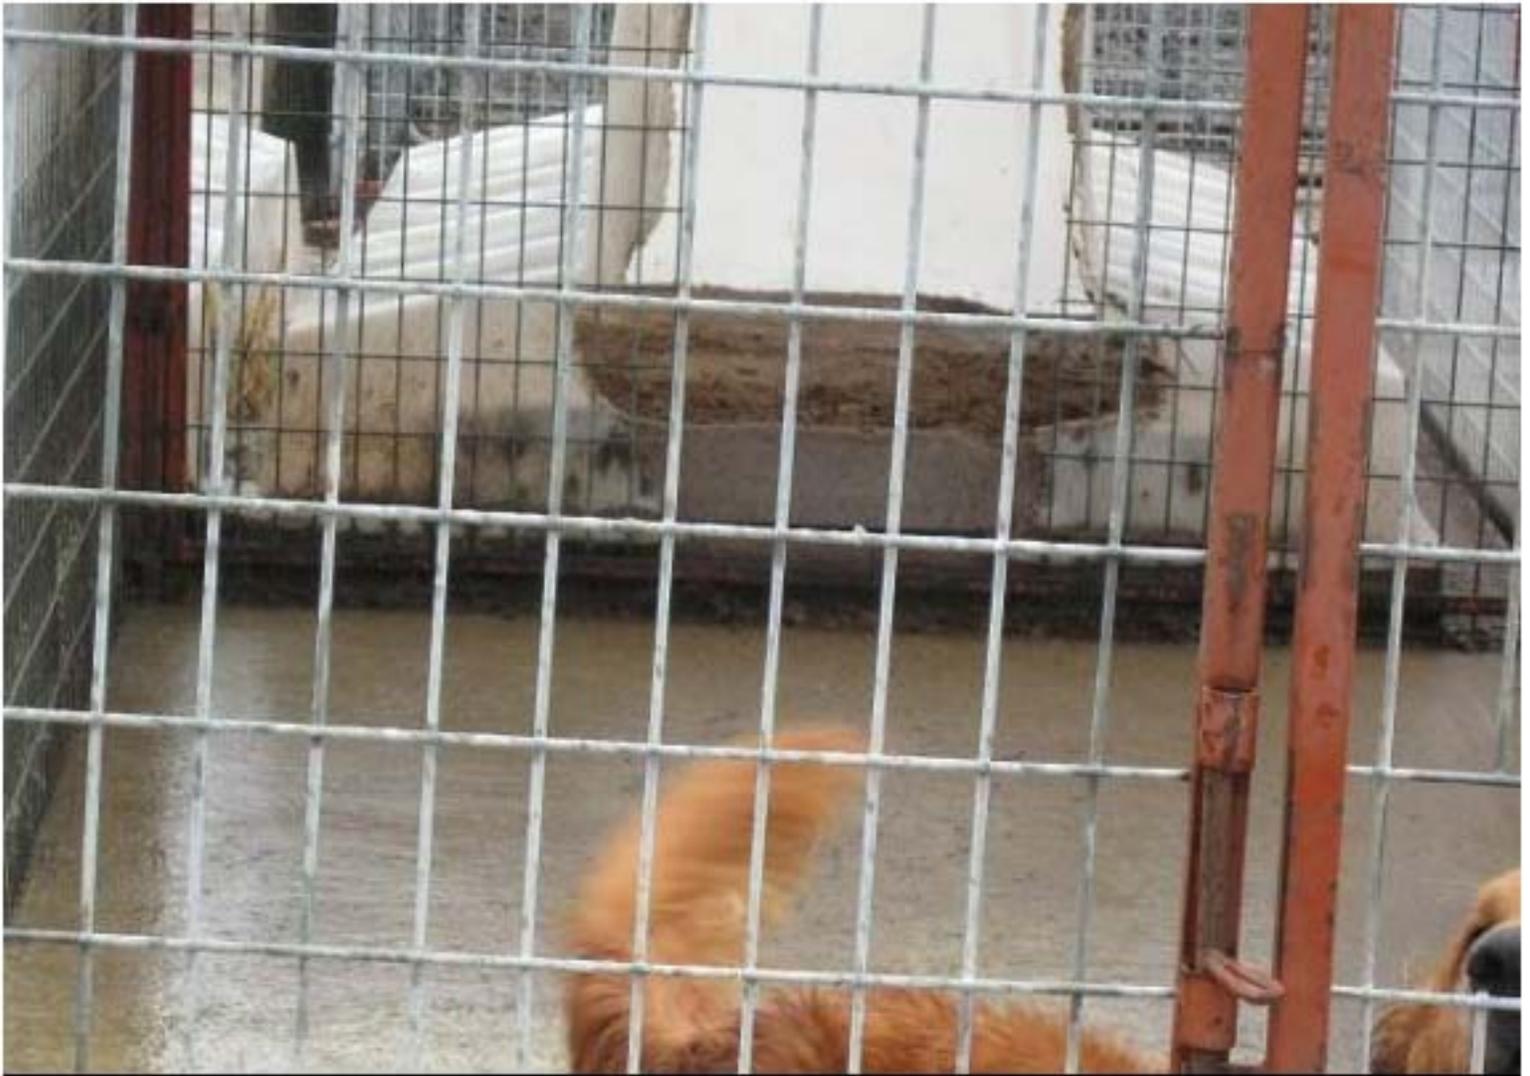
CFR: 3.1 (c) (1) (i)

Photographer:	Randall Wagner (ACI)	Legal Name:	Registration:	42-A-1253
Photo Taken:	Thu, Sep 23, '10	DAVE RUTER		
Inspection:	280100021210681			
Description:	The metal support and framing structural strength are affect from the excessive rusting. Pipe section at the bottom is missing from rusting.

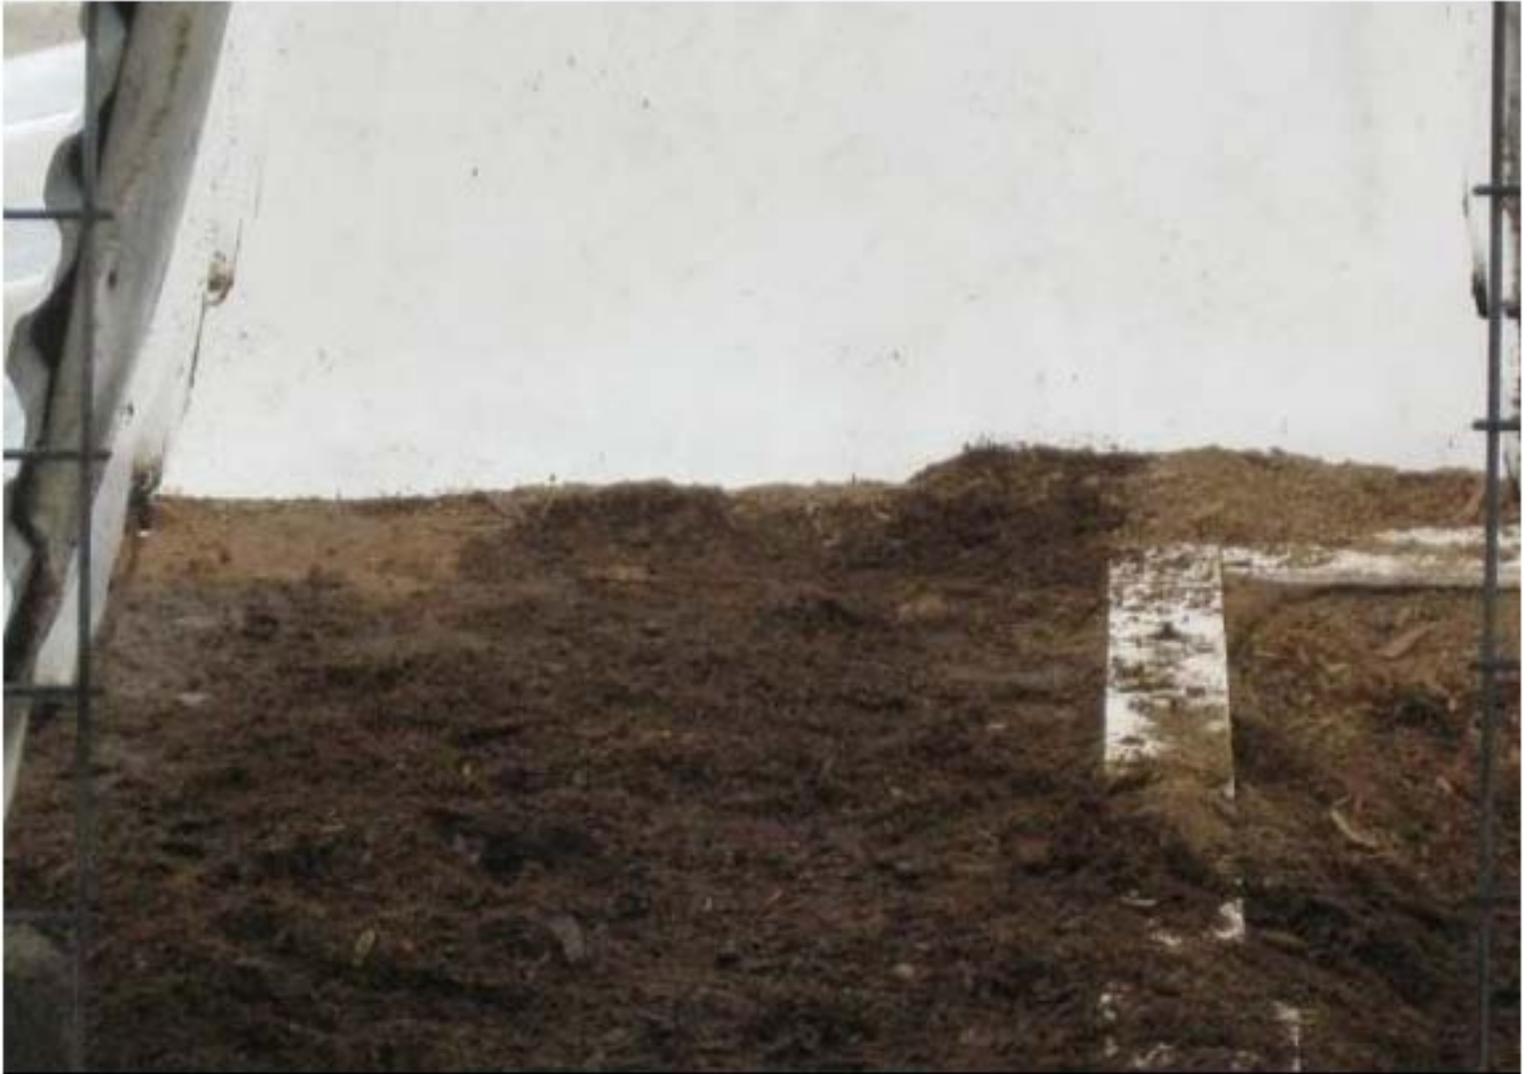
CFR: 3.4 (b) (3)

Photographer:	Randall Wagner (ACI)	Legal Name:	Registration:	42-A-1253
Photo Taken:	Thu, Sep 23, '10	DAVE RUTER		
Inspection:	280100021210681			
Description:	The outdoor dog house does not have protection from the elements.

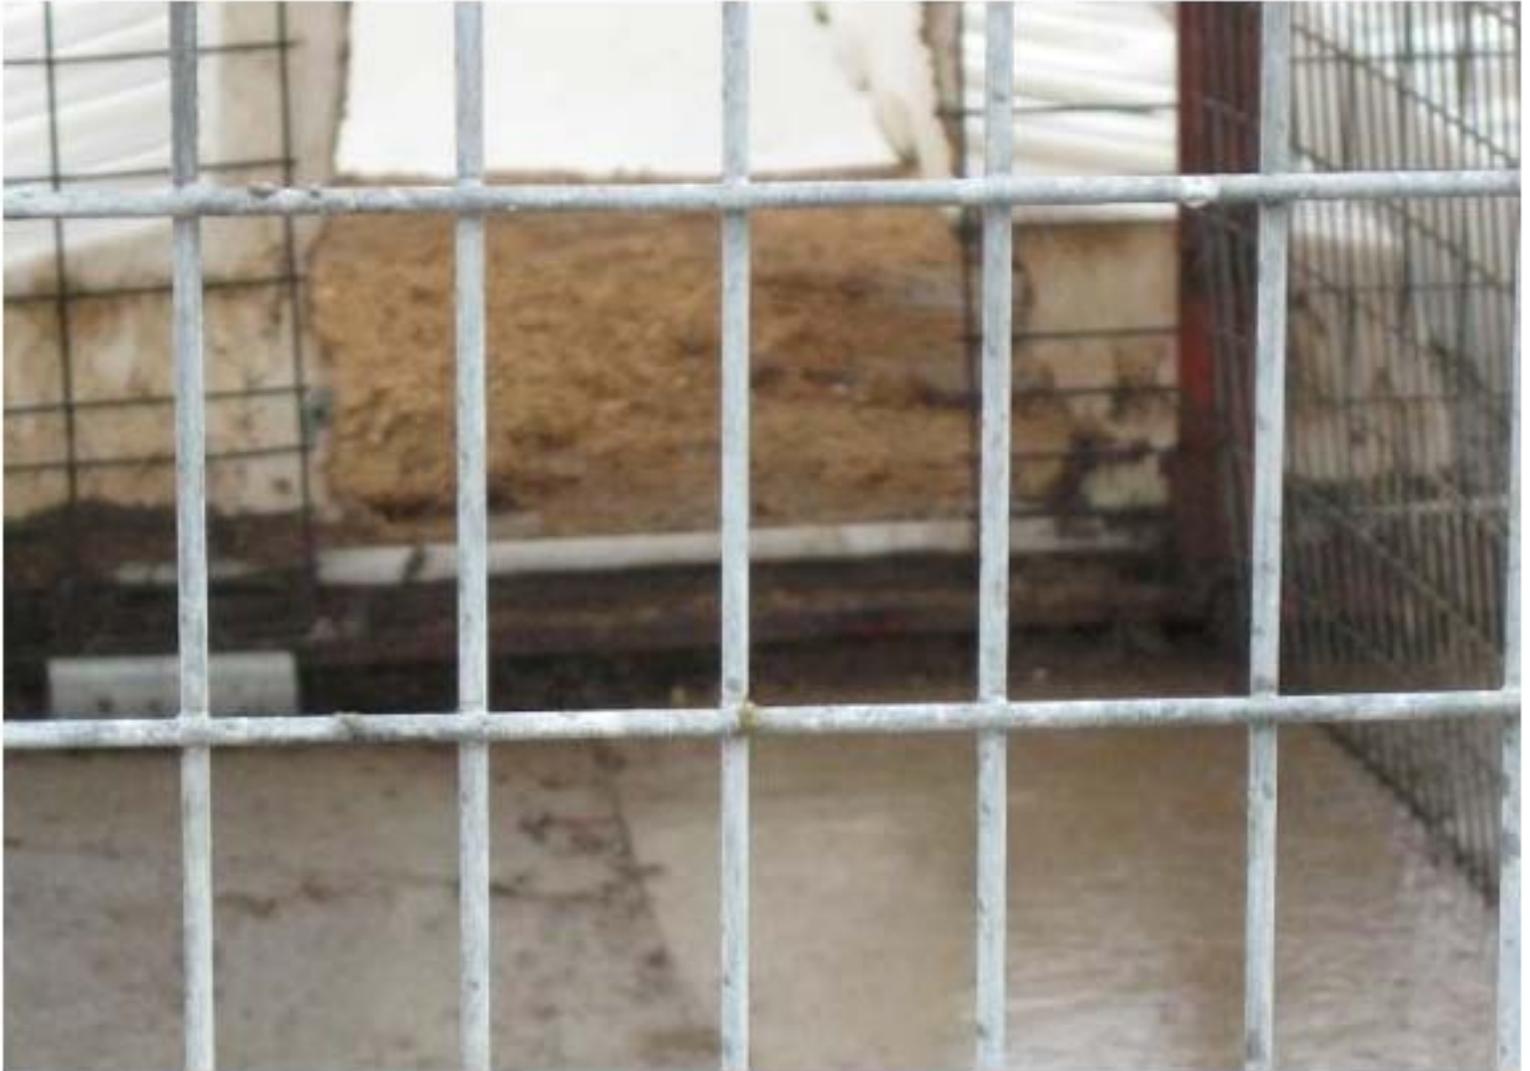
CFR: 3.1 (c) (2)

Photographer:	Randall Wagner (ACI)	Legal Name:	Registration:	42-A-1253
Photo Taken:	Thu, Sep 23, '10	DAVE RUTER		
Inspection:	280100021210681			
Description:	The inside of the outdoor dog house with the wood flooring worn through and or is extremely soiled.

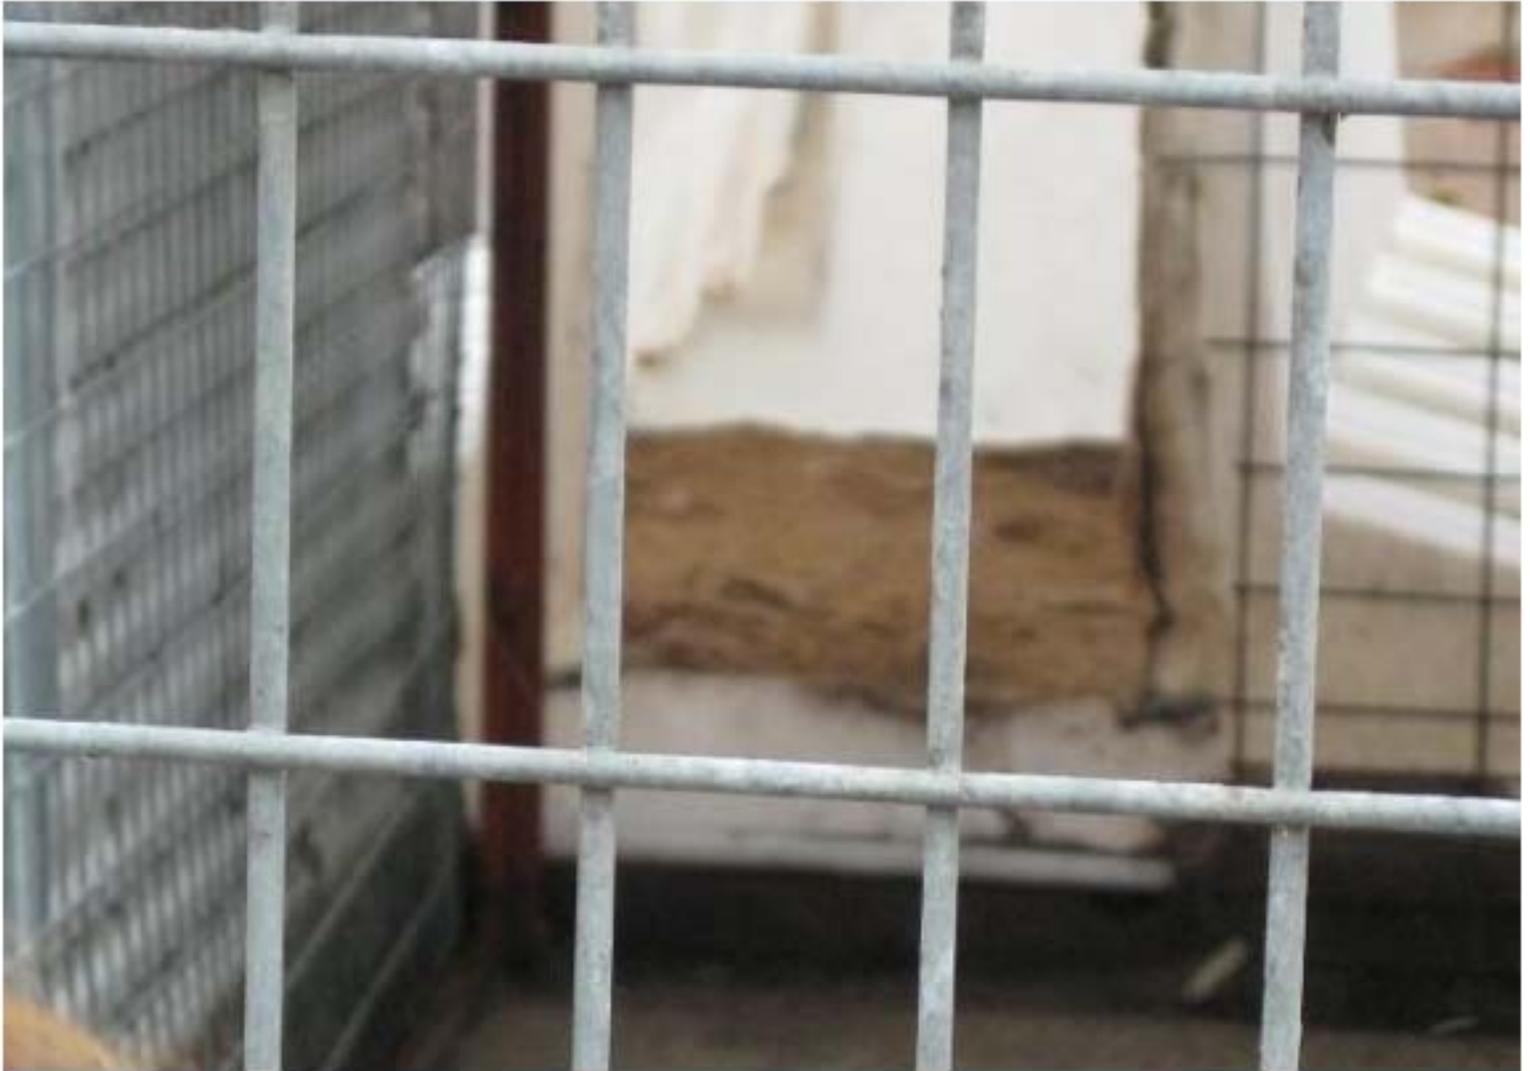
CFR: 3.1 (c) (2)

Photographer:	Randall Wagner (ACI)	Legal Name:	Registration:	42-A-1253
Photo Taken:	Thu, Sep 23, '10	DAVE RUTER		
Inspection:	280100021210681			
Description:	The wood flooring for the outdoor dog house is worn and soiled. Also, the wood is retaining moisture or has wet appearance.

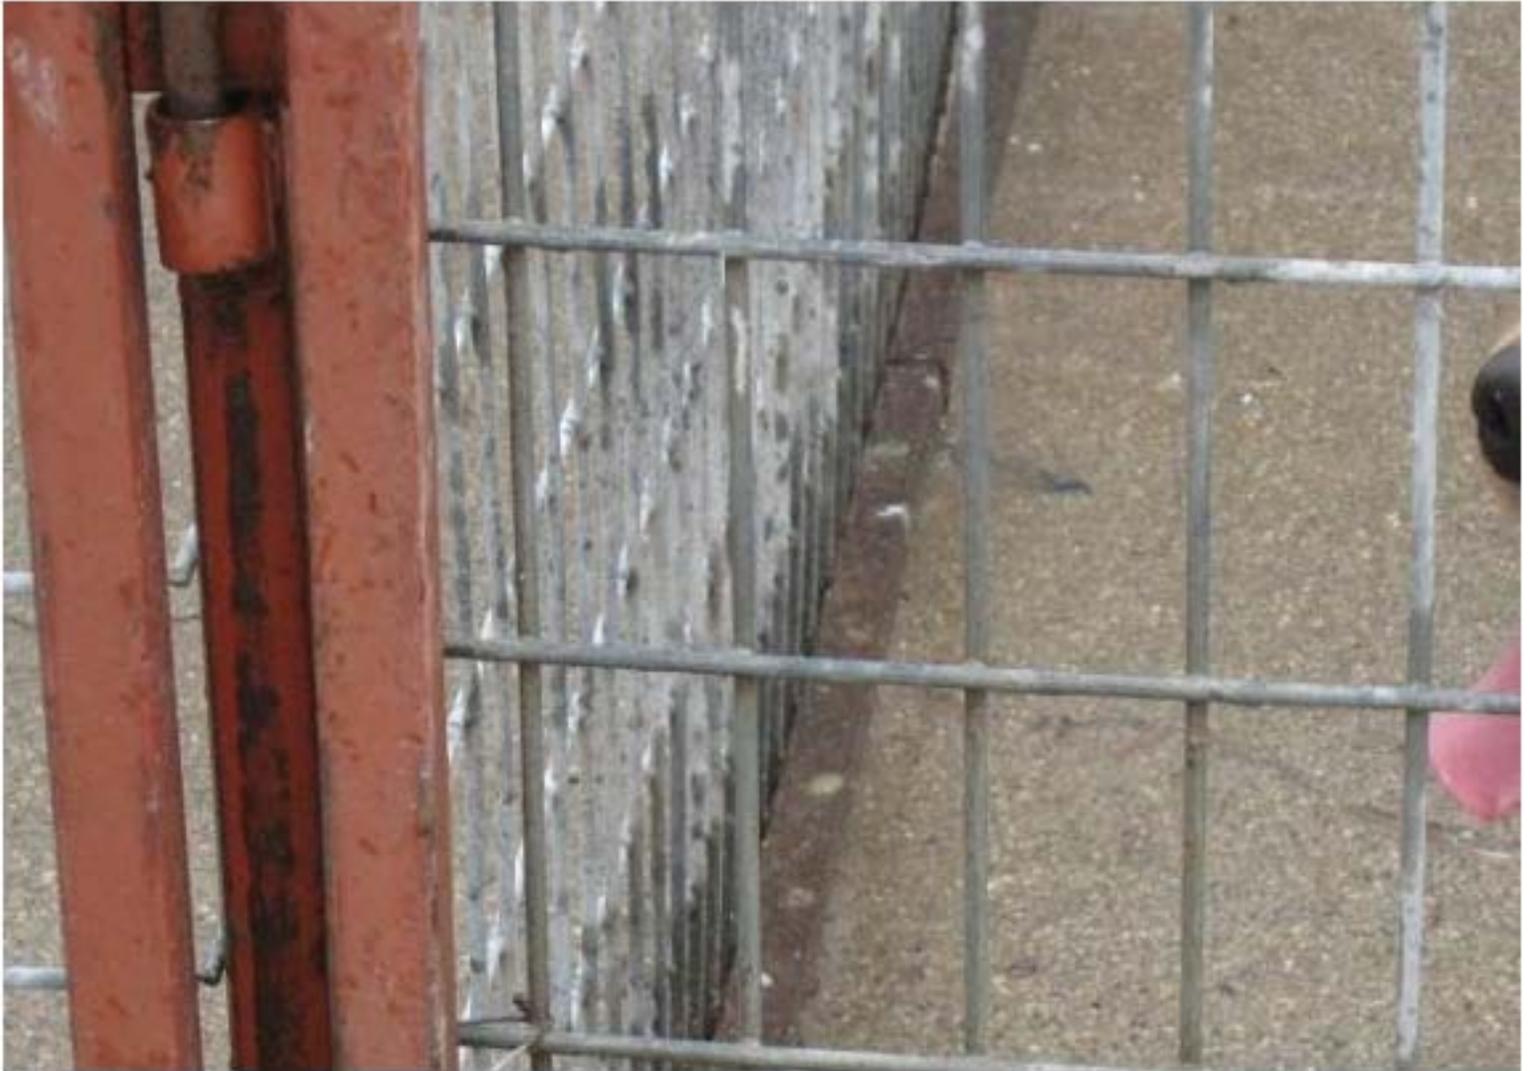
CFR: 3.4 (b) (3)

Photographer:	Randall Wagner (ACI)	Legal Name:	Registration:	42-A-1253
Photo Taken:	Thu, Sep 23, '10	DAVE RUTER		
Inspection:	280100021210681			
Description:	The outdoor dog house does not have protection from the elements.
