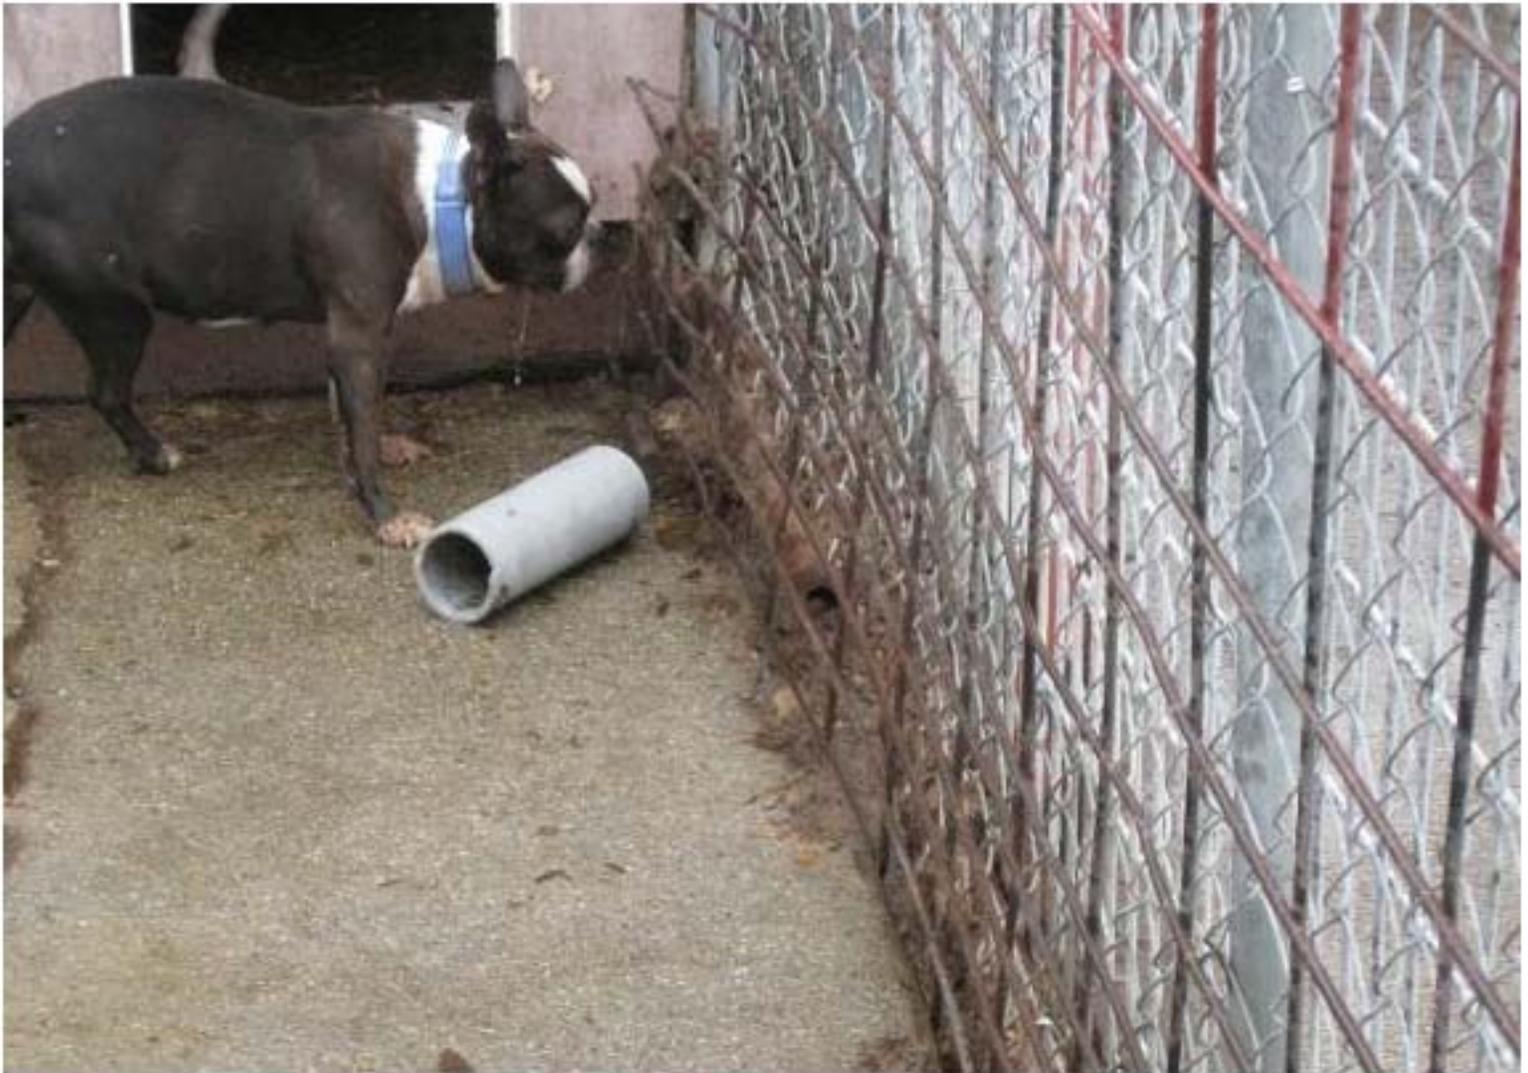
CFR: 3.1 (c) (1) (i)

Photographer:	Randall Wagner (ACI)	Legal Name:	Registration:	42-A-1253
Photo Taken:	Thu, Sep 23, '10	DAVE RUTER		
Inspection:	280100021210681			
Description:	The bottom metal bar for the framing is excessively rusty and flaking at the surface.

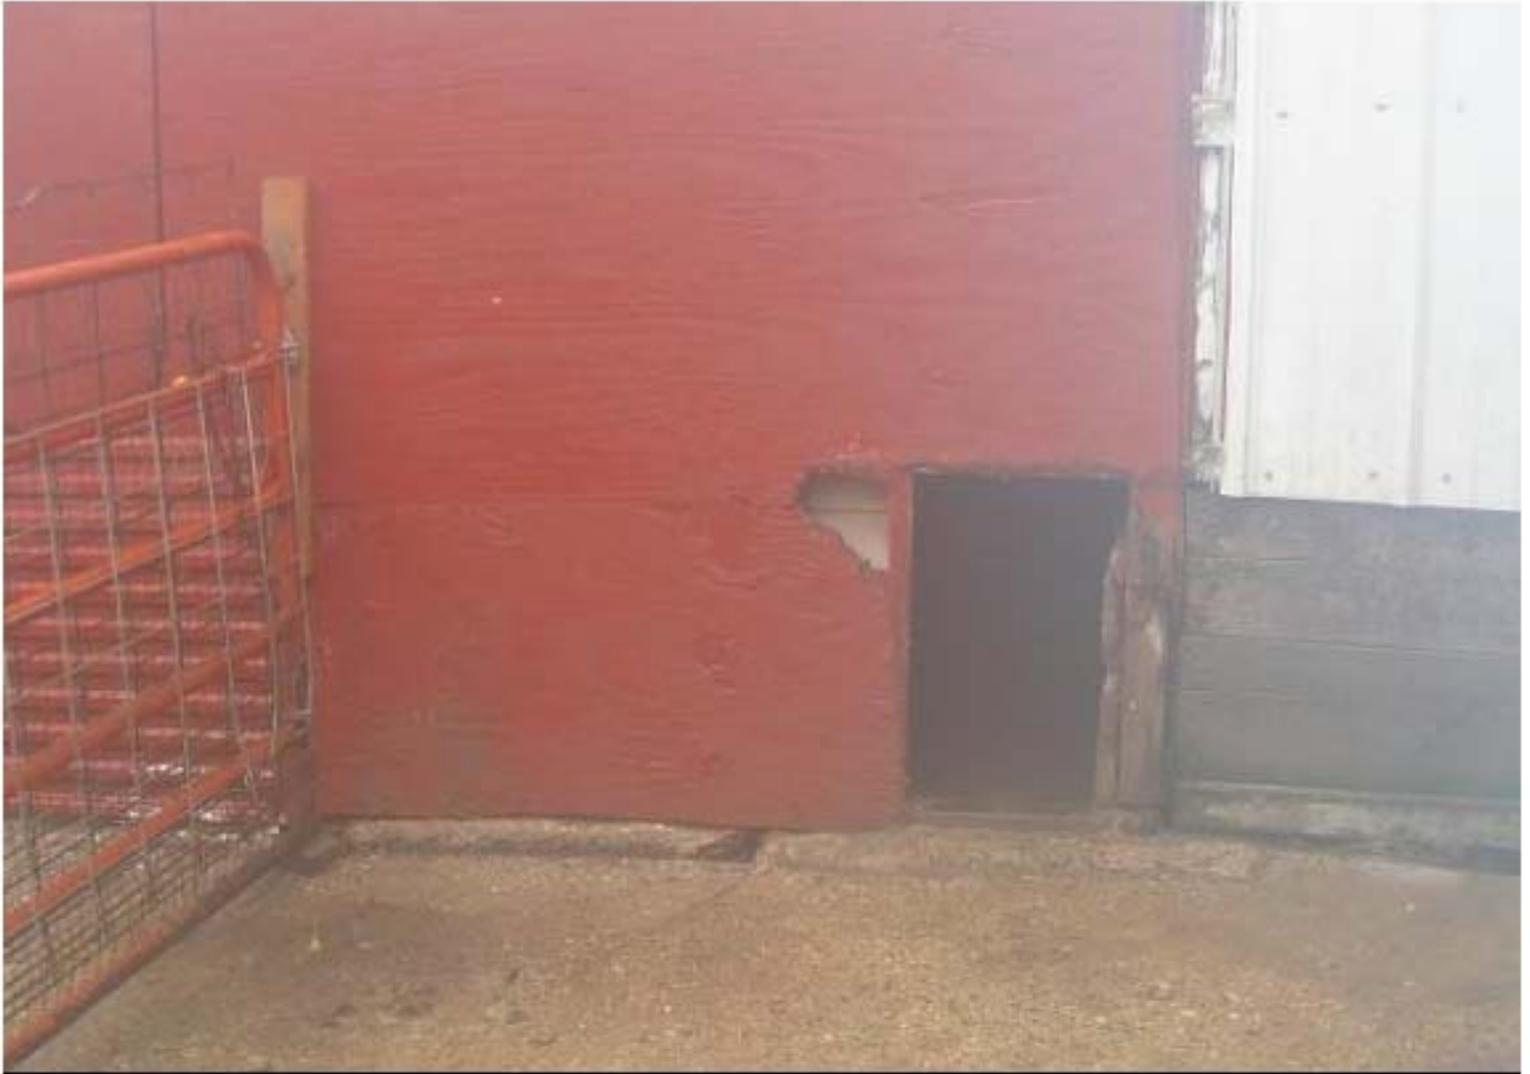
CFR: 3.1 (c) (1) (i)

Photographer:	Randall Wagner (ACI)	Legal Name:	Registration:	42-A-1253
Photo Taken:	Thu, Sep 23, '10	DAVE RUTER		
Inspection:	280100021210681			
Description:	The bottom part of the metal panel, which is excessively rusty and flaking at the metal surface.

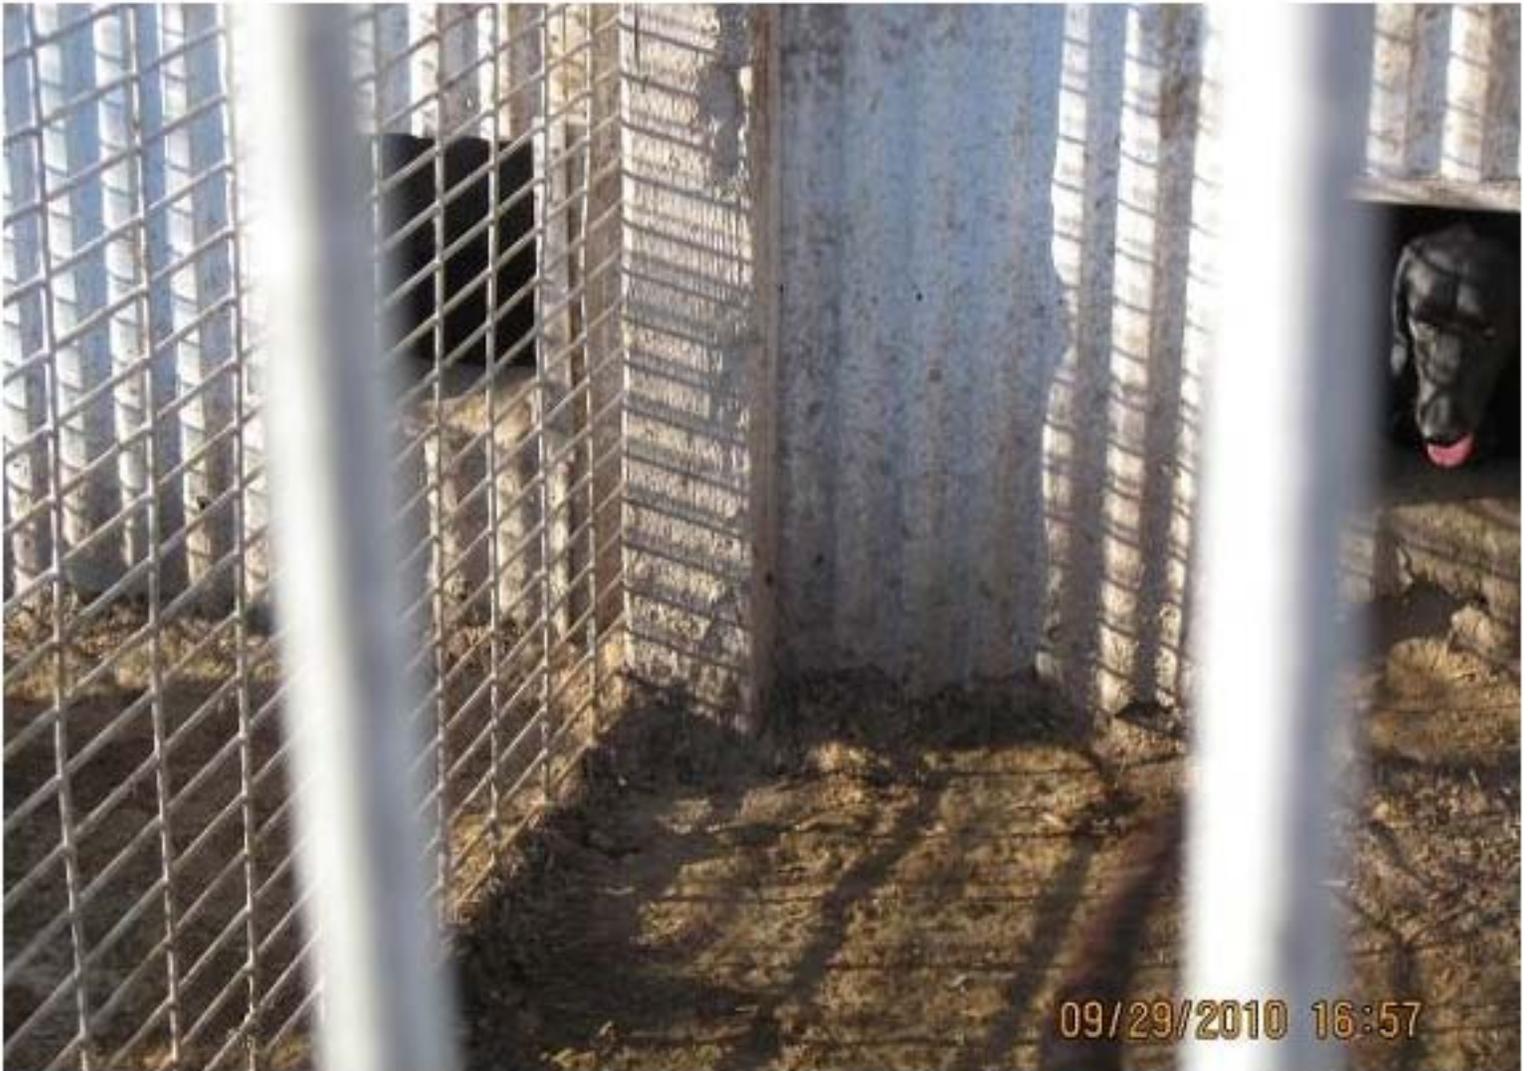
Photographer:	Randall Wagner (ACI)	Legal Name:	Registration:	42-A-1251
Photo Taken:	Wed, Sep 29, '10	DEAN DEKKERS		
Inspection:	272101837410831			
Description:	The tin surface at the bottom of the shed is rusted away and exposes bare wood surface or gaps for fecal waste to get into.

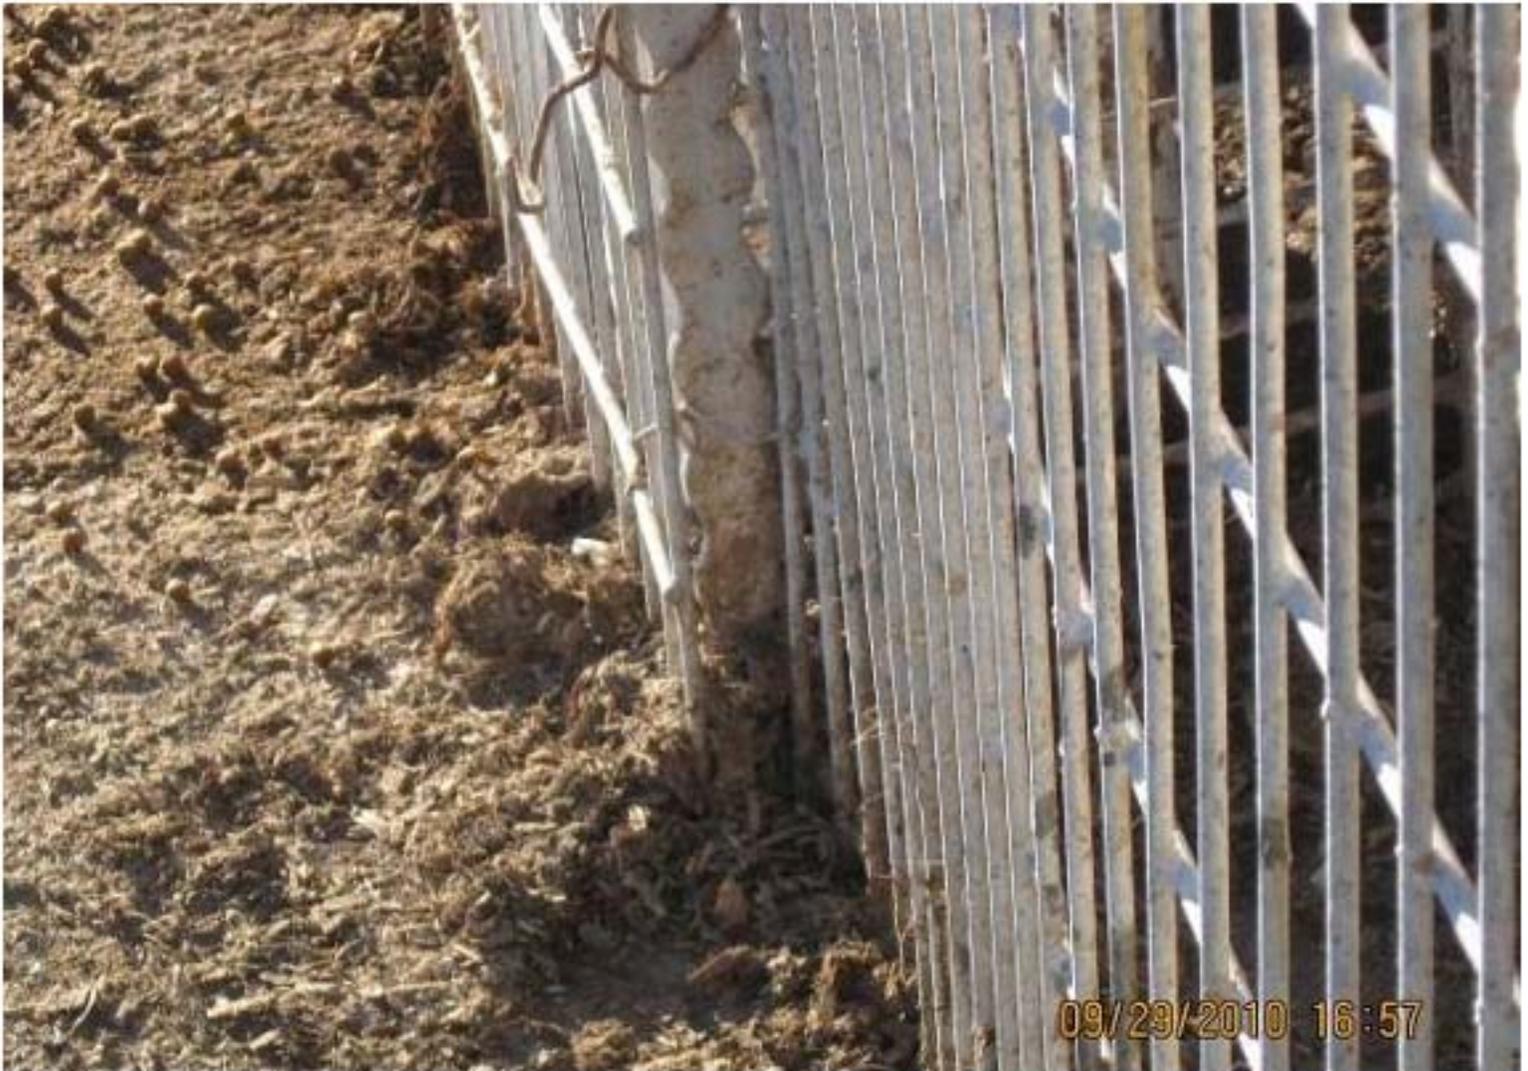
CFR: 3.1 (c) (2)

Photographer:	Randall Wagner (ACI)	Legal Name:	Registration:	42-A-1251
Photo Taken:	Wed, Sep 29, '10	DEAN DEKKERS		
Inspection:	272101837410831			
Description:	The tin is rusted away for back wall allowing for the plywood under neath to get soiled and gaps to harbor fecal waste.

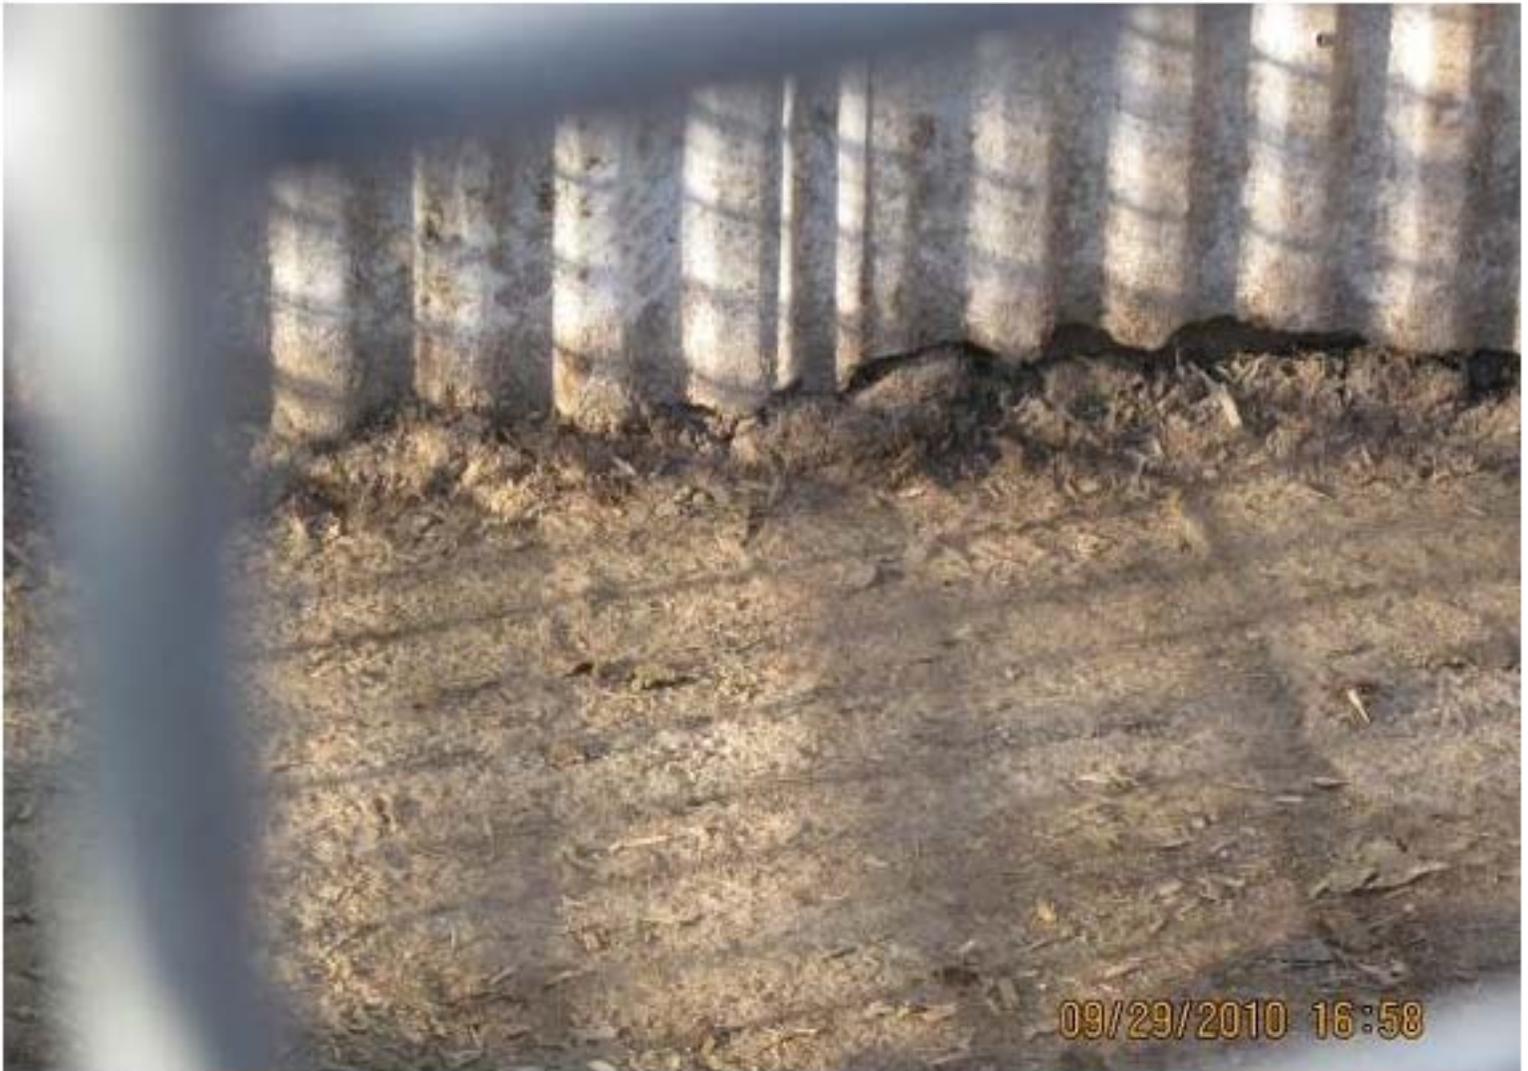
CFR: 3.1 (c) (2)

Photographer:	Randall Wagner (ACI)	Legal Name:	Registration:	42-A-1251
Photo Taken:	Wed, Sep 29, '10	DEAN DEKKERS		
Inspection:	272101837410831			
Description:	The tin wall is rusty at the bottom and the surface is worn indicates the surface is not being maintained.

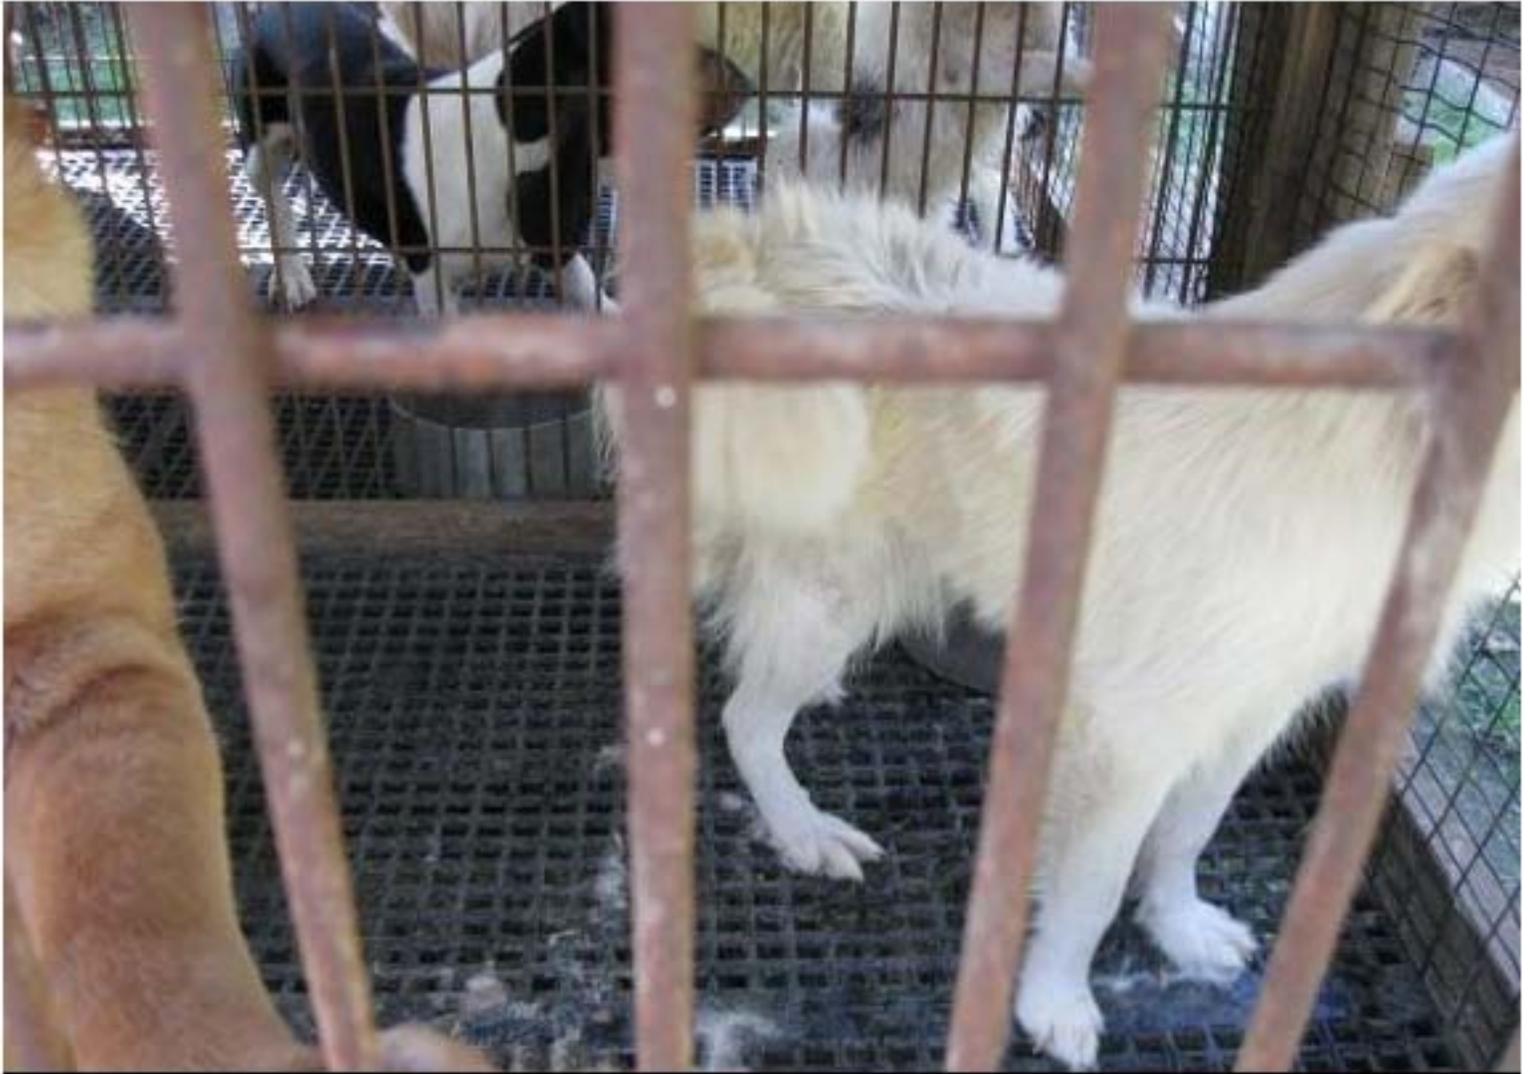
CFR: 3.1 (c) (1) (i)

Photographer:	John J. Lies, ACI	Legal Name:	Registration:	42-A-1238
Photo Taken:	Wed, Aug 25, '10 P.M.	CATHY SPEER		
Inspection:	238101248530491			
Description:	3.1 (c)(1)(i) Housing facilities General Surfaces with excessive rust that prevents proper cleaning and/or affects structural strength.

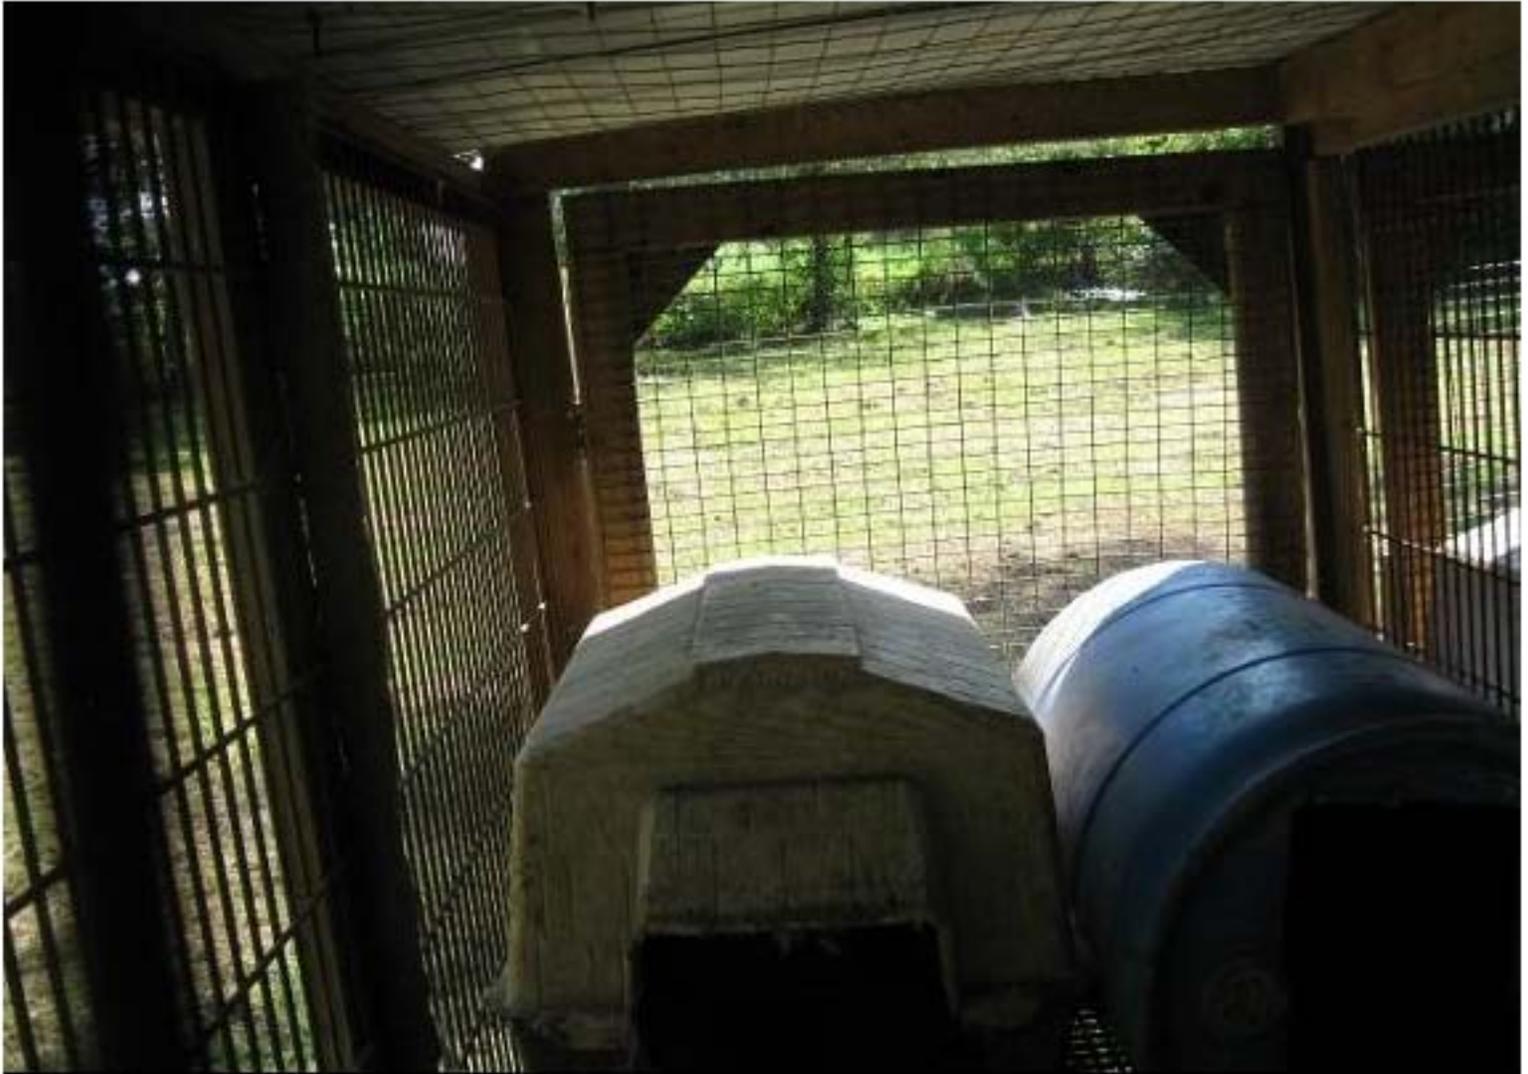
CFR: 3.1 (c) (1) (i)

Photographer:	John J. Lies, ACI	Legal Name:	Registration:	42-A-1238
Photo Taken:	Wed, Aug 25, '10 P.M.	CATHY SPEER		
Inspection:	238101248530491			
Description:	3.1 (c)(1)(i): Housing Facilities General Surfaces: Rust that prevents proper cleaning or affects structural strength.

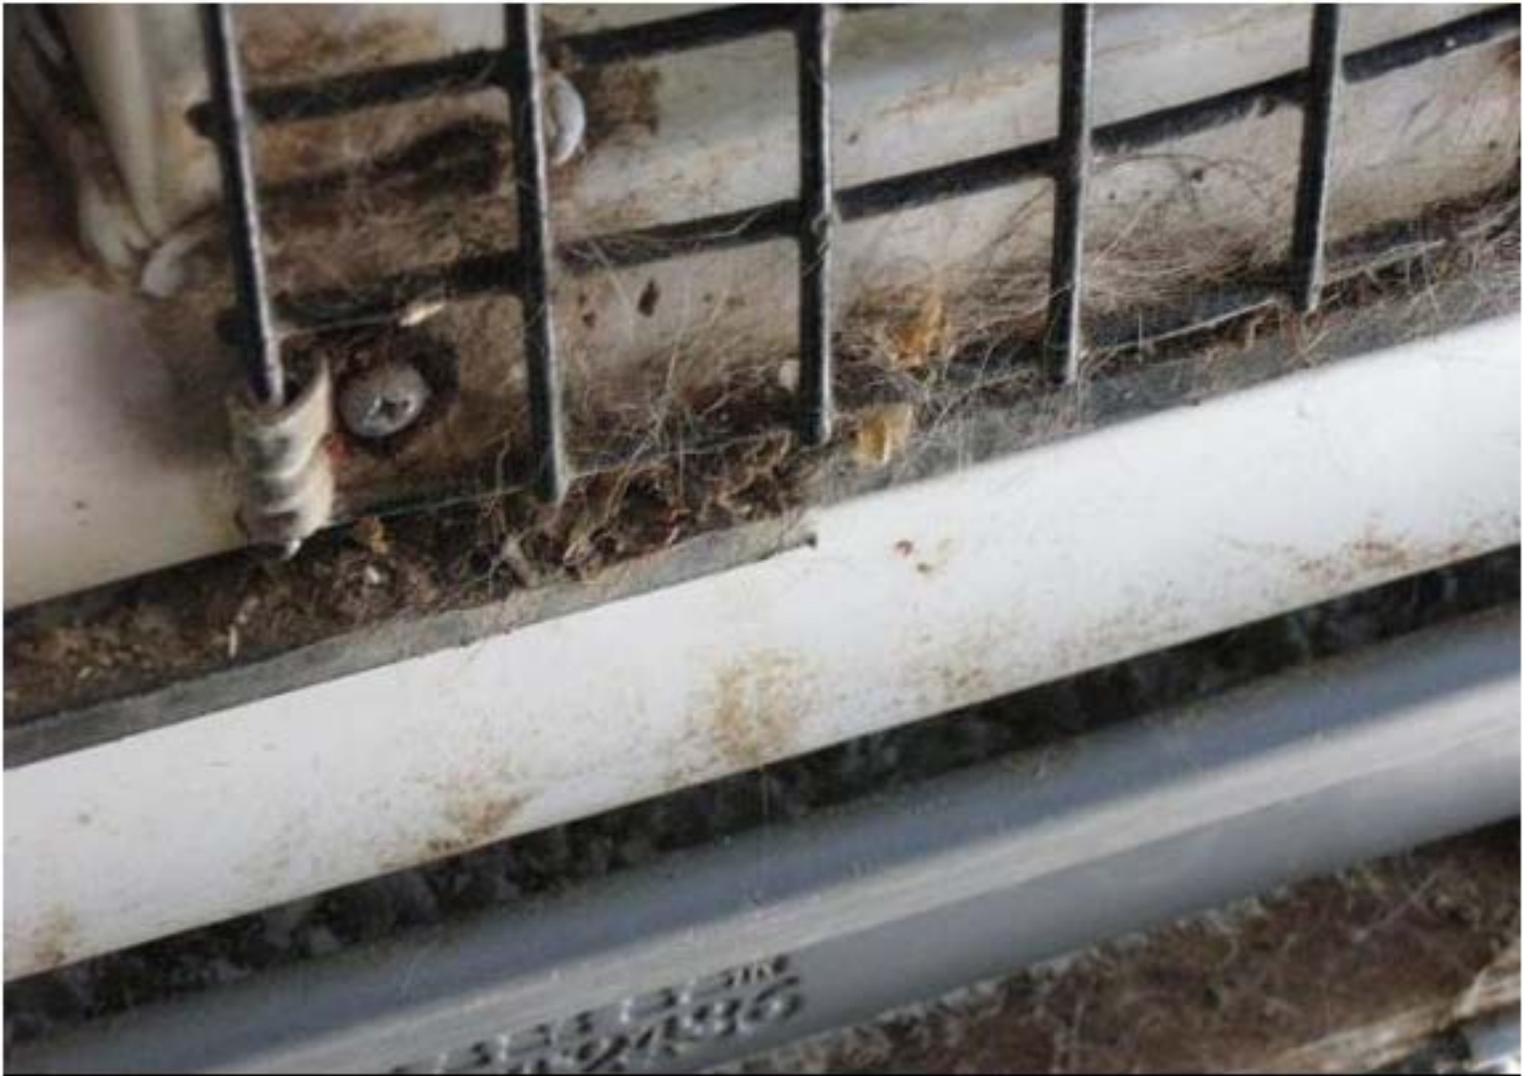
CFR: 3.1 (c) (1) (i)

Photographer:	John J. Lies, ACI	Legal Name:	Registration:	42-A-1238
Photo Taken:	Wed, Aug 25, '10 P.M.	CATHY SPEER		
Inspection:	238101248530491			
Description:	3.1 (c)(1)(i): Housing Facilities General Surfaces: Rust that prevents proper cleaning or affects structural strength.

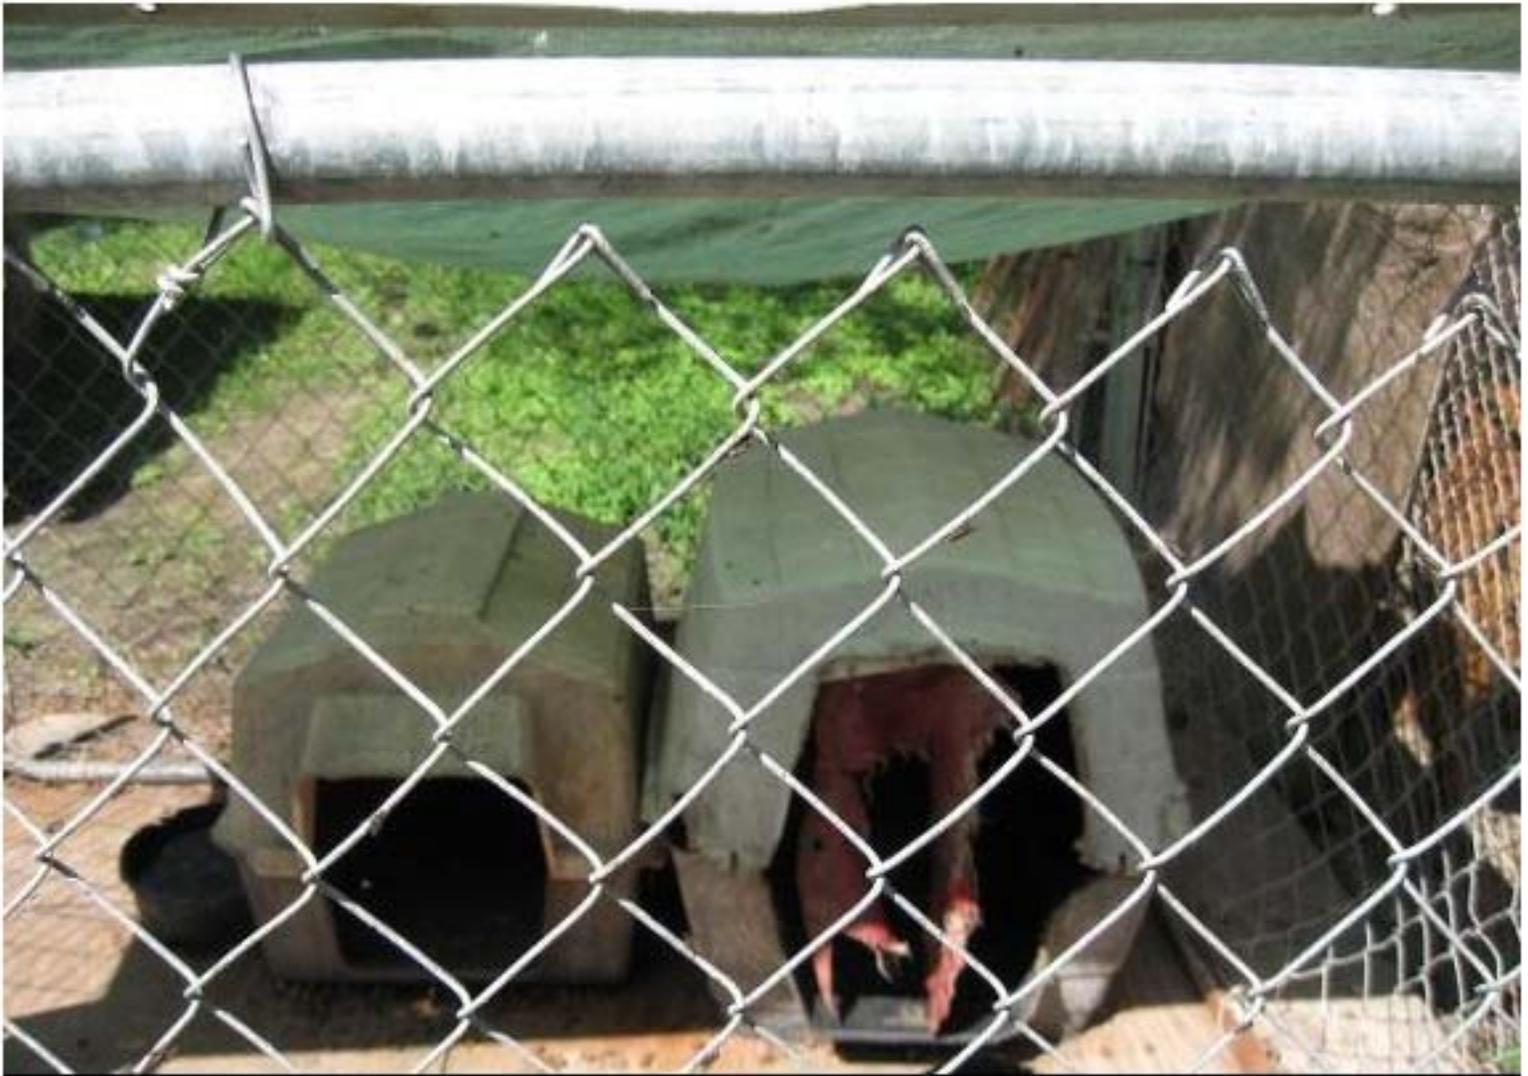
CFR: 3.1 (c) (1) (i)

Photographer:	John J. Lies, ACI	Legal Name:	Registration:	42-A-1238
Photo Taken:	Wed, Aug 25, '10 P.M.	CATHY SPEER		
Inspection:	238101248530491			
Description:	3.1 (c)(1)(i) Housing facilities General Surfaces with excessive rust that prevents proper cleaning and/or affects structural strength.

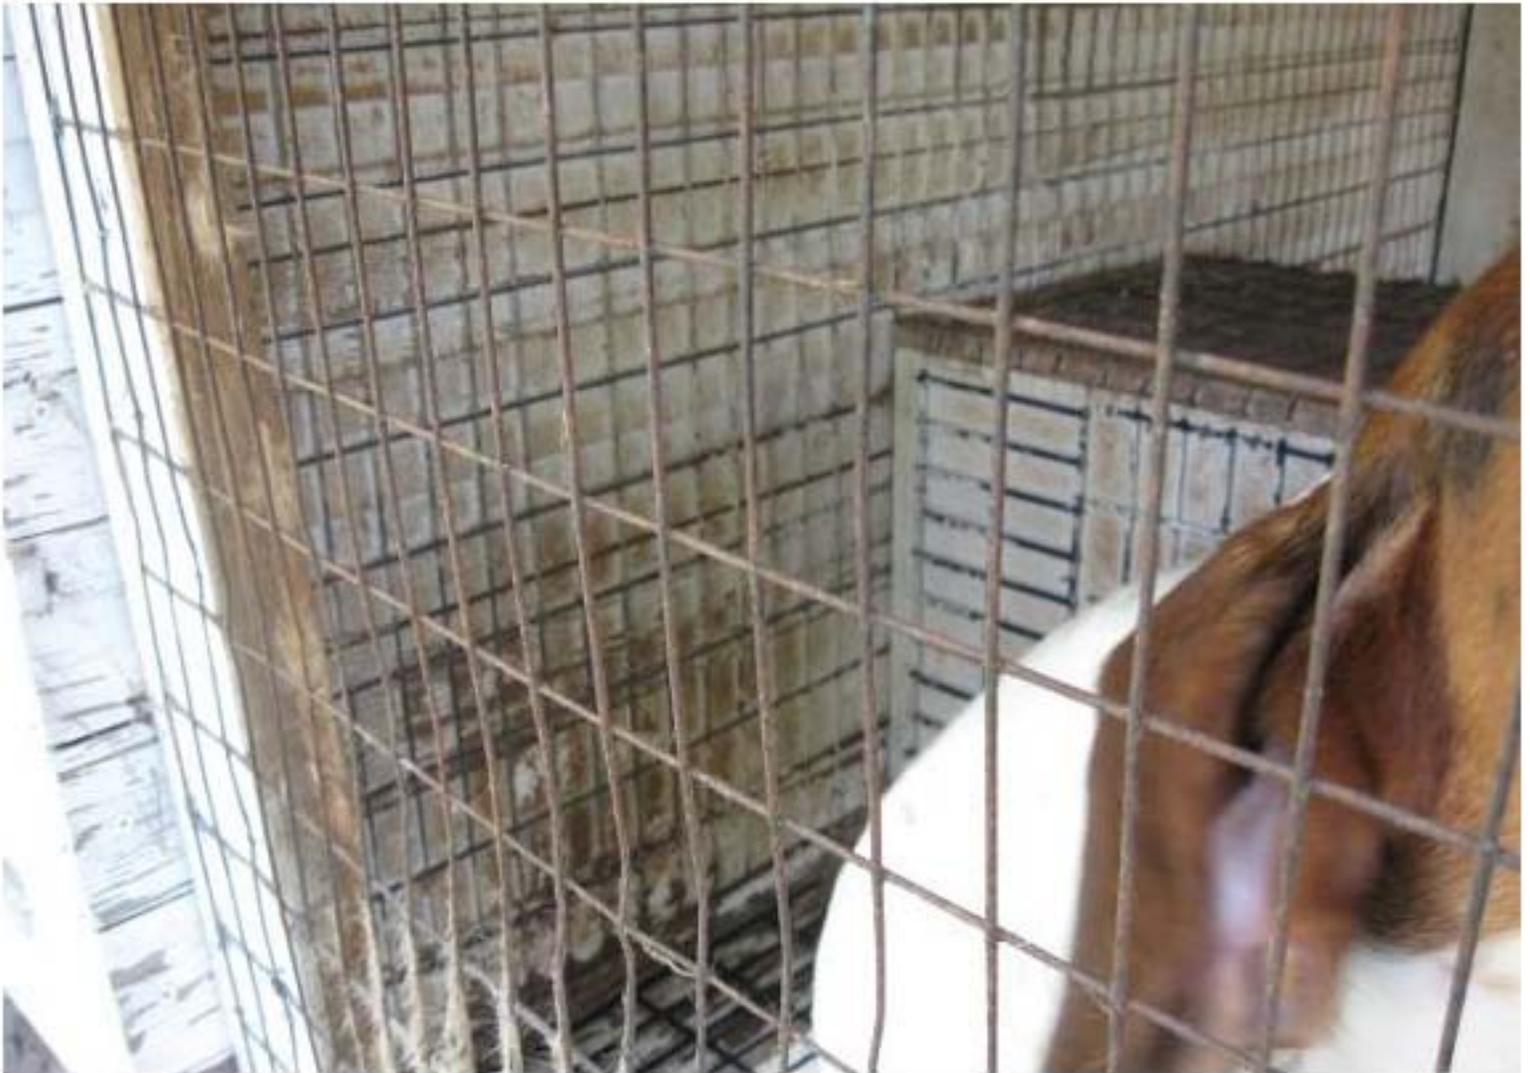
CFR: 3.1 (c) (1) (i), 3.1 (c) (1) (ii)

Photographer:	John J. Lies, ACI	Legal Name:	Registration:	42-A-1238
Photo Taken:	Wed, Aug 25, '10 P.M.	CATHY SPEER		
Inspection:	238101248530491			
Description:	3.1 (c)(1)(i) Housing facilities General Surfaces with excessive rust that prevents proper cleaning and/or affects structural strength.

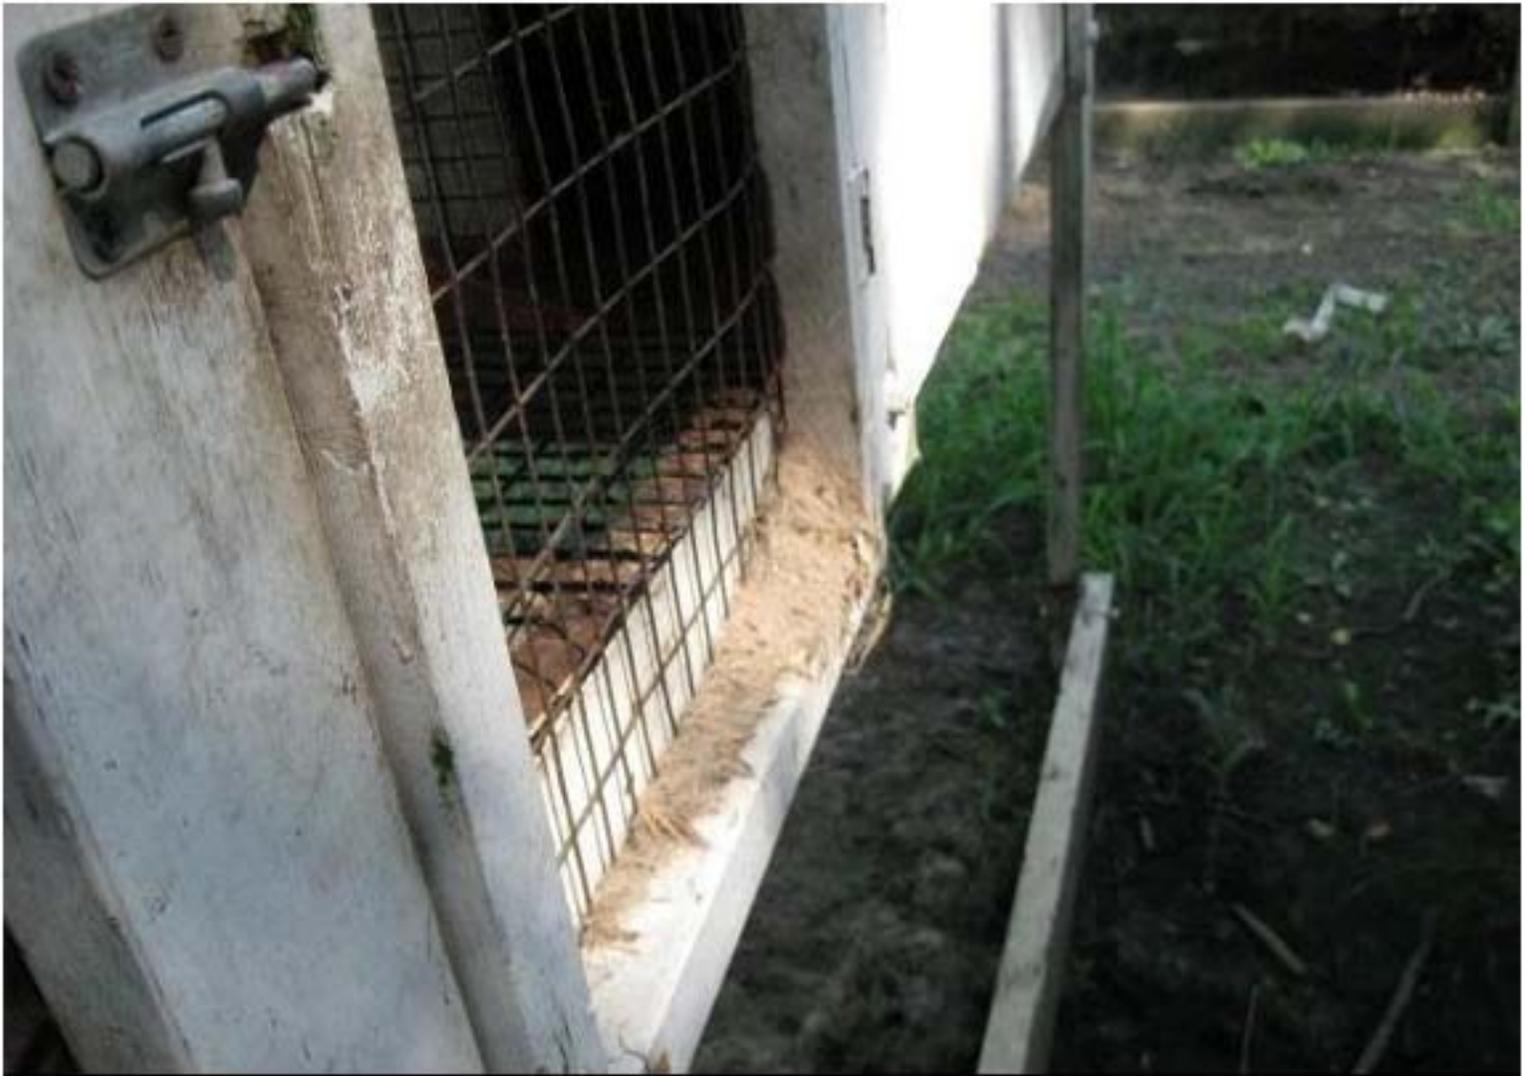
CFR: 3.1 (c) (1) (i)

Photographer:	John J. Lies, ACI	Legal Name:	Registration:	42-A-1238
Photo Taken:	Wed, Aug 25, '10 P.M.	CATHY SPEER		
Inspection:	238101248530491			
Description:	3.1 (c)(1)(i): Housing Facilities General Surfaces: Rust that prevents proper cleaning or affects structural strength.

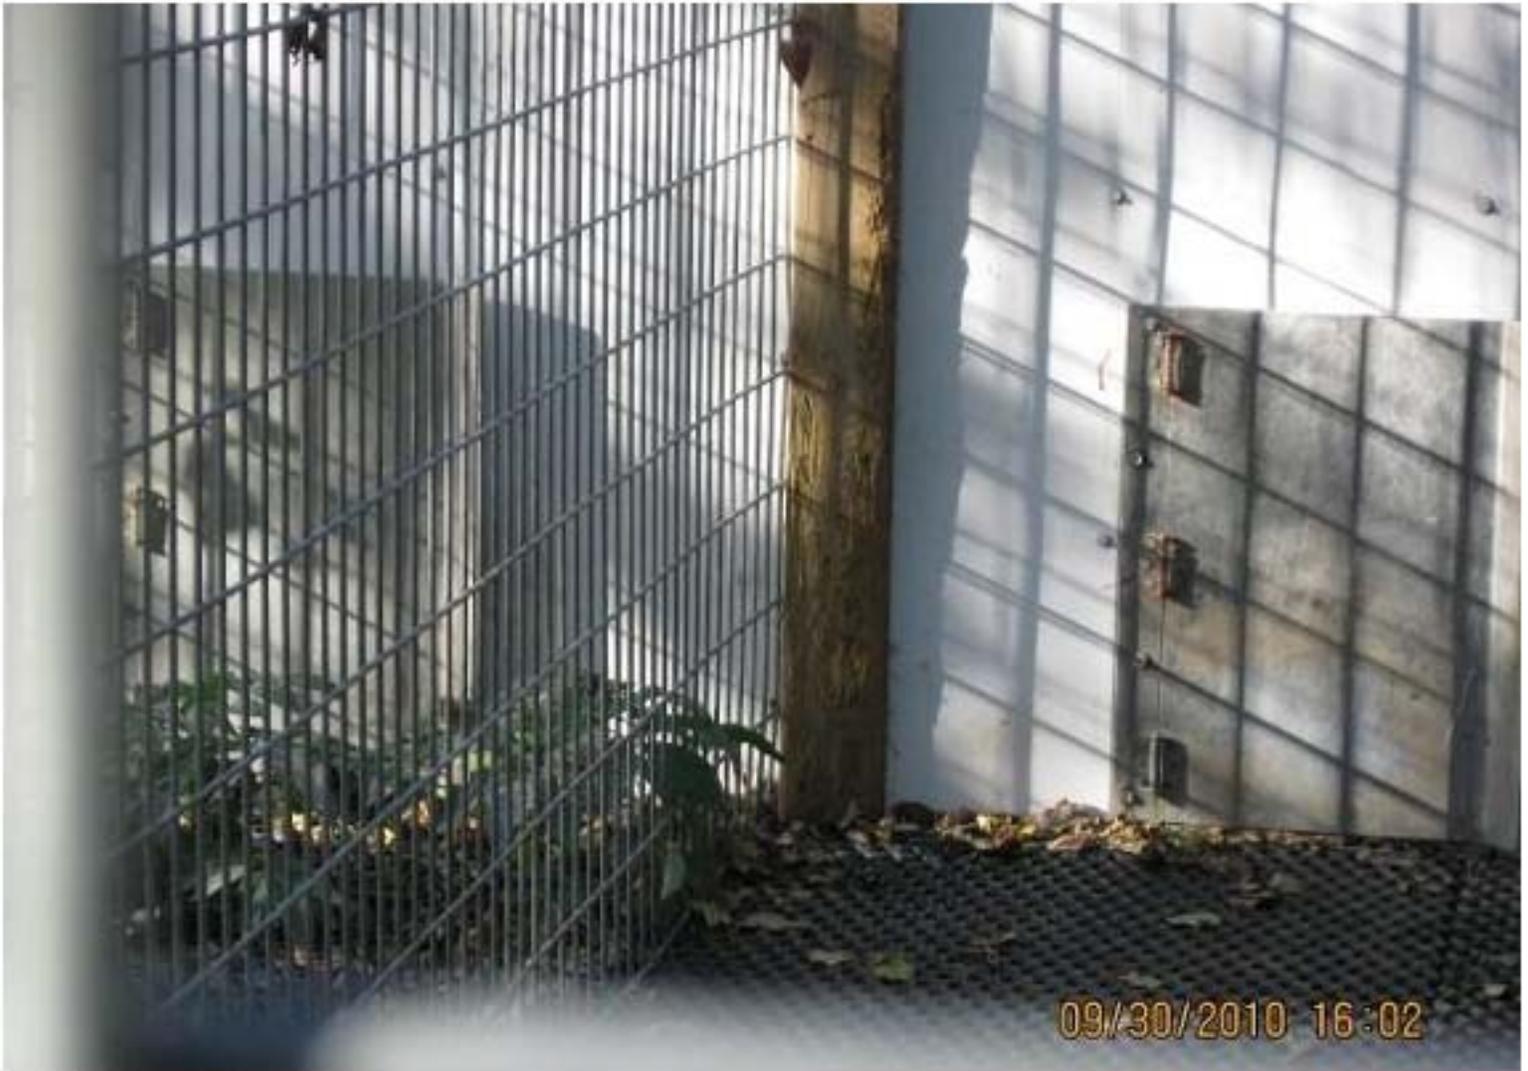
CFR: 3.1 (c) (1) (i)

Photographer:	Randall Wagner (ACI)	Legal Name:	Registration:	42-A-1200
Photo Taken:	Wed, Sep 29, '10	ILIEN YMKER		
Inspection:	272101655460937			
Description:	The metal pipe framing for the dividers has excessive rust and pitting on the metal surface.

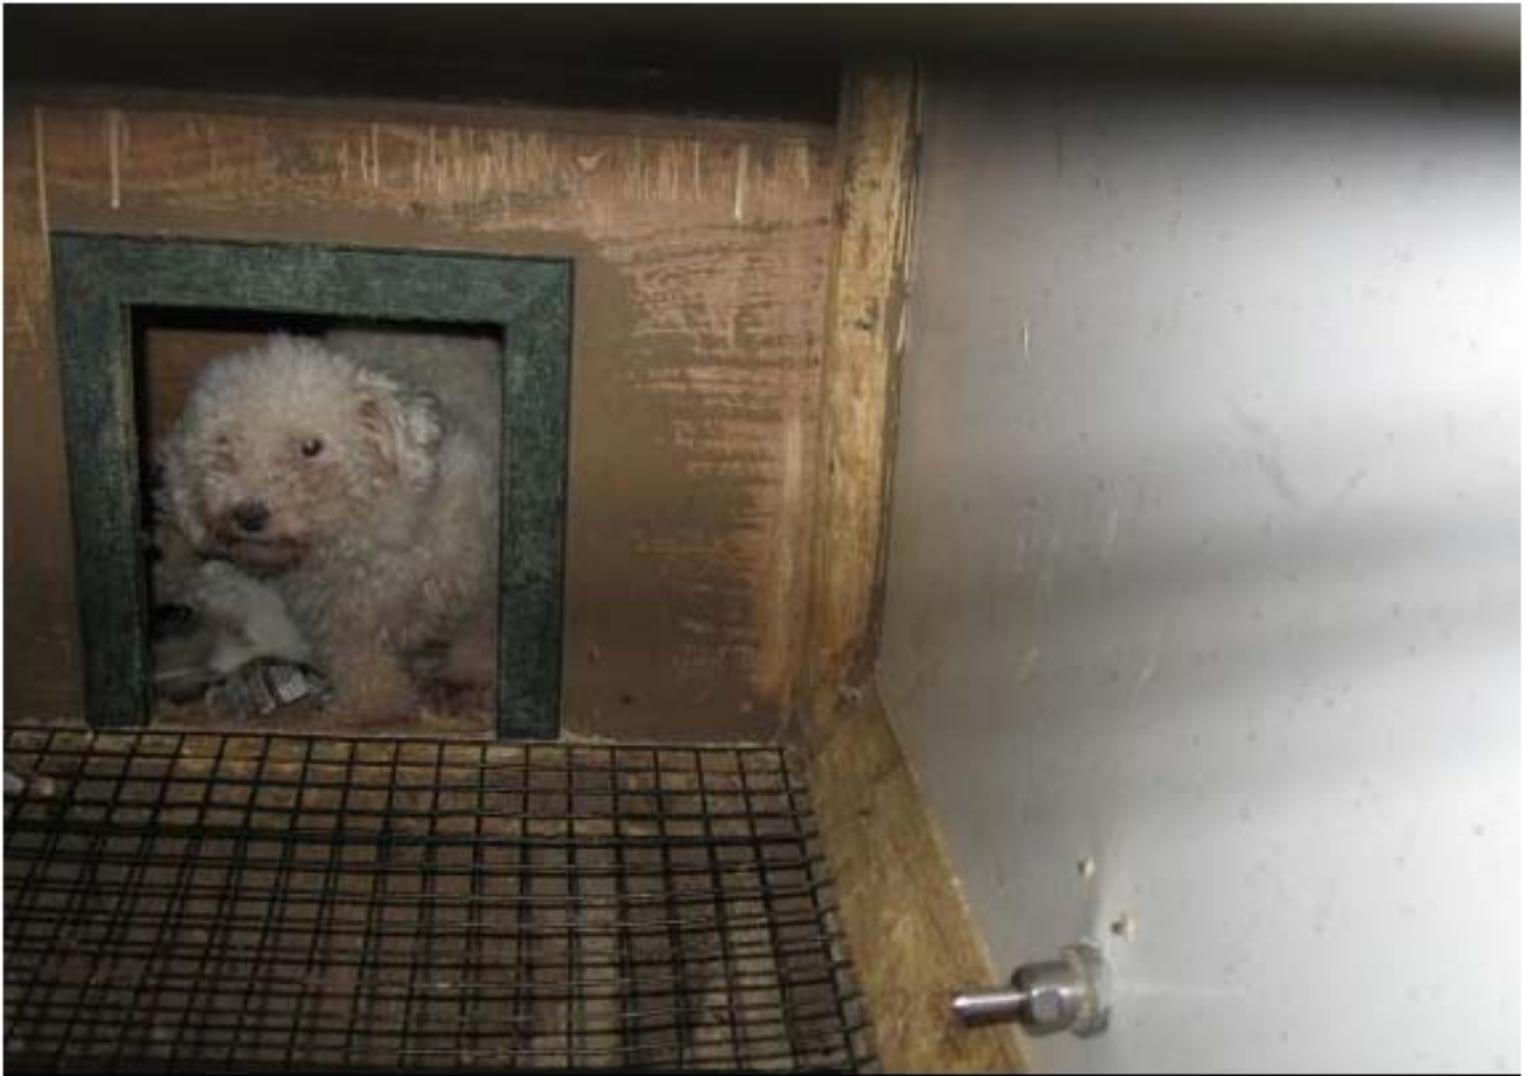
CFR: 3.3 (e) (1)

Photographer:	AnnMarie Houser	Legal Name:	Registration:	42-A-1156
Photo Taken:	Tue, Sep 28, '10	aproximately 1545	Lawrence Nolt	
Inspection:	344101014100854			
Description:	Wooden surfaces are no longer impervious to moisture.
