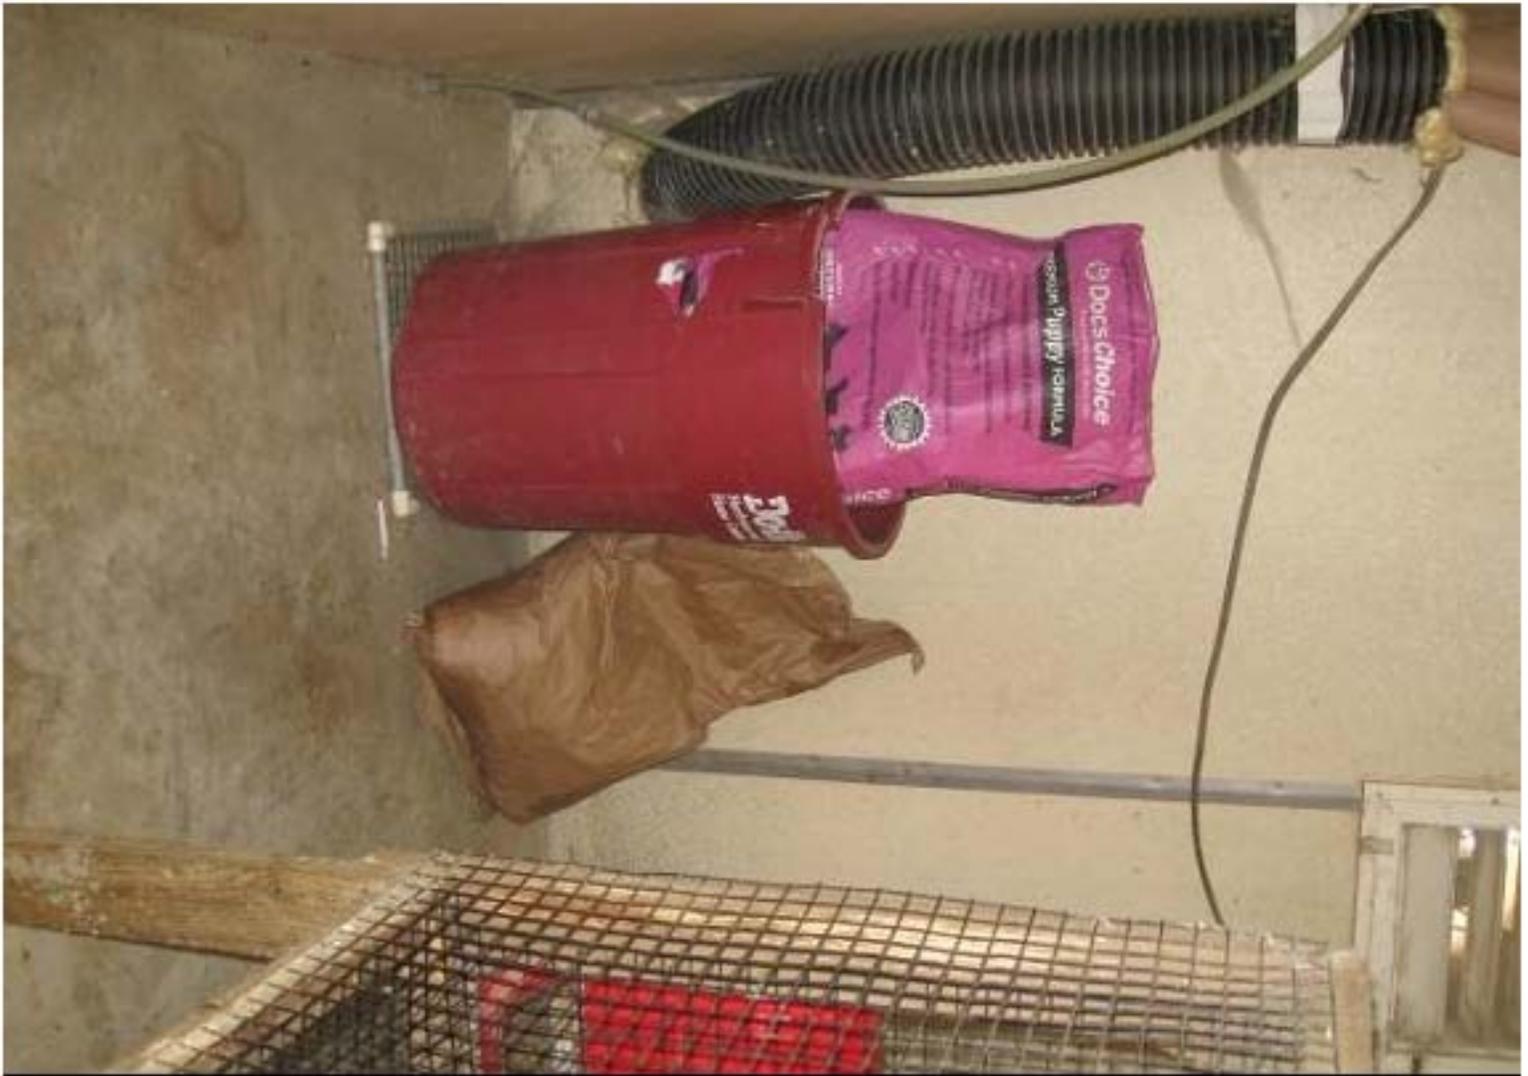
CFR: 3.3 (e) (1)

Photographer:	AnnMarie Houser	Legal Name:	Registration:	42-A-1156
Photo Taken:	Tue, Sep 28, '10	aproximately 1545	Lawrence Nolt	
Inspection:	344101014100854			
Description:	Wooden surfaces are no longer impervious to moisture.

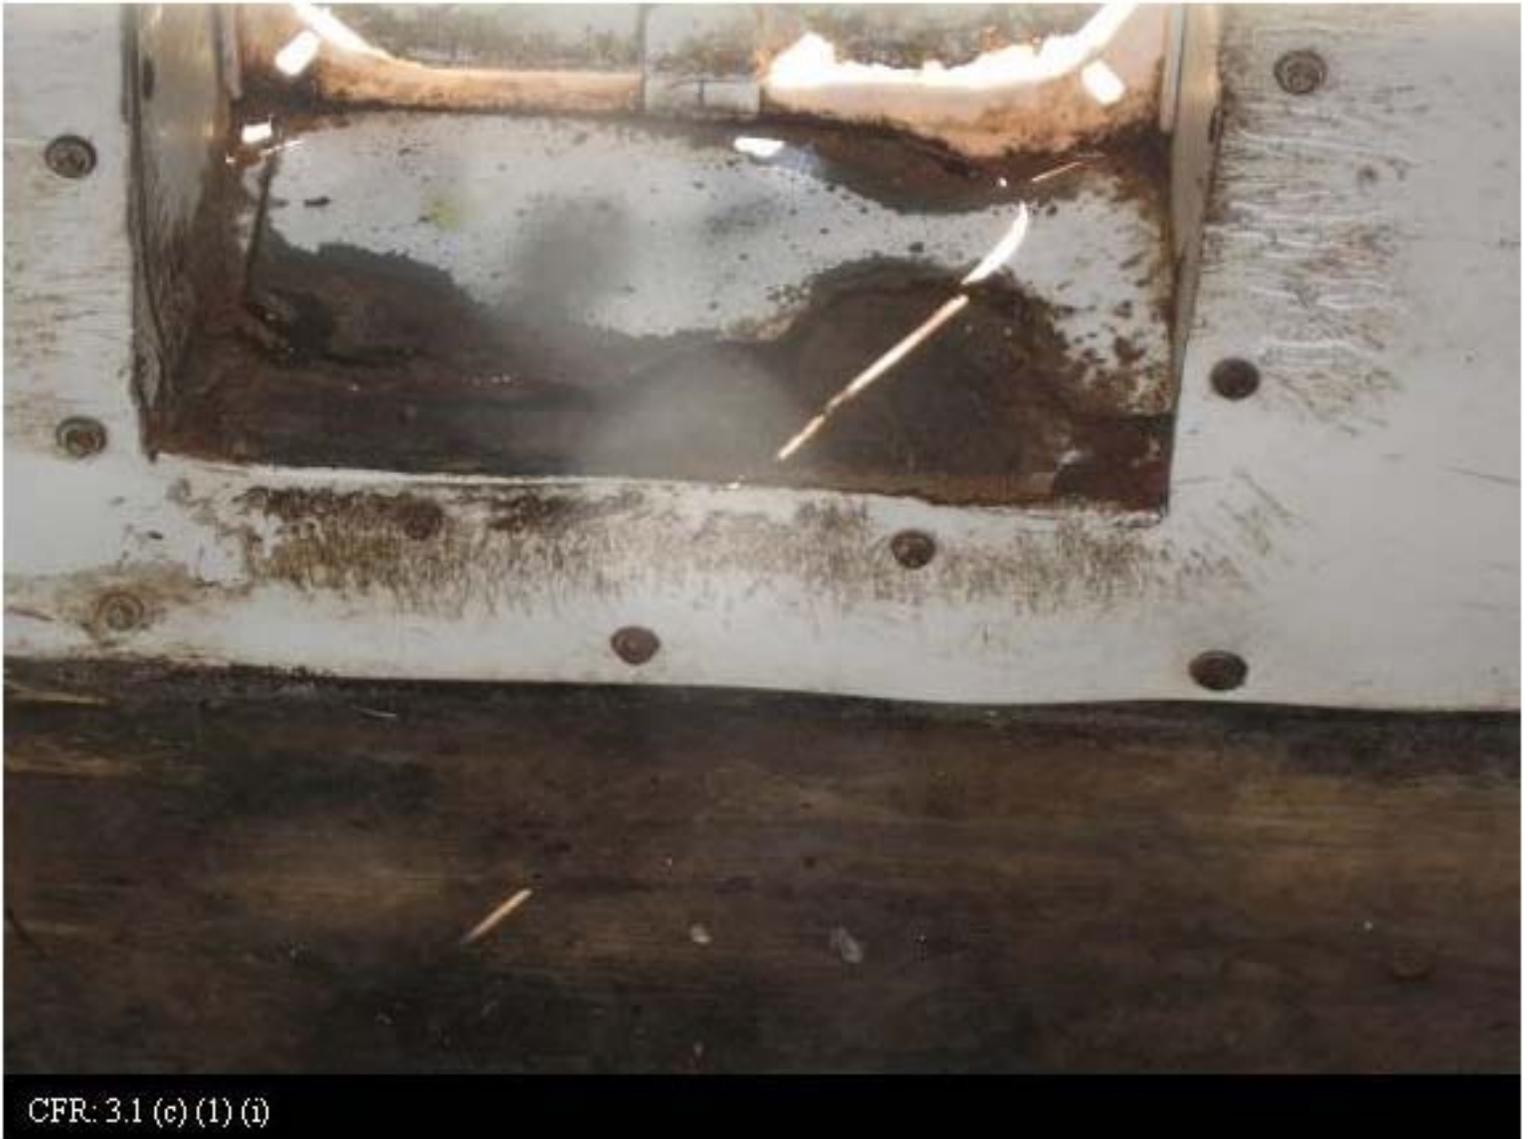
CFR: 3.1 (c) (1) (i)

Photographer:	Randall Wagner (ACI)	Legal Name:	Registration:	42-A-1099
Photo Taken:	Tue, Sep 21, '10	DONALD MINTEN		
Inspection:	264101525000667			
Description:	The tin surface is rusting/flaking excessively and affecting the surface strength or rusting away.

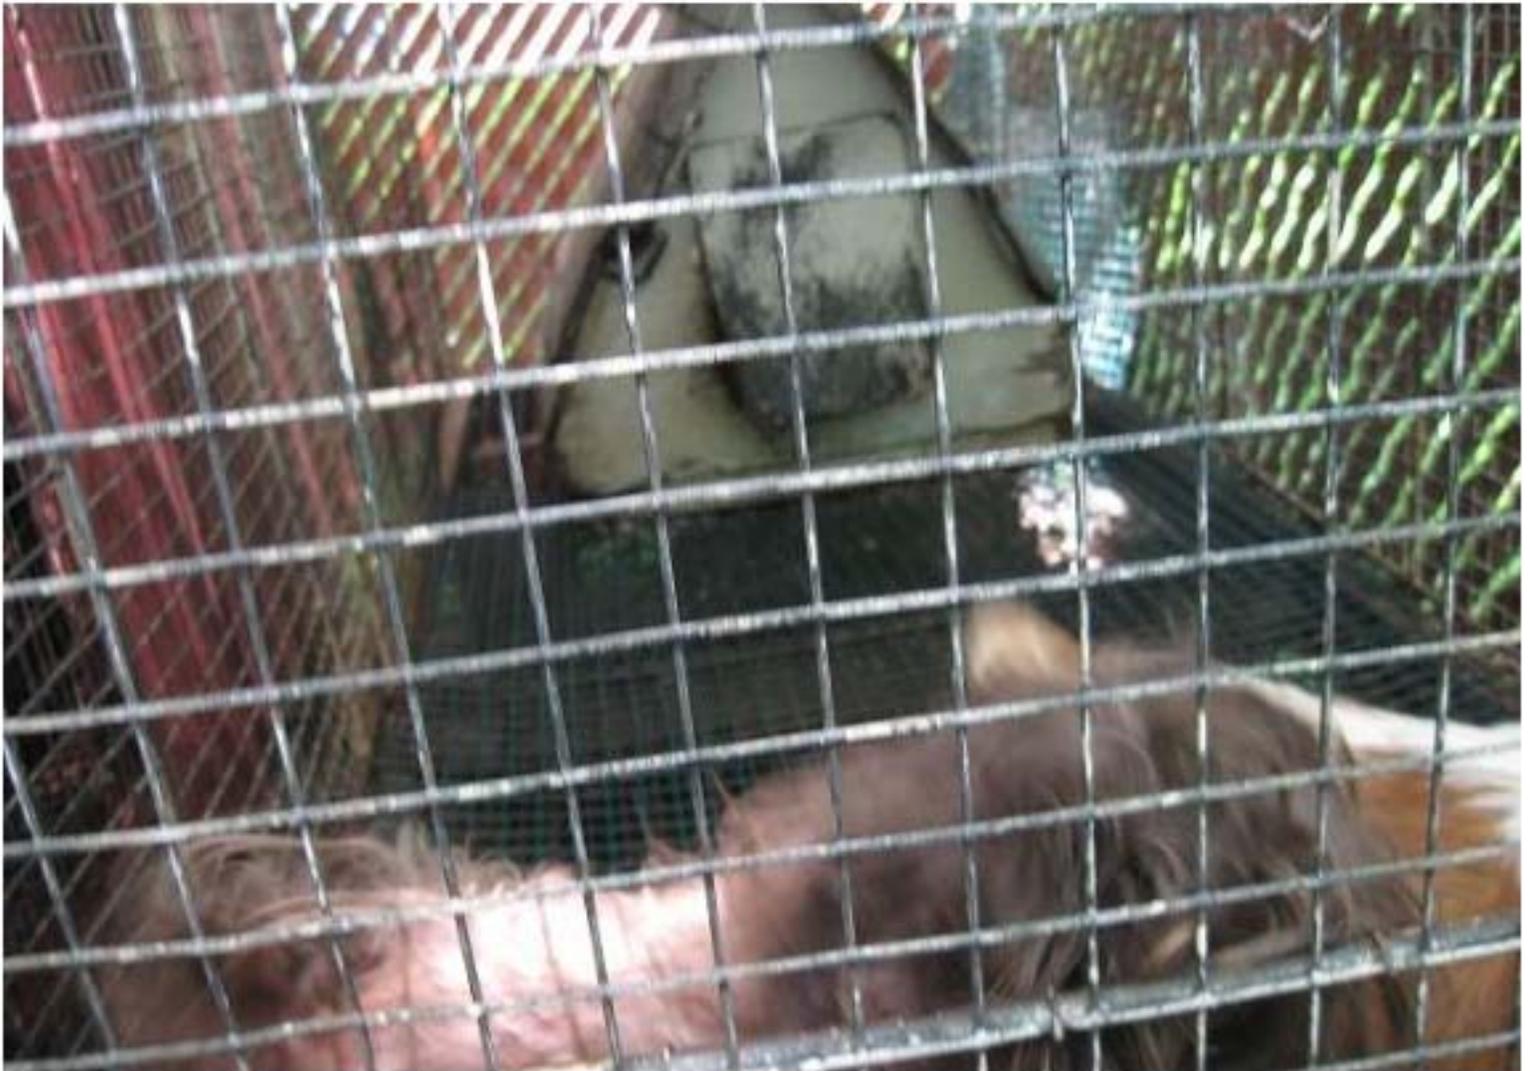
Photographer:	Randall Wagner (ACI)	Legal Name:	Registration:	42-A-1026
Photo Taken:	Thu, Sep 23, '10	GENE HOOGENDOORN HILDA HOOGENDOORN		
Inspection:	279102330050899			
Description:	The metal pipe framing is excessively rusting and pitting.

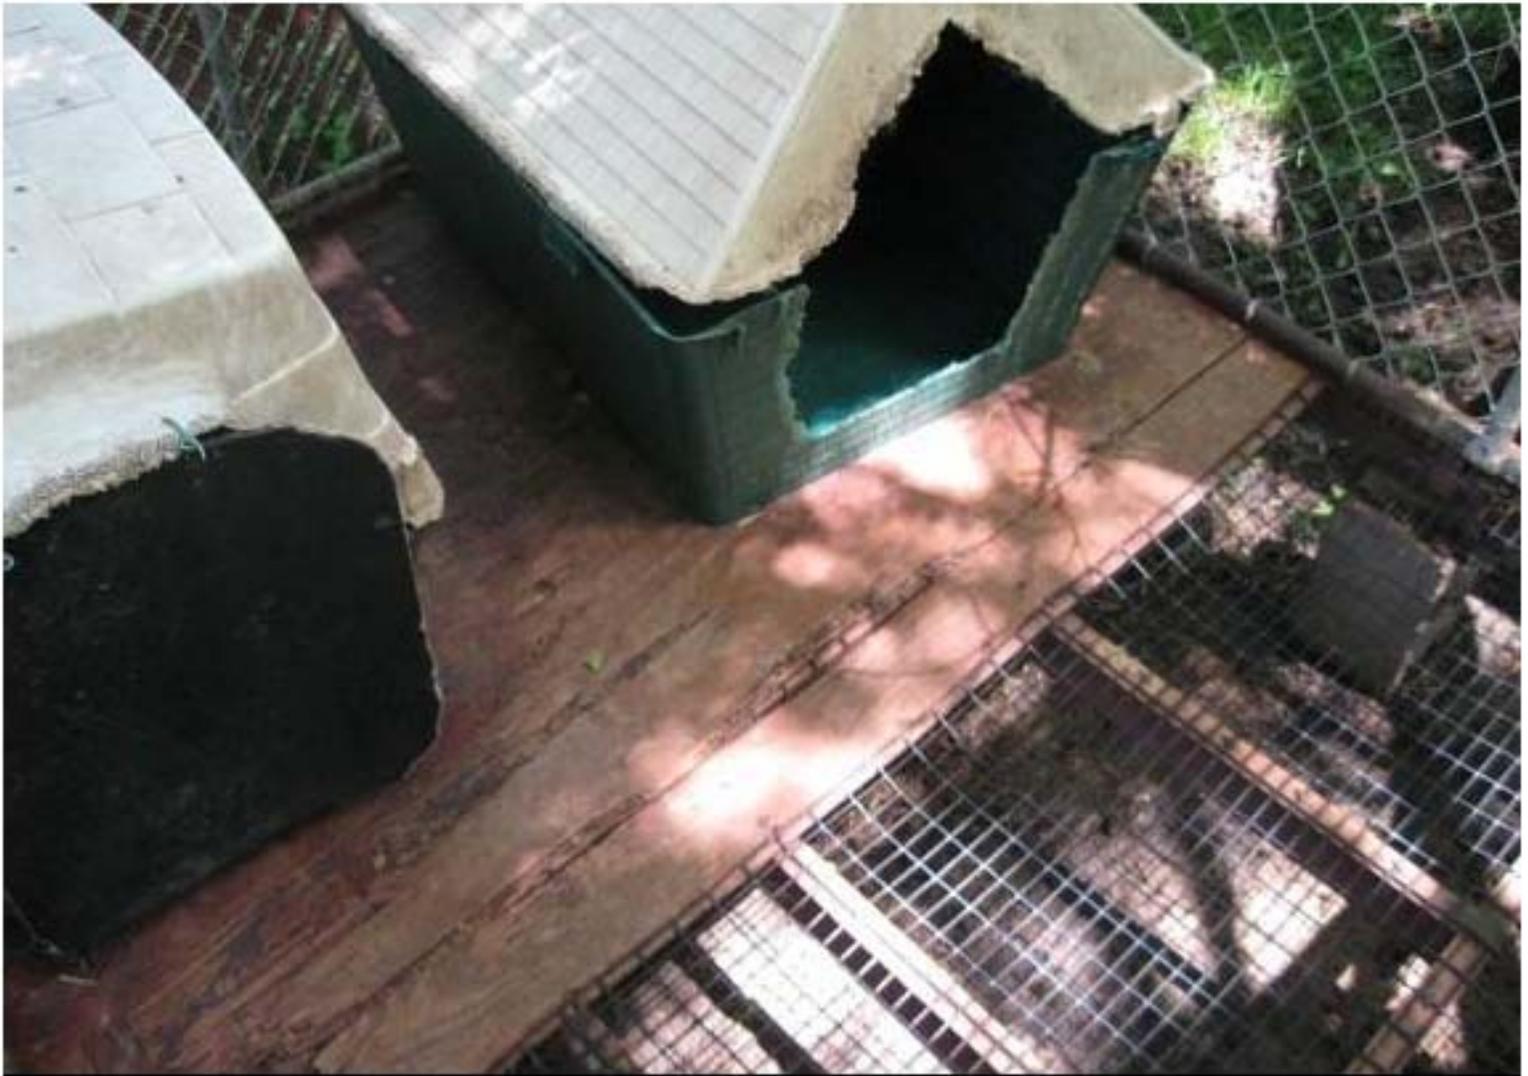
CFR: 3.4 (b) (3), 3.4 (c), 3.4 (b)

Photographer:	John J. Lies, ACI	Legal Name:	Registration:	42-A-0913
Photo Taken:	Thu, Jun 3, '10 P.M.	LUCILLE GODFREY		
Inspection:	153102116010659			
Description:	3.4(b), (b)(3), Outdoor Housing: shelter falling apart needs to be replaced, no wind/rain break. 3.4 (c) Construction: Worn wood no longer impervious to moisture.

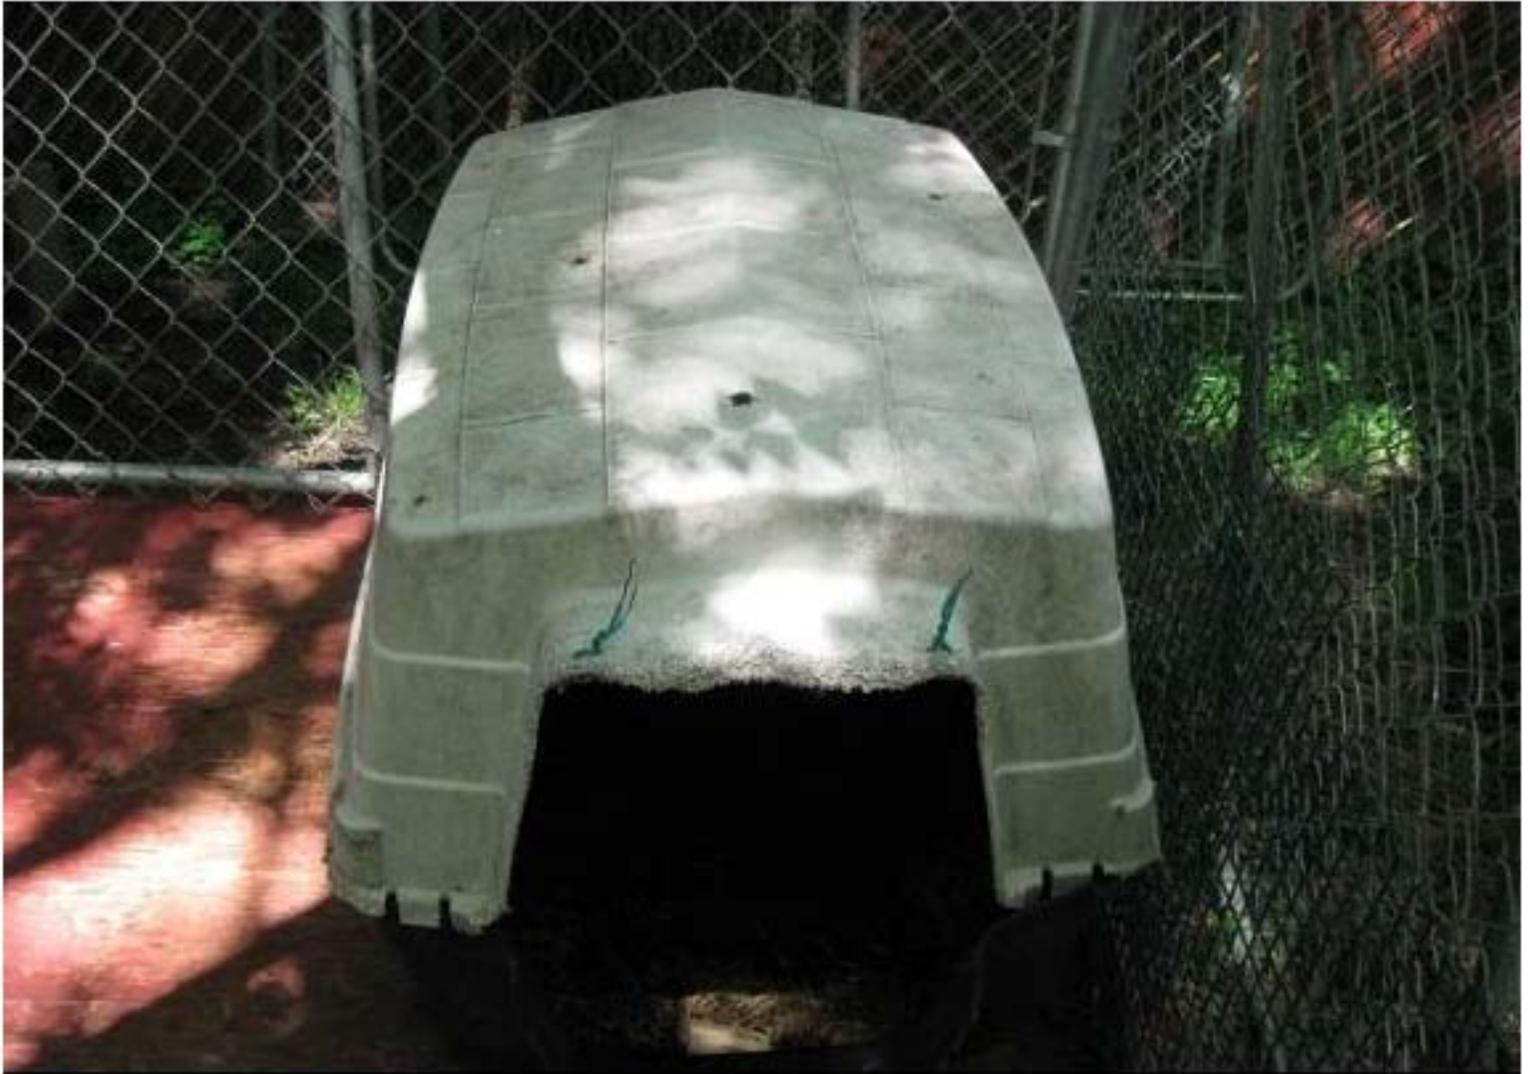
CFR: 3.4 (b) (3), 3.4 (c), 3.4 (b)

Photographer:	John J. Lies, ACI	Legal Name:	Registration:	42-A-0913
Photo Taken:	Thu, Jun 3, '10 P.M.	LUCILLE GODFREY		
Inspection:	153102116010659			
Description:	3.4(b), (b)(3), Outdoor Housing: shelter falling apart needs to be replaced, no wind/rain break. 3.4 (c) Construction: Worn wood no longer impervious to moisture.

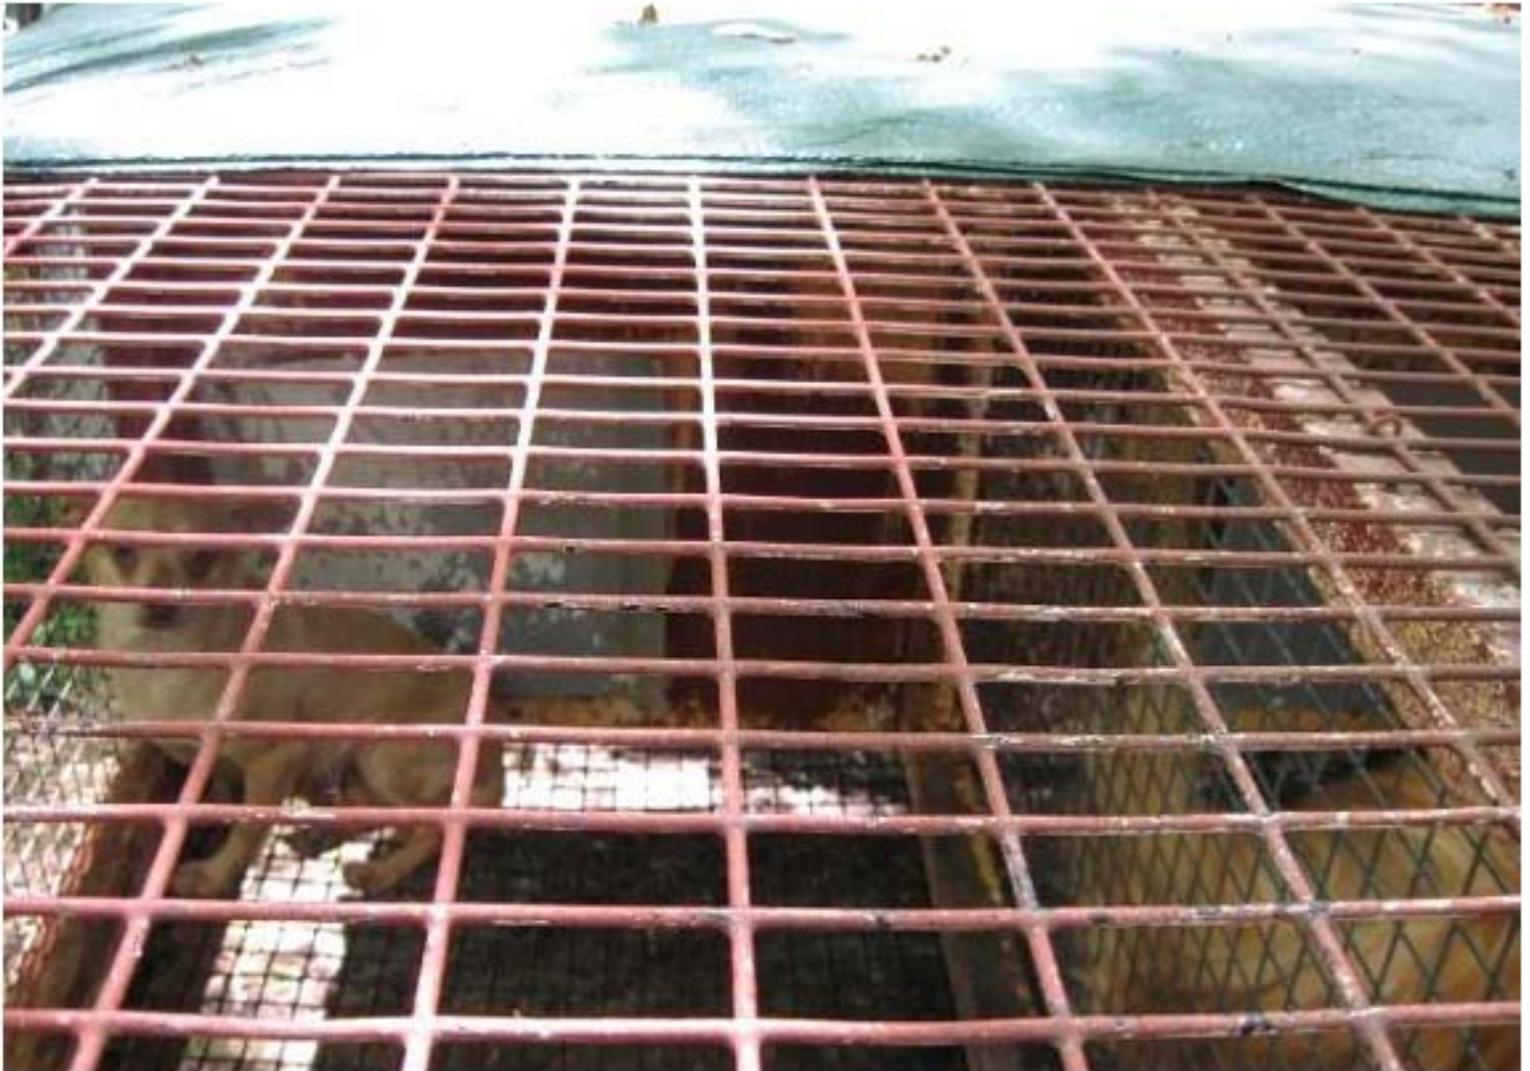
Photographer:	John J. Lies, ACI	Legal Name:	Registration:	42-A-0913
Photo Taken:	Thu, Jun 3, '10 P.M.	LUCILLE GODFREY		
Inspection:	153102116010659			
Description:	3.4(c) Outdoor housing construction: Worn and/or chewed wood that is no longer impervious to moisture.

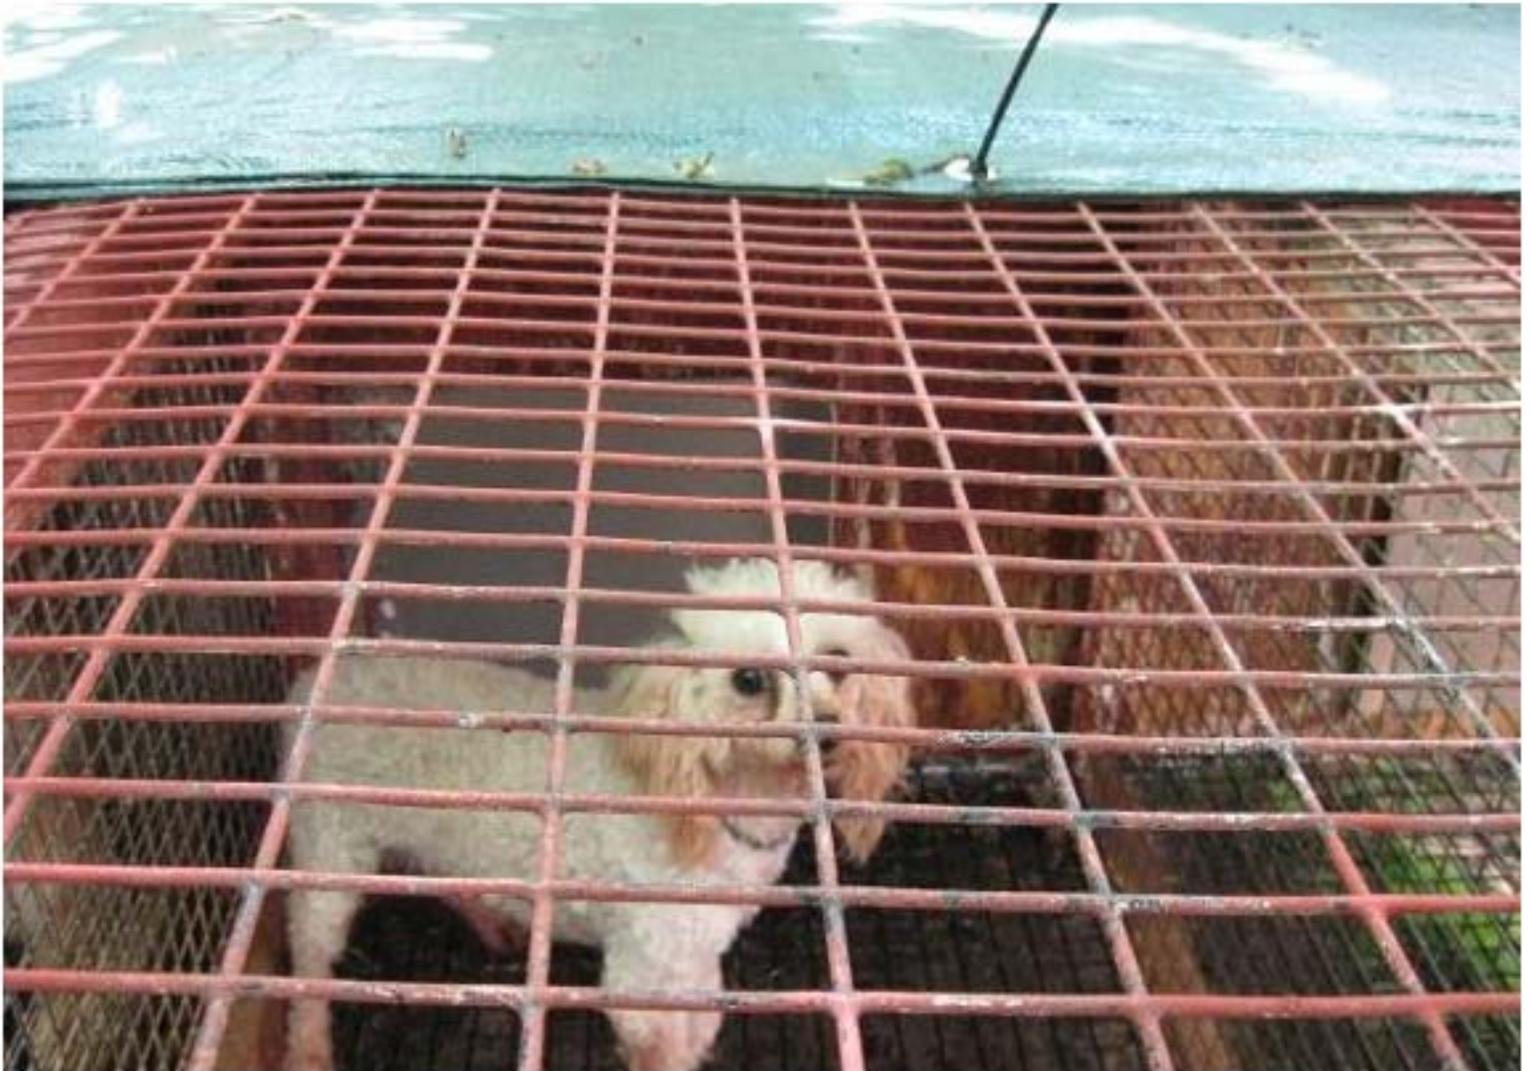
Photographer:	John J. Lies, ACI	Legal Name:	Registration:	42-A-0913
Photo Taken:	Thu, Jun 3, '10 P.M.	LUCILLE GODFREY		
Inspection:	153102116010659			
Description:	3.4(c) Outdoor housing construction: Worn and/or chewed wood that is no longer impervious to moisture.

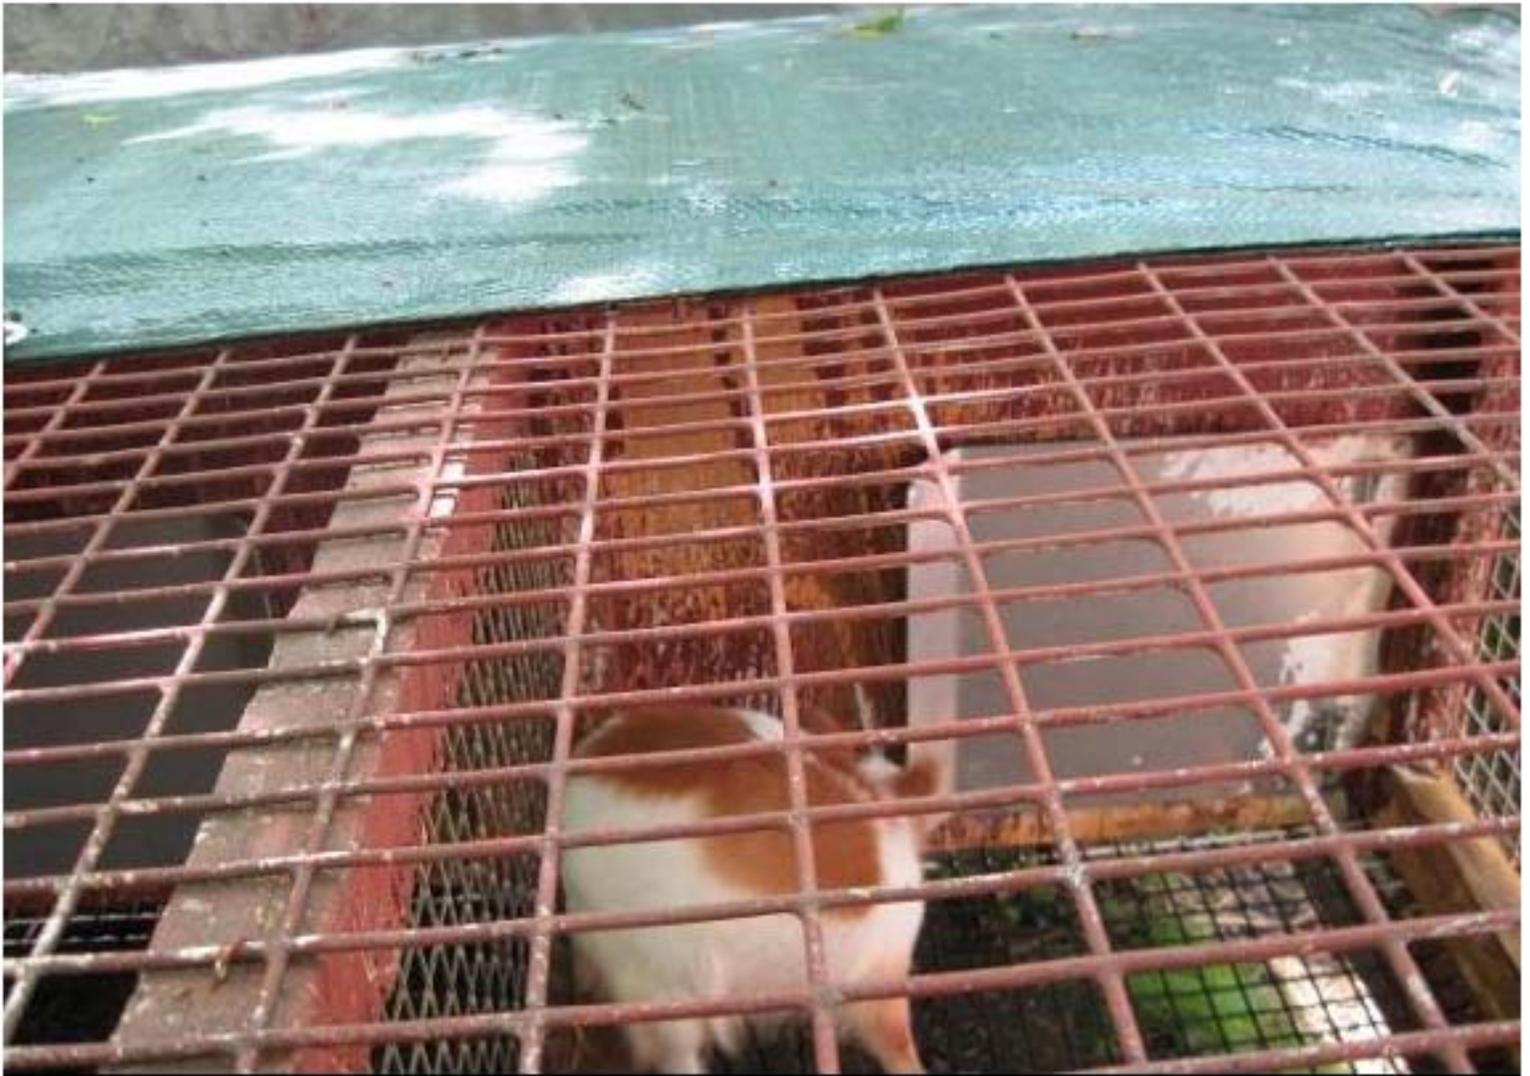
Photographer:	John J. Lies, ACI	Legal Name:	Registration:	42-A-0913
Photo Taken:	Thu, Jun 3, '10 P.M.	LUCILLE GODFREY		
Inspection:	153102116010659			
Description:	3.4(c) Outdoor housing construction: Worn and/or chewed wood that is no longer impervious to moisture.

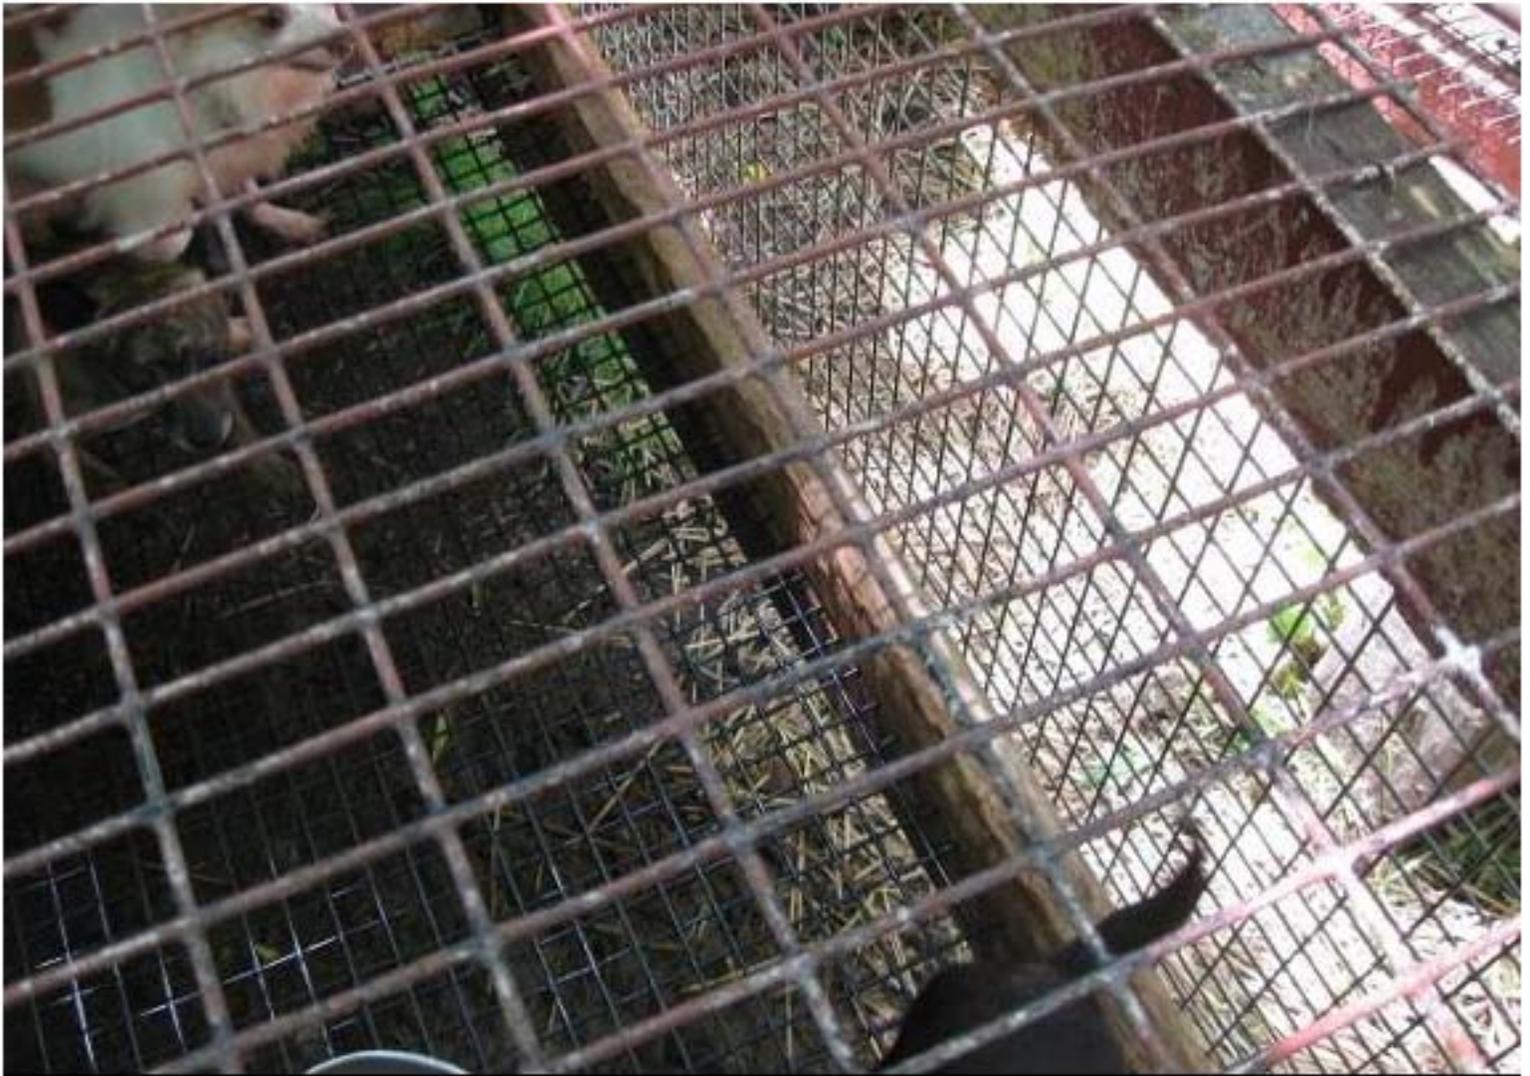
Photographer:	John J. Lies, ACI	Legal Name:	Registration:	42-A-0913
Photo Taken:	Thu, Jun 3, '10 P.M.	LUCILLE GODFREY		
Inspection:	153102116010659			
Description:	3.4(c) Outdoor housing construction: Worn and/or chewed wood that is no longer impervious to moisture.

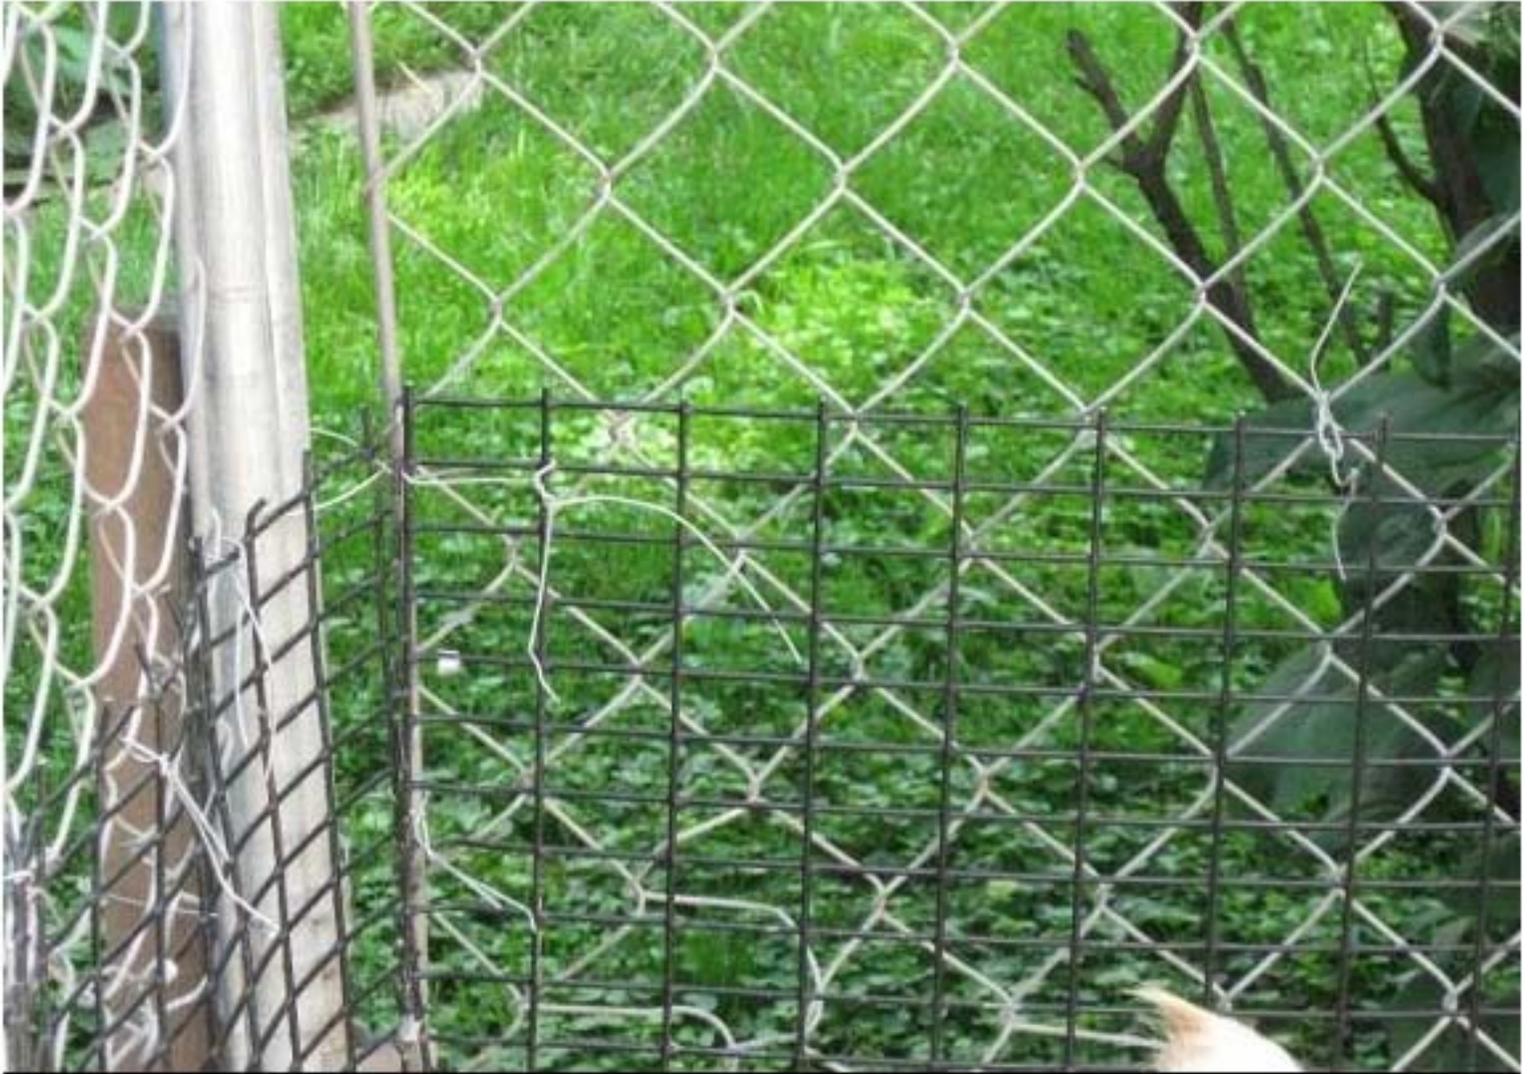
Photographer:	John J. Lies, ACI	Legal Name:	Registration:	42-A-0913
Photo Taken:	Thu, Jun 3, '10 P.M.	LUCILLE GODFREY		
Inspection:	153102116010659			
Description:	3.4(c) Outdoor housing construction: Worn and/or chewed wood that is no longer impervious to moisture.

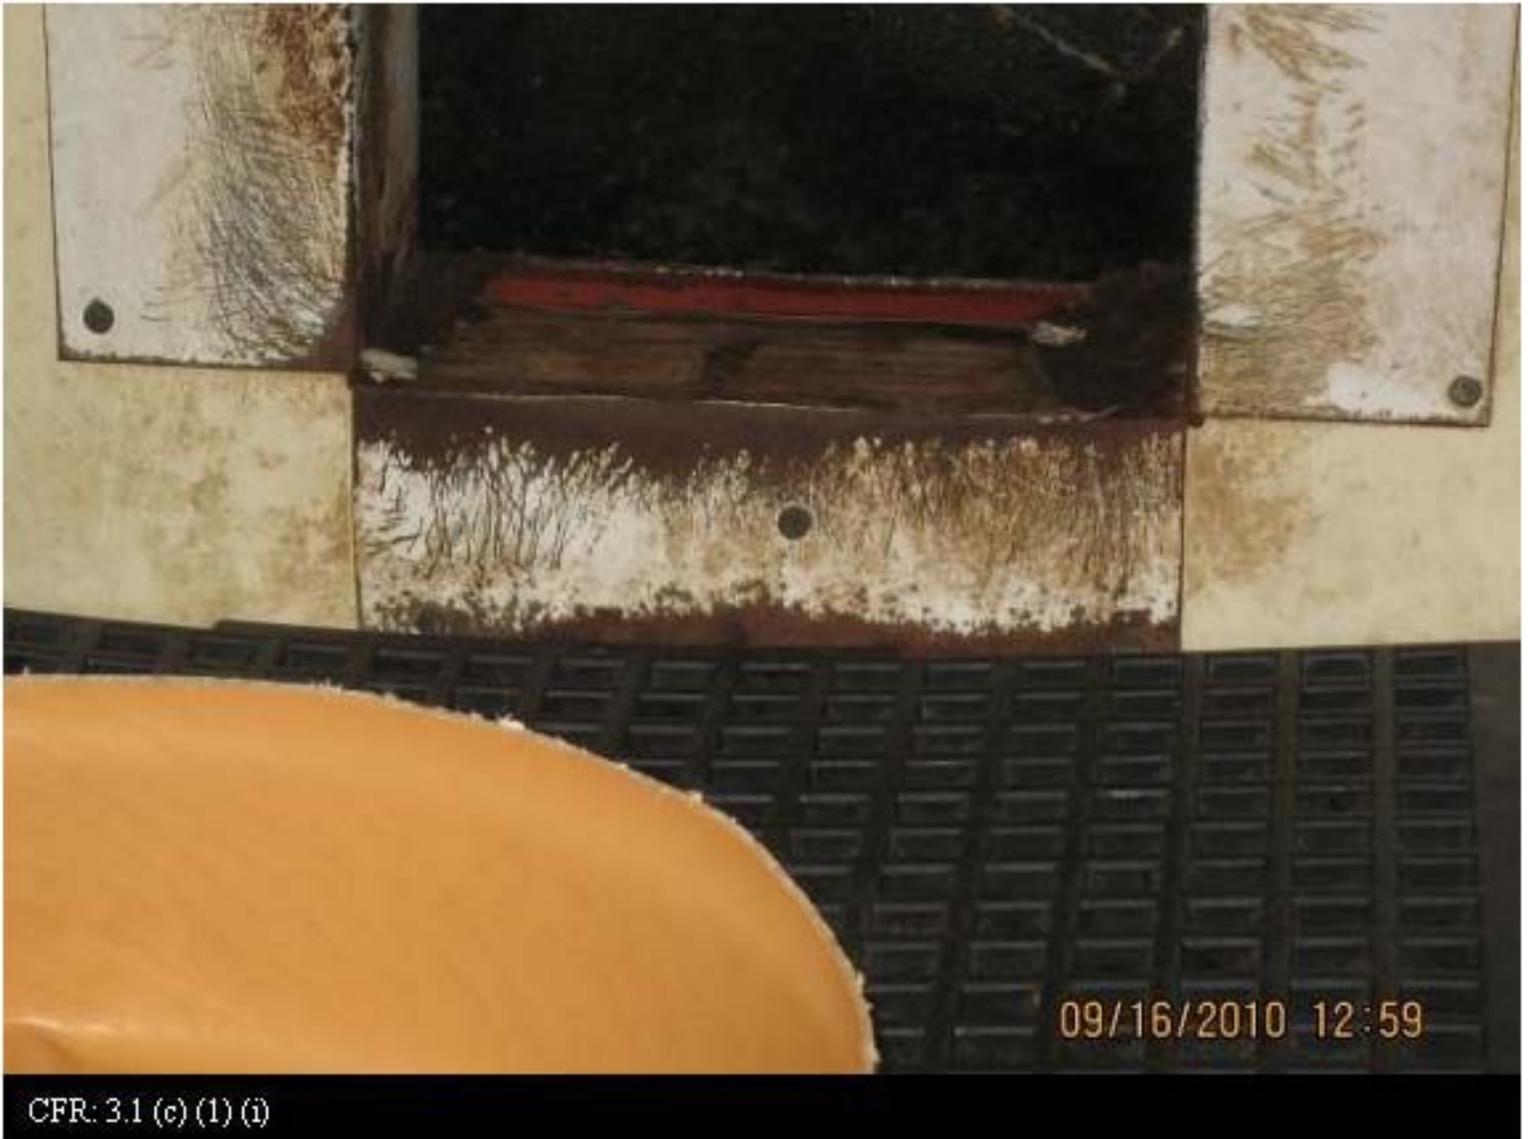
Photographer:	Randall Wagner (ACI)	Legal Name:	Registration:	42-A-0791
Photo Taken:	Thu, Sep 16, '10	ARIE BYL HELEN BYL		
Inspection:	259101424060729			
Description:	The tin insert is excessively rusty and flaking at the surface and rusting apart affecting the structural integrity.

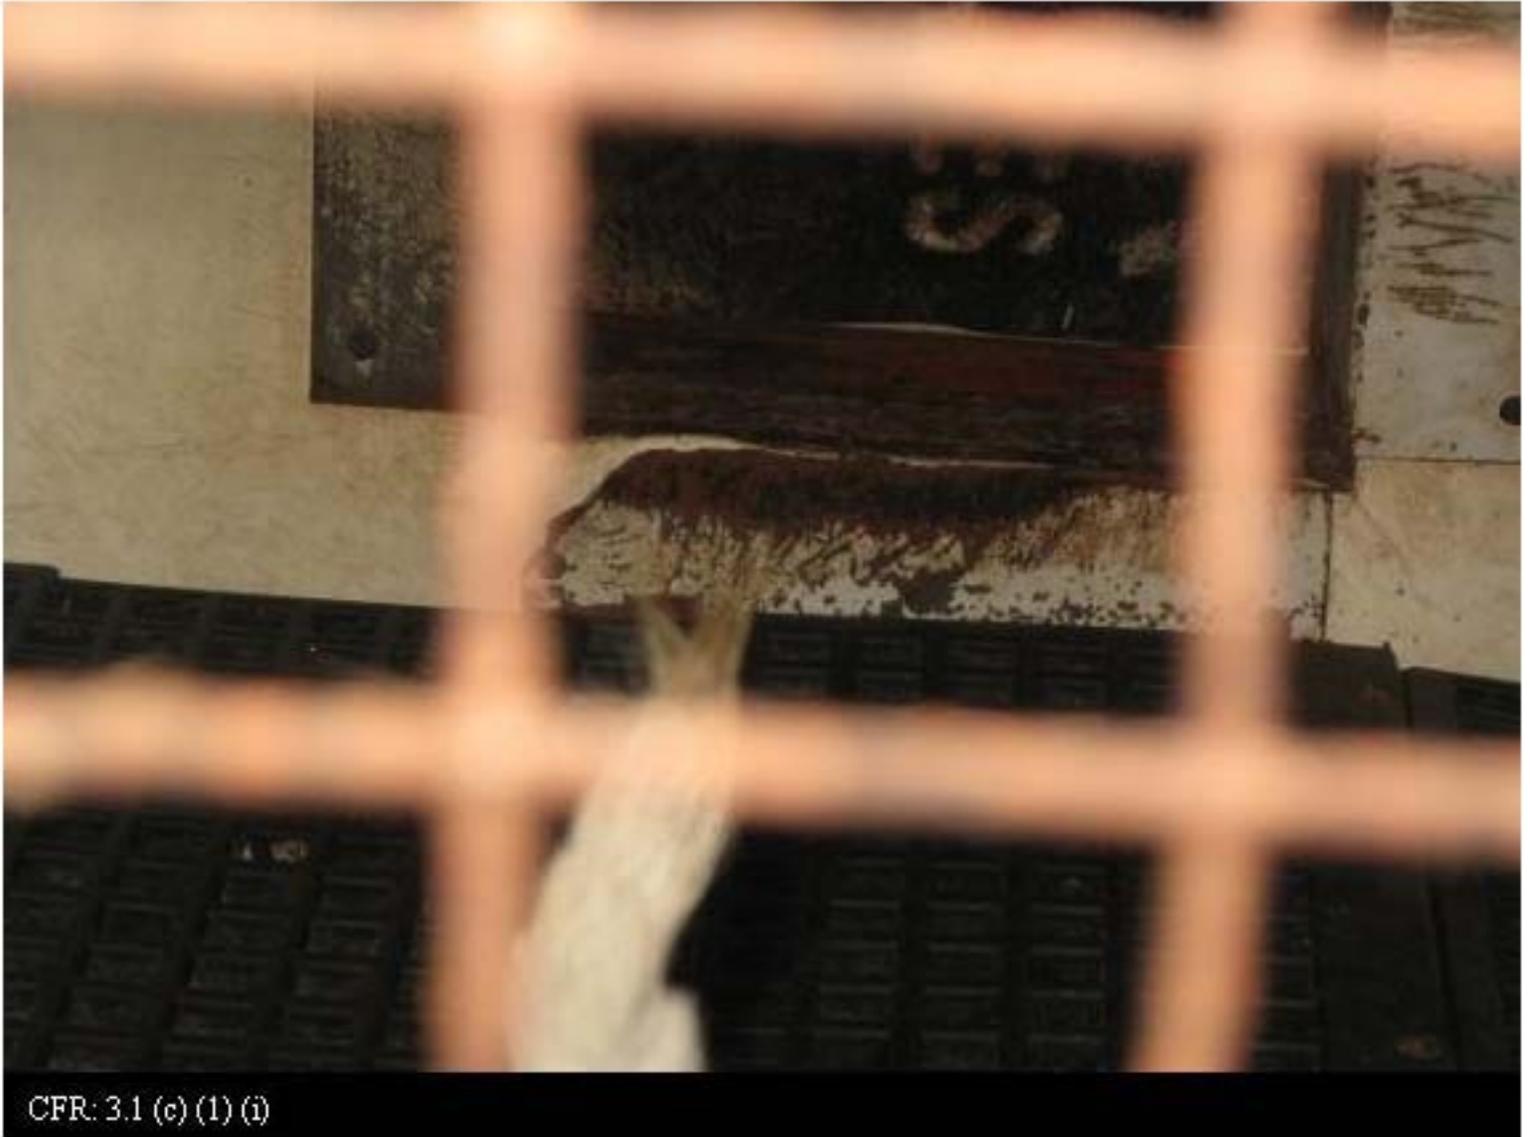
Photographer:	Randall Wagner (ACI)	Legal Name:	Registration:	42-A-0791
Photo Taken:	Thu, Sep 16, '10	ARIE BYL		
Inspection:	259101424060729	HELEN BYL		
Description:	The tin insert is rusted apart at the bottom indicating the structural strength is affected.

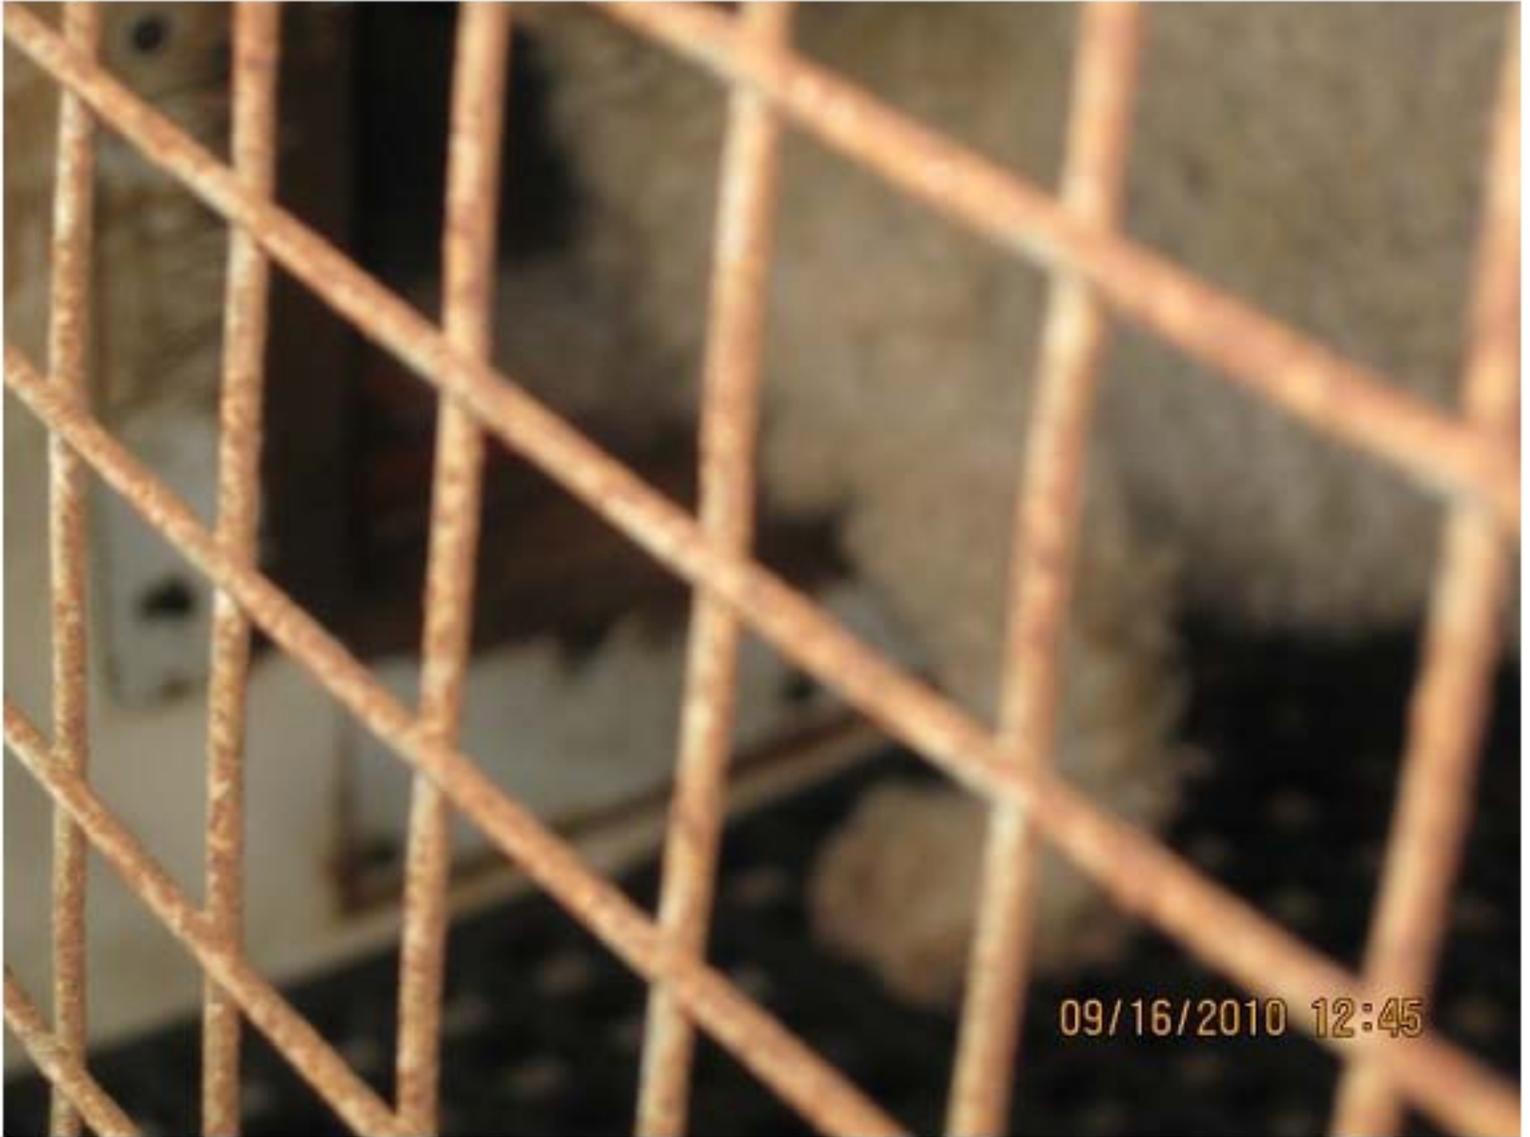
CFR: 3.1 (c) (1) (i)

Photographer:	Randall Wagner (ACI)	Legal Name:	Registration:	42-A-0791
Photo Taken:	Thu, Sep 16, '10	ARIE BYL		
Inspection:	259101424060729	HELEN BYL		
Description:	The tin insert excessive rusting and flaking is causing it to rust apart affecting the structural integrity.
