Photographer: Heather Cole, VMO      Legal Name: PAMELA SELLNER      Registration: 42-C-0084  
Photo Taken: Mon, Nov 22, '10 approximately 1100      TOM SELLNER  
Inspection: 326101741280061  
Description:

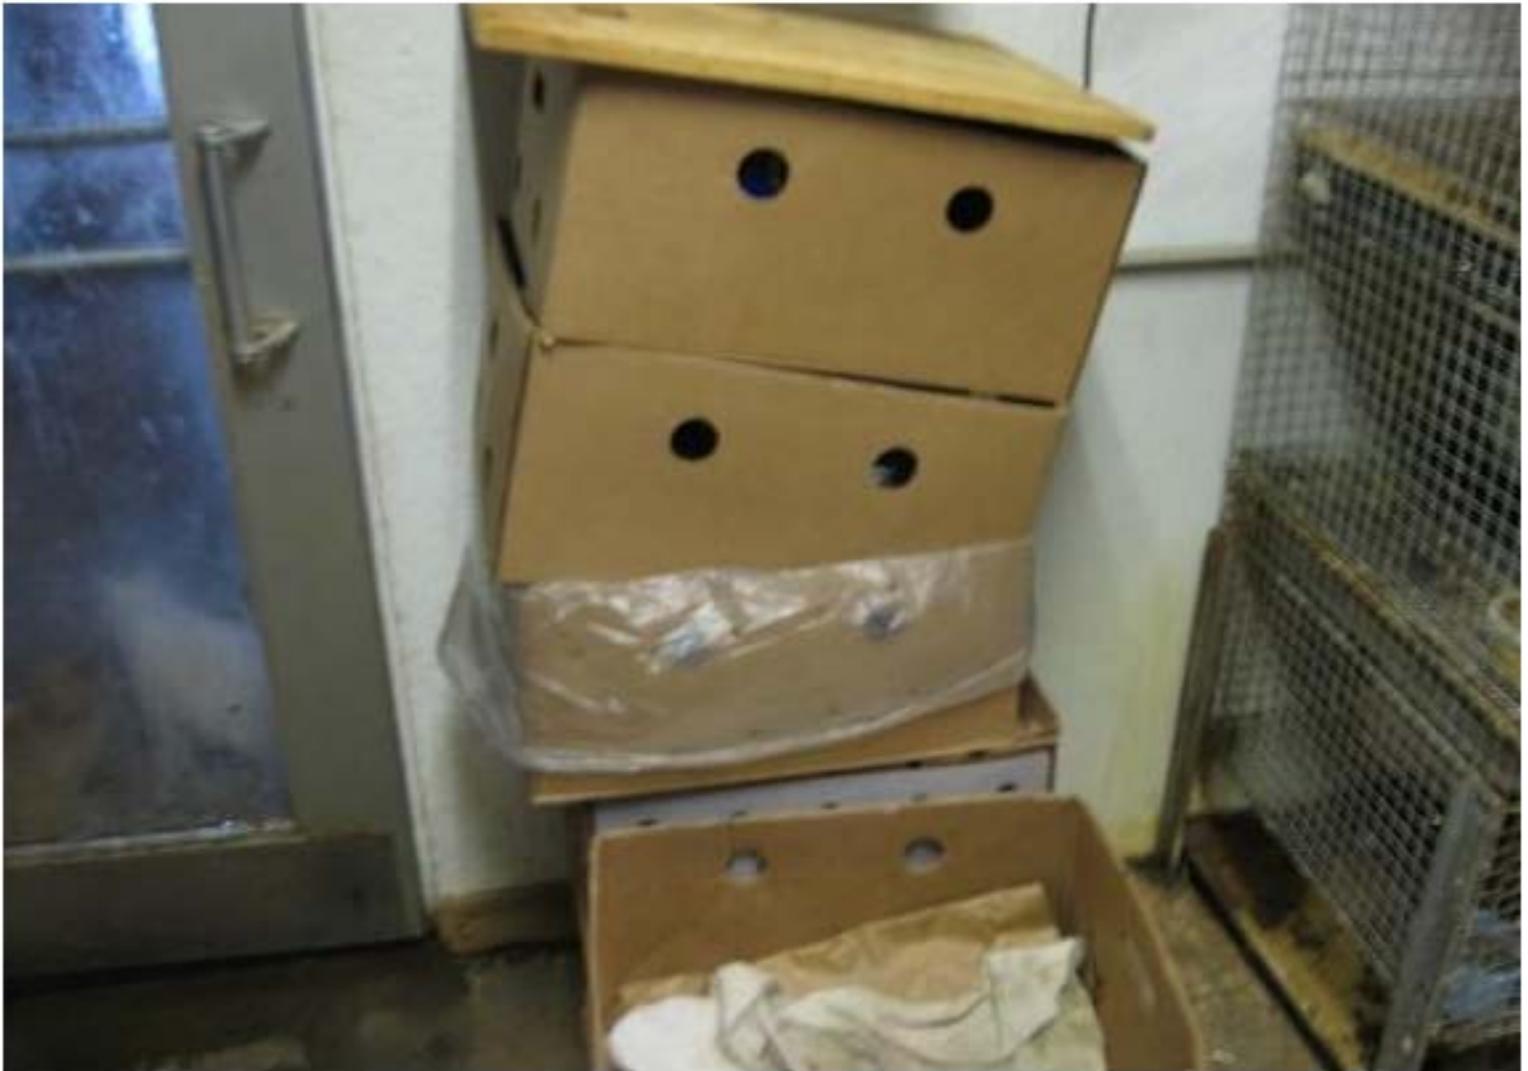
FOIA11-282000869

Photographer:	Chad Moore	Legal Name:	Registration:	42-C-0081
Photo Taken:	Wed, Dec 8, '10	Approximately 11:30	JOYCE DE COCK RICHARD DE COCK	
Inspection:	342101854230123			
Description:	Unchanged, inadequate enrichment plan for non-human primates. Additionally, the plan is not approved by the attending veterinarian.

CFR: 3.75 (e)

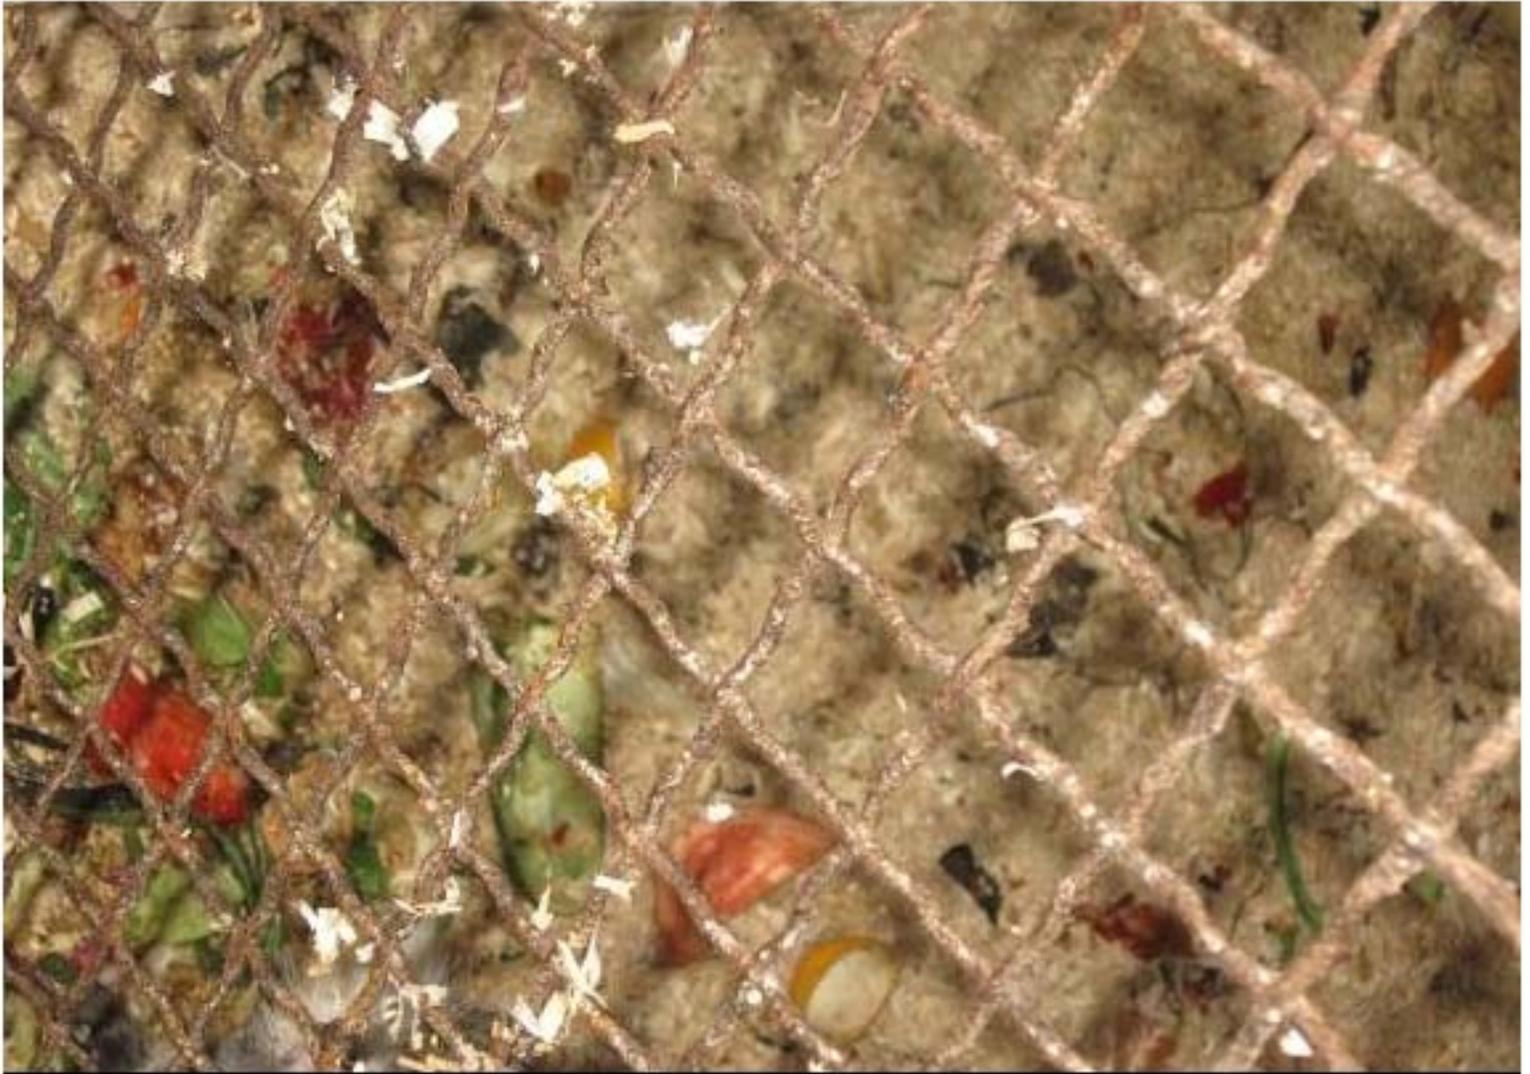
FOIA11-282000882

Photographer:	Chad Moore	Legal Name:	Registration:	42-C-0081
Photo Taken:	Wed, Aug 25, '10	Approximately 12:00	JOYCE DE COCK	
Inspection:	237102249530984	RICHARD DE COCK		
Description:	Rusted chain link fencing on vervet enclosure

CFR: 3.80 (a), 3.84 (a)

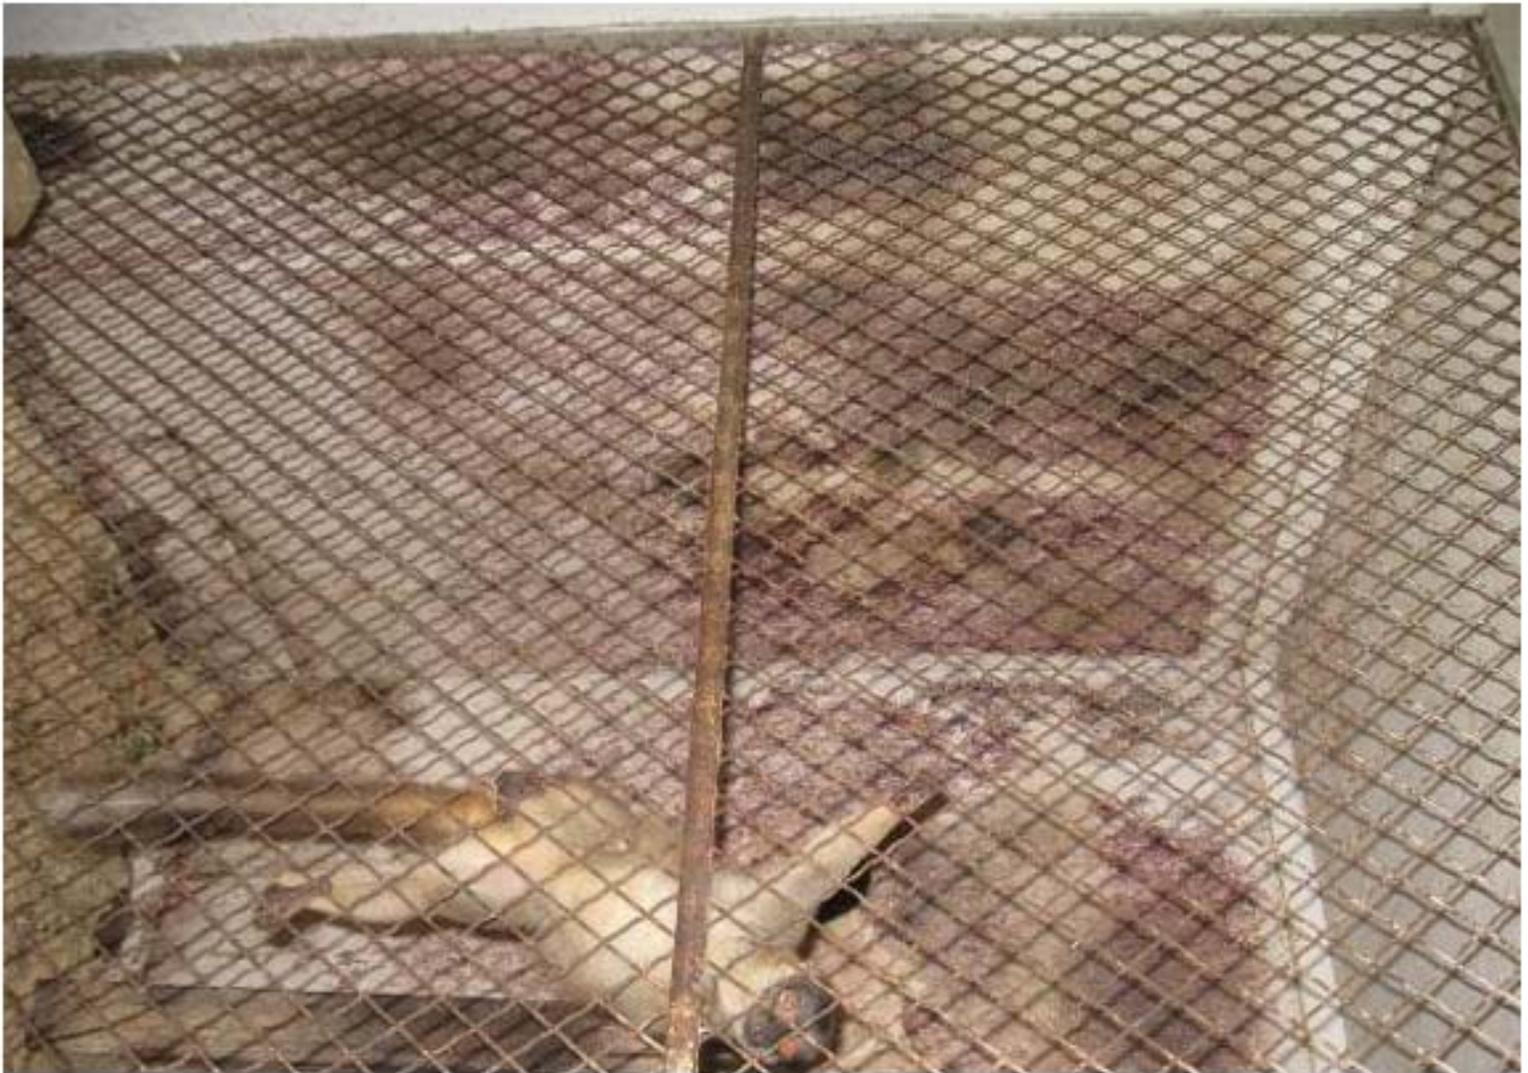
FOIA11-282000883

Photographer:	Chad Moore	Legal Name:	Registration:	42-C-0081
Photo Taken:	Mon, Aug 30, '10	Approximately 12:00	JOYCE DE COCK RICHARD DE COCK	
Inspection:	237102249530984			
Description:	Rusted chain link fencing on vervet enclosure

CFR: 3.80 (a), 3.84 (a)

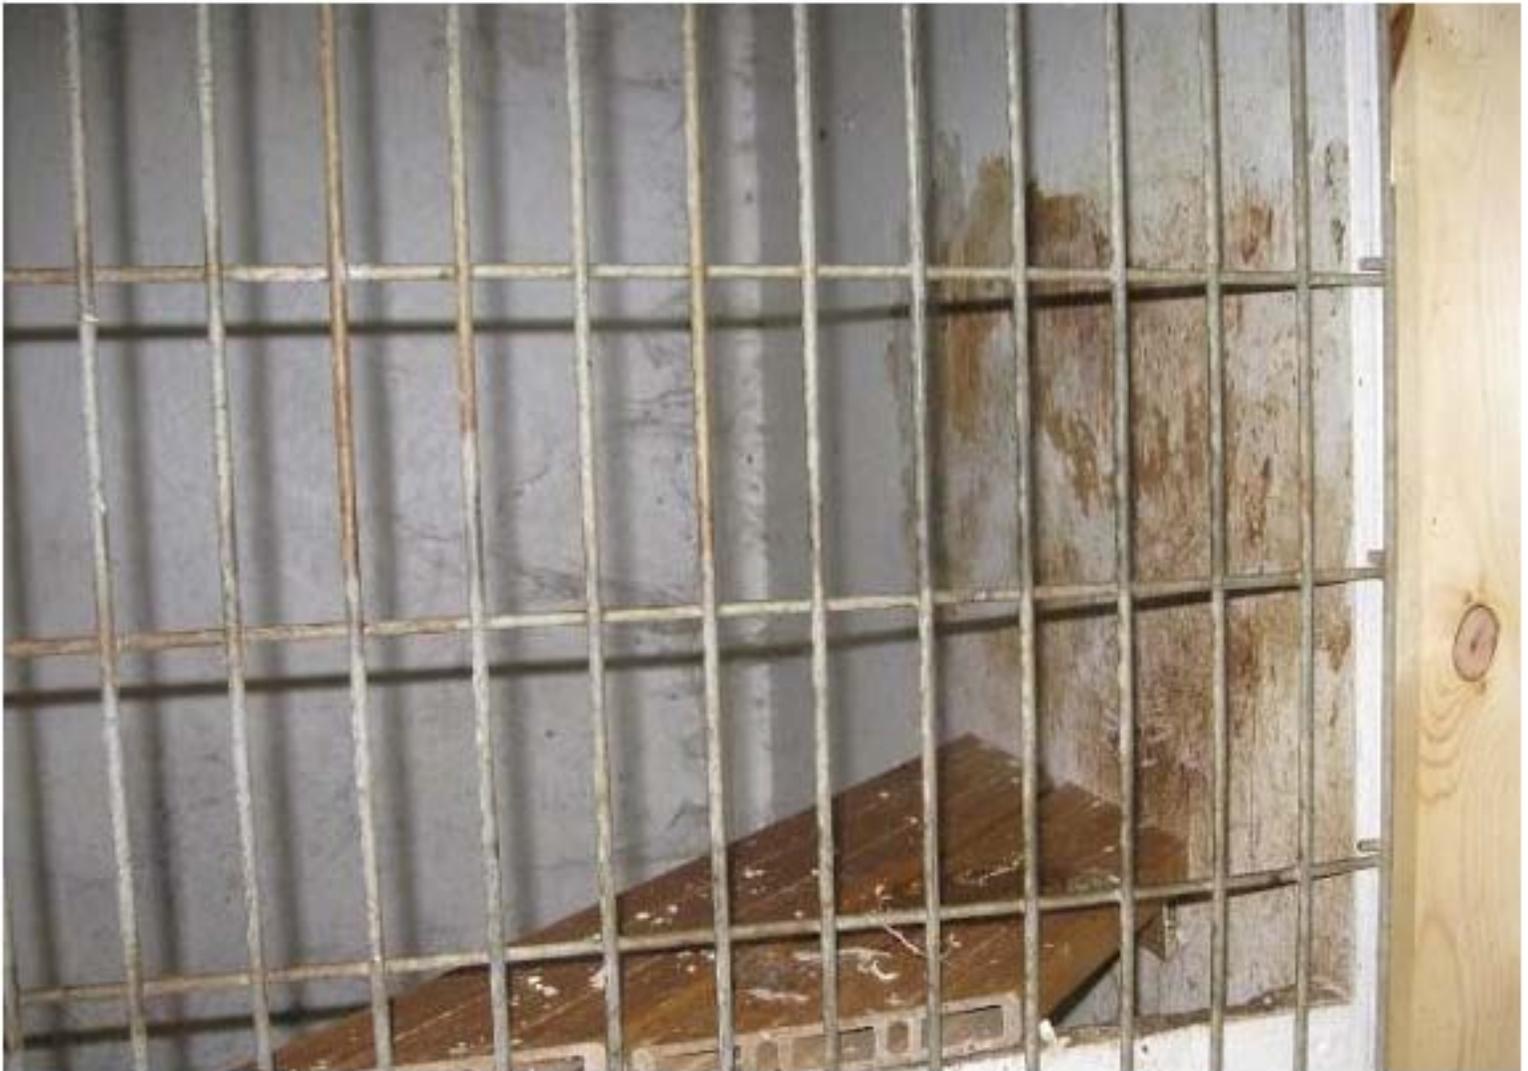
Photographer:	Chad Moore	Legal Name:	Registration:	42-C-0081
Photo Taken:	Wed, Aug 25, '10 Aproximately 12:00	JOYCE DE COCK RICHARD DE COCK		
Inspection:	237102249530984			
Description:	Unsealed exposed wood on walls. Rusted chain link fencing, both located on/in lemurs enclosure. Excessive feces, food wastes, grime on floor and walls of same enclosure			FOIA11-282000884

CFR: 3.80 (a)

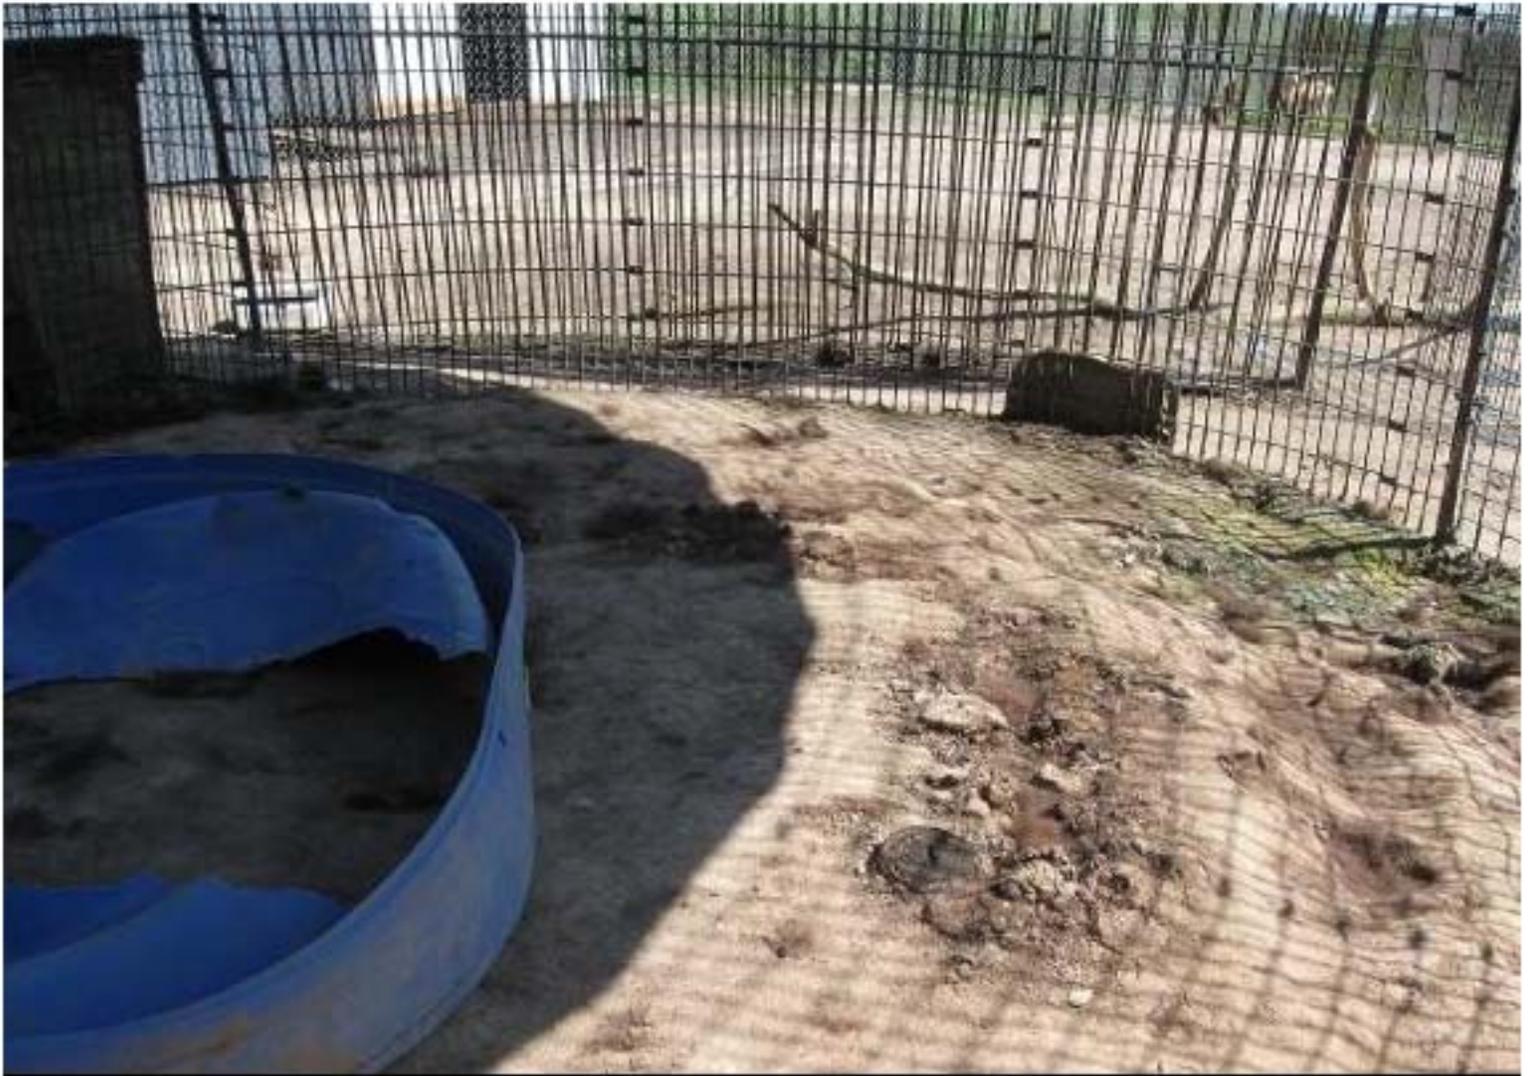
FOIA11-282000900

Photographer:	Chad Moore	Legal Name:	Registration:	42-C-0081
Photo Taken:	Wed, Aug 25, '10 Approximately 12:00	JOYCE DE COCK RICHARD DE COCK		
Inspection:	237102249530984			
Description:	Broken, chewed pool in bear enclosure. Excessive fur and feces in same enclosure

CFR: 3.131 (a)

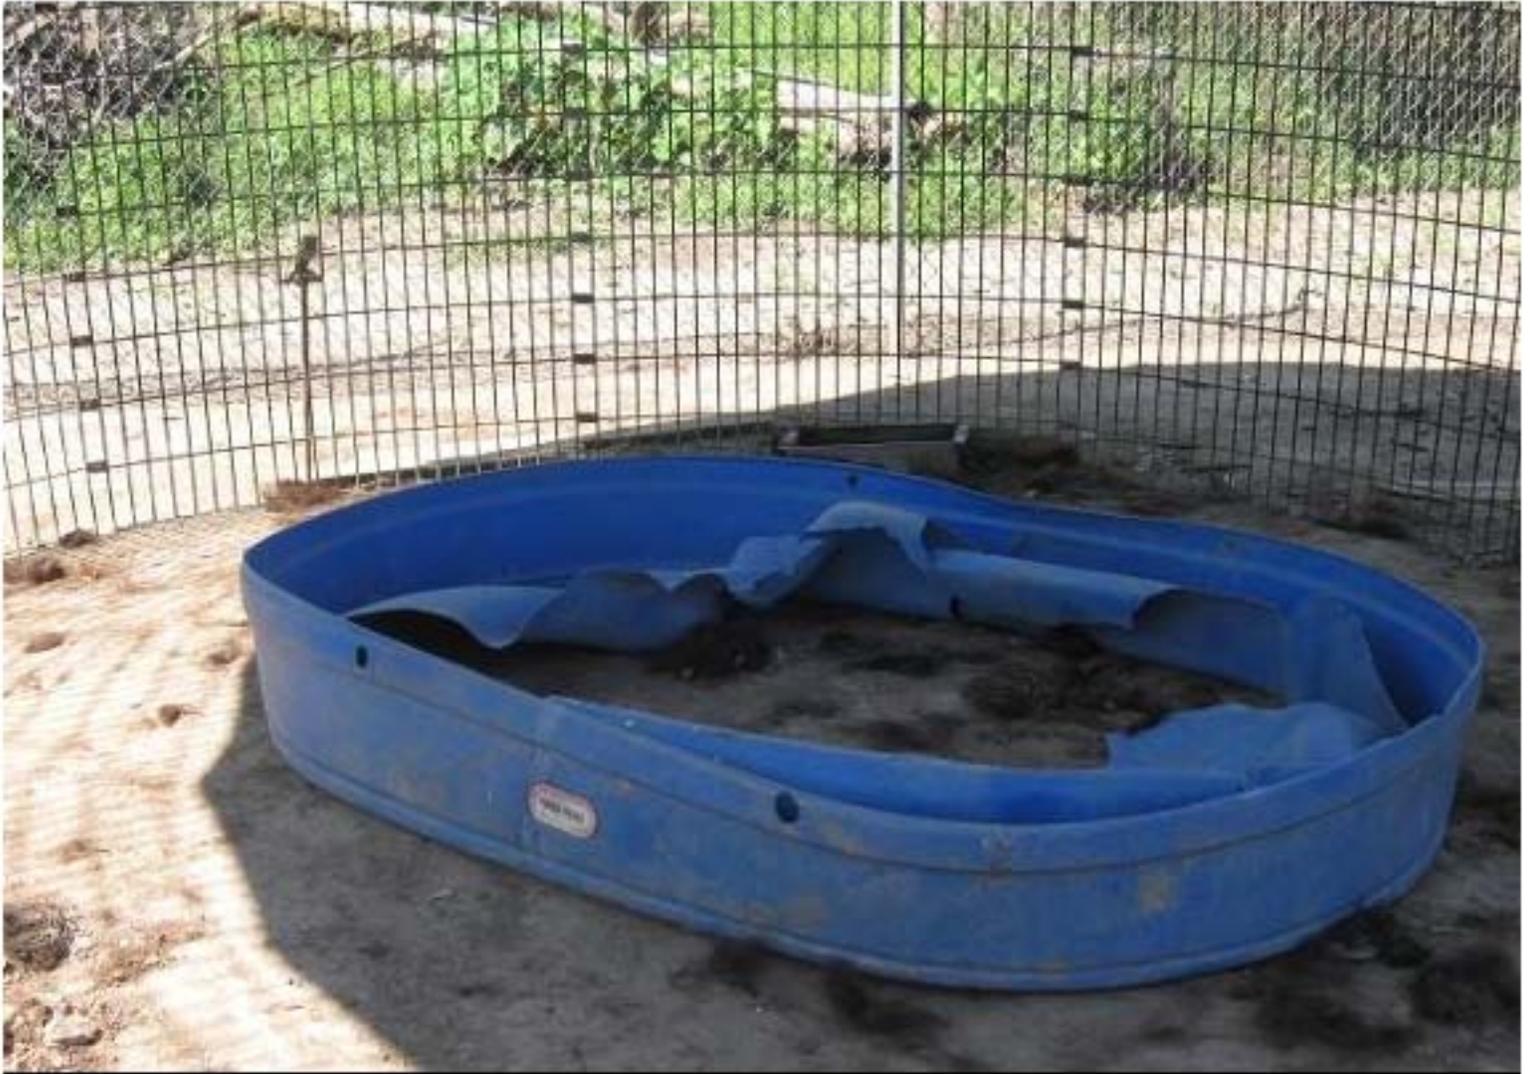
FOIA11-282000901

Photographer:	Chad Moore	Legal Name:	Registration:	42-C-0081
Photo Taken:	Wed, Aug 25, '10 Approximately 12:00	JOYCE DE COCK RICHARD DE COCK		
Inspection:	237102249530984			
Description:	Broken, chewed pool in bear enclosure. Excessive fur and feces in same enclosure

CFR: 3.131 (a)

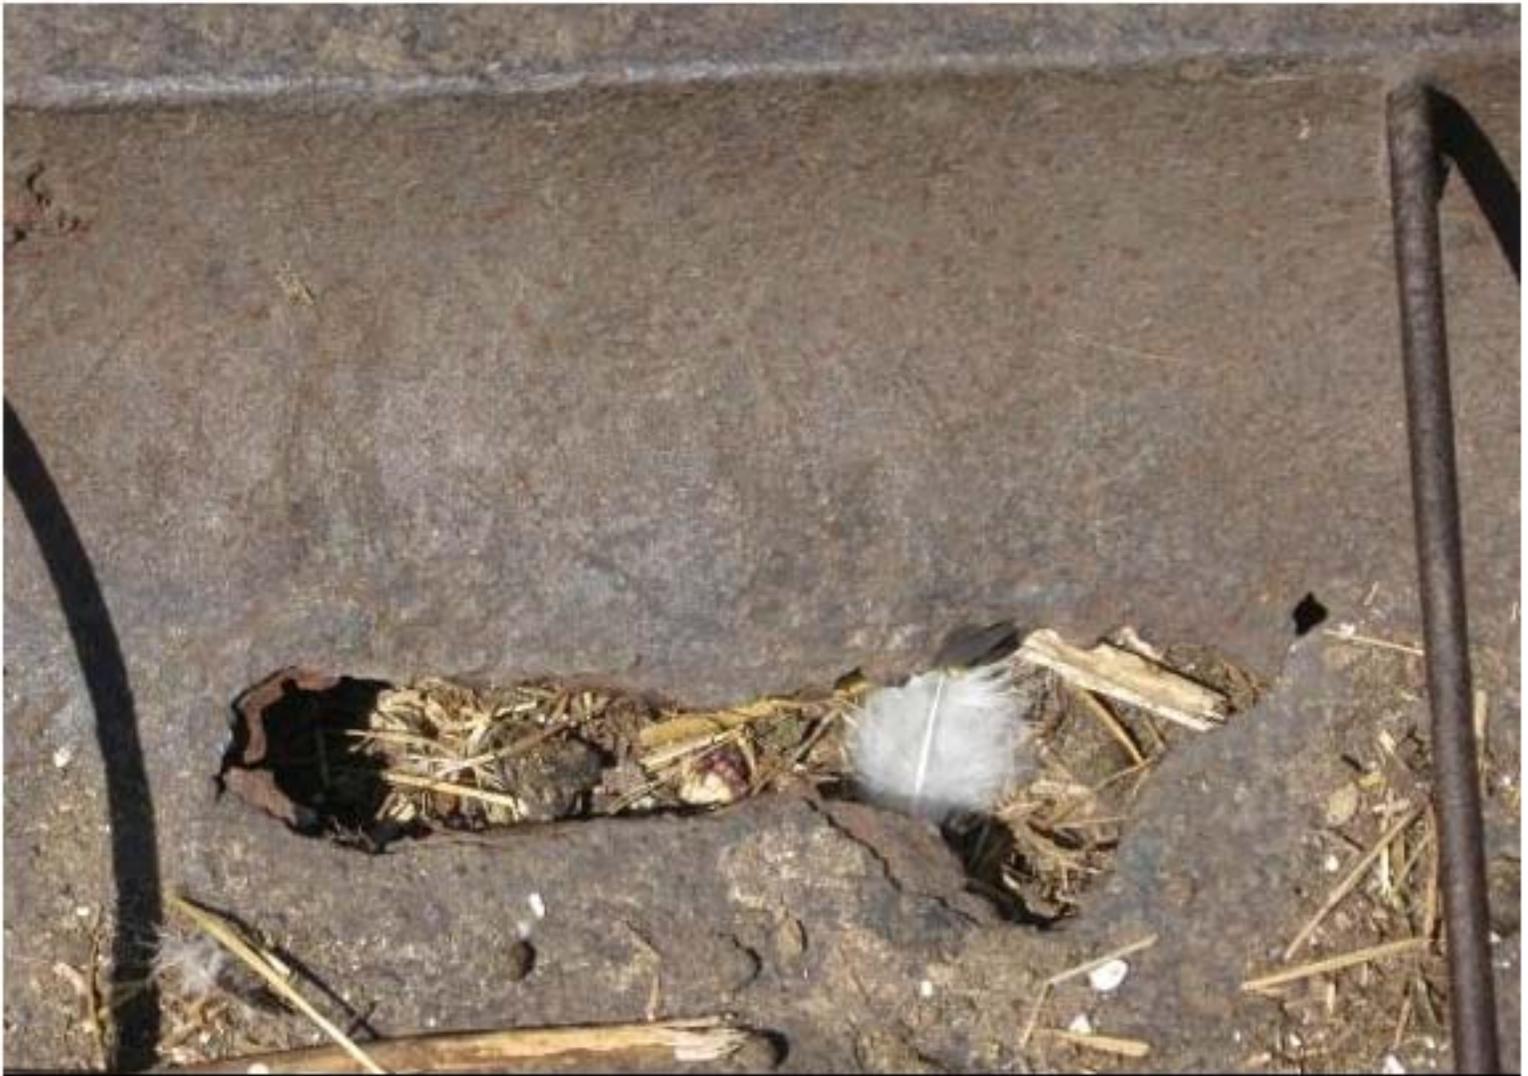
FOIA11-282000914

Photographer:	Chad Moore	Legal Name:	Registration:	42-C-0081
Photo Taken:	Wed, Aug 25, '10 Approximately 12:00	JOYCE DE COCK RICHARD DE COCK		
Inspection:	237102249530984			
Description:	Broken, rusted goat feed trough

CFR: 3.131 (c)

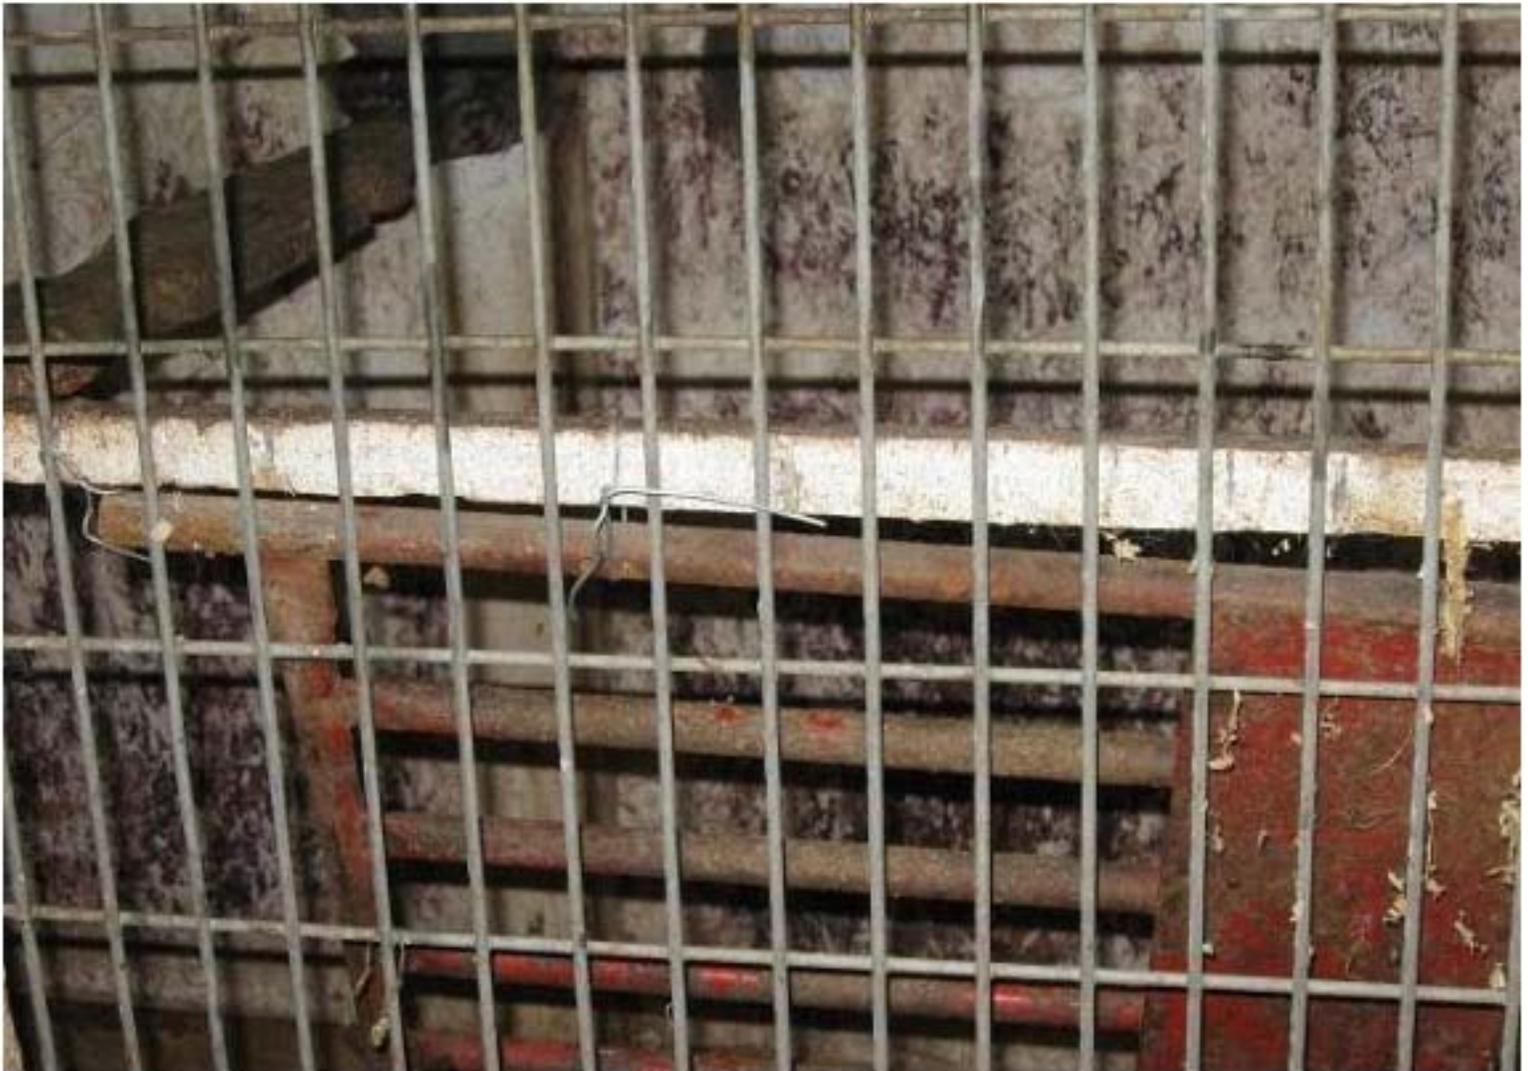
FOIA11-282000922

Photographer:	Chad Moore	Legal Name:	Registration:	42-C-0081
Photo Taken:	Thu, May 13, '10	Approximately 12:00	JOYCE DE COCK	
Inspection:	134100903280828	RICHARD DE COCK		
Description:	Exposed, worn wood surfaces in nonhuman primate enclosures.

CFR: 3.80 (a)

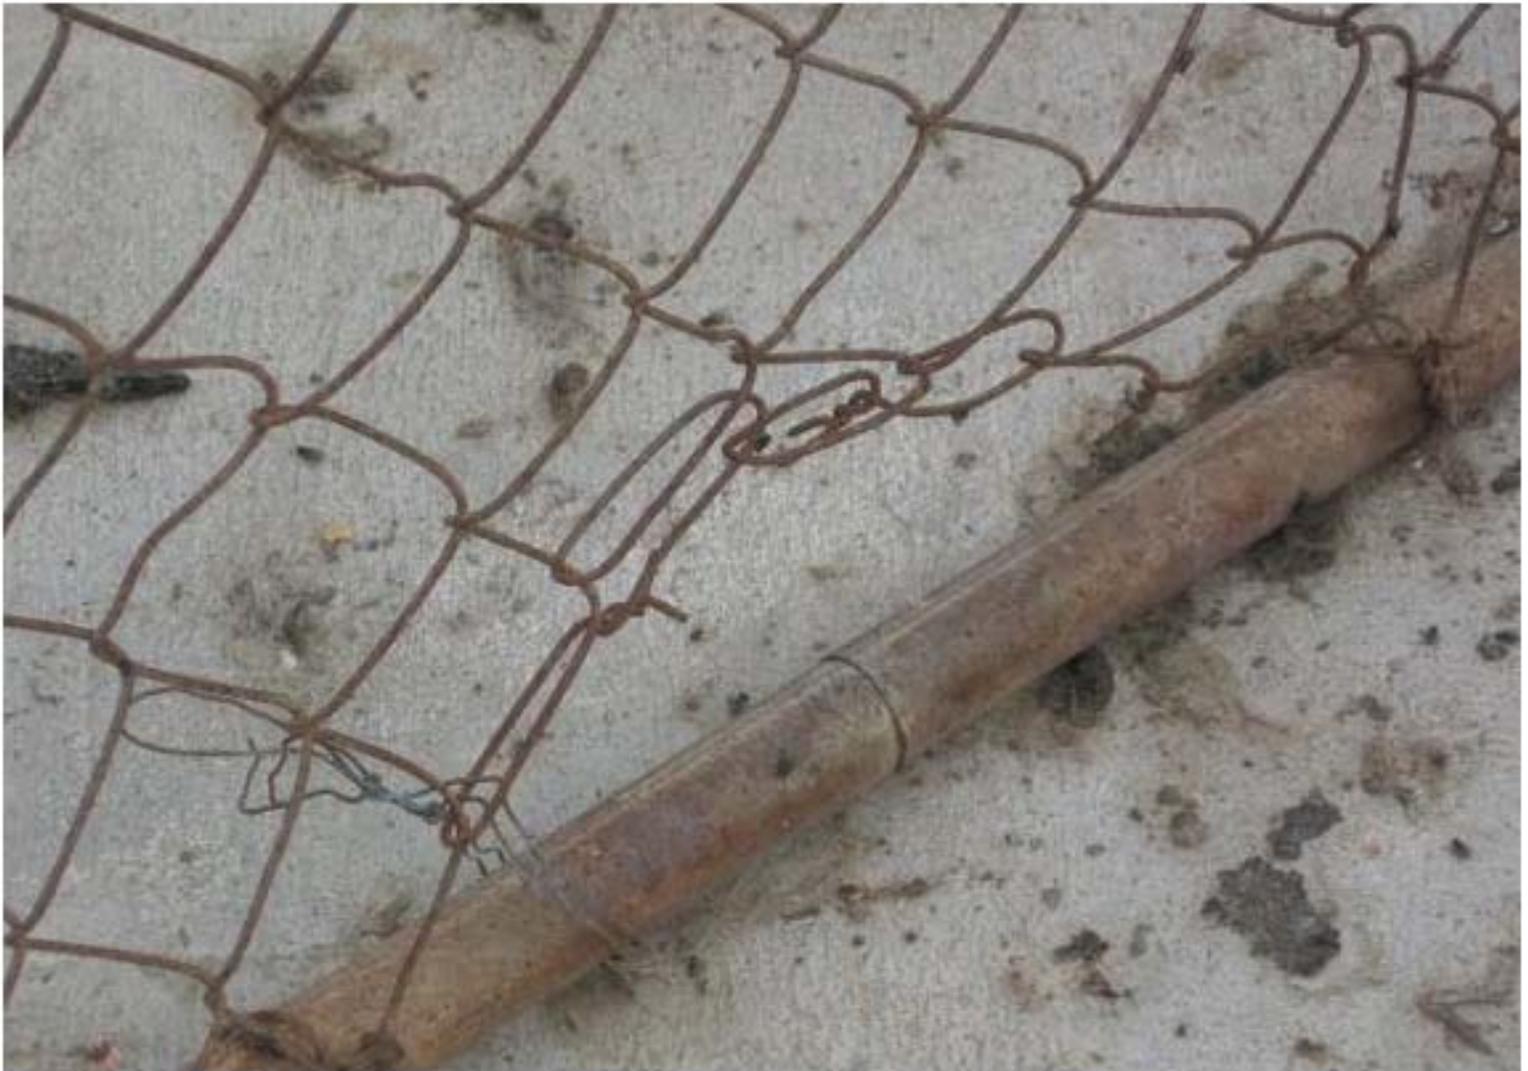
FOIA11-282001000

Photographer:	D Watkins	Legal Name:	Registration:	42-B-0168
Photo Taken:	Mon, Sep 13, '10 Afternoon	CAROLYN ARENDS JULIE ARENDS		
Inspection:	256102256060832			
Description:	Broken, rusted chain link fencing with accumulation of hair and fecal material

CFR: 3.6 (a) (2) (i), 3.11 (a)

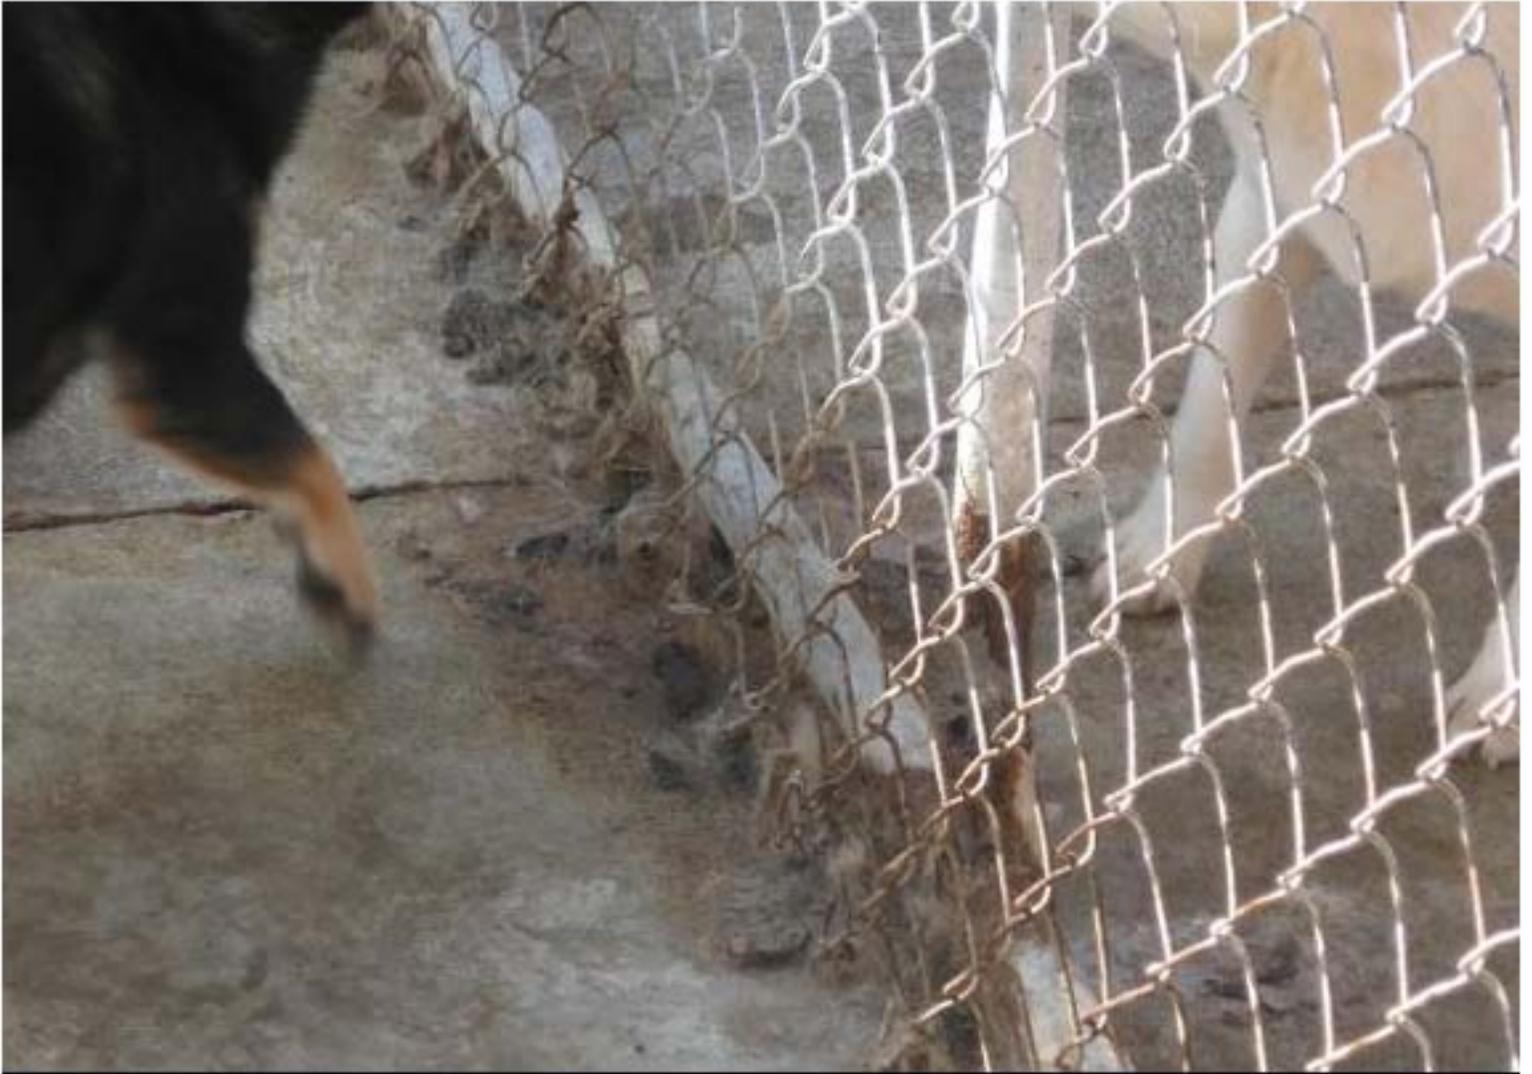
FOIA11-282001006

Photographer:	D Watkins	Legal Name:	Registration:	42-B-0168
Photo Taken:	Mon, Sep 13, '10 Afternoon	CAROLYN ARENDS JULIE ARENDS		
Inspection:	256102256060832			
Description:	Broken, rusted fence post and accumulation of hair and feces on bottom bar

CFR: 3.1 (b), 3.6 (a) (2) (i)

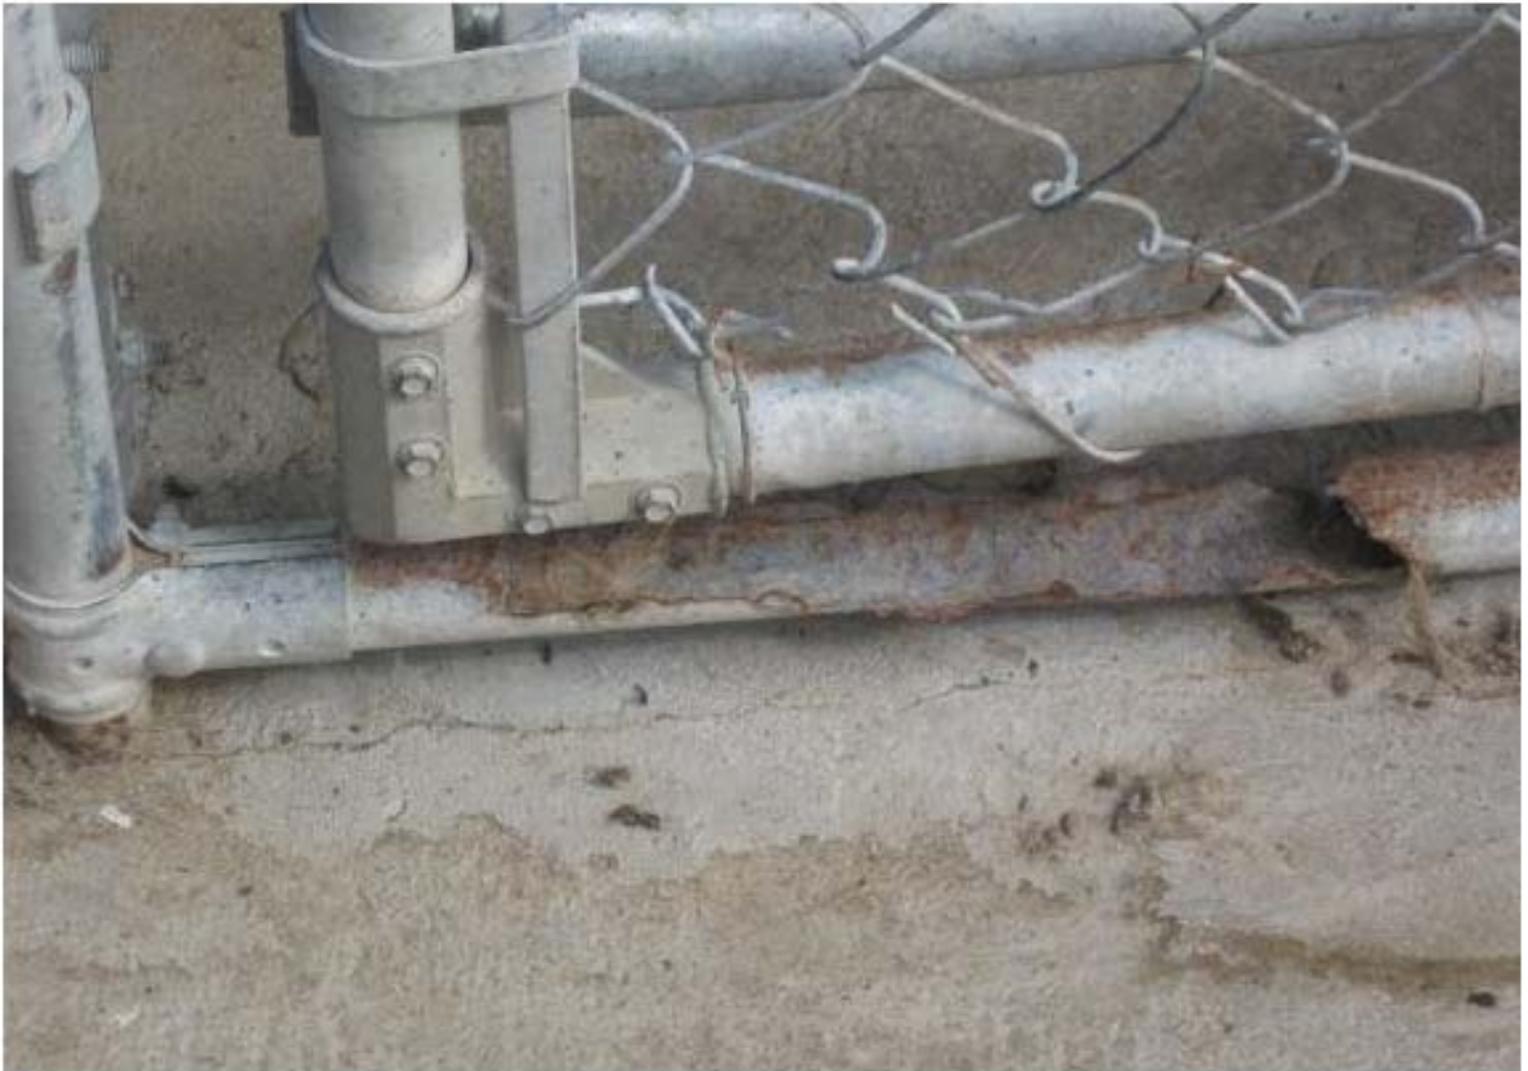
FOIA11-282001007

Photographer:	D Watkins	Legal Name:	Registration:	42-B-0168
Photo Taken:	Mon, Sep 13, '10 Afternoon	CAROLYN ARENDS JULIE ARENDS		
Inspection:	256102256060832			
Description:	Rusted, broken fence post in kennel and accumulation of hair in feces on lower chain link fence and bottom bar

CFR: 3.6 (a) (2) (i)

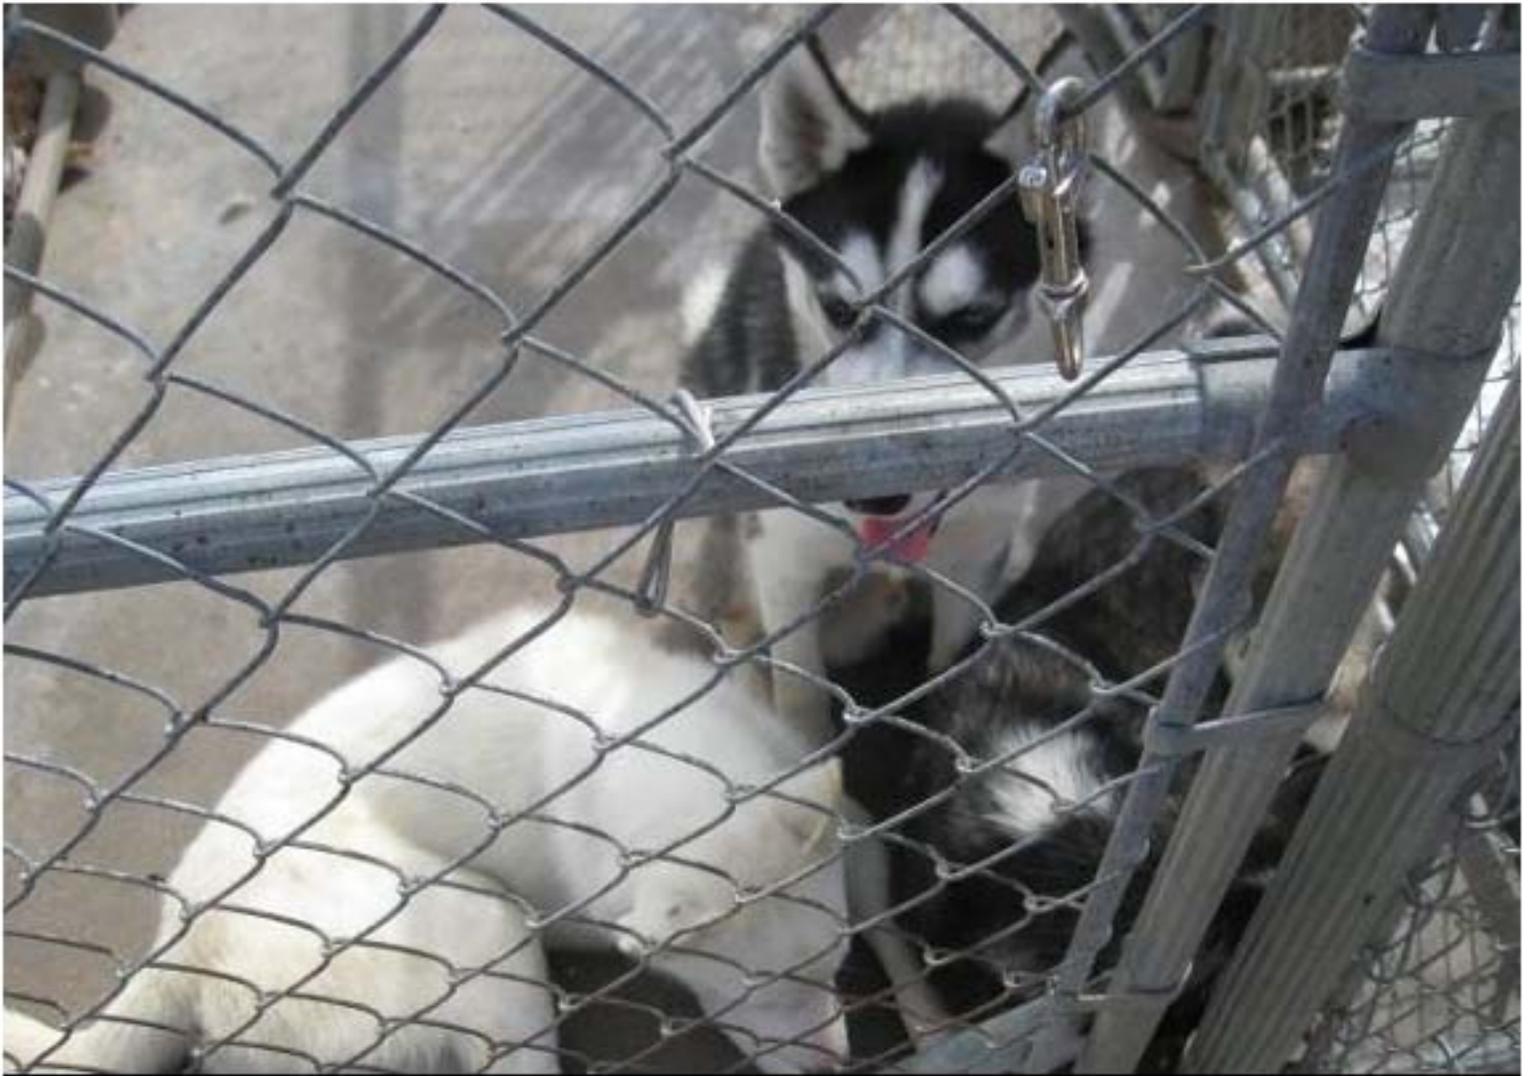
FOIA11-282001008

Photographer:	D Watkins	Legal Name:	Registration:	42-B-0168
Photo Taken:	Mon, Sep 13, '10 Afternoon	CAROLYN ARENDS JULIE ARENDS		
Inspection:	256102256060832			
Description:	Rusted, broken bottom railing on primary enclosure

CFR: 3.4 (b)

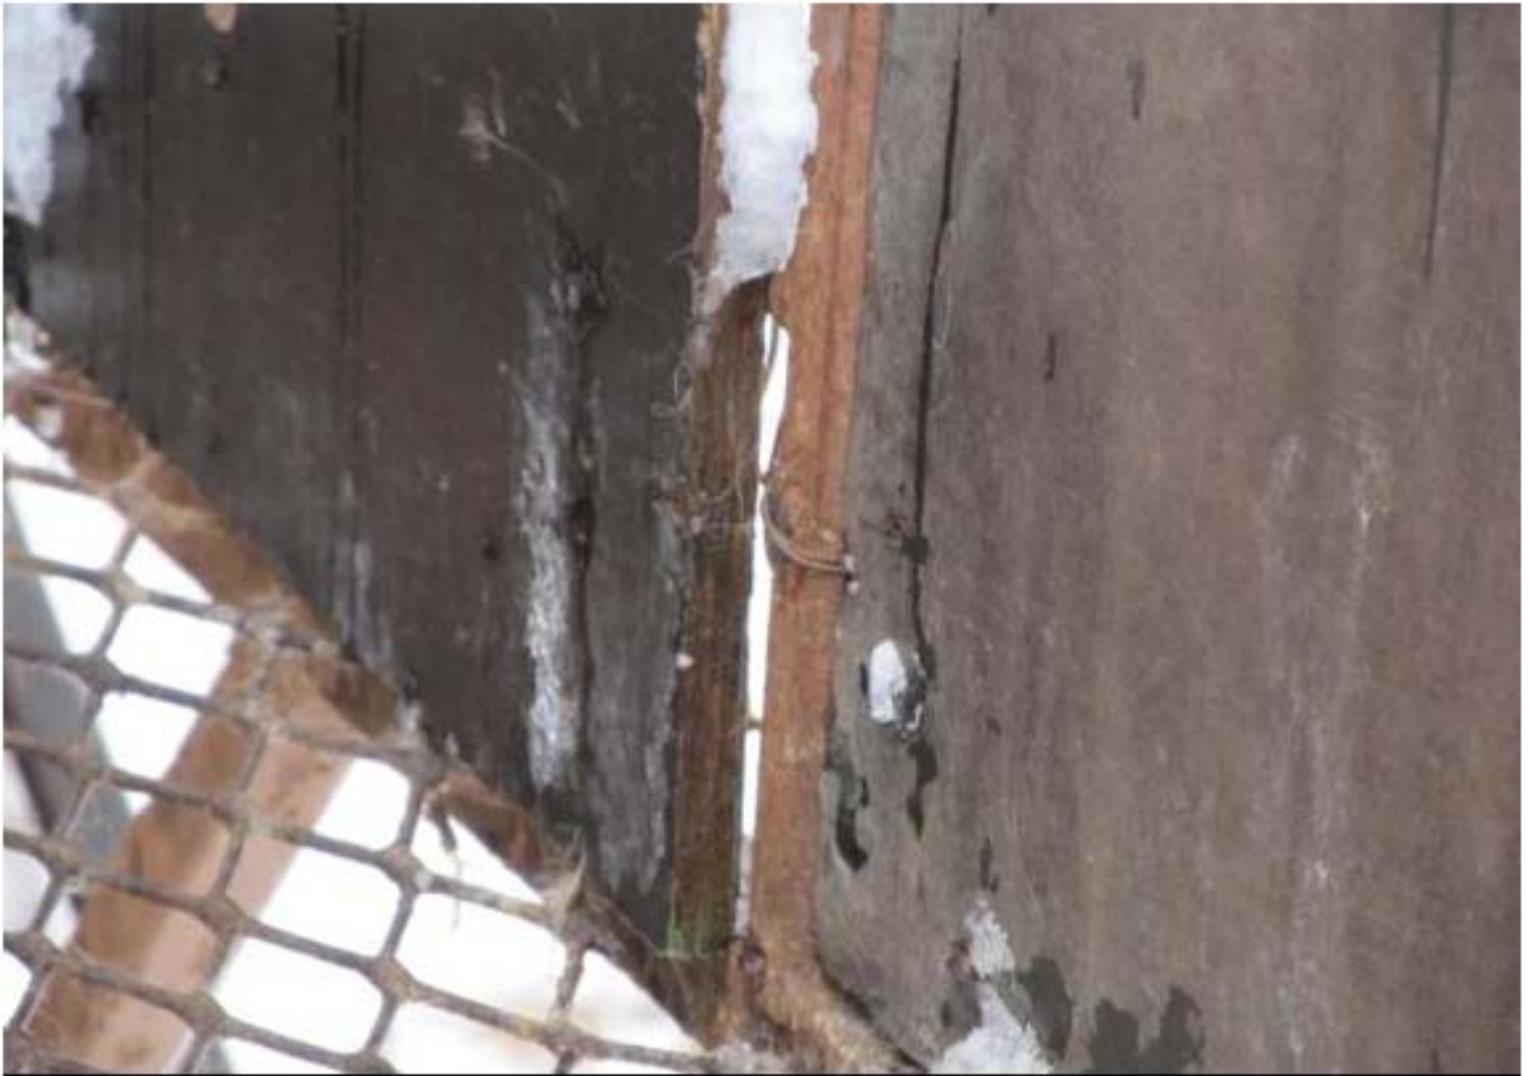
FOIA11-282001034

Photographer:	Heather Cole	Legal Name:	Registration:	42-A-1438
Photo Taken:	Wed, Dec 22, '10	Menno Borntreger		
Inspection:	356101519380479	Toby Borntreger		
Description:	Close-up of the floor of an outside run of the North kennel. Flaking rust is present on the floor of the cage where the wire coating has worn off.

CFR: 3.1 (c) (1) (i)
