Photographer: Heather Cole, VMO      Legal Name: PAMELA SELLNER      Registration: 42-C-0084  
Photo Taken: Mon, Nov 22, '10 approximately 1100      TOM SELLNER  
Inspection: 326101741280061  
Description:

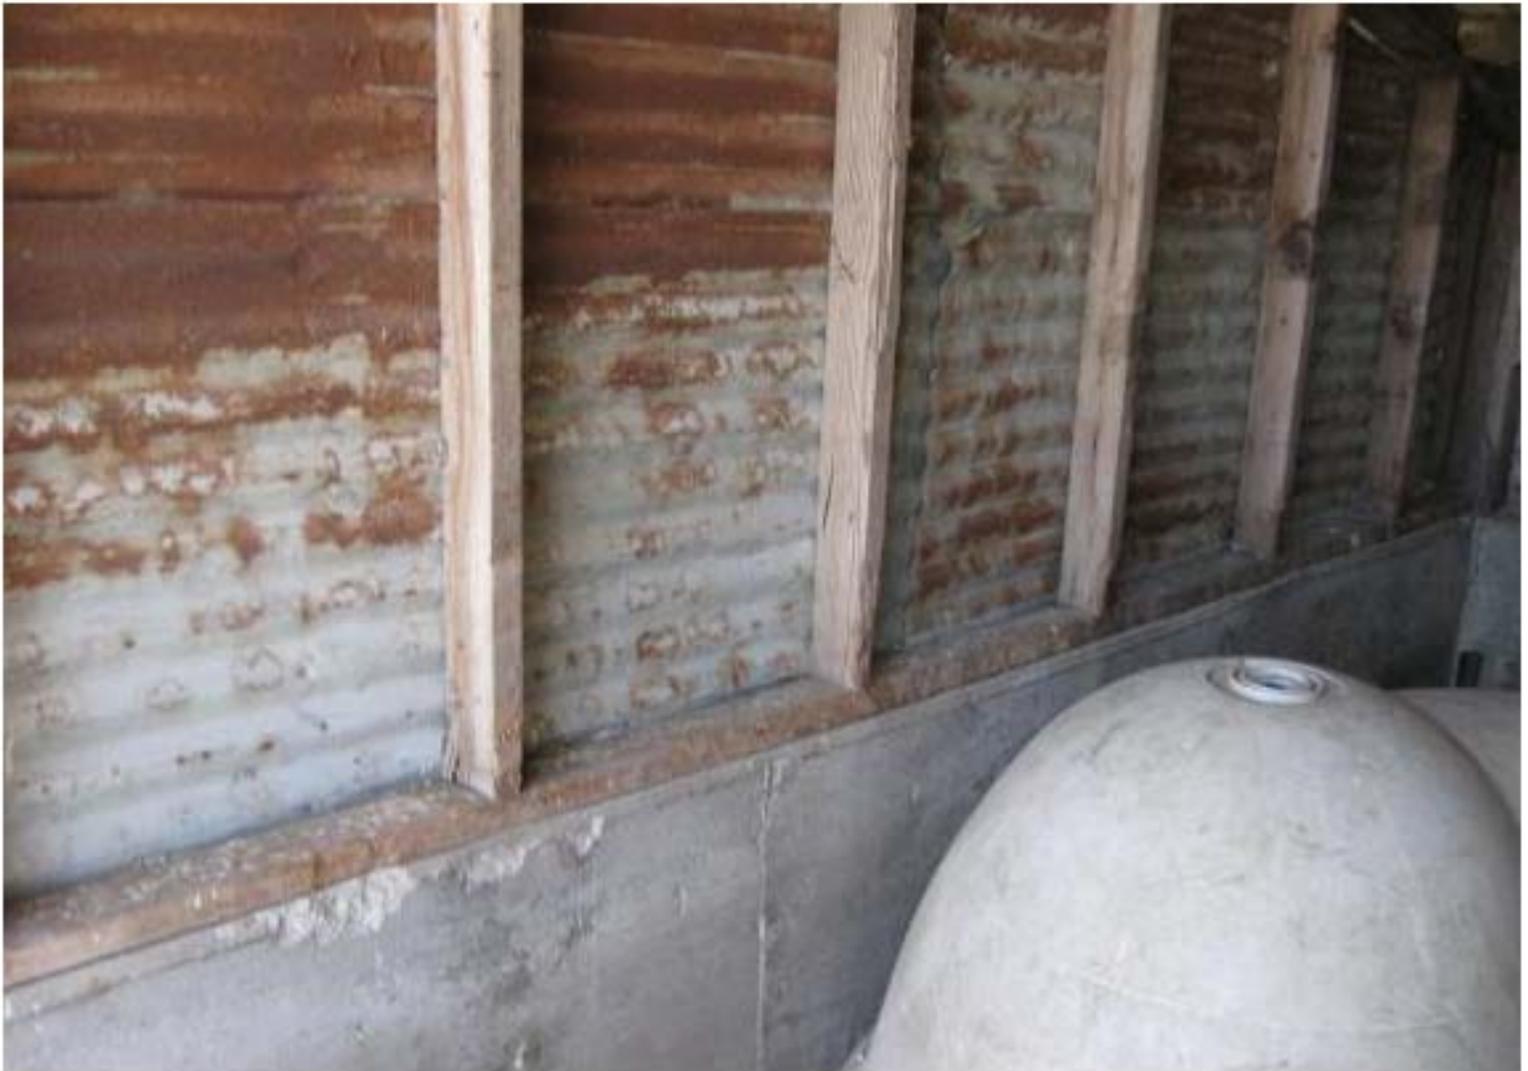
Photographer:	John J. Lies, ACI	Legal Name:	Registration:	42-A-1431
Photo Taken:	Tue, May 4, '10 A.M.	Ivan Yoder		
Inspection:	124100831140632			
Description:	3.6 (a)(2)(ix): Primary Enclosures. Surfaces: Rusted tin and bare wood

CFR: 3.6 (a) (2) (ix)
