Photographer:	Tracy Thompson	Legal Name:	42-R-0044
Photo Taken:	Fri, Sep 17, '10 10:03 AM	EXEMPLAR GENETICS	
Inspection:	260100001290326		
Description:	Numerous flies all over the surfaces, feed, animals, and excreta where research and "B" license animals are housed.

Photographer:	Tracy Thompson	Legal Name:	42-B-0270
Photo Taken:	Fri, Sep 17, '10 11:14 AM	EXEMPLAR GENETICS	
Inspection:	260100039360229		
Description:	Yucatan pig showing overgrown hooves and "flat-foot" due to chronicity of problem on slatted flooring.

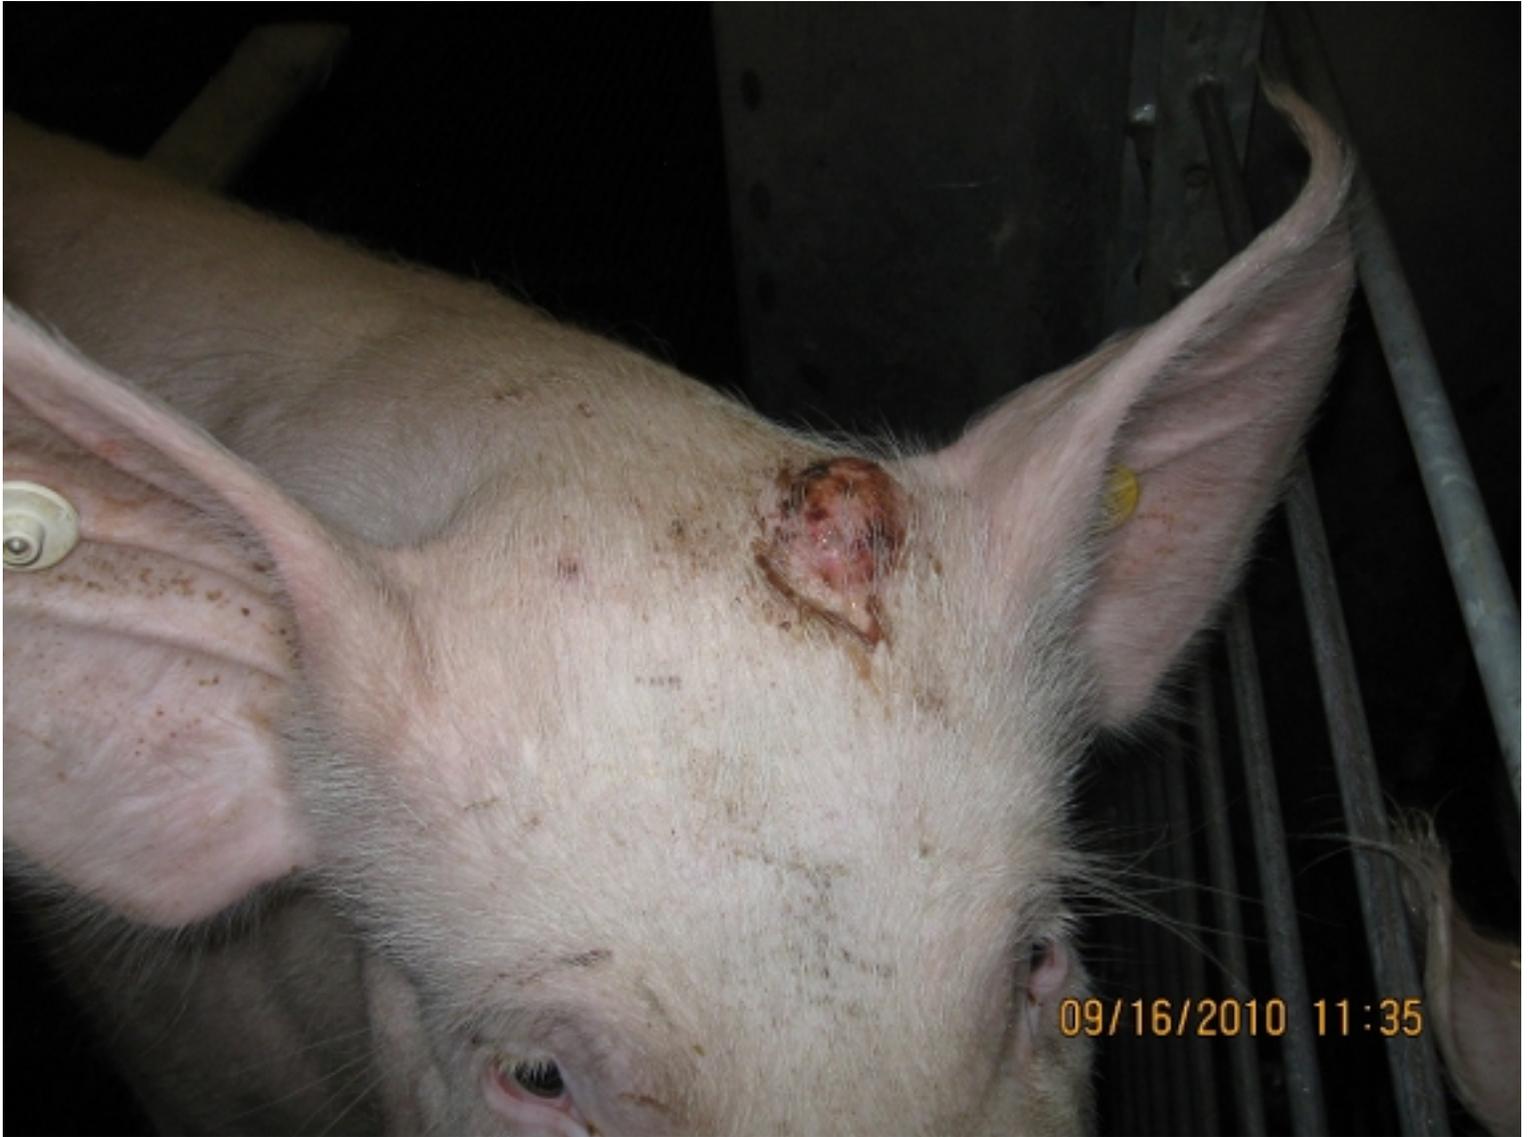
Photographer:	Tracy Thompson	Legal Name:	42-B-0270
Photo Taken:	Fri, Sep 17, '10 11:35 AM	EXEMPLAR GENETICS	
Inspection:	260100039360229		
Description:	Sow #920 with raised, reddened purulent nodule on head.

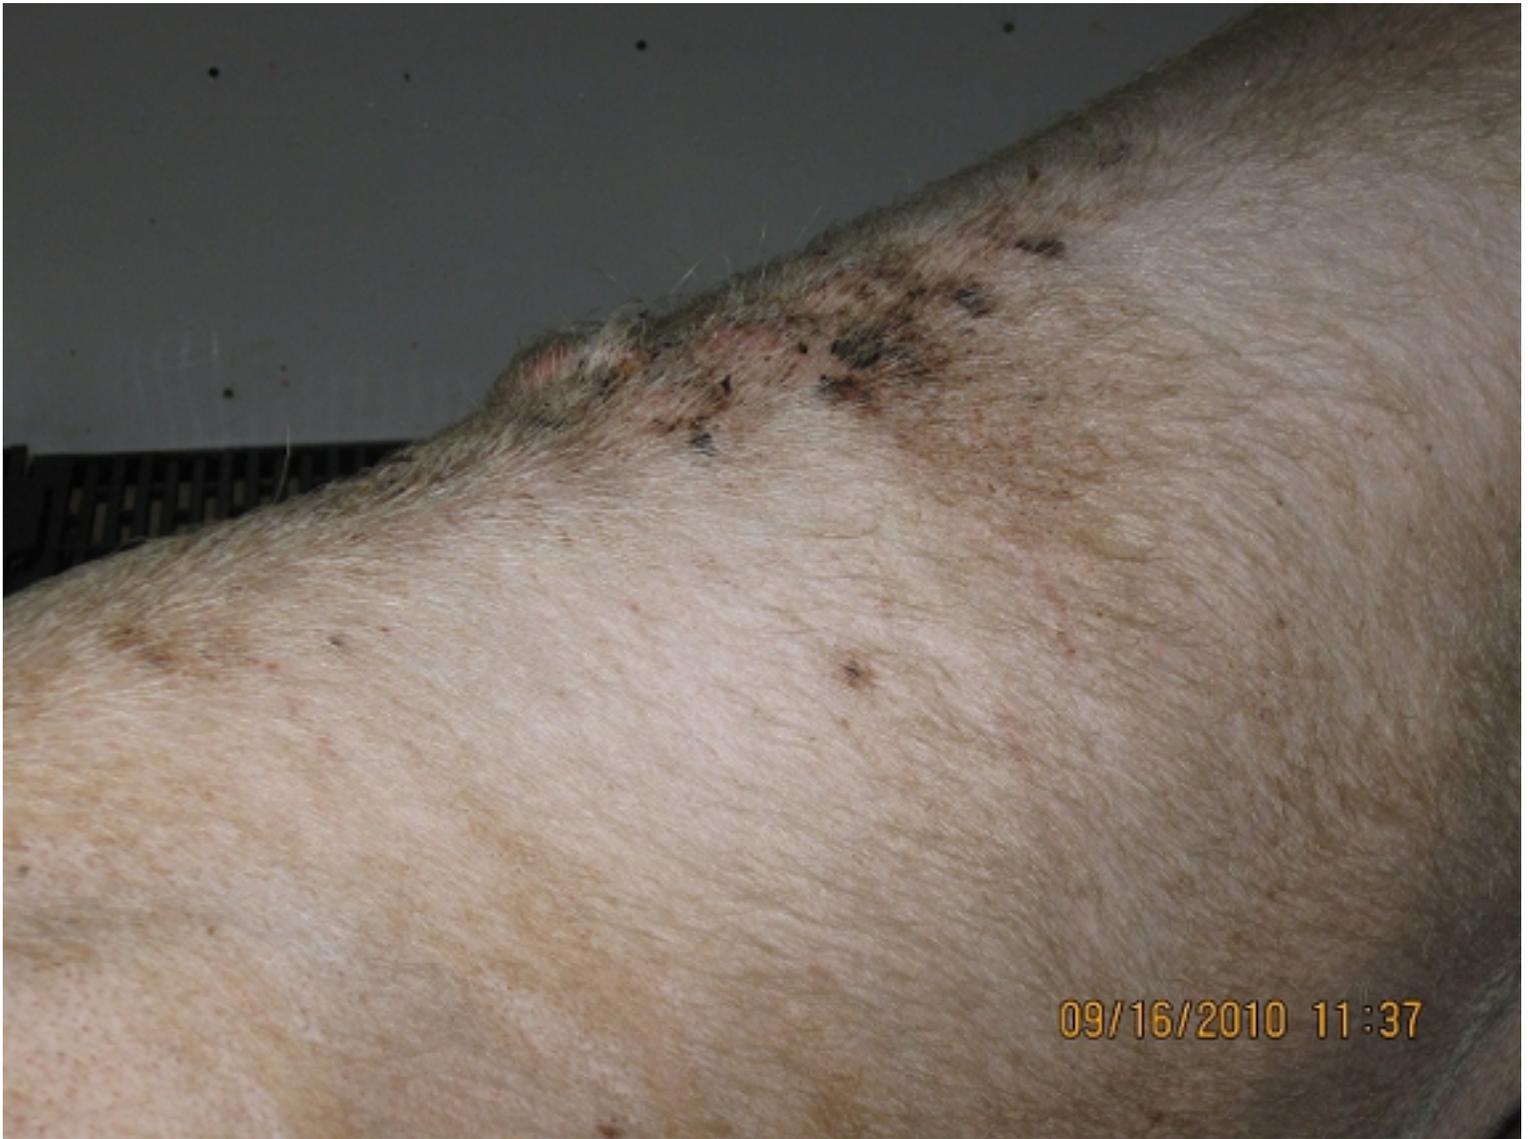
Photographer:	Tracy Thompson	Legal Name:	42-B-0270
Photo Taken:	Fri, Sep 17, '10 11:37 AM	EXEMPLAR GENETICS	
Inspection:	260100039360229		
Description:	Sow #900 with numerous raised, reddened skin nodules over thoracic spine.

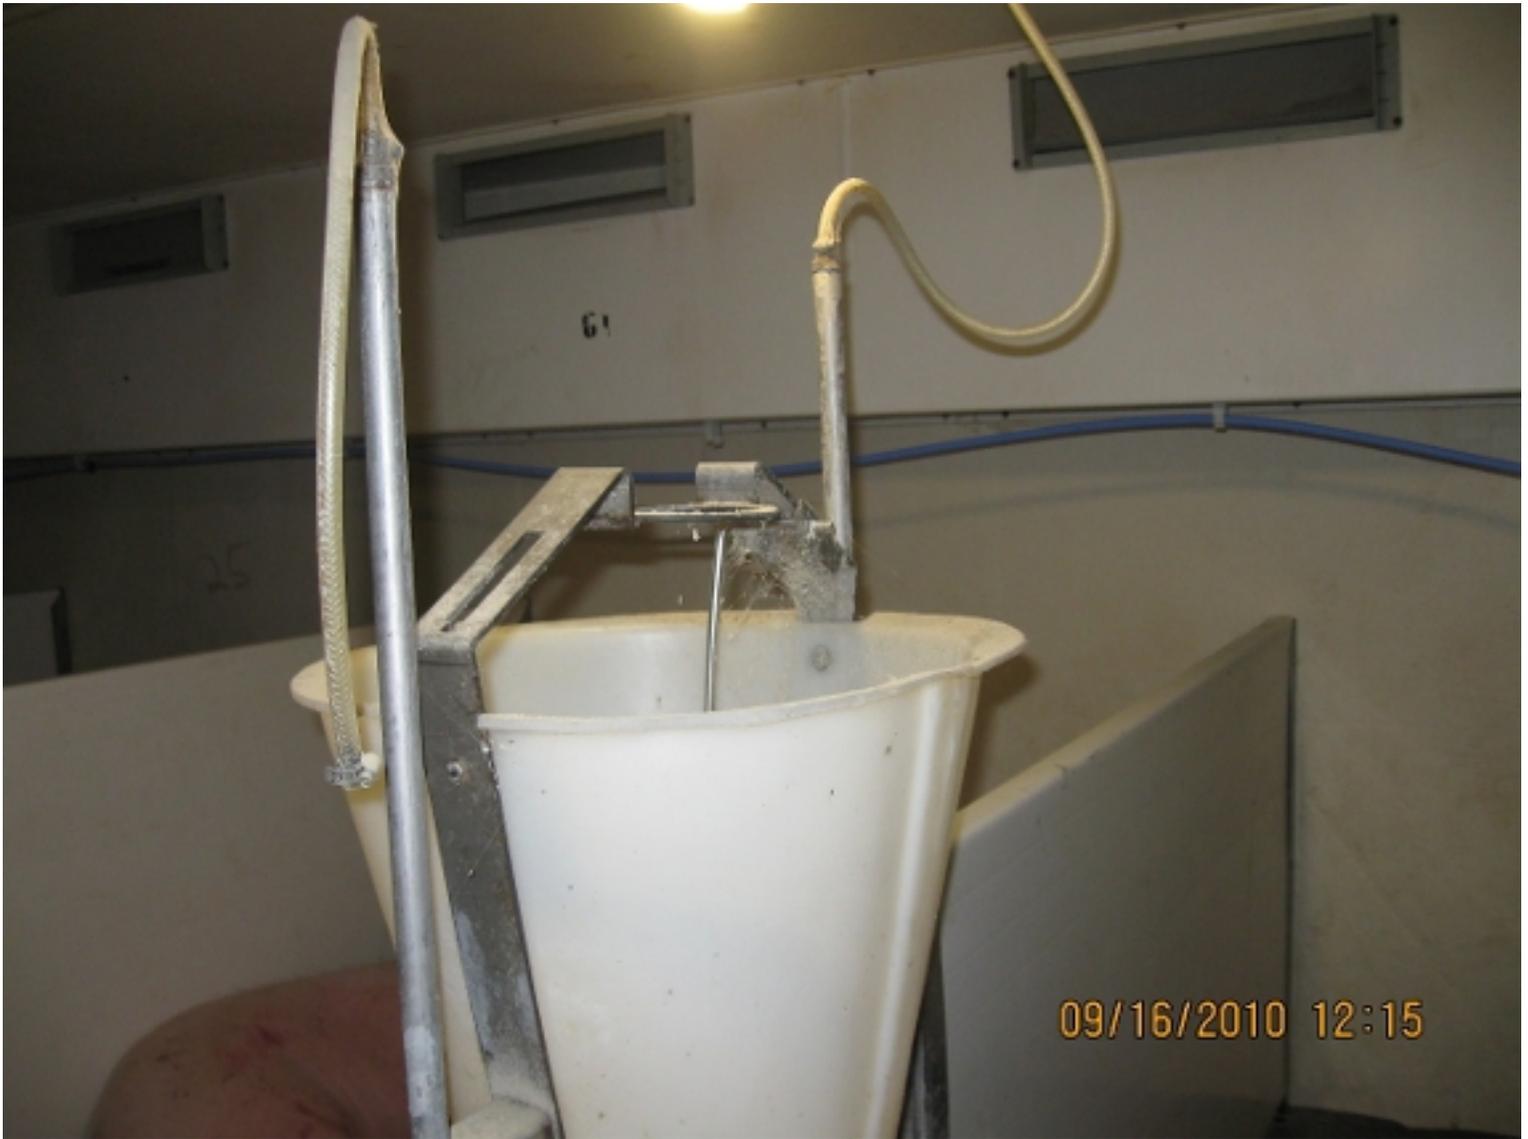
Photographer:	Tracy Thompson	Legal Name:	42-B-0270
Photo Taken:	Fri, Sep 17, '10 13:10 PM	EXEMPLAR GENETICS	
Inspection:	260100039360229		
Description:	Cobwebs, dust, and debris on feeder for 3 gilts.

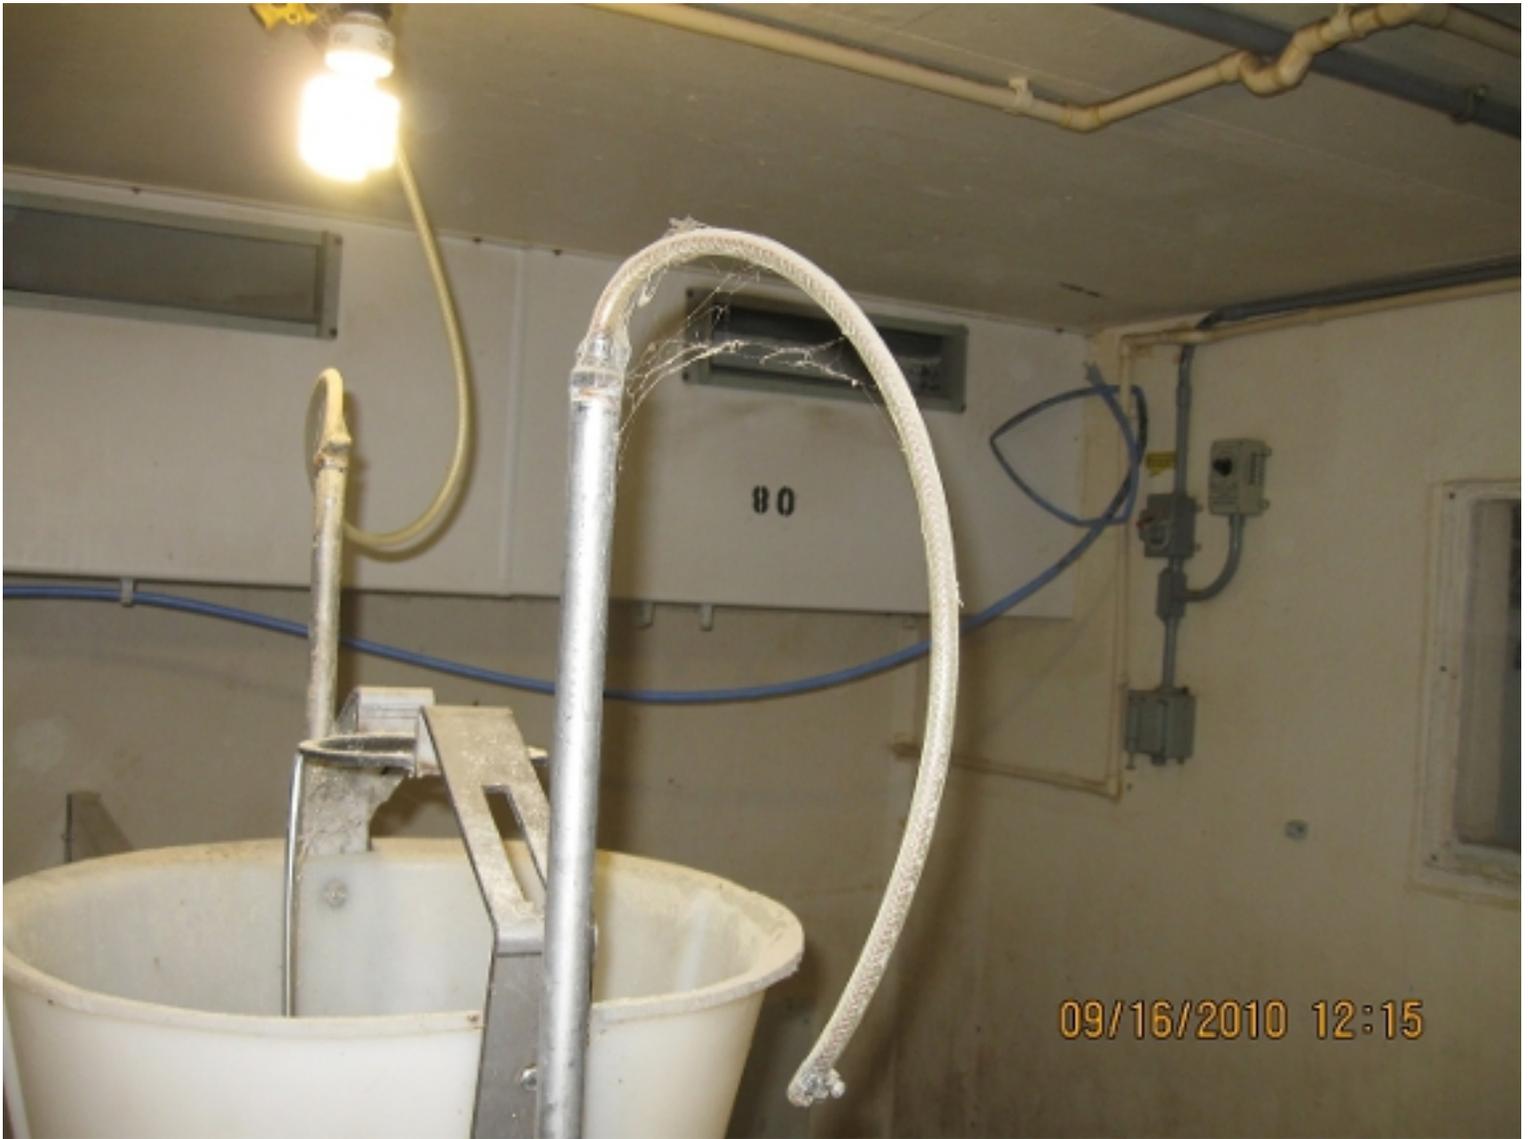
Photographer:	Tracy Thompson	Legal Name:	42-B-0270
Photo Taken:	Fri, Sep 17, '10 13:10 PM	EXEMPLAR GENETICS	
Inspection:	260100039360229		
Description:	Cobwebs, dust, and debris on feeder for 3 gilts.

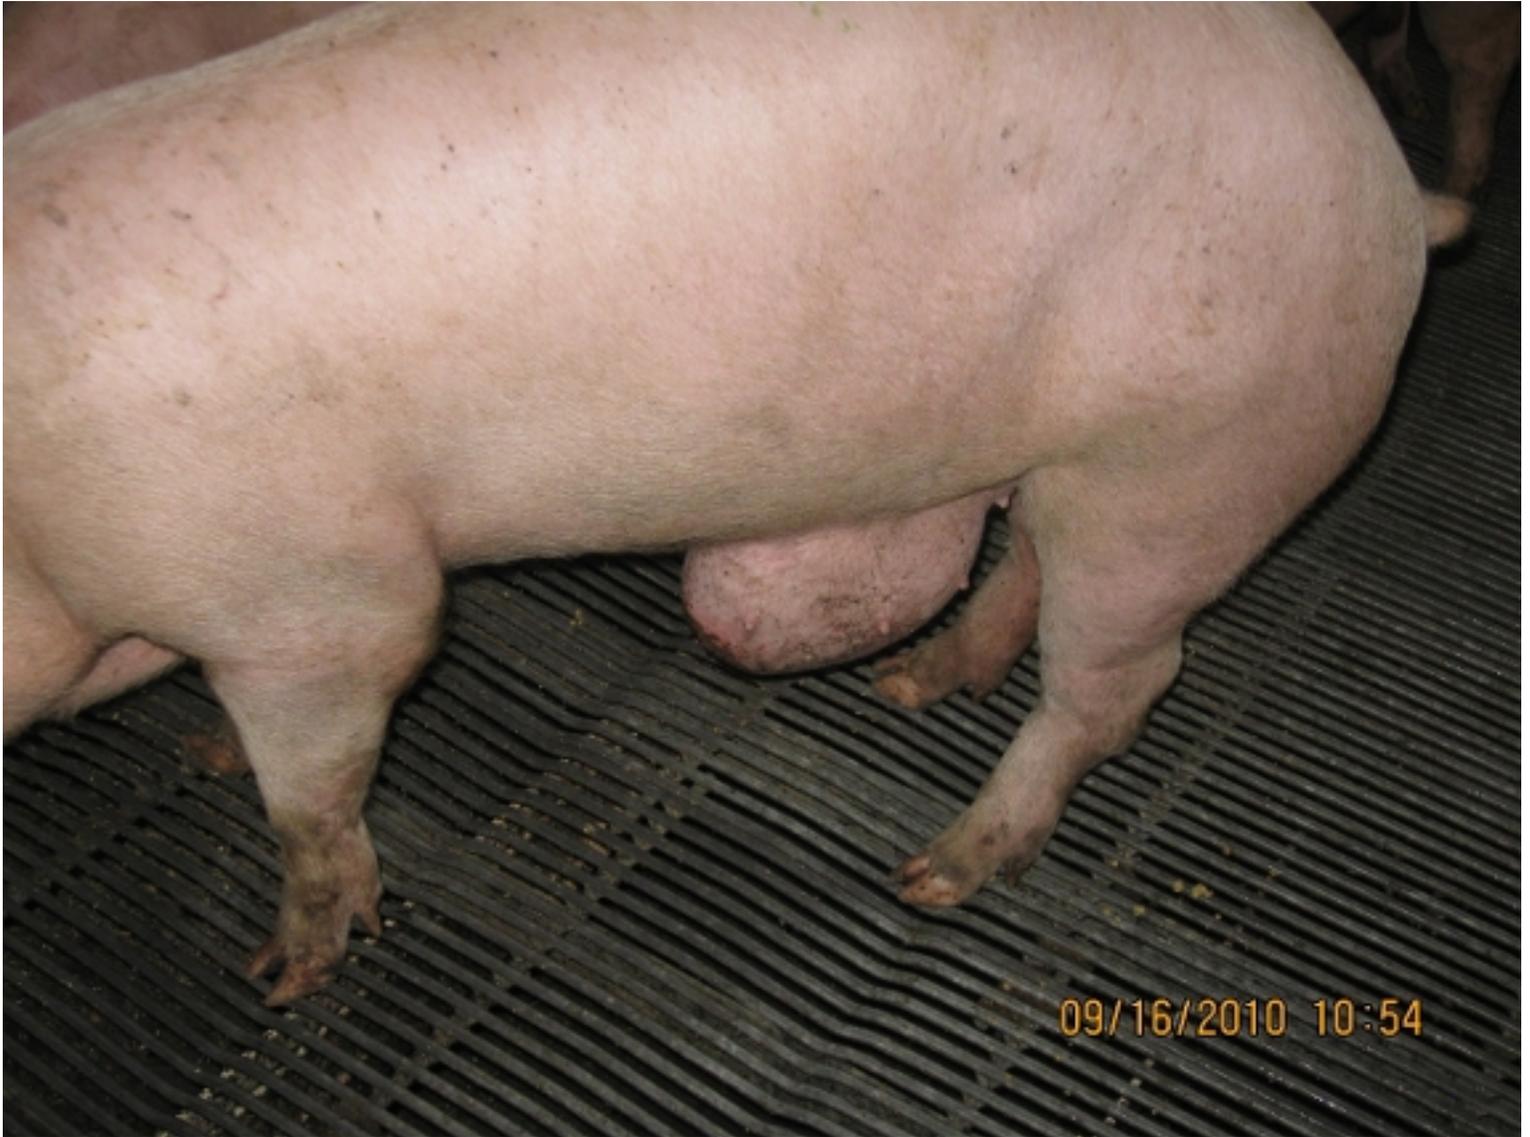
Photographer:	Tracy Thompson	Legal Name:	42-B-0270
Photo Taken:	Fri, Sep 17, '10 10:54 AM	EXEMPLAR GENETICS	
Inspection:	260100039360229		
Description:	Pig #5022 with pendulous abdominal swelling.

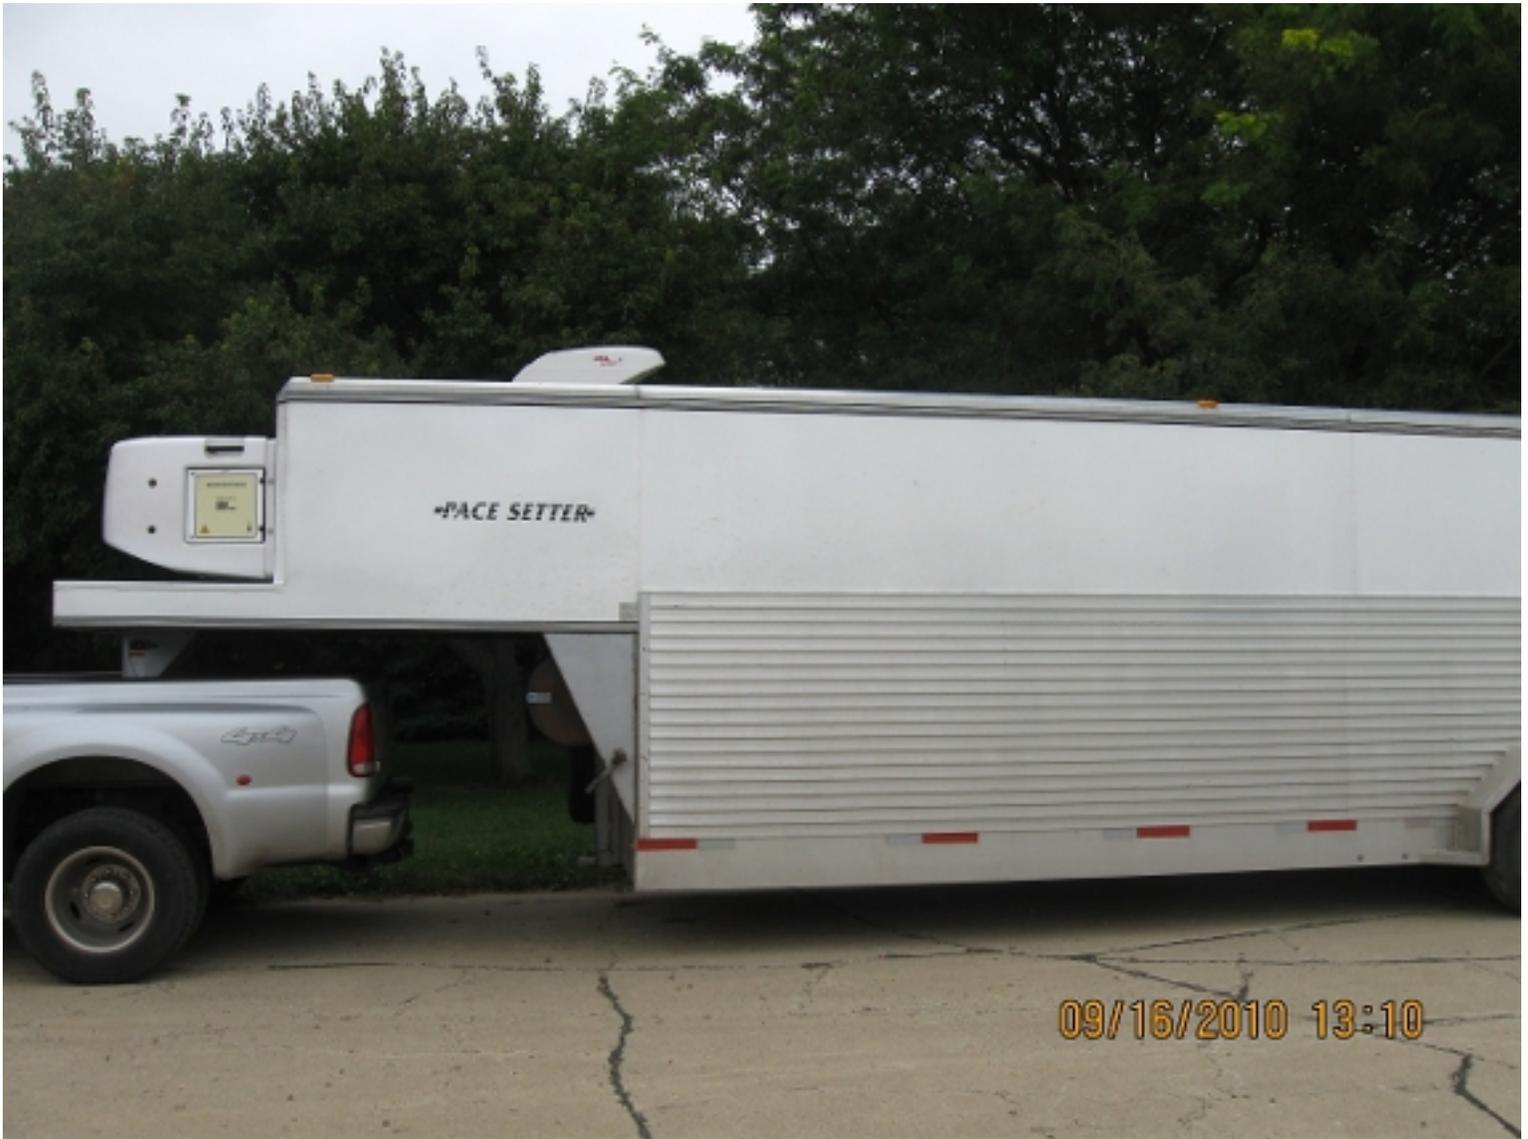
Photographer:	Tracy Thompson	Legal Name:	42-B-0270
Photo Taken:	Fri, Sep 17, '10 13:10 PM	EXEMPLAR GENETICS	
Inspection:	260100039360229		
Description:	Overview of primary conveyance where 39 pigs perished on 9/12/10 between 21:00 and 05:45

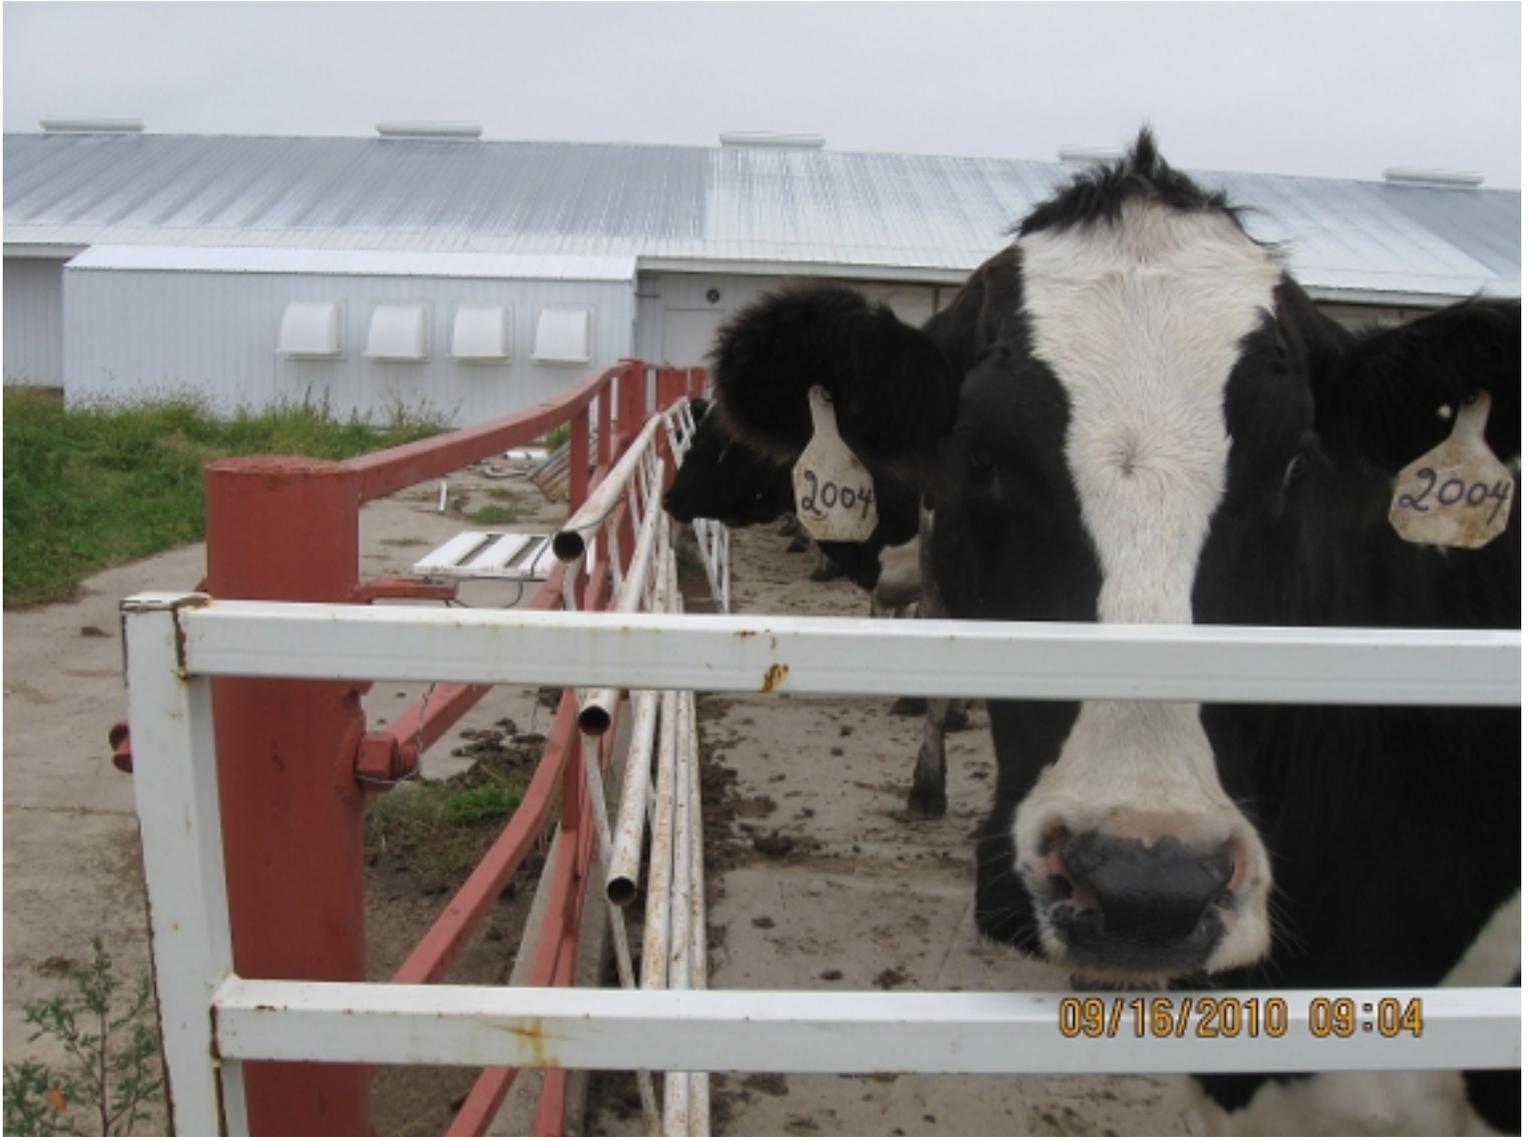
Photographer:	Tracy Thompson	Legal Name:	42-B-0270
Photo Taken:	Fri, Sep 17, '10 09:04 AM	EXEMPLAR GENETICS	
Inspection:	260100039360229		
Description:	Unnecessary cattle panels in outdoor housing for 17 cows.

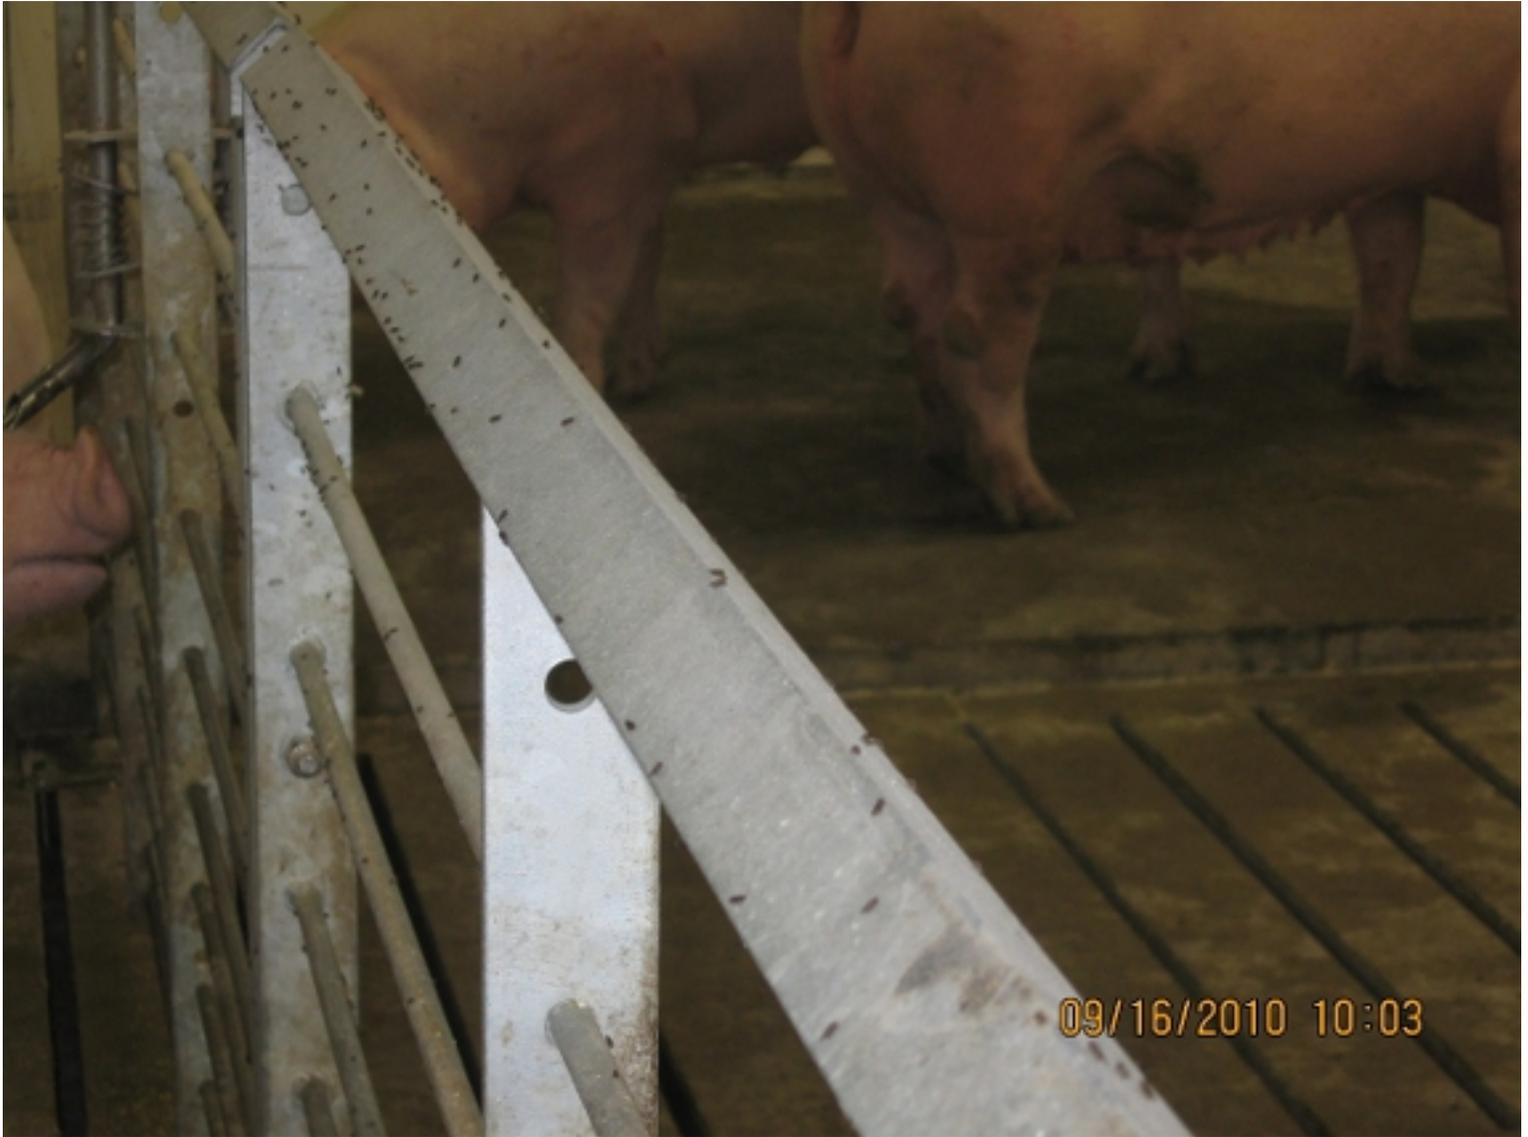
Photographer:	Tracy Thompson	Legal Name:	42-B-0270
Photo Taken:	Fri, Sep 17, '10 10:03 AM	EXEMPLAR GENETICS	
Inspection:	260100039360229		
Description:	Numerous flies on surfaces in #3 indoor housing facility for pigs

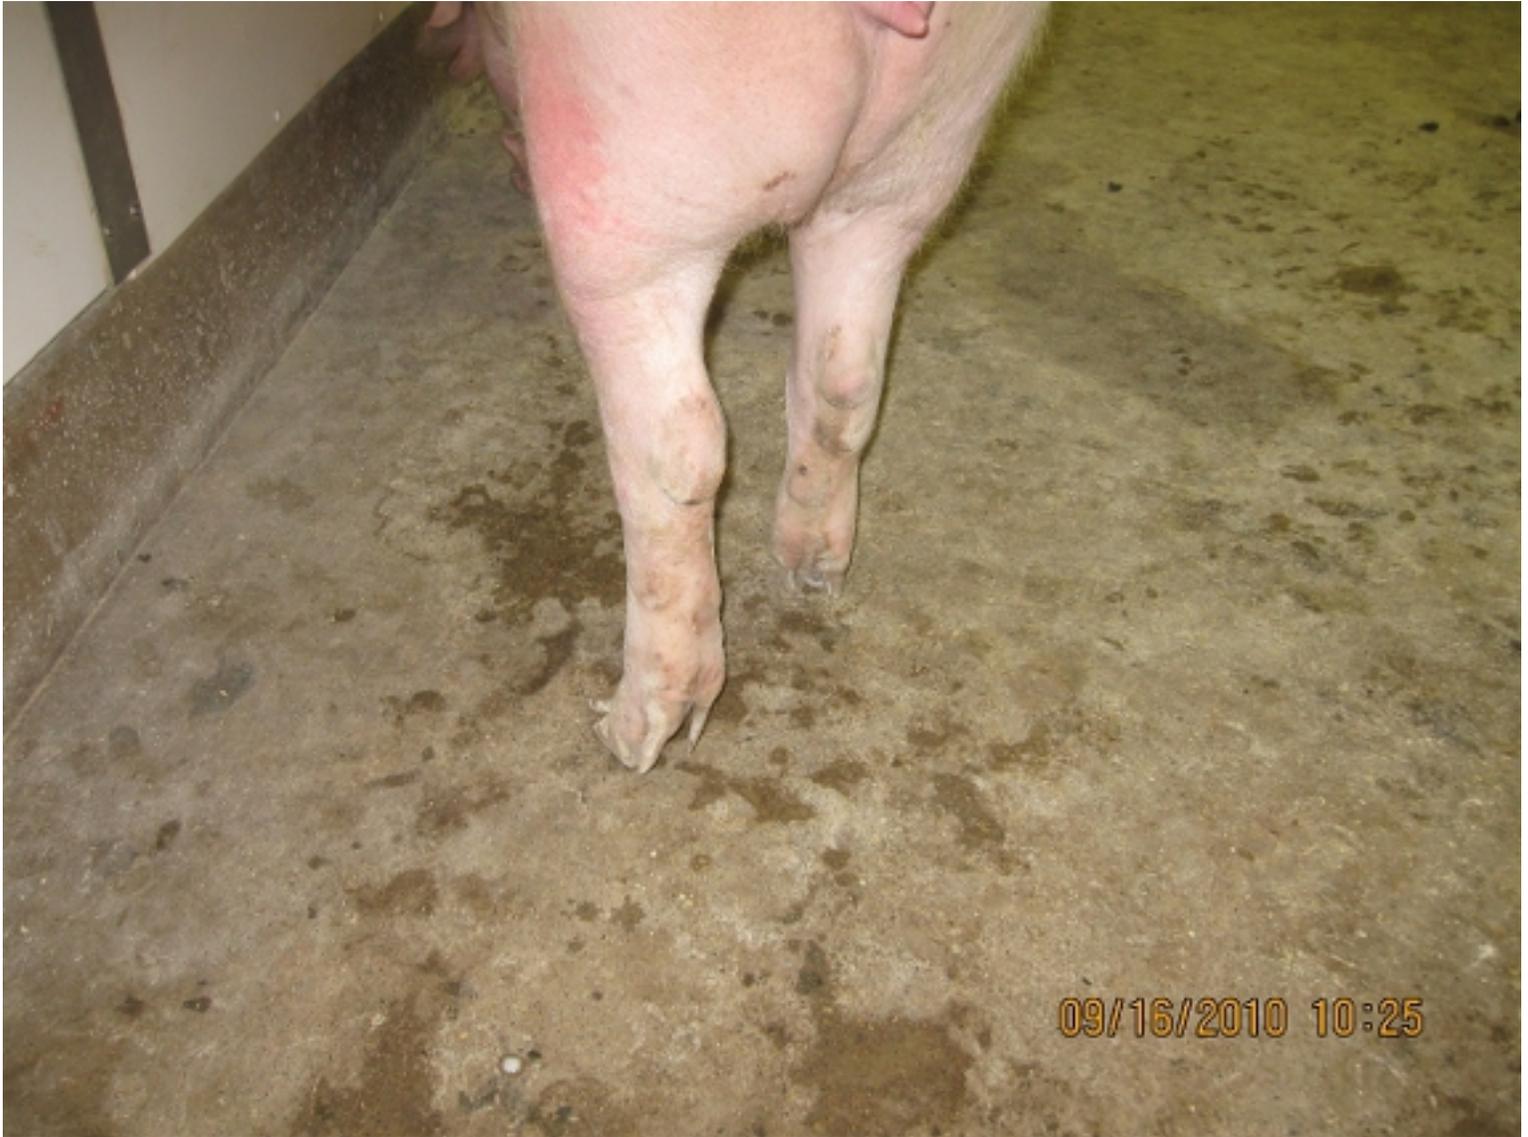
Photographer:	Tracy Thompson	Legal Name:	42-B-0270
Photo Taken:	Fri, Sep 17, '10 10:25 AM	EXEMPLAR GENETICS	
Inspection:	260100039360229		
Description:	Sow #423 with overgrown hooves and lameness that appears to be due to either a swelling or deformity of the left rear foot.

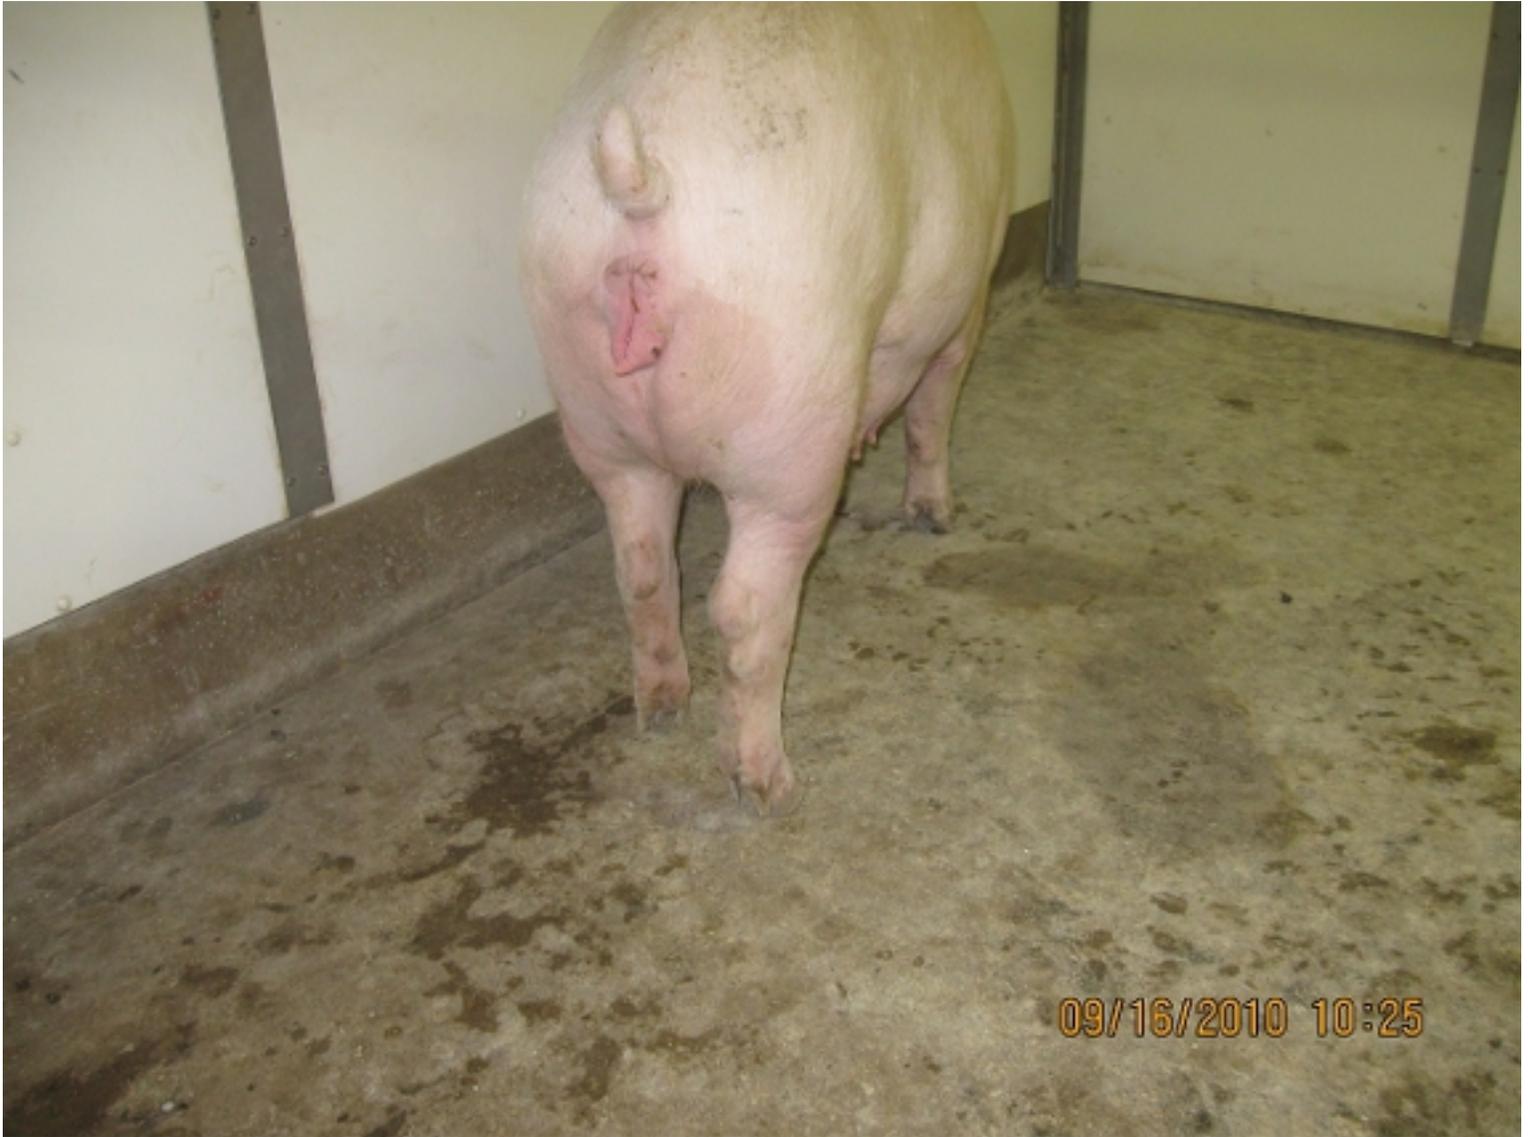
Photographer:	Tracy Thompson	Legal Name:	42-B-0270
Photo Taken:	Fri, Sep 17, '10 10:25 AM	EXEMPLAR GENETICS	
Inspection:	260100039360229		
Description:	Sow #423 with overgrown hooves and lameness that appears to be due to either a swelling or deformity of the left rear foot.

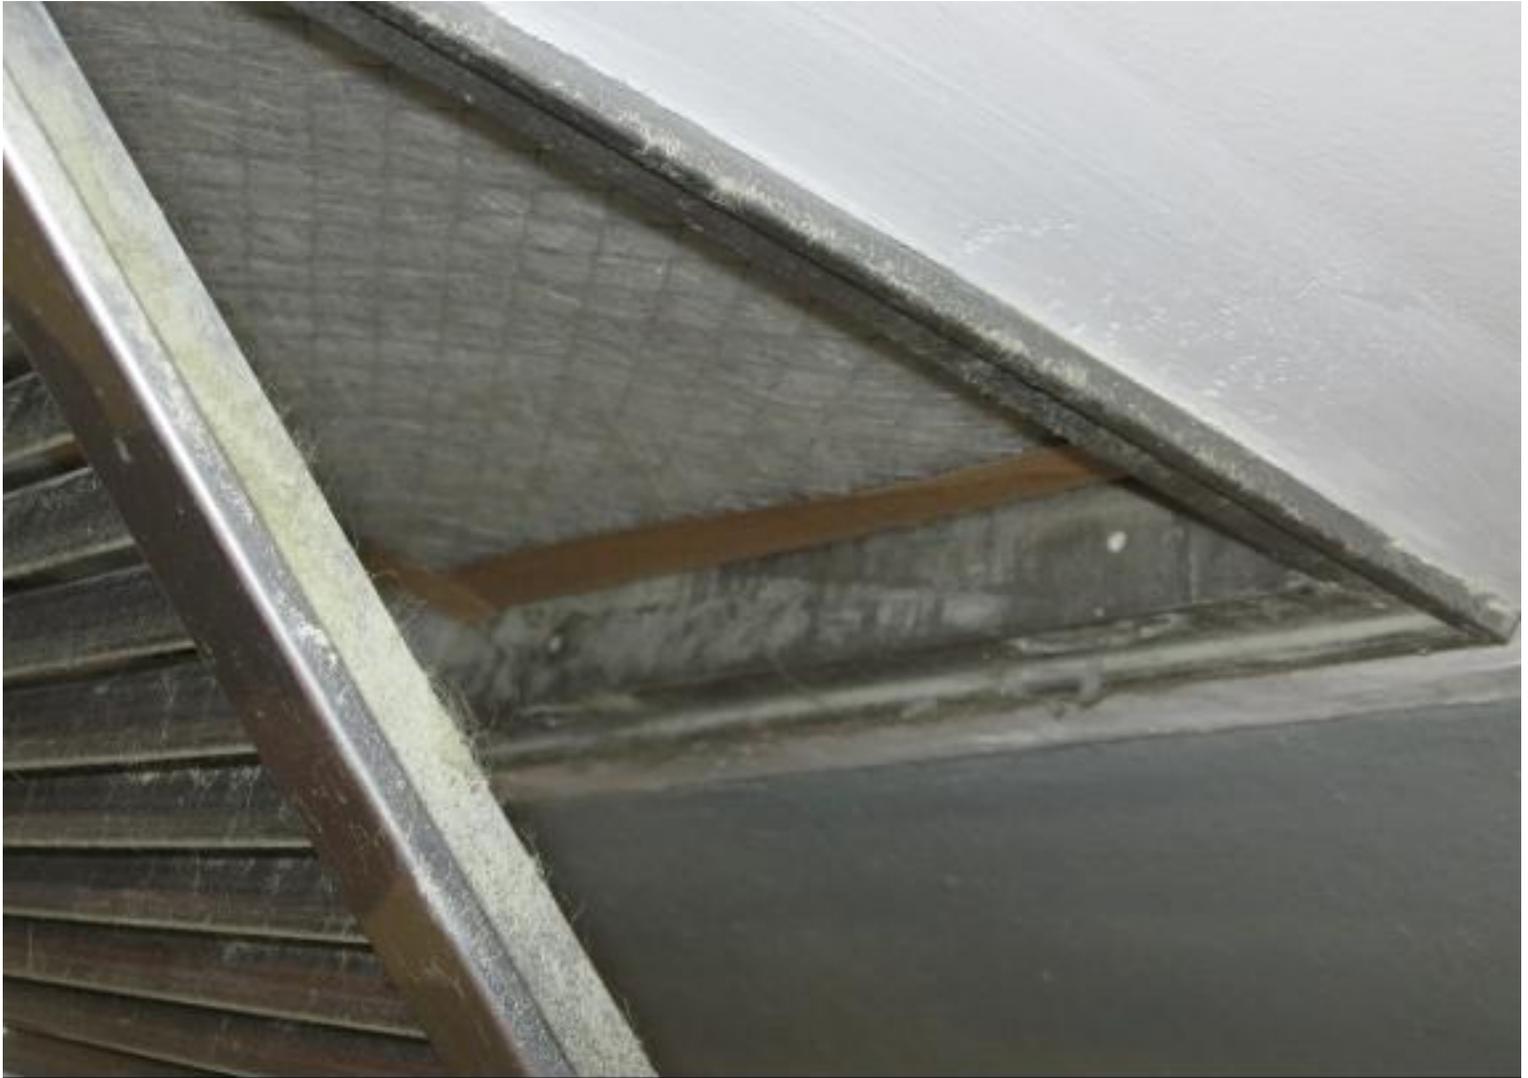
CFR: 3.1 (a)

Photographer:	R. Brandes, D.V.M.	Legal Name:	58-R-0003
Photo Taken:	Fri, May 28, '10 8:30 AM	UNIVERSITY OF FLORIDA	
Inspection:	145101622390914		
Description:	Cat procedure/behavior room. Cats roam freely around in this room They can potentially claw, chew or break through the filter and gain access into the ventilation ducts.

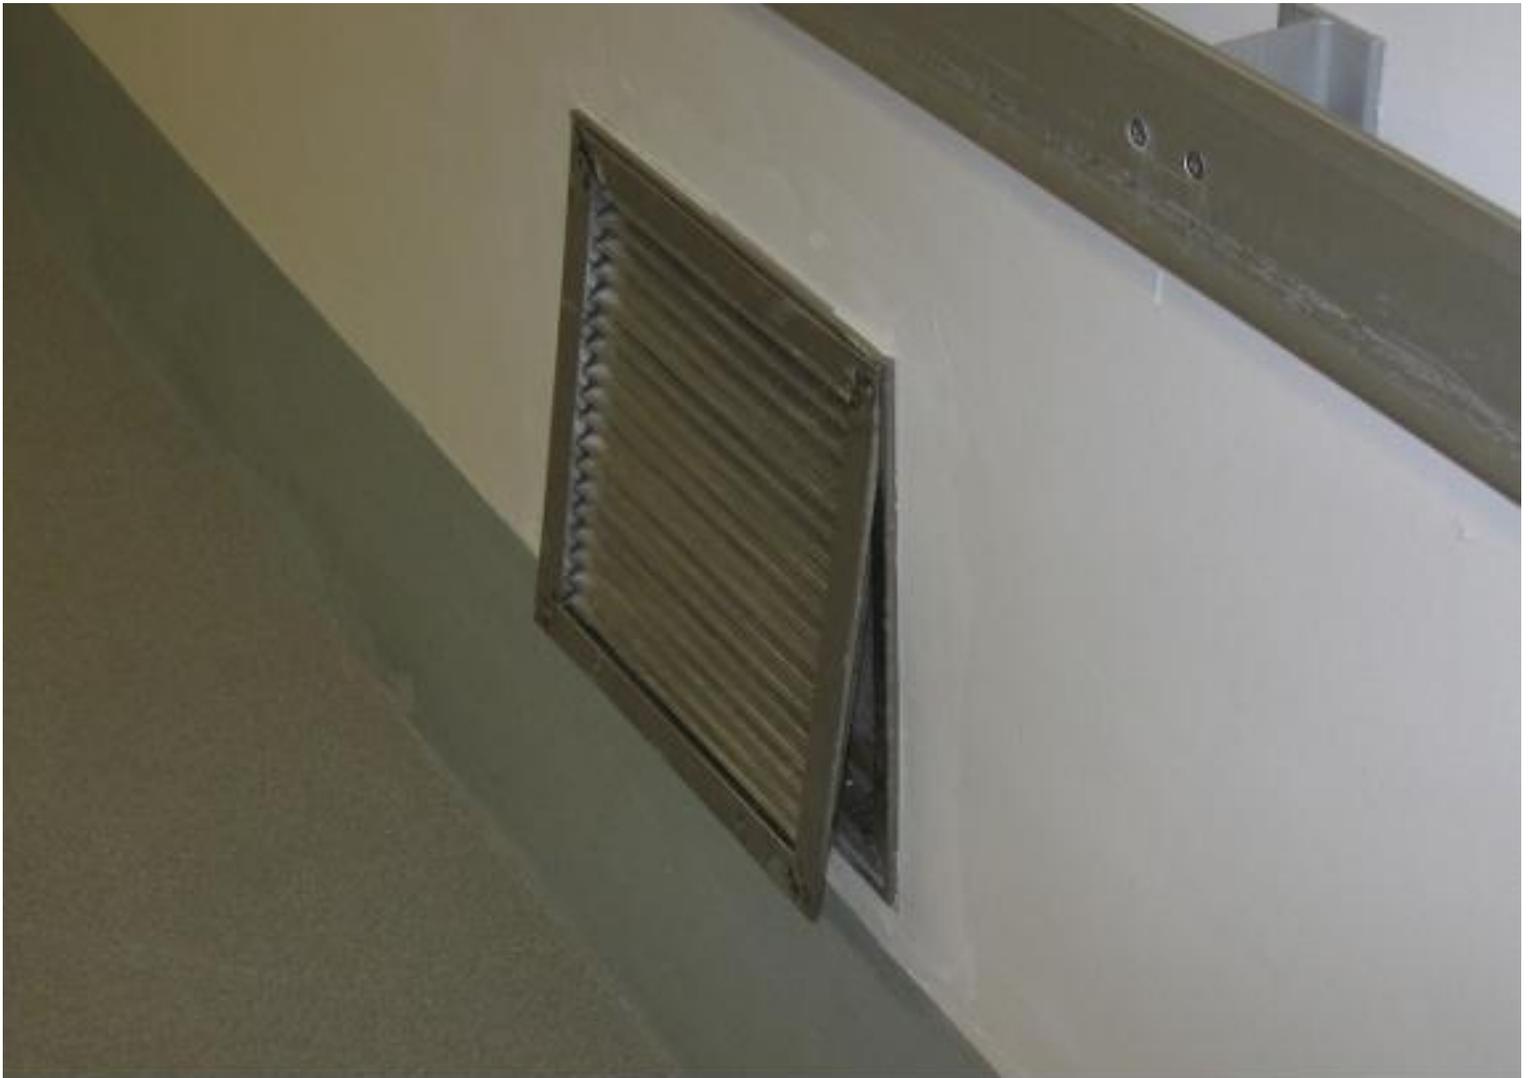
CFR: 3.1 (a)

Photographer:	R. Brandes, D.V.M.	Legal Name:	58-R-0003
Photo Taken:	Fri, May 28, '10 8:30 AM	UNIVERSITY OF FLORIDA	
Inspection:	145101622390914		
Description:	Ventilation grates in cat "Brain" room. Cats do roam freely in this room.

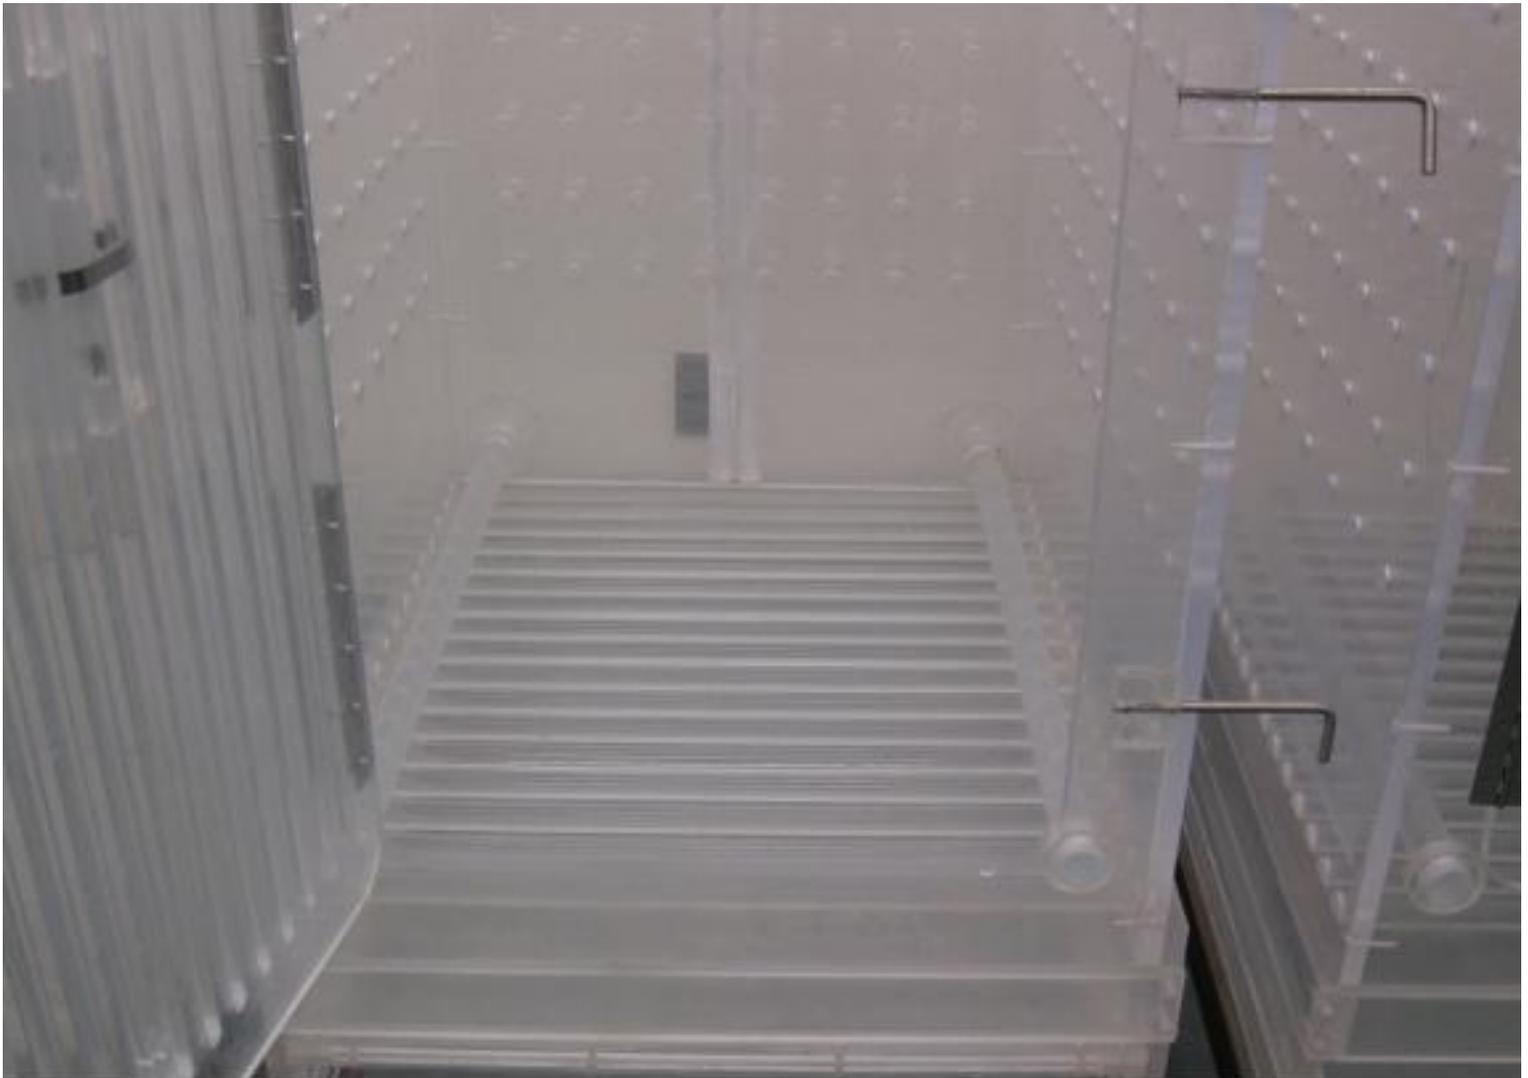
CFR: 3.80

Description: Primate metabolic cage
