Photographer:	Tracy Thompson	Legal Name:	42-R-0044
Photo Taken:	Fri, Sep 17, '10 10:03 AM	EXEMPLAR GENETICS	
Inspection:	260100001290326		
Description:	Numerous flies all over the surfaces, feed, animals, and excreta where research and "B" license animals are housed.

Photographer:	Tracy Thompson	Legal Name:	42-B-0270
Photo Taken:	Fri, Sep 17, '10 11:14 AM	EXEMPLAR GENETICS	
Inspection:	260100039360229		
Description:	Yucatan pig showing overgrown hooves and "flat-foot" due to chronicity of problem on slatted flooring.

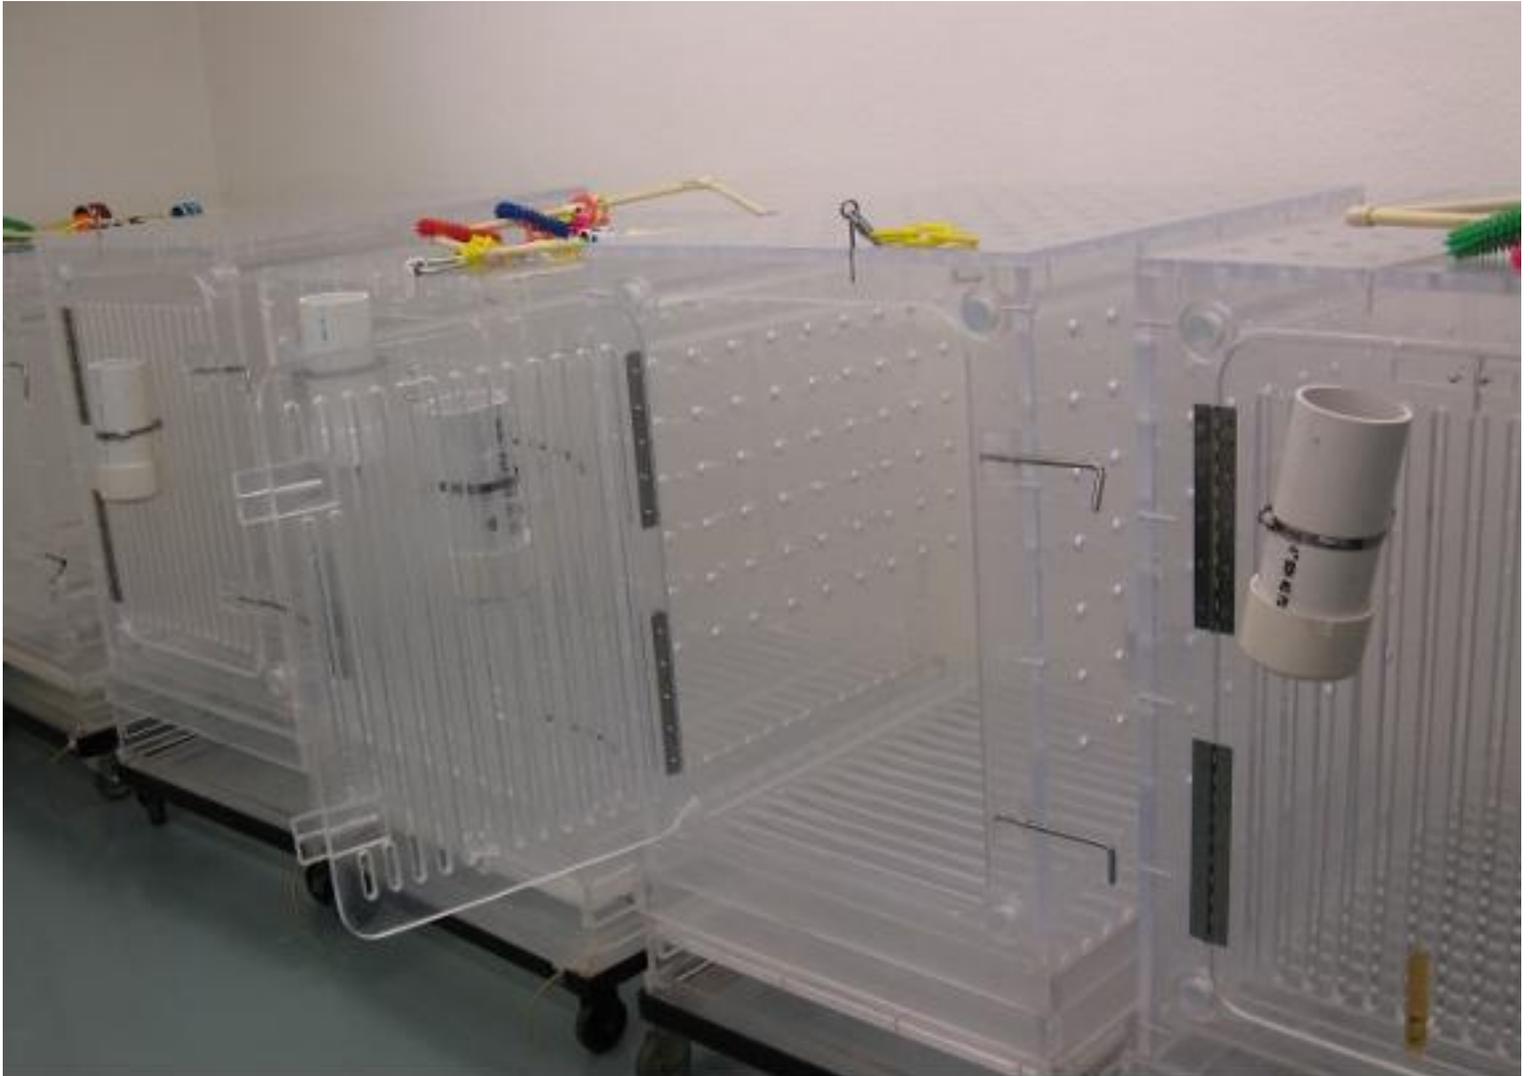
CFR: 3.80

Description: Primate metabolic cage

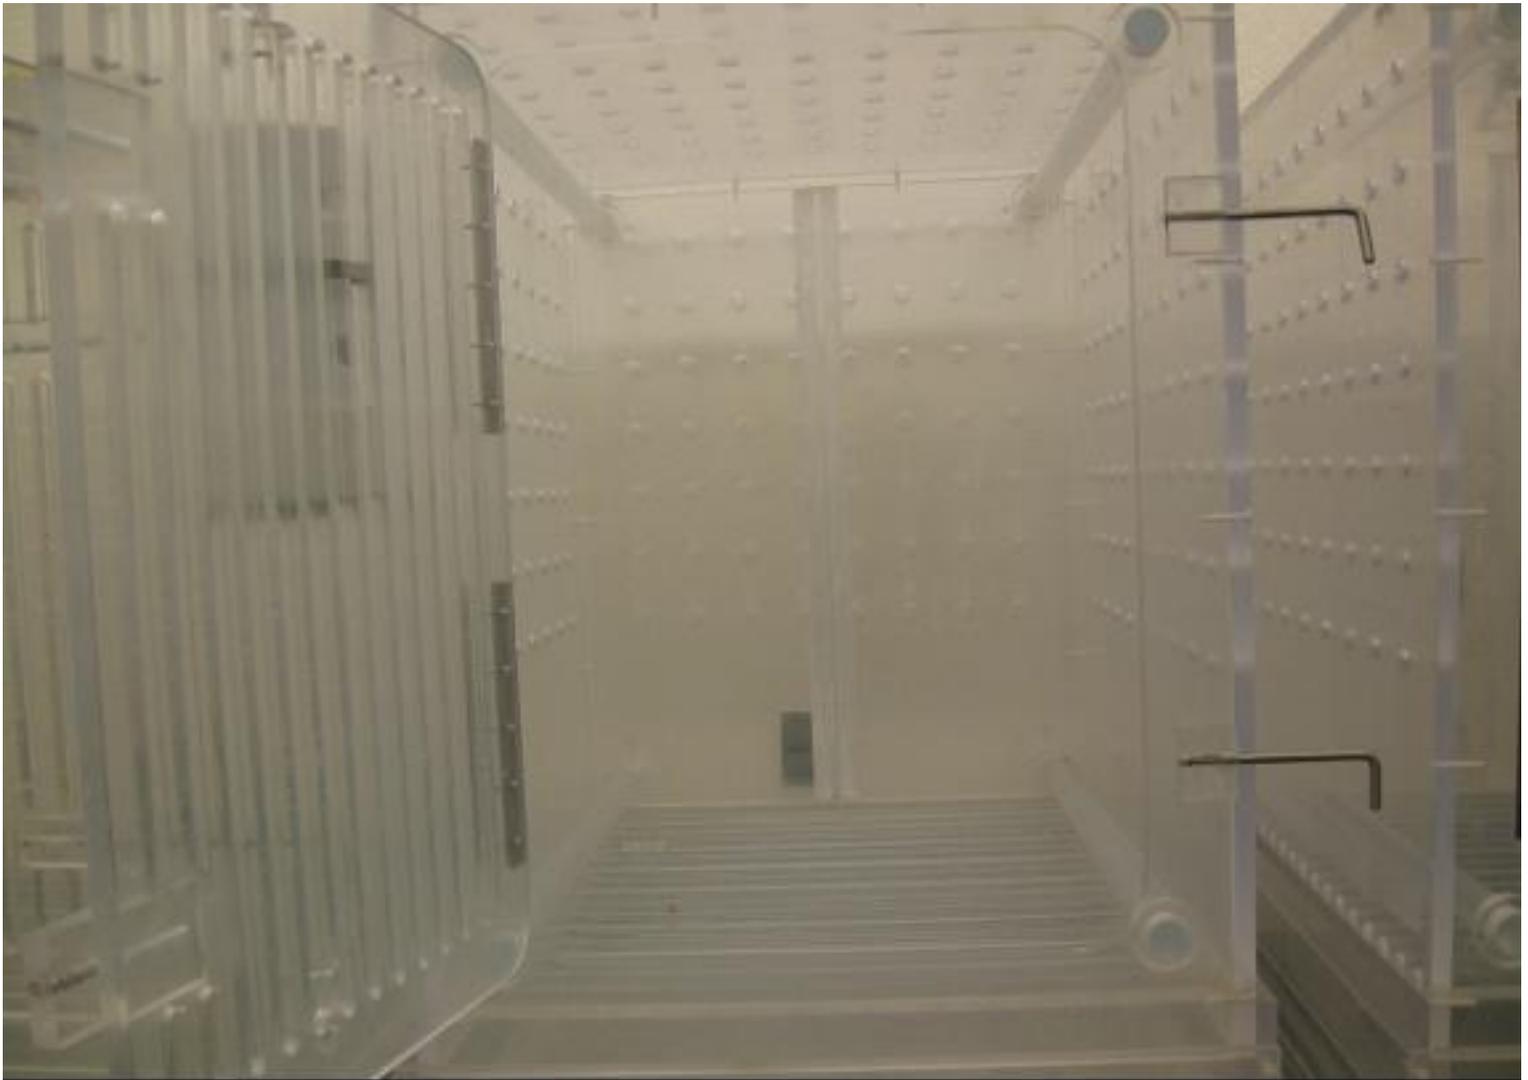
CFR: 3.80

Description: Primate metabolic cage

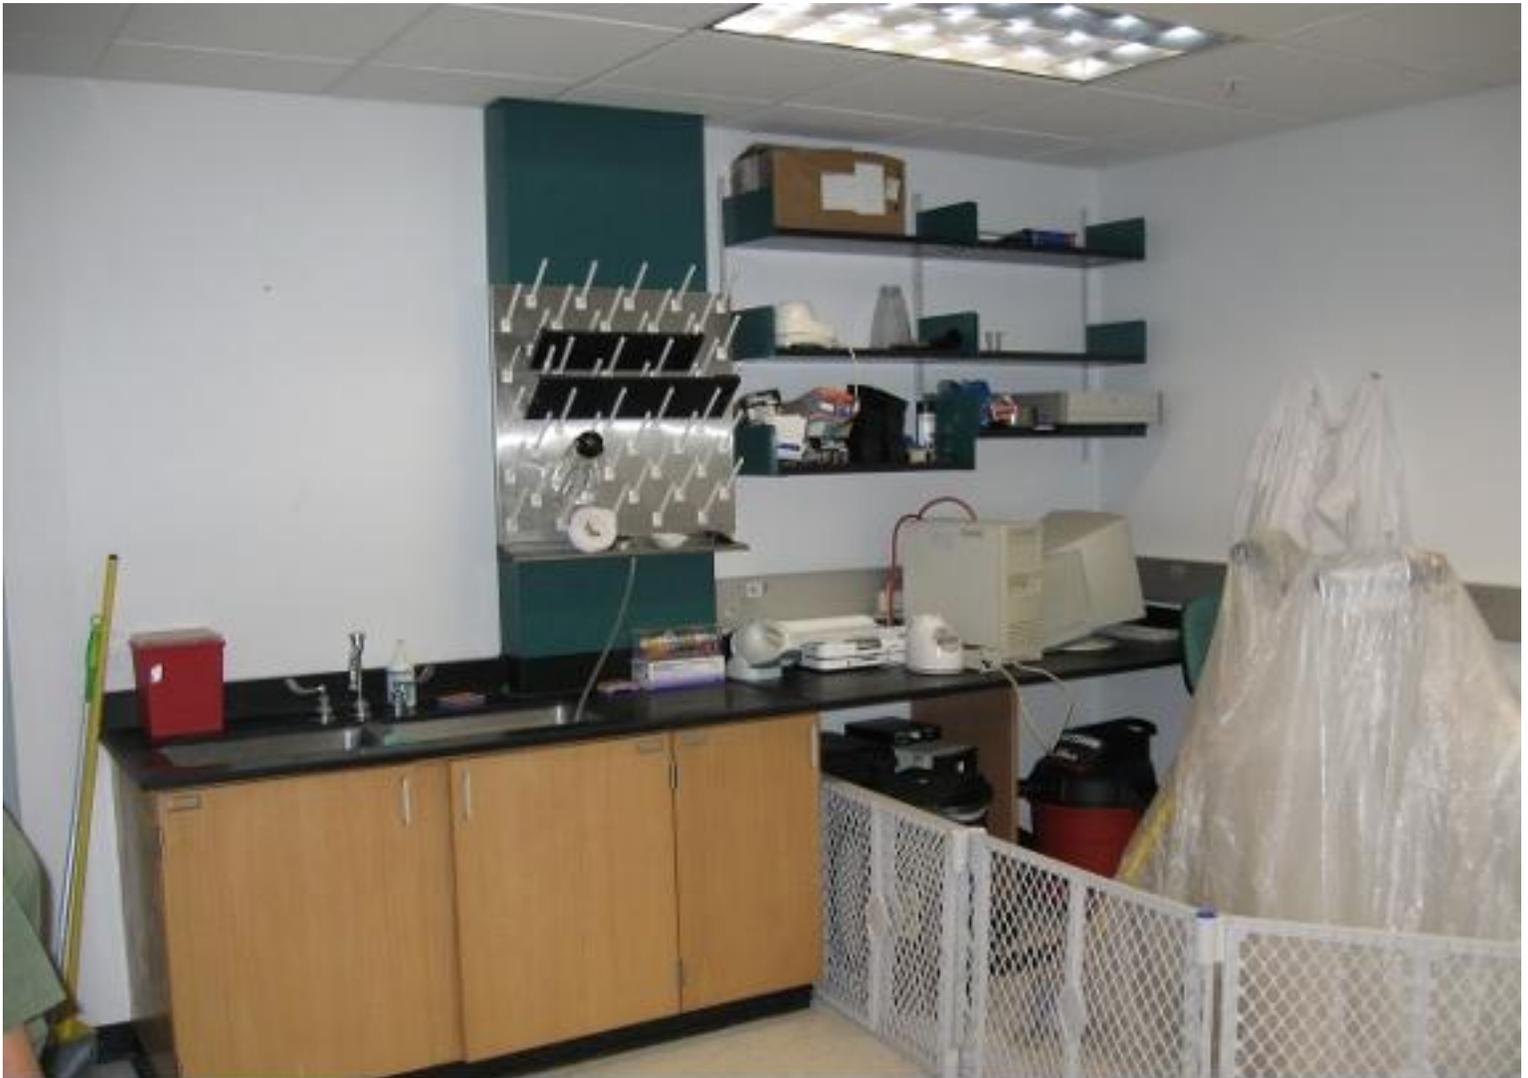
CFR: 3.1 (b)

Photographer:	R. Brandes, D.V.M.	Legal Name:	58-R-0003
Photo Taken:	Fri, May 28, '10 8:25 AM	UNIVERSITY OF FLORIDA	
Inspection:	145101622390914		
Description:	Cat procedure/behavior room. Cats roam freely around in this room

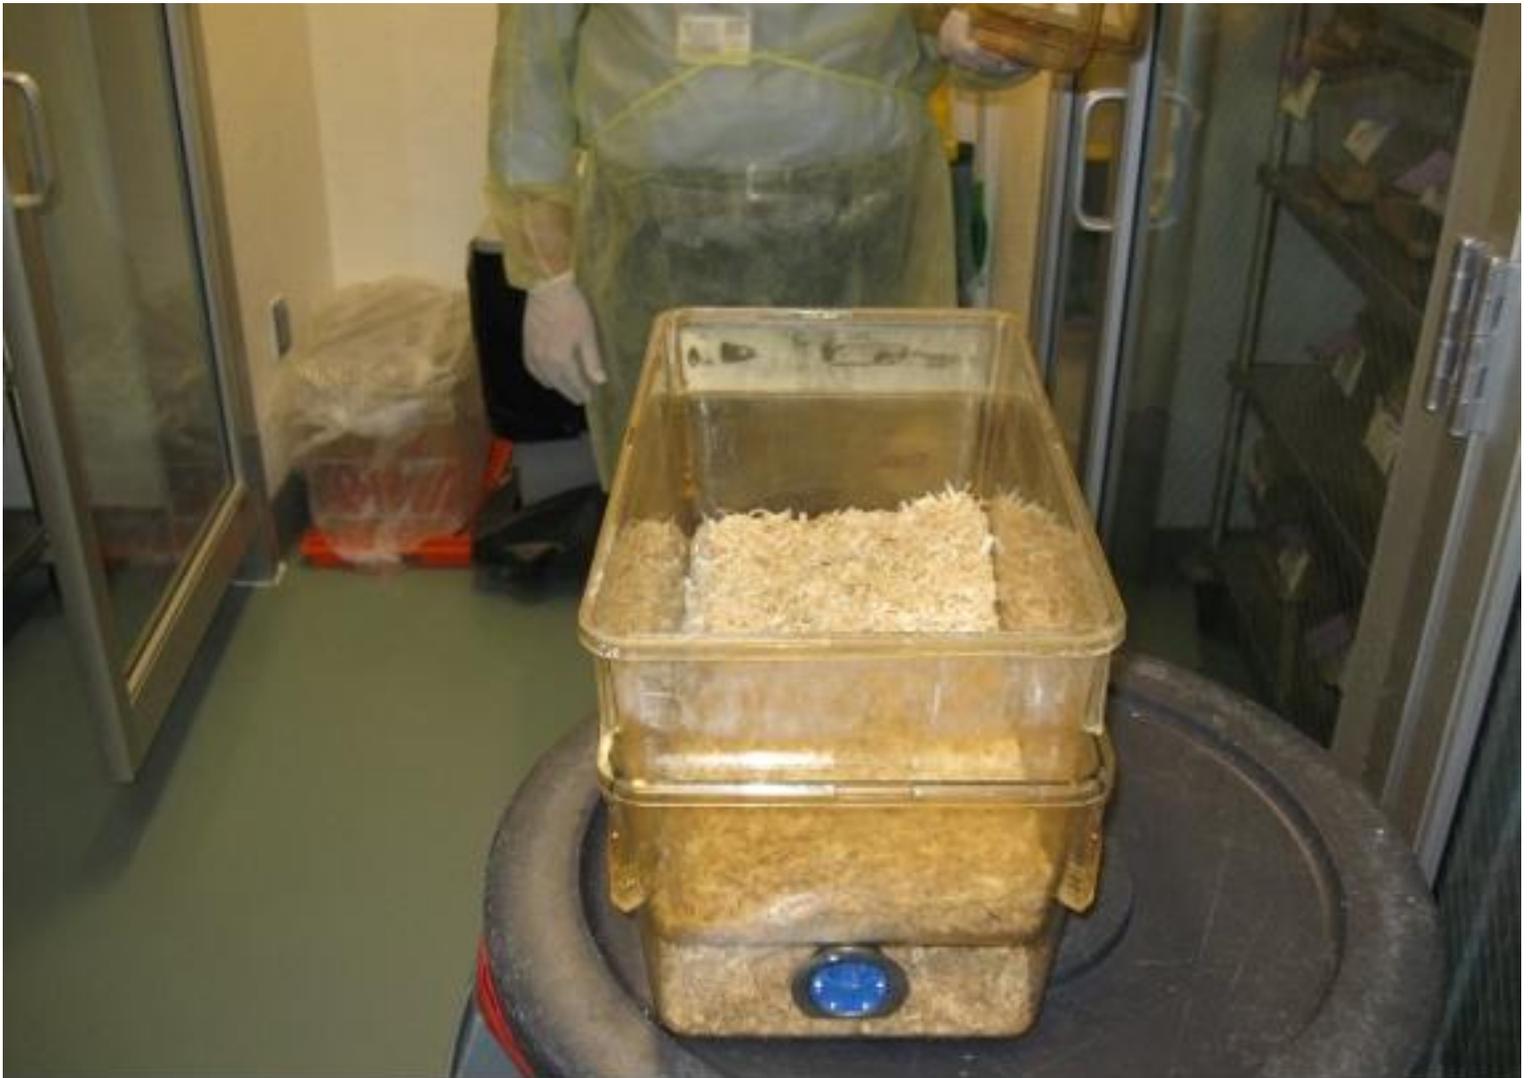
CFR: 2.38 (f)

Photographer:	R. Brandes, D.V.M.	Legal Name:	58-R-0003
Photo Taken:	Fri, May 28, '10 8:45 AM	UNIVERSITY OF FLORIDA	
Inspection:	145101622390914		
Description:	Representative empty cage for the Rice rats with bedding. (Not the actual cage where the rats died)

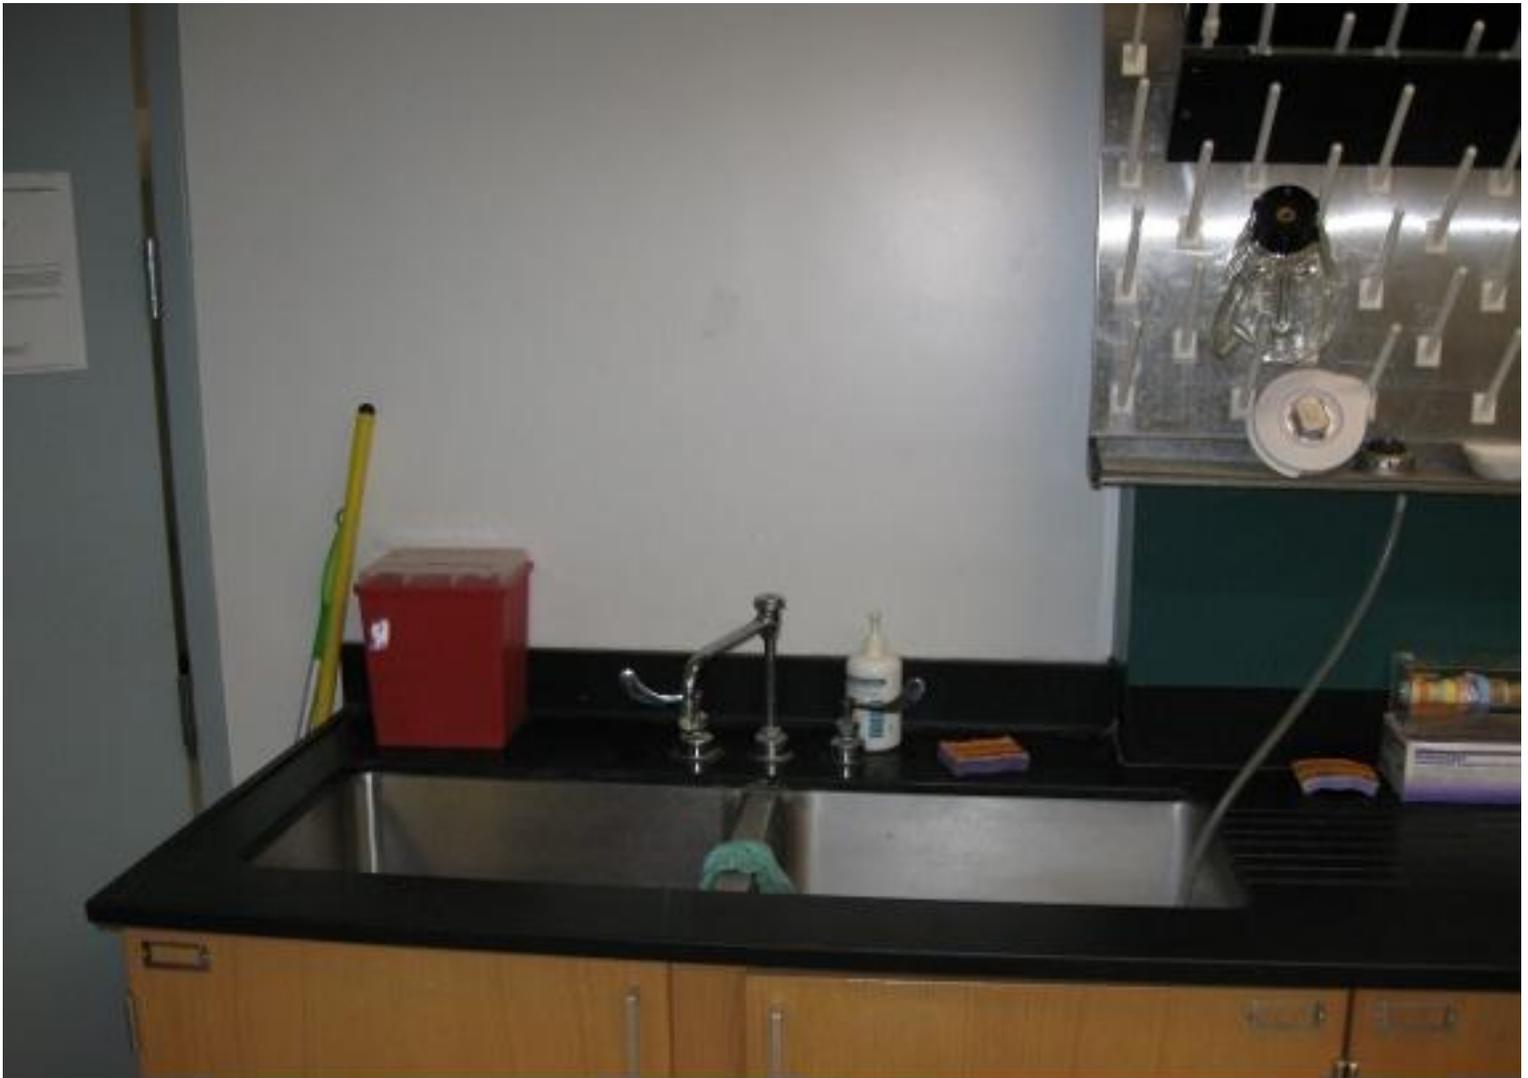
CFR: 3.1 (b)

Photographer:	R. Brandes, D.V.M.	Legal Name:	58-R-0003
Photo Taken:	Fri, May 28, '10 8:25 AM	UNIVERSITY OF FLORIDA	
Inspection:	145101622390914		
Description:	Cat procedure/behavior room. Cats roam freely around in this room

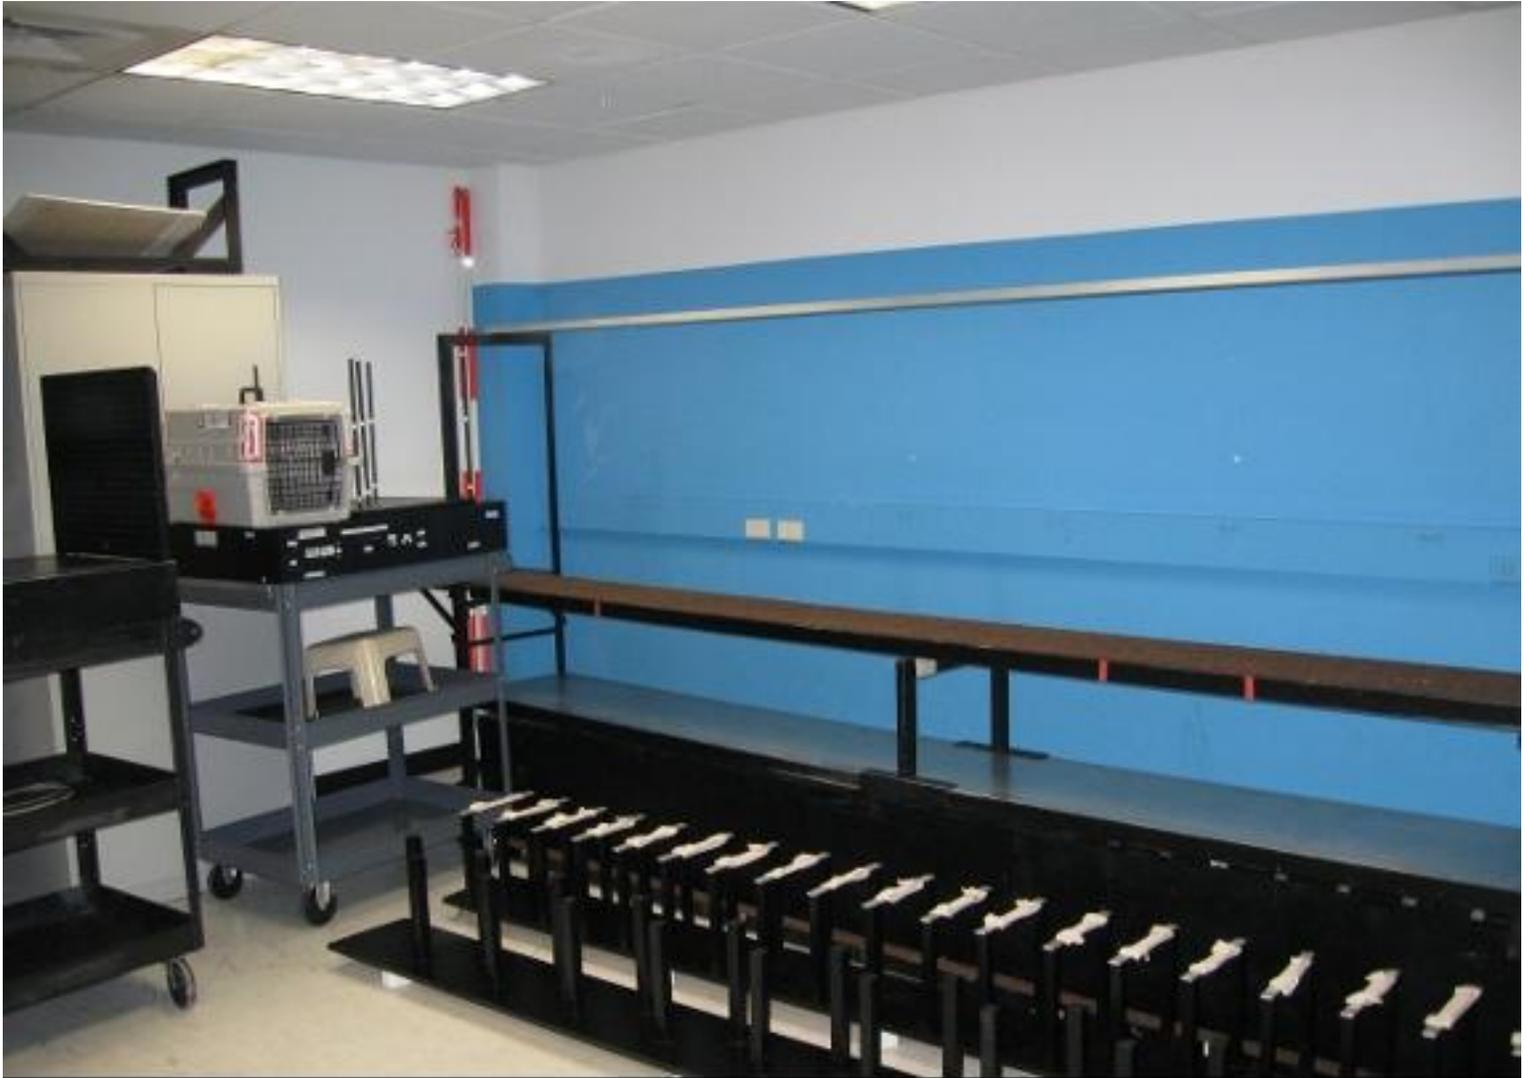
CFR: 3.1 (b)

Photographer:	R. Brandes, D.V.M.	Legal Name:	58-R-0003
Photo Taken:	Fri, May 28, '10 8:25 AM	UNIVERSITY OF FLORIDA	
Inspection:	145101622390914		
Description:	Cat procedure/behavior room. Cats roam freely around in this room. The cats are supposed to stay on these 2 horizontal walks, but frequently do not stay on these structures

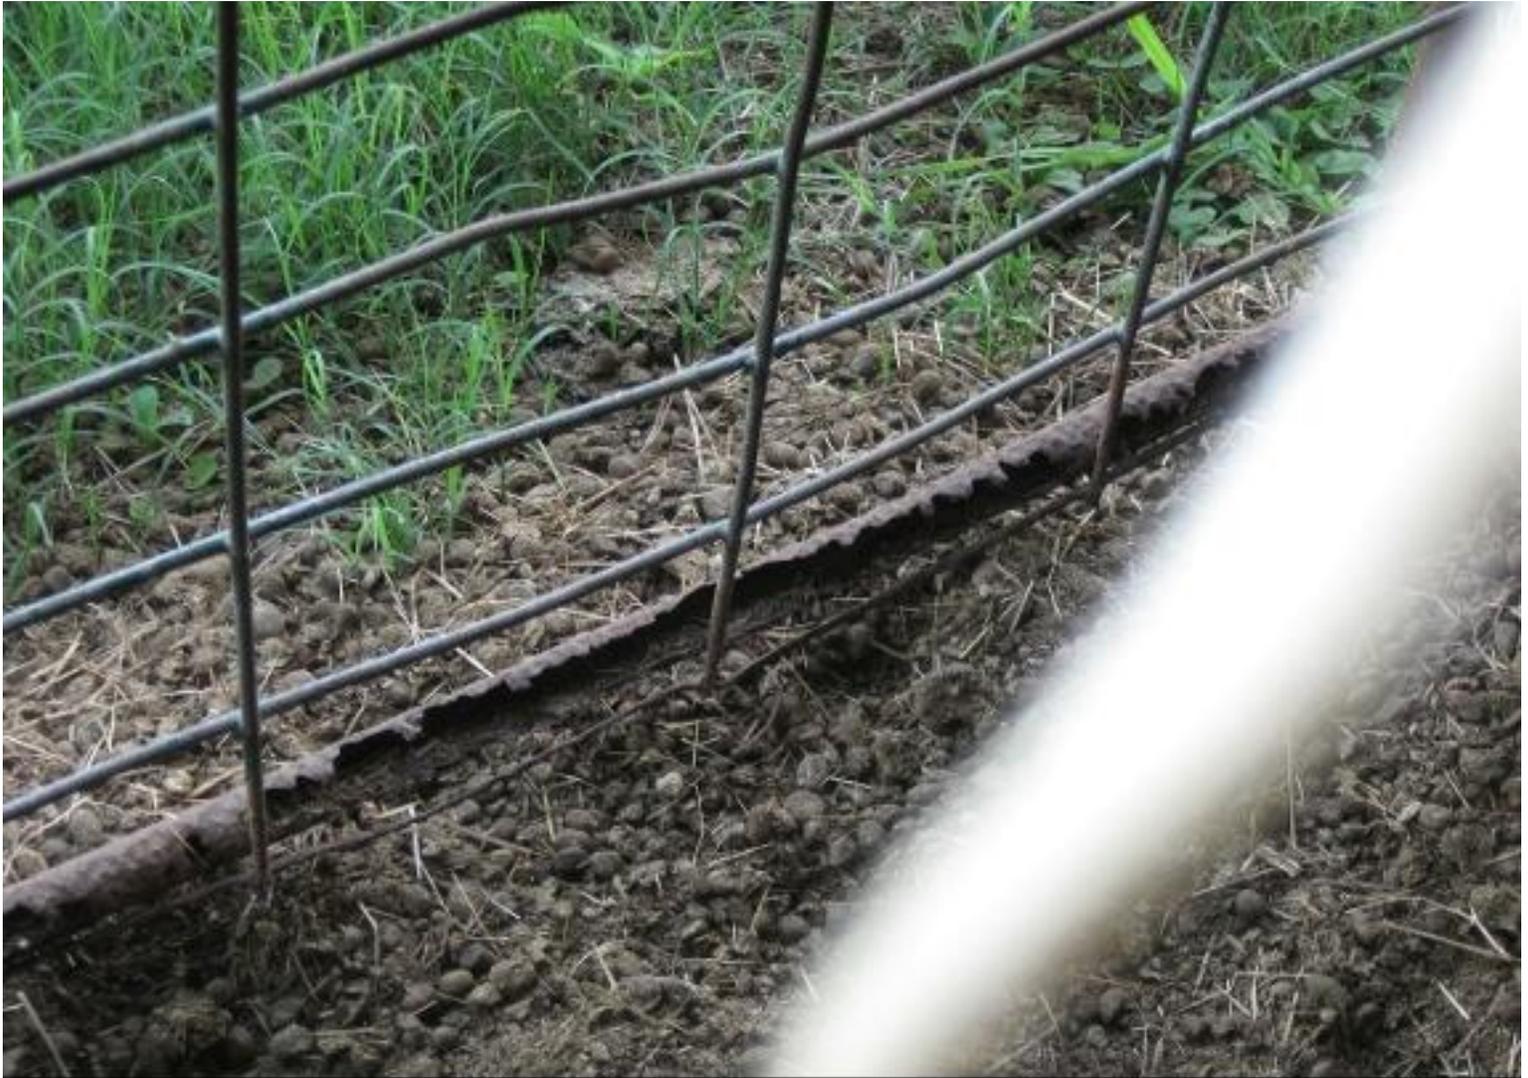
CFR: 3.125 (a)

Photographer:	R. Brandes, D.V.M.	Legal Name:	58-R-0003
Photo Taken:	Fri, May 28, '10 8:10 AM	UNIVERSITY OF FLORIDA	
Inspection:	145101622390914		
Description:	Rusty, deteriorated metal on left sheep enclosure gate

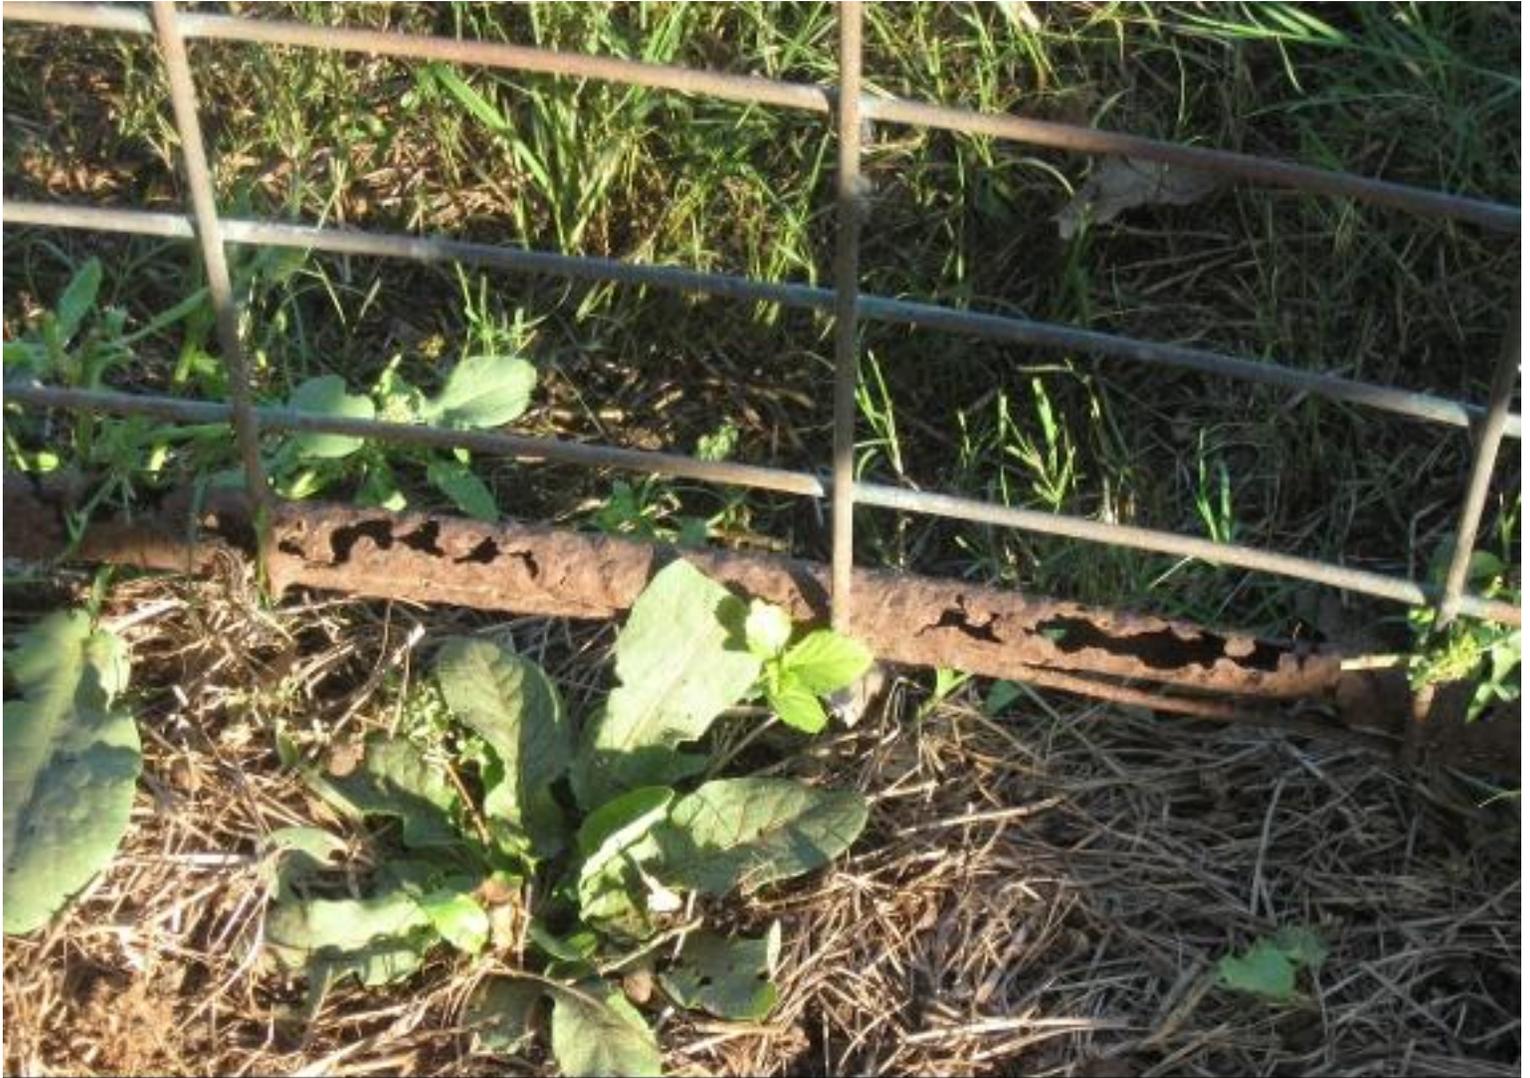
CFR: 3.125 (a)

Description: Rusty, deteriorated metal on right sheep enclosure gate

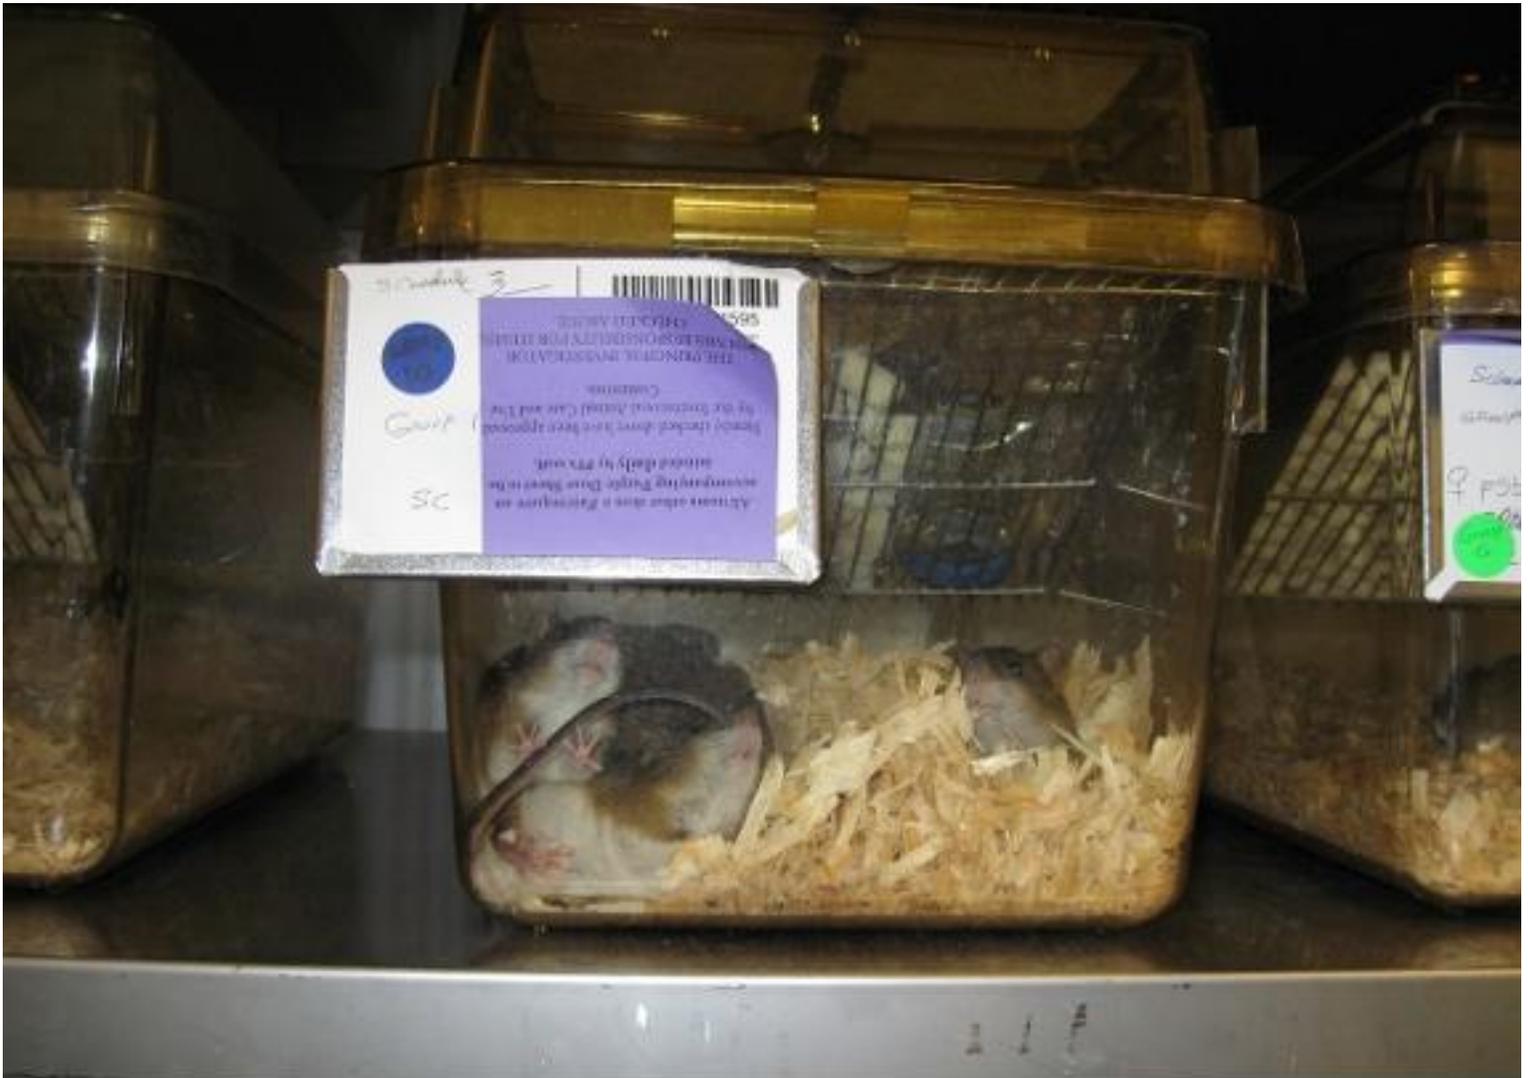
CFR: 2.38 (f)

Photographer:	R. Brandes, D.V.M.	Legal Name:	58-R-0003
Photo Taken:	Tue, Jun 1, '10 8:45 AM	UNIVERSITY OF FLORIDA	
Inspection:	145101622390914		
Description:	Representative Rice rat cage with rats inside. This is not the cage where the incident took place

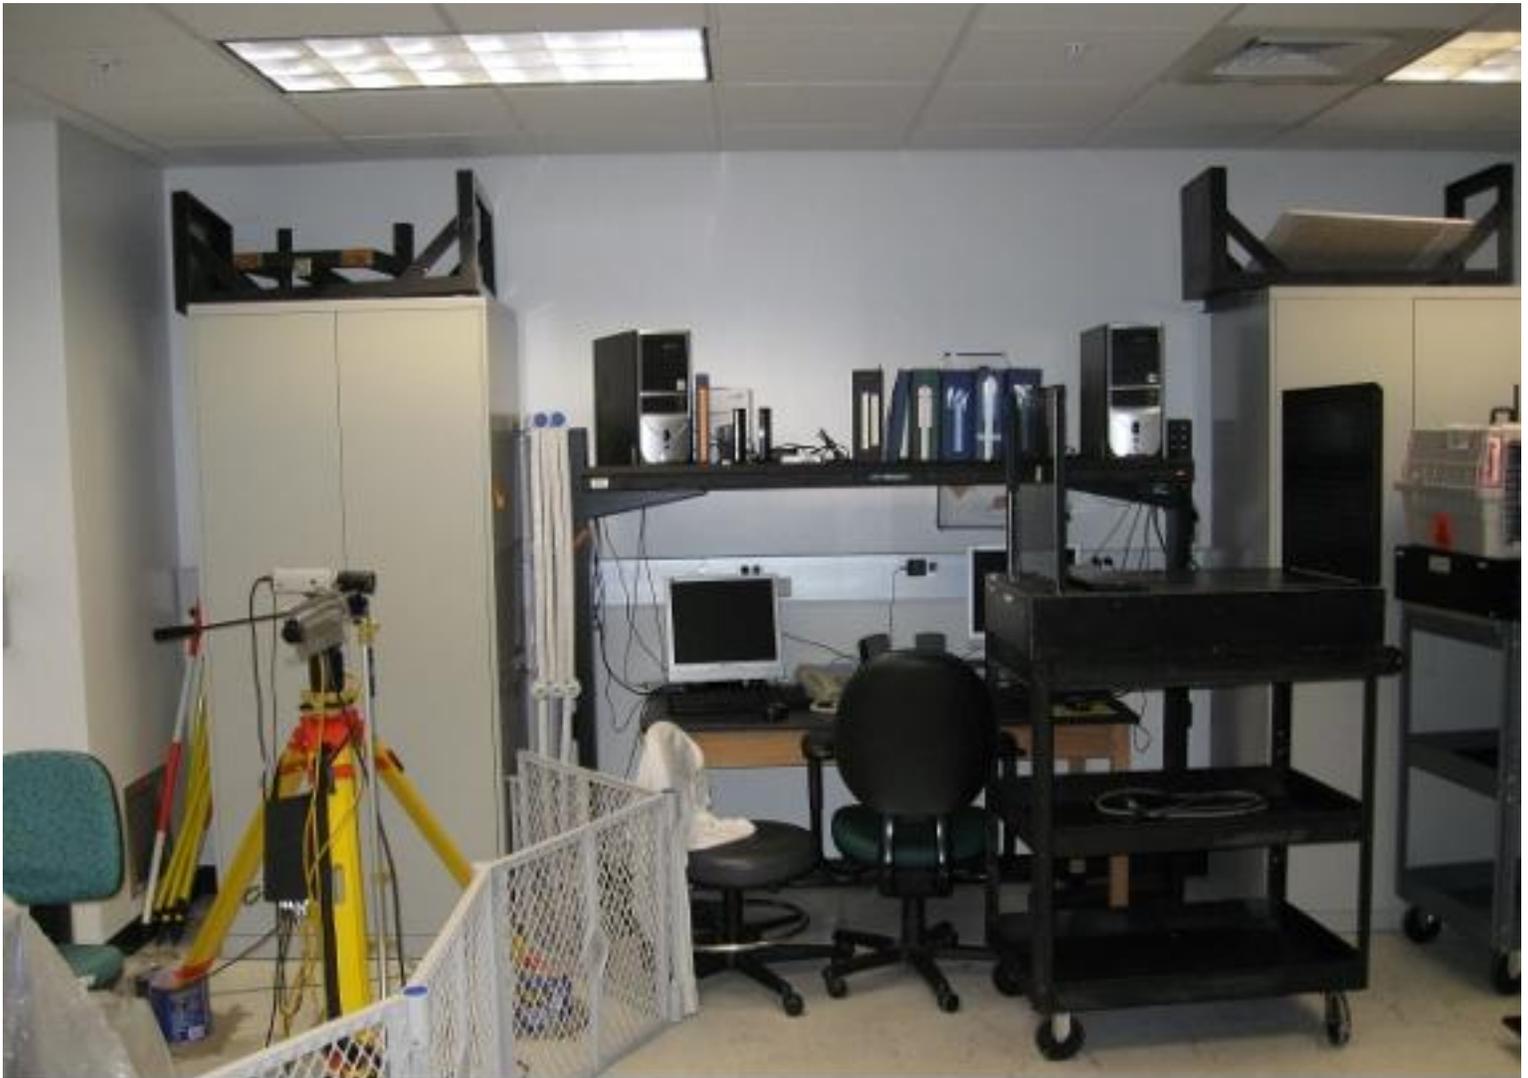
CFR: 3.1 (b)

Description: Cat procedure/behavior room. Cats roam freely around in this room

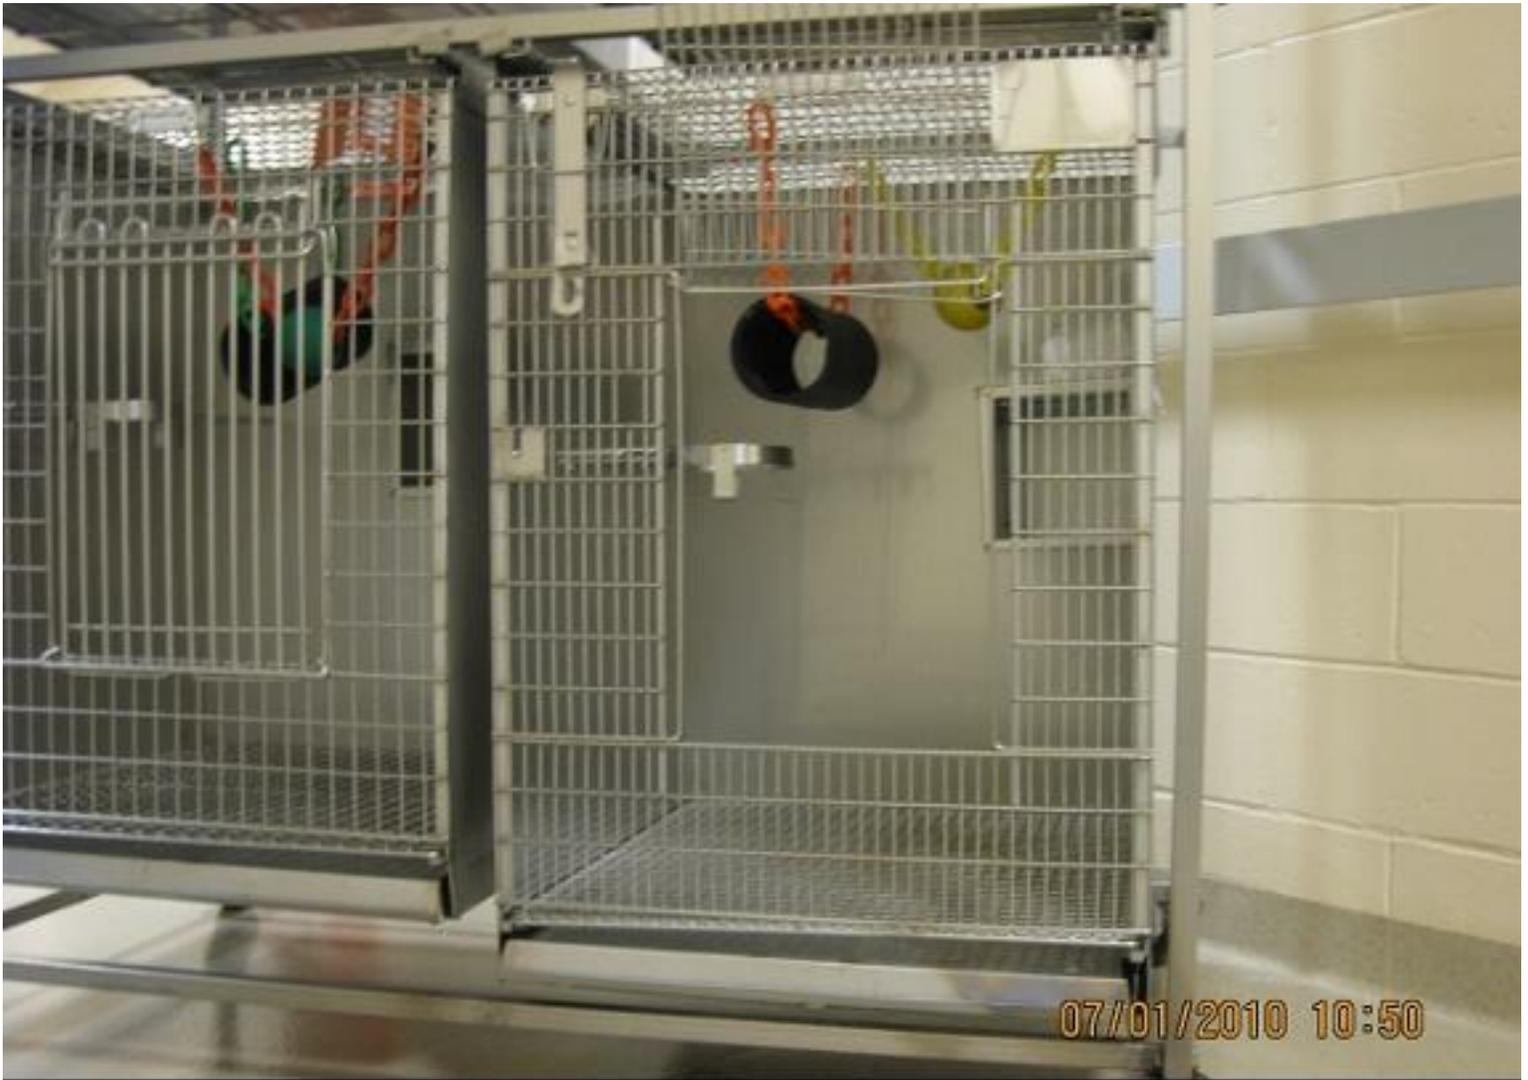
CFR: 3.84 (a), 2.33 (b) (3)

Photographer:	Paula Gladue	Legal Name:	14-R-0019
Photo Taken:	Thu, Jul 1, '10 10:50 AM	HARVARD MEDICAL SCHOOL	
Inspection:	181102029000845		
Description:	Close up of an example of a primary enclosure of a quad unit for Tamarins containing an opaque enrichment tunnel.

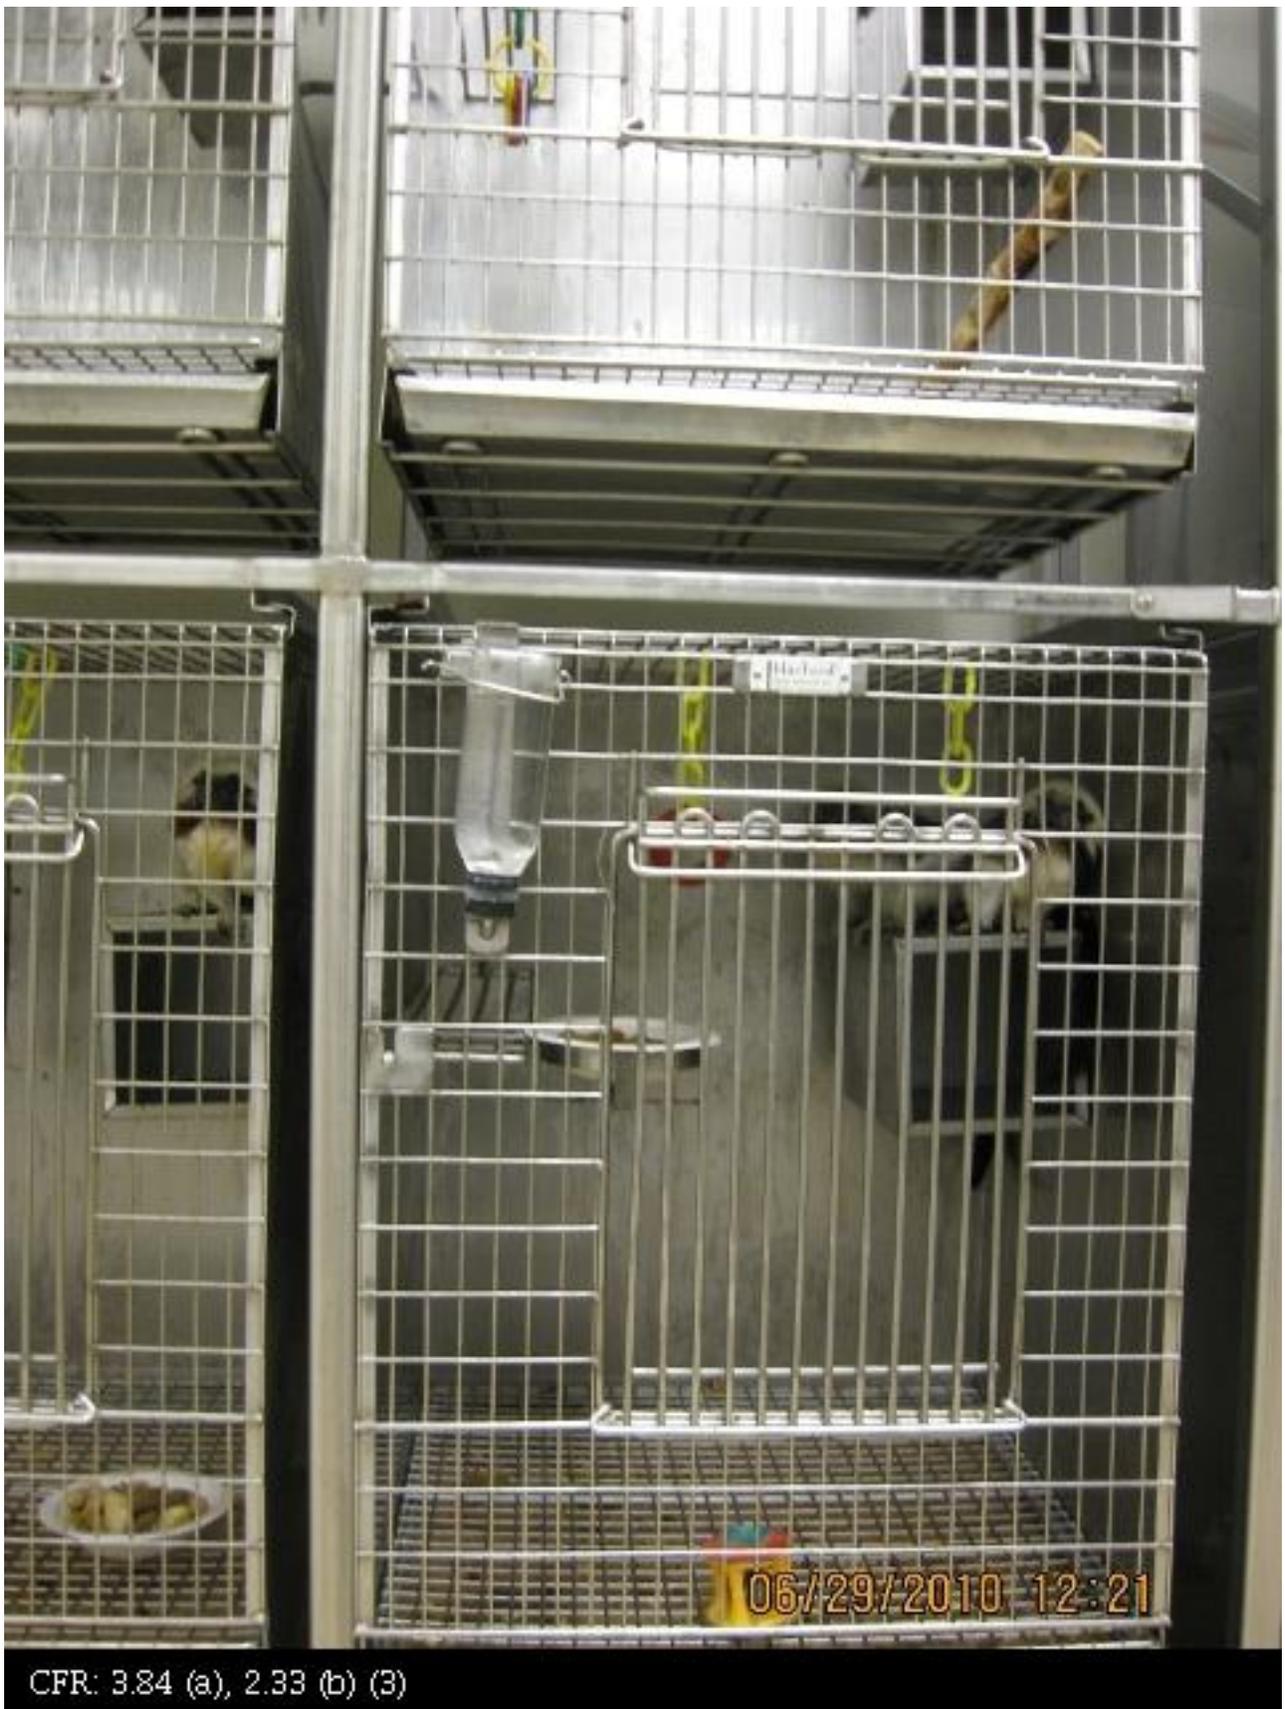
CFR: 3.84 (a), 2.33 (b) (3)

Photographer:	Paula Gladue	Legal Name:	HARVARD MEDICAL SCHOOL	14-R-0019
Photo Taken:	Tue, Jun 29, '10 12:21 PM			
Inspection:	181102029000845			
Description:	Close up of a typical primary enclosure for Tamarins in a quad unit. NOT the same enclosure involved in 6/9/10 incident.
