Photographer:	Tracy Thompson	Legal Name:	42-R-0044
Photo Taken:	Fri, Sep 17, '10 10:03 AM	EXEMPLAR GENETICS	
Inspection:	260100001290326		
Description:	Numerous flies all over the surfaces, feed, animals, and excreta where research and "B" license animals are housed.

Photographer:	Tracy Thompson	Legal Name:	42-B-0270
Photo Taken:	Fri, Sep 17, '10 11:14 AM	EXEMPLAR GENETICS	
Inspection:	260100039360229		
Description:	Yucatan pig showing overgrown hooves and "flat-foot" due to chronicity of problem on slatted flooring.

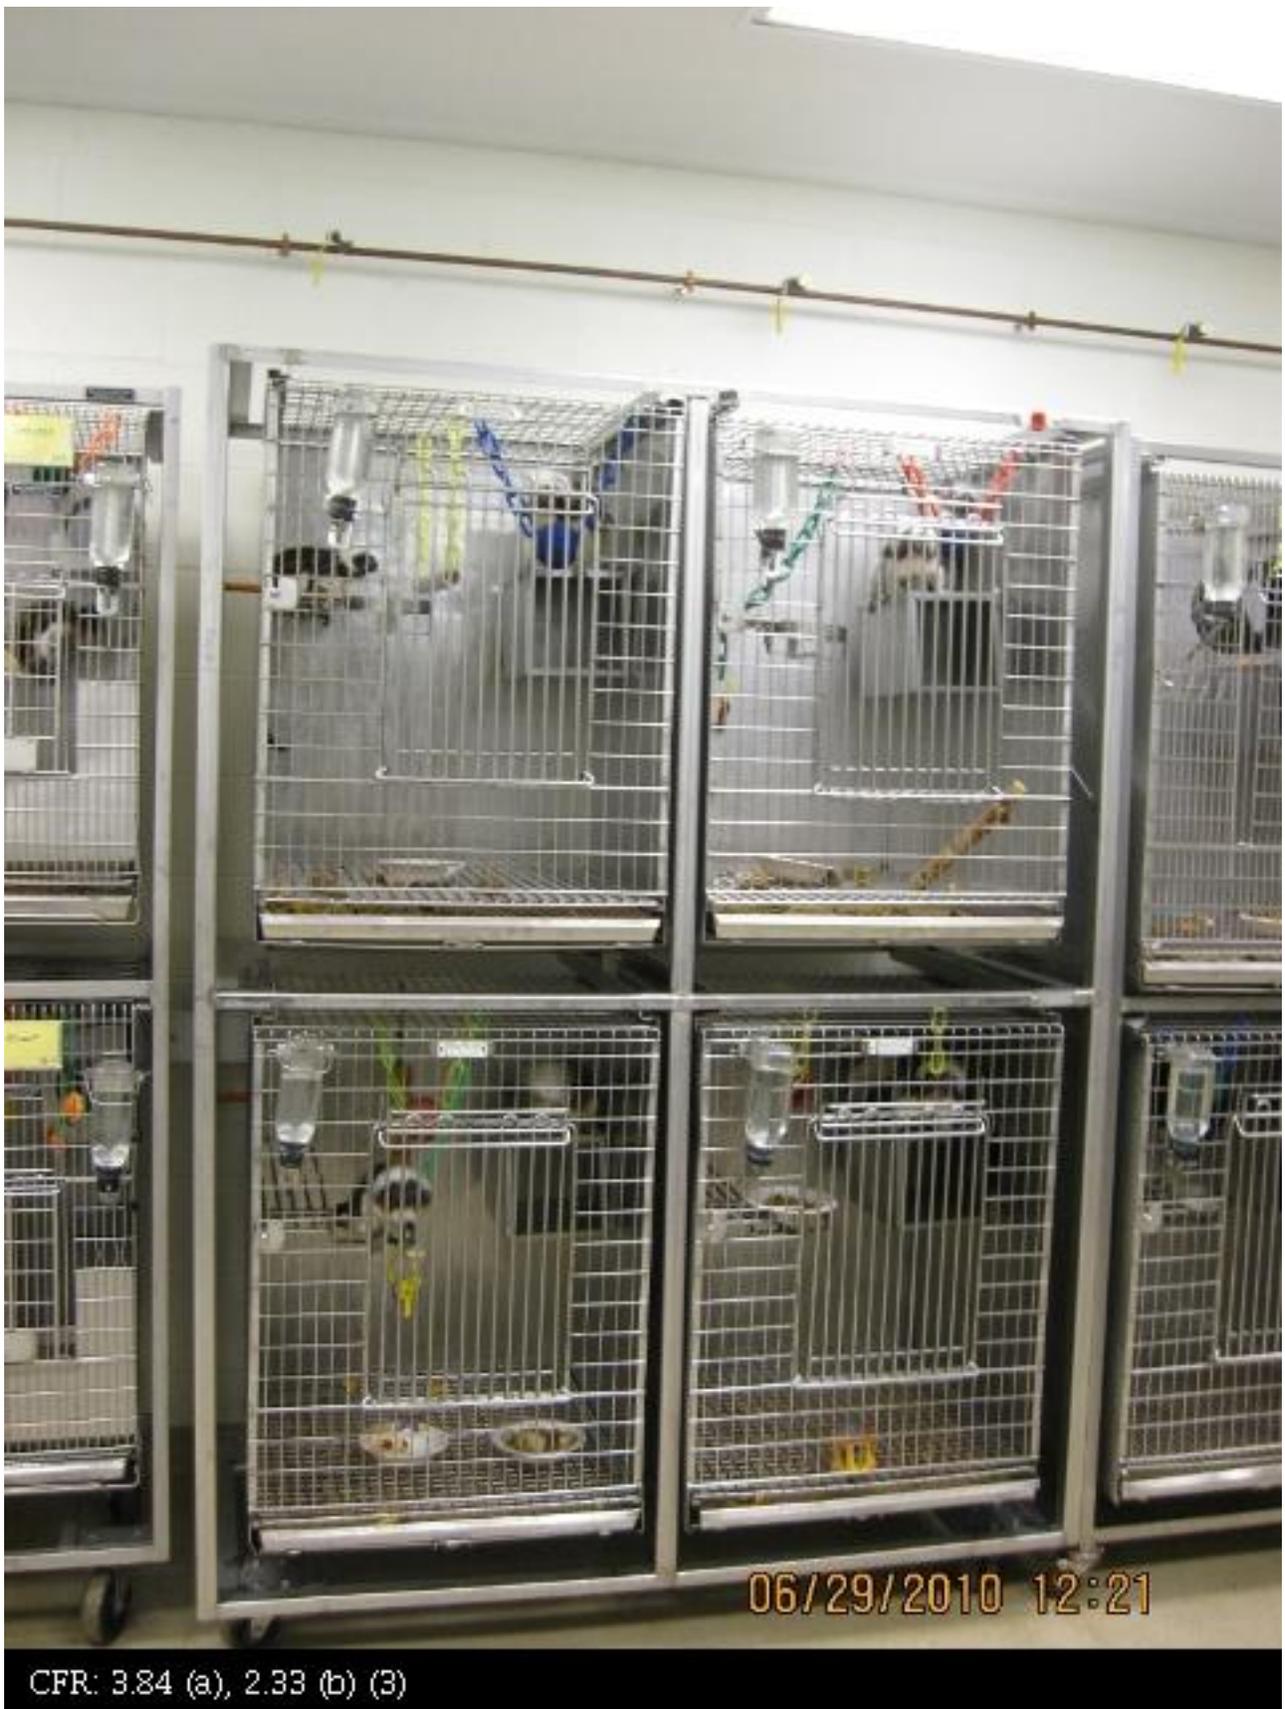
CFR: 3.84 (a), 2.33 (b) (3)

Photographer:	Paula Gladue	Legal Name:	HARVARD MEDICAL SCHOOL	14-R-0019
Photo Taken:	Tue, Jun 29, '10 12:21 PM			
Inspection:	181102029000845			
Description:	Example of configuration of a quad unit housing Tamarins. NOT the same unit as the one involved in the 6/9/10 incident.

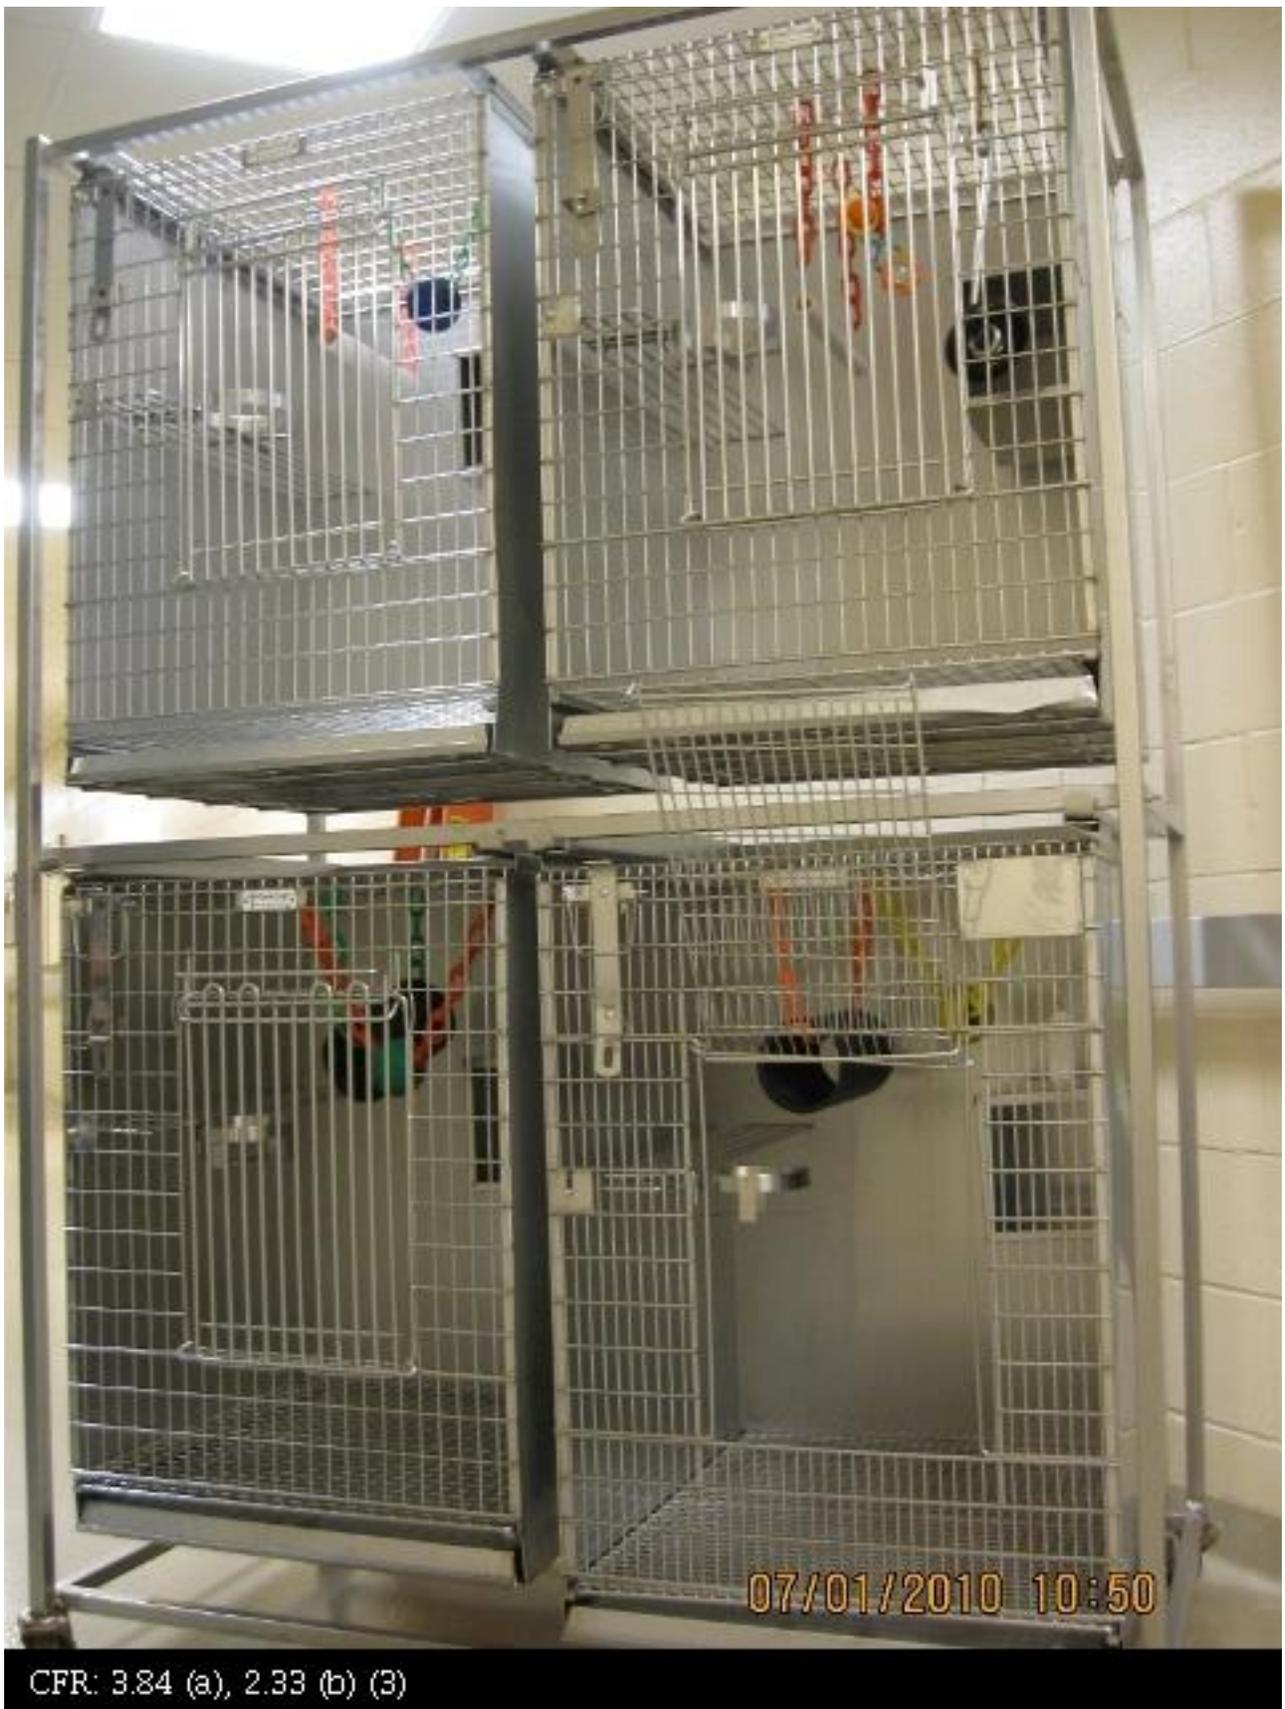
CFR: 3.84 (a), 2.33 (b) (3)

Photographer:	Paula Gladue	Legal Name:	HARVARD MEDICAL SCHOOL	14-R-0019
Photo Taken:	Thu, Jul 1, '10 10:50 AM			
Inspection:	181102029000845			
Description:	Example of configuration of a quad unit for Tamarins with opaque enrichment tunnels inside some of the enclosures.

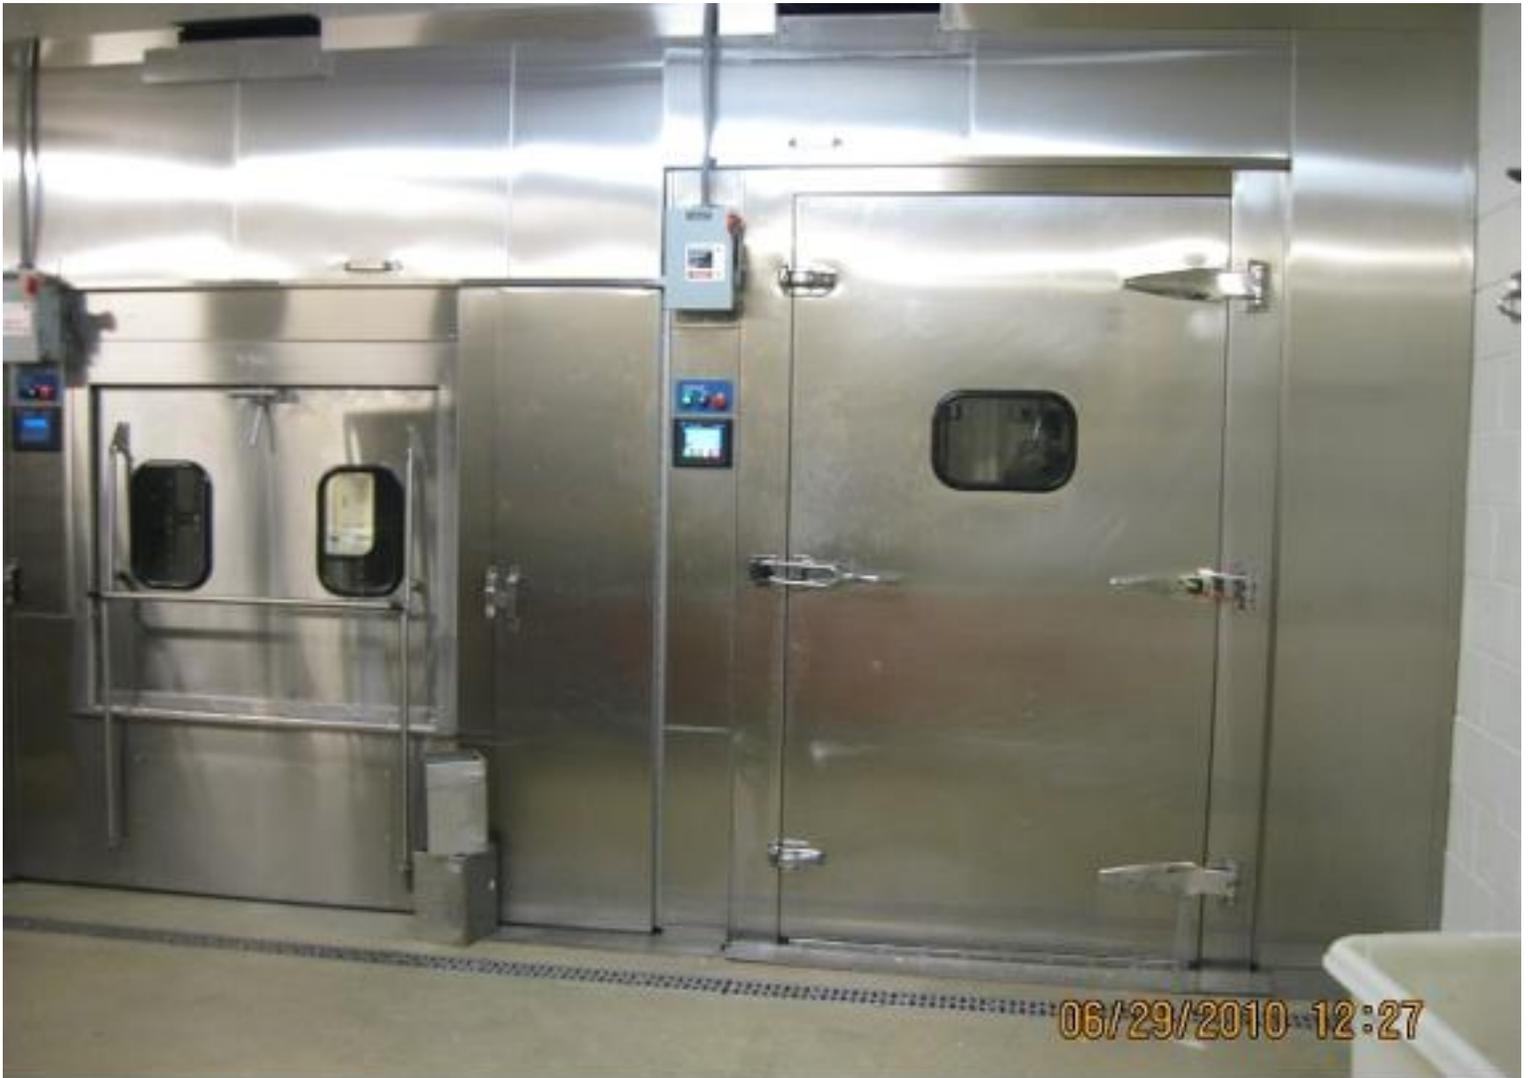
CFR: 3.84 (a), 2.33 (b) (3)

Photographer:	Paula Gladue	Legal Name:	14-R-0019
Photo Taken:	Tue, Jun 29, '10 12:27 PM	HARVARD MEDICAL SCHOOL	
Inspection:	181102029000845		
Description:	Cage wash room. Two larger units for cage racks are located on each side of the room; a smaller unit used for nest boxes & receptacles is located between the 2 larger units.

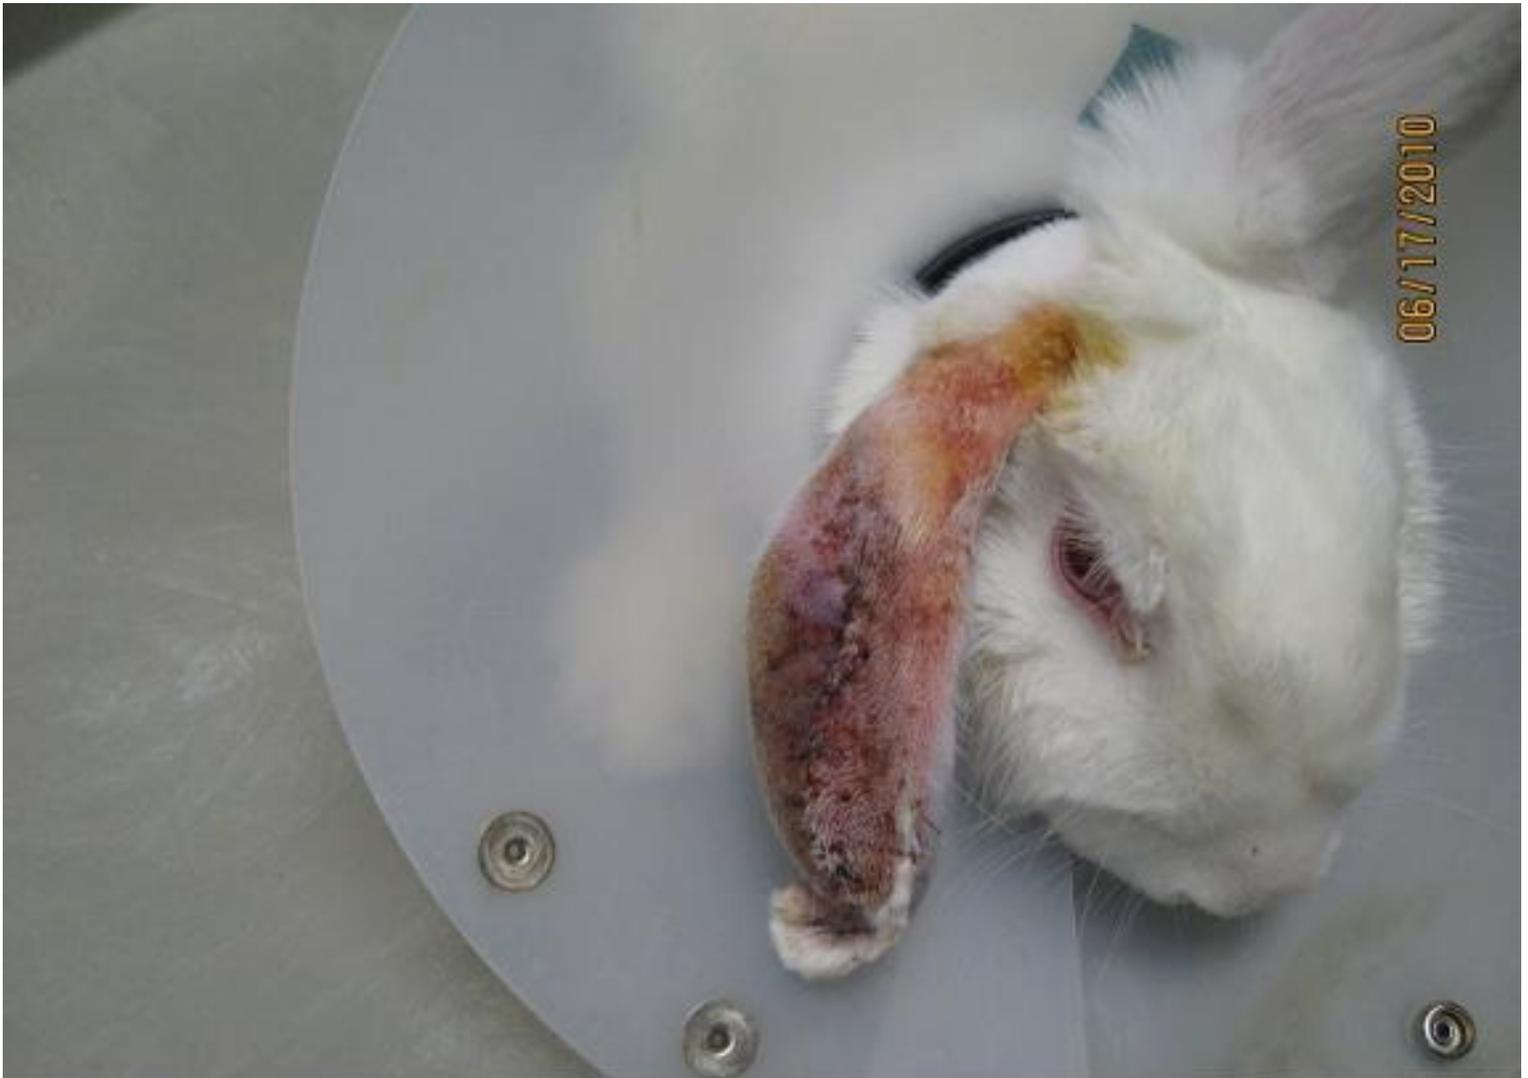
CFR: 2.31 (c) (7)

Photographer:	Miava Binkley, VMO	Legal Name:	55-R-0001
Photo Taken:	Thu, Jun 17, '10 1:32pm	WAKE FOREST UNIVERSITY	
Inspection:	169101431060103		
Description:	Aural hematoma. No pressure bandage applied.

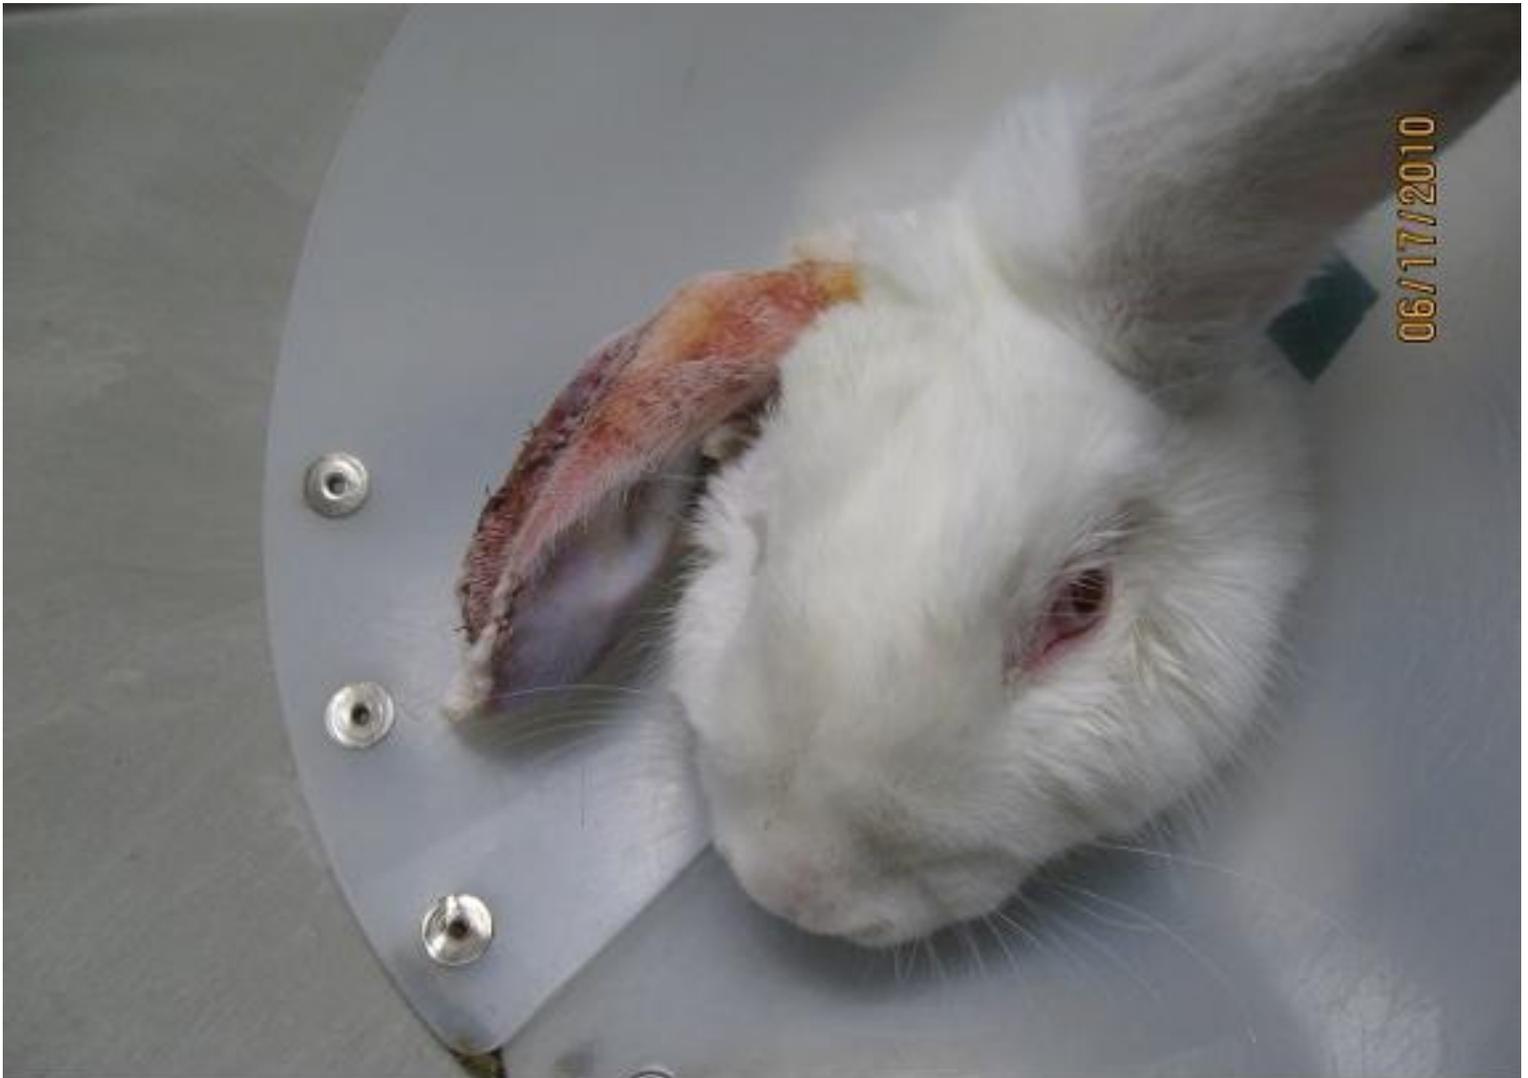
CFR: 2.31 (c) (7)

Photographer:	Miava Binkley, VMO	Legal Name:	55-R-0001
Photo Taken:	Thu, Jun 17, '10 1:32pm	WAKE FOREST UNIVERSITY	
Inspection:	169101431060103		
Description:	Aural hematoma. No pressure bandage applied.

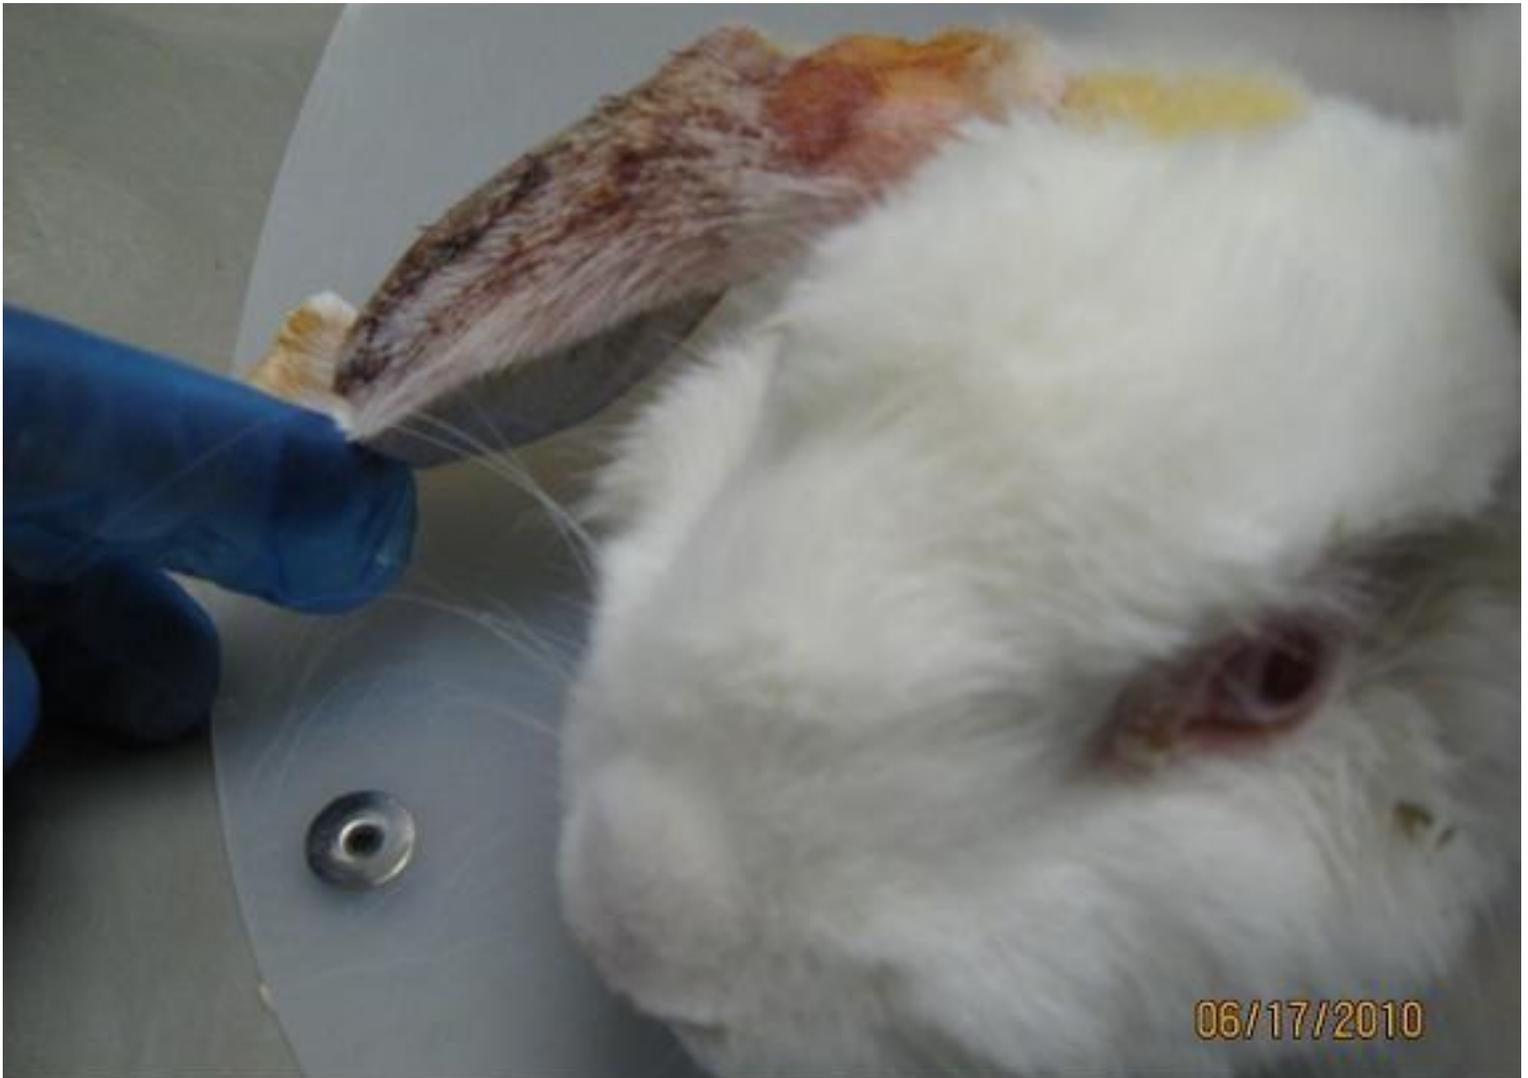
CFR: 2.31 (c) (7)

Photographer:	Miava Binkley, VMO	Legal Name:	55-R-0001
Photo Taken:	Thu, Jun 17, '10 1:31pm	WAKE FOREST UNIVERSITY	
Inspection:	169101431060103		
Description:	Aural hematoma. No pressure bandage applied.

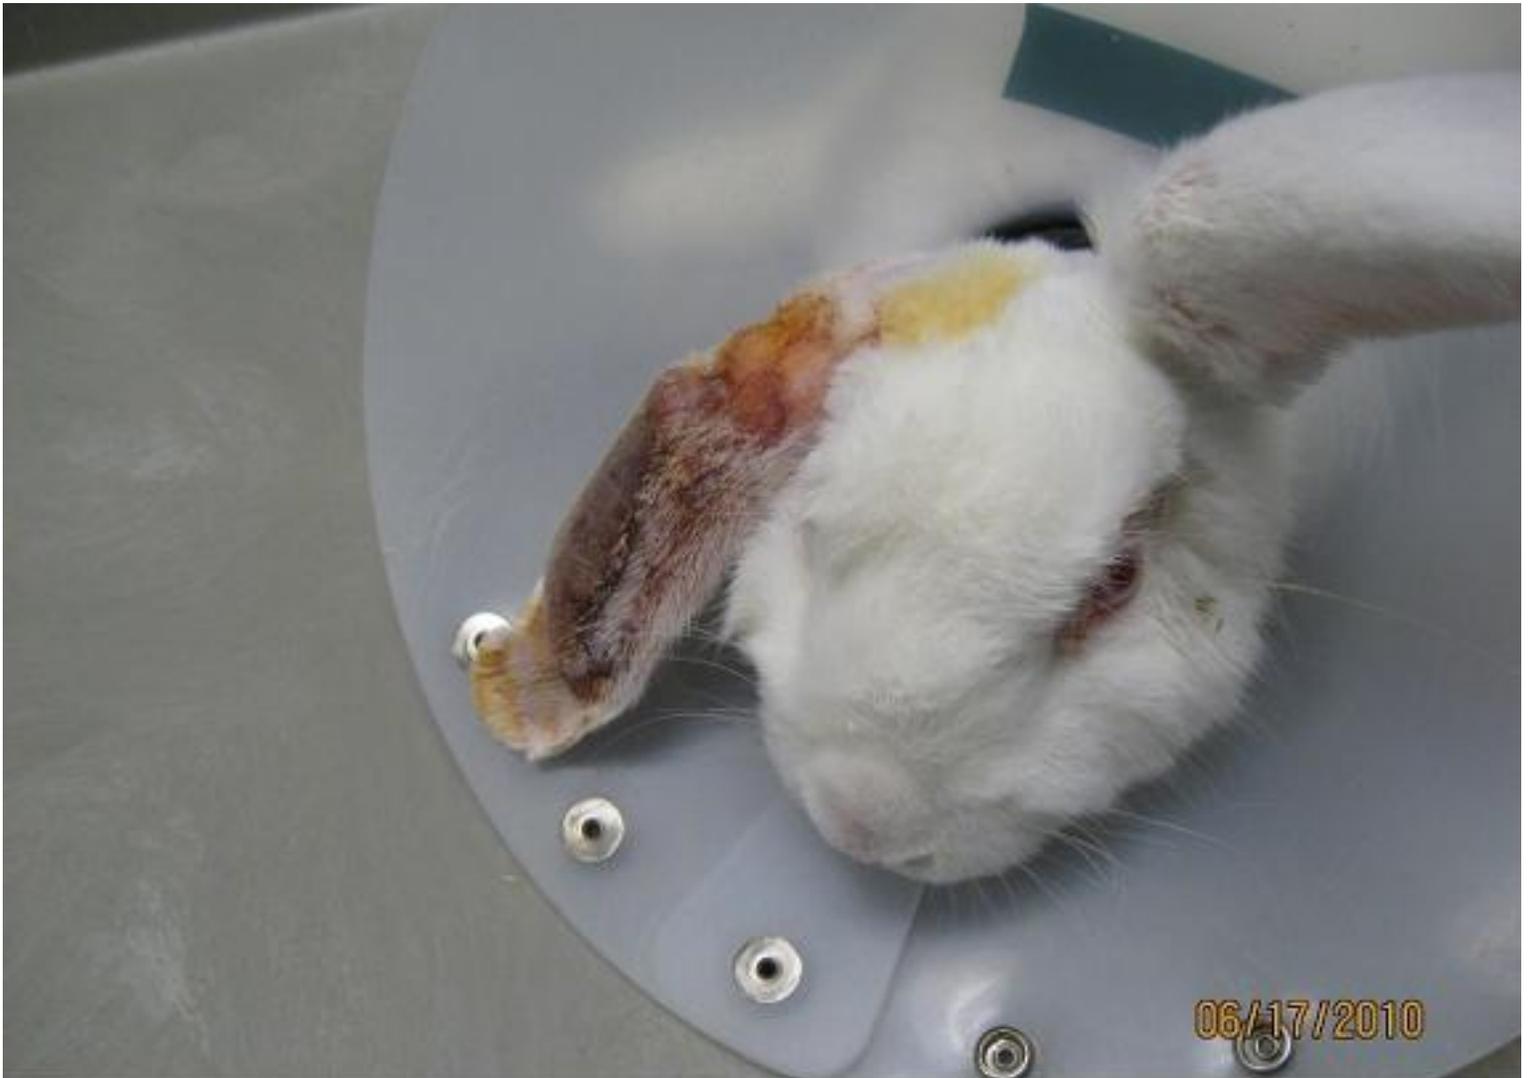
CFR: 2.31 (c) (7)

Photographer:	Miava Binkley, VMO	Legal Name:	55-R-0001
Photo Taken:	Thu, Jun 17, '10 1:31pm	WAKE FOREST UNIVERSITY	
Inspection:	169101431060103		
Description:	Aural hematoma. No pressure bandage applied.
