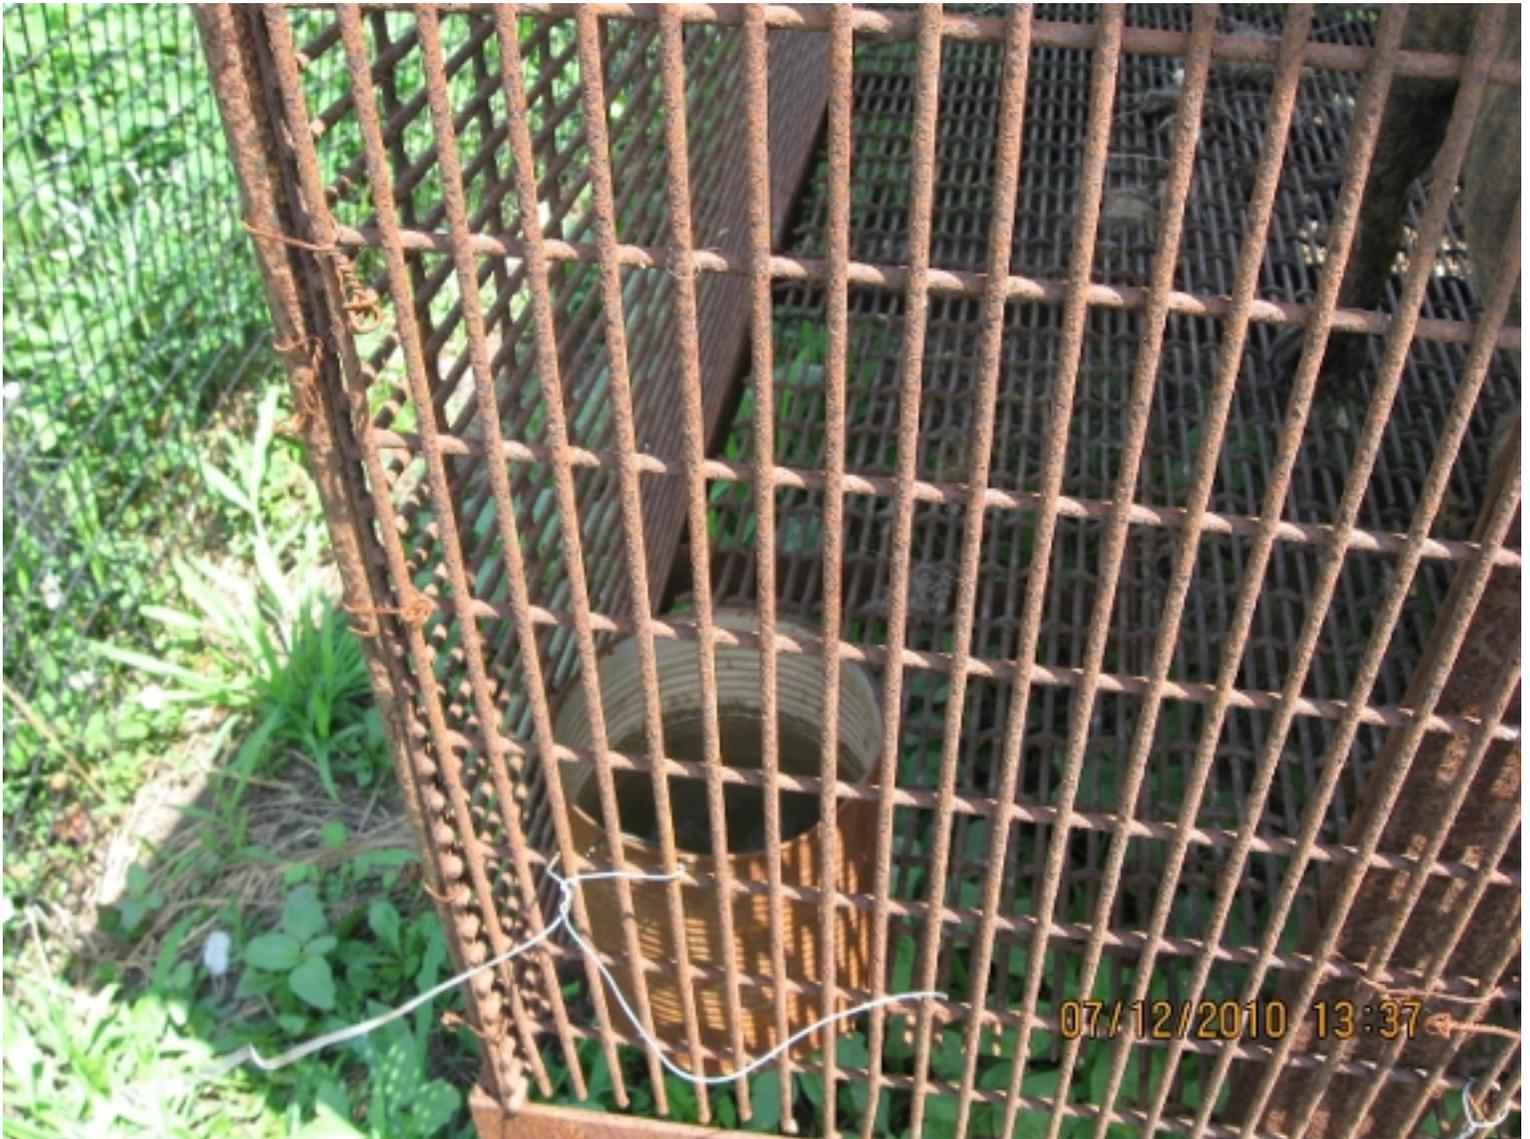
Photographer:	clb	Legal Name:	34-A-0186
Photo Taken:	Mon, Jul 12, '10 2:37 PM	MATTHEW SCHWARTZ	
Inspection:	224101526120878		
Description:	kennel made of rusty metal, and rusty coffee can used for water receptacle

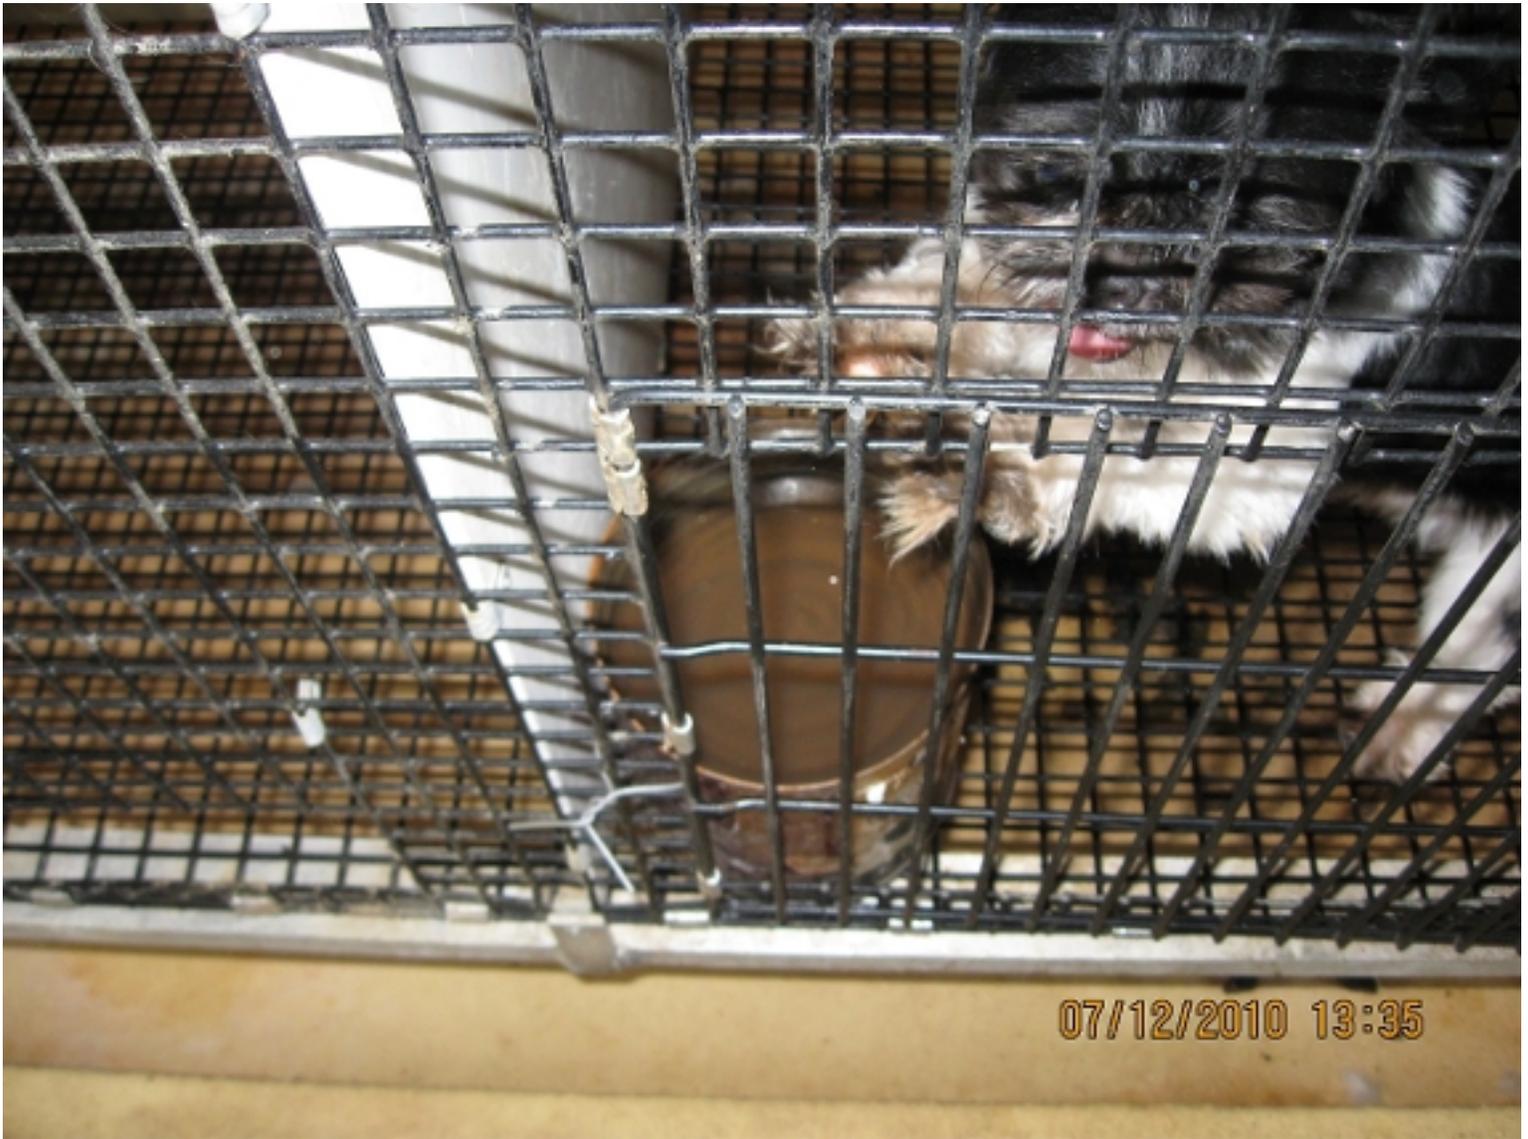
Photographer:	clb	Legal Name:	34-A-0186
Photo Taken:	Mon, Jul 12, '10 2:35 PM	MATTHEW SCHWARTZ	
Inspection:	224101526120878		
Description:	rusty coffee can used as water receptacle

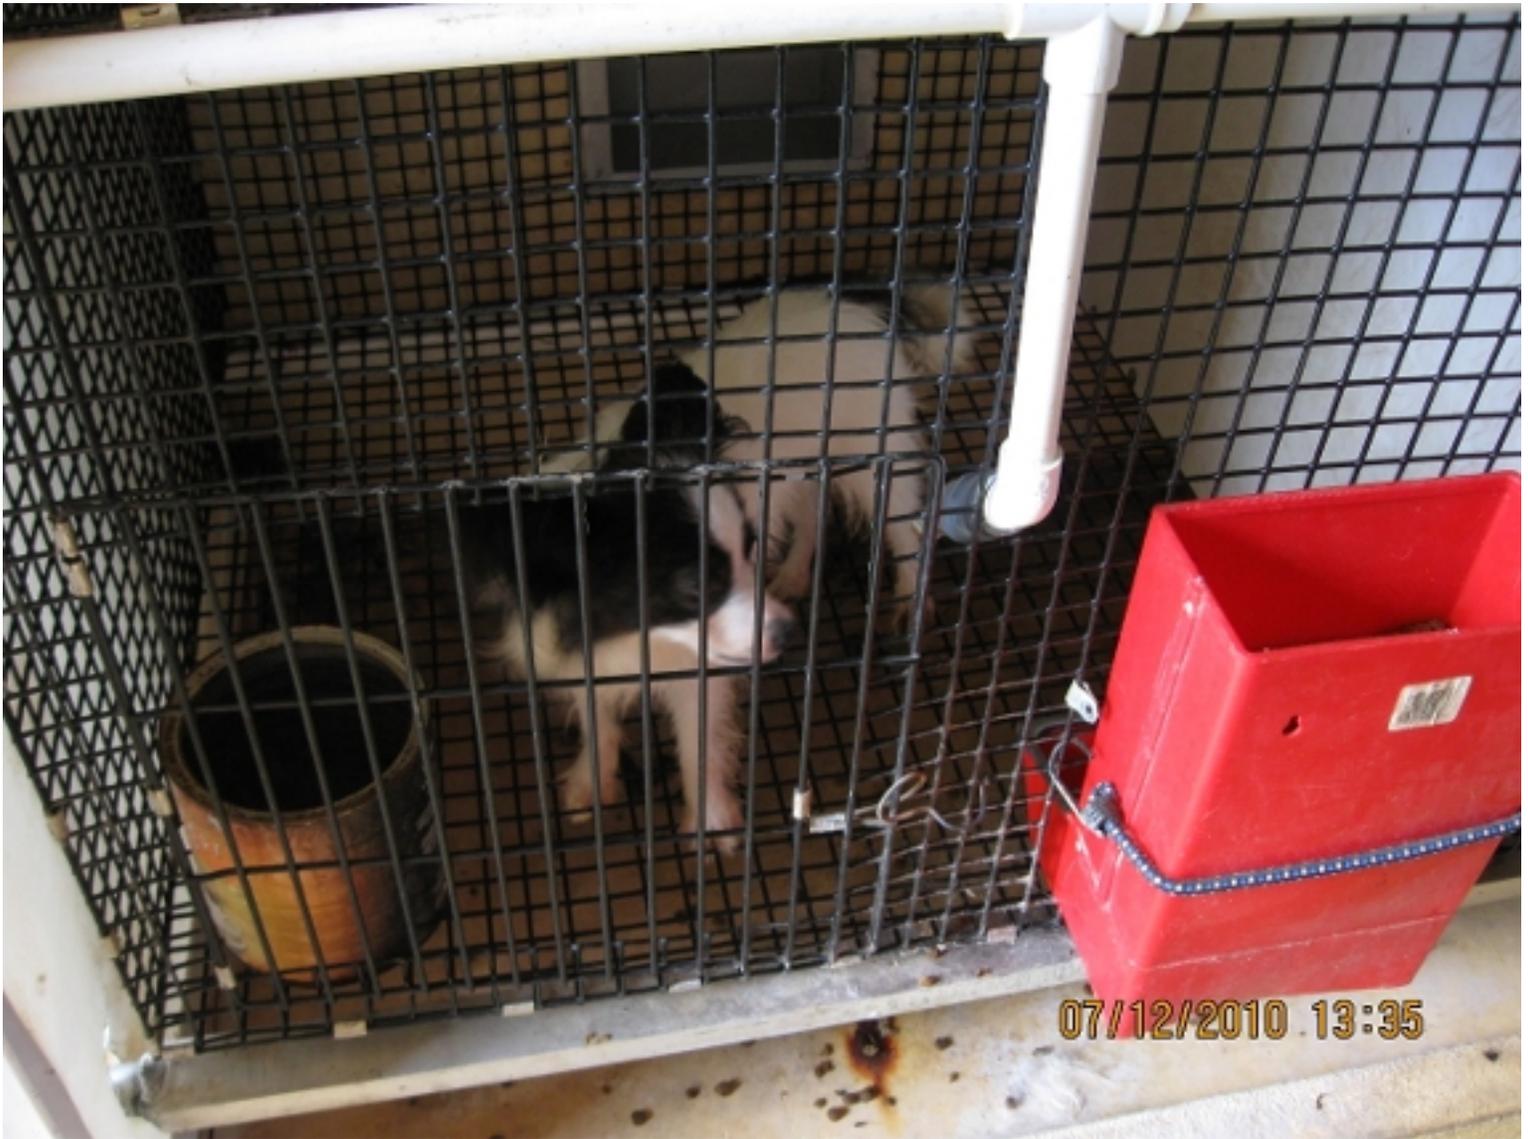
Photographer:	clb	Legal Name:	34-A-0186
Photo Taken:	Mon, Jul 12, '10 2:35 PM	MATTHEW SCHWARTZ	
Inspection:	224101526120878		
Description:	black and white papillon with torn toe nail, and rusty water receptacle

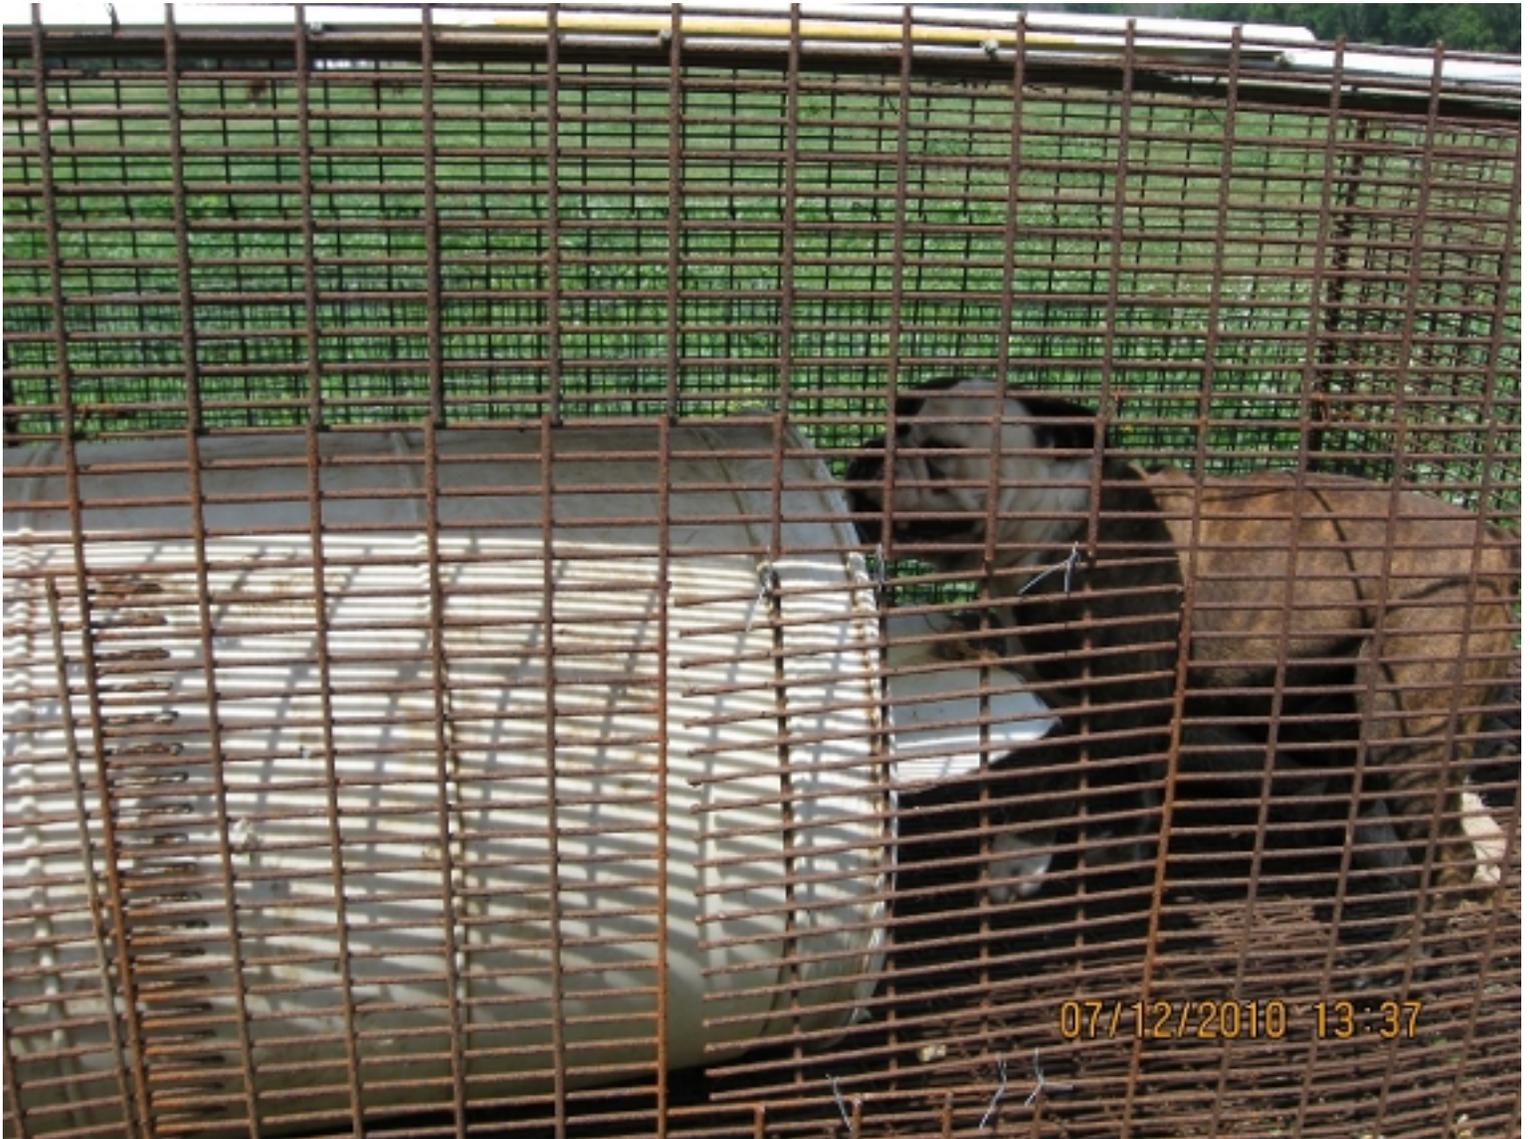
Photographer:	clb	Legal Name:	34-A-0186
Photo Taken:	Mon, Jul 12, '10 2:37 PM	MATTHEW SCHWARTZ	
Inspection:	224101526120878		
Description:	kennel made of rusty metal that cannot be sanitized

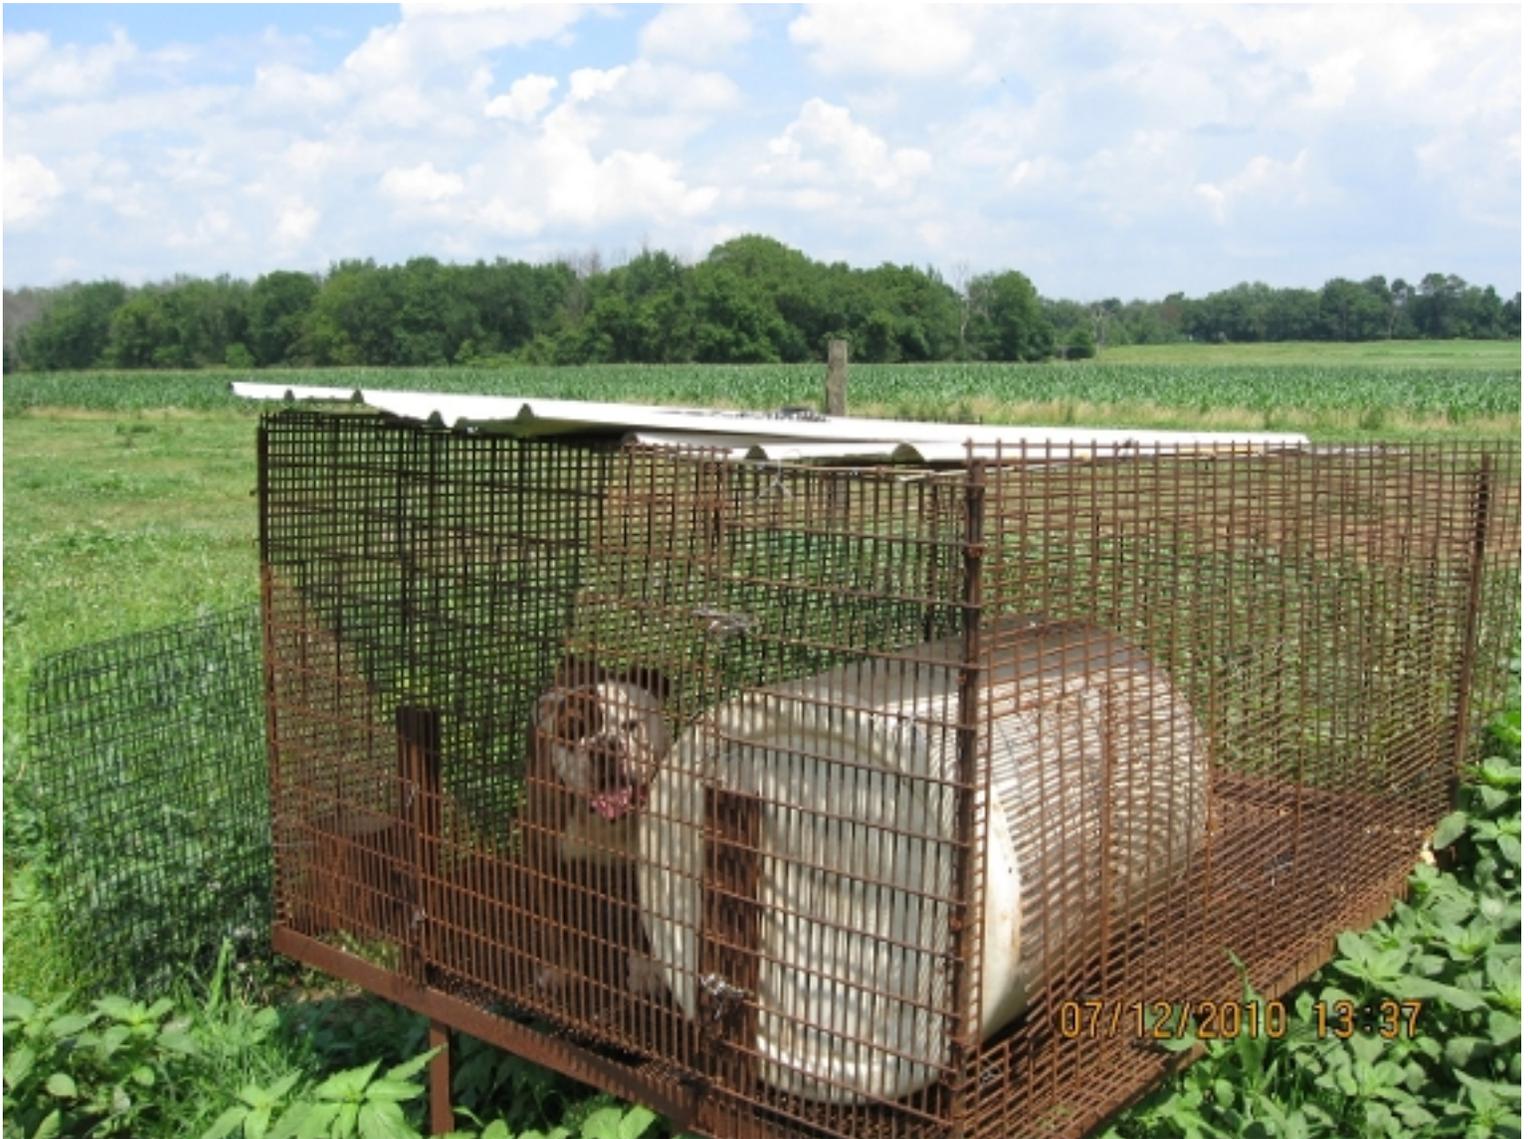
Photographer:	clb	Legal Name:	34-A-0186
Photo Taken:	Mon, Jul 12, '10 2:37 PM	MATTHEW SCHWARTZ	
Inspection:	224101526120878		
Description:	kennel made of rusty metal that cannot be sanitized

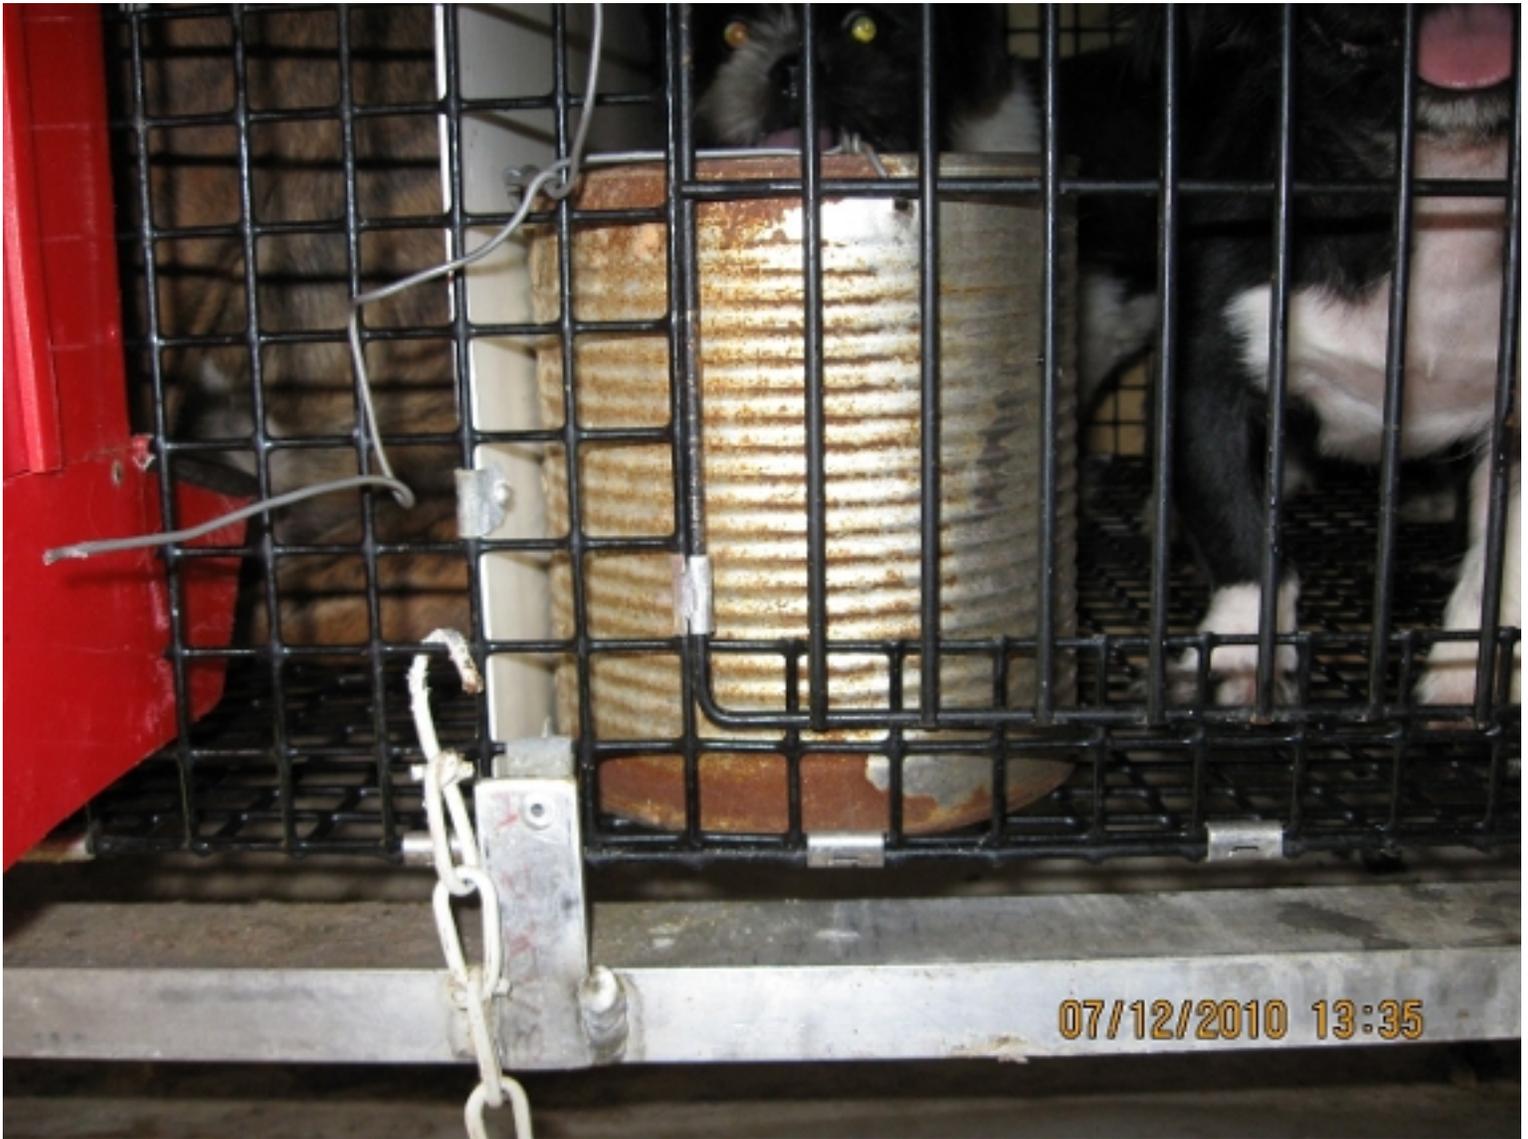
Photographer:	clb	Legal Name:	34-A-0186
Photo Taken:	Mon, Jul 12, '10 2:35 PM	MATTHEW SCHWARTZ	
Inspection:	224101526120878		
Description:	rusty coffee can being used as a water receptacle that cannot be sanitized

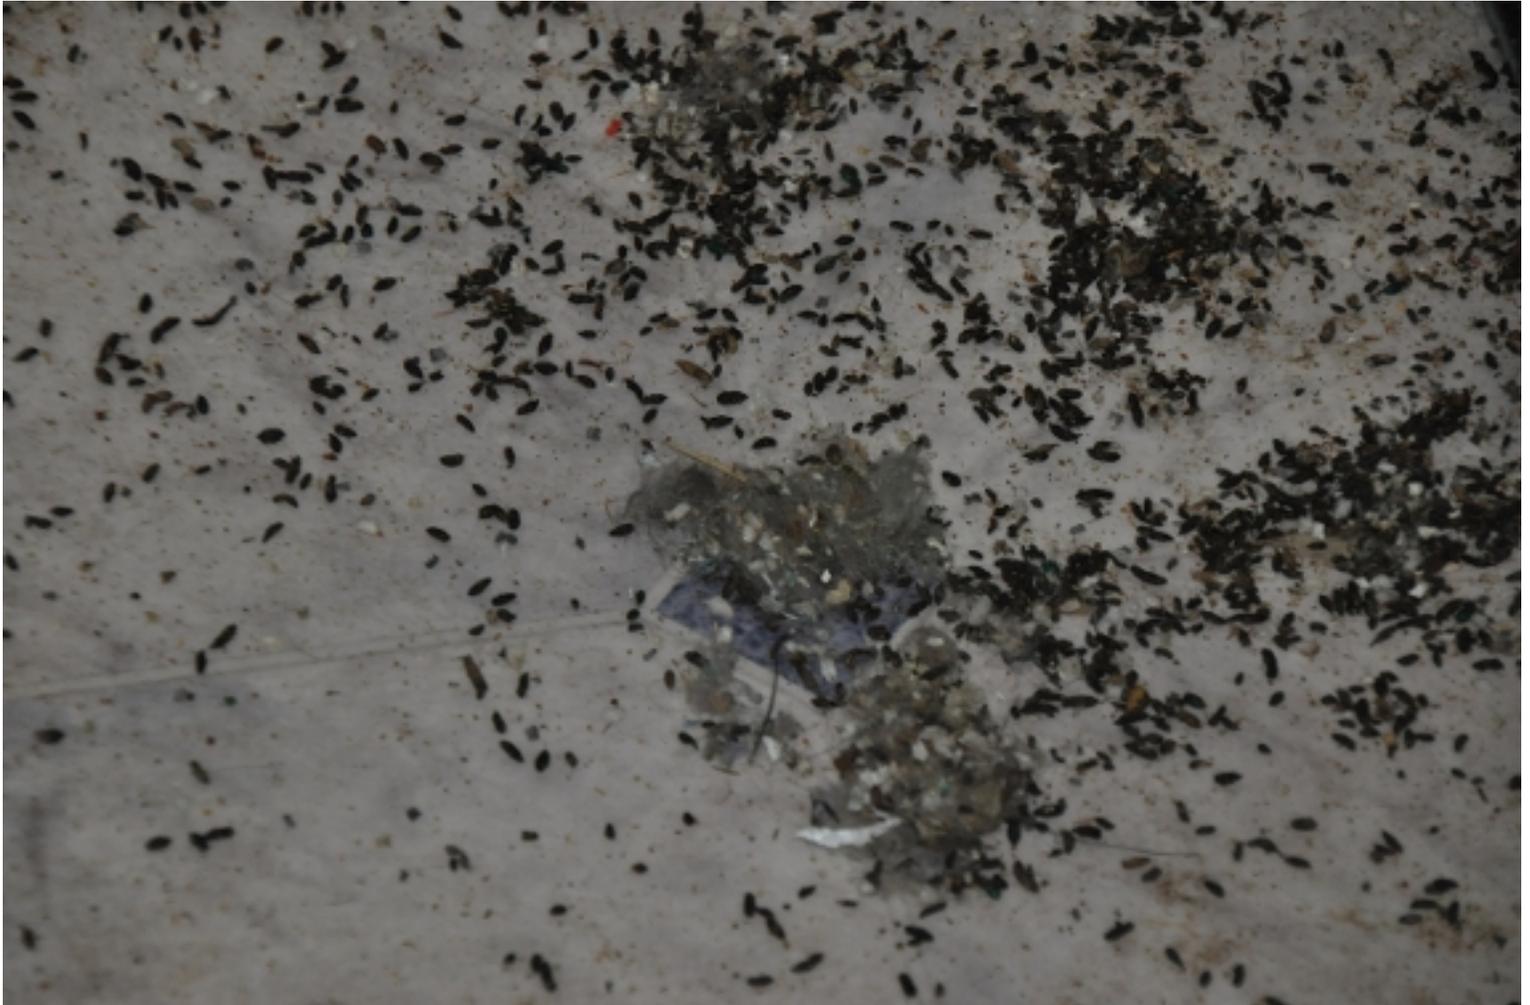
Photographer:	Brenton Cox, ACI	Legal Name:	35-A-0272
Photo Taken:	Sun, May 15, '11 1121	PERRY OTTO	
Inspection:	132111258270724		
Description:	Close up of Accumulation of rodent excreta beside the plastic trashcan holding the animals feed, which is inside the animal housing area.

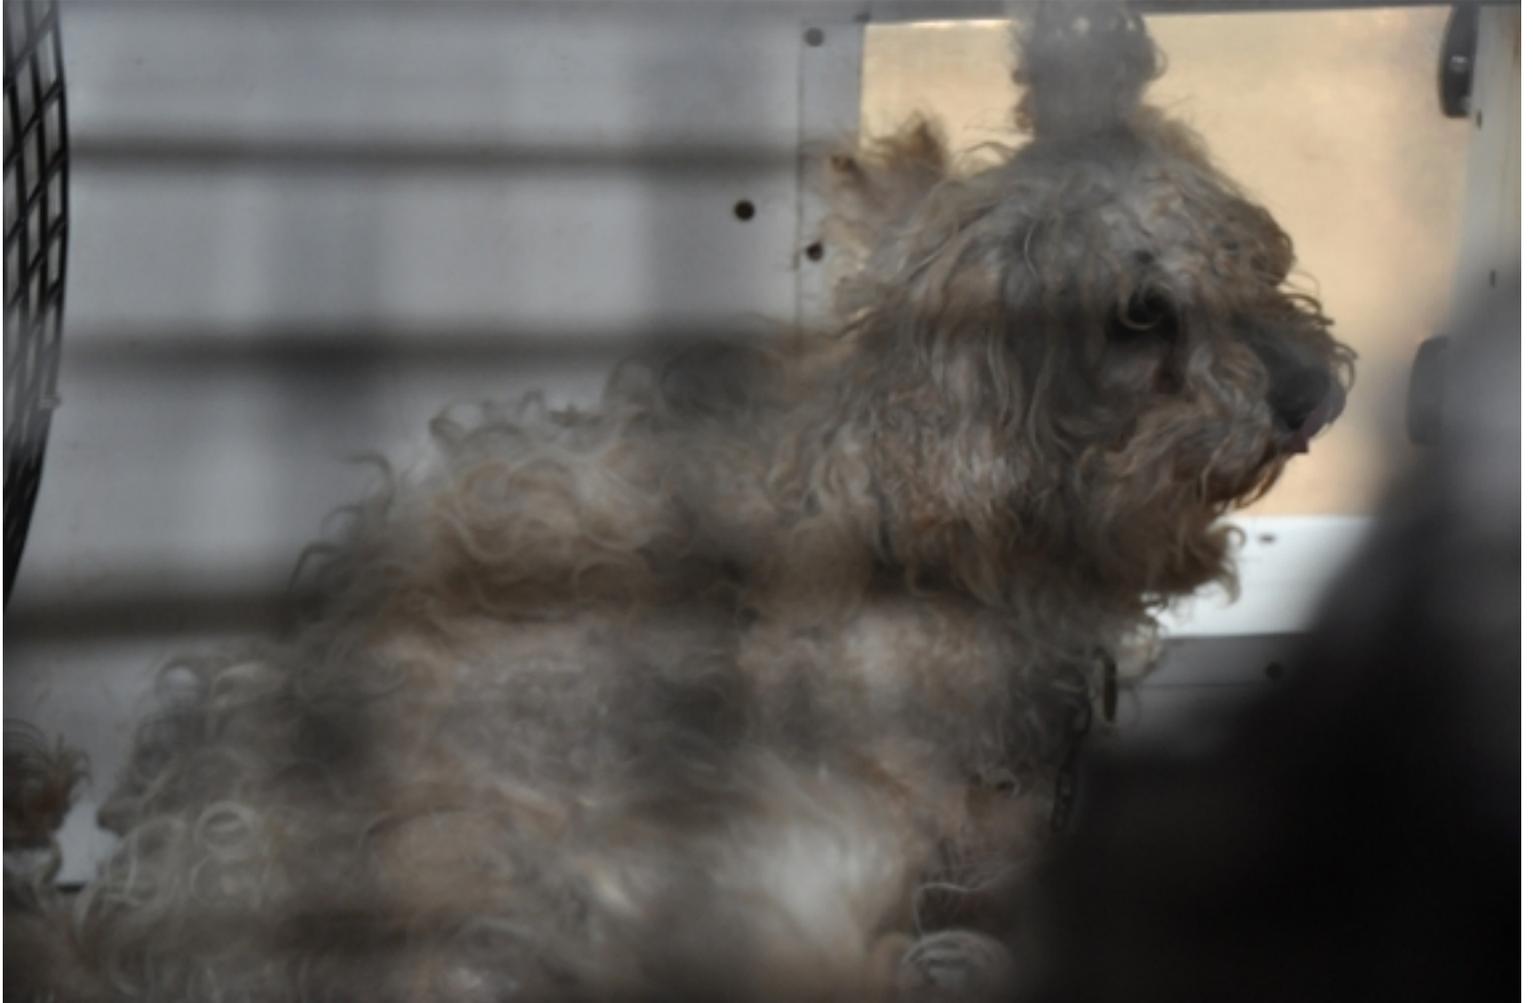
Photographer:	Brenton Cox, ACI	Legal Name:	35-A-0272
Photo Taken:	Sun, May 15, '11 1117	PERRY OTTO	
Inspection:	132111258270724		
Description:	Dog showing an excessive amount of matting.

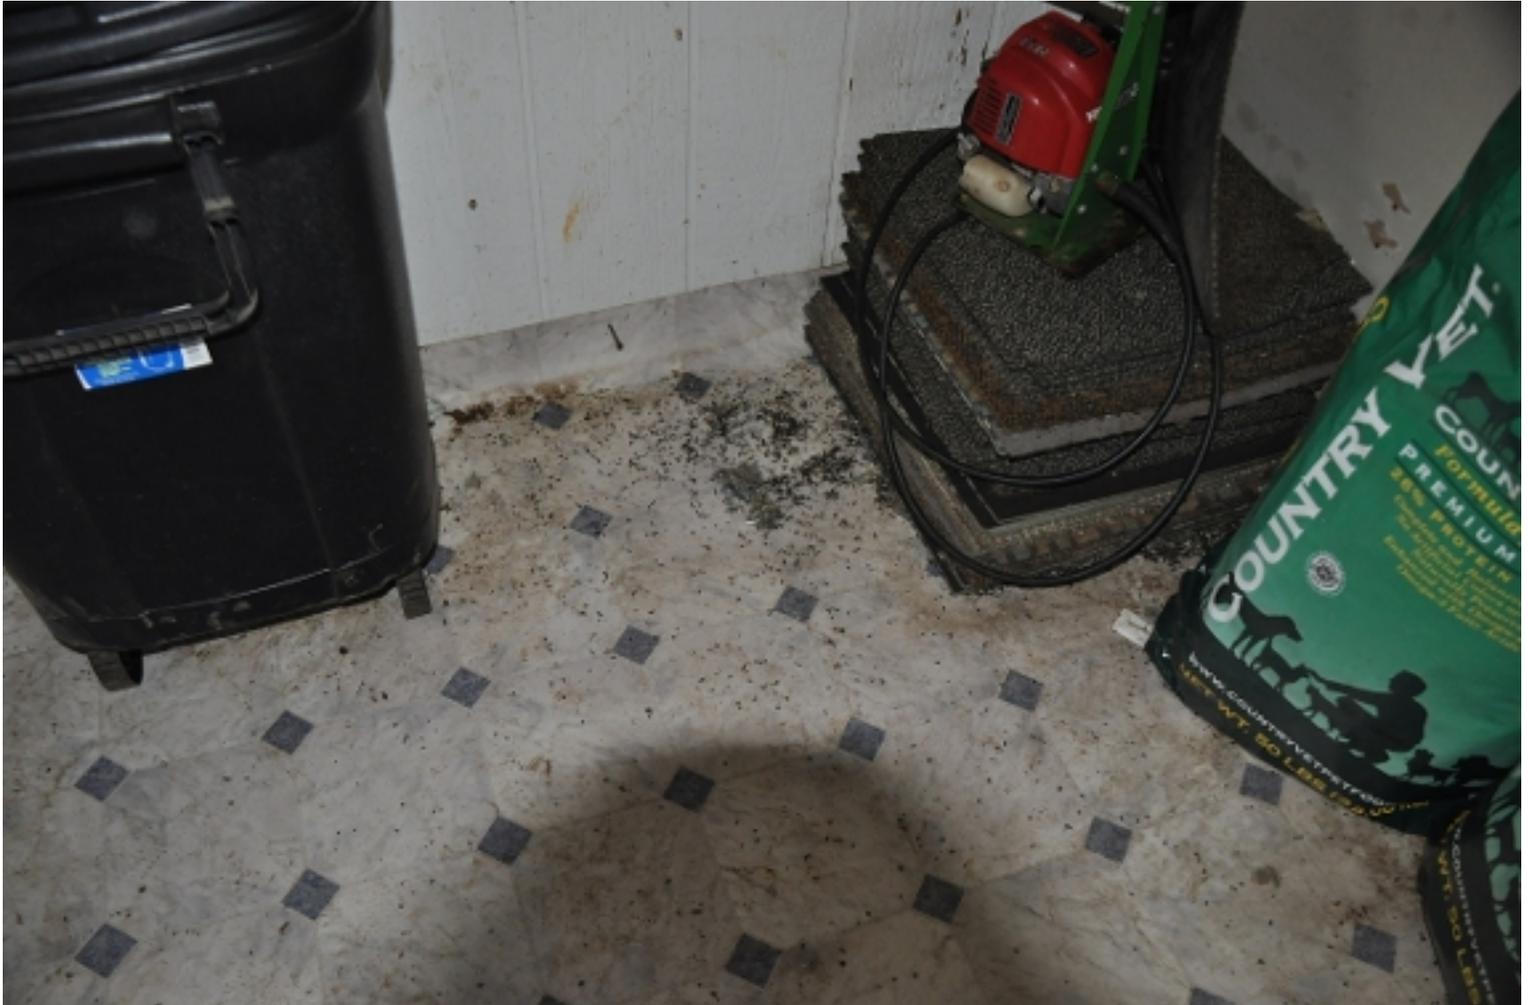
Photographer:	Brenton Cox, ACI	Legal Name:	35-A-0272
Photo Taken:	Sun, May 15, '11 1121	PERRY OTTO	
Inspection:	13211258270724		
Description:	Accumulation of rodent excreta beside the plastic trashcan holding the animals feed, which is inside the animal housing area.

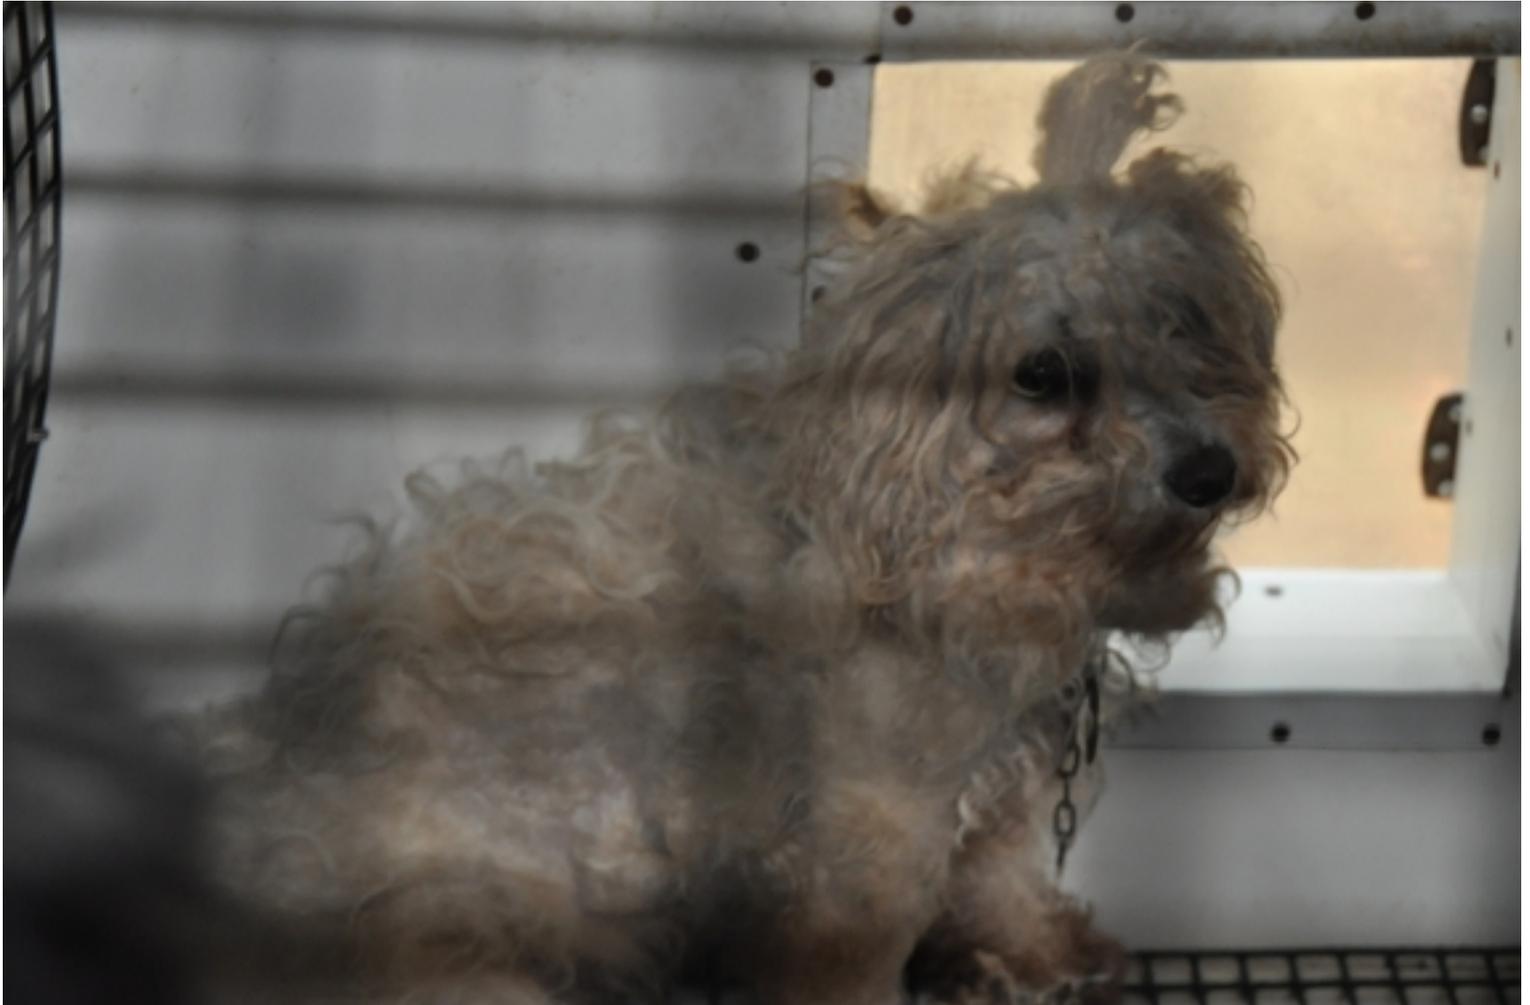
Photographer:	Brenton Cox, ACI	Legal Name:	35-A-0272
Photo Taken:	Sun, May 15, '11 1117	PERRY OTTO	
Inspection:	132111258270724		
Description:	Dog showing an excessive amount of matting.

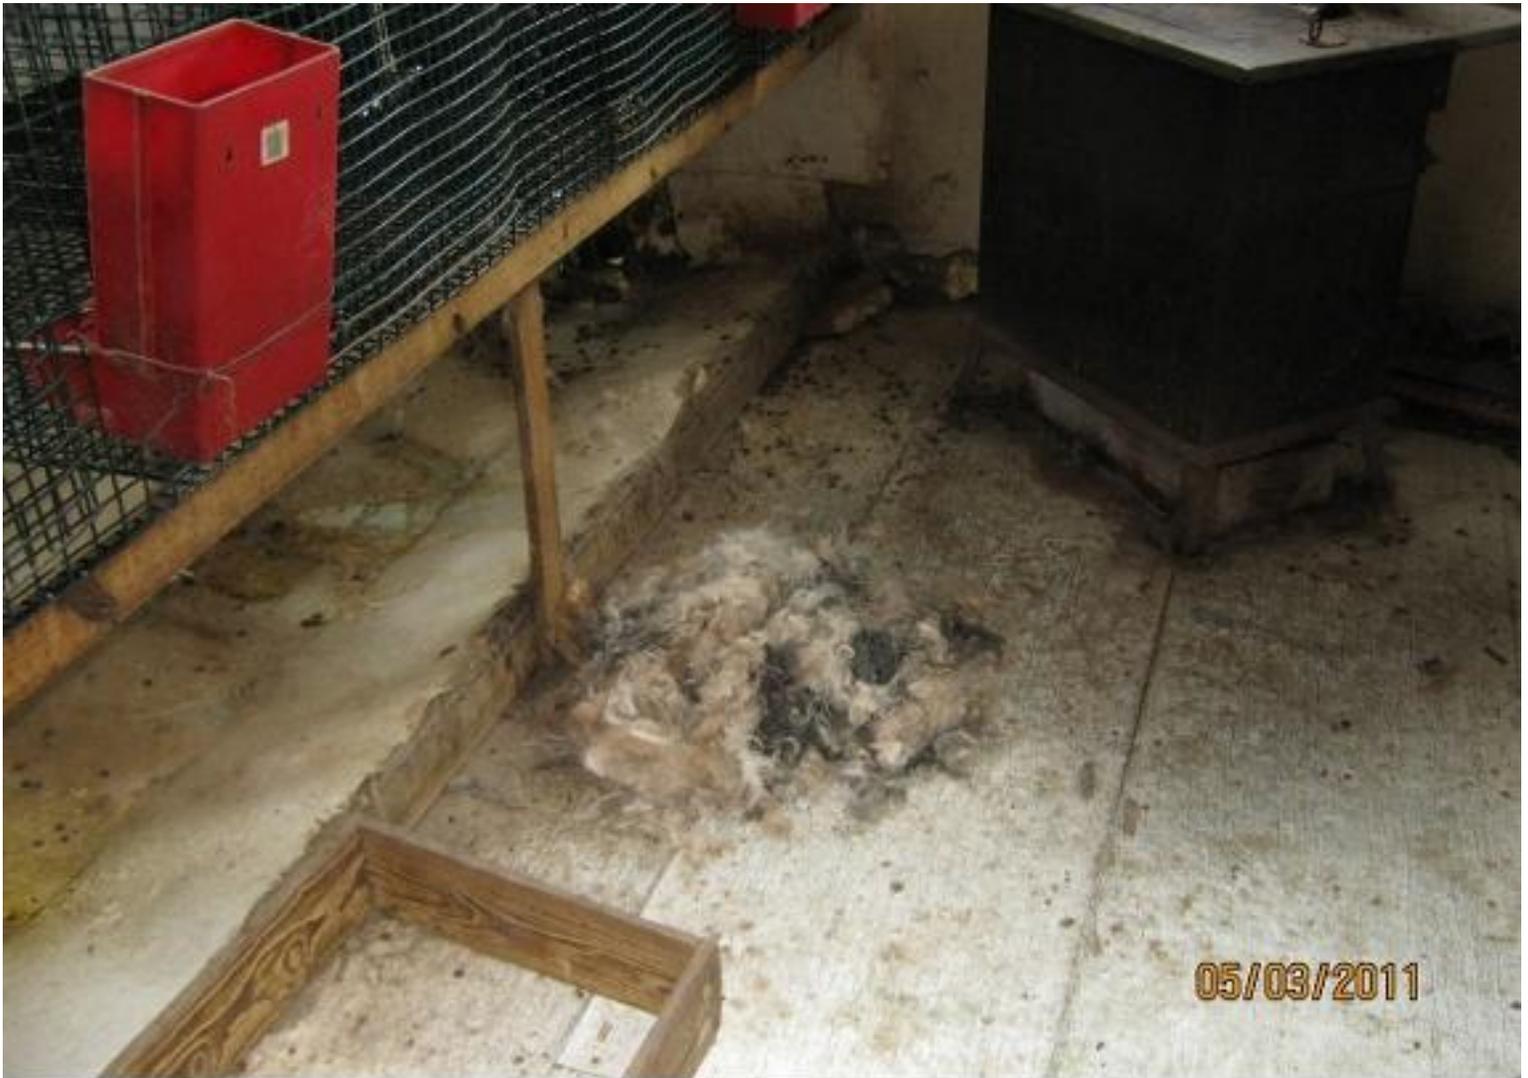
CFR: 3.11 (c), 3.11 (c)

Photographer:	Brenton Cox, ACI	Legal Name:	35-A-0272
Photo Taken:	Tue, May 3, '11 1257	PERRY OTTO	
Inspection:	12311221050479		
Description:	Pile of discarded dog hair, as well as discarded dog food and cobwebs on the dog primary housing area.

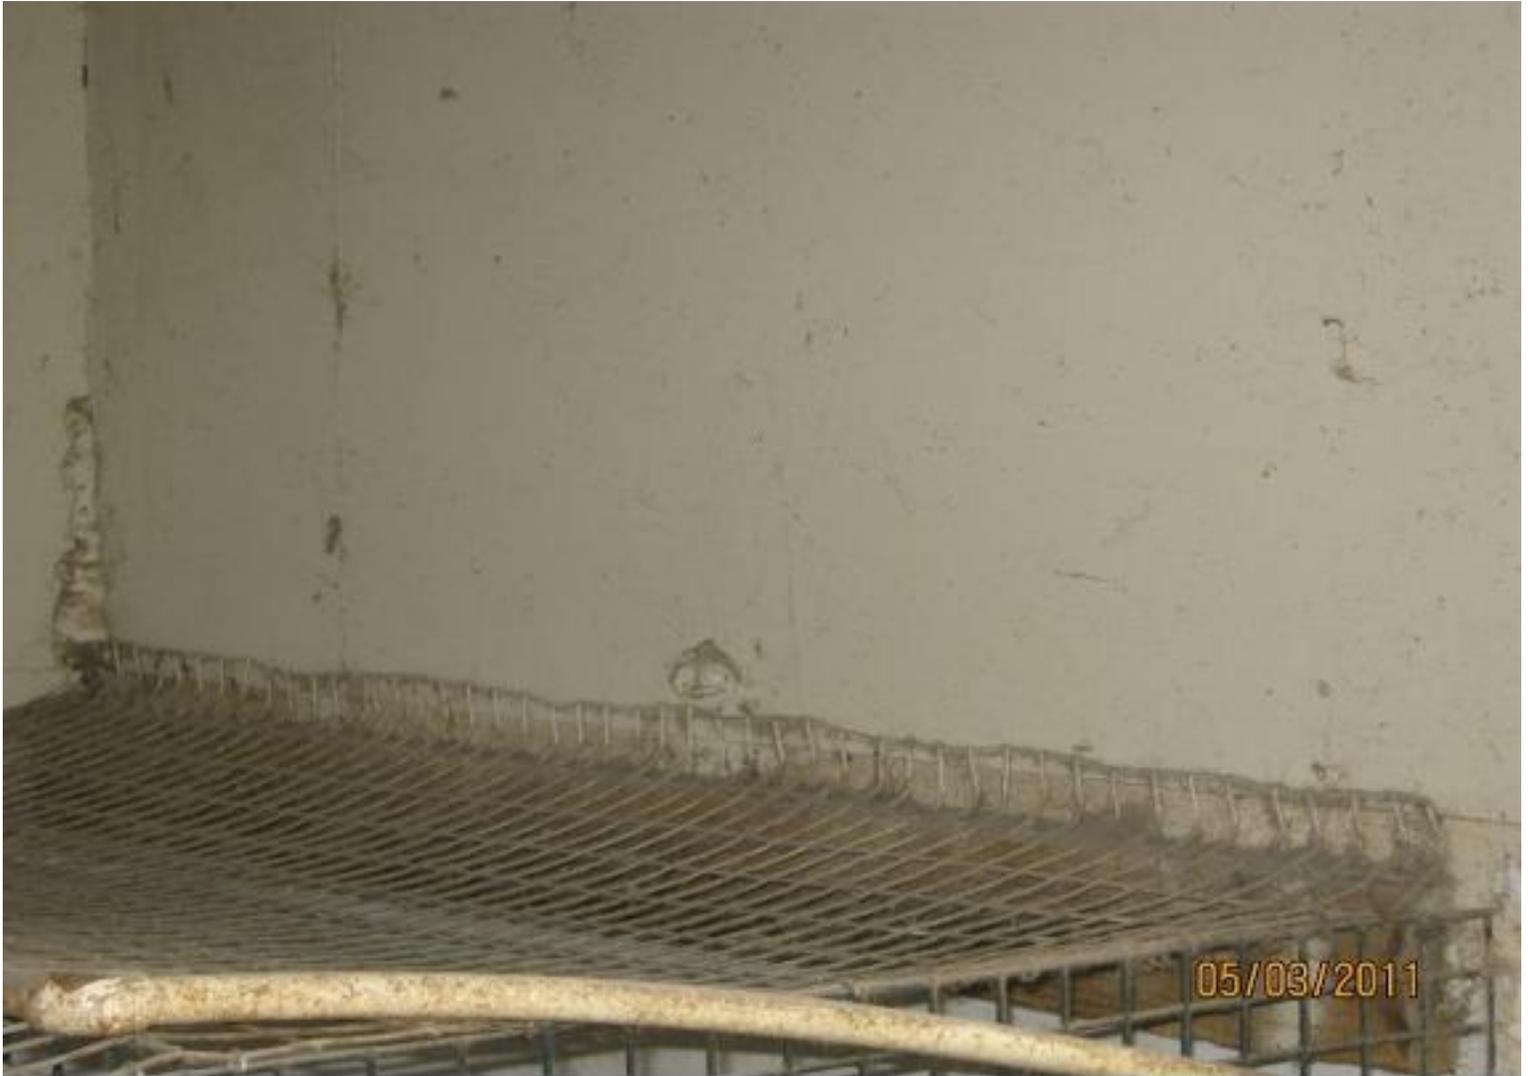
CFR: 3.11 (c)

Photographer:	Brenton Cox, ACI	Legal Name:	35-A-0272
Photo Taken:	Tue, May 3, '11 1257	PERRY OTTO	
Inspection:	12311221050479		
Description:	Build up of cobwebs and dog hair on top of occupied raised dog cages in the primary dog housing area.

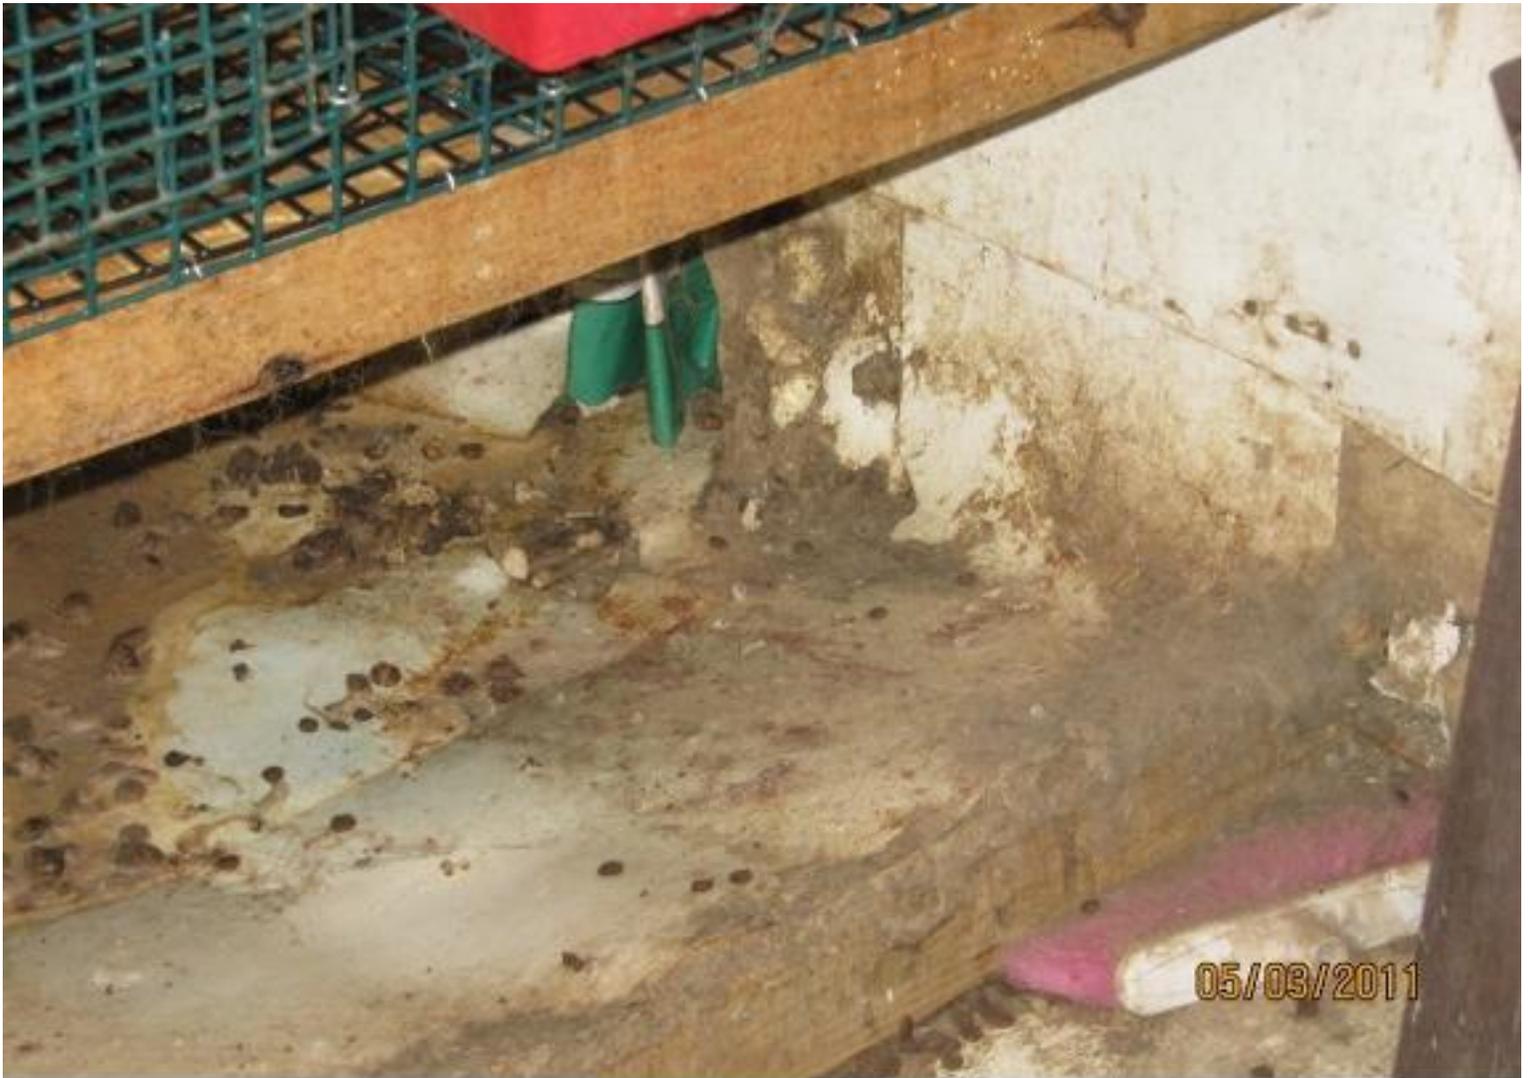
CFR: 3.11 (c), 3.11 (c)

Photographer:	Brenton Cox, ACI	Legal Name:	35-A-0272
Photo Taken:	Tue, May 3, '11 1257	PERRY OTTO	
Inspection:	12311221050479		
Description:	Build up of dog hair, as well as dog food and cobwebs on the dog primary housing area directly under occupied raised dog cages.
