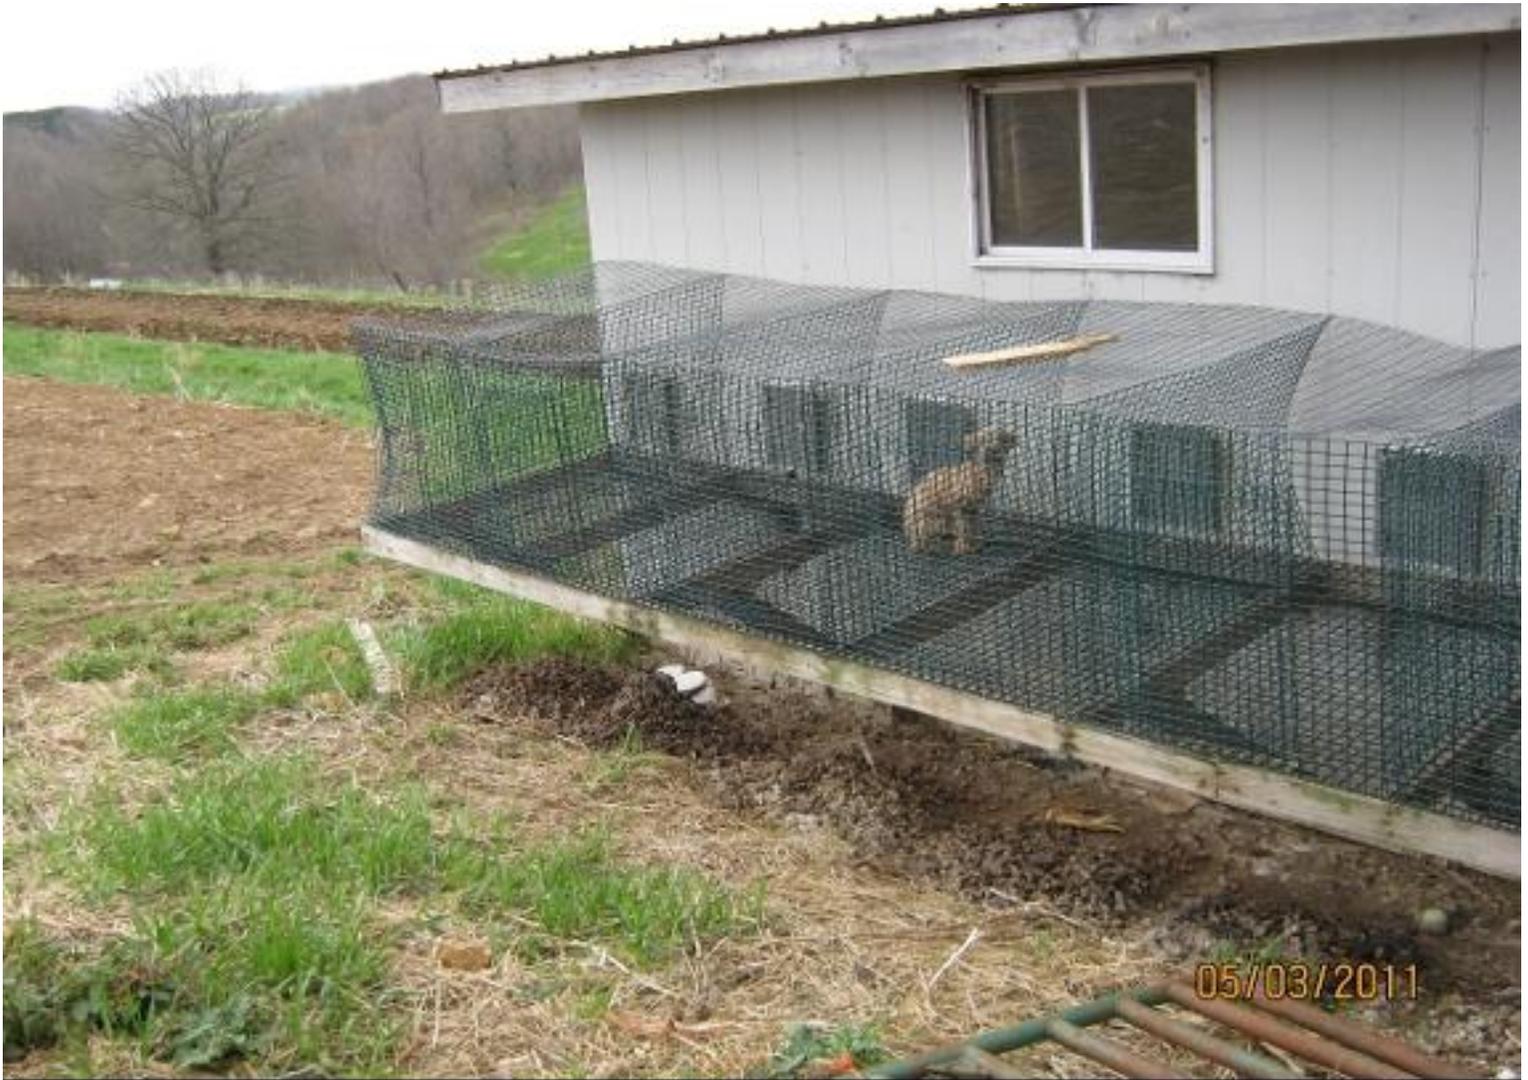
CFR: 3.11 (c)

Photographer:	Brenton Cox, ACI	Legal Name:	35-A-0272
Photo Taken:	Tue, May 3, '11 101	PERRY OTTO	
Inspection:	123111221050479		
Description:	Large build up of dog excreta piled up directly under raised wire cages attached to the dog housing area.

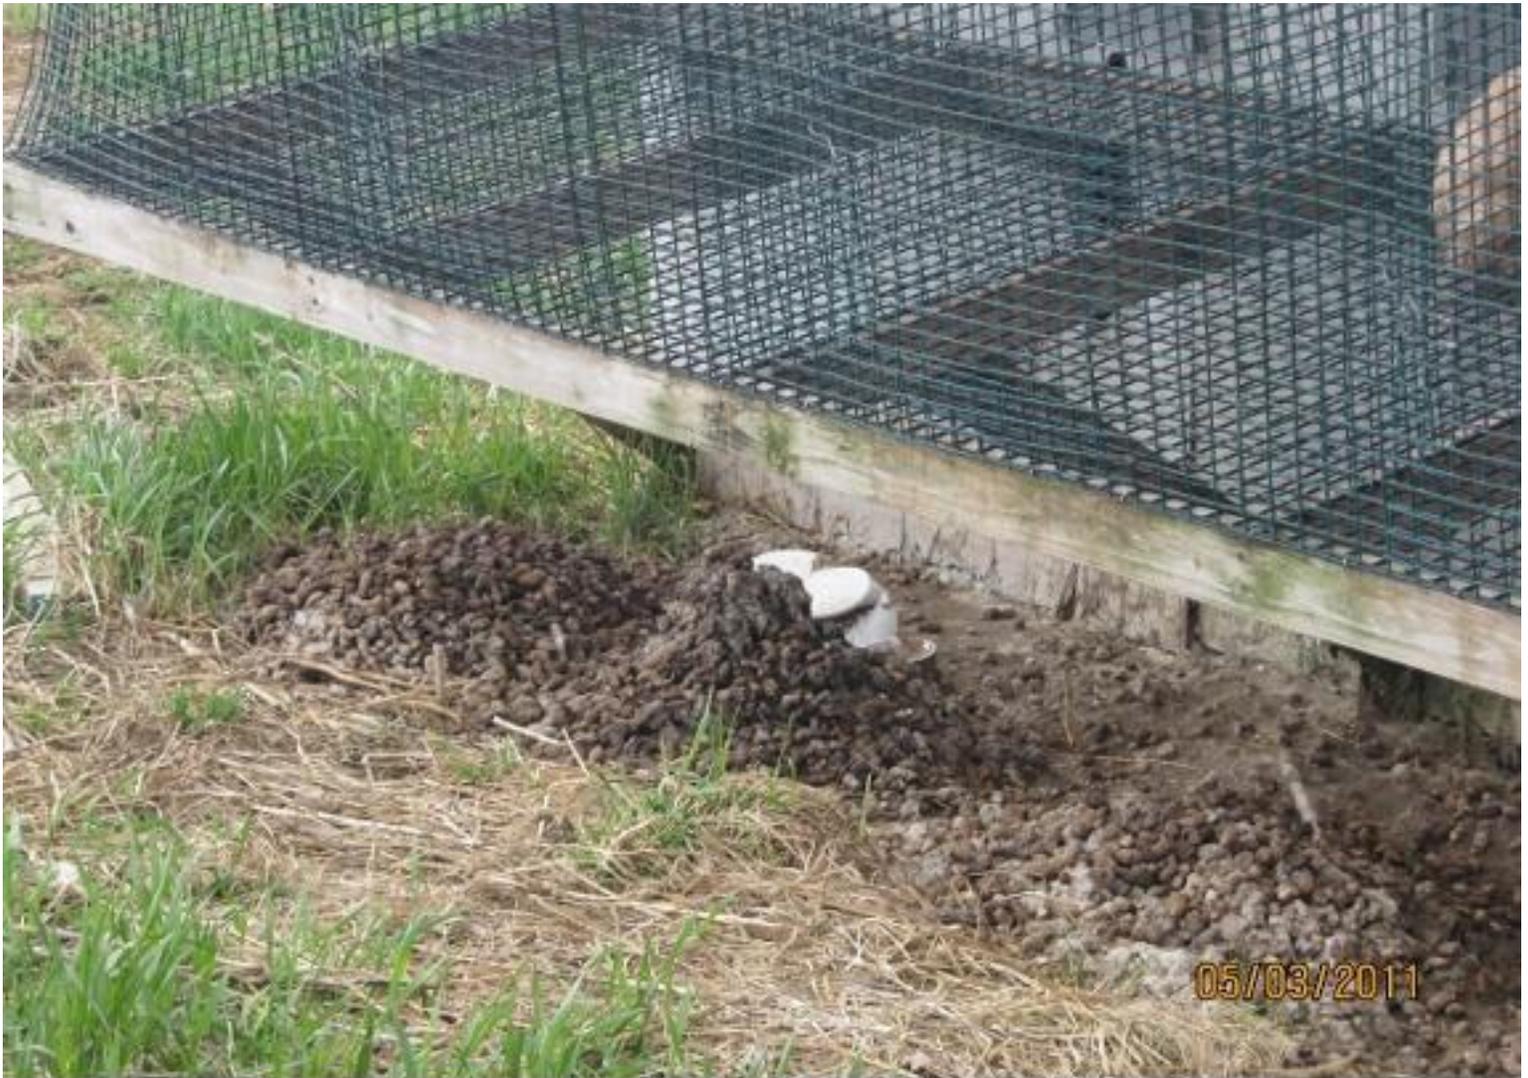
CFR: 3.11 (c)

Photographer:	Brenton Cox, ACI	Legal Name:	35-A-0272
Photo Taken:	Tue, May 3, '11 101	PERRY OTTO	
Inspection:	12311221050479		
Description:	Close up of large build up of dog excreta piled up directly under raised wire cages attached to the dog housing area.

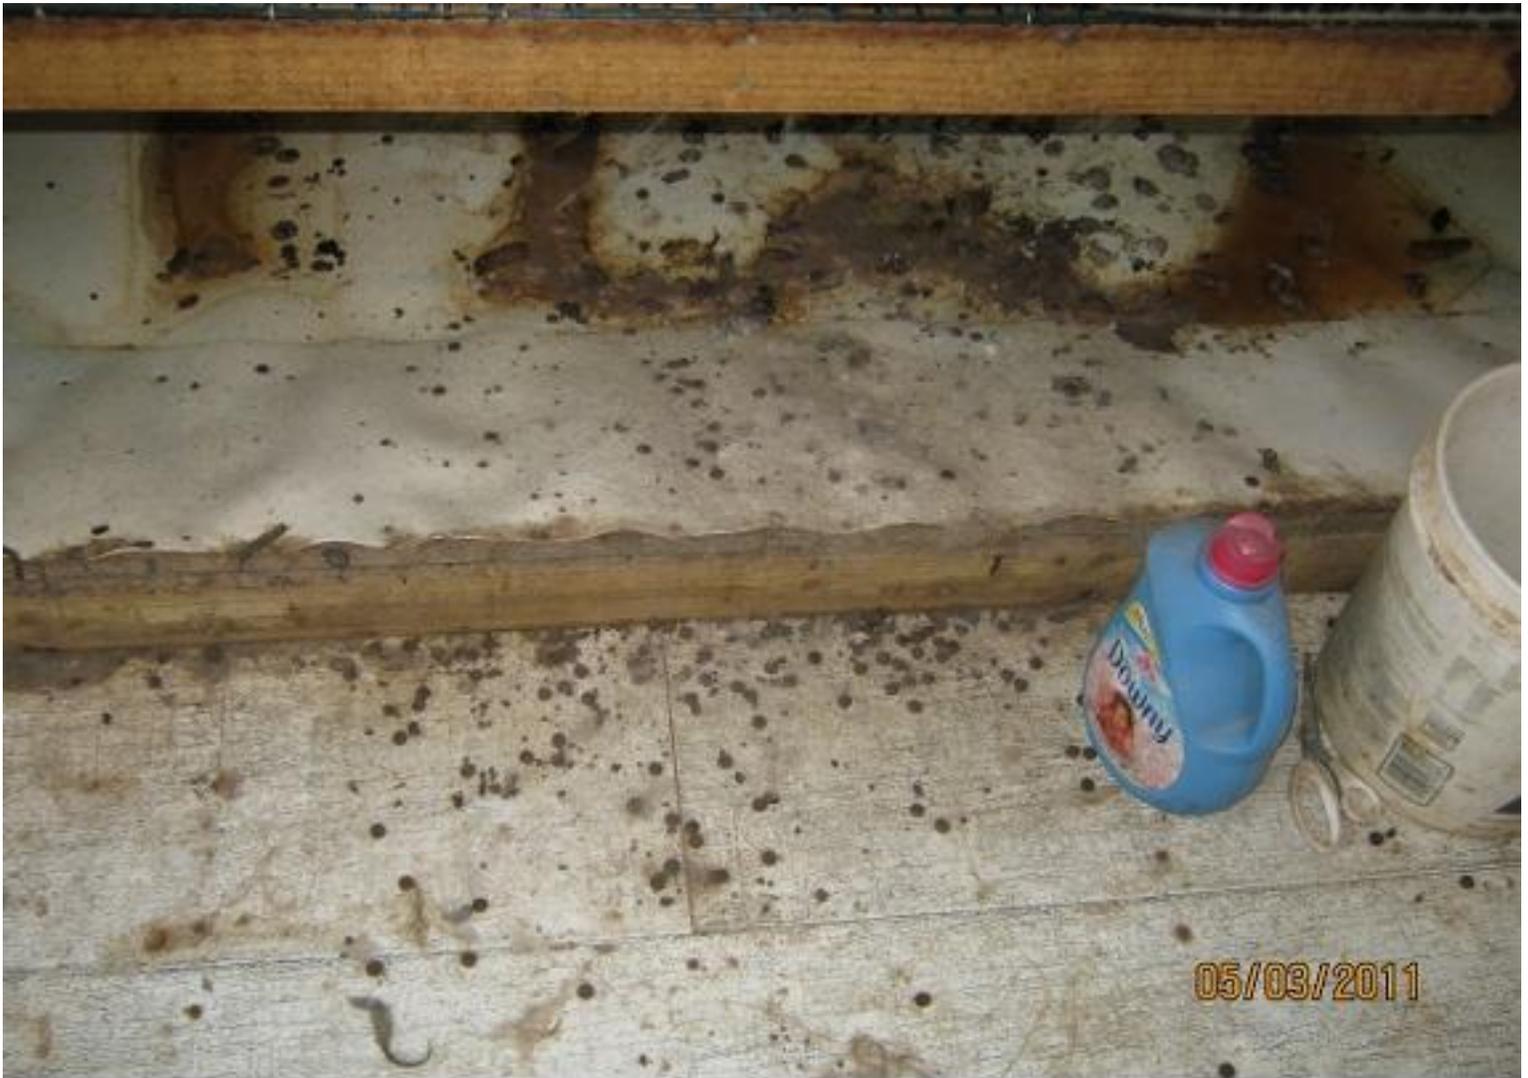
CFR: 3.11 (c)

Photographer:	Brenton Cox, ACI	Legal Name:	35-A-0272
Photo Taken:	Tue, May 3, '11 1258	PERRY OTTO	
Inspection:	123111221050479		
Description:	Build up of dog hair, as well as dog food and cobwebs on the dog primary housing area directly under occupied raised dog cages.

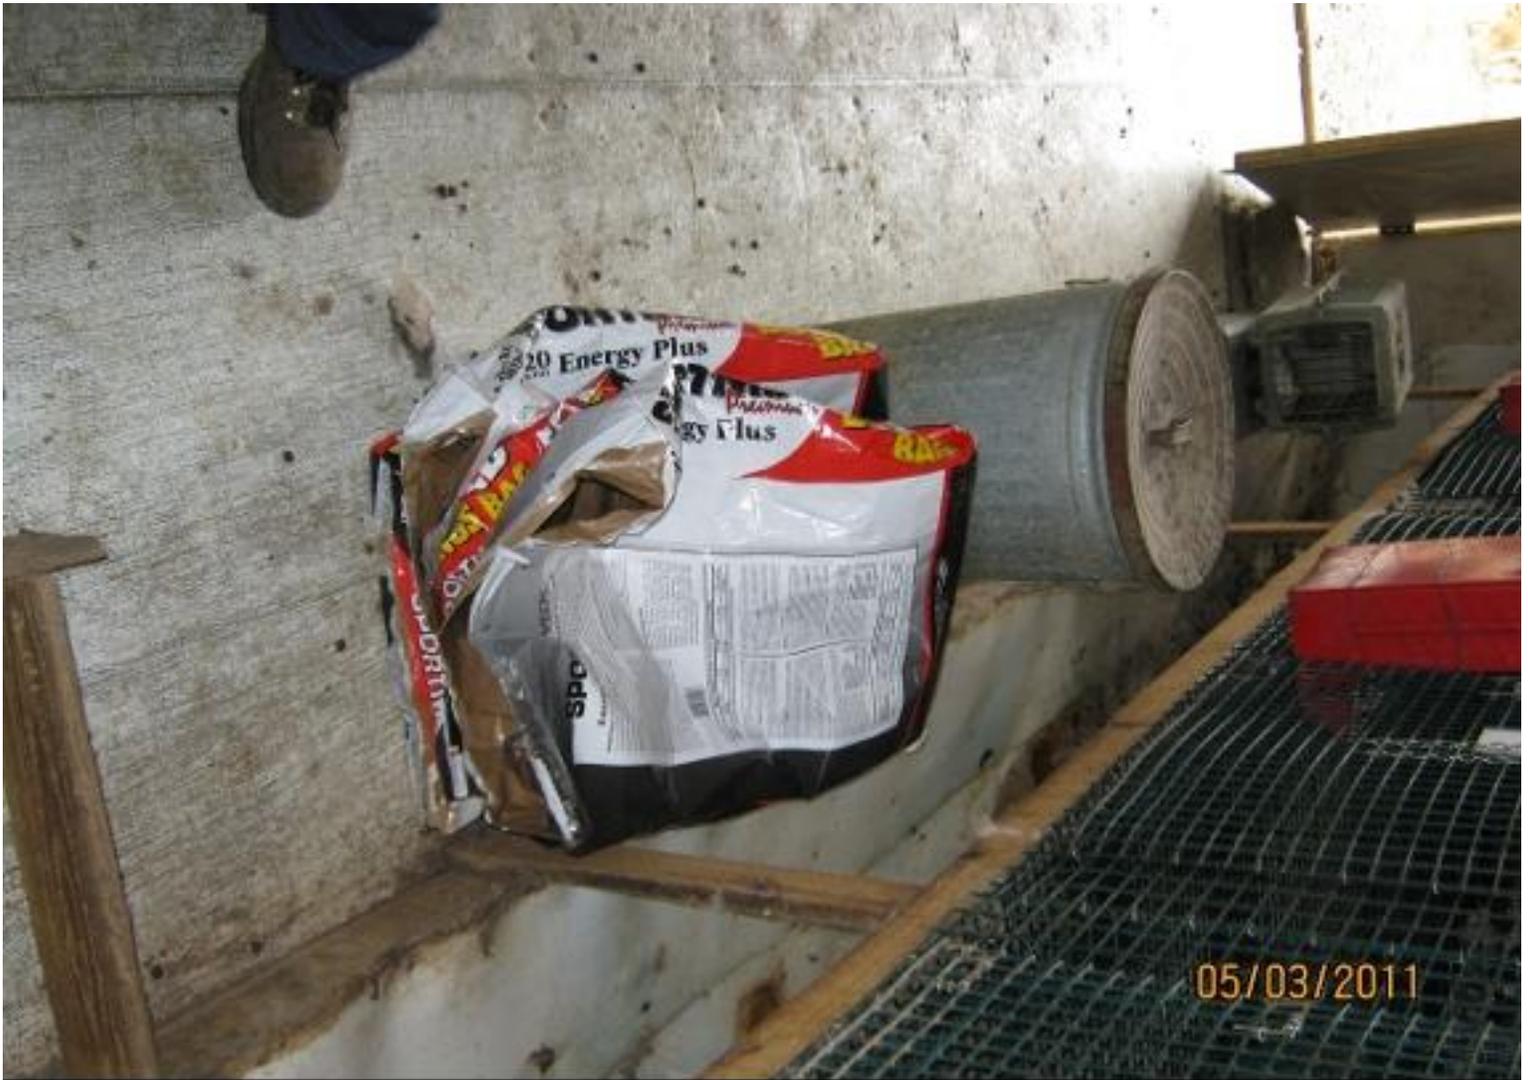
CFR: 3.11 (c)

Photographer:	Brenton Cox, ACI	Legal Name:	35-A-0272
Photo Taken:	Tue, May 3, '11 1258	PERRY OTTO	
Inspection:	12311221050479		
Description:	Discarded animal feed bags inside the primary housing area directly beside and under occupied raised animal cages.

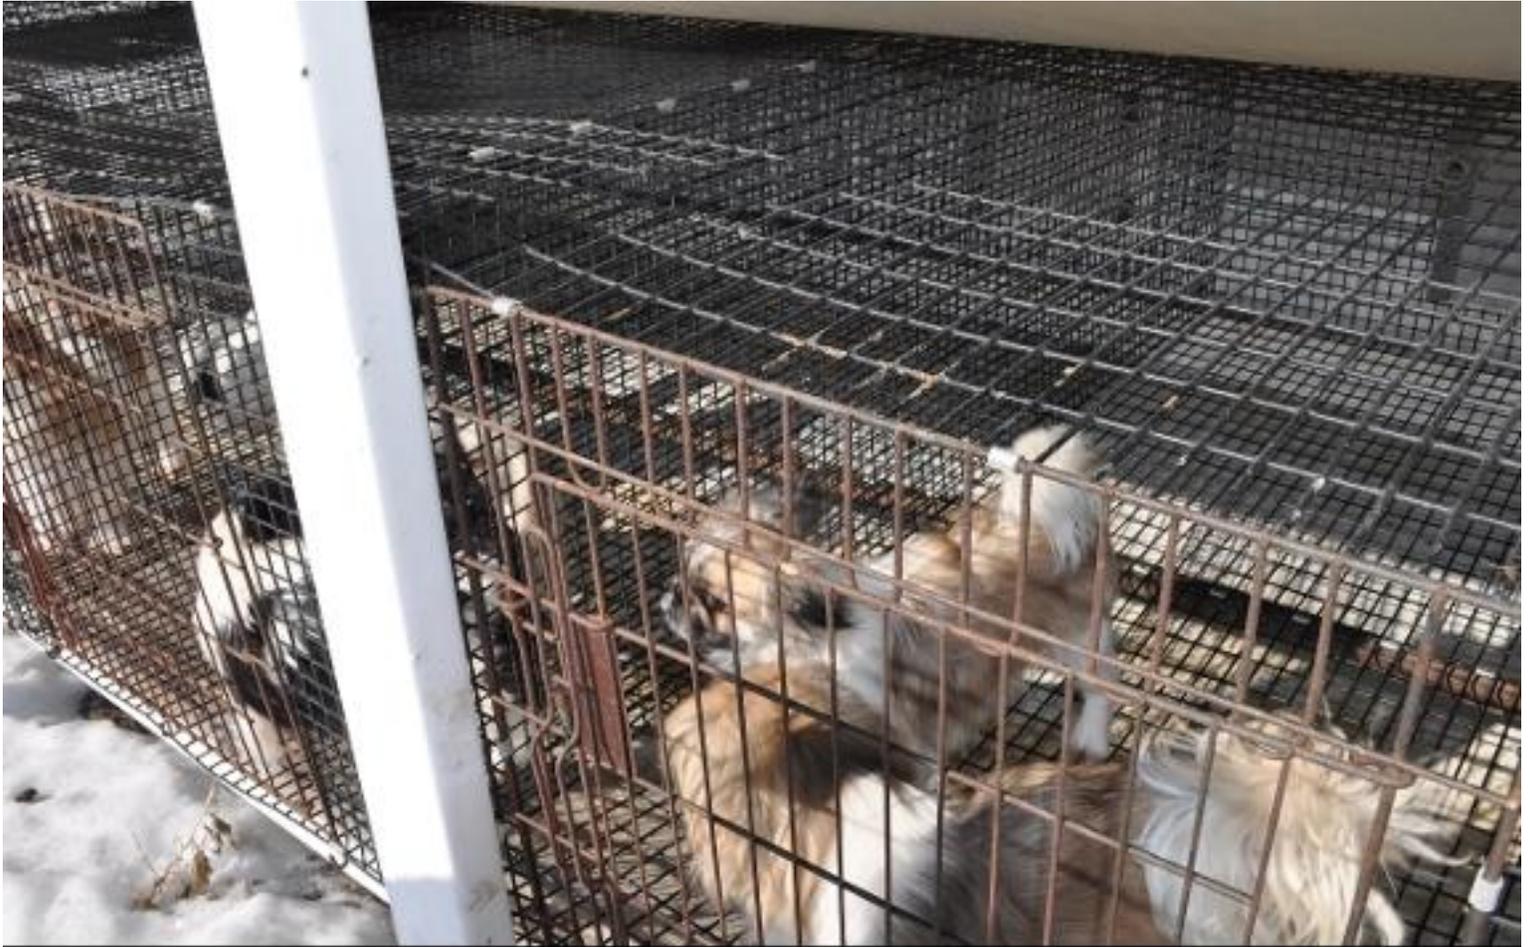
CFR: 3.1 (a)

Description: floor breaking away from the wall of the kennel

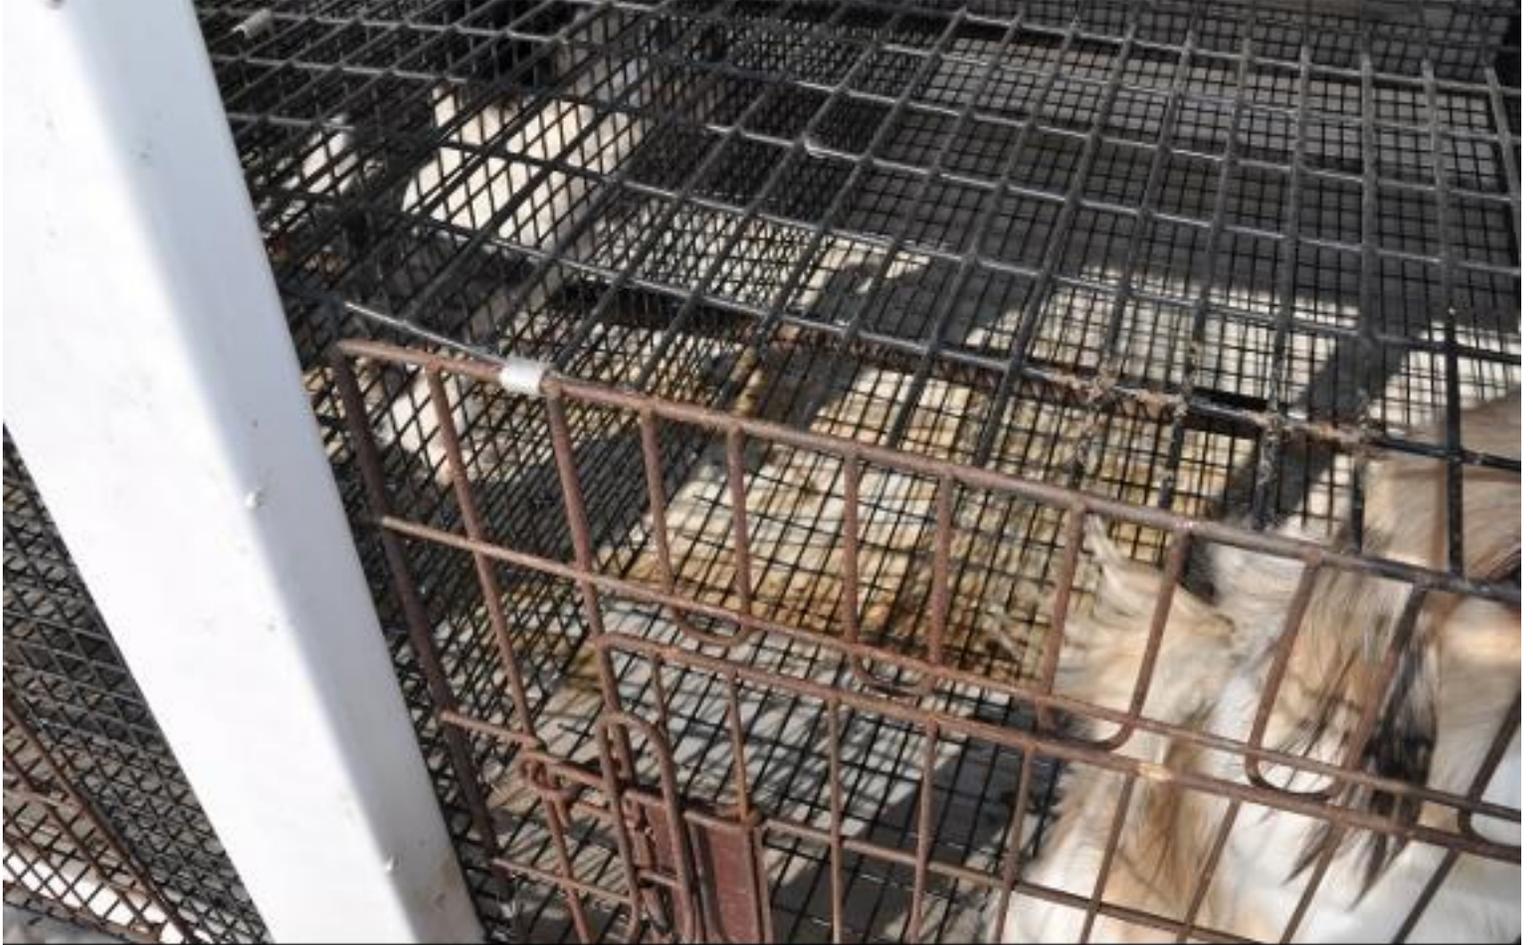
CFR: 3.1 (a)

Photographer:	clb	Legal Name:	34-A-0186
Photo Taken:	Wed, Feb 16, '11 1:55 pm	MATTHEW SCHWARTZ	
Inspection:	48111433530597		
Description:	floor breaking away from the wall of the kennel

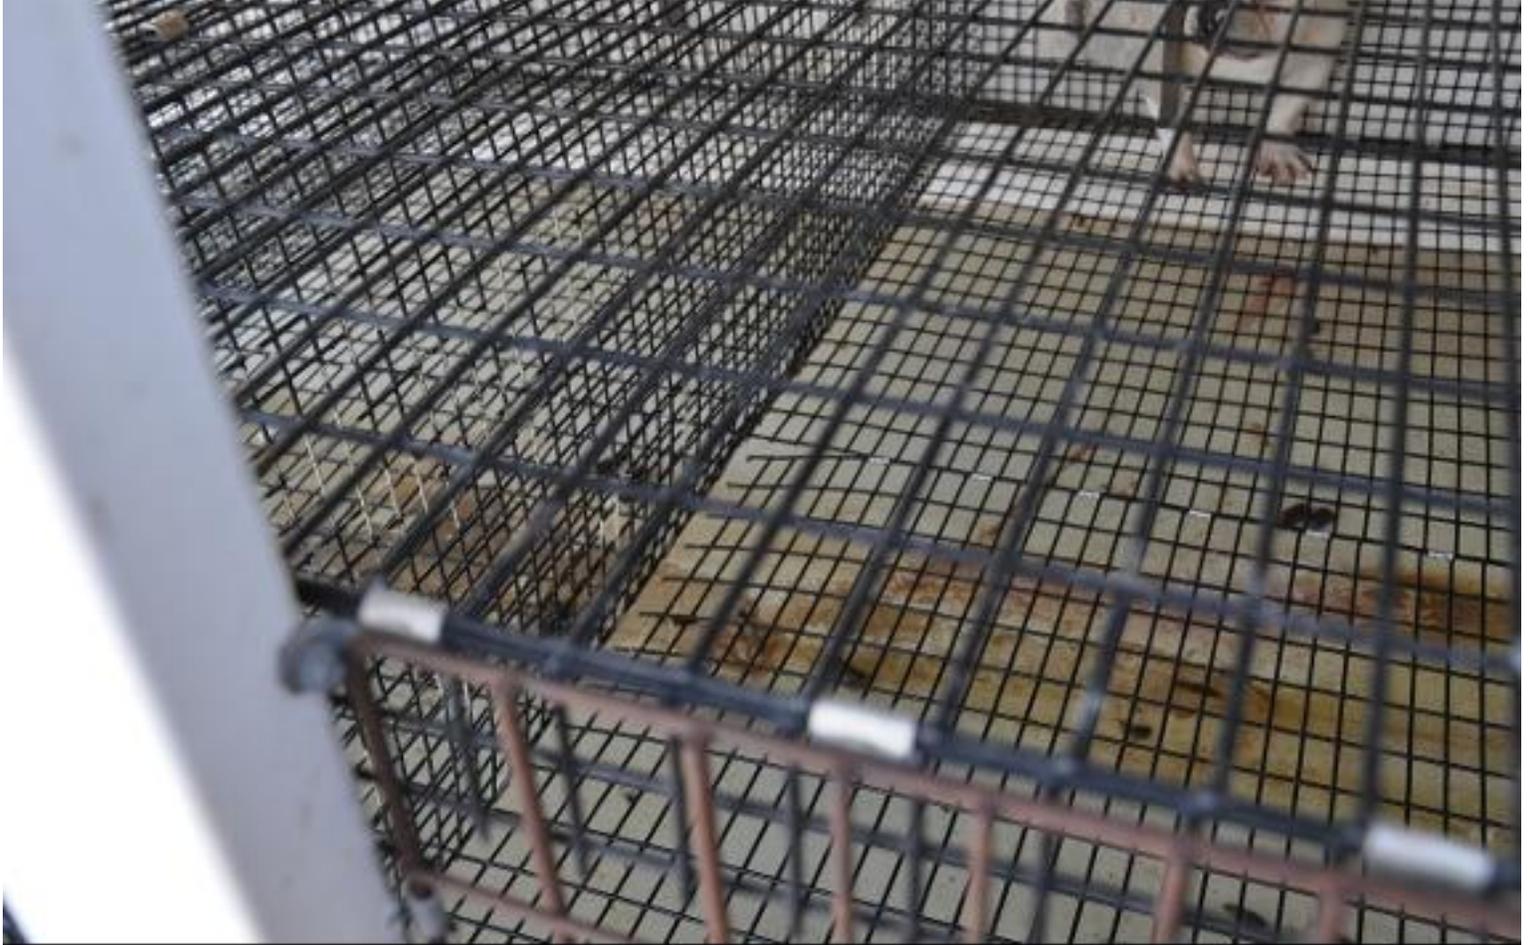
CFR: 3.1 (a)

Photographer:	clb	Legal Name:	34-A-0186
Photo Taken:	Wed, Feb 16, '11 1:59 PM	MATTHEW SCHWARTZ	
Inspection:	48111433530597		
Description:	Floor of kennel breaking away from the floor.

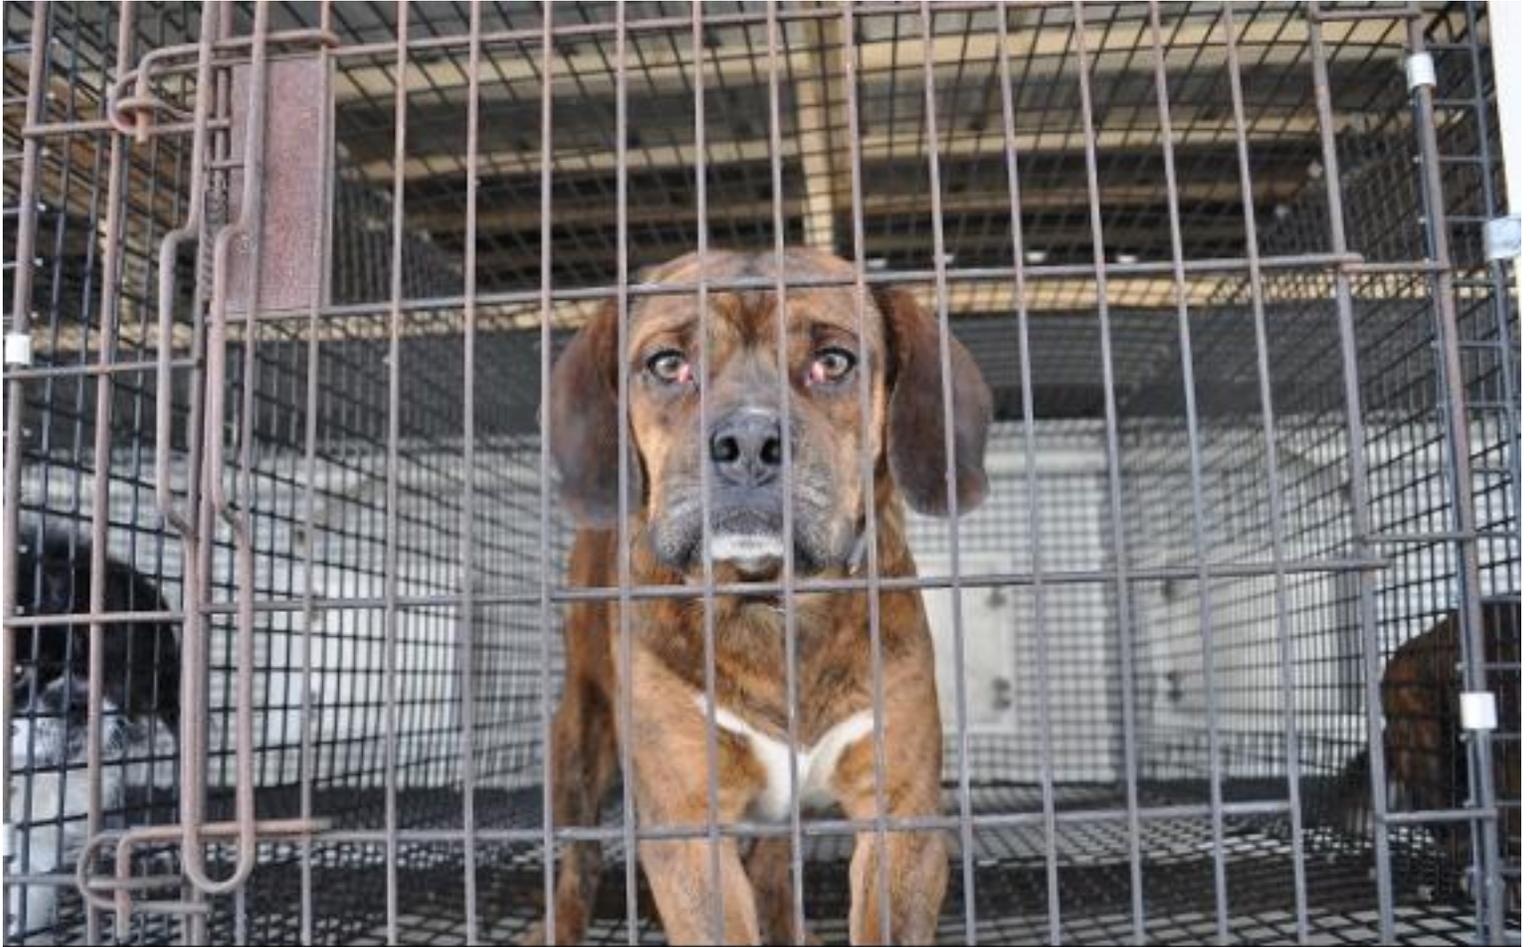
CFR: 2.40 (b) (2)

Photographer:	clb	Legal Name:	34-A-0186
Photo Taken:	Wed, Feb 16, '11 1:57 PM	MATTHEW SCHWARTZ	
Inspection:	48111433530597		
Description:	fleshy inflammation on the interior of the beagle/bulldog mix
