Inspection Report

GEORGE HANNEFORD JR

Type: ROUTINE INSPECTION

Date: Mar-30-2011

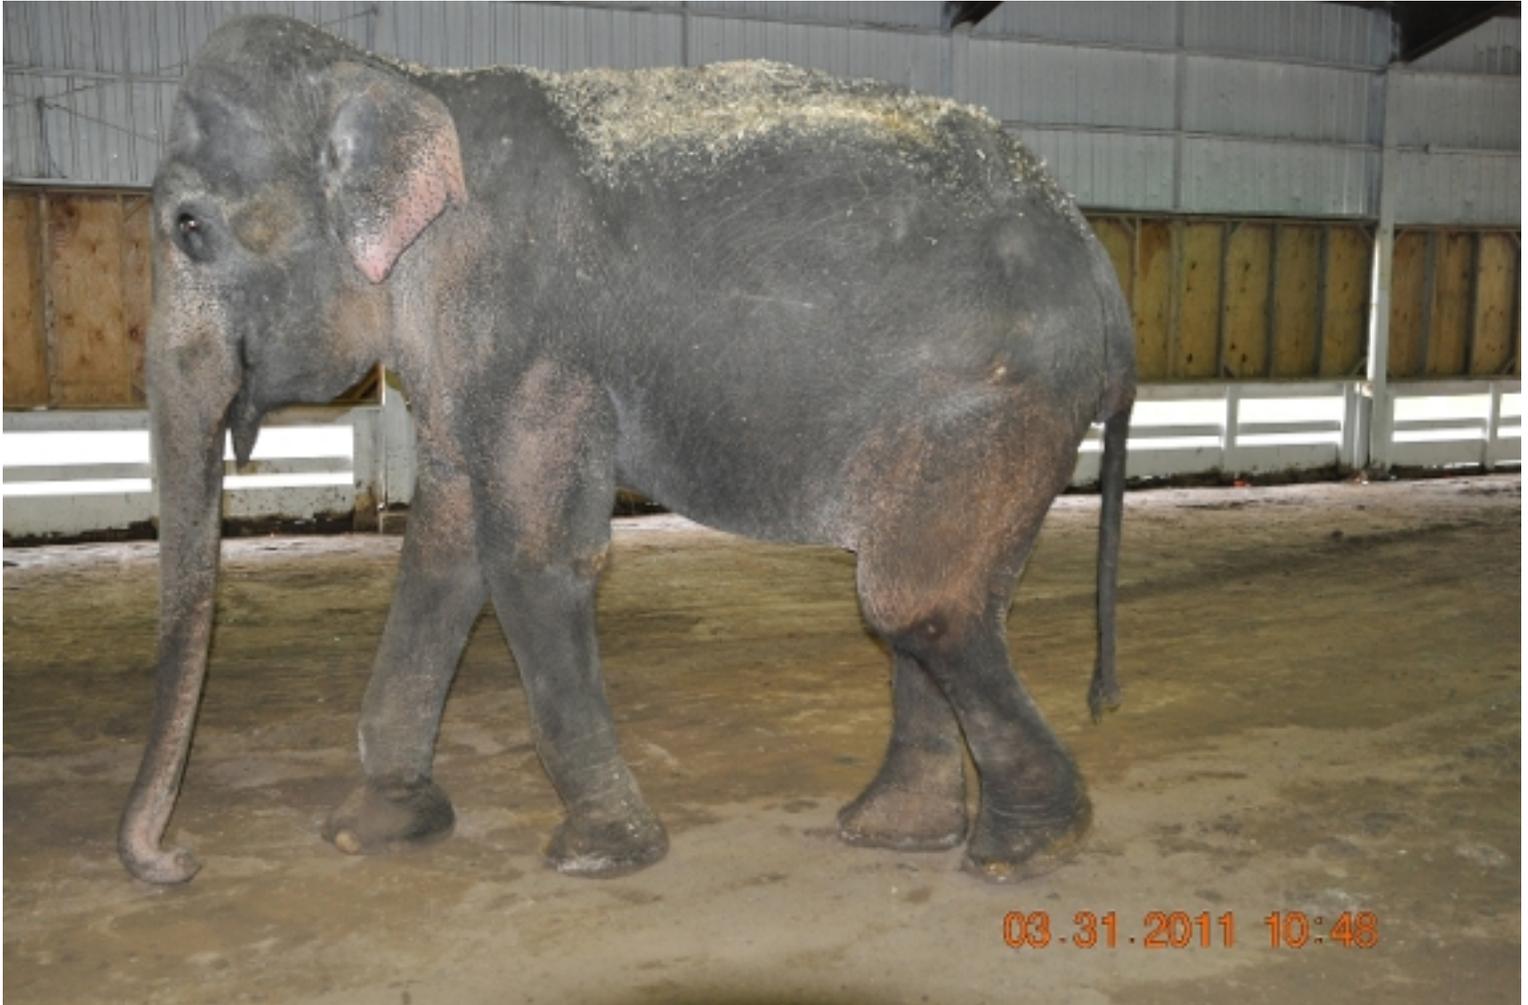
Photographer:	Paula Gladue	Legal Name:	58-C-0666
Photo Taken:	Thu, Mar 31, '11 10:48 AM	GEORGE HANNEFORD JR	
Inspection:	90110018200625		
Description:	Follow-up picture of "Liz" from left side 3-31-11.

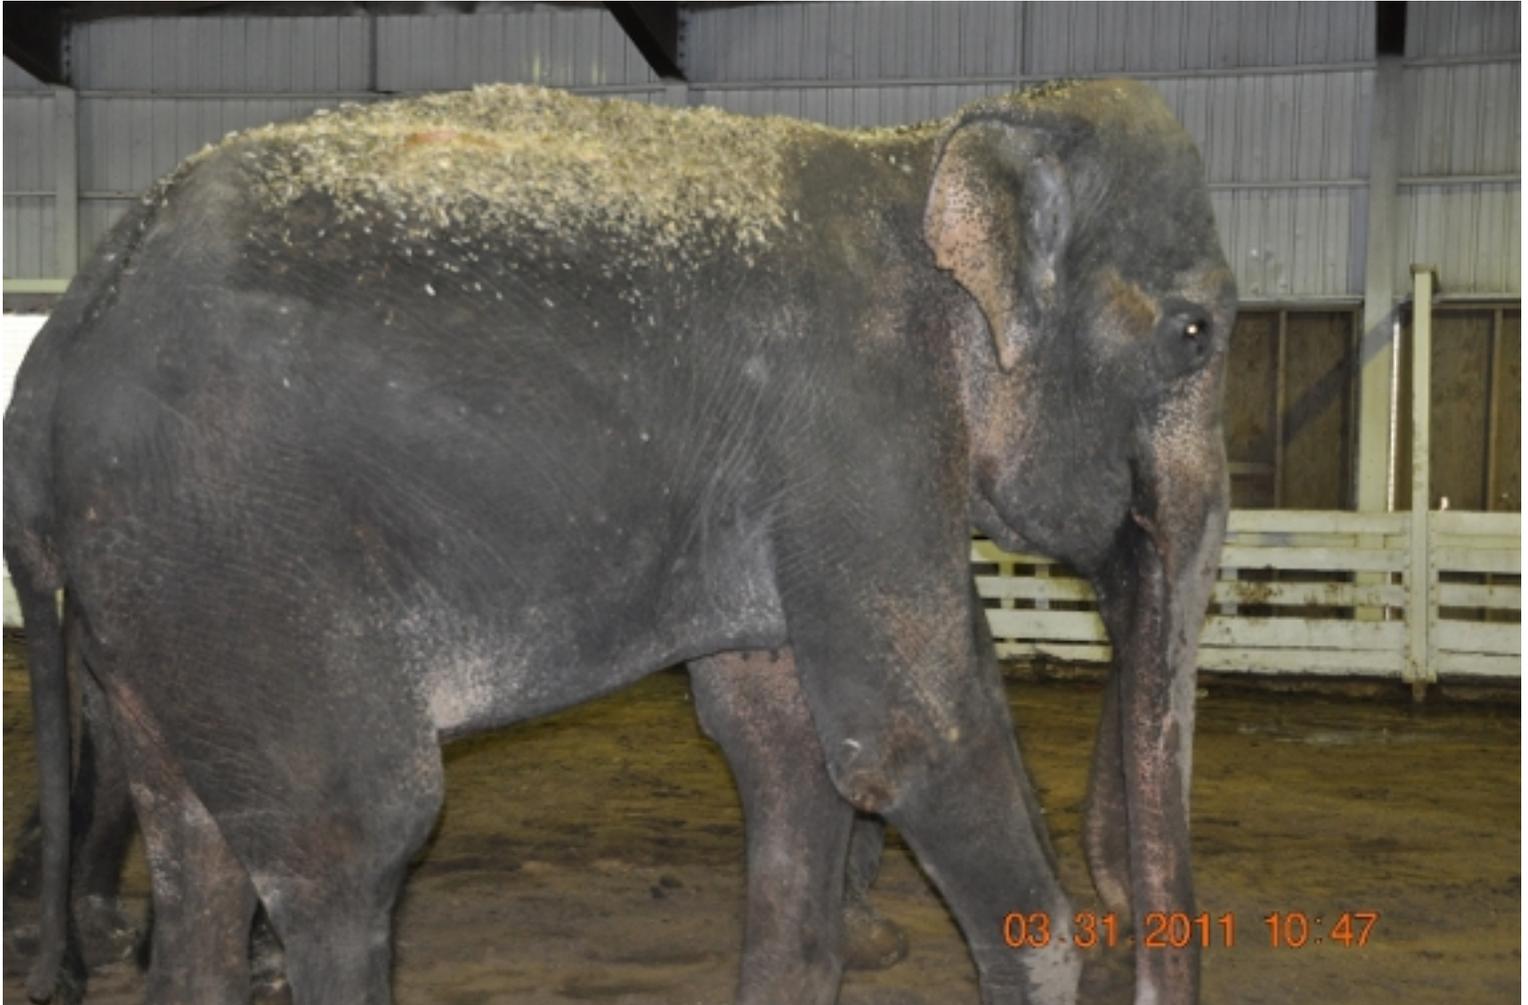
Photographer:	Paula Gladue	Legal Name:	58-C-0666
Photo Taken:	Thu, Mar 31, '11 10:47 AM	GEORGE HANNEFORD JR	
Inspection:	90110018200625		
Description:	Follow-up picture of "Liz" from right side 3-31-11.

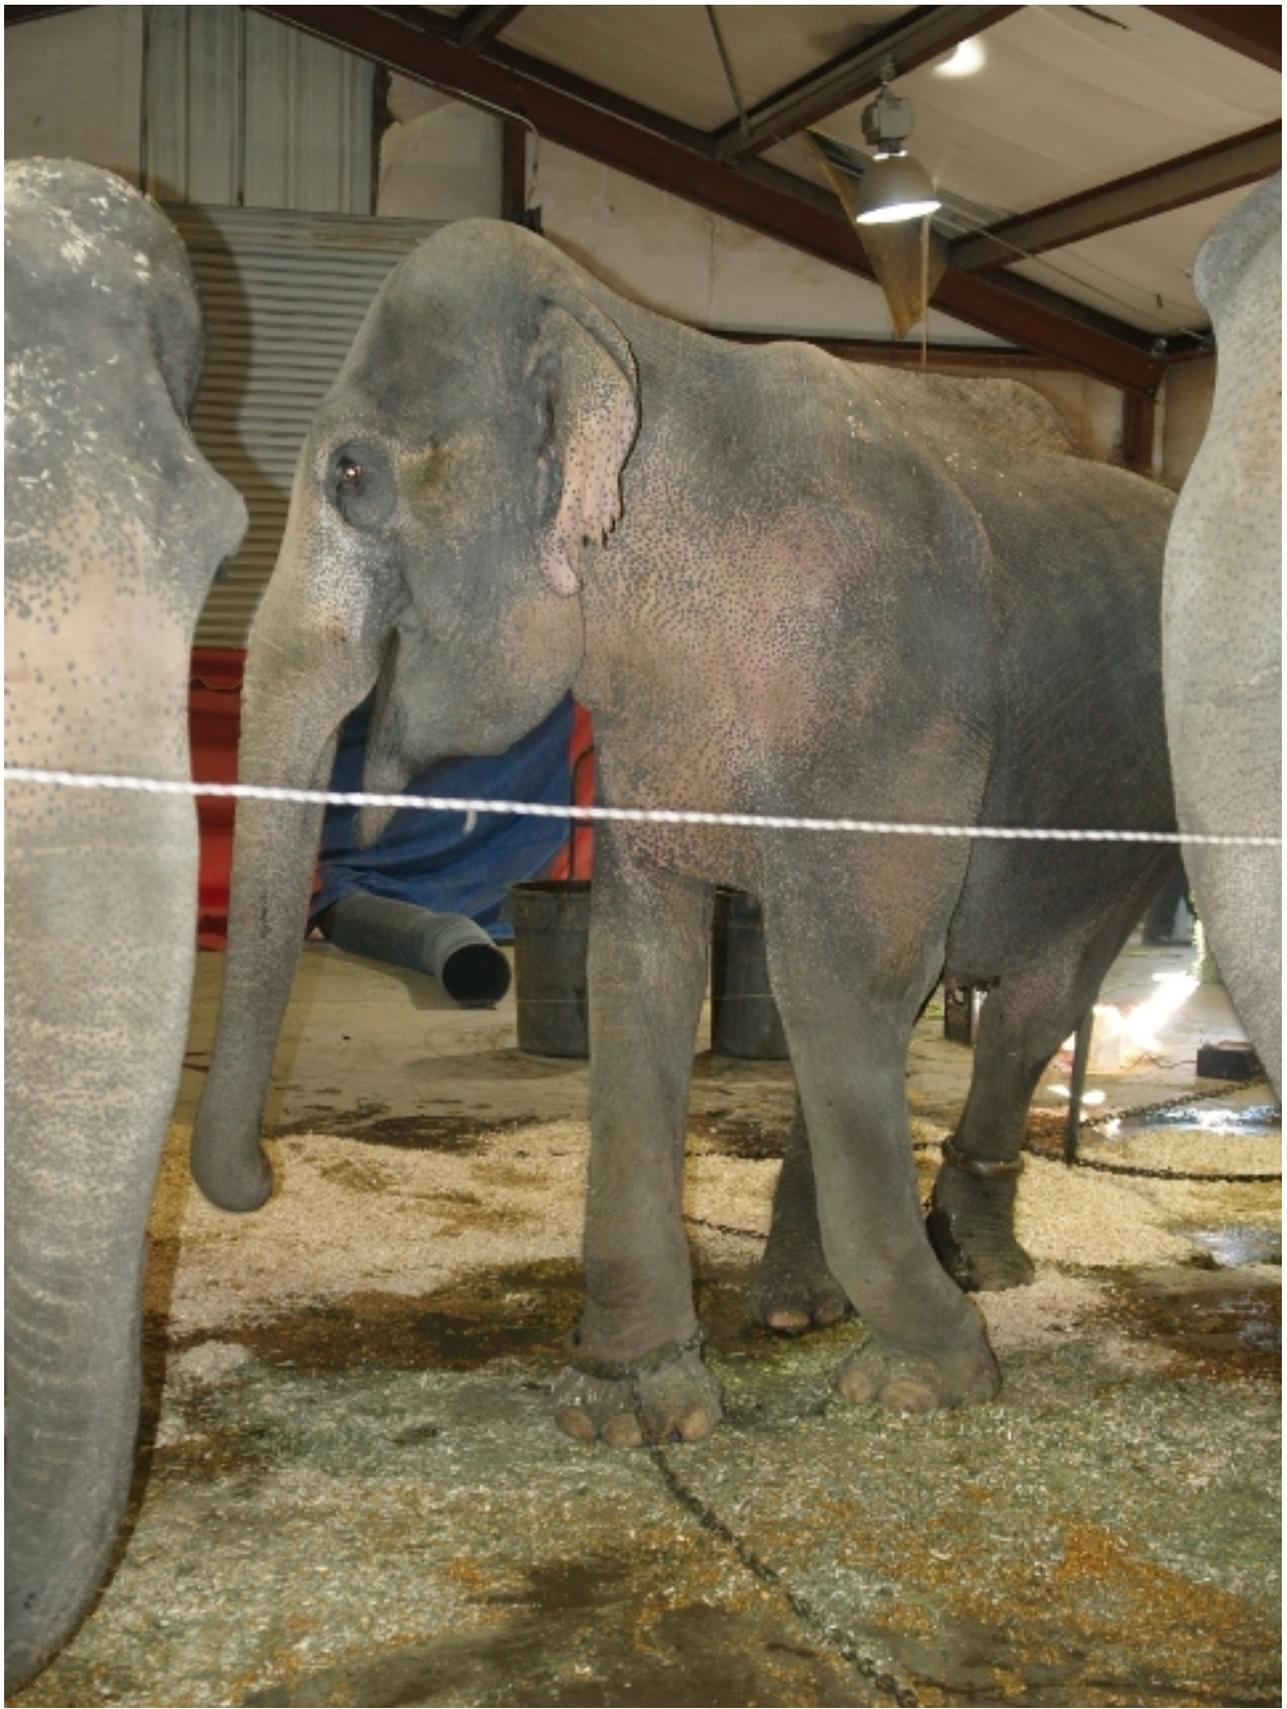
1. Liz, a 36 year old Asian Elephant, was noted to be thin and underweight. The elephant's pelvis and dorsal processes of the spinal vertebrae were prominent and her ribs were visible. The most recent weight recorded on 6/30/10 was 4760 pounds.

Description: View from front left - Asian Elephant "Liz" - note prominent scapula and back bone; ribs are visible.

Per this Regulation, an exhibitor should use appropriate methods to maintain the health of the animal. The elephant should have a complete and comprehensive veterinary exam by a veterinarian who is experienced in elephant medicine and husbandry to review the current diet, determine the cause of the weight loss, and make recommendations for an adequate diet to meet the nutritional needs of this elephant. In addition, Licensee should weigh the elephant on a more frequent basis to monitor any changes in her weight. Correct by 3/14/11.

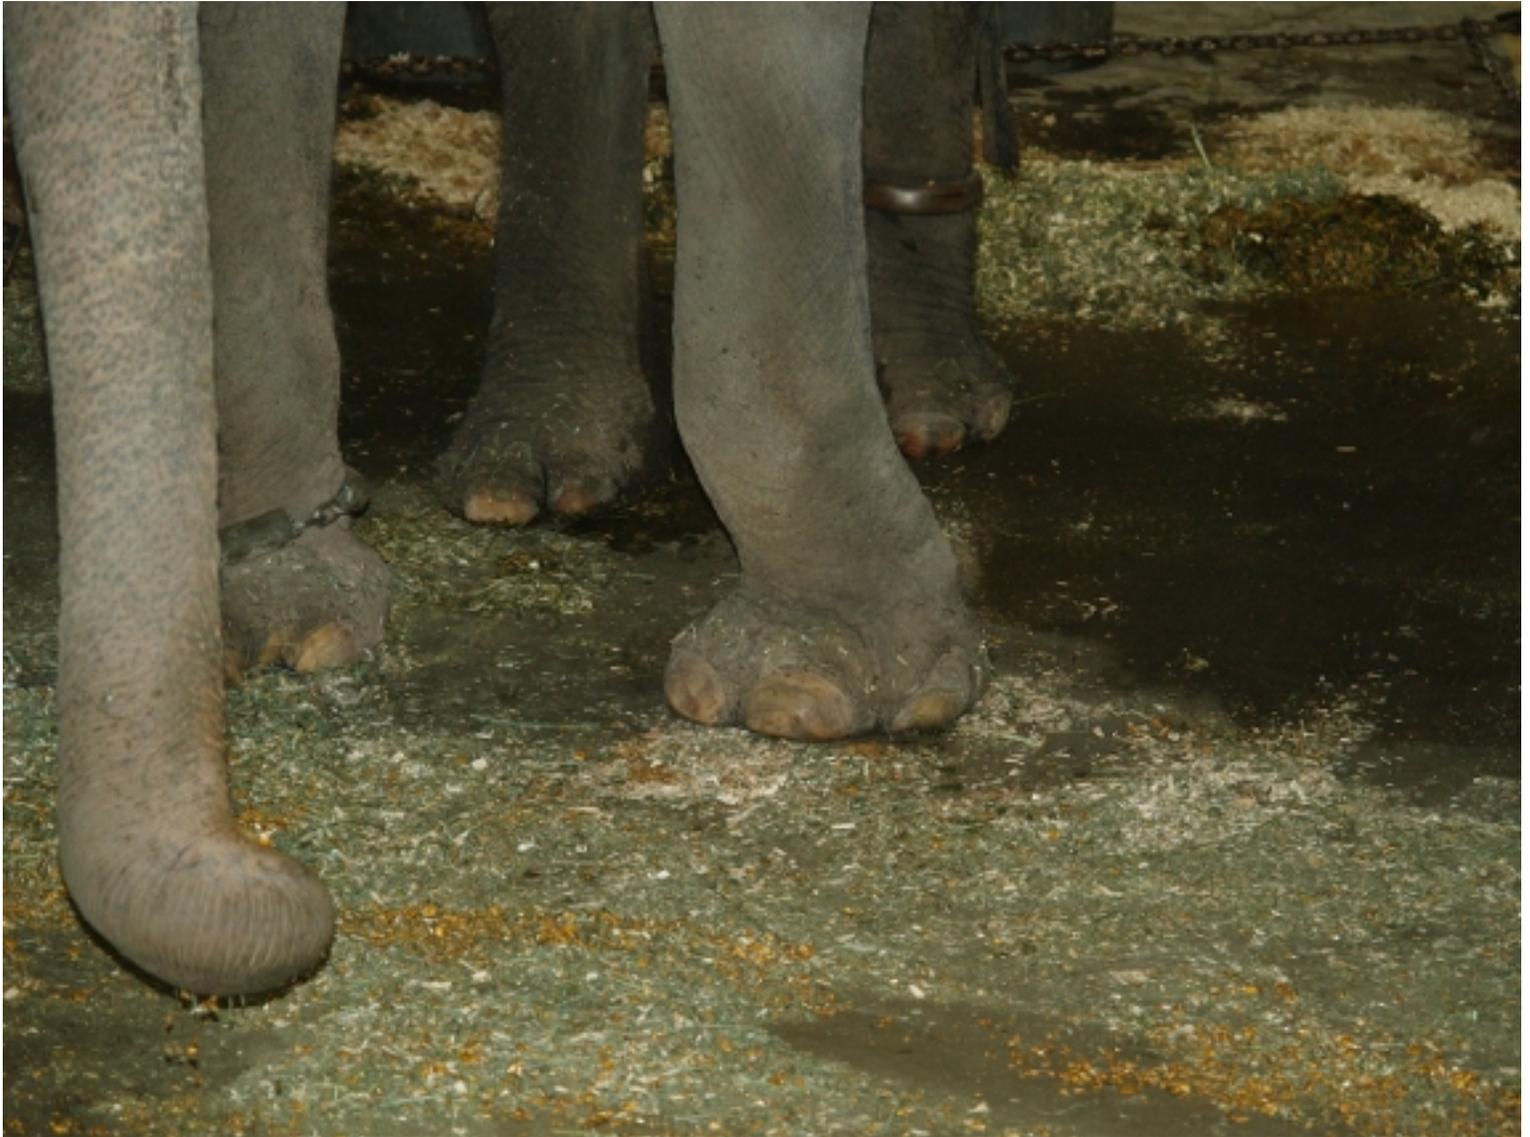
2. Liz, a 36 year old Asian Elephant, was noted to have an angular limb deformity of the front left leg as well as a congenital deformjity of the right hind leg. Both of these conditions have affected her gait.

Photographer:	Denise Sofranko	Legal Name:	58-C-0666
Photo Taken:	Sat, Feb 12, '11 before 10:30 AM	GEORGE HANNEFORD JR	
Inspection:	44111453090862		
Description:	Close up of angular deformity of left front leg of Asian Elephant "Liz"

Per this Regulation, an exhibitor should use appropriate methods to maintain the health of the animal. Liz has been examined in the past by the attending veterinarian; however due to the nature of the deformities and her advancing age, the elephant should be examined and evaluated at appropriate intervals by a veterinarian who is experienced in elephant medicine and husbandry to assess her suitability for performances and travel. Included in this evaluation should be a discussion of behaviors required for performance, appropriate exercise, and substrate. Correct by 3/14/11.

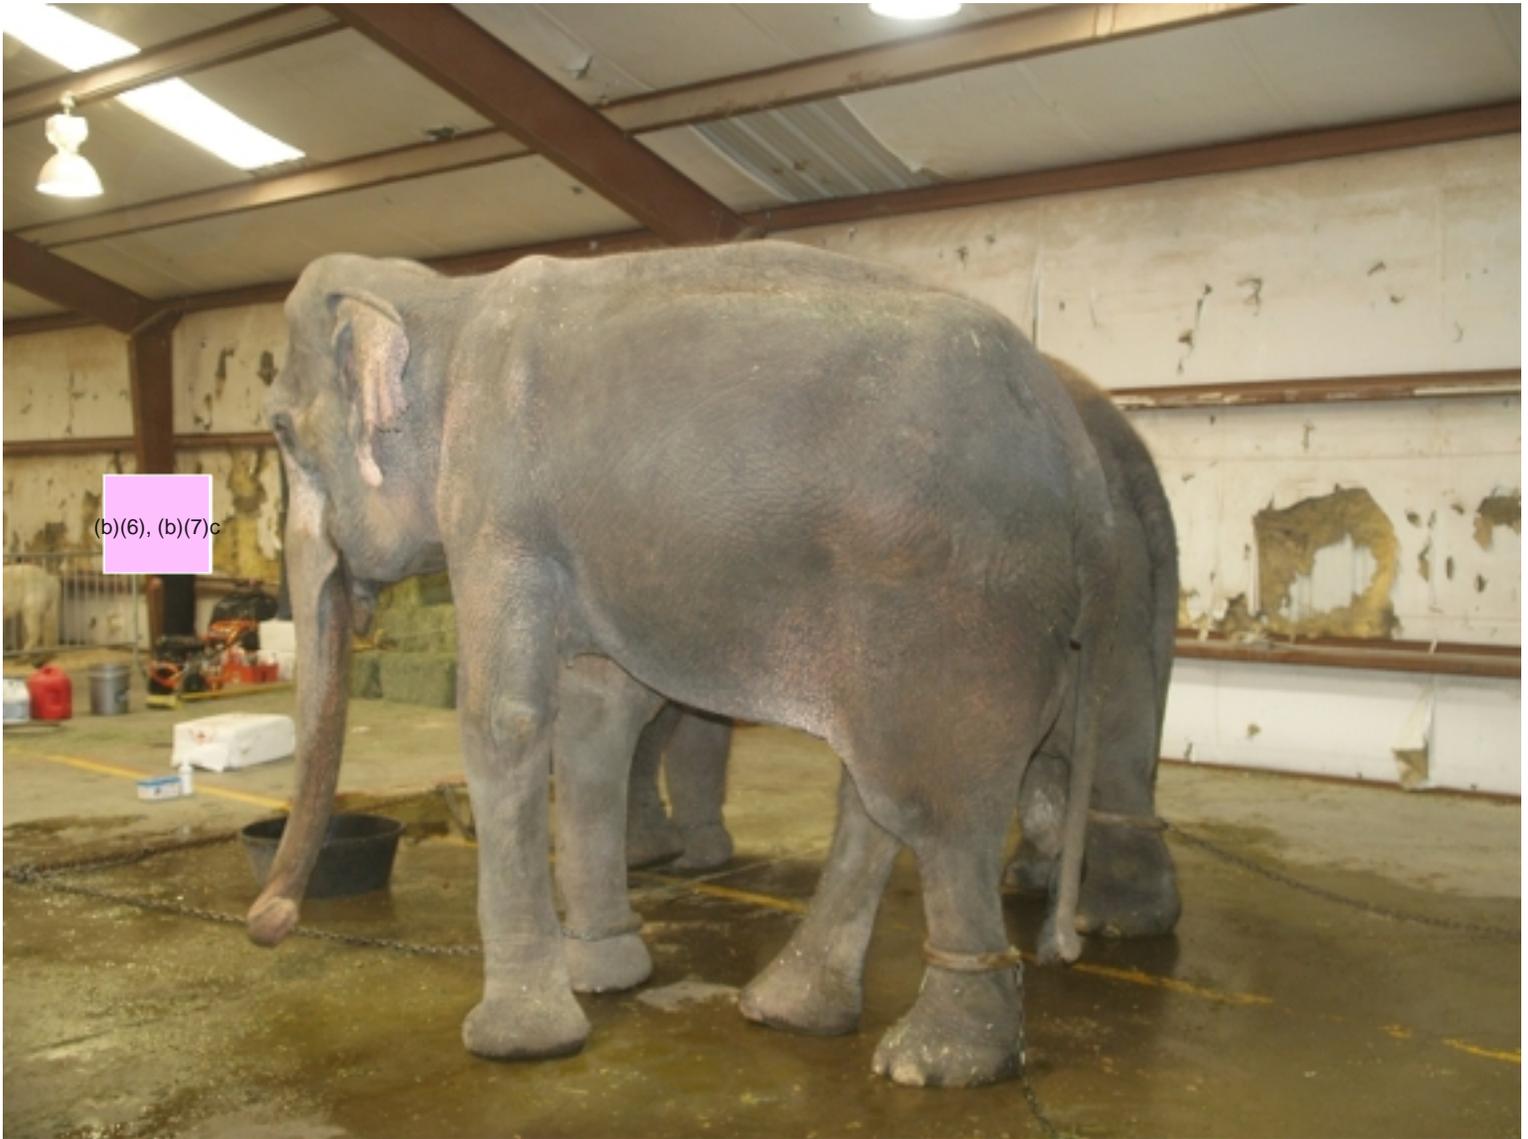
Photographer:	Denise Sofranko	Legal Name:	58-C-0666
Photo Taken:	Sat, Feb 12, '11 before 10:30 AM	GEORGE HANNEFORD JR	
Inspection:	44111453090862		
Description:	View of Asian Elephant "Liz" from her left side showing prominent scapula, dorsal spine, and pelvis.

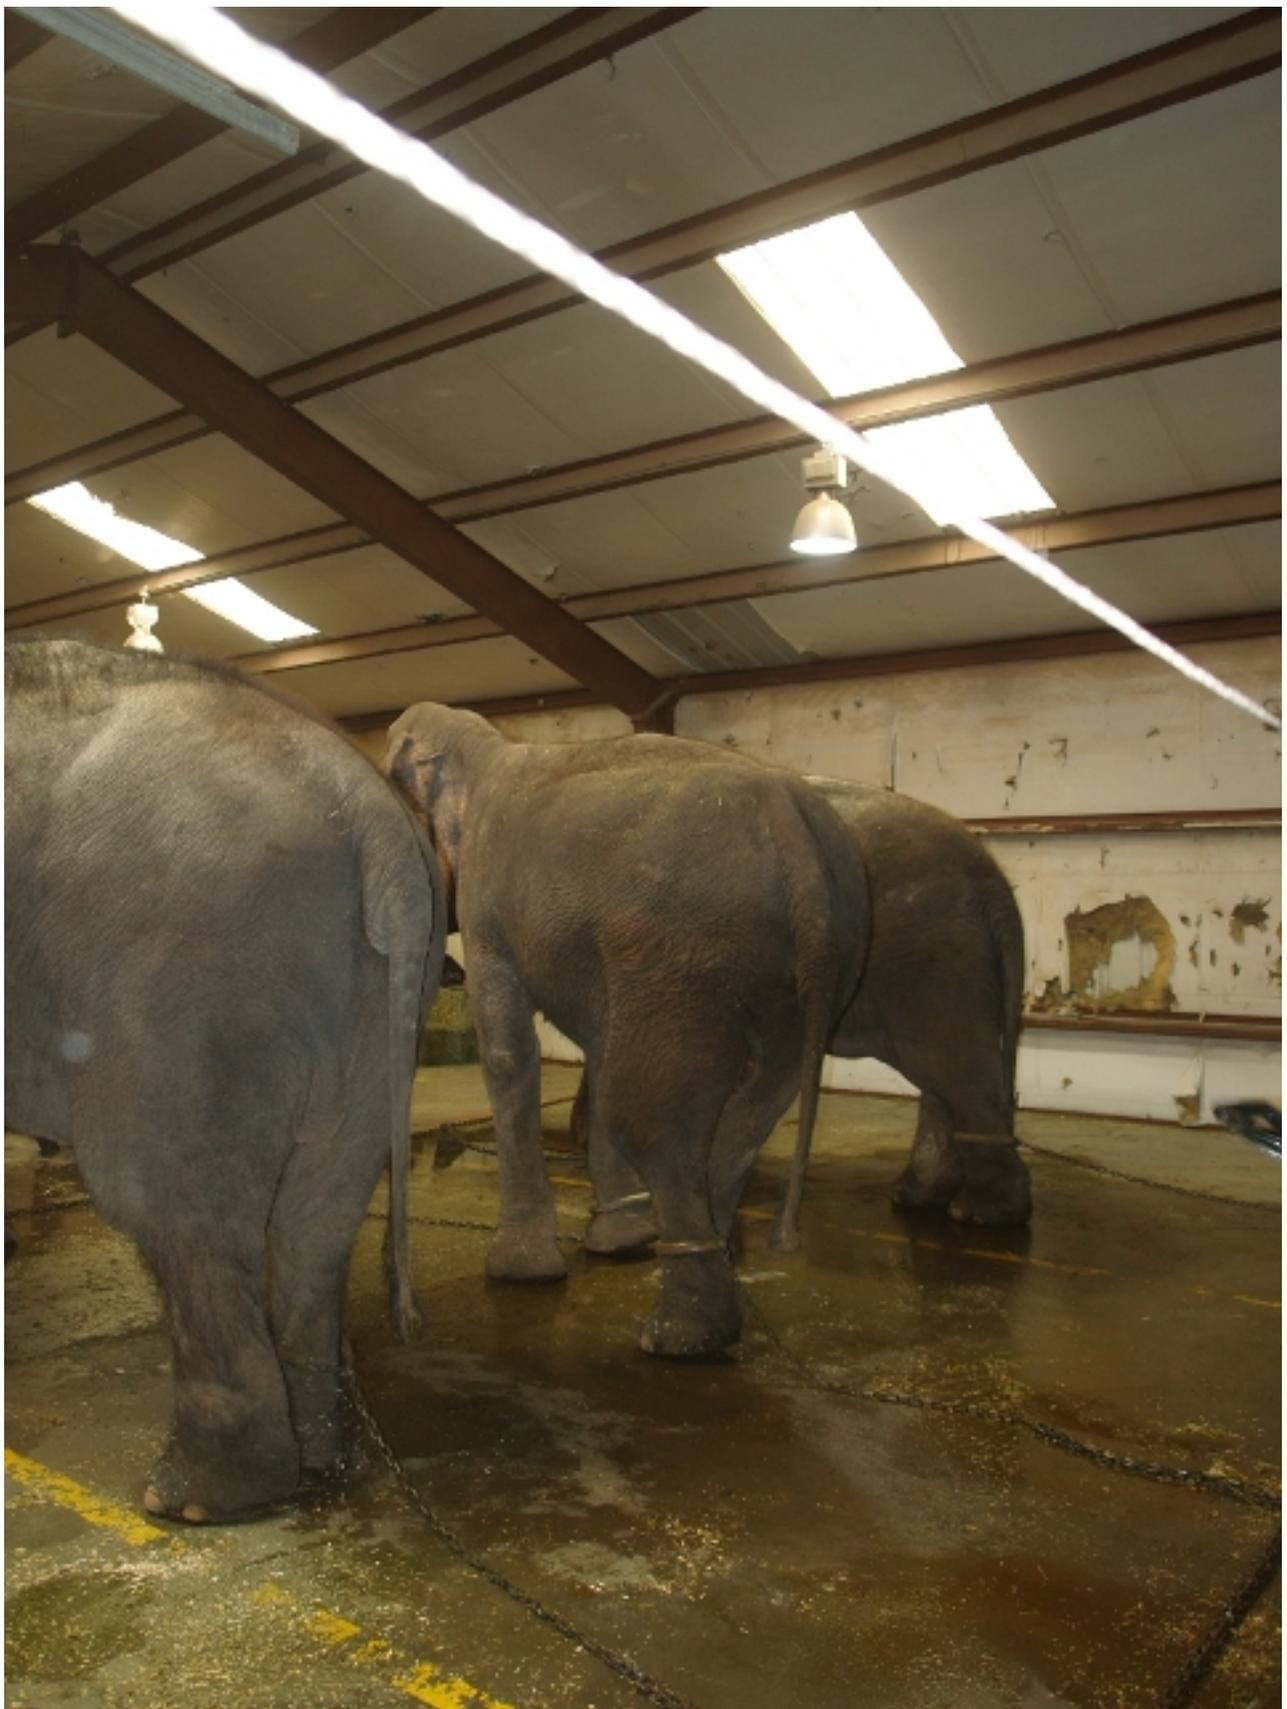
Photographer: Denise Sofranko Legal Name: 58-C-0666
Photo Taken: Sat, Feb 12, '11 before 10:30 AM GEORGE HANNEFORD JR
Inspection: 44111453090862
Description: View from rear - Asian Elephant "Liz" is in the middle. Note the unusual stance of her rear legs compared to the other 2 elephants & her prominent spine, scapula and pelvis.

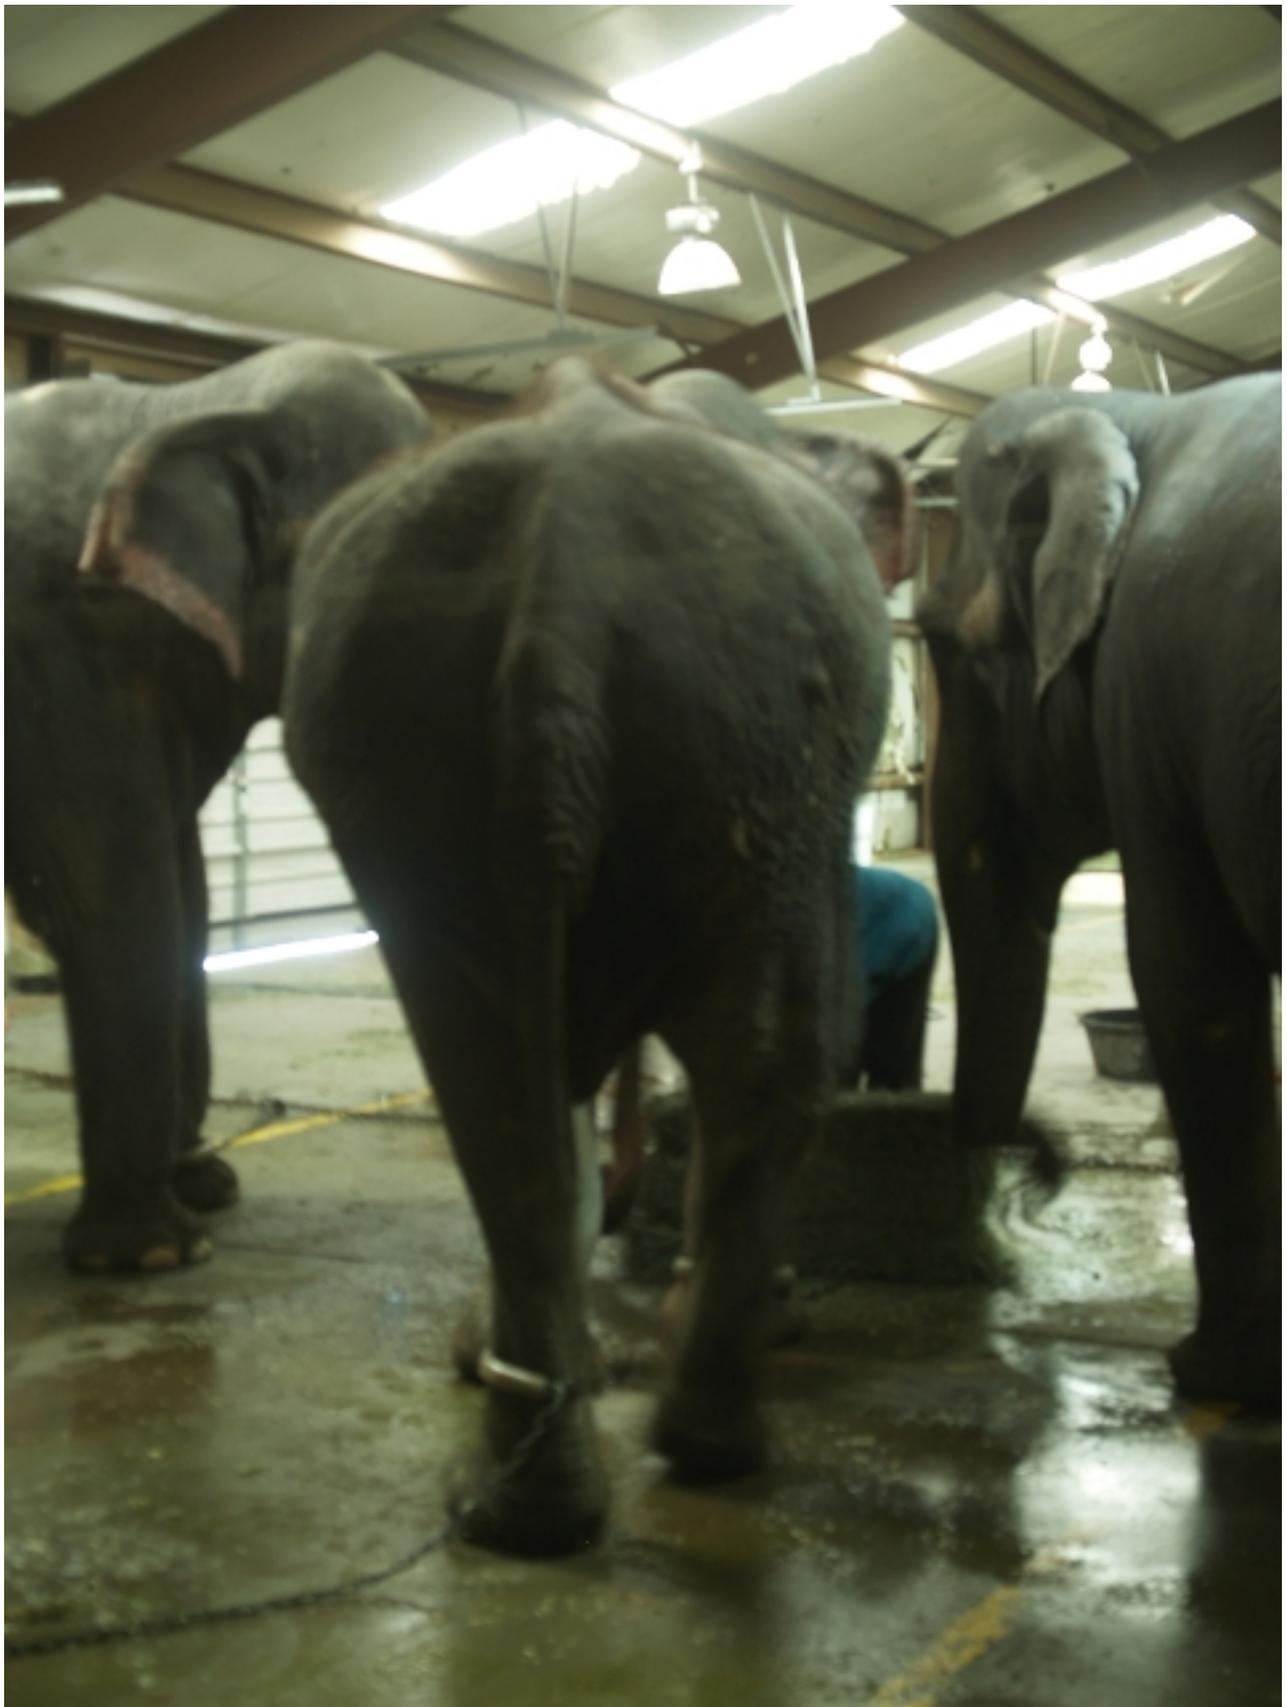
Description: View from rear - Asian Elephant "Liz" is in the middle. Note prominent back bone and pelvis.

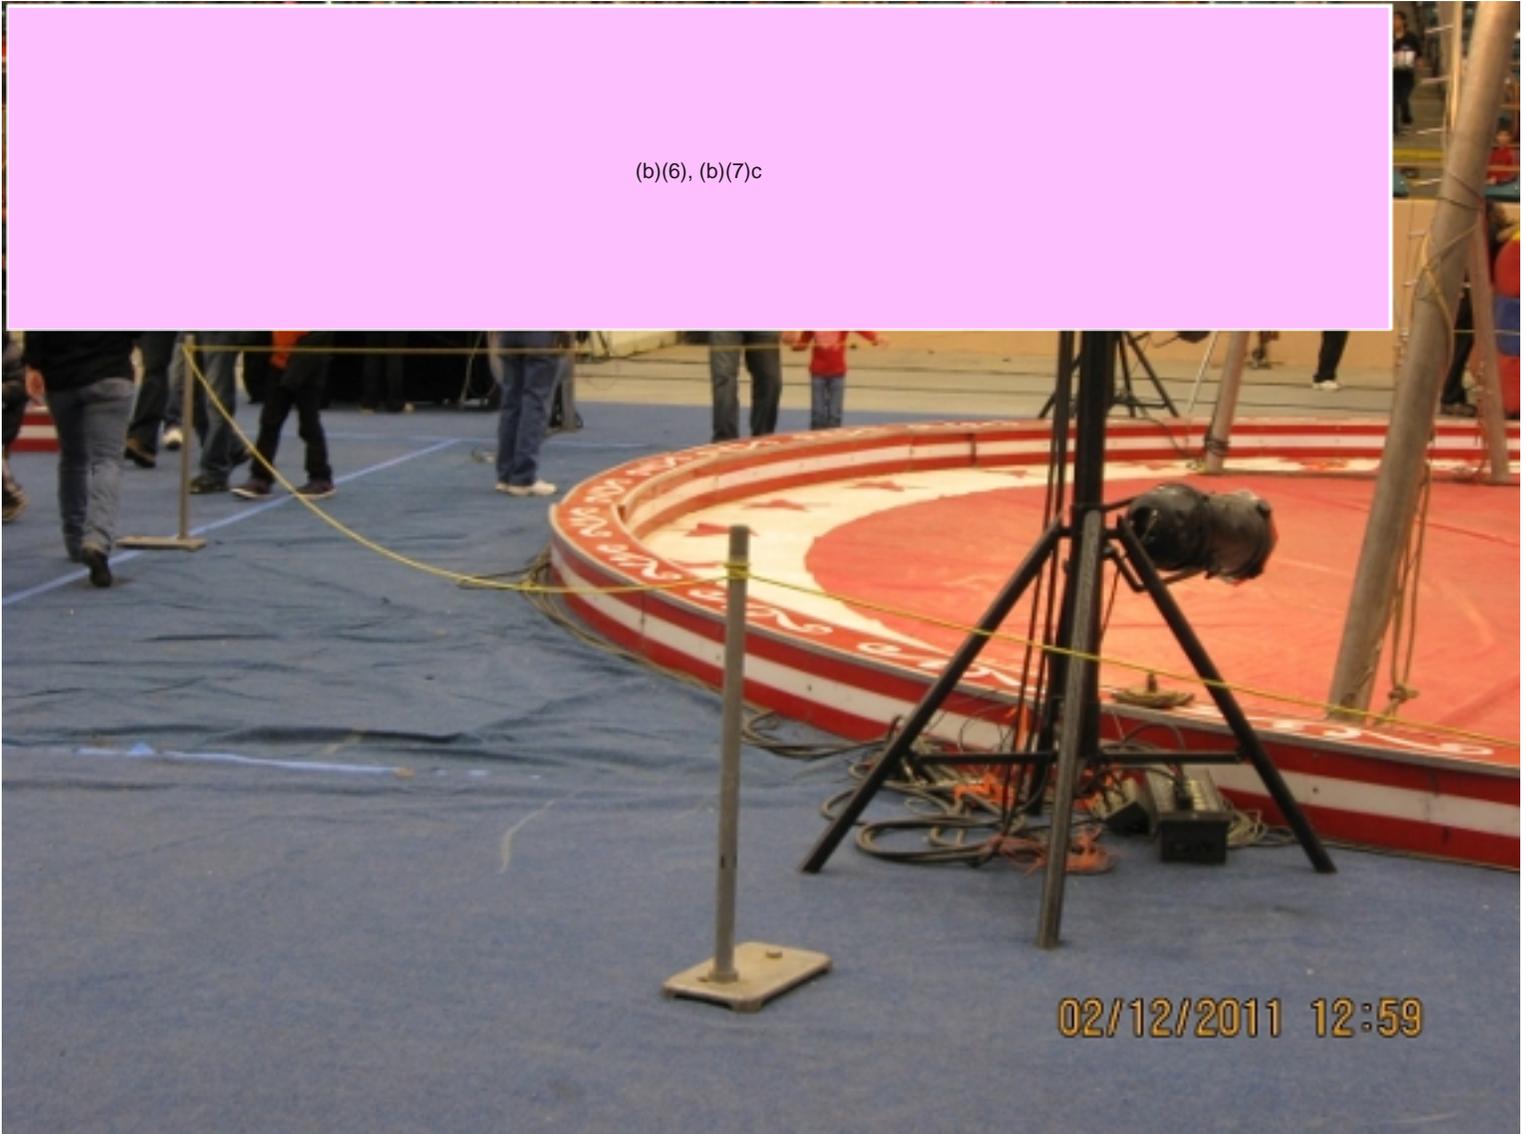
1. APHIS personnel were on-site during appearances of the Shrine Circus at the Tingley Coliseum in Albuquerque, NM on 2/11/11 and 2/12/11 and observed the elephant rides given before the show, at intermission, and after the show. The public barrier surrounding the Elephant ride area was made up of rope strung between free-standing vertical metal posts that were approximately 2 feet high, and spaced about 1 post every 20 feet around the ride area. There was slack in the rope that resulted in sagging of the rope mid-way between adjacent posts. Members of the public crowded around the ride area while the rides were in progress.

Photographer:	Paula Gladue	Legal Name:	58-C-0666
Photo Taken:	Sat, Feb 12, '11 12:59 PM EST (10:	GEORGE HANNEFORD JR	
Inspection:	44111453090862		
Description:	Close up showing the type of the public barrier that was set up around the elephant ride area

Per this Regulation, any animal must be handled during public exhibition so that there is minimal risk of harm to the animal and to the public, with sufficient distance and/or barriers between the animal and the general viewing public so as to assure the safety of the animal and the public. There was an insufficient physical barrier in place around the ride area between the Elephant and the viewing public in order to minimize the risk of harm to both the animal and the public. The Licensee needs to address this item for the safety of the Elephant and members of the public. Correct from this date forward.

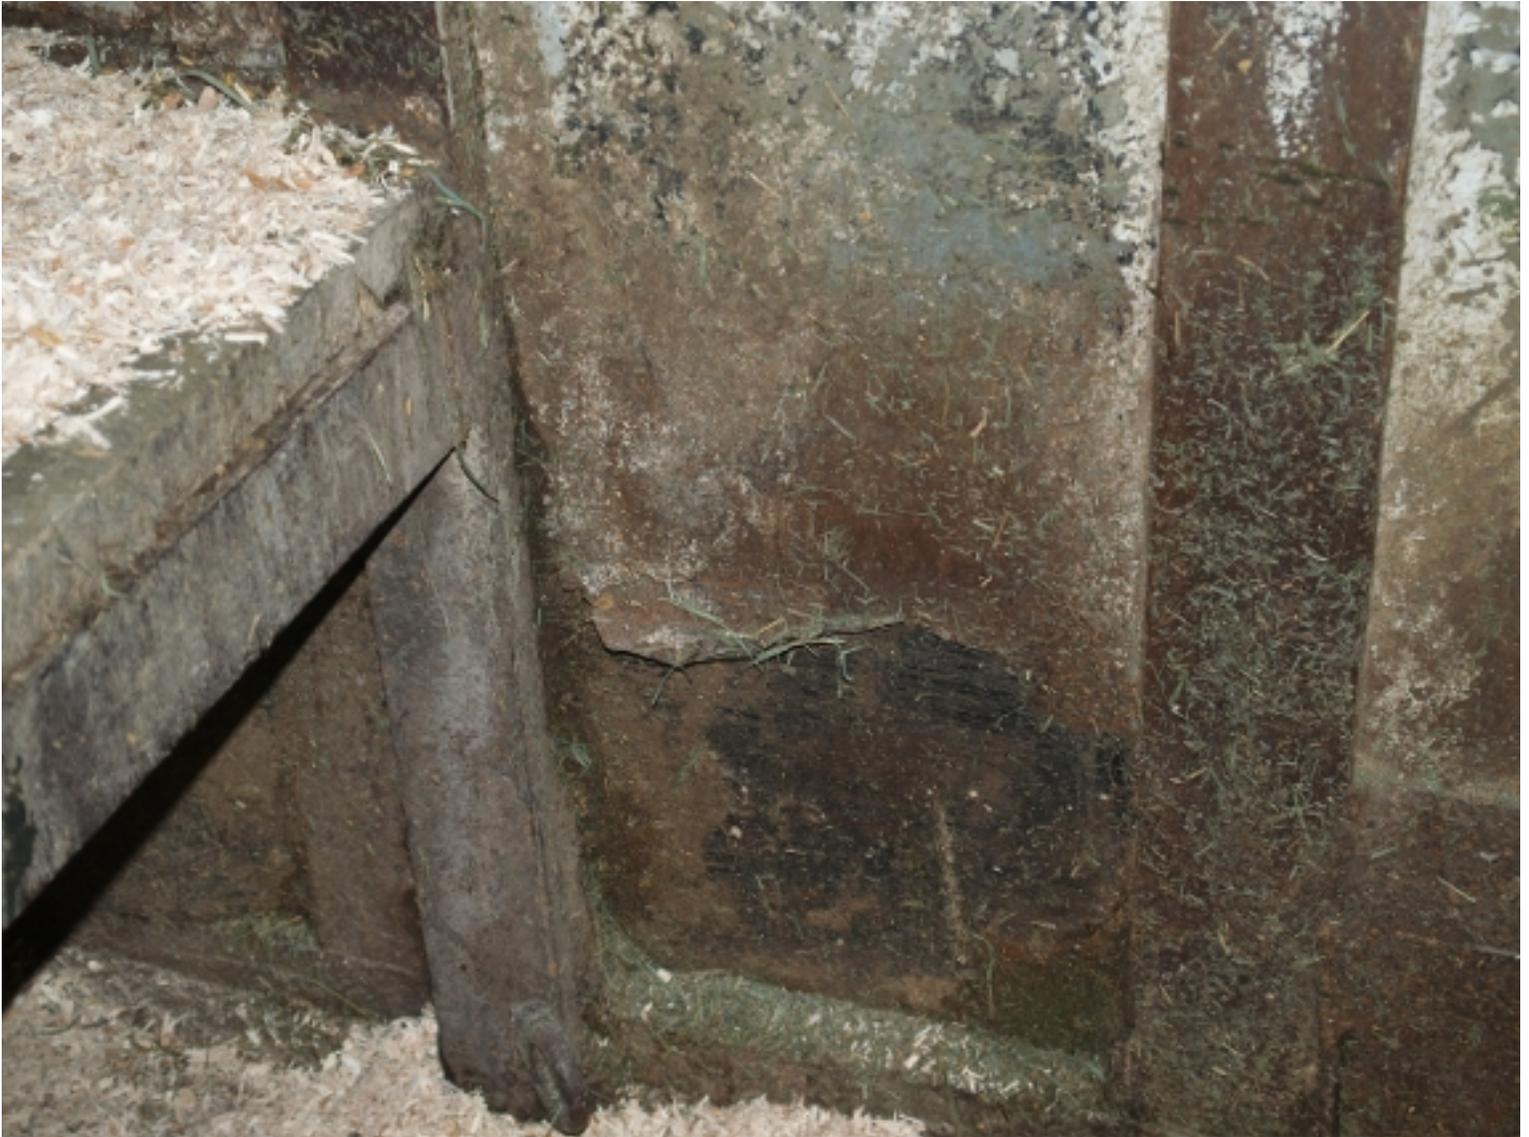
1. There are numerous areas in the trailer where the metal lining is rusting and or deteriorating resulting in sharp and jagged edges that could cause an injury to the Elephants during transportation.

Photographer: denise sofranko Legal Name: 58-C-0666
Photo Taken: Sun, Feb 13, '11 ~9 AM MST GEORGE HANNEFORD JR
Inspection: 44111453090862
Description: Sharp metal edges at floor level in the trailer used to transport the 3 elephants.

Per this Section, animal cargo spaces used to transport animals should be constructed to ensure the safety and protect the animals. The Licensee needs to repair or replace the damaged metal so that there are no longer any sharp edges that could cause an injury to the Elephants. Correct by 3/1/11.
