## Public Barriers at Dangerous Animal Exhibits – A Study

### Response to Recommendation 1 from OIG Audit Report 33601-0001-23

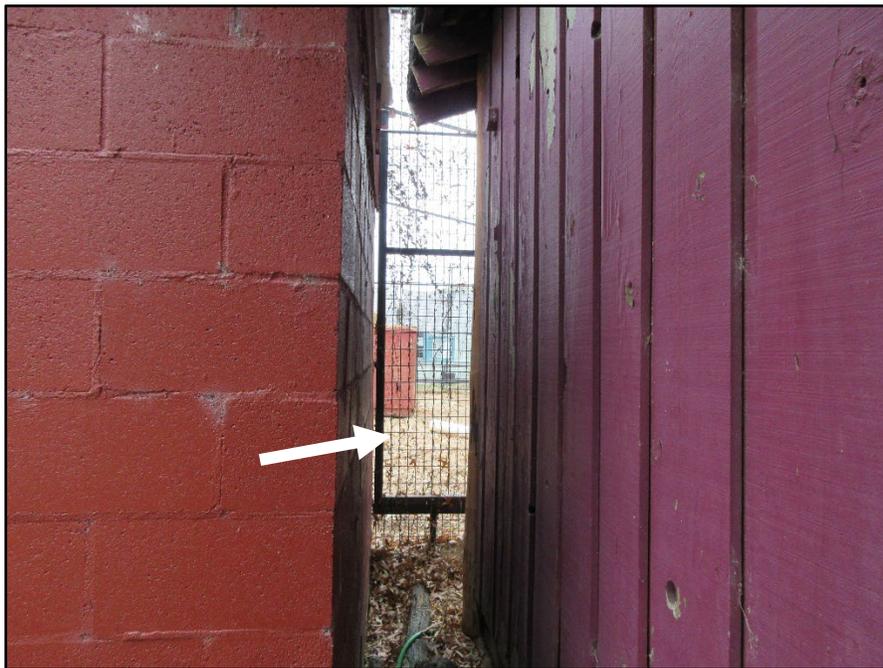
Internal SMEs concluded that only 1 dangerous animal exhibit in the study had a public barrier deficiency that represented a risk of injury to the viewing public. This was a lion exhibit with the night house for the lions and a reptile house situated adjacent to the exhibit. An unprotected 21.5" space exists between the buildings that allows direct access to the wall of the primary enclosure (**Figure 3**).

**Figure 3:** Lion exhibit with an unprotected gap between the lion house and a reptile house allowing direct access to the primary enclosure. Arrow indicates the wall of the primary enclosure.

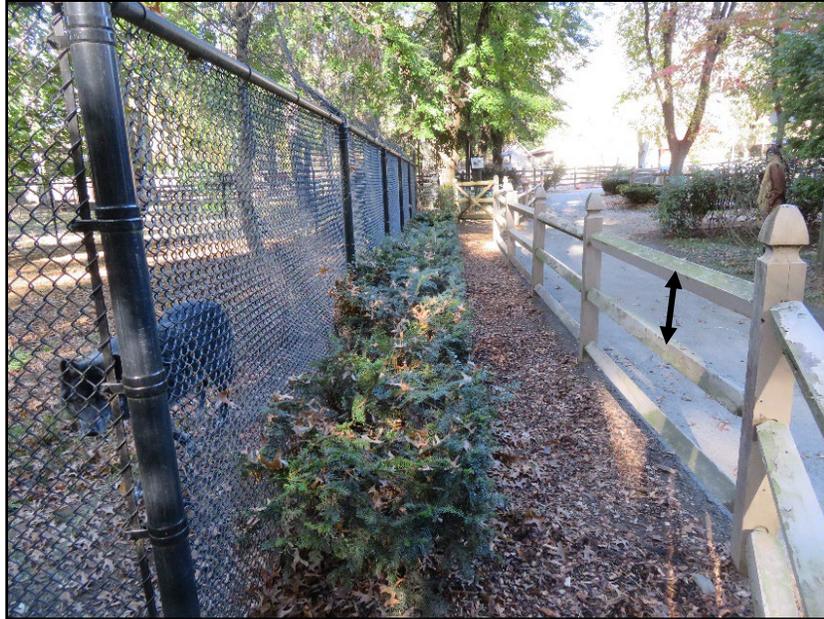
In total, the external consultant identified three exhibits with public barriers that scored less than 3/3 (3 out of 3). All three exhibits contained wolves and all 3 were located at different facilities. A maned wolf exhibit had a barrier that was 35” high and positioned 37” from the primary enclosure and was scored 1/3. A grey wolf exhibit had a barrier that was positioned 36” from the primary enclosure and was scored 2/3. And another grey wolf exhibit was scored 2/3 due to gaps through which an unattended child could easily pass (**Figure 5**).

**Figure 5:** Public barrier at a grey wolf exhibit scoring 2 out 3. Gaps (arrow) between rails of this post and rail fence could allow an unattended child easy access to the primary enclosure.

In their report, the external consultant provided this summary conclusion on the adequacy of these 3 barriers: “Due to these three barriers providing VISUAL cues for a “reasonable adult” to not pass under, over or through the barriers, and due to the natural behavior of wolves to be shy and retreating, the barriers subjectively are considered passable (with minor improvements). It is in the interest of creating an objective and unified approach to evaluating barriers in front of dangerous animals (see DEFINED PARAMETERS [**Figure 4**]), that these three enclosures were identified.”
