Colorado State University and USDA Researchers Find Potential Solution for Woodpecker Damage to Utility Pole Crossarms

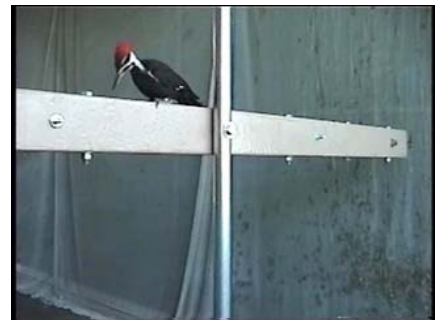
*Pileated woodpecker
on coated crossarm*

This study was conducted at the National Wildlife Research Center, where 18 pileated woodpeckers that were caught and later released were presented with uncoated crossarms and crossarms that were coated with the polyurea elastomer. Biologists tracked the birds' pecking progress for 10 days and found no measurable damage to the coated crossarms, while the woodpeckers pecked away an average of 29.5 grams of dried wood from the uncoated crossarms.
