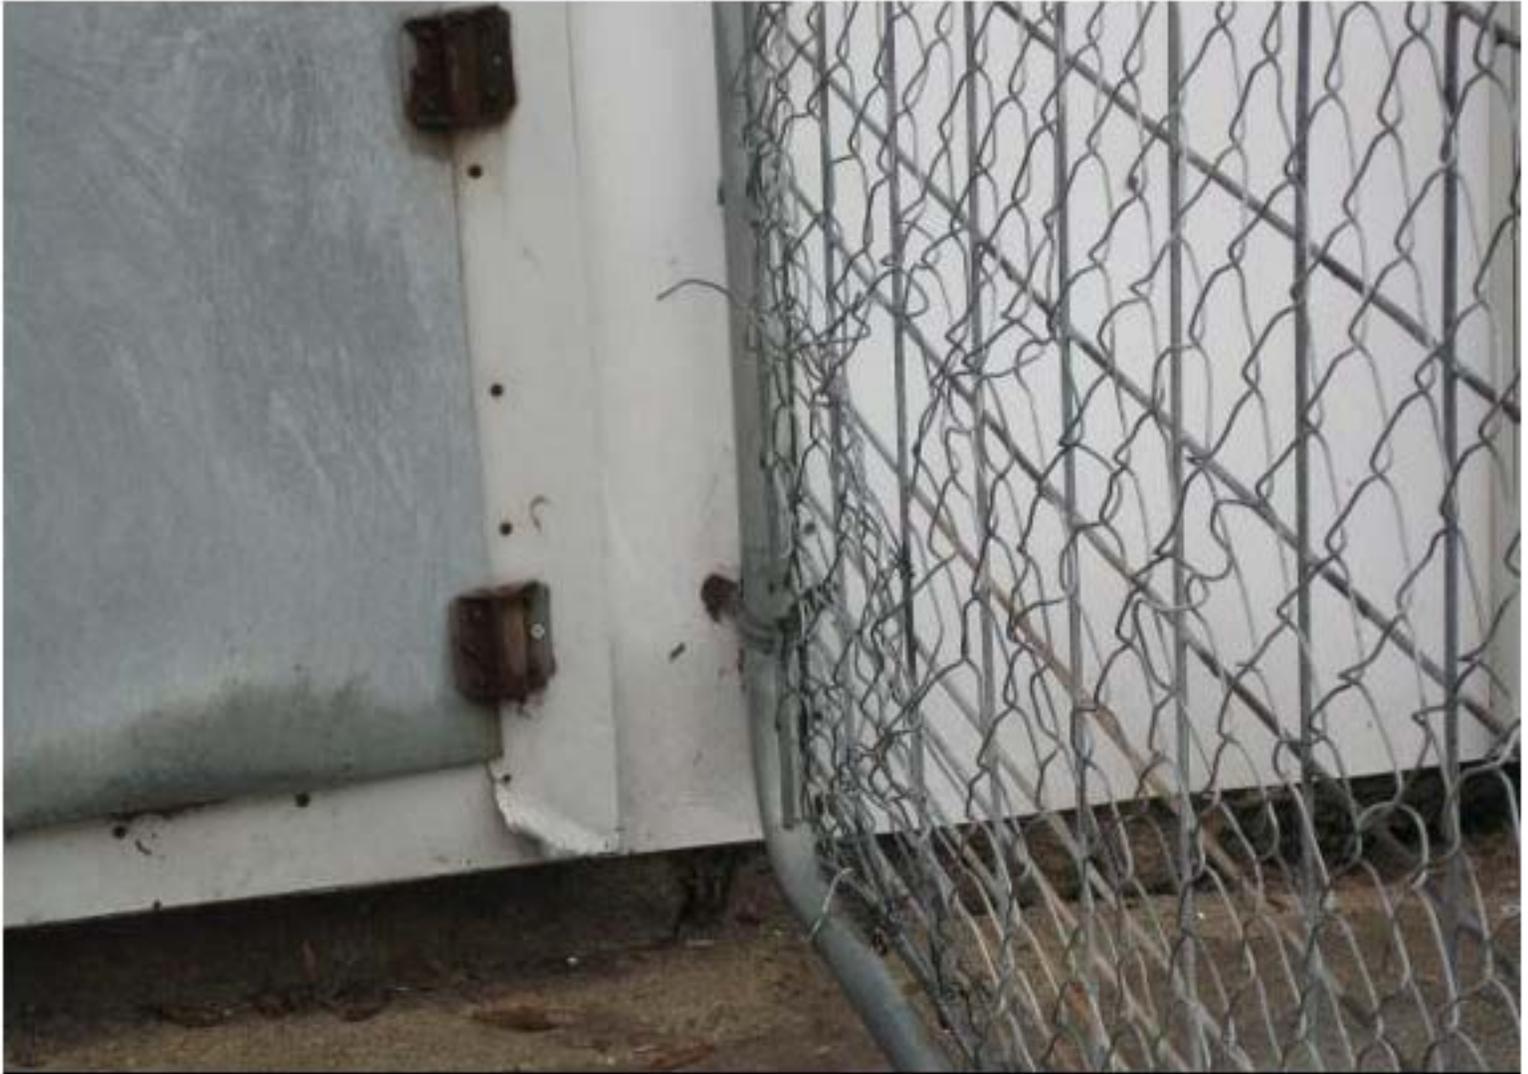
CFR: 3.1 (c) (1) (ii)

Photographer:	Randall Wagner (ACI)	Legal Name:	Registration:	42-A-1253
Photo Taken:	Thu, Sep 23, '10	DAVE RUTER		
Inspection:	280100021210681			
Description:	The tin framing and chain link fence are exposing and sharp edge and protruding sharp points.

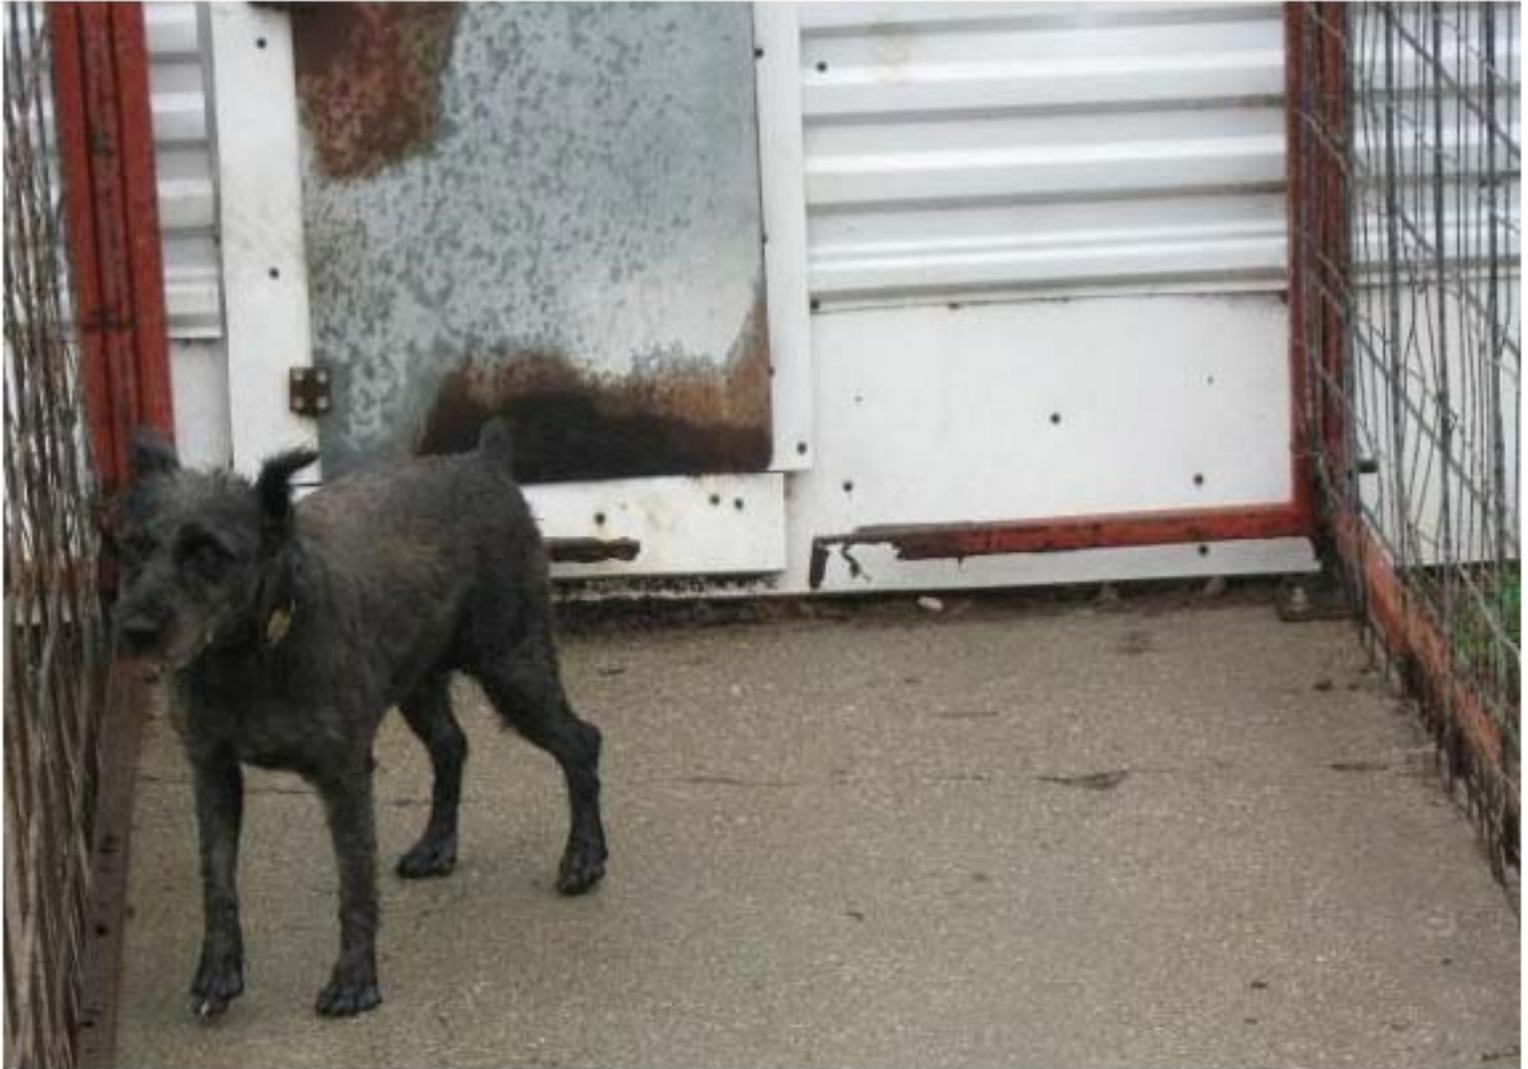
CFR: 3.1 (c) (1) (i)

Photographer:	Randall Wagner (ACI)	Legal Name:	Registration:	42-A-1253
Photo Taken:	Thu, Sep 23, '10	DAVE RUTER		
Inspection:	280100021210681			
Description:	The metal doors surface is excessively rusty and flaking.

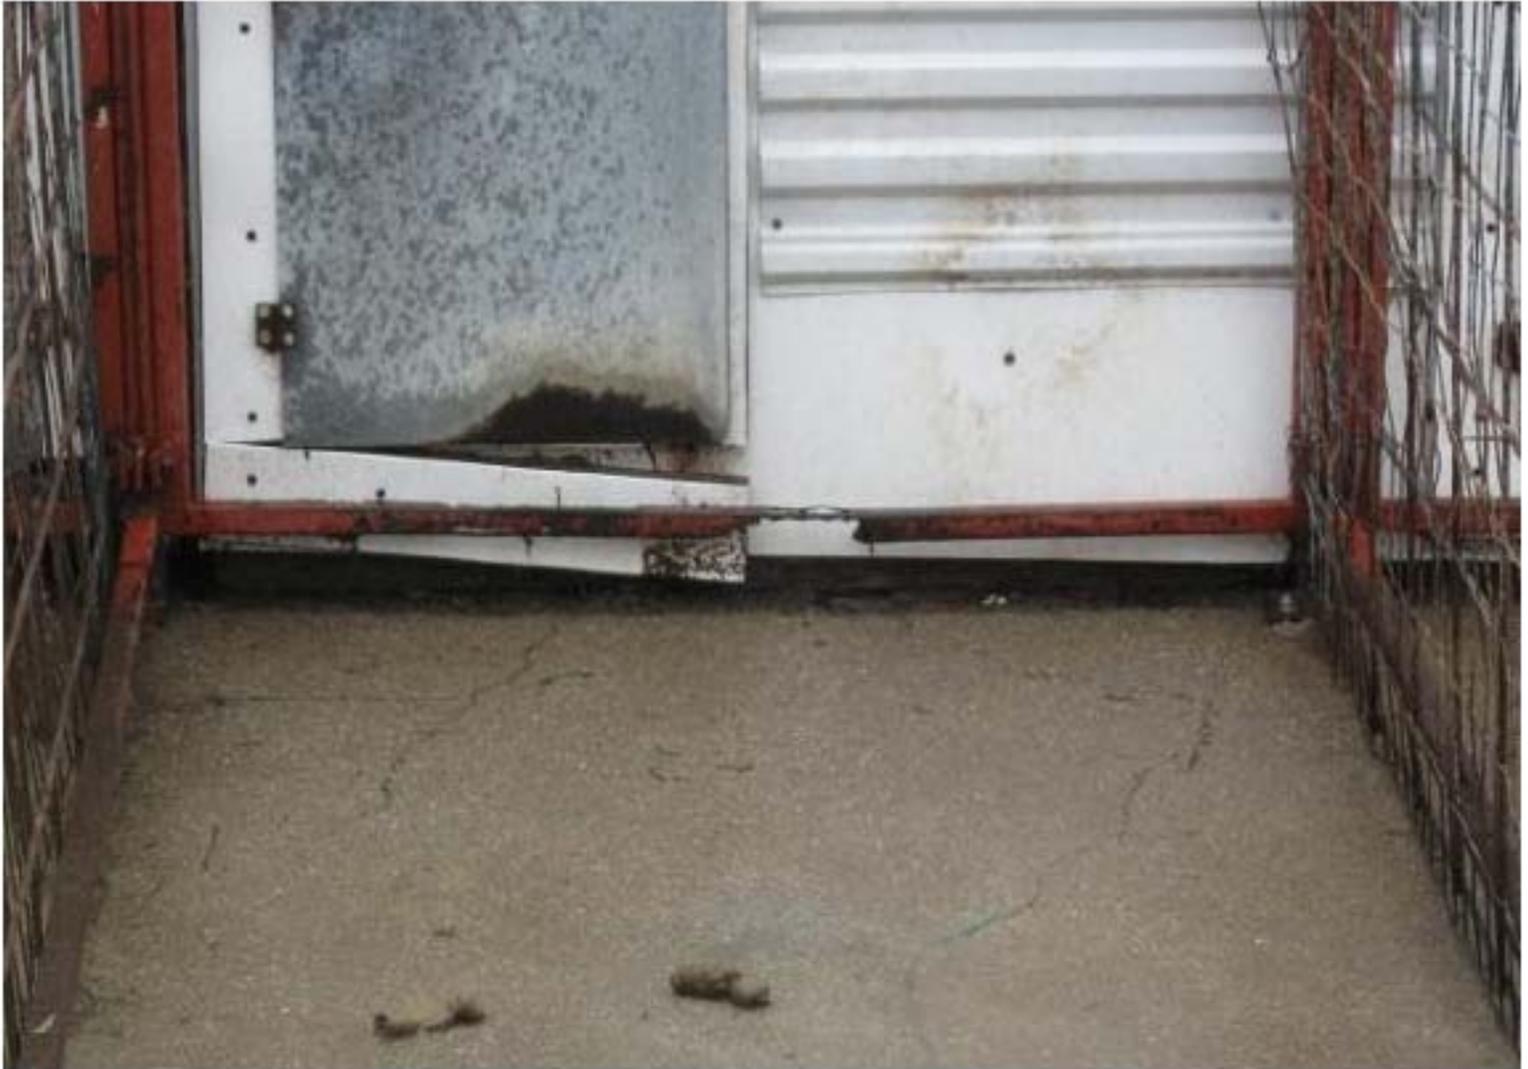
CFR: 3.1 (c) (1) (i)

Photographer:	Randall Wagner (ACI)	Legal Name:	Registration:	42-A-1253
Photo Taken:	Thu, Sep 23, '10	DAVE RUTER		
Inspection:	280100021210681			
Description:	The bottom of the metal doors surface is excessively rusty and flaking. An edge is created from the rust process.

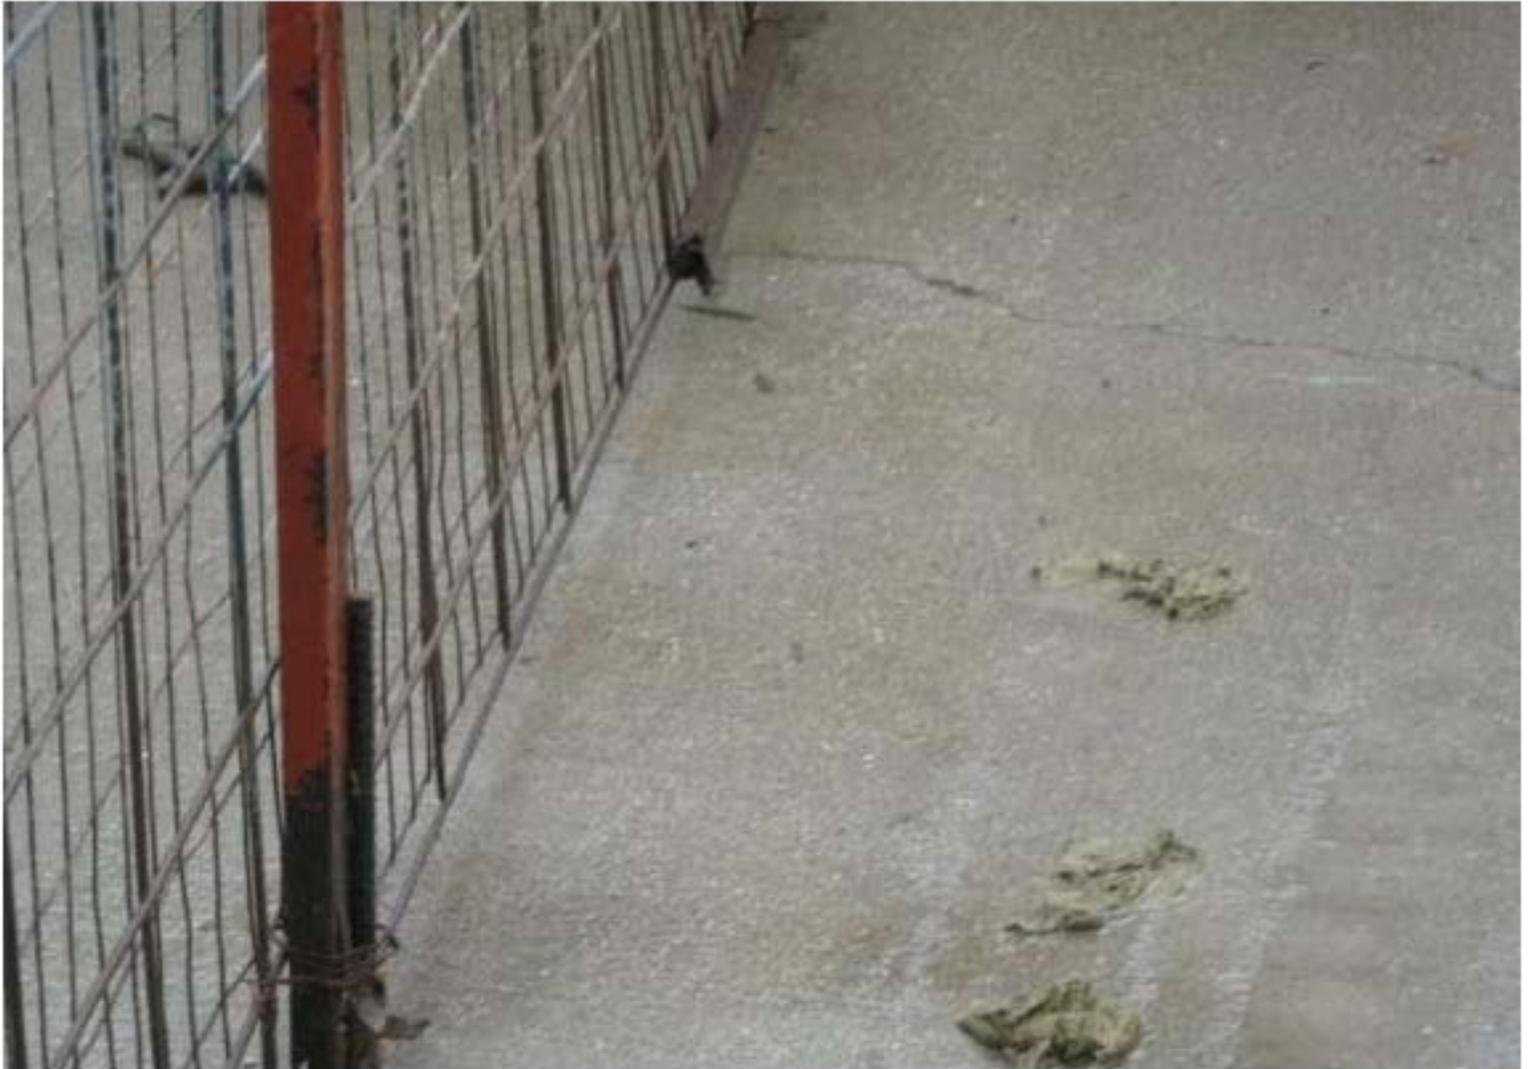
CFR: 3.1 (c) (1) (i)

Photographer:	Randall Wagner (ACI)	Legal Name:	Registration:	42-A-1253
Photo Taken:	Thu, Sep 23, '10	DAVE RUTER		
Inspection:	280100021210681			
Description:	The support and pipe framing structural strength are affected from the excessive rusting. The bottom support pipe is rusted off at the bottom.

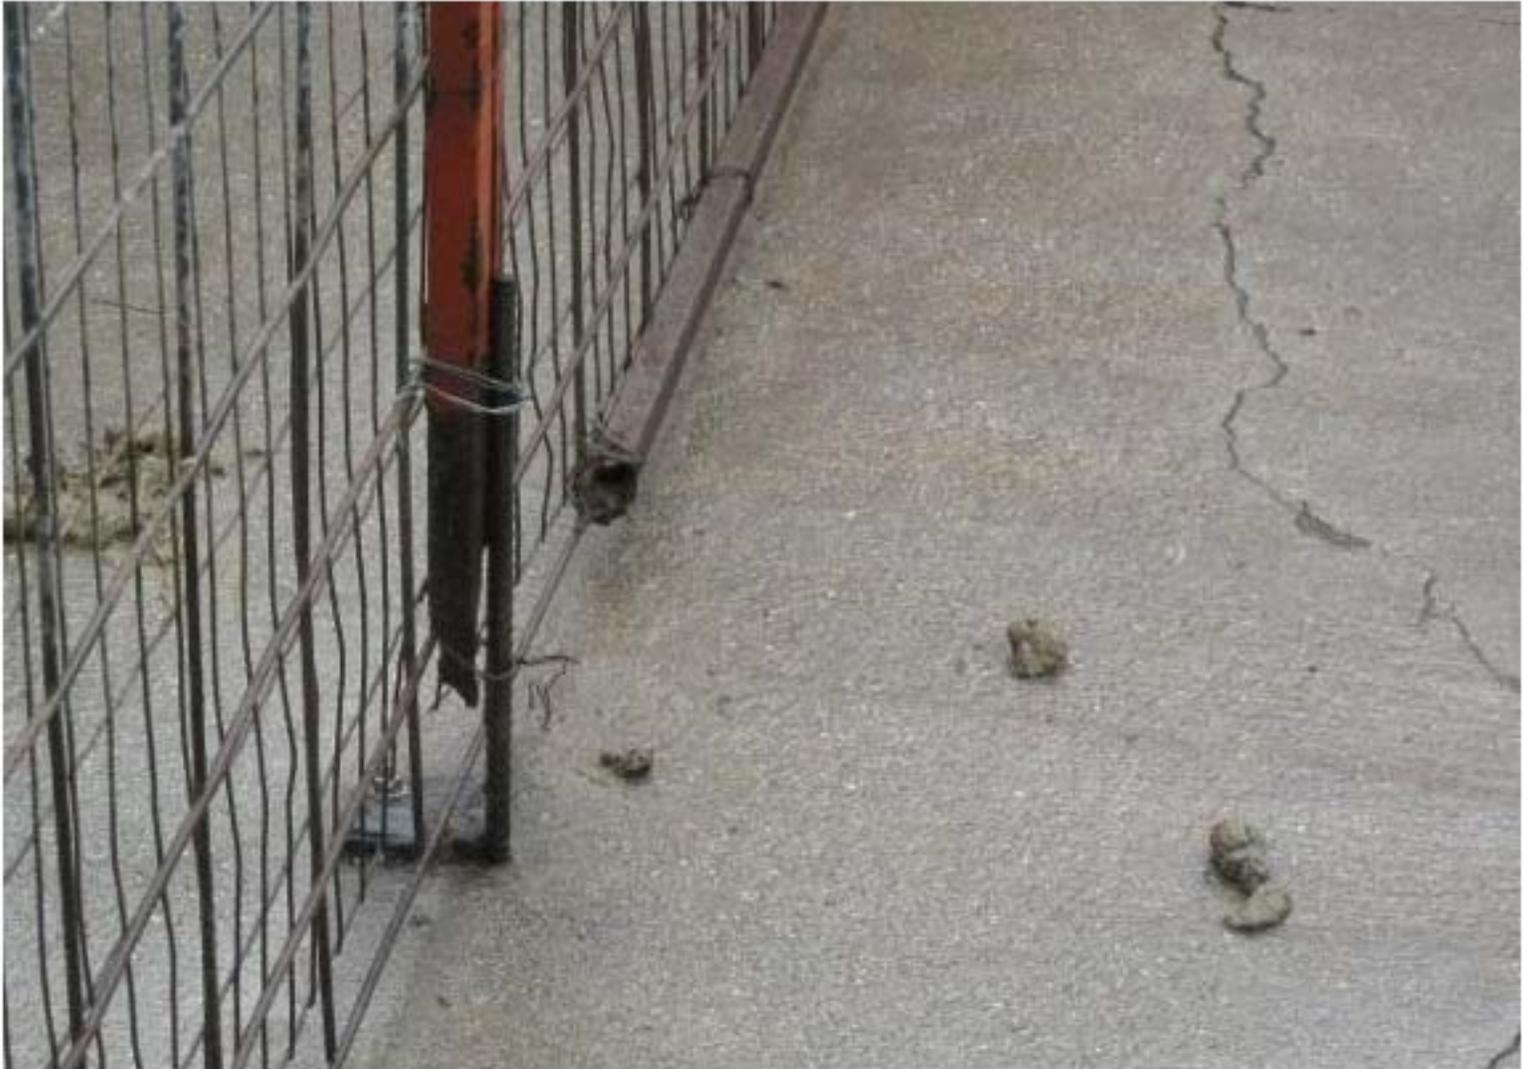
CFR: 3.1 (c) (1) (i)

Photographer:	Randall Wagner (ACI)	Legal Name:	Registration:	42-A-1253
Photo Taken:	Thu, Sep 23, '10	DAVE RUTER		
Inspection:	280100021210681			
Description:	The metal pipe support structural strength is affected from the excessive rusting. The metal bar is rusted off or coming apart.

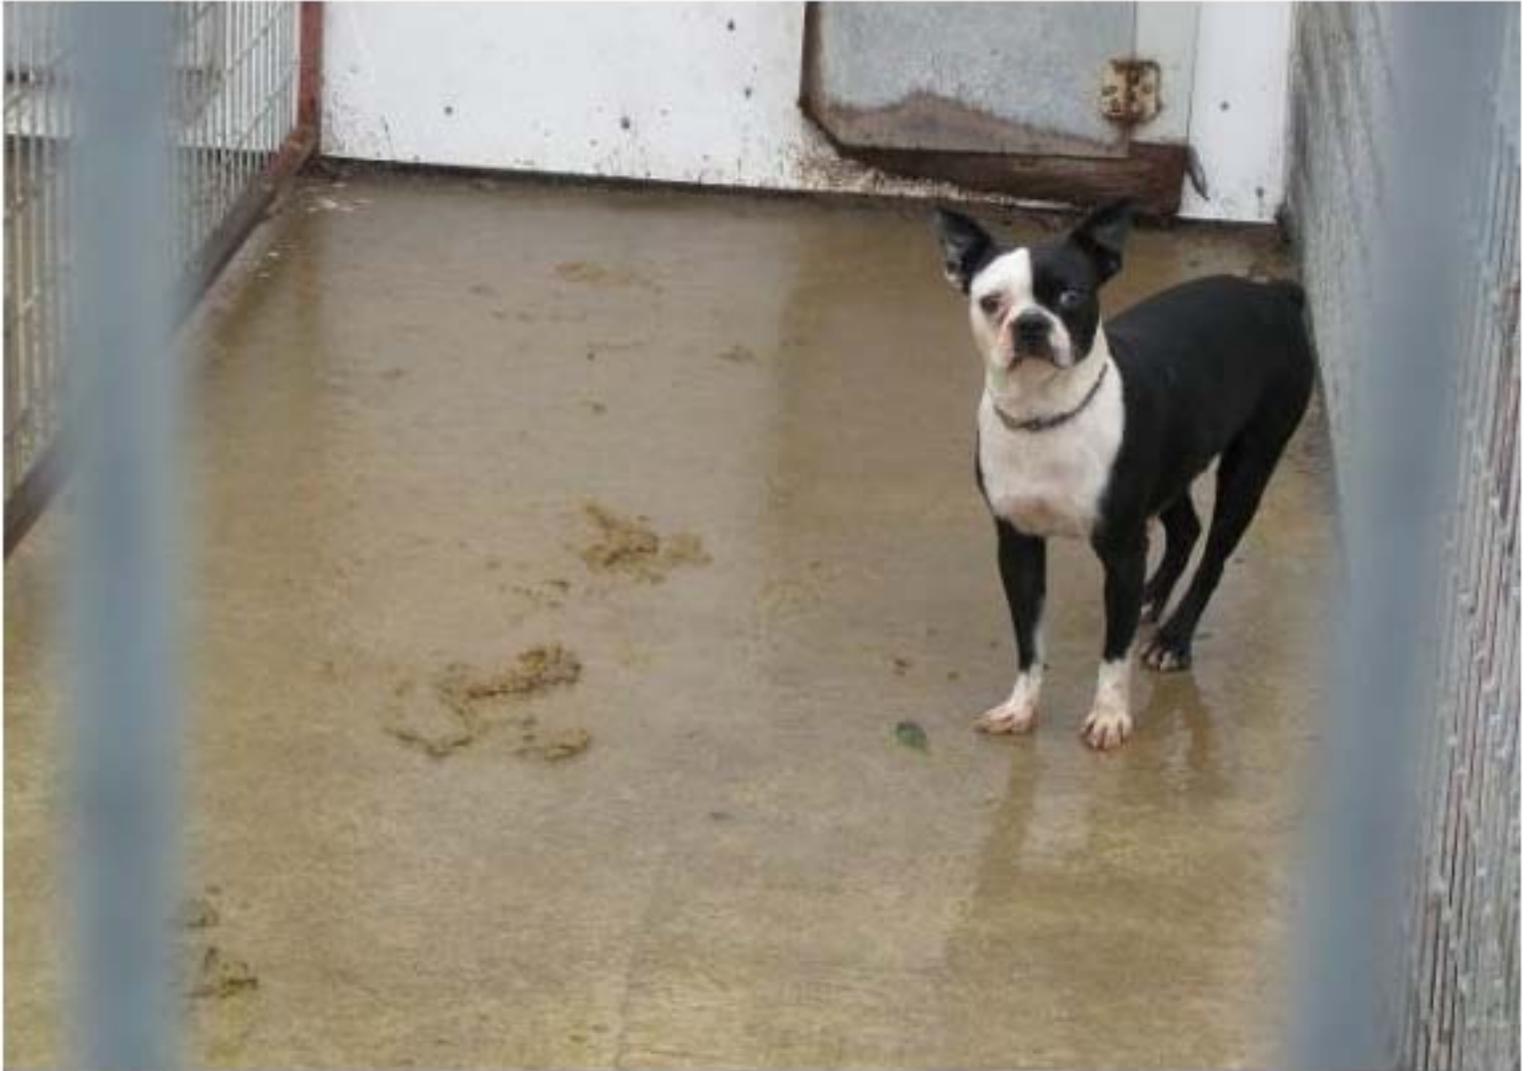
CFR: 3.1 (c) (1) (i)

Photographer:	Randall Wagner (ACI)	Legal Name:	Registration:	42-A-1253
Photo Taken:	Thu, Sep 23, '10	DAVE RUTER		
Inspection:	280100021210681			
Description:	The bottom of the metal door is excessively rusting and flaking.

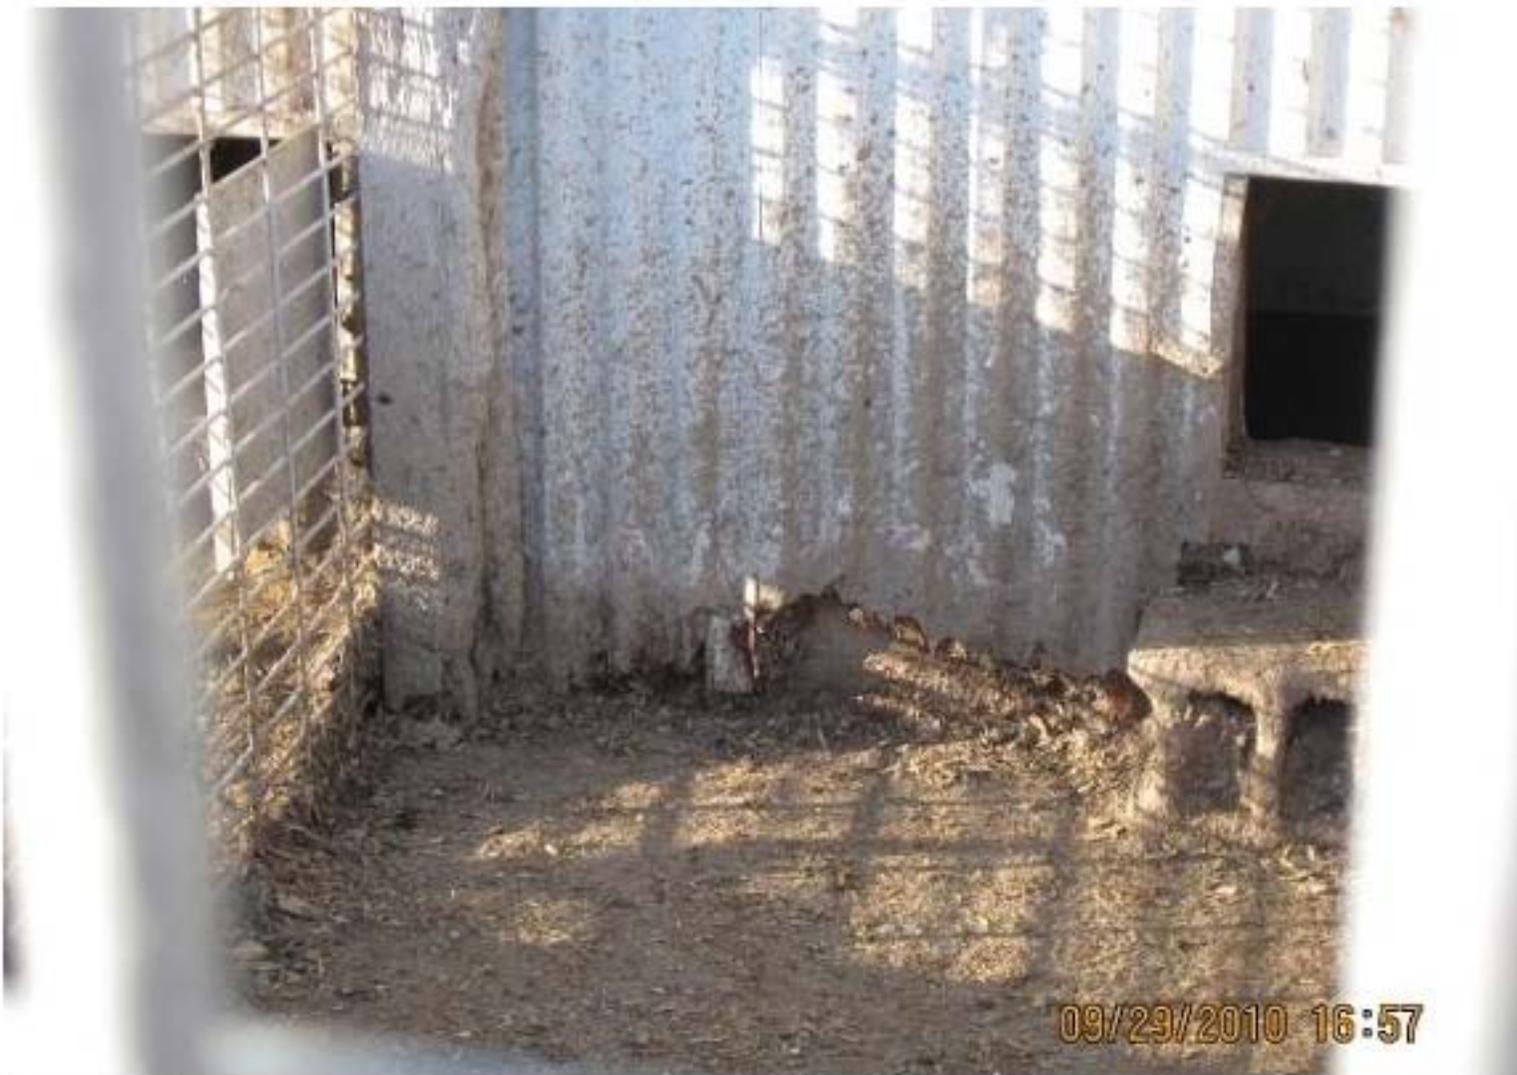
CFR: 3.1 (c) (2)

Photographer:	Randall Wagner (ACI)	Legal Name:	Registration:	42-A-1251
Photo Taken:	Wed, Sep 29, '10	DEAN DEKKERS		
Inspection:	272101837410831			
Description:	The back wood support is rotten or worn/soiled at the bottom. The support is also chewed/scratched.

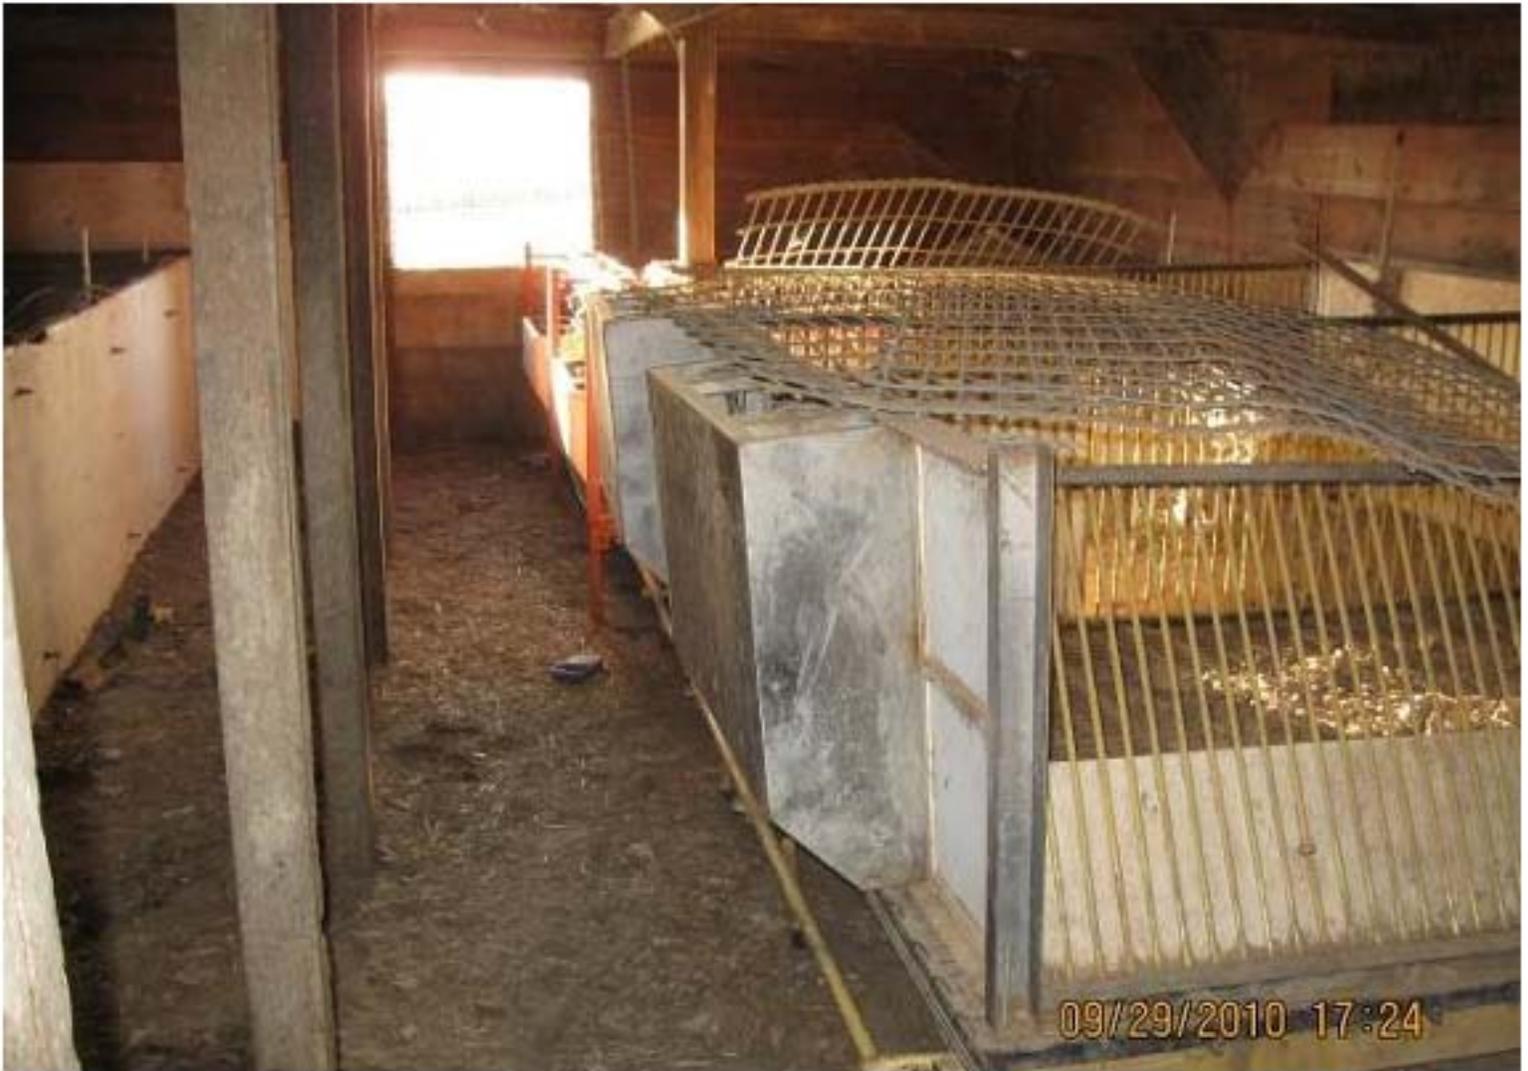
CFR: 3.11 (c)

Photographer:	Randall Wagner (ACI)	Legal Name:	Registration:	42-A-1251
Photo Taken:	Wed, Sep 29, '10	DEAN DEKKERS		
Inspection:	272101837410831			
Description:	The alley way with excessive fecal waste/discarded matter on the ground and old hog cages next to white plastic large kennels on left.

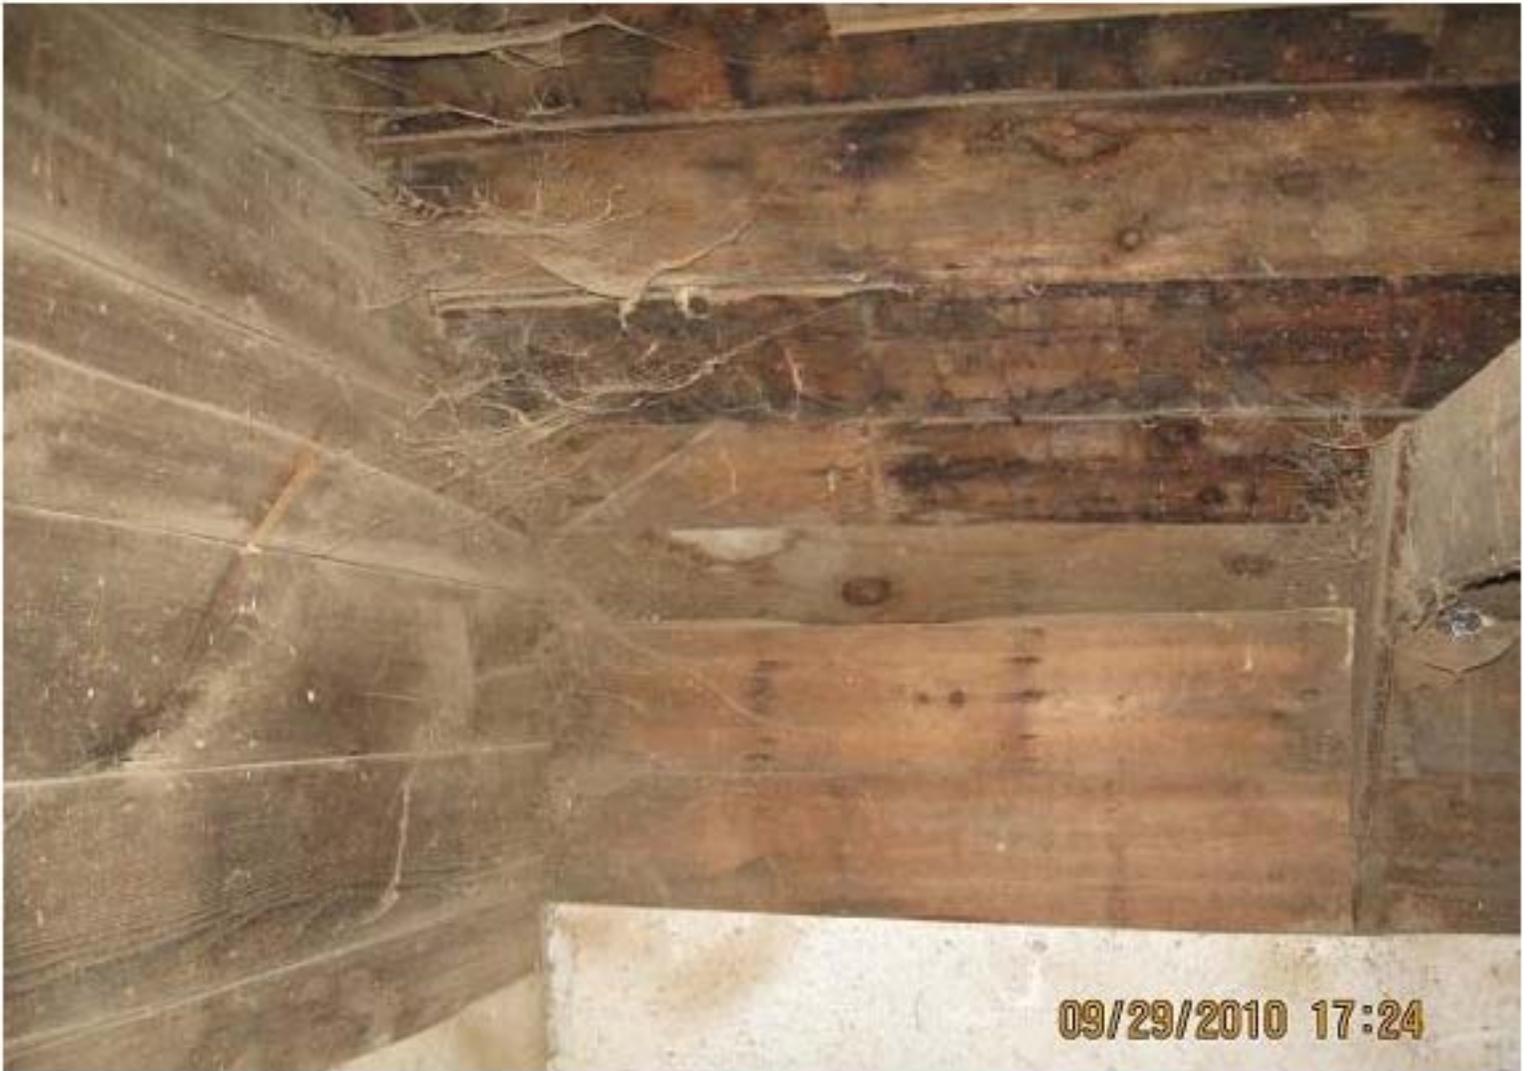
CFR: 3.11 (c)

Photographer:	Randall Wagner (ACI)	Legal Name:	Registration:	42-A-1251
Photo Taken:	Wed, Sep 29, '10	DEAN DEKKERS		
Inspection:	272101837410831			
Description:	The excessive cob webs above the large dog enclosures inside shed.

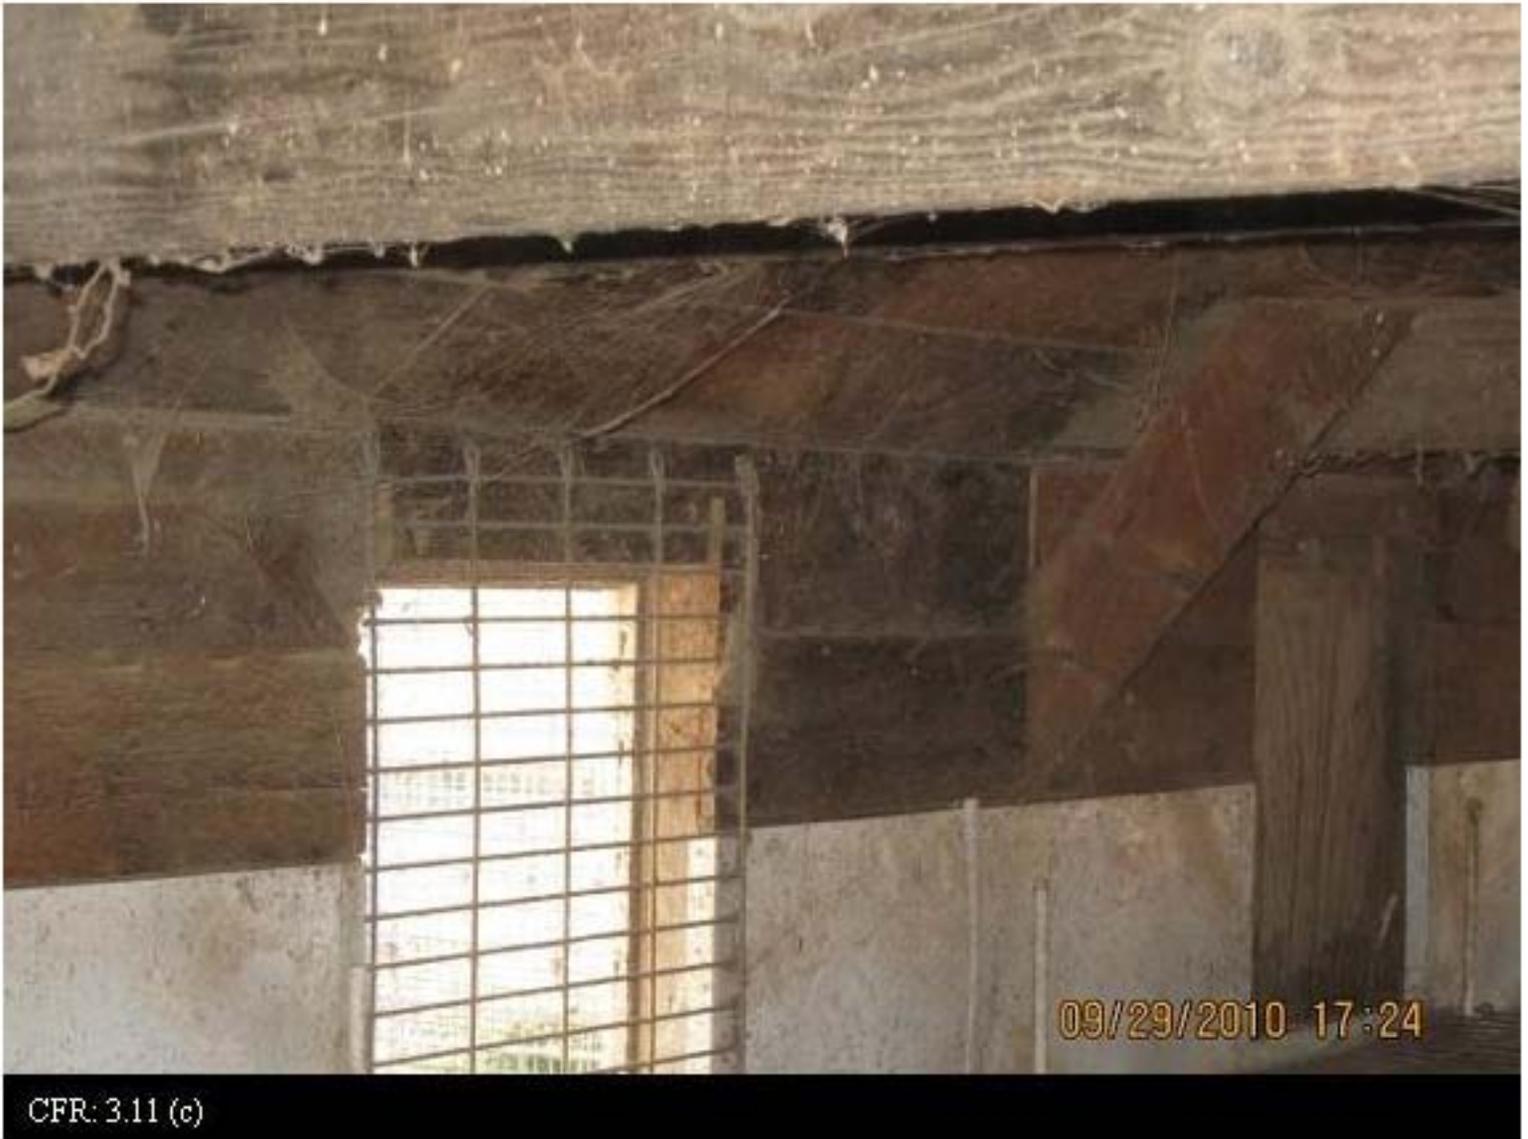
Photographer:	Randall Wagner (ACI)	Legal Name:	Registration:	42-A-1251
Photo Taken:	Wed, Sep 29, '10	DEAN DEKKERS		
Inspection:	272101837410831			
Description:	Excessive cob webs/dust above the white plastic large dog enclosures in shed.

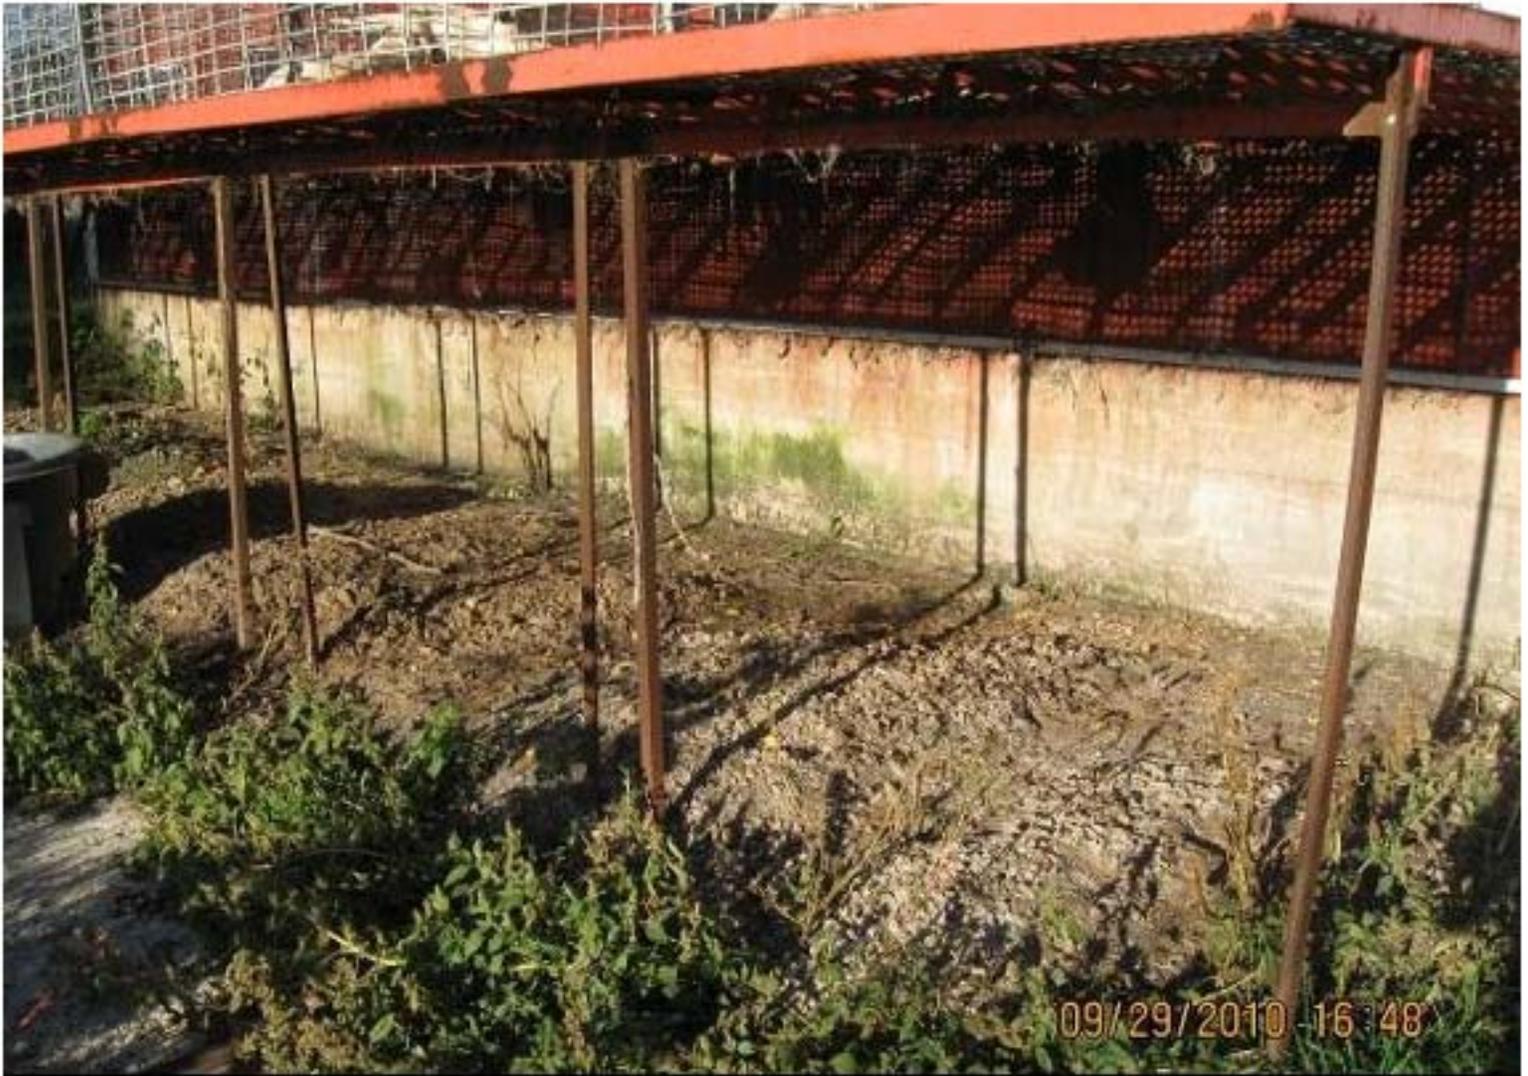
CFR: 3.11 (a)

Photographer:	Randall Wagner (ACI)	Legal Name:	Registration:	42-A-1251
Photo Taken:	Wed, Sep 29, '10	DEAN DEKKERS		
Inspection:	272101837410831			
Description:	Excessive accumulation of fecal waste under neath runs (white to gray in color) indicates the area is not cleaned as often as necessary.

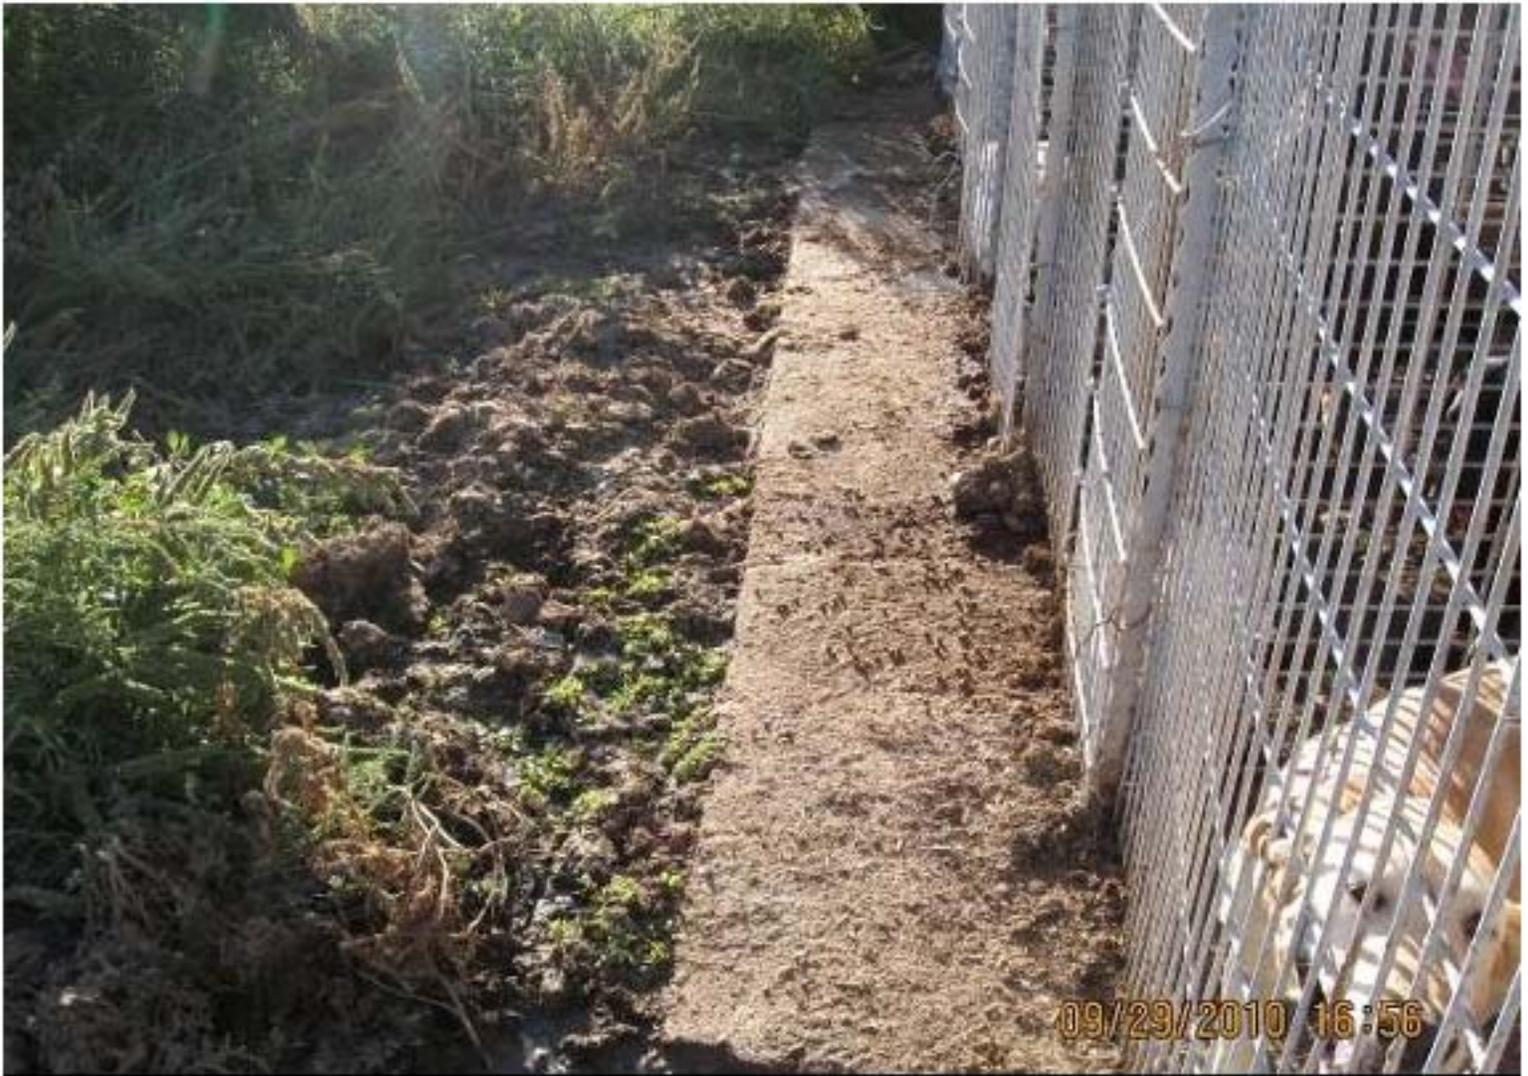
CFR: 3.1 (f)

Photographer:	Randall Wagner (ACI)	Legal Name:	Registration:	42-A-1251
Photo Taken:	Wed, Sep 29, '10	DEAN DEKKERS		
Inspection:	272101837410831			
Description:	The fecal/food waste at the edge of the cement for large dogs does not rapidly eliminate the waste or is not removed often enough.

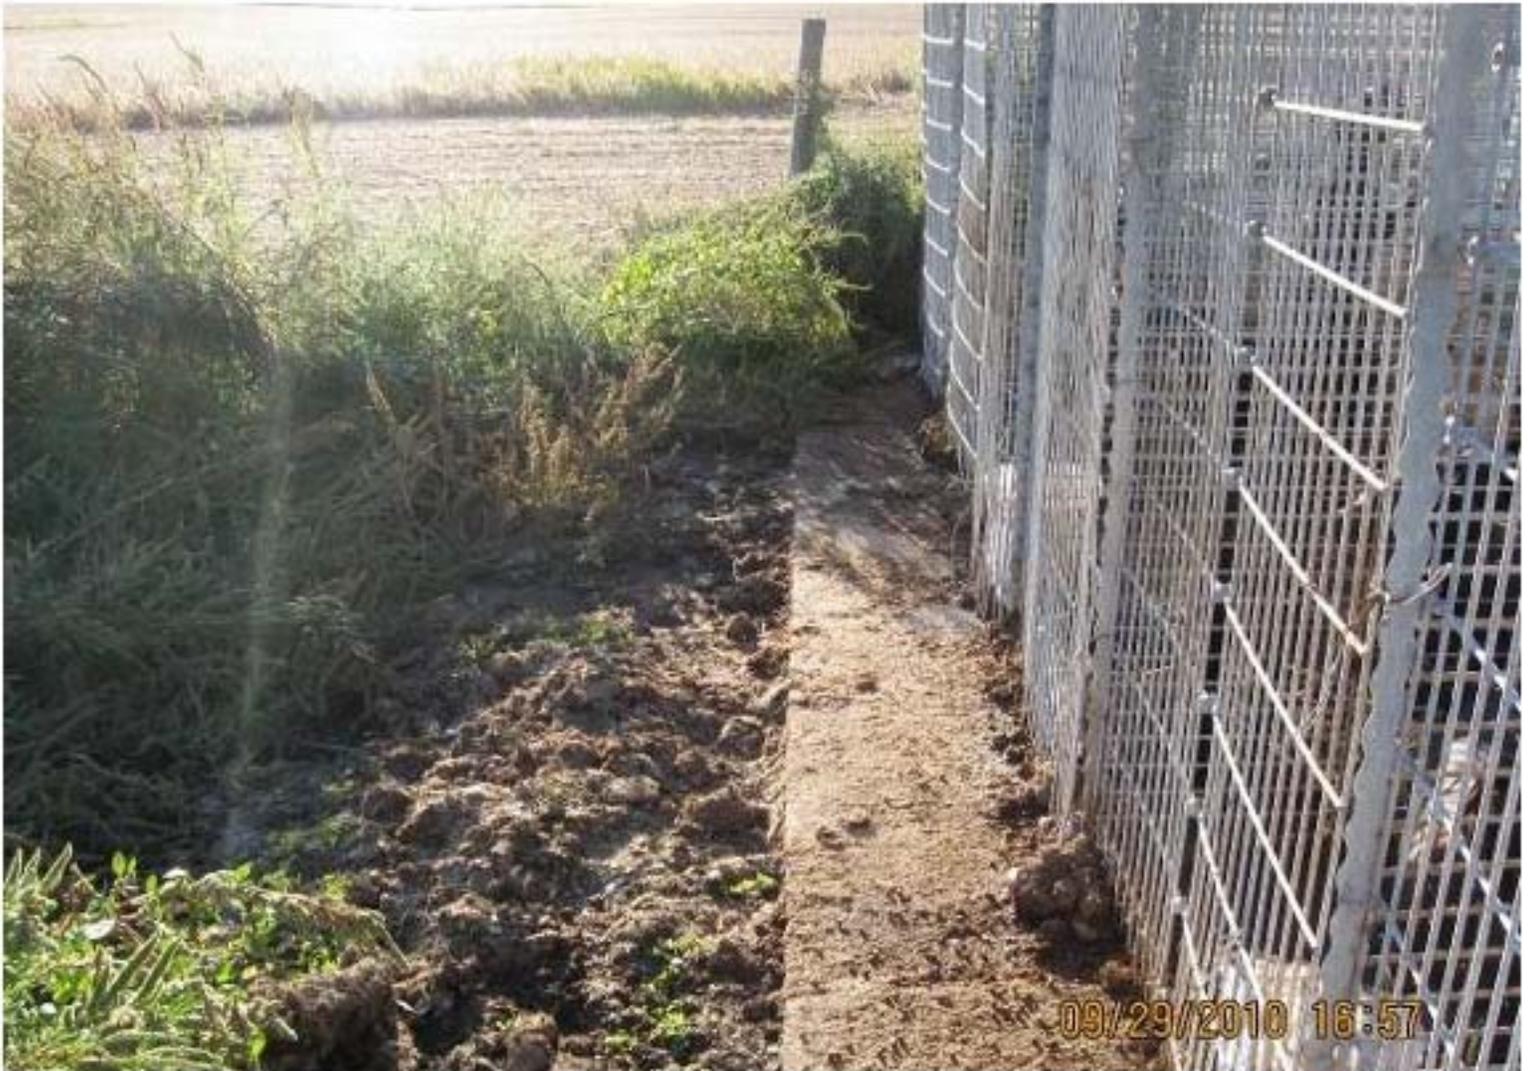
CFR: 3.1 (f)

Photographer:	Randall Wagner (ACI)	Legal Name:	Registration:	42-A-1251
Photo Taken:	Wed, Sep 29, '10	DEAN DEKKERS		
Inspection:	272101837410831			
Description:	The drainage along the edge of the cement for large dogs does not rapidly eliminate the fecal waste and or is not being removed often enough.
