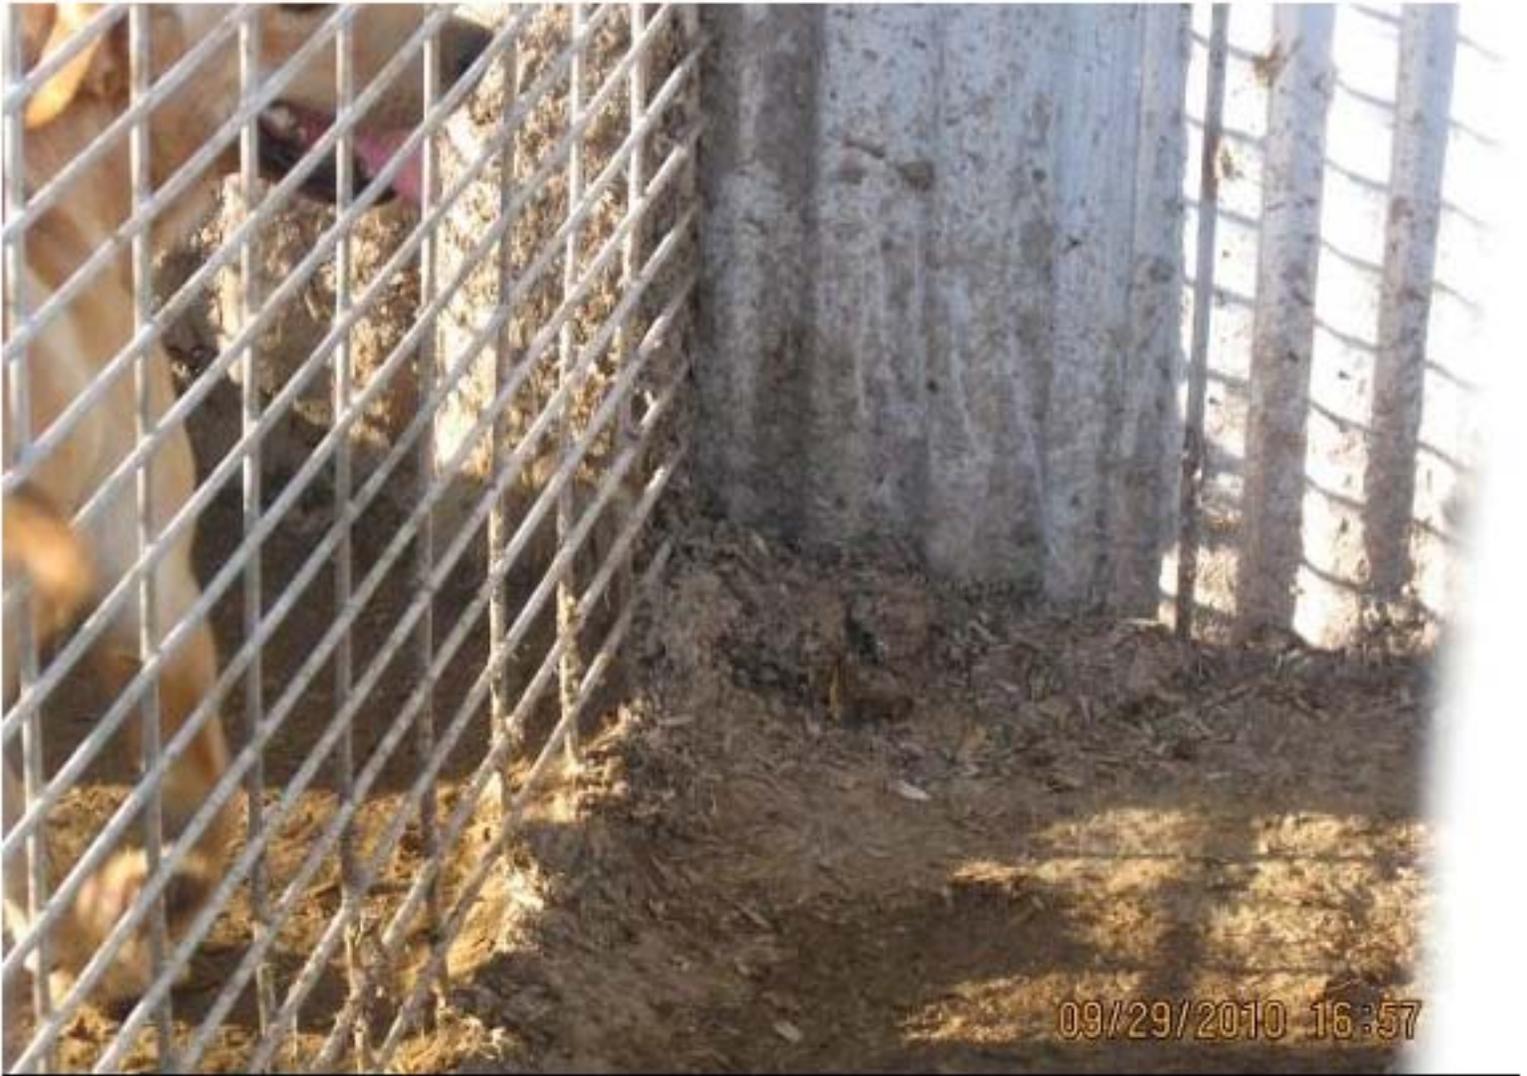
CFR: 3.1 (c) (3)

Photographer:	Randall Wagner (ACI)	Legal Name:	Registration:	42-A-1251
Photo Taken:	Wed, Sep 29, '10	DEAN DEKKERS		
Inspection:	272101837410831			
Description:	Close in view of the accumulation fecal waste/discarded matter and brown matter on back wall, indicates daily spot-cleaning not happening.

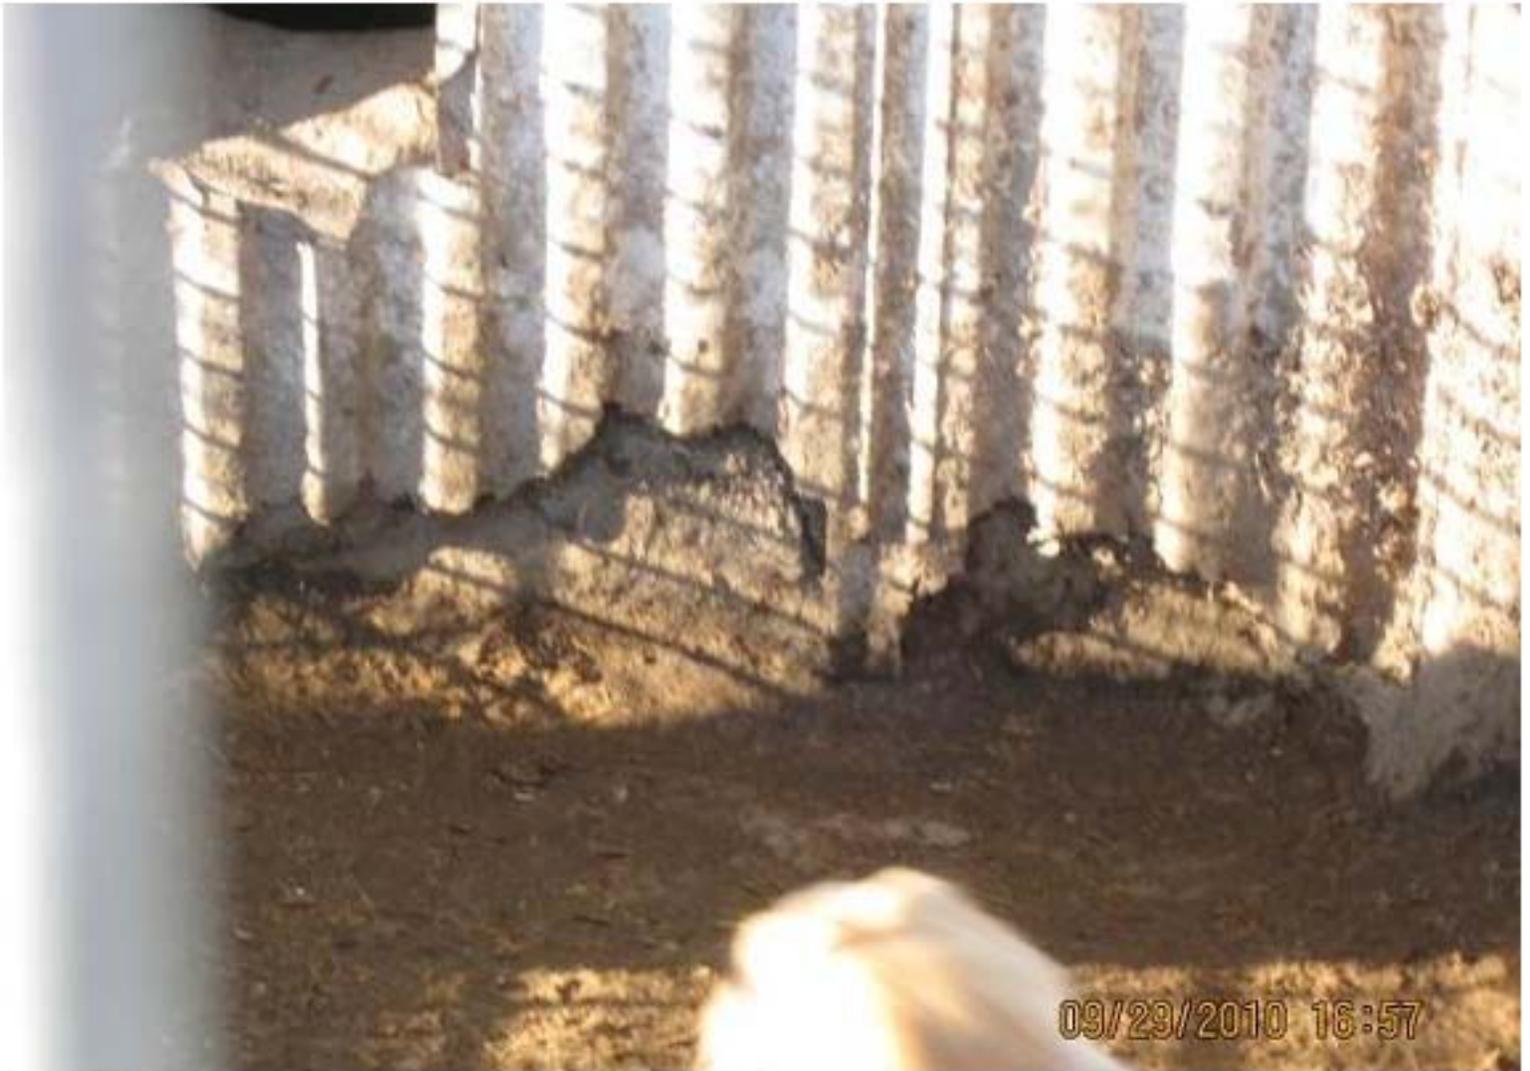
CFR: 3.1 (c) (2)

Photographer:	Randall Wagner (ACI)	Legal Name:	Registration:	42-A-1251
Photo Taken:	Wed, Sep 29, '10	DEAN DEKKERS		
Inspection:	272101837410831			
Description:	The tin is rusted away for back wall allowing for the plywood under neath to get soiled and gaps to harbor fecal waste.

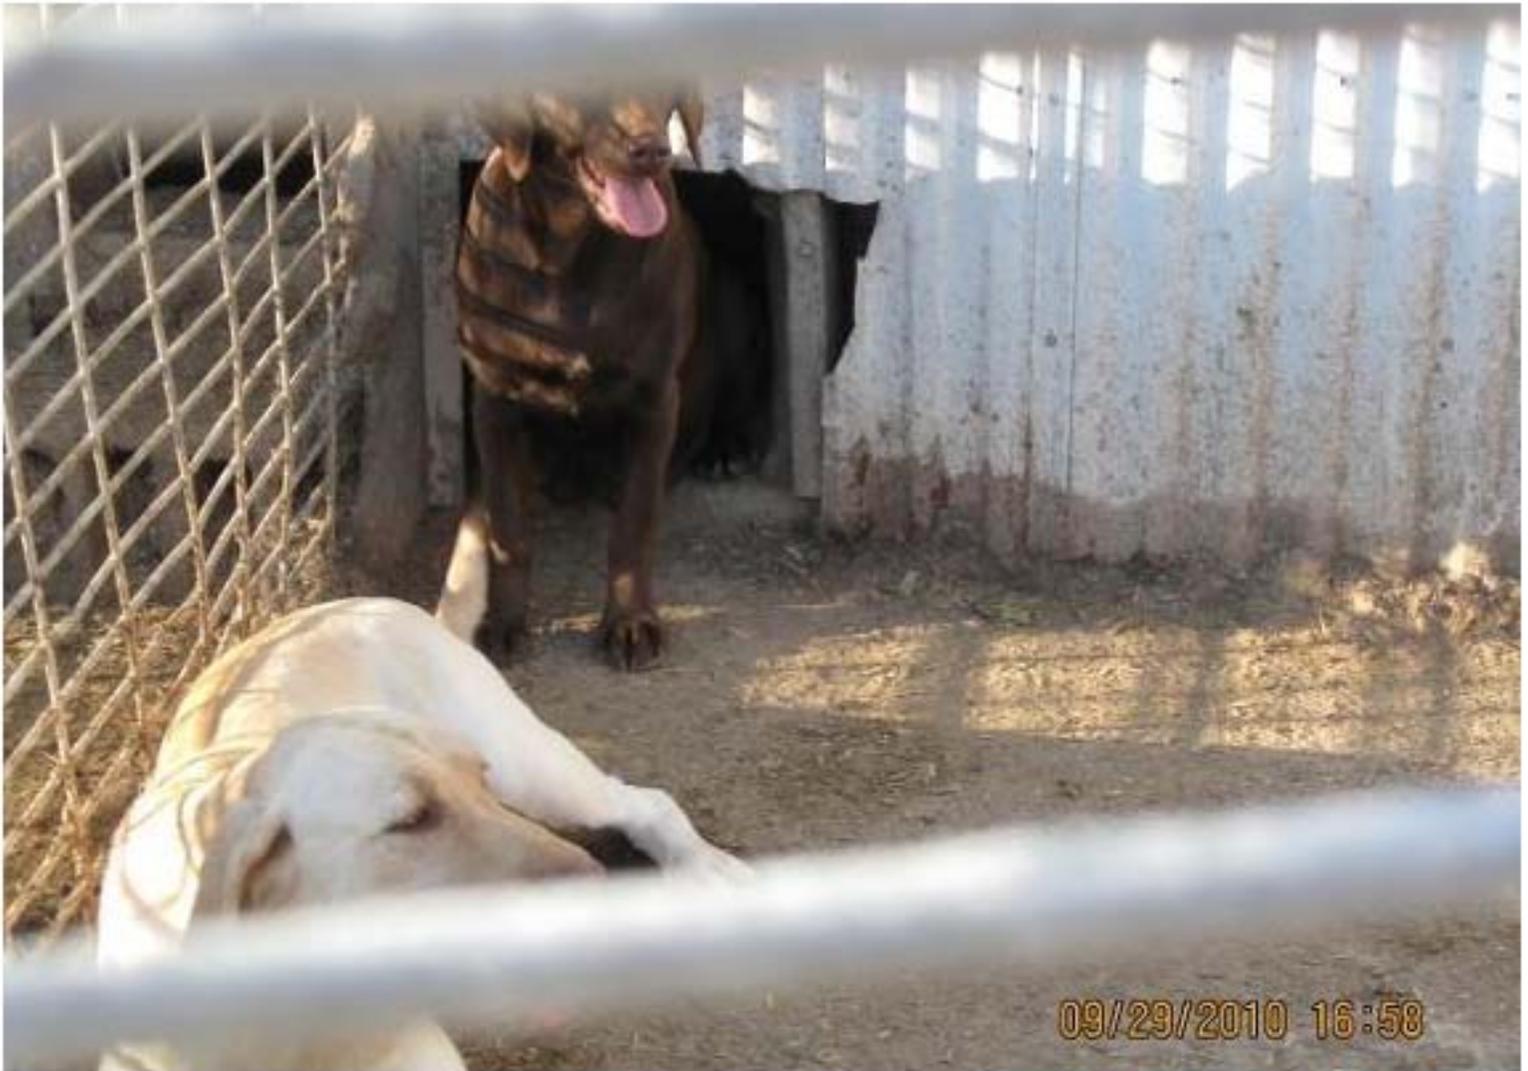
CFR: 3.1 (c) (2)

Photographer:	Randall Wagner (ACI)	Legal Name:	Registration:	42-A-1251
Photo Taken:	Wed, Sep 29, '10	DEAN DEKKERS		
Inspection:	272101837410831			
Description:	The tin wall is rusty at the bottom and the surface is worn indicates the surface is not being maintained.

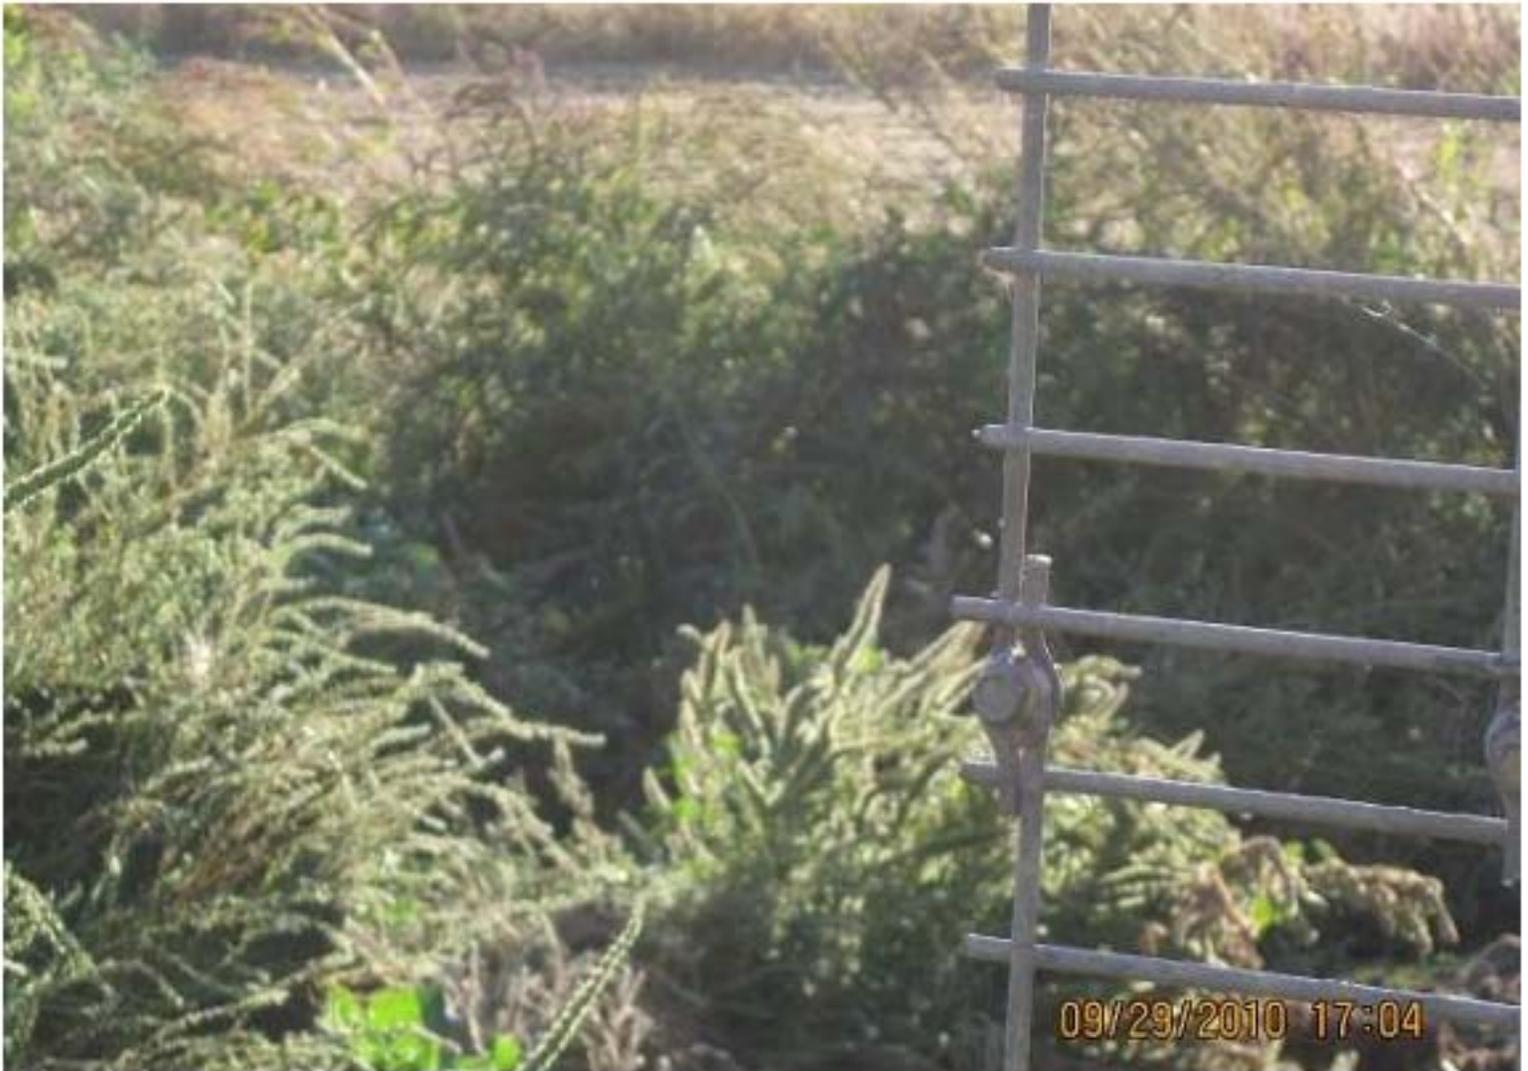
CFR: 3.11 (c)

Photographer:	Randall Wagner (ACI)	Legal Name:	Registration:	42-A-1251
Photo Taken:	Wed, Sep 29, '10	DEAN DEKKERS		
Inspection:	272101837410831			
Description:	The excessively tall weeds along the edge of the cement near the accumulation of fecal waste.

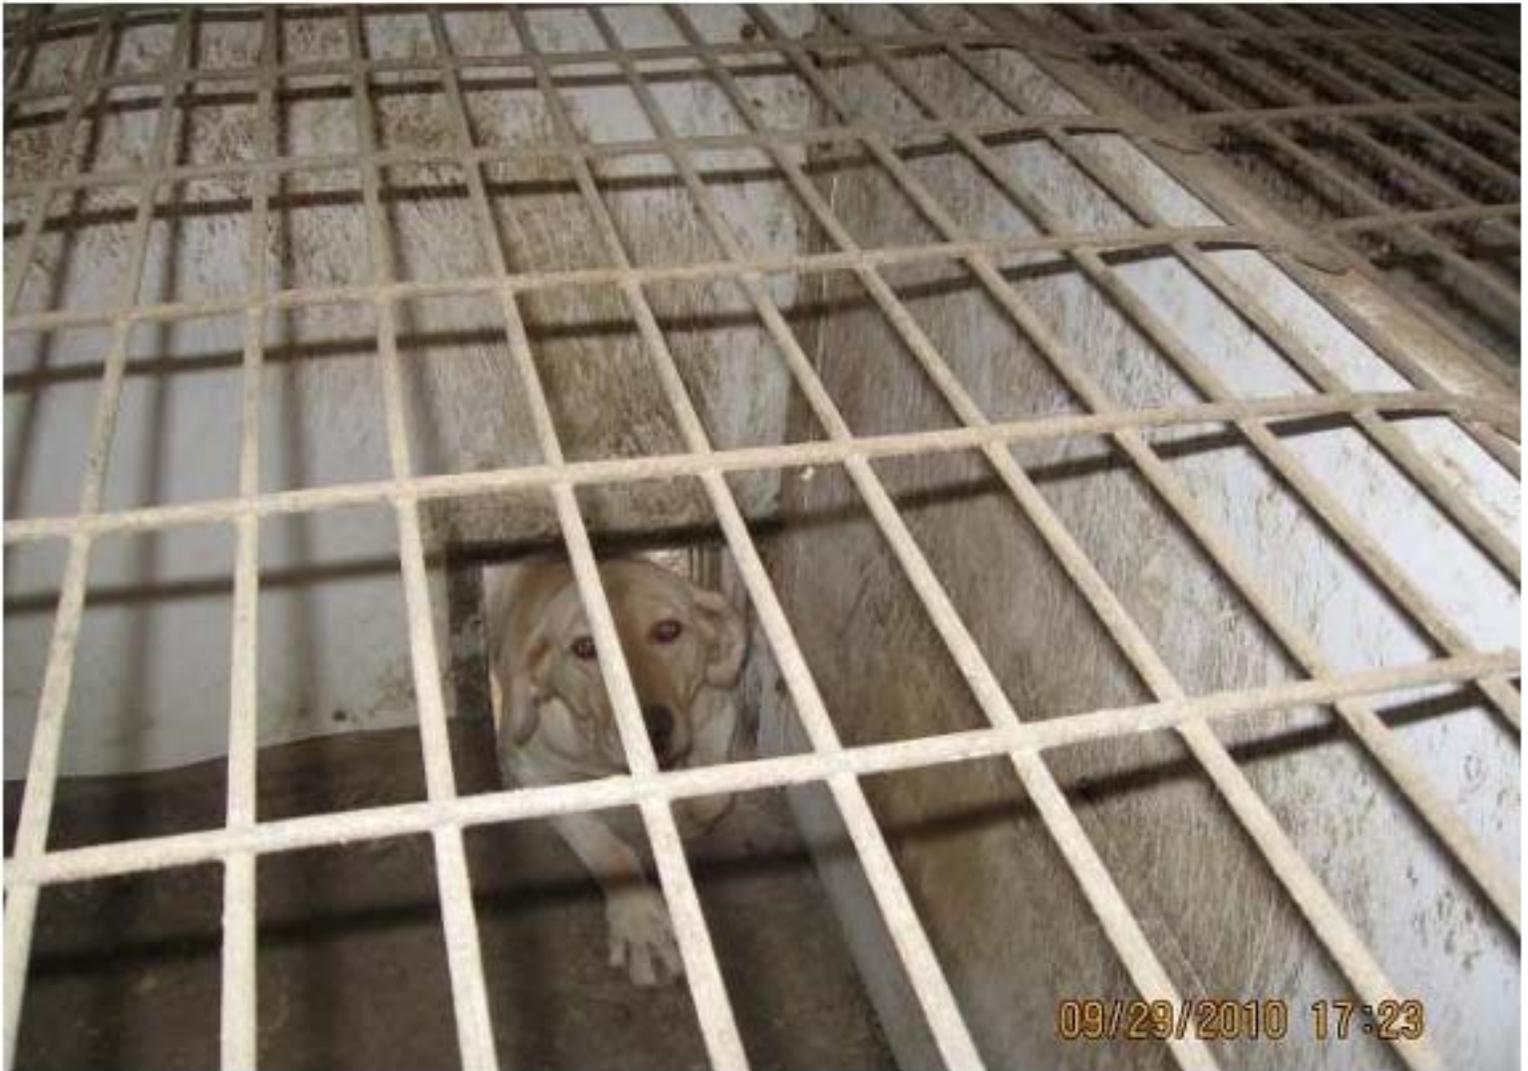
CFR: 3.1 (c) (3)

Photographer:	Randall Wagner (ACI)	Legal Name:	Registration:	42-A-1251
Photo Taken:	Wed, Sep 29, '10	DEAN DEKKERS		
Inspection:	272101837410831			
Description:	Accumulation of brown excrement or discarded matter on the plastic surface of large dog kennel.

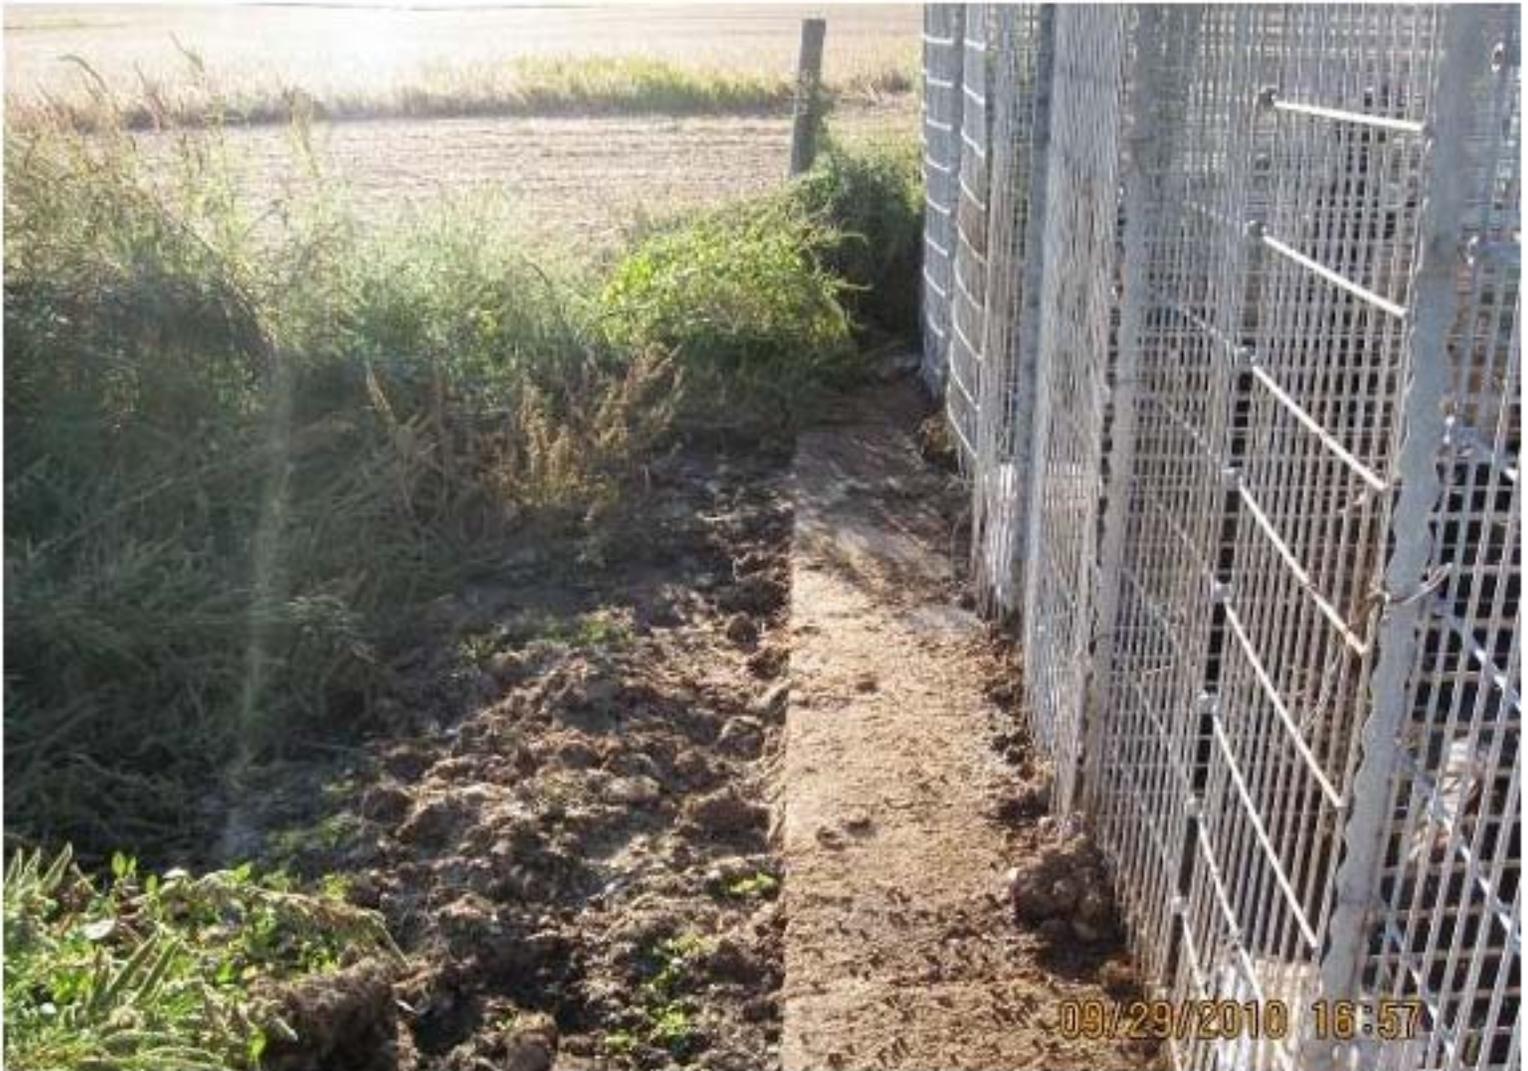
CFR: 3.11 (c)

Photographer:	Randall Wagner (ACI)	Legal Name:	Registration:	42-A-1251
Photo Taken:	Wed, Sep 29, '10	DEAN DEKKERS		
Inspection:	272101837410831			
Description:	The excessively tall weeds along the runs on the cement near the accumulation of fecal waste.

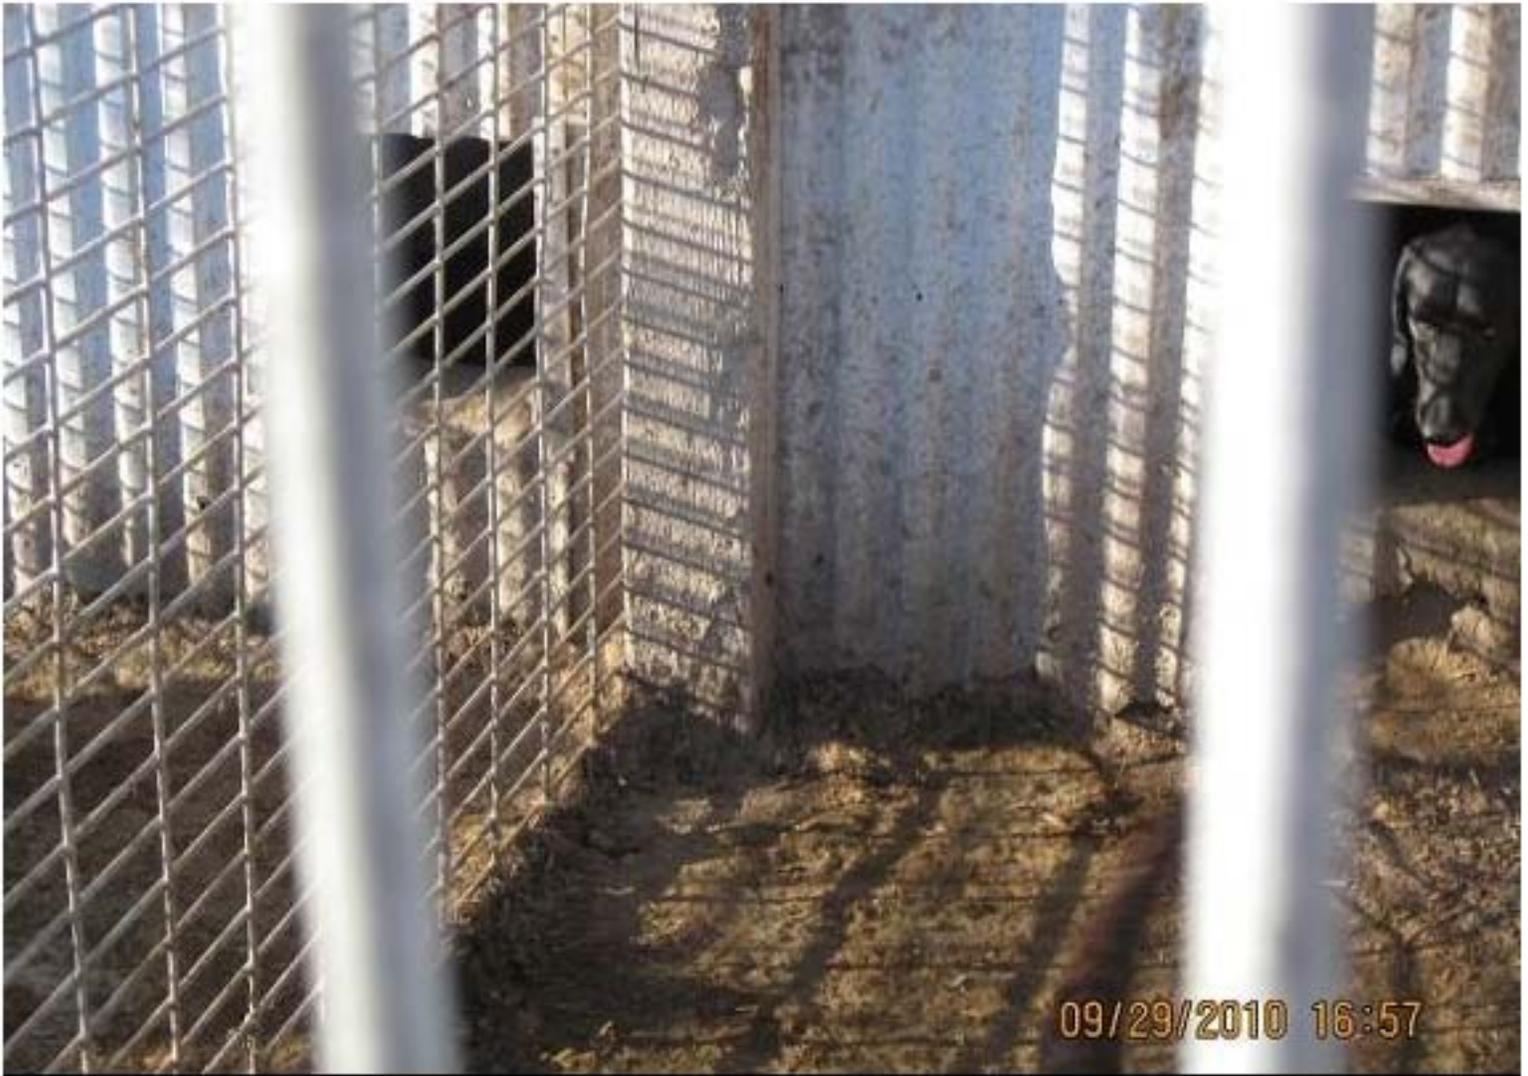
CFR: 3.1 (c) (2)

Photographer:	Randall Wagner (ACI)	Legal Name:	Registration:	42-A-1251
Photo Taken:	Wed, Sep 29, '10	DEAN DEKKERS		
Inspection:	272101837410831			
Description:	The wood board support on back wall is chewed/scratched and or soiled. The wood surface is not be maintained.

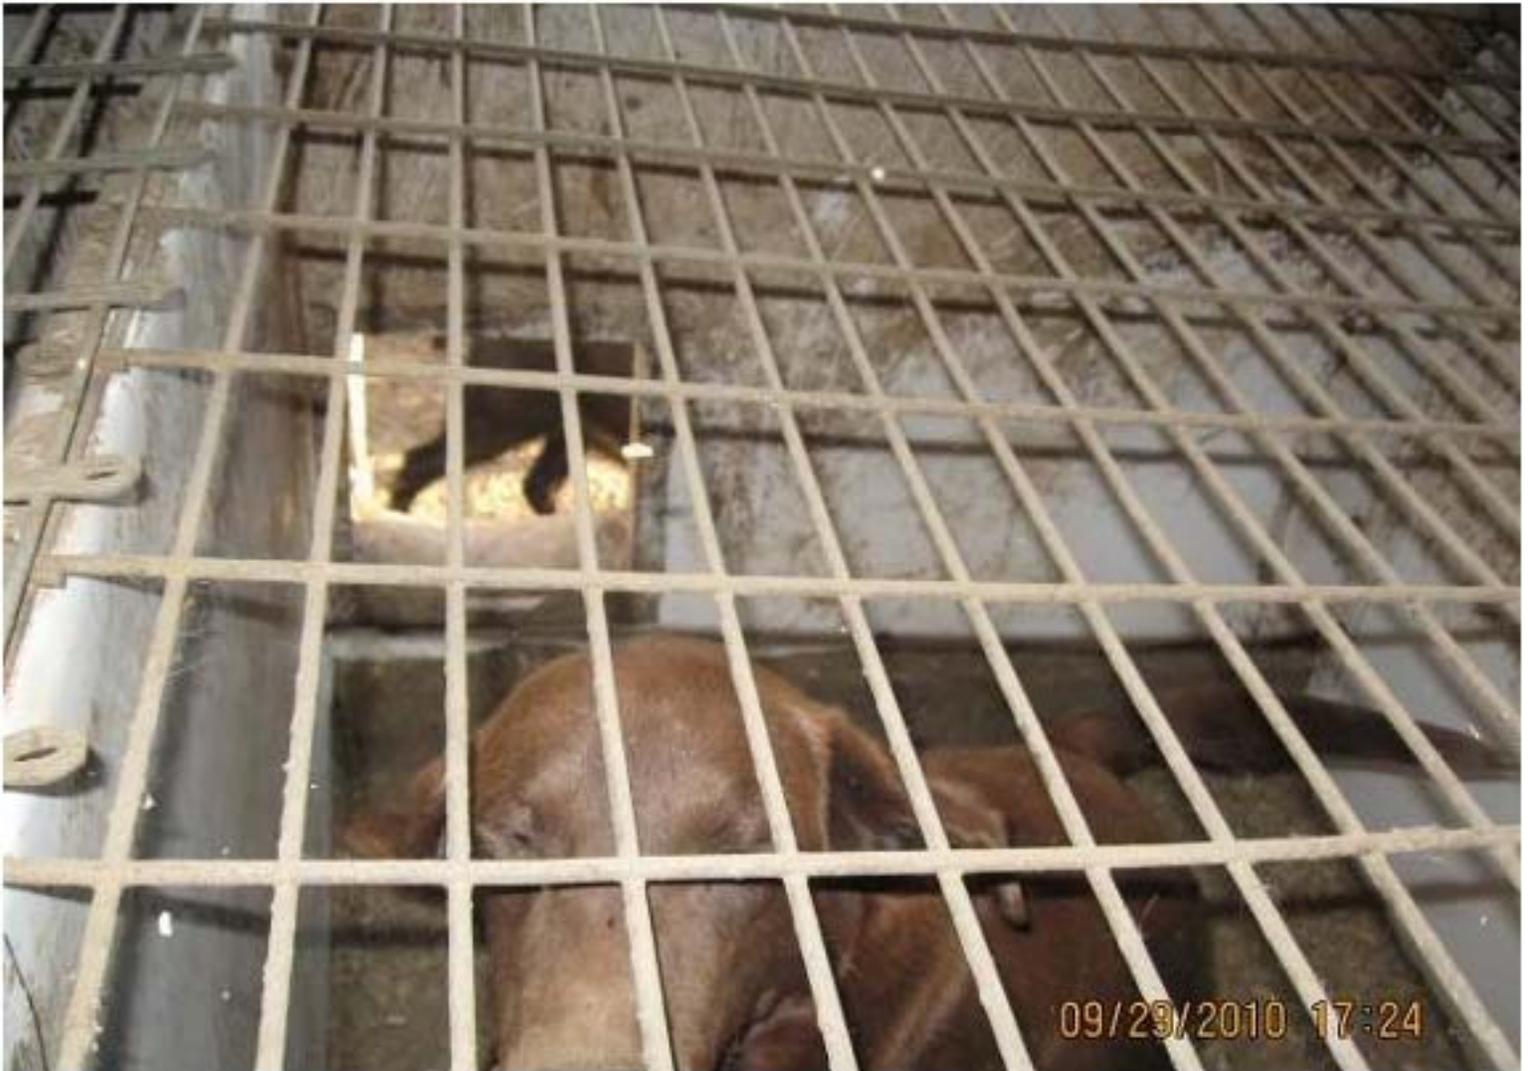
CFR: 3.1 (c) (3)

Photographer:	Randall Wagner (ACI)	Legal Name:	Registration:	42-A-1251
Photo Taken:	Wed, Sep 29, '10	DEAN DEKKERS		
Inspection:	272101837410831			
Description:	The accumulation of brown dust/dirt/excrement on the plastic walls of the large dog kennel.

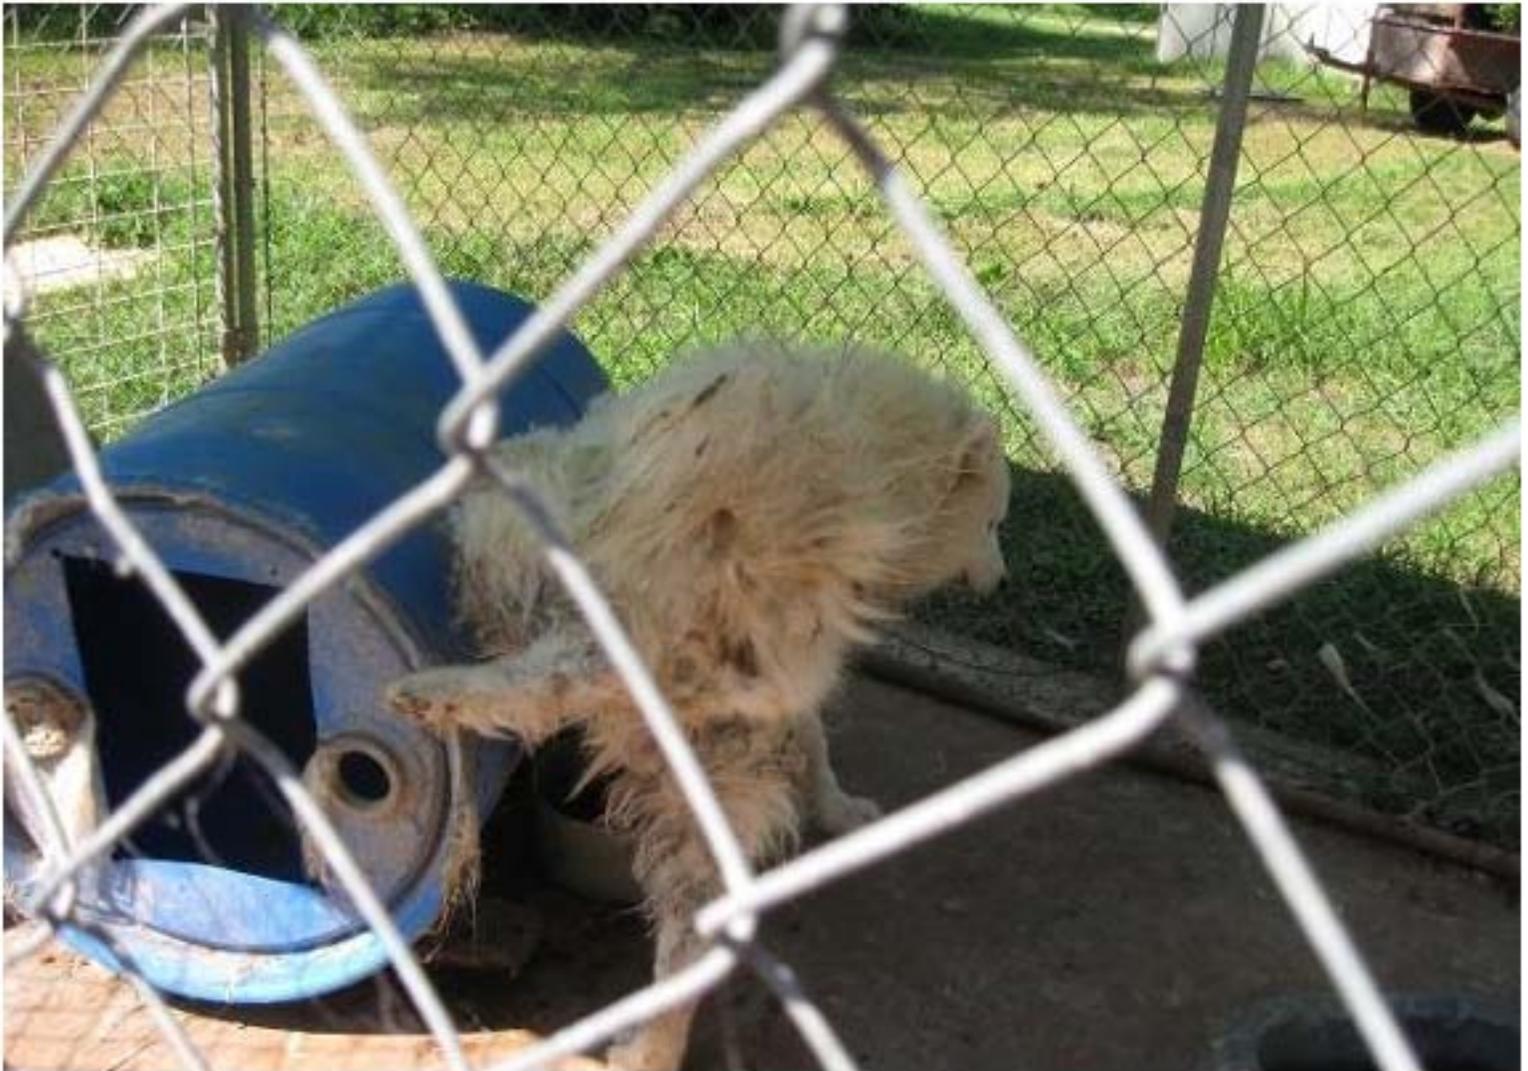
CFR: 2.40 (b) (2)

Photographer:	John J. Lies, ACI	Legal Name:	Registration:	42-A-1238
Photo Taken:	Wed, Aug 25, '10 P.M.	CATHY SPEER		
Inspection:	238101248530491			
Description:	2.40 (b)(2) Veterinary Care: Hair mats need to be removed and hair coat groomed

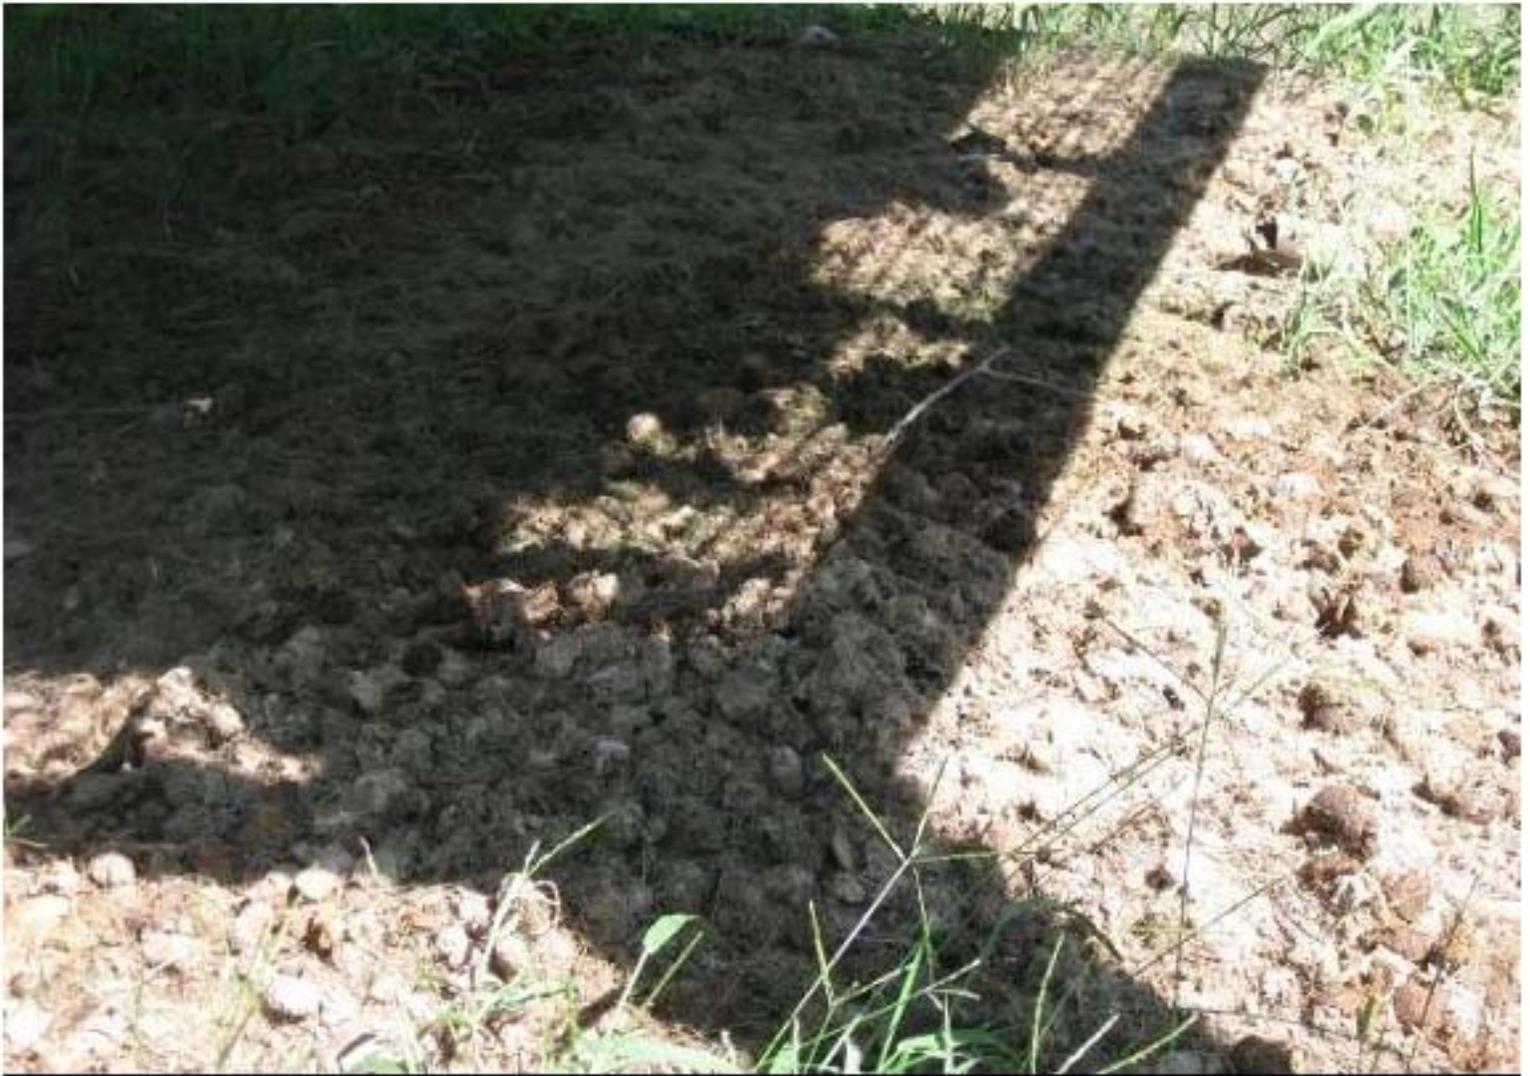
CFR: 3.11 (a)

Photographer:	John J. Lies, ACI	Legal Name:	Registration:	42-A-1238
Photo Taken:	Wed, Aug 25, '10 P.M.	CATHY SPEER		
Inspection:	238101248530491			
Description:	3.11 (a) Cleaning: Primary enclosures need to be cleaned to remove dirt, debris, hair from around the enclosures and excreta from under the enclosures.

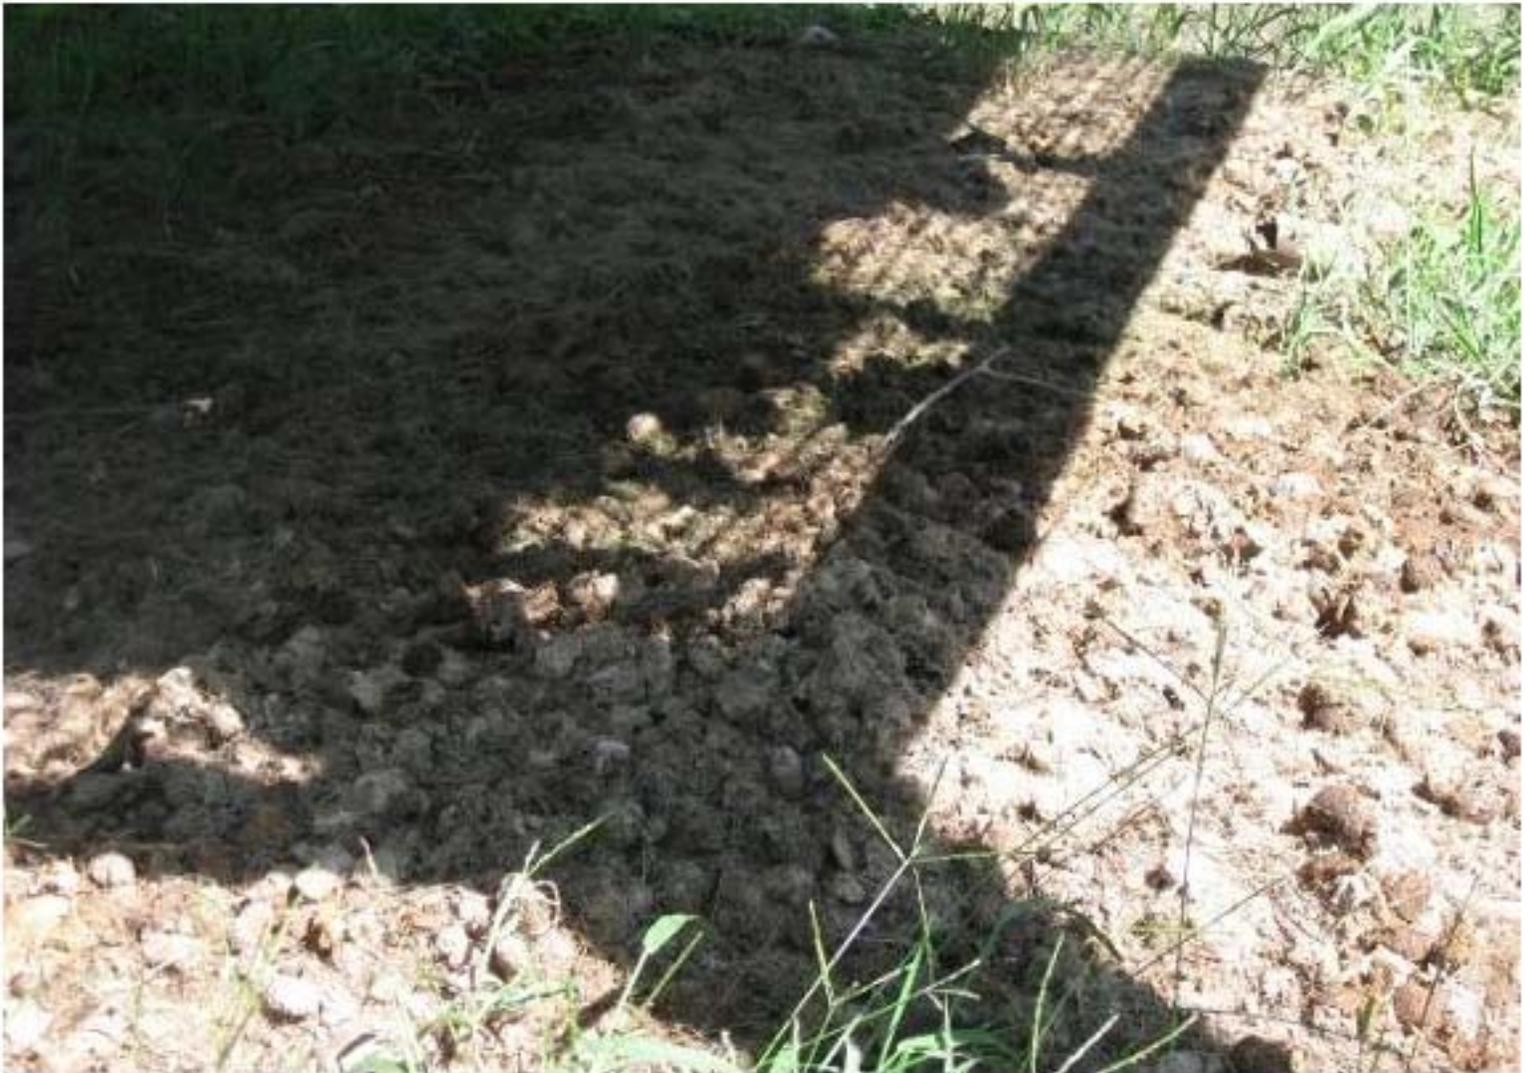
CFR: 3.11 (a)

Photographer:	John J. Lies, ACI	Legal Name:	Registration:	42-A-1238
Photo Taken:	Wed, Aug 25, '10 P.M.	CATHY SPEER		
Inspection:	238101248530491			
Description:	3.11 (a) Cleaning: Primary enclosures need to be cleaned to remove dirt, debris, hair from around the enclosures and excreta from under the enclosures.

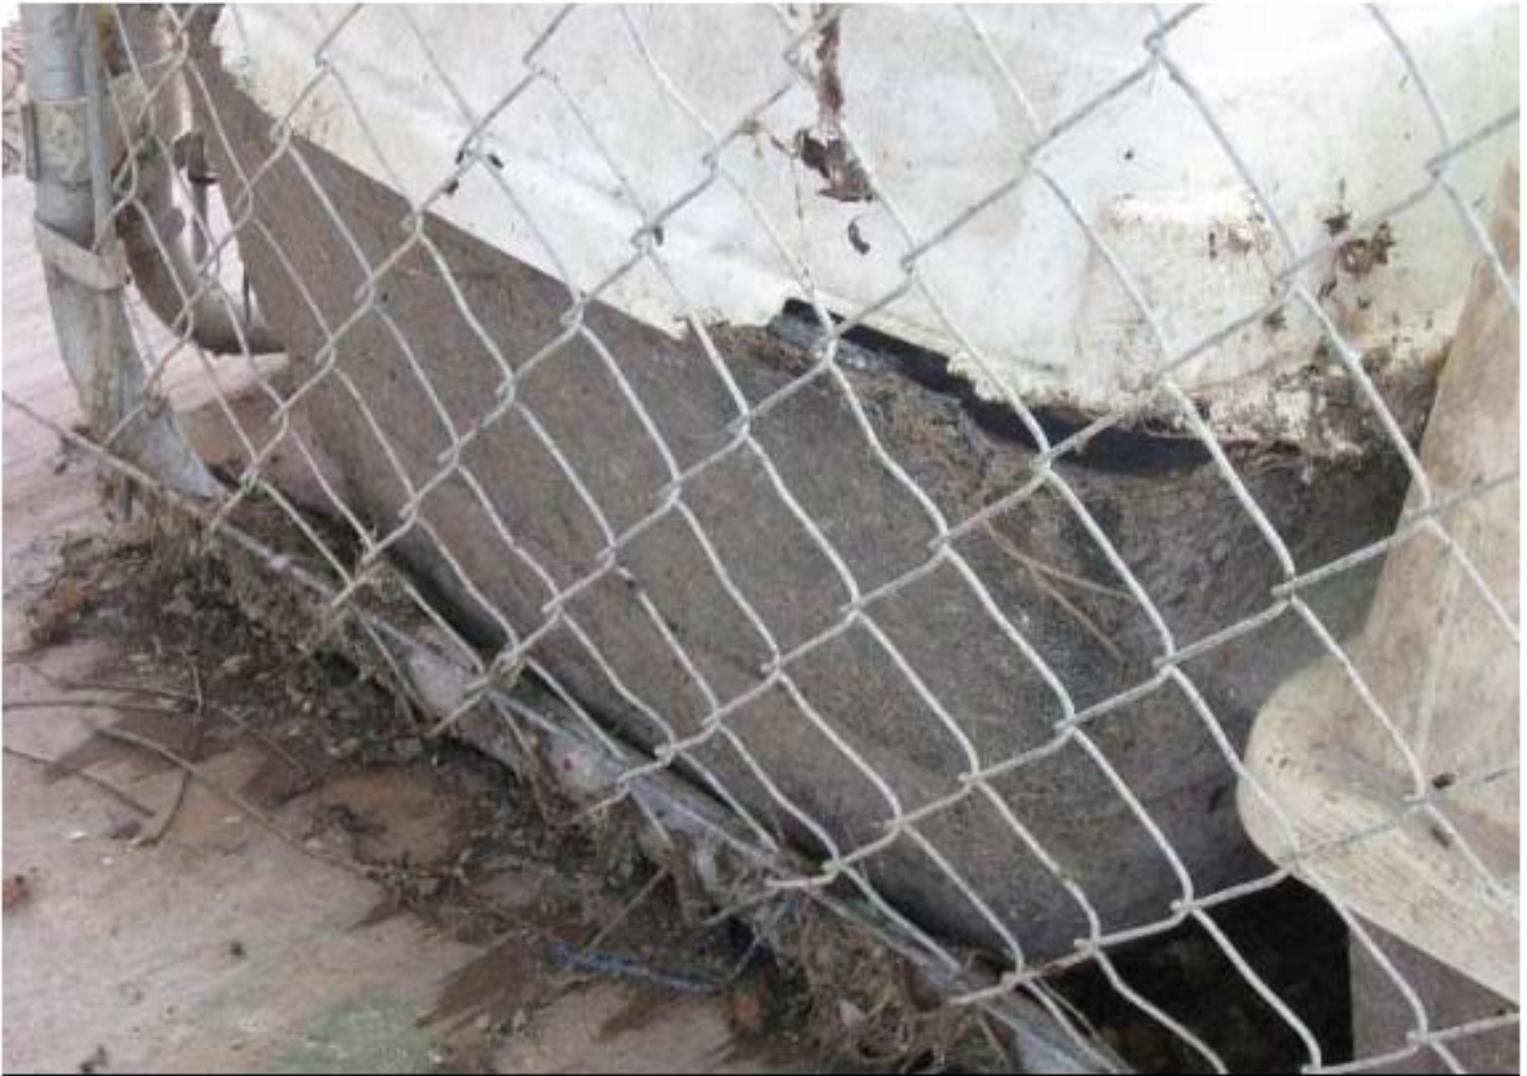
CFR: 3.1 (f), 3.1 (c) (2), 3.11 (a) (2)

Photographer:	John J. Lies, ACI	Legal Name:	Registration:	42-A-1238
Photo Taken:	Wed, Aug 25, '10 P.M.	CATHY SPEER		
Inspection:	238101248530491			
Description:	3.1 (f) General Housing Waste Disposal: Excreta, hair, food waste around the enclosures needs to be removed. 3.1 (c)(2) Maintenance of surfaces chewed edges on dogs house. 3.11(a)(2) Cleaning

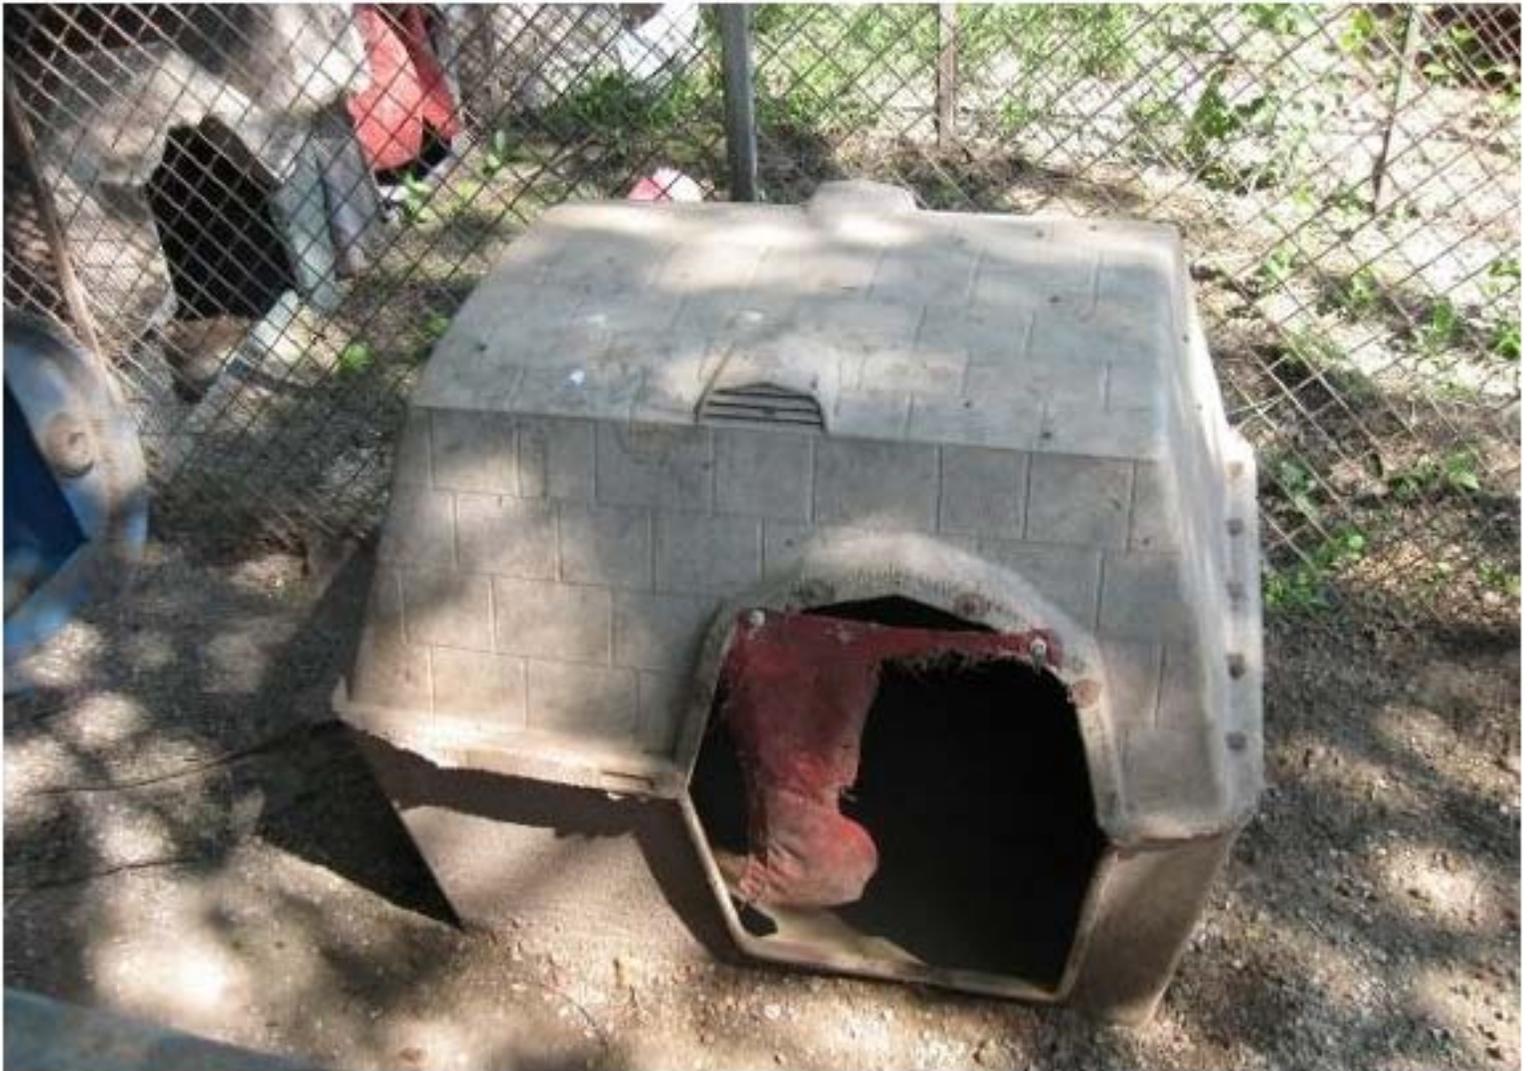
CFR: 3.4 (b), 3.11 (a) (2)

Photographer:	John J. Lies, ACI	Legal Name:	Registration:	42-A-1238
Photo Taken:	Wed, Aug 25, '10 P.M.	CATHY SPEER		
Inspection:	238101248530491			
Description:	3.4 (b)(3) Outdoor housing: No wind/rain break. 3.11 (a)(2) Cleaning: Shelter and hard surfaces need to be sanitized.			FOIA11-282000310
