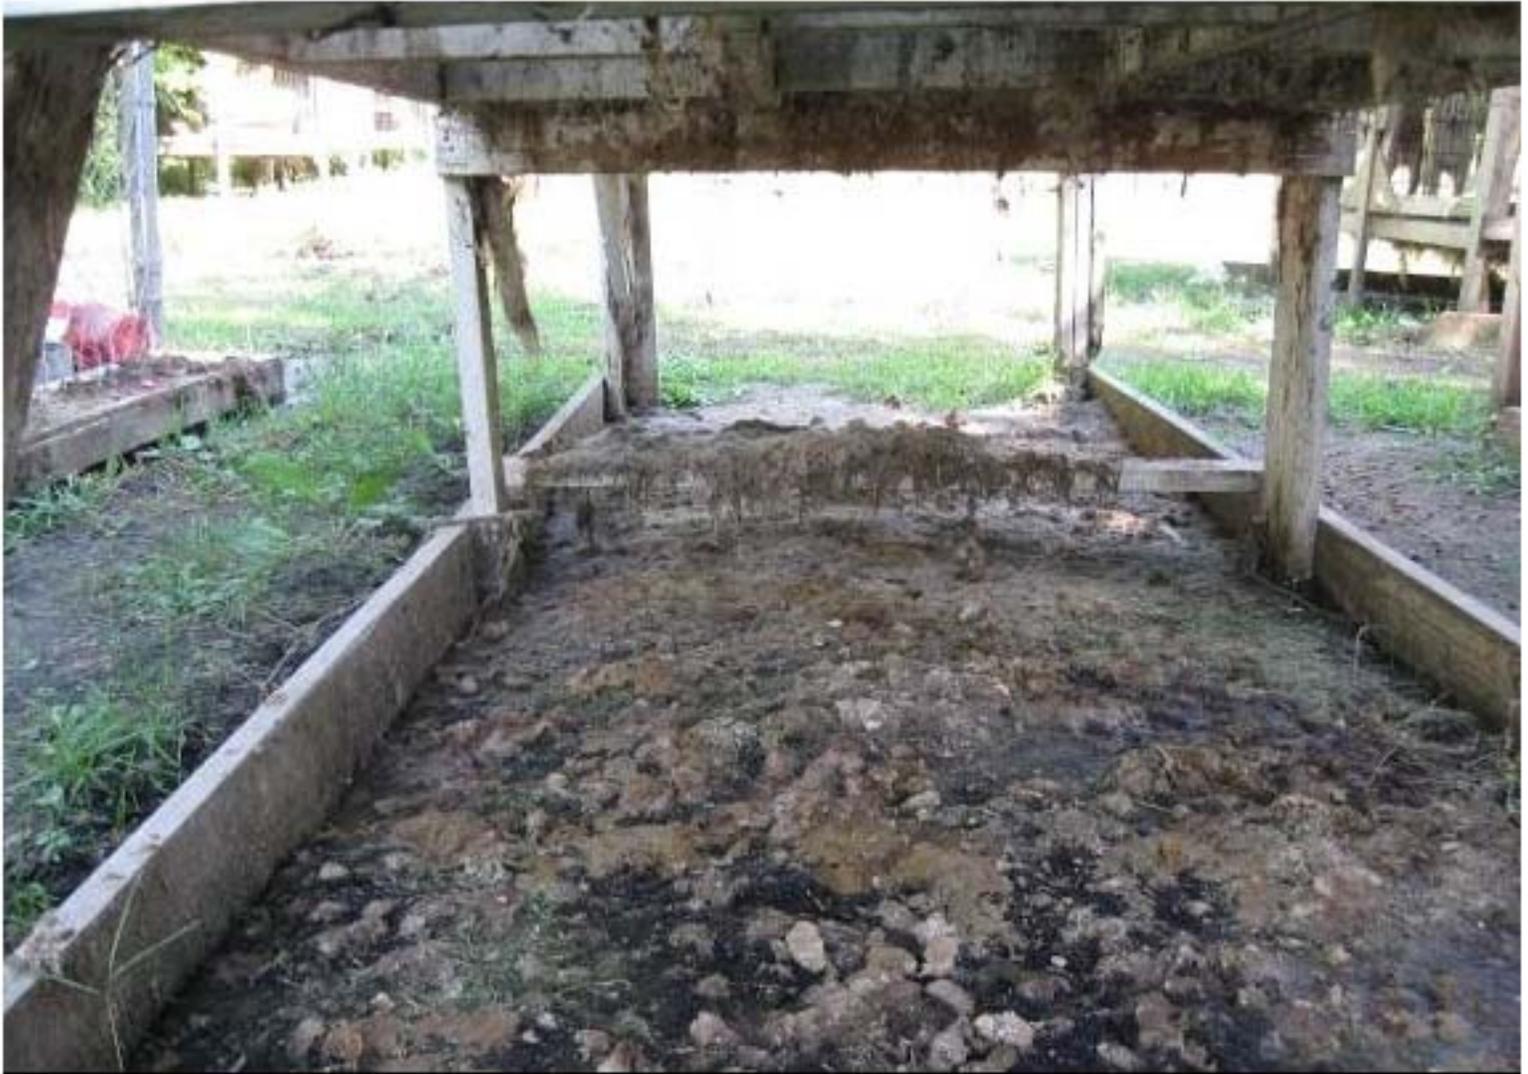
CFR: 3.11 (a)

Photographer:	John J. Lies, ACI	Legal Name:	Registration:	42-A-1238
Photo Taken:	Wed, Aug 25, '10 P.M.	CATHY SPEER		
Inspection:	238101248530491			
Description:	3.11 (a) Cleaning: Primary enclosures need to be cleaned to remove dirt, debris, hair from around the enclosures and excreta from under the enclosures.

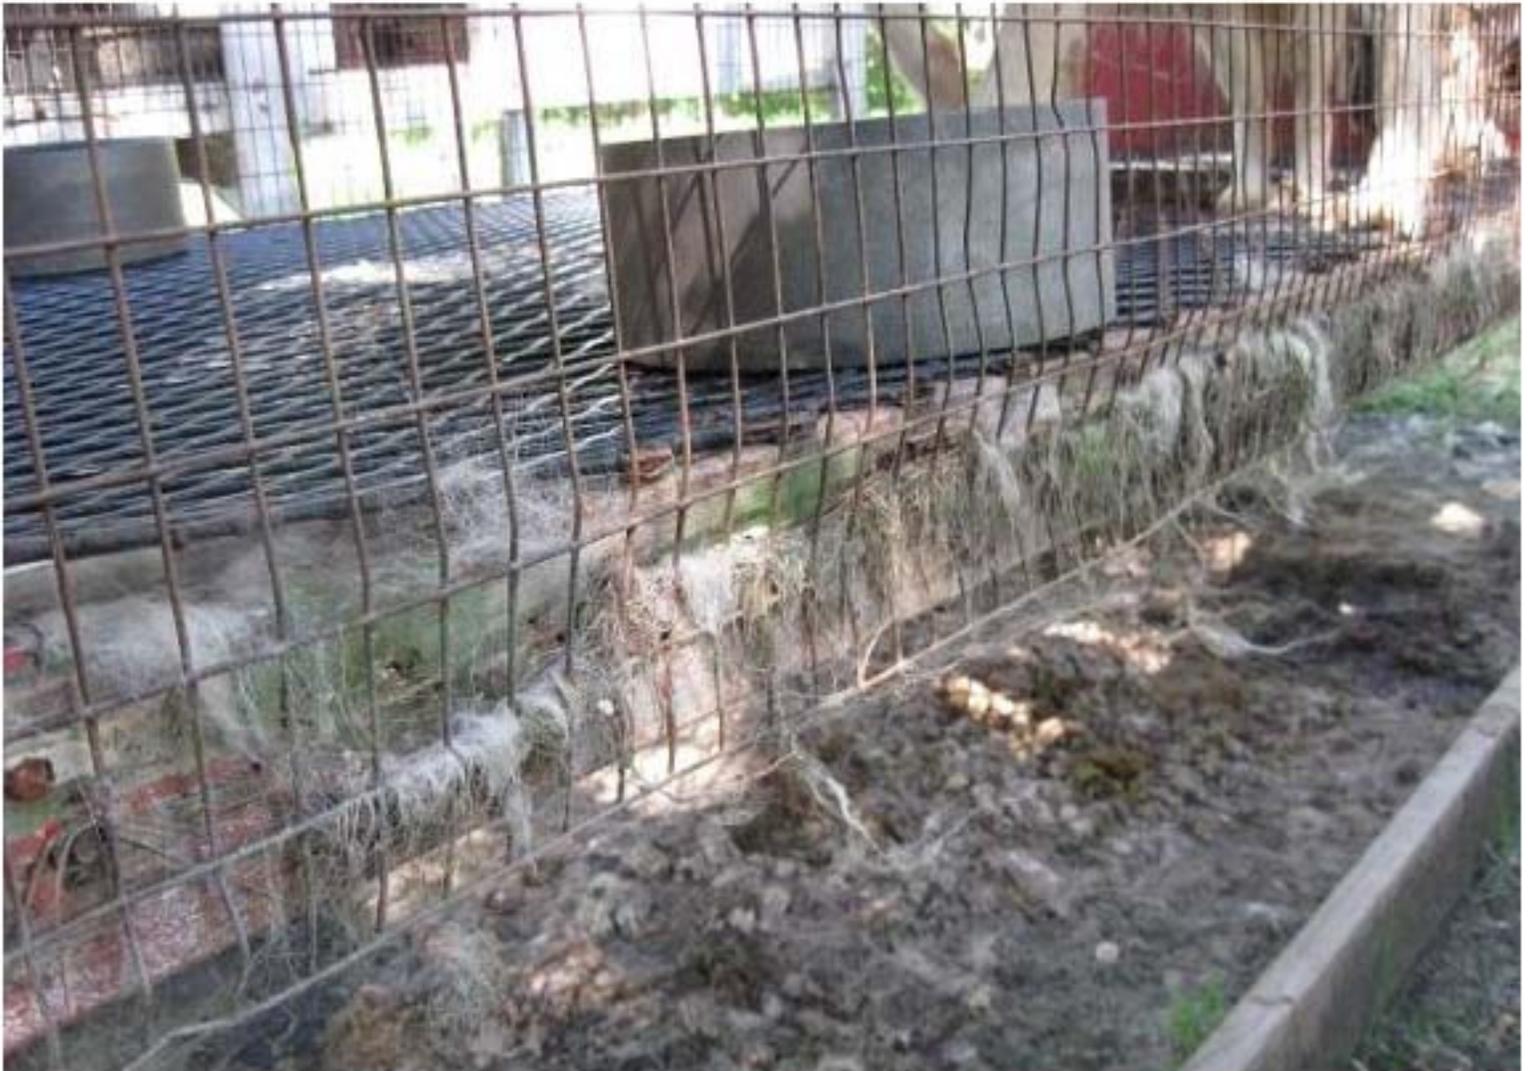
CFR: 3.11 (a)

Photographer:	John J. Lies, ACI	Legal Name:	Registration:	42-A-1238
Photo Taken:	Wed, Aug 25, '10 P.M.	CATHY SPEER		
Inspection:	238101248530491			
Description:	3.11 (a) Cleaning: Primary enclosures need to be cleaned to remove dirt, debris, hair from around the enclosures and excreta from under the enclosures.

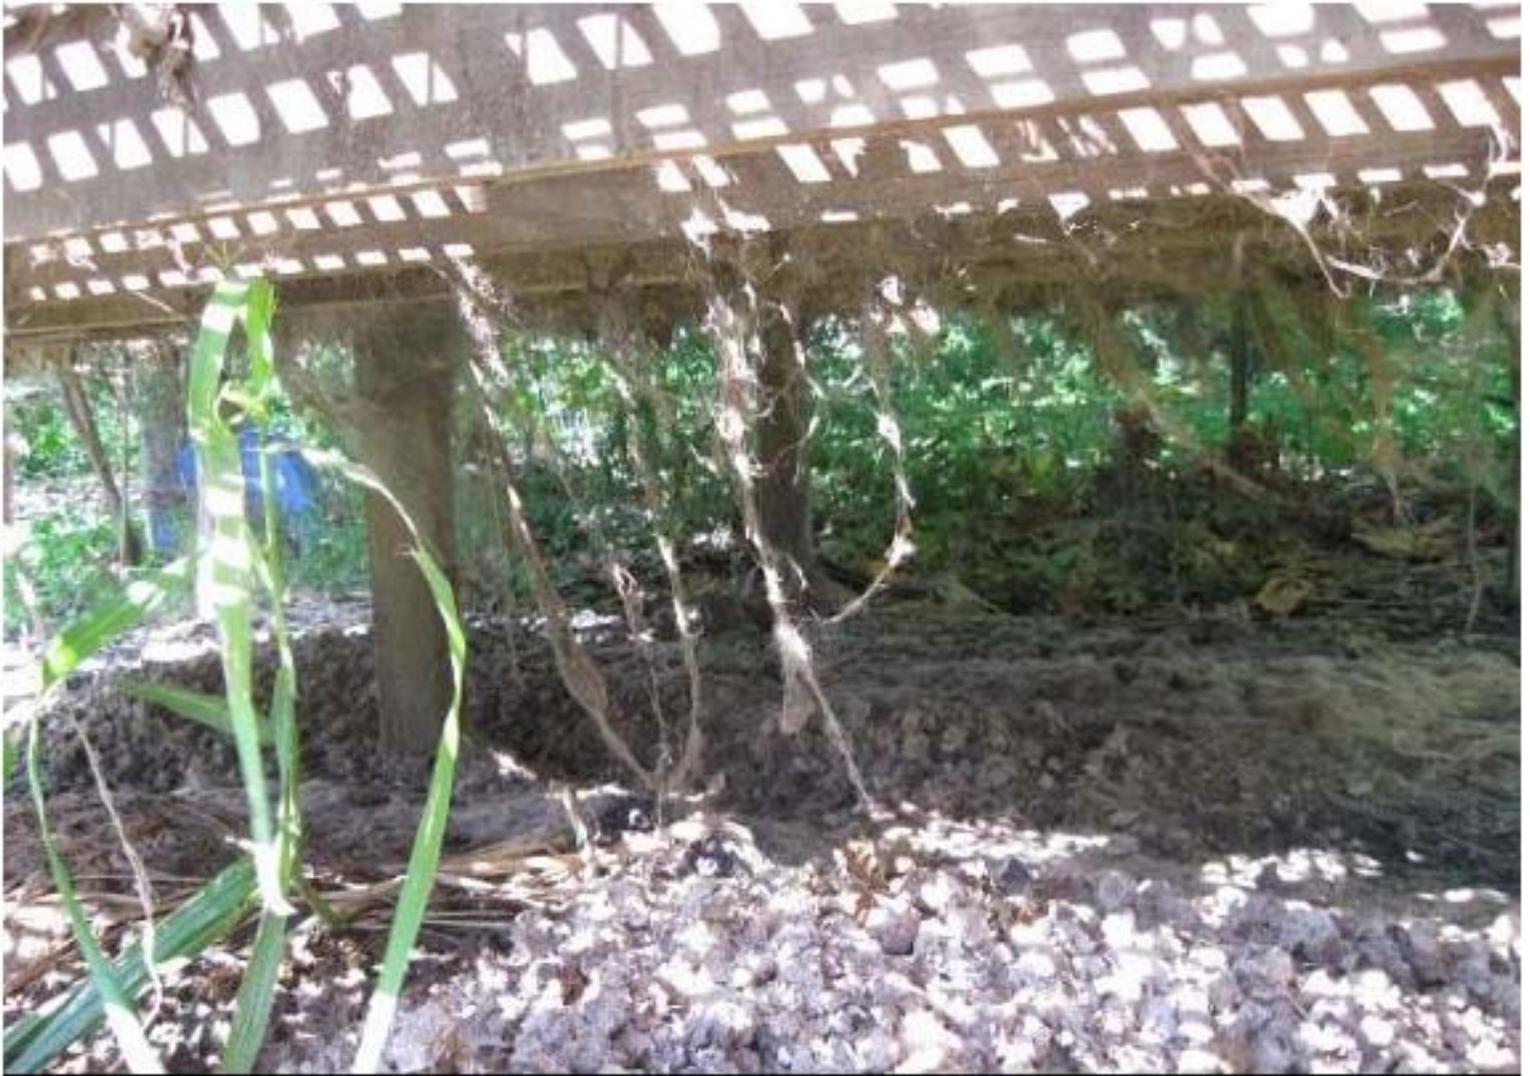
CFR: 3.11 (a)

Photographer:	John J. Lies, ACI	Legal Name:	Registration:	42-A-1238
Photo Taken:	Wed, Aug 25, '10 P.M.	CATHY SPEER		
Inspection:	238101248530491			
Description:	3.11 (a) Cleaning: Primary enclosures need to be cleaned to remove dirt, debris, hair from around the enclosures and excreta from under the enclosures.

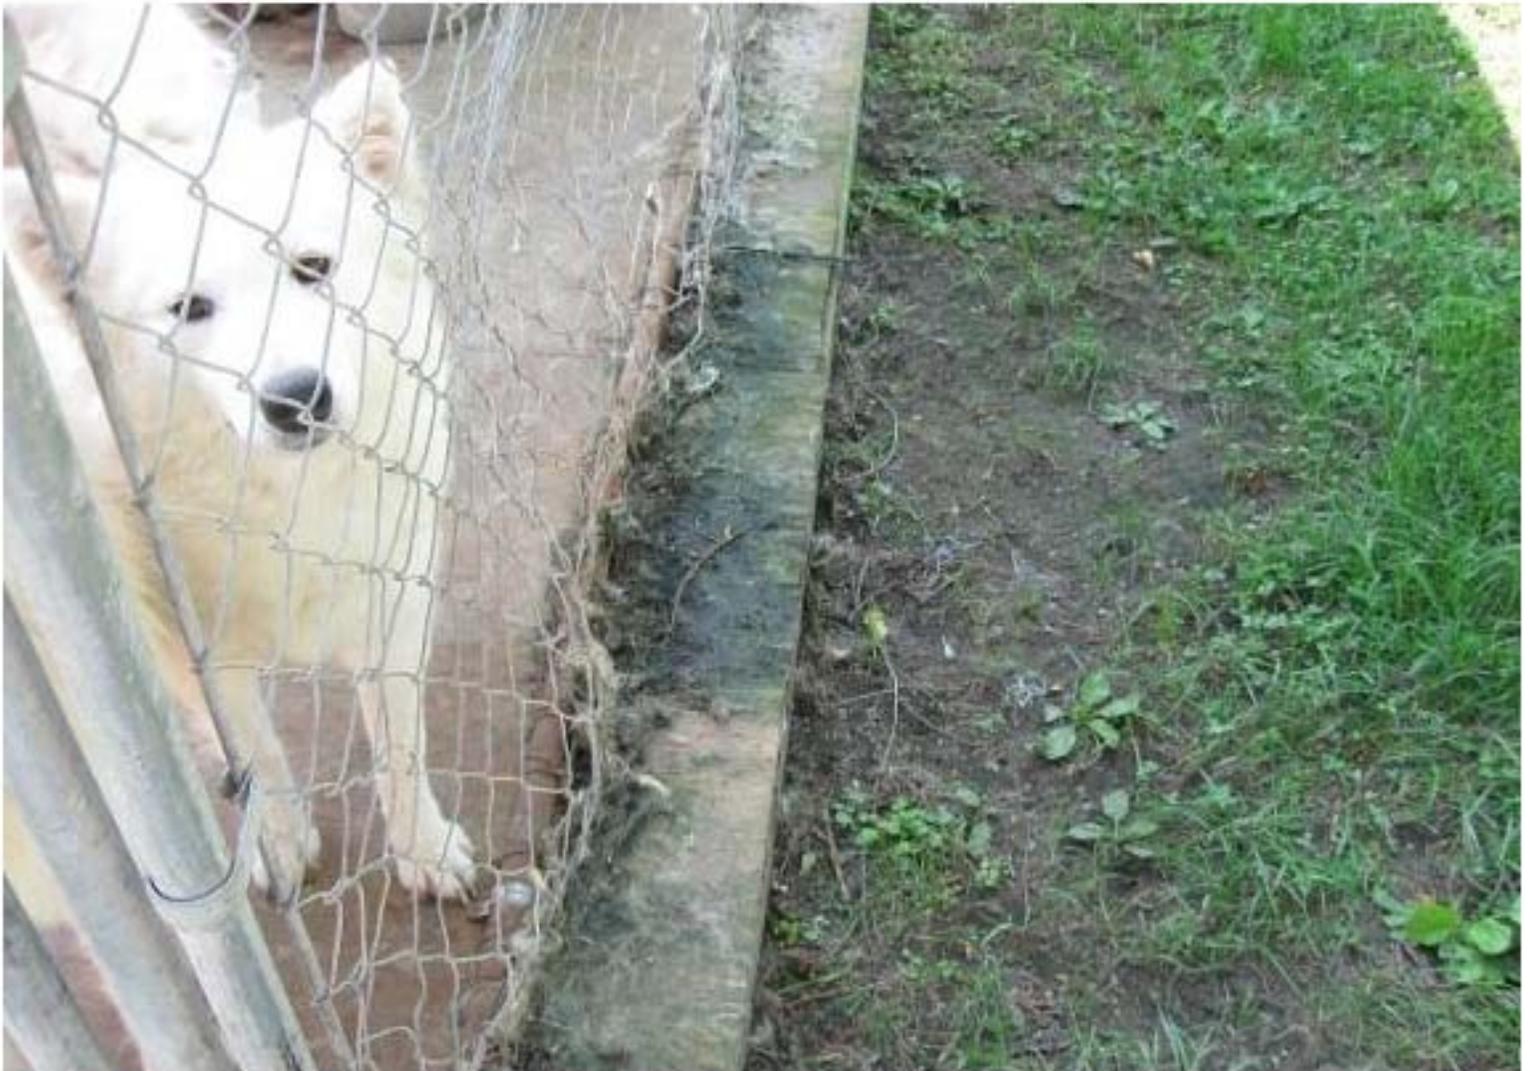
CFR: 3.1 (f)

Photographer:	John J. Lies, ACI	Legal Name:	Registration:	42-A-1238
Photo Taken:	Wed, Aug 25, '10 P.M.	CATHY SPEER		
Inspection:	238101248530491			
Description:	3.1 (f) General Housing Waste Disposal: Excreta, hair, food waste around the enclosures needs to be removed.

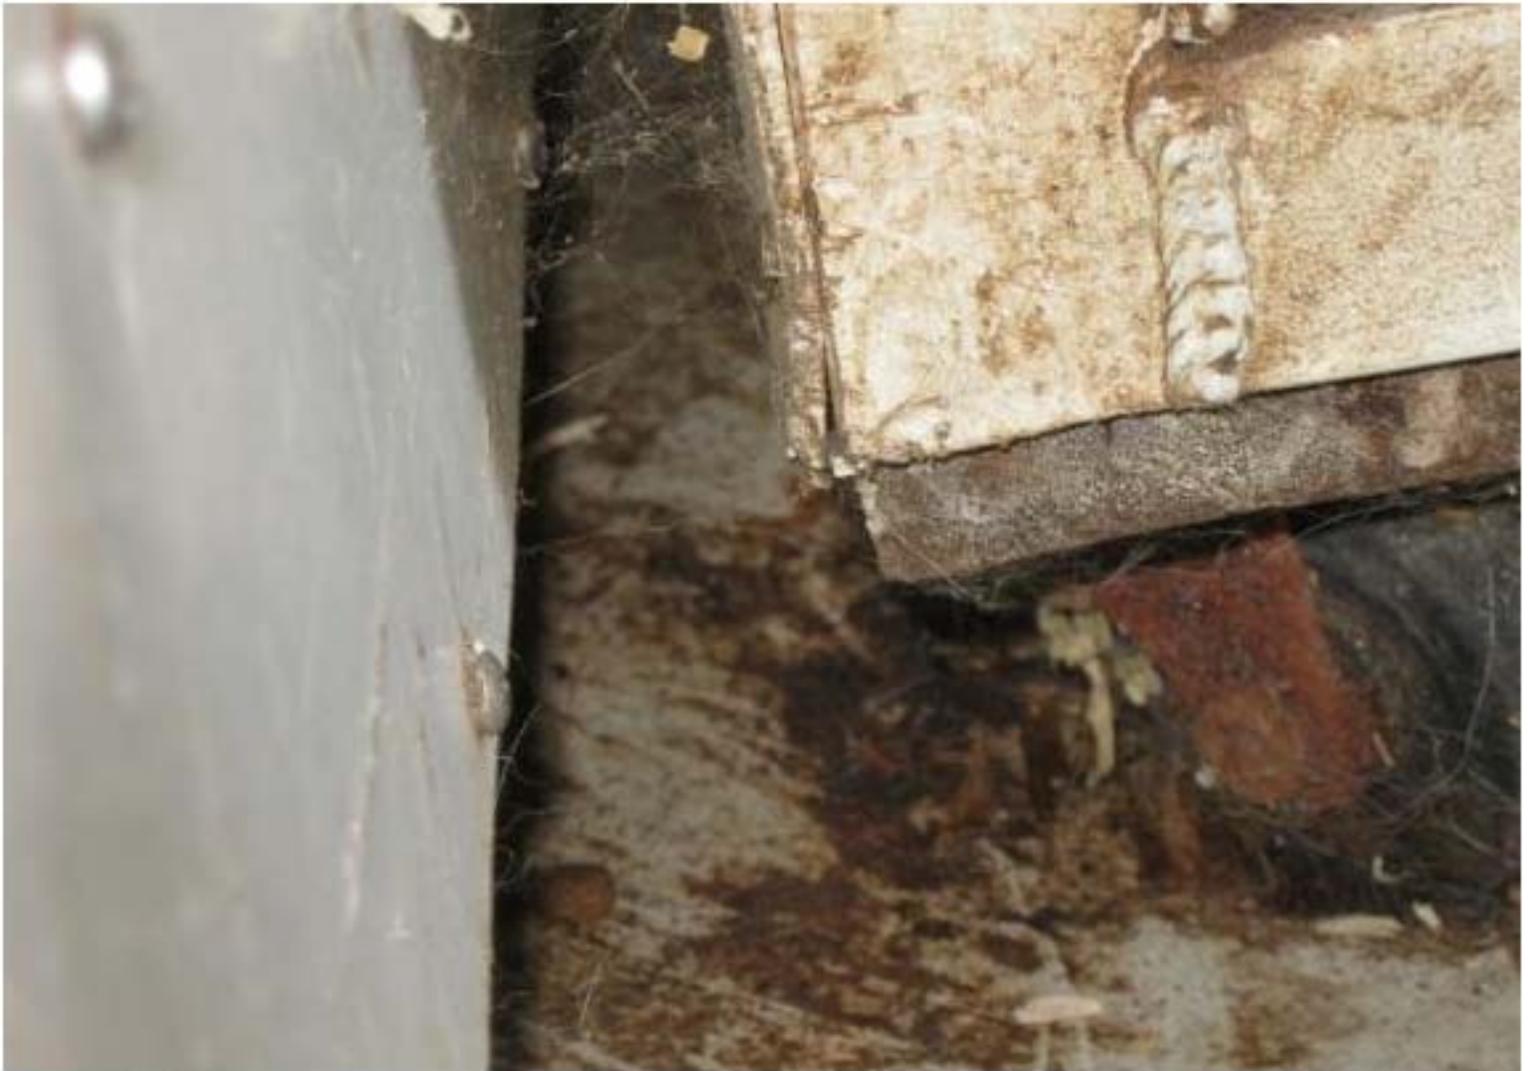
CFR: 3.1 (c) (3)

Photographer:	John J. Lies, ACI	Legal Name:	Registration:	42-A-1238
Photo Taken:	Wed, Aug 25, '10 P.M.	CATHY SPEER		
Inspection:	238101248530491			
Description:	3.1 (c)(3) Housing Facilities Cleaning: Hair, dirt, grime, excreta. Needs to be removed from floors, walls and fronts of the enclosures inside of the building.

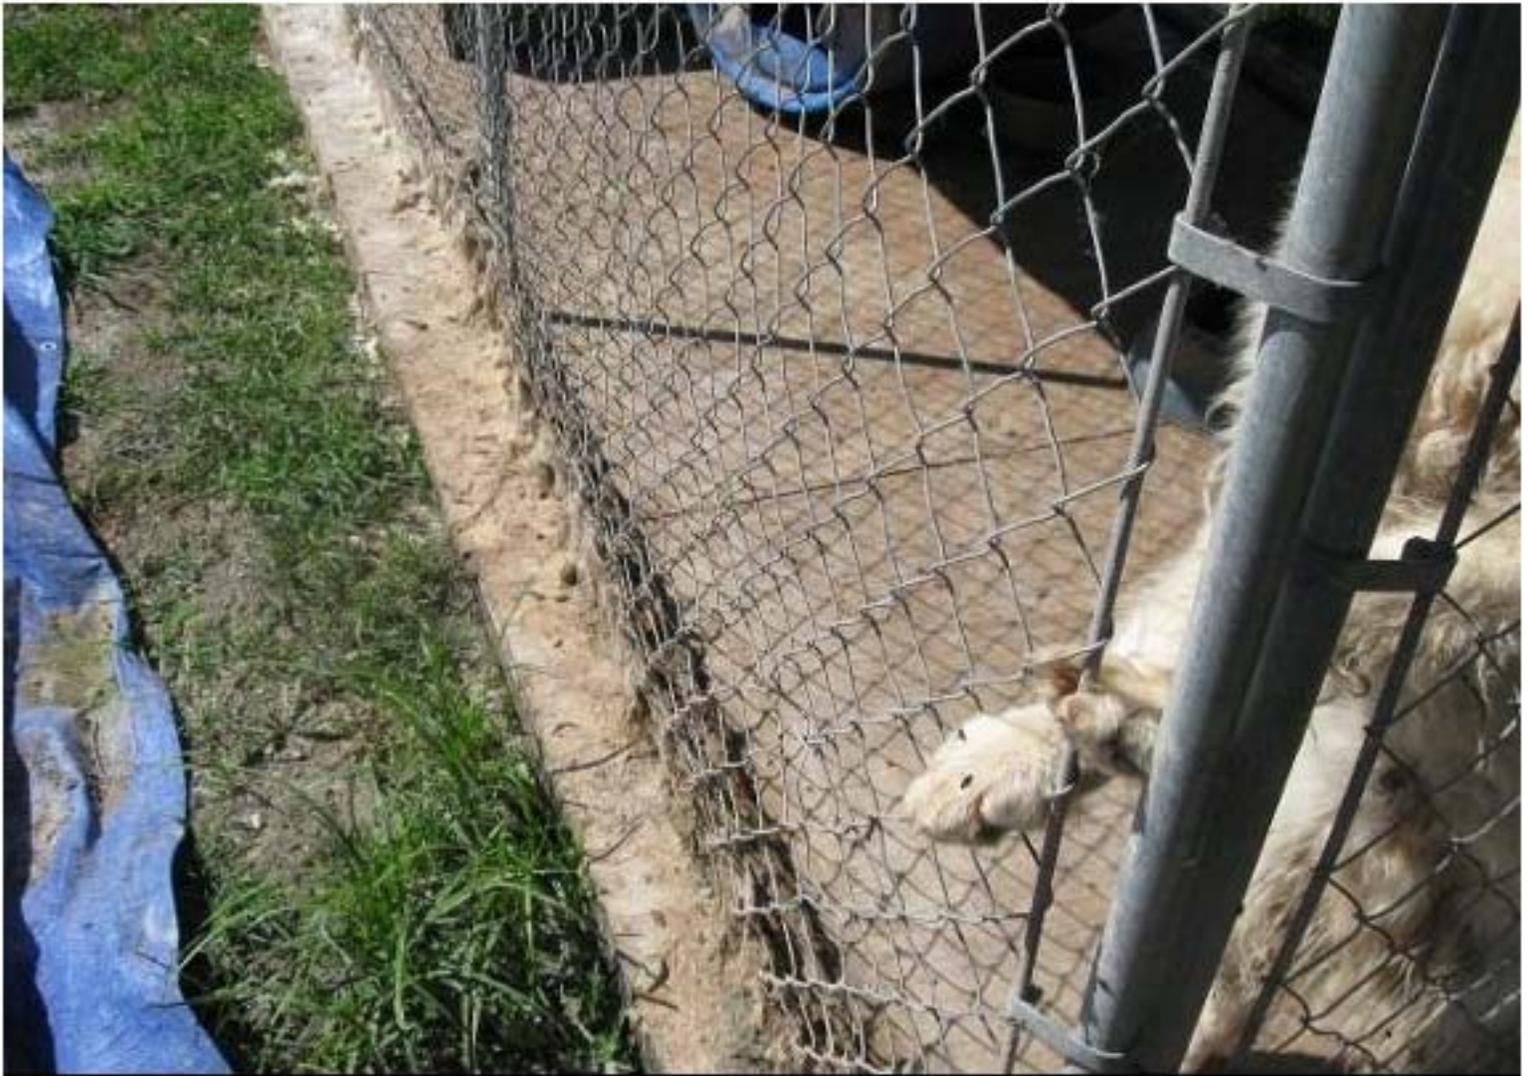
CFR: 3.1 (f)

Photographer:	John J. Lies, ACI	Legal Name:	Registration:	42-A-1238
Photo Taken:	Wed, Aug 25, '10 P.M.	CATHY SPEER		
Inspection:	238101248530491			
Description:	3.1 (f) General Housing Waste Disposal: Excreta, hair, food waste around the enclosures needs to be removed.

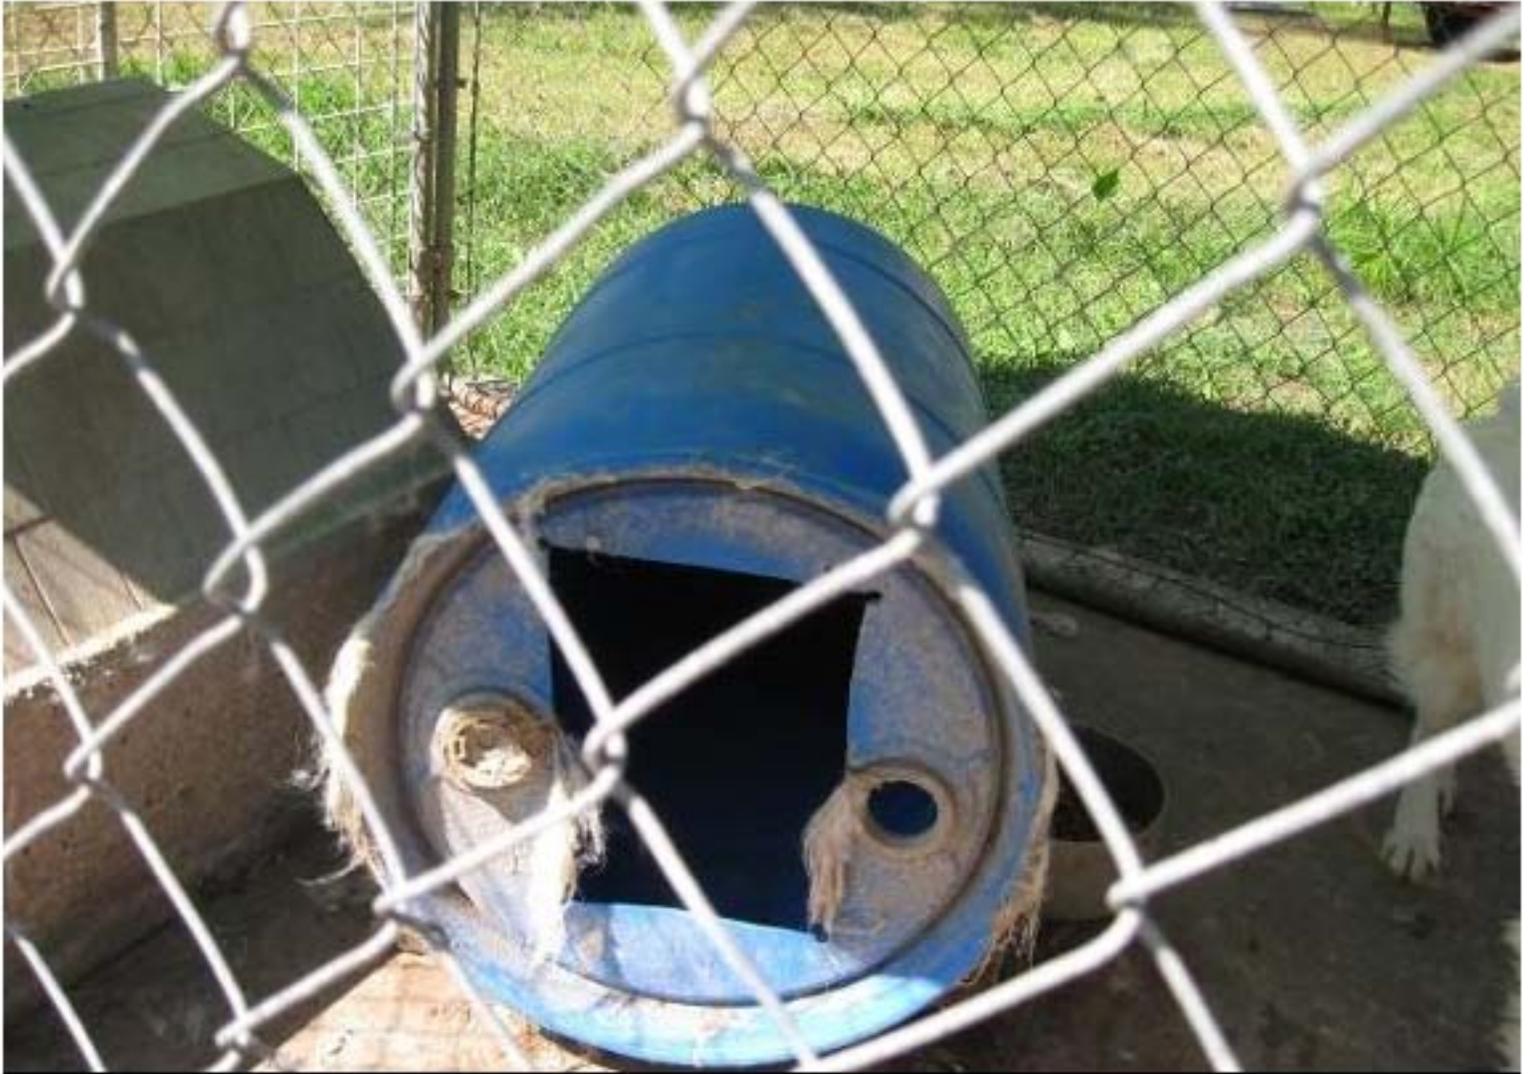
CFR: 3.4 (b), 3.11 (a) (2)

Photographer:	John J. Lies, ACI	Legal Name:	Registration:	42-A-1238
Photo Taken:	Wed, Aug 25, '10 P.M.	CATHY SPEER		
Inspection:	238101248530491			
Description:	3.4 (b)(3) Outdoor housing: No wind/rain break. 3.11 (a)(2) Cleaning: Shelter and hard surfaces need to be sanitized.

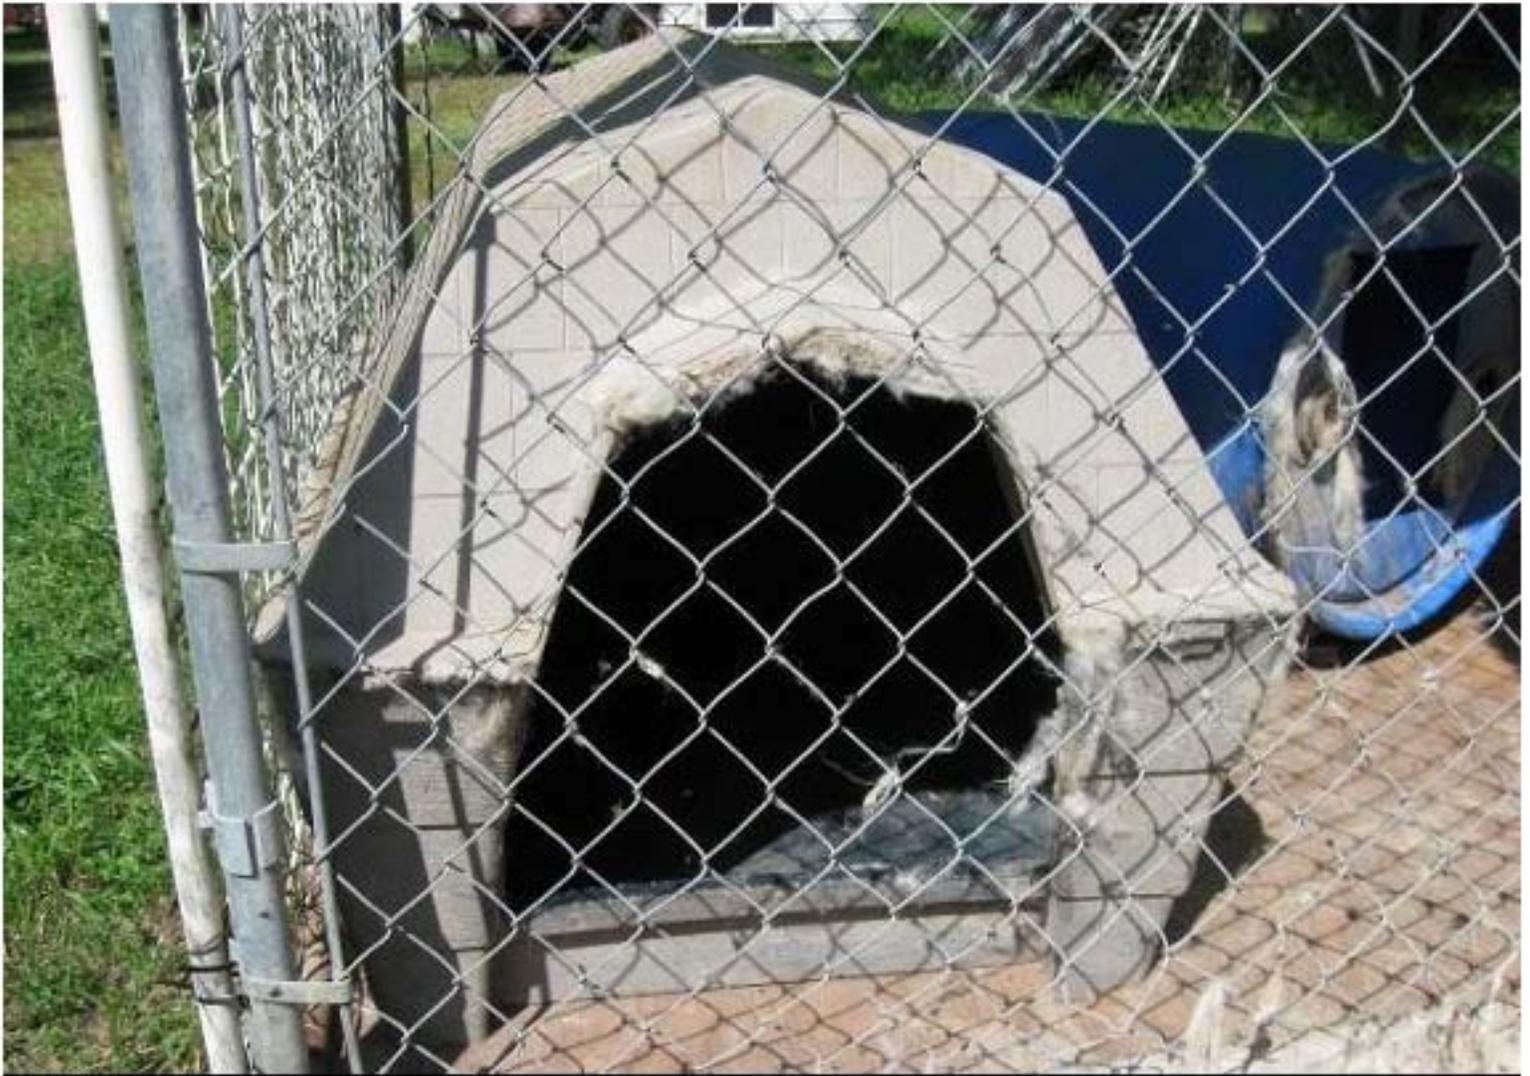
CFR: 3.4 (b) (3), 3.11 (a) (2)

Photographer:	John J. Lies, ACI	Legal Name:	Registration:	42-A-1238
Photo Taken:	Wed, Aug 25, '10 P.M.	CATHY SPEER		
Inspection:	238101248530491			
Description:	3.4 (b)(3) Outdoor housing: No wind/rain break. 3.11 (a)(2) Cleaning: Shelter and hard surfaces need to be sanitized.

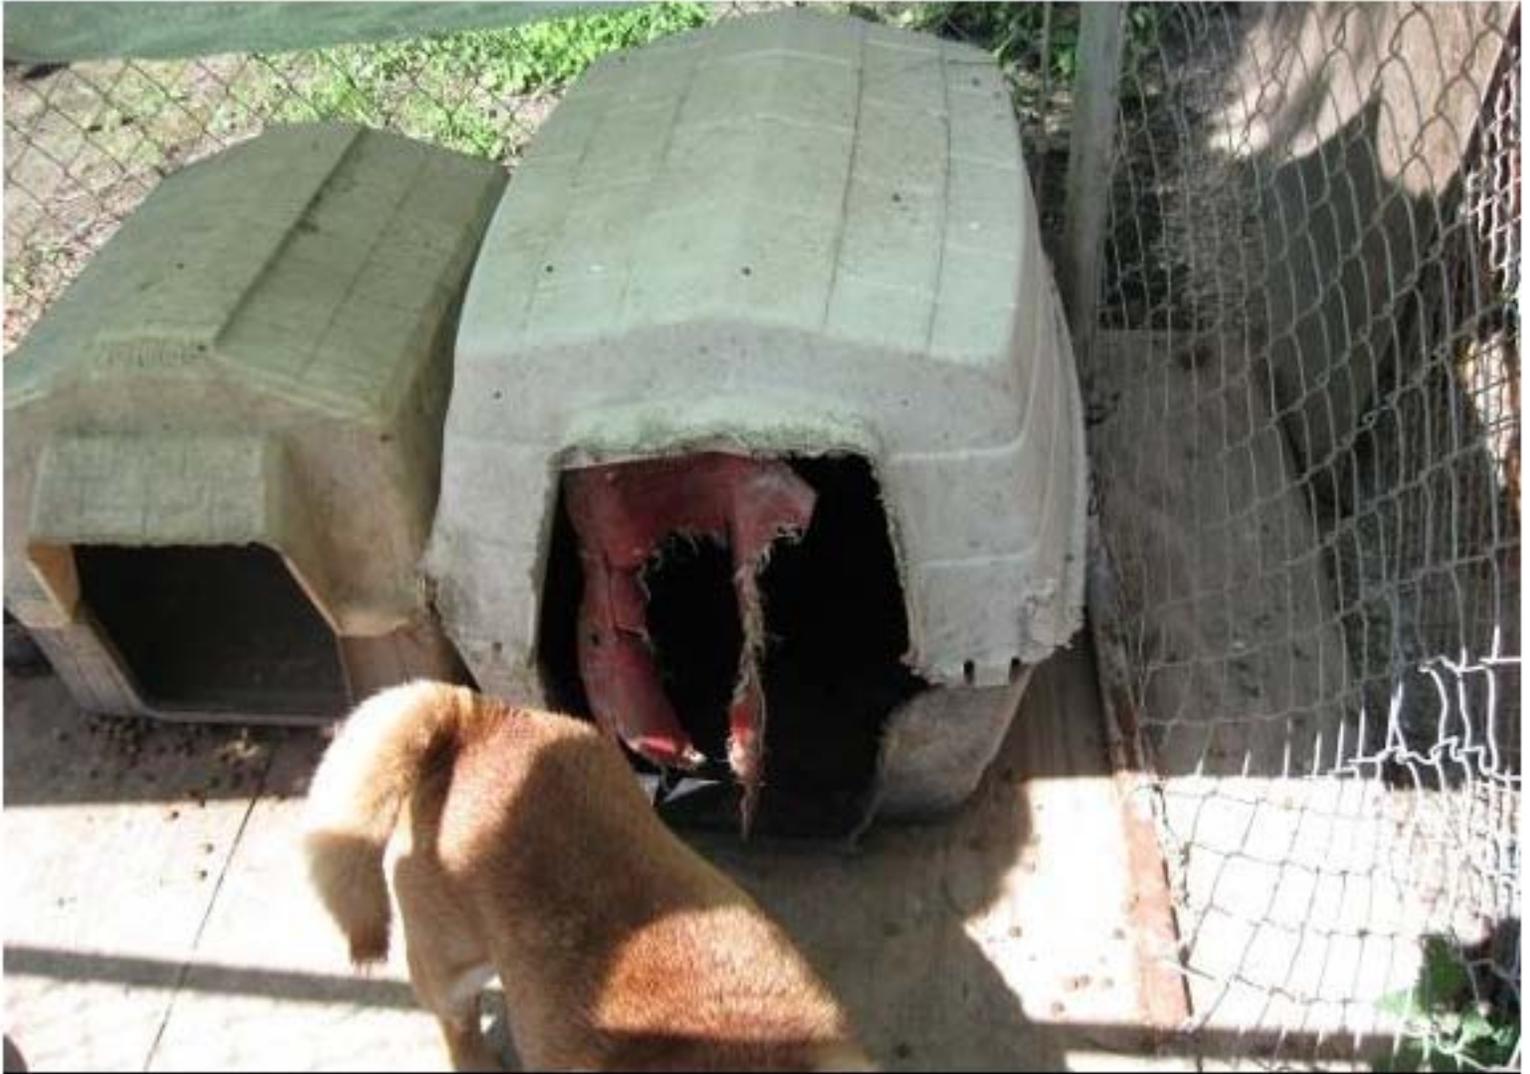
CFR: 3.4 (b) (3), 3.11 (a) (2)

Photographer:	John J. Lies, ACI	Legal Name:	Registration:	42-A-1238
Photo Taken:	Wed, Aug 25, '10 P.M.	CATHY SPEER		
Inspection:	238101248530491			
Description:	3.4 (b)(3) Outdoor housing: No wind/rain break. 3.11 (a)(2) Cleaning: Shelter and hard surfaces need to be sanitized.

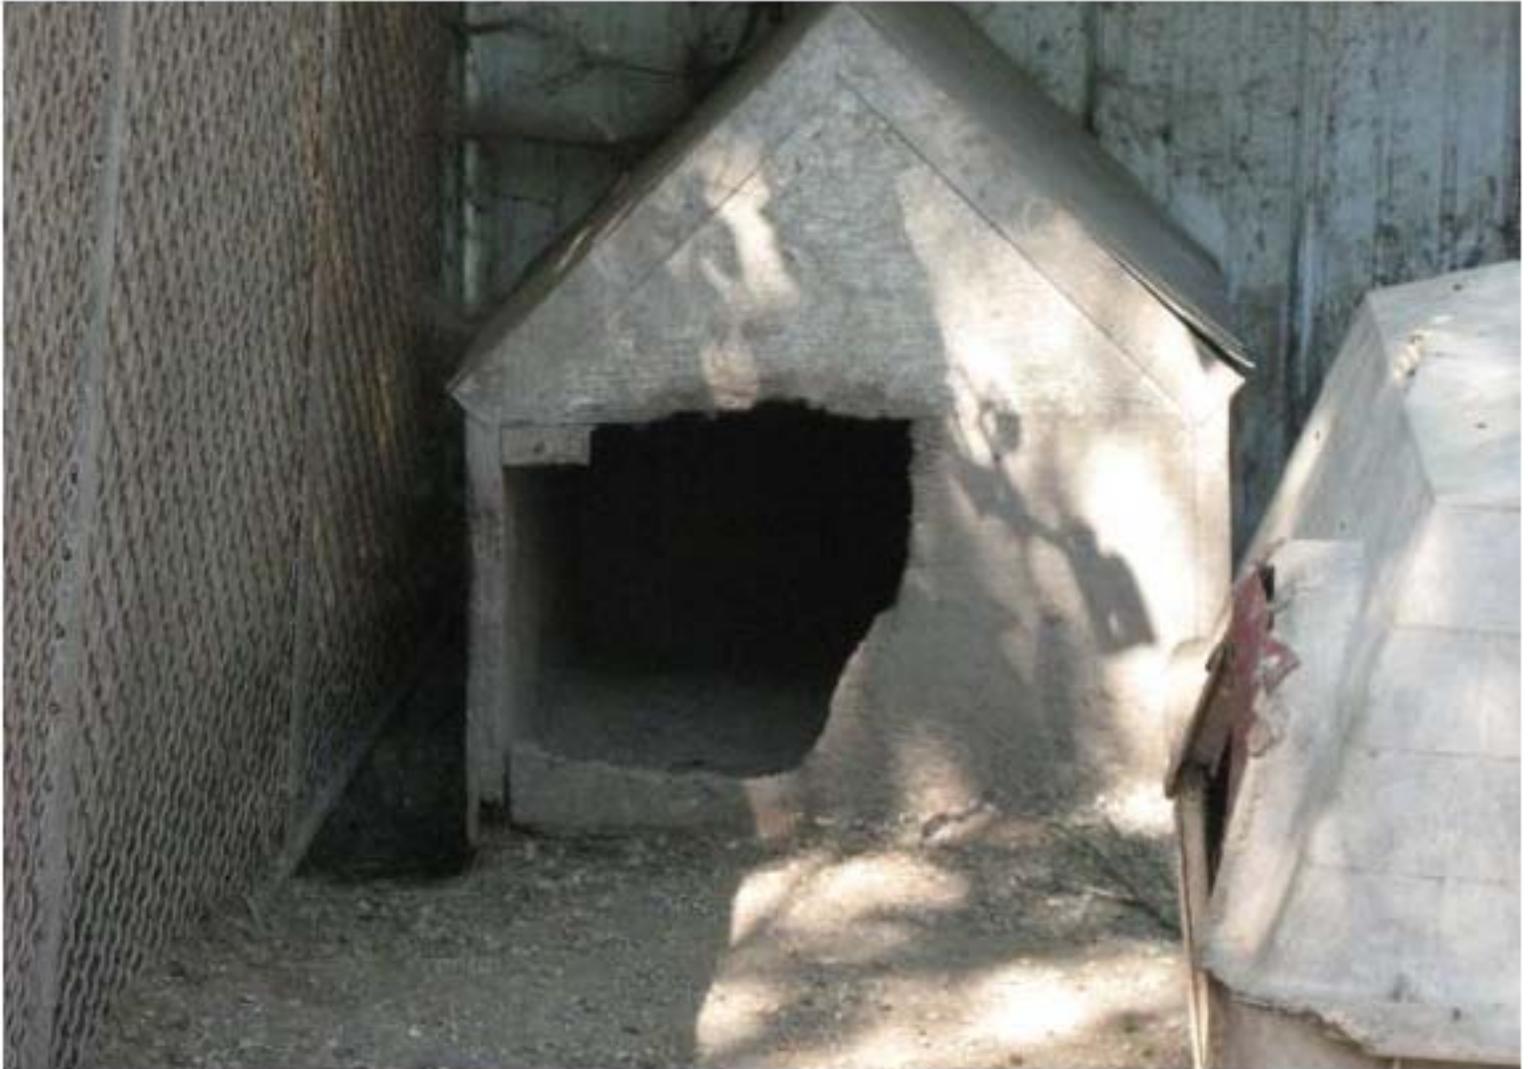
CFR: 3.4 (b) (3), 3.11 (a) (2)

Photographer:	John J. Lies, ACI	Legal Name:	Registration:	42-A-1238
Photo Taken:	Wed, Aug 25, '10 P.M.	CATHY SPEER		
Inspection:	238101248530491			
Description:	3.4 (b)(3) Outdoor housing: No wind/rain break. 3.11 (a)(2) Cleaning: Shelter and hard surfaces need to be sanitized.			FOIA11-282000320

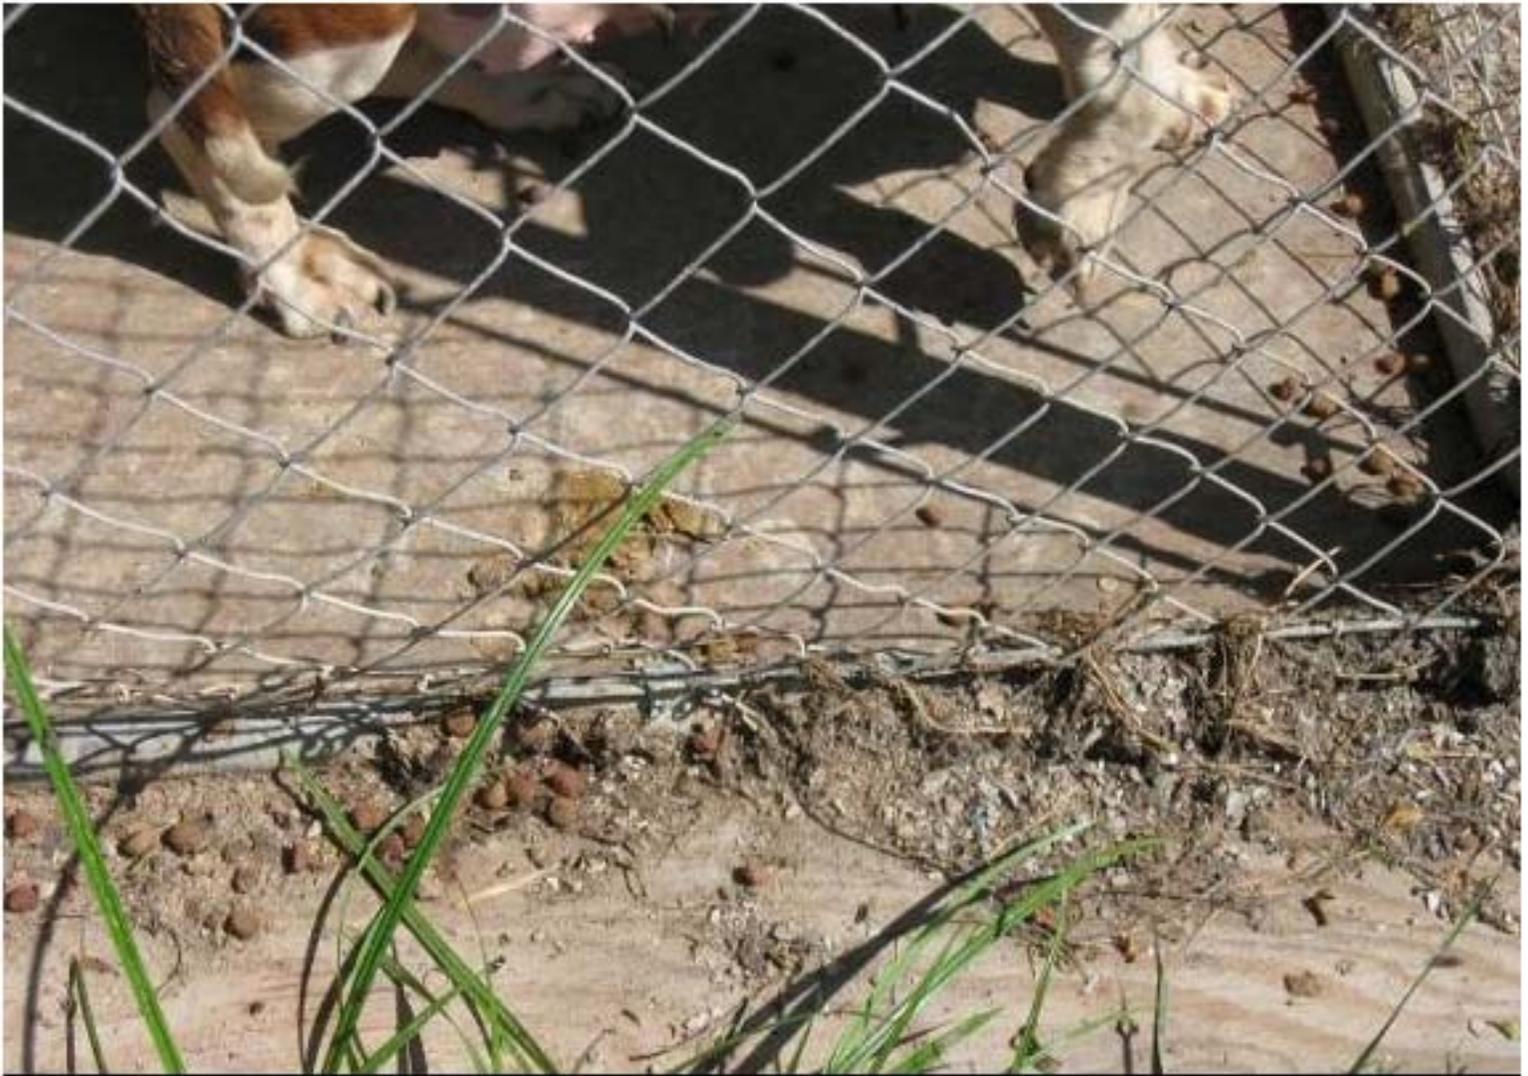
CFR: 3.1 (f)

Photographer:	John J. Lies, ACI	Legal Name:	Registration:	42-A-1238
Photo Taken:	Wed, Aug 25, '10 P.M.	CATHY SPEER		
Inspection:	238101248530491			
Description:	3.1 (f) General Housing Waste Disposal: Excreta, hair, food waste around the enclosures needs to be removed.

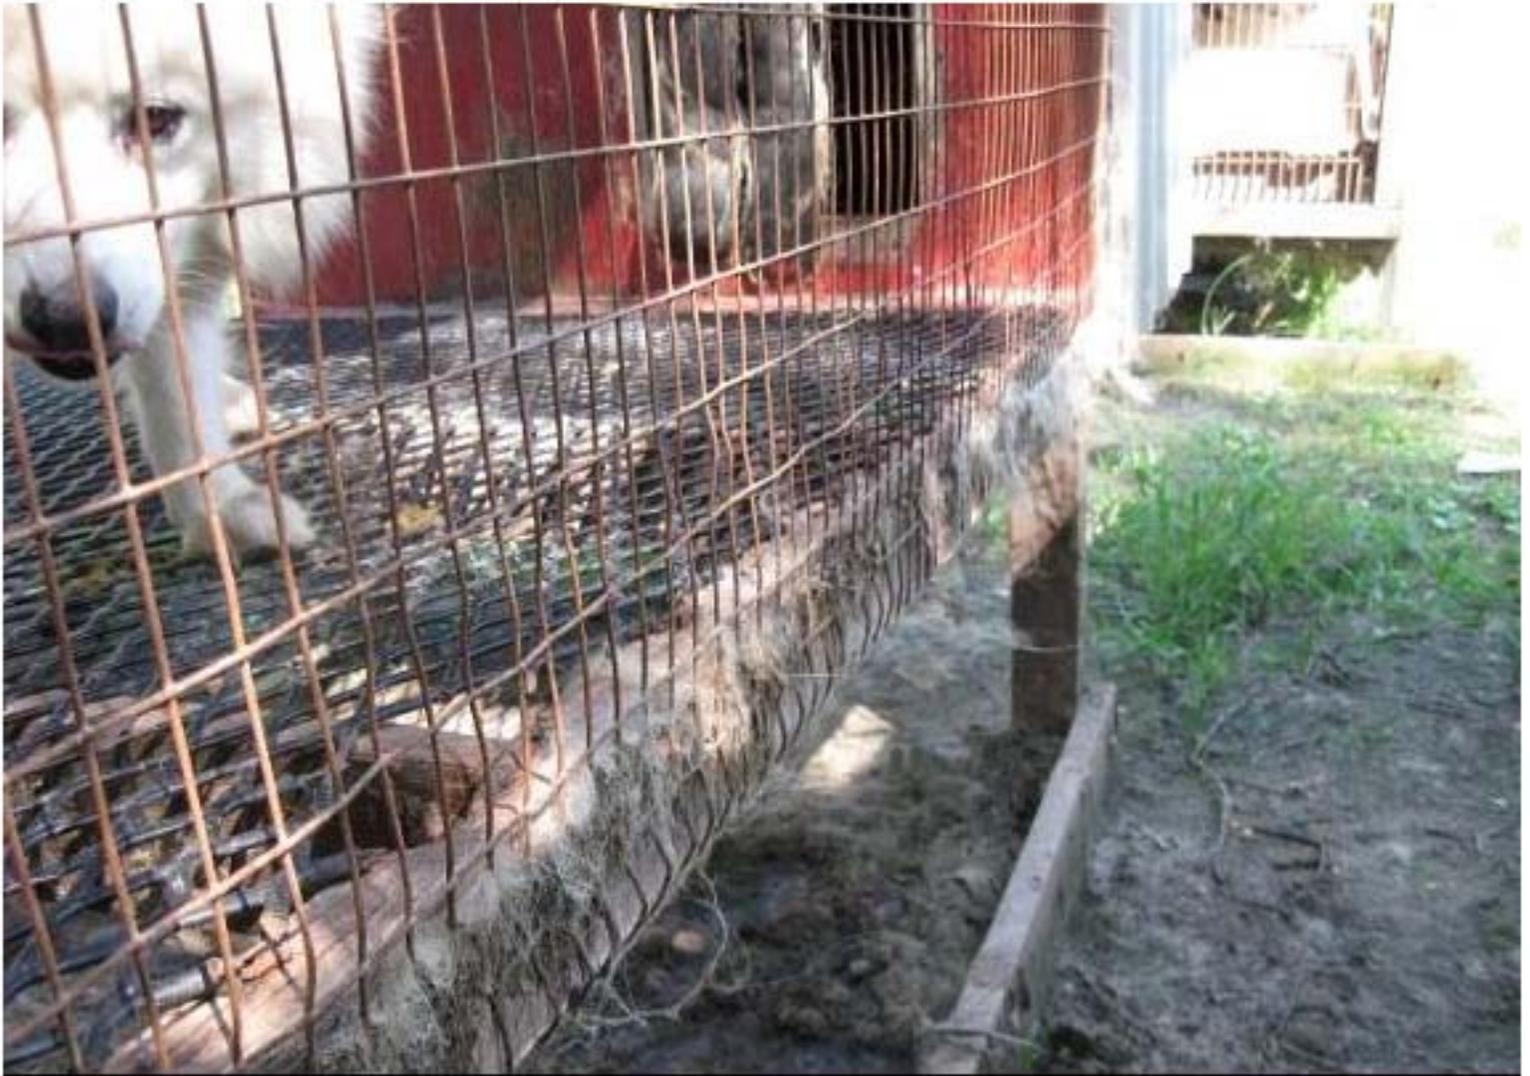
CFR: 3.11 (a)

Photographer:	John J. Lies, ACI	Legal Name:	Registration:	42-A-1238
Photo Taken:	Wed, Aug 25, '10 P.M.	CATHY SPEER		
Inspection:	238101248530491			
Description:	3.11 (a) Cleaning: Primary enclosures need to be cleaned to remove dirt, debris, hair from around the enclosures and excreta from under the enclosures.

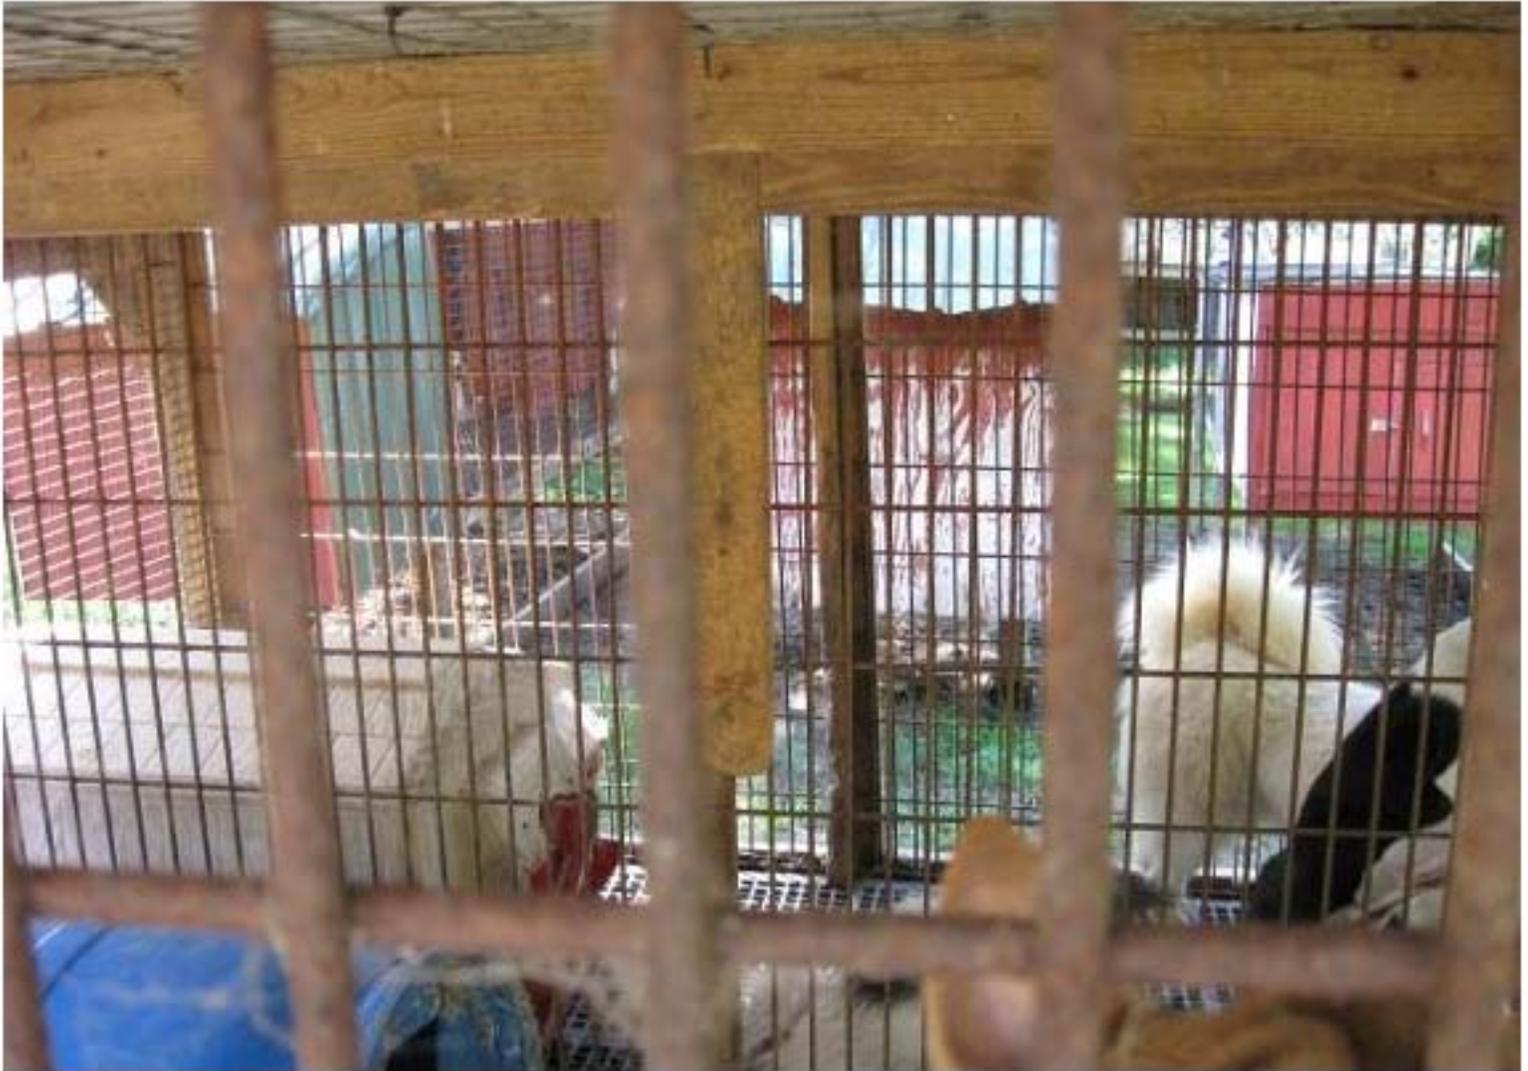
CFR: 3.1 (c) (1) (i)

Photographer:	John J. Lies, ACI	Legal Name:	Registration:	42-A-1238
Photo Taken:	Wed, Aug 25, '10 P.M.	CATHY SPEER		
Inspection:	238101248530491			
Description:	3.1 (c)(1)(i): Housing Facilities General Surfaces: Rust that prevents proper cleaning or affects structural strength.
