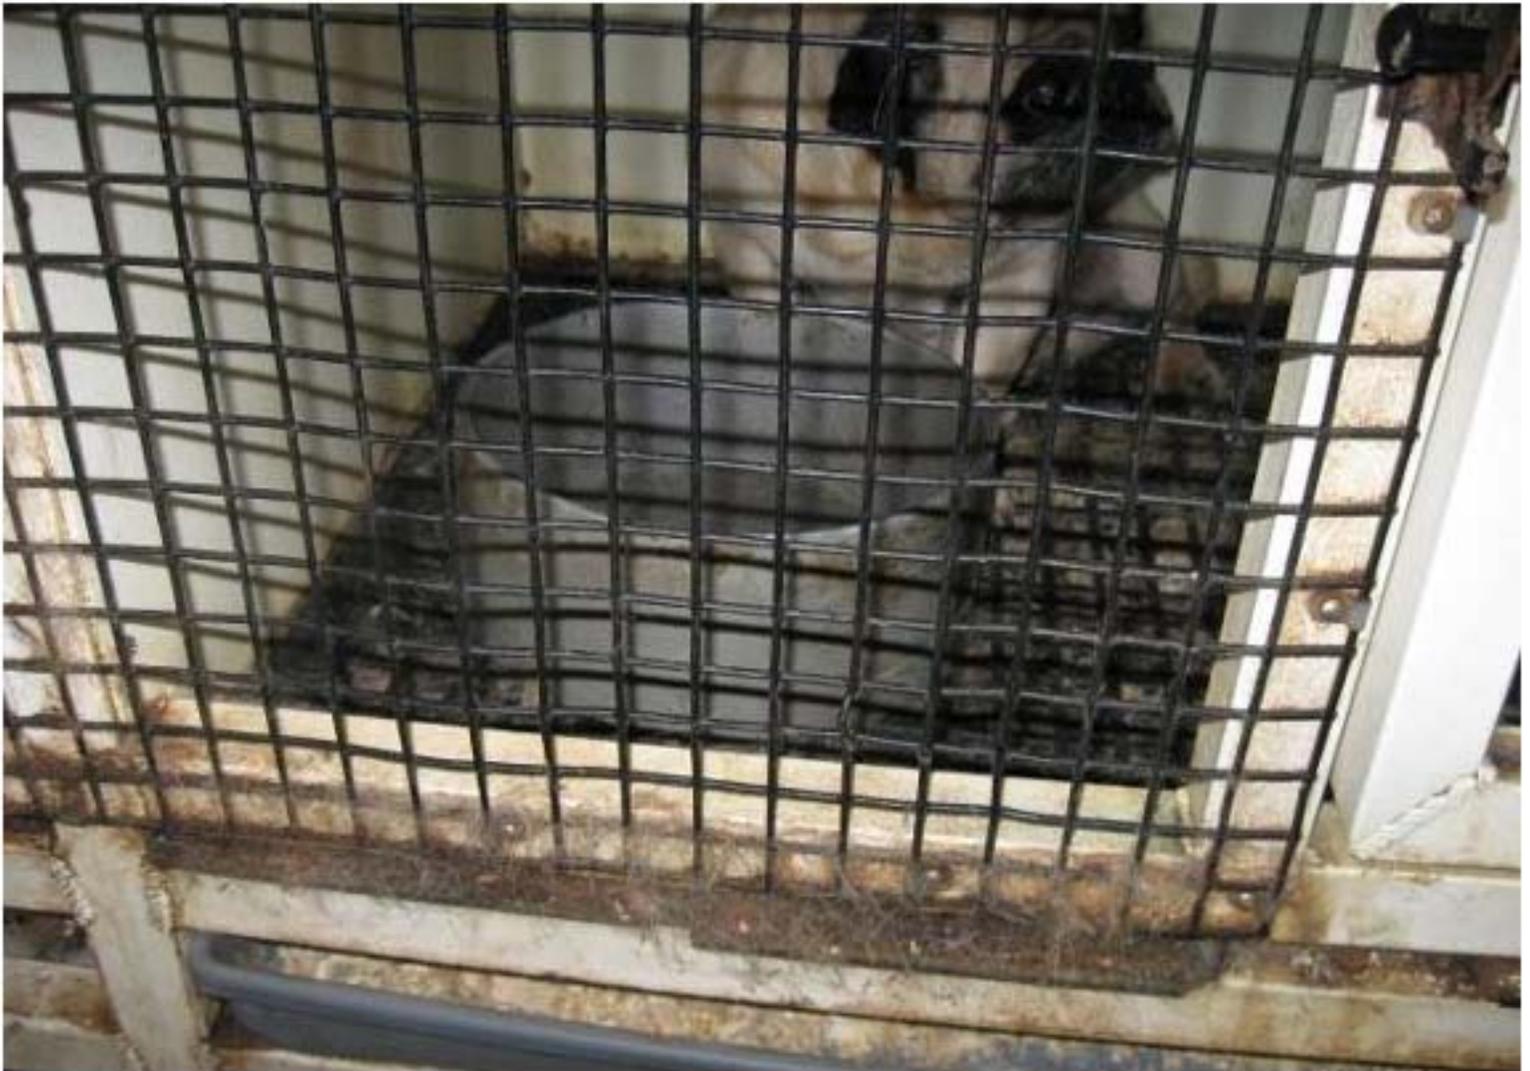
CFR: 3.1 (c) (3)

Photographer:	John J. Lies, ACI	Legal Name:	Registration:	42-A-1238
Photo Taken:	Wed, Aug 25, '10 P.M.	CATHY SPEER		
Inspection:	238101248530491			
Description:	3.1 (c)(3) Cleaning: Surfaces of housing facility needs to be cleaned.

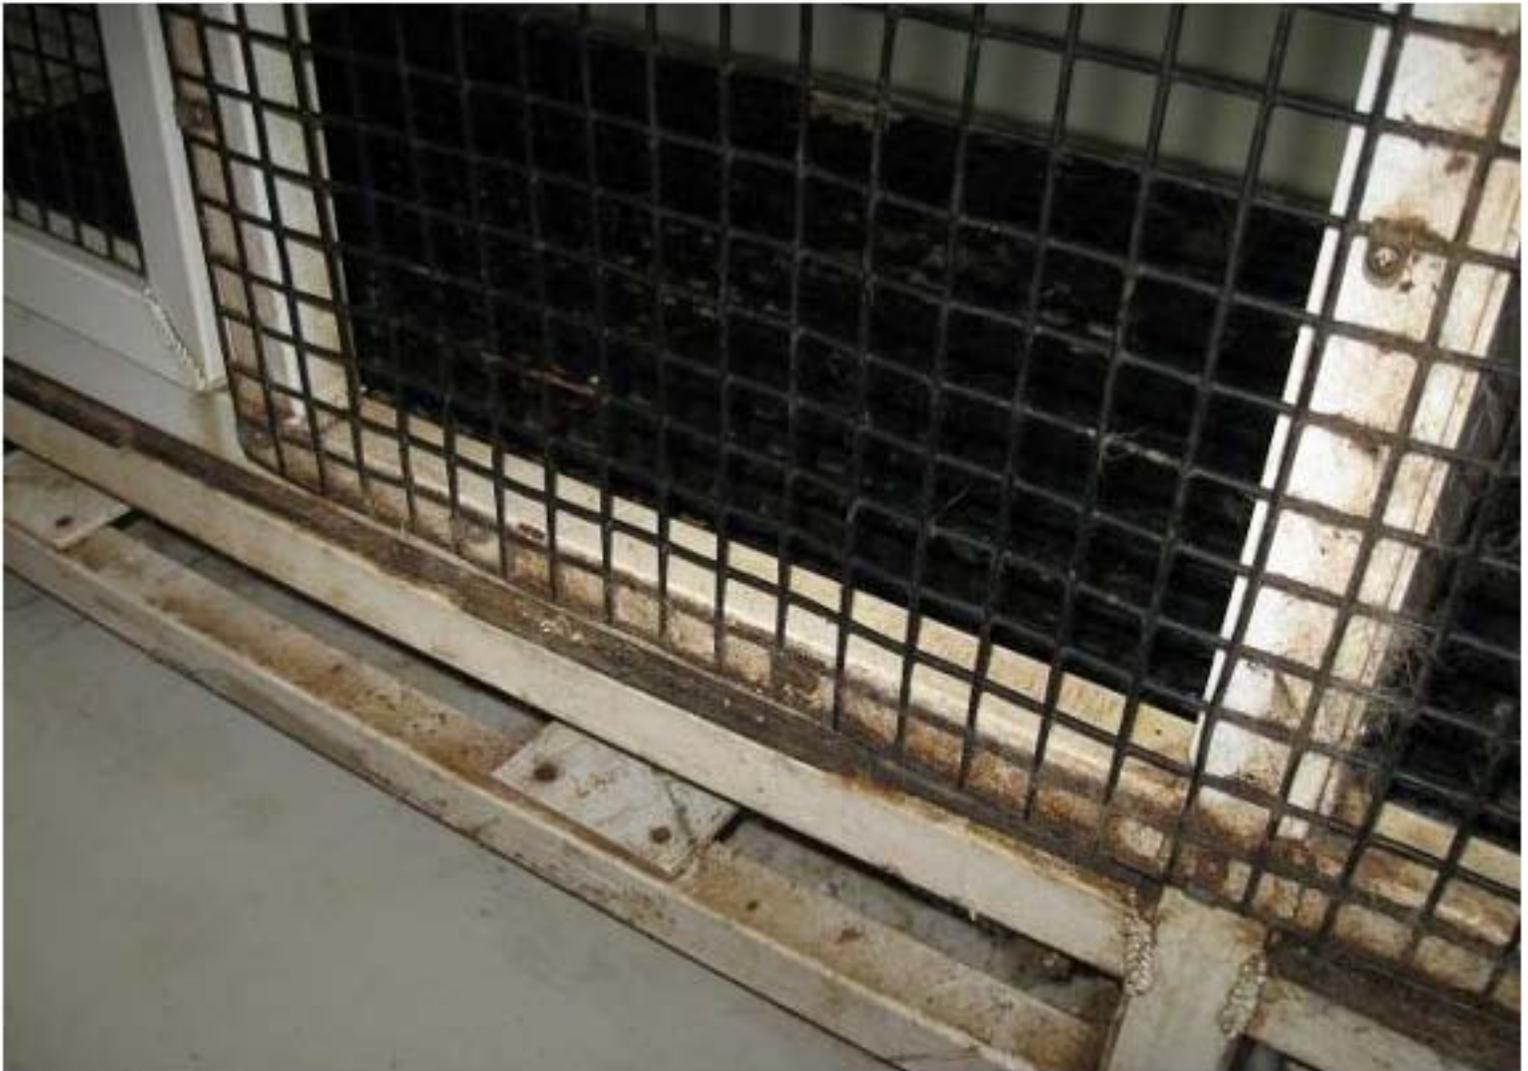
CFR: 3.1 (c) (3)

Photographer:	John J. Lies, ACI	Legal Name:	Registration:	42-A-1238
Photo Taken:	Wed, Aug 25, '10 P.M.	CATHY SPEER		
Inspection:	238101248530491			
Description:	3.1 (c)(3) Cleaning: Surfaces of housing facility needs to be cleaned.

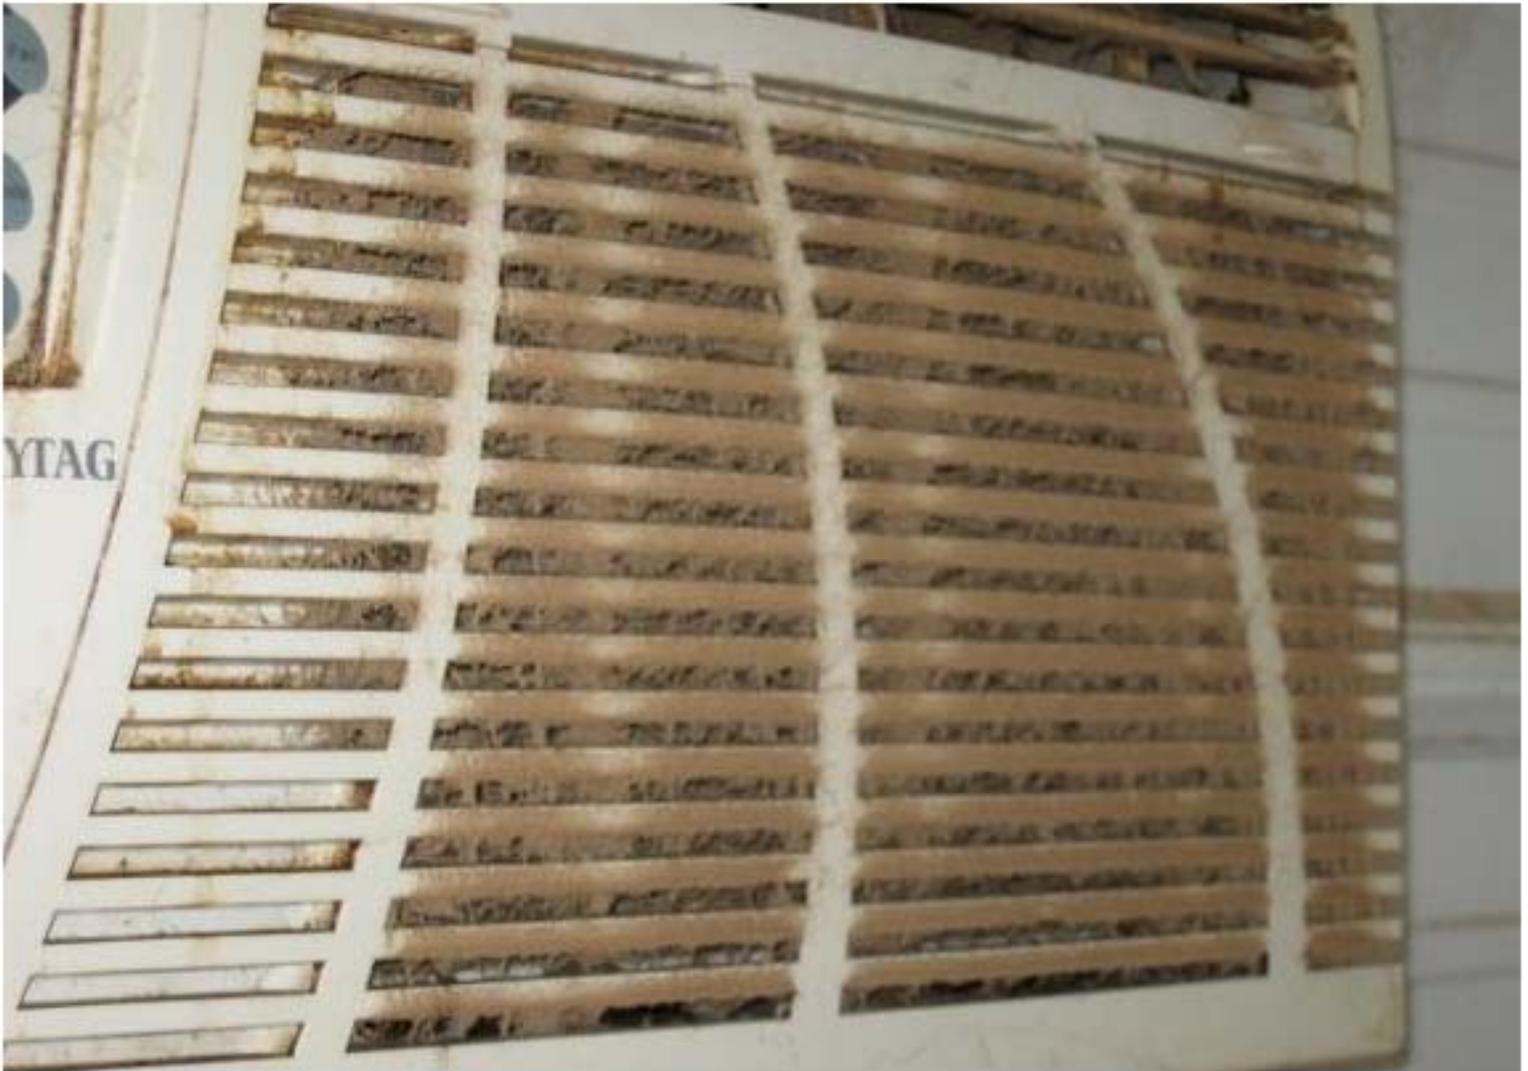
CFR: 3.1 (c) (3)

Photographer:	John J. Lies, ACI	Legal Name:	Registration:	42-A-1238
Photo Taken:	Wed, Aug 25, '10 P.M.	CATHY SPEER		
Inspection:	238101248530491			
Description:	3.1 (c)(3) Housing Facilities Cleaning: Hair, dirt, grime, excreta. Needs to be removed from floors, walls and fronts of the enclosures inside of the building.

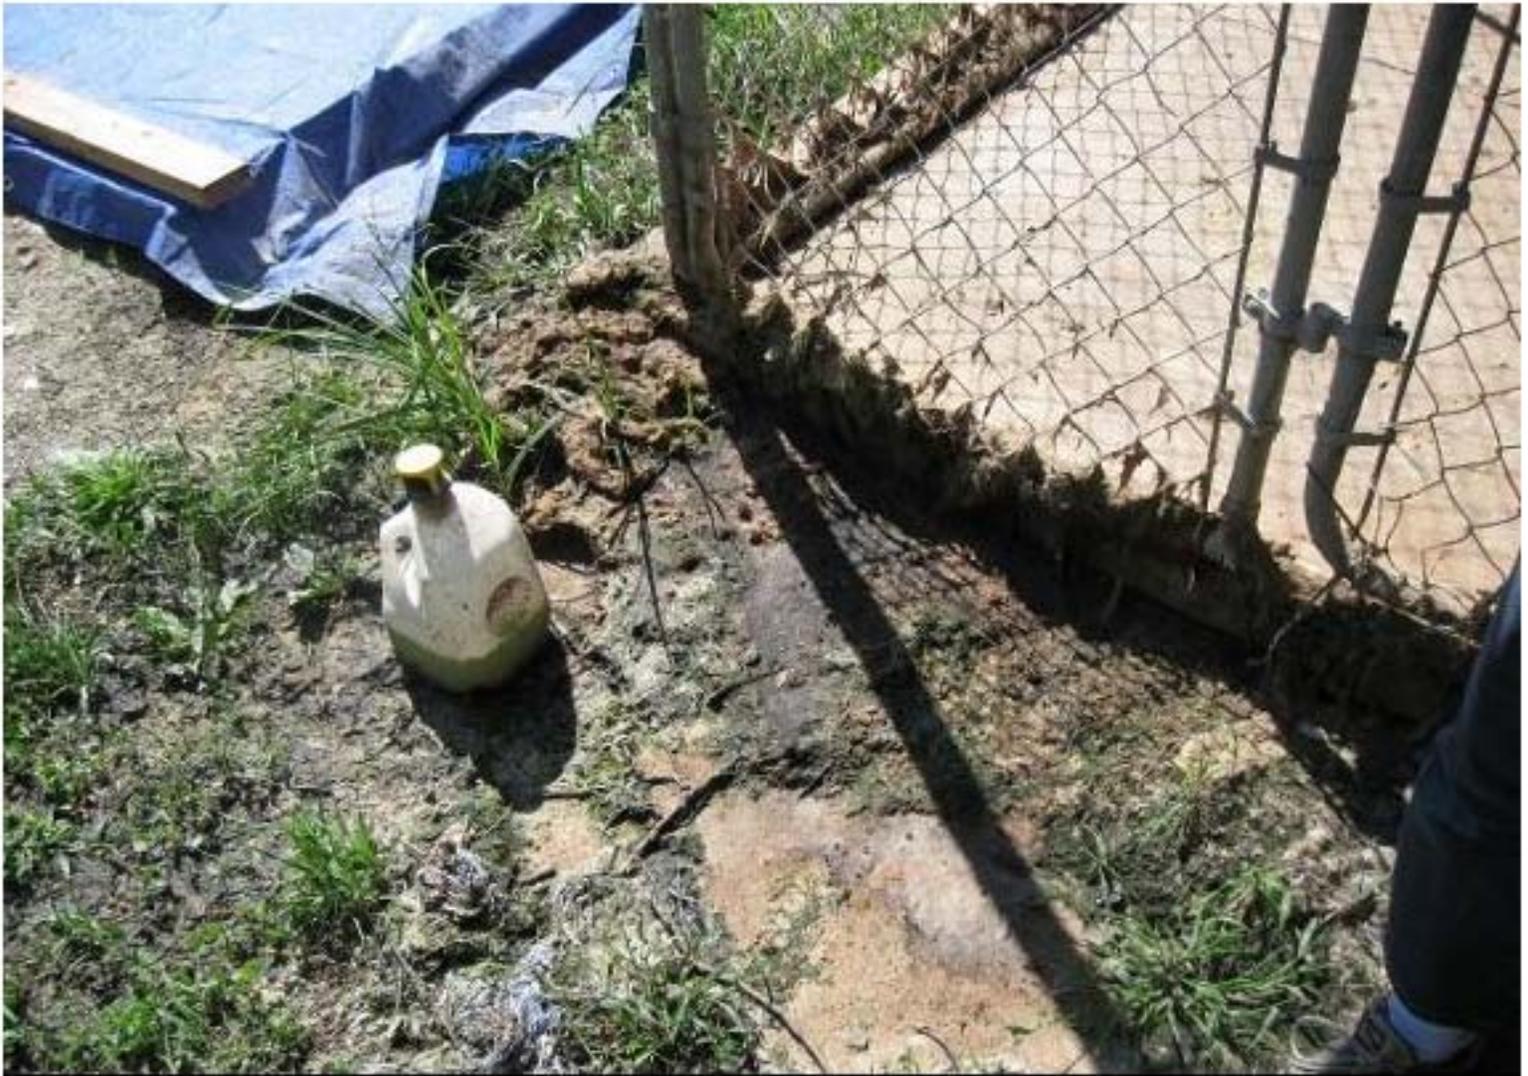
CFR: 3.1 (f)

Photographer:	John J. Lies, ACI	Legal Name:	Registration:	42-A-1238
Photo Taken:	Wed, Aug 25, '10 P.M.	CATHY SPEER		
Inspection:	238101248530491			
Description:	3.1 (f) General Housing Waste Disposal: Excreta, hair, food waste around the enclosures needs to be removed.

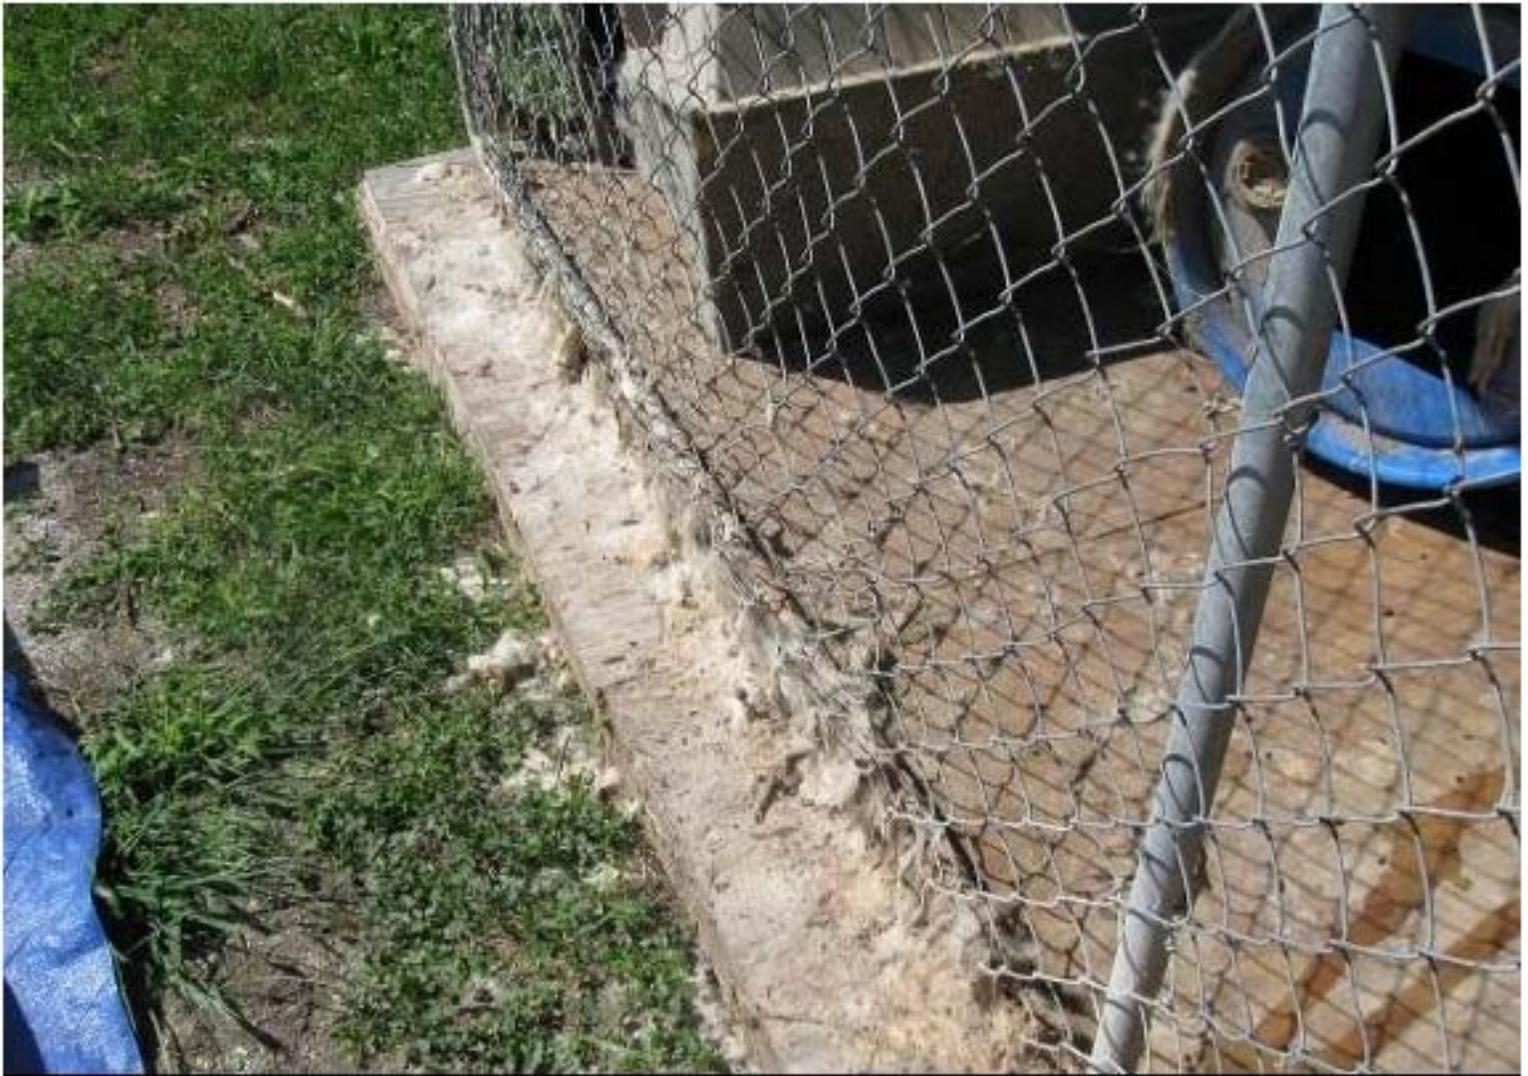
CFR: 3.1 (f)

Photographer:	John J. Lies, ACI	Legal Name:	Registration:	42-A-1238
Photo Taken:	Wed, Aug 25, '10 P.M.	CATHY SPEER		
Inspection:	238101248530491			
Description:	3.1 (f) General Housing Waste Disposal: Excreta, hair, food waste around the enclosures needs to be removed.

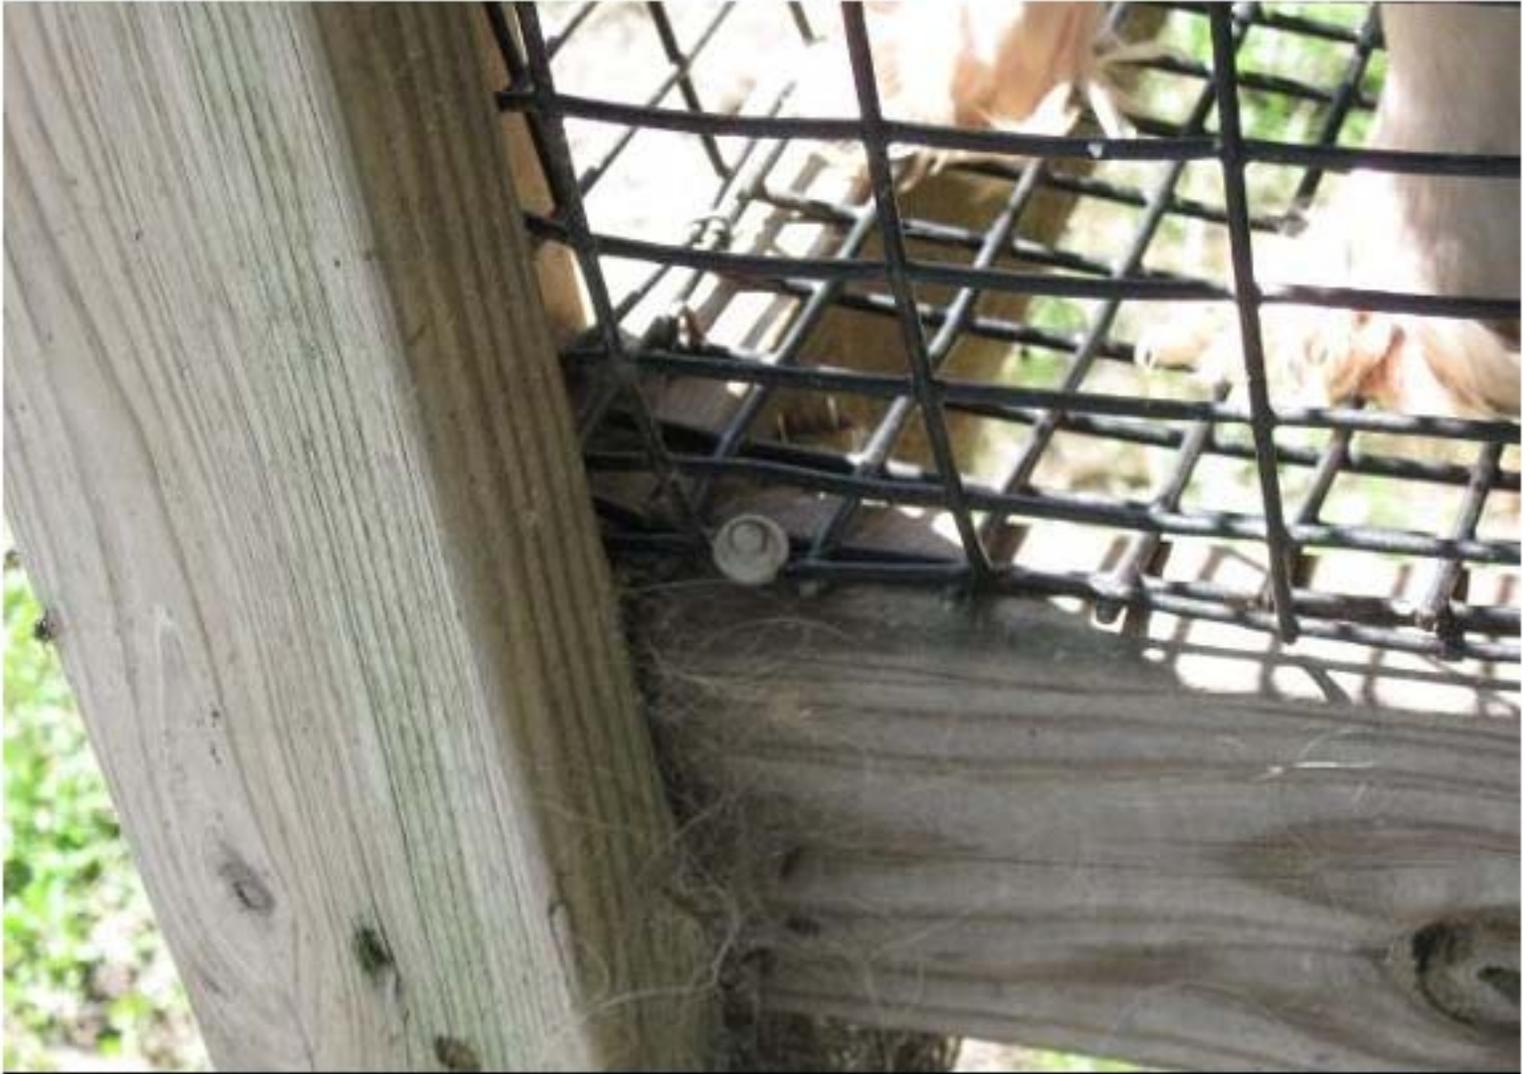
CFR: 3.11 (a)

Photographer:	John J. Lies, ACI	Legal Name:	Registration:	42-A-1238
Photo Taken:	Wed, Aug 25, '10 P.M.	CATHY SPEER		
Inspection:	238101248530491			
Description:	3.11 (a) Cleaning: Primary enclosures need to be cleaned to remove dirt, debris, hair from around the enclosures and excreta from under the enclosures.

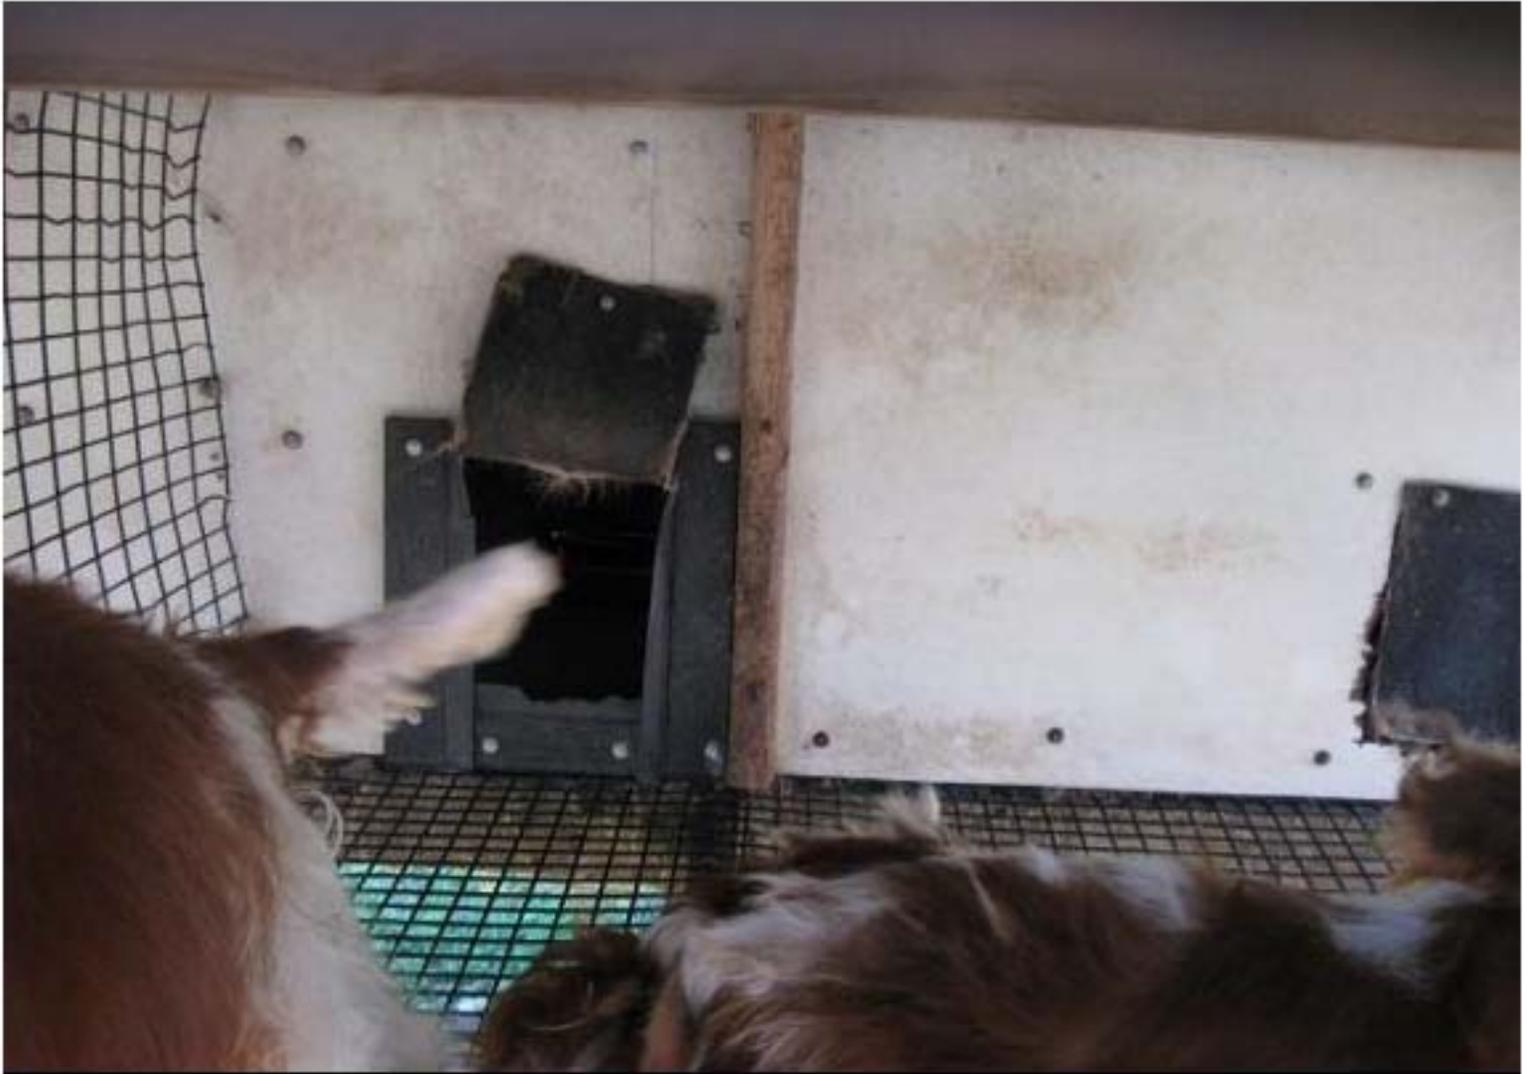
CFR: 3.4 (b) (3), 3.11 (a) (2)

Photographer:	John J. Lies, ACI	Legal Name:	Registration:	42-A-1238
Photo Taken:	Wed, Aug 25, '10 P.M.	CATHY SPEER		
Inspection:	238101248530491			
Description:	3.4 (b)(3) Outdoor housing: No wind/rain break. 3.11 (a)(2) Cleaning: Shelter and hard surfaces need to be sanitized.			FOIA11-282000331

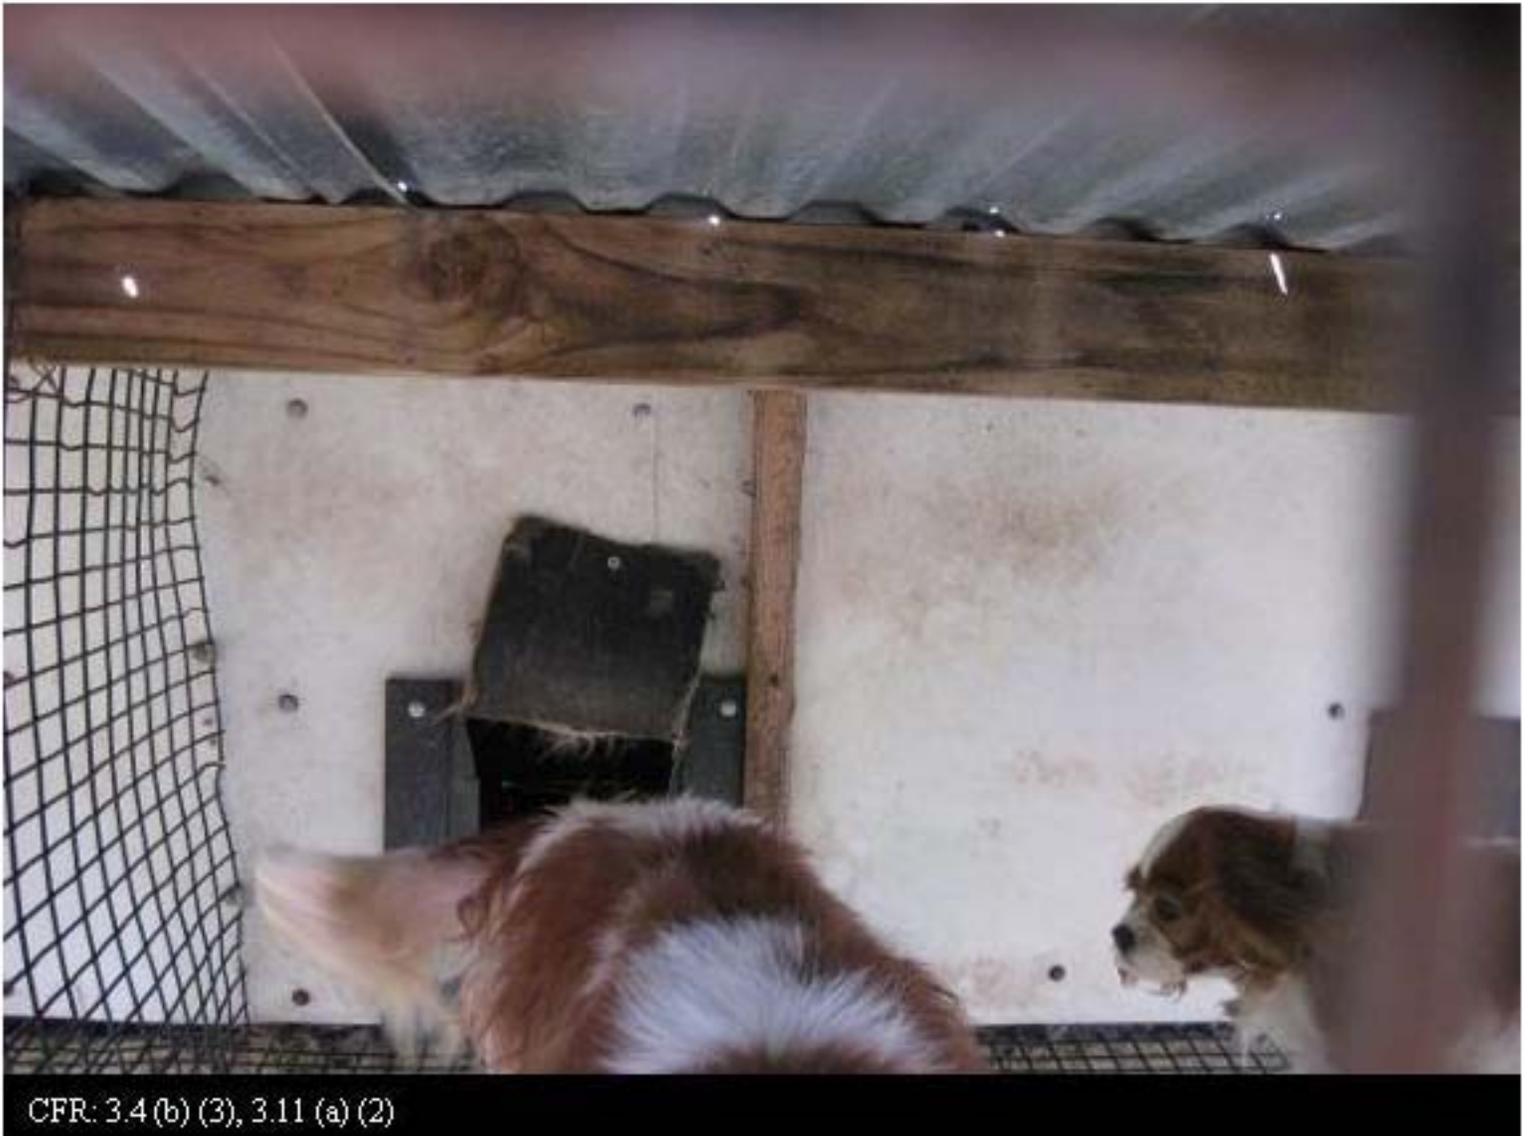
Photographer:	John J. Lies, ACI	Legal Name:	Registration:	42-A-1238
Photo Taken:	Wed, Aug 25, '10 P.M.	CATHY SPEER		
Inspection:	238101248530491			
Description:	3.4 (b)(3) Outdoor housing: No wind/rain break. 3.11 (a)(2) Cleaning: Shelter and hard surfaces need to be sanitized.			FOIA11-282000332

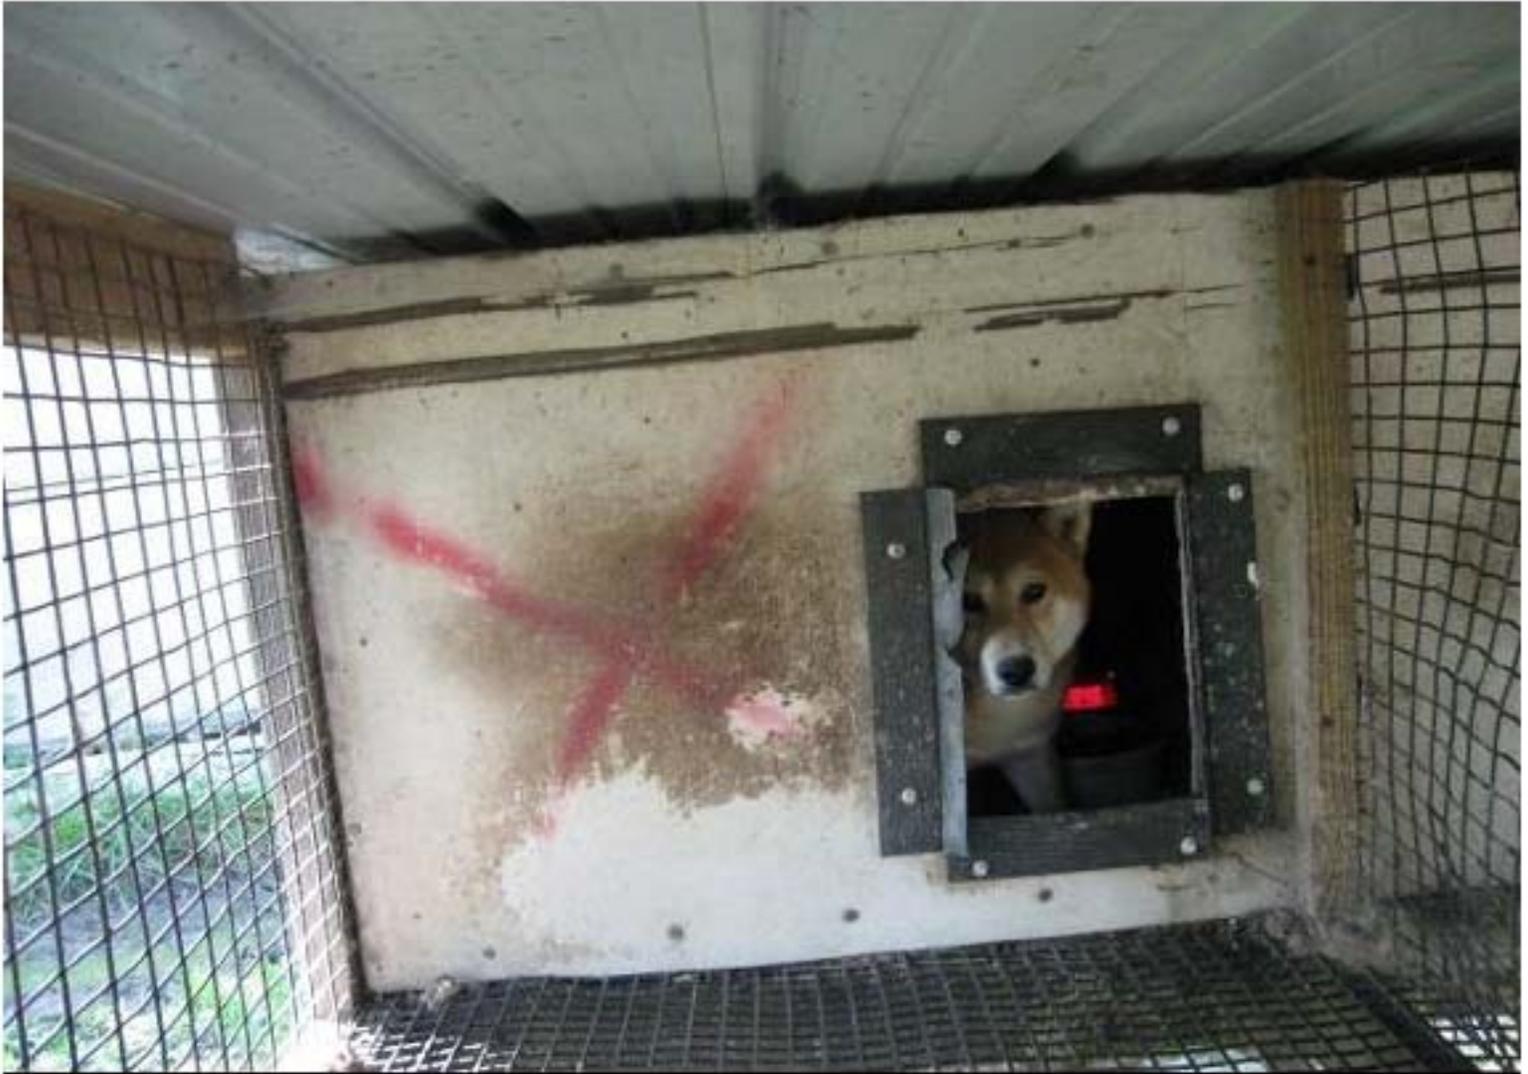
CFR: 3.4 (b) (3), 3.11 (a) (2)

Photographer:	John J. Lies, ACI	Legal Name:	Registration:	42-A-1238
Photo Taken:	Wed, Aug 25, '10 P.M.	CATHY SPEER		
Inspection:	238101248530491			
Description:	3.4 (b)(3) Outdoor housing: No wind/rain break. 3.11 (a)(2) Cleaning: Shelter and hard surfaces need to be sanitized.			FOIA11-282000333

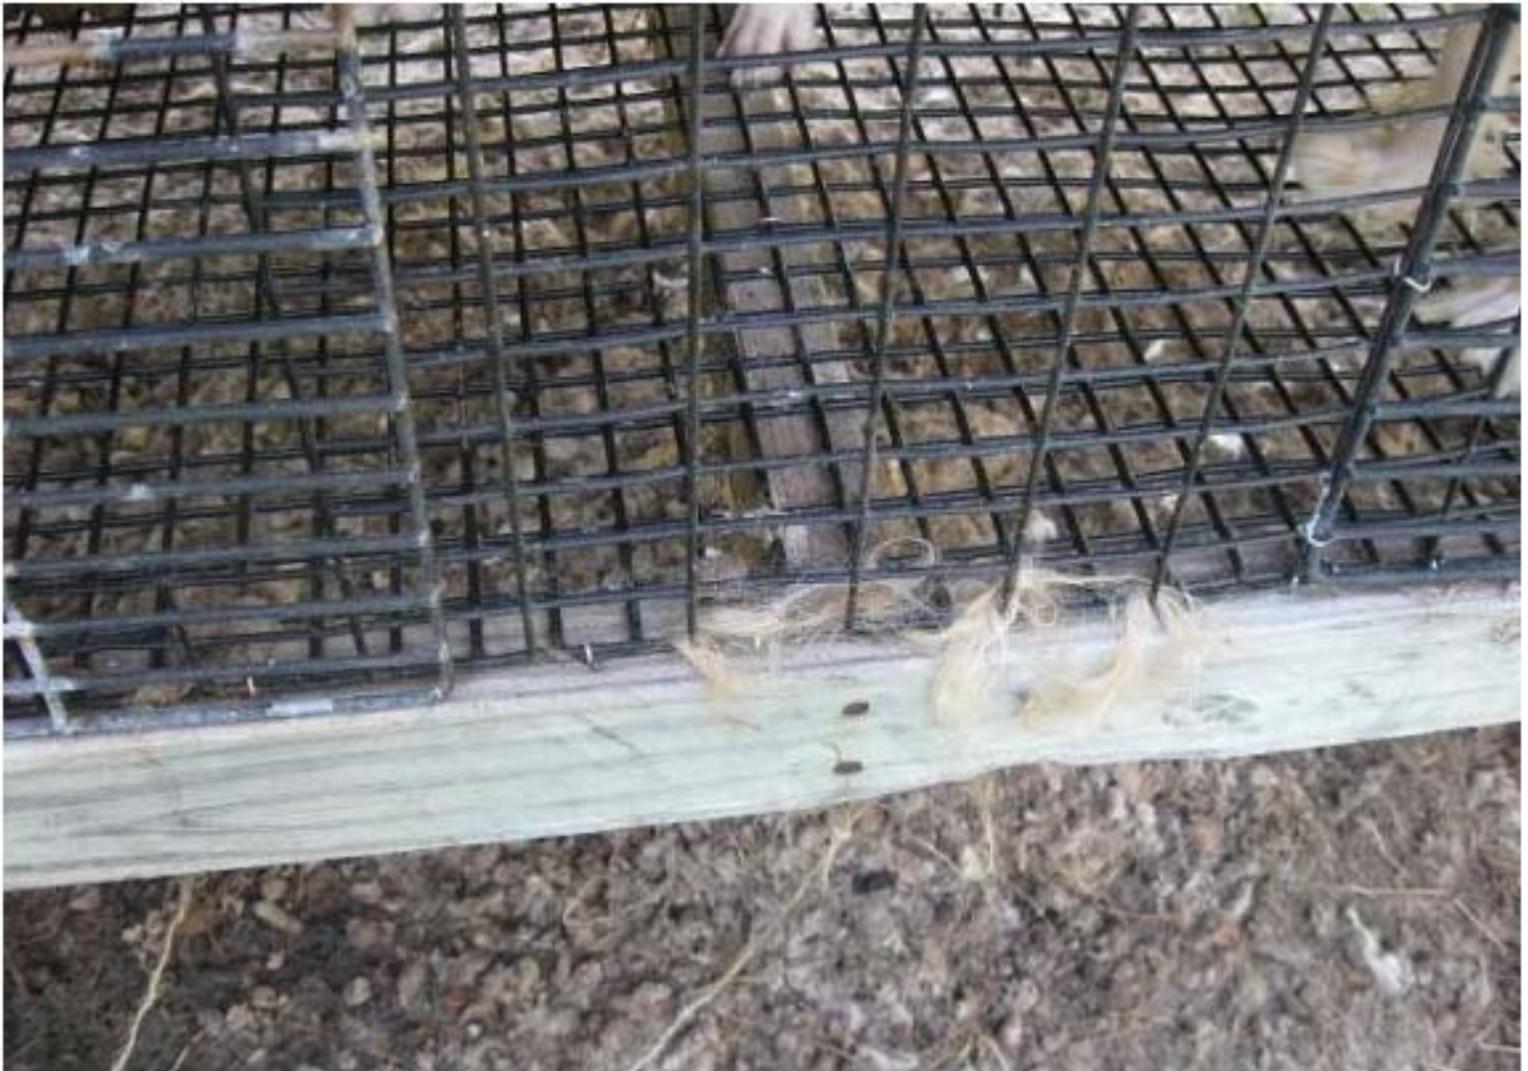
CFR: 3.11 (a)

Photographer:	John J. Lies, ACI	Legal Name:	Registration:	42-A-1238
Photo Taken:	Wed, Aug 25, '10 P.M.	CATHY SPEER		
Inspection:	238101248530491			
Description:	3.11 (a) Cleaning: Primary enclosures need to be cleaned to remove dirt, debris, hair from around the enclosures and excreta from under the enclosures.

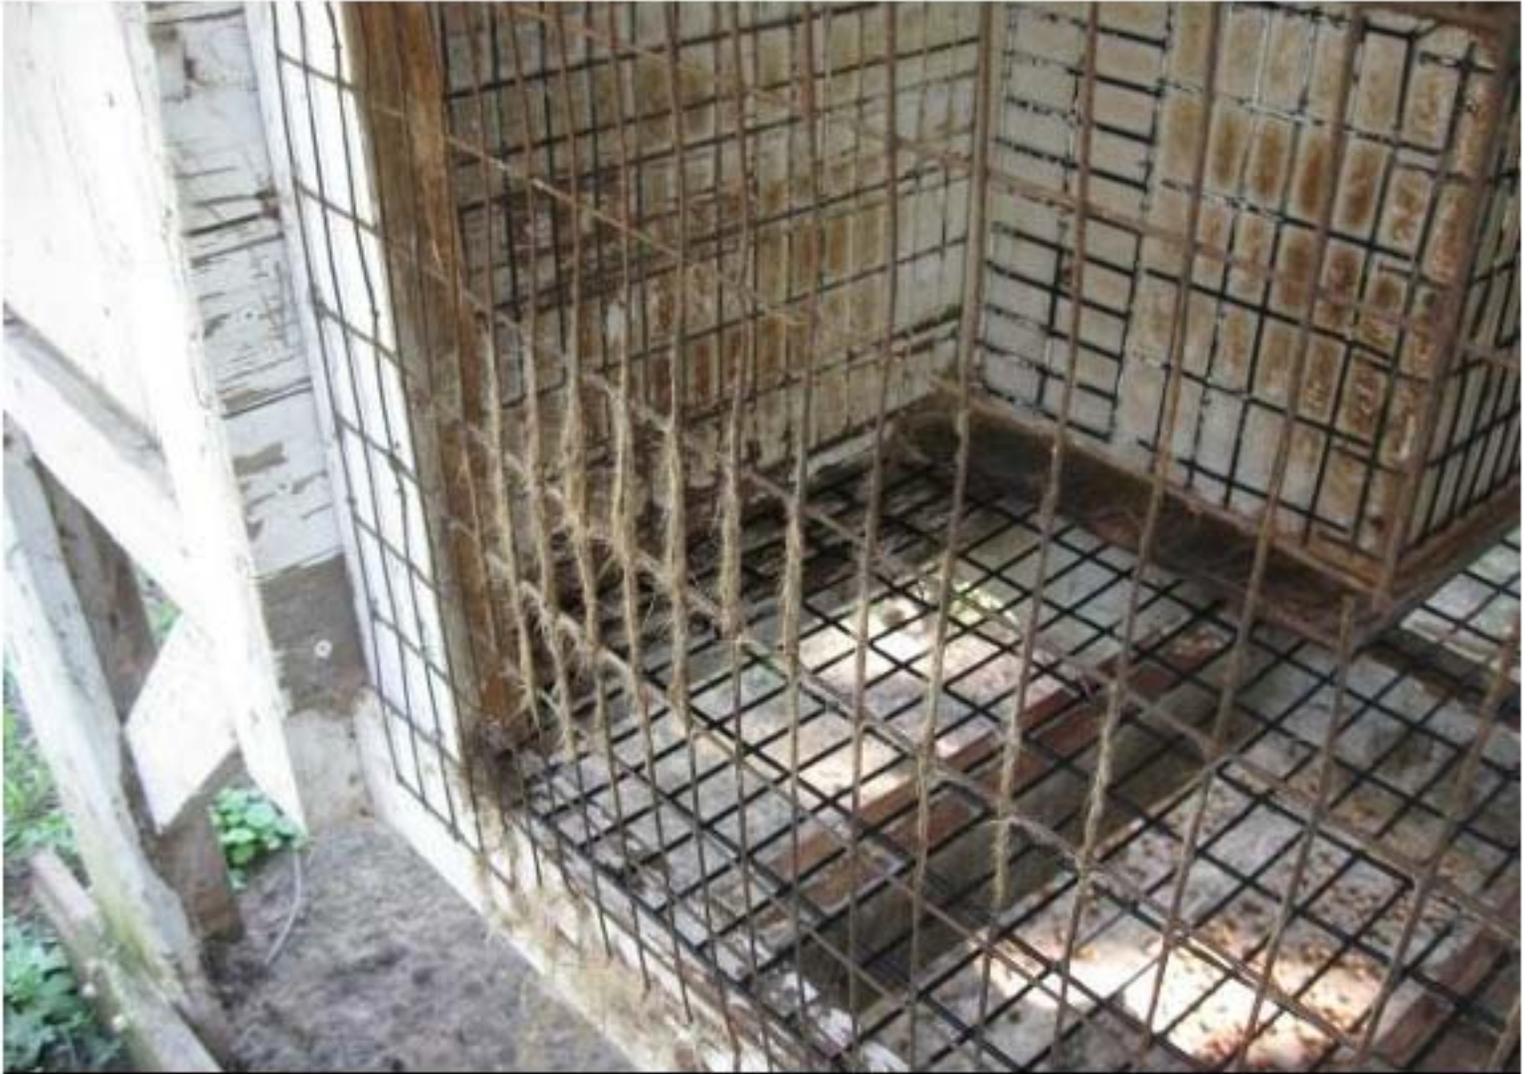
CFR: 3.11 (a) (2)

Photographer:	John J. Lies, ACI	Legal Name:	Registration:	42-A-1238
Photo Taken:	Wed, Aug 25, '10 P.M.	CATHY SPEER		
Inspection:	238101248530491			
Description:	3.11 (a)(2) Cleaning: Shelter and/or hard surfaces need to be sanitized.

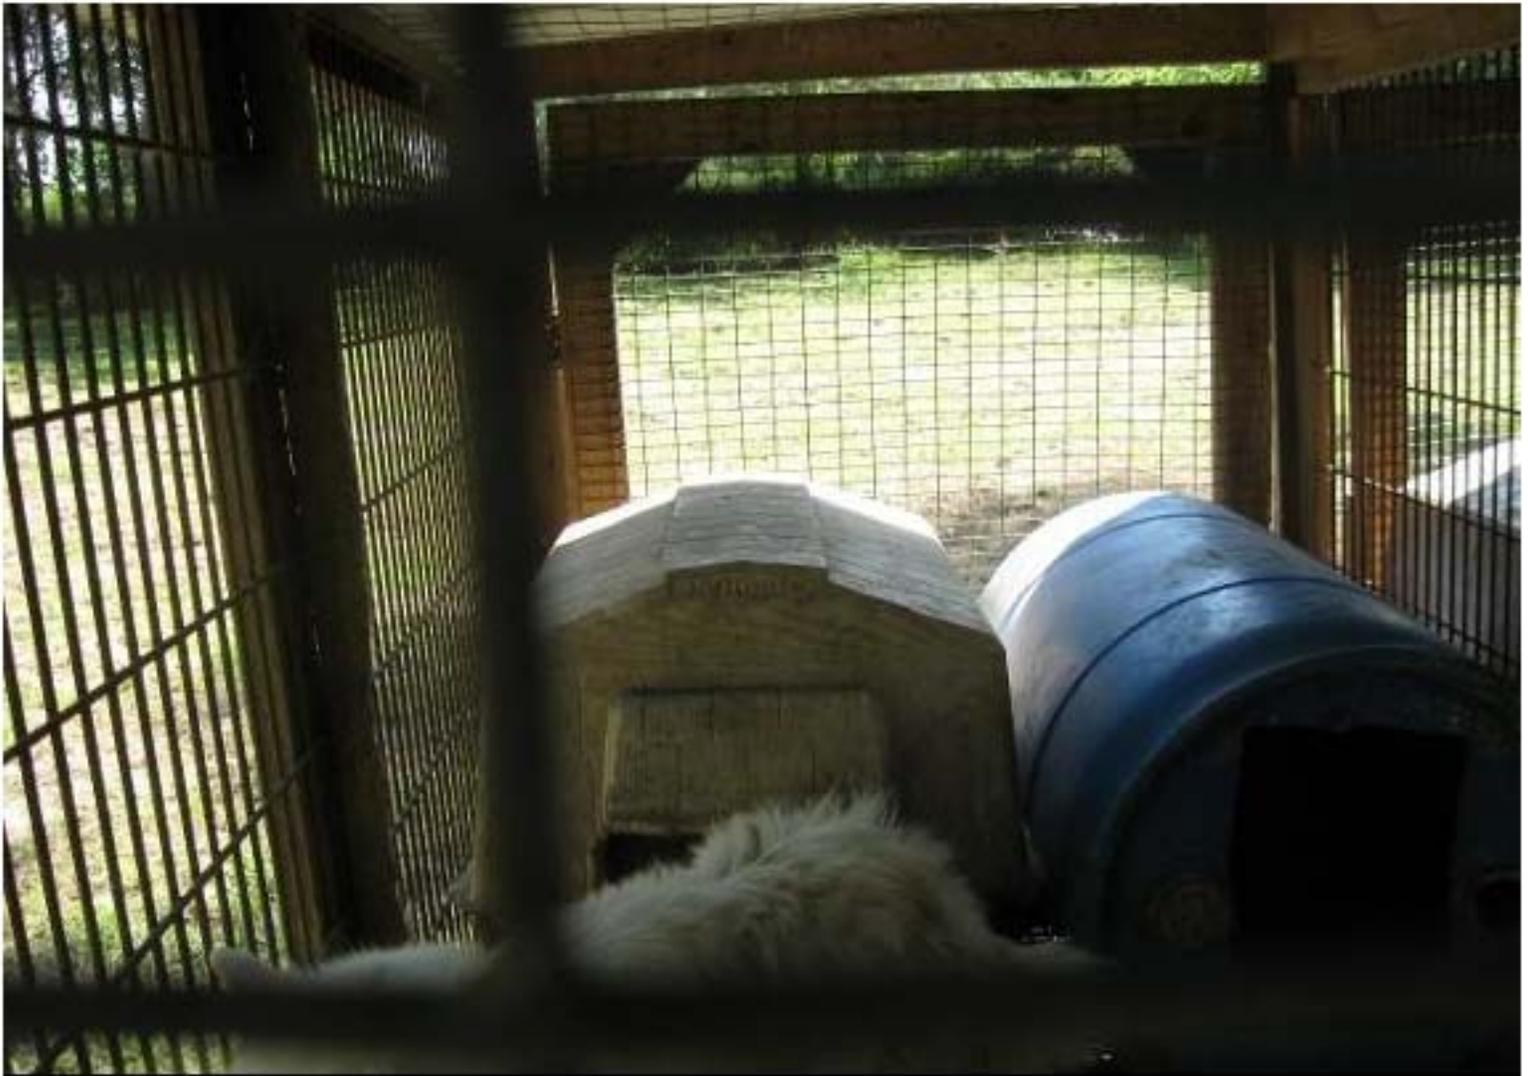
CFR: 3.4 (b) (3), 3.11 (a) (2)

Photographer:	John J. Lies, ACI	Legal Name:	Registration:	42-A-1238
Photo Taken:	Wed, Aug 25, '10 P.M.	CATHY SPEER		
Inspection:	238101248530491			
Description:	3.4 (b)(3) Outdoor housing: No wind/rain break. 3.11 (a)(2) Cleaning: Shelter and hard surfaces need to be sanitized.

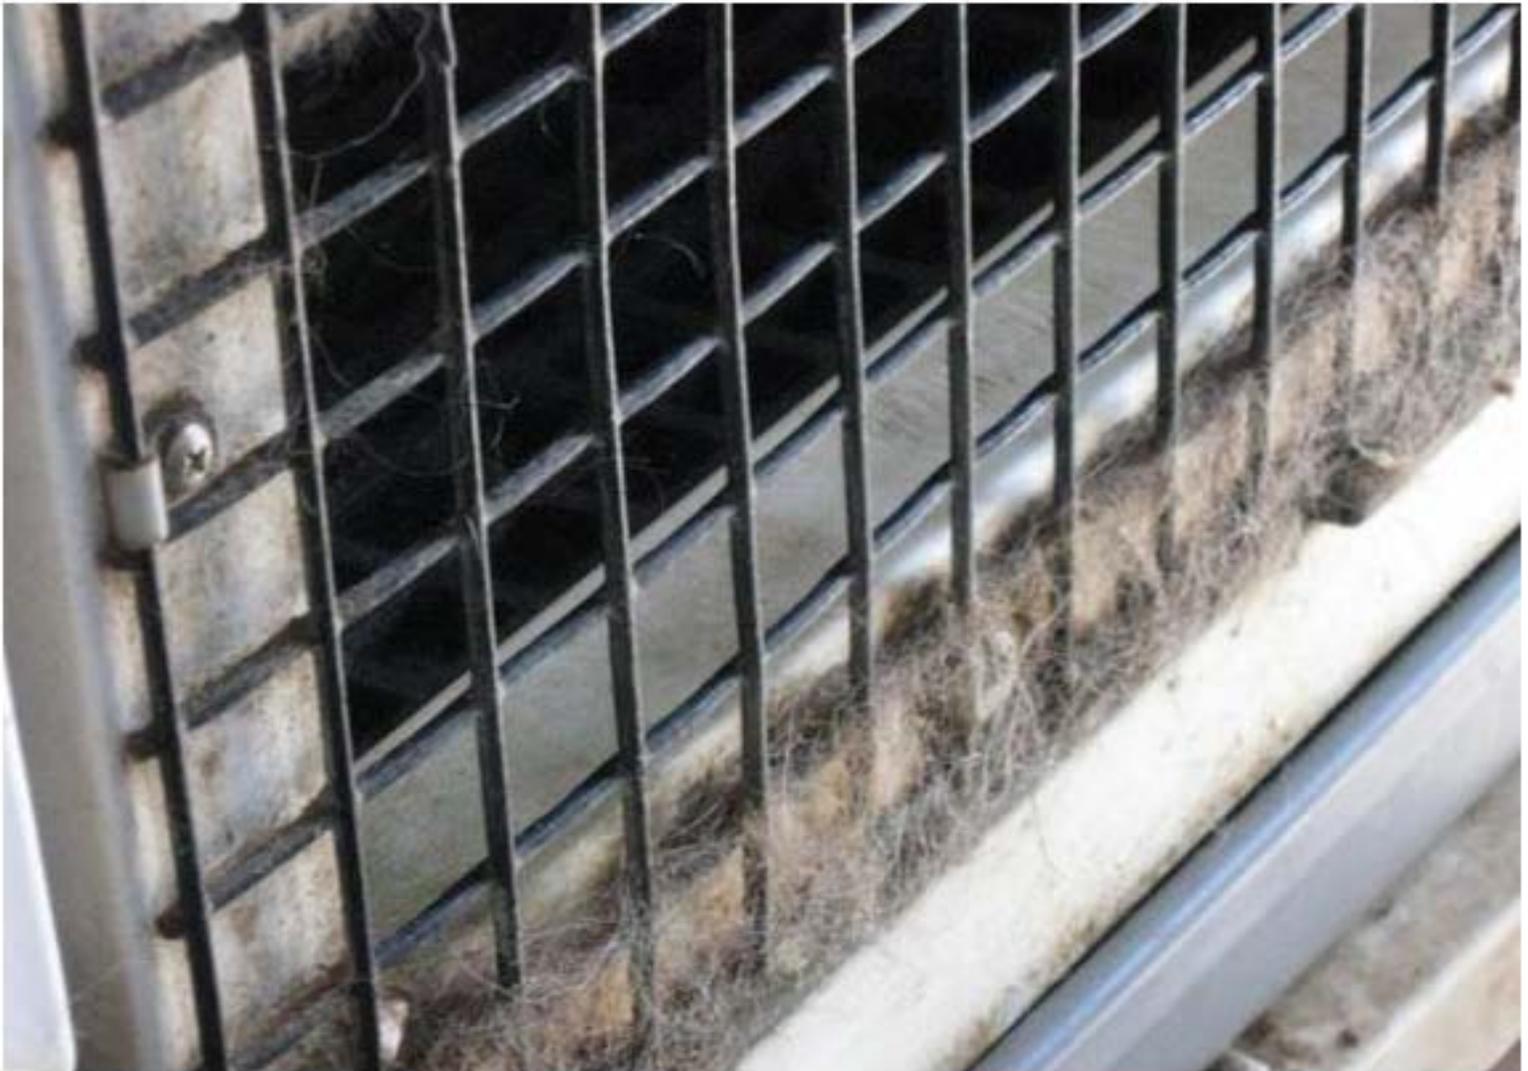
CFR: 3.1 (c) (3)

Photographer:	John J. Lies, ACI	Legal Name:	Registration:	42-A-1238
Photo Taken:	Wed, Aug 25, '10 P.M.	CATHY SPEER		
Inspection:	238101248530491			
Description:	3.1 (c)(3) Housing Facilities Cleaning: Hair, dirt, grime, excreta. Needs to be removed from floors, walls and fronts of the enclosures inside of the building.
