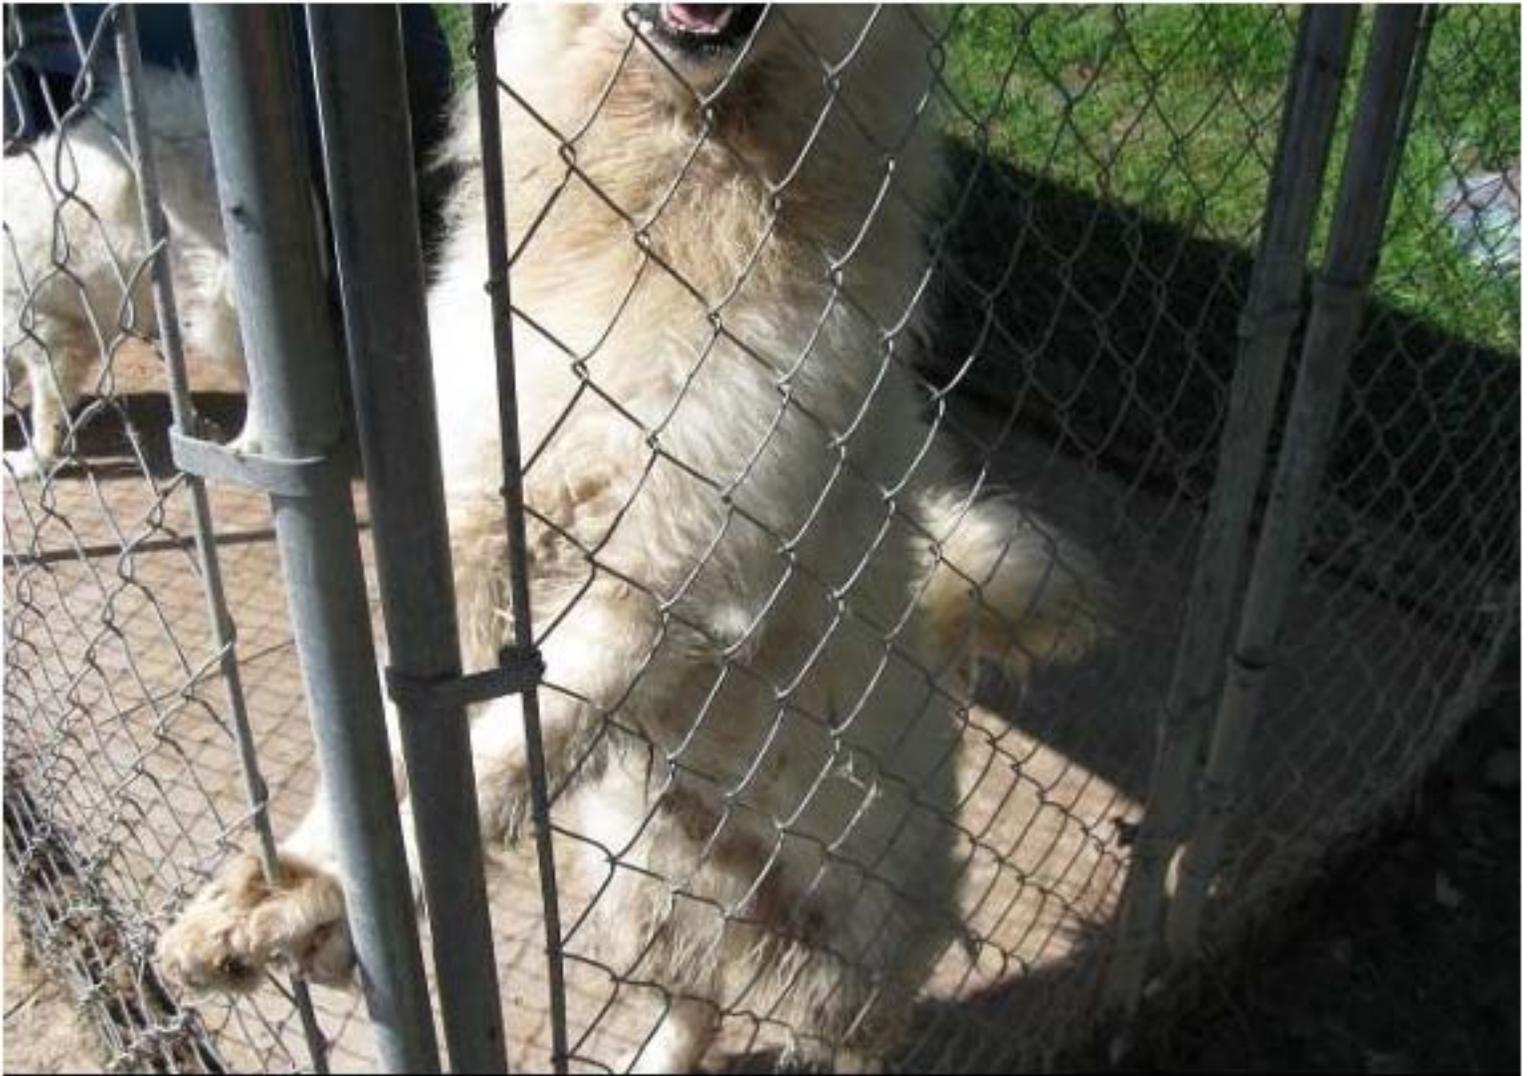
CFR: 2.40 (b) (2)

Photographer:	John J. Lies, ACI	Legal Name:	Registration:	42-A-1238
Photo Taken:	Wed, Aug 25, '10 P.M.	CATHY SPEER		
Inspection:	238101248530491			
Description:	2.40 (a)(2) Veterinary Care: Hair mats need to be removed and hair coat groomed.

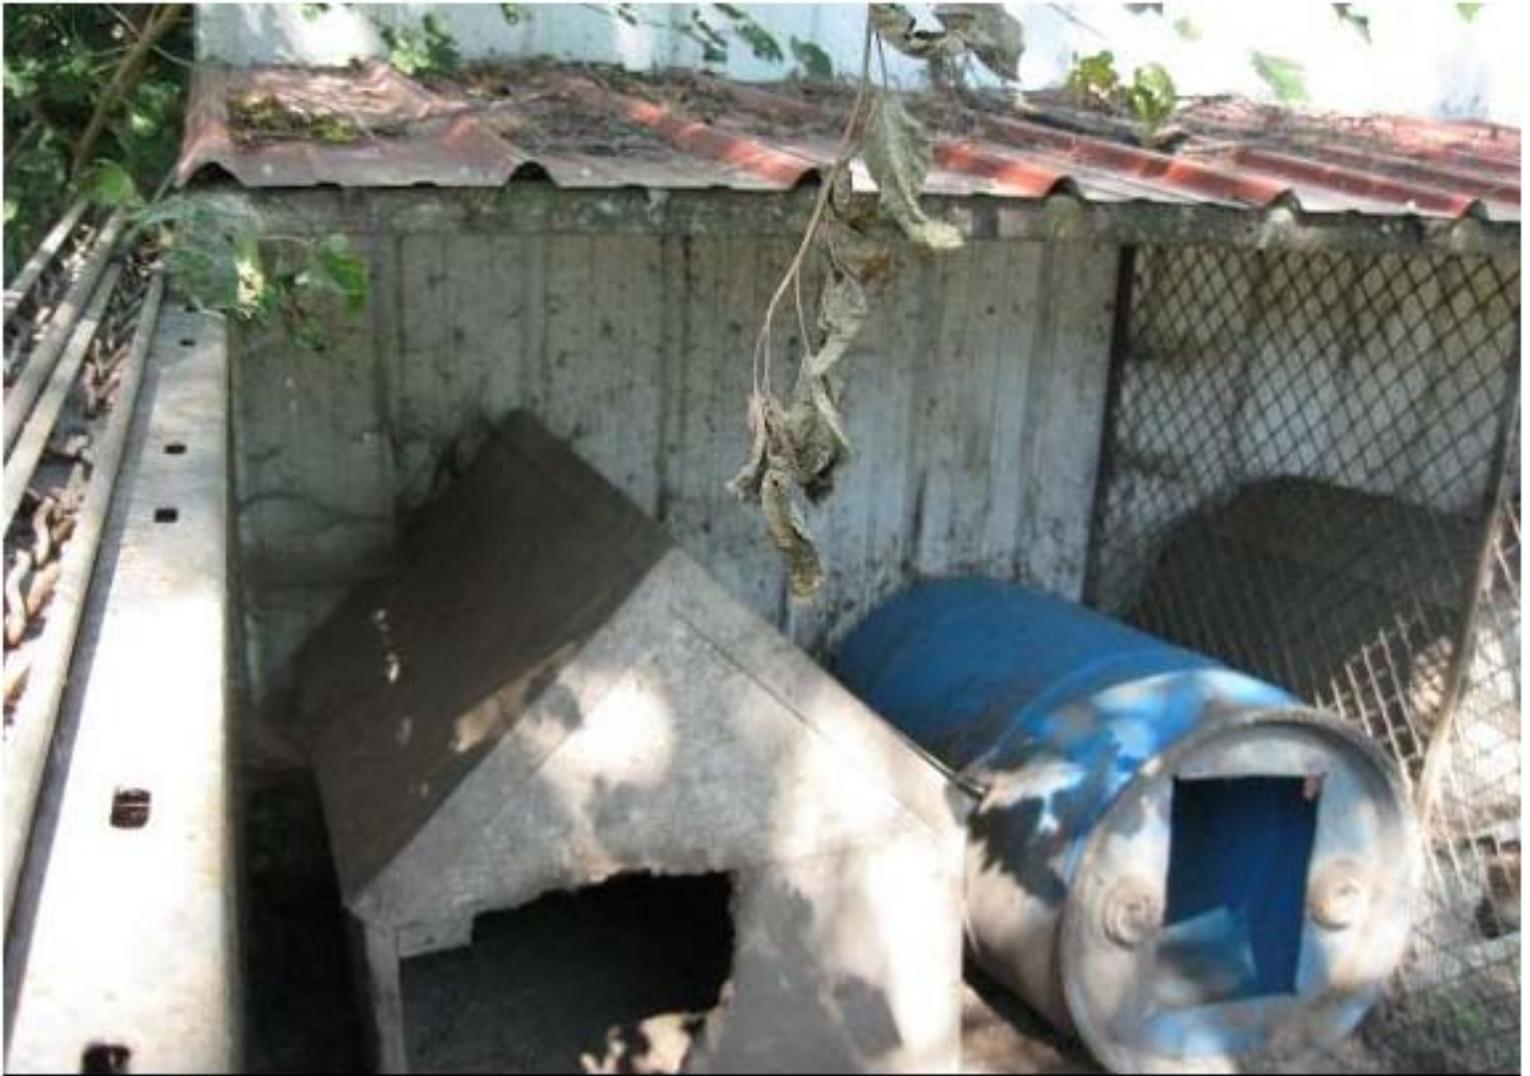
CFR: 3.4 (b) (3), 3.11 (a) (2)

Photographer:	John J. Lies, ACI	Legal Name:	Registration:	42-A-1238
Photo Taken:	Wed, Aug 25, '10 P.M.	CATHY SPEER		
Inspection:	238101248530491			
Description:	3.4 (b)(3) Outdoor housing: No wind/rain break. 3.11 (a)(2) Cleaning: Shelter and hard surfaces need to be sanitized.

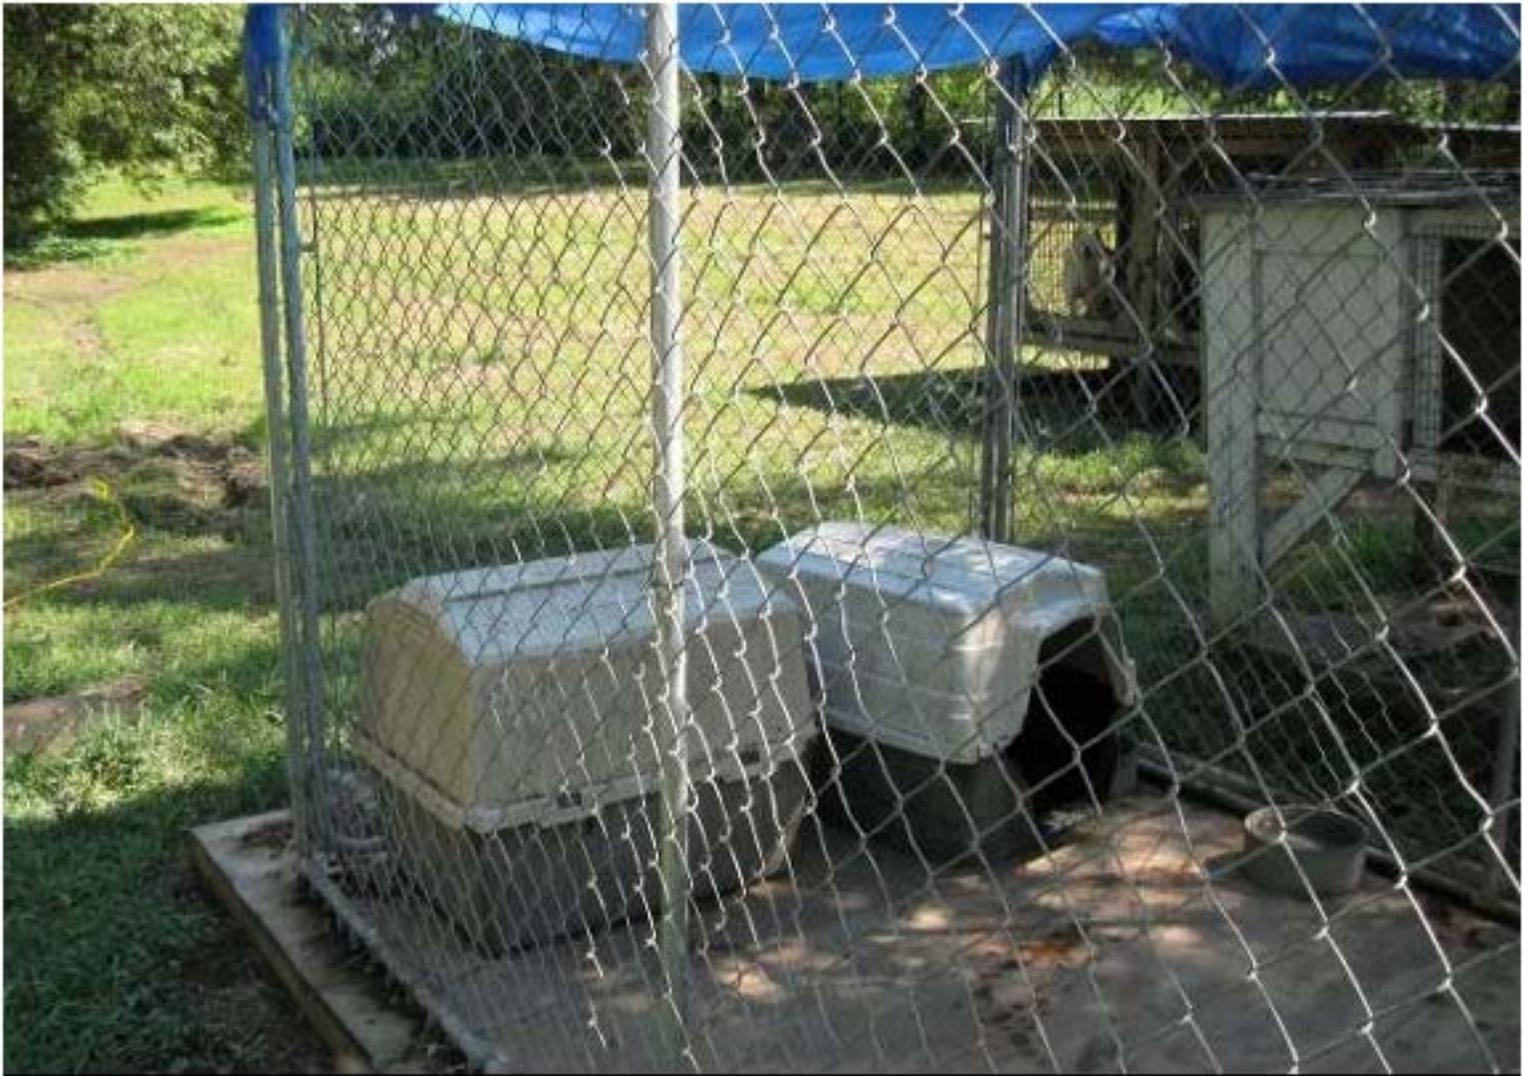
CFR: 3.1 (f)

Photographer:	John J. Lies, ACI	Legal Name:	Registration:	42-A-1238
Photo Taken:	Wed, Aug 25, '10 P.M.	CATHY SPEER		
Inspection:	238101248530491			
Description:	3.1 (f) General Housing Waste Disposal: Excreta, hair, food waste around the enclosures needs to be removed.

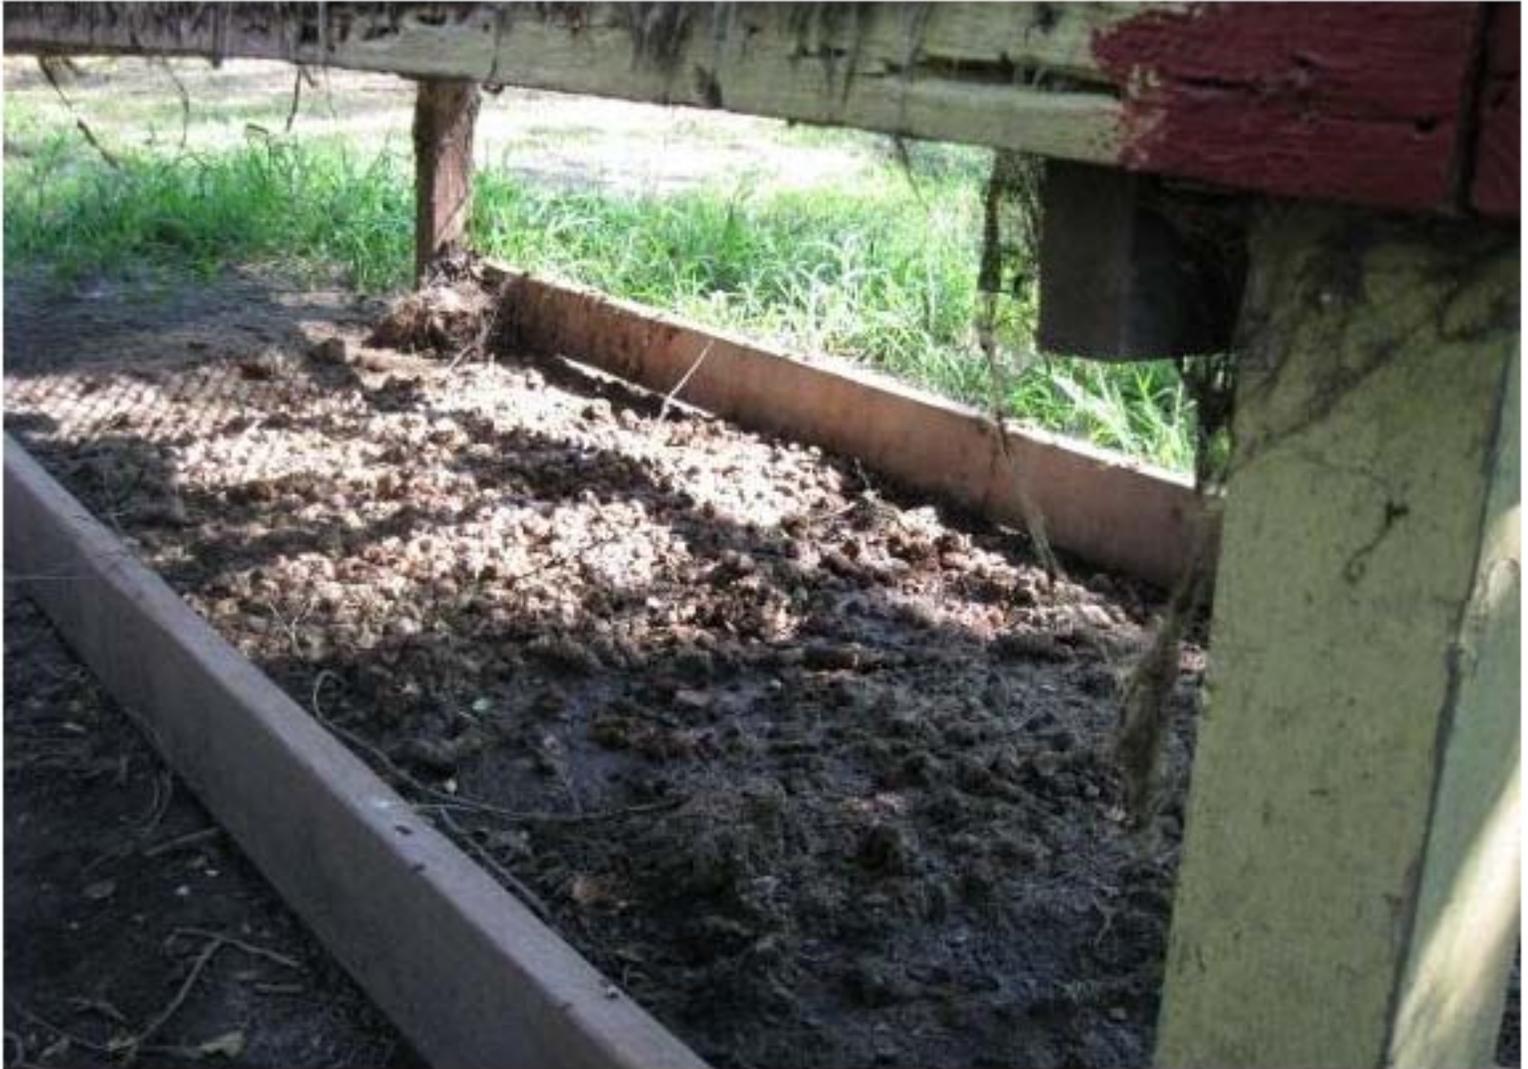
CFR: 3.11 (a)

Photographer:	John J. Lies, ACI	Legal Name:	Registration:	42-A-1238
Photo Taken:	Wed, Aug 25, '10 P.M.	CATHY SPEER		
Inspection:	238101248530491			
Description:	3.11 (a) Cleaning: Primary enclosures need to be cleaned to remove dirt, debris, hair from around the enclosures and excreta from under the enclosures.

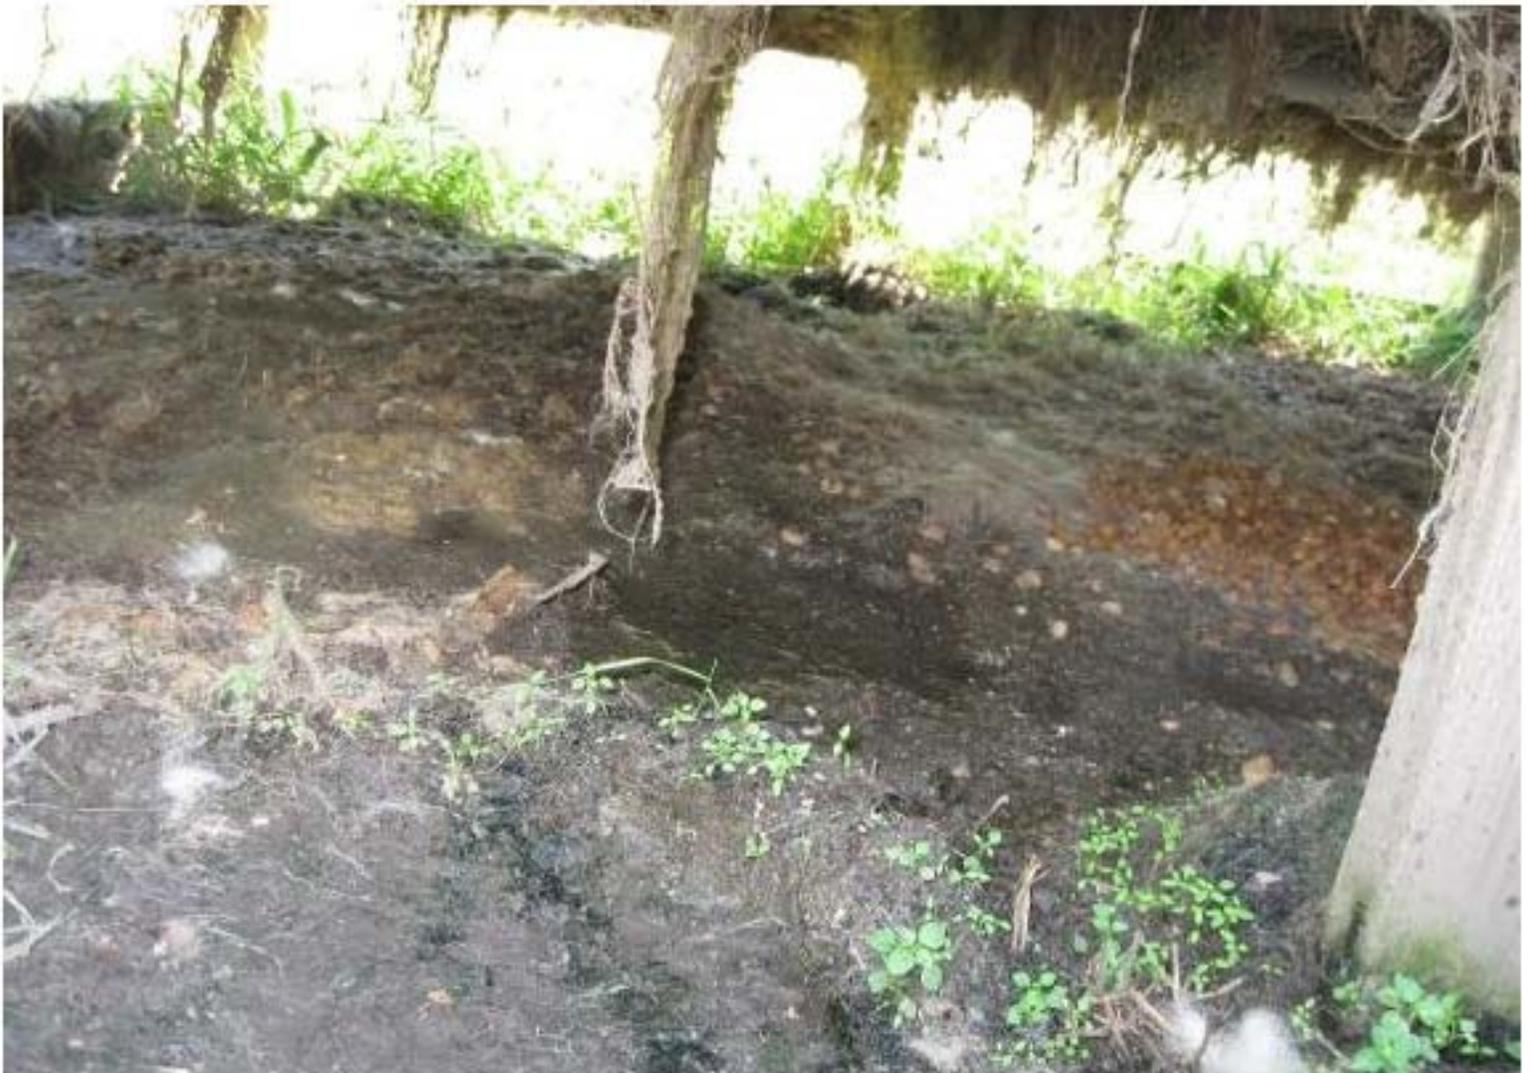
CFR: 3.11 (a)

Photographer:	John J. Lies, ACI	Legal Name:	Registration:	42-A-1238
Photo Taken:	Wed, Aug 25, '10 P.M.	CATHY SPEER		
Inspection:	238101248530491			
Description:	3.11 (a) Cleaning: Primary enclosures need to be cleaned to remove dirt, debris, hair from around the enclosures and excreta from under the enclosures.

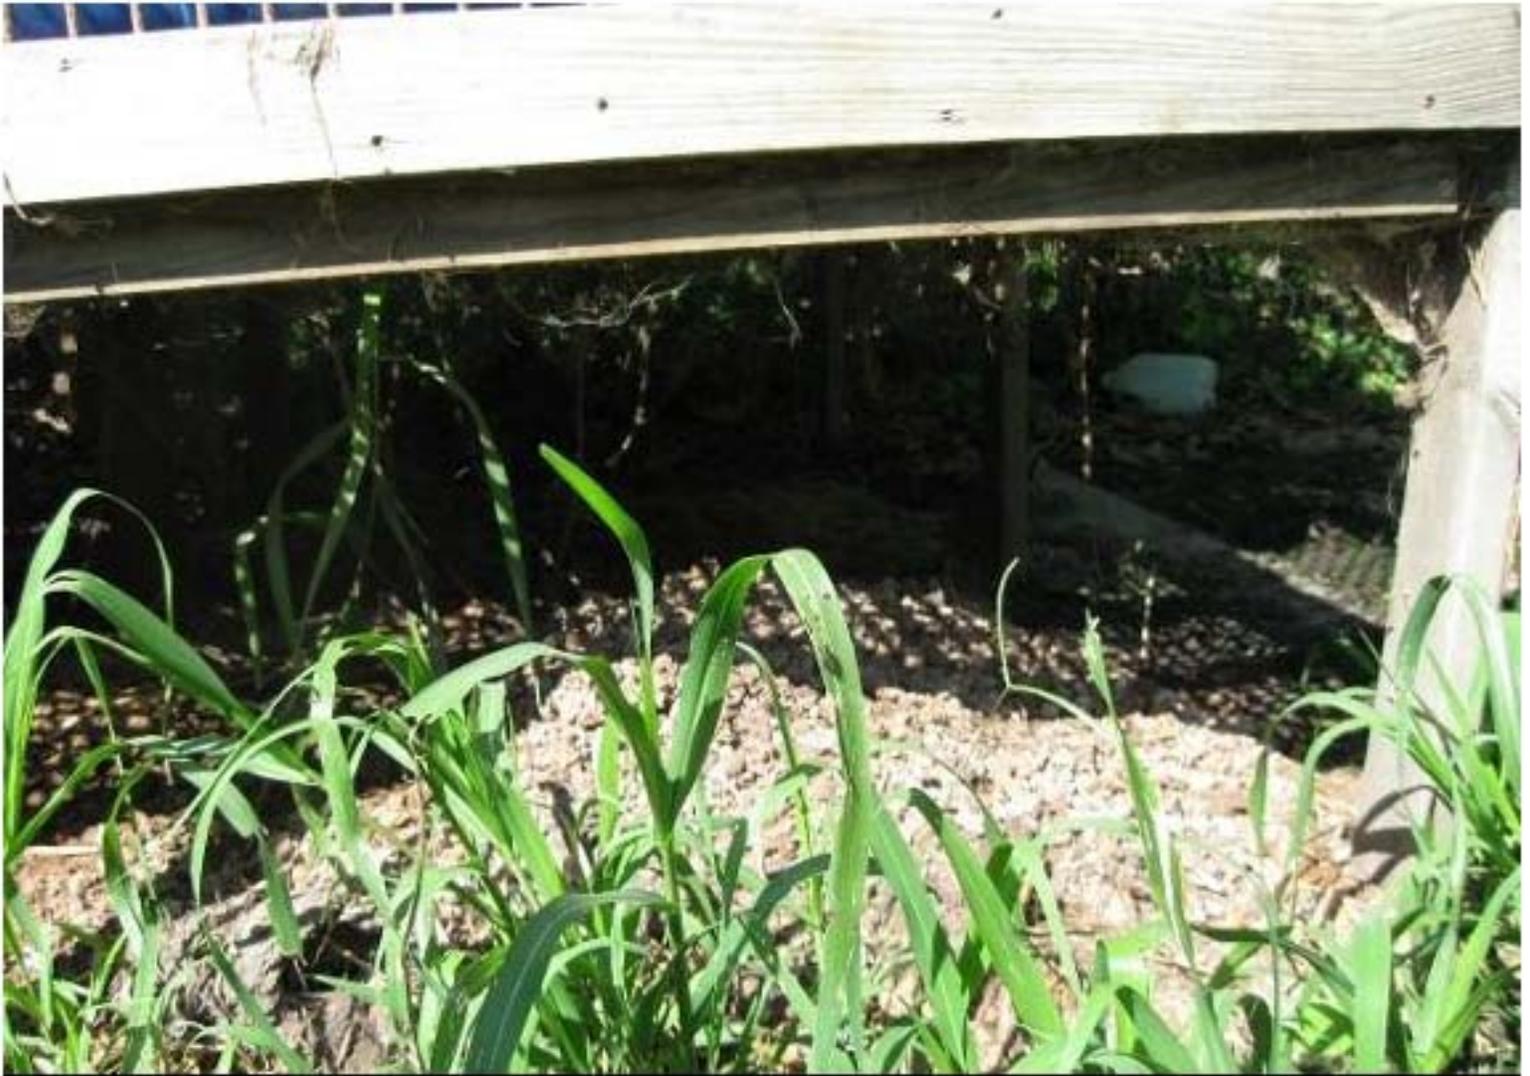
CFR: 3.11 (a)

Photographer:	John J. Lies, ACI	Legal Name:	Registration:	42-A-1238
Photo Taken:	Wed, Aug 25, '10 P.M.	CATHY SPEER		
Inspection:	238101248530491			
Description:	3.11 (a) Cleaning: Primary enclosures need to be cleaned to remove dirt, debris, hair from around the enclosures and excreta from under the enclosures.

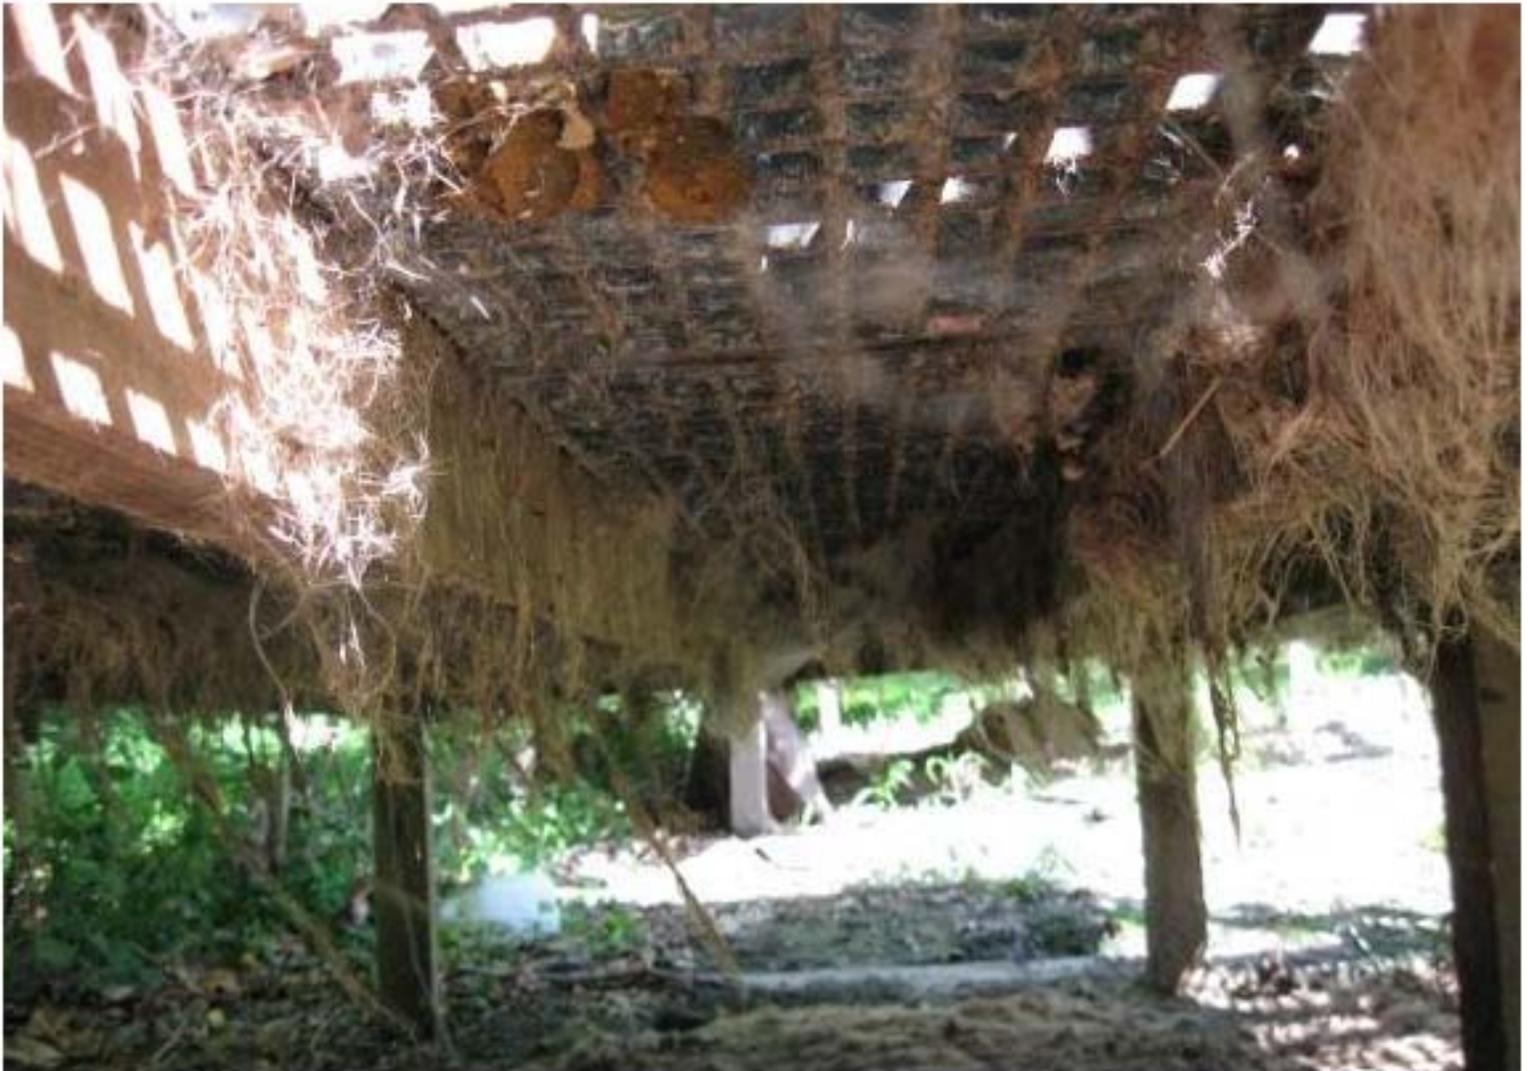
CFR: 3.11 (a)

Photographer:	John J. Lies, ACI	Legal Name:	Registration:	42-A-1238
Photo Taken:	Wed, Aug 25, '10 P.M.	CATHY SPEER		
Inspection:	238101248530491			
Description:	3.11 (a) Cleaning: Primary enclosures need to be cleaned to remove dirt, debris, hair from around the enclosures and excreta from under the enclosures.

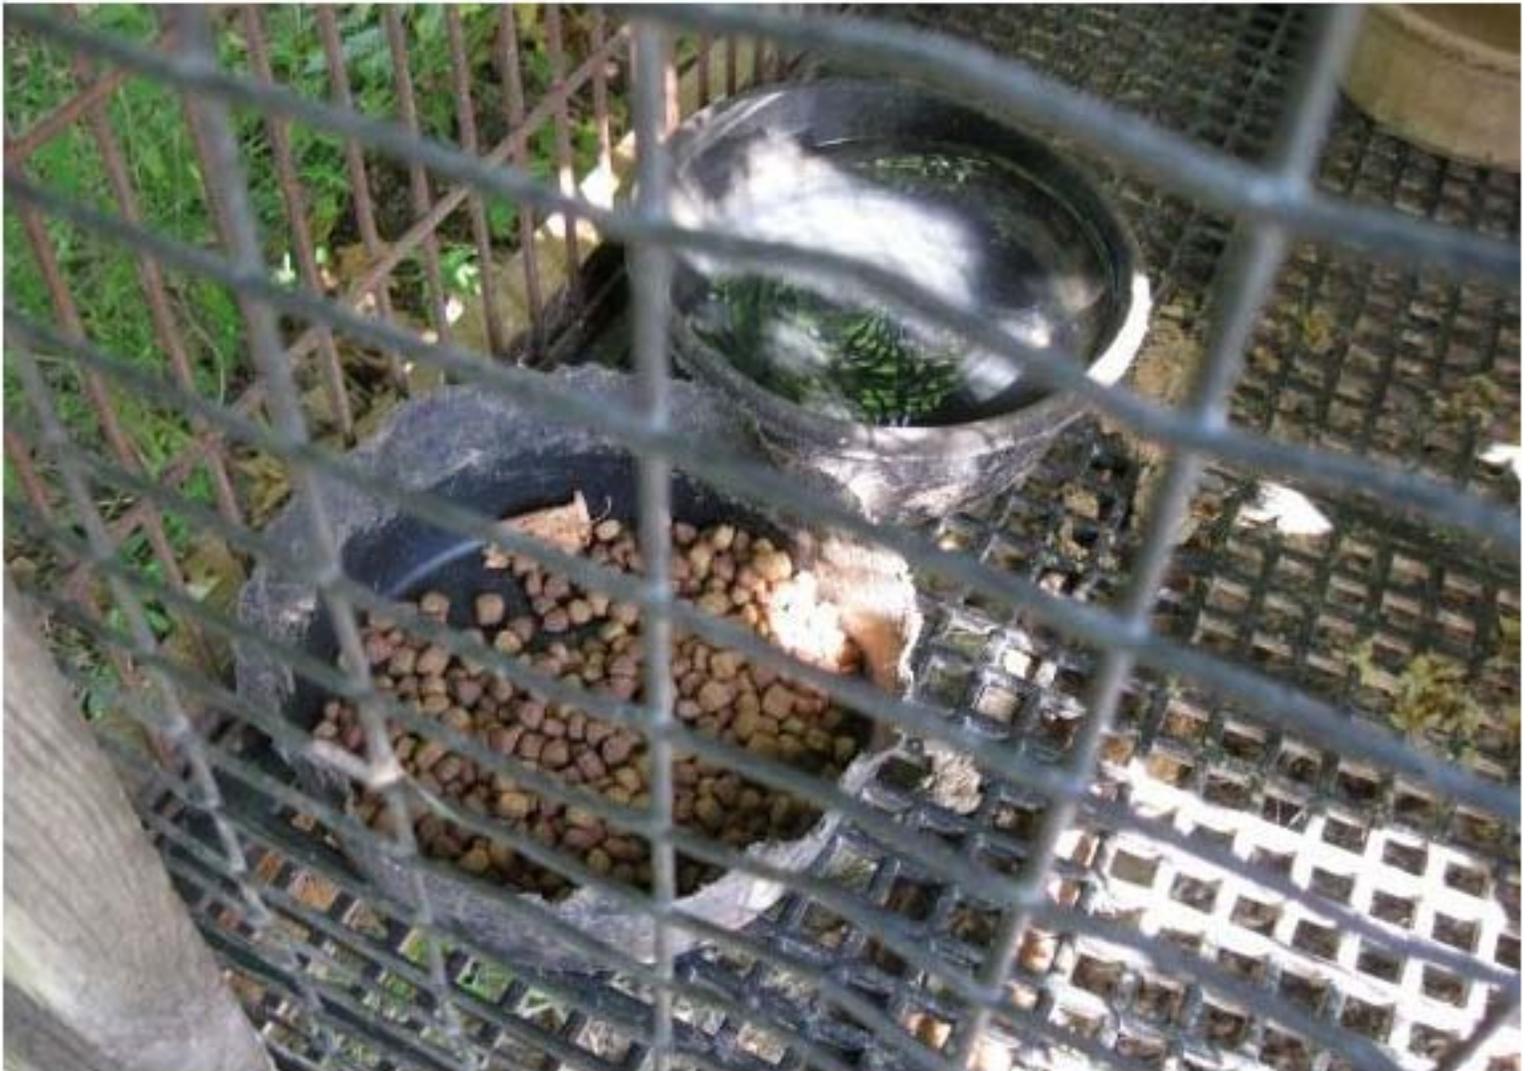
CFR: 3.11 (a) (2)

Photographer:	John J. Lies, ACI	Legal Name:	Registration:	42-A-1238
Photo Taken:	Wed, Aug 25, '10 P.M.	CATHY SPEER		
Inspection:	238101248530491			
Description:	3.11 (a)(2) Cleaning: Shelter and/or hard surfaces need to be sanitized.

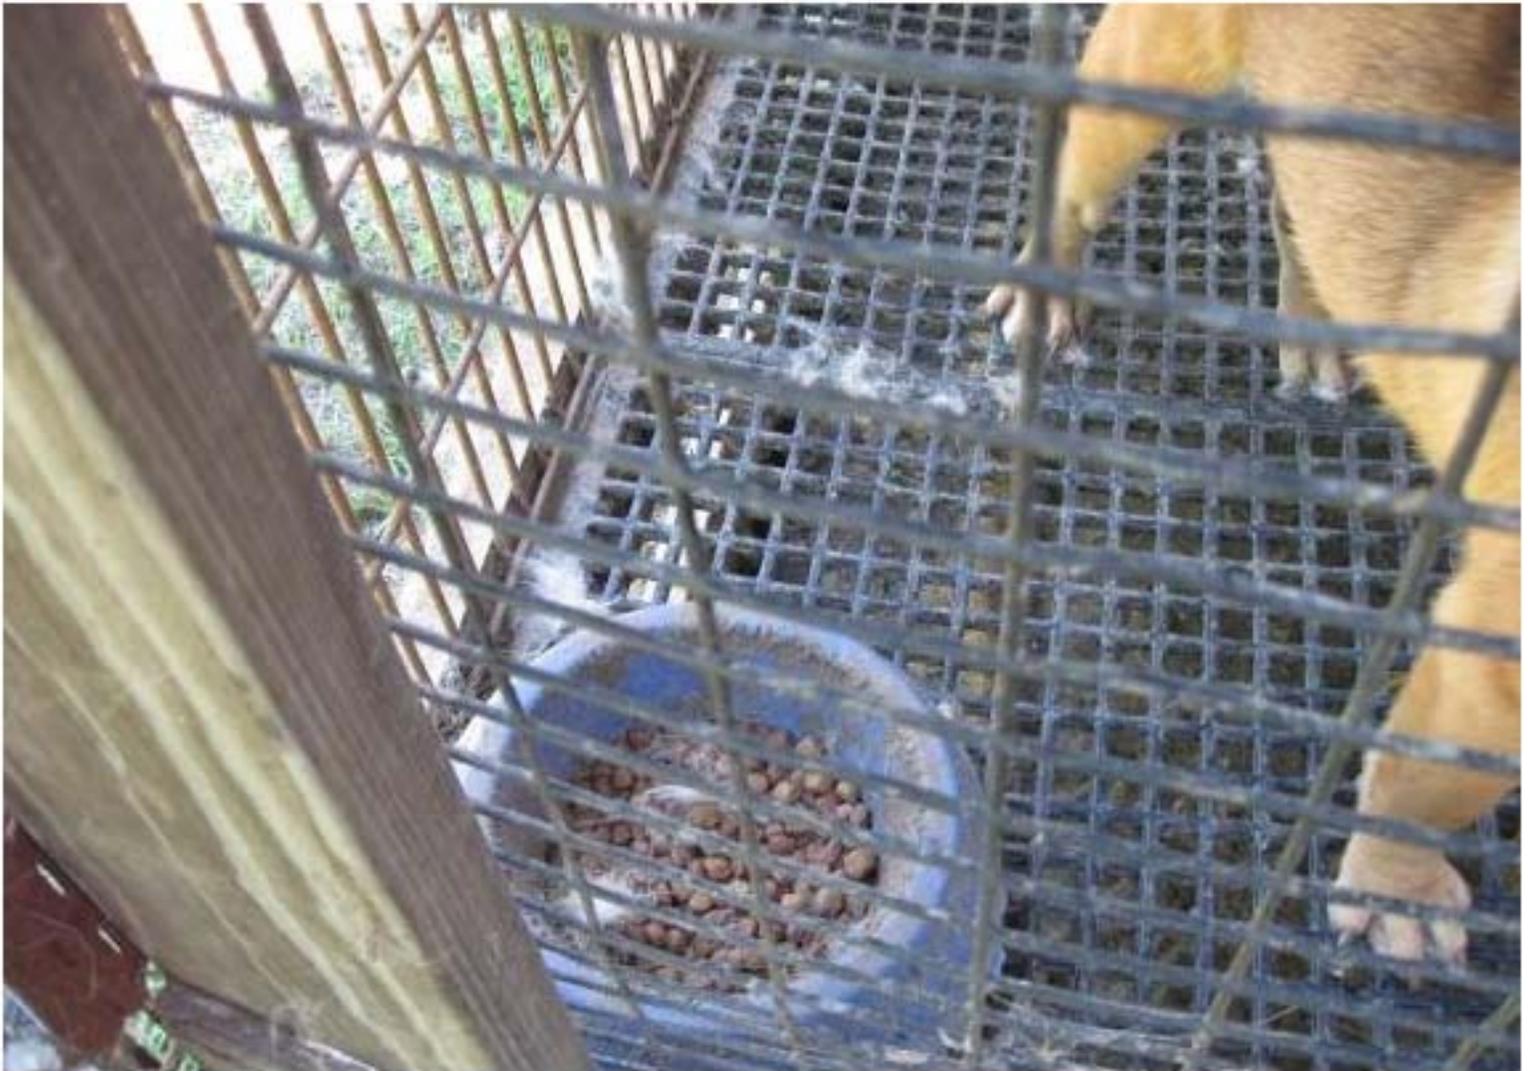
CFR: 3.11 (a) (2)

Photographer:	John J. Lies, ACI	Legal Name:	Registration:	42-A-1238
Photo Taken:	Wed, Aug 25, '10 P.M.	CATHY SPEER		
Inspection:	238101248530491			
Description:	3.11 (a)(2) Cleaning: Shelter and/or hard surfaces need to be sanitized.

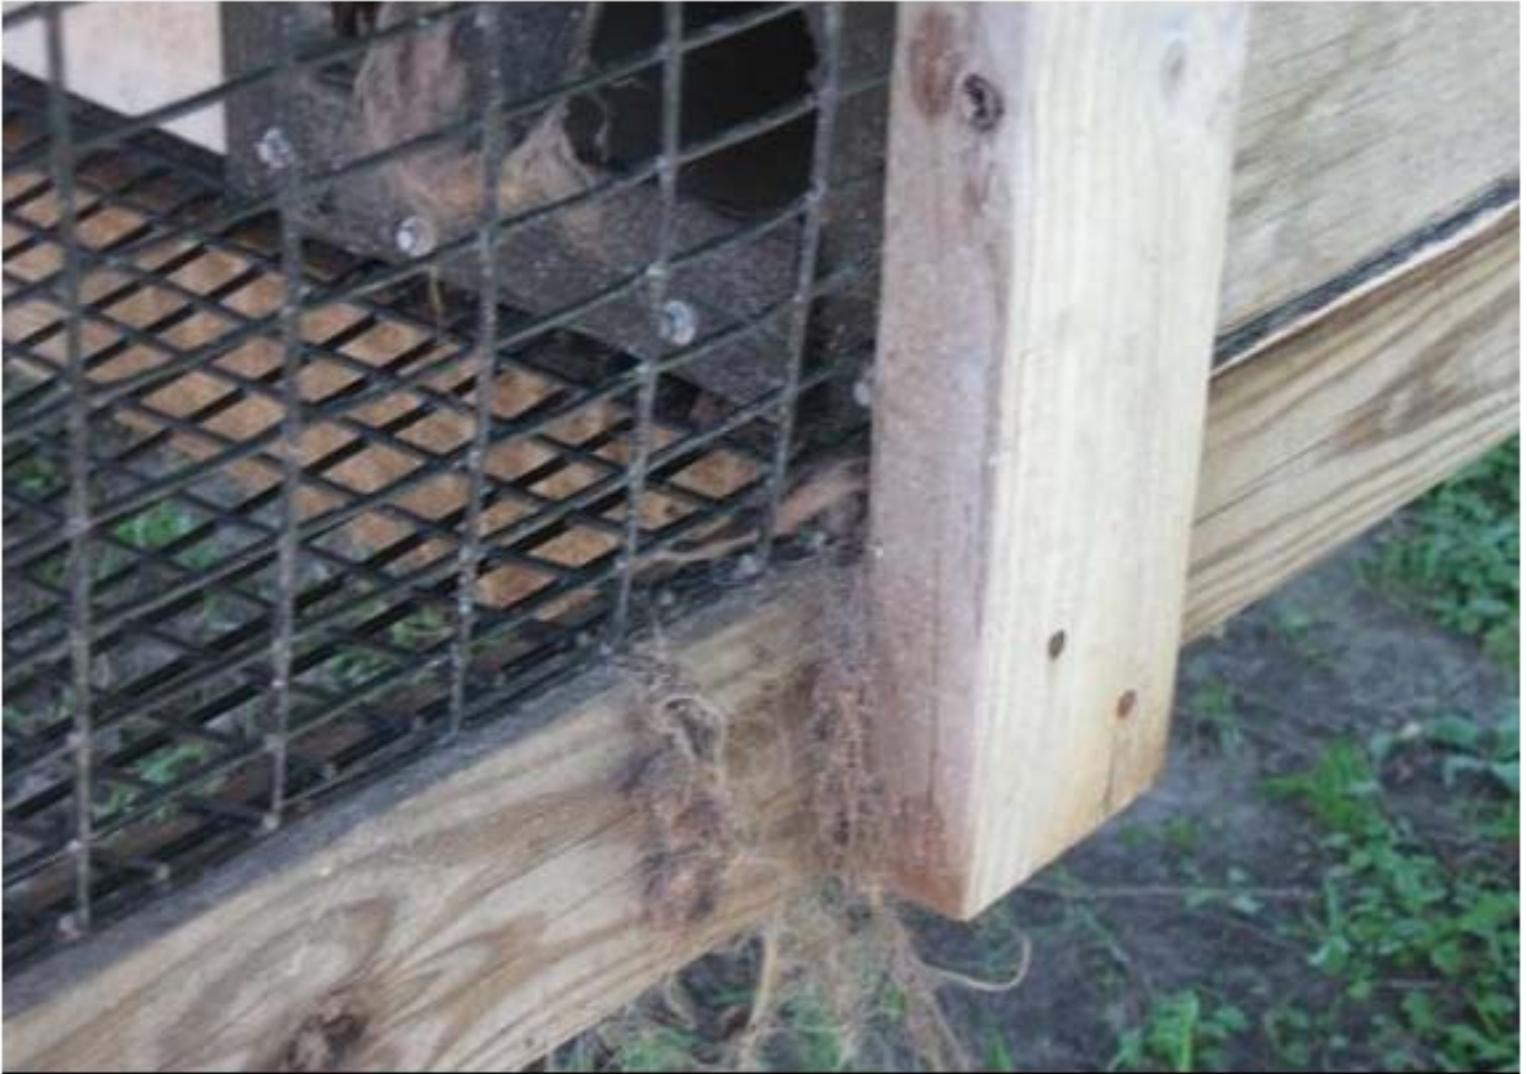
CFR: 3.11 (a)

Photographer:	John J. Lies, ACI	Legal Name:	Registration:	42-A-1238
Photo Taken:	Wed, Aug 25, '10 P.M.	CATHY SPEER		
Inspection:	238101248530491			
Description:	3.11 (a) Cleaning: Primary enclosures need to be cleaned to remove dirt, debris, hair from around the enclosures and excreta from under the enclosures.

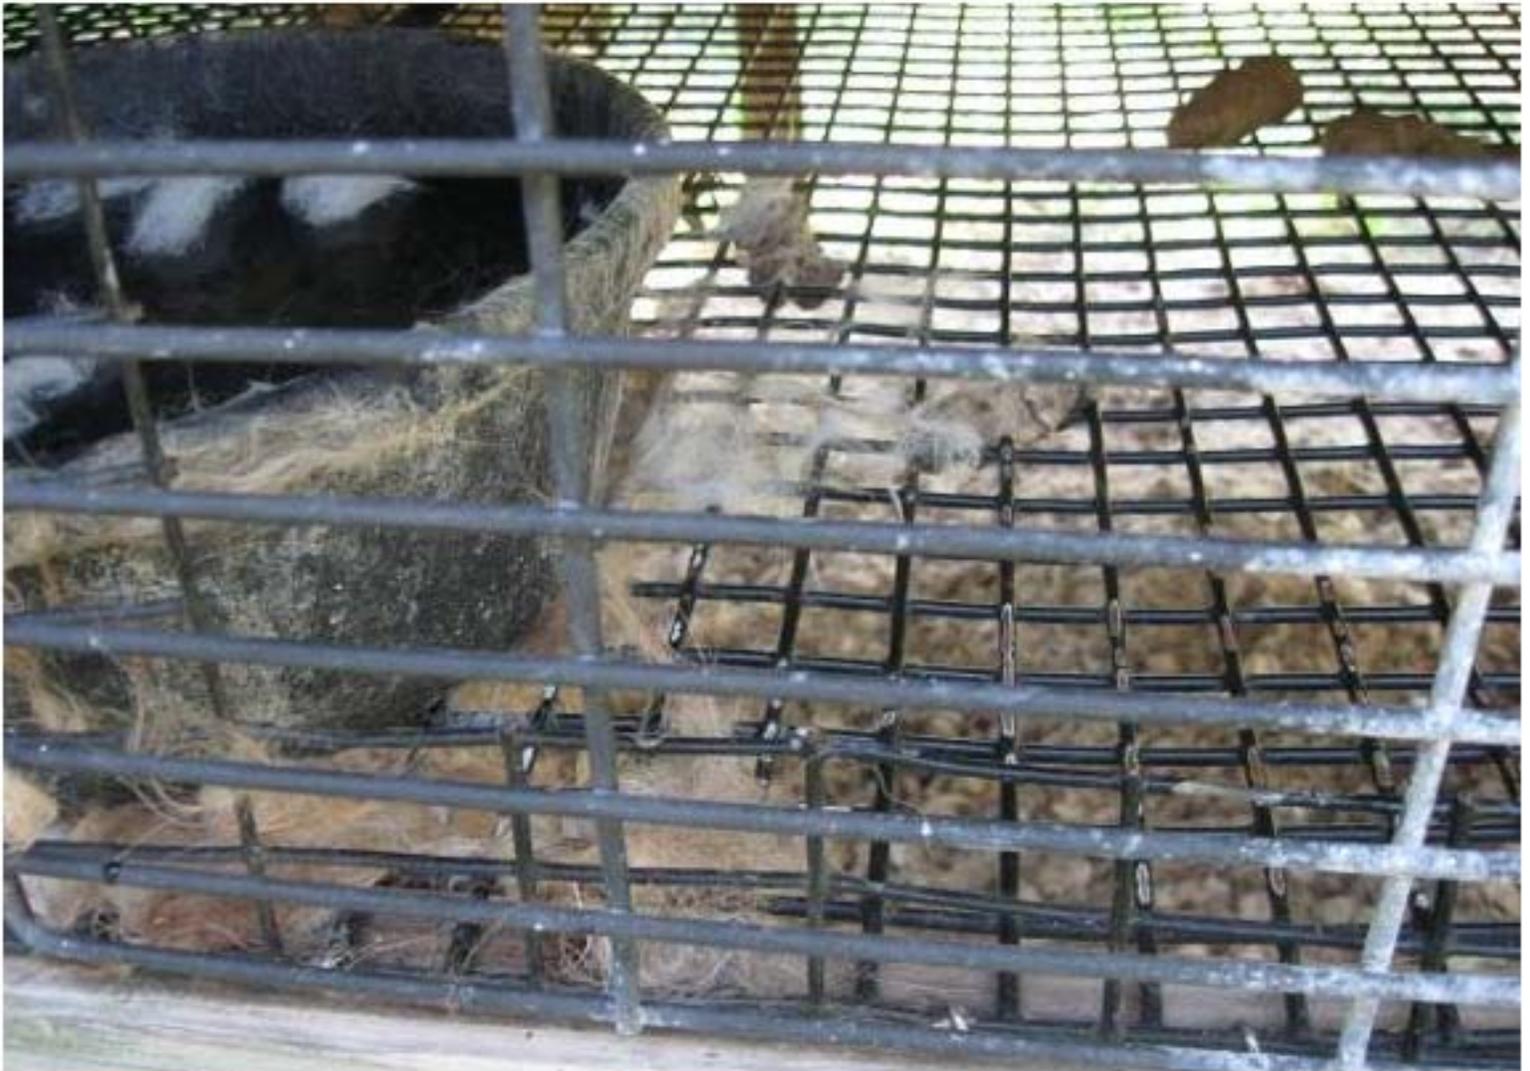
CFR: 3.11 (a) (2)

Photographer:	John J. Lies, ACI	Legal Name:	Registration:	42-A-1238
Photo Taken:	Wed, Aug 25, '10 P.M.	CATHY SPEER		
Inspection:	238101248530491			
Description:	3.11 (a)(2) Cleaning: Shelter and/or hard surfaces need to be sanitized.

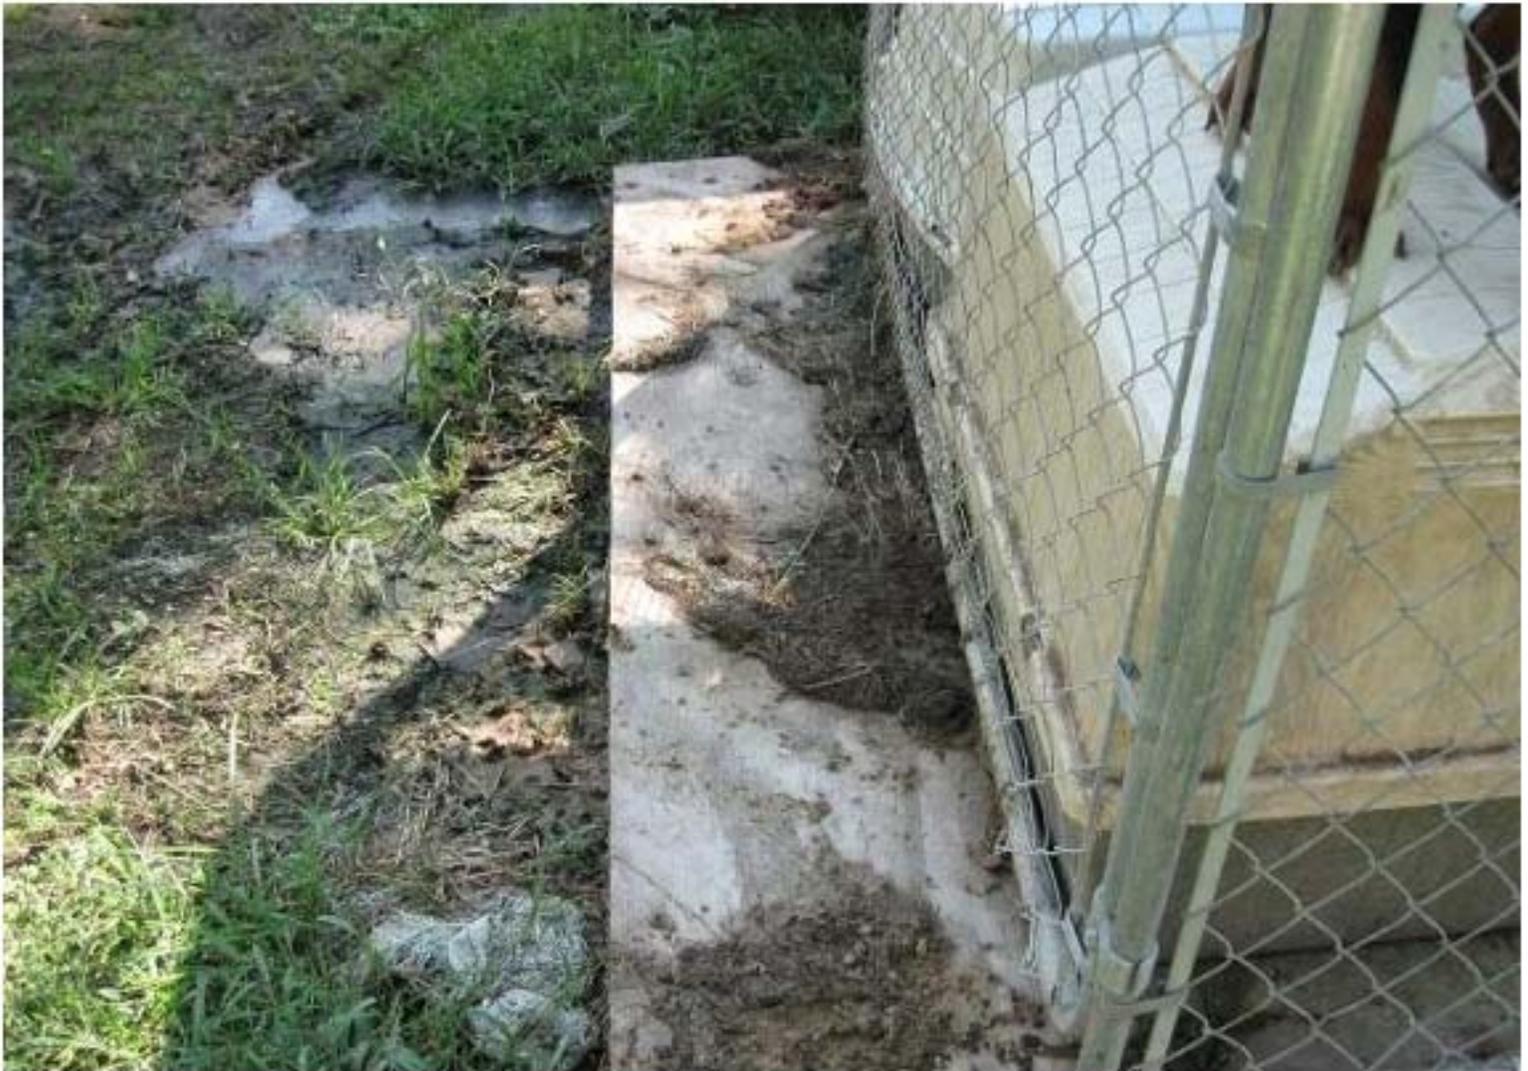
CFR: 3.1 (f)

Photographer:	John J. Lies, ACI	Legal Name:	Registration:	42-A-1238
Photo Taken:	Wed, Aug 25, '10 P.M.	CATHY SPEER		
Inspection:	238101248530491			
Description:	3.1 (f) General Housing Waste Disposal: Excreta, hair, food waste around the enclosures needs to be removed.

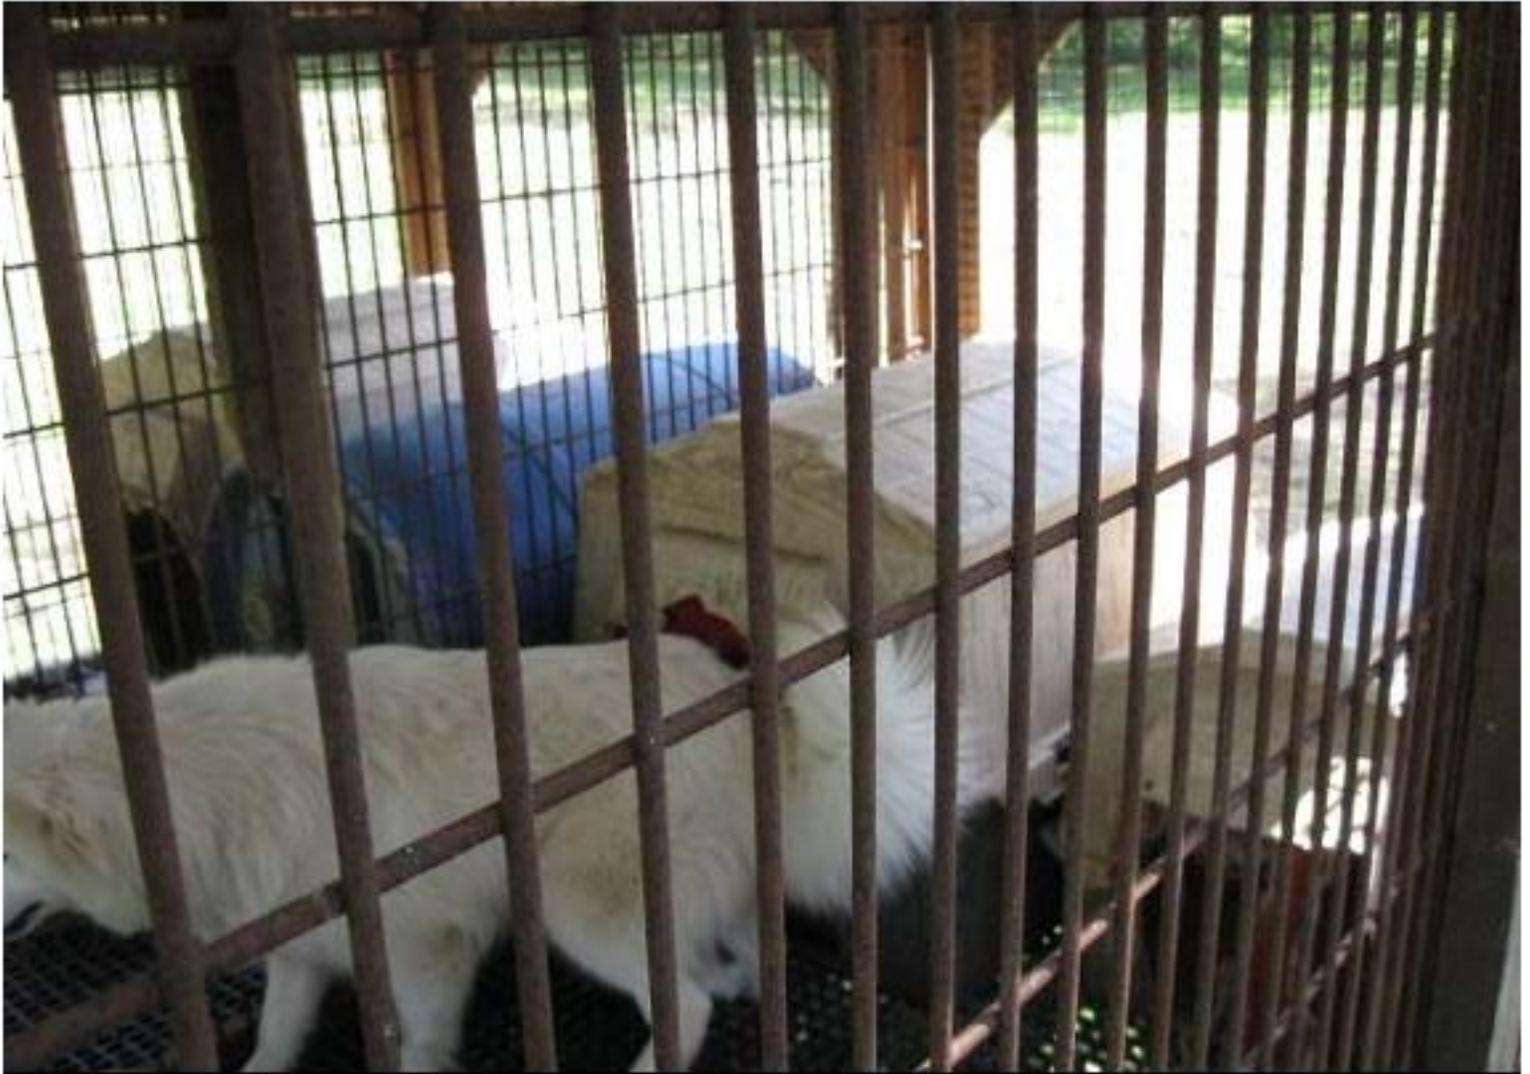
CFR: 3.1 (c) (1) (i)

Photographer:	John J. Lies, ACI	Legal Name:	Registration:	42-A-1238
Photo Taken:	Wed, Aug 25, '10 P.M.	CATHY SPEER		
Inspection:	238101248530491			
Description:	3.1 (c)(1)(i) Housing facilities General Surfaces with excessive rust that prevents proper cleaning and/or affects structural strength.
