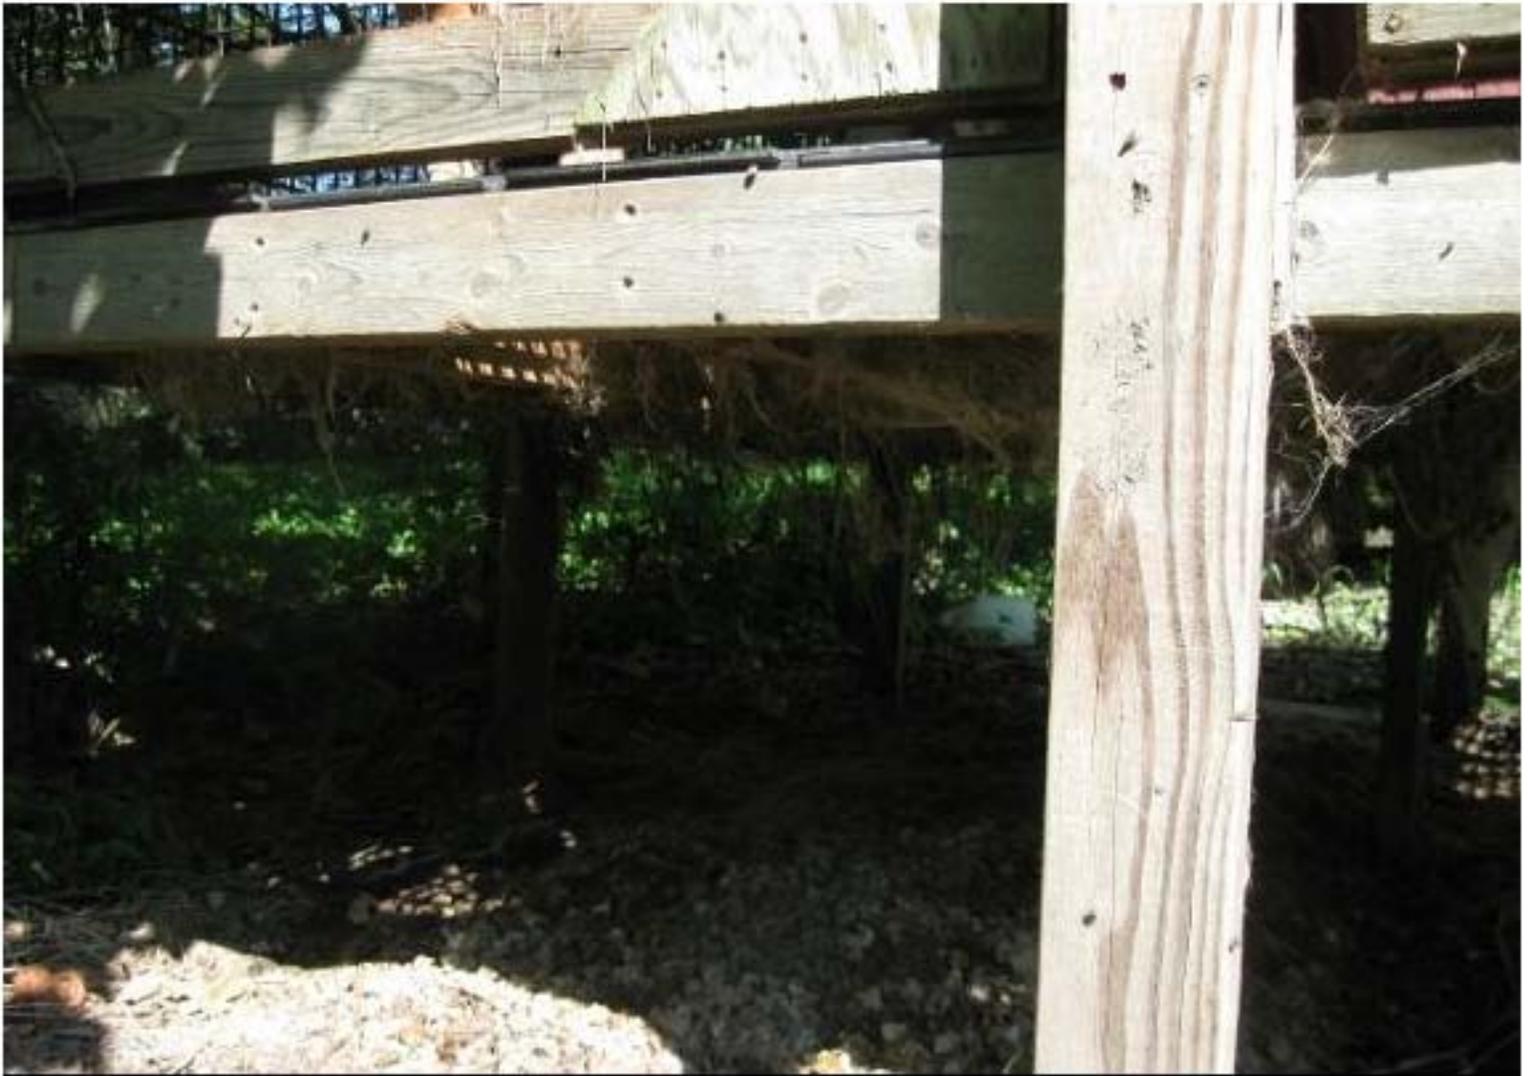
CFR: 3.11 (a)

Photographer:	John J. Lies, ACI	Legal Name:	Registration:	42-A-1238
Photo Taken:	Wed, Aug 25, '10 P.M.	CATHY SPEER		
Inspection:	238101248530491			
Description:	3.11 (a) Cleaning: Primary enclosures need to be cleaned to remove dirt, debris, hair from around the enclosures and excreta from under the enclosures.

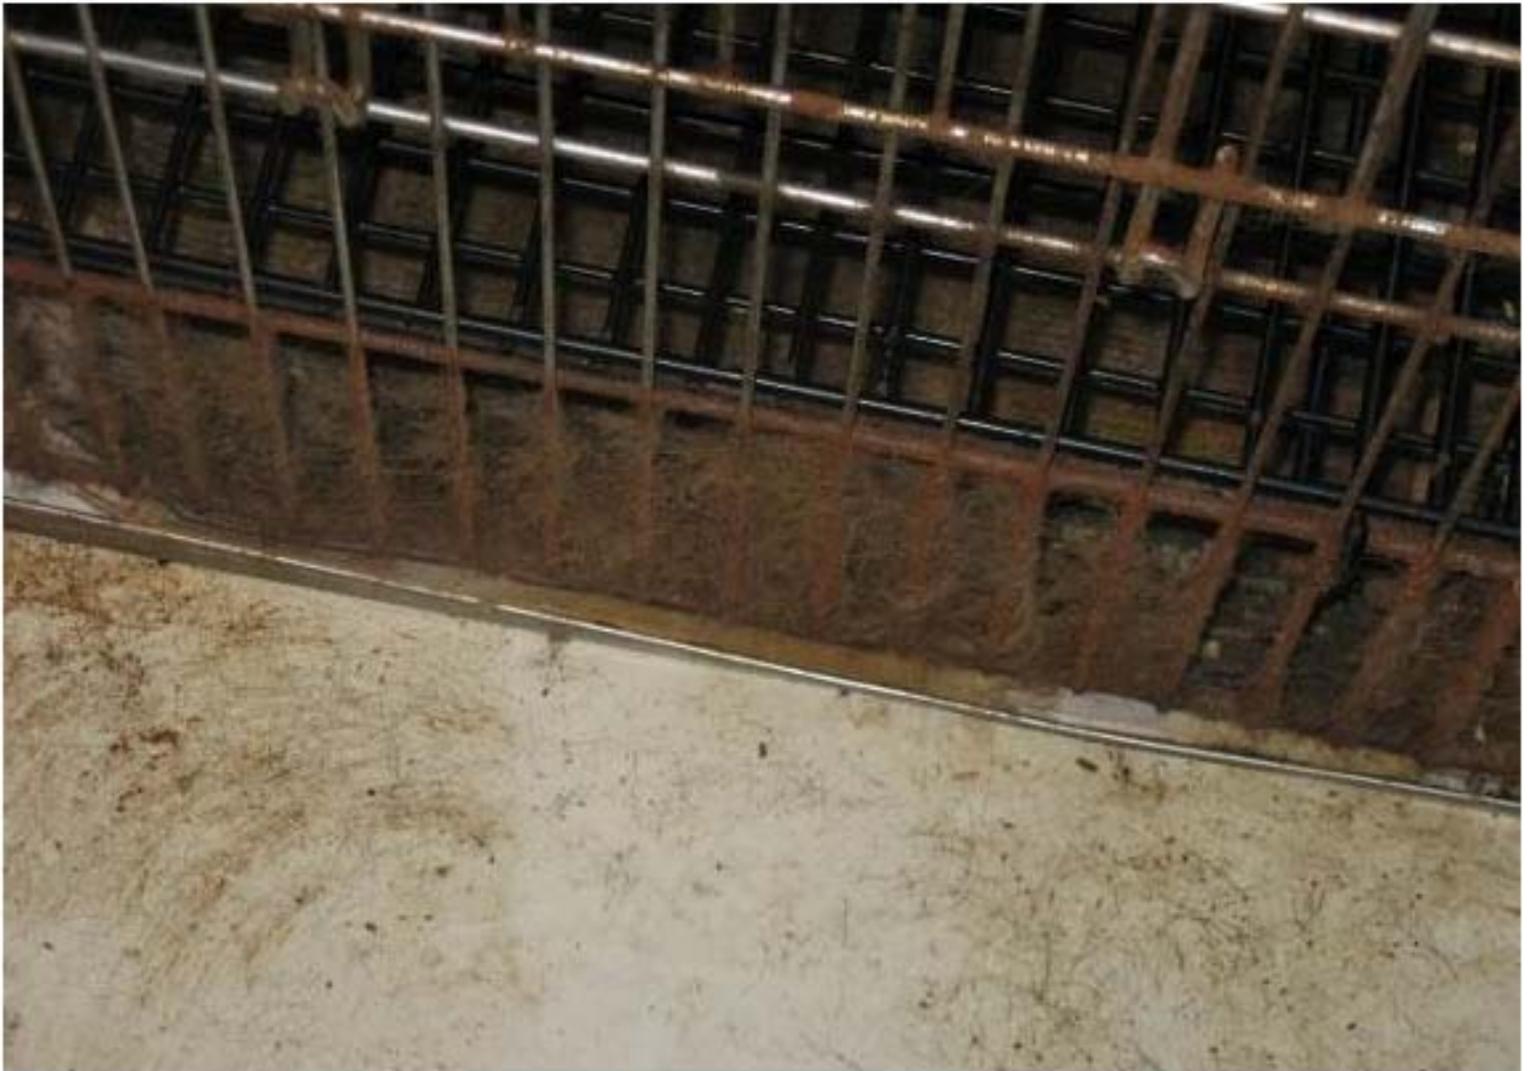
CFR: 3.1 (c) (3)

Photographer:	John J. Lies, ACI	Legal Name:	Registration:	42-A-1238
Photo Taken:	Wed, Aug 25, '10 P.M.	CATHY SPEER		
Inspection:	238101248530491			
Description:	3.1 (c)(3) Housing Facilities Cleaning: Hair, dirt, grime, excreta. Needs to be removed from floors, walls and fronts of the enclosures inside of the building.

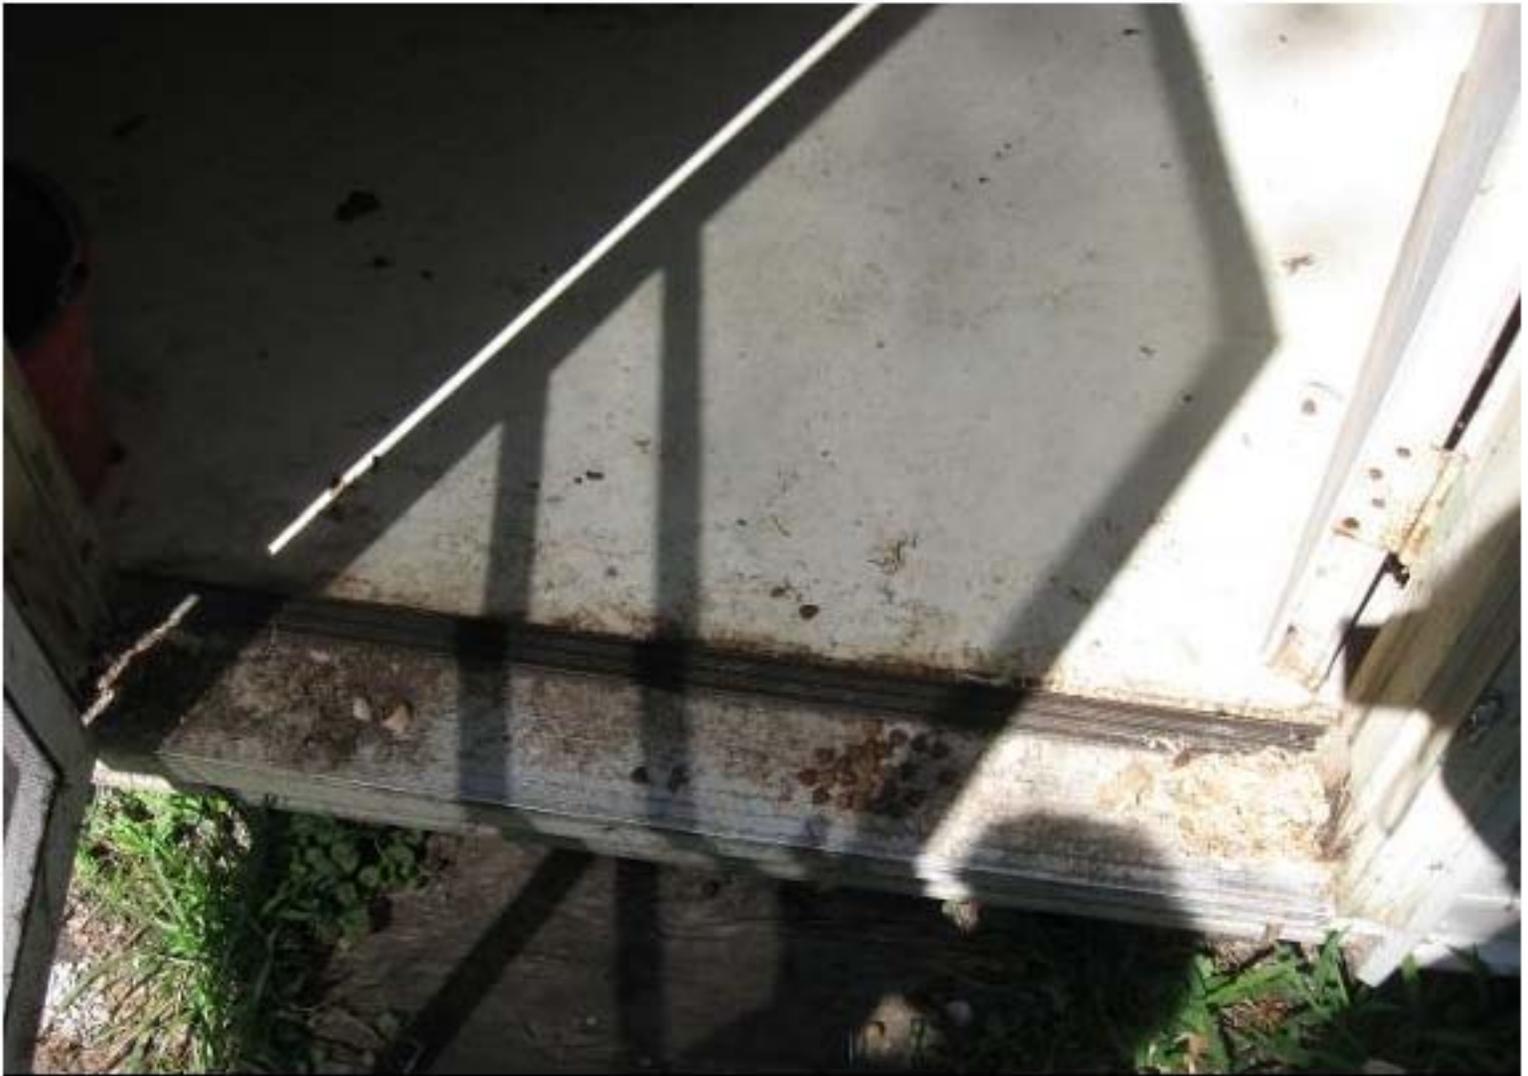
CFR: 3.1 (c) (3)

Photographer:	John J. Lies, ACI	Legal Name:	Registration:	42-A-1238
Photo Taken:	Wed, Aug 25, '10 P.M.	CATHY SPEER		
Inspection:	238101248530491			
Description:	3.1 (c)(3) Housing Facilities Cleaning: Hair, dirt, grime, excreta. Needs to be removed from floors, walls and fronts of the enclosures inside of the building.

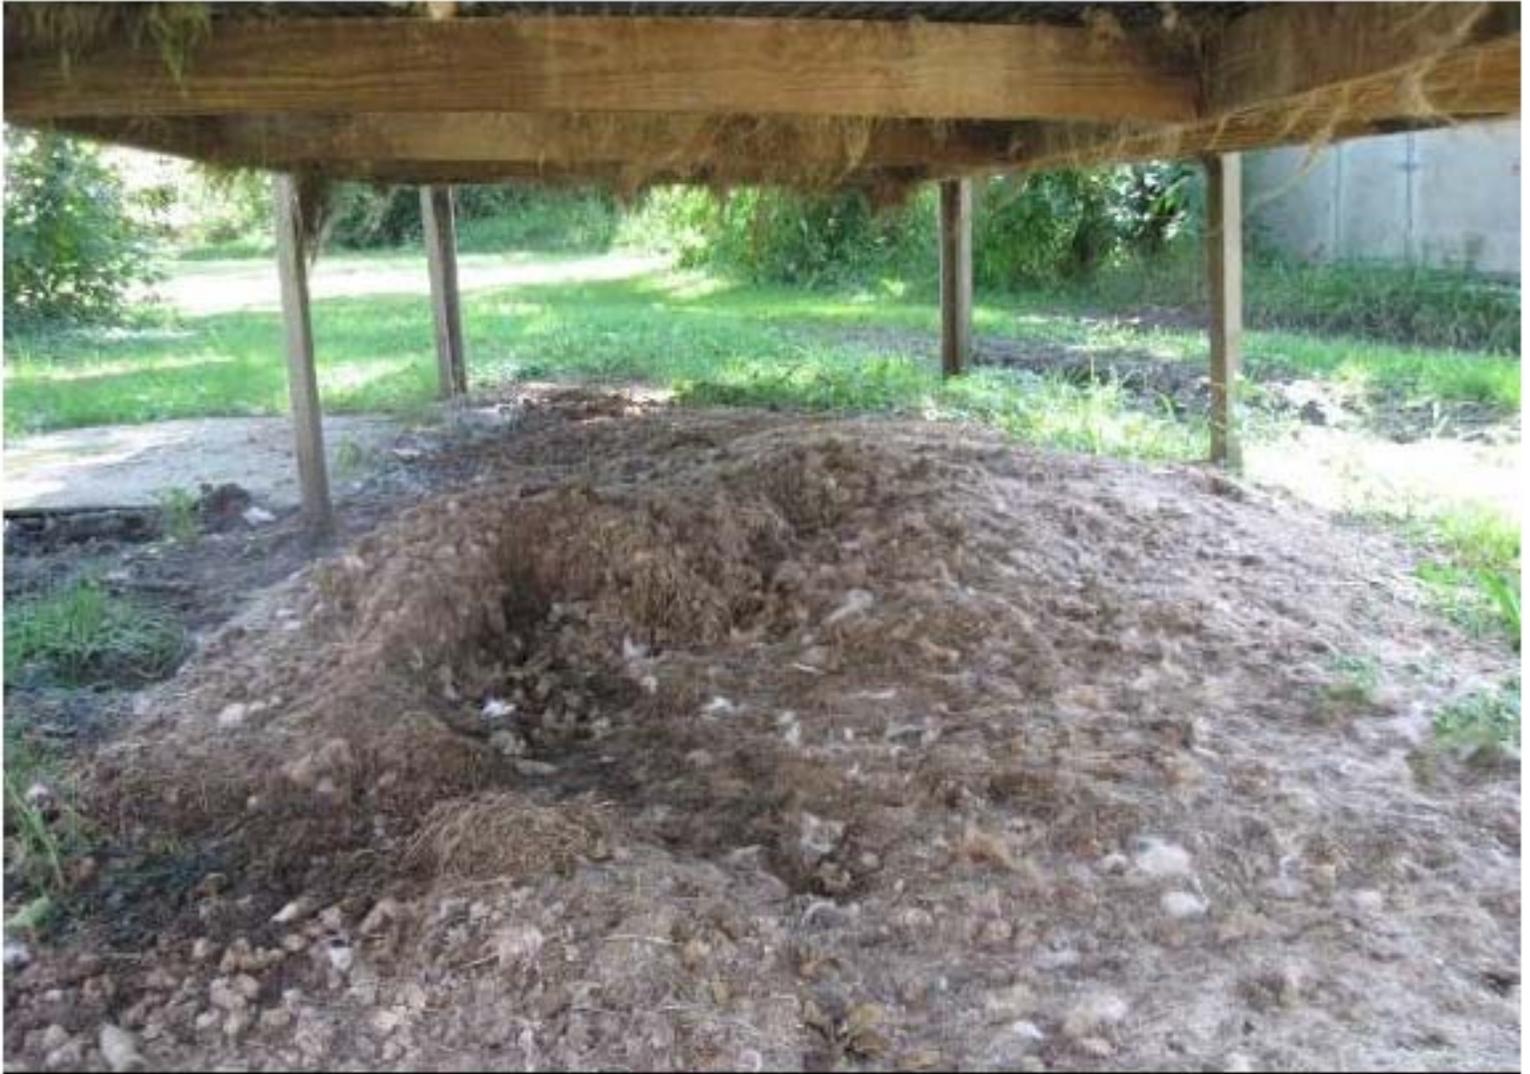
CFR: 3.11 (a)

Photographer:	John J. Lies, ACI	Legal Name:	Registration:	42-A-1238
Photo Taken:	Wed, Aug 25, '10 P.M.	CATHY SPEER		
Inspection:	238101248530491			
Description:	3.11 (a) Cleaning: Primary enclosures need to be cleaned to remove dirt, debris, hair from around the enclosures and excreta from under the enclosures.

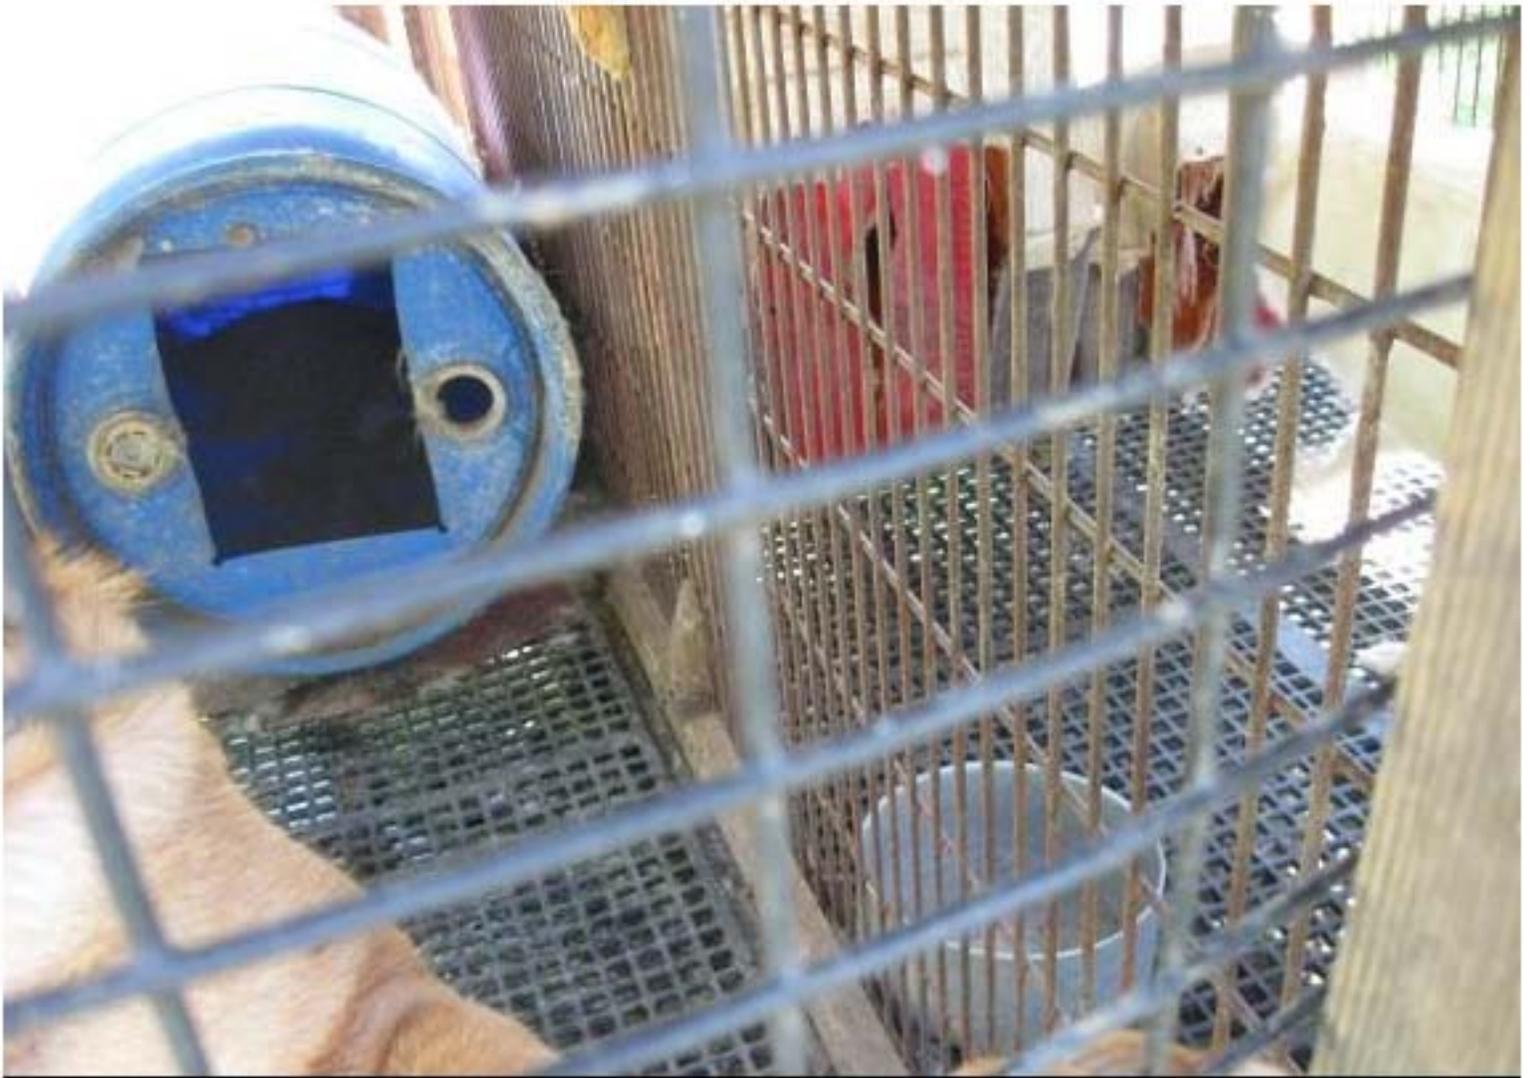
CFR: 3.4 (b) (3), 3.11 (a) (2)

Photographer:	John J. Lies, ACI	Legal Name:	Registration:	42-A-1238
Photo Taken:	Wed, Aug 25, '10 P.M.	CATHY SPEER		
Inspection:	238101248530491			
Description:	3.4 (b)(3) Outdoor housing: No wind/rain break. 3.11 (a)(2) Cleaning: Shelter and hard surfaces need to be sanitized.

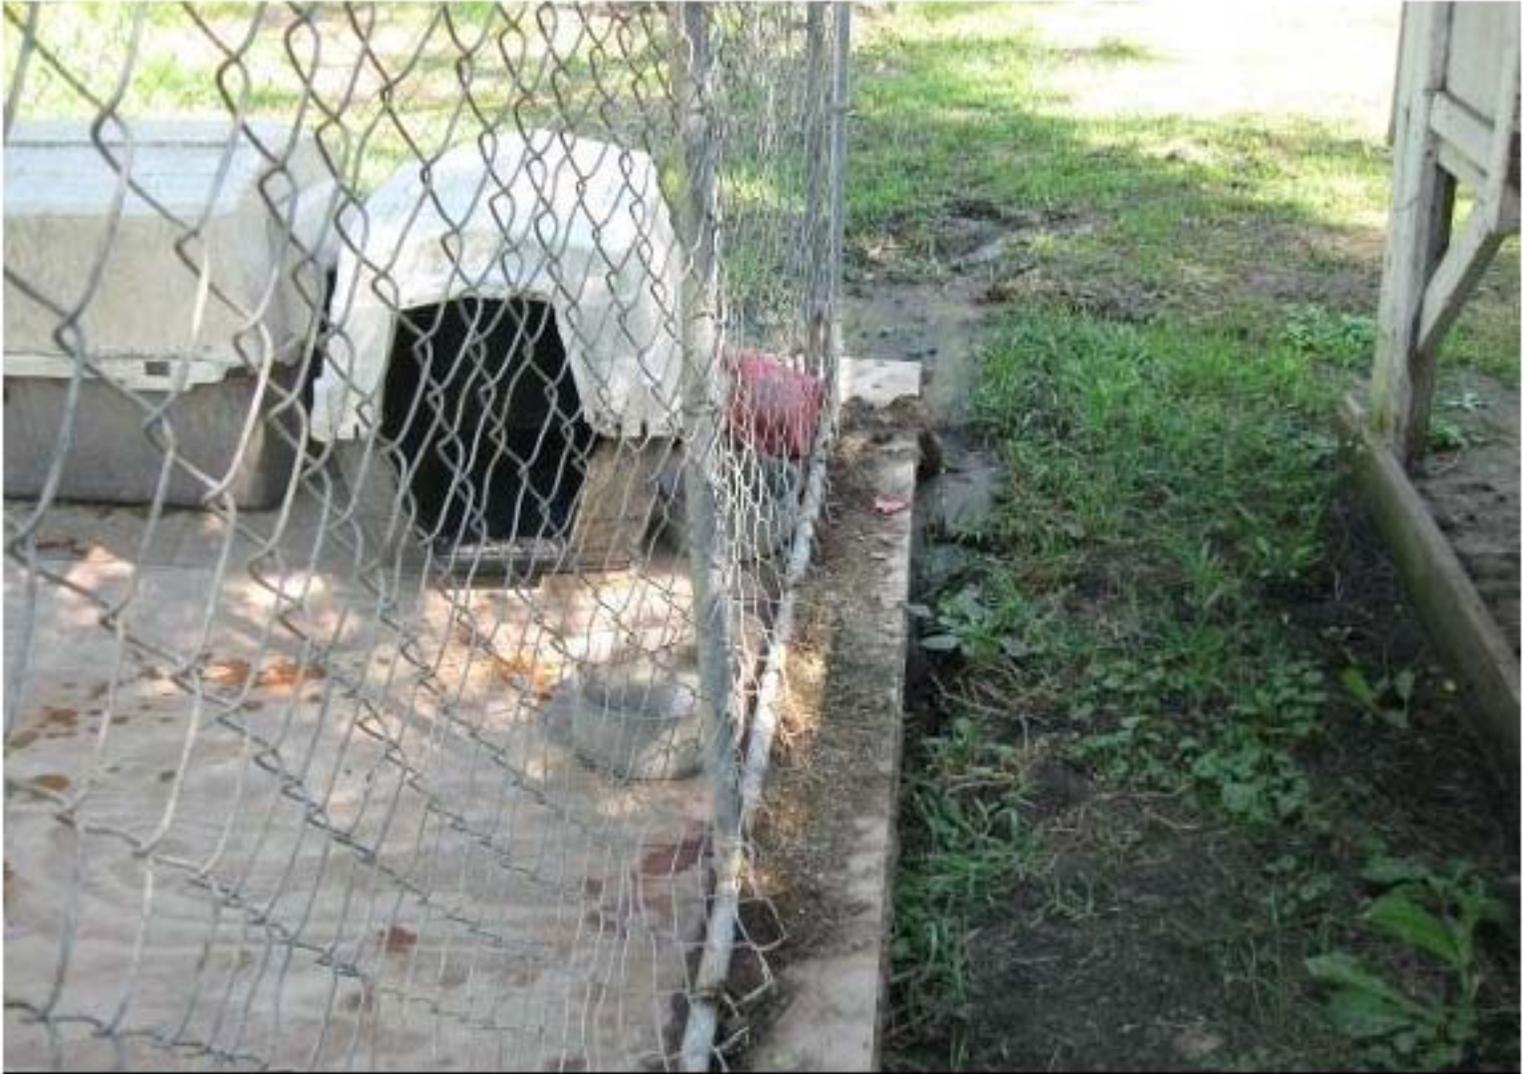
CFR: 3.1 (f)

Photographer:	John J. Lies, ACI	Legal Name:	Registration:	42-A-1238
Photo Taken:	Wed, Aug 25, '10 P.M.	CATHY SPEER		
Inspection:	238101248530491			
Description:	3.1 (f) General Housing Waste Disposal: Excreta, hair, food waste around the enclosures needs to be removed.

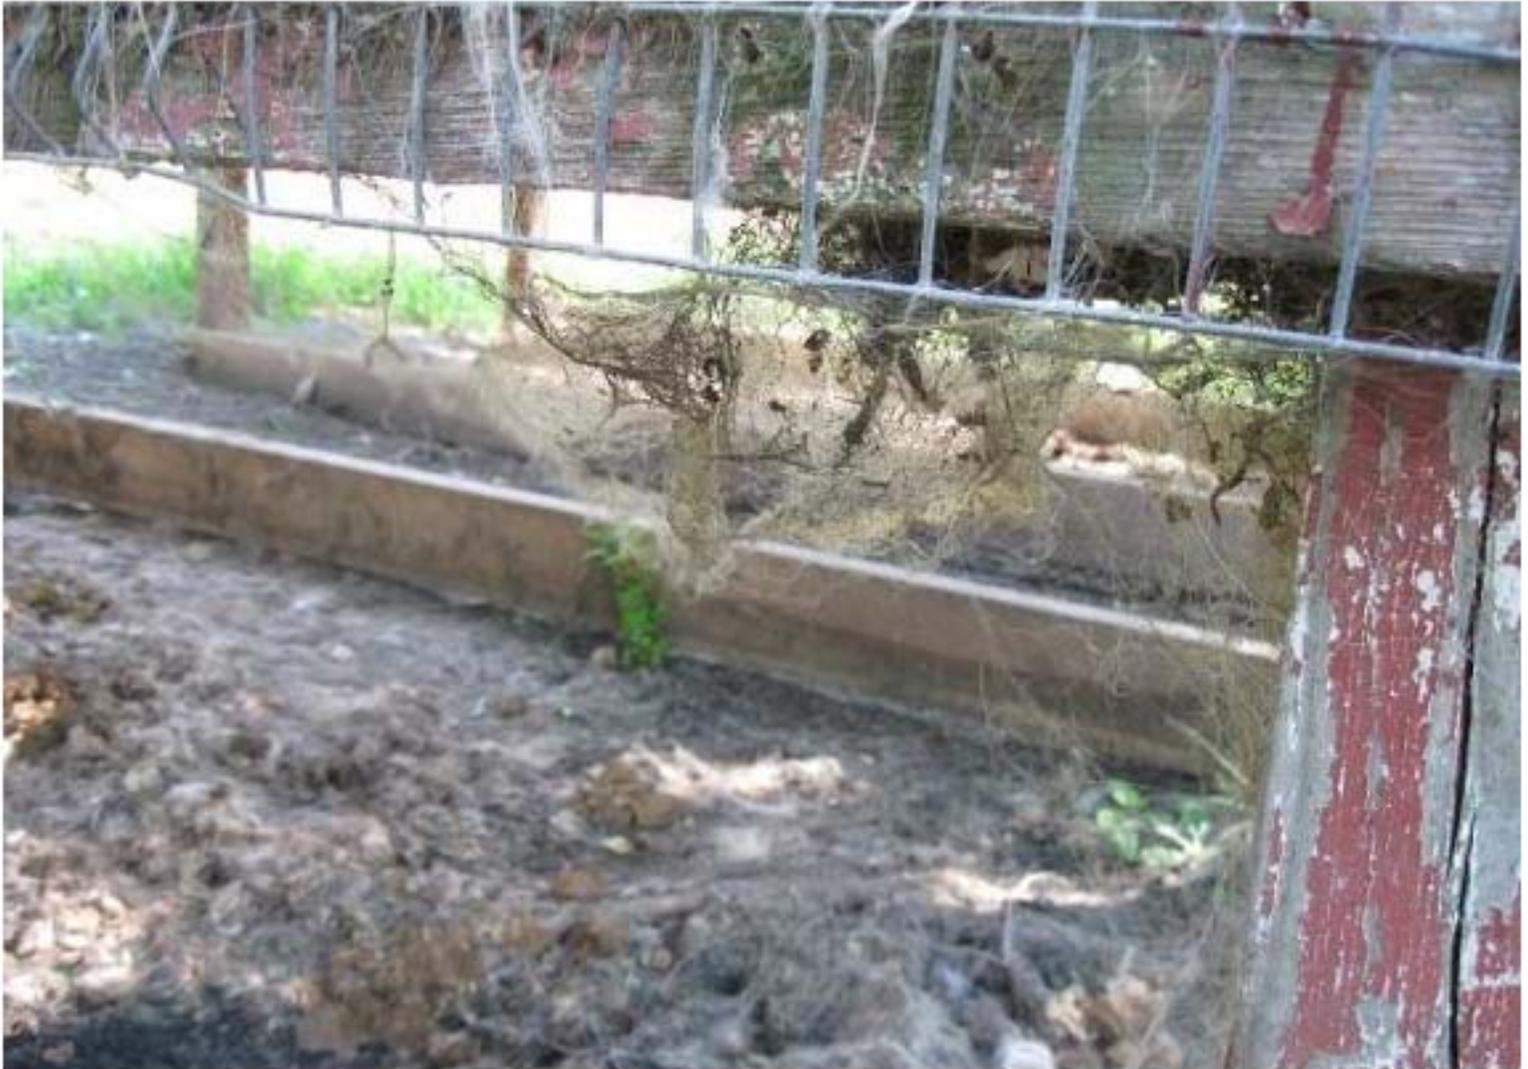
CFR: 3.11 (a)

Photographer:	John J. Lies, ACI	Legal Name:	Registration:	42-A-1238
Photo Taken:	Wed, Aug 25, '10 P.M.	CATHY SPEER		
Inspection:	238101248530491			
Description:	3.11 (a) Cleaning: Primary enclosures need to be cleaned to remove dirt, debris, hair from around the enclosures and excreta from under the enclosures.

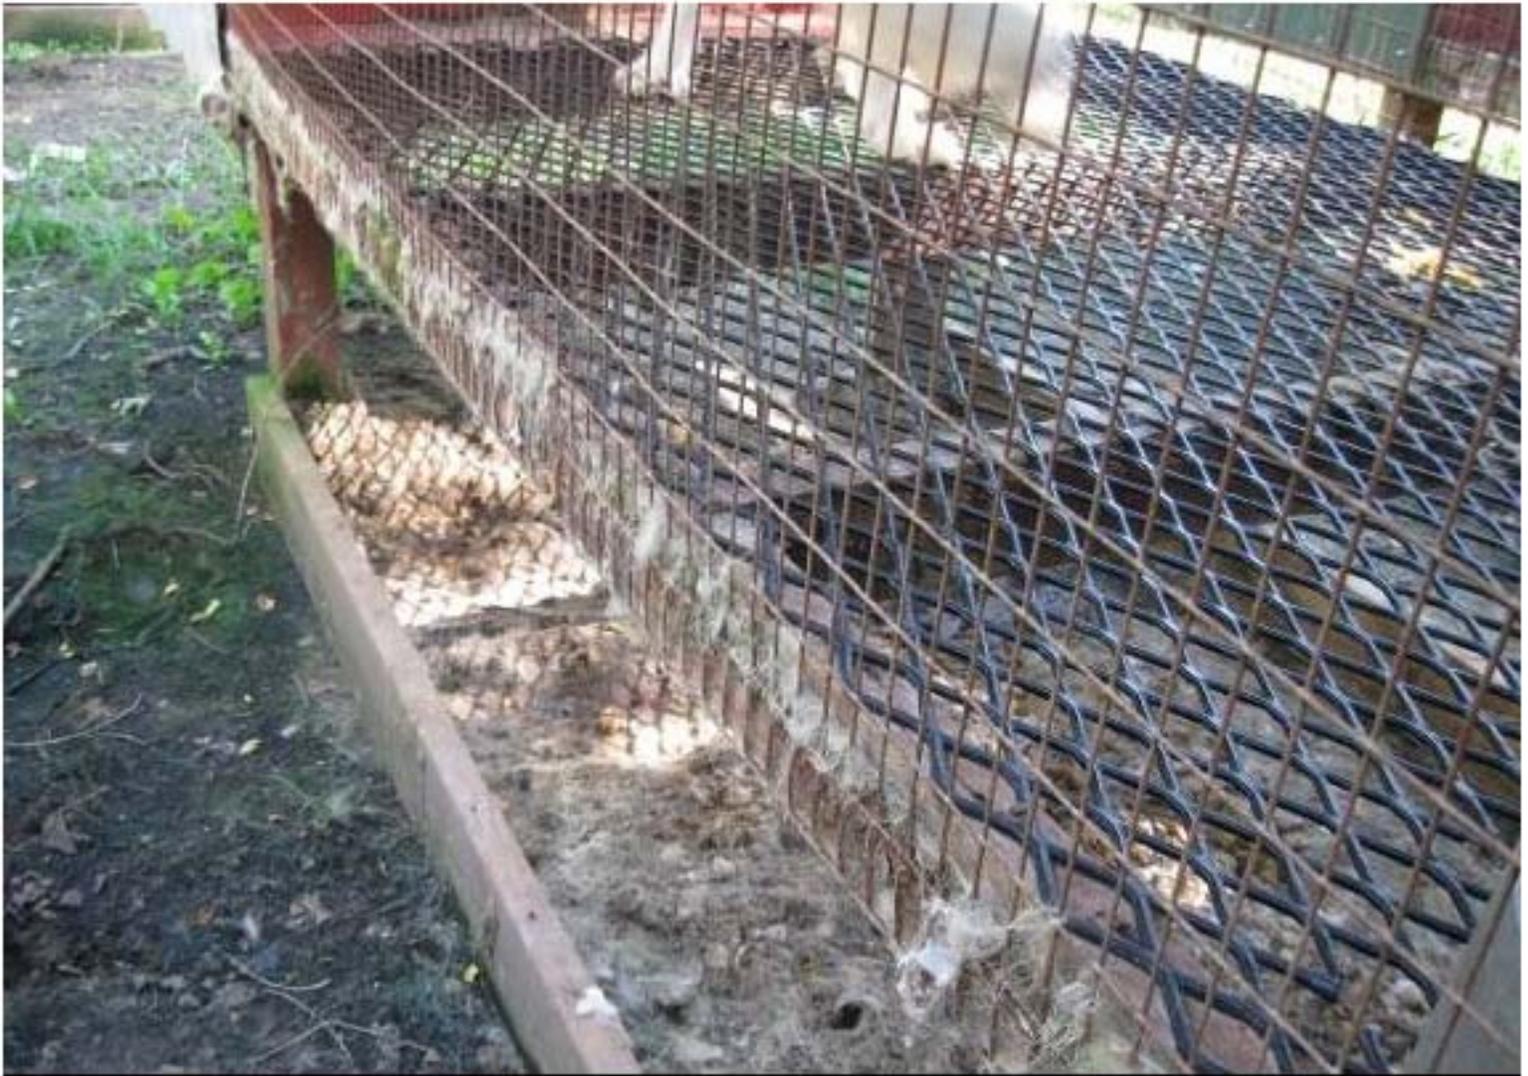
CFR: 3.11 (a)

Photographer:	John J. Lies, ACI	Legal Name:	Registration:	42-A-1238
Photo Taken:	Wed, Aug 25, '10 P.M.	CATHY SPEER		
Inspection:	238101248530491			
Description:	3.11 (a) Cleaning: Primary enclosures need to be cleaned to remove dirt, debris, hair from around the enclosures and excreta from under the enclosures.

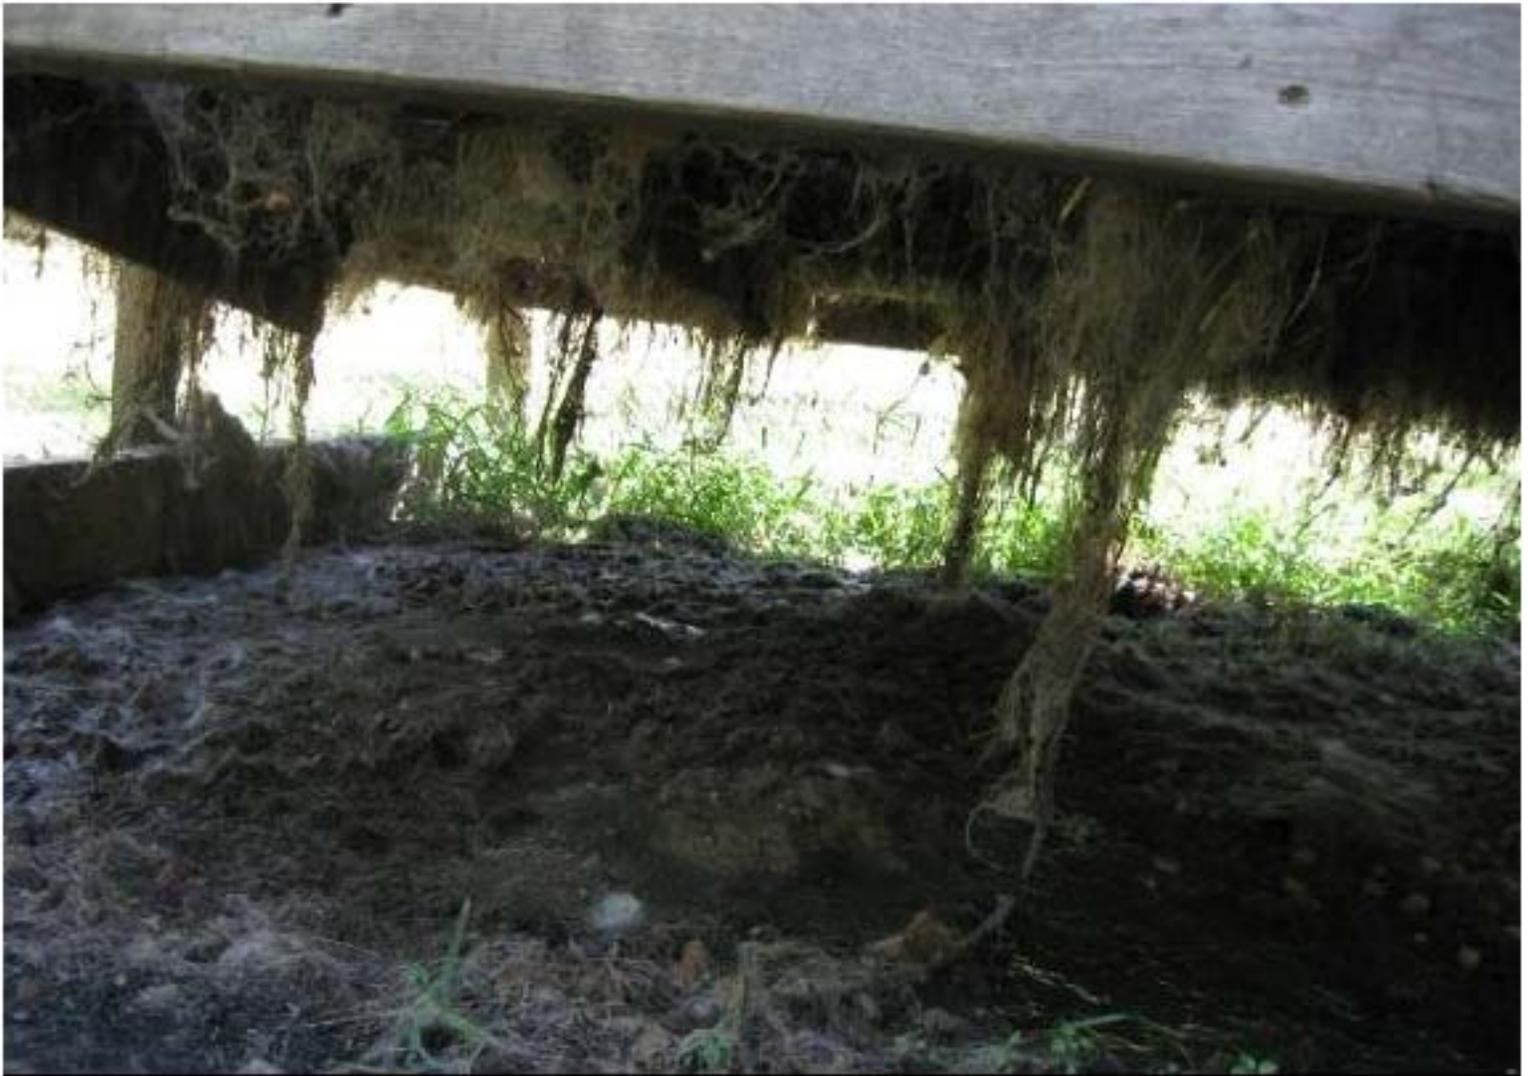
CFR: 3.11 (a)

Photographer:	John J. Lies, ACI	Legal Name:	Registration:	42-A-1238
Photo Taken:	Wed, Aug 25, '10 P.M.	CATHY SPEER		
Inspection:	238101248530491			
Description:	3.11 (a) Cleaning: Primary enclosures need to be cleaned to remove dirt, debris, hair from around the enclosures and excreta from under the enclosures.

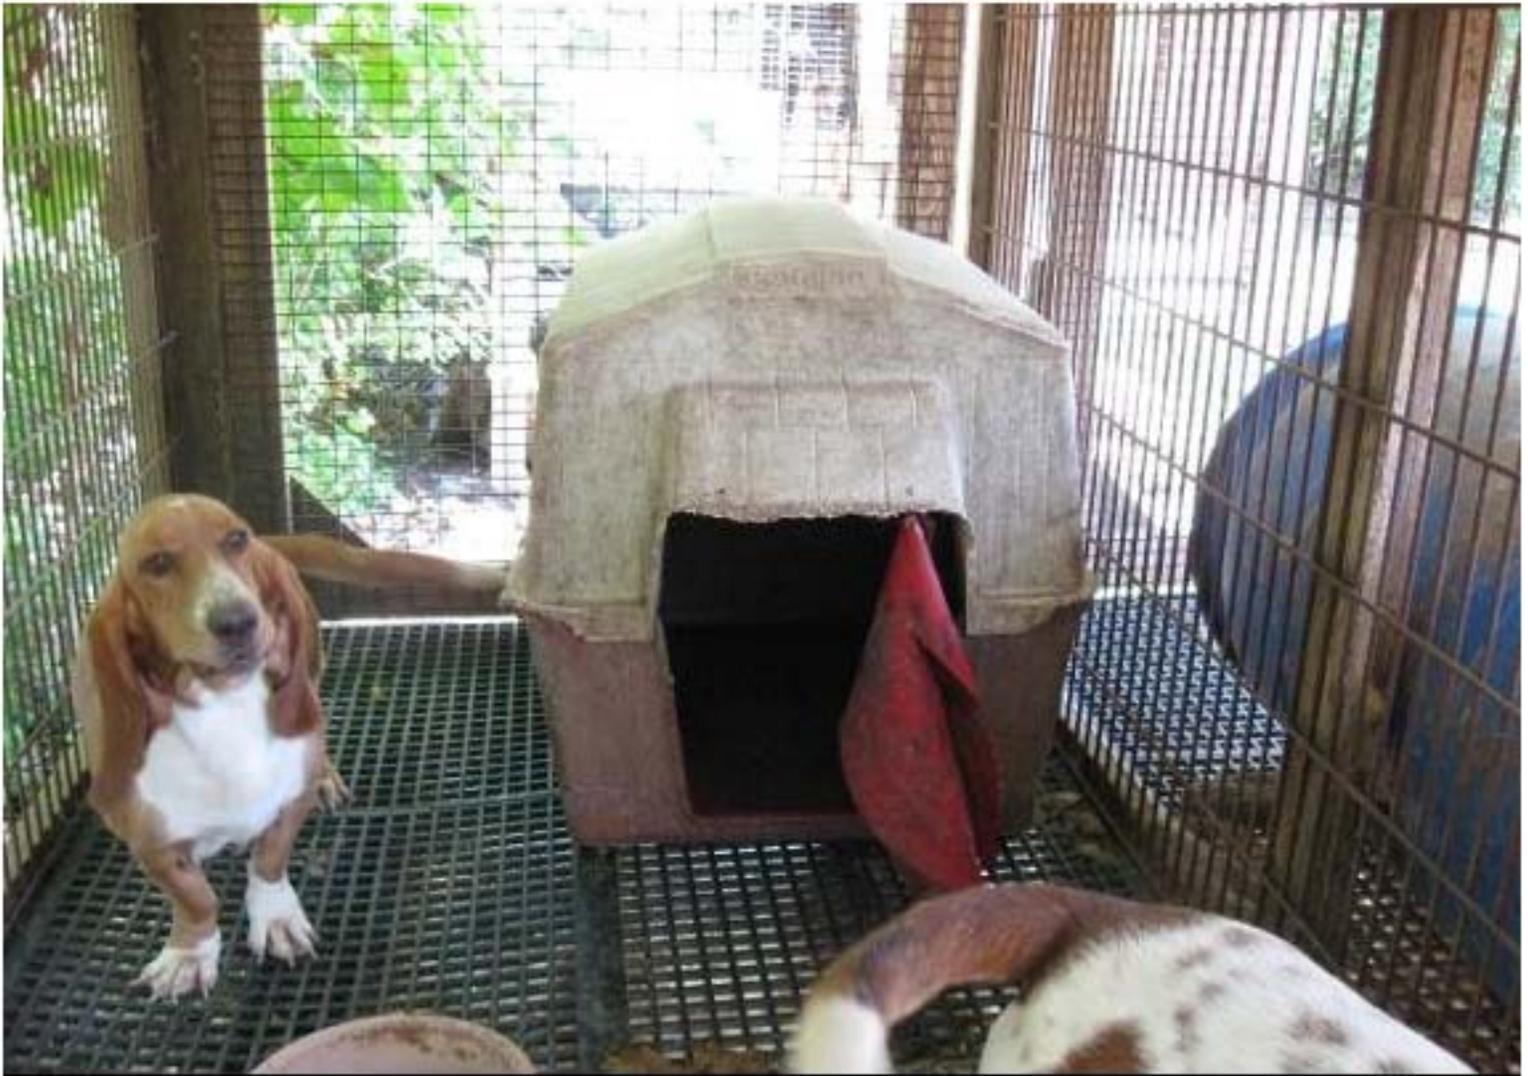
CFR: 3.4 (b) (3), 3.11 (a) (2)

Photographer:	John J. Lies, ACI	Legal Name:	Registration:	42-A-1238
Photo Taken:	Wed, Aug 25, '10 P.M.	CATHY SPEER		
Inspection:	238101248530491			
Description:	3.4 (b)(3) Outdoor housing: No wind/rain break. 3.11 (a)(2) Cleaning: Shelter and hard surfaces need to be sanitized.			FOIA11-282000369

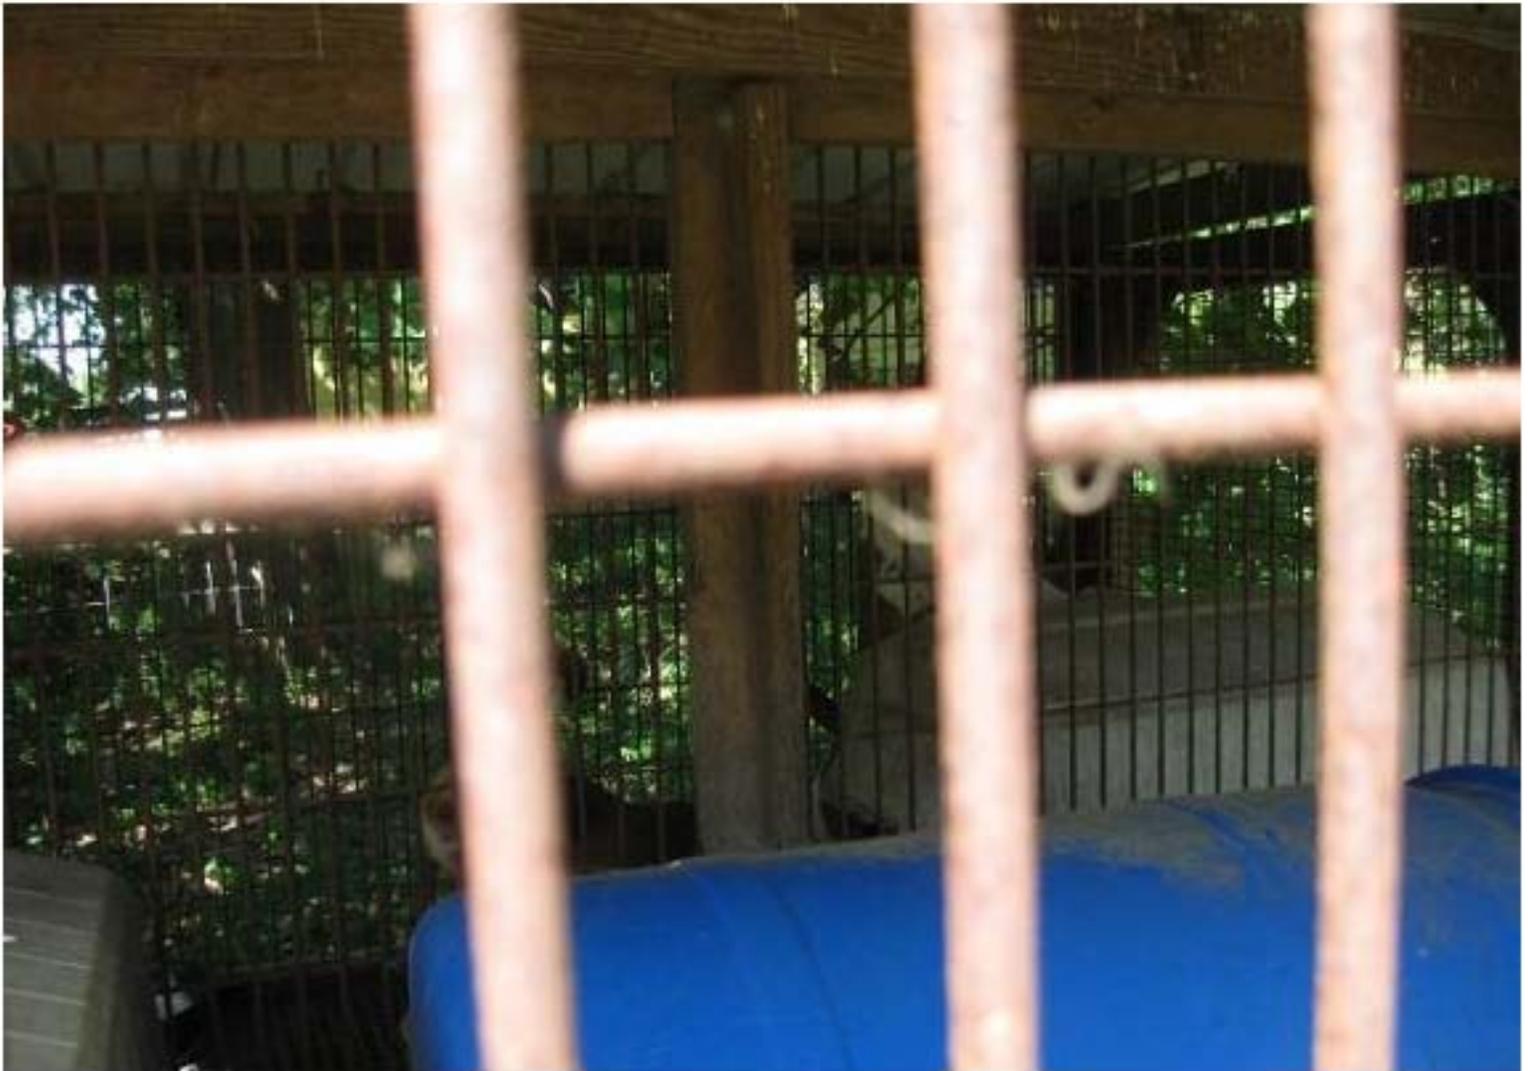
CFR: 3.1 (c) (1) (i)

Photographer:	John J. Lies, ACI	Legal Name:	Registration:	42-A-1238
Photo Taken:	Wed, Aug 25, '10 P.M.	CATHY SPEER		
Inspection:	238101248530491			
Description:	3.1 (c)(1)(i): Housing Facilities General Surfaces: Rust that prevents proper cleaning or affects structural strength.

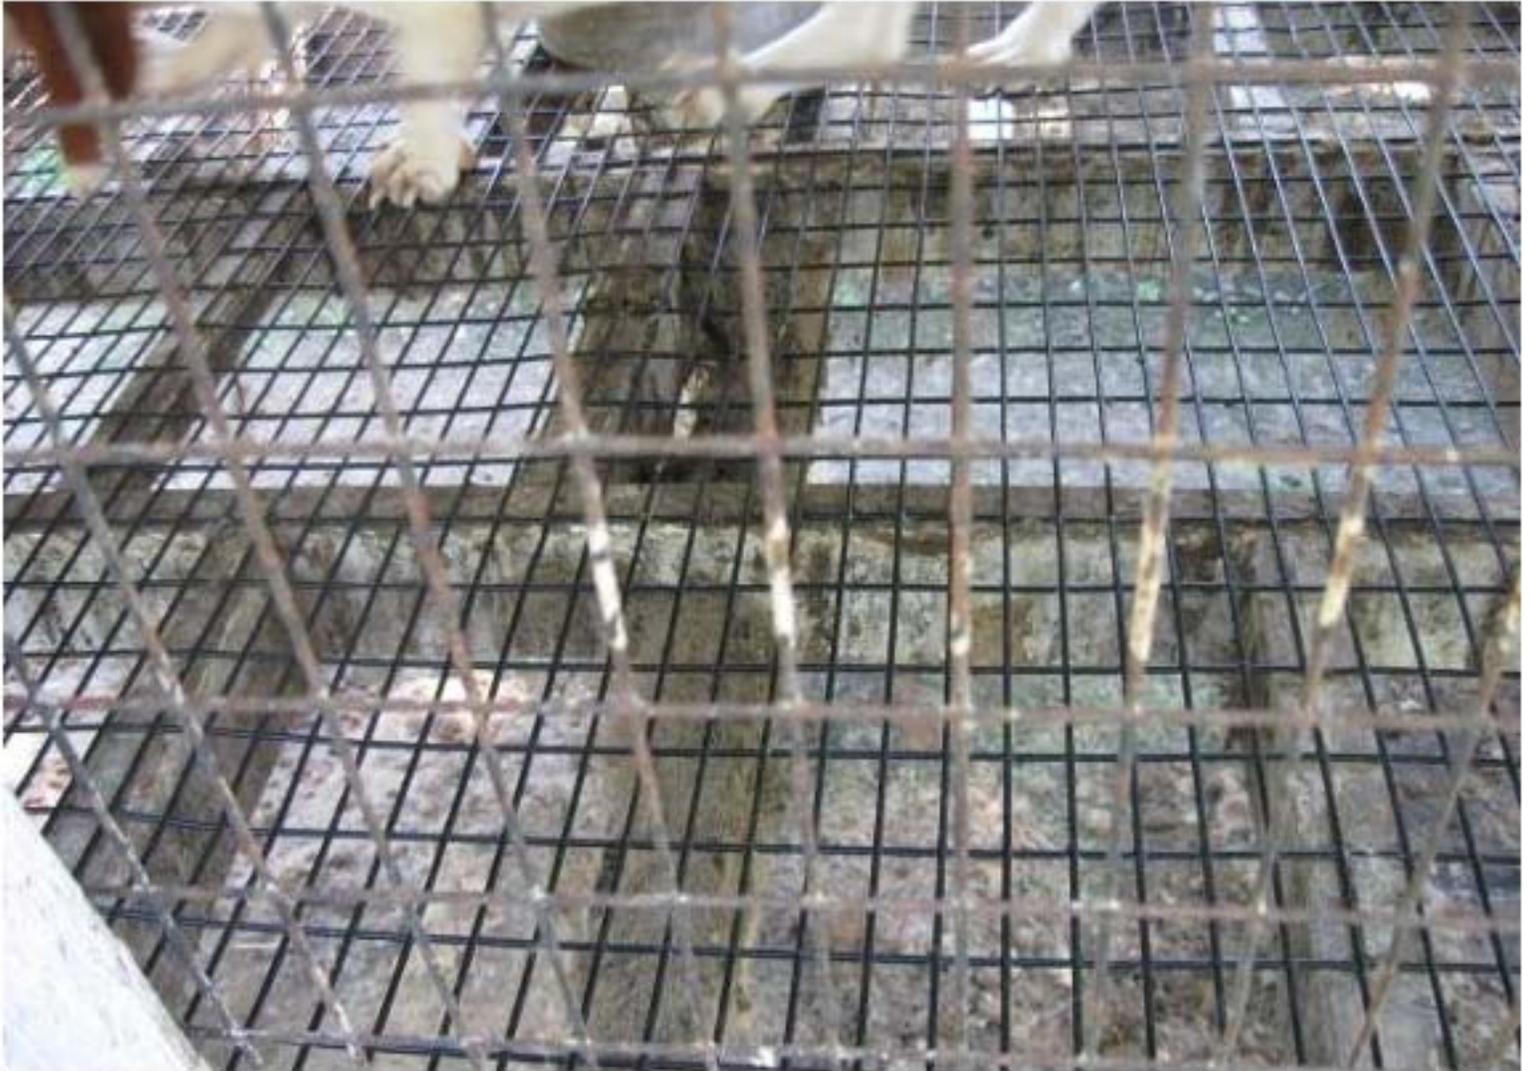
CFR: 3.1 (c) (1) (i)

Photographer:	John J. Lies, ACI	Legal Name:	Registration:	42-A-1238
Photo Taken:	Wed, Aug 25, '10 P.M.	CATHY SPEER		
Inspection:	238101248530491			
Description:	3.1 (c)(1)(i) Housing facilities General Surfaces with excessive rust that prevents proper cleaning and/or affects structural strength.

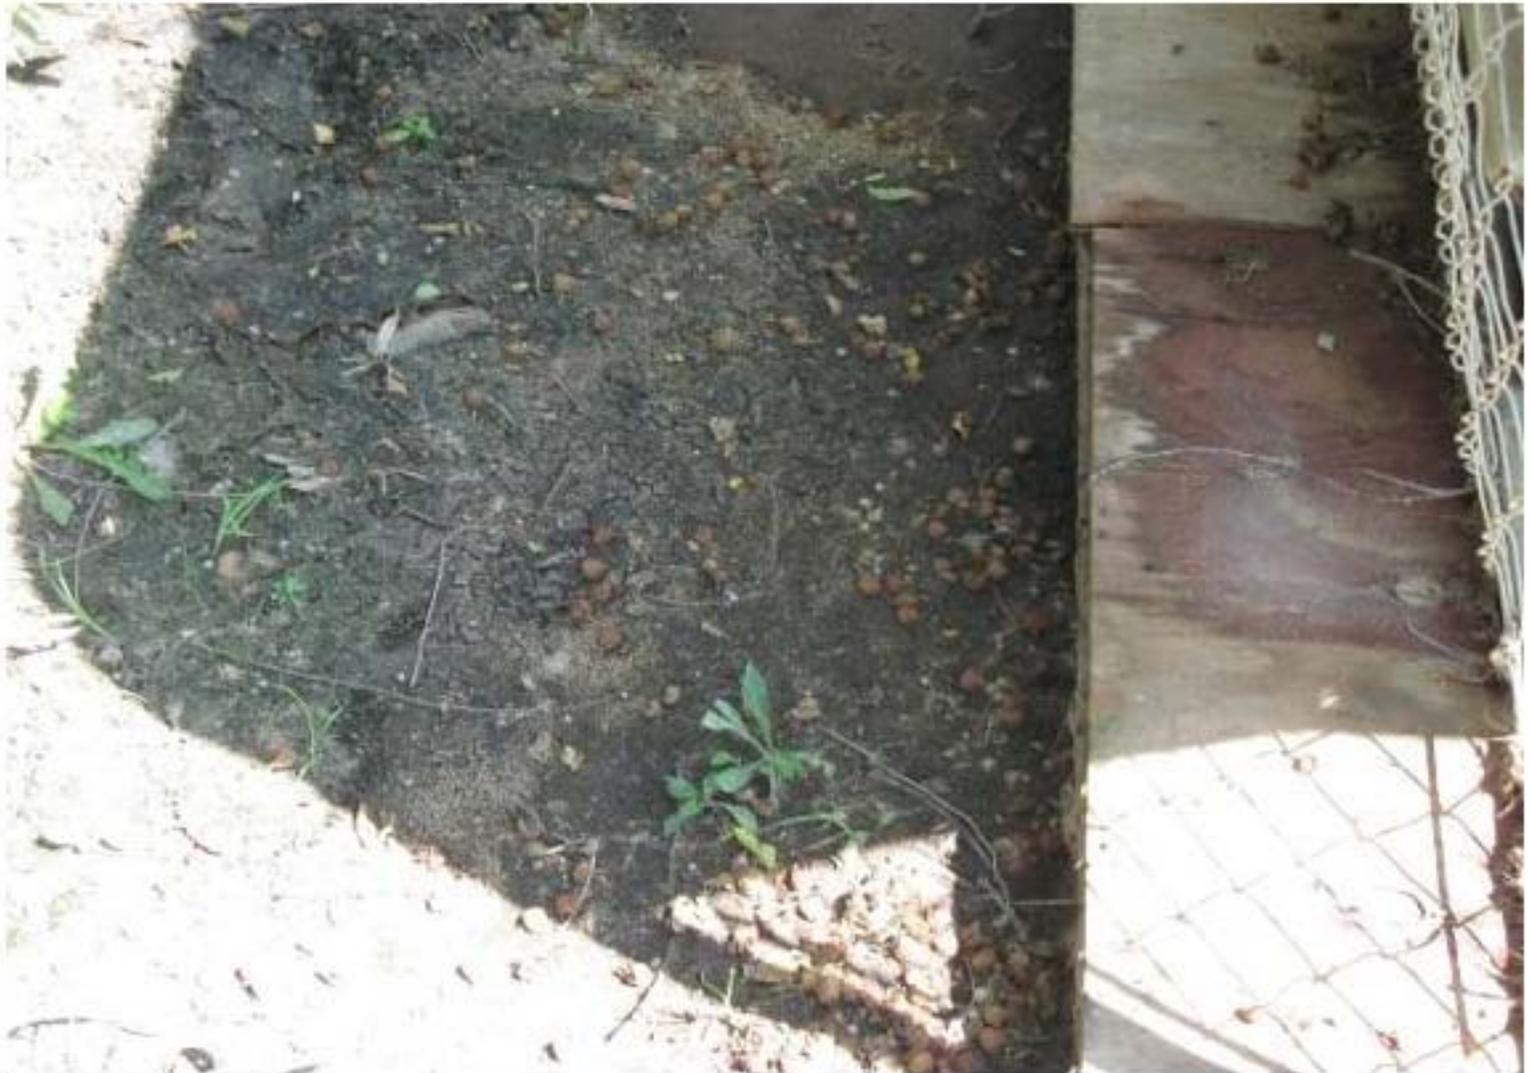
CFR: 3.1 (f)

Photographer:	John J. Lies, ACI	Legal Name:	Registration:	42-A-1238
Photo Taken:	Wed, Aug 25, '10 P.M.	CATHY SPEER		
Inspection:	238101248530491			
Description:	3.1 (f) General Housing Waste Disposal: Excreta, hair, food waste around the enclosures needs to be removed.
