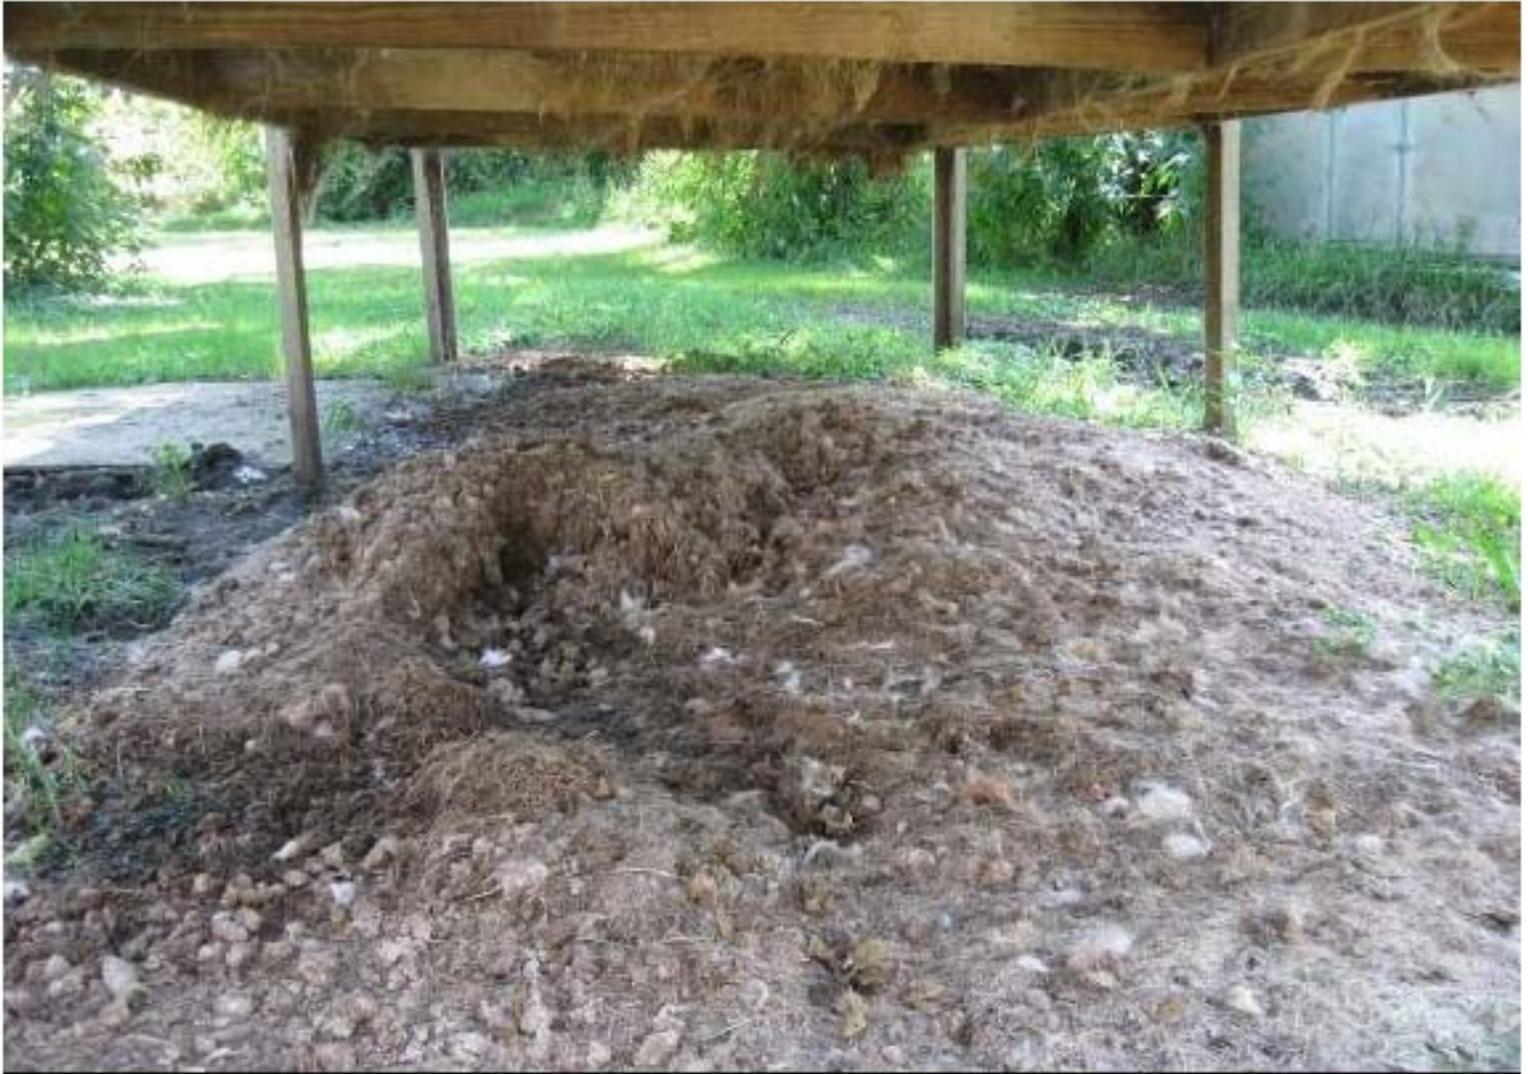
CFR: 3.11 (a)

Photographer:	John J. Lies, ACI	Legal Name:	Registration:	42-A-1238
Photo Taken:	Wed, Aug 25, '10 P.M.	CATHY SPEER		
Inspection:	238101248530491			
Description:	3.11 (a) Cleaning: Primary enclosures need to be cleaned to remove dirt, debris, hair from around the enclosures and excreta from under the enclosures.

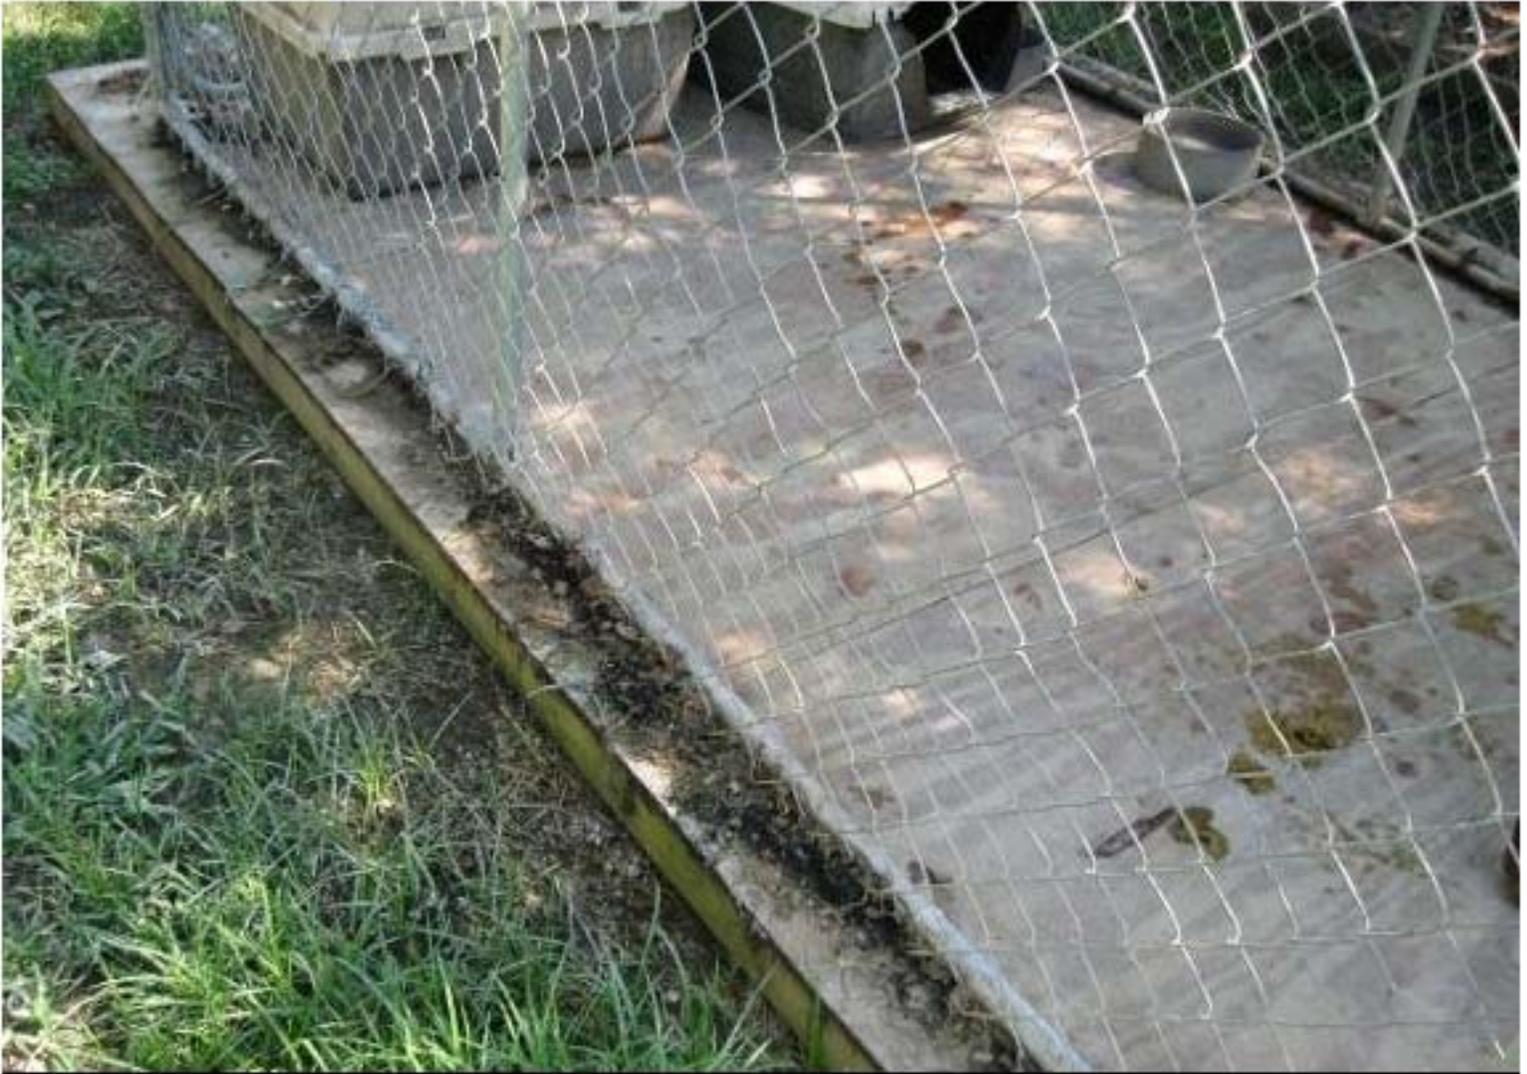
CFR: 3.1 (f)

Photographer:	John J. Lies, ACI	Legal Name:	Registration:	42-A-1238
Photo Taken:	Wed, Aug 25, '10 P.M.	CATHY SPEER		
Inspection:	238101248530491			
Description:	3.1 (f) General Housing Waste Disposal: Excreta, hair, food waste around the enclosures needs to be removed.

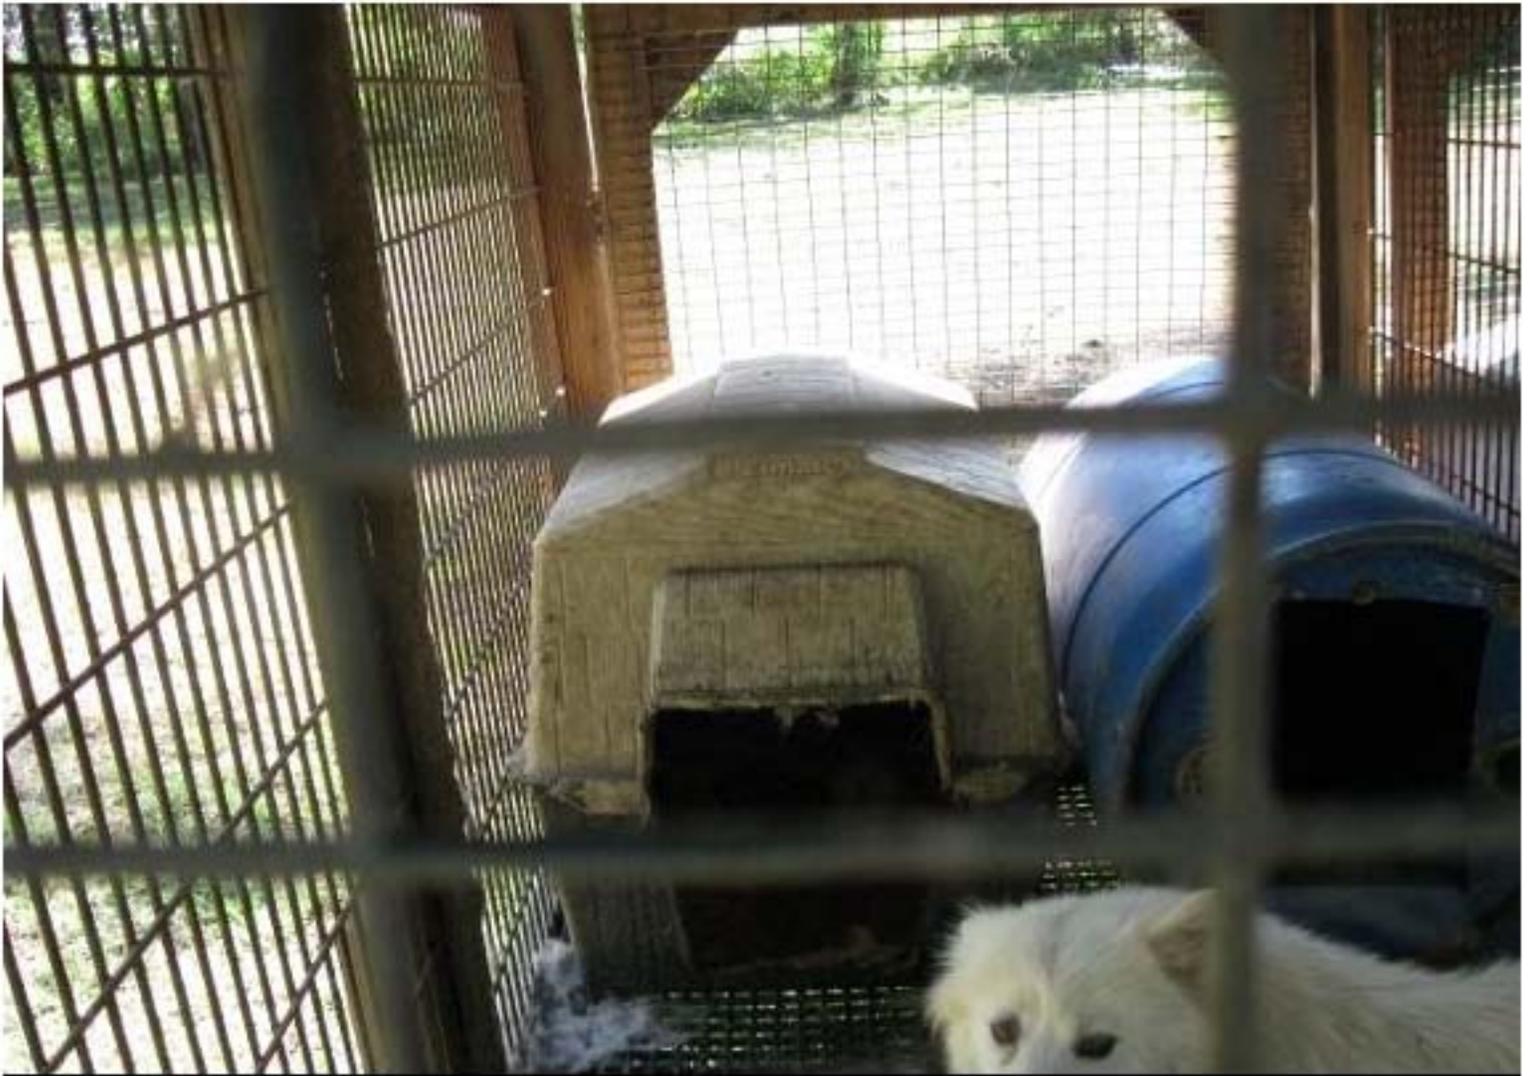
CFR: 3.4 (b) (3), 3.11 (a) (2)

Photographer:	John J. Lies, ACI	Legal Name:	Registration:	42-A-1238
Photo Taken:	Wed, Aug 25, '10 P.M.	CATHY SPEER		
Inspection:	238101248530491			
Description:	3.4 (b)(3) Outdoor housing: No wind/rain break. 3.11 (a)(2) Cleaning: Shelter and hard surfaces need to be sanitized.			FOIA11-282000379

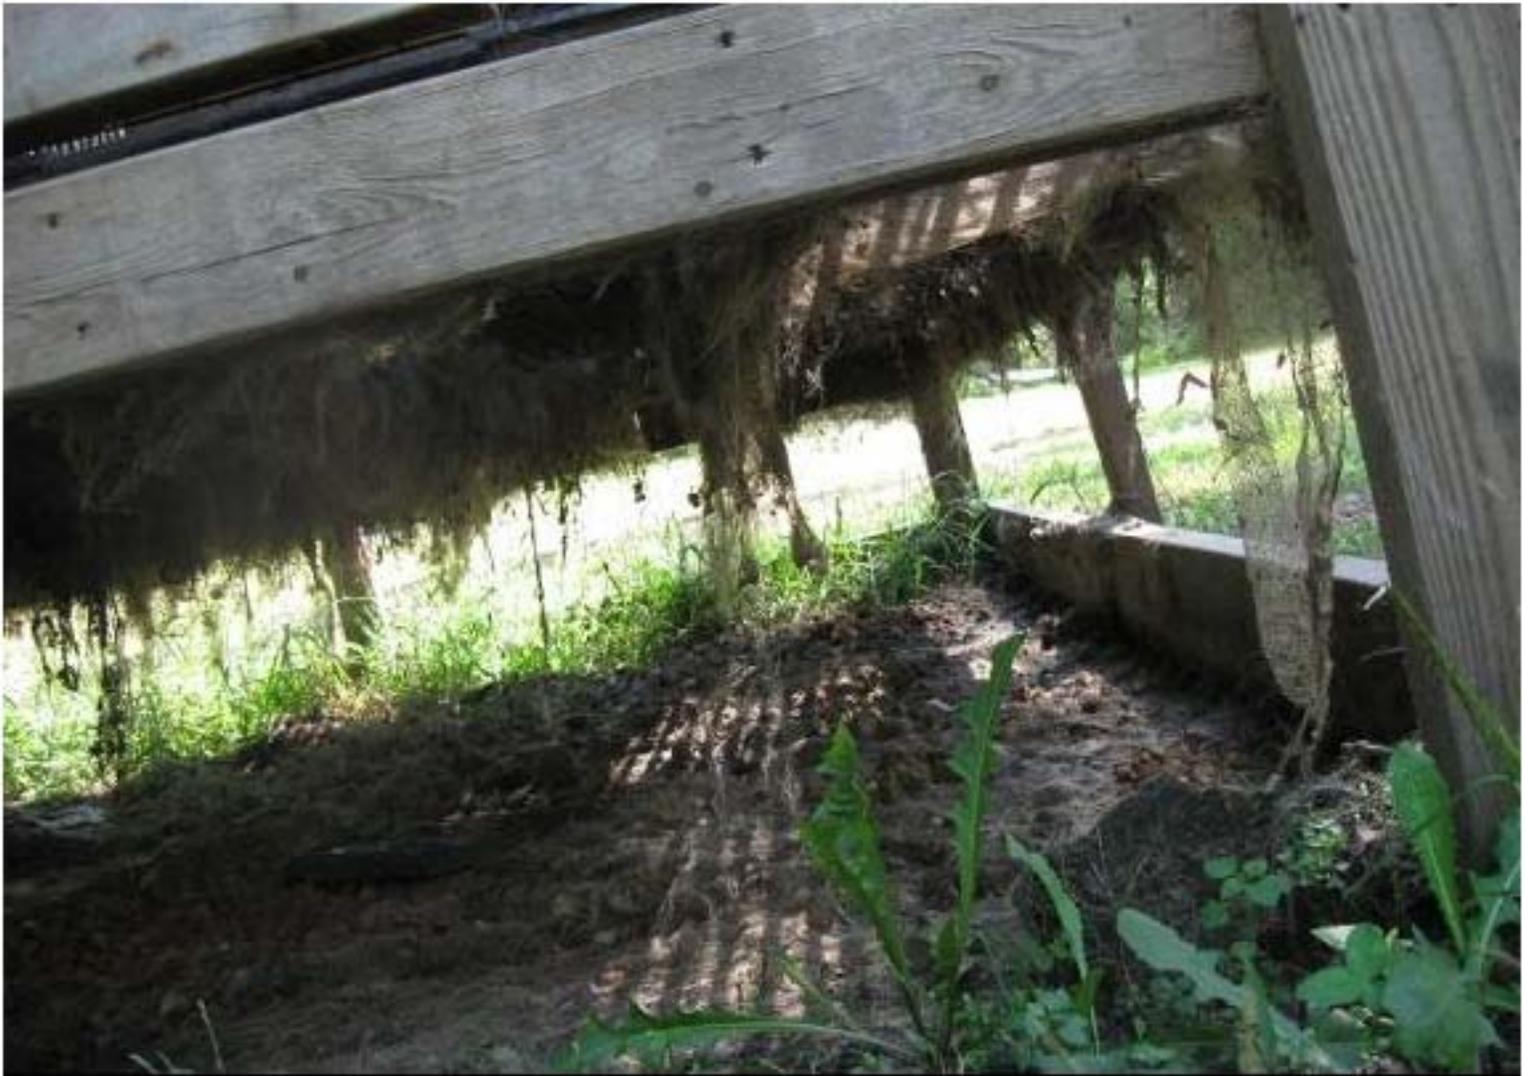
CFR: 3.11 (a)

Photographer:	John J. Lies, ACI	Legal Name:	Registration:	42-A-1238
Photo Taken:	Wed, Aug 25, '10 P.M.	CATHY SPEER		
Inspection:	238101248530491			
Description:	3.11 (a) Cleaning: Primary enclosures need to be cleaned to remove dirt, debris, hair from around the enclosures and excreta from under the enclosures.

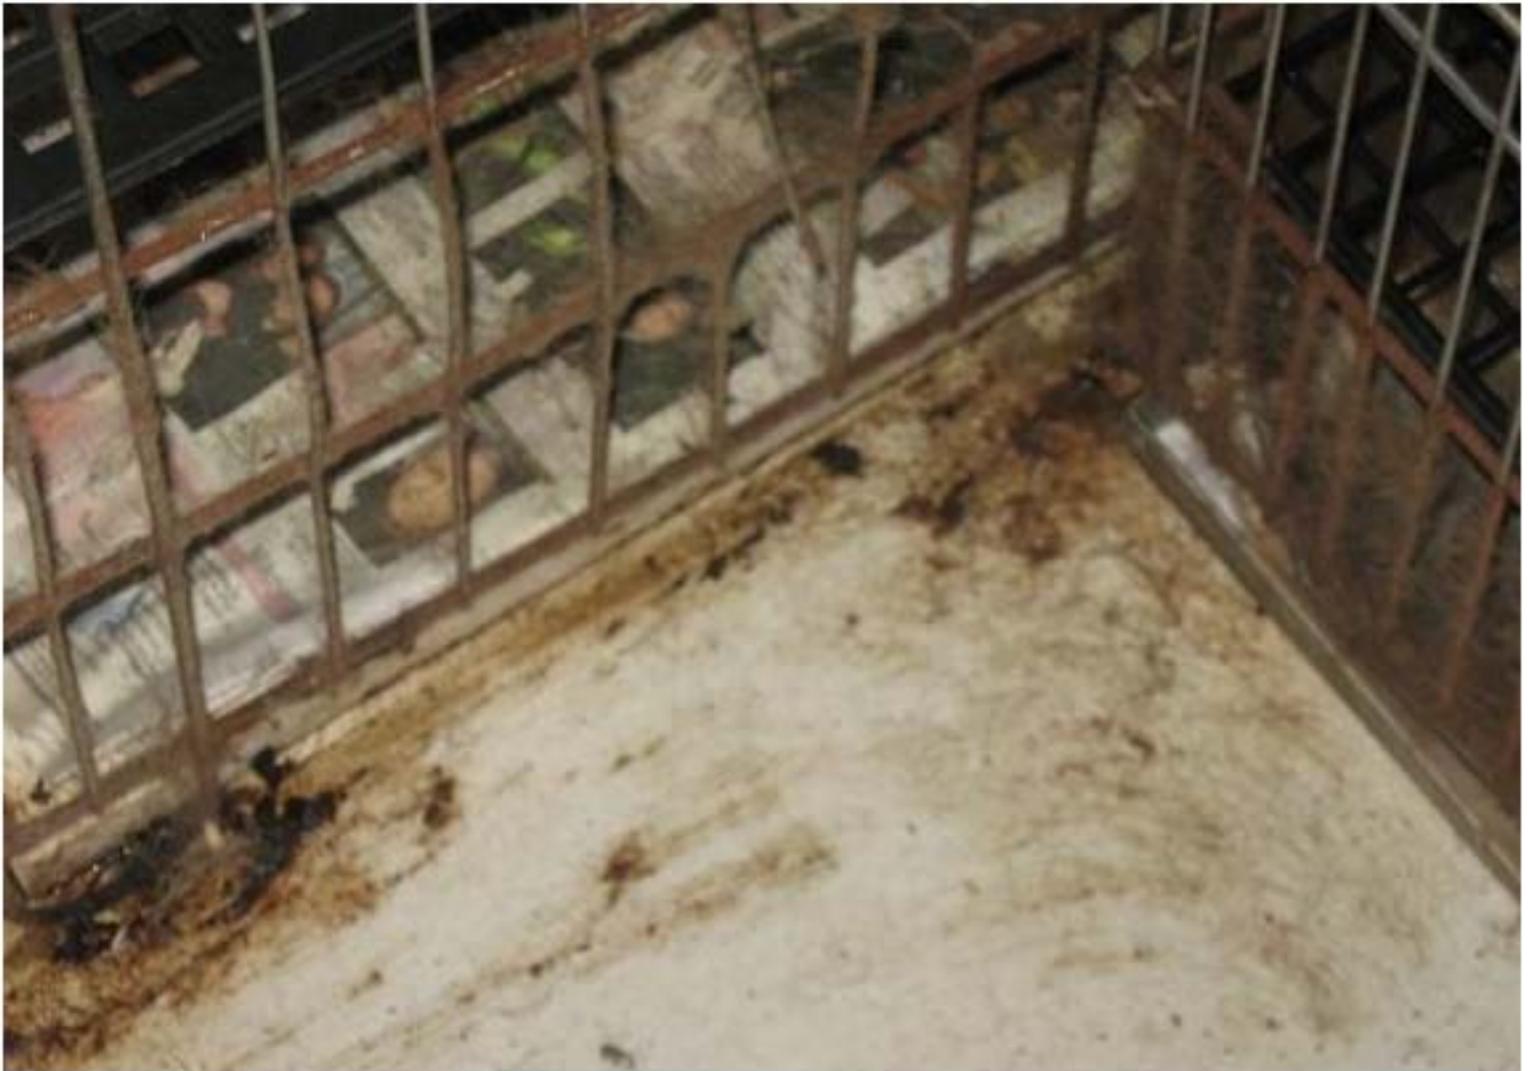
CFR: 3.1 (c) (3)

Photographer:	John J. Lies, ACI	Legal Name:	Registration:	42-A-1238
Photo Taken:	Wed, Aug 25, '10 P.M.	CATHY SPEER		
Inspection:	238101248530491			
Description:	3.1 (c)(3) Housing Facilities Cleaning: Hair, dirt, grime, excreta. Needs to be removed from floors, walls and fronts of the enclosures inside of the building.

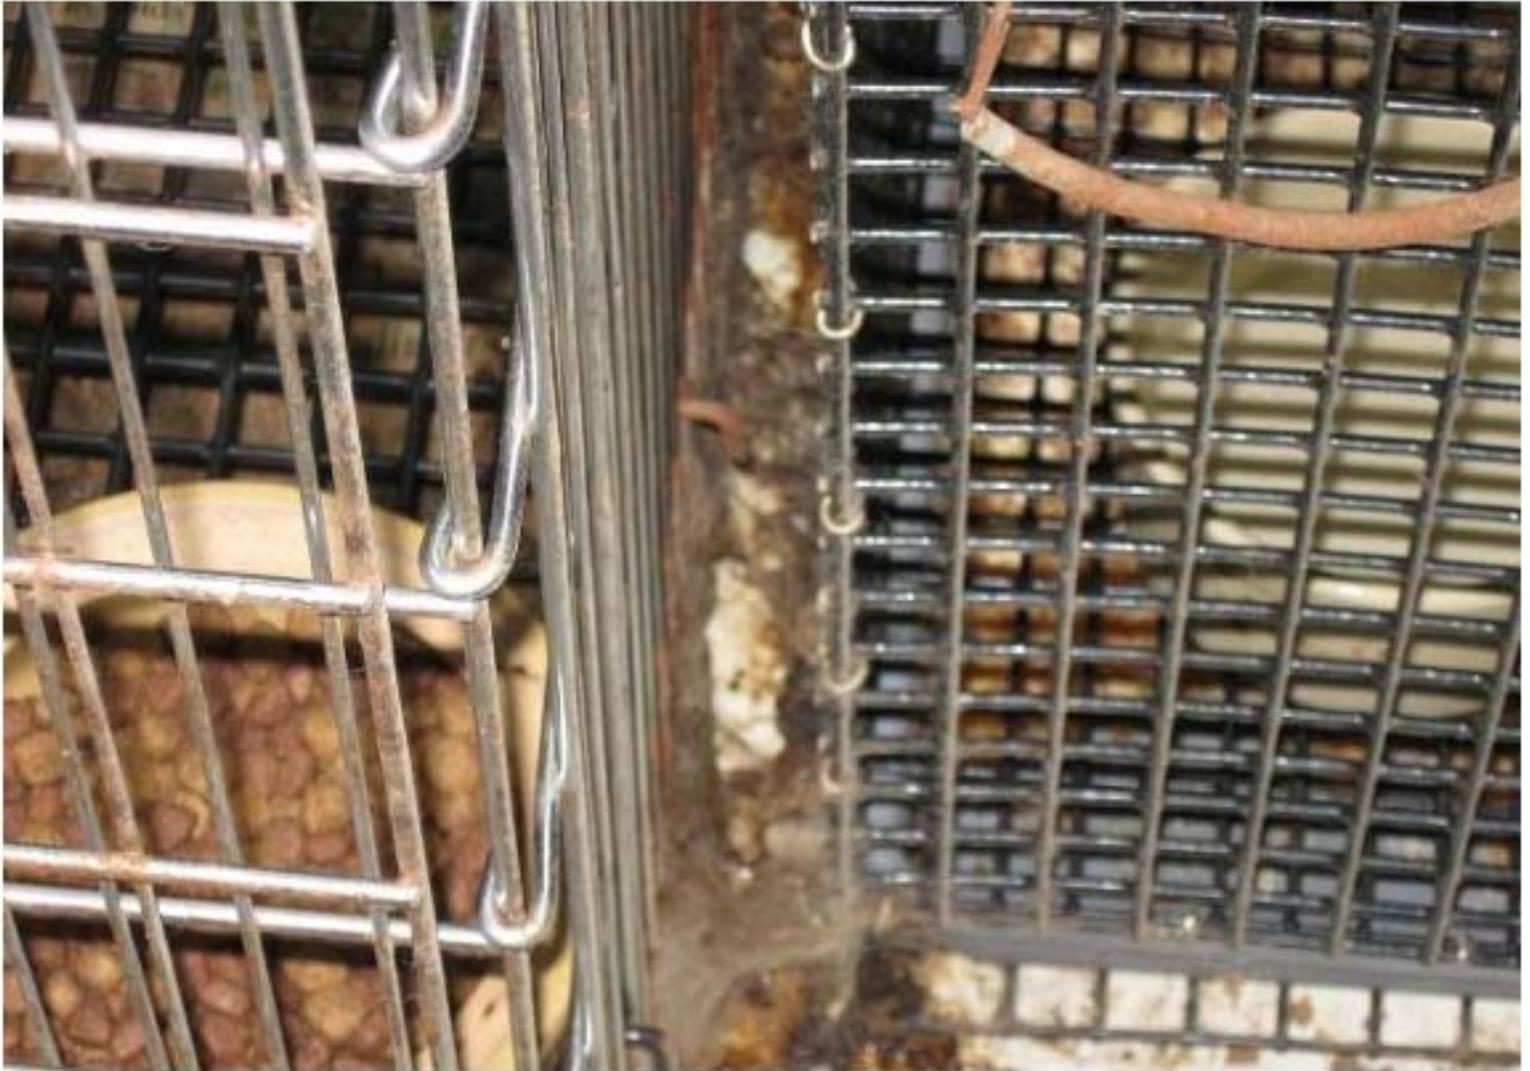
CFR: 3.1 (c) (3)

Photographer:	John J. Lies, ACI	Legal Name:	Registration:	42-A-1238
Photo Taken:	Wed, Aug 25, '10 P.M.	CATHY SPEER		
Inspection:	238101248530491			
Description:	3.1 (c)(3) Cleaning: Surfaces of housing facility needs to be cleaned.

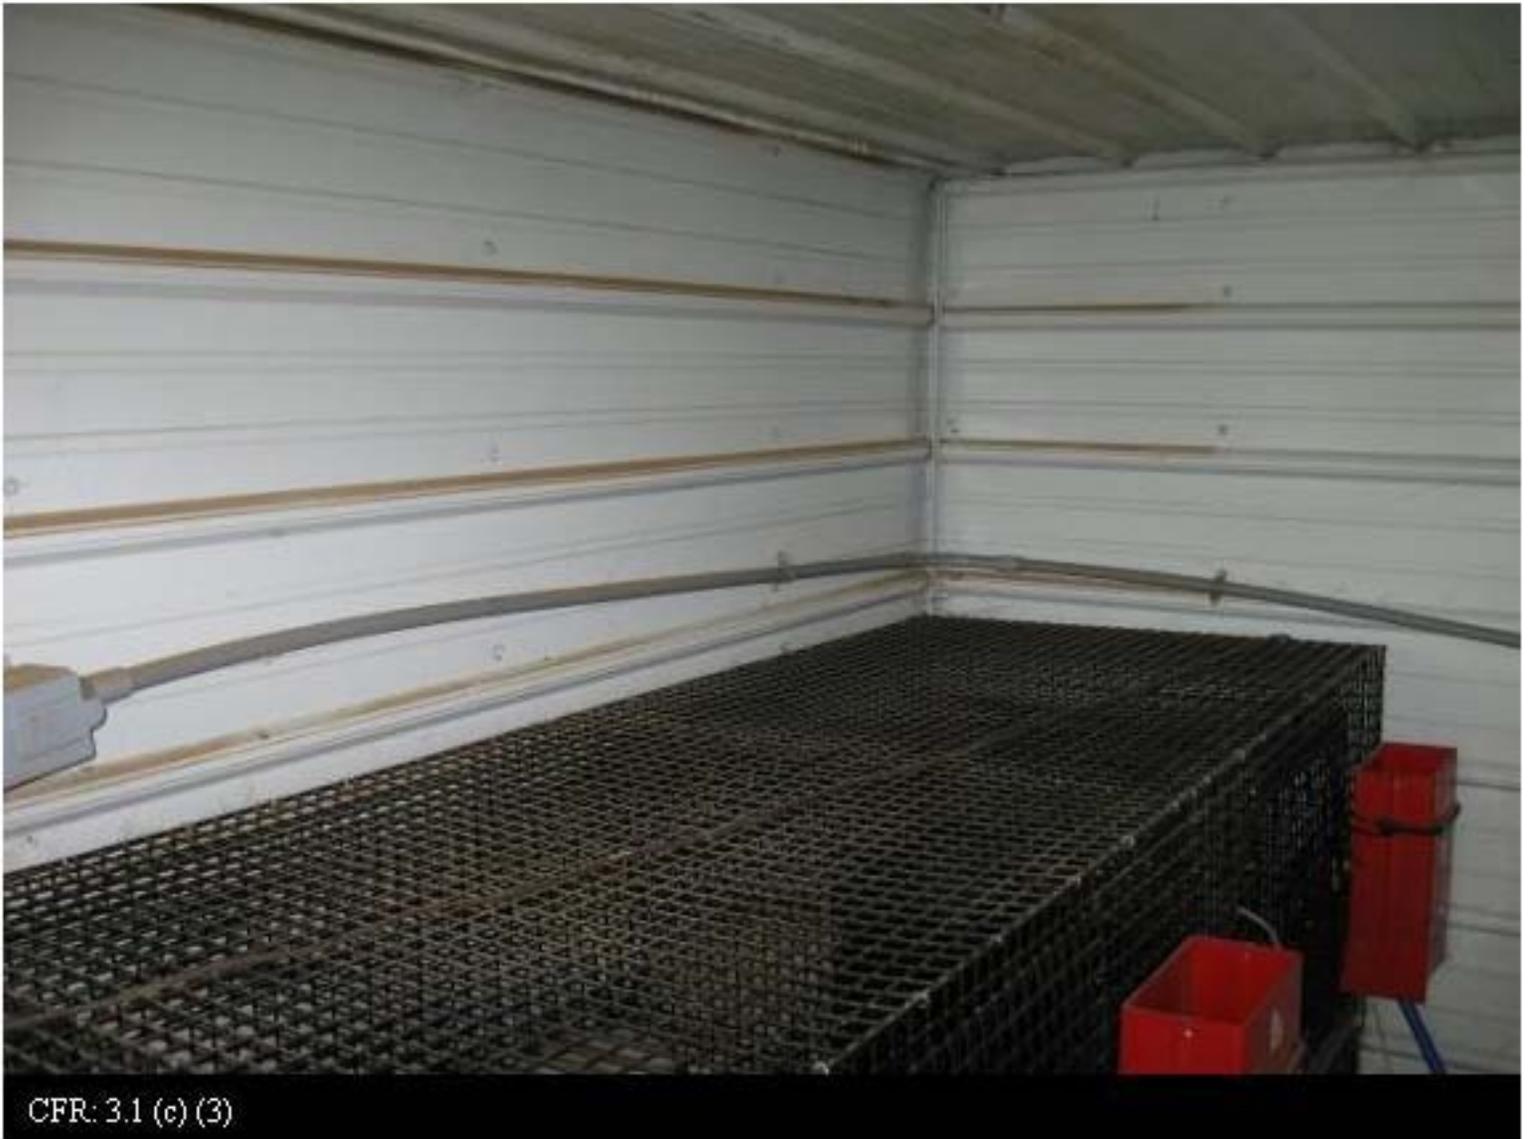
Photographer:	John J. Lies, ACI	Legal Name:	Registration:	42-A-1238
Photo Taken:	Wed, Aug 25, '10 P.M.	CATHY SPEER		
Inspection:	238101248530491			
Description:	3.1 (c)(3) Cleaning: Surfaces of housing facility needs to be cleaned.

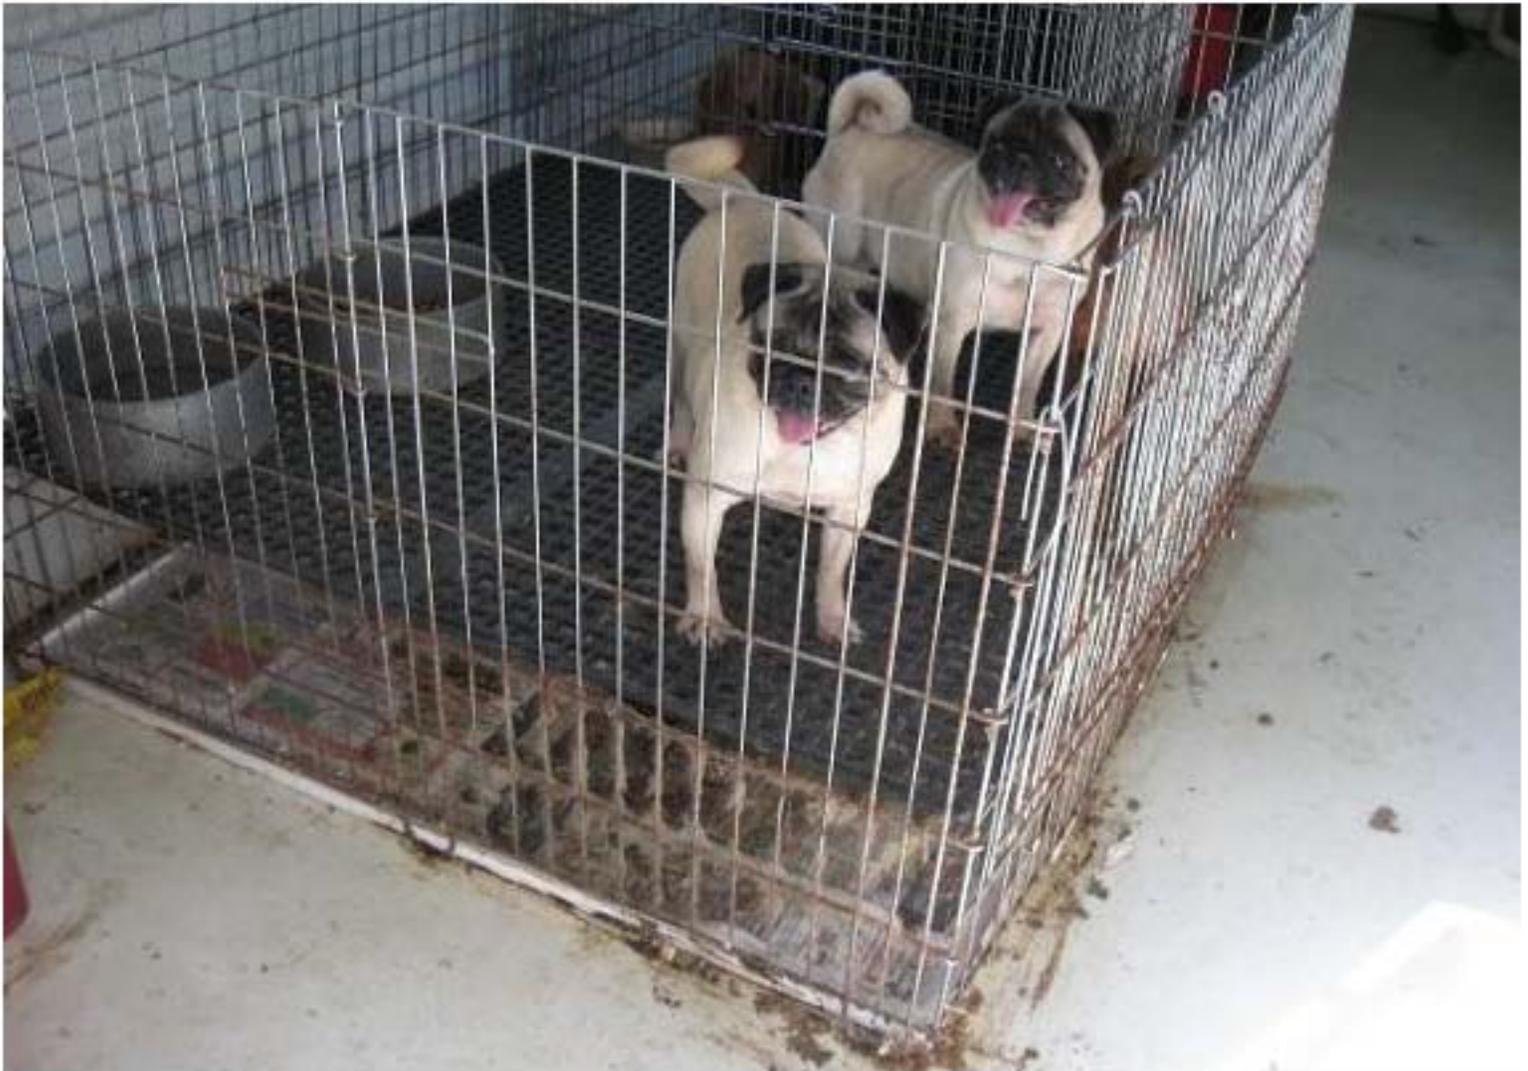
CFR: 3.1 (c) (3)

Photographer:	John J. Lies, ACI	Legal Name:	Registration:	42-A-1238
Photo Taken:	Wed, Aug 25, '10 P.M.	CATHY SPEER		
Inspection:	238101248530491			
Description:	3.1 (c)(3) Cleaning: Surfaces of housing facility needs to be cleaned.

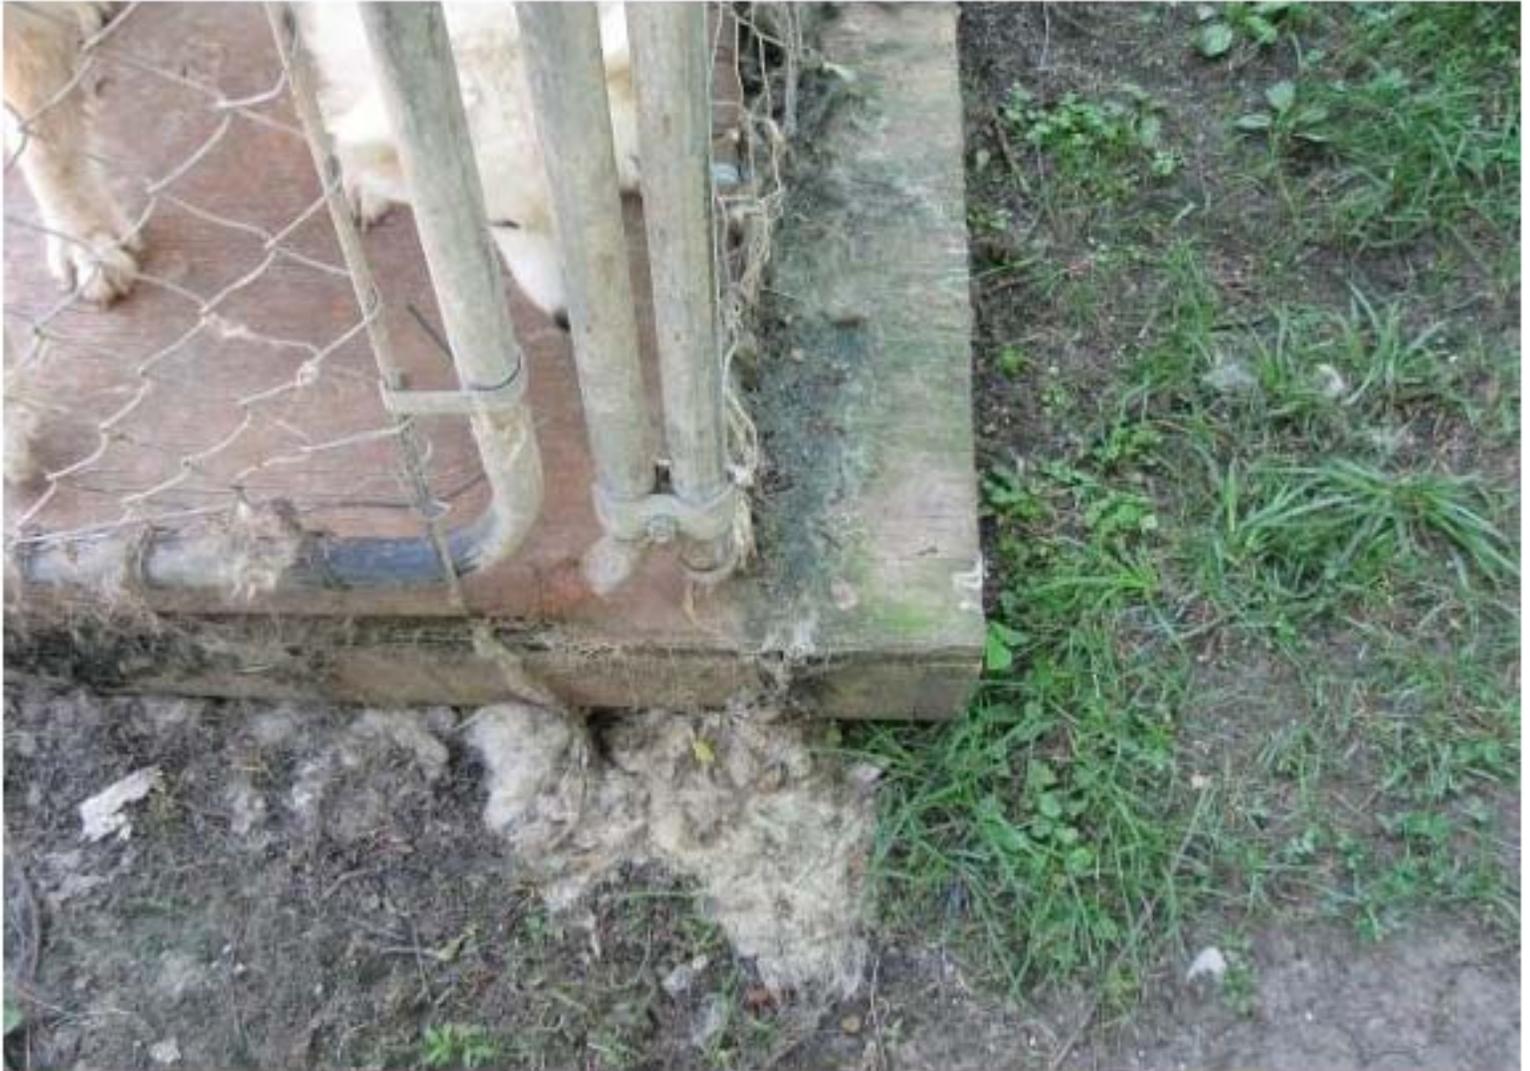
CFR: 3.1 (f)

Photographer:	John J. Lies, ACI	Legal Name:	Registration:	42-A-1238
Photo Taken:	Wed, Aug 25, '10 P.M.	CATHY SPEER		
Inspection:	238101248530491			
Description:	3.1 (f) General Housing Waste Disposal: Excreta, hair, food waste around the enclosures needs to be removed.

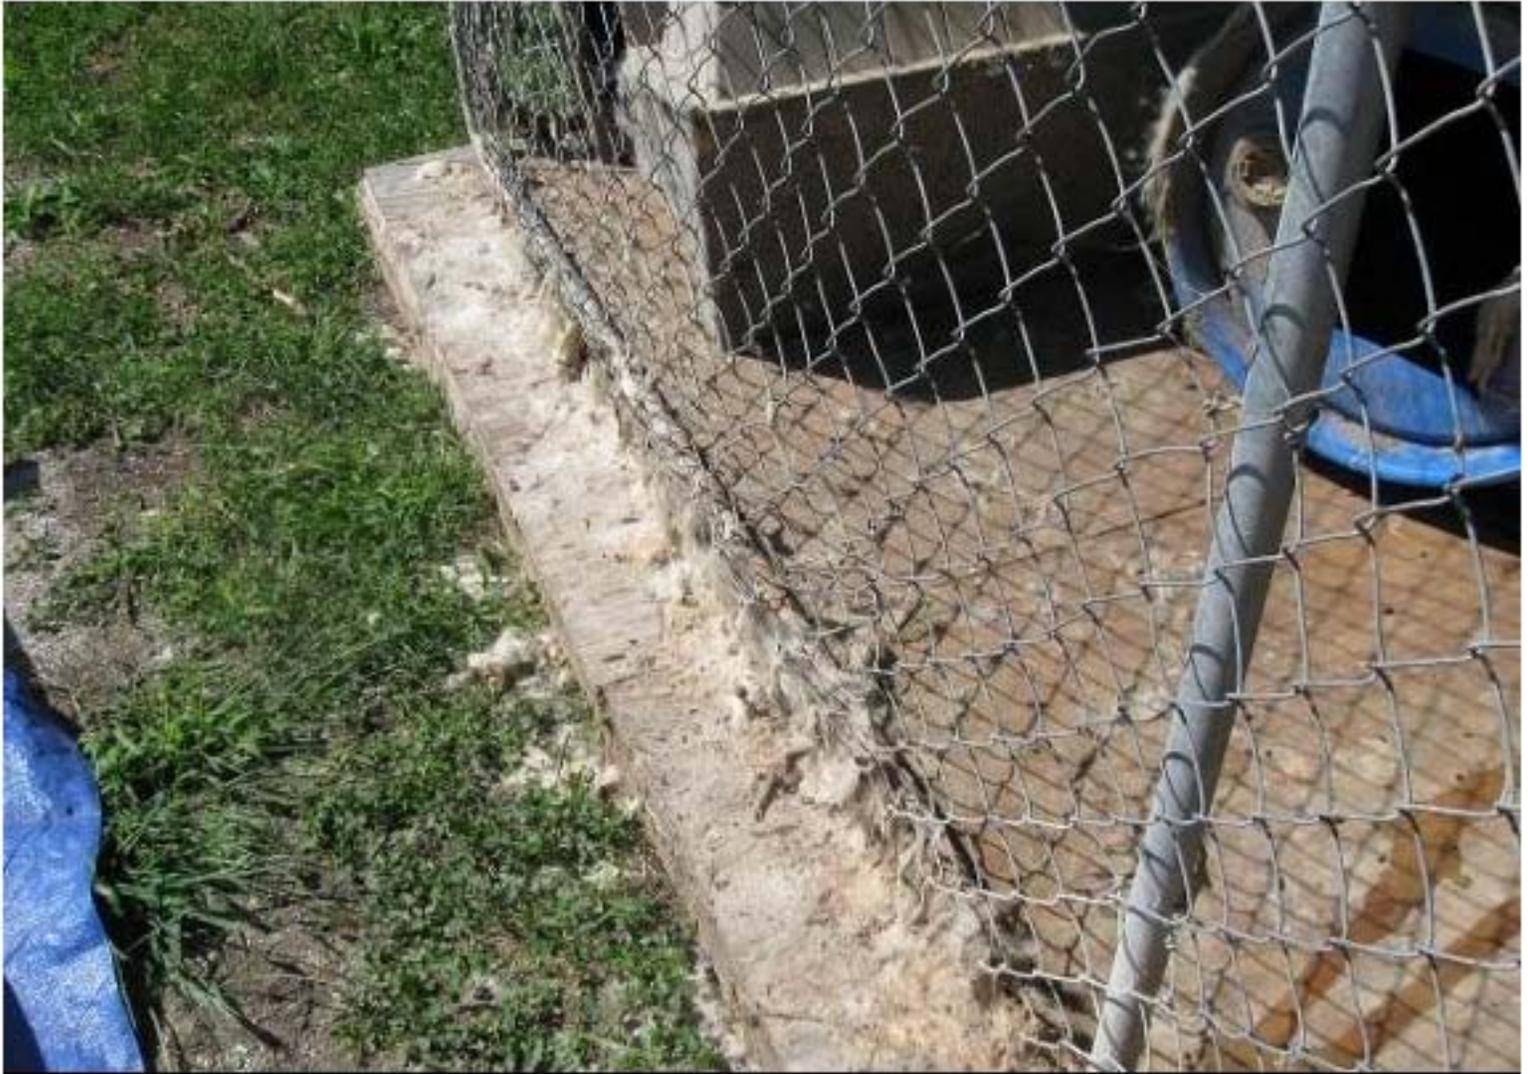
CFR: 3.1 (f)

Photographer:	John J. Lies, ACI	Legal Name:	Registration:	42-A-1238
Photo Taken:	Wed, Aug 25, '10 P.M.	CATHY SPEER		
Inspection:	238101248530491			
Description:	3.1 (f) General Housing Waste Disposal: Excreta, hair, food waste around the enclosures needs to be removed.

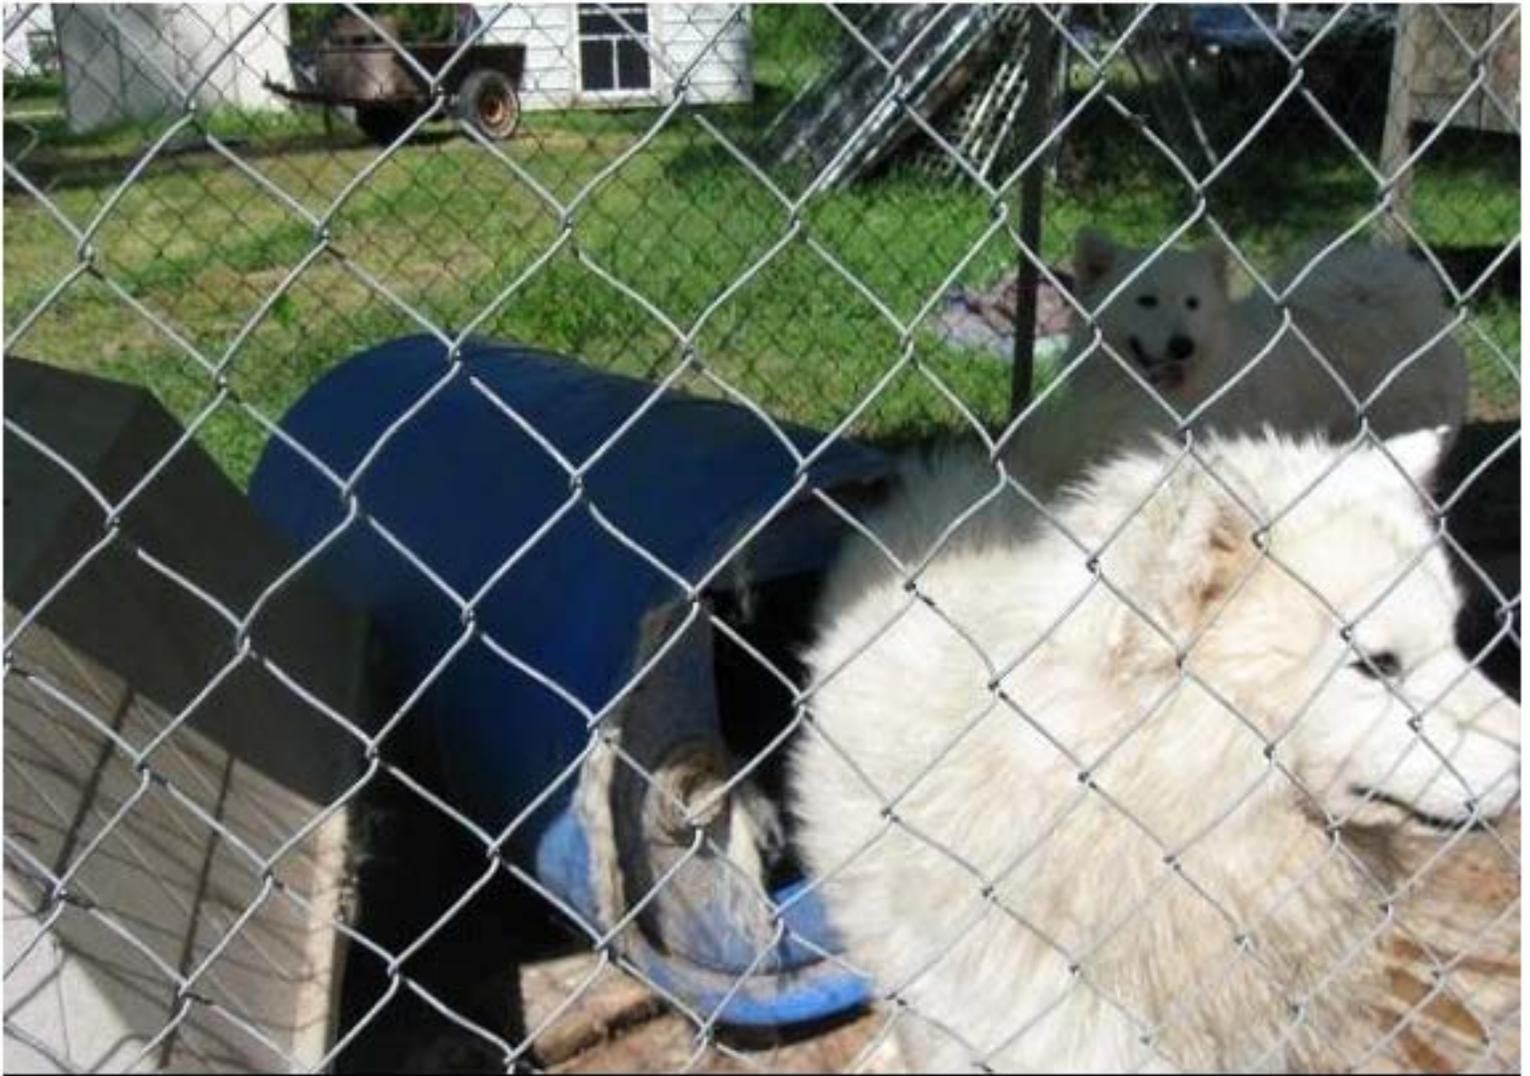
CFR: 3.4 (b)

Photographer:	John J. Lies, ACI	Legal Name:	Registration:	42-A-1238
Photo Taken:	Wed, Aug 25, '10 P.M.	CATHY SPEER		
Inspection:	238101248530491			
Description:	3.4 (b) Outdoor housing: Shelter blue barrel not of sufficient size for dogs.

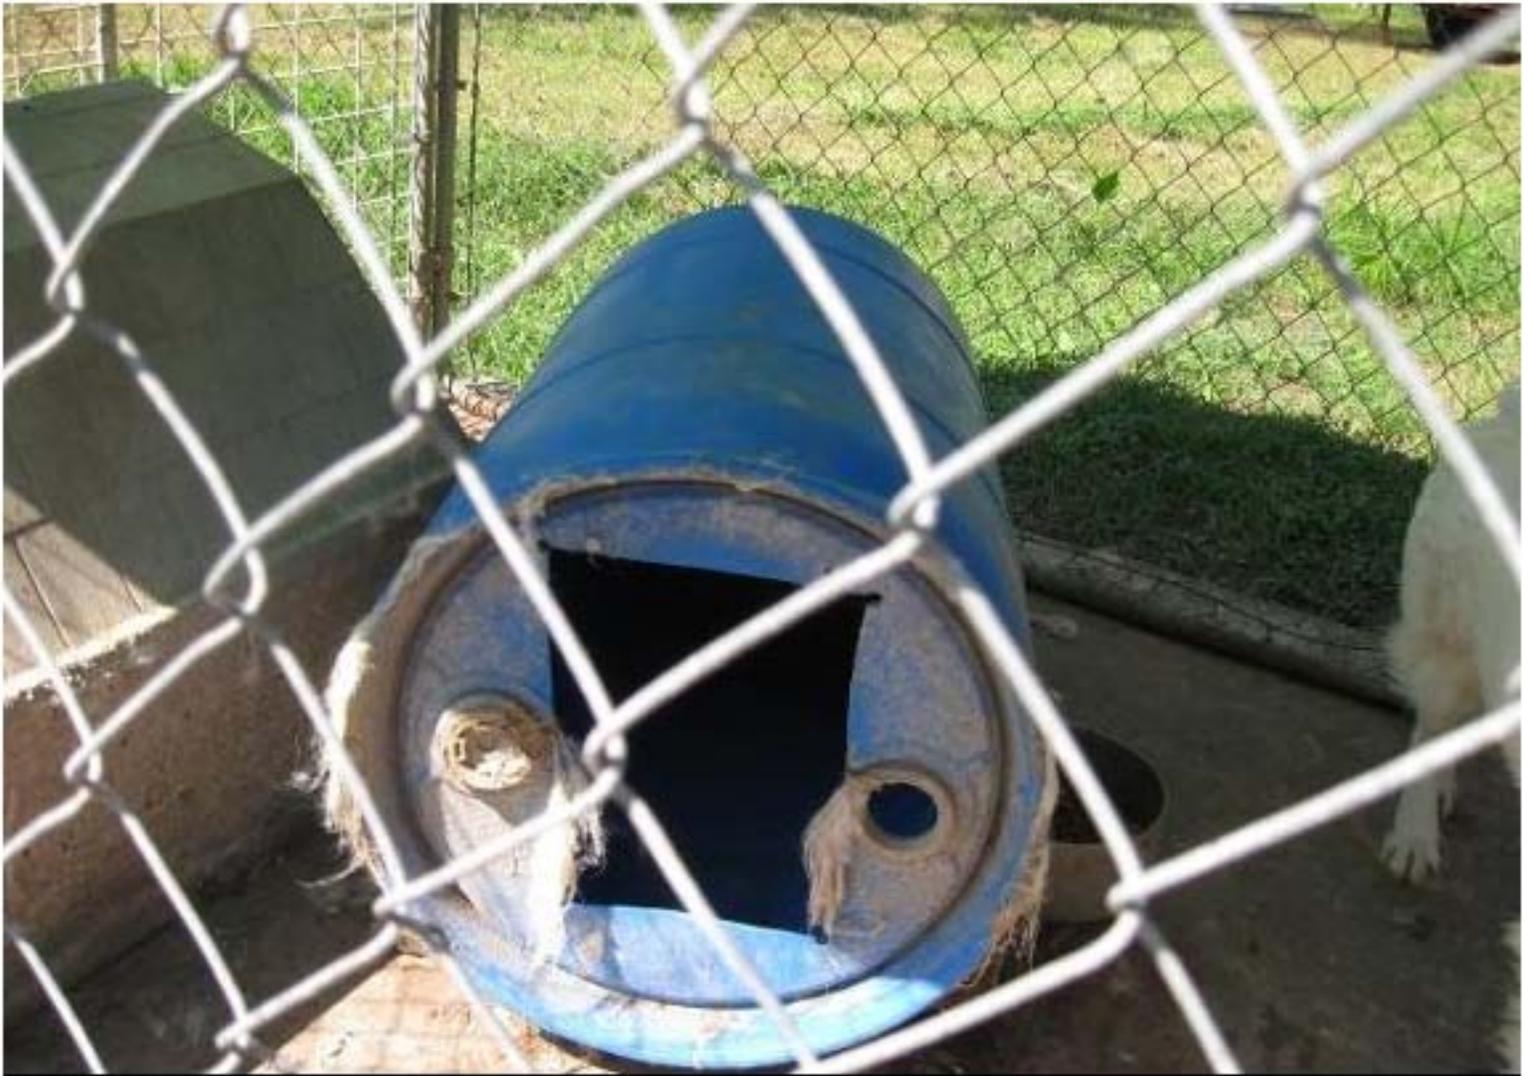
CFR: 3.4 (b) (3), 3.11 (a) (2)

Photographer:	John J. Lies, ACI	Legal Name:	Registration:	42-A-1238
Photo Taken:	Wed, Aug 25, '10 P.M.	CATHY SPEER		
Inspection:	238101248530491			
Description:	3.4 (b)(3) Outdoor housing: No wind/rain break. 3.11 (a)(2) Cleaning: Shelter and hard surfaces need to be sanitized.

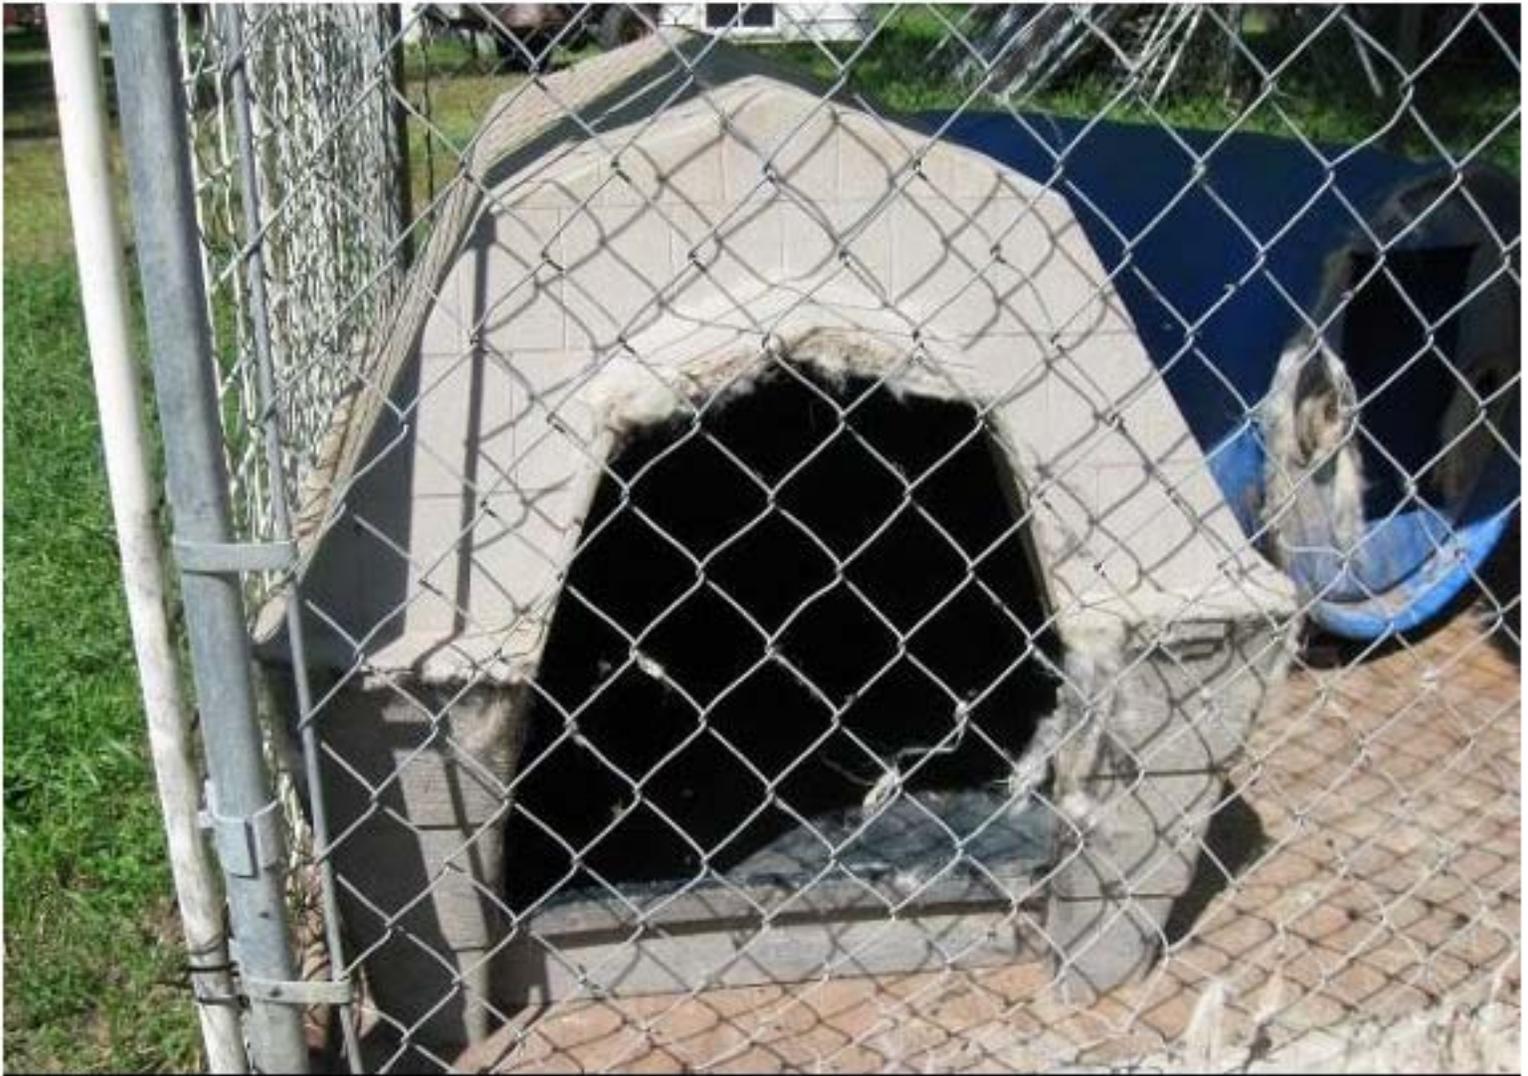
CFR: 3.4 (b) (3), 3.11 (a) (2)

Photographer:	John J. Lies, ACI	Legal Name:	Registration:	42-A-1238
Photo Taken:	Wed, Aug 25, '10 P.M.	CATHY SPEER		
Inspection:	238101248530491			
Description:	3.4 (b)(3) Outdoor housing: No wind/rain break. 3.11 (a)(2) Cleaning: Shelter and hard surfaces need to be sanitized.
