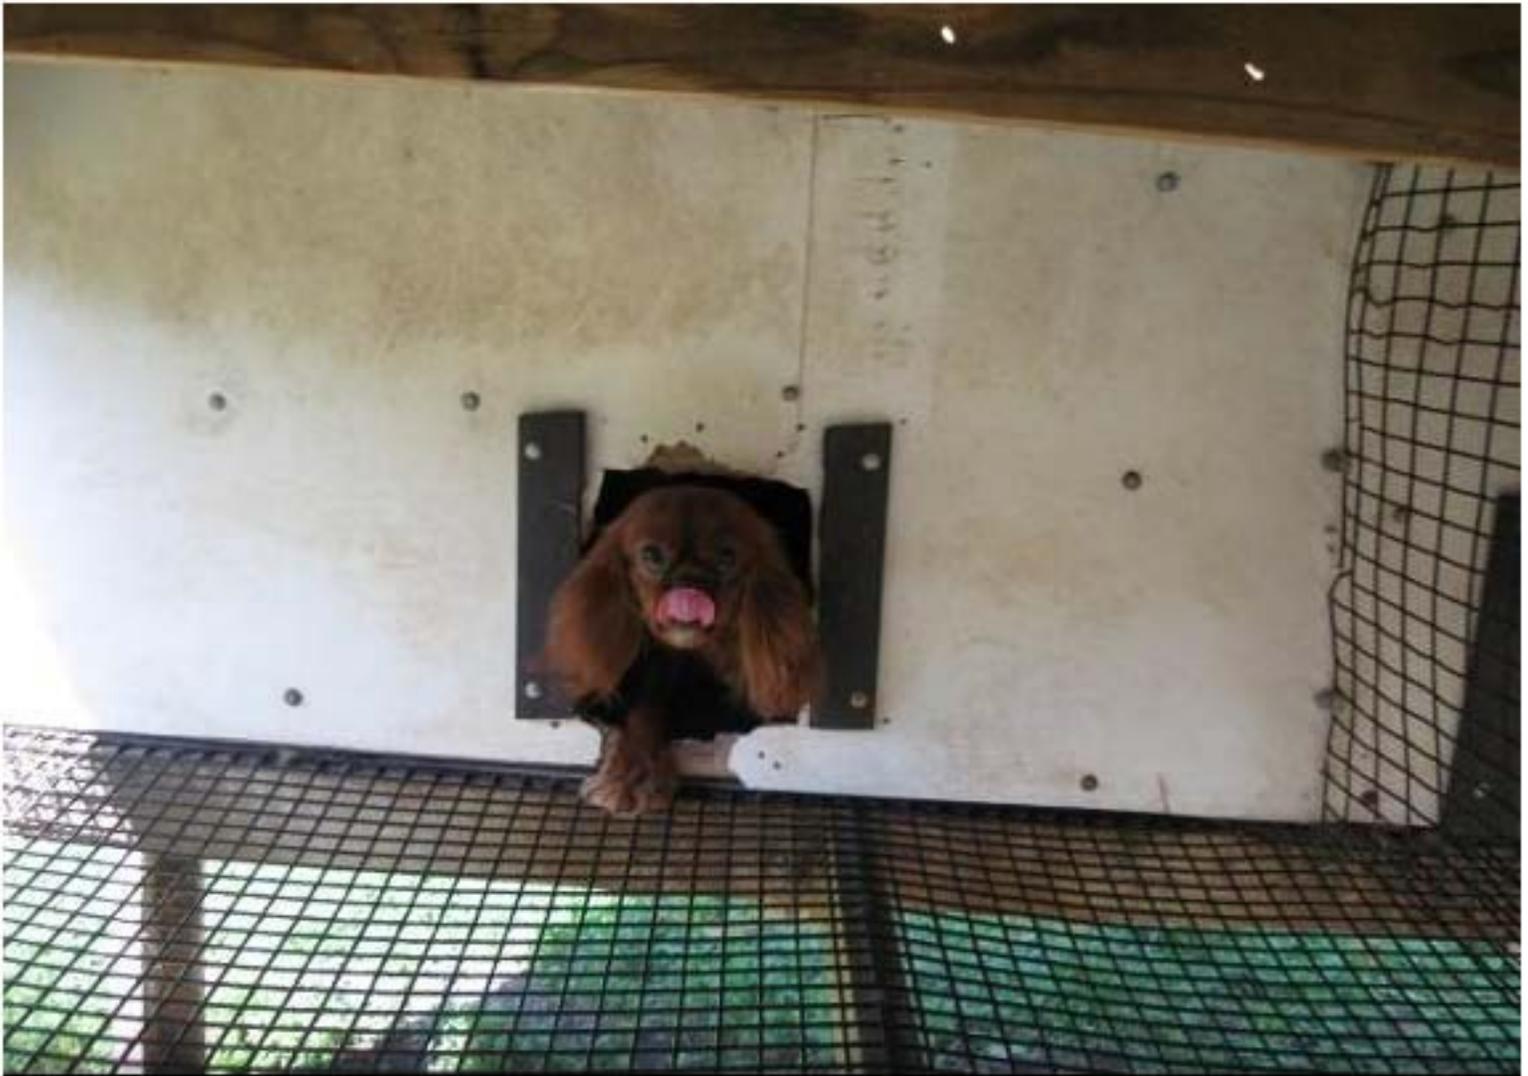
CFR: 3.4 (b) (3), 3.11 (a) (2)

Photographer:	John J. Lies, ACI	Legal Name:	Registration:	42-A-1238
Photo Taken:	Wed, Aug 25, '10 P.M.	CATHY SPEER		
Inspection:	238101248530491			
Description:	3.4 (b)(3) Outdoor housing: No wind/rain break. 3.11 (a)(2) Cleaning: Shelter and hard surfaces need to be sanitized.

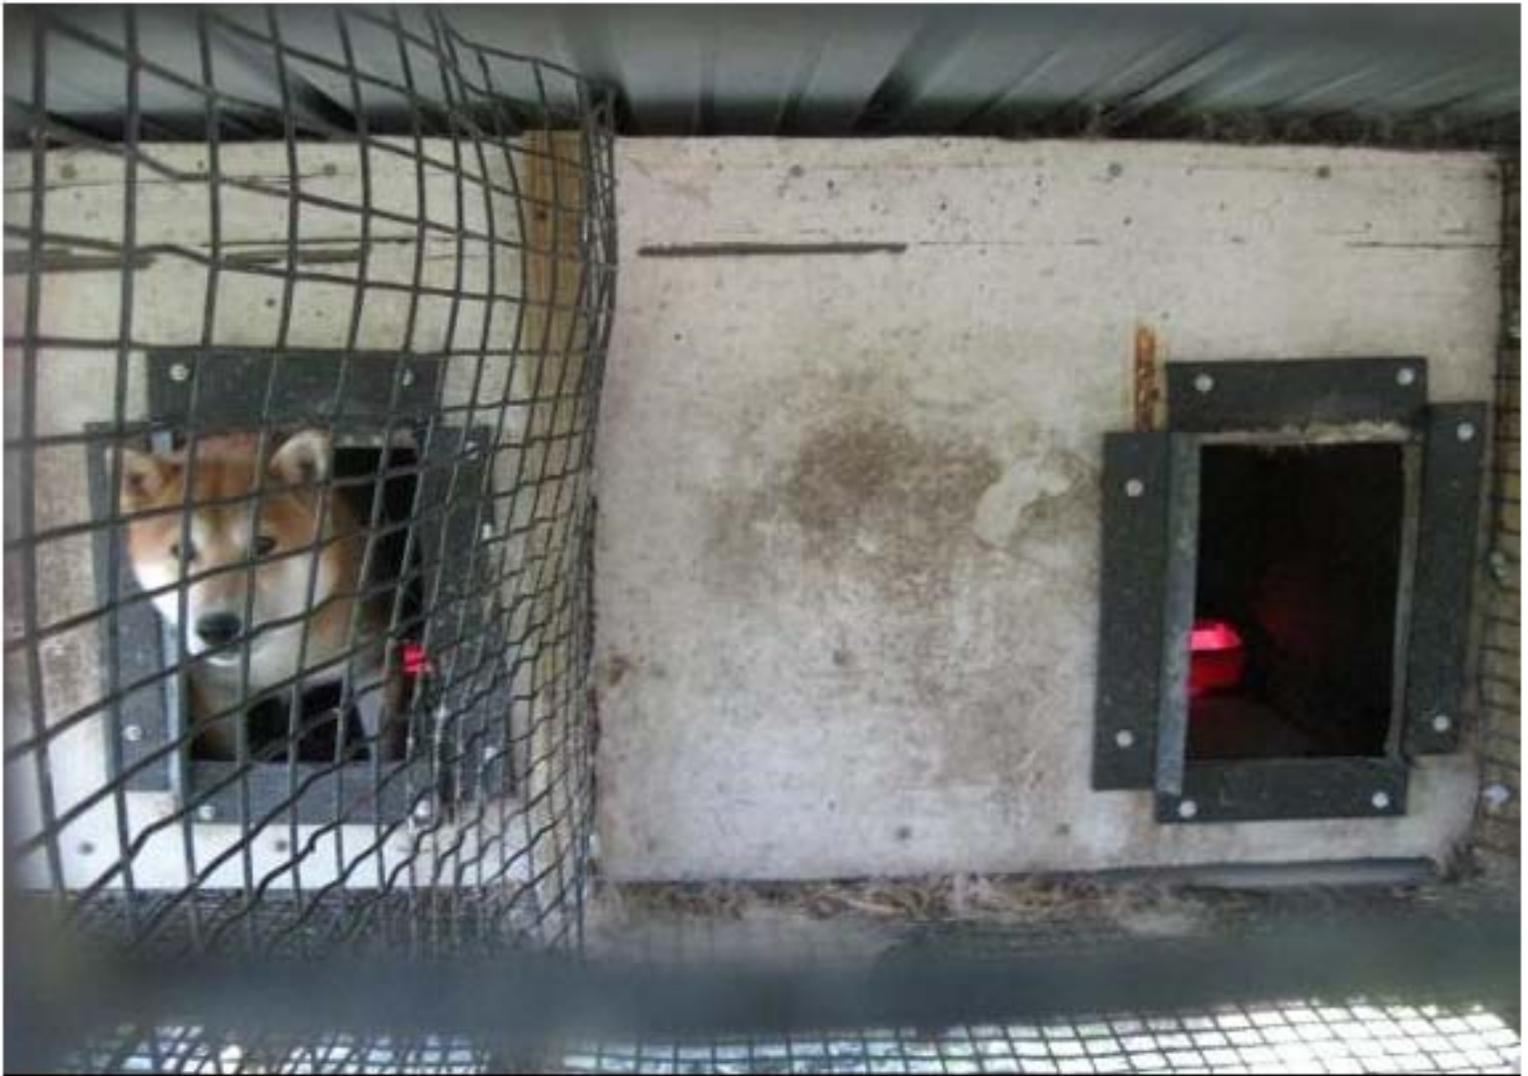
CFR: 3.4 (b) (3), 3.11 (a) (2)

Photographer:	John J. Lies, ACI	Legal Name:	Registration:	42-A-1238
Photo Taken:	Wed, Aug 25, '10 P.M.	CATHY SPEER		
Inspection:	238101248530491			
Description:	3.4 (b)(3) Outdoor housing: No wind/rain break. 3.11 (a)(2) Cleaning: Shelter and hard surfaces need to be sanitized.

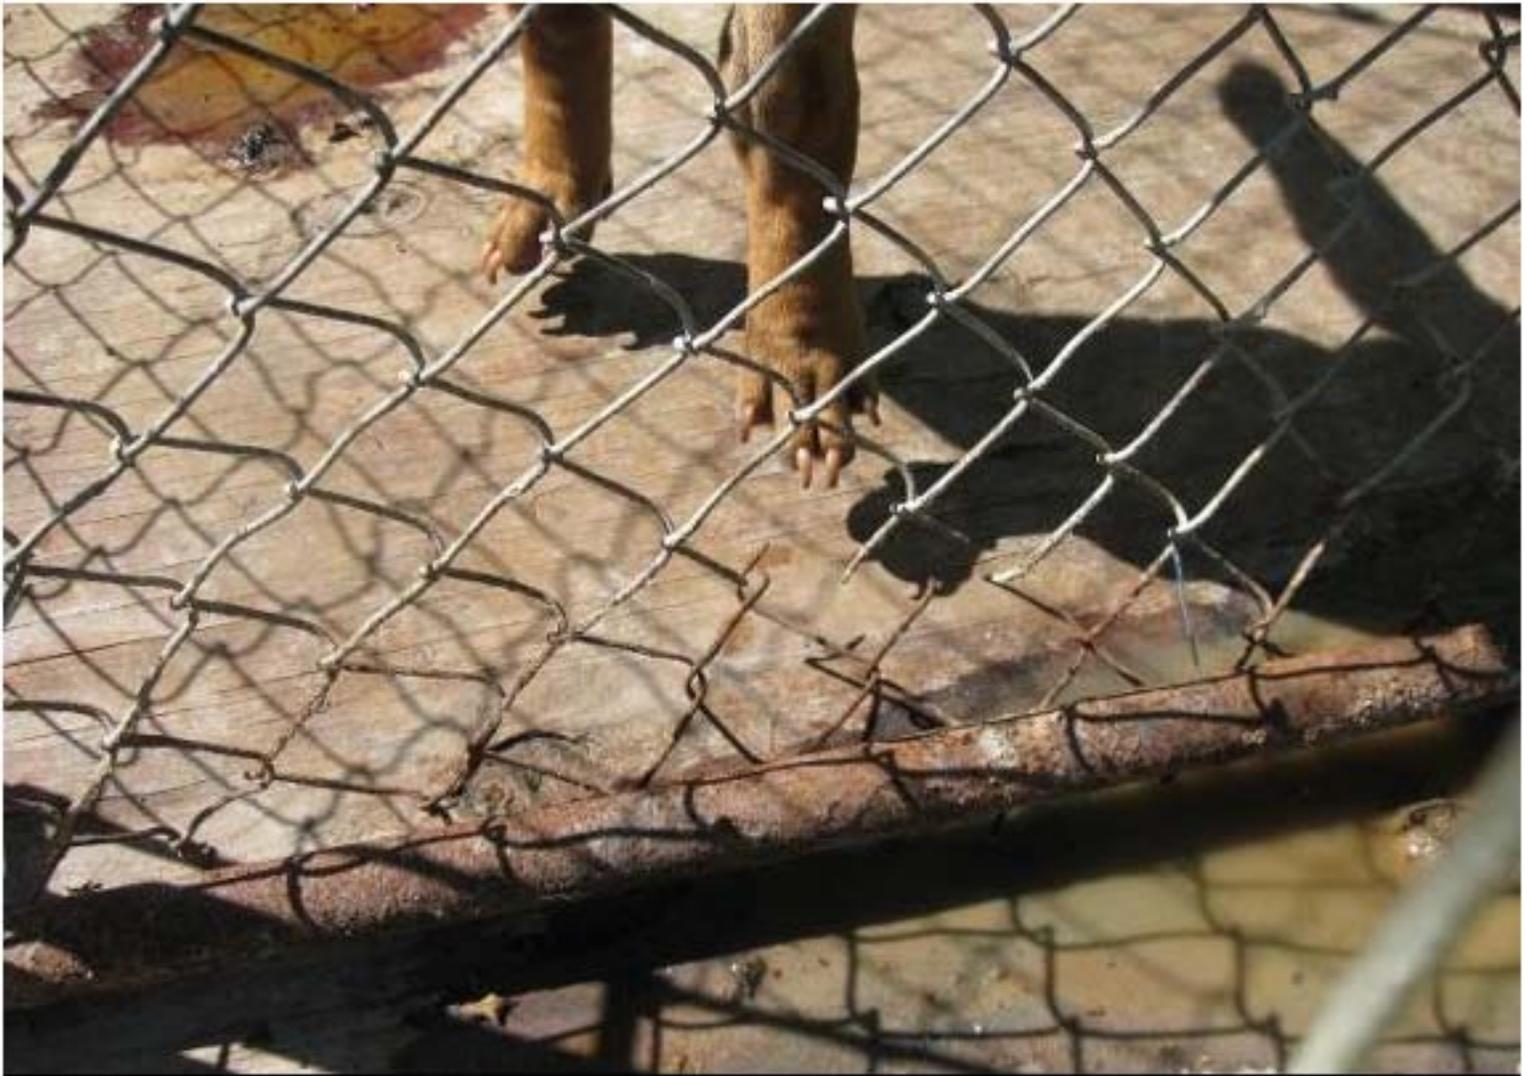
CFR: 3.1 (c) (1) (i), 3.1 (c) (1) (ii)

Photographer:	John J. Lies, ACI	Legal Name:	Registration:	42-A-1238
Photo Taken:	Wed, Aug 25, '10 P.M.	CATHY SPEER		
Inspection:	238101248530491			
Description:	3.1 (c)(1)(i) Housing facilities General Surfaces with excessive rust that prevents proper cleaning and/or affects structural strength.

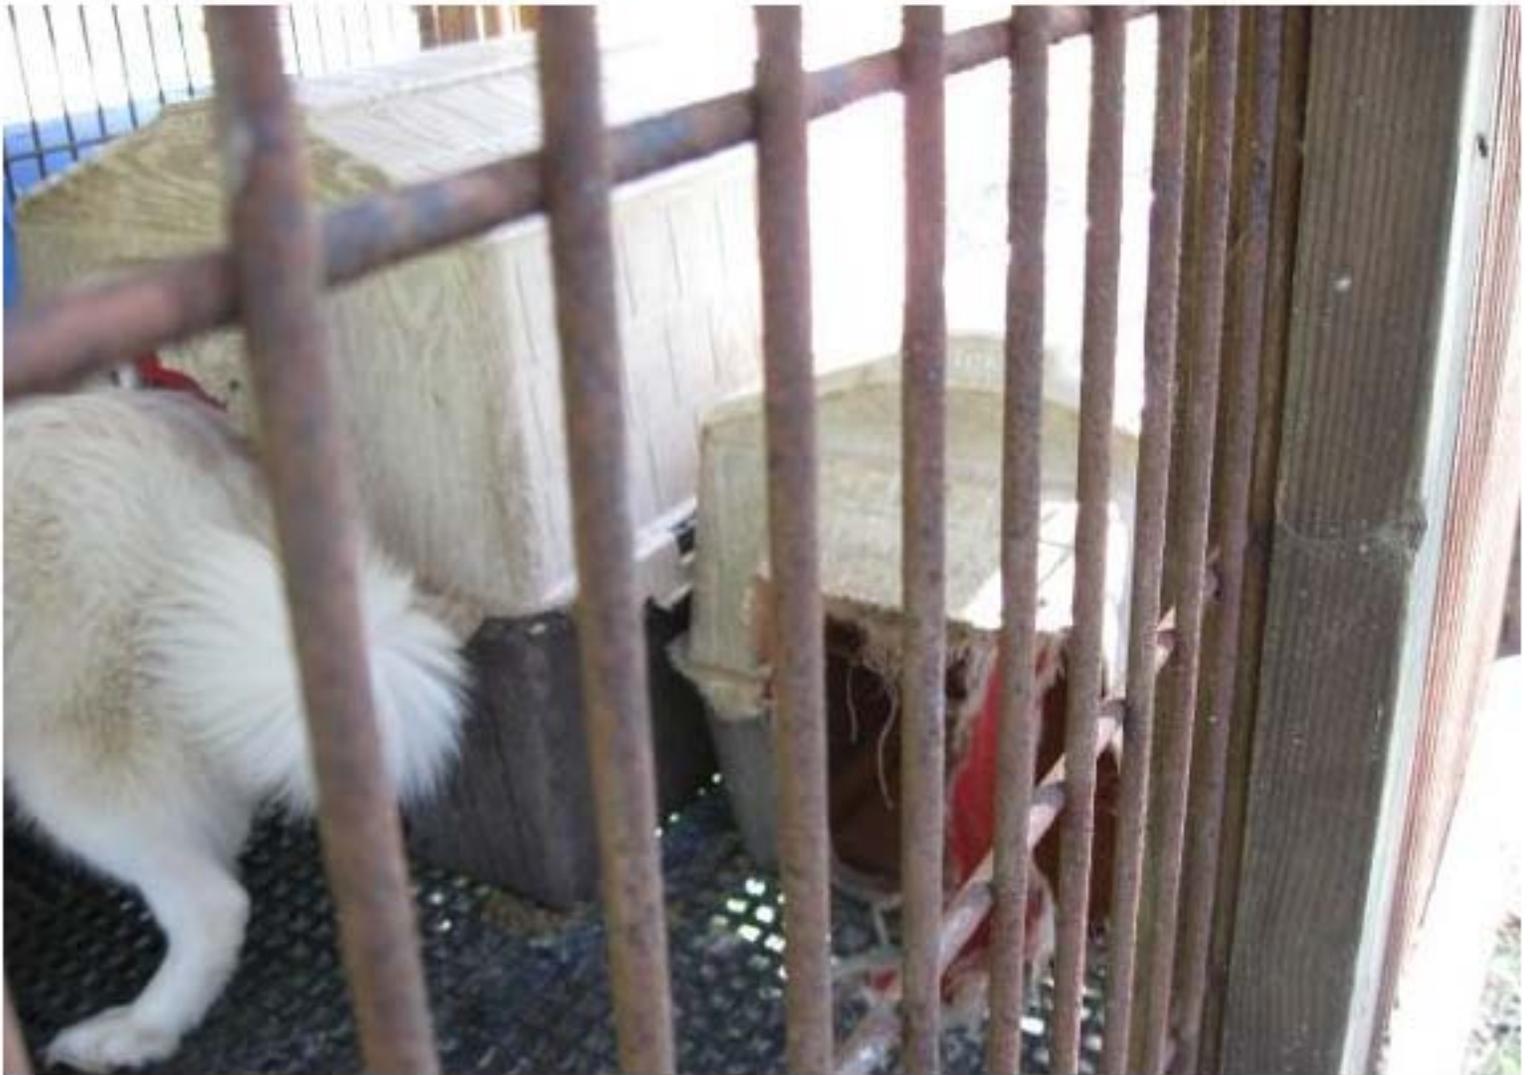
CFR: 3.1 (c) (1) (i)

Photographer:	John J. Lies, ACI	Legal Name:	Registration:	42-A-1238
Photo Taken:	Wed, Aug 25, '10 P.M.	CATHY SPEER		
Inspection:	238101248530491			
Description:	3.1 (c)(1)(i): Housing Facilities General Surfaces: Rust that prevents proper cleaning or affects structural strength.

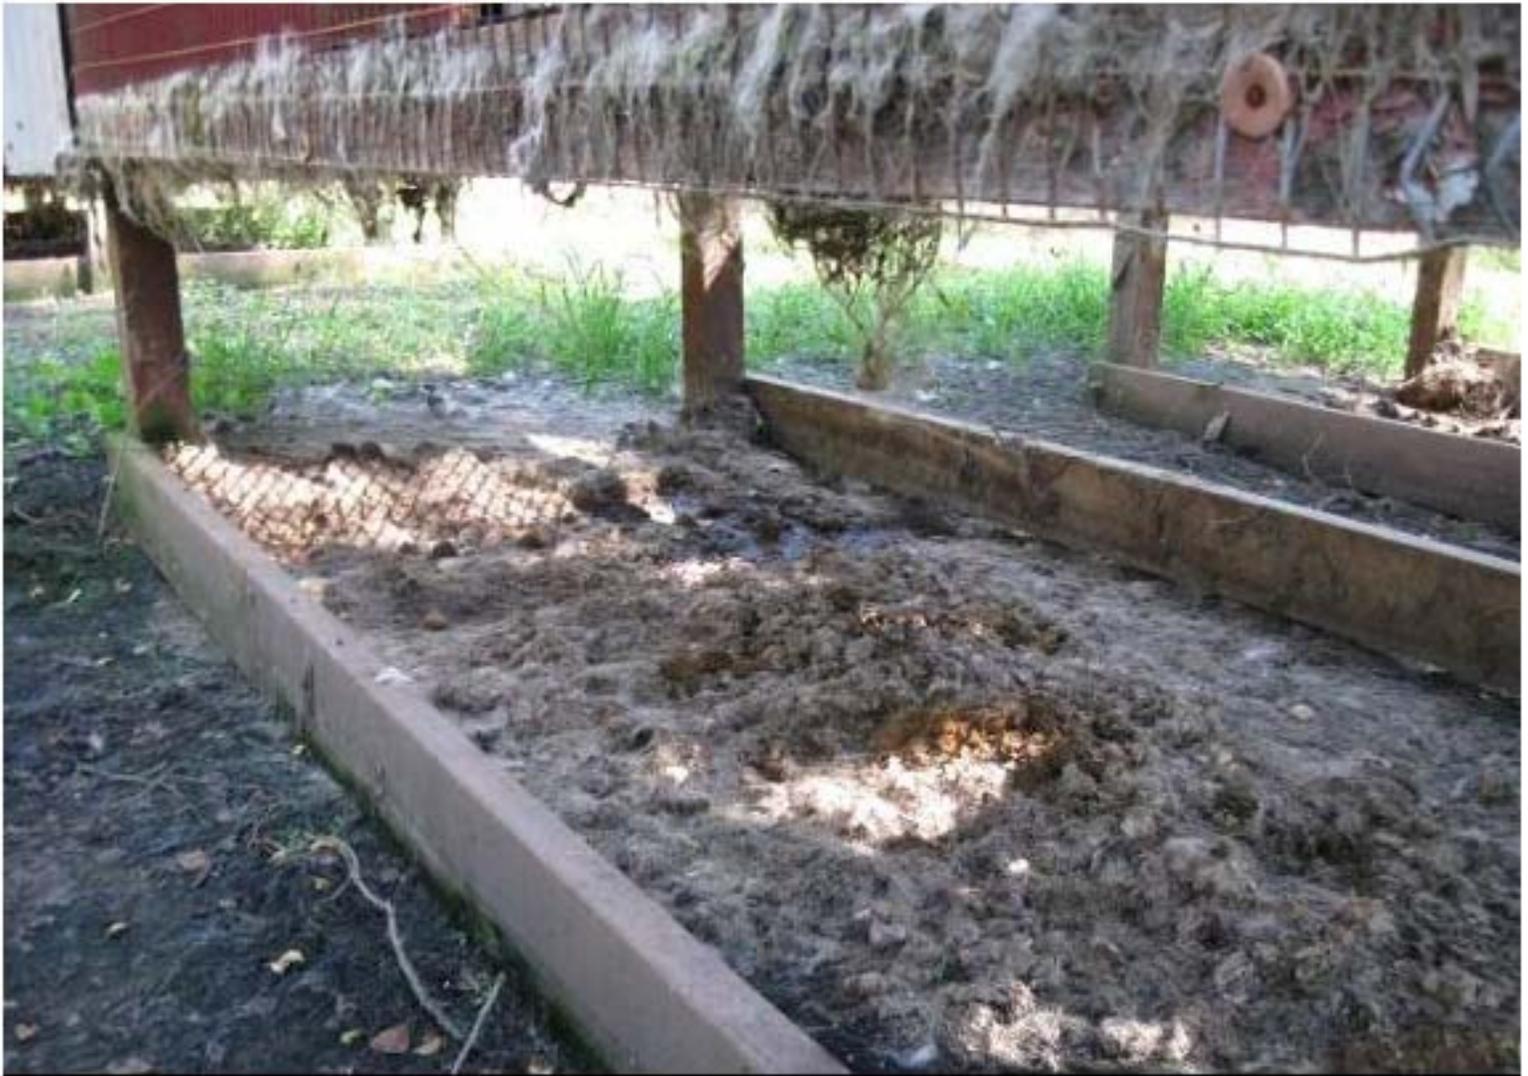
CFR: 3.11 (a)

Photographer:	John J. Lies, ACI	Legal Name:	Registration:	42-A-1238
Photo Taken:	Wed, Aug 25, '10 P.M.	CATHY SPEER		
Inspection:	238101248530491			
Description:	3.11 (a) Cleaning: Primary enclosures need to be cleaned to remove dirt, debris, hair from around the enclosures and excreta from under the enclosures.

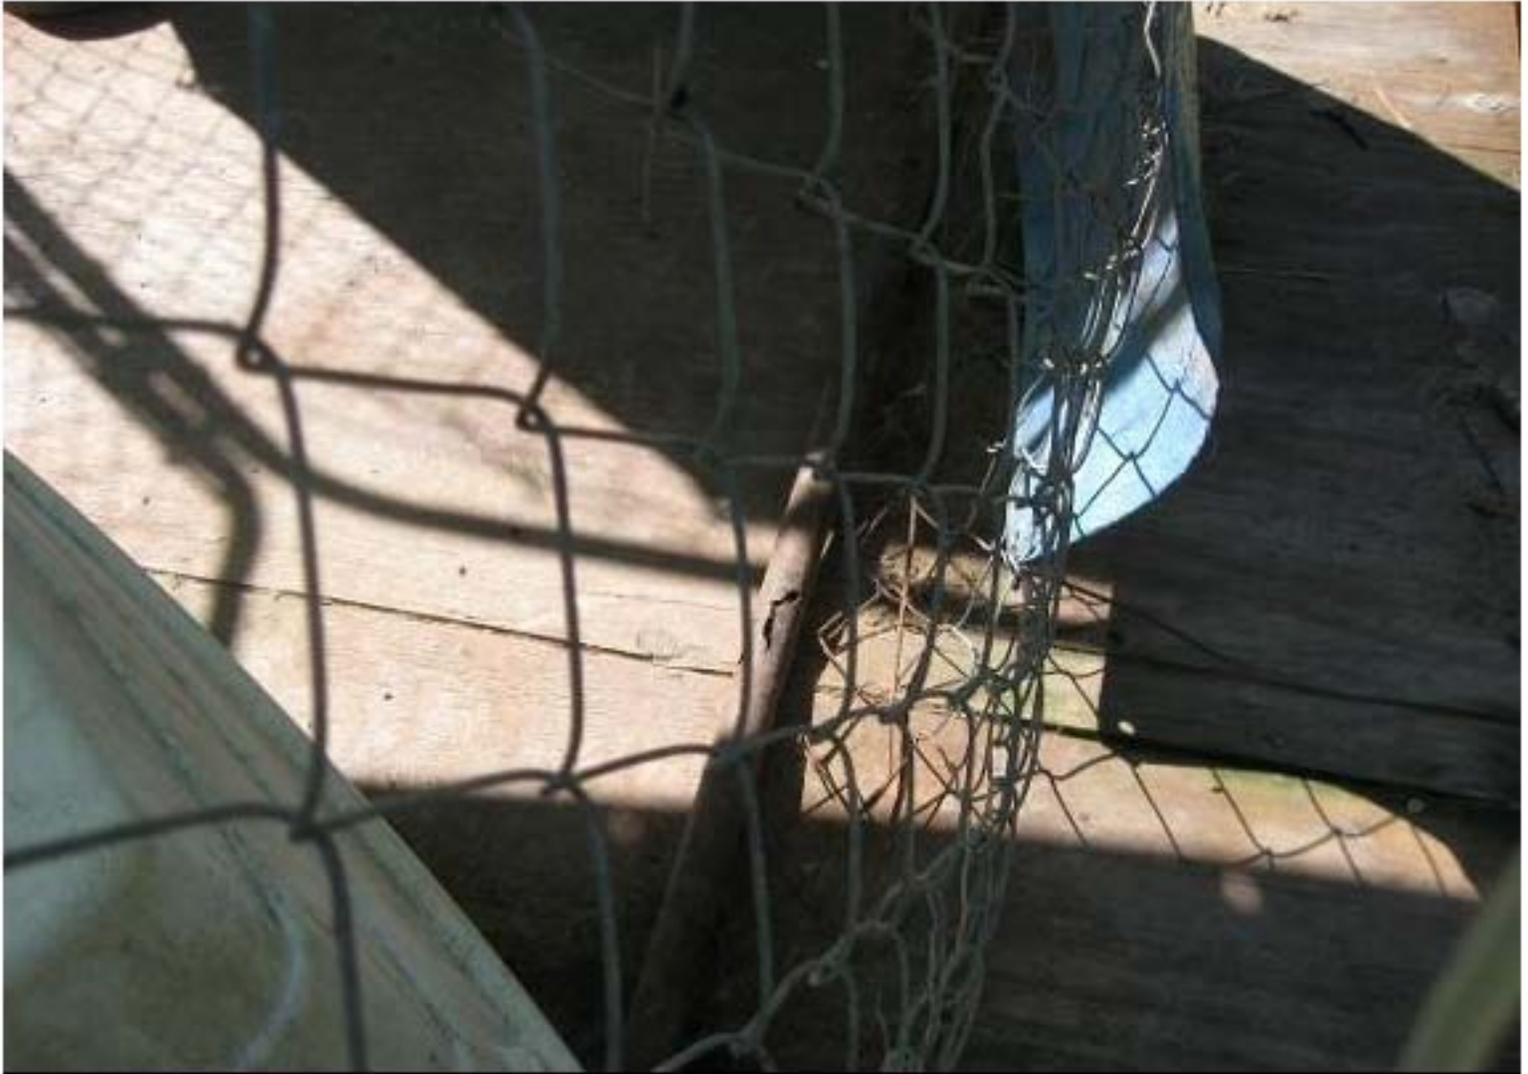
CFR: 3.1 (f)

Photographer:	John J. Lies, ACI	Legal Name:	Registration:	42-A-1238
Photo Taken:	Wed, Aug 25, '10 P.M.	CATHY SPEER		
Inspection:	238101248530491			
Description:	3.1 (f) General Housing Waste Disposal: Excreta, hair, food waste around the enclosures needs to be removed.

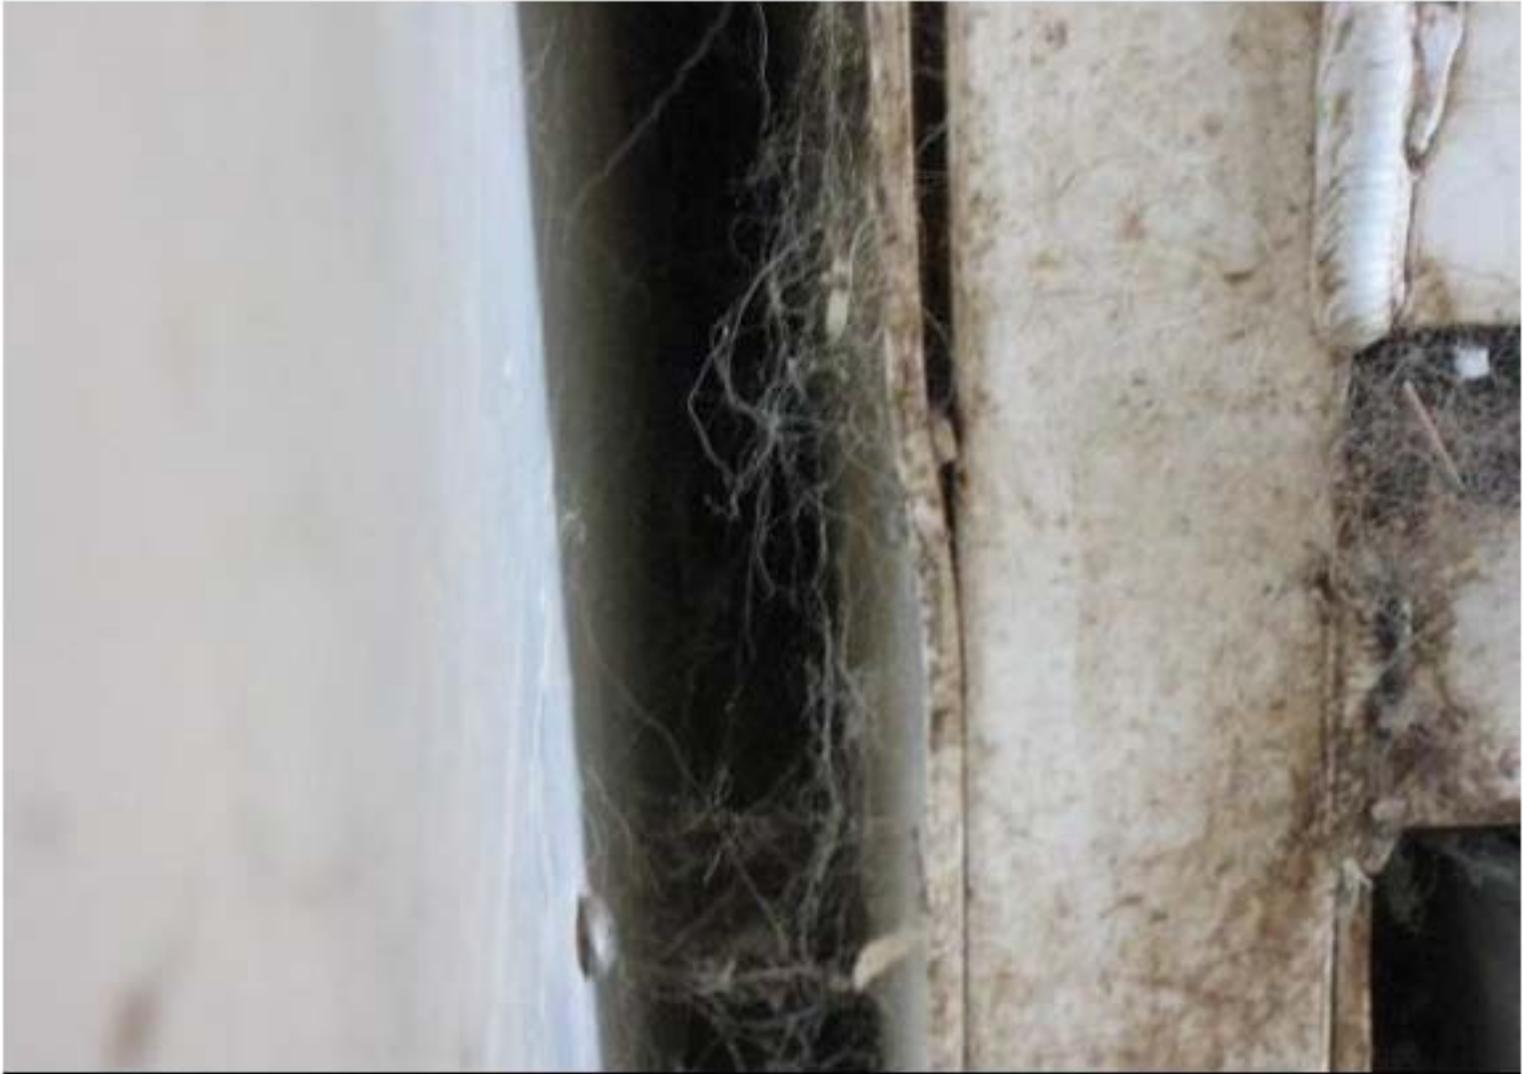
CFR: 3.1 (c) (3)

Photographer:	John J. Lies, ACI	Legal Name:	Registration:	42-A-1238
Photo Taken:	Wed, Aug 25, '10 P.M.	CATHY SPEER		
Inspection:	238101248530491			
Description:	3.1 (c)(3) Housing Facilities Cleaning: Hair, dirt, grime, excreta. Needs to be removed from floors, walls and fronts of the enclosures inside of the building.

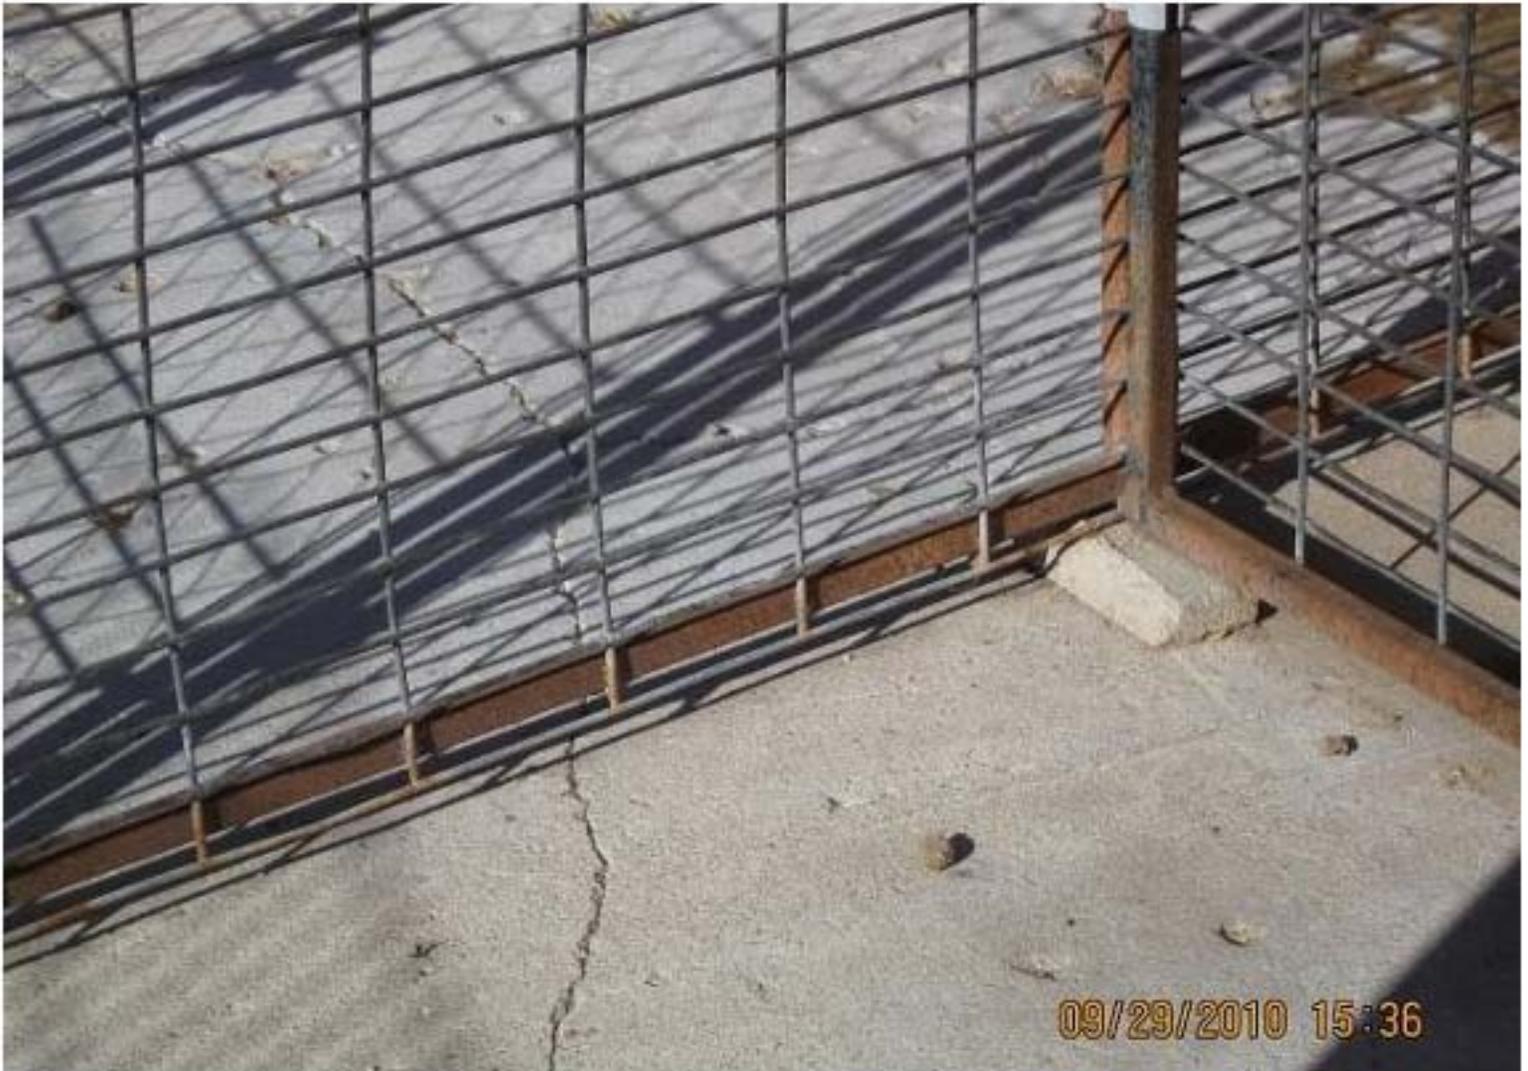
CFR: 3.1 (c) (1) (i)

Photographer:	Randall Wagner (ACI)	Legal Name:	Registration:	42-A-1200
Photo Taken:	Wed, Sep 29, '10	ILIEN YMKER		
Inspection:	272101655460937			
Description:	The metal pipe framing for the dividers has excessive rust and pitting on the metal surface.

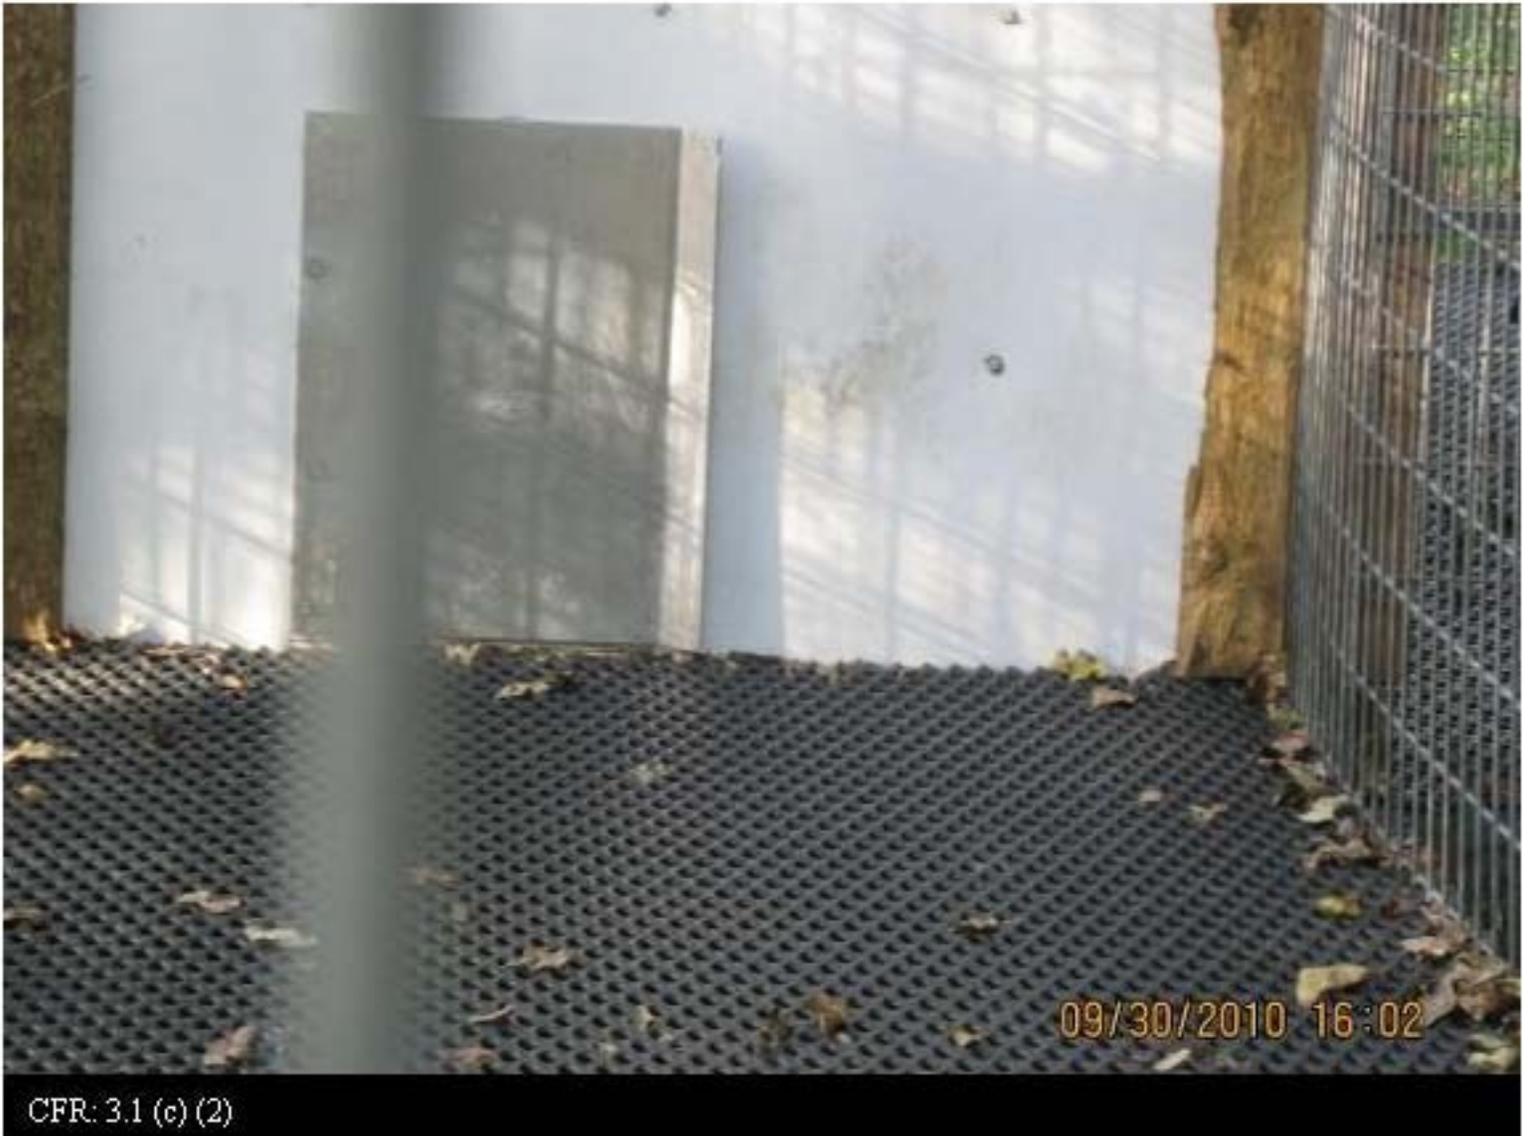
Photographer:	Randall Wagner (ACI)	Legal Name:	Registration:	42-A-1199
Photo Taken:	Thu, Sep 30, '10	DANIEL MINTEN		
Inspection:	273101714460695			
Description:	The wood support in the back is excessively chewed and scratched.

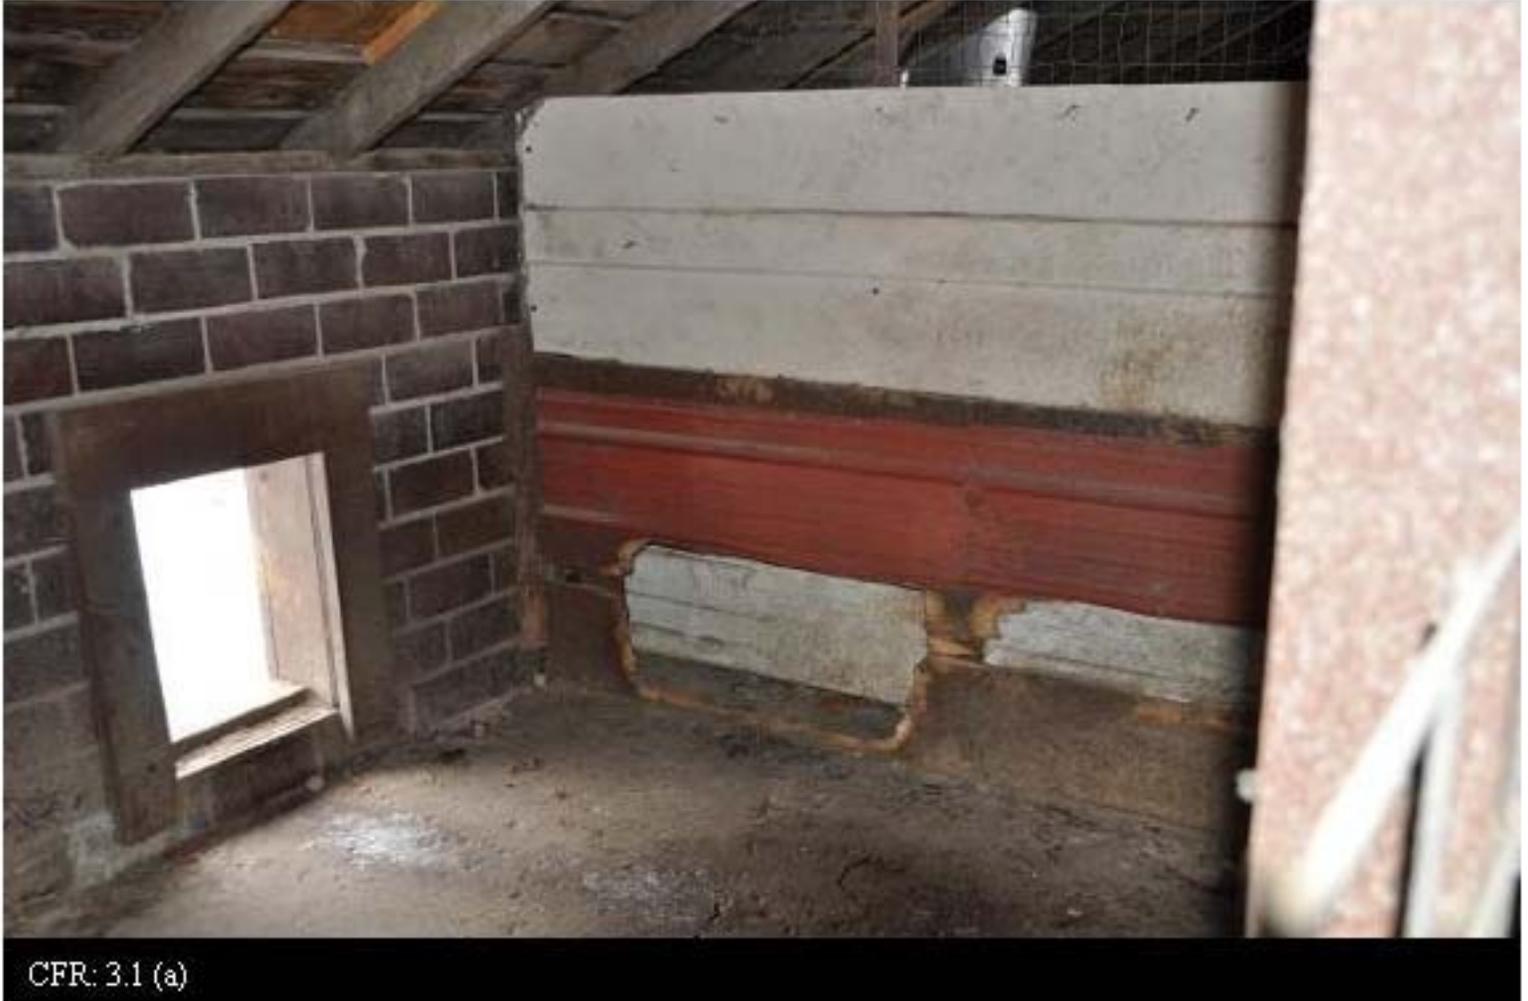
Photographer:	Heather Cole	Legal Name:	Registration:	42-A-1163
Photo Taken:	Mon, Dec 6, '10	DIANA WENDEL		
Inspection:	340101319240662			
Description:	Distant photo of 2 large holes chewed in the wood of the dividing wall between the 1st and 2nd pens on the right in the large dog building. Photo is taken looking from the 2nd pen towards the 1st pen.

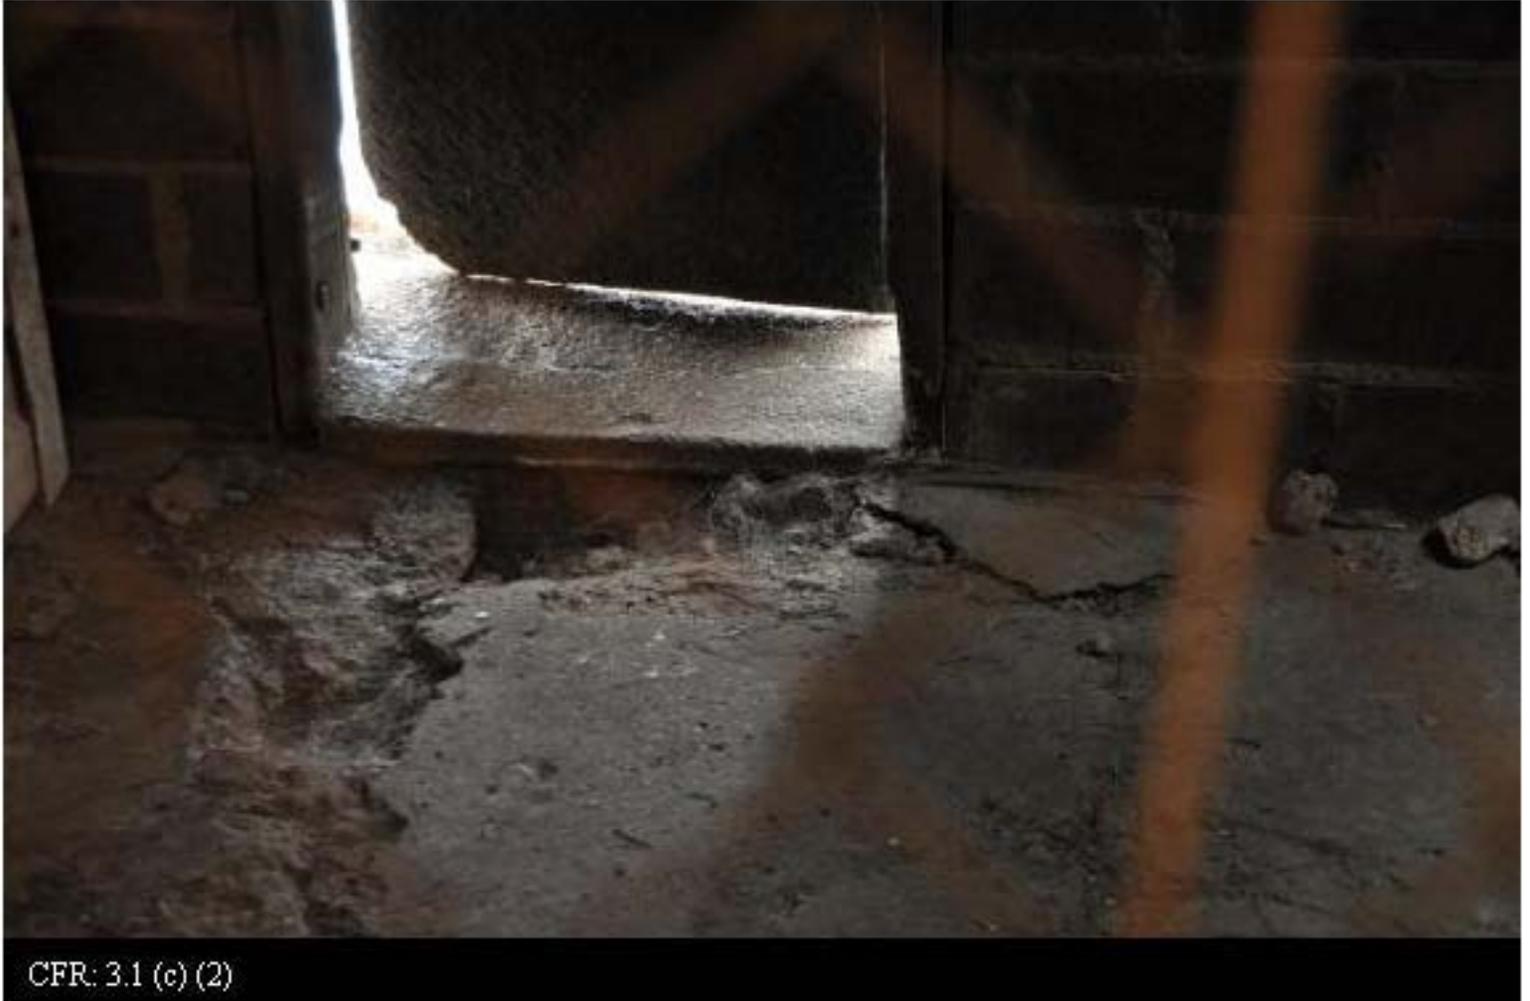
CFR: 3.1 (c) (2)

Photographer:	Heather Cole	Legal Name:	Registration:	42-A-1163
Photo Taken:	Mon, Dec 6, '10	DIANA WENDEL		
Inspection:	340101319240662			
Description:	Inside the large dog building, last pen on the right. Deep hole in the cement with cracks extending out from it. Porous, rocky surfaces exposed.

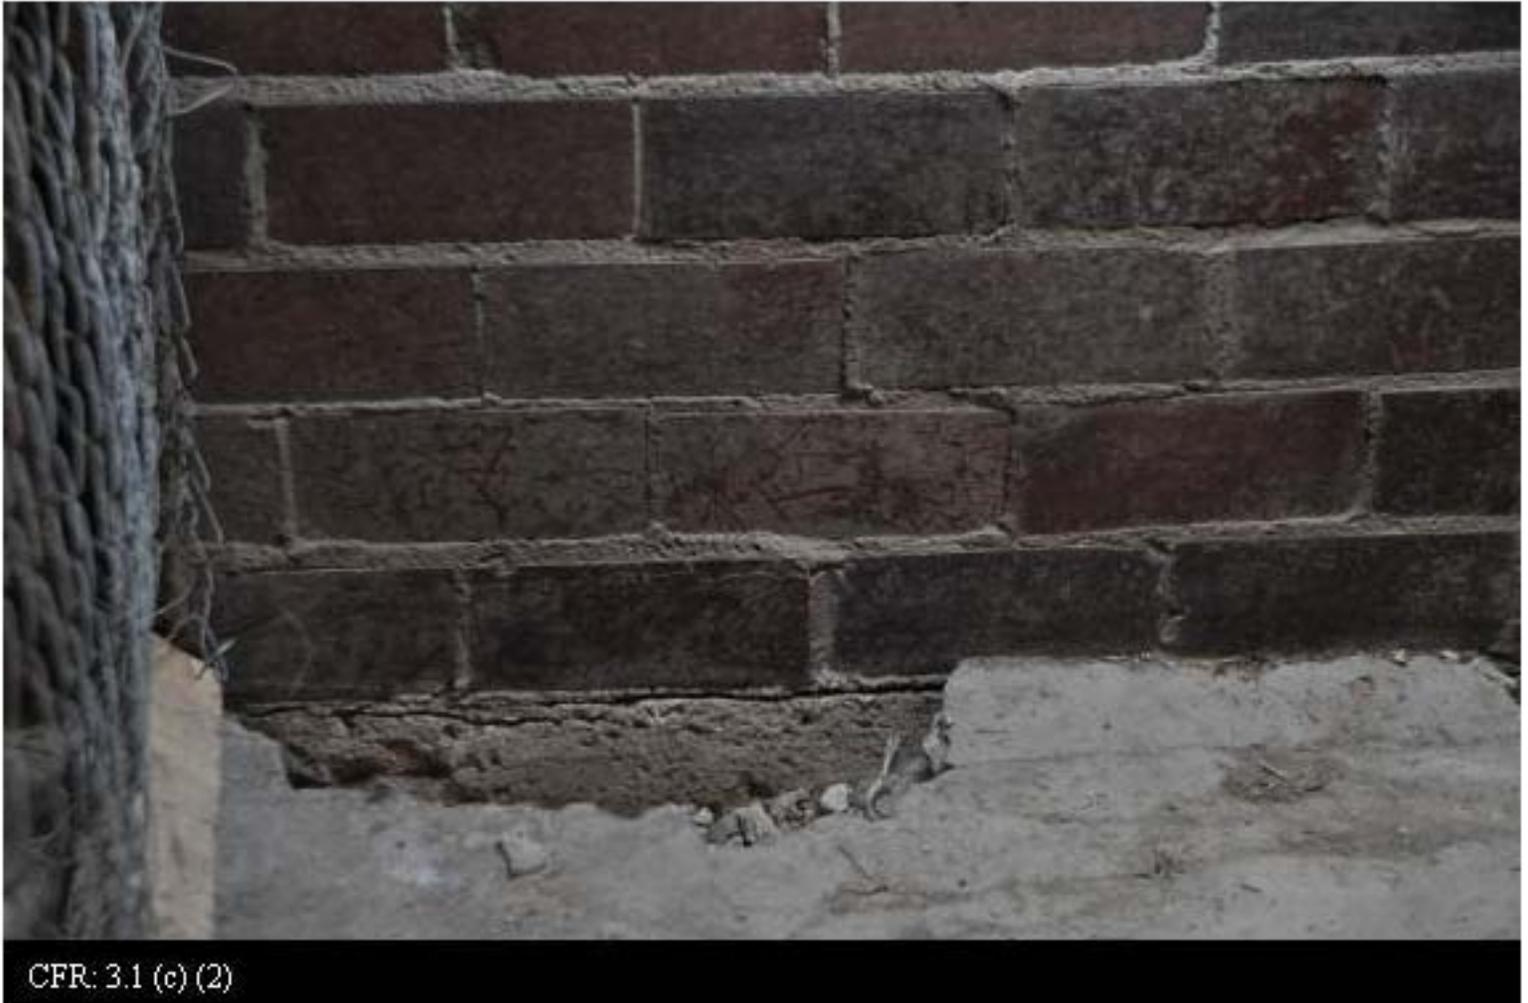
Photographer:	Heather Cole	Legal Name:	Registration:	42-A-1163
Photo Taken:	Mon, Dec 6, '10	DIANA WENDEL		
Inspection:	340101319240662			
Description:	Inside of the large dog building, the second to the last pen on the right. Deep hole adjacent to the outside wall of the primary enclosure. Porous, rocky surfaces exposed.

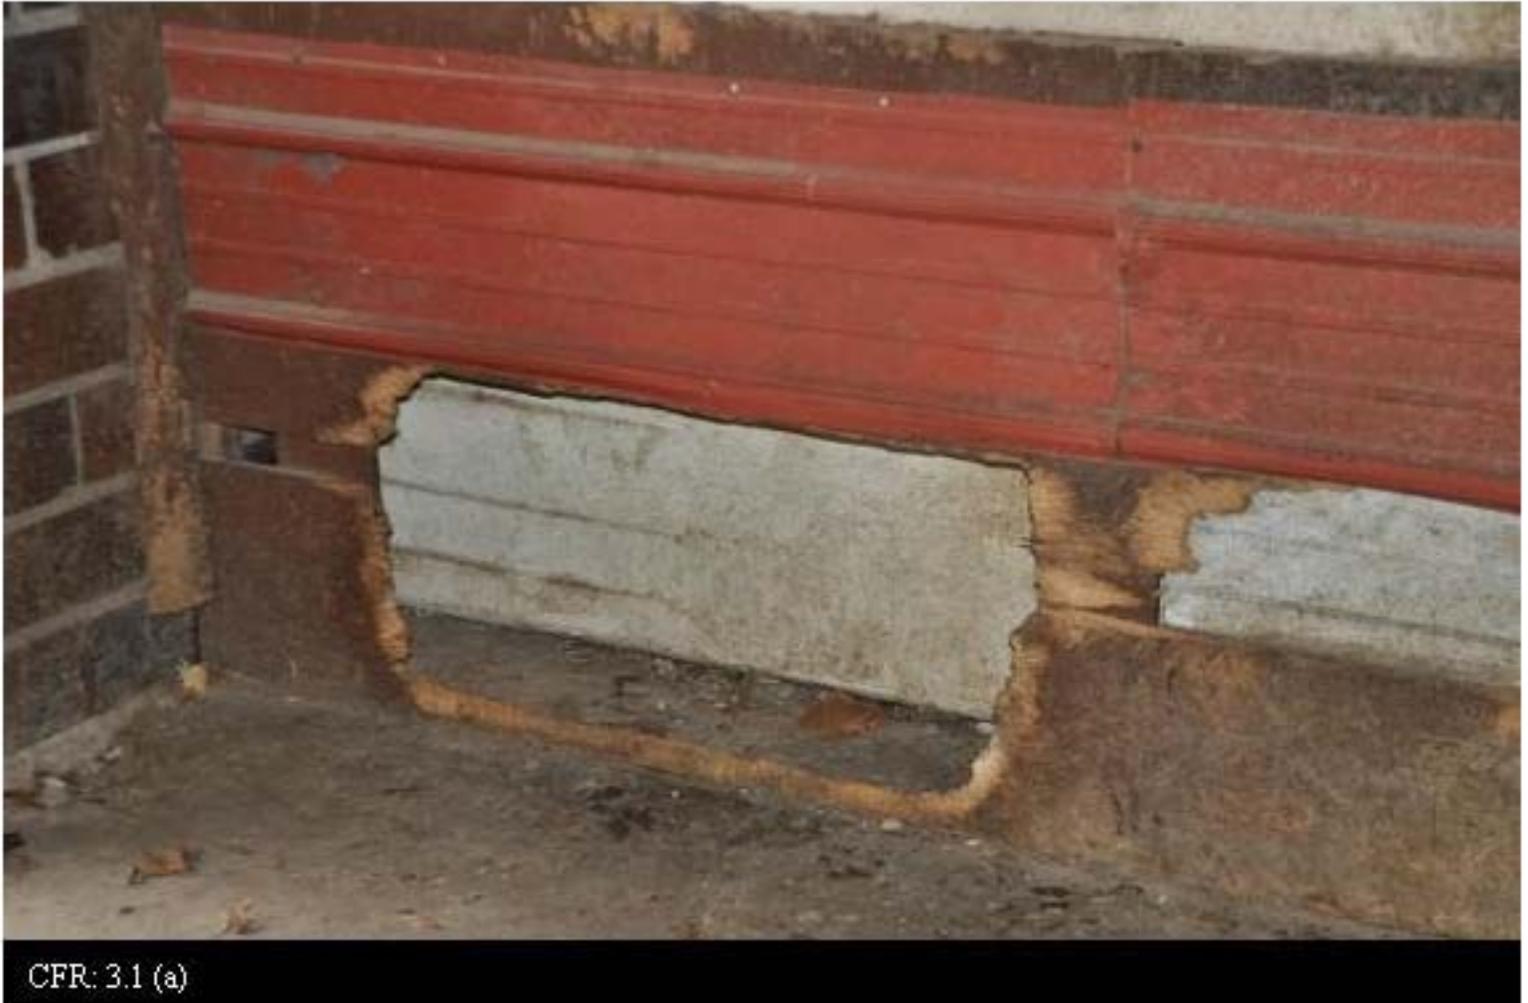
FOIA 11-28200418

Photographer:	Heather Cole	Legal Name:	Registration:	42-A-1163
Photo Taken:	Mon, Dec 6, '10	DIANA WENDEL		
Inspection:	340101319240662			
Description:	Close-up of the 2 large holes chewed in the wood of the dividing wall between the 1st and 2nd pens on the right in the large dog building. Photo is taken looking from the 2nd pen towards the 1st pen.
