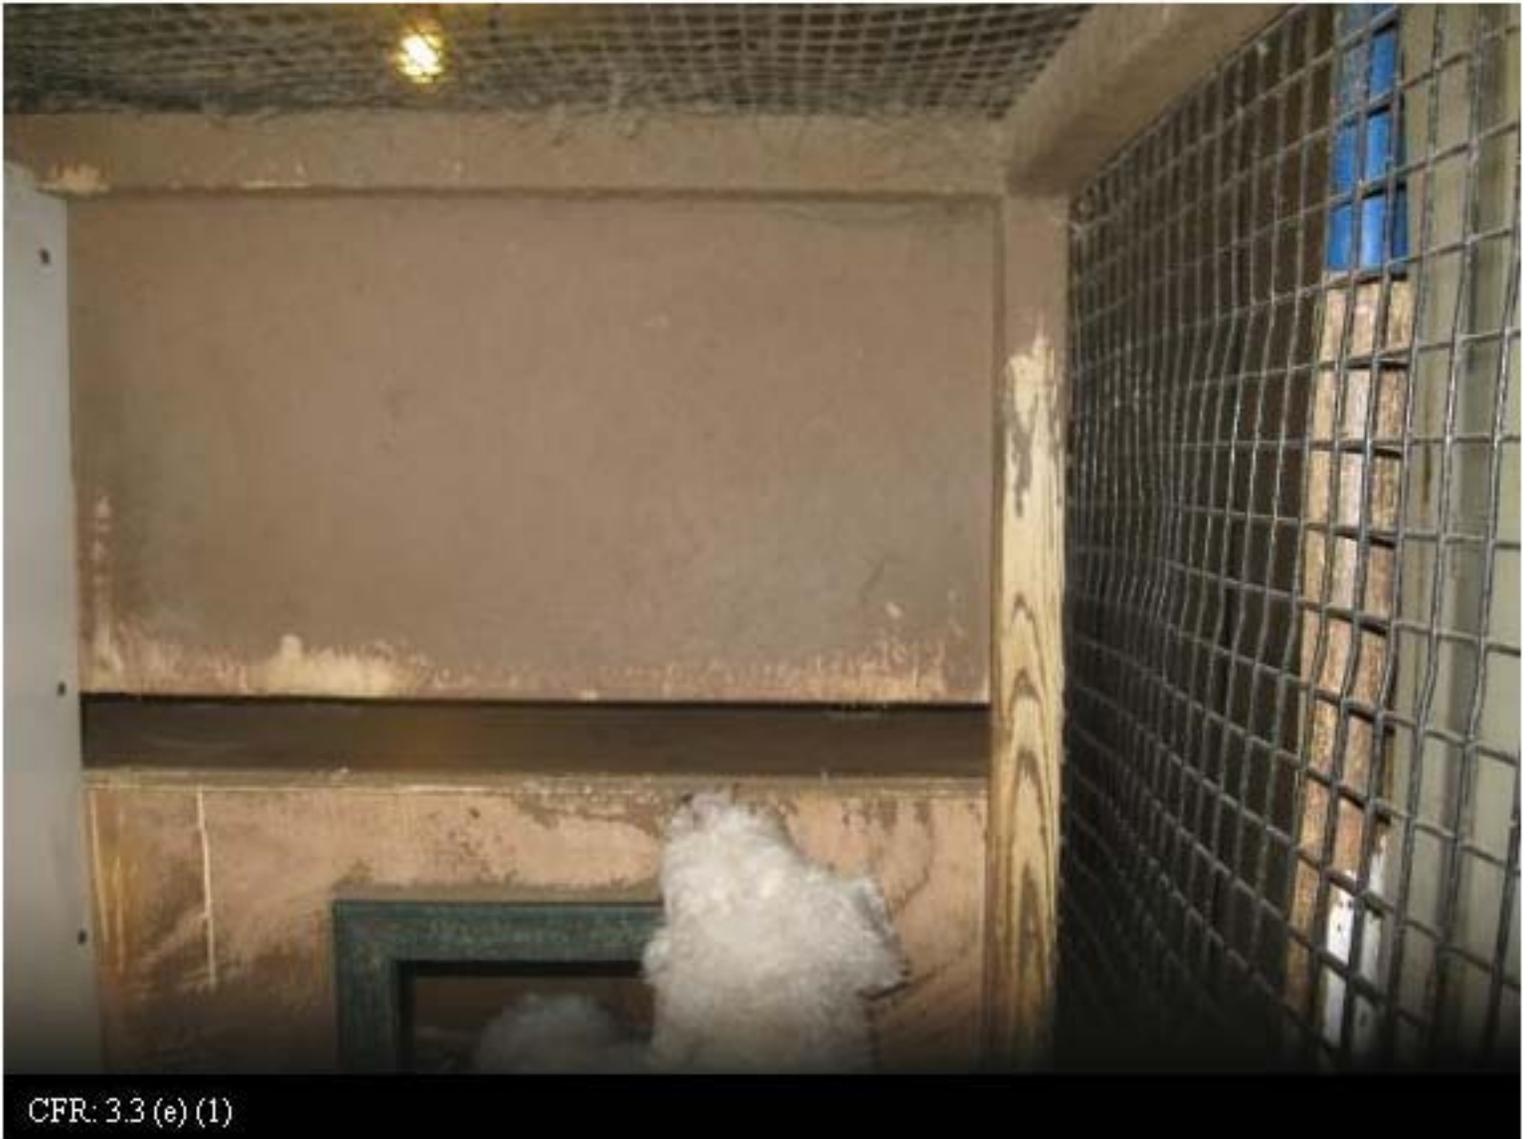
CFR: 3.3 (e) (1)

Photographer:	AnnMarie Houser	Legal Name:	Registration:	42-A-1156
Photo Taken:	Tue, Sep 28, '10	aproximately 1545	Lawrence Nolt	
Inspection:	344101014100854			
Description:	Wooden surfaces are no longer impervious to moisture.

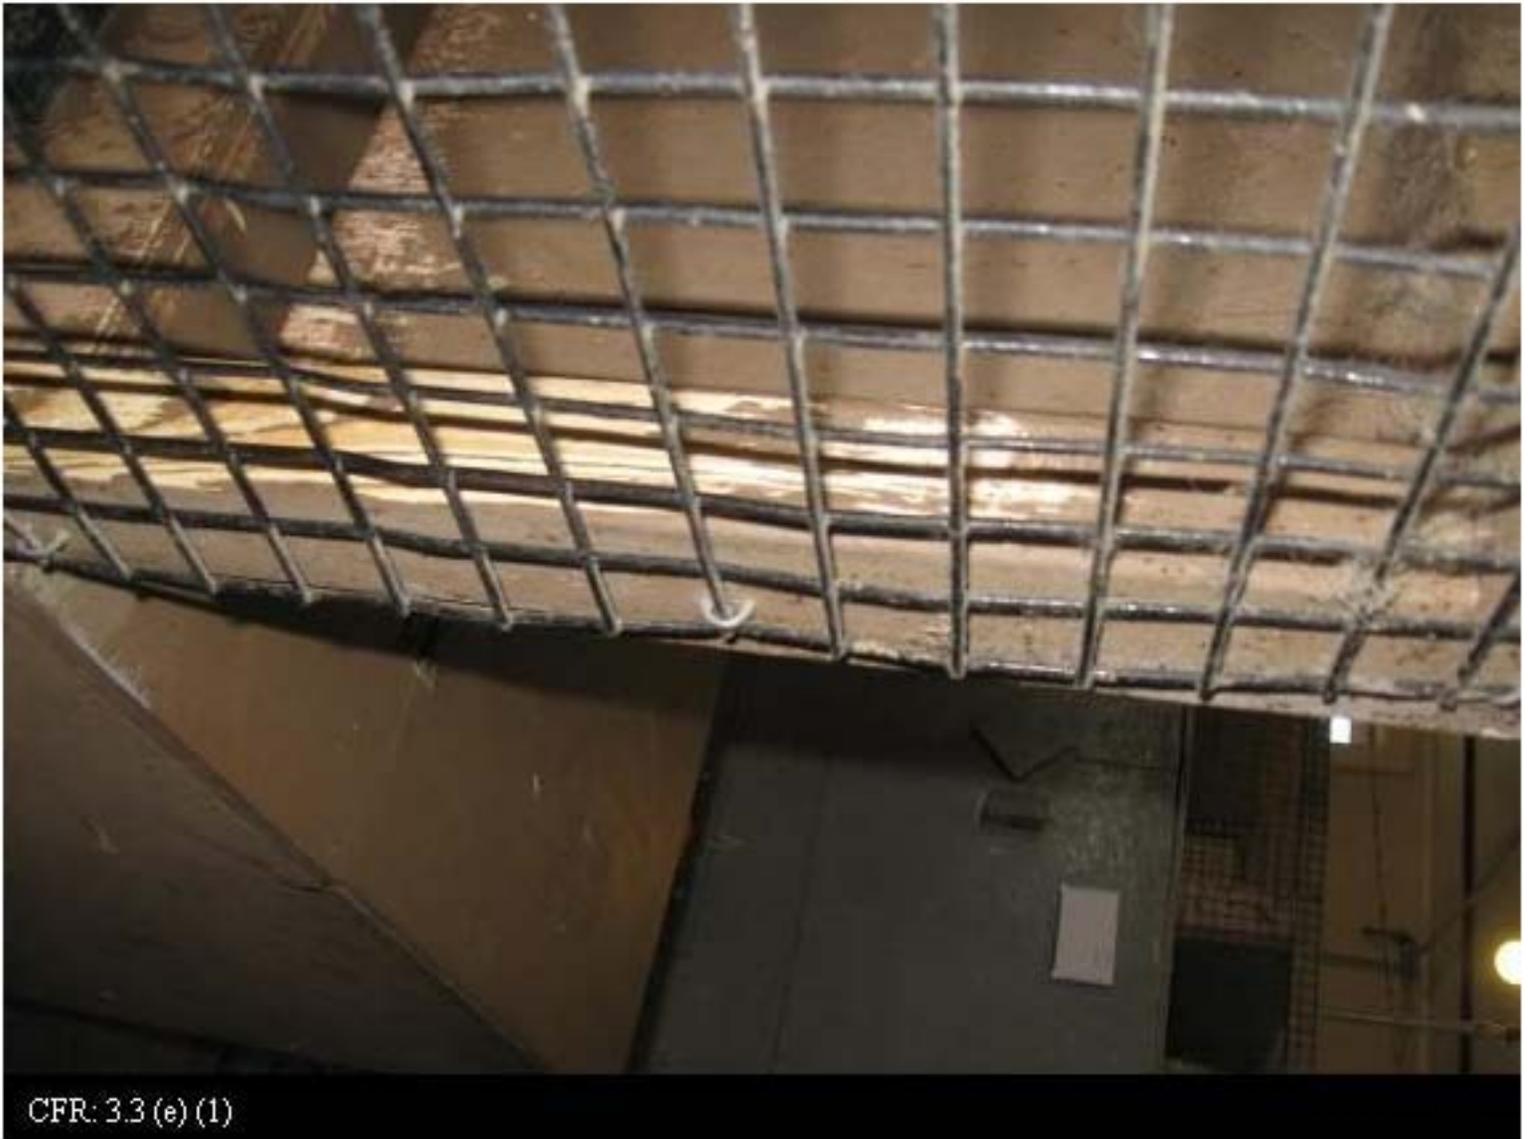
Photographer:	AnnMarie Houser	Legal Name:	Registration:	42-A-1156
Photo Taken:	Tue, Sep 28, '10	aproximately 1545	Lawrence Nolt	
Inspection:	344101014100854			
Description:	Wooden surfaces are no longer impervious to moisture.

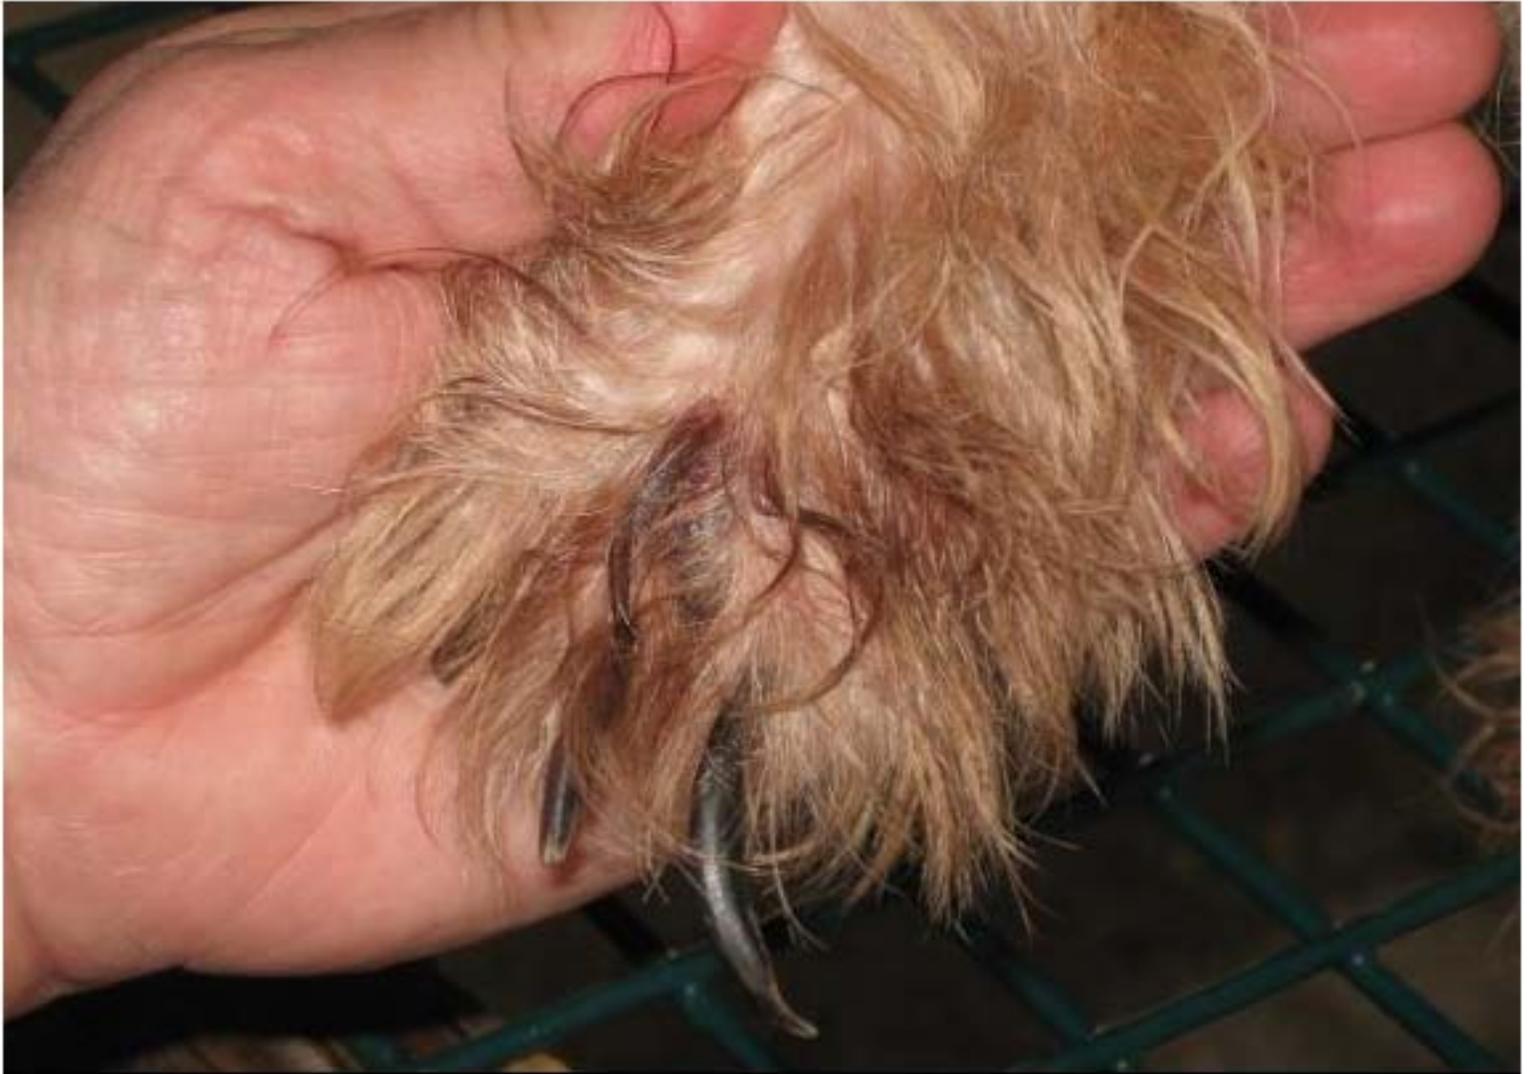
CFR: 2.40 (b) (2)

Photographer:	AnnMarie Houser	Legal Name:	Registration:	42-A-1156
Photo Taken:	Tue, Sep 28, '10 approximately 1545	Lawrence Nolt		
Inspection:	344101014100854			
Description:	Dog has excessively long toenails.

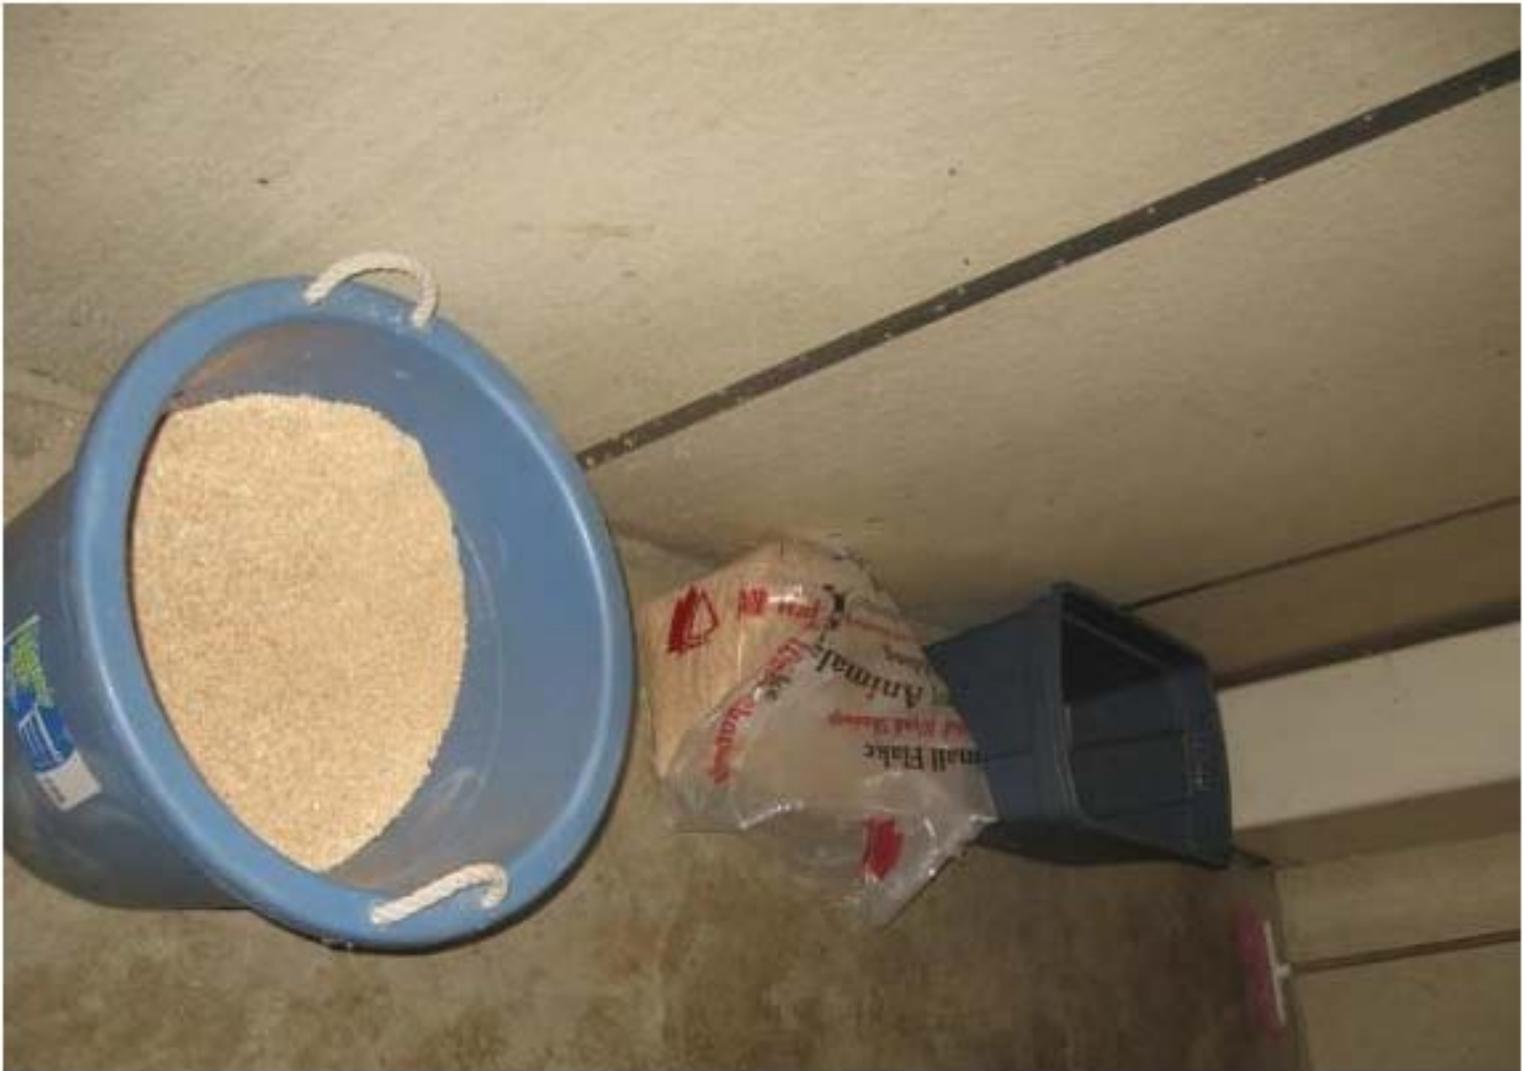
CFR: 3.1 (e)

Photographer:	AnnMarie Houser	Legal Name:	Registration:	42-A-1156
Photo Taken:	Tue, Sep 28, '10	aproximately 1545	Lawrence Nolt	
Inspection:	344101014100854			
Description:	Open supplies of bedding stored on floor in the animal area and is not in leak proof containers.

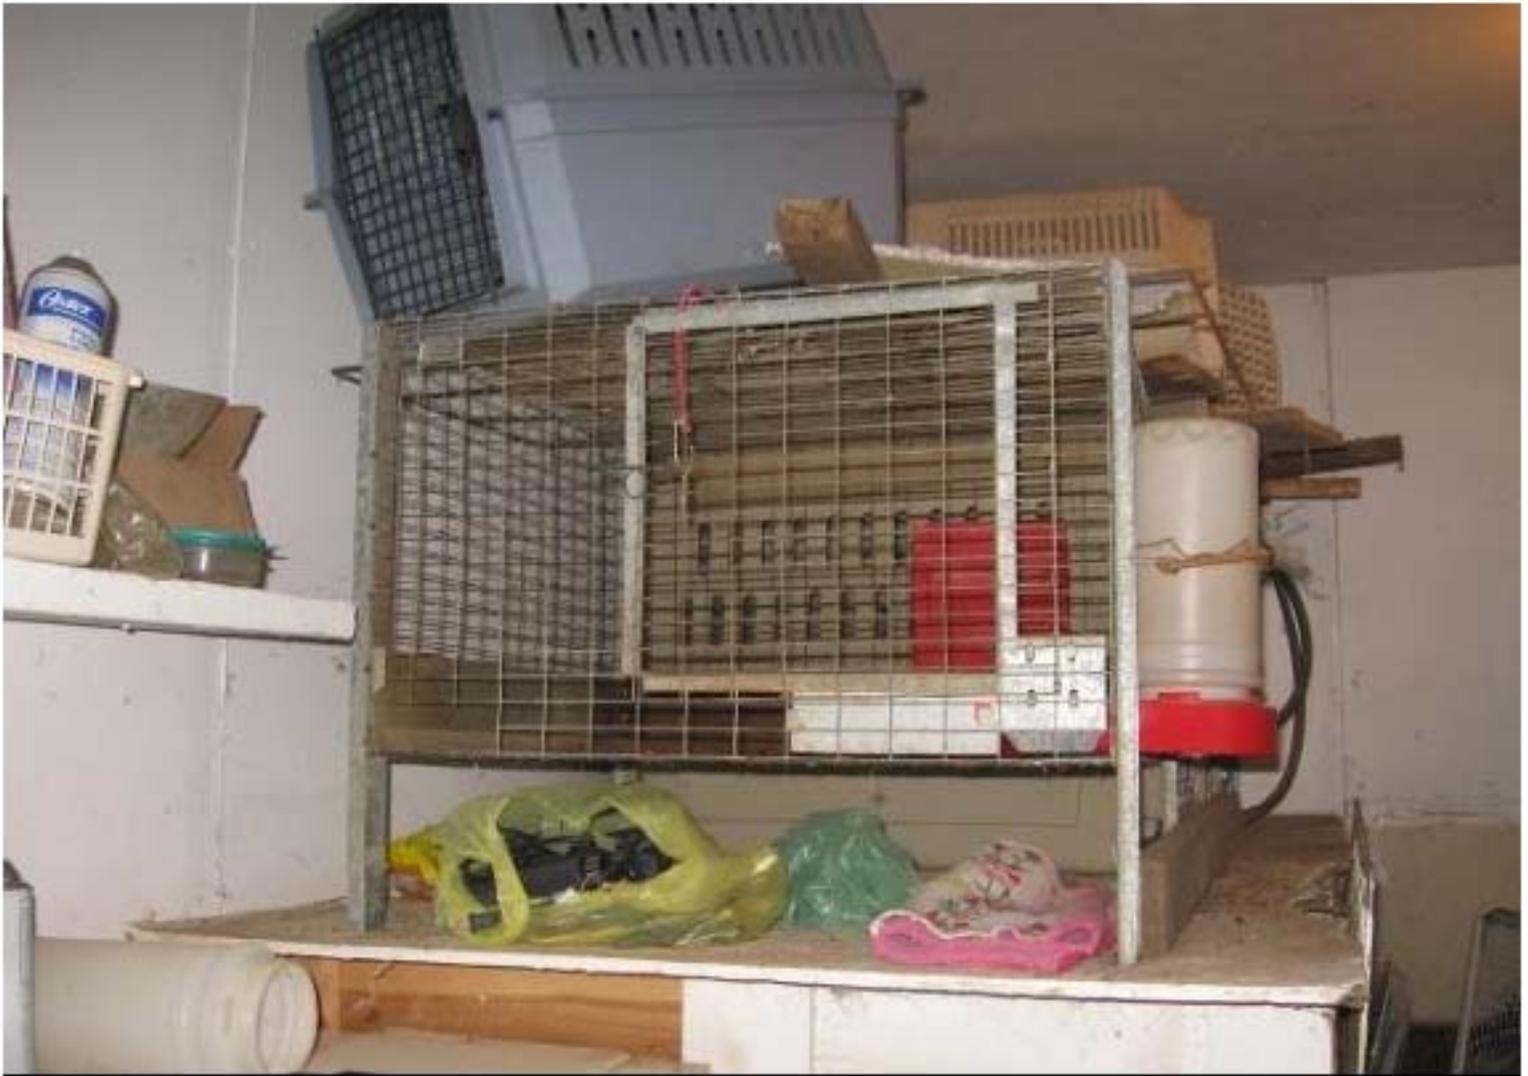
CFR: 3.11 (c)

Photographer:	Cynthia M. Neis	Legal Name:	Registration:	42-A-1134
Photo Taken:	Tue, Jan 11, '11	DIANE HOBERT		
Inspection:	11111402500998			
Description:	Accumulation of materials in the animal housing area. Items and enclosure tops are excessively dusty.

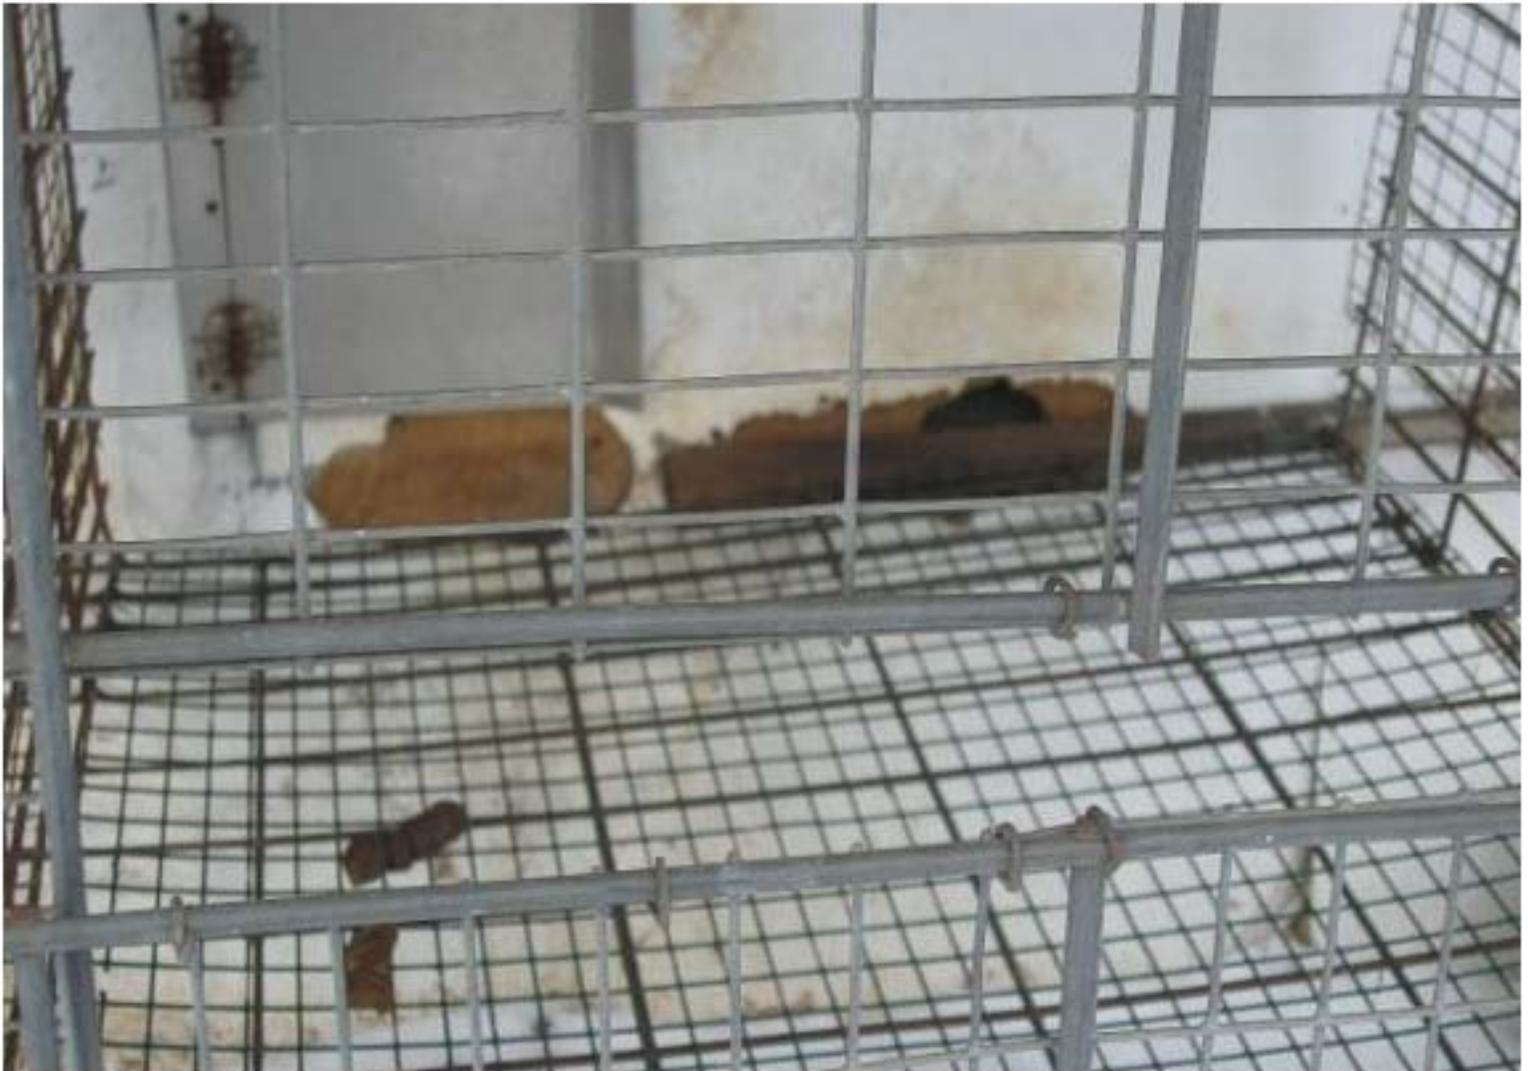
CFR: 3.3 (e) (1) (iii)

Photographer:	Cynthia M. Neis	Legal Name:	Registration:	42-A-1134
Photo Taken:	Tue, Jan 11, '11	DIANE HOBERT		
Inspection:	11111402500998			
Description:	Damaged wall covering directly beneath door and to the right of door and near the floor.

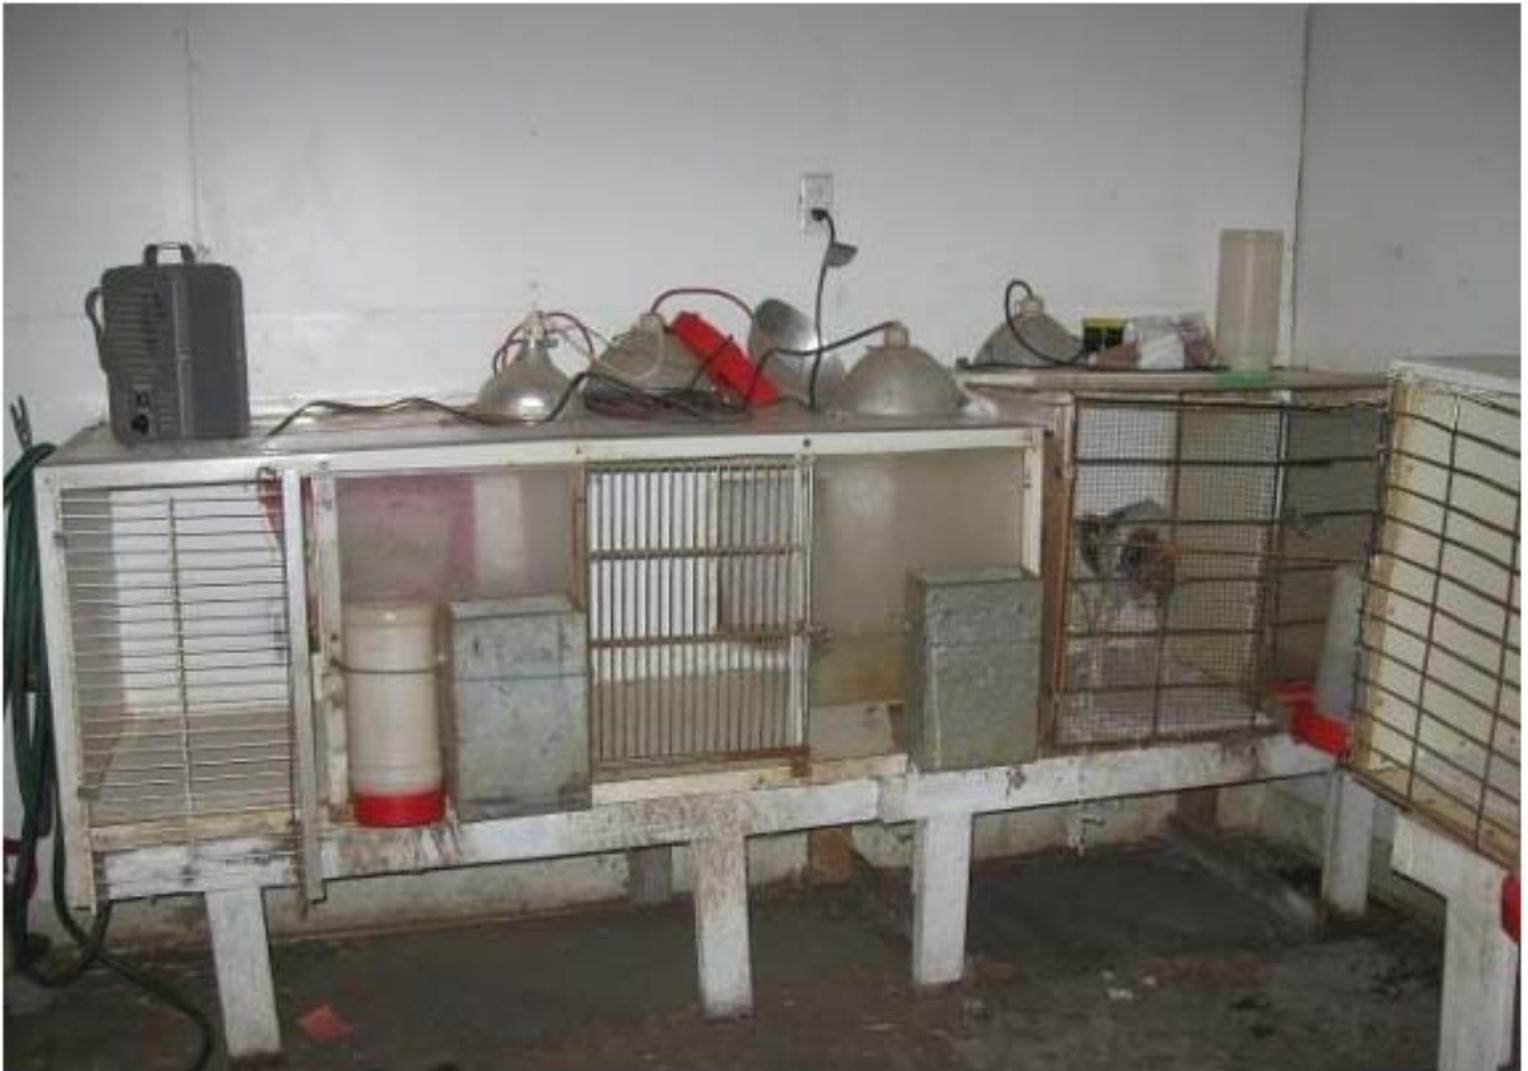
CFR: 3.11 (c), 3.10

Photographer:	Cynthia M. Neis	Legal Name:	Registration:	42-A-1134
Photo Taken:	Tue, Jan 11, '11	DIANE HOBERT		
Inspection:	11111402500998			
Description:	Accumulation of materials in the animal housing area. Items and enclosure tops are excessively dusty. The enclosure to the left has no water. The water receptacle on right has water line visible.

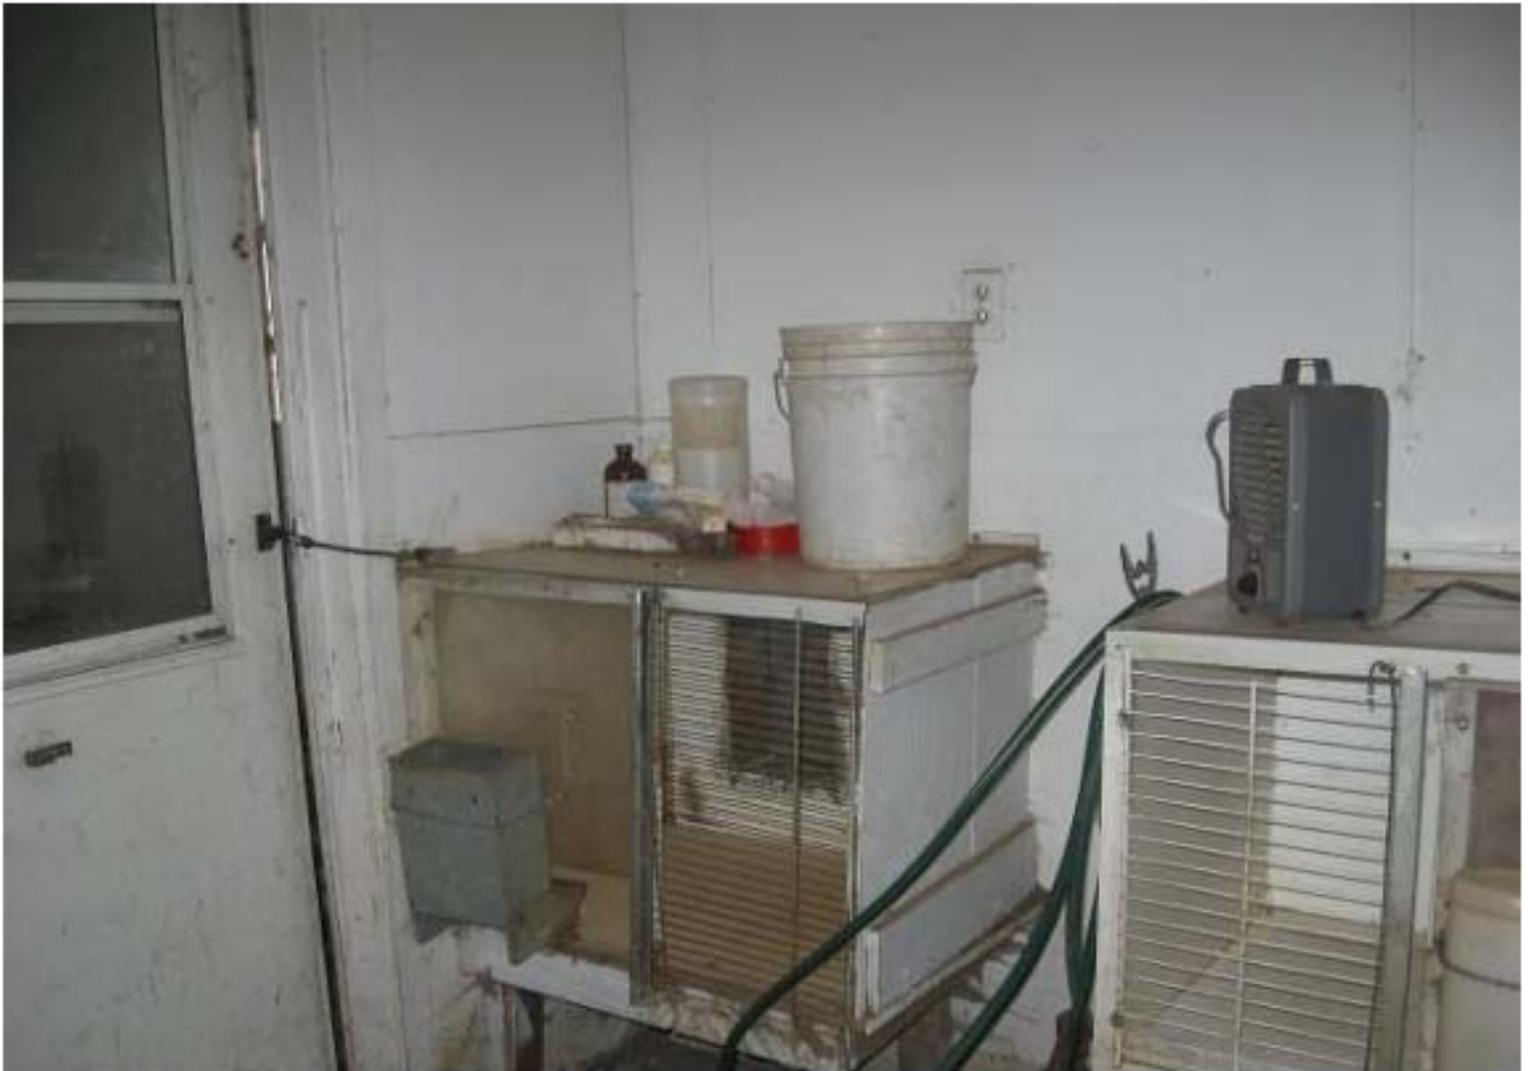
CFR: 3.11 (c)

Photographer:	Cynthia M. Neis	Legal Name:	Registration:	42-A-1134
Photo Taken:	Tue, Jan 11, '11	DIANE HOBERT		
Inspection:	11111402500998			
Description:	Accumulation of materials in the animal housing area. Items and enclosure tops are excessively dusty.

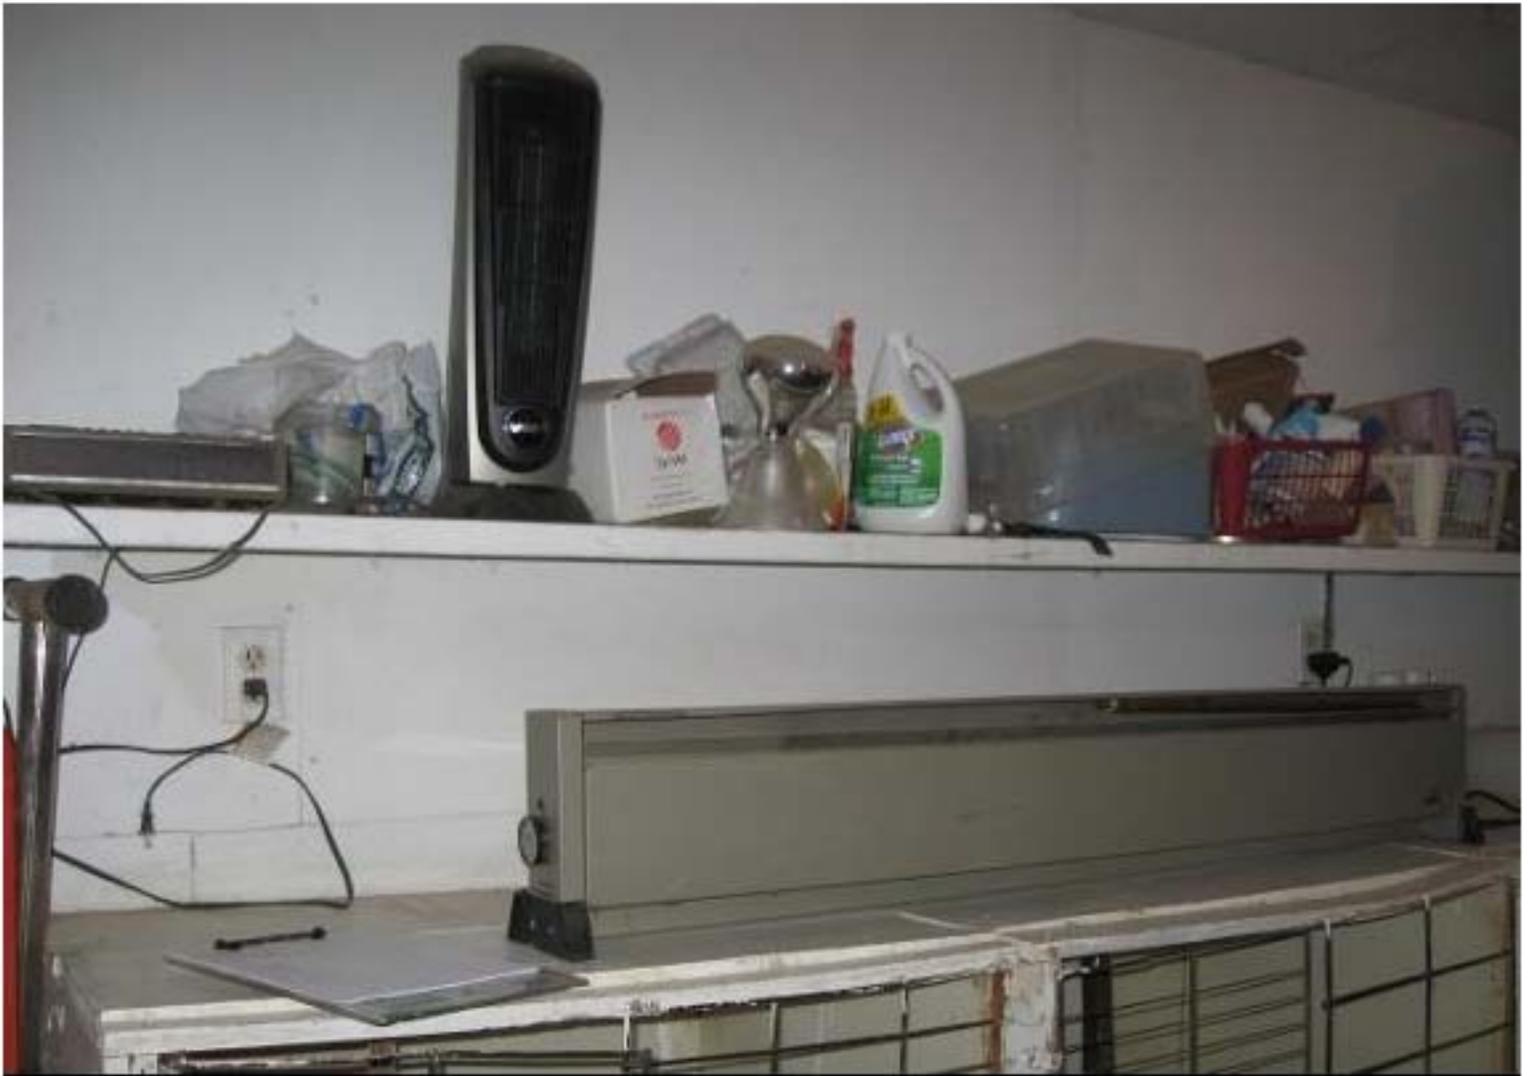
CFR: 3.11 (c)

Photographer:	Cynthia M. Neis	Legal Name:	Registration:	42-A-1134
Photo Taken:	Tue, Jan 11, '11	DIANE HOBERT		
Inspection:	11111402500998			
Description:	Accumulation of materials in the animal housing area. Items and enclosure tops are excessively dusty.

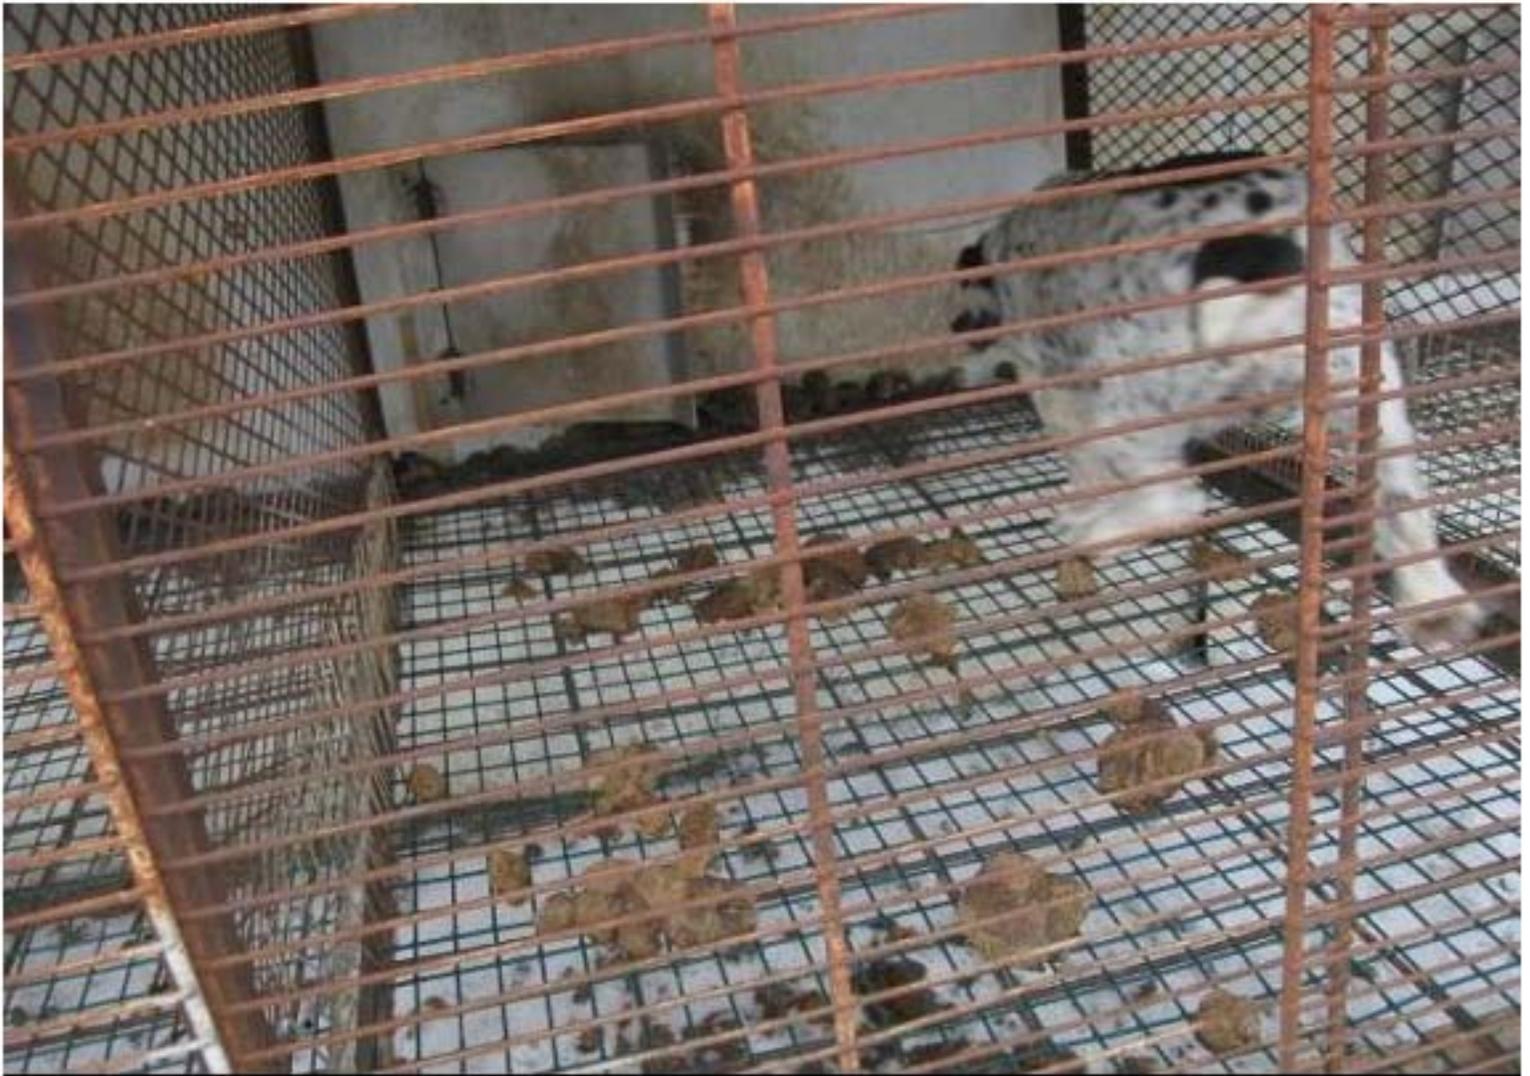
CFR: 3.11 (a), 3.3 (e) (1) (iii)

Photographer:	Cynthia M. Neis	Legal Name:	Registration:	42-A-1134
Photo Taken:	Tue, Jan 11, '11	DIANE HOBERT		
Inspection:	11111402500998			
Description:	Excessive accumulation of animal waste.

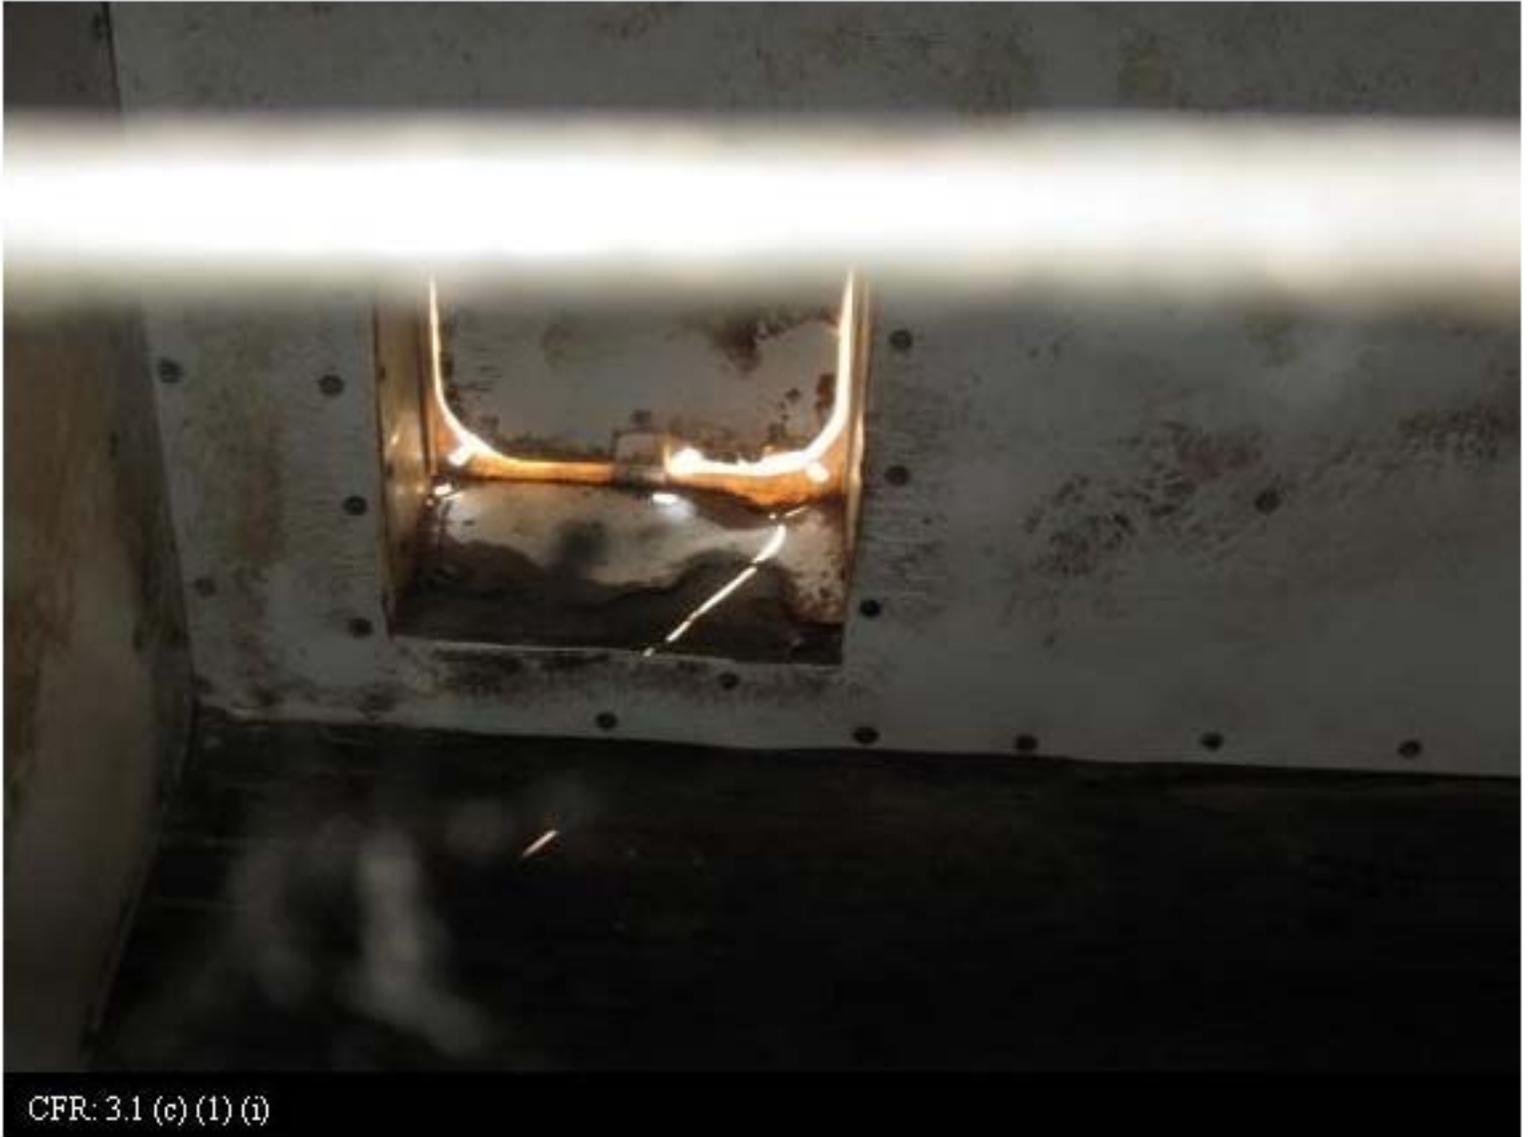
CFR: 3.1 (c) (1) (i)

Photographer:	Randall Wagner (ACI)	Legal Name:	Registration:	42-A-1099
Photo Taken:	Tue, Sep 21, '10	DONALD MINTEN		
Inspection:	264101525000667			
Description:	The tin surface is rusting/flaking excessively and affecting the surface strength or rusting away.

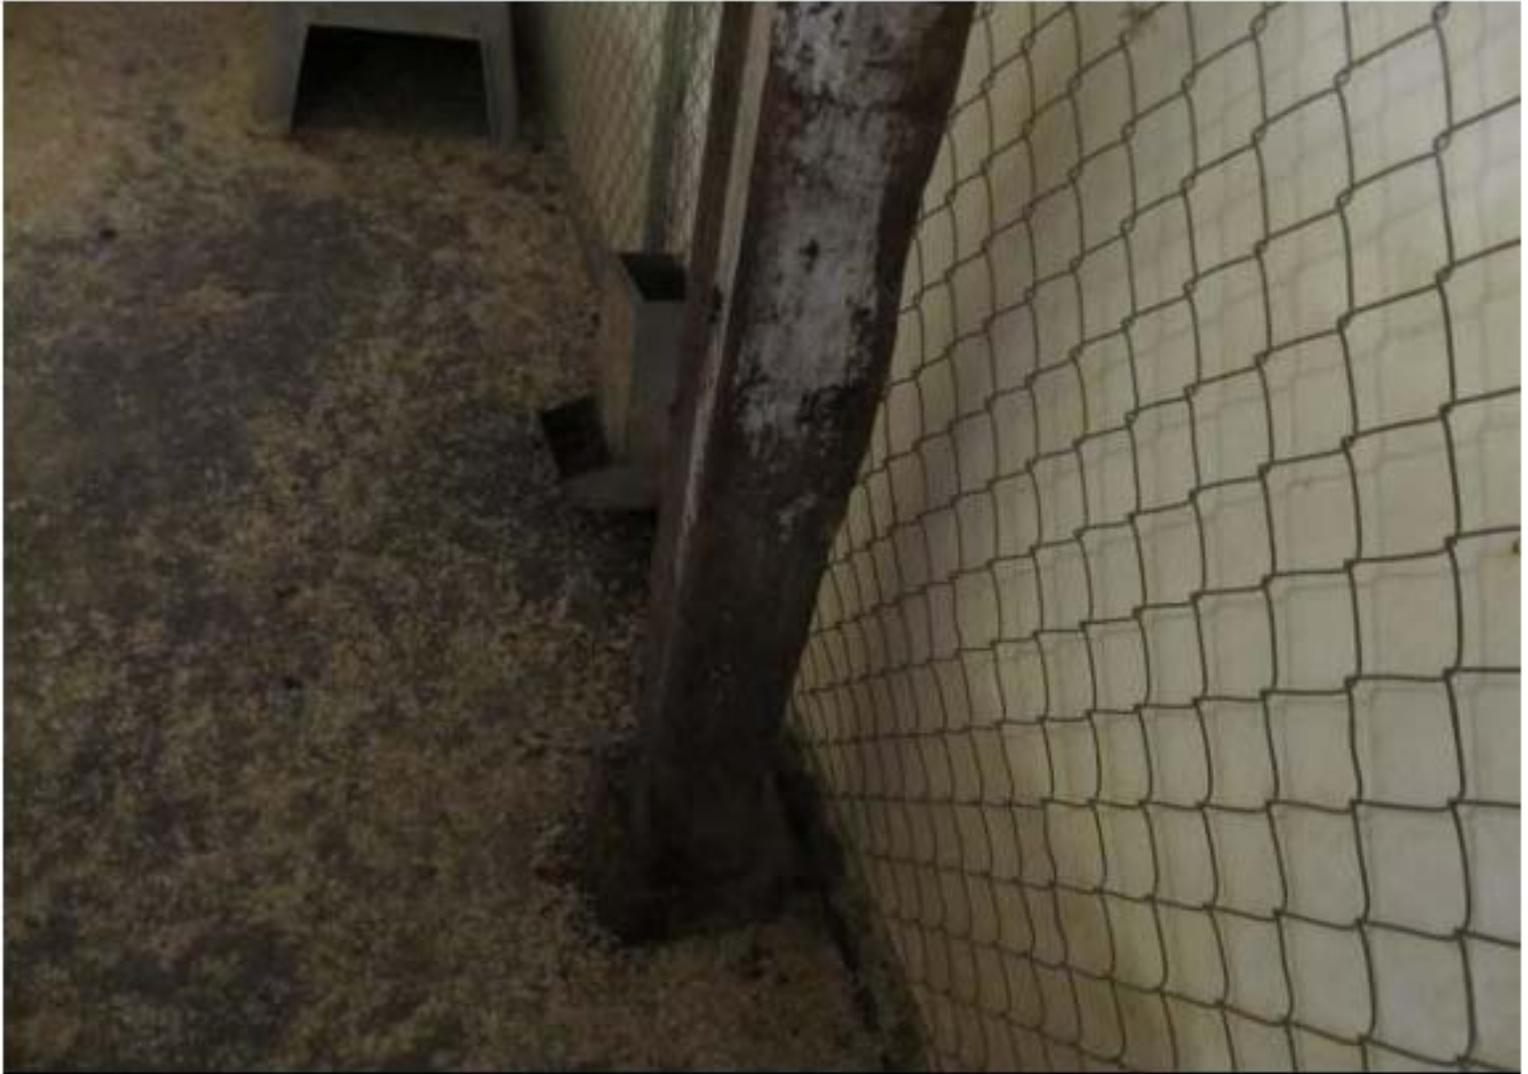
CFR: 3.1 (c) (2)

Photographer:	Brenda Pietrosante	Legal Name:	Registration:	42-A-1066
Photo Taken:	Wed, Jan 26, '11	ELAINE BROOKS		
Inspection:	27111608430587	THOMAS R. H. BROOKS		
Description:	A chewed wooden support beam in the first cage on the left in the main room of the housing facility.

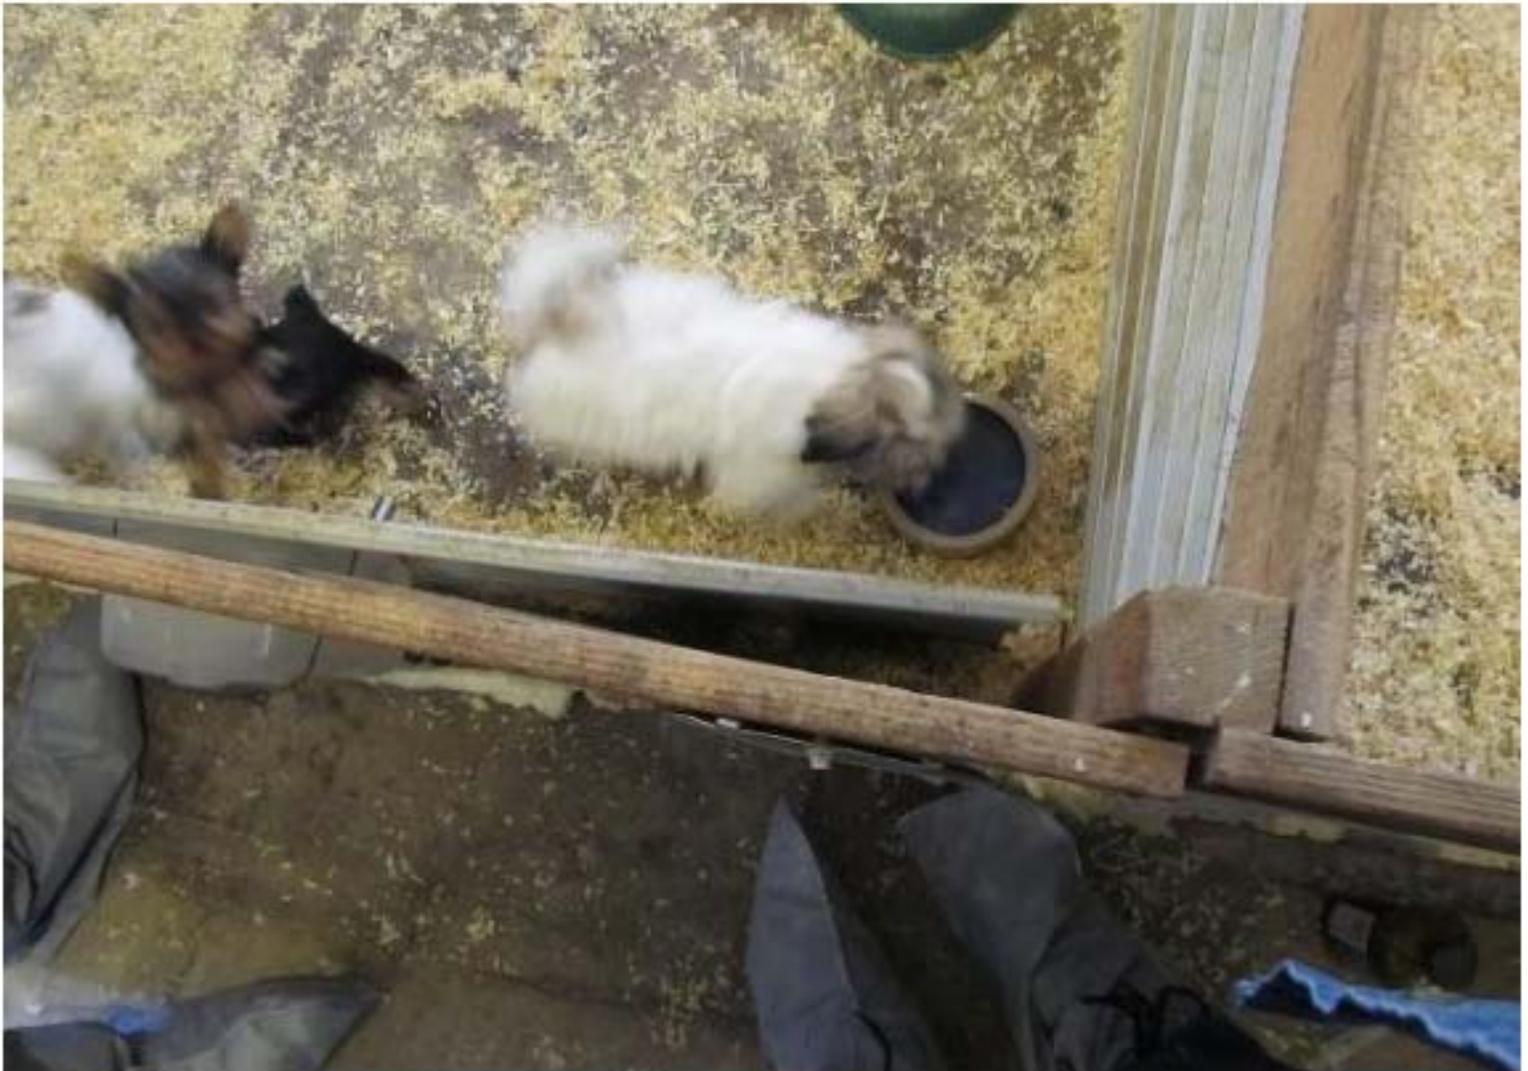
CFR: 3.1 (a)

Photographer:	Brenda Pietrosante	Legal Name:	Registration:	42-A-1066
Photo Taken:	Wed, Jan 26, '11	ELAINE BROOKS		
Inspection:	27111608430587	THOMAS R. H. BROOKS		
Description:	In the main room of the housing facility, within the 4th pen on the right, a metal panel within the primary enclosure has become detached from an adjacent metal panel.
