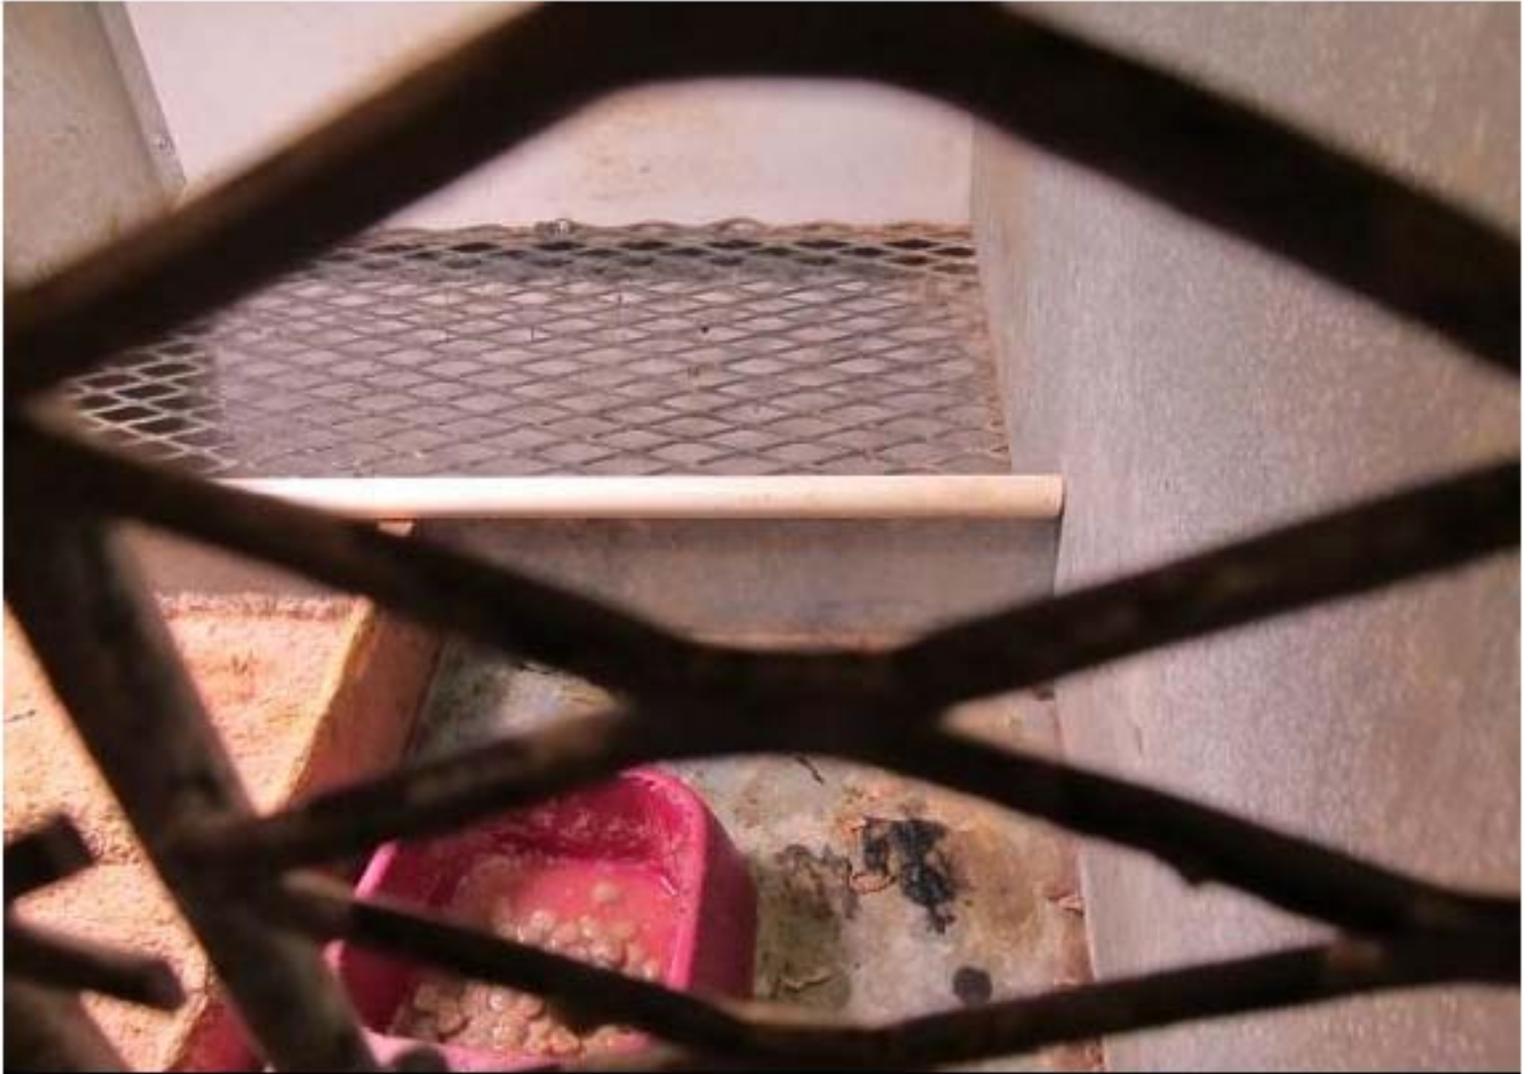
CFR: 3.11 (b) (2)

Photographer:	Brenda Pietrosante	Legal Name:	Registration:	42-A-1066
Photo Taken:	Wed, Jan 26, '11	ELAINE BROOKS		
Inspection:	27111608430587	THOMAS R. H. BROOKS		
Description:	An accumulation of old, dried feces on the floor of the last primary enclosure on the left in the whelping room. Enclosure contains one sick pup.

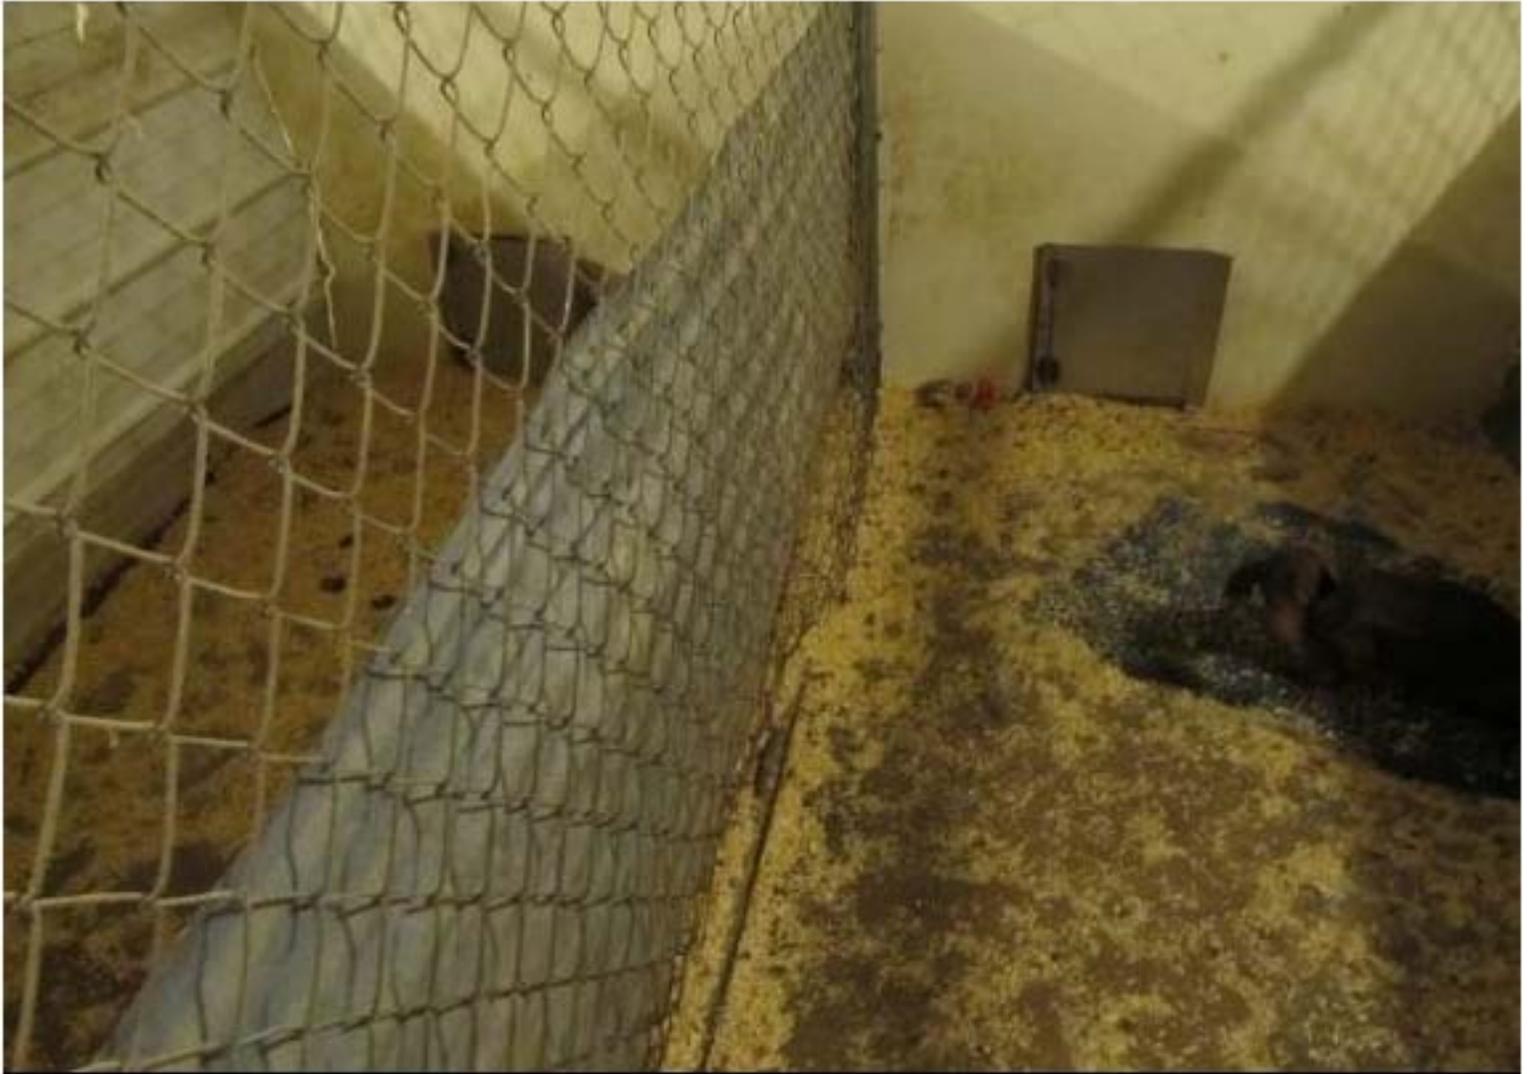
CFR: 3.1 (a)

Photographer:	Brenda Pietrosante	Legal Name:	Registration:	42-A-1066
Photo Taken:	Wed, Jan 26, '11	ELAINE BROOKS		
Inspection:	27111608430587	THOMAS R. H. BROOKS		
Description:	A hole in the chain-link fence at the bottom back, left of the cage.

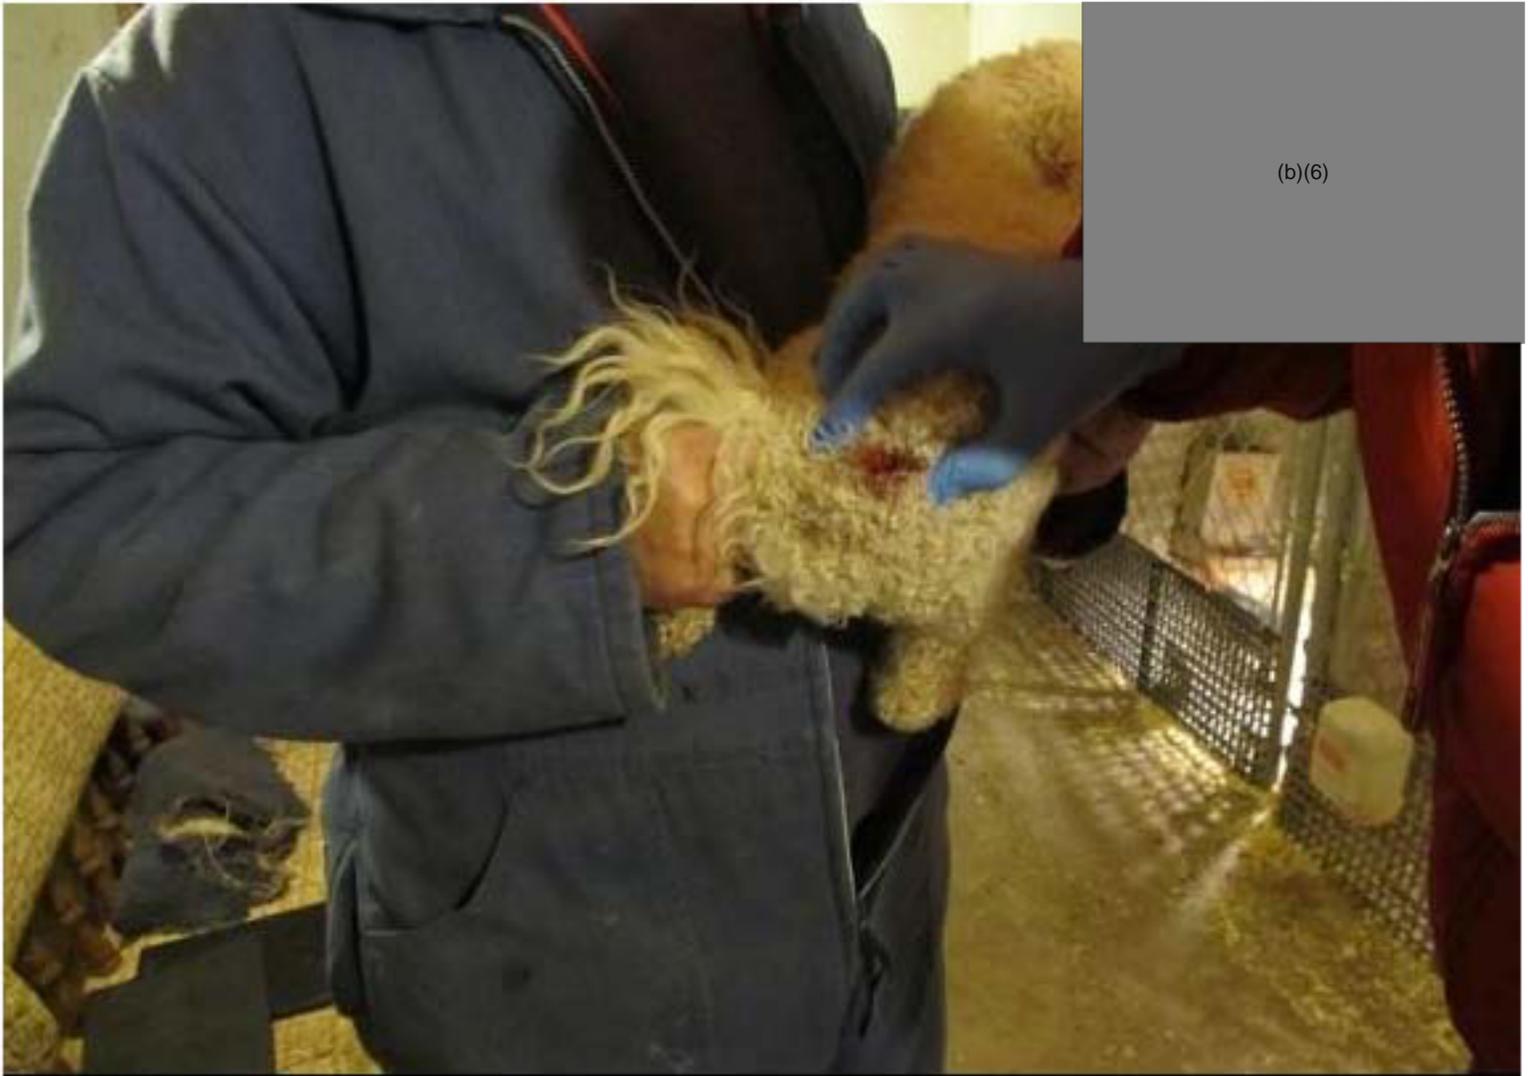
CFR: 2.40 (b) (2)

Photographer:	Brenda Pietrosante	Legal Name:	Registration:	42-A-1066
Photo Taken:	Wed, Jan 26, '11	ELAINE BROOKS		
Inspection:	27111608430587	THOMAS R. H. BROOKS		
Description:	A dog with a puncture wound at the base of her tail. The puncture wound is red and swollen with no discharge. The dog reacts negatively when the surrounding area is touched.

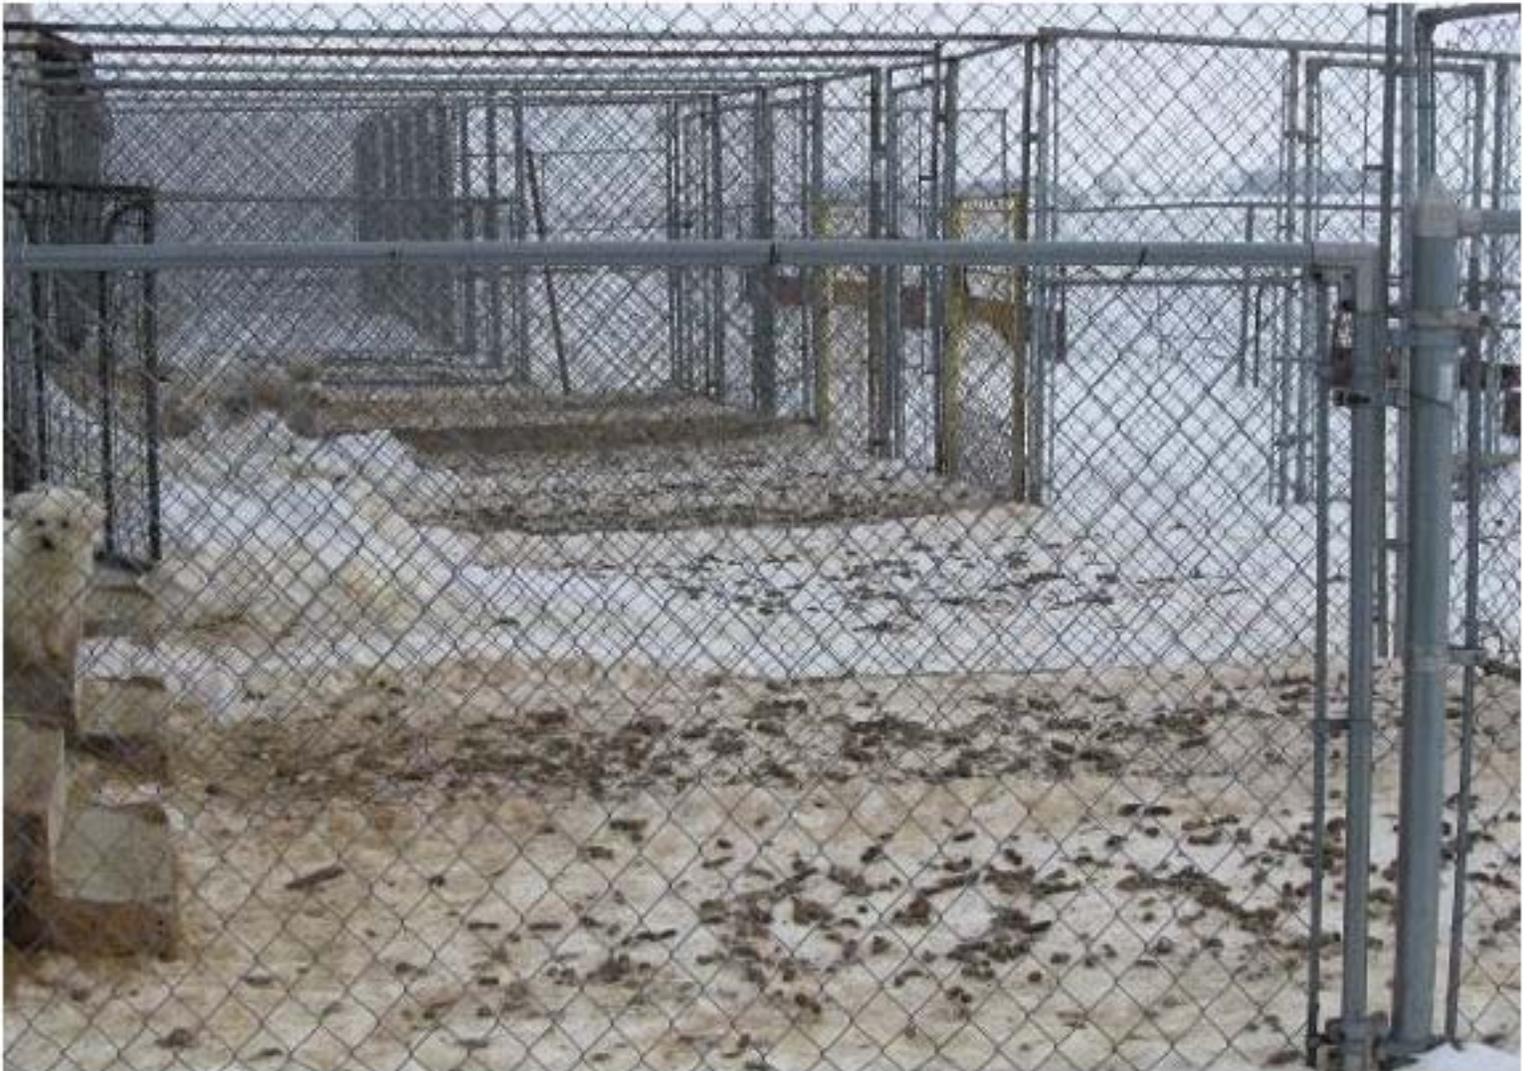
CFR: 3.11 (b) (2)

Photographer:	Brenda Pietrosante	Legal Name:	Registration:	42-A-1066
Photo Taken:	Wed, Jan 26, '11	ELAINE BROOKS		
Inspection:	27111608430587	THOMAS R. H. BROOKS		
Description:	Severe accumulation of snow and feces covering the entire floor of the outdoor runs of the sheltered housing facility.

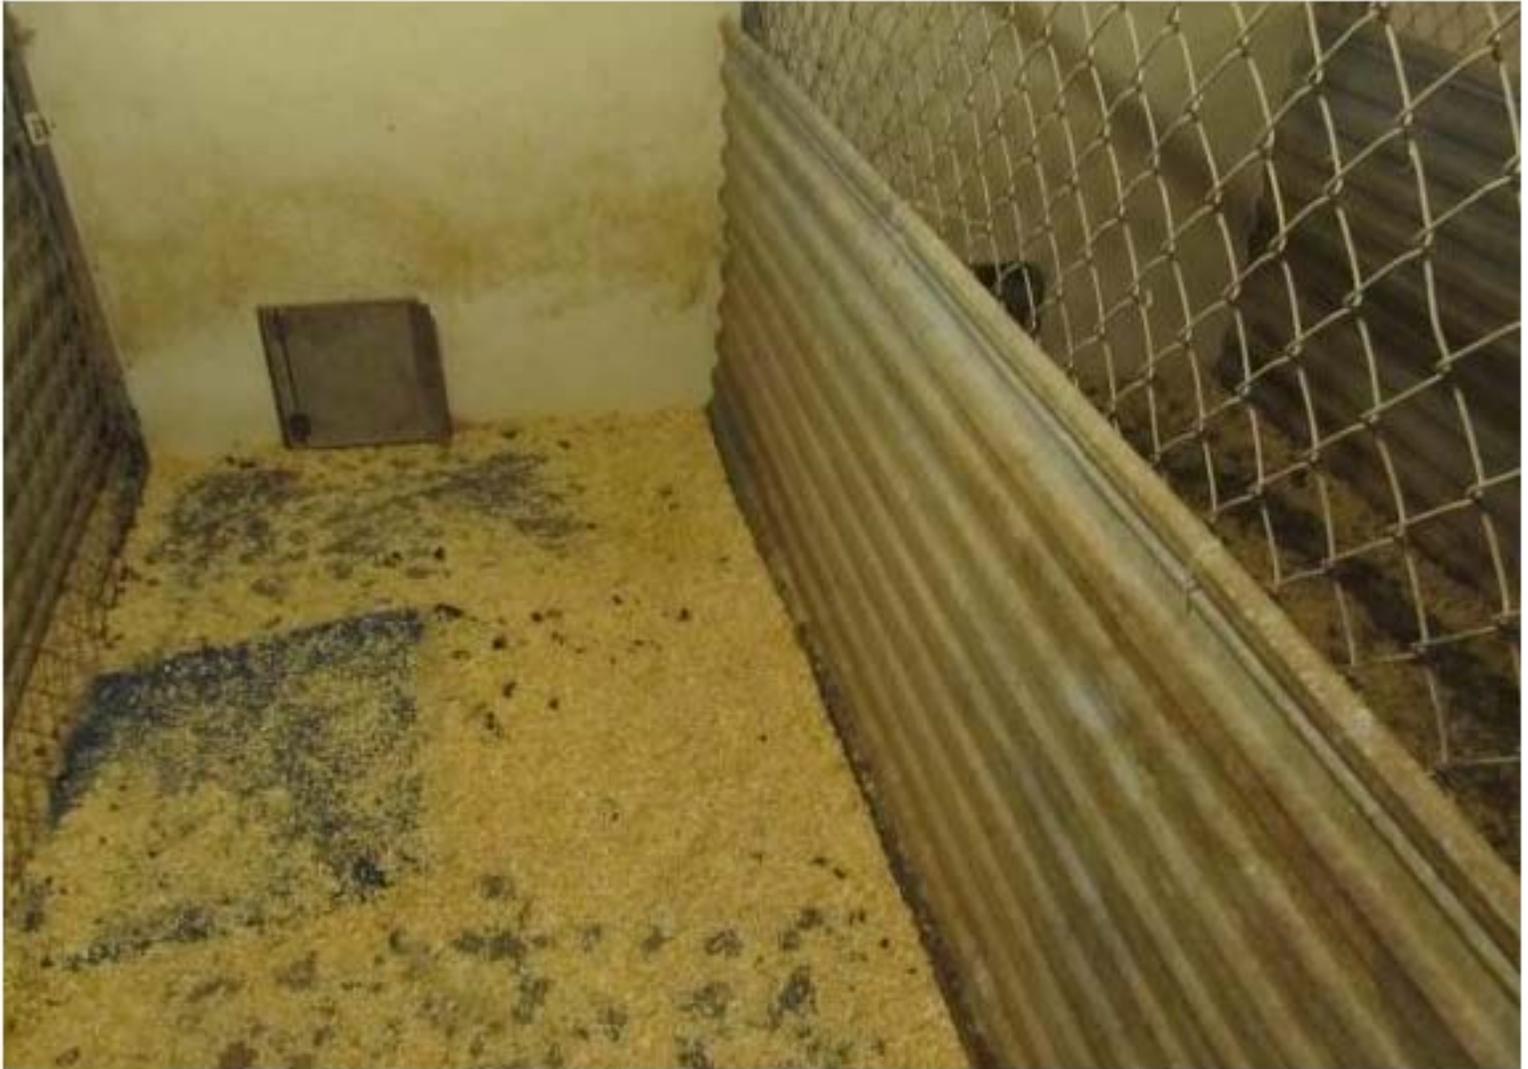
CFR: 3.1 (a)

Photographer:	Brenda Pietrosante	Legal Name:	Registration:	42-A-1066
Photo Taken:	Wed, Jan 26, '11	ELAINE BROOKS		
Inspection:	27111608430587	THOMAS R. H. BROOKS		
Description:	Large sheet of tin that is becoming detached from the fence. The metal panel is very loosely attached to the fence and unstable.

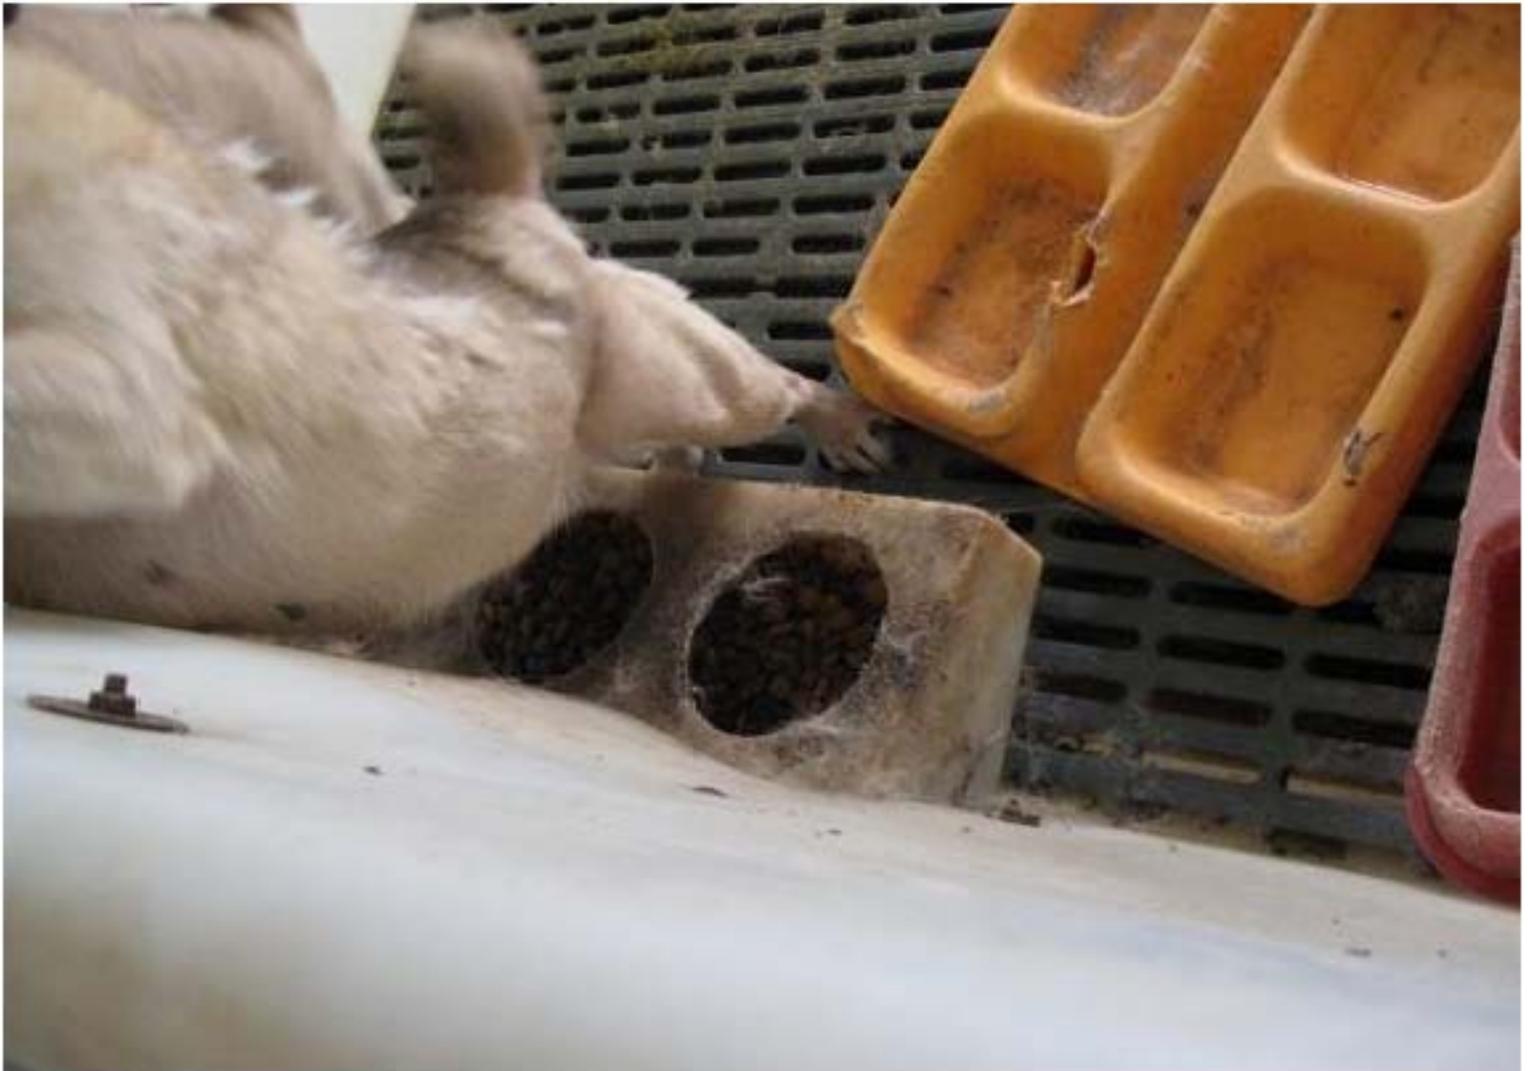
CFR: 3.1 (c) (3)

Photographer:	Randall Wagner (ACI)	Legal Name:	Registration:	42-A-1031
Photo Taken:	Thu, Sep 16, '10	DEBRA OOLMAN		
Inspection:	274101629440154	JASON OOLMAN		
Description:	The surface of the white feeder has an accumulation of black film on the surface, indicating the feeders are not cleaned regularly.

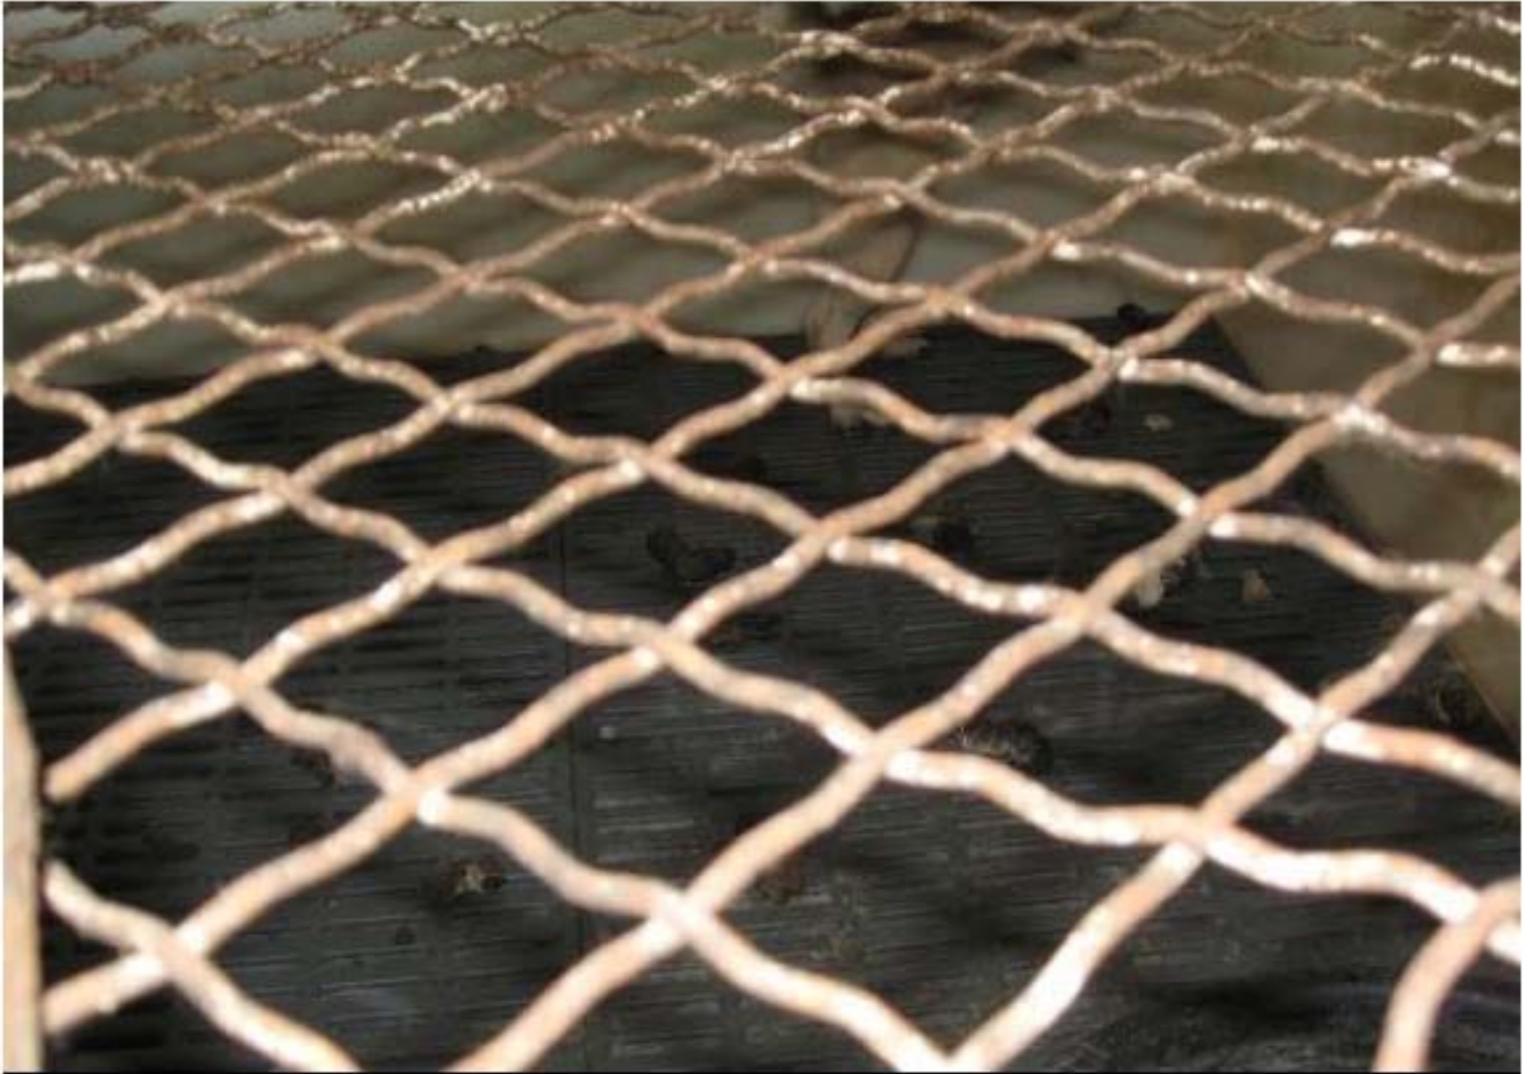
CFR: 3.1 (c) (3)

Photographer:	Randall Wagner (ACI)	Legal Name:	Registration:	42-A-1031
Photo Taken:	Thu, Sep 16, '10	DEBRA OOLMAN		
Inspection:	274101629440154	JASON OOLMAN		
Description:	The accumulation of black to white feca waste on the hog flooring indicates daily spot-cleaning is not happening.

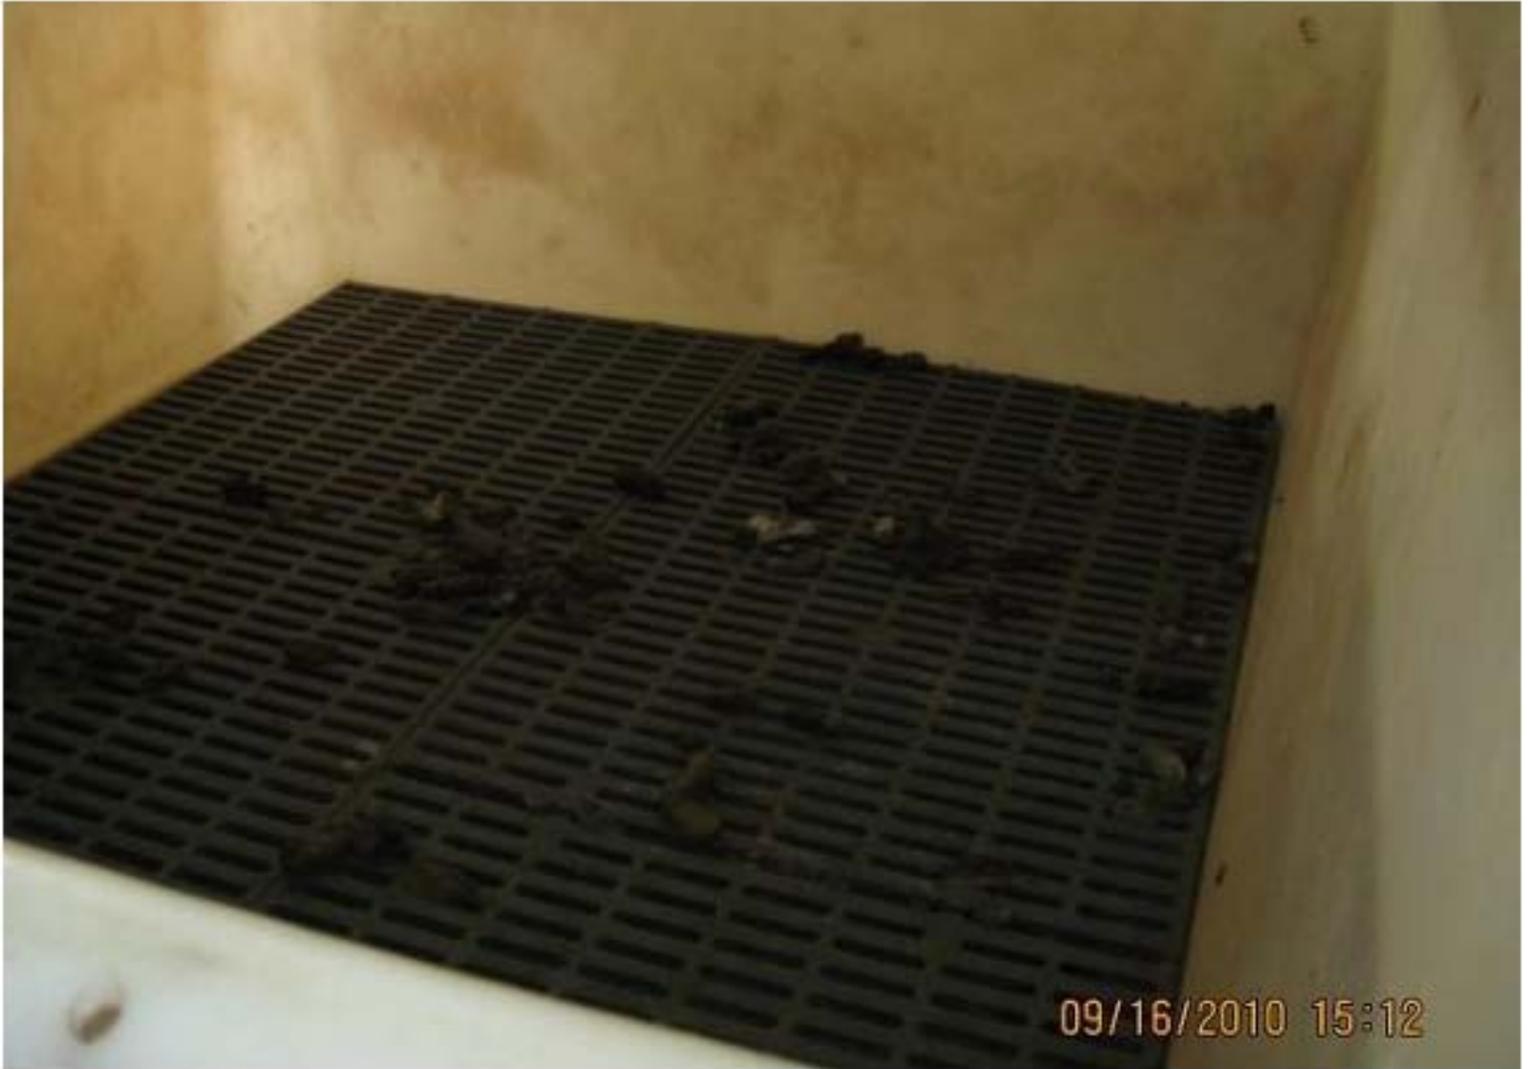
CFR: 3.1 (c) (3)

Photographer:	Randall Wagner (ACI)	Legal Name:	Registration:	42-A-1031
Photo Taken:	Thu, Sep 16, '10	DEBRA OOLMAN		
Inspection:	274101629440154	JASON OOLMAN		
Description:	The excessive accumulation of fecal waste black to white in color indicates daily spot-cleaning is not taking place.

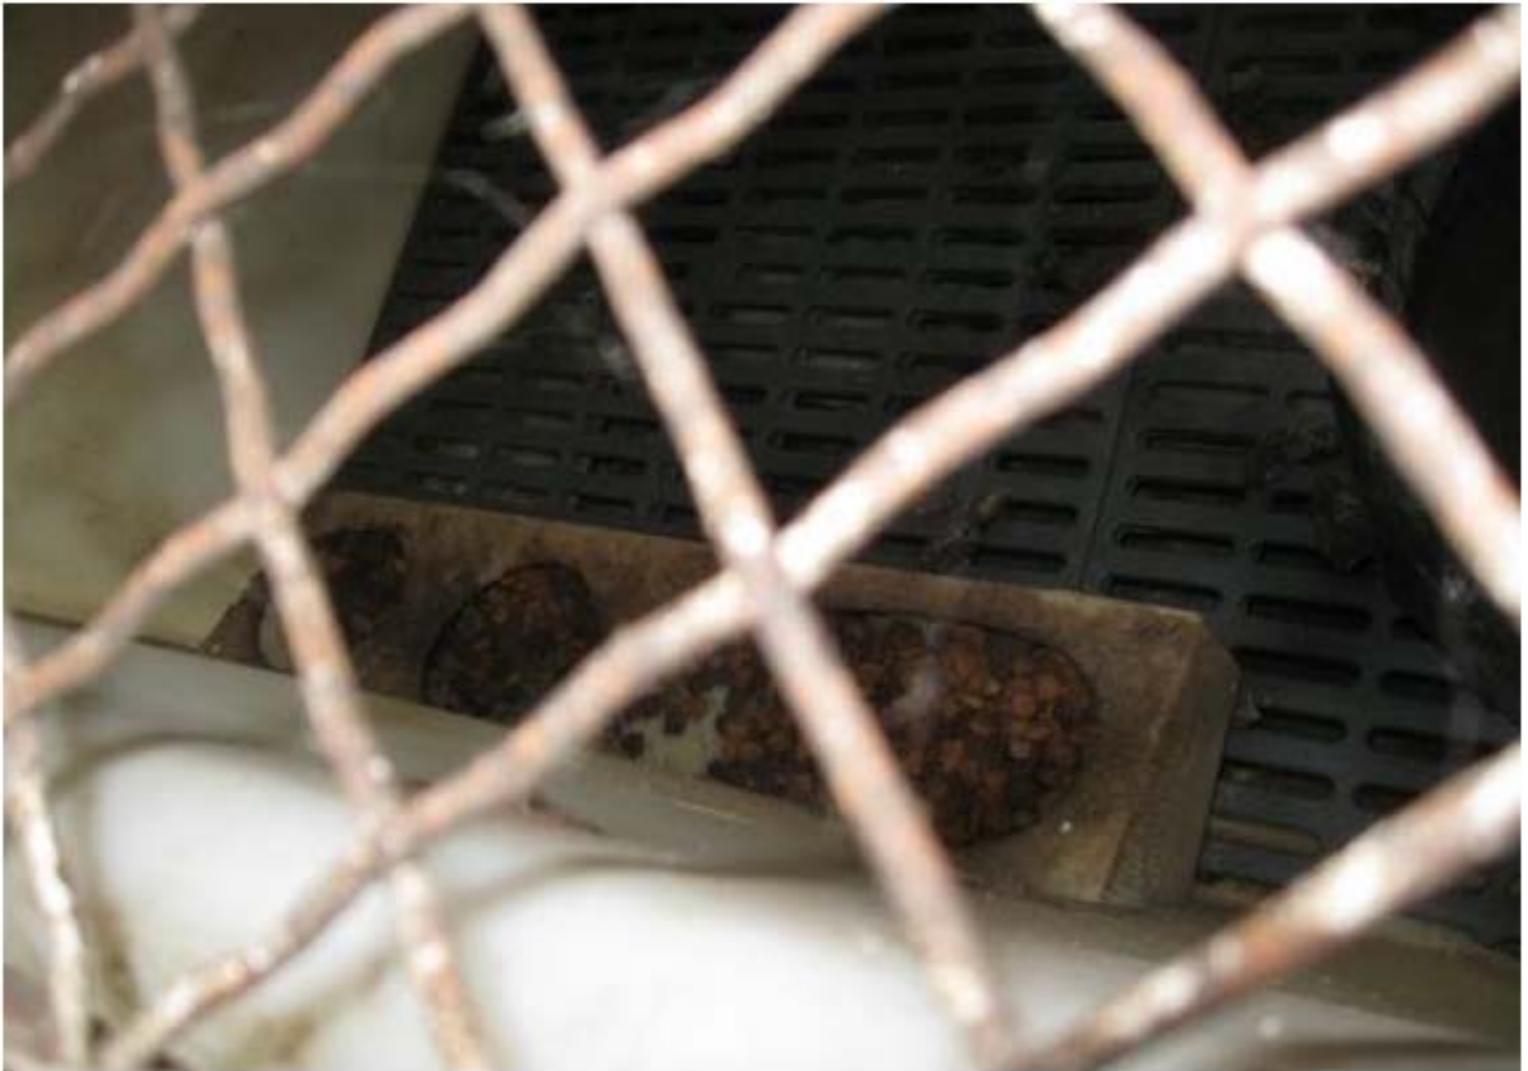
CFR: 3.1 (c) (3)

Photographer:	Randall Wagner (ACI)	Legal Name:	Registration:	42-A-1031
Photo Taken:	Thu, Sep 16, '10	DEBRA OOLMAN		
Inspection:	274101629440154	JASON OOLMAN		
Description:	The accumulation of brown film on the white feeder's surface indicates the feeders are not being clean/sanitized regularly.

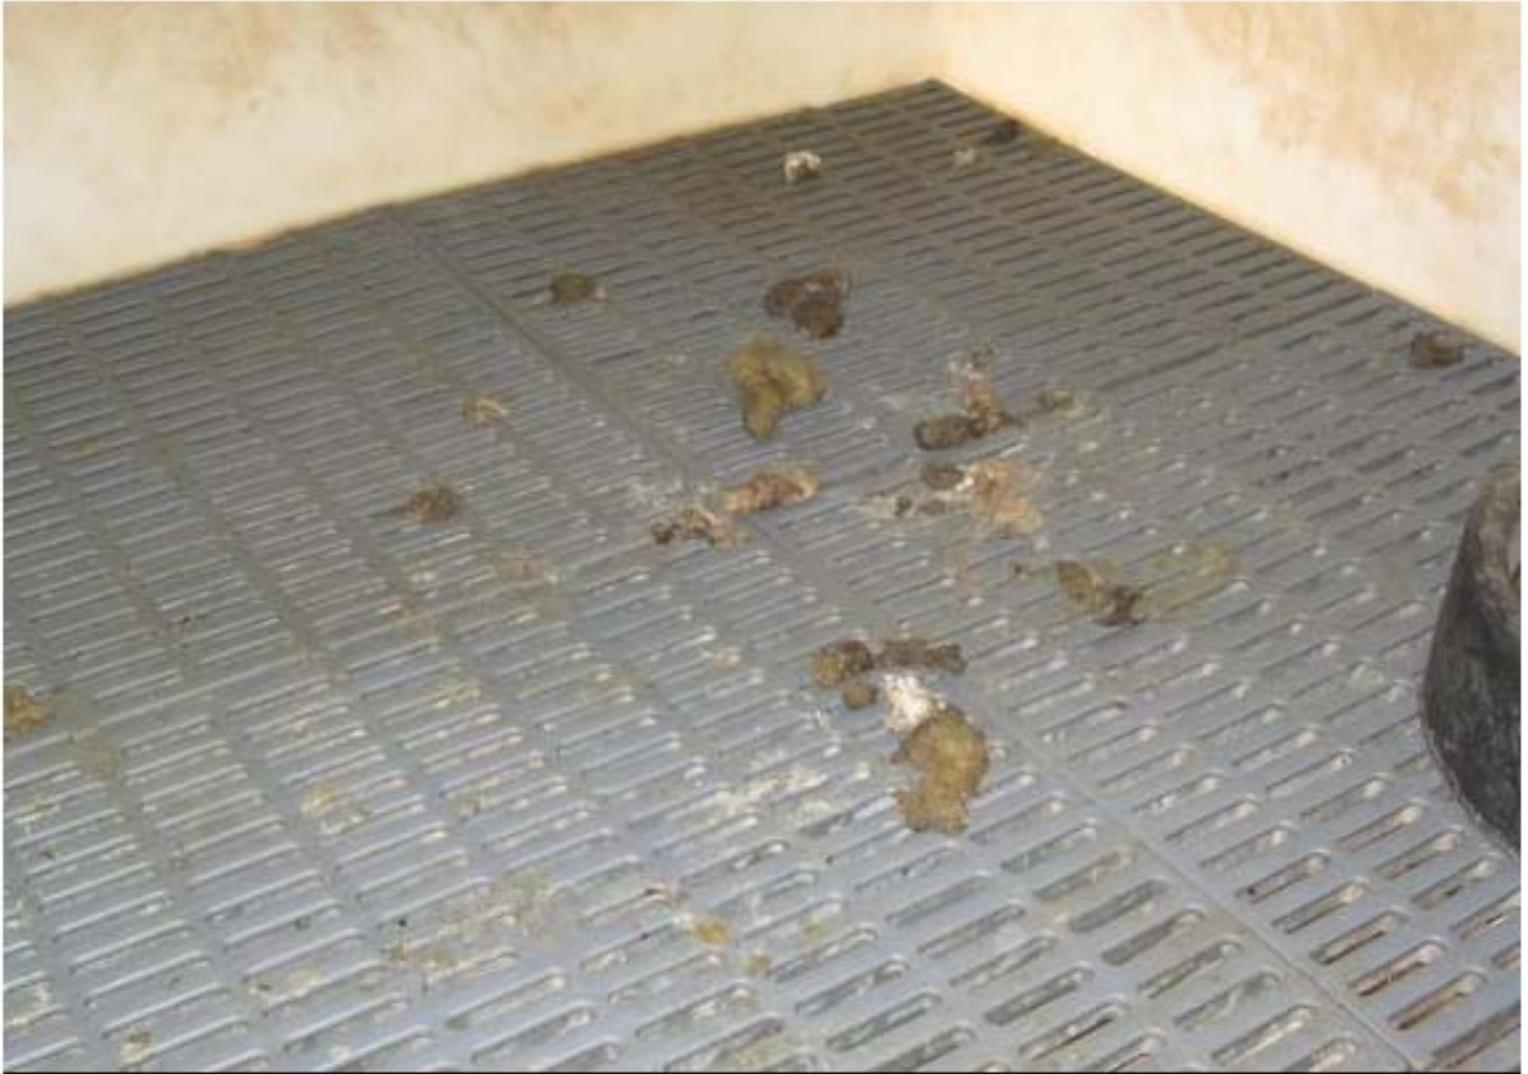
CFR: 3.1 (c) (3)

Photographer:	Randall Wagner (ACI)	Legal Name:	Registration:	42-A-1031
Photo Taken:	Thu, Sep 16, '10	DEBRA OOLMAN		
Inspection:	274101629440154	JASON OOLMAN		
Description:	The accumulation of fecal waste on the hog flooring indicates daily spot-cleaning is not taking place.

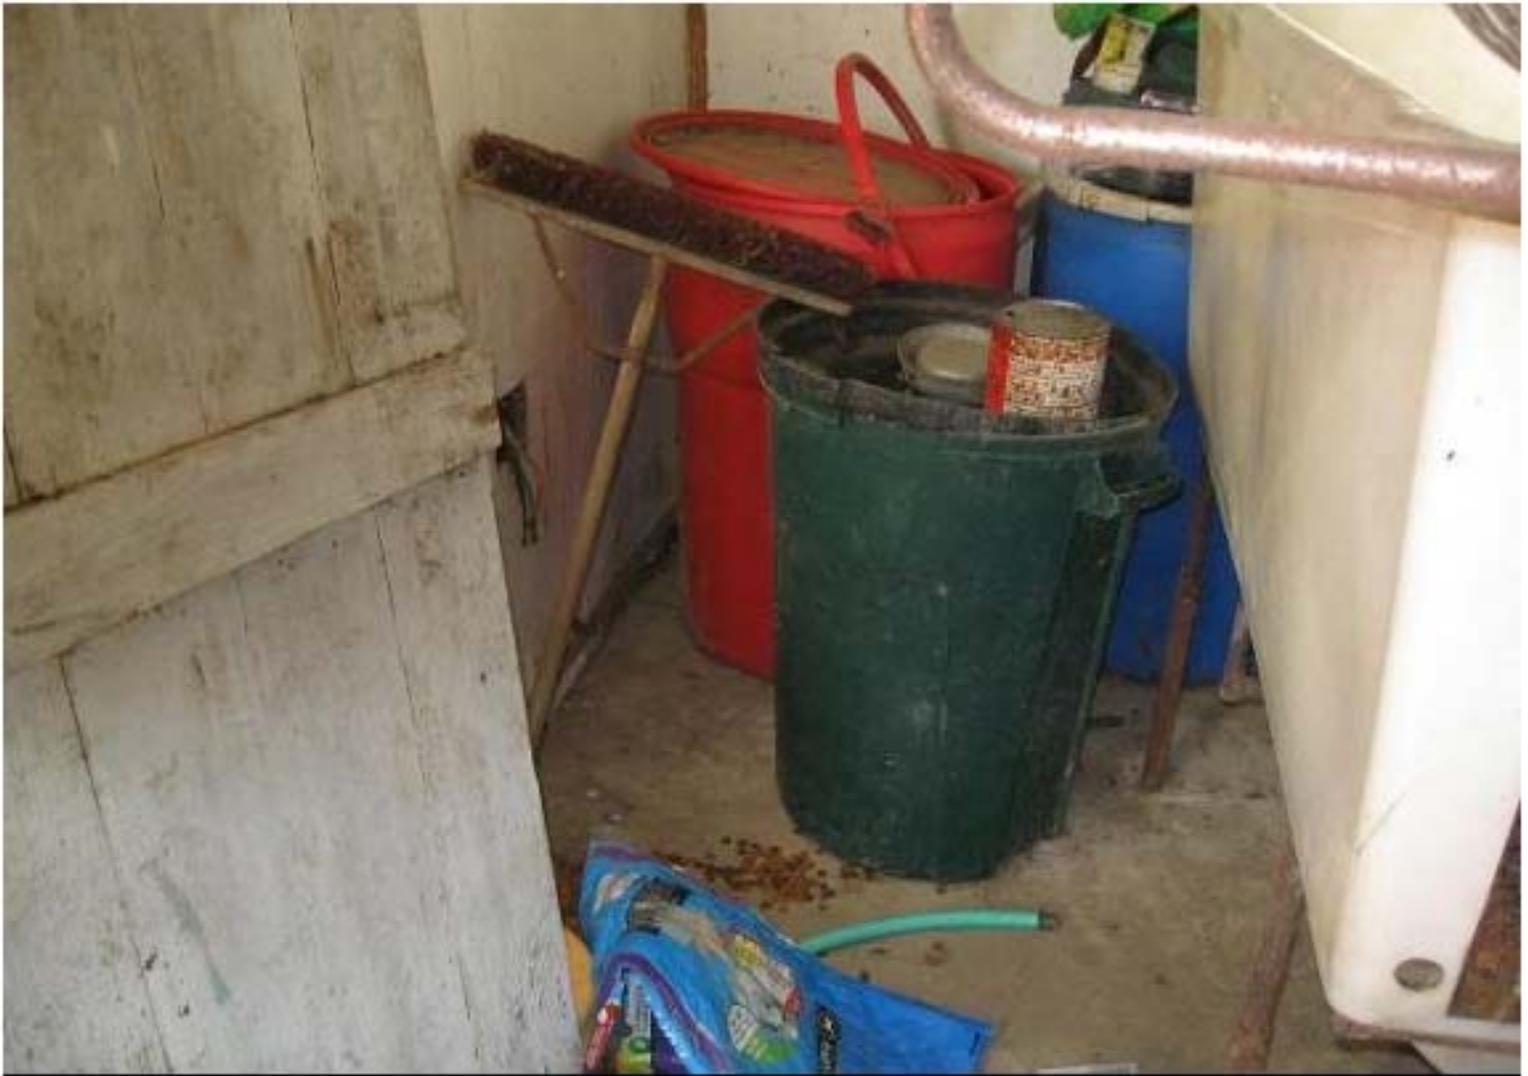
CFR: 3.11 (c)

Photographer:	Randall Wagner (ACI)	Legal Name:	Registration:	42-A-1031
Photo Taken:	Thu, Sep 16, '10	DEBRA OOLMAN		
Inspection:	274101629440154	JASON OOLMAN		
Description:	The empty dog food bag, dog food on the floor, discarded matter and item(s) inside the dog kennel.

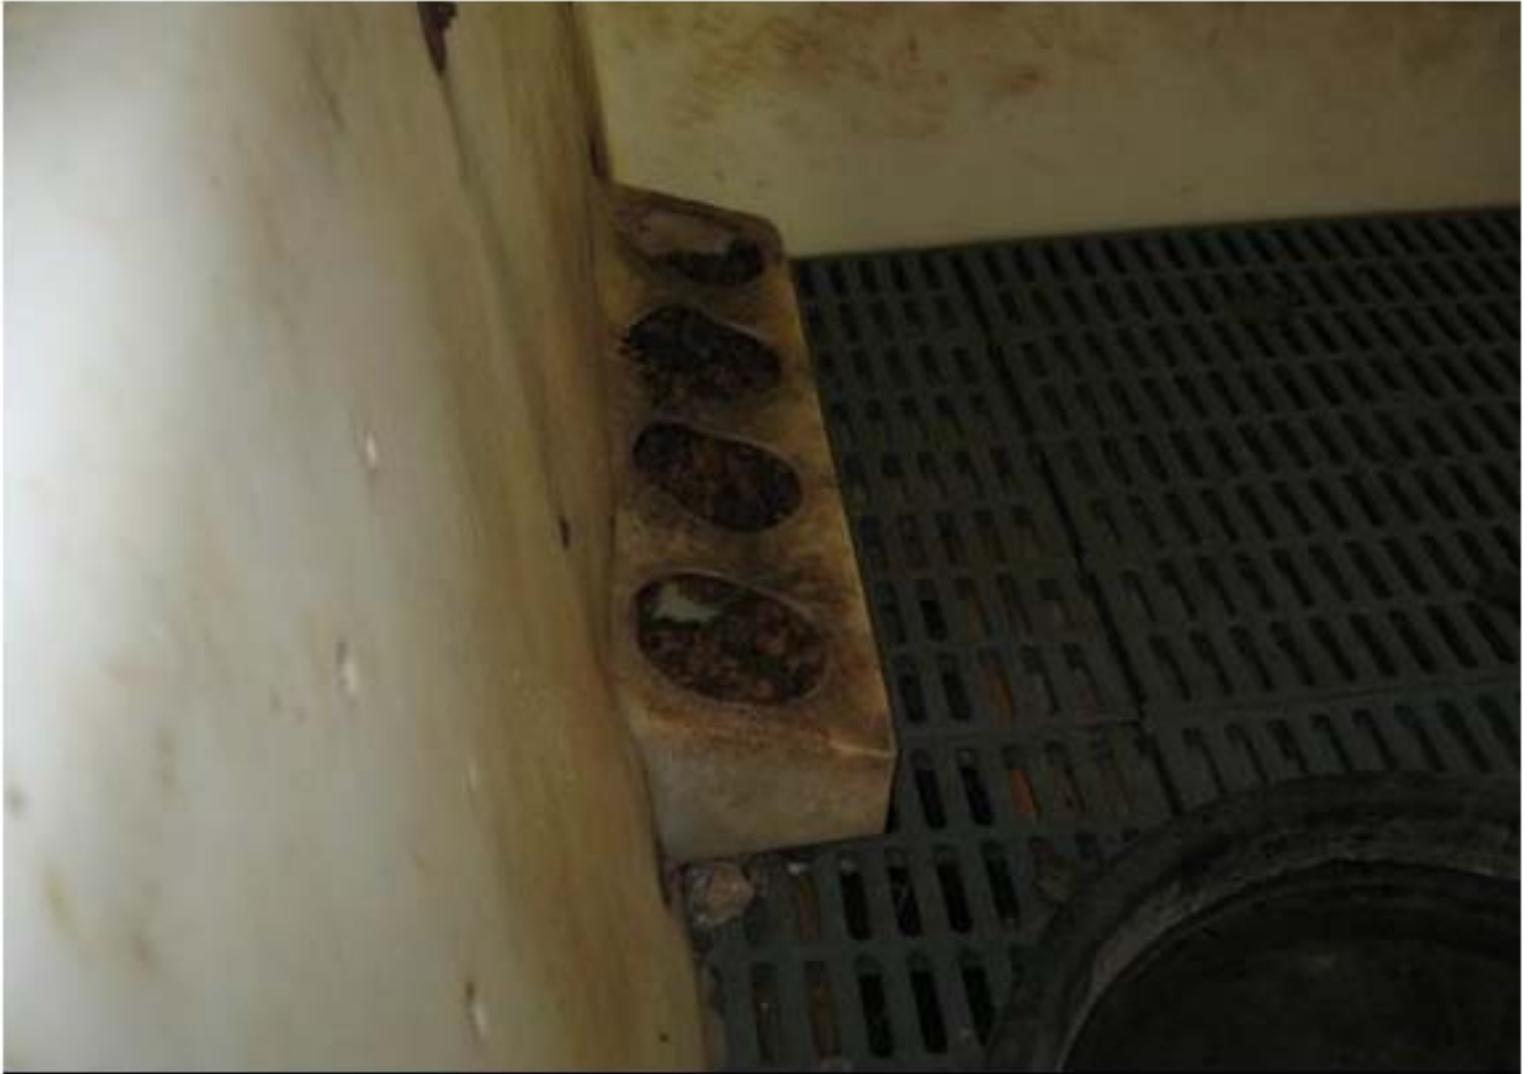
CFR: 3.1 (c) (3)

Photographer:	Randall Wagner (ACI)	Legal Name:	Registration:	42-A-1031
Photo Taken:	Thu, Sep 16, '10	DEBRA OOLMAN		
Inspection:	274101629440154	JASON OOLMAN		
Description:	The white feeder has accumulation of brown discarded matter on the surface, indicates cleaning/sanitization is not taking place regularly.

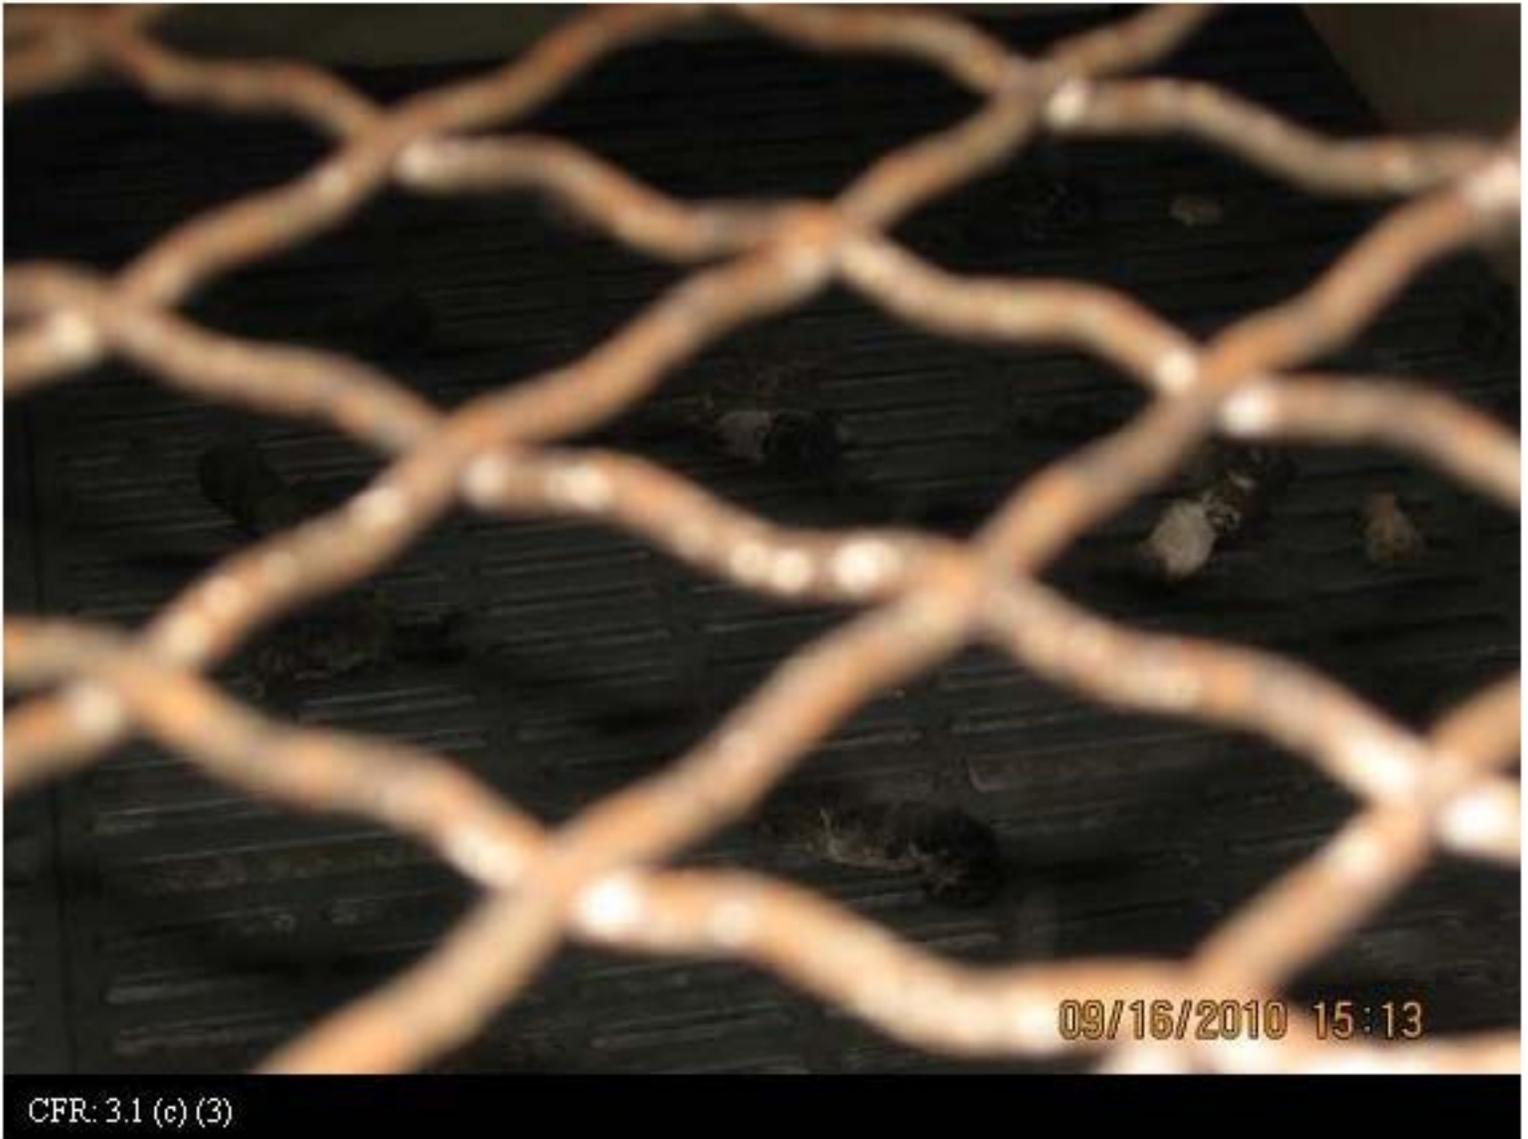
Photographer:	Randall Wagner (ACI)	Legal Name:	Registration:	42-A-1031
Photo Taken:	Thu, Sep 16, '10	DEBRA OOLMAN		
Inspection:	274101629440154	JASON OOLMAN		
Description:	The accumulation of black to white fecal waste on the hog flooring indicates daily spot-cleaning is not taking place.
