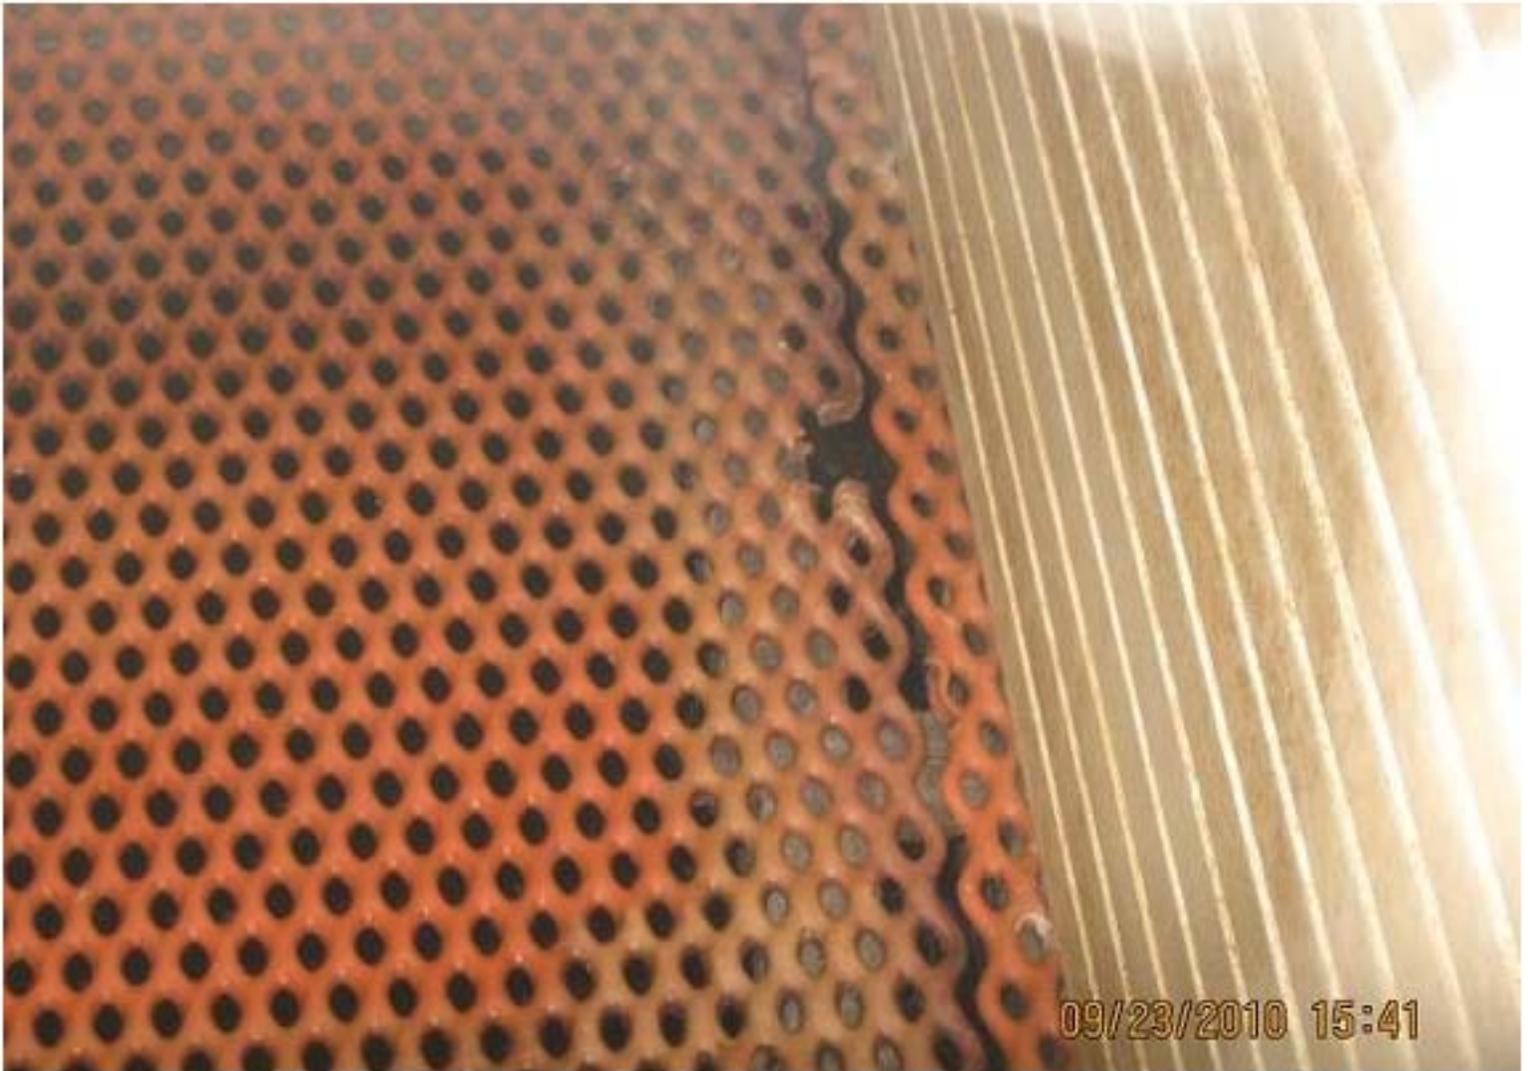
CFR: 3.1 (a)

Photographer:	Randall Wagner (ACI)	Legal Name:	Registration:	42-A-1026
Photo Taken:	Thu, Sep 23, '10	GENE HOOGENDOORN HILDA HOOGENDOORN		
Inspection:	279102330050899			
Description:	The hole in the hog flooring is in need of repair.

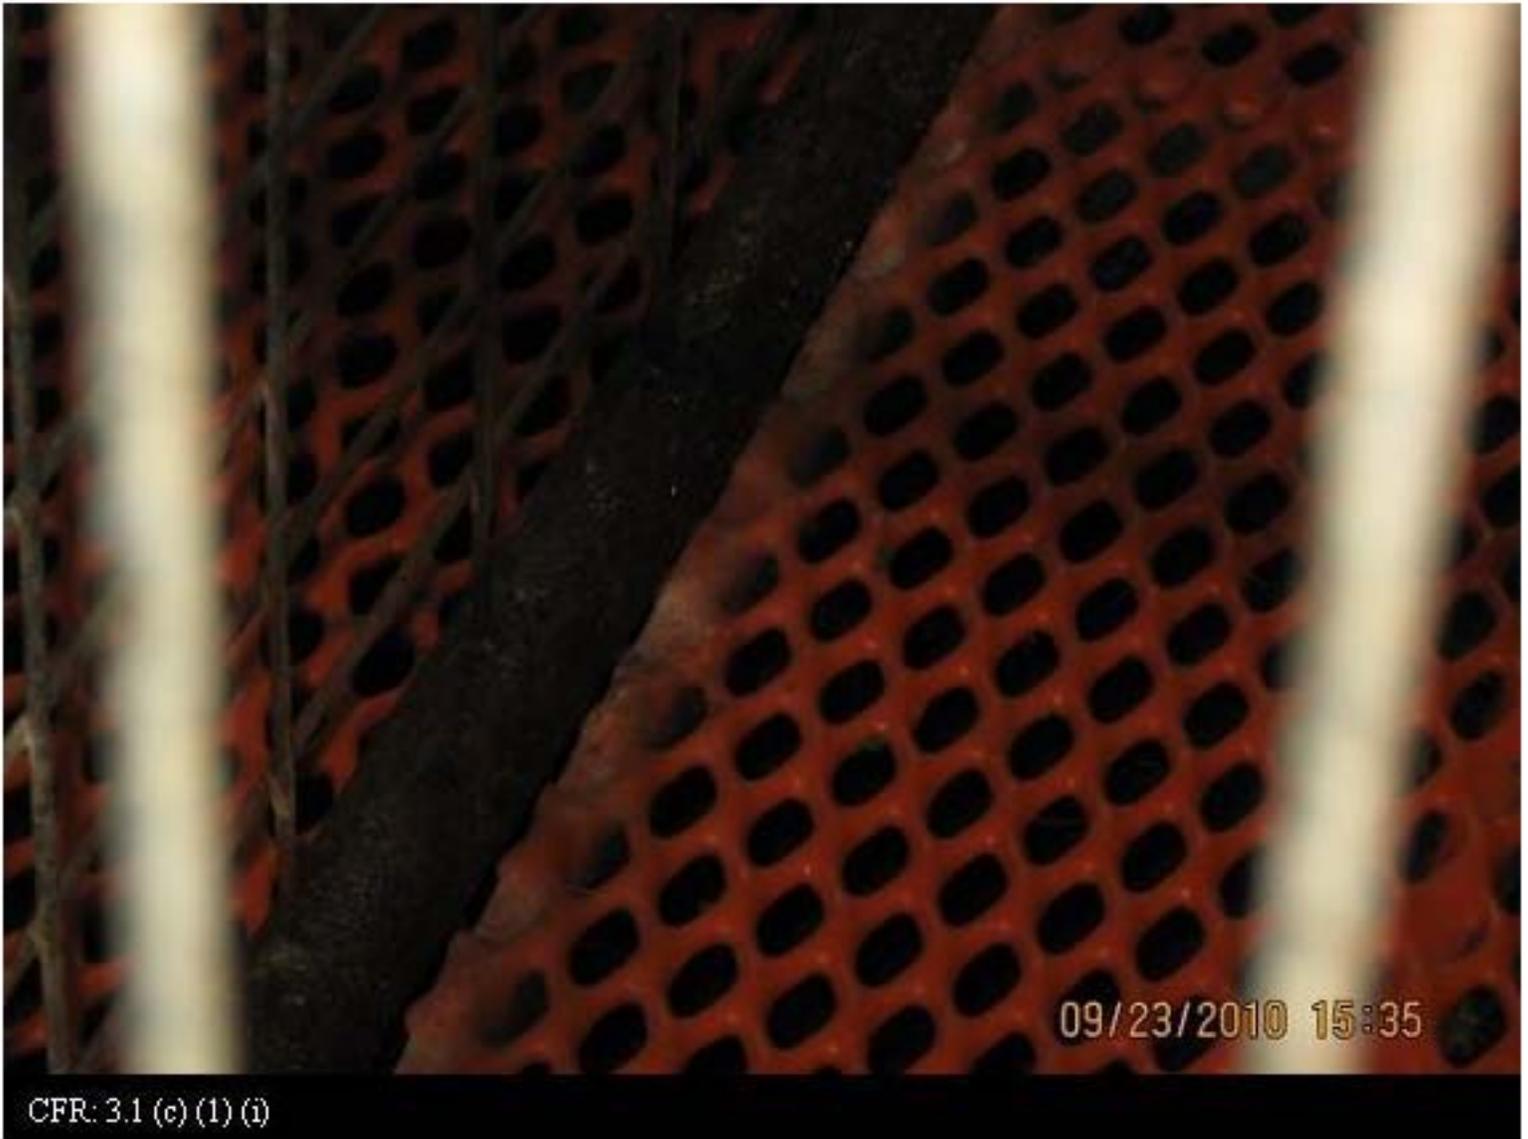
Photographer:	Randall Wagner (ACI)	Legal Name:	Registration:	42-A-1026
Photo Taken:	Thu, Sep 23, '10	GENE HOOGENDOORN HILDA HOOGENDOORN		
Inspection:	279102330050899			
Description:	The metal pipe framing surface is excessive rusting and pitting.

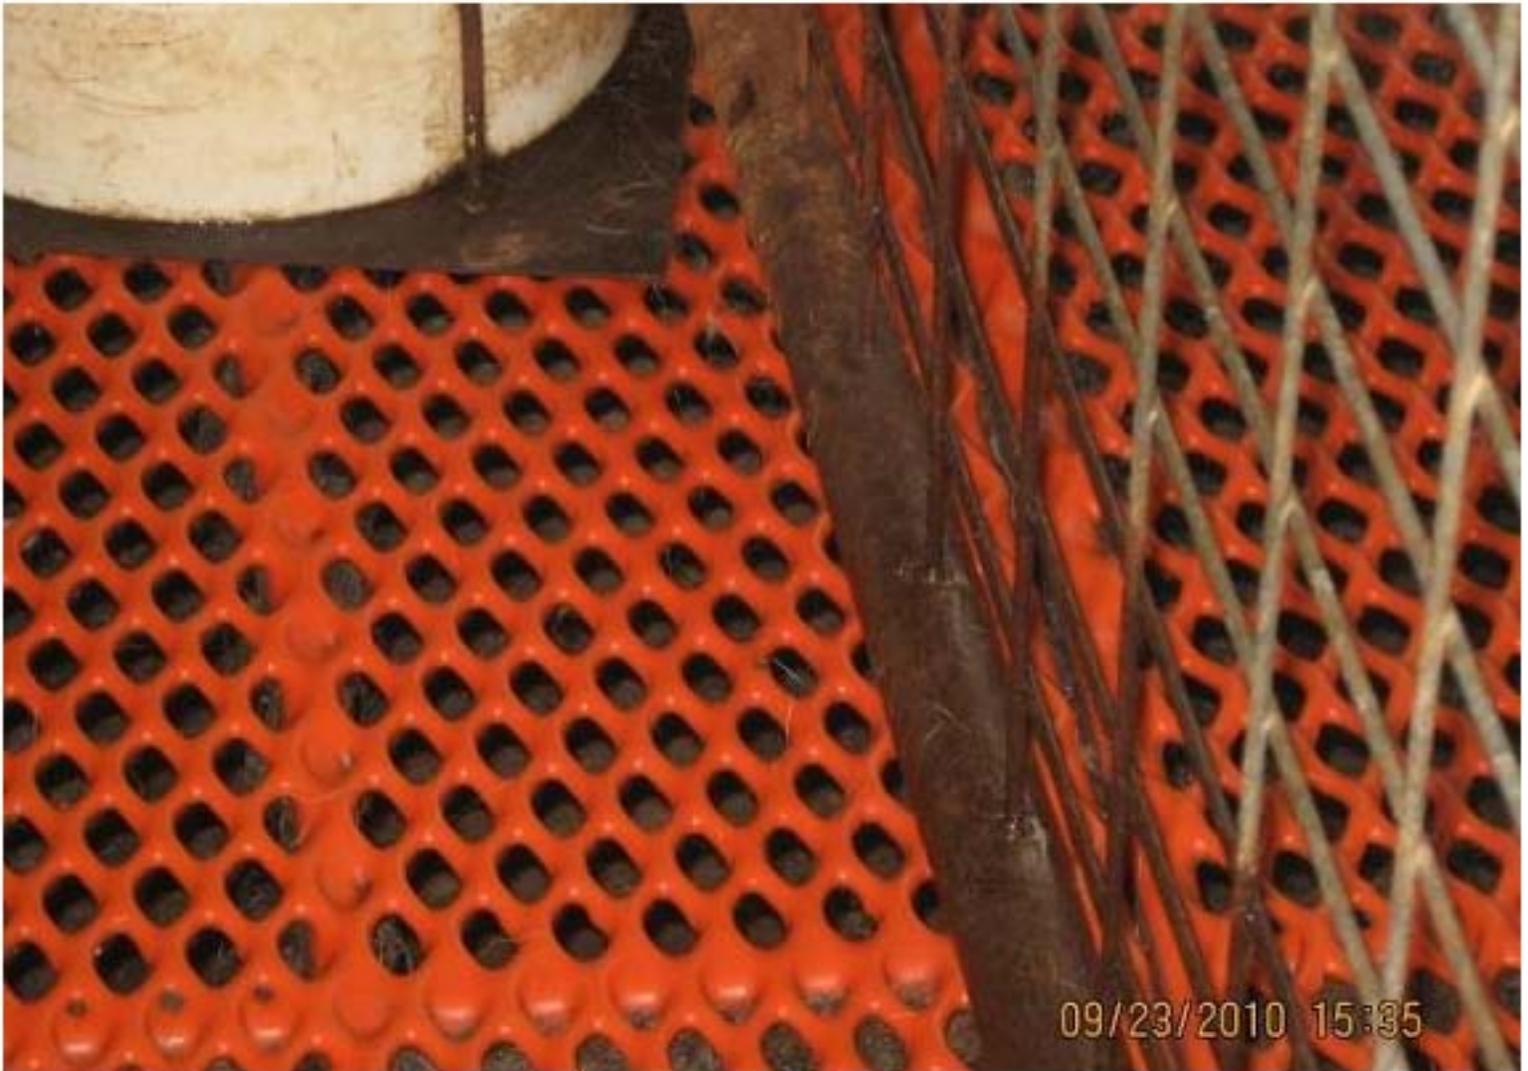
CFR: 3.1 (c) (1) (i)

Photographer:	Randall Wagner (ACI)	Legal Name:	Registration:	42-A-1026
Photo Taken:	Thu, Sep 23, '10	GENE HOOGENDOORN HILDA HOOGENDOORN		
Inspection:	279102330050899			
Description:	The metal pipe framing is excessively rusting and pitting.

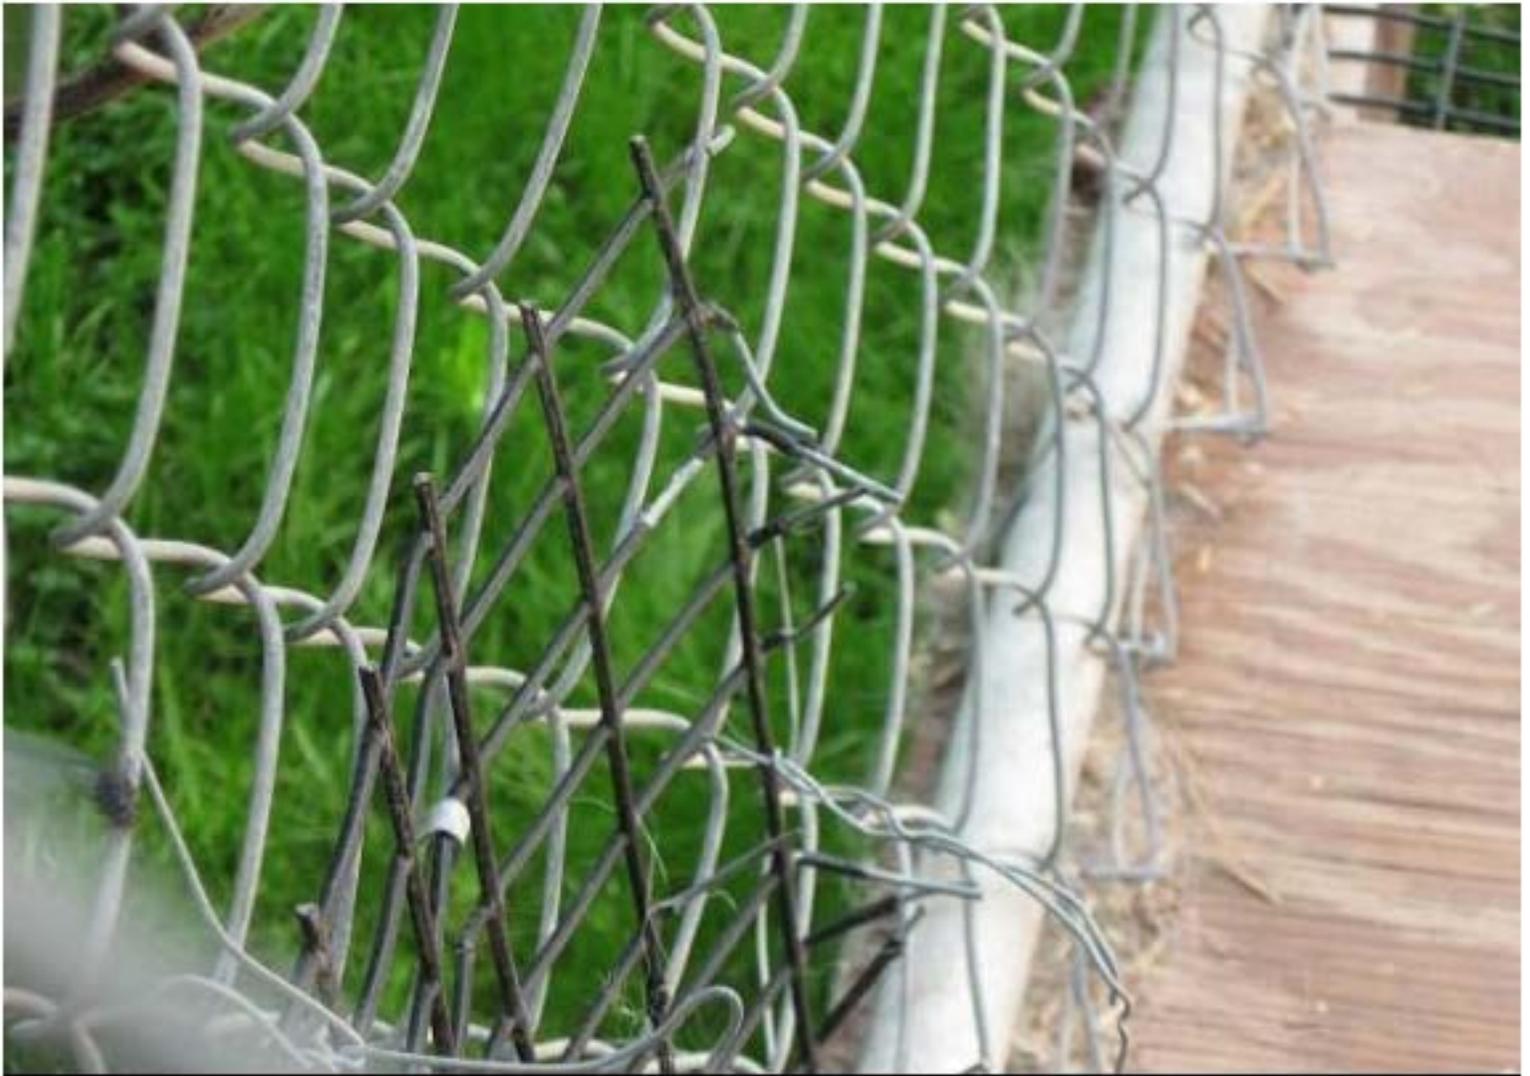
CFR: 3.6 (a) (2)

Photographer:	John J. Lies, ACI	Legal Name:	Registration:	42-A-0913
Photo Taken:	Thu, Jun 3, '10 P.M.	LUCILLE GODFREY		
Inspection:	153102116010659			
Description:	3.6 (a)(2) Primary Enclosures: Sharp wire points inside of a dog enclosure.

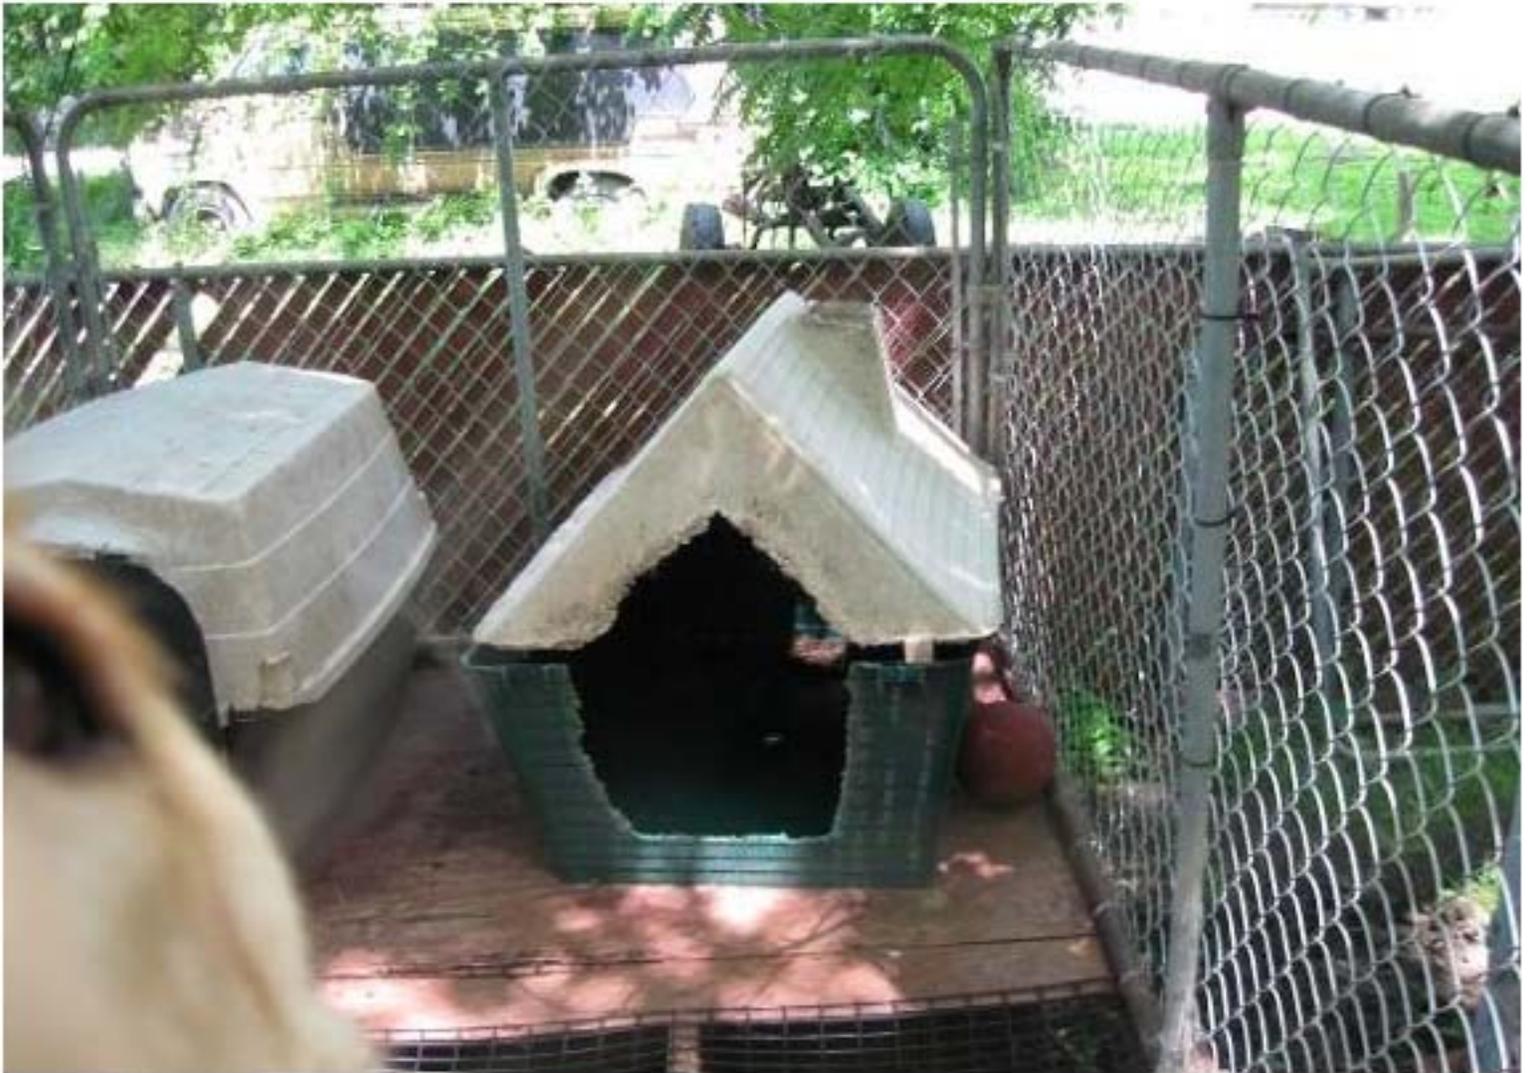
CFR: 3.4 (b) (3), 3.4 (c), 3.4 (b)

Photographer:	John J. Lies, ACI	Legal Name:	Registration:	42-A-0913
Photo Taken:	Thu, Jun 3, '10 P.M.	LUCILLE GODFREY		
Inspection:	153102116010659			
Description:	3.4(b), (b)(3), Outdoor Housing: shelter falling apart needs to be replaced, no wind/rain break. 3.4 (c) Construction: Worn wood no longer impervious to moisture.

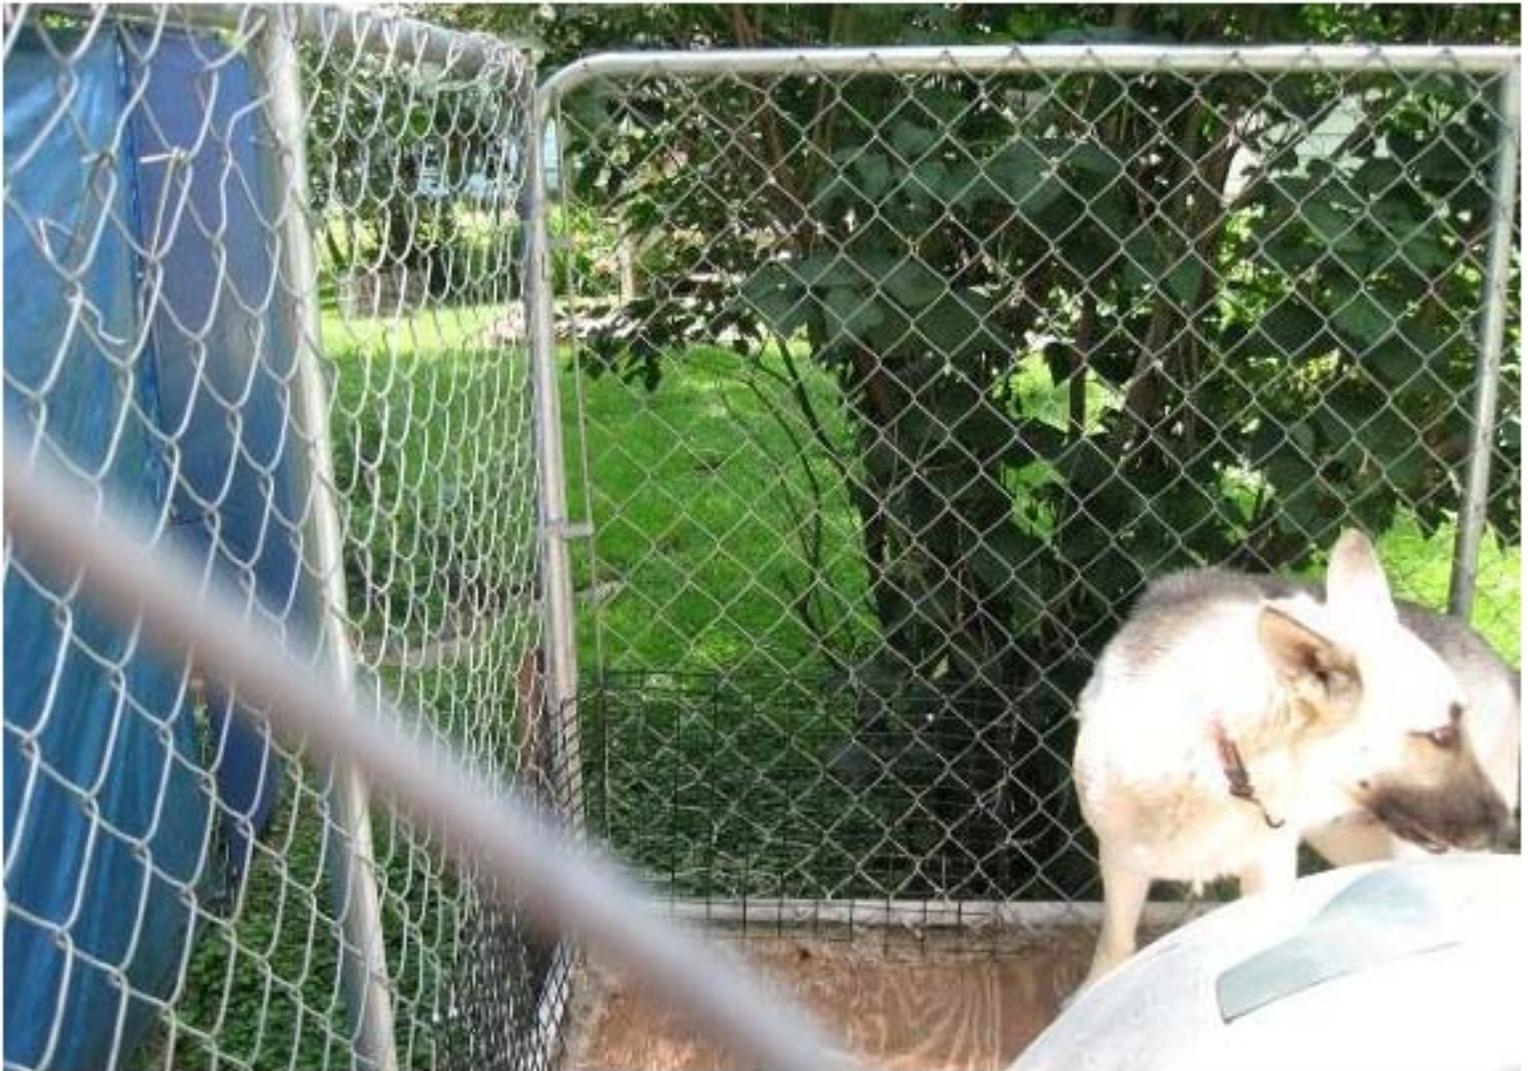
CFR: 3.4(c)

Photographer:	John J. Lies, ACI	Legal Name:	Registration:	42-A-0913
Photo Taken:	Thu, Jun 3, '10 P.M.	LUCILLE GODFREY		
Inspection:	153102116010659			
Description:	3.4(c) Outdoor housing construction: Worn and/or chewed wood that is no longer impervious to moisture.

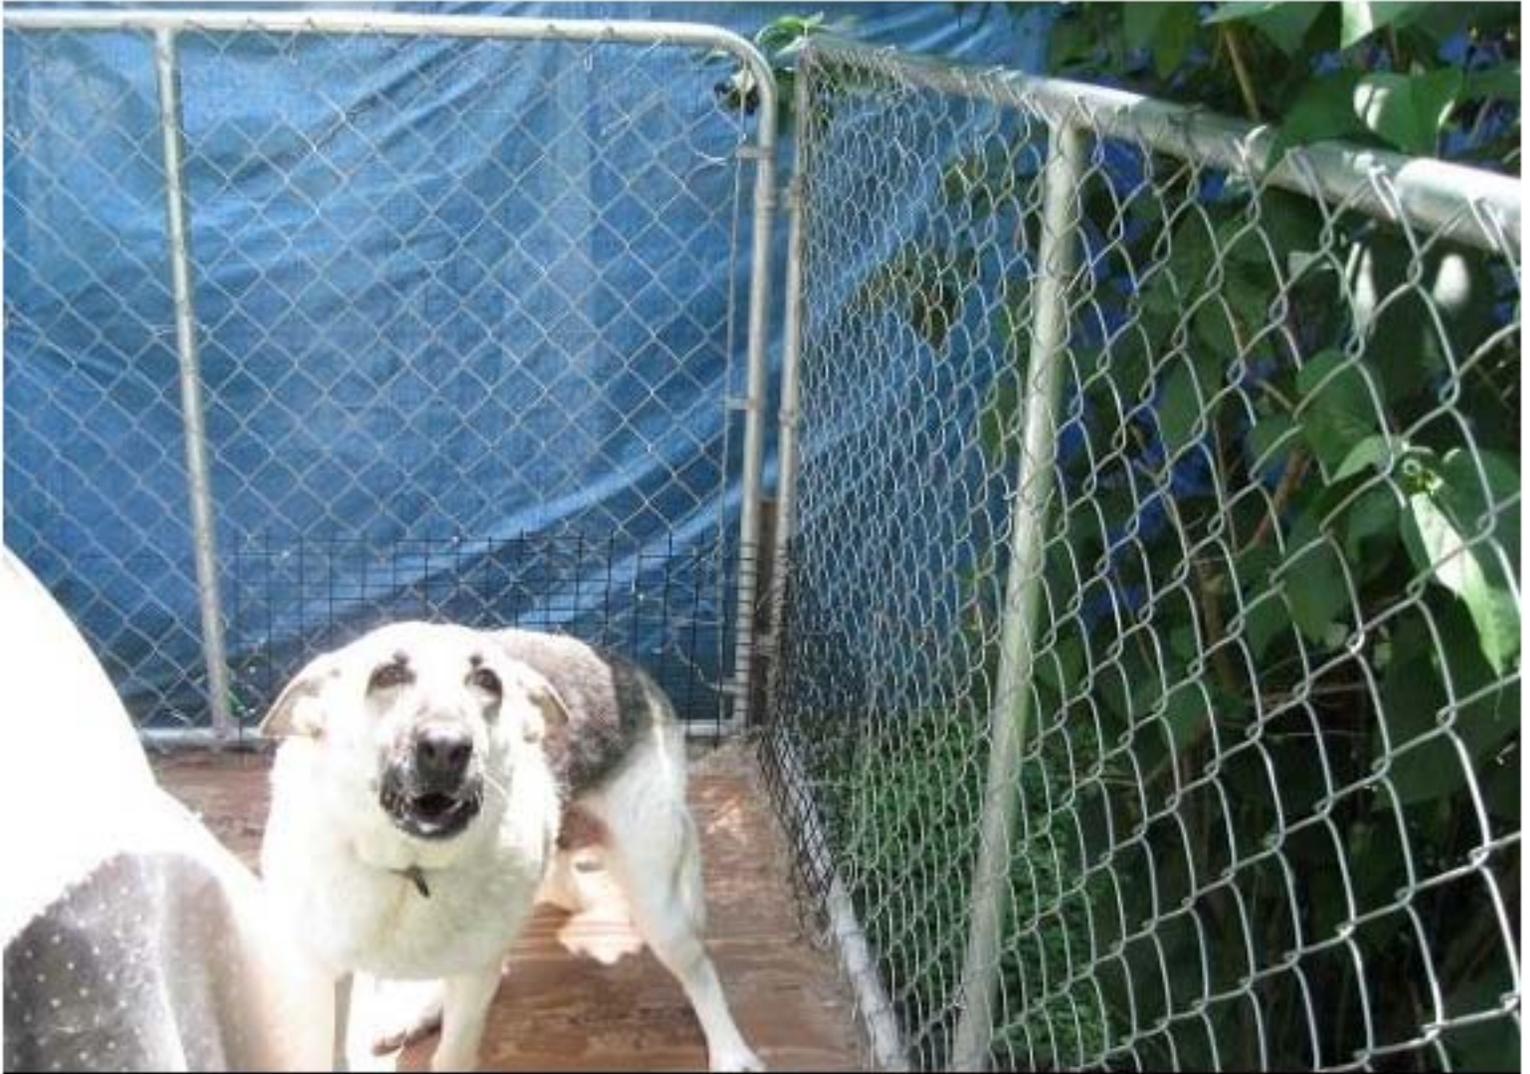
CFR: 3.4(c)

Photographer:	John J. Lies, ACI	Legal Name:	Registration:	42-A-0913
Photo Taken:	Thu, Jun 3, '10 P.M.	LUCILLE GODFREY		
Inspection:	153102116010659			
Description:	3.4(c) Outdoor housing construction: Worn and/or chewed wood that is no longer impervious to moisture.

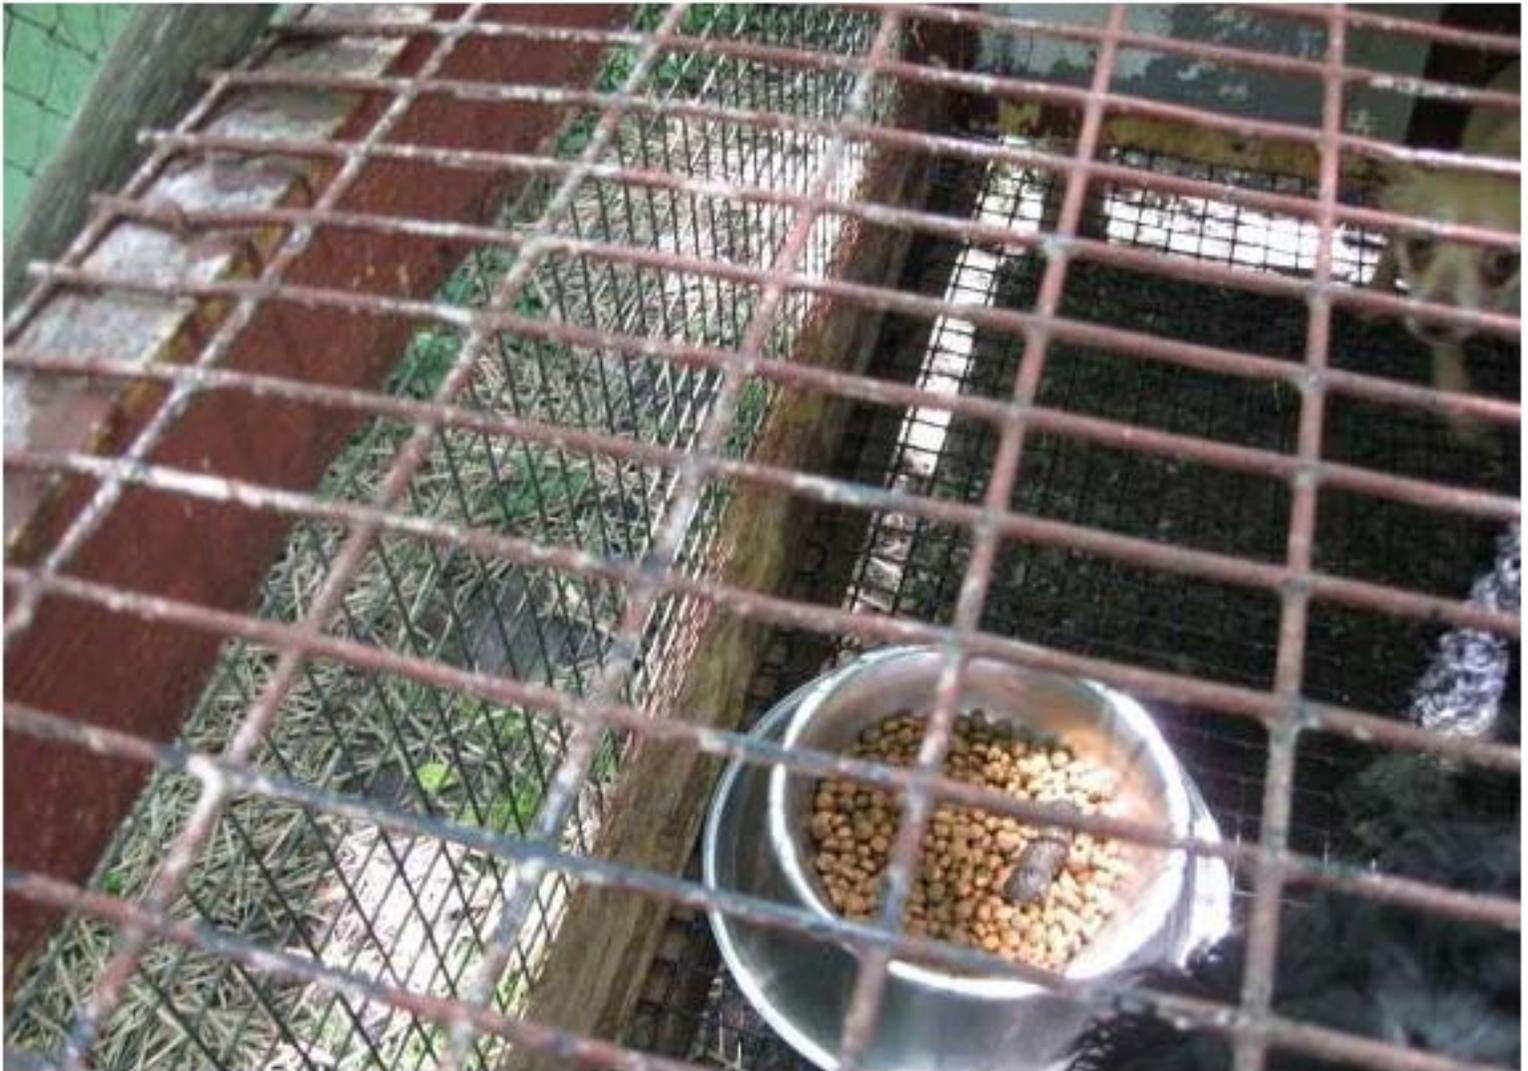
CFR: 3.4(c)

Photographer:	John J. Lies, ACI	Legal Name:	Registration:	42-A-0913
Photo Taken:	Thu, Jun 3, '10 P.M.	LUCILLE GODFREY		
Inspection:	153102116010659			
Description:	3.4(c) Outdoor housing construction: Worn and/or chewed wood that is no longer impervious to moisture.

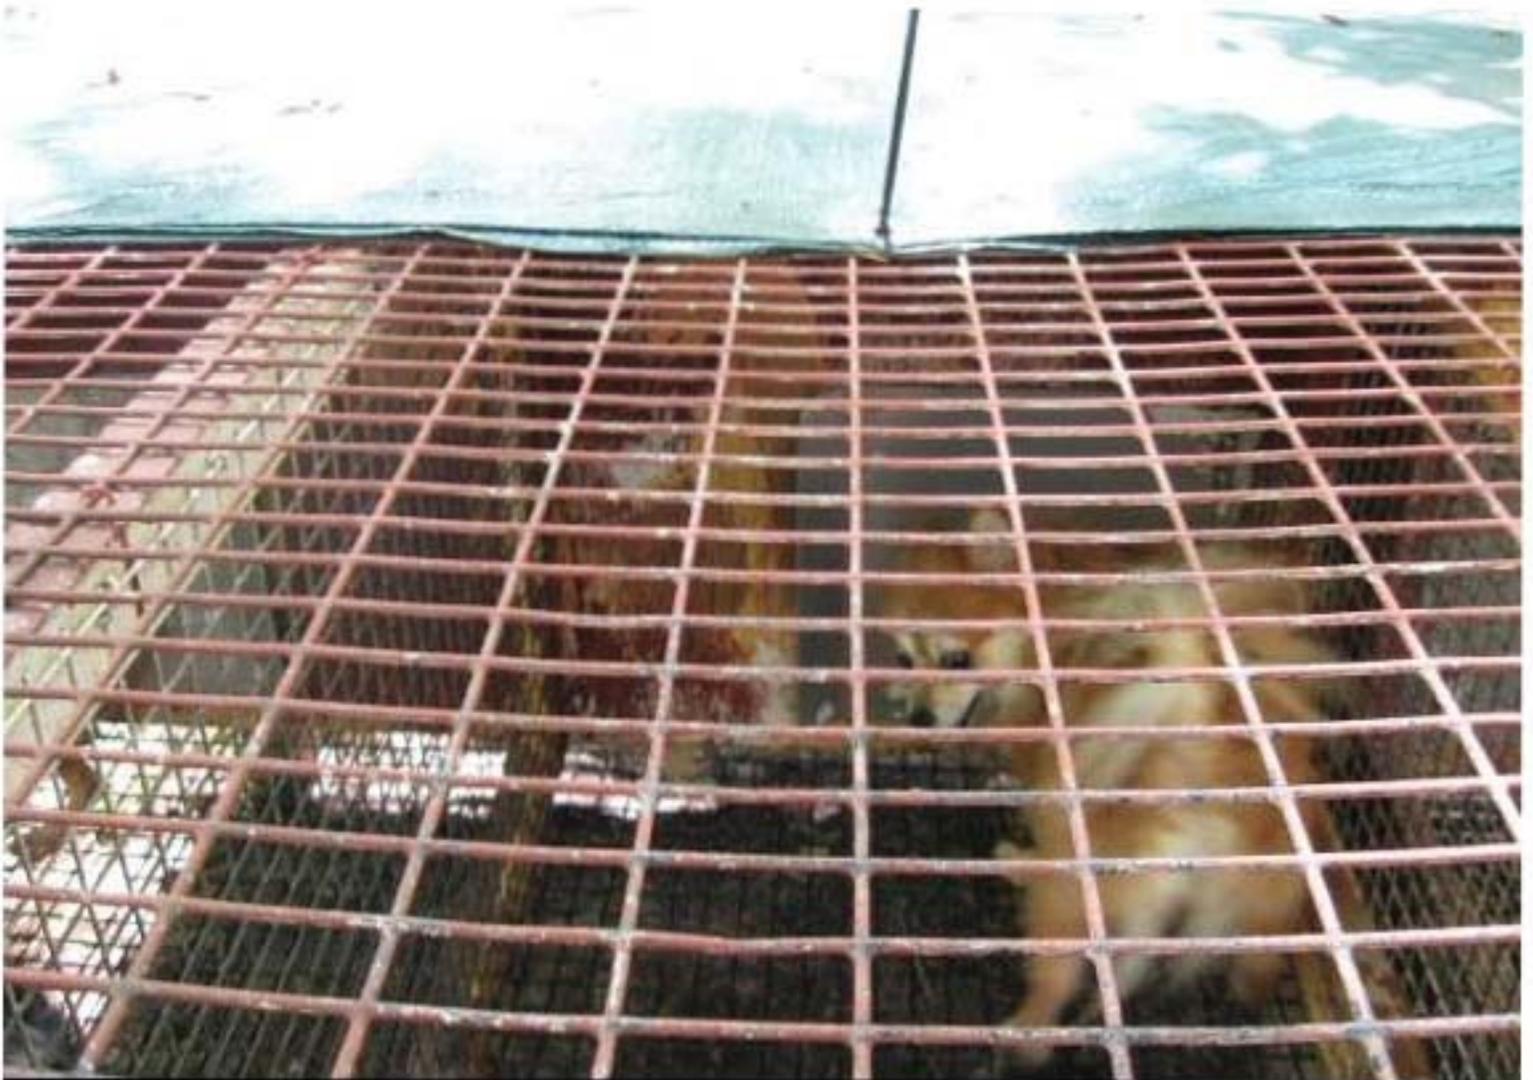
CFR: 3.4 (c)

Photographer:	John J. Lies, ACI	Legal Name:	Registration:	42-A-0913
Photo Taken:	Thu, Jun 3, '10 P.M.	LUCILLE GODFREY		
Inspection:	153102116010659			
Description:	3.4(c) Outdoor housing construction: Worn and/or chewed wood that is no longer impervious to moisture.

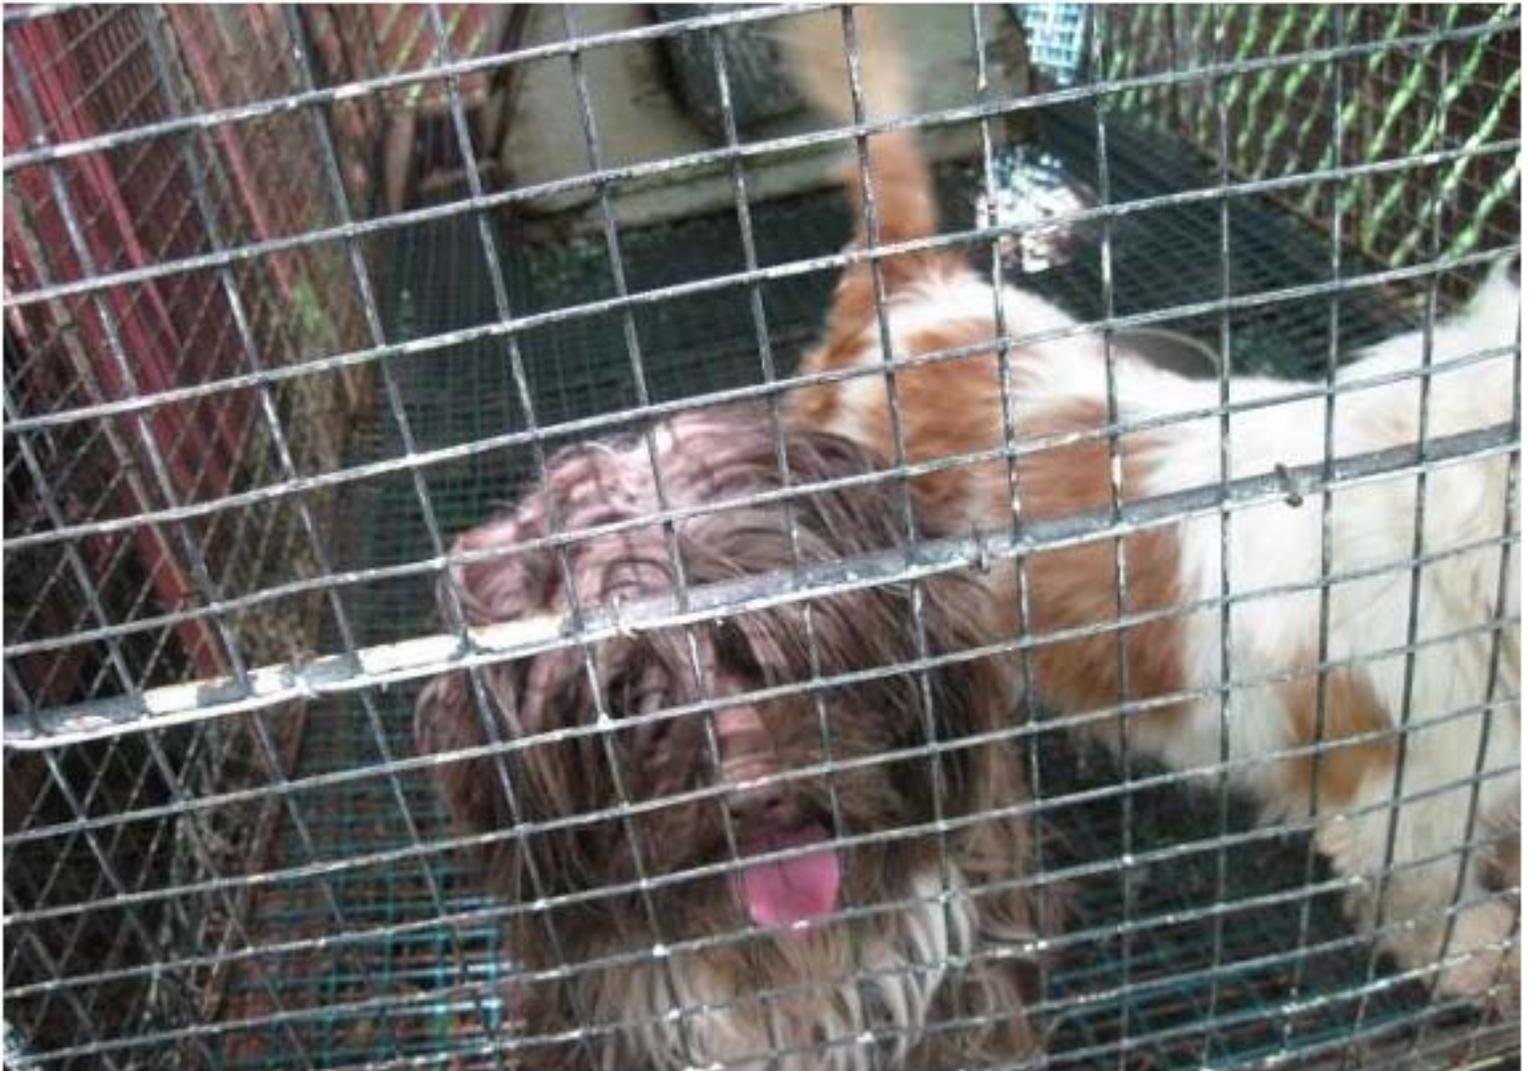
CFR: 2.40 (b) (2)

Photographer:	John J. Lies, ACI	Legal Name:	Registration:	42-A-0913
Photo Taken:	Thu, Jun 3, '10 P.M.	LUCILLE GODFREY		
Inspection:	153102116010659			
Description:	2.40 (b)(2) Veterinary Care; Long haired dog in need of grooming.

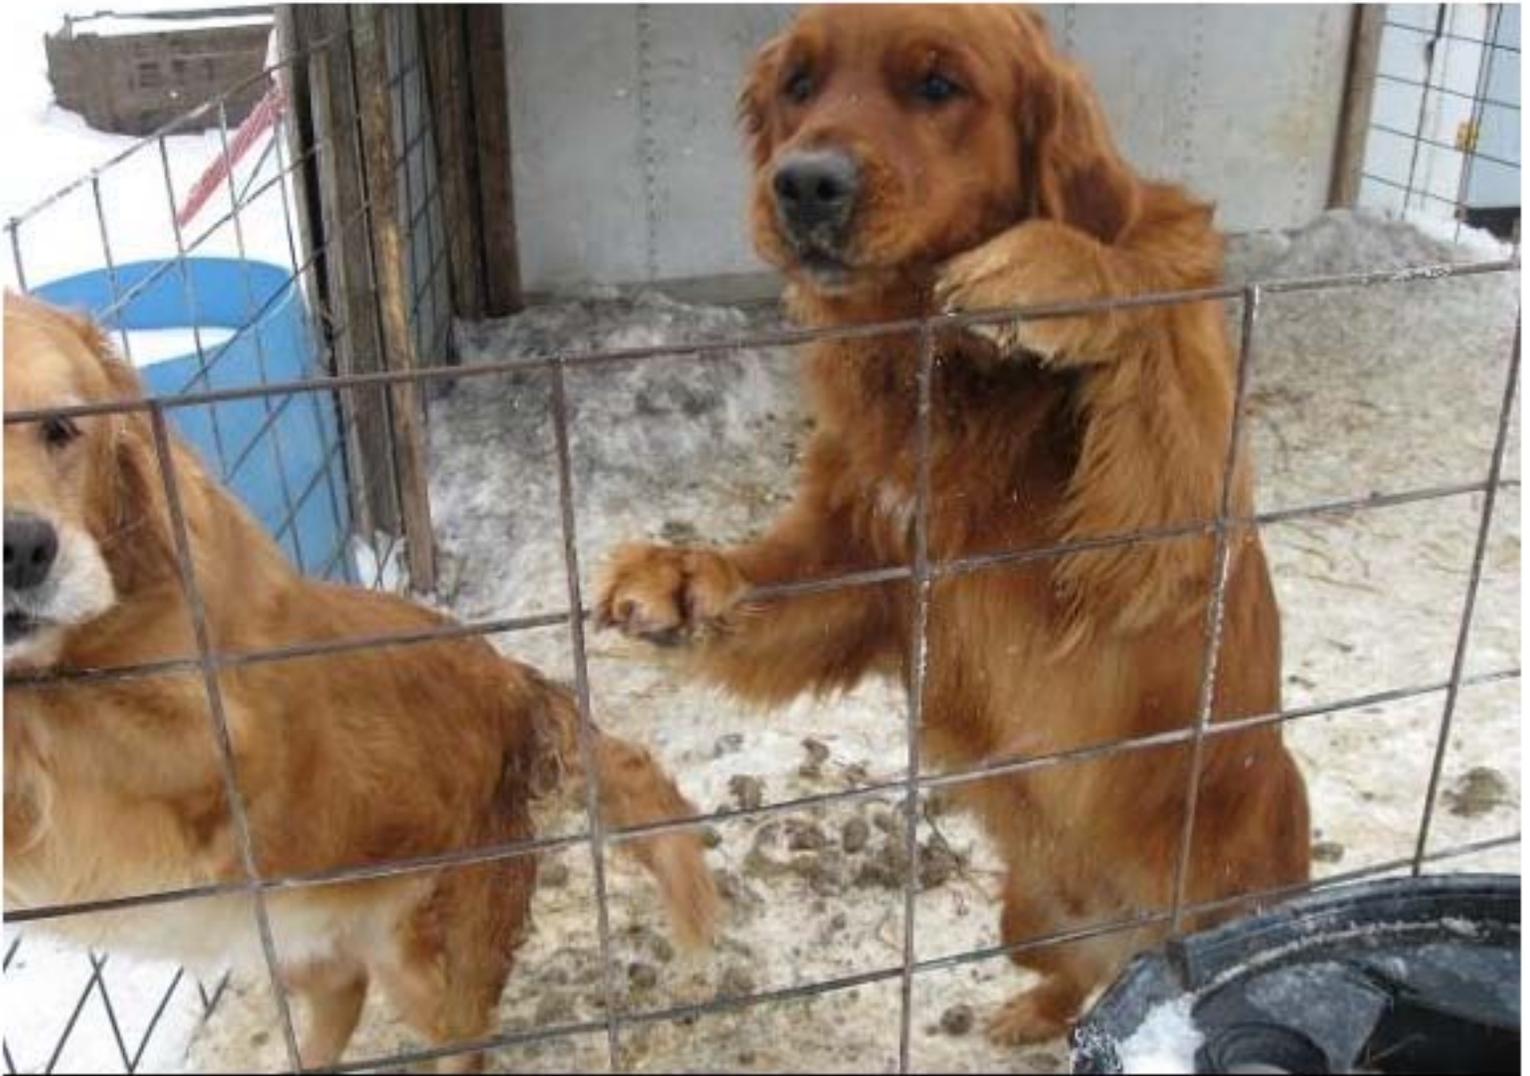
CFR: 3.1 (a), 3.1 (c) (3)

Photographer:	John J. Lies, ACI	Legal Name:	Registration:	42-A-0895
Photo Taken:	Fri, Jan 28, '11 A.M.	RANDY STOEN		
Inspection:	28110143480200			
Description:	3.1 (c)(3) Housing General Cleaning: Enclosures need to be cleaned to remove snow & Feces.3.1 (a) Construction: Cattle panel opening allow the dogs to stick their heads through the openings.

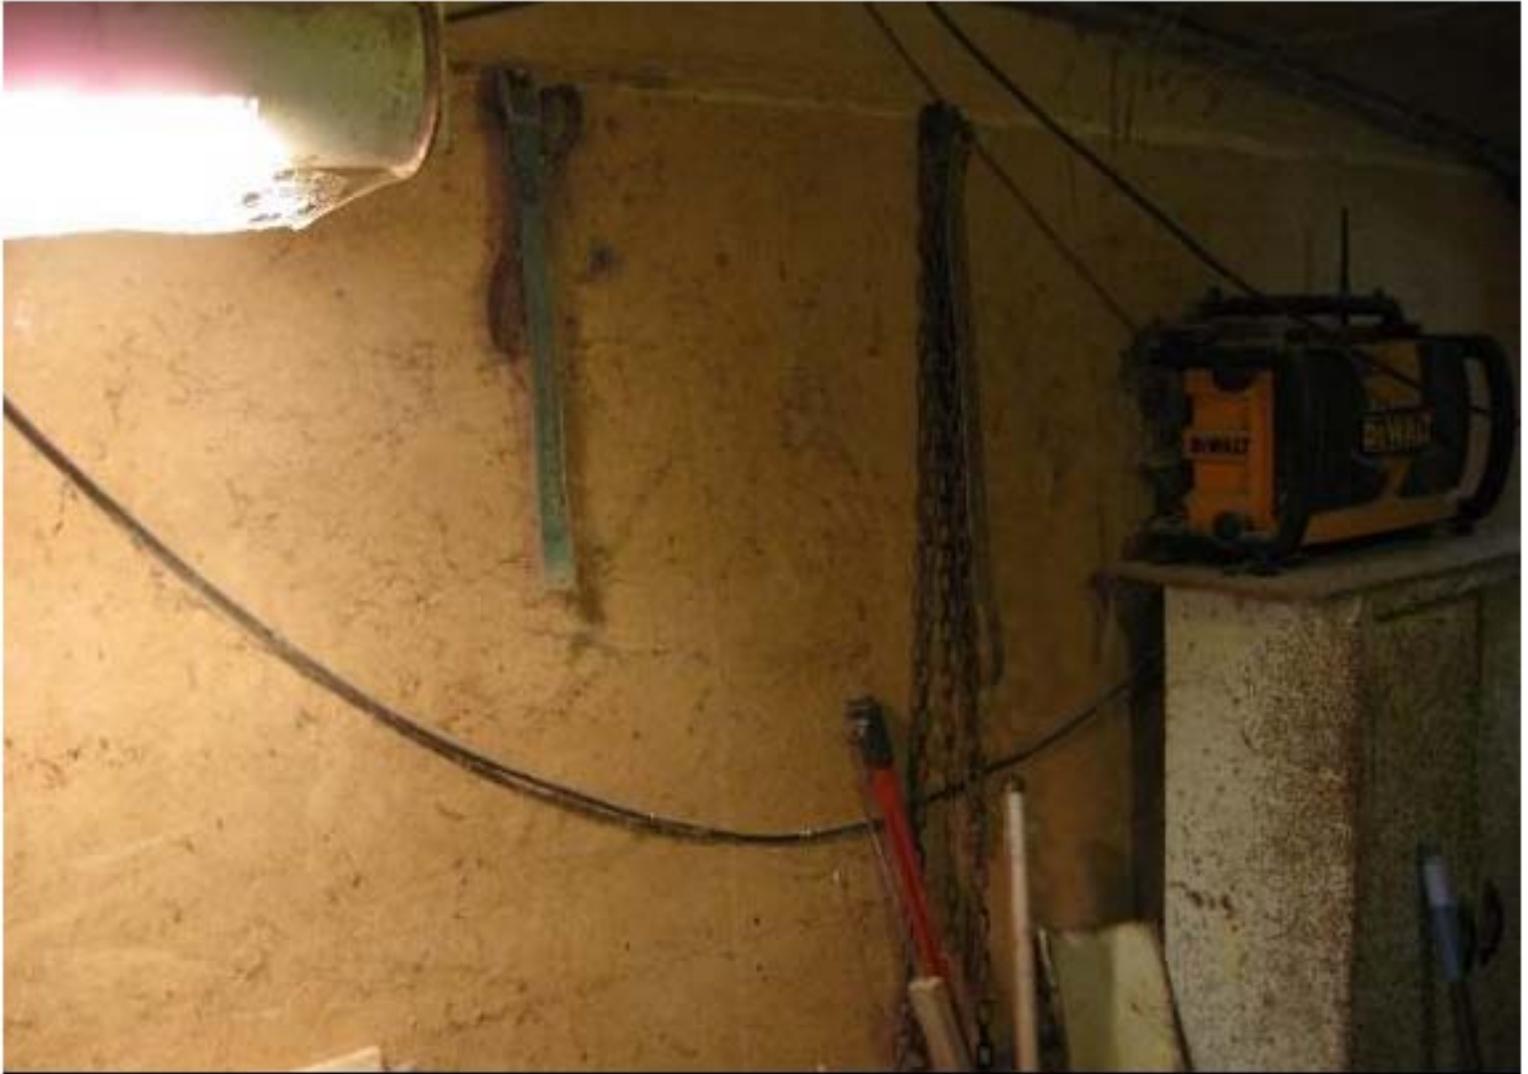
CFR: 3.11 (c)

Photographer:	John J. Lies, ACI	Legal Name:	Registration:	42-A-0895
Photo Taken:	Fri, Jan 28, '11 A.M.	RANDY STOEN		
Inspection:	28110143480200			
Description:	3.1 (c)(3) General Housing Cleaning: Buildup of dirt, hair oils on walls inside of enclosures.3.11 (c) Housekeeping, dirt, hair, spider webs and clutter needs to be removed.			FOIA11-282000544

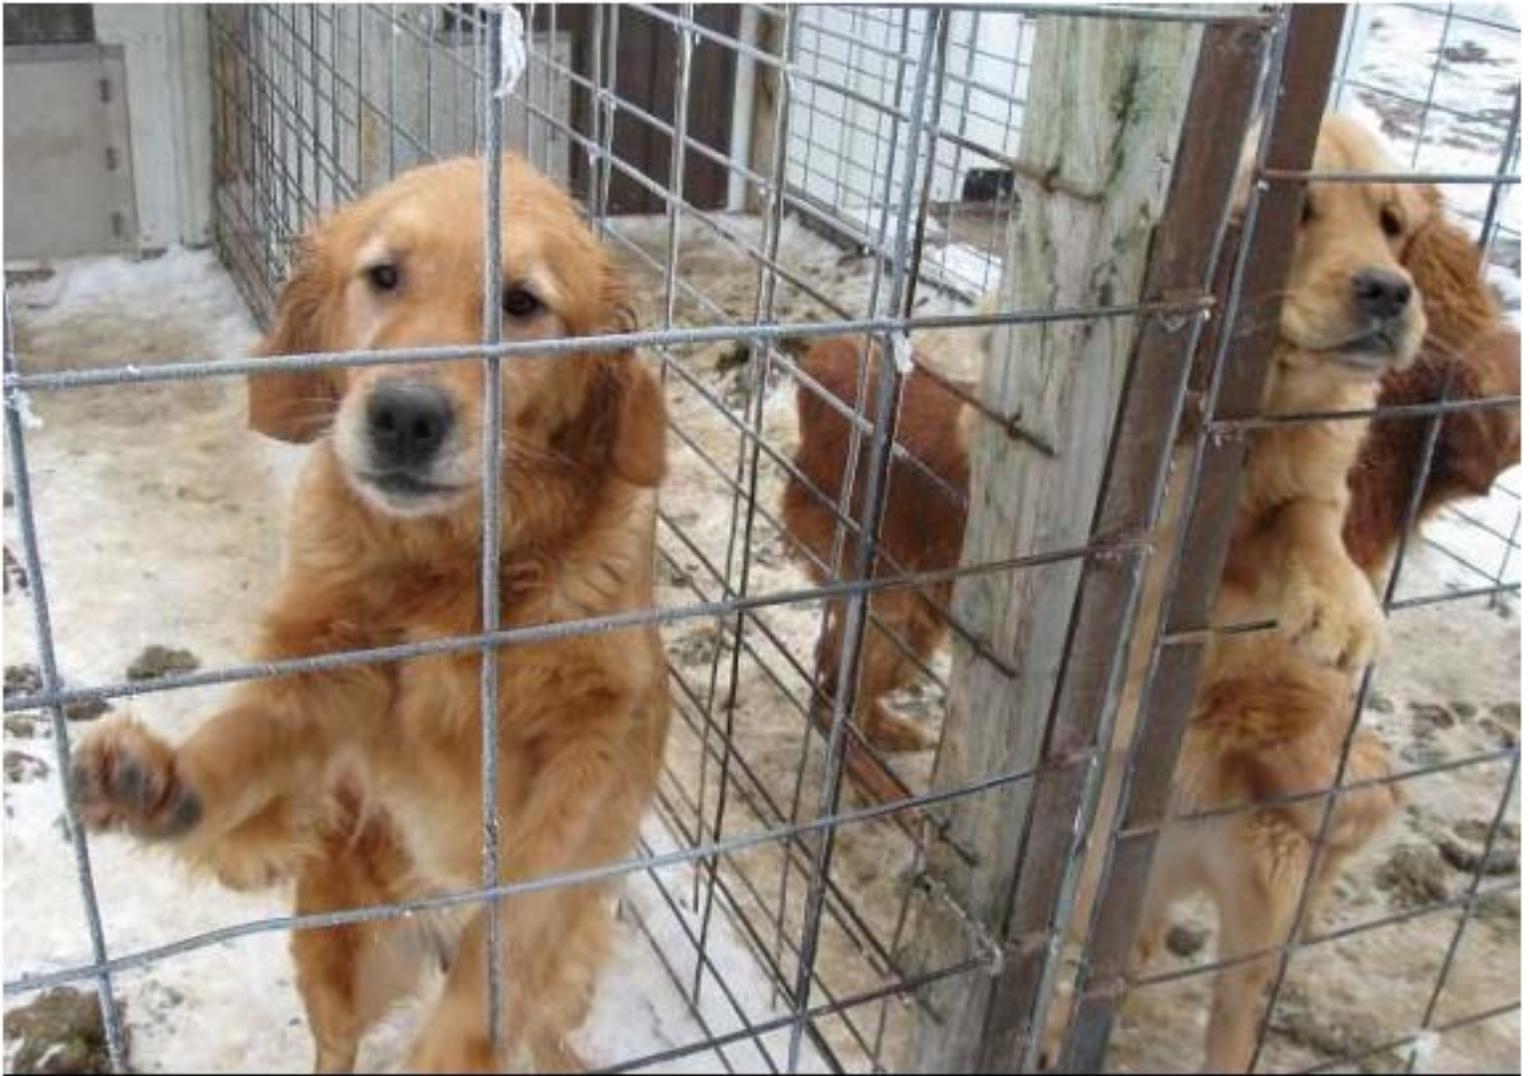
CFR: 3.1 (a), 3.1 (c) (3)

Photographer:	John J. Lies, ACI	Legal Name:	Registration:	42-A-0895
Photo Taken:	Fri, Jan 28, '11 A.M.	RANDY STOEN		
Inspection:	28110143480200			
Description:	3.1 (c)(3) Housing General Cleaning: Enclosures need to be cleaned to remove snow & Feces.3.1 (a) Construction: Cattle panel opening allow the dogs to stick their heads through the openings.
