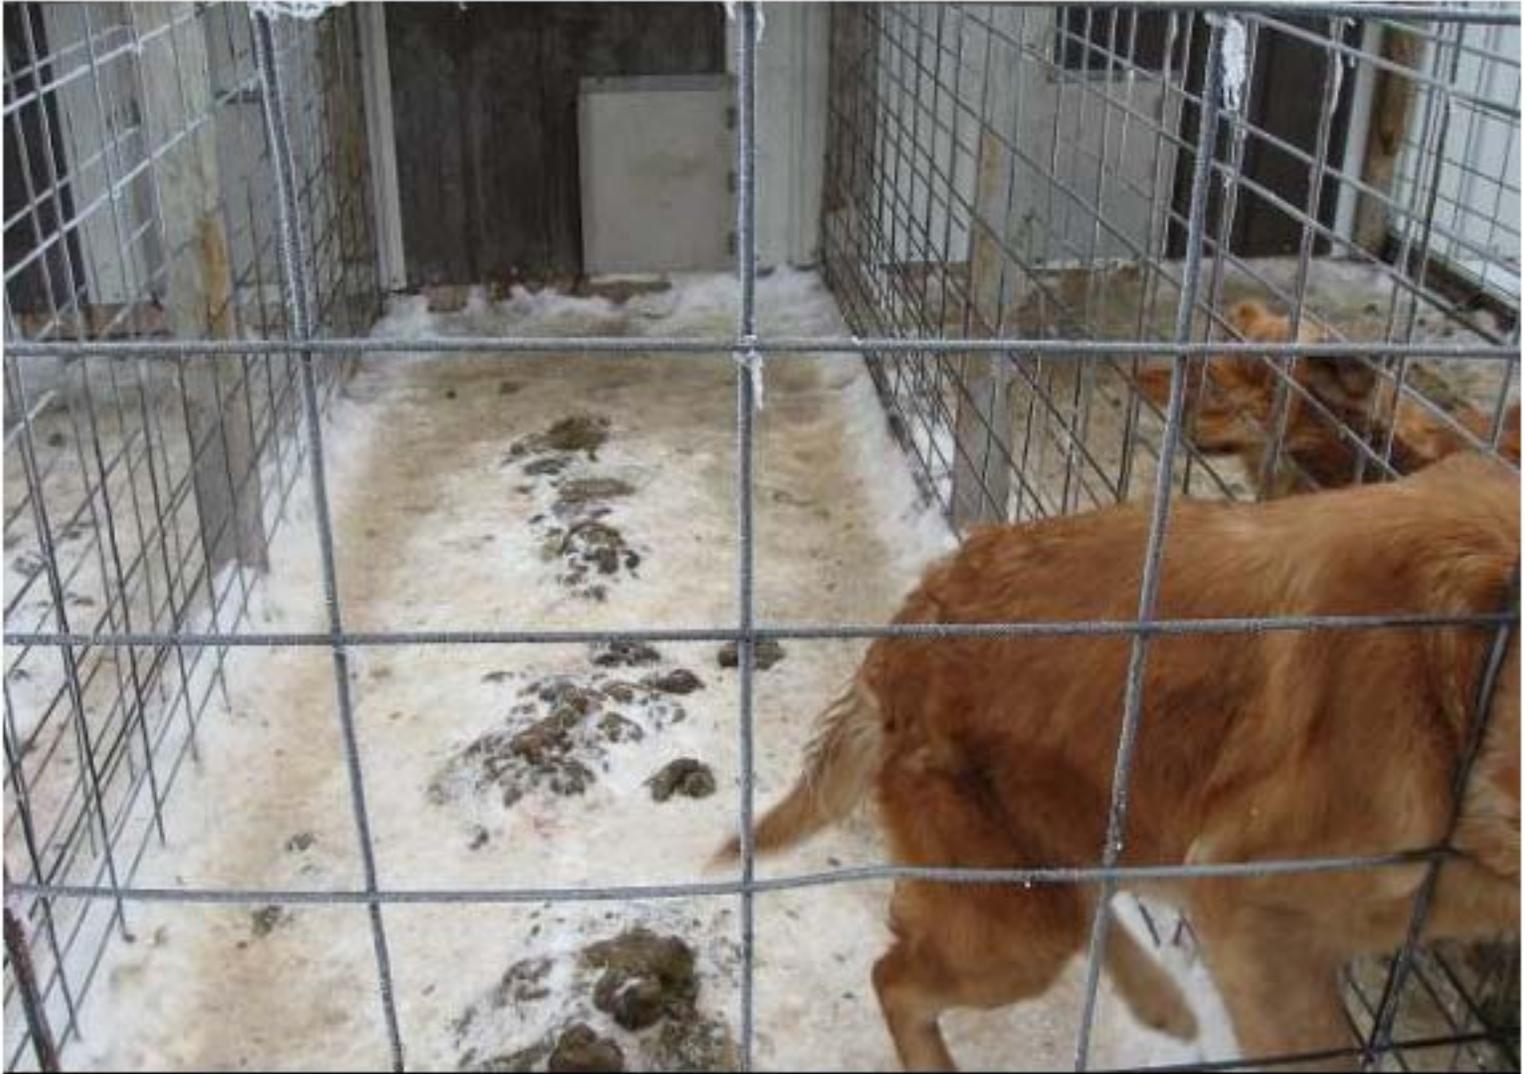
CFR: 3.1 (a), 3.1 (c) (3)

Photographer:	John J. Lies, ACI	Legal Name:	Registration:	42-A-0895
Photo Taken:	Fri, Jan 28, '11 A.M.	RANDY STOEN		
Inspection:	28110143480200			
Description:	3.1 (c)(3) Housing General Cleaning: Enclosures need to be cleaned to remove snow & Feces.3.1 (a) Construction: Cattle panel opening allow the dogs to stick their heads through the openings.

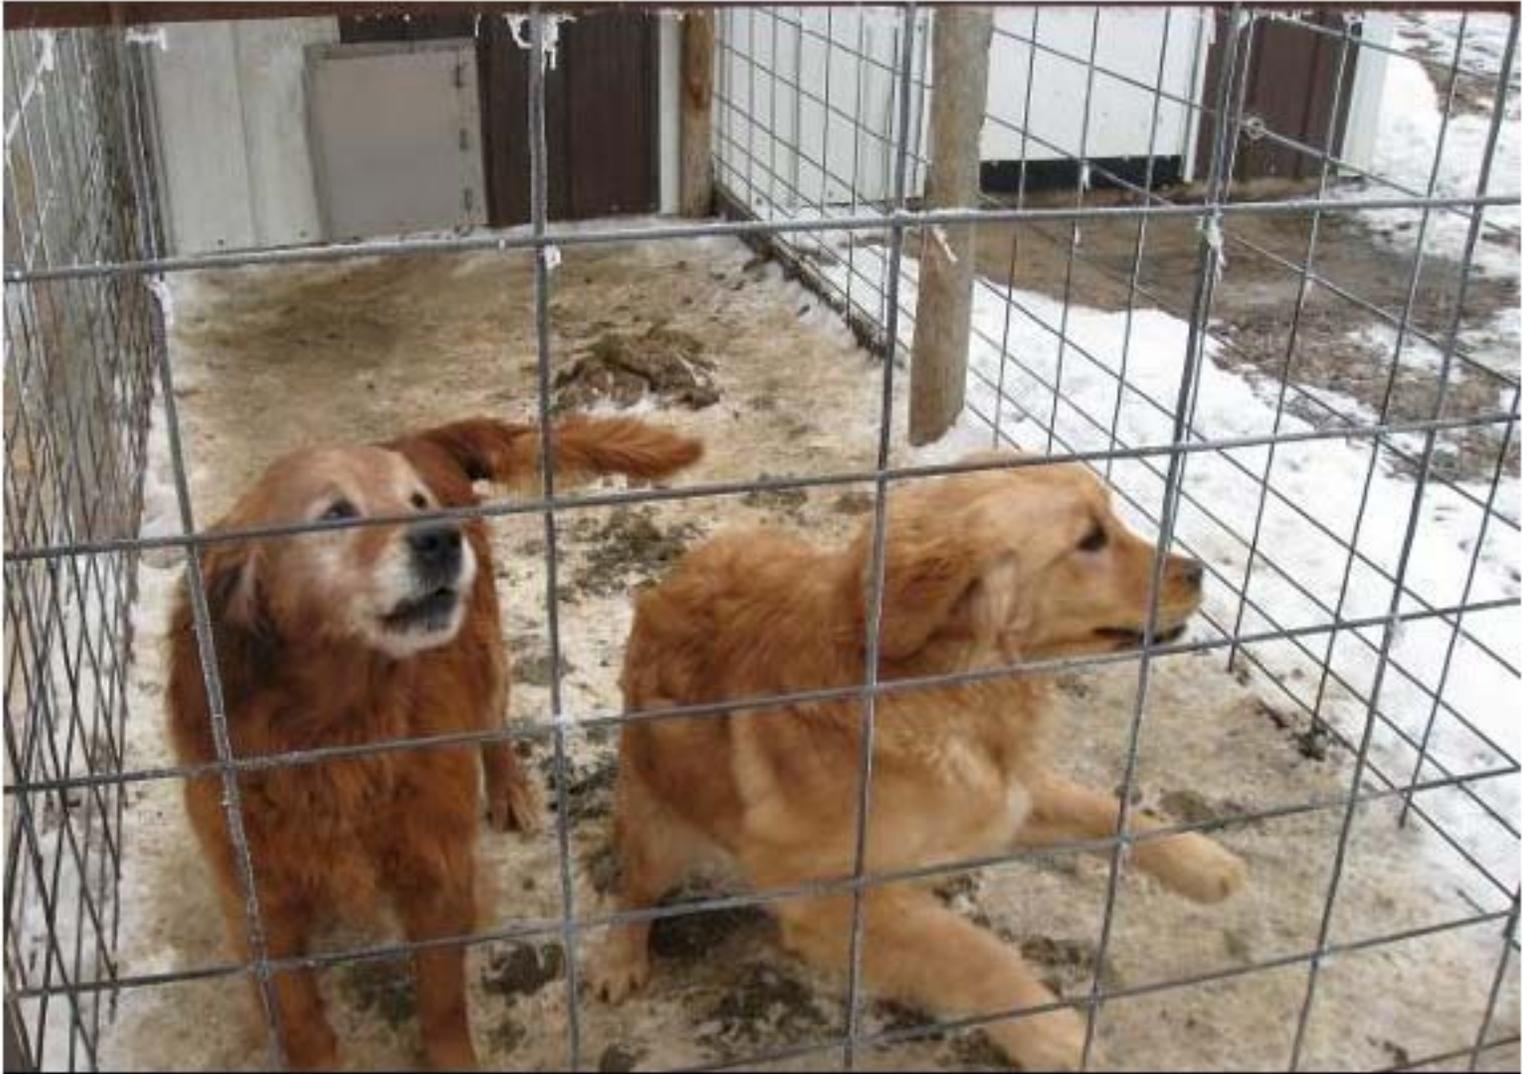
CFR: 3.1 (a), 3.1 (c) (3)

Photographer:	John J. Lies, ACI	Legal Name:	Registration:	42-A-0895
Photo Taken:	Fri, Jan 28, '11 A.M.	RANDY STOEN		
Inspection:	28110143480200			
Description:	3.1 (c)(3) Housing General Cleaning: Enclosures need to be cleaned to remove snow & Feces.3.1 (a) Construction: Cattle panel opening allow the dogs to stick their heads through the openings.

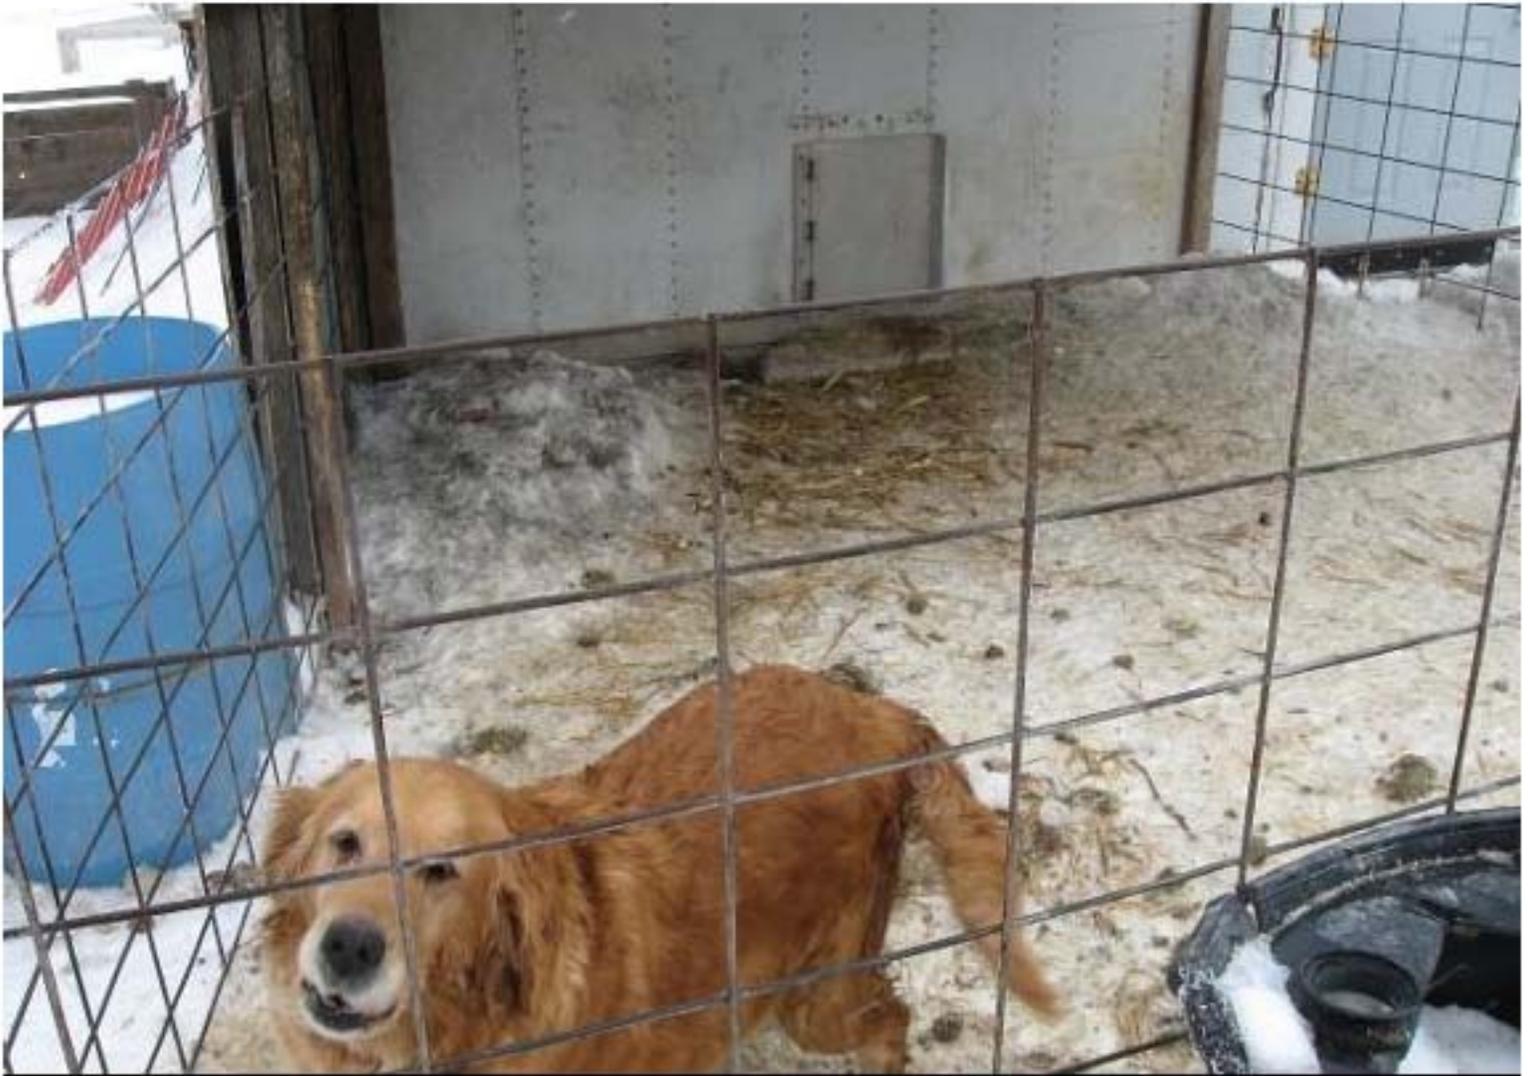
CFR: 3.1 (a), 3.1 (c) (3)

Photographer:	John J. Lies, ACI	Legal Name:	Registration:	42-A-0895
Photo Taken:	Fri, Jan 28, '11 A.M.	RANDY STOEN		
Inspection:	28110143480200			
Description:	3.1 (c)(3) Housing General Cleaning: Enclosures need to be cleaned to remove snow & Feces.3.1 (a) Construction: Cattle panel opening allow the dogs to stick their heads through the openings.

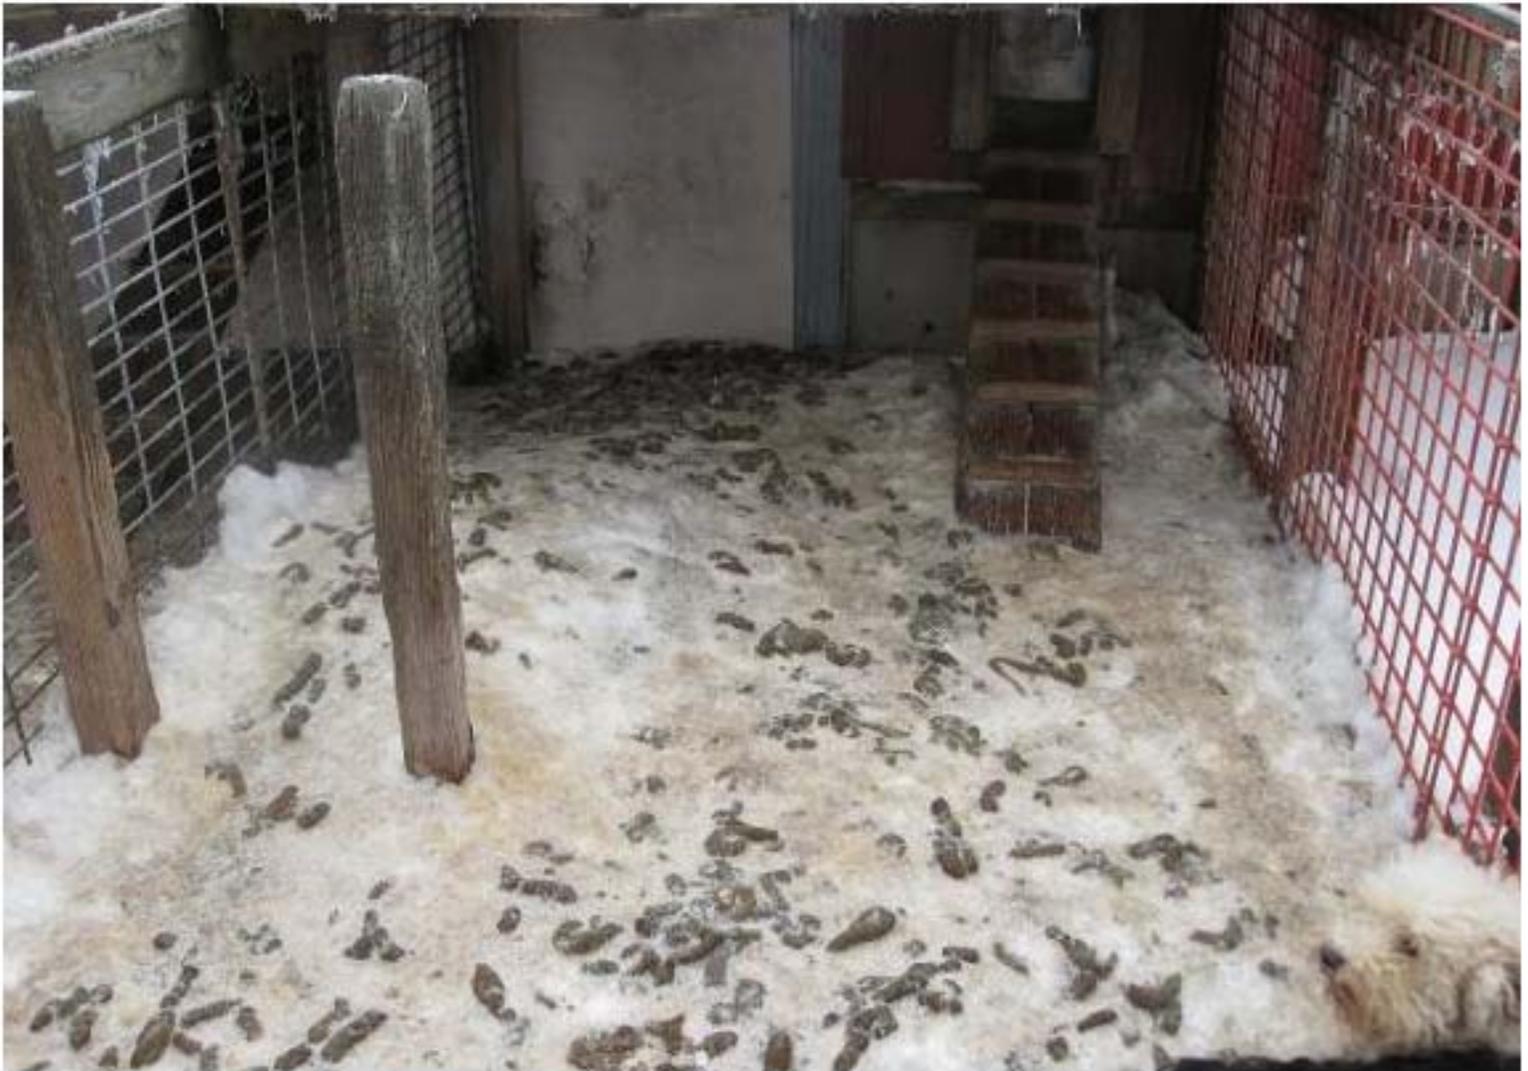
CFR: 3.1 (c) (3)

Photographer:	John J. Lies, ACI	Legal Name:	Registration:	42-A-0895
Photo Taken:	Fri, Jan 28, '11 A.M.	RANDY STOEN		
Inspection:	28110143480200			
Description:	3.1 (c)(3) Housing General Cleaning: The enclosures need to be cleaned to remove snow and feces.

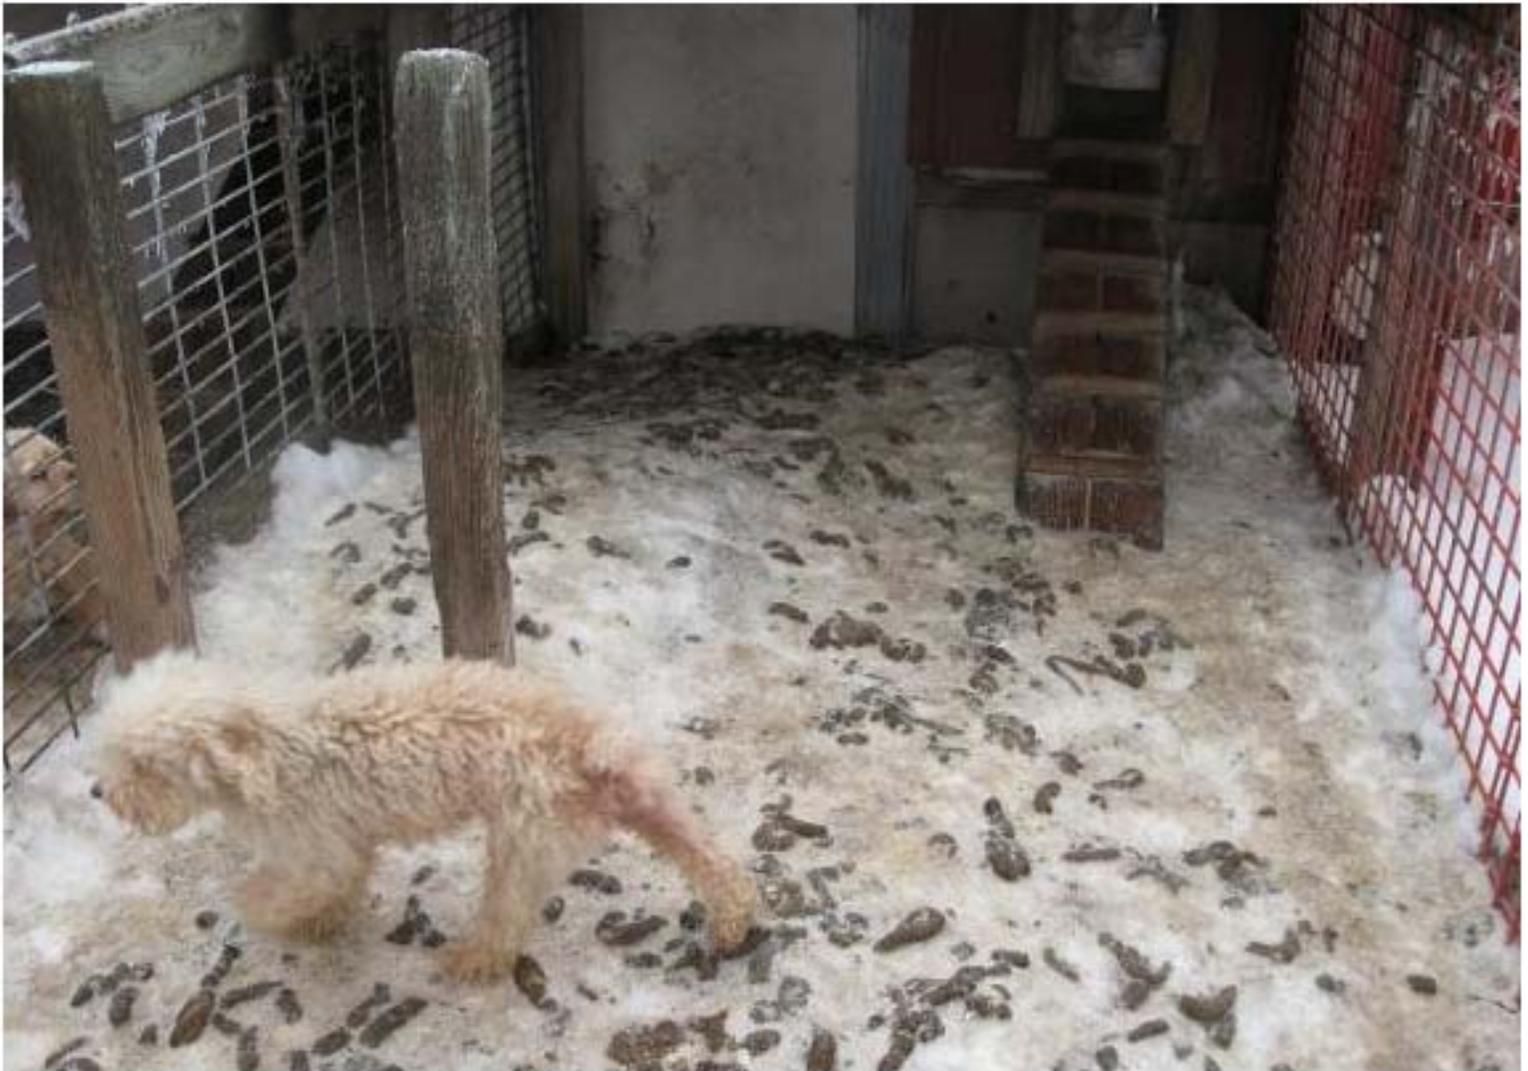
CFR: 3.1 (c) (3)

Photographer:	John J. Lies, ACI	Legal Name:	Registration:	42-A-0895
Photo Taken:	Fri, Jan 28, '11 A.M.	RANDY STOEN		
Inspection:	28110143480200			
Description:	3.1 (c)(3) Housing General Cleaning: The enclosures need to be cleaned to remove snow and feces.

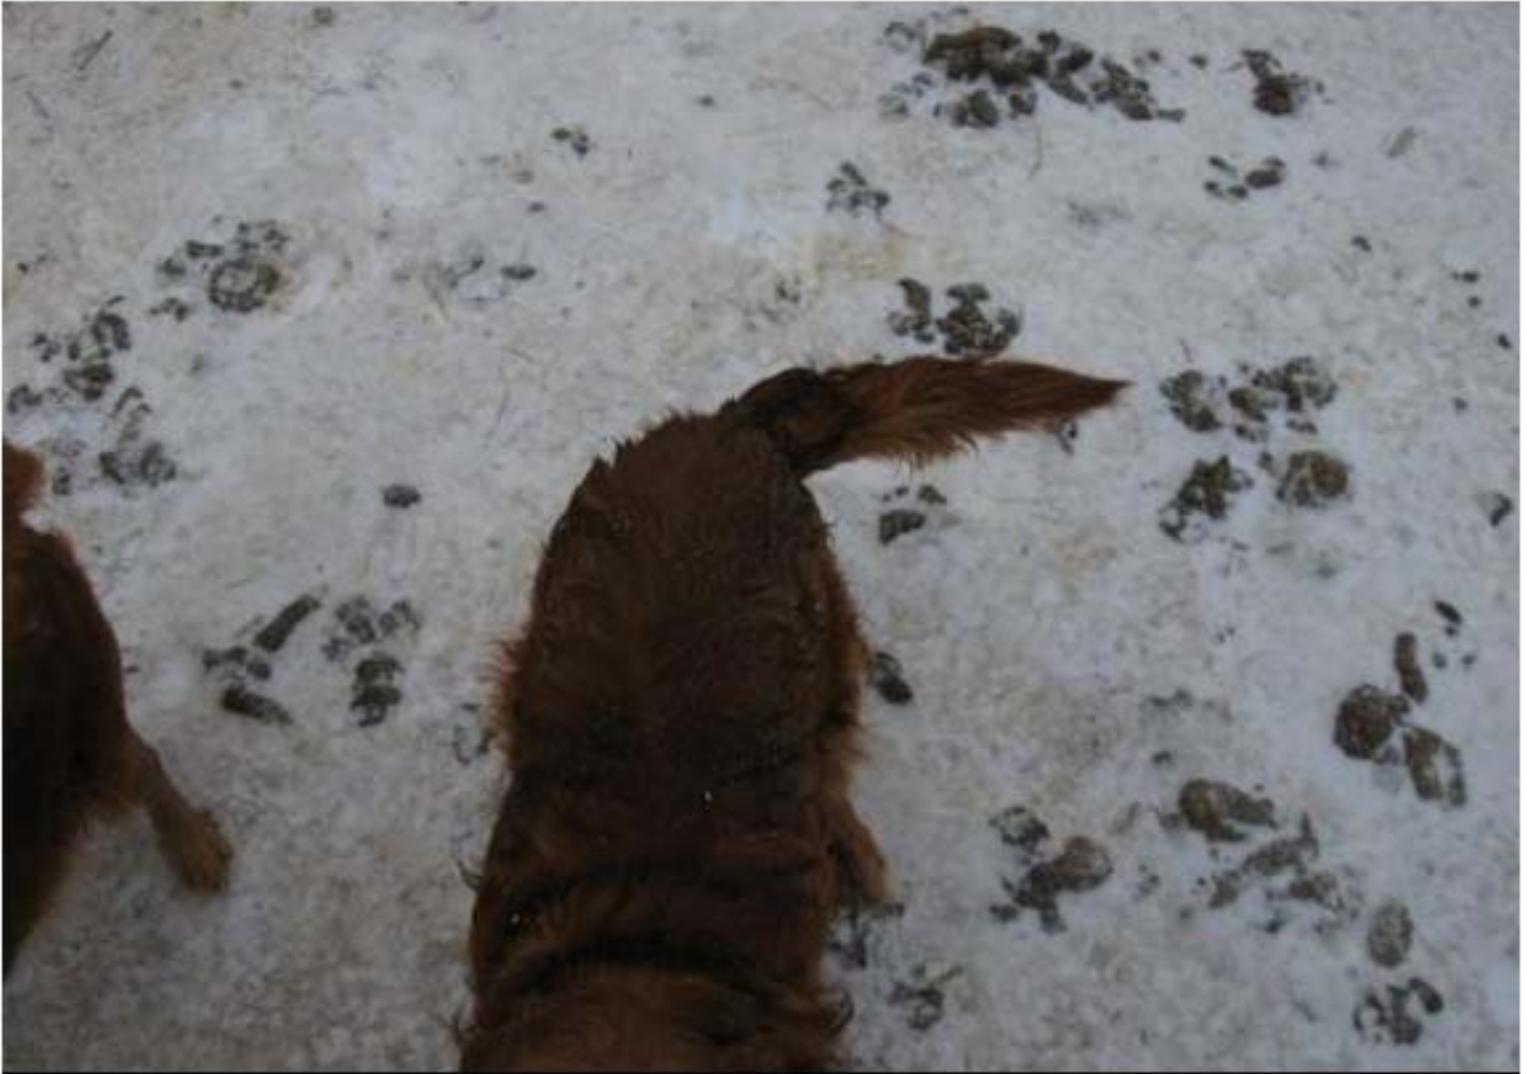
CFR: 3.1 (c) (3)

Photographer:	John J. Lies, ACI	Legal Name:	Registration:	42-A-0895
Photo Taken:	Fri, Jan 28, '11 A.M.	RANDY STOEN		
Inspection:	28110143480200			
Description:	3.1 (c)(3) Housing General Cleaning: Enclosures need to be cleaned to remove snow & Feces.

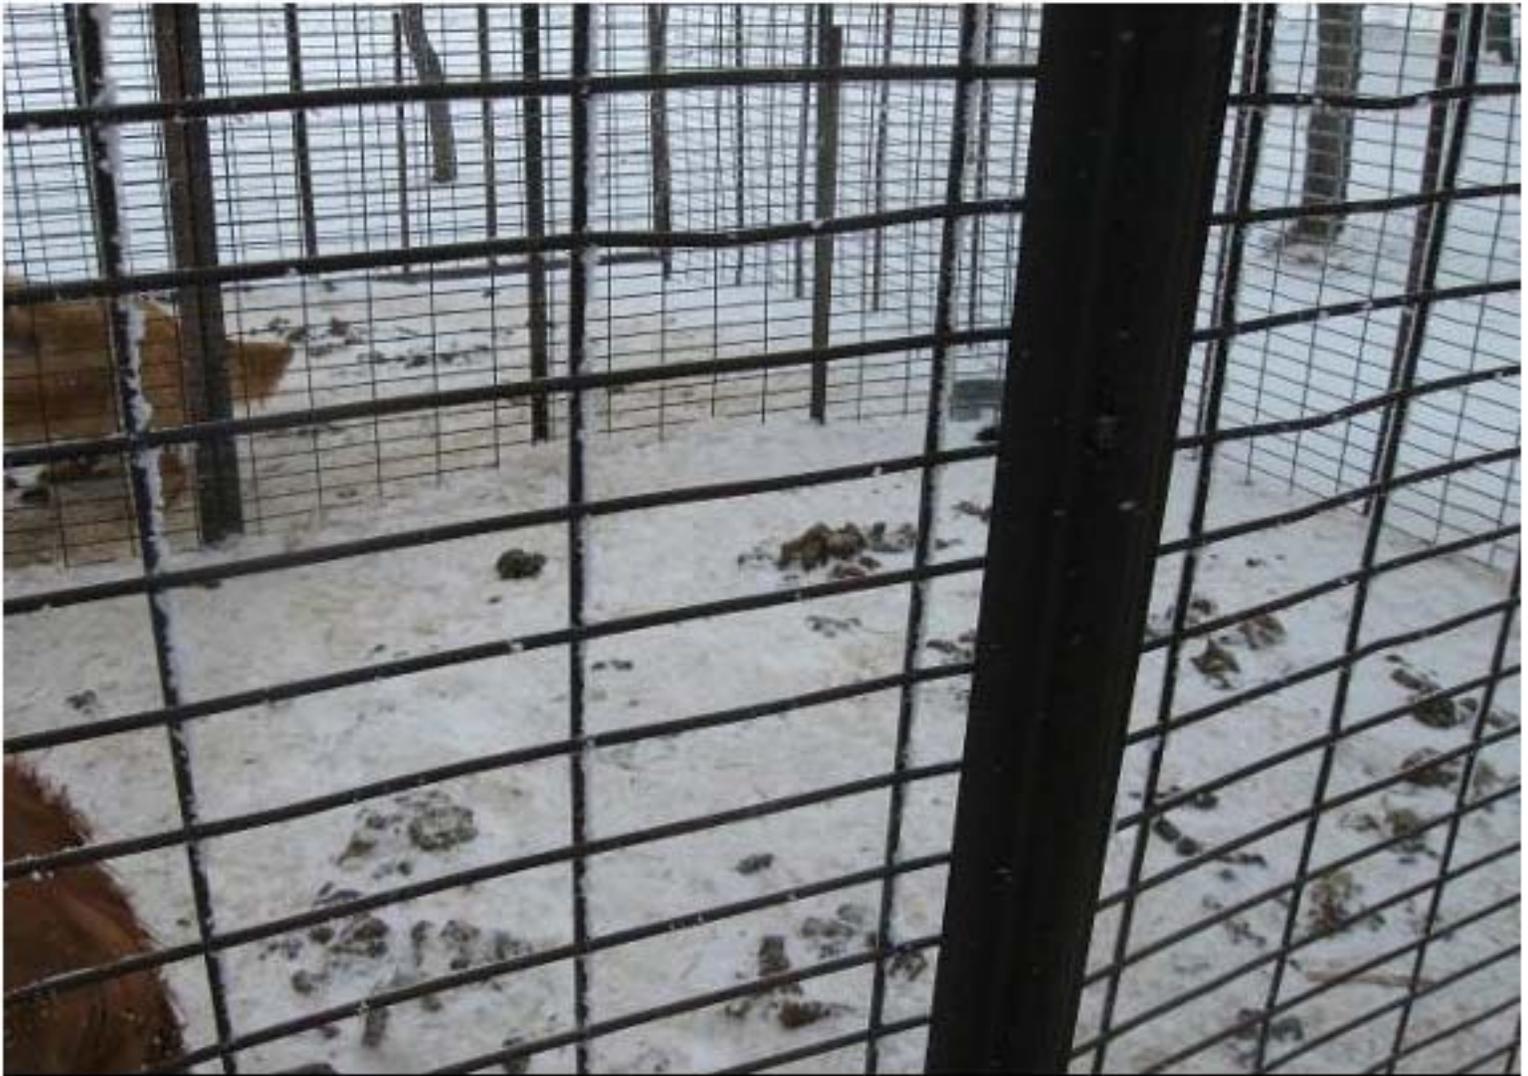
CFR: 3.1 (c) (3)

Photographer:	John J. Lies, ACI	Legal Name:	Registration:	42-A-0895
Photo Taken:	Fri, Jan 28, '11 A.M.	RANDY STOEN		
Inspection:	28110143480200			
Description:	3.1 (c)(3) Housing General Cleaning: Enclosures need to be cleaned to remove snow & Feces.

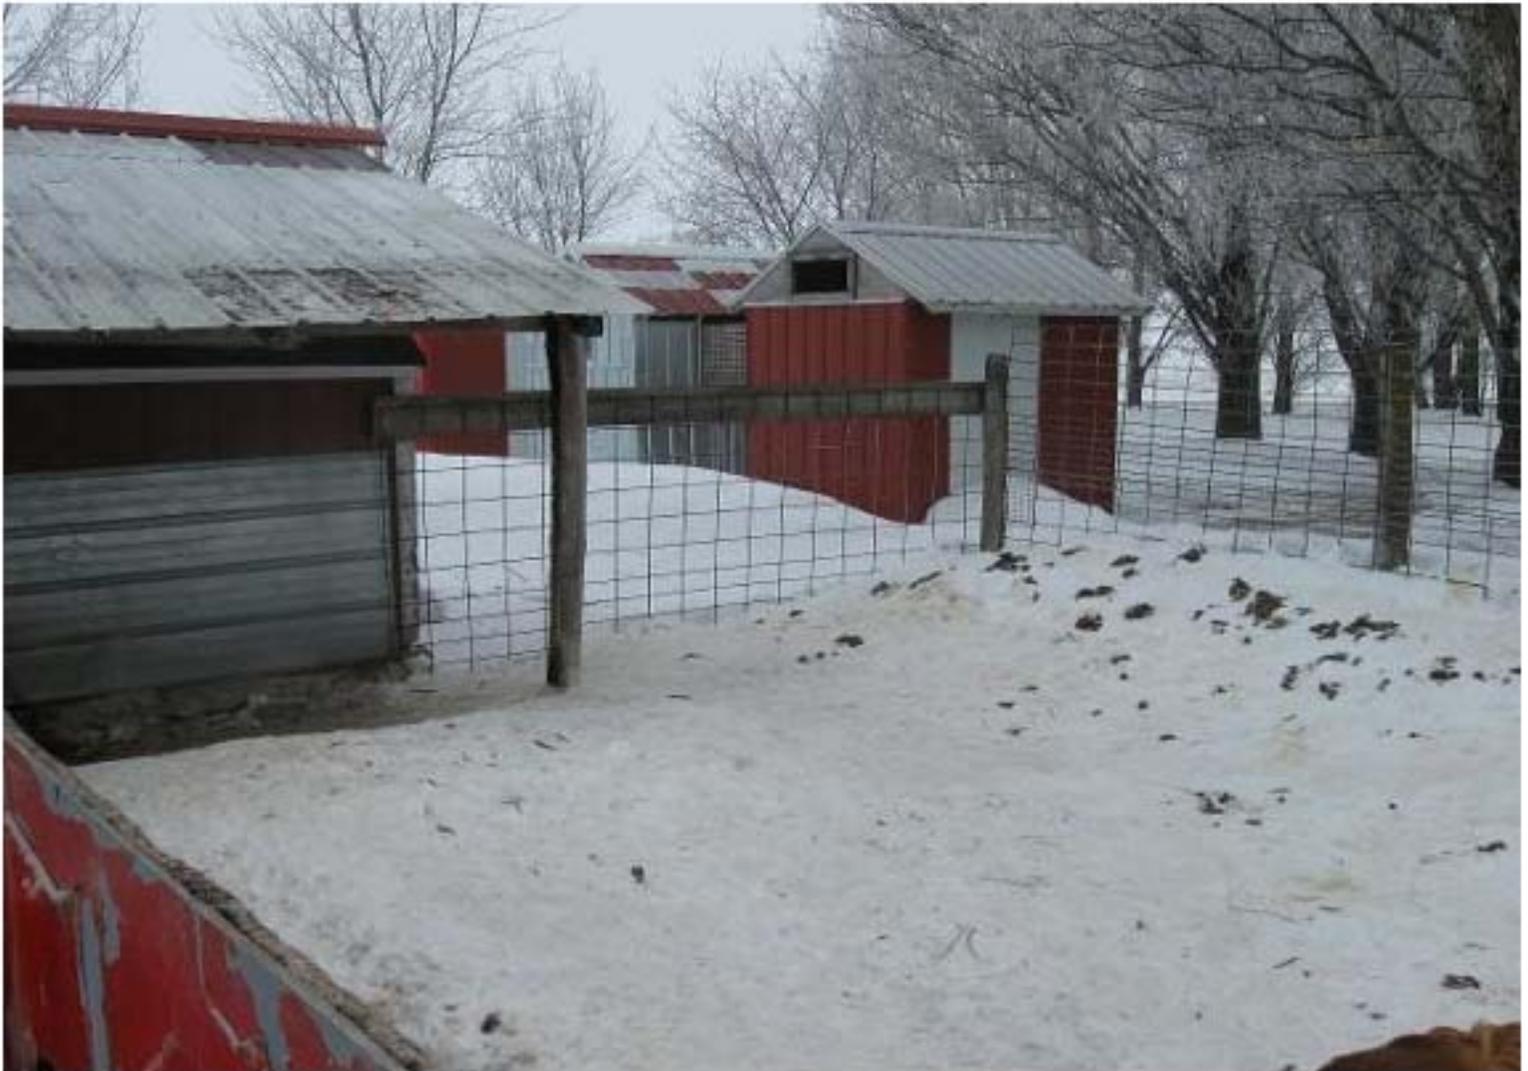
CFR: 3.1 (c) (3)

Photographer:	John J. Lies, ACI	Legal Name:	Registration:	42-A-0895
Photo Taken:	Fri, Jan 28, '11 A.M.	RANDY STOEN		
Inspection:	28110143480200			
Description:	3.1 (c)(3) Housing General Cleaning: Enclosures need to be cleaned to remove snow & Feces.

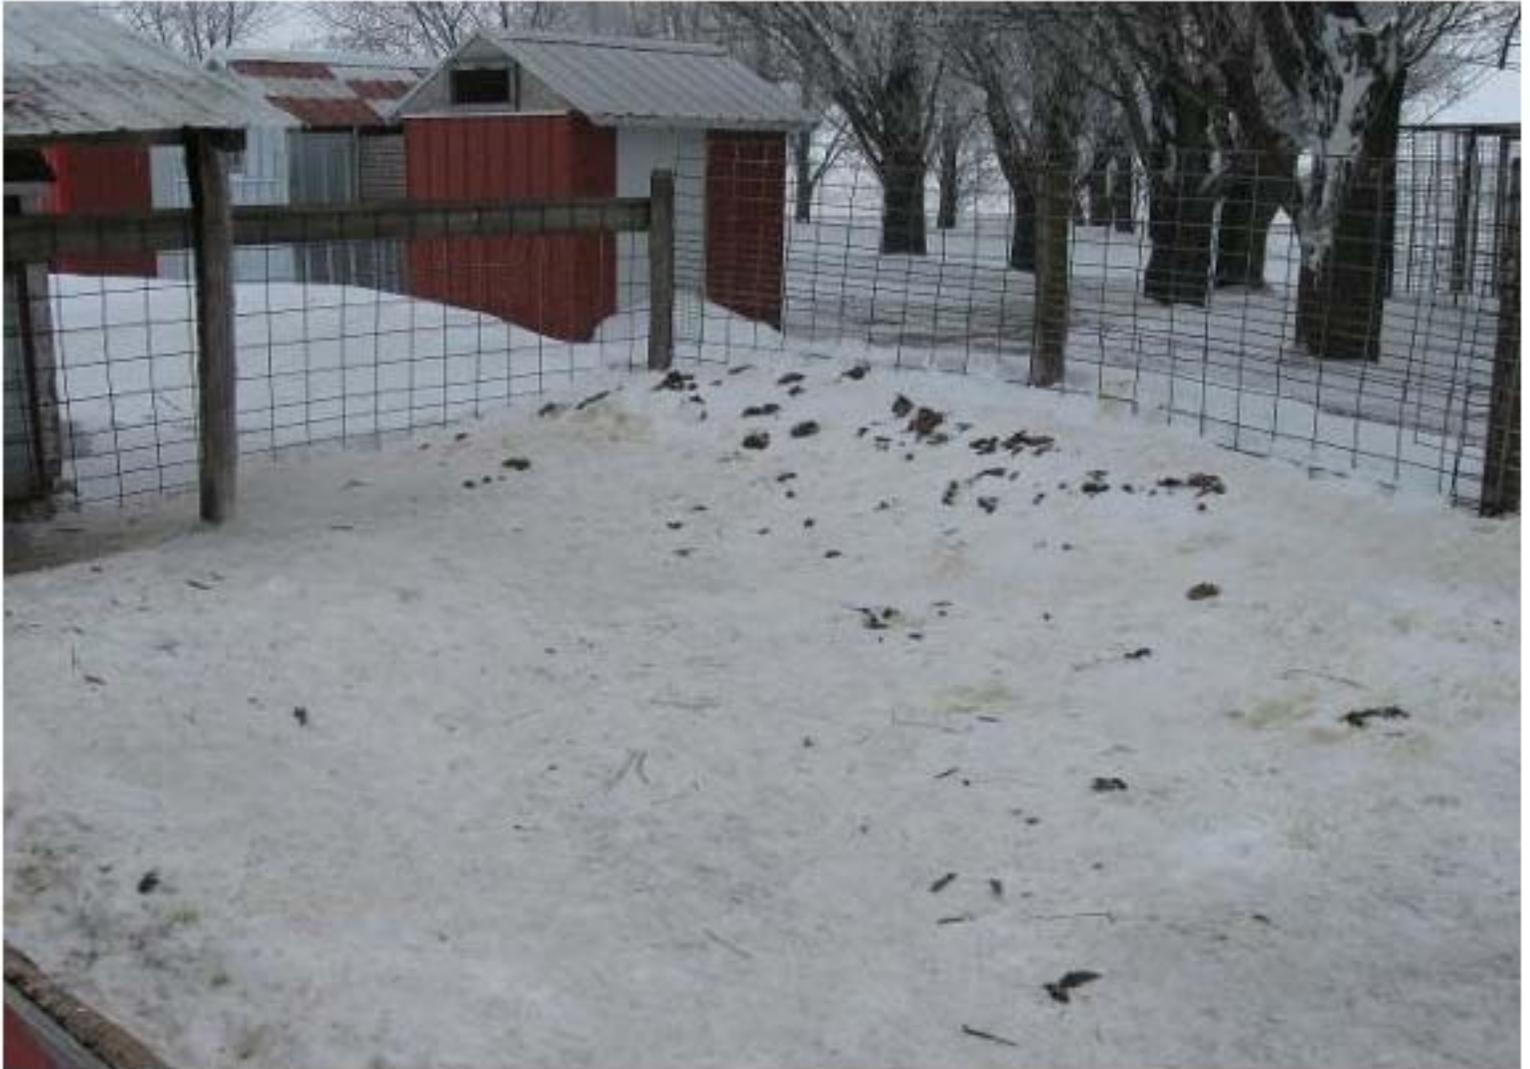
CFR: 3.1 (c) (3)

Photographer:	John J. Lies, ACI	Legal Name:	Registration:	42-A-0895
Photo Taken:	Fri, Jan 28, '11 A.M.	RANDY STOEN		
Inspection:	28110143480200			
Description:	3.1 (c)(3) Housing General Cleaning: Enclosures need to be cleaned to remove snow & Feces.

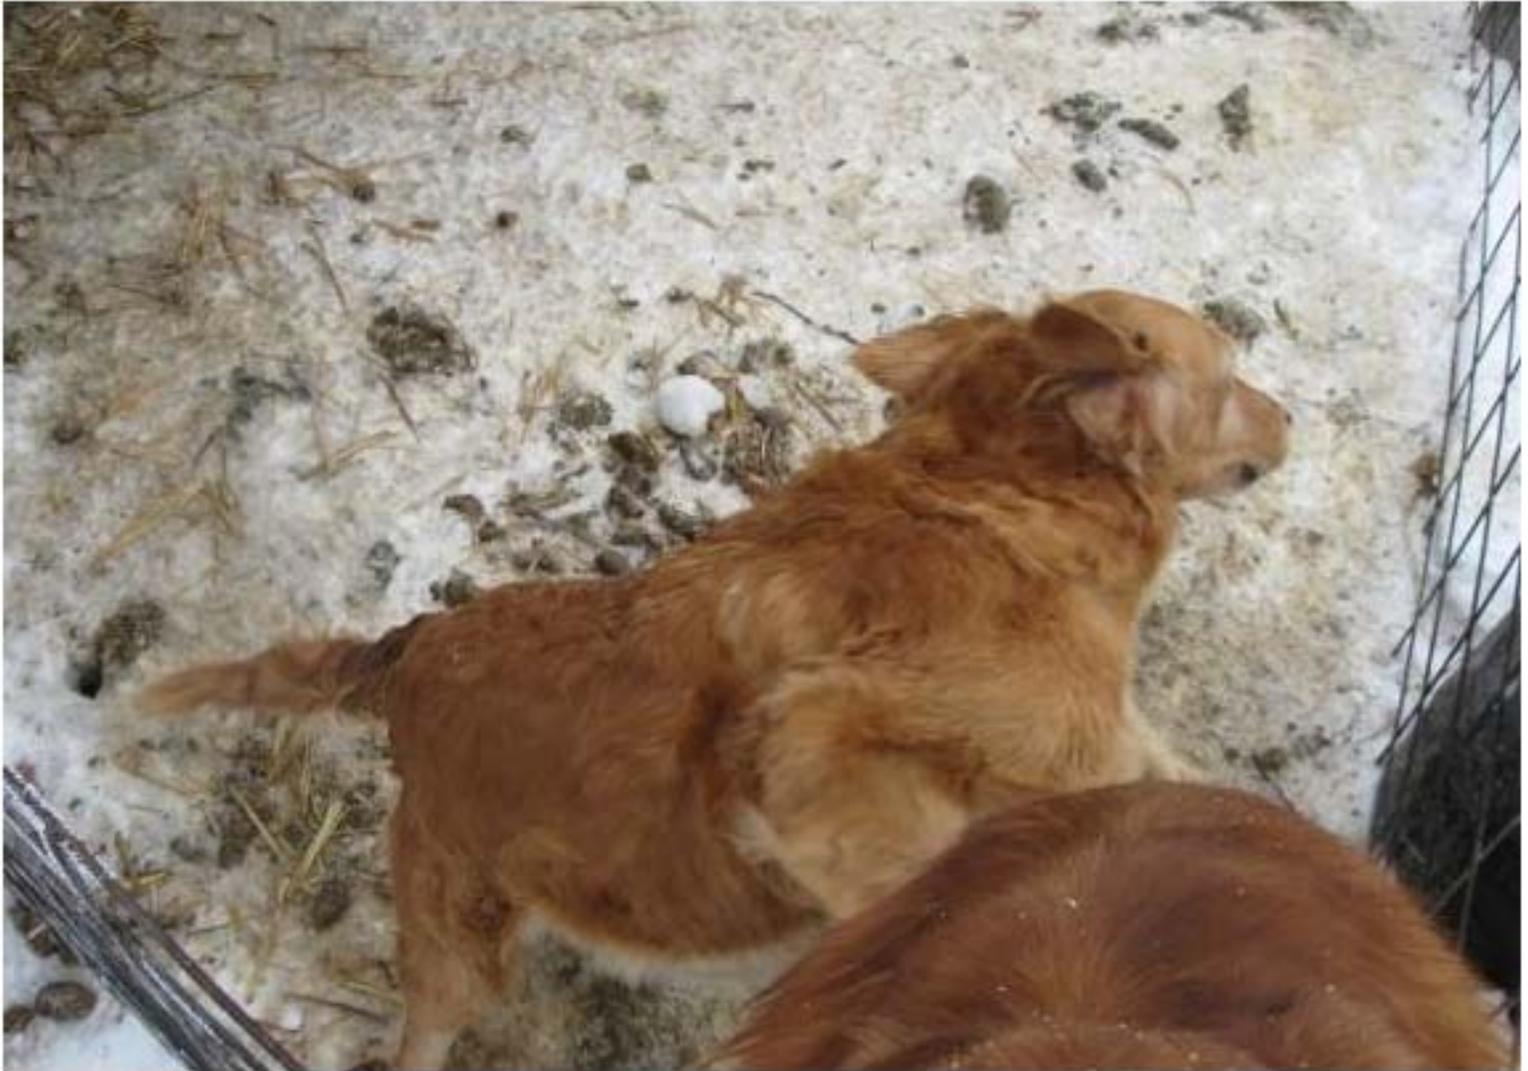
CFR: 3.1 (c) (3)

Photographer:	John J. Lies, ACI	Legal Name:	Registration:	42-A-0895
Photo Taken:	Fri, Jan 28, '11 A.M.	RANDY STOEN		
Inspection:	28110143480200			
Description:	3.1 (c)(3) Housing General Cleaning: Enclosures need to be cleaned to remove snow & Feces.

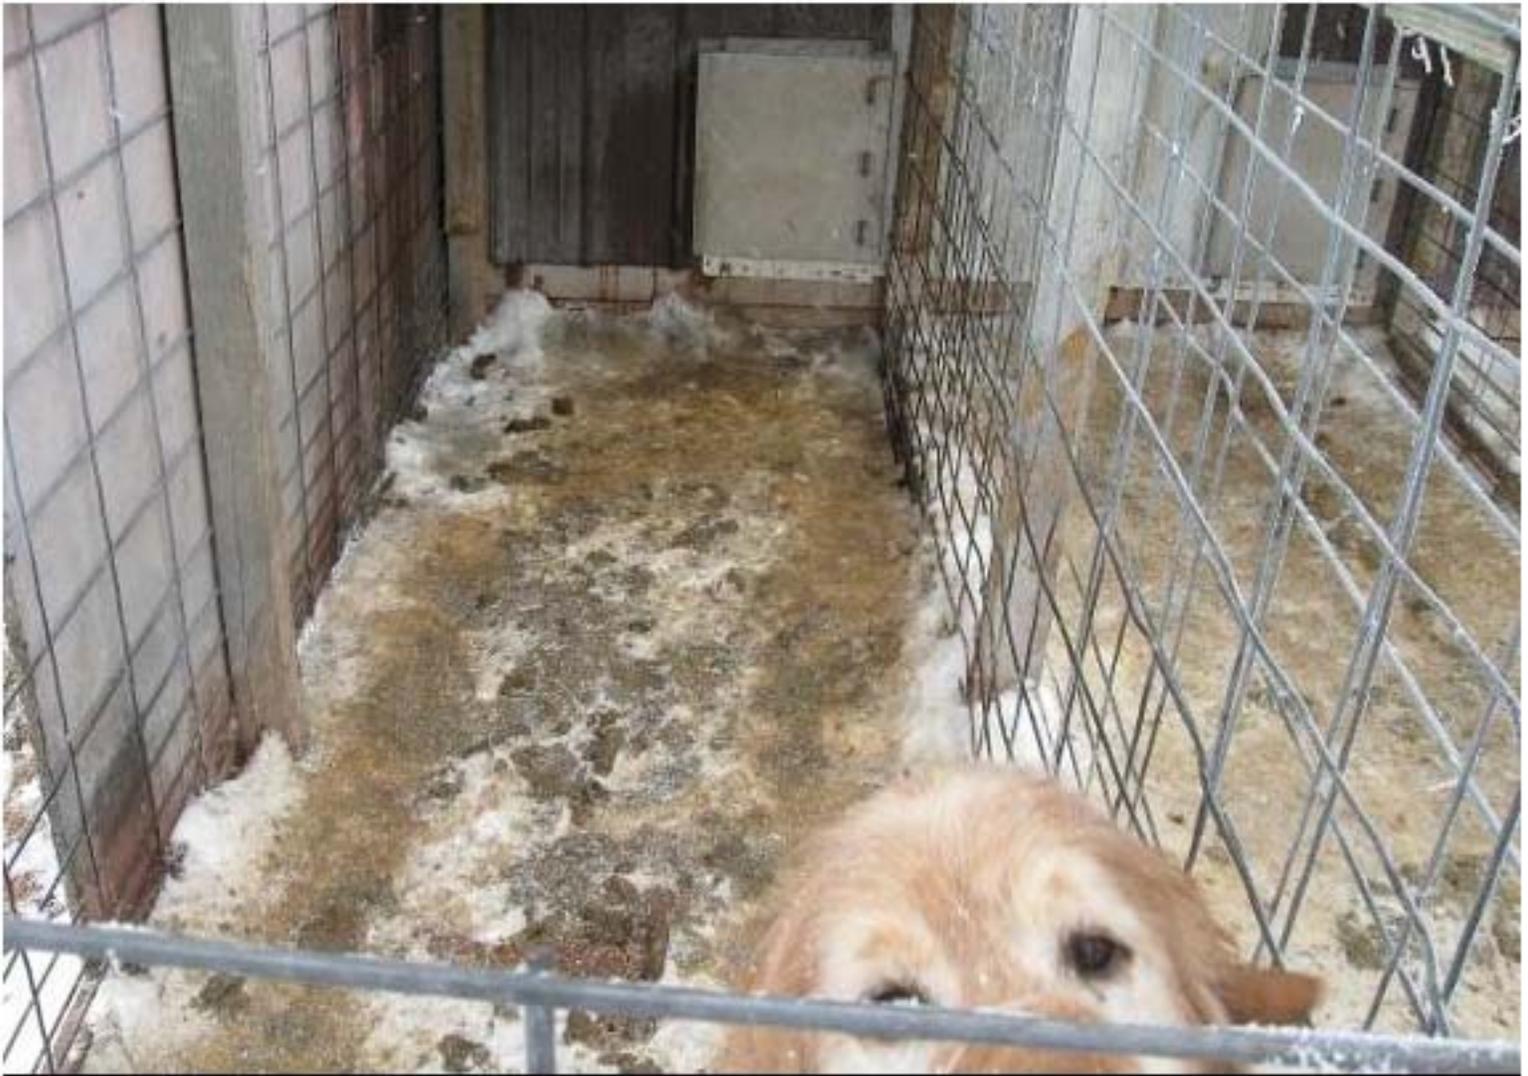
CFR: 3.1 (c) (3)

Photographer:	John J. Lies, ACI	Legal Name:	Registration:	42-A-0895
Photo Taken:	Fri, Jan 28, '11 A.M.	RANDY STOEN		
Inspection:	28110143480200			
Description:	3.1 (c)(3) Housing General Cleaning: Enclosures need to be cleaned to remove snow & Feces.

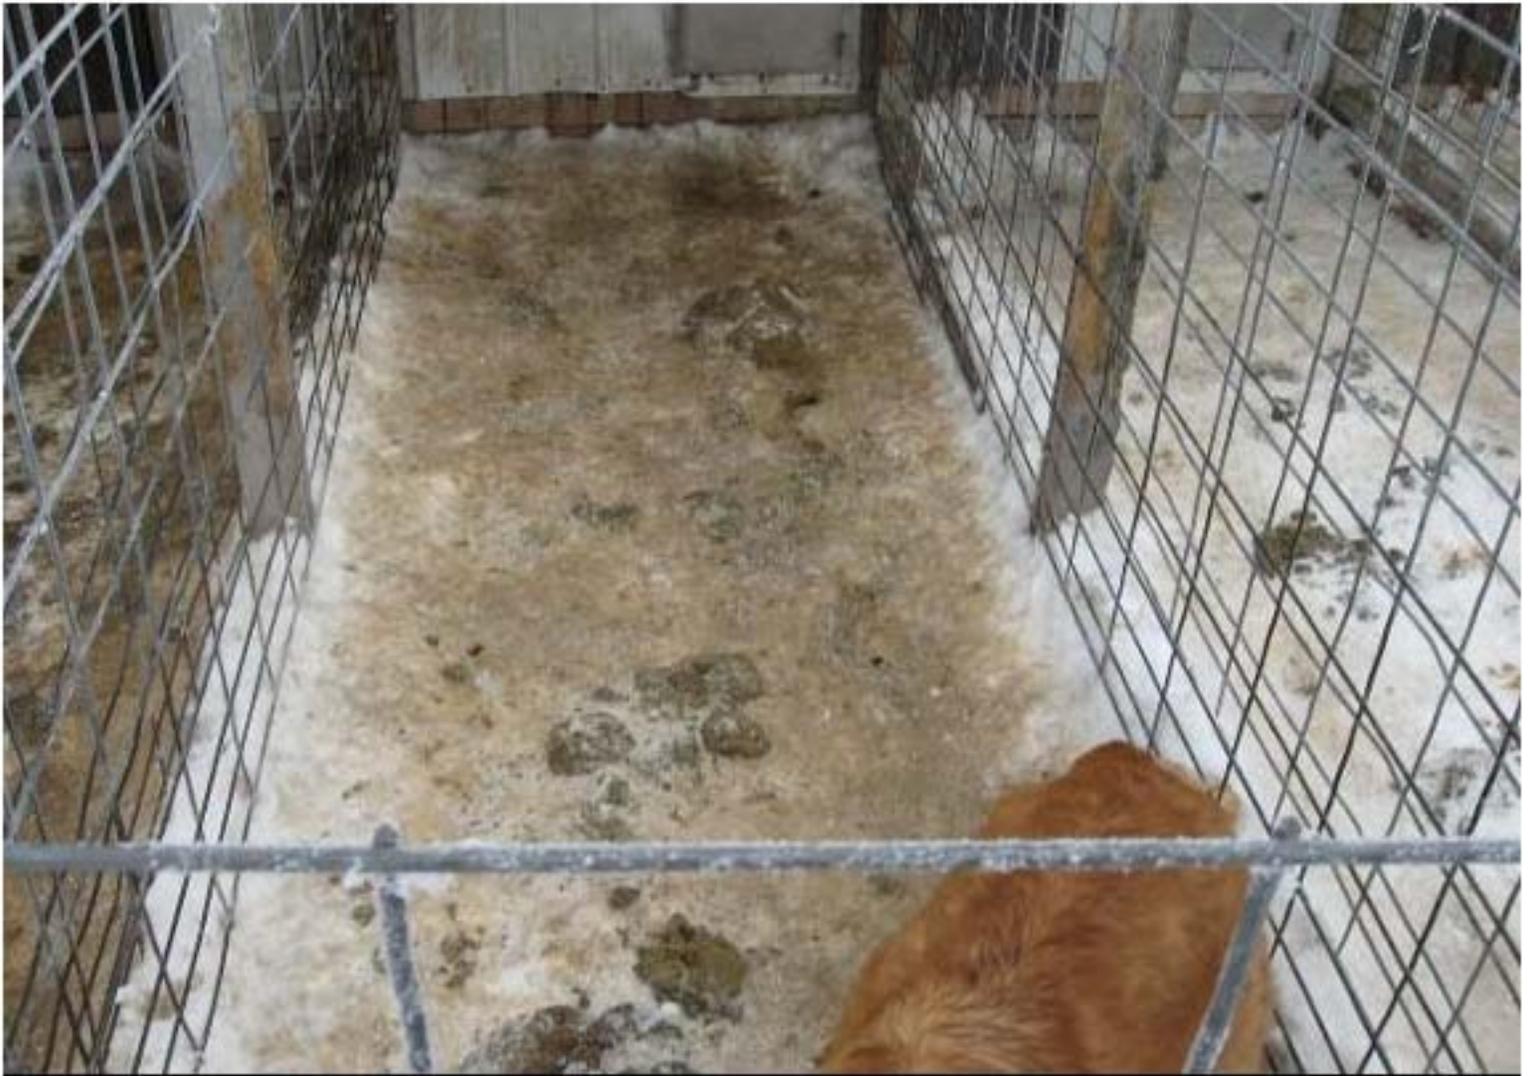
CFR: 3.1 (c) (3)

Photographer:	John J. Lies, ACI	Legal Name:	Registration:	42-A-0895
Photo Taken:	Fri, Jan 28, '11 A.M.	RANDY STOEN		
Inspection:	28110143480200			
Description:	3.1 (c)(3) Housing General Cleaning: Enclosures need to be cleaned to remove snow & Feces.

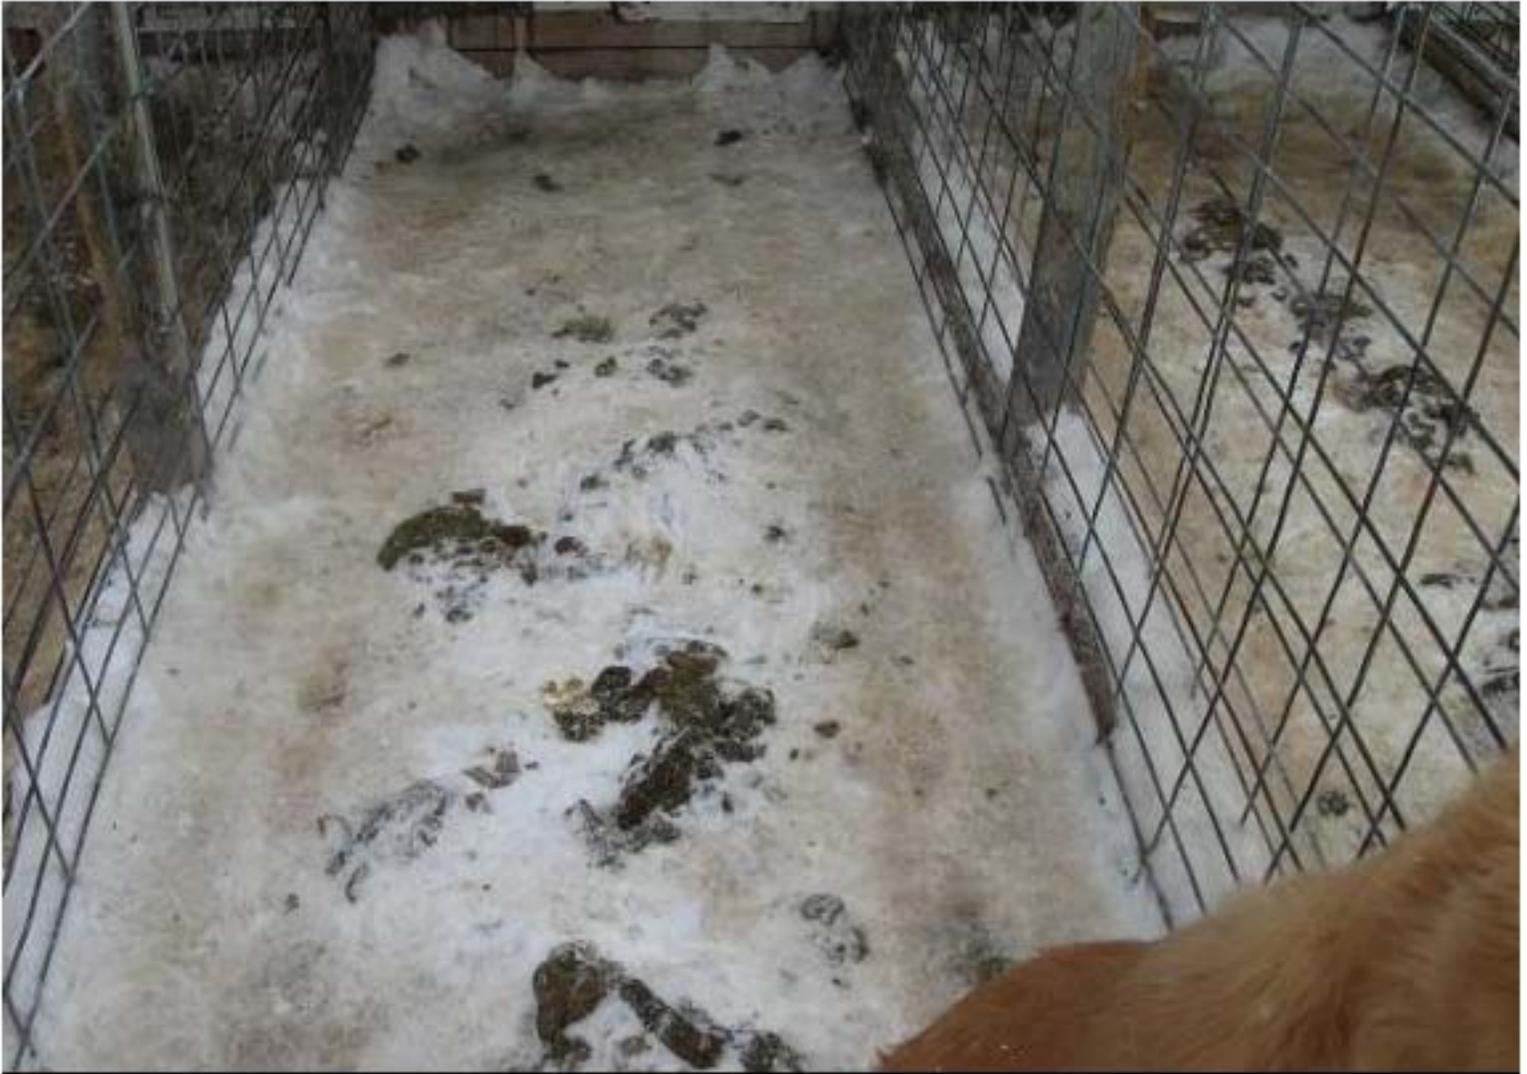
CFR: 3.1 (c) (3)

Photographer:	John J. Lies, ACI	Legal Name:	Registration:	42-A-0895
Photo Taken:	Fri, Jan 28, '11 A.M.	RANDY STOEN		
Inspection:	28110143480200			
Description:	3.1 (c)(3) Housing General Cleaning: Enclosures need to be cleaned to remove snow & Feces.
