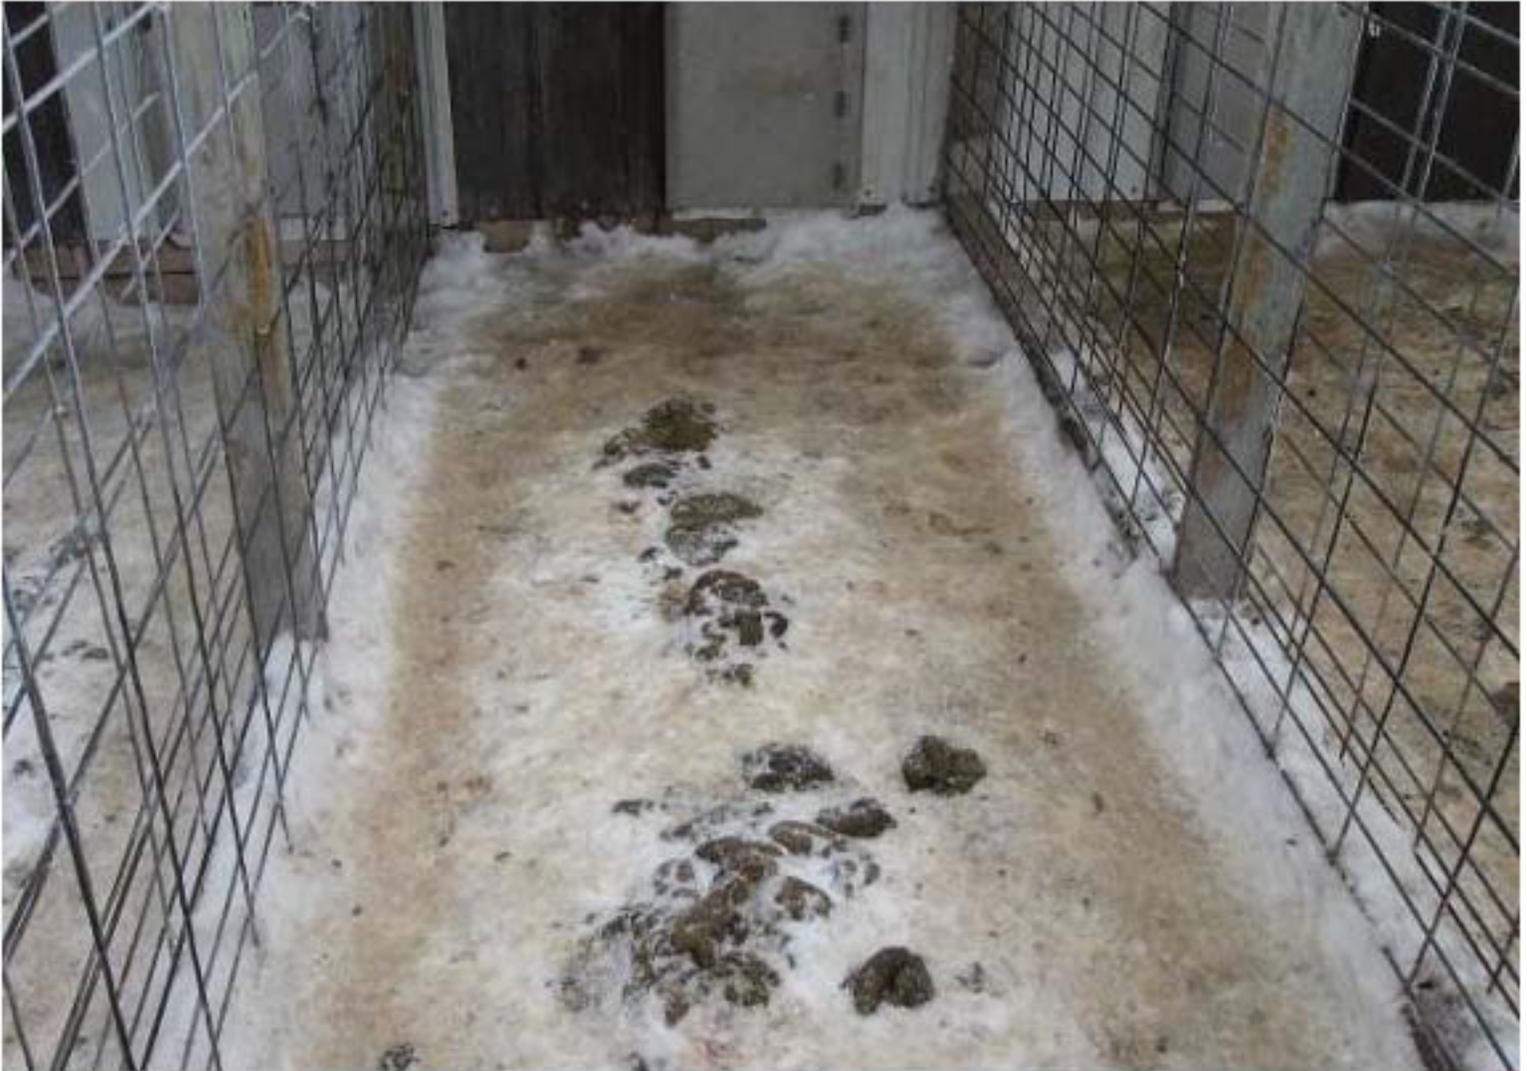
CFR: 3.1 (c) (3)

Photographer:	John J. Lies, ACI	Legal Name:	Registration:	42-A-0895
Photo Taken:	Fri, Jan 28, '11 A.M.	RANDY STOEN		
Inspection:	28110143480200			
Description:	3.1 (c)(3) Housing General Cleaning: Enclosures need to be cleaned to remove snow & Feces.

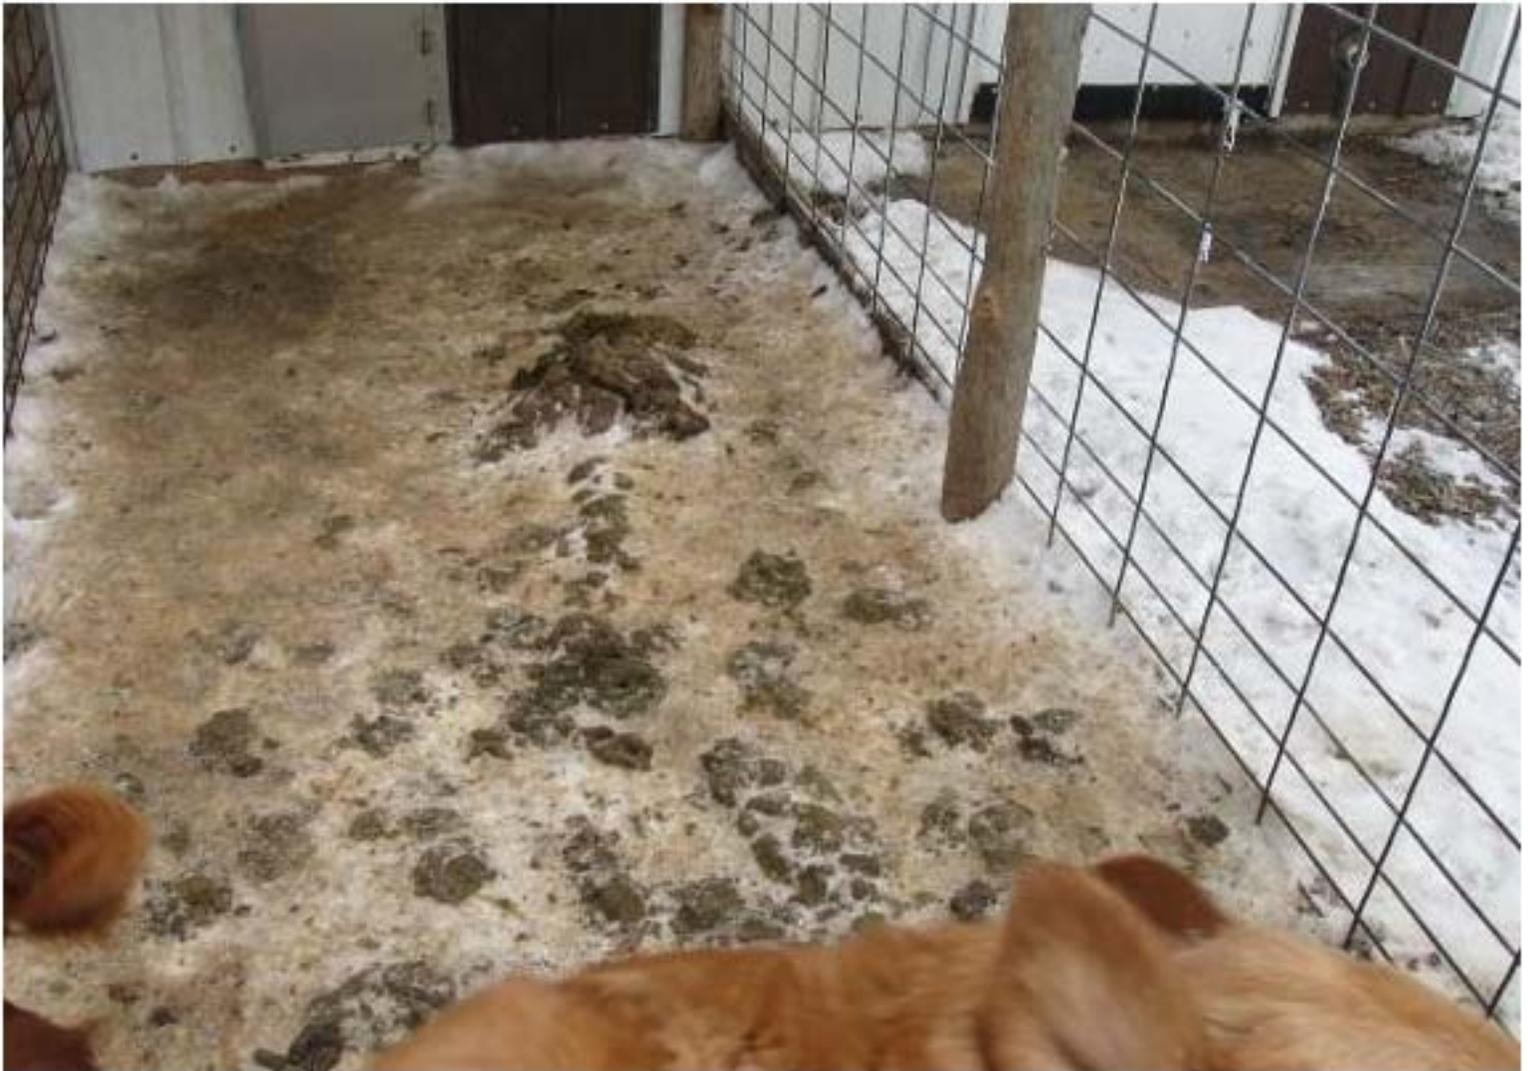
CFR: 3.1 (c) (3)

Photographer:	John J. Lies, ACI	Legal Name:	Registration:	42-A-0895
Photo Taken:	Fri, Jan 28, '11 A.M.	RANDY STOEN		
Inspection:	28110143480200			
Description:	3.1 (c)(3) Housing General Cleaning: Enclosures need to be cleaned to remove snow & Feces.

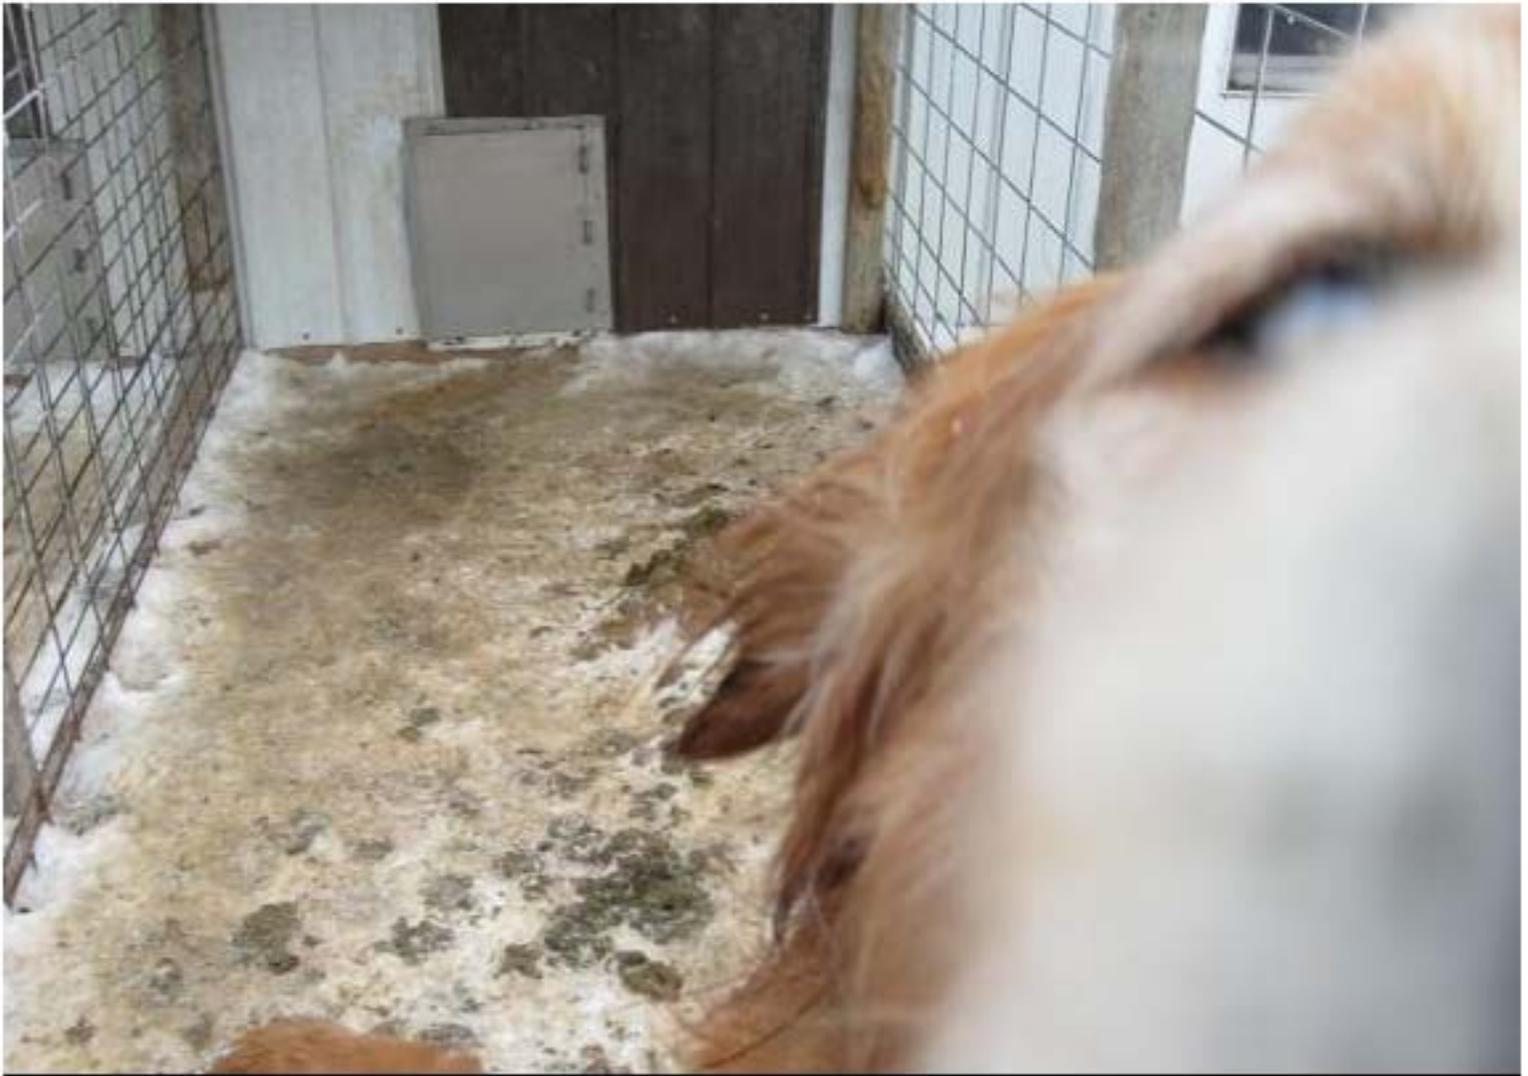
CFR: 3.1 (c) (3)

Photographer:	John J. Lies, ACI	Legal Name:	Registration:	42-A-0895
Photo Taken:	Fri, Jan 28, '11 A.M.	RANDY STOEN		
Inspection:	28110143480200			
Description:	3.1 (c)(3) Housing General Cleaning: Enclosures need to be cleaned to remove snow & Feces.

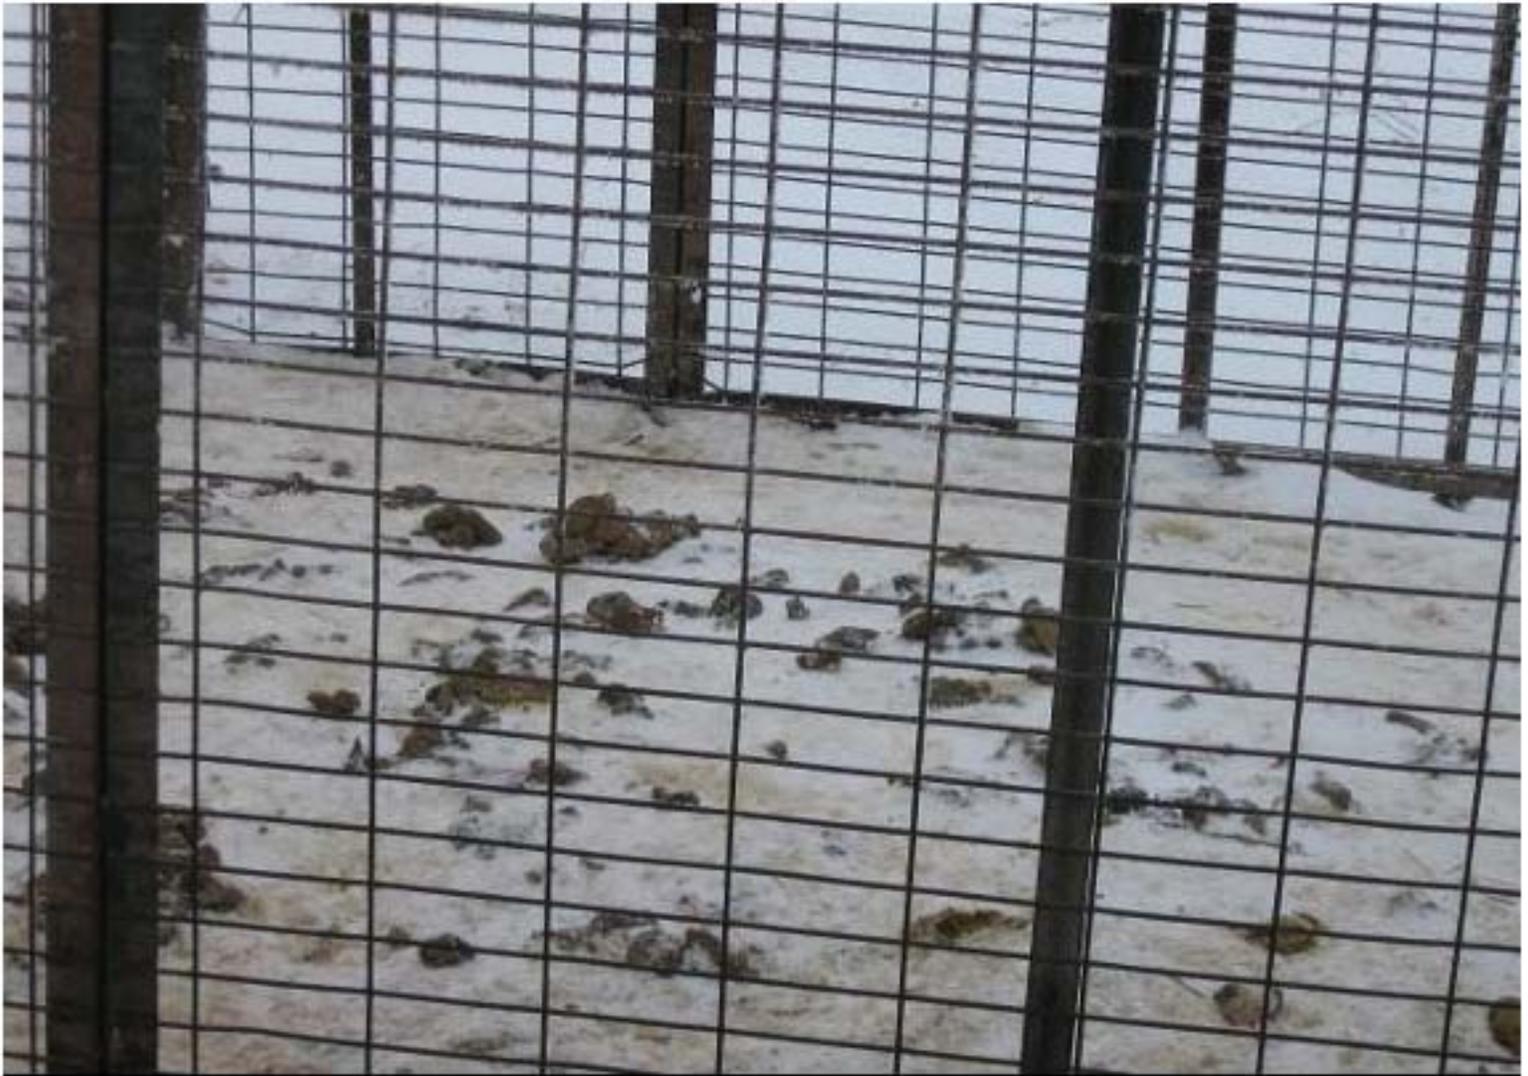
CFR: 3.1 (c) (3)

Photographer:	John J. Lies, ACI	Legal Name:	Registration:	42-A-0895
Photo Taken:	Fri, Jan 28, '11 A.M.	RANDY STOEN		
Inspection:	28110143480200			
Description:	3.1 (c)(3) Housing General Cleaning: Enclosures need to be cleaned to remove snow & Feces.

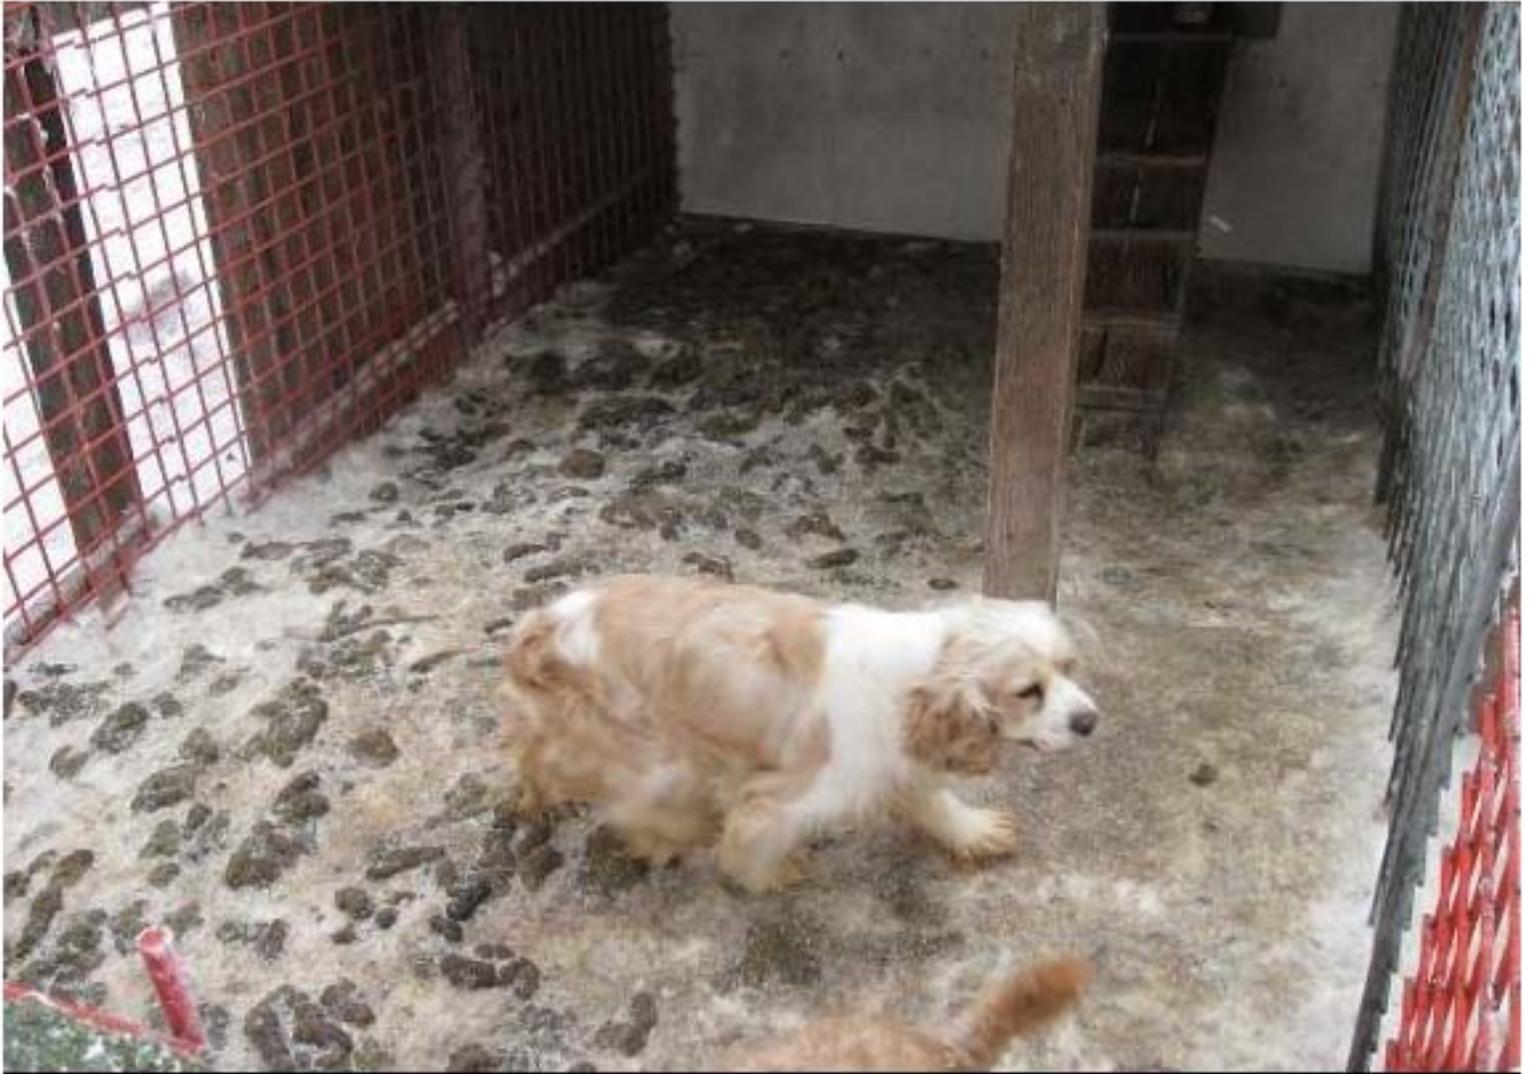
CFR: 3.1 (c) (3)

Photographer:	John J. Lies, ACI	Legal Name:	Registration:	42-A-0895
Photo Taken:	Fri, Jan 28, '11 A.M.	RANDY STOEN		
Inspection:	28110143480200			
Description:	3.1 (c)(3) Housing General Cleaning: The enclosures need to be cleaned to remove snow and feces.

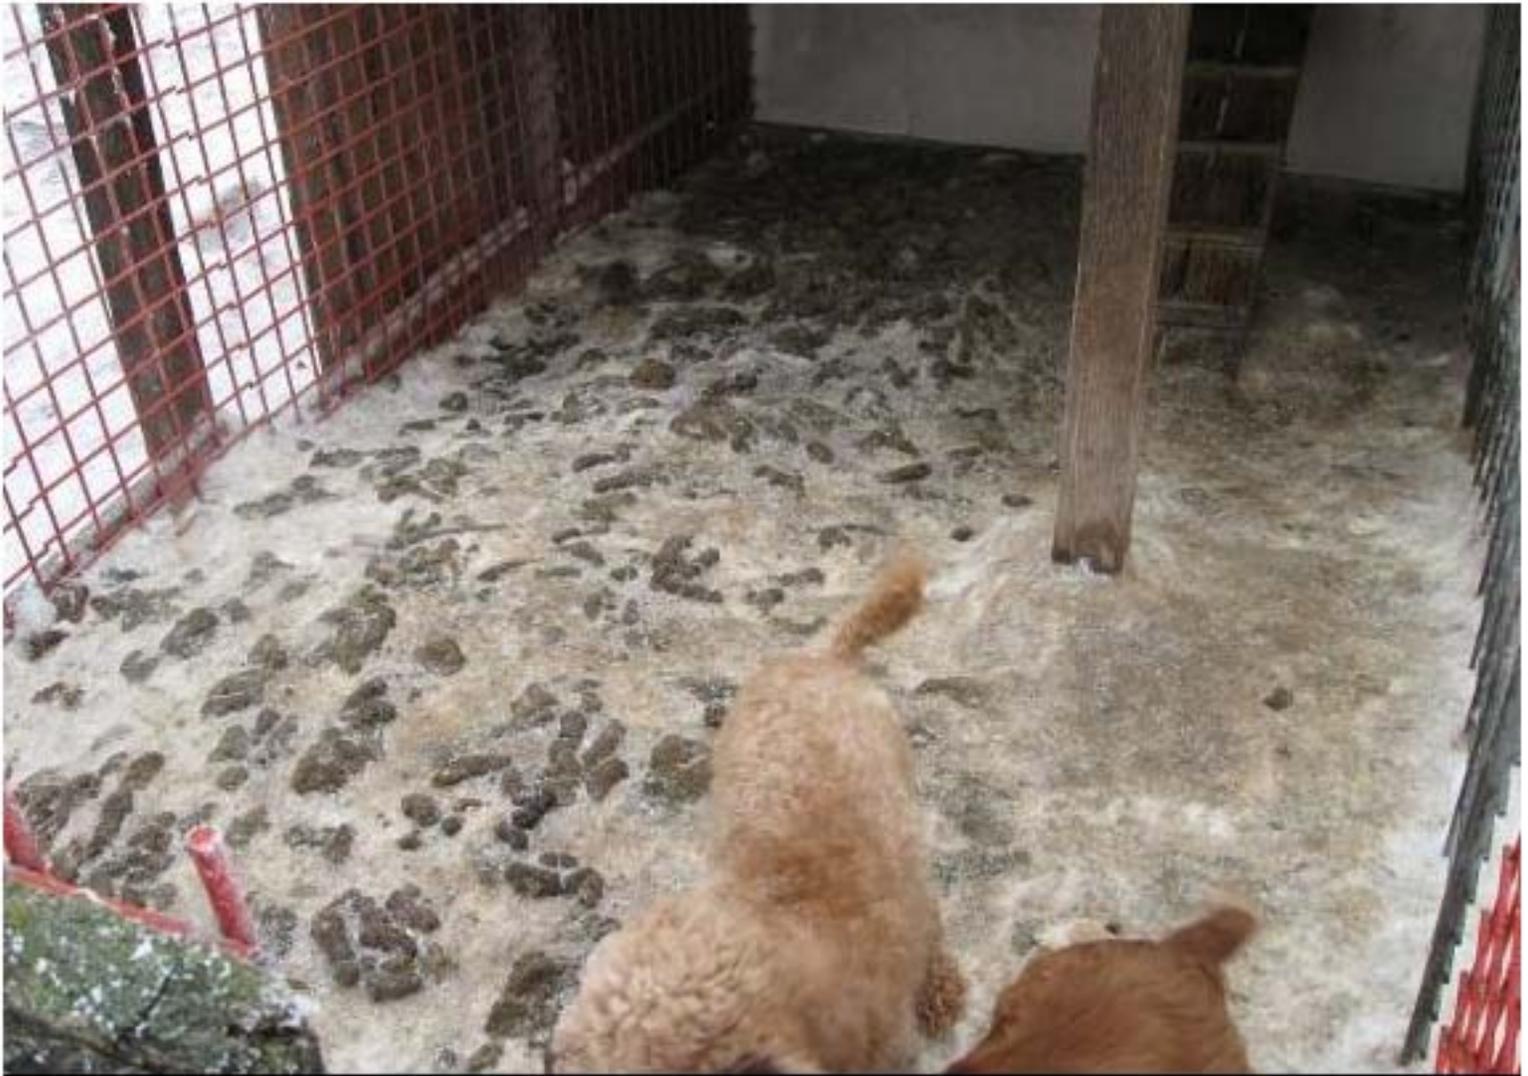
CFR: 3.1 (c) (3)

Photographer:	John J. Lies, ACI	Legal Name:	Registration:	42-A-0895
Photo Taken:	Fri, Jan 28, '11 A.M.	RANDY STOEN		
Inspection:	28110143480200			
Description:	3.1 (c)(3) Housing General Cleaning: The enclosures need to be cleaned to remove snow and feces.

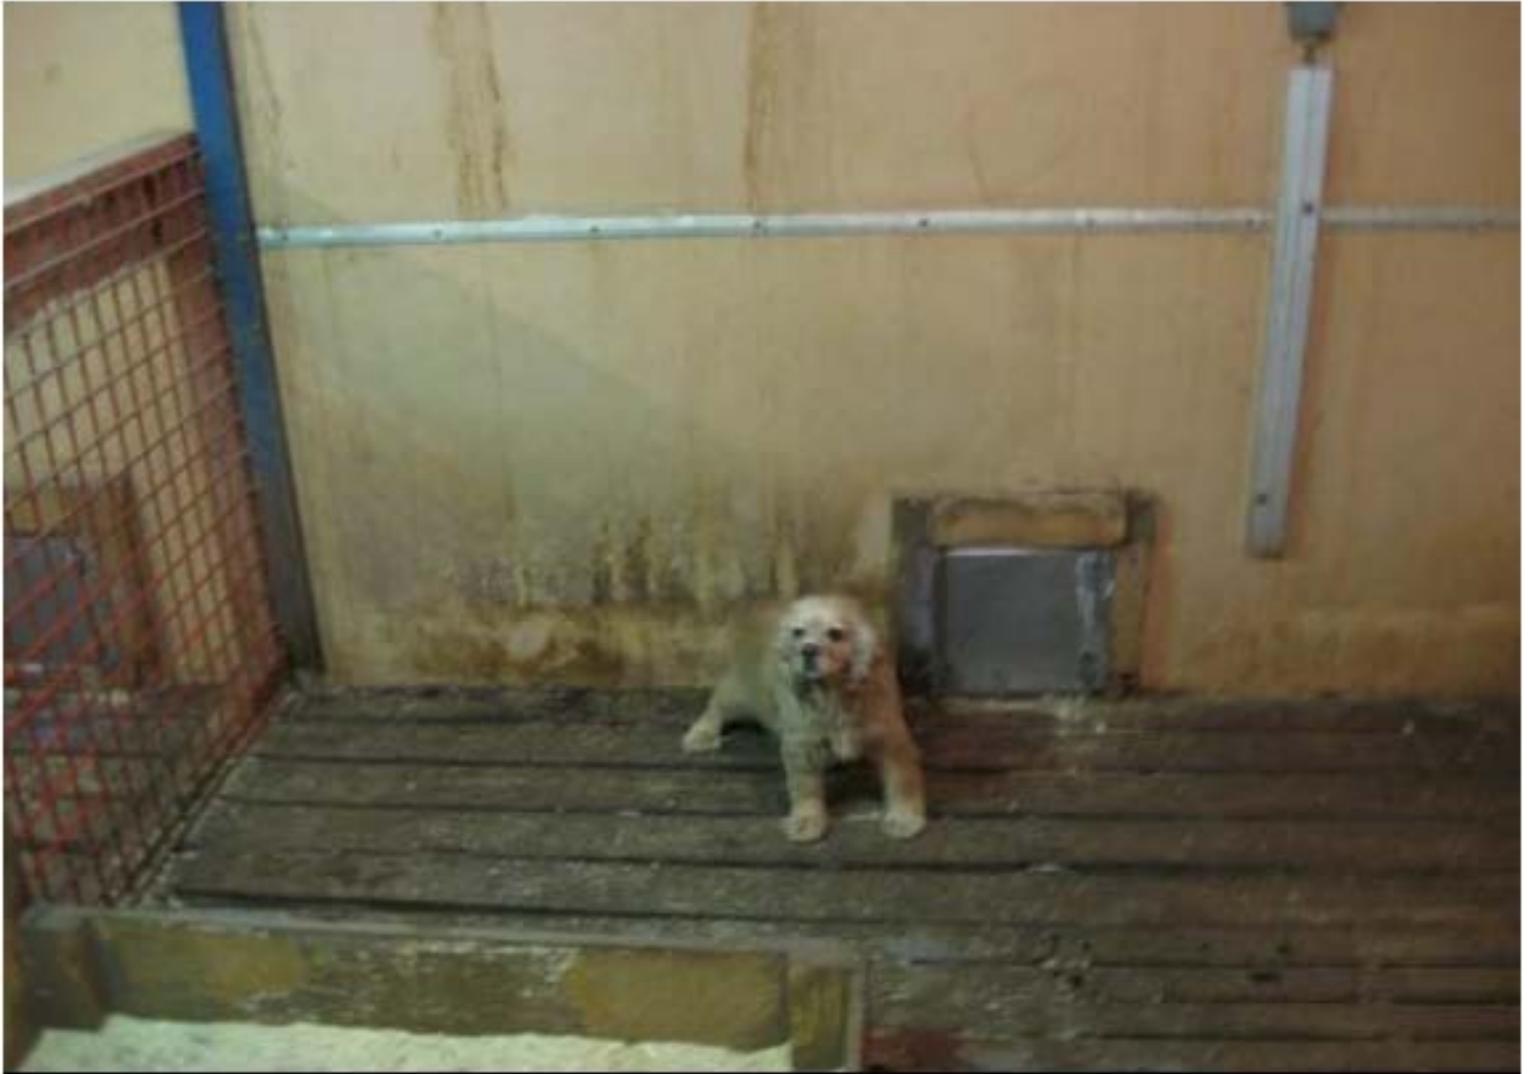
CFR: 3.1 (c) (3)

Photographer:	John J. Lies, ACI	Legal Name:	Registration:	42-A-0895
Photo Taken:	Fri, Jan 28, '11 A.M.	RANDY STOEN		
Inspection:	28110143480200			
Description:	3.1 (c)(3) General Housing Cleaning: Buildup of dirt, hair oils on walls inside of enclosures.

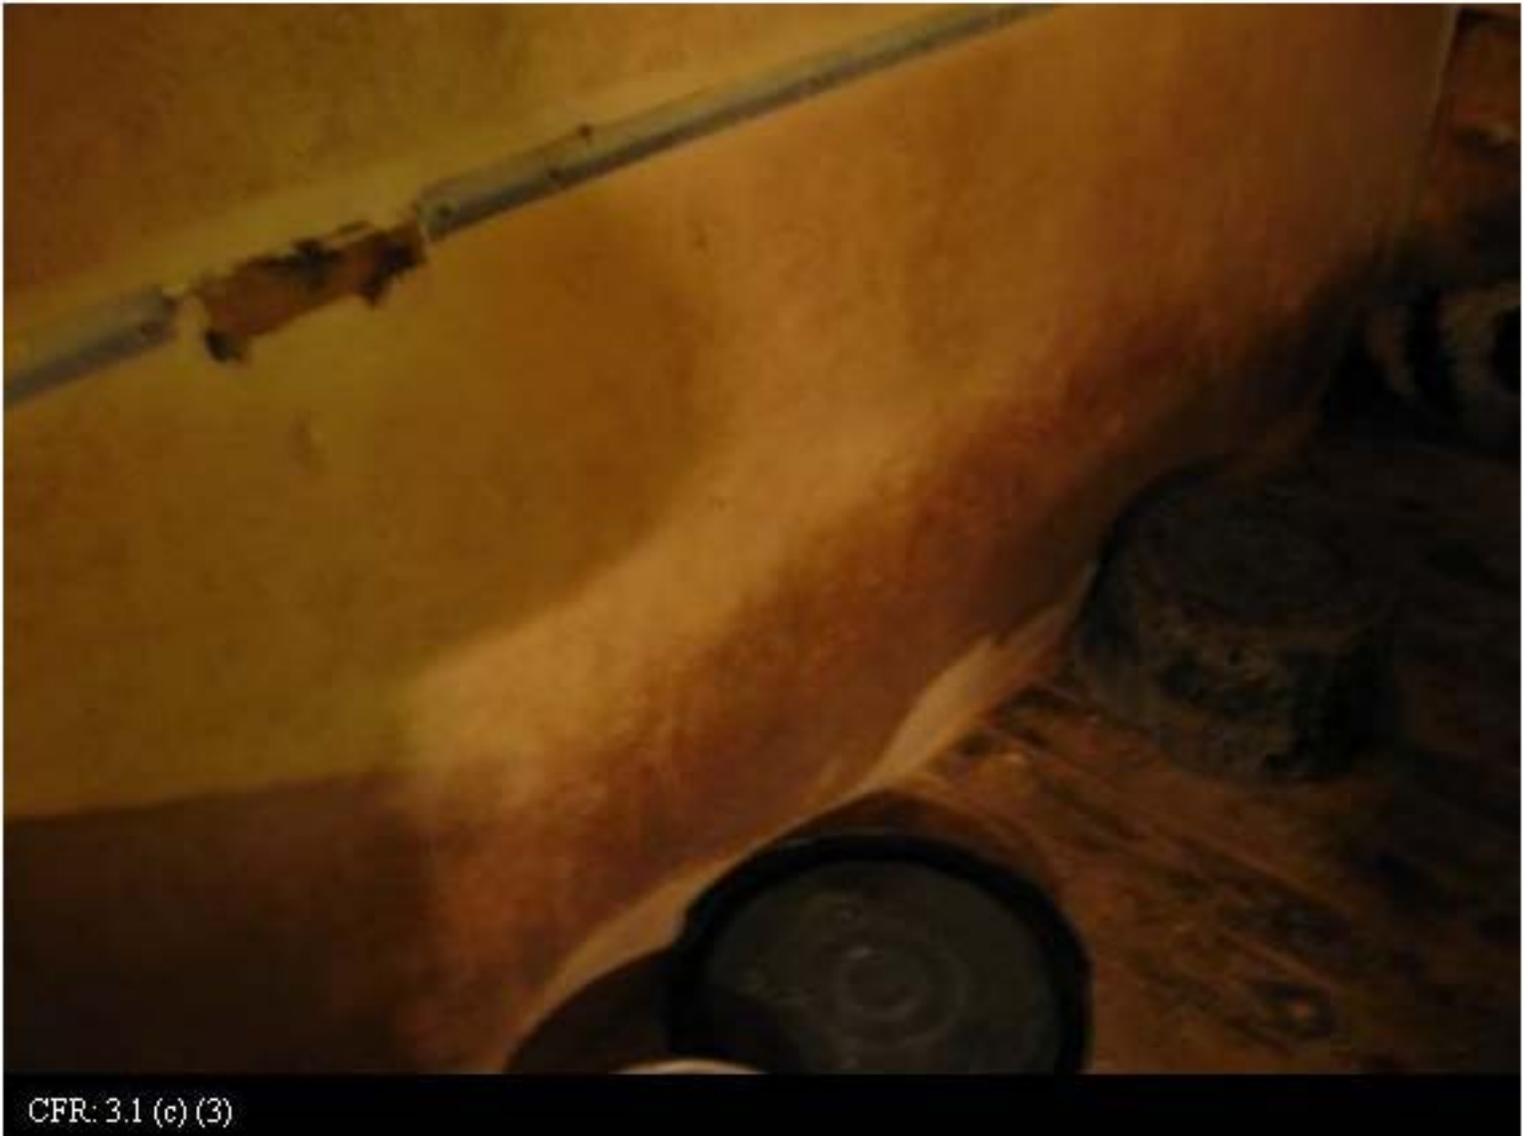
Photographer:	John J. Lies, ACI	Legal Name:	Registration:	42-A-0895
Photo Taken:	Fri, Jan 28, '11 A.M.	RANDY STOEN		
Inspection:	28110143480200			
Description:	3.1 (c)(3) General Housing Cleaning: Buildup of dirt, hair oils on walls inside of enclosures.

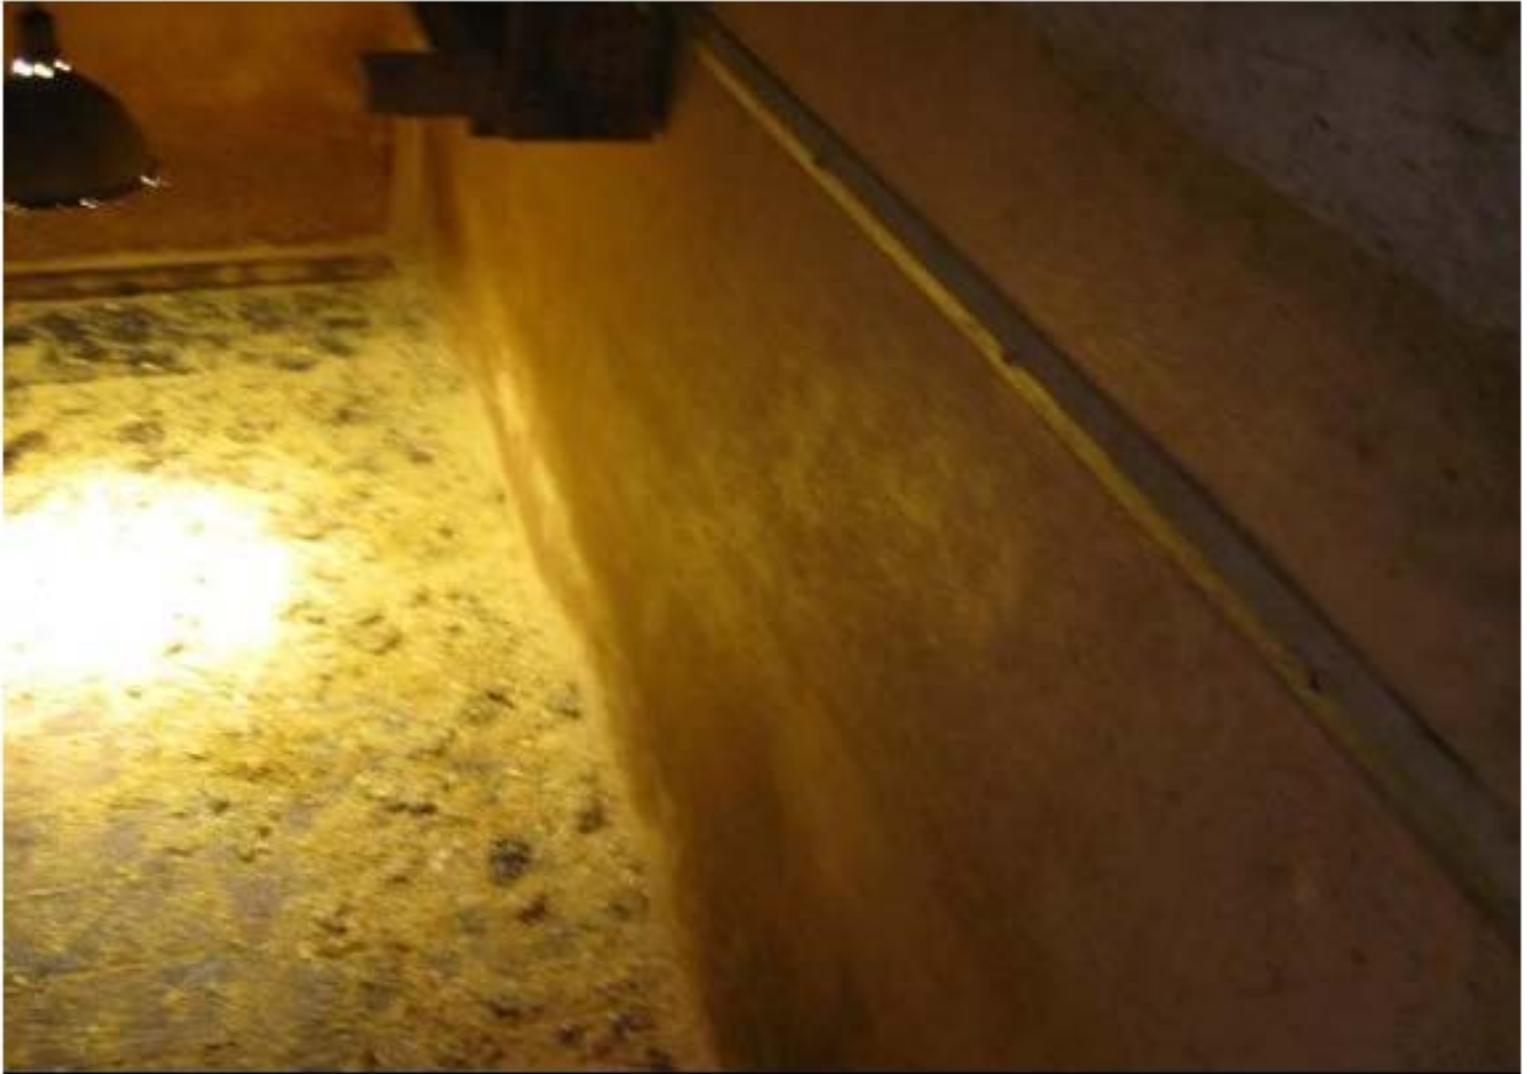
CFR: 3.1 (c) (3)

Photographer:	John J. Lies, ACI	Legal Name:	Registration:	42-A-0895
Photo Taken:	Fri, Jan 28, '11 A.M.	RANDY STOEN		
Inspection:	28110143480200			
Description:	3.1 (c)(3) General Housing Cleaning: Buildup of dirt, hair oils on walls inside of enclosures.

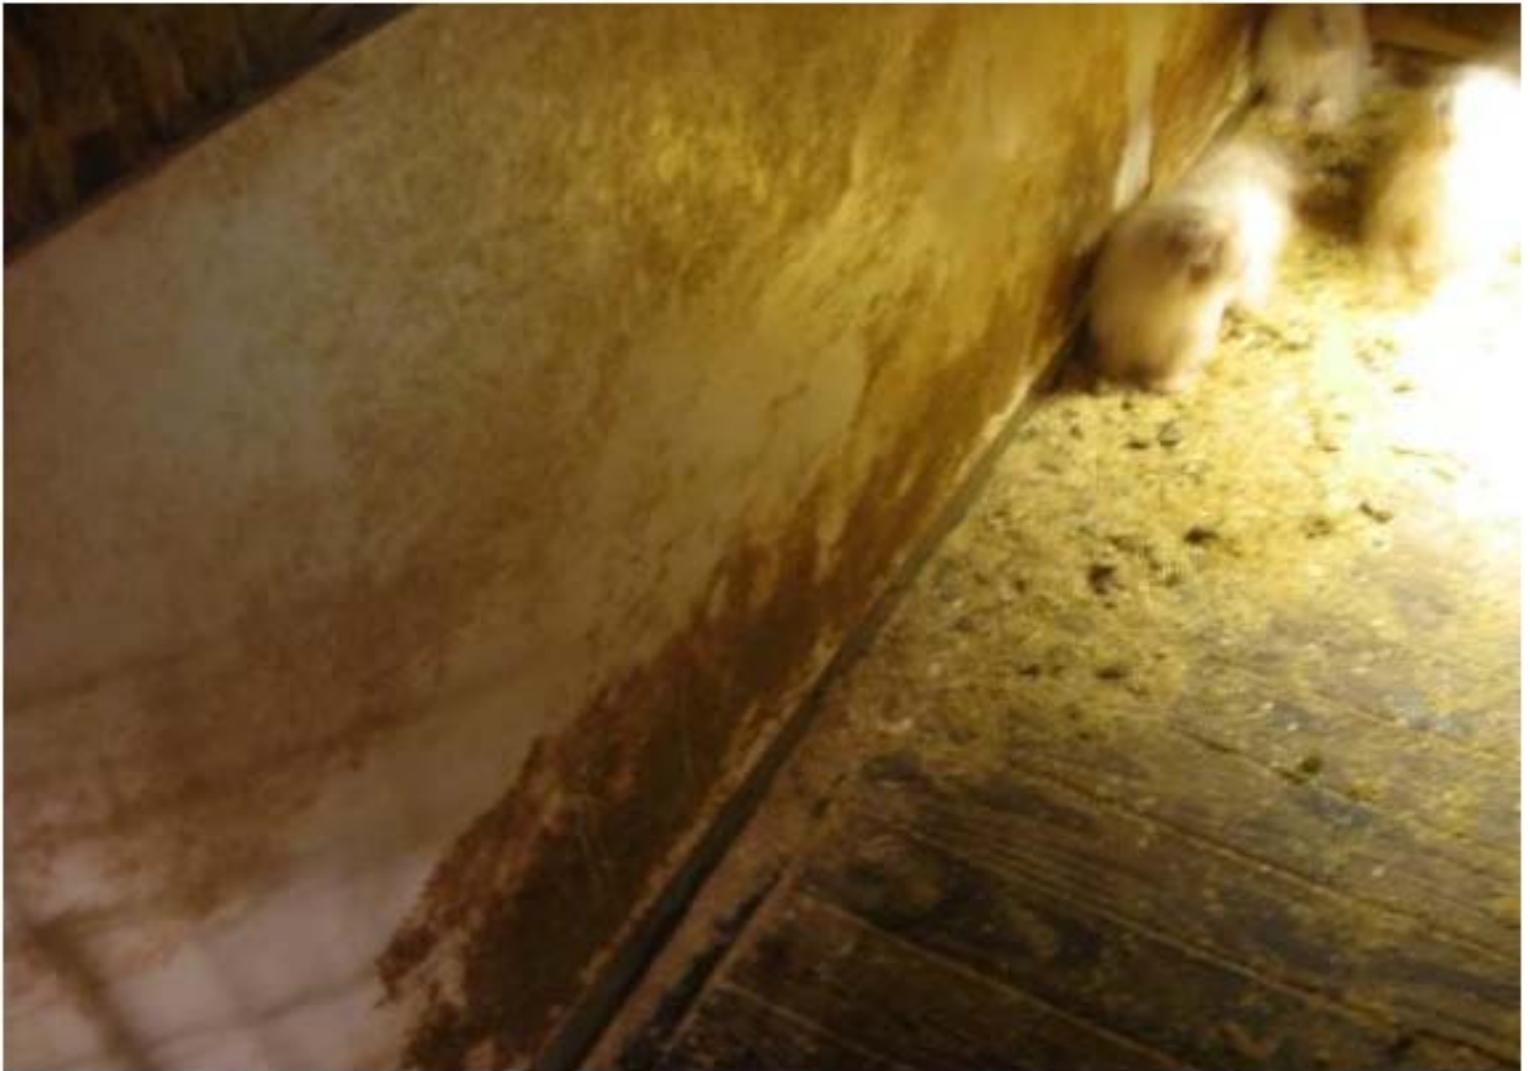
CFR: 3.1 (c) (3)

Photographer:	John J. Lies, ACI	Legal Name:	Registration:	42-A-0895
Photo Taken:	Fri, Jan 28, '11 A.M.	RANDY STOEN		
Inspection:	28110143480200			
Description:	3.1 (c)(3) General Housing Cleaning: Buildup of dirt, hair oils on walls inside of enclosures.

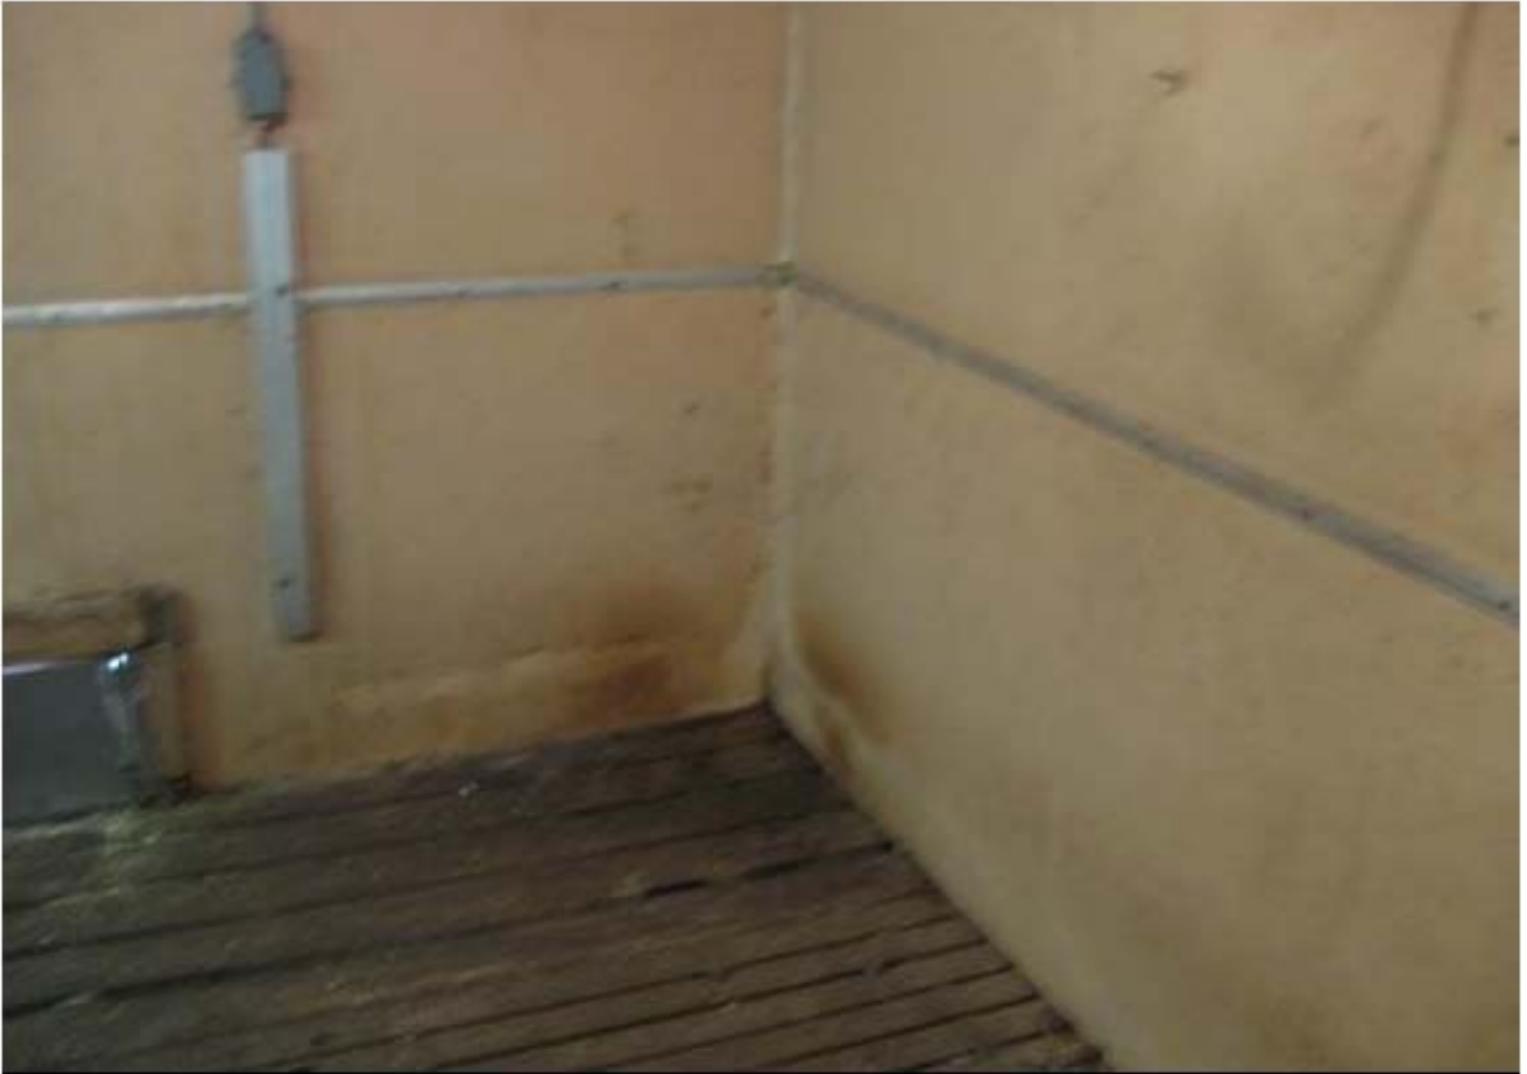
CFR: 3.1 (c) (3)

Photographer:	John J. Lies, ACI	Legal Name:	Registration:	42-A-0895
Photo Taken:	Fri, Jan 28, '11 A.M.	RANDY STOEN		
Inspection:	28110143480200			
Description:	3.1 (c)(3) General Housing Cleaning: Buildup of dirt, hair oils on walls inside of enclosures.

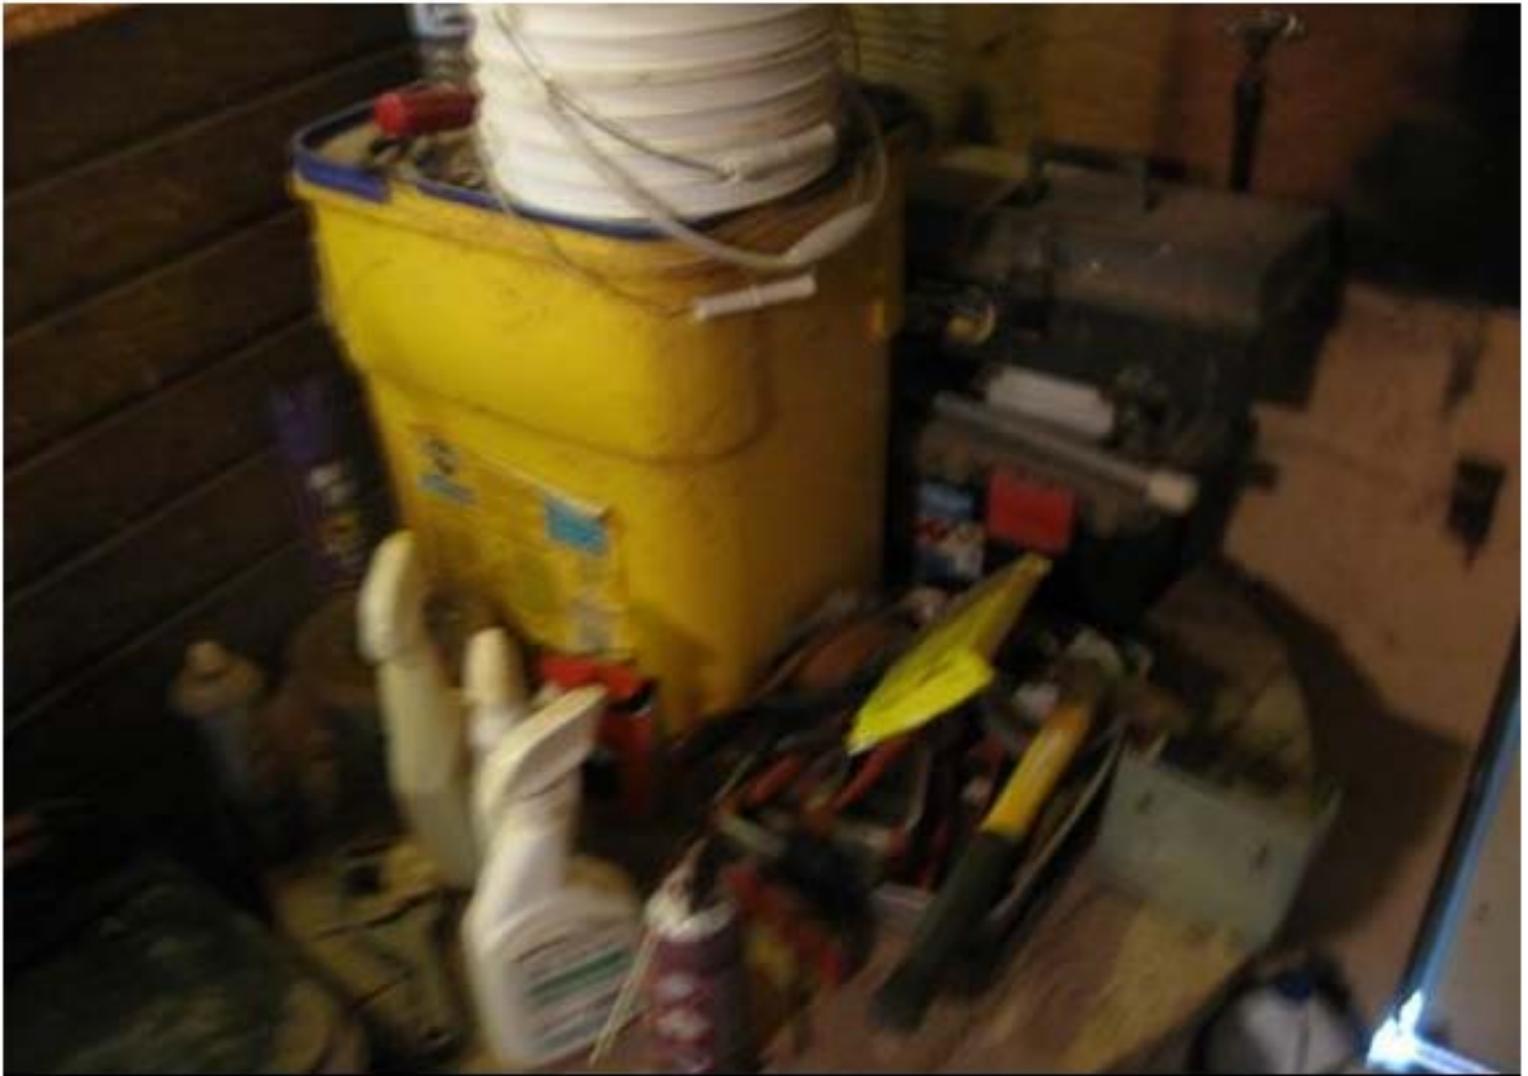
CFR: 3.11 (c)

Photographer:	John J. Lies, ACI	Legal Name:	Registration:	42-A-0895
Photo Taken:	Fri, Jan 28, '11 A.M.	RANDY STOEN		
Inspection:	28110143480200			
Description:	3.1 (c)(3) General Housing Cleaning: Buildup of dirt, hair oils on walls inside of enclosures.3.11 (c) Housekeeping, dirt, hair, spider webs and clutter needs to be removed.			FOIA11-282000570

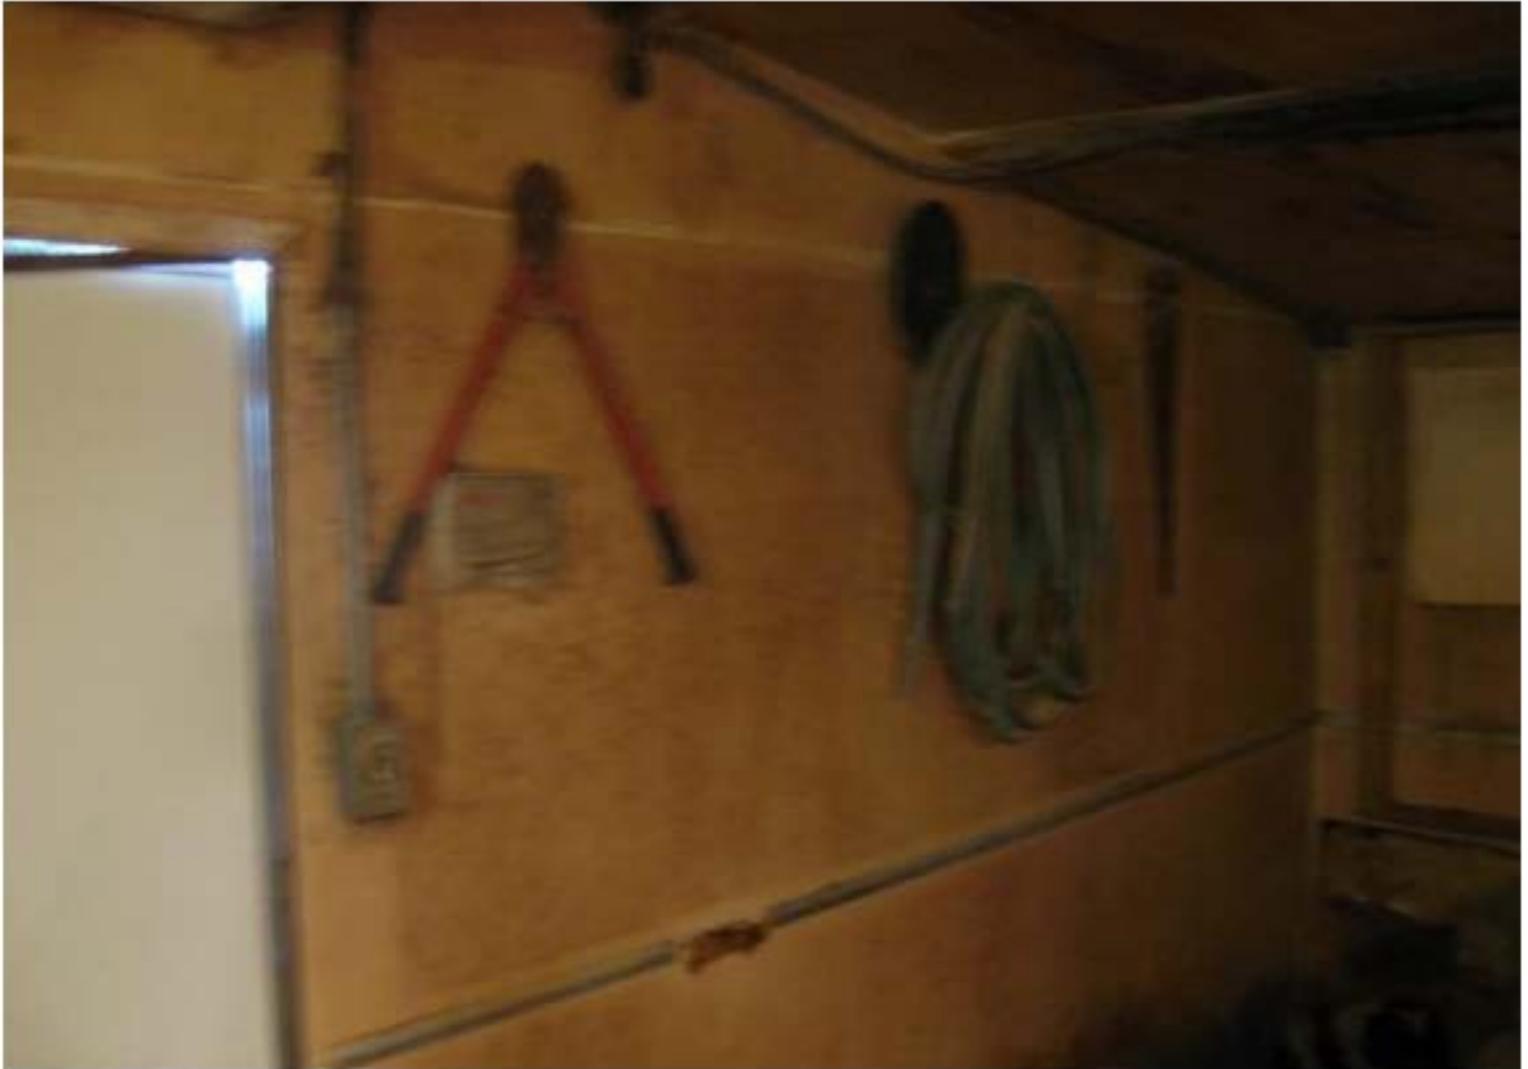
CFR: 3.11 (c)

Photographer:	John J. Lies, ACI	Legal Name:	Registration:	42-A-0895
Photo Taken:	Fri, Jan 28, '11 A.M.	RANDY STOEN		
Inspection:	28110143480200			
Description:	3.1 (c)(3) General Housing Cleaning: Buildup of dirt, hair oils on walls inside of enclosures.3.11 (c) Housekeeping, dirt, hair, spider webs and clutter needs to be removed.
