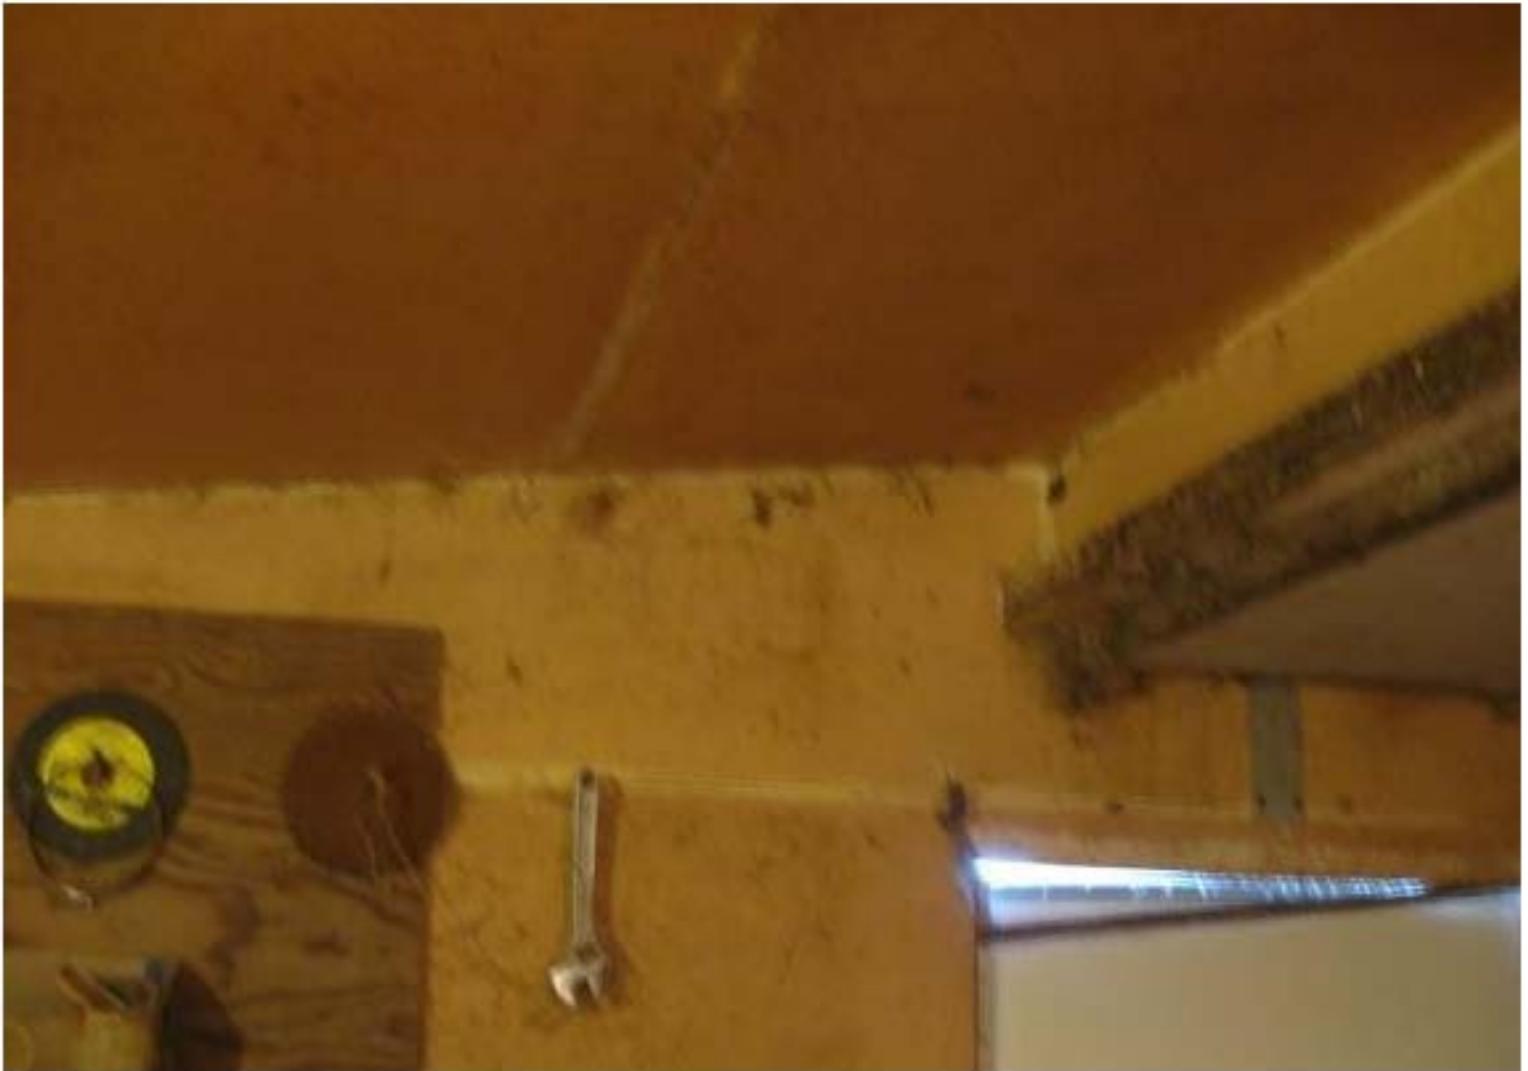
CFR: 3.11 (c)

Photographer:	John J. Lies, ACI	Legal Name:	Registration:	42-A-0895
Photo Taken:	Fri, Jan 28, '11 A.M.	RANDY STOEN		
Inspection:	28110143480200			
Description:	3.1 (c)(3) General Housing Cleaning: Buildup of dirt, hair oils on walls inside of enclosures.3.11 (c) Housekeeping, dirt, hair, spider webs and clutter needs to be removed.			FOIA11-282000572

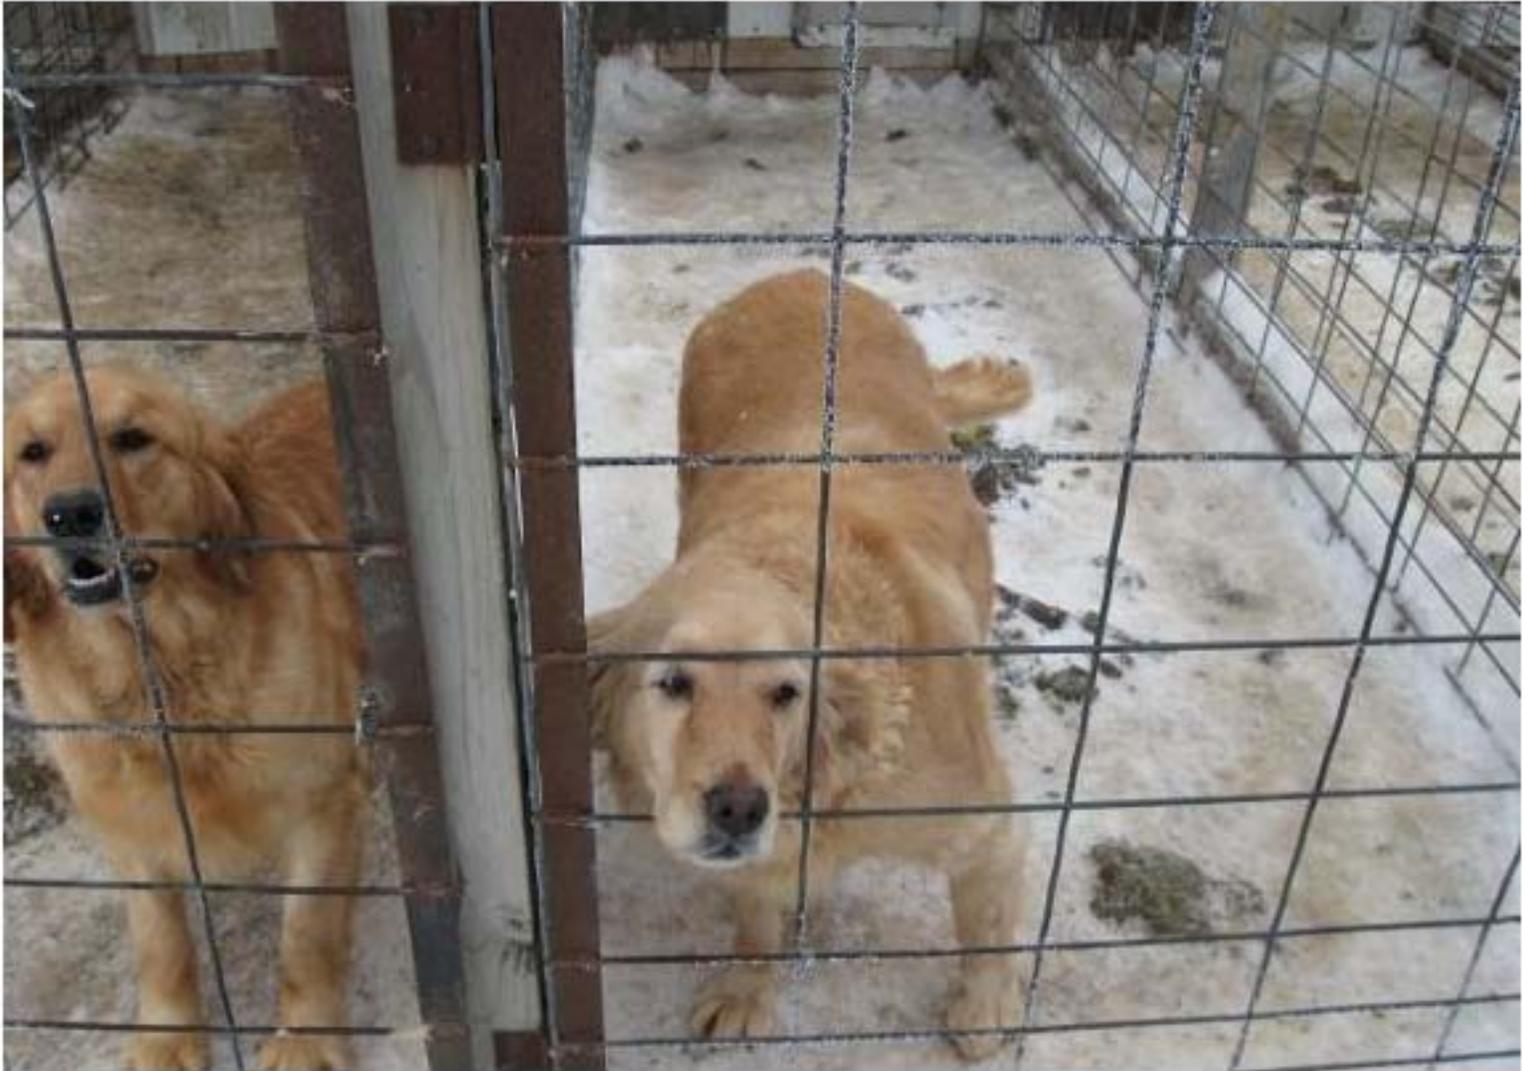
CFR: 3.1 (a), 3.1 (c) (3)

Photographer:	John J. Lies, ACI	Legal Name:	Registration:	42-A-0895
Photo Taken:	Fri, Jan 28, '11 A.M.	RANDY STOEN		
Inspection:	28110143480200			
Description:	3.1 (c)(3) Housing General Cleaning: Enclosures need to be cleaned to remove snow & Feces.3.1 (a) Construction: Cattle panel opening allow the dogs to stick their heads through the openings.

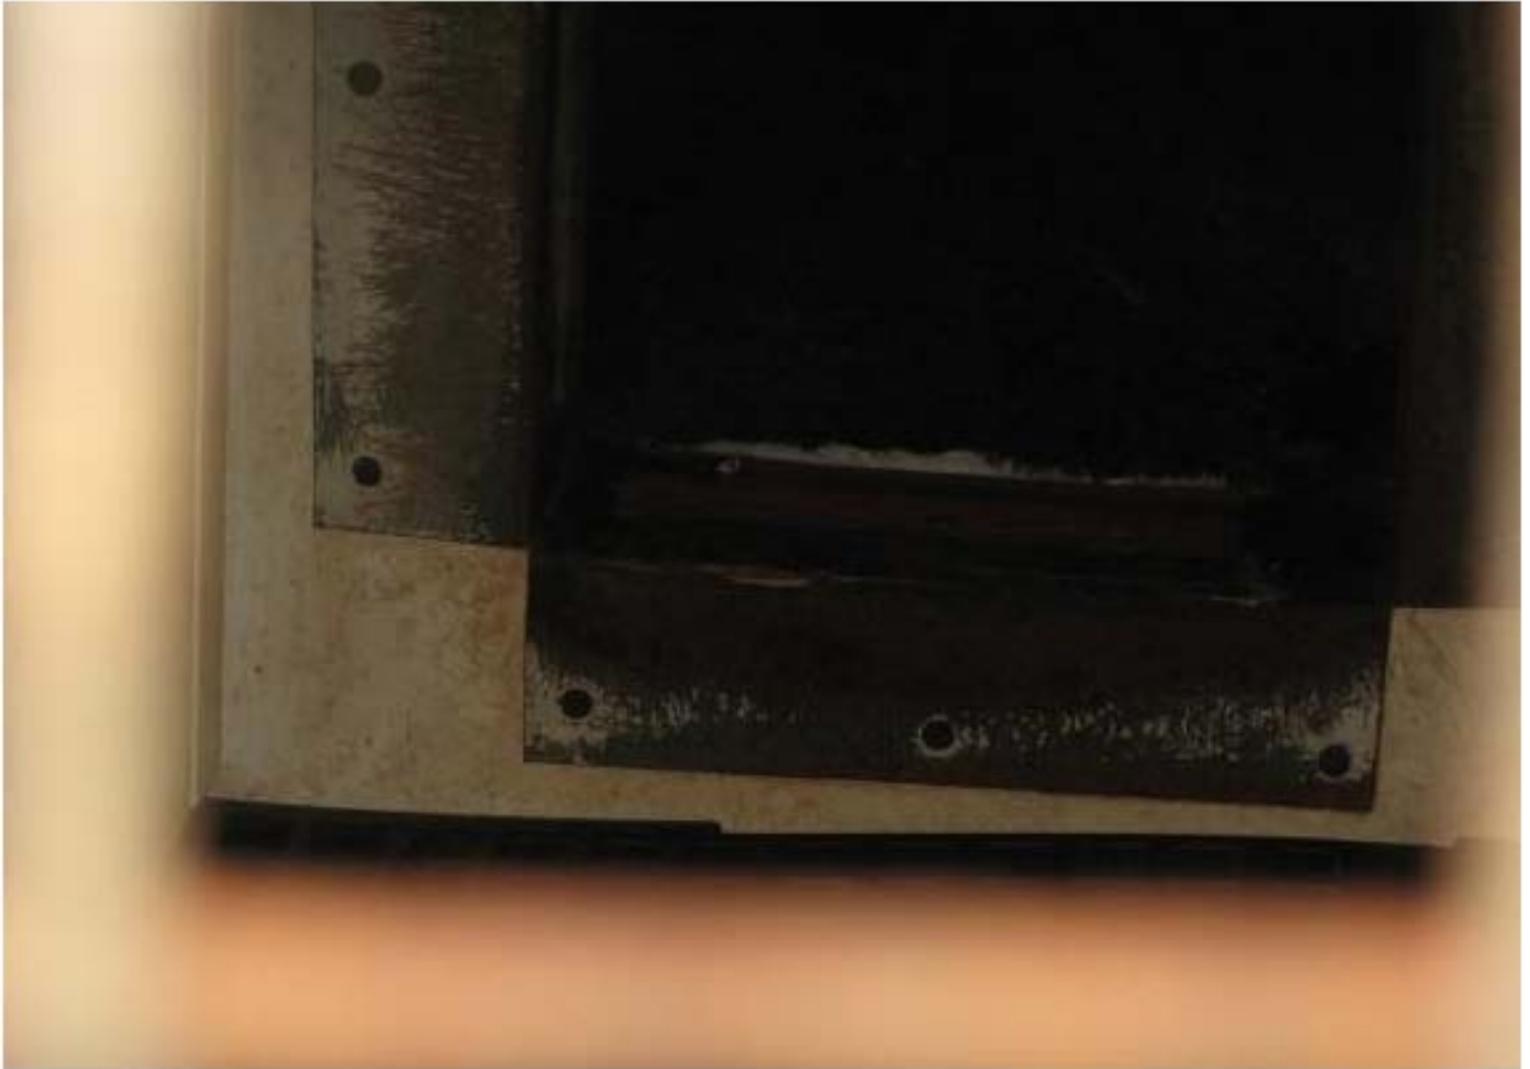
CFR: 3.1 (c) (1) (i)

Photographer:	Randall Wagner (ACI)	Legal Name:	Registration:	42-A-0791
Photo Taken:	Thu, Sep 16, '10	ARIE BYL HELEN BYL		
Inspection:	259101424060729			
Description:	The tin insert surface is excessively rusting and flaking.

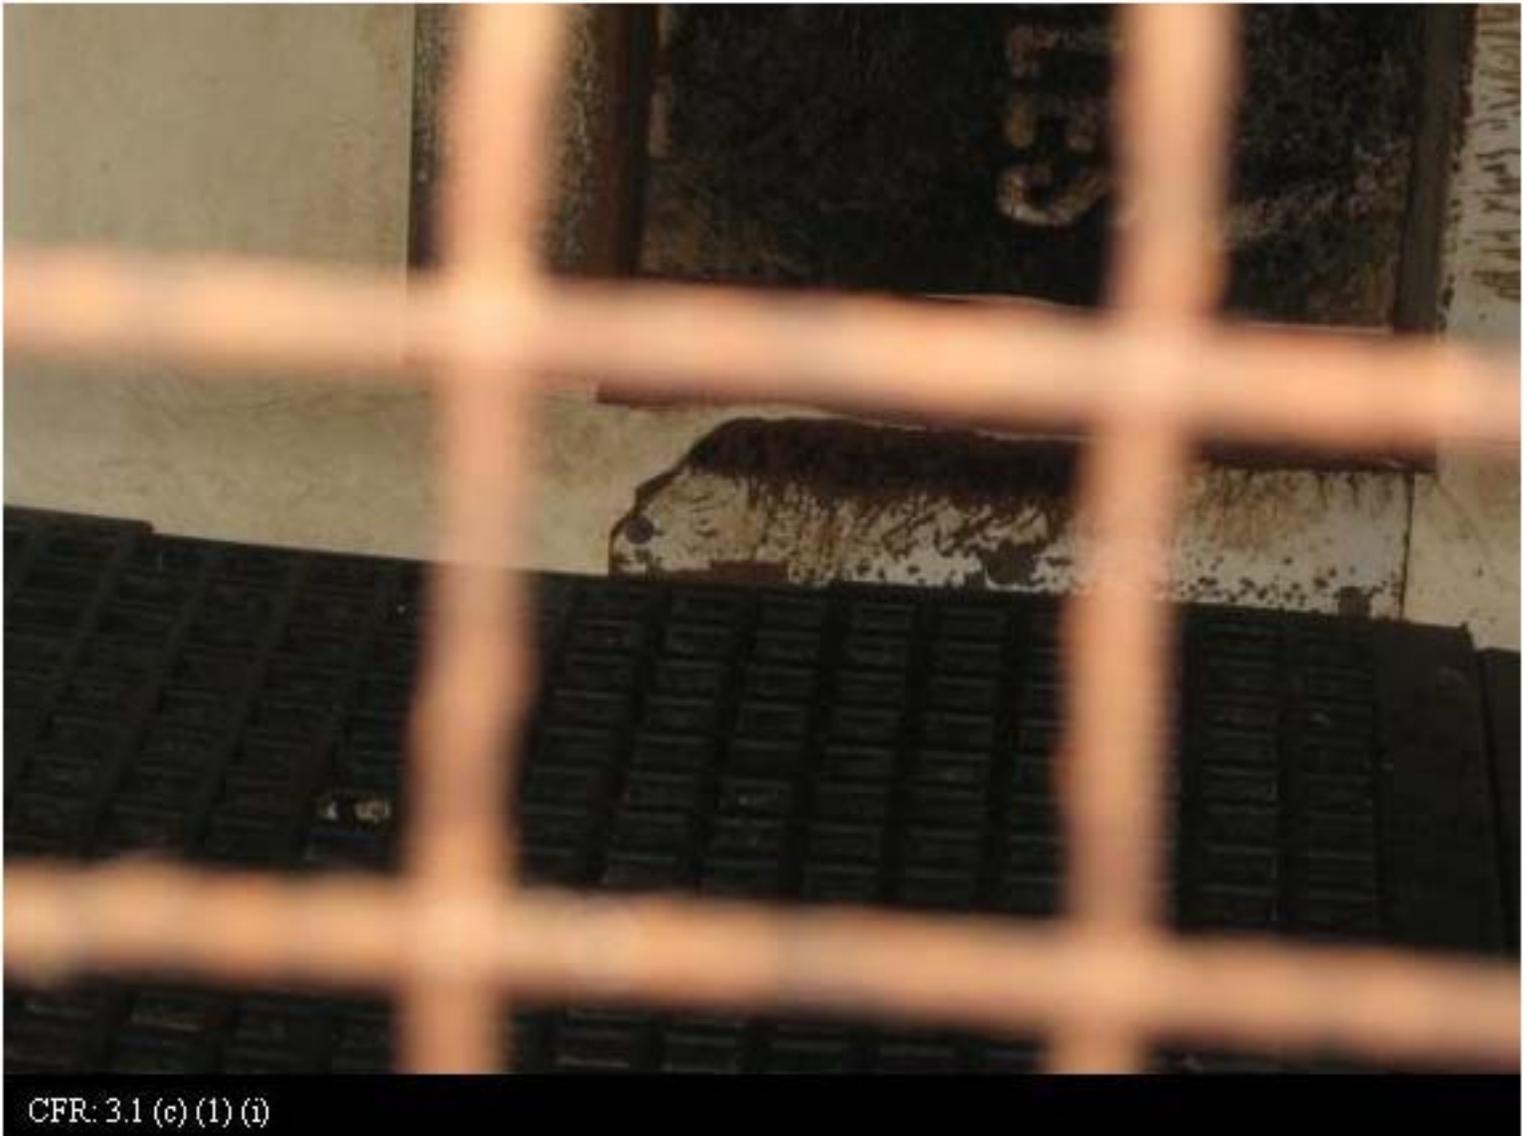
Photographer:	Randall Wagner (ACI)	Legal Name:	Registration:	42-A-0791
Photo Taken:	Thu, Sep 16, '10	ARIE BYL HELEN BYL		
Inspection:	259101424060729			
Description:	The tin insert is excessively rusty and flaking at the surface and rusting apart affecting the structural integrity.

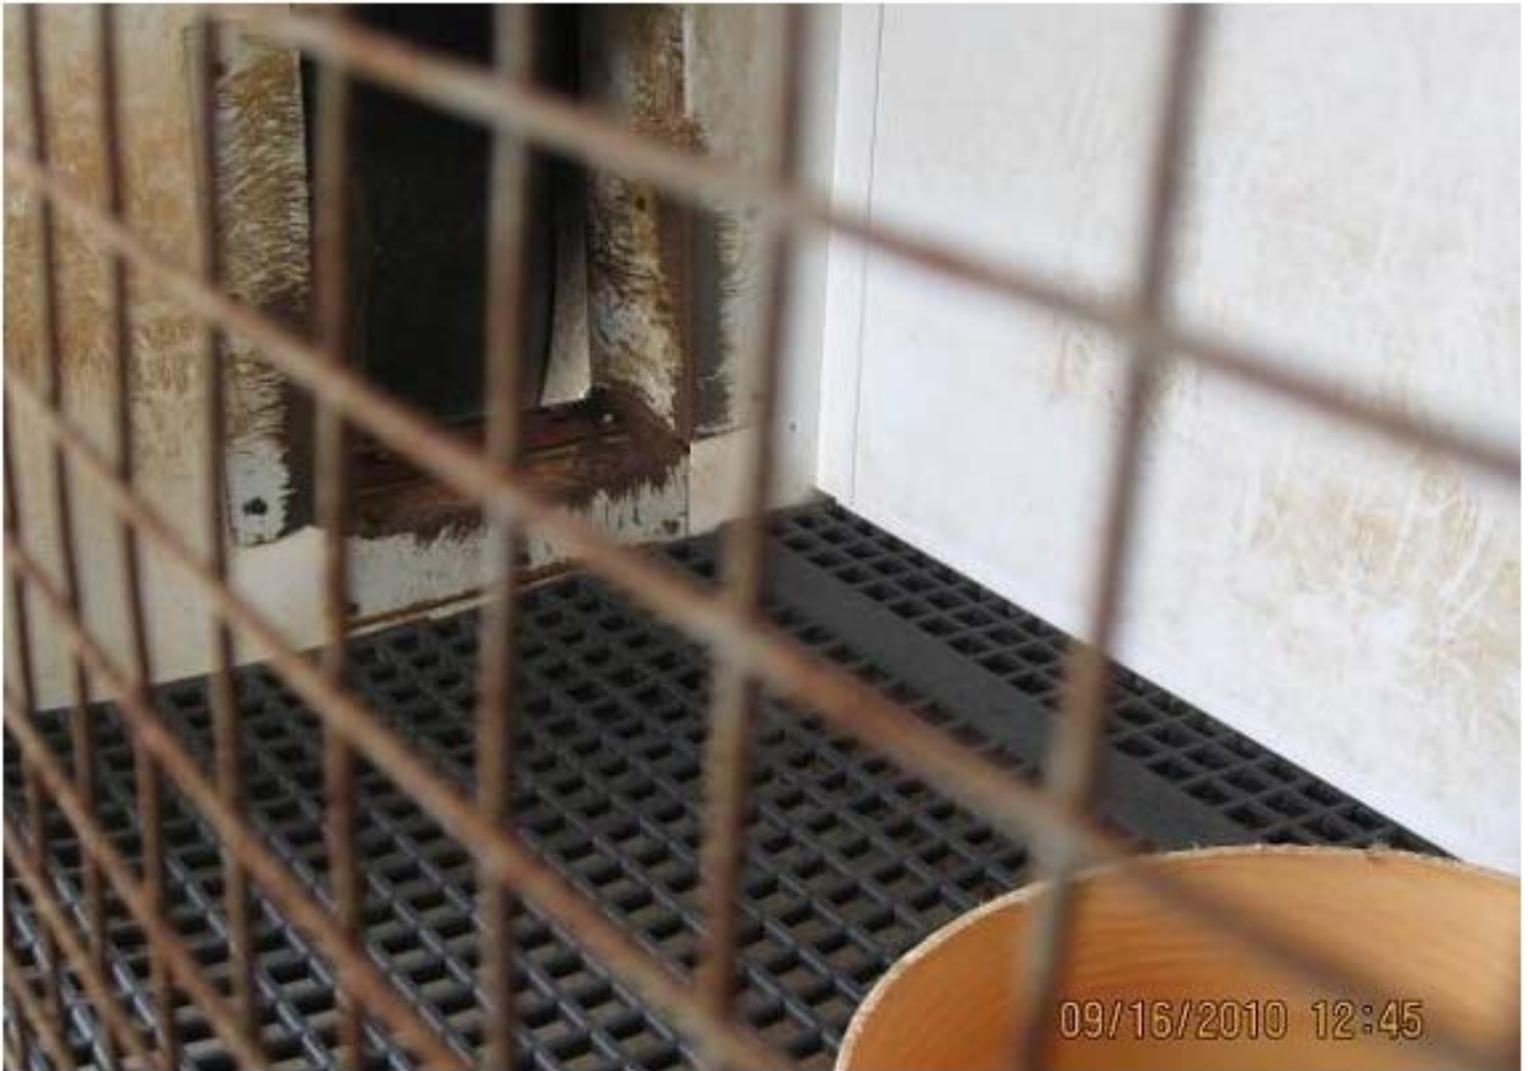
CFR: 3.1 (c) (1) (i)

Photographer:	Randall Wagner (ACI)	Legal Name:	Registration:	42-A-0791
Photo Taken:	Thu, Sep 16, '10	ARIE BYL HELEN BYL		
Inspection:	259101424060729			
Description:	The tin insert has excessive rusting and flaking of the surface.

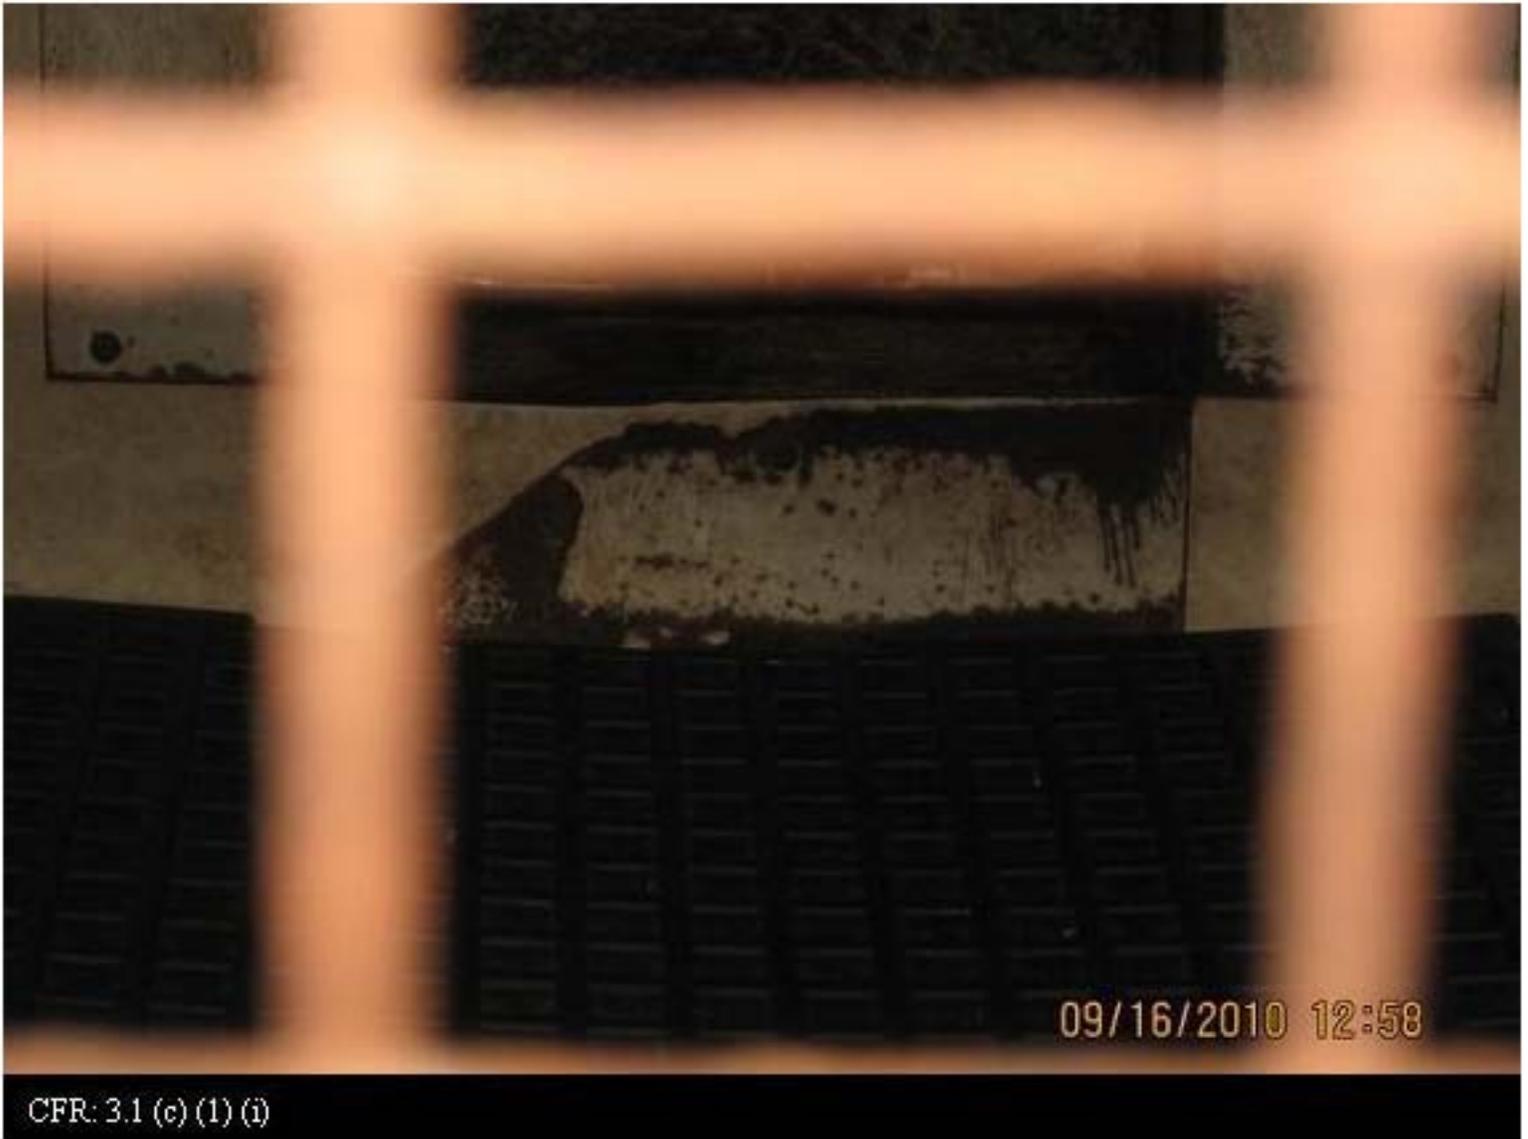
Photographer:	Randall Wagner (ACI)	Legal Name:	Registration:	42-A-0791
Photo Taken:	Thu, Sep 16, '10	ARIE BYL		
Inspection:	259101424060729	HELEN BYL		
Description:	The tin insert is rusted apart at the bottom indicating the structural strength is affected.

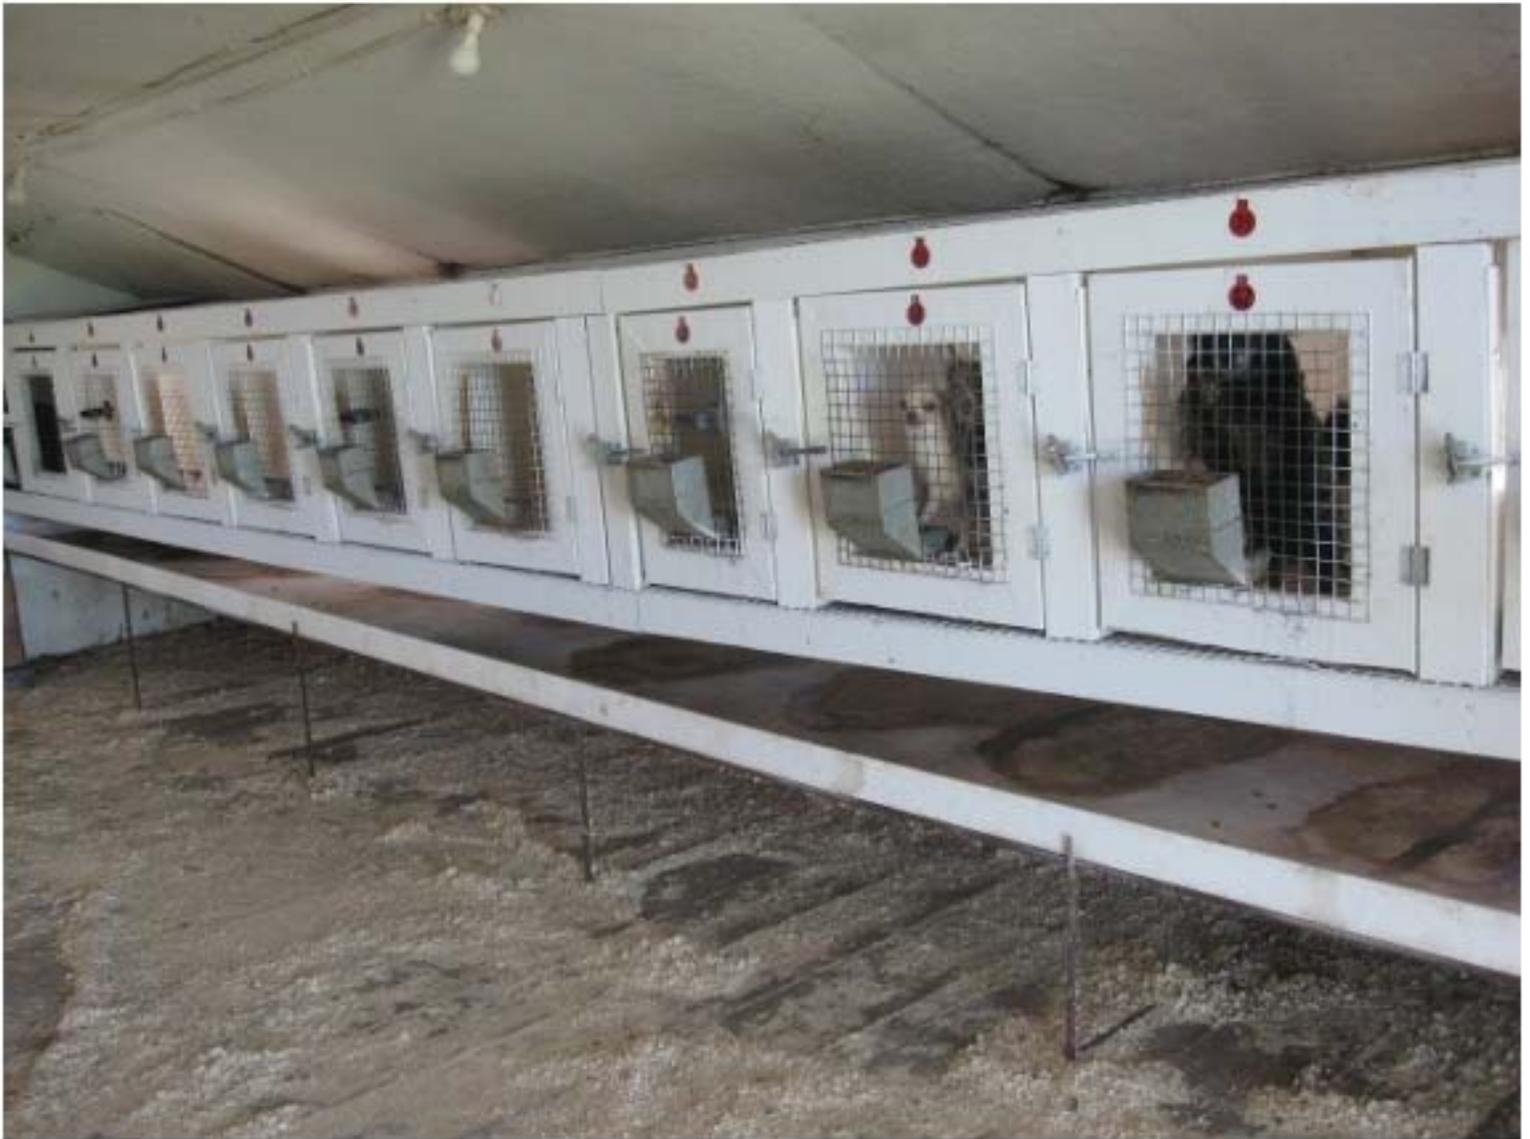
Photographer:	Brenda Pietrosante	Legal Name:	Registration:	42-A-0757
Photo Taken:	Tue, Jun 29, '10	GARY FELTS		
Inspection:	181101035340927			
Description:	Areas under cages is clean and has no accumulation

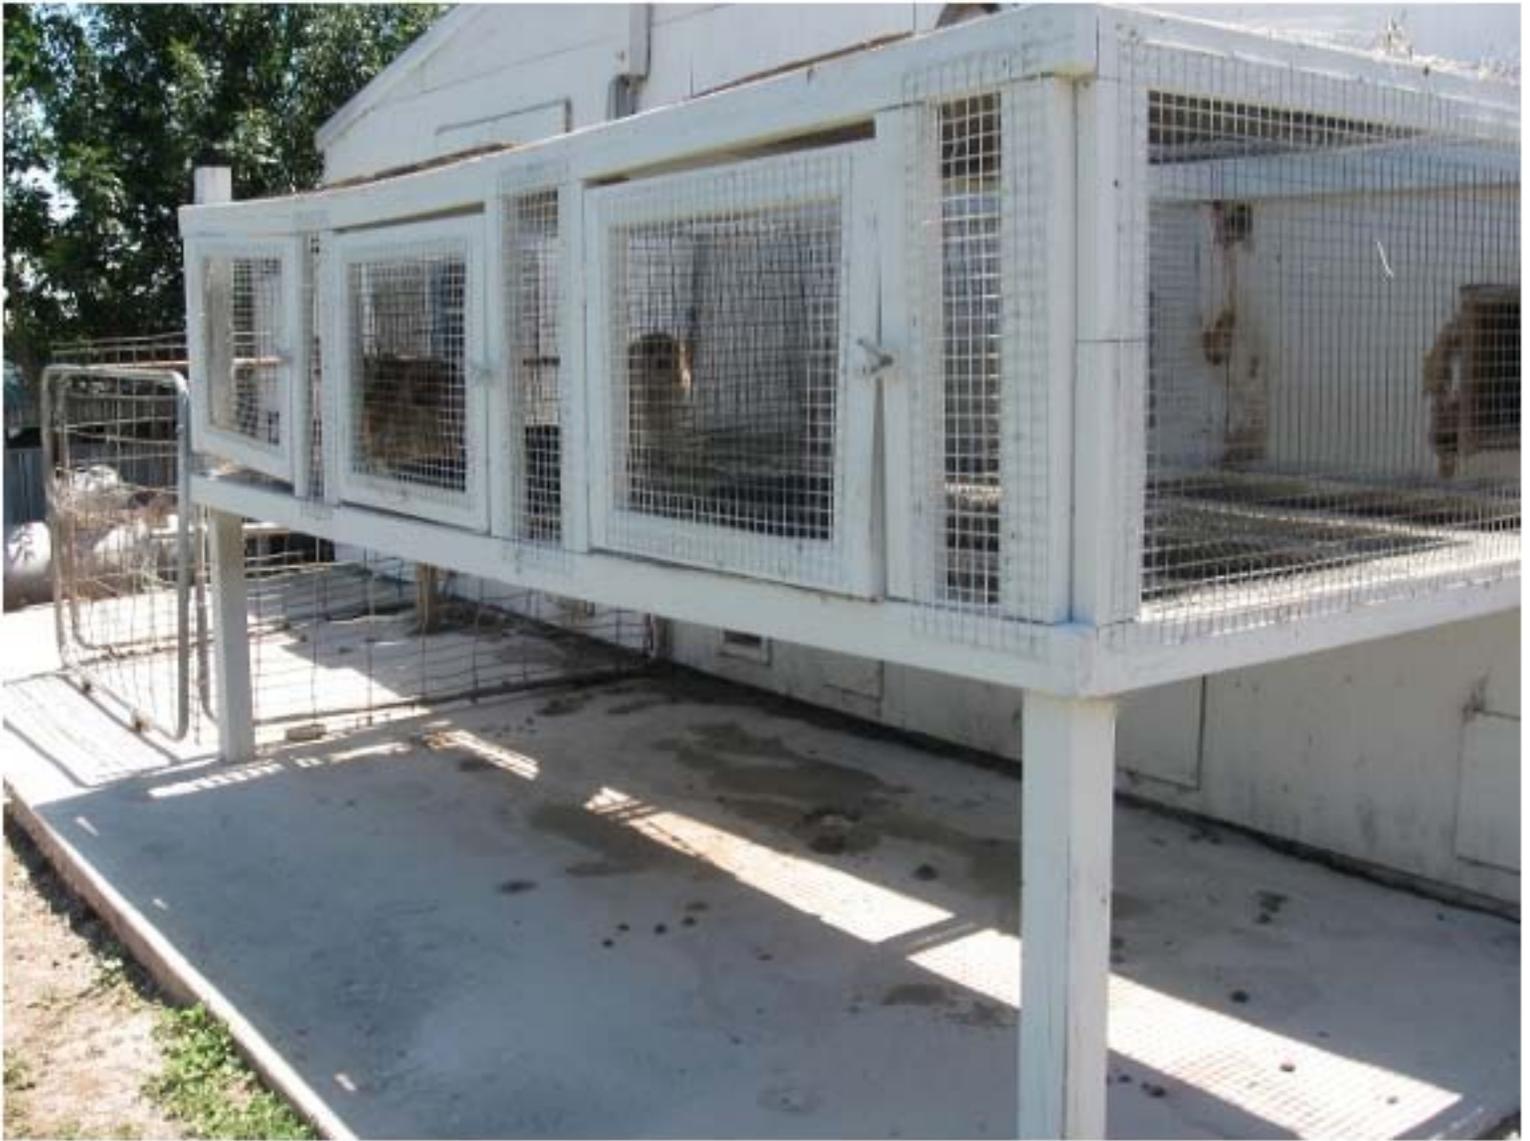
Photographer:	Brenda Pietrosante	Legal Name:	Registration:	42-A-0757
Photo Taken:	Tue, Jun 29, '10	GARY FELTS		
Inspection:	181101035340927			
Description:	Cleaned and painted, pens stabilized.

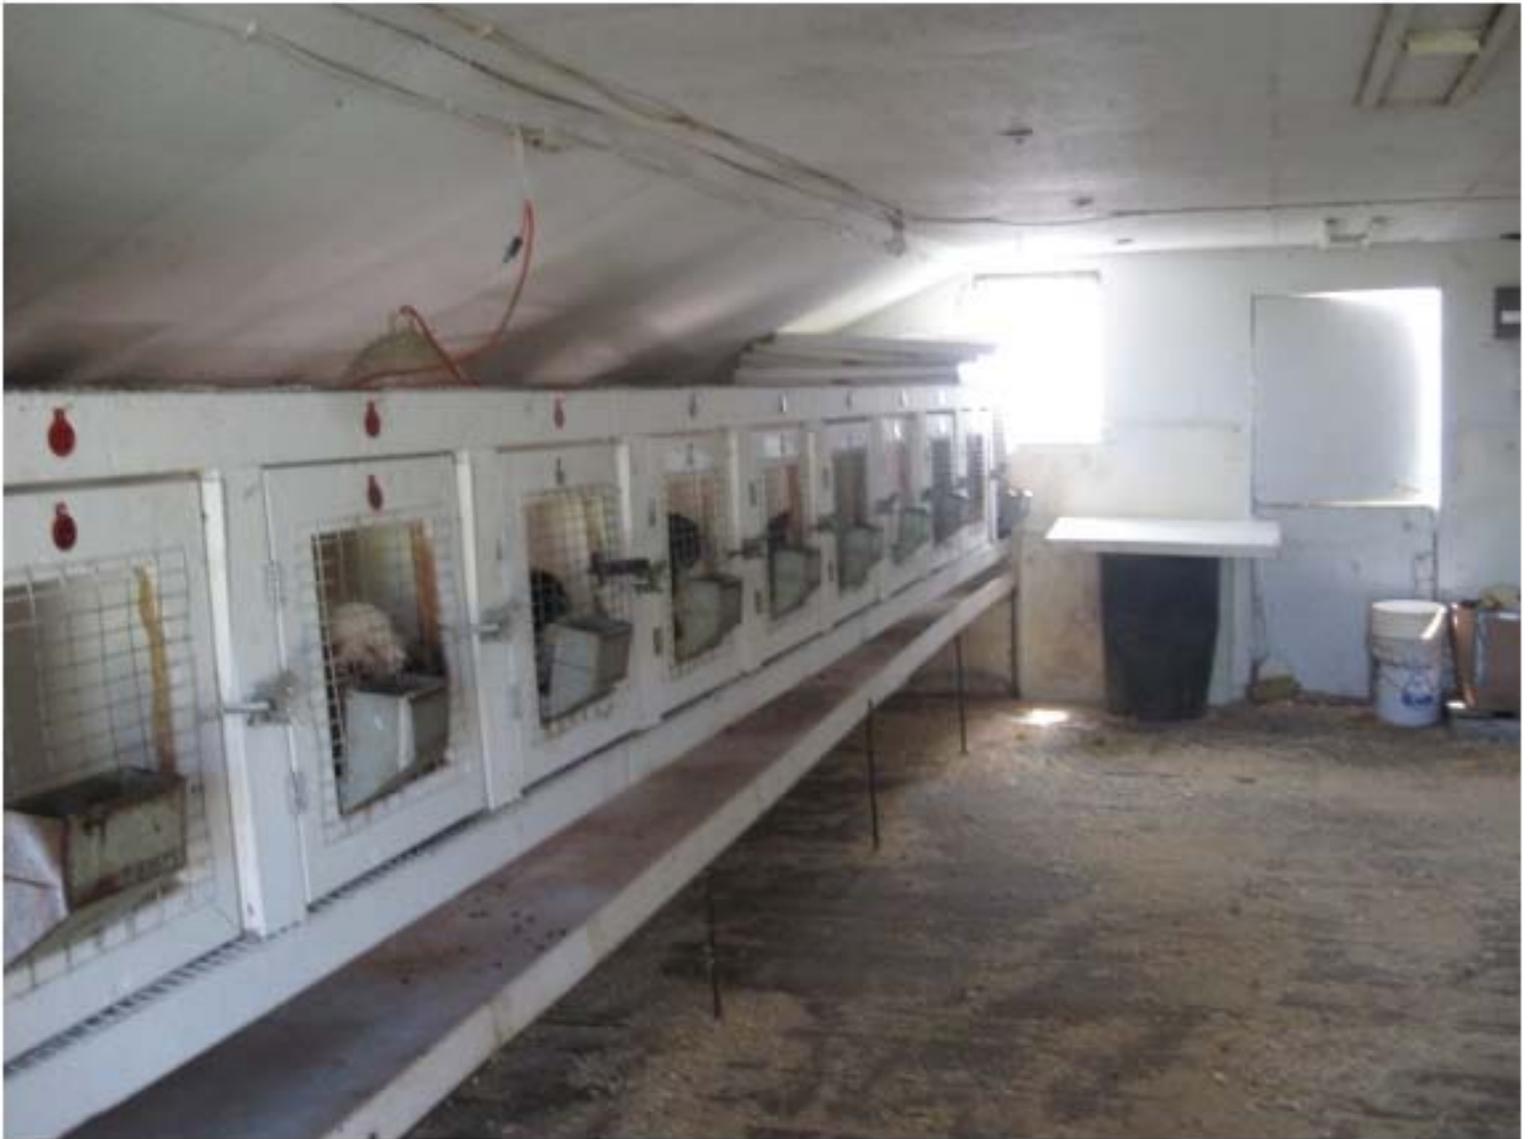
Photographer:	Brenda Pietrosante	Legal Name:	Registration:	42-A-0757
Photo Taken:	Tue, Jun 29, '10	GARY FELTS		
Inspection:	181101035340927			
Description:	Cleaned, painted, with good ventilation

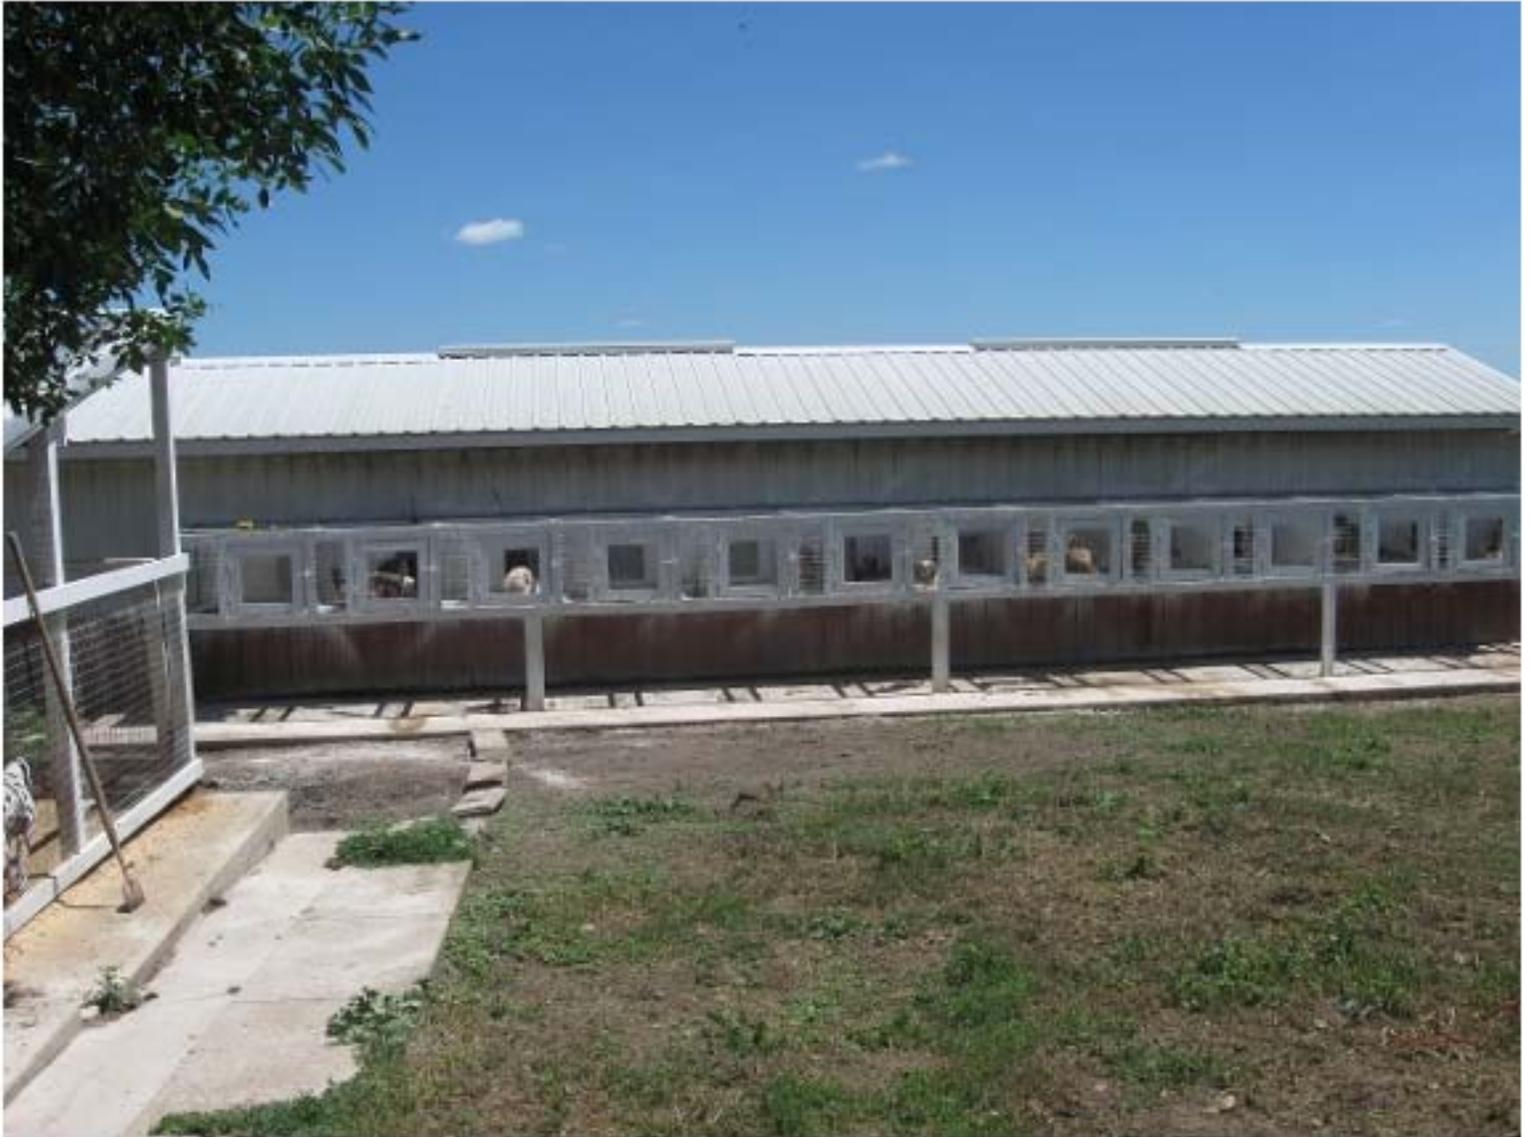
Photographer:	Brenda Pietrosante	Legal Name:	Registration:	42-A-0757
Photo Taken:	Tue, Jun 29, '10	GARY FELTS		
Inspection:	181101035340927			
Description:	Area around facility cleaned and in good condition

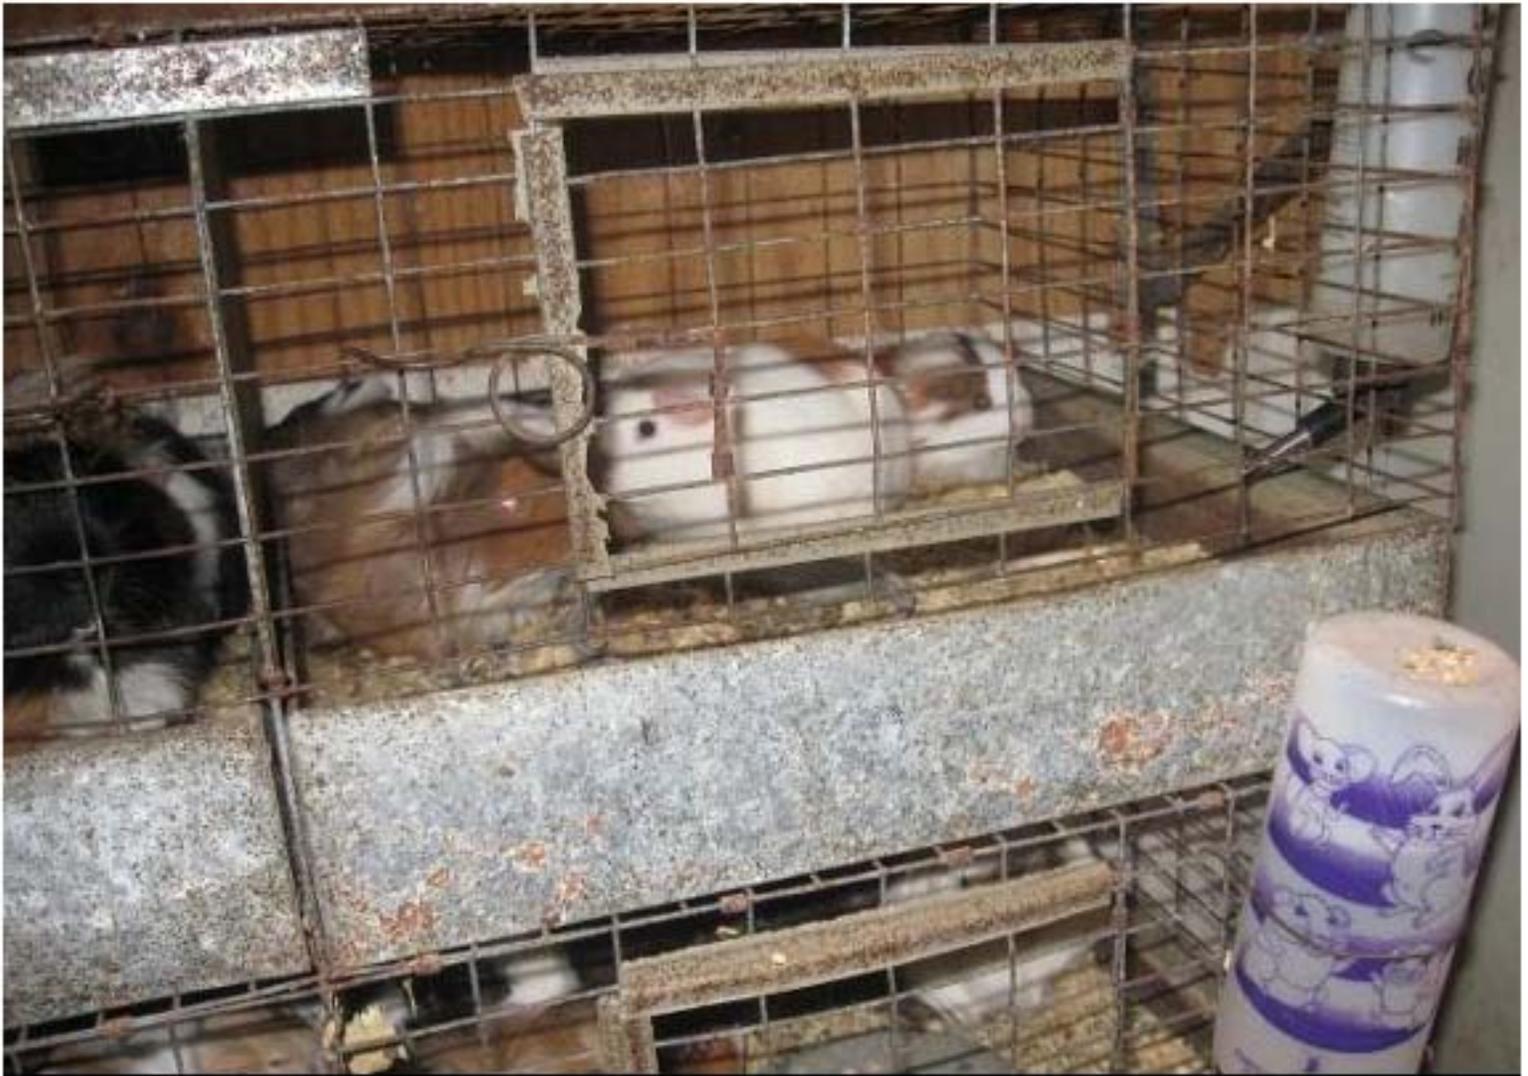
CFR: 3.25 (a)

Photographer:	Dr. Watkins	Legal Name:	Registration:	42-A-0757
Photo Taken:	Tue, Mar 30, '10	GARY FELTS		
Inspection:	93101755460273			
Description:	Guinea Pigs in rusted enclosures
