Photographer: Heather Cole, VMO      Legal Name: PAMELA SELLNER      Registration: 42-C-0084  
Photo Taken: Mon, Nov 22, '10 approximately 1100      TOM SELLNER  
Inspection: 326101741280061  
Description:

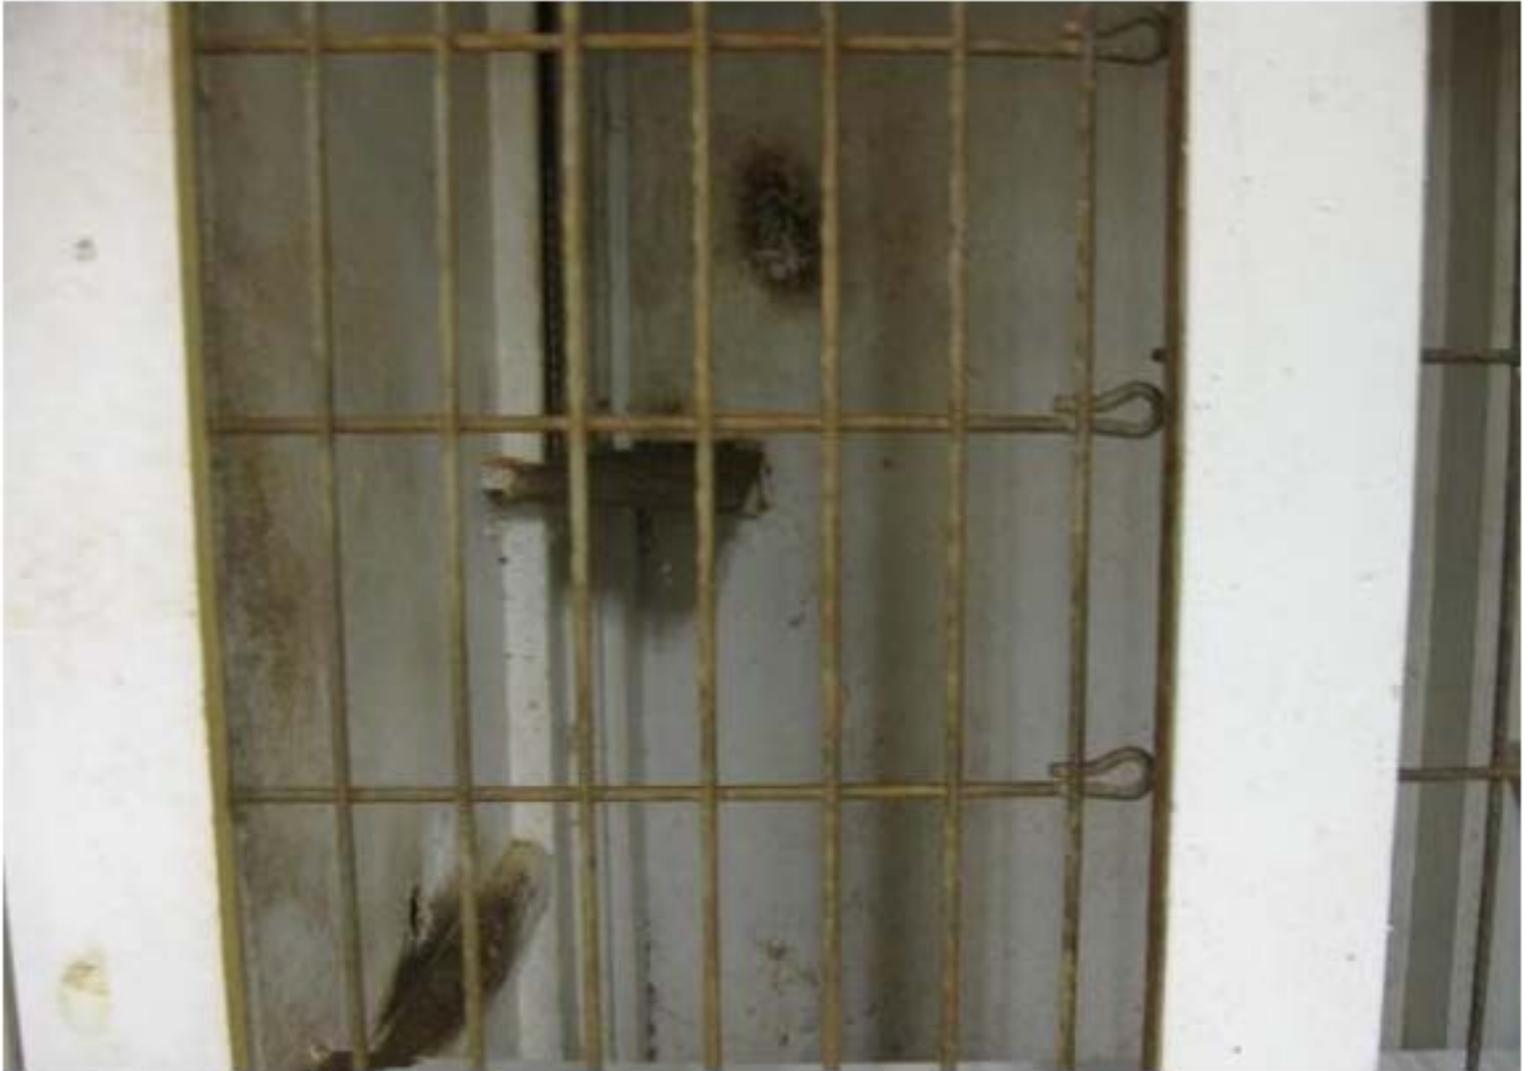
CFR: 3.80 (a)

Photographer:	Chad Moore	Legal Name:	Registration:	42-C-0081
Photo Taken:	Wed, Dec 8, '10	Approximately 11:30	JOYCE DE COCK	
Inspection:	342101854230123	RICHARD DE COCK		
Description:	Exposed unsealed wood on ledges, walls, and perches of male vervet enclosure.

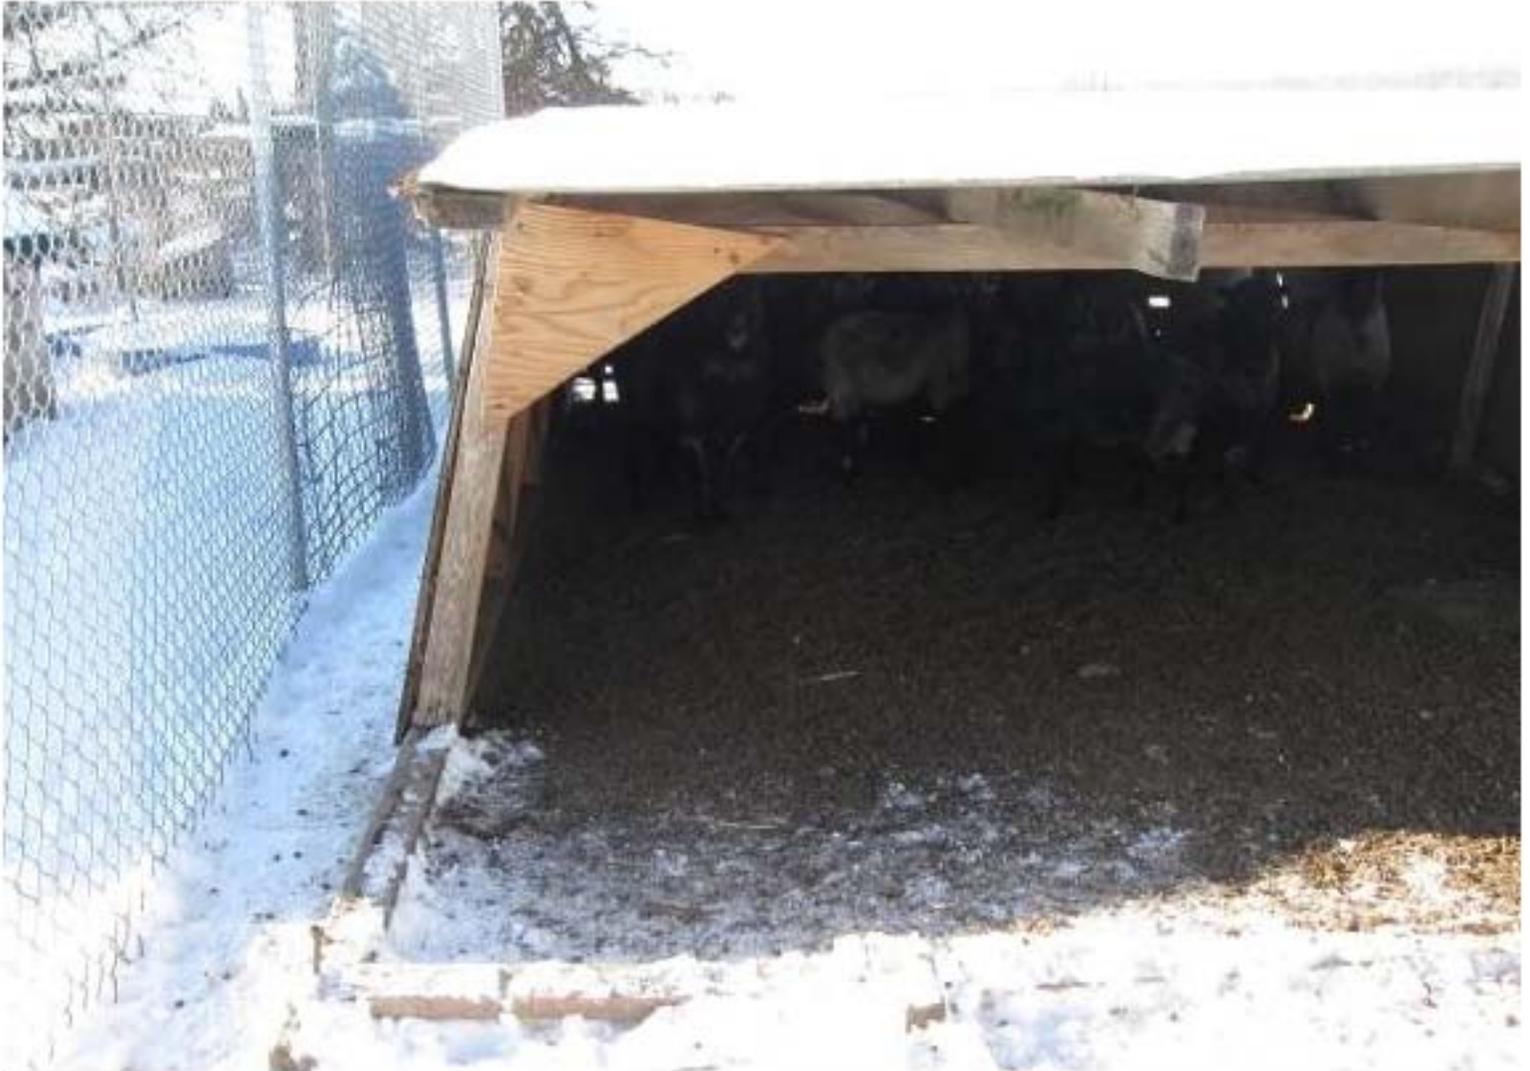
CFR: 3.125 (a)

Photographer:	Chad Moore	Legal Name:	Registration:	42-C-0081
Photo Taken:	Wed, Dec 8, '10	Approximately 11:30	JOYCE DE COCK	
Inspection:	342101854230123	RICHARD DE COCK		
Description:	Structurally unsound sheep shelter

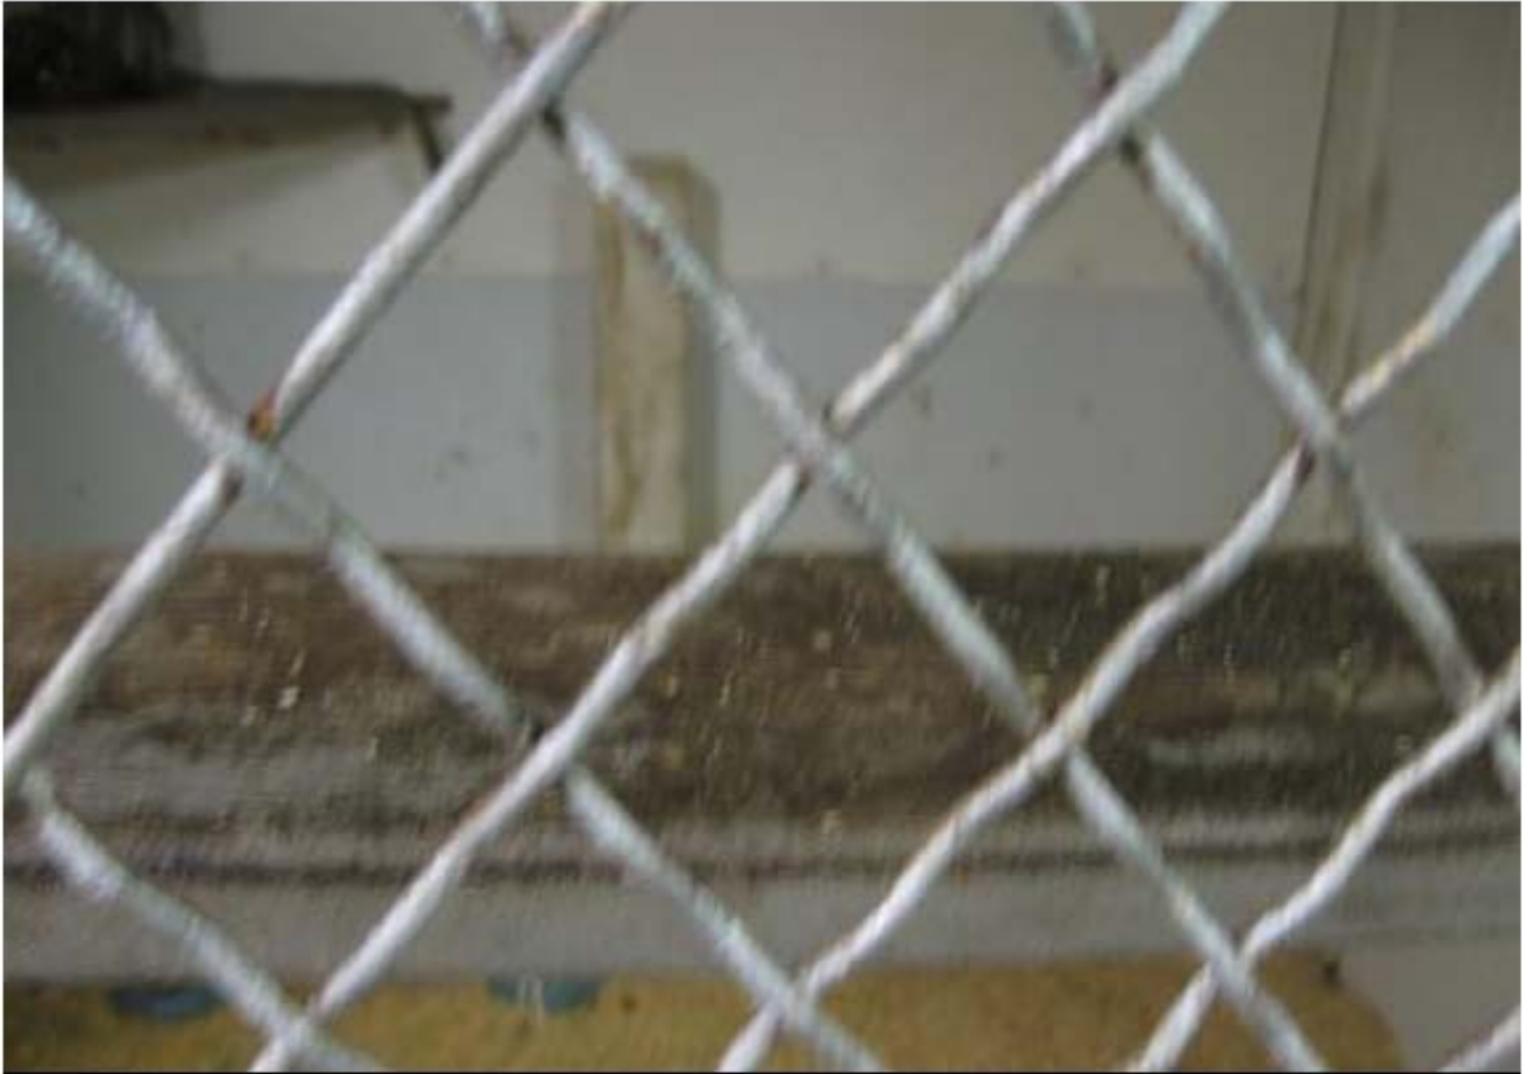
CFR: 3.80 (a)

Photographer:	Chad Moore	Legal Name:	Registration:	42-C-0081
Photo Taken:	Wed, Dec 8, '10	Approximately 11:30	JOYCE DE COCK	
Inspection:	342101854230123	RICHARD DE COCK		
Description:	Unsealed fencing of female vervet enclosure.

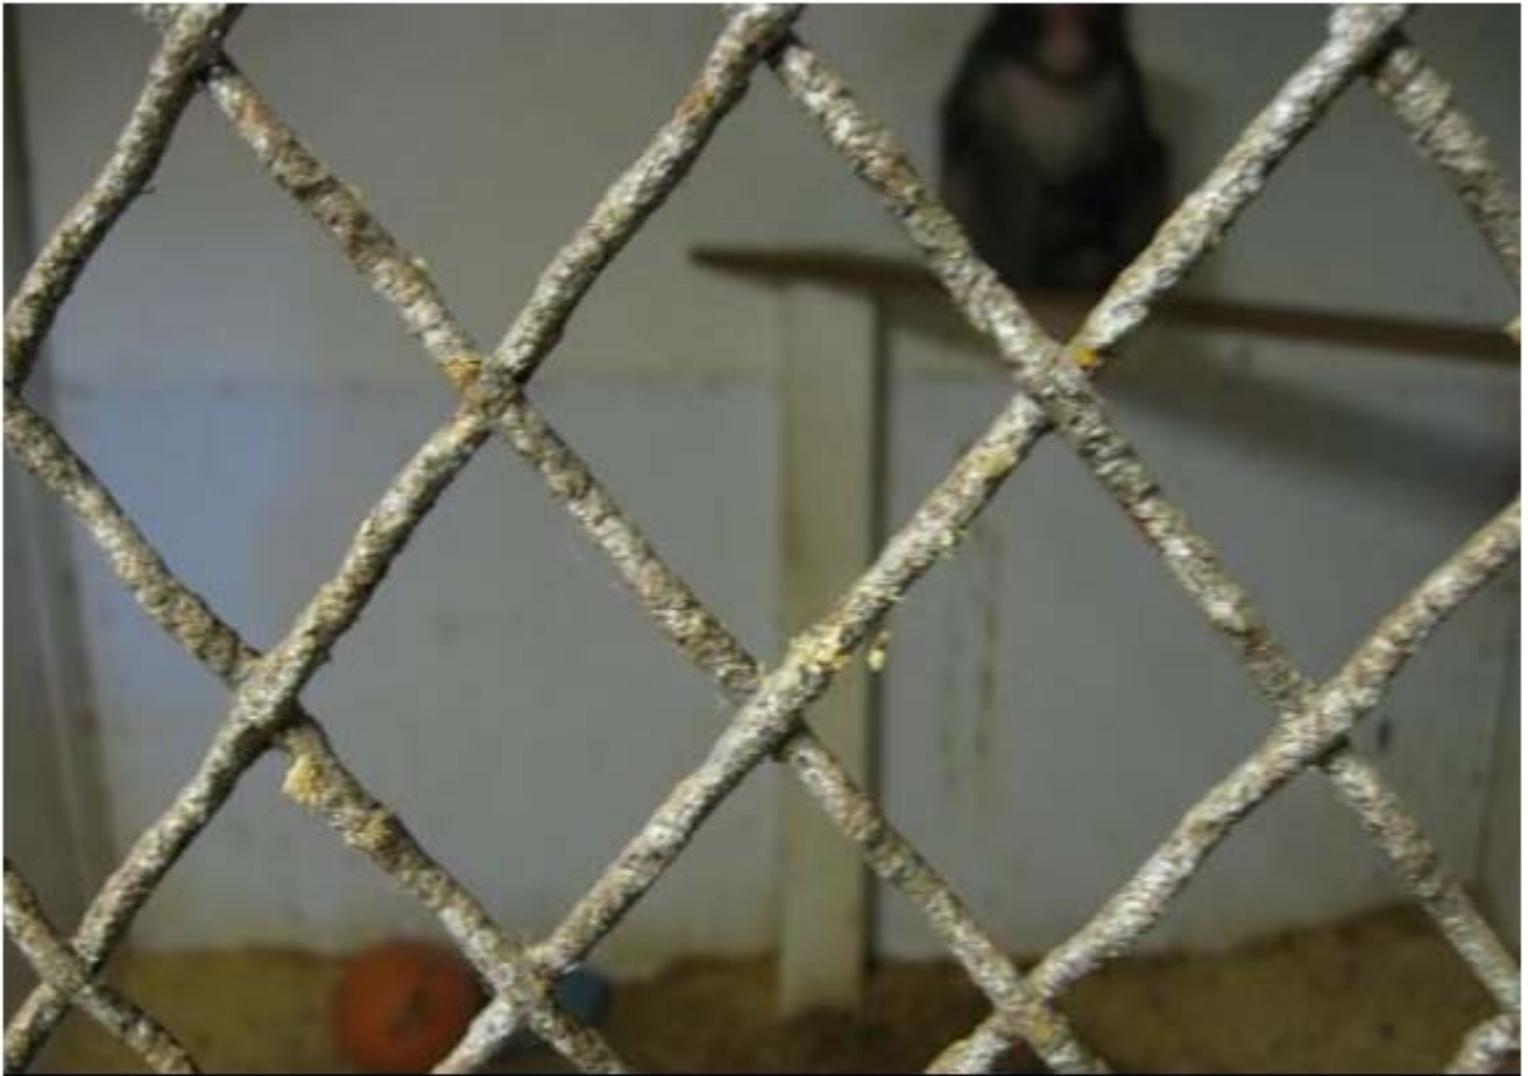
CFR: 3.80 (a)

Photographer:	Chad Moore	Legal Name:	Registration:	42-C-0081
Photo Taken:	Wed, Dec 8, '10	Approximately 11:30	JOYCE DE COCK	
Inspection:	342101854230123	RICHARD DE COCK		
Description:	Unsealed fencing of male macaque enclosure.

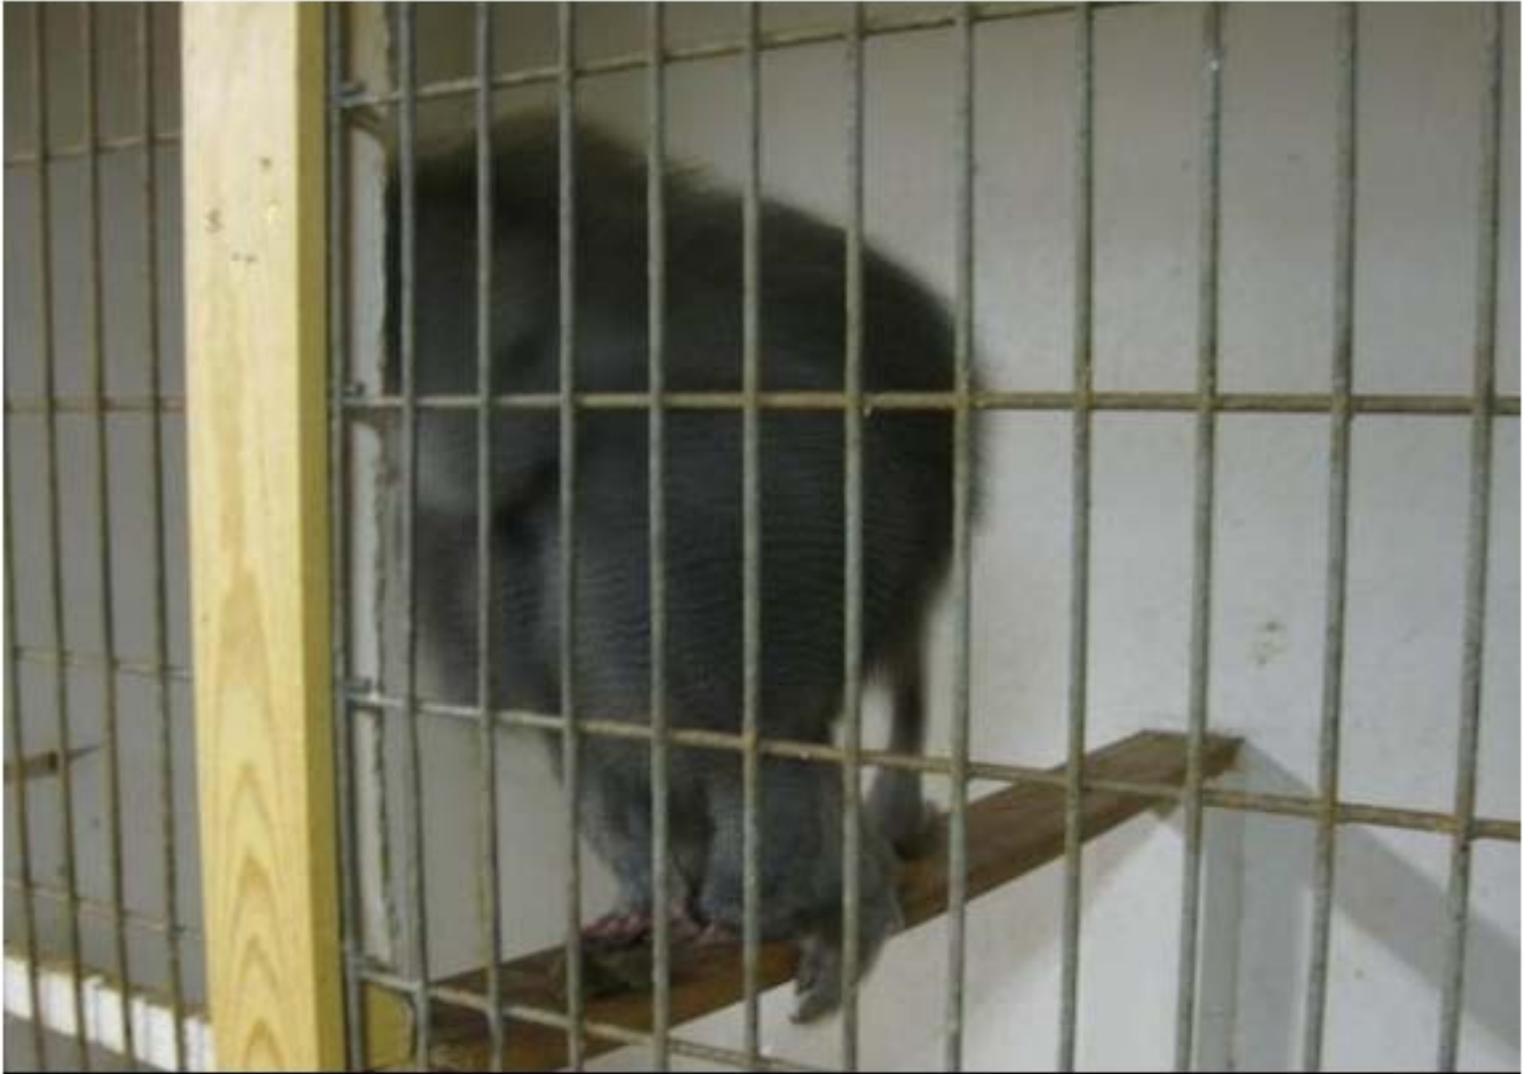
CFR: 3.80 (a), 2.40 (b) (2)

Photographer:	Chad Moore	Legal Name:	Registration:	42-C-0081
Photo Taken:	Wed, Dec 8, '10	Approximately 11:30	JOYCE DE COCK	
Inspection:	342101854230123	RICHARD DE COCK		
Description:	Older male baboon "Bobby" with hunched posture, muscle loss in both legs. Unsealed fencing of older male baboon enclosure.

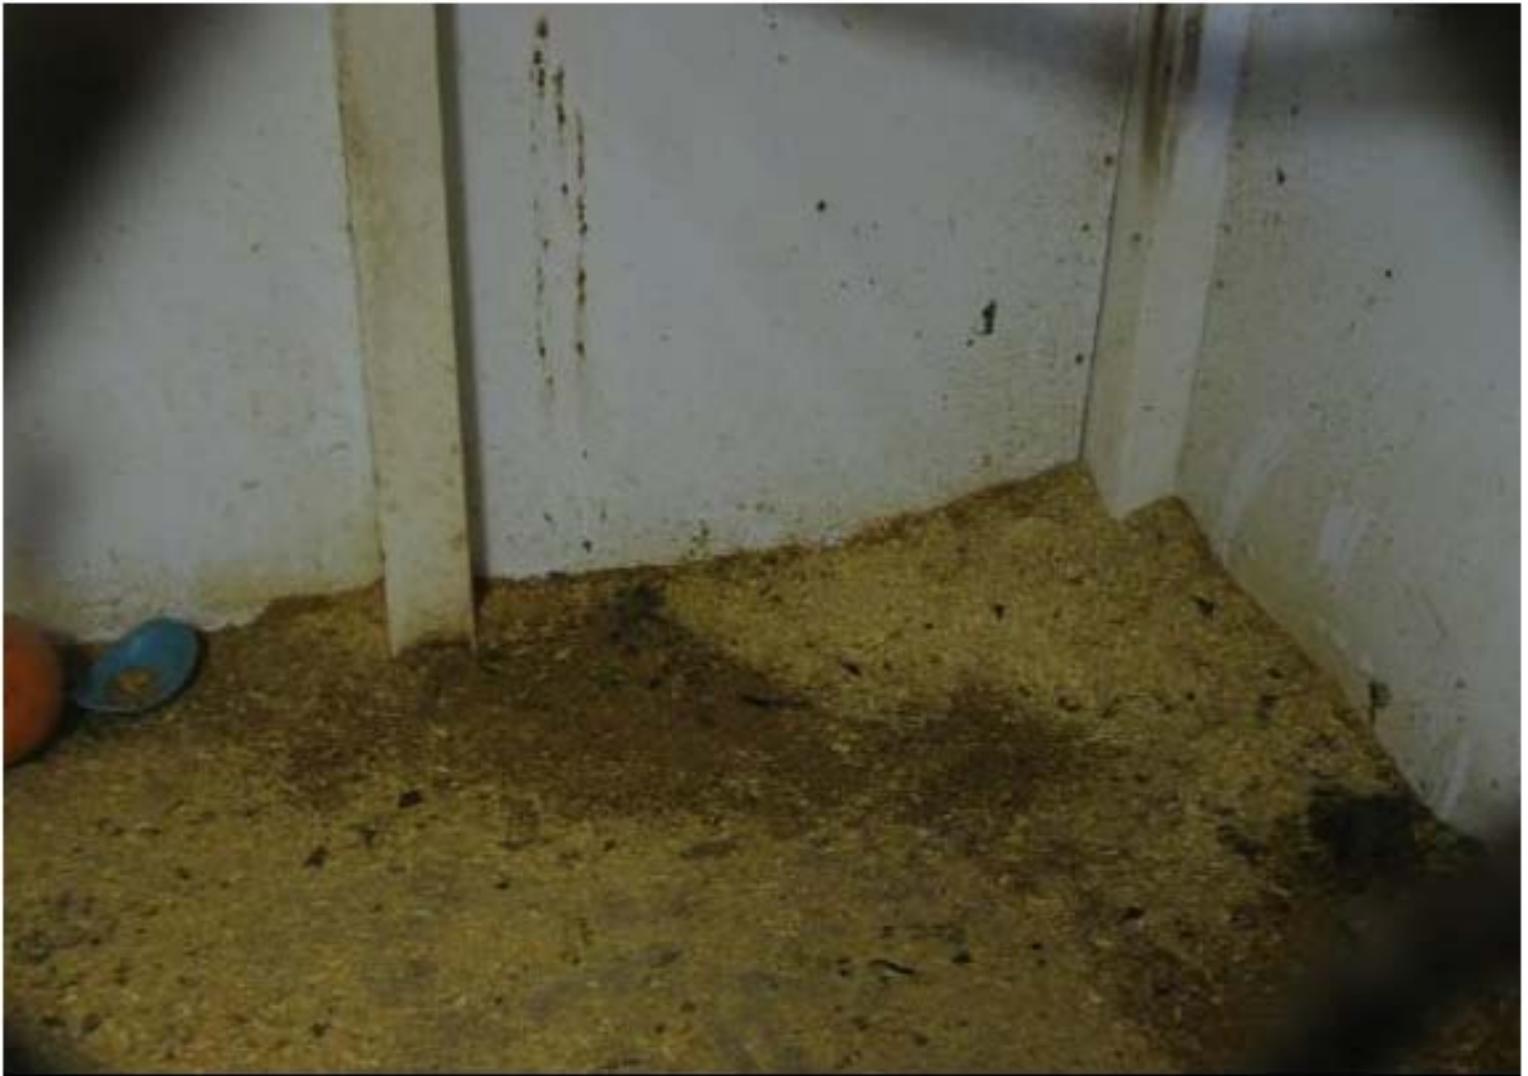
CFR: 3.84 (a)

Photographer:	Chad Moore	Legal Name:	Registration:	42-C-0081
Photo Taken:	Wed, Dec 8, '10	Approximately 11:30	JOYCE DE COCK	
Inspection:	342101854230123	RICHARD DE COCK		
Description:	Feces and food waste inside of male macaque enclosure

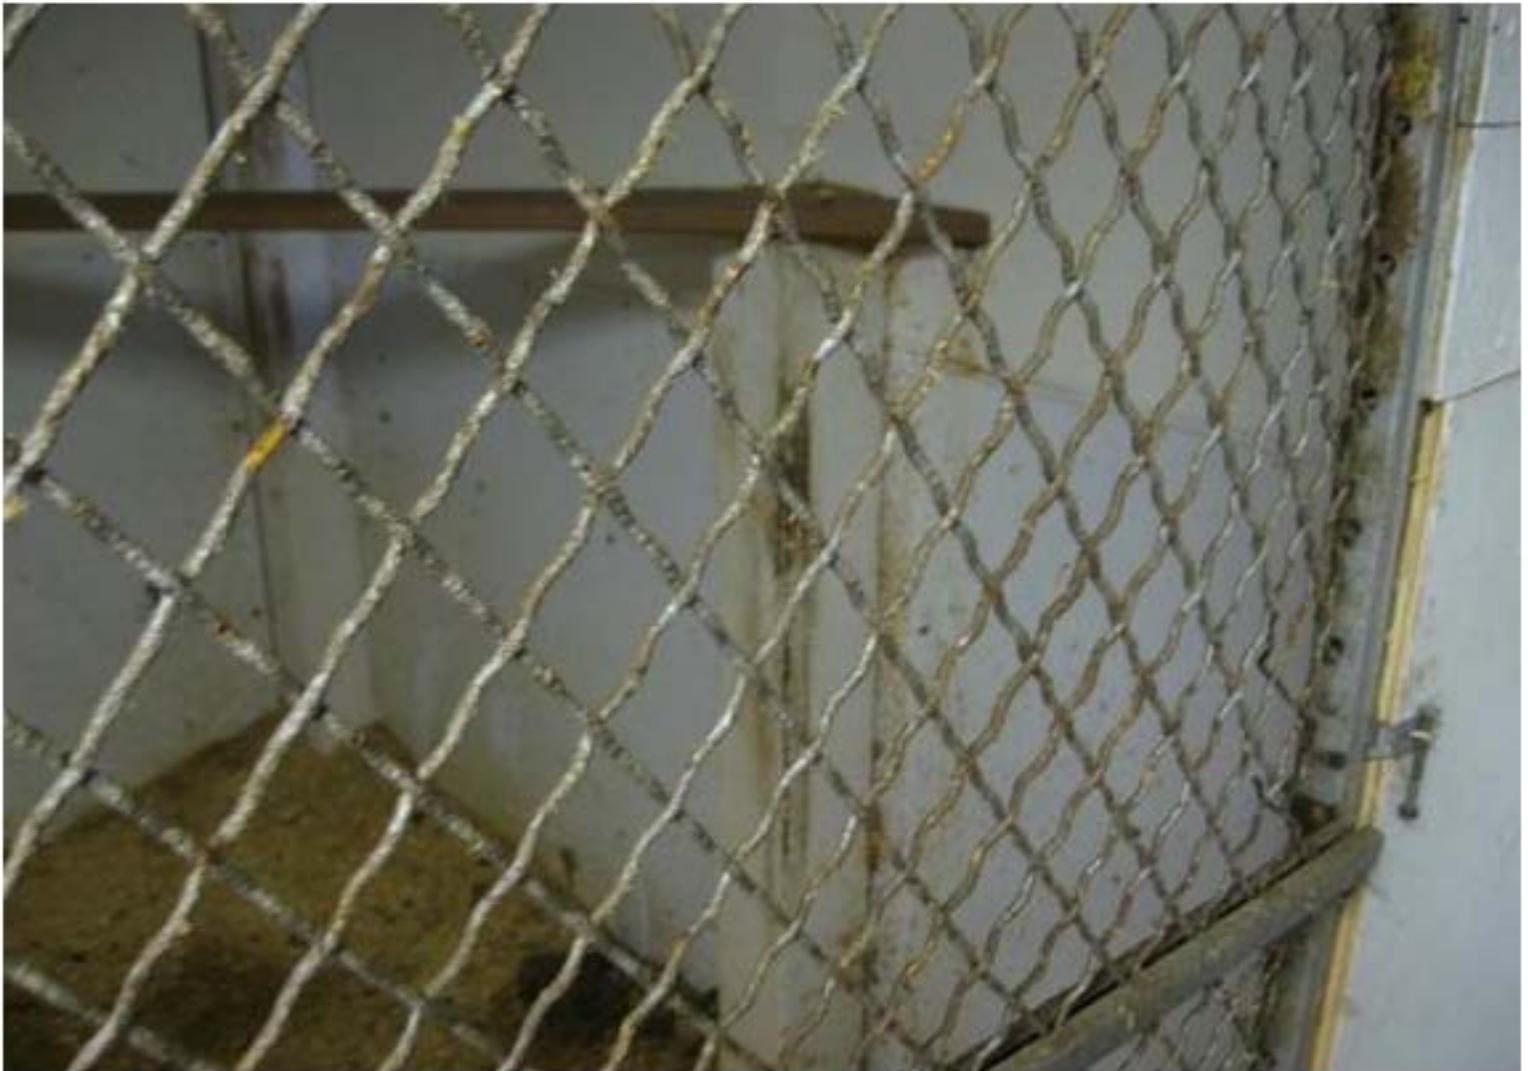
CFR: 3.84 (a)

Photographer:	Chad Moore	Legal Name:	Registration:	42-C-0081
Photo Taken:	Wed, Dec 8, '10	Approximately 11:30	JOYCE DE COCK	
Inspection:	342101854230123	RICHARD DE COCK		
Description:	Feces and food waste in female vervet enclosure.

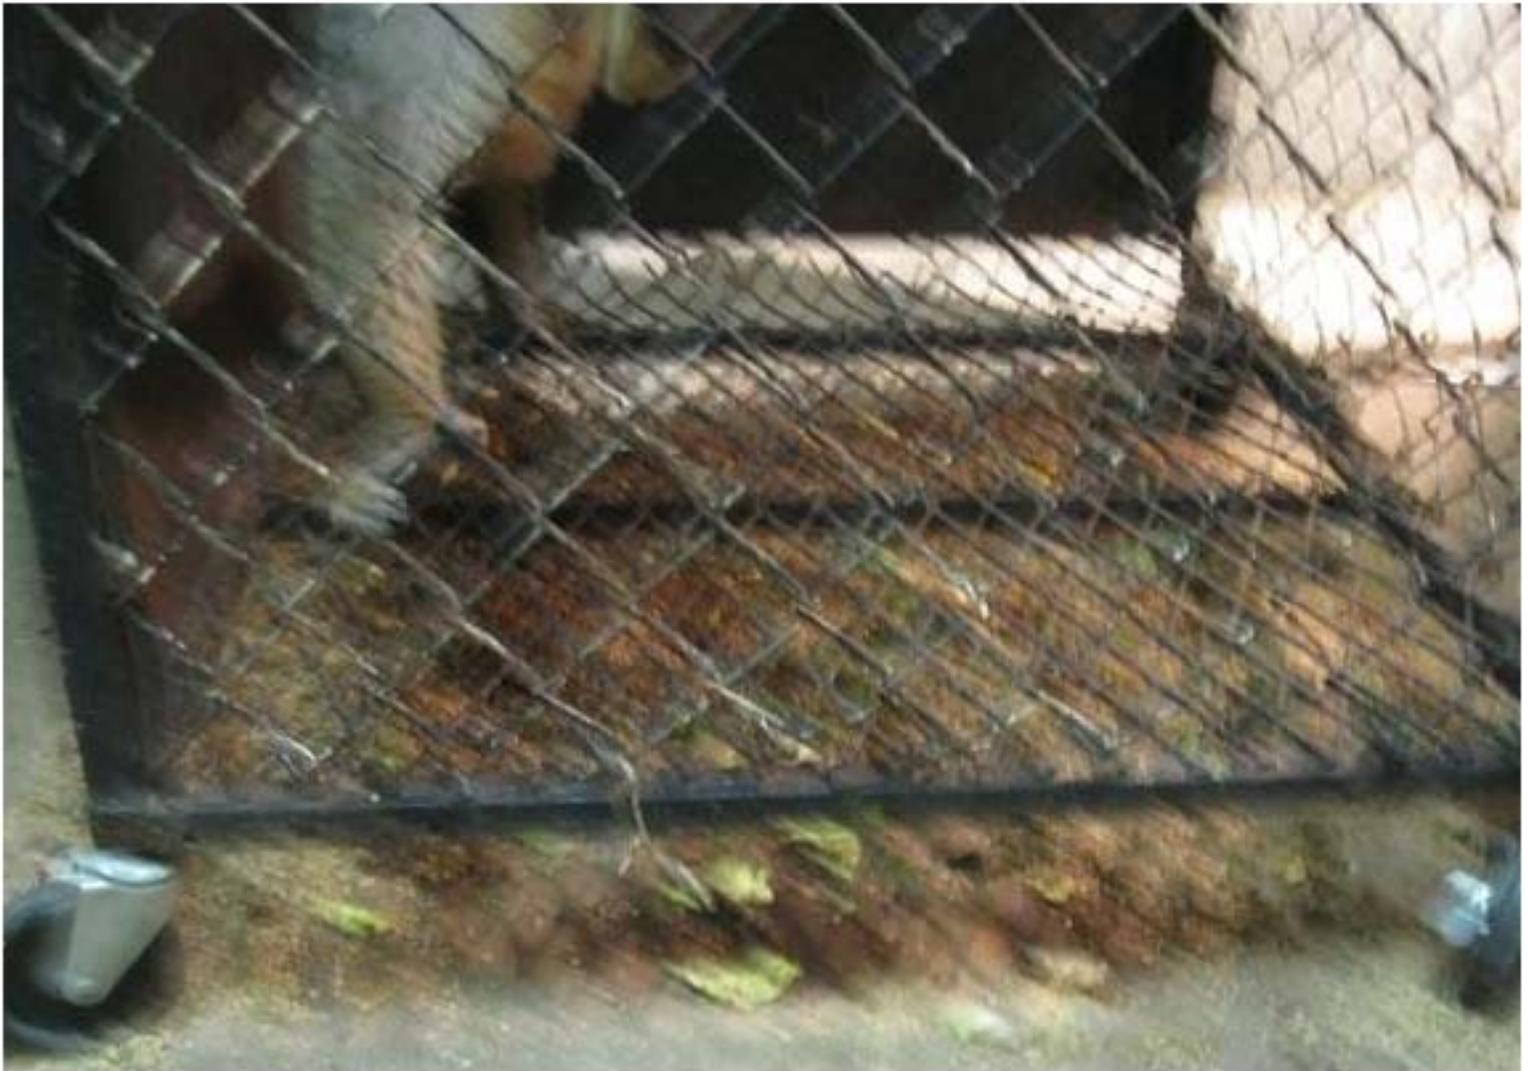
CFR: 3.84 (a)

Photographer:	Chad Moore	Legal Name:	Registration:	42-C-0081
Photo Taken:	Wed, Dec 8, '10	Approximately 11:30	JOYCE DE COCK	
Inspection:	342101854230123	RICHARD DE COCK		
Description:	Feces and food waste under lemurs' enclosure.

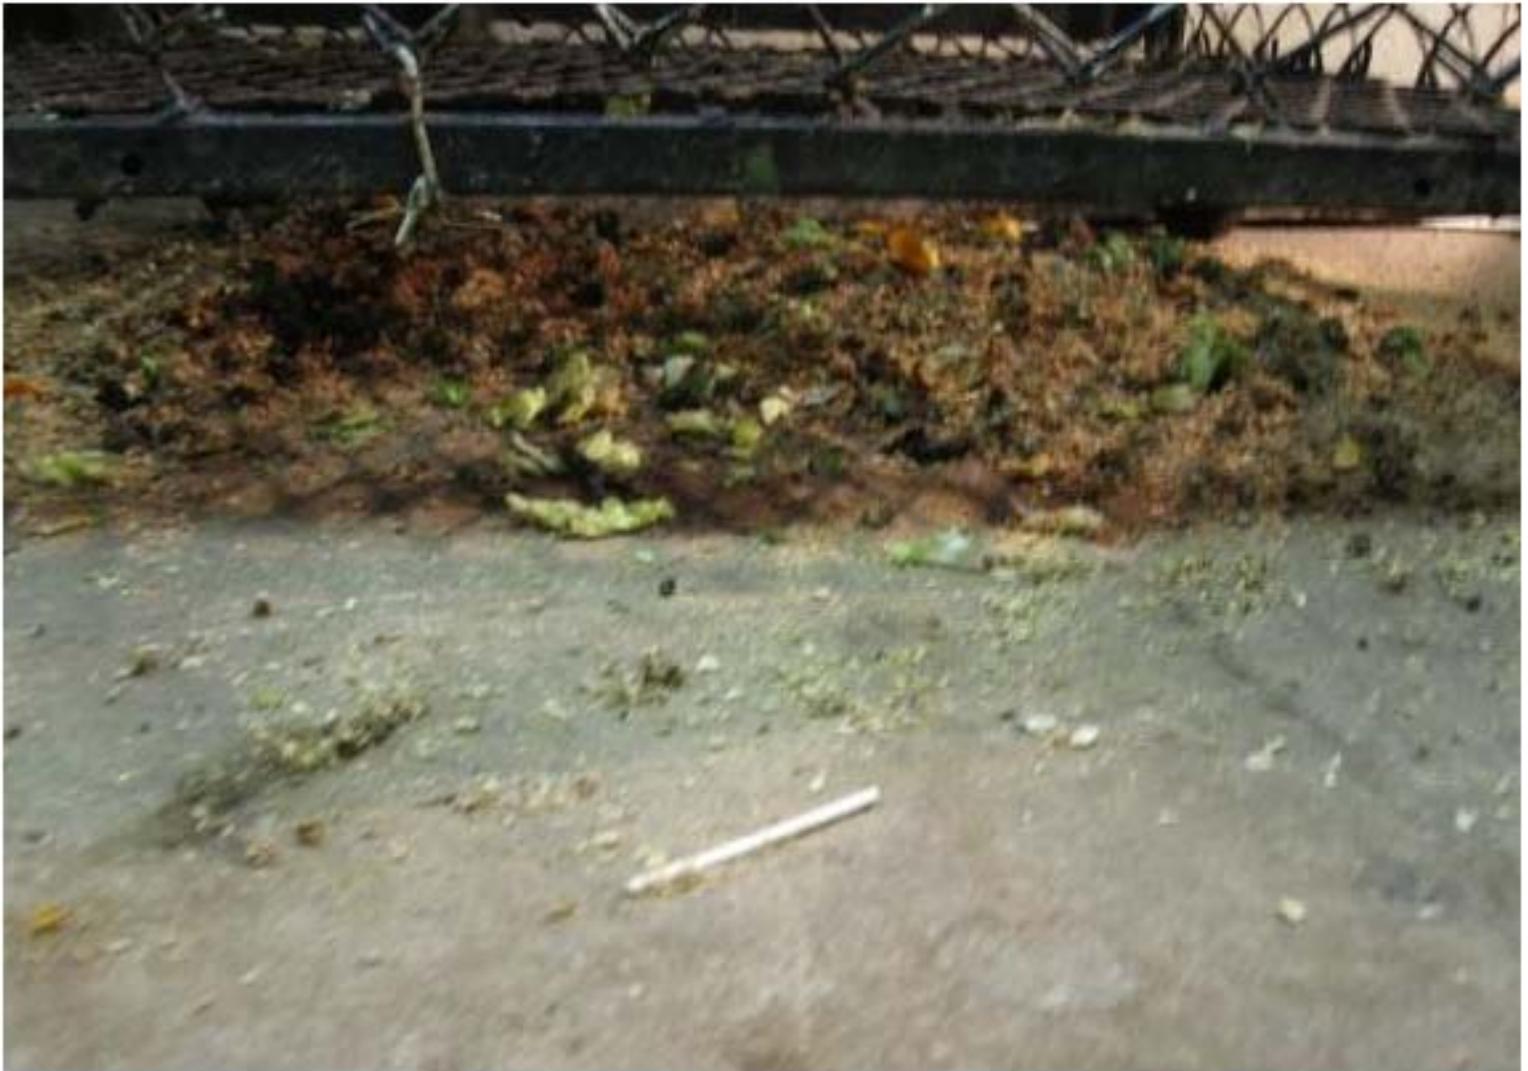
CFR: 3.84 (a)

Photographer:	Chad Moore	Legal Name:	Registration:	42-C-0081
Photo Taken:	Wed, Dec 8, '10	Approximately 11:30	JOYCE DE COCK	
Inspection:	342101854230123	RICHARD DE COCK		
Description:	Feces and food waste under lemurs' enclosure.

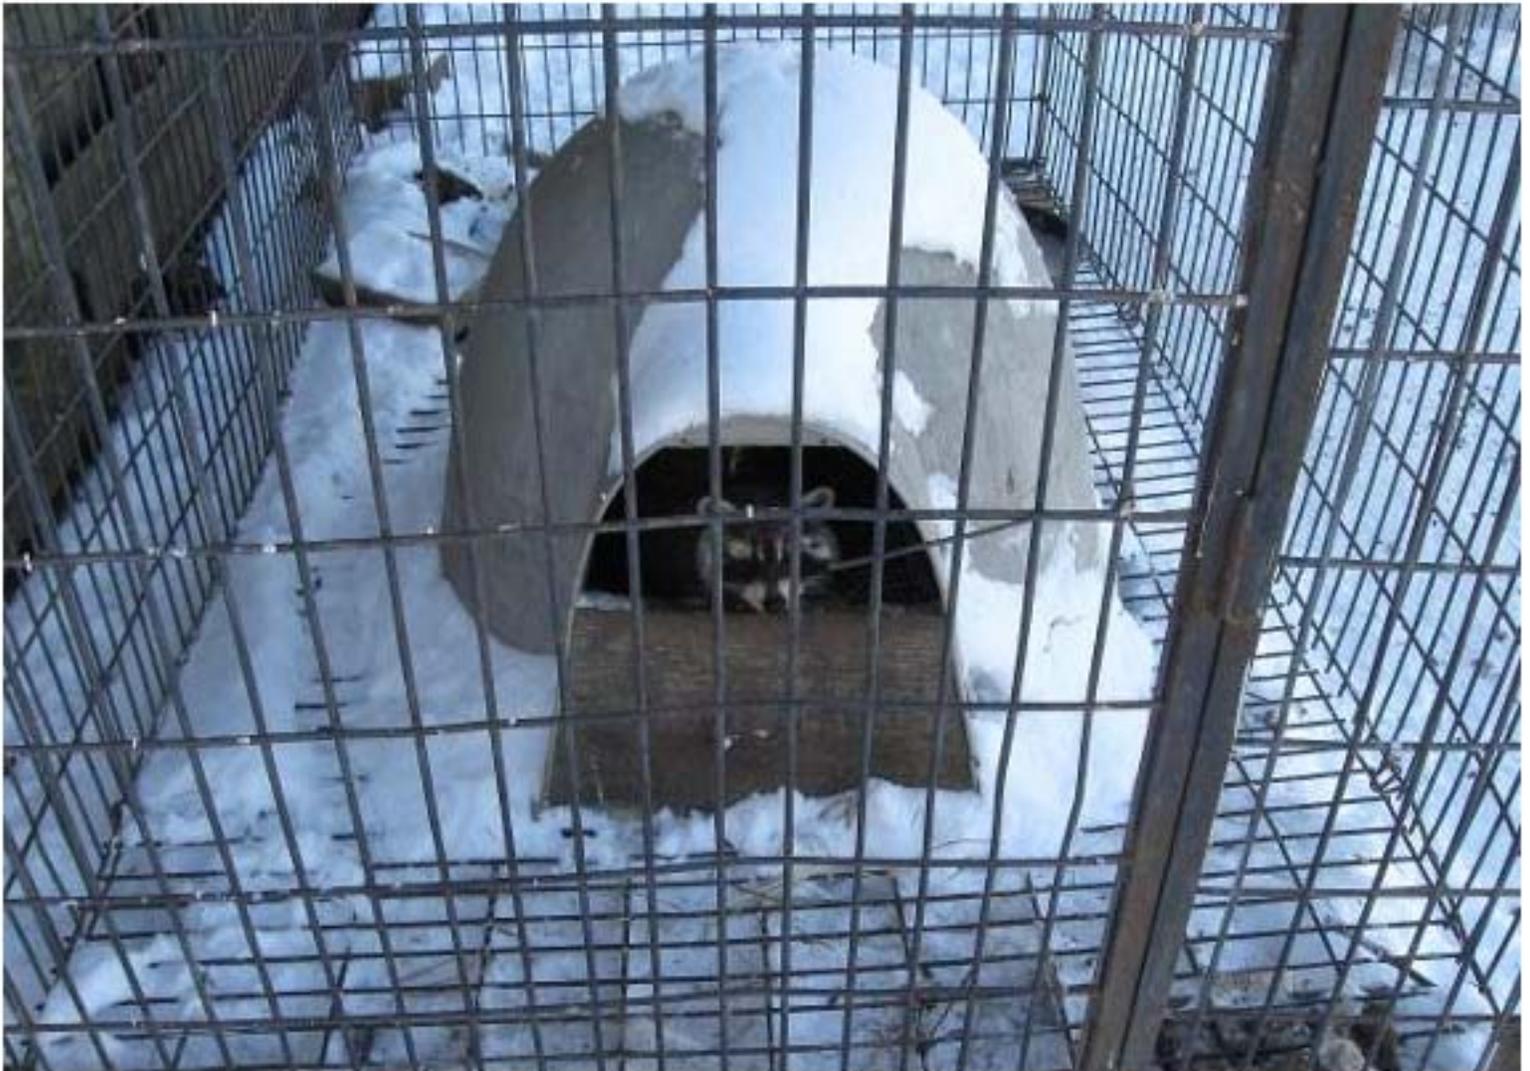
CFR: 3.131 (a)

Photographer:	Chad Moore	Legal Name:	Registration:	42-C-0081
Photo Taken:	Wed, Dec 8, '10	Approximately 11:30	JOYCE DE COCK	
Inspection:	342101854230123	RICHARD DE COCK		
Description:	Excessive feces in raccoon enclosure

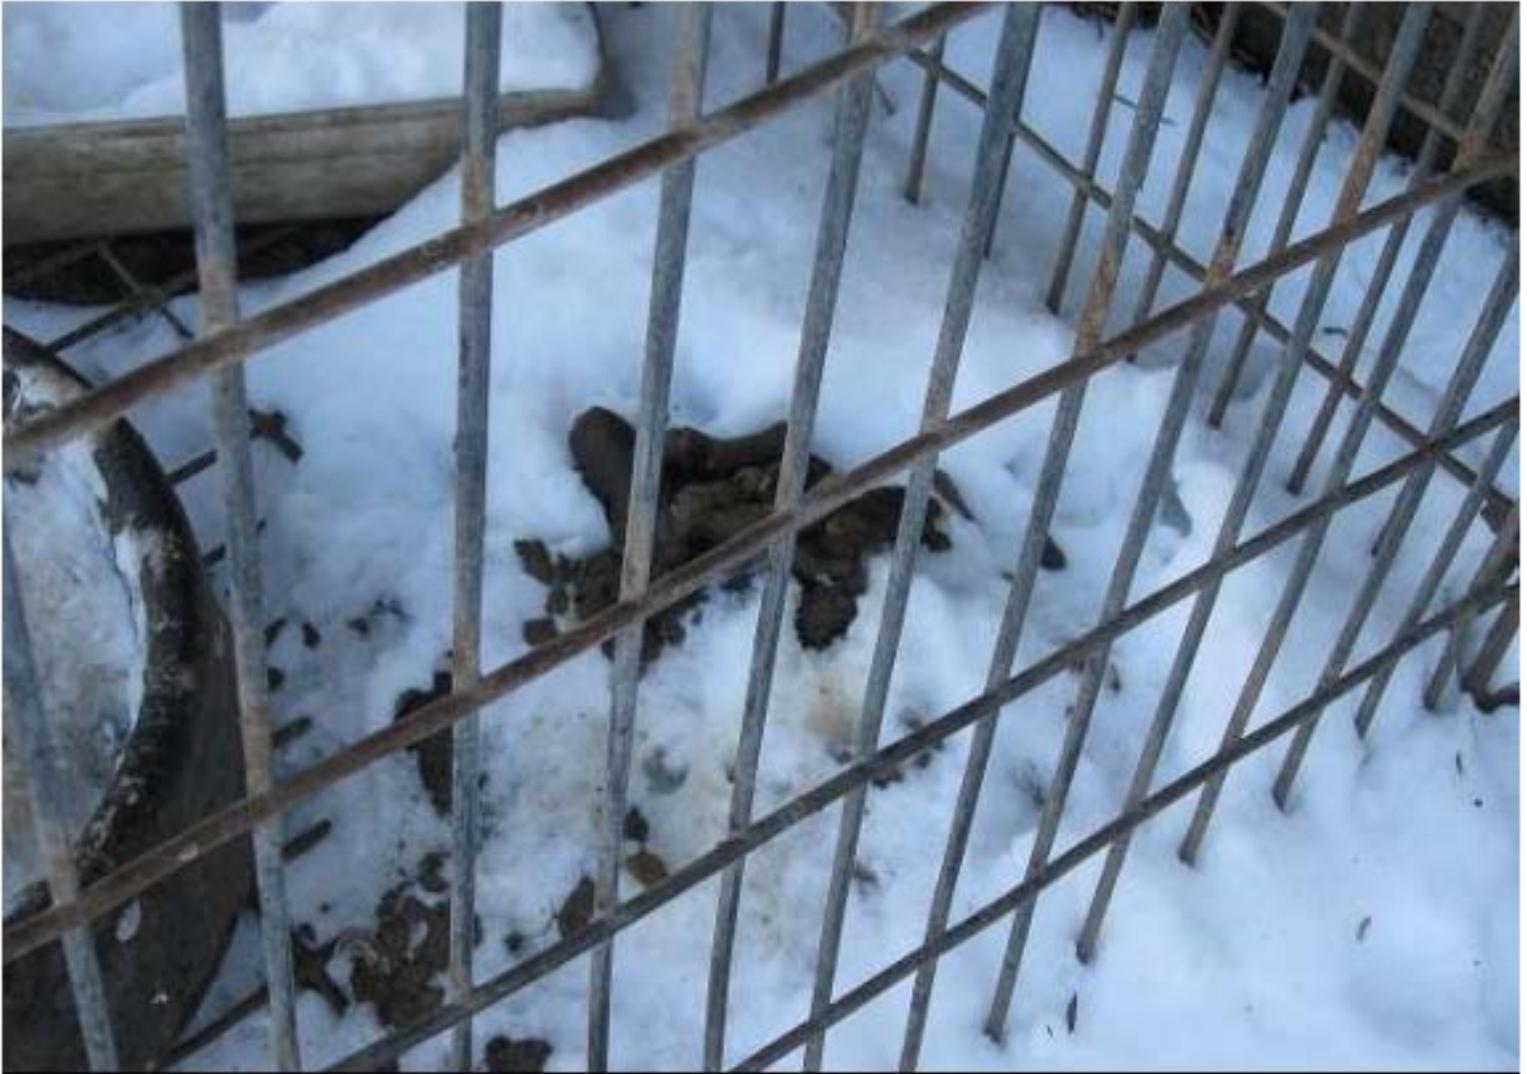
CFR: 3.131 (a)

Photographer:	Chad Moore	Legal Name:	Registration:	42-C-0081
Photo Taken:	Wed, Dec 8, '10	Approximately 11:30	JOYCE DE COCK RICHARD DE COCK	
Inspection:	342101854230123			
Description:	Feces and food waste in raccoon enclosure.

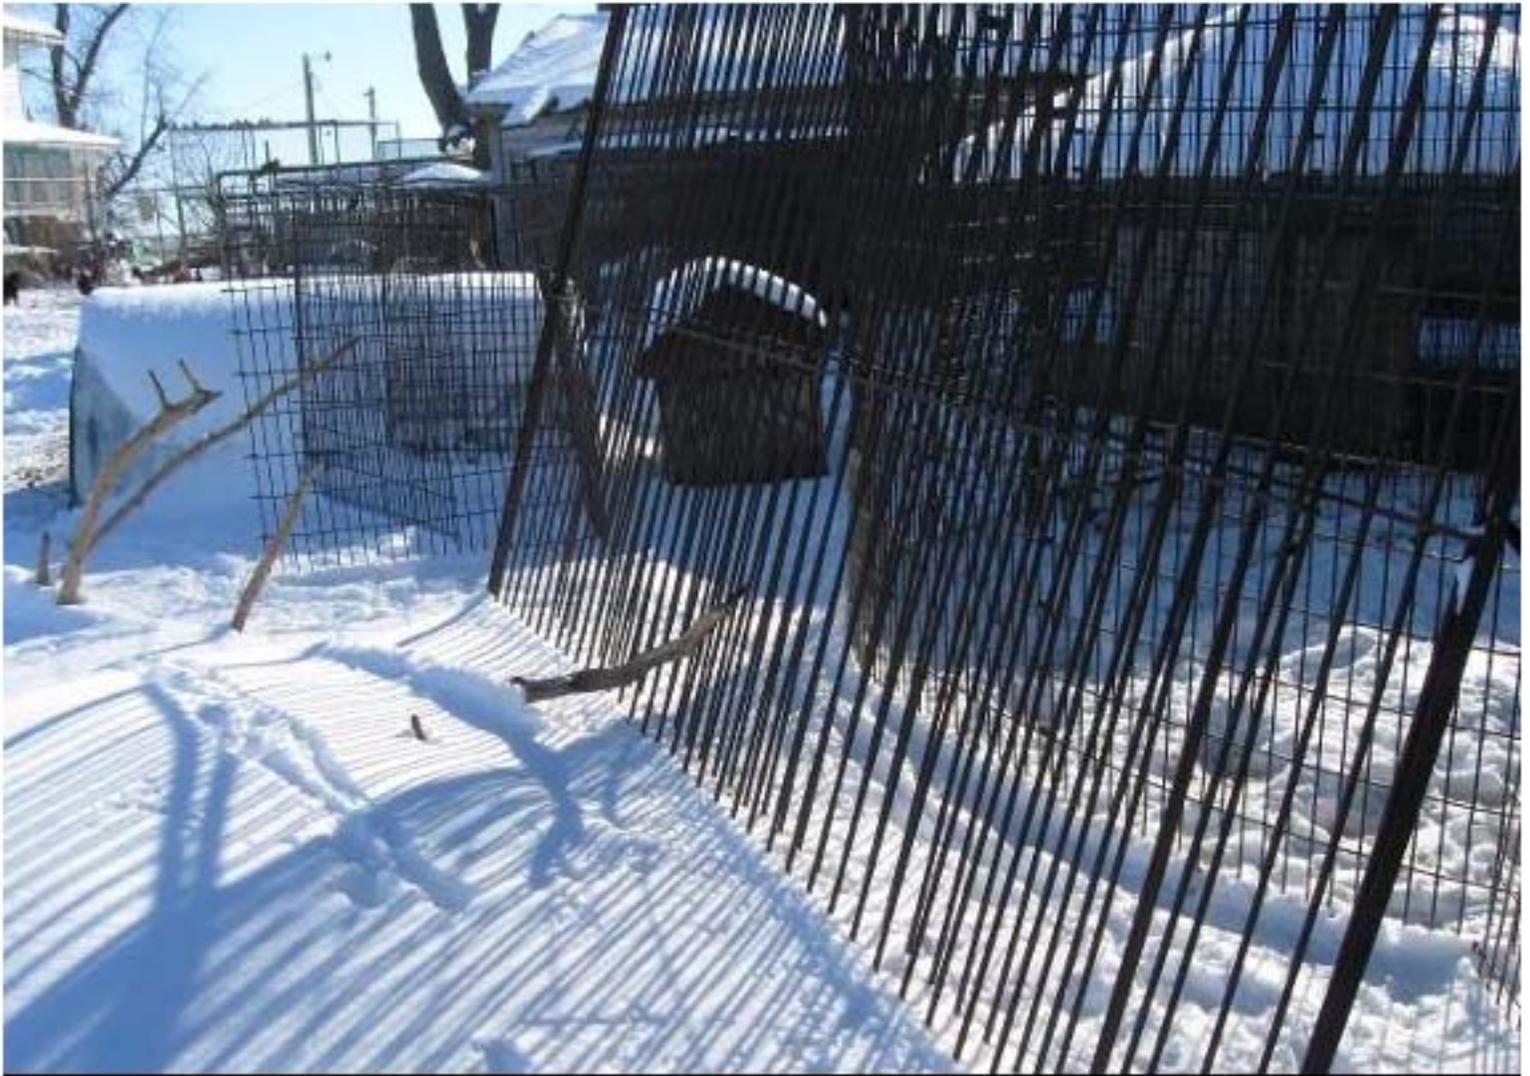
CFR: 3.131 (c)

Photographer:	Chad Moore	Legal Name:	Registration:	42-C-0081
Photo Taken:	Wed, Dec 8, '10	Unused items, clutter	JOYCE DE COCK	
Inspection:	342101854230123	RICHARD DE COCK		
Description:	Unused fencing inside of goat pasture

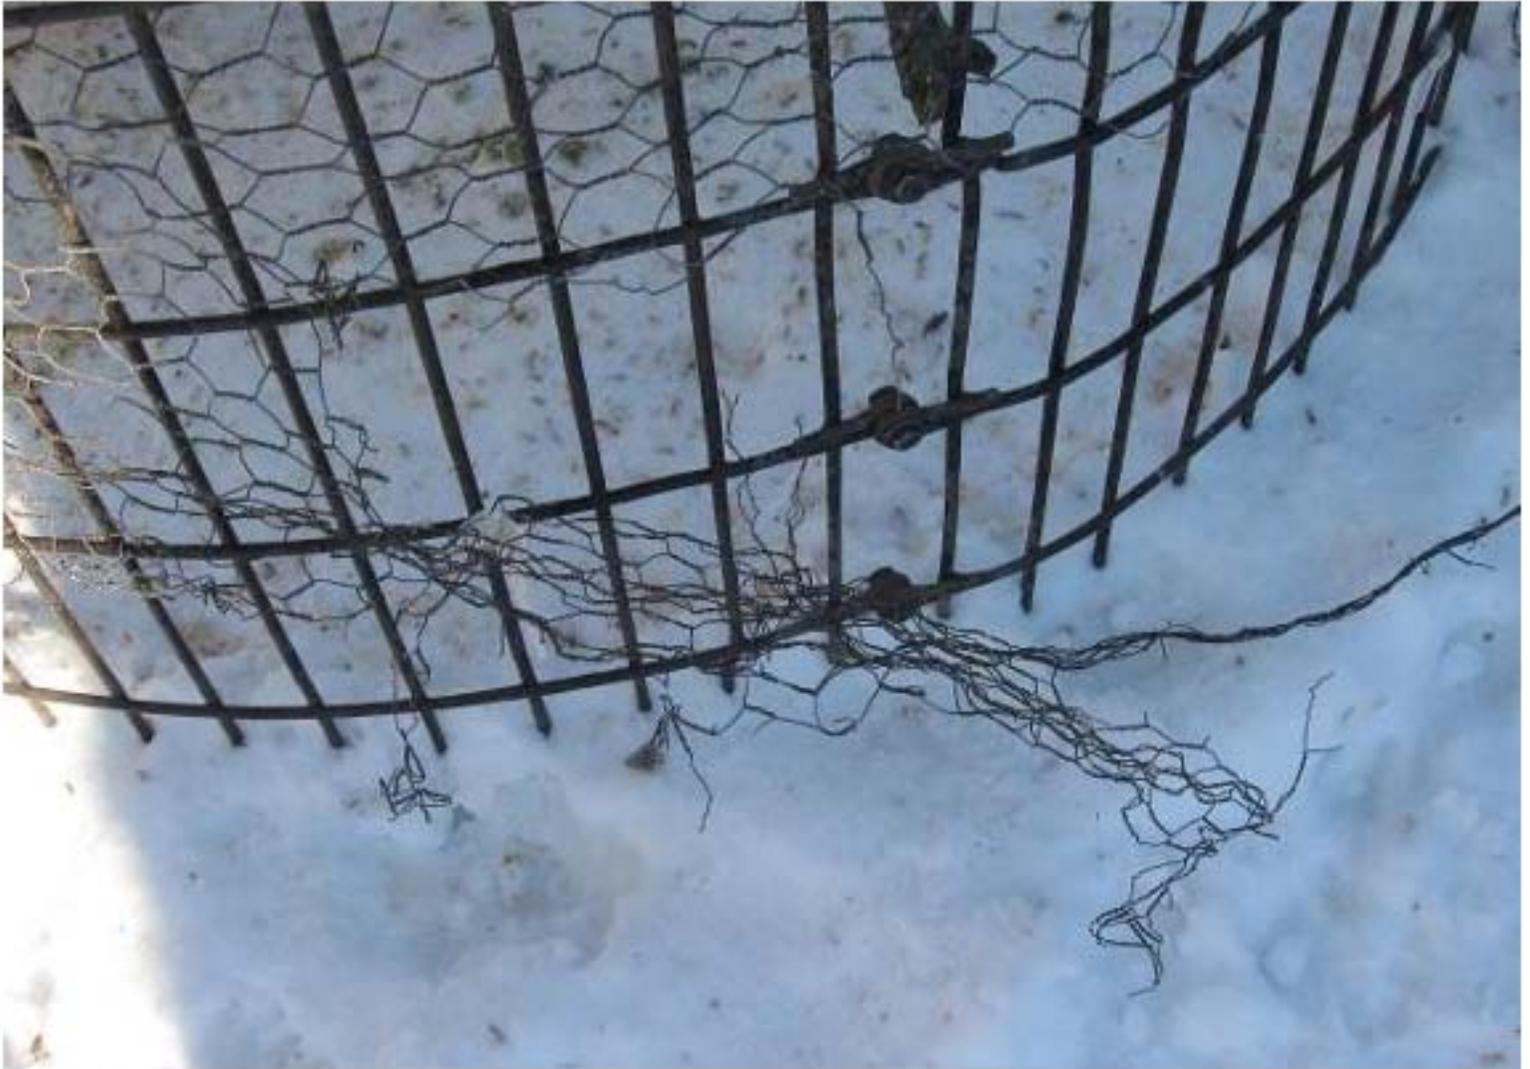
CFR: 3.131 (c)

Photographer:	Chad Moore	Legal Name:	Registration:	42-C-0081
Photo Taken:	Wed, Dec 8, '10	Approximately 11:30	JOYCE DE COCK	
Inspection:	342101854230123	RICHARD DE COCK		
Description:	Stray wires, unattached fencing inside of goat pasture
