Photographer: Heather Cole, VMO      Legal Name: PAMELA SELLNER      Registration: 42-C-0084  
Photo Taken: Mon, Nov 22, '10 approximately 1100      TOM SELLNER  
Inspection: 326101741280061  
Description:

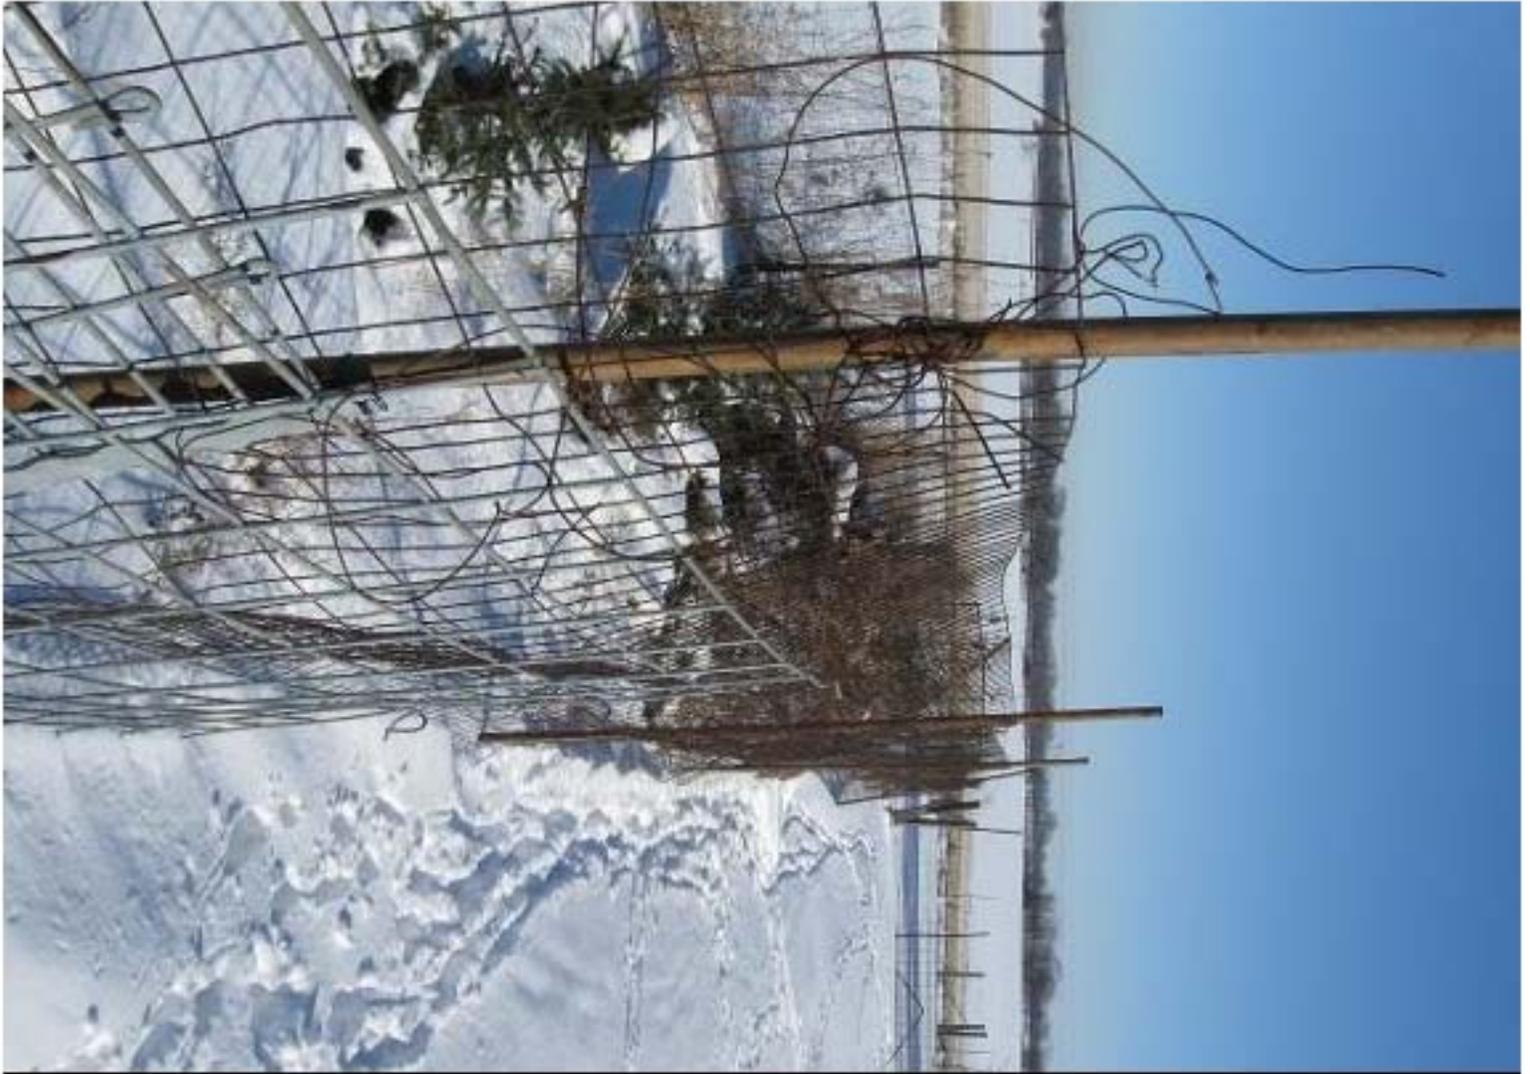
CFR: 3.131 (c)

Photographer:	Chad Moore	Legal Name:	Registration:	42-C-0081
Photo Taken:	Wed, Dec 8, '10	Approximately 11:30	JOYCE DE COCK	
Inspection:	342101854230123	RICHARD DE COCK		
Description:	Stray wires, unattached fencing inside of goat pasture

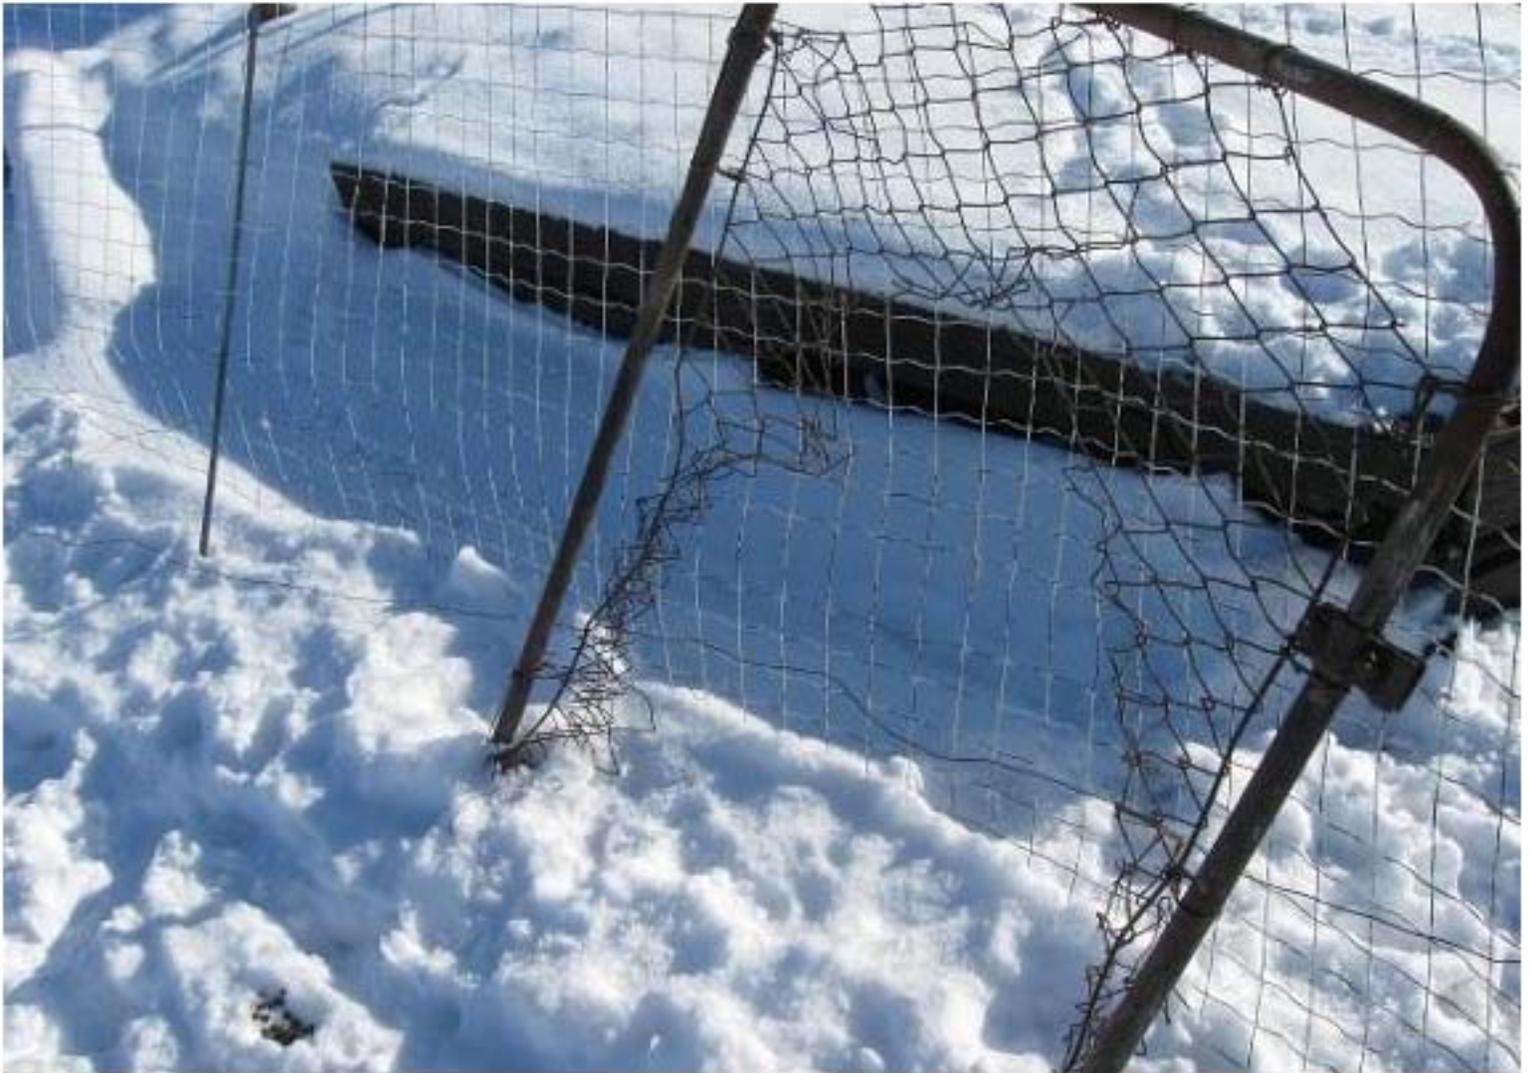
CFR: 3.131 (c)

Photographer:	Chad Moore	Legal Name:	Registration:	42-C-0081
Photo Taken:	Wed, Dec 8, '10	Approximately 11:30	JOYCE DE COCK RICHARD DE COCK	
Inspection:	342101854230123			
Description:	Stray wires, unattached fencing inside of sheep pasture

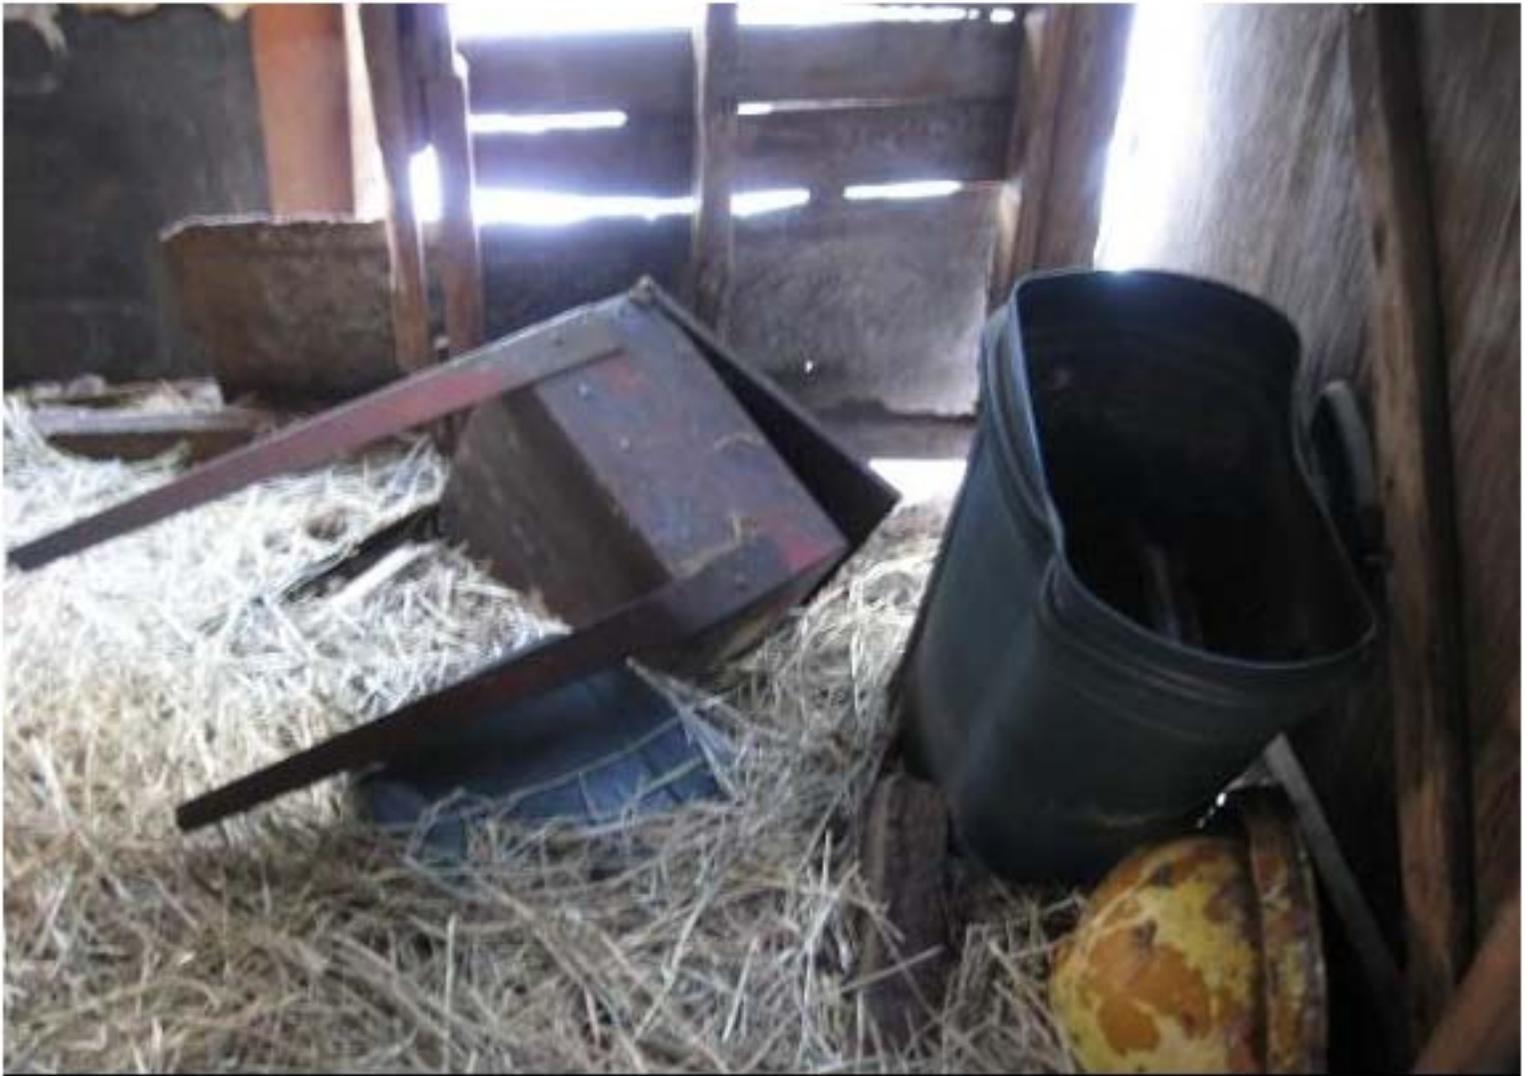
CFR: 3.131 (c)

Photographer:	Chad Moore	Legal Name:	Registration:	42-C-0081
Photo Taken:	Wed, Dec 8, '10	Approximately 11:30	JOYCE DE COCK	
Inspection:	342101854230123	RICHARD DE COCK		
Description:	Unused items, clutter inside of goat shelter

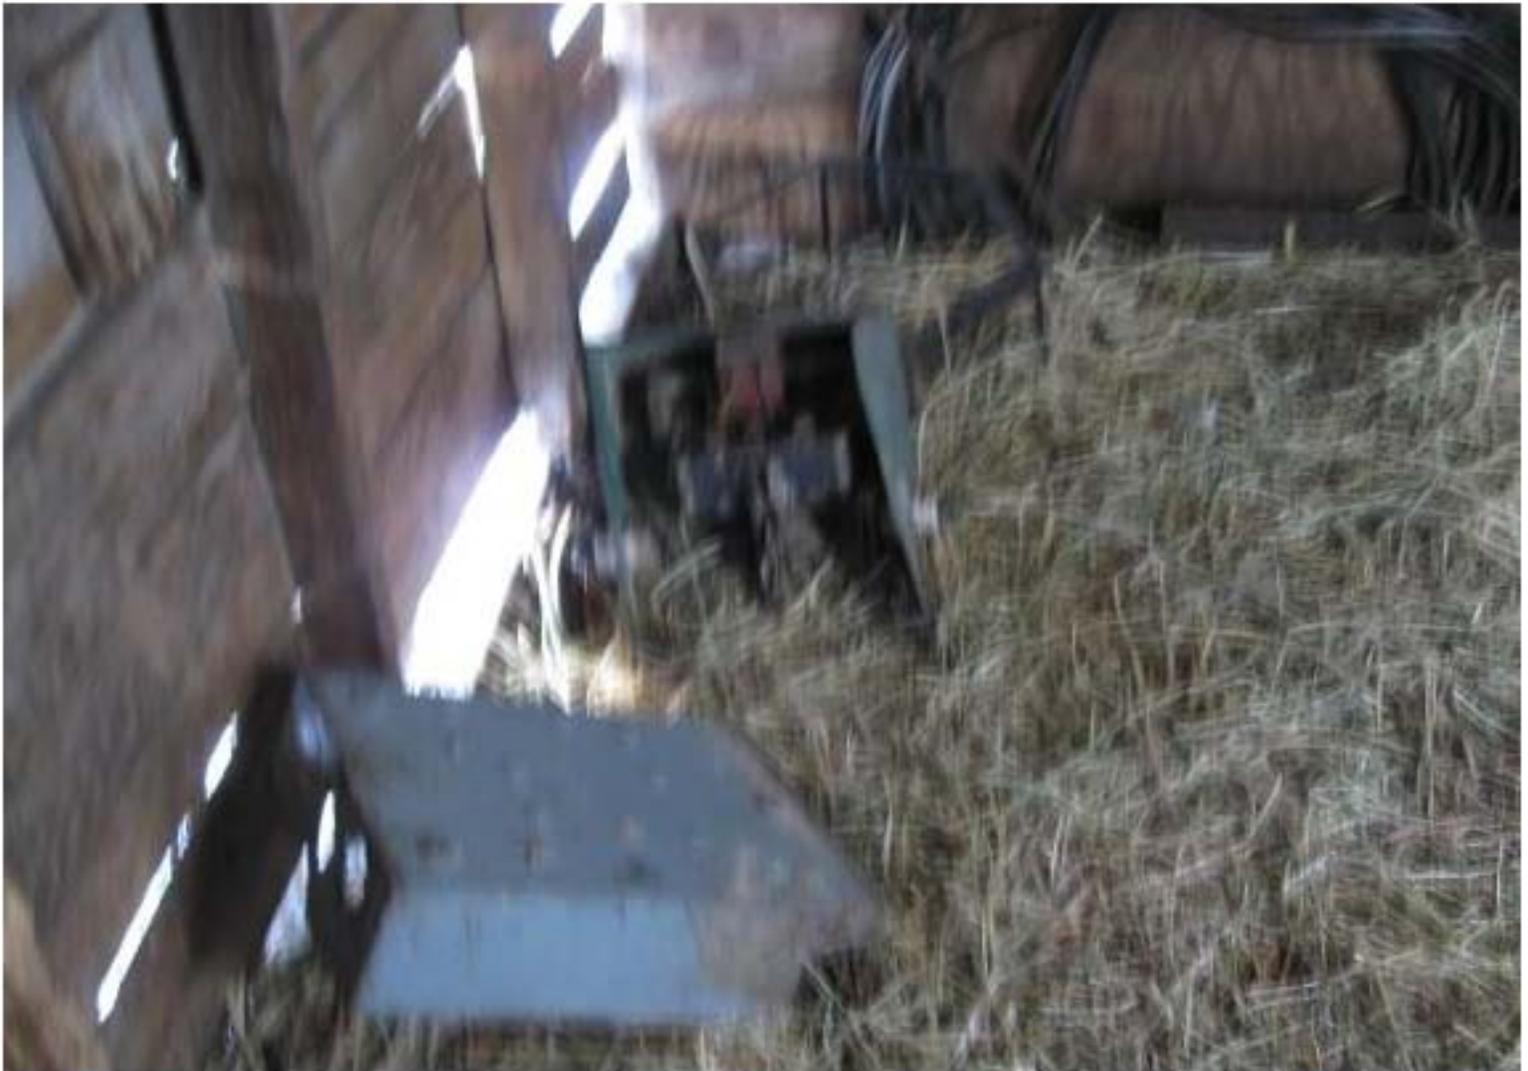
CFR: 3.131 (c)

Photographer:	Chad Moore	Legal Name:	Registration:	42-C-0081
Photo Taken:	Wed, Dec 8, '10	Approximately 11:30	JOYCE DE COCK	
Inspection:	342101854230123	RICHARD DE COCK		
Description:	Unused items, clutter inside of goat shelter

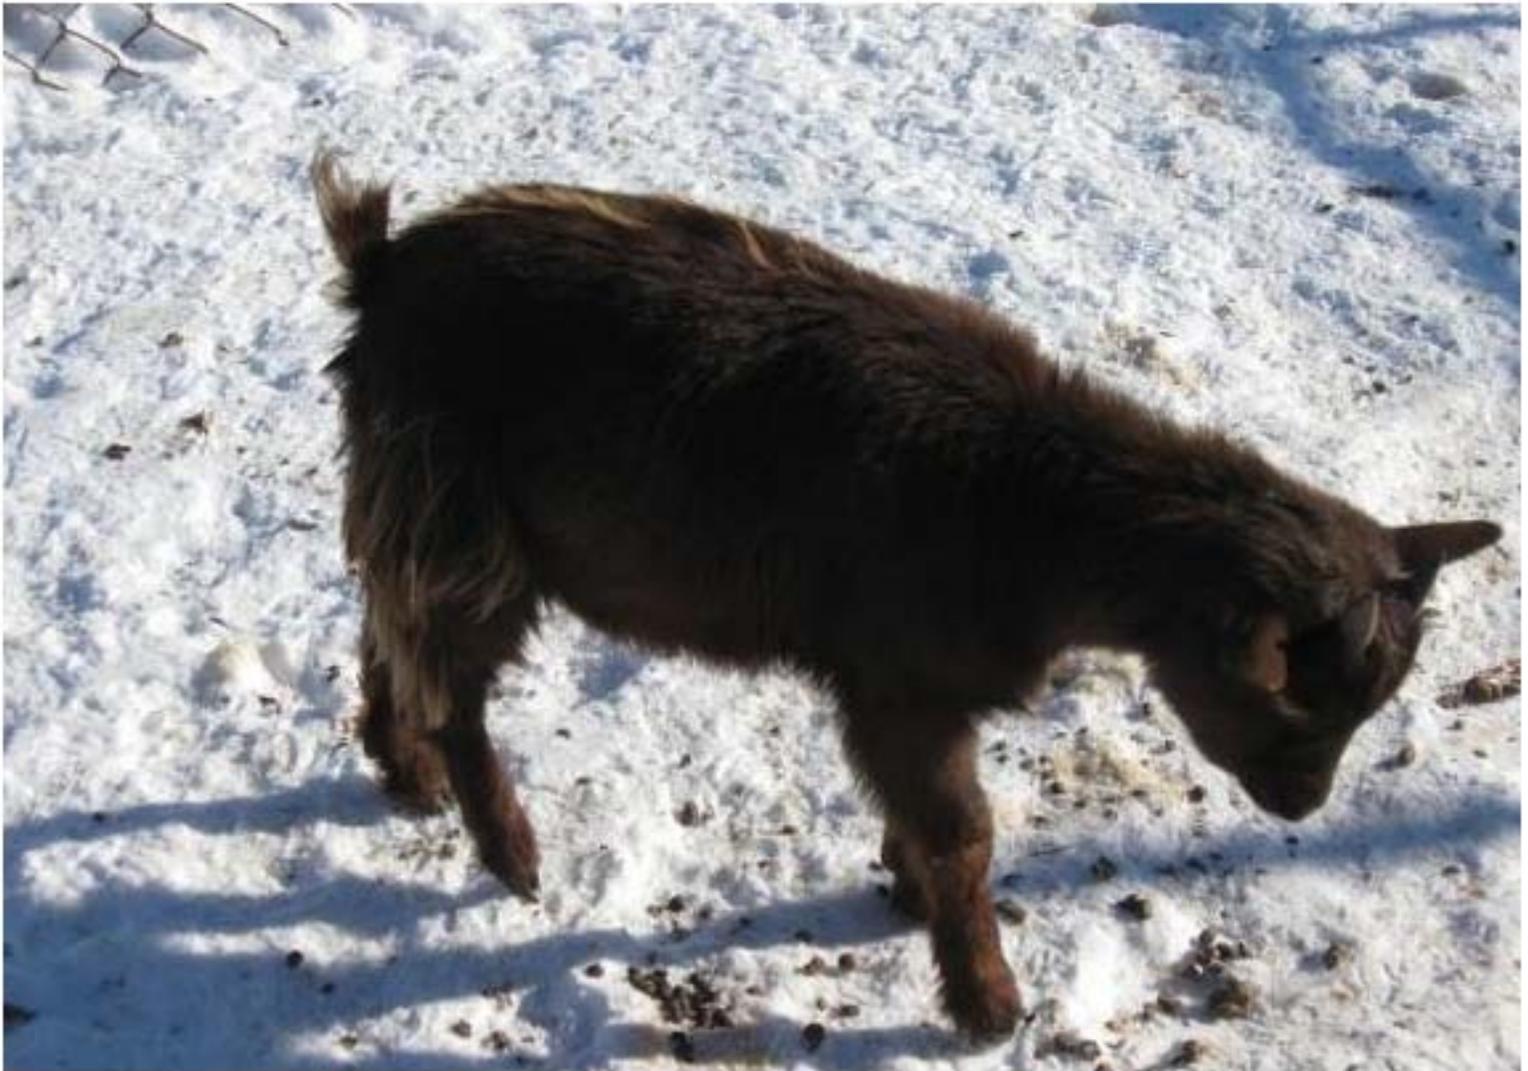
CFR: 2.40 (b) (2)

Photographer:	Chad Moore	Legal Name:	Registration:	42-C-0081
Photo Taken:	Wed, Dec 8, '10	Approximately 11:30	JOYCE DE COCK	
Inspection:	342101854230123	RICHARD DE COCK		
Description:	Brown and tan goat limping, not bearing full weight on right hind limb.

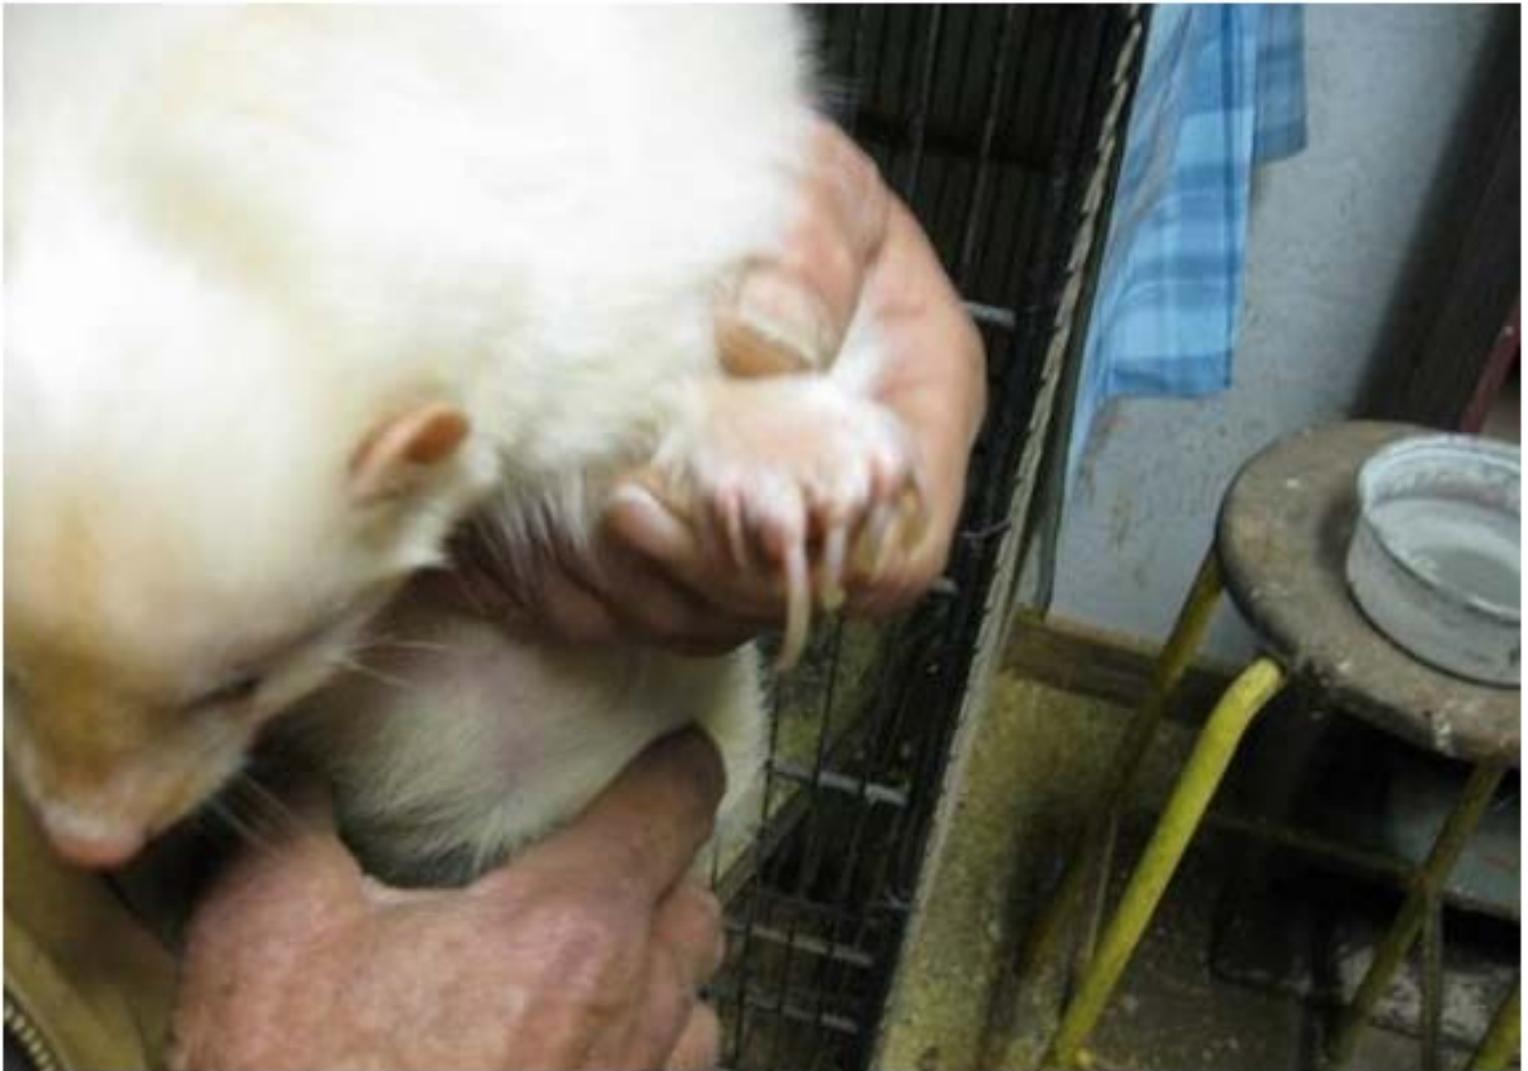
CFR: 2.40 (b) (2)

Photographer:	Chad Moore	Legal Name:	Registration:	42-C-0081
Photo Taken:	Wed, Dec 8, '10	Approximately 11:30	JOYCE DE COCK	
Inspection:	342101854230123	RICHARD DE COCK		
Description:	Excessively long skunk nails

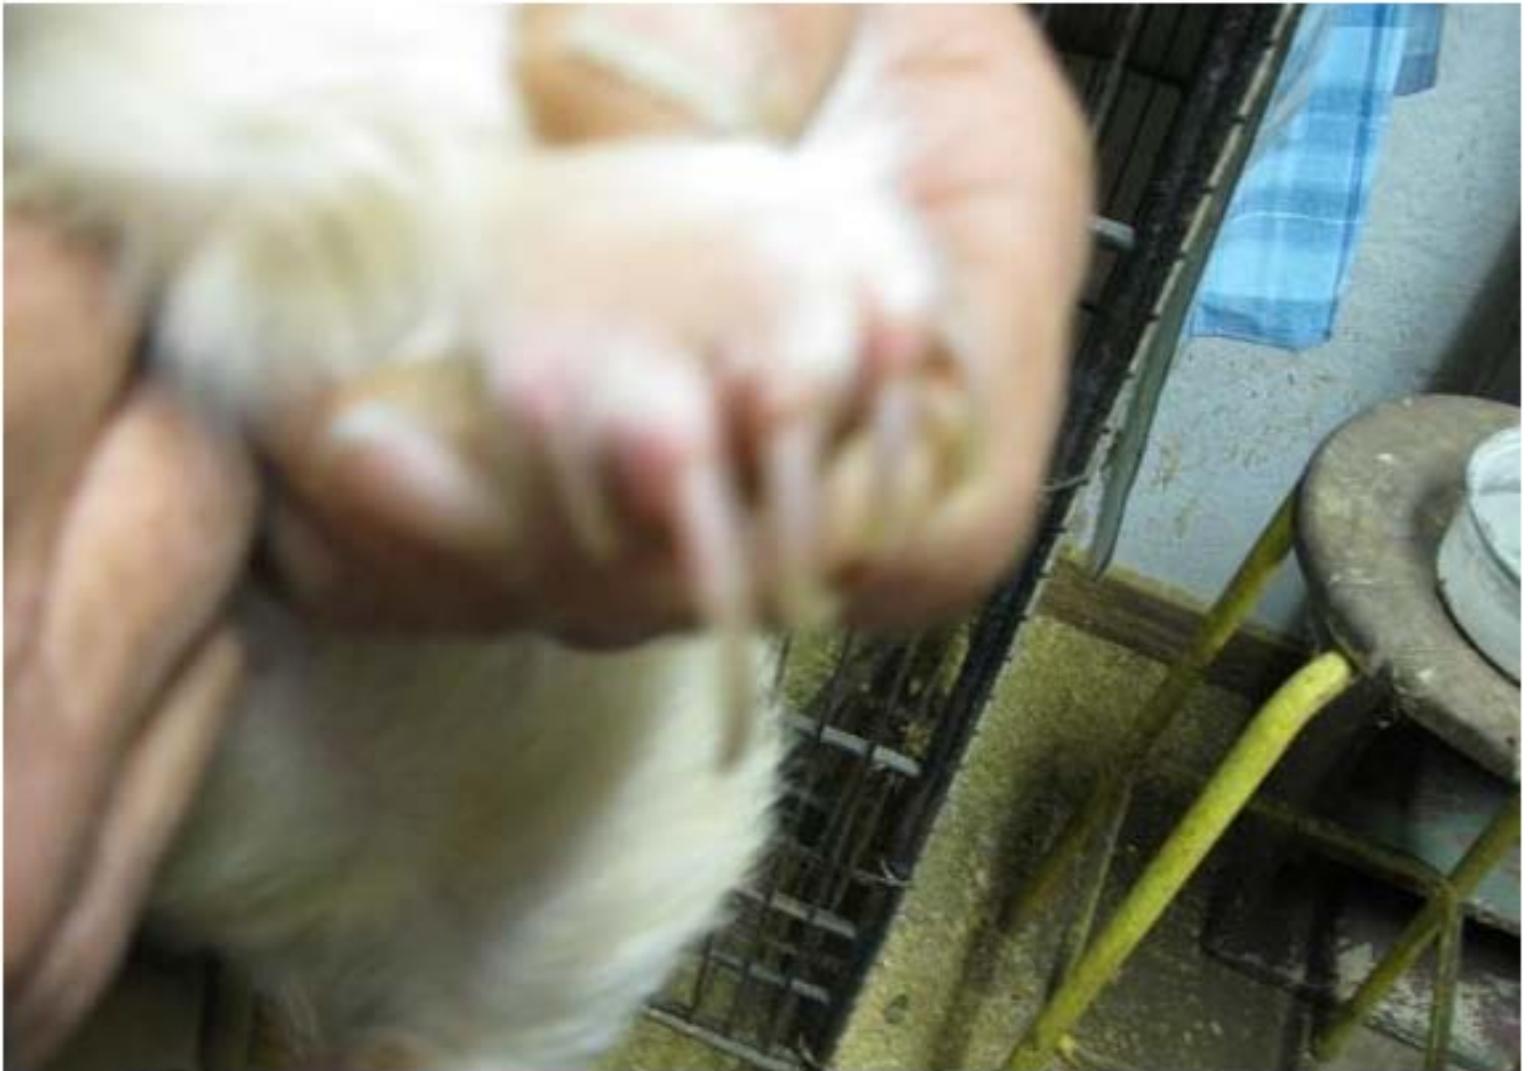
CFR: 2.40 (b) (2)

Photographer:	Chad Moore	Legal Name:	Registration:	42-C-0081
Photo Taken:	Wed, Dec 8, '10	Approximately 11:30	JOYCE DE COCK	
Inspection:	342101854230123	RICHARD DE COCK		
Description:	Excessively long skunk nails

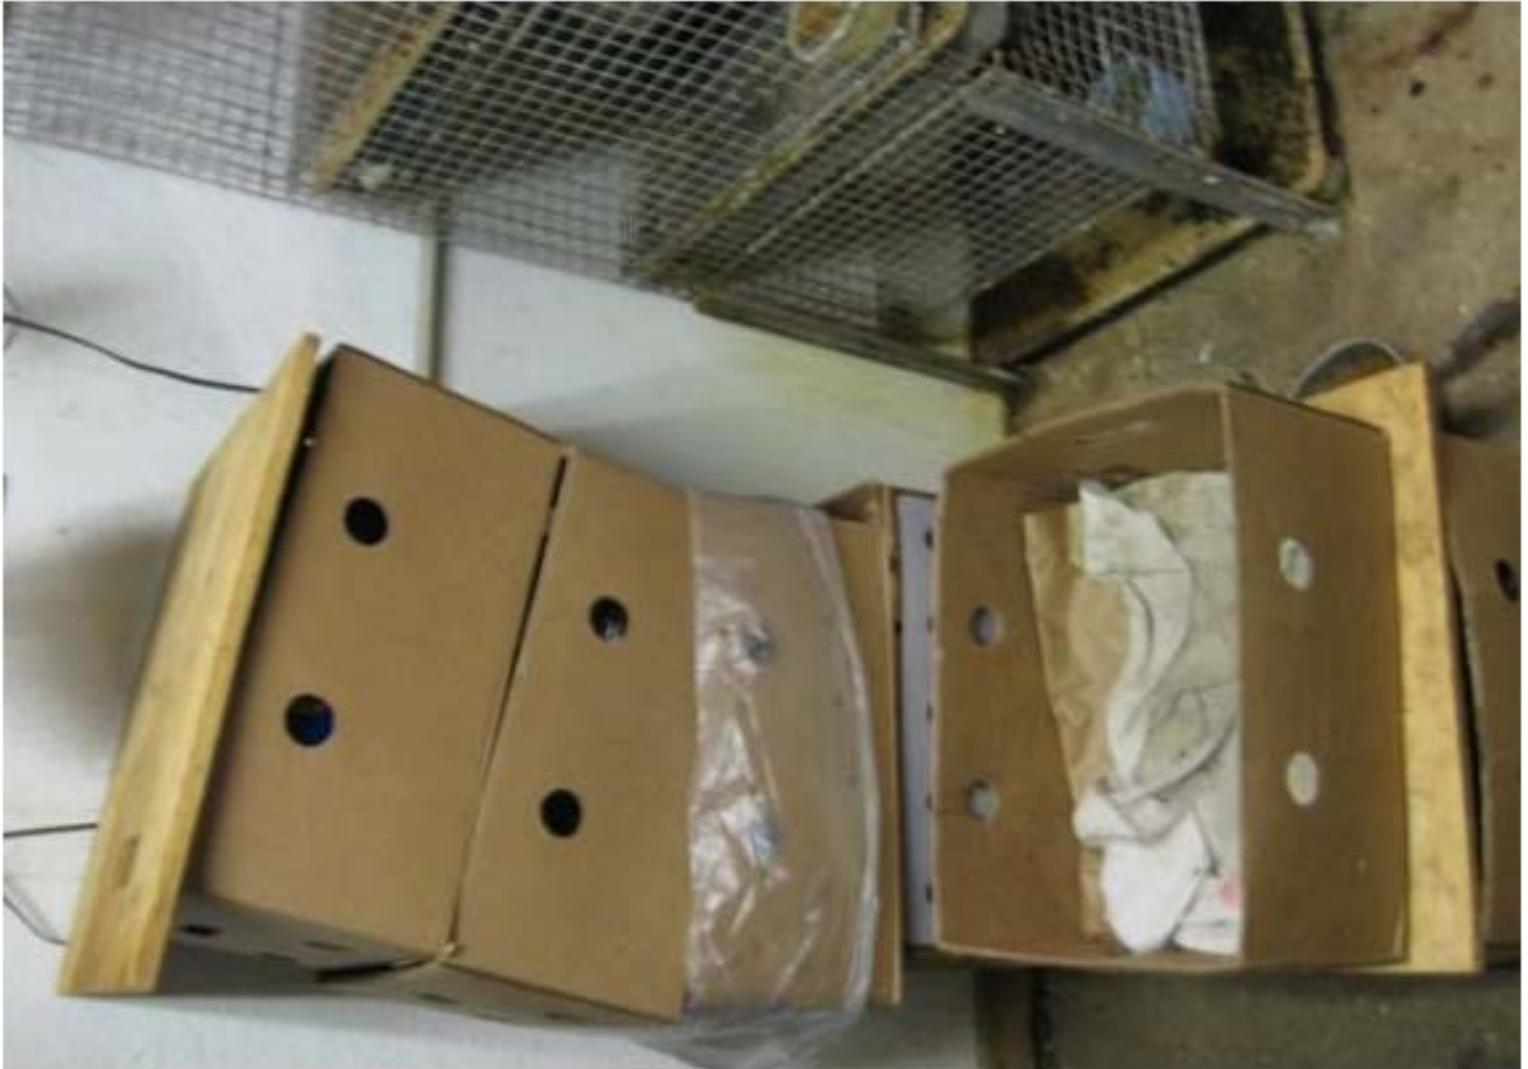
Photographer:	Chad Moore	Legal Name:	Registration:	42-C-0081
Photo Taken:	Wed, Dec 8, '10	Approximately 11:30	JOYCE DE COCK	
Inspection:	342101854230123	RICHARD DE COCK		
Description:	Eight boxes of produce stored inappropriately inside of animal room against the wall and on the floor.

CFR: 3.75 (e)

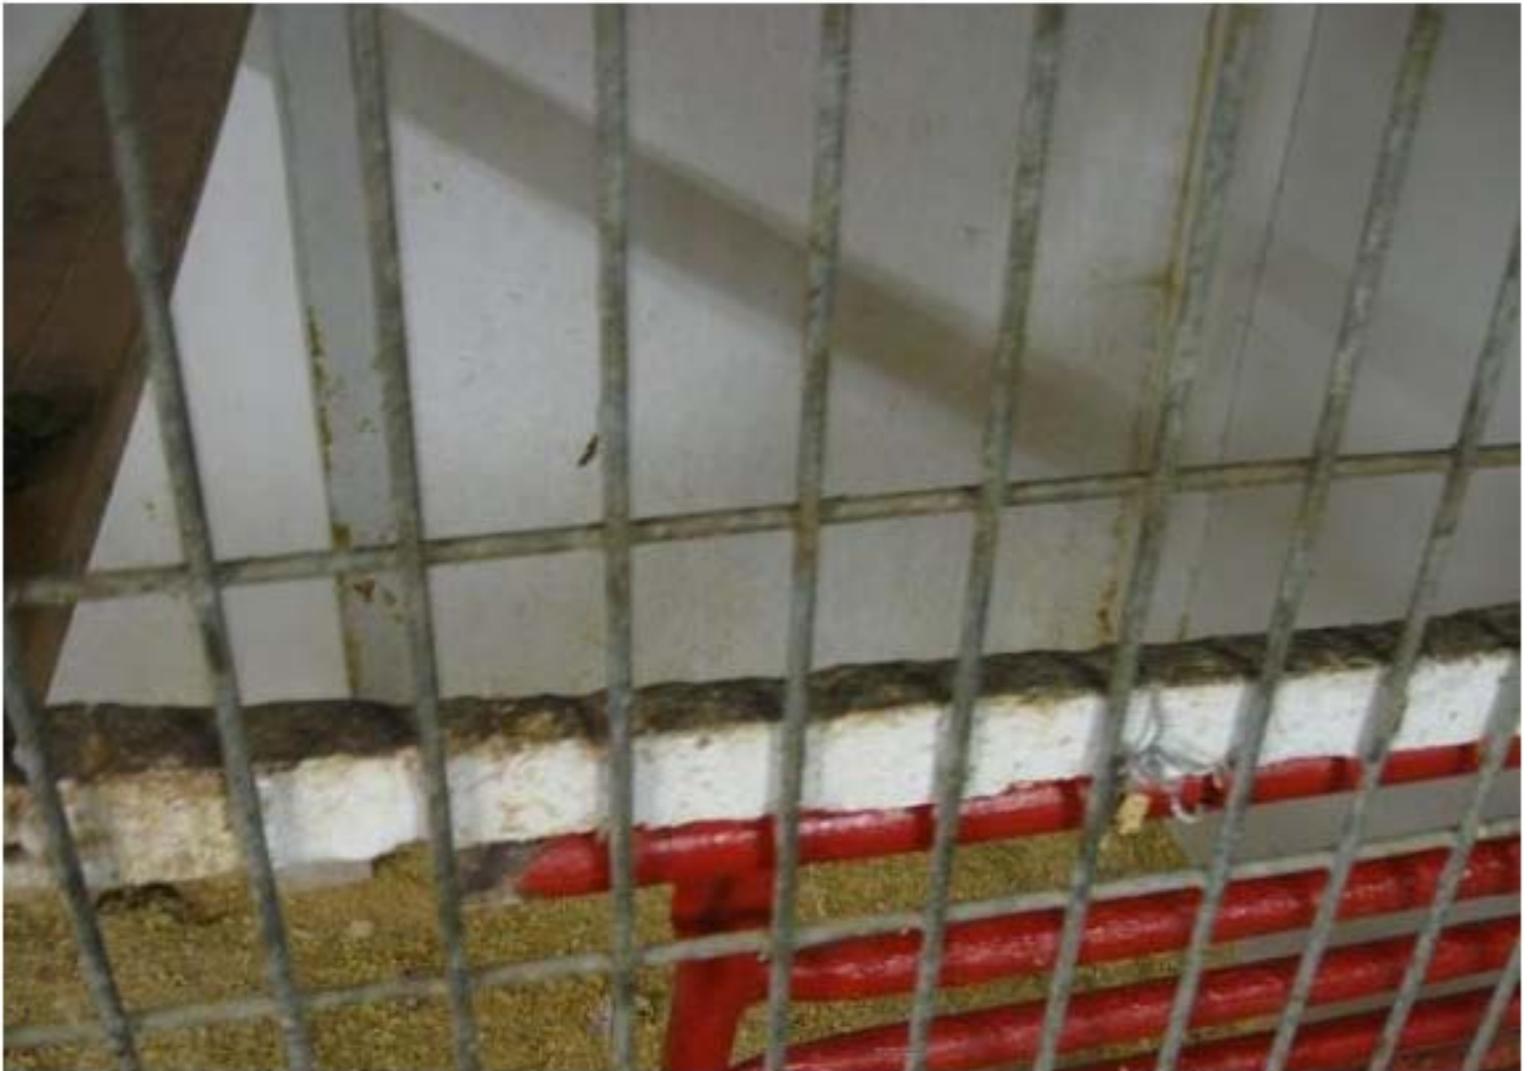
Photographer:	Chad Moore	Legal Name:	Registration:	42-C-0081
Photo Taken:	Wed, Dec 8, '10	Approximately 11:30	JOYCE DE COCK	
Inspection:	342101854230123	RICHARD DE COCK		
Description:	Structurally unsound sheep sheep shelter

CFR: 3.80 (a)

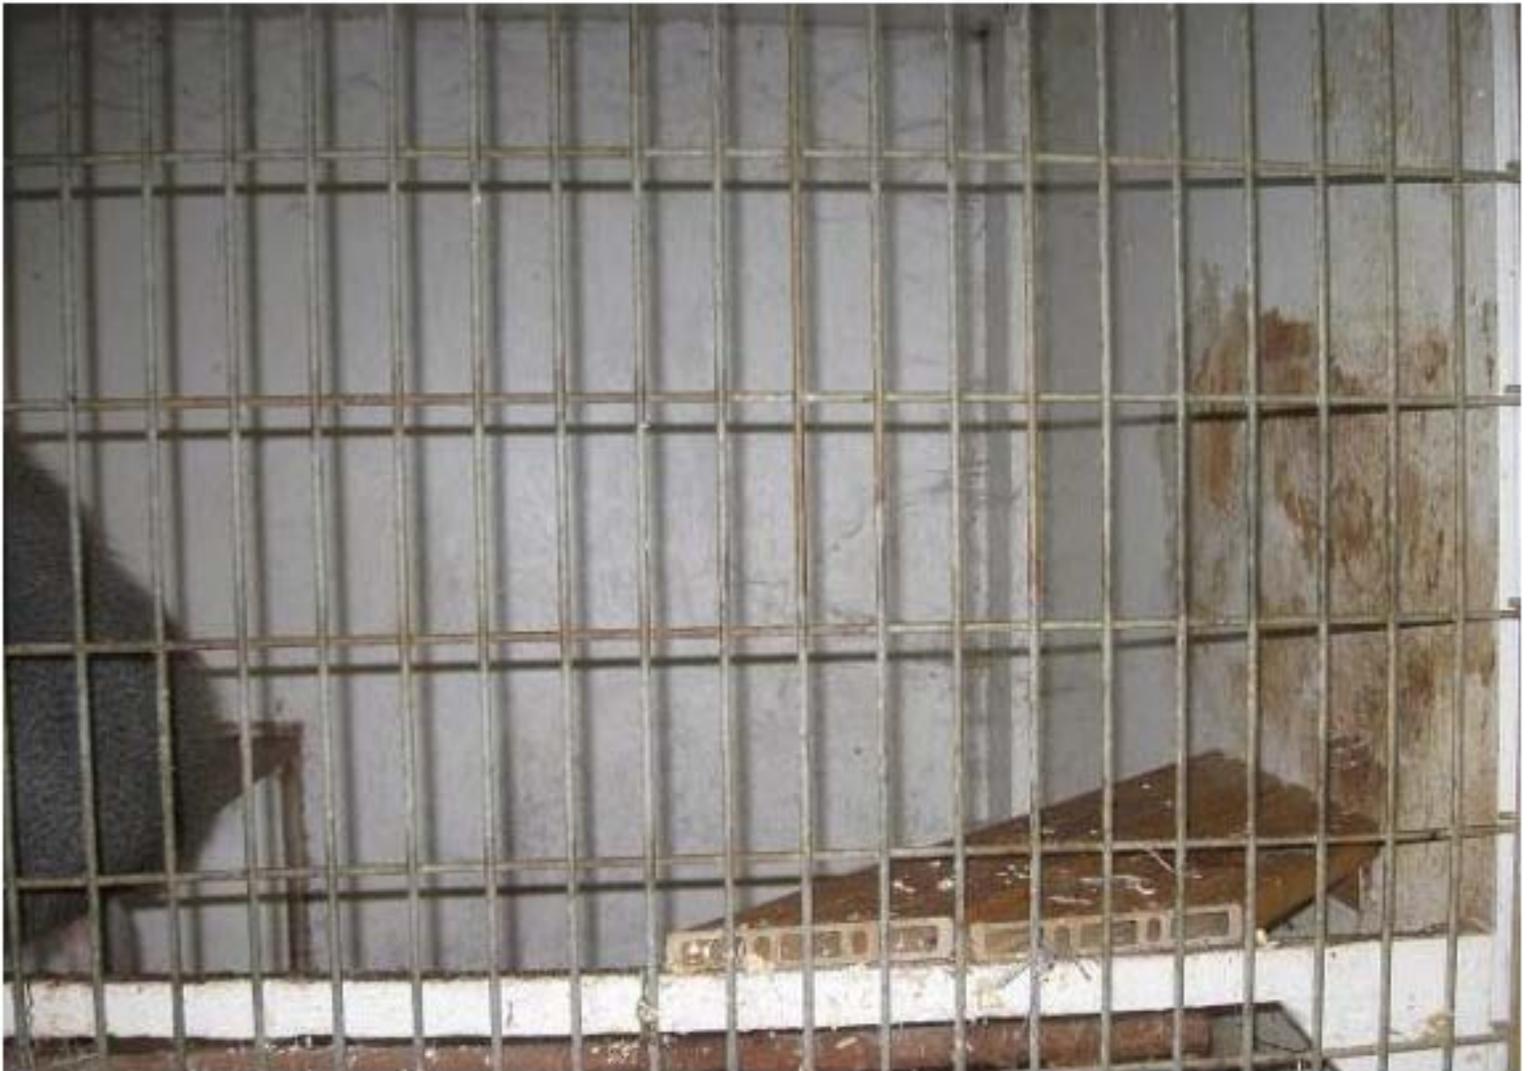
Photographer:	Chad Moore	Legal Name:	Registration:	42-C-0081
Photo Taken:	Mon, Aug 30, '10	Approximately 12:00	JOYCE DE COCK	
Inspection:	237102249530984	RICHARD DE COCK		
Description:	Unsealed, exposed wood on shelves and wall of vervet enclosure

CFR: 3.80 (a)

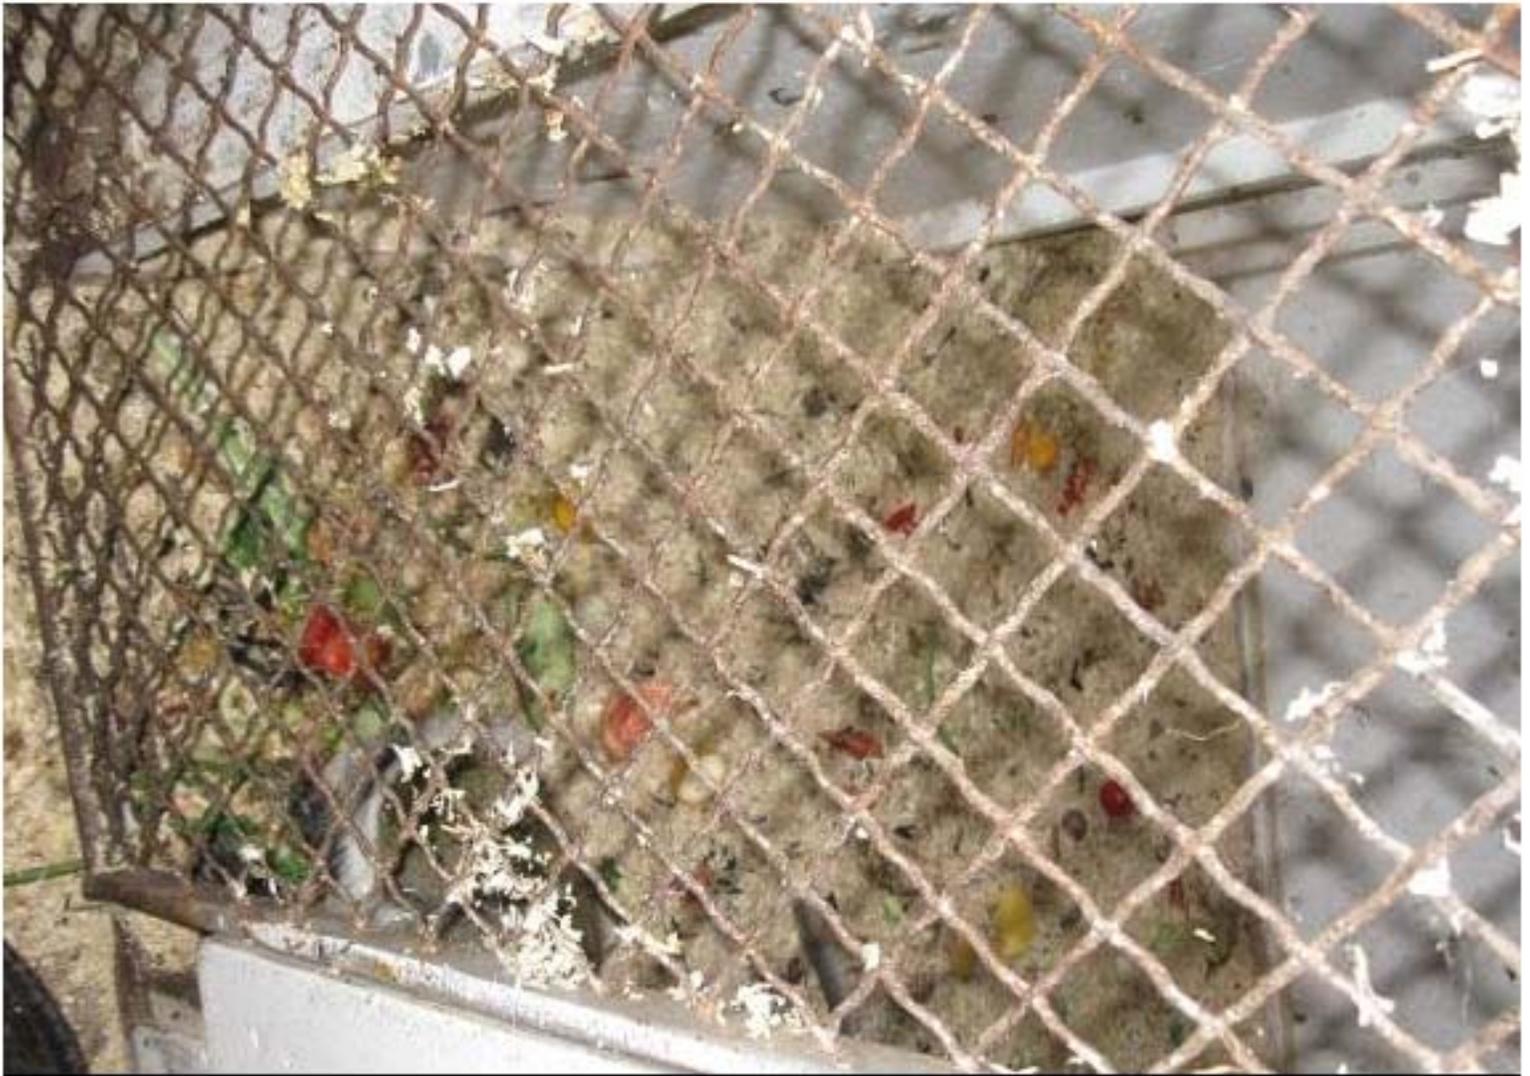
Photographer:	Chad Moore	Legal Name:	Registration:	42-C-0081
Photo Taken:	Wed, Aug 25, '10 Approximately 12:00	JOYCE DE COCK RICHARD DE COCK		
Inspection:	237102249530984			
Description:	Exposed, unsealed wood in male baboon enclosure

CFR: 3.80 (a)

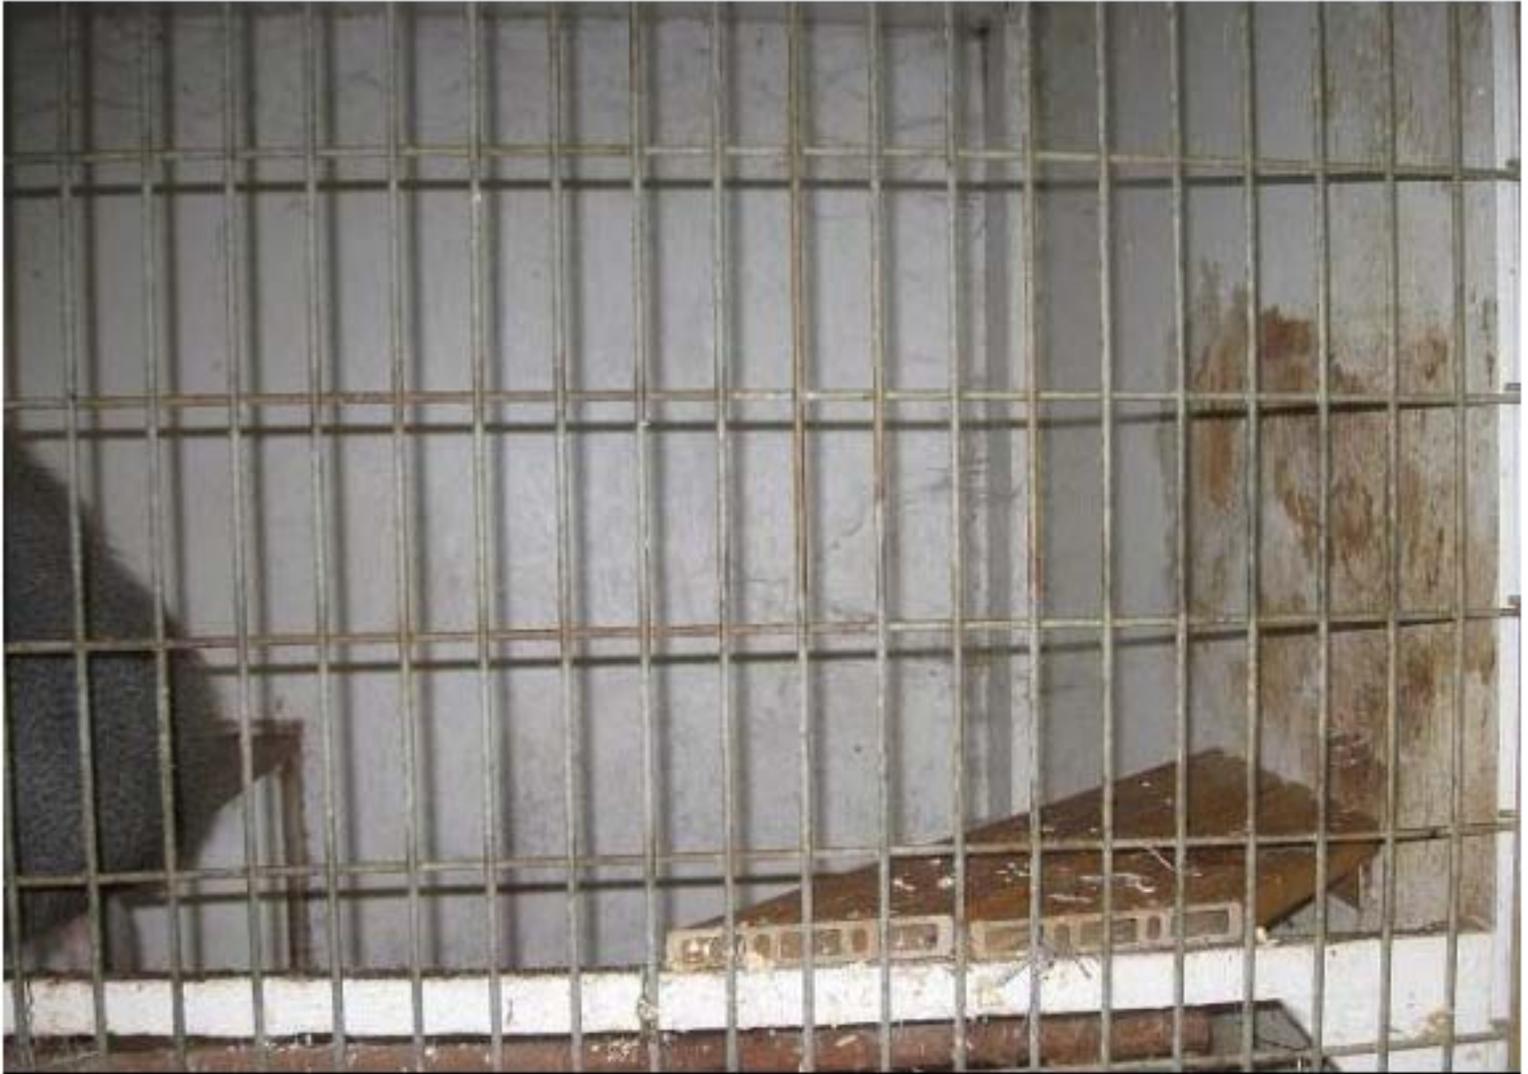
Photographer:	Chad Moore	Legal Name:	Registration:	42-C-0081
Photo Taken:	Wed, Aug 25, '10 Approximately 12:00	JOYCE DE COCK RICHARD DE COCK		
Inspection:	237102249530984			
Description:	Exposed, unsealed wood in male baboon enclosure

CFR: 3.80 (a)

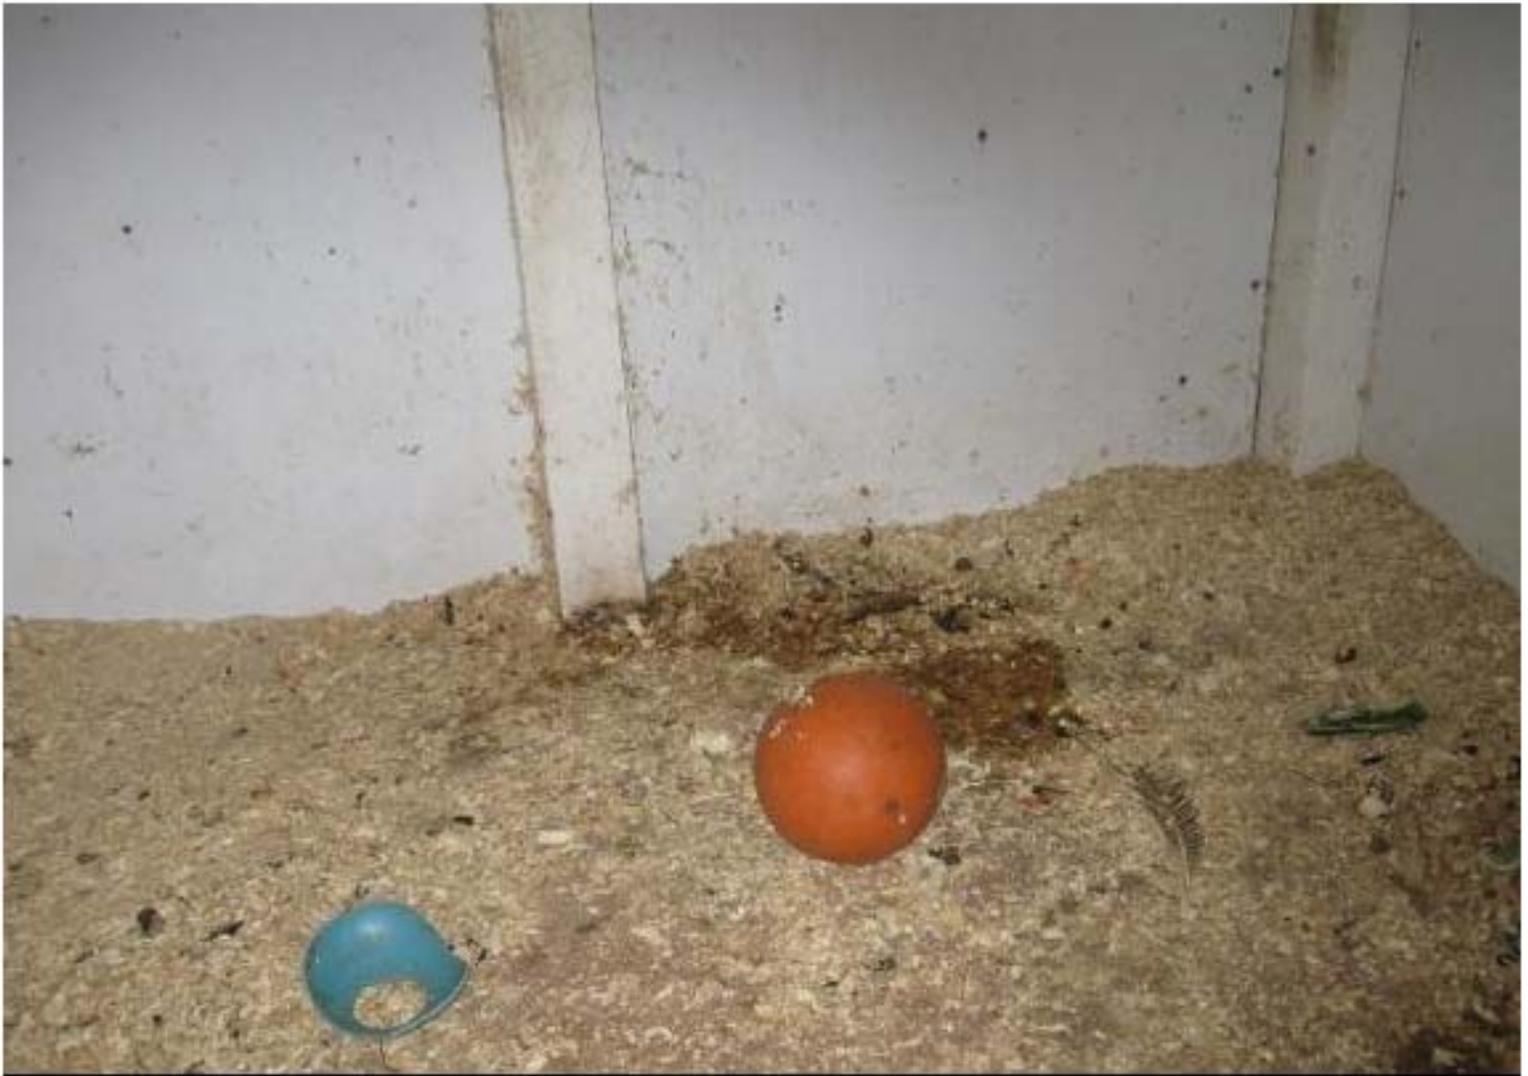
Photographer: Chad Moore      Legal Name: JOYCE DE COCK      Registration: 42-C-0081  
Photo Taken: Wed, Aug 25, '10    Approximately 12:00    RICHARD DE COCK  
Inspection: 237102249530984  
Description: Inadequate, unapproved enrichment plan for the nonhuman primates at the facility

CFR: 3.84(a)
