Photographer: Heather Cole, VMO      Legal Name: PAMELA SELLNER      Registration: 42-C-0084  
Photo Taken: Mon, Nov 22, '10 approximately 1100      TOM SELLNER  
Inspection: 326101741280061  
Description:

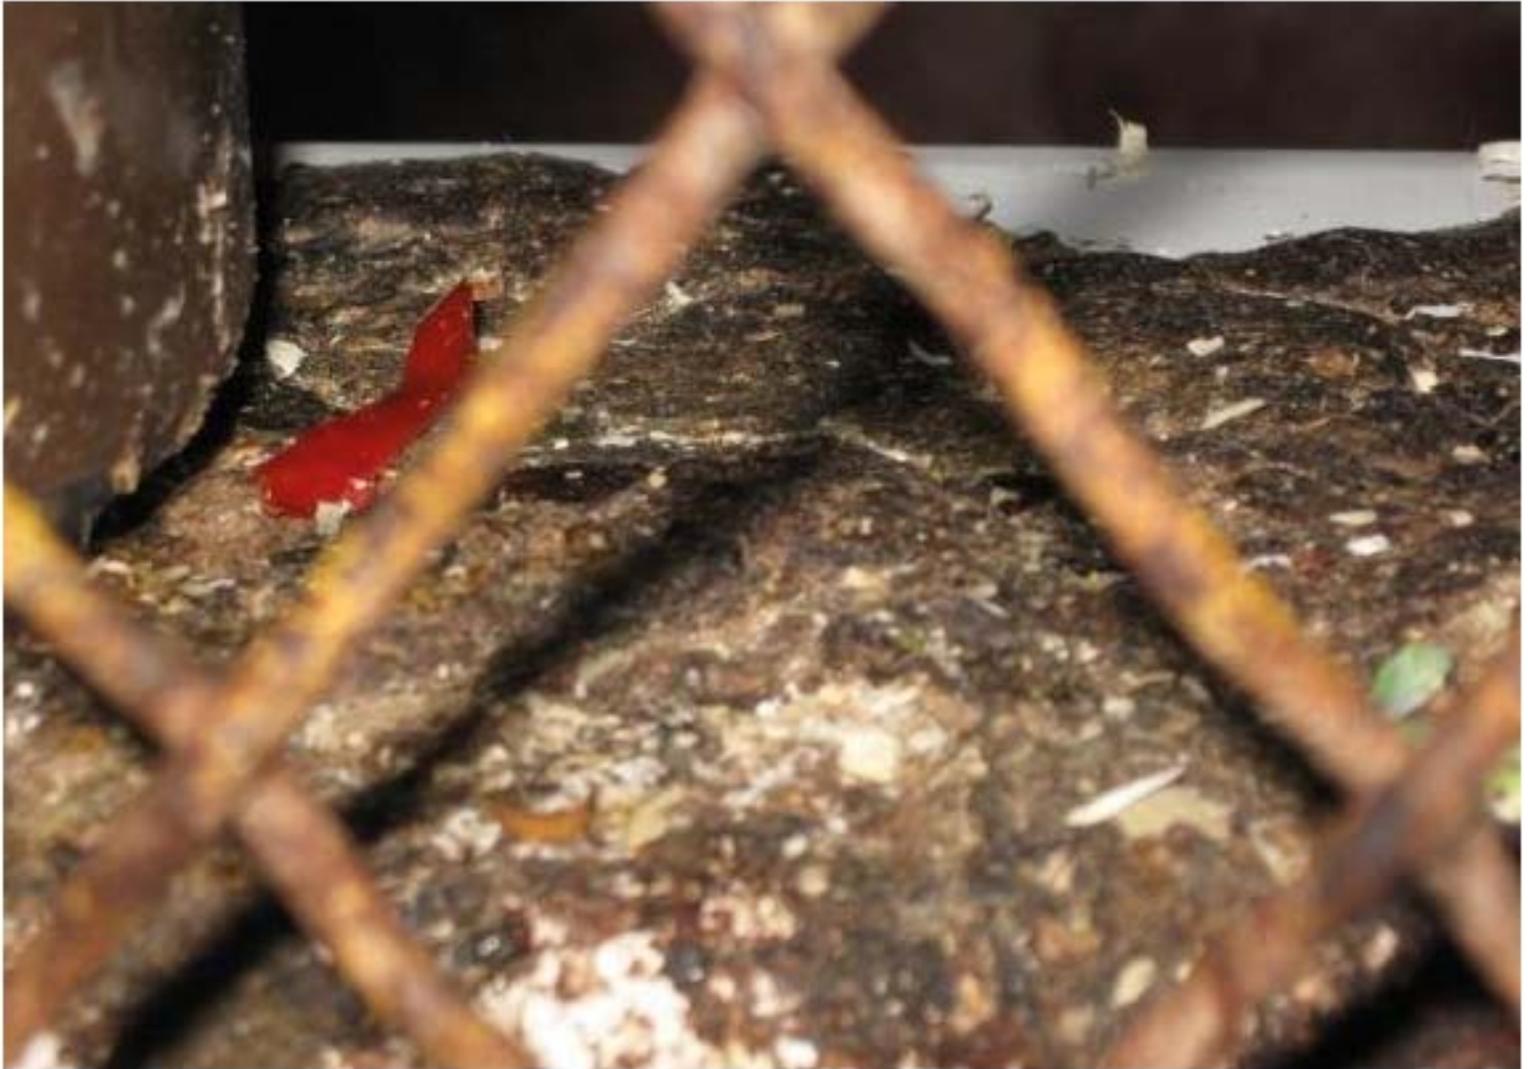
Photographer:	Chad Moore	Legal Name:	Registration:	42-C-0081
Photo Taken:	Wed, Aug 25, '10 Approximately 12:00	JOYCE DE COCK RICHARD DE COCK		
Inspection:	237102249530984			
Description:	Excessive food wastes, feces in male macaque enclosure

CFR: 3.84 (a)

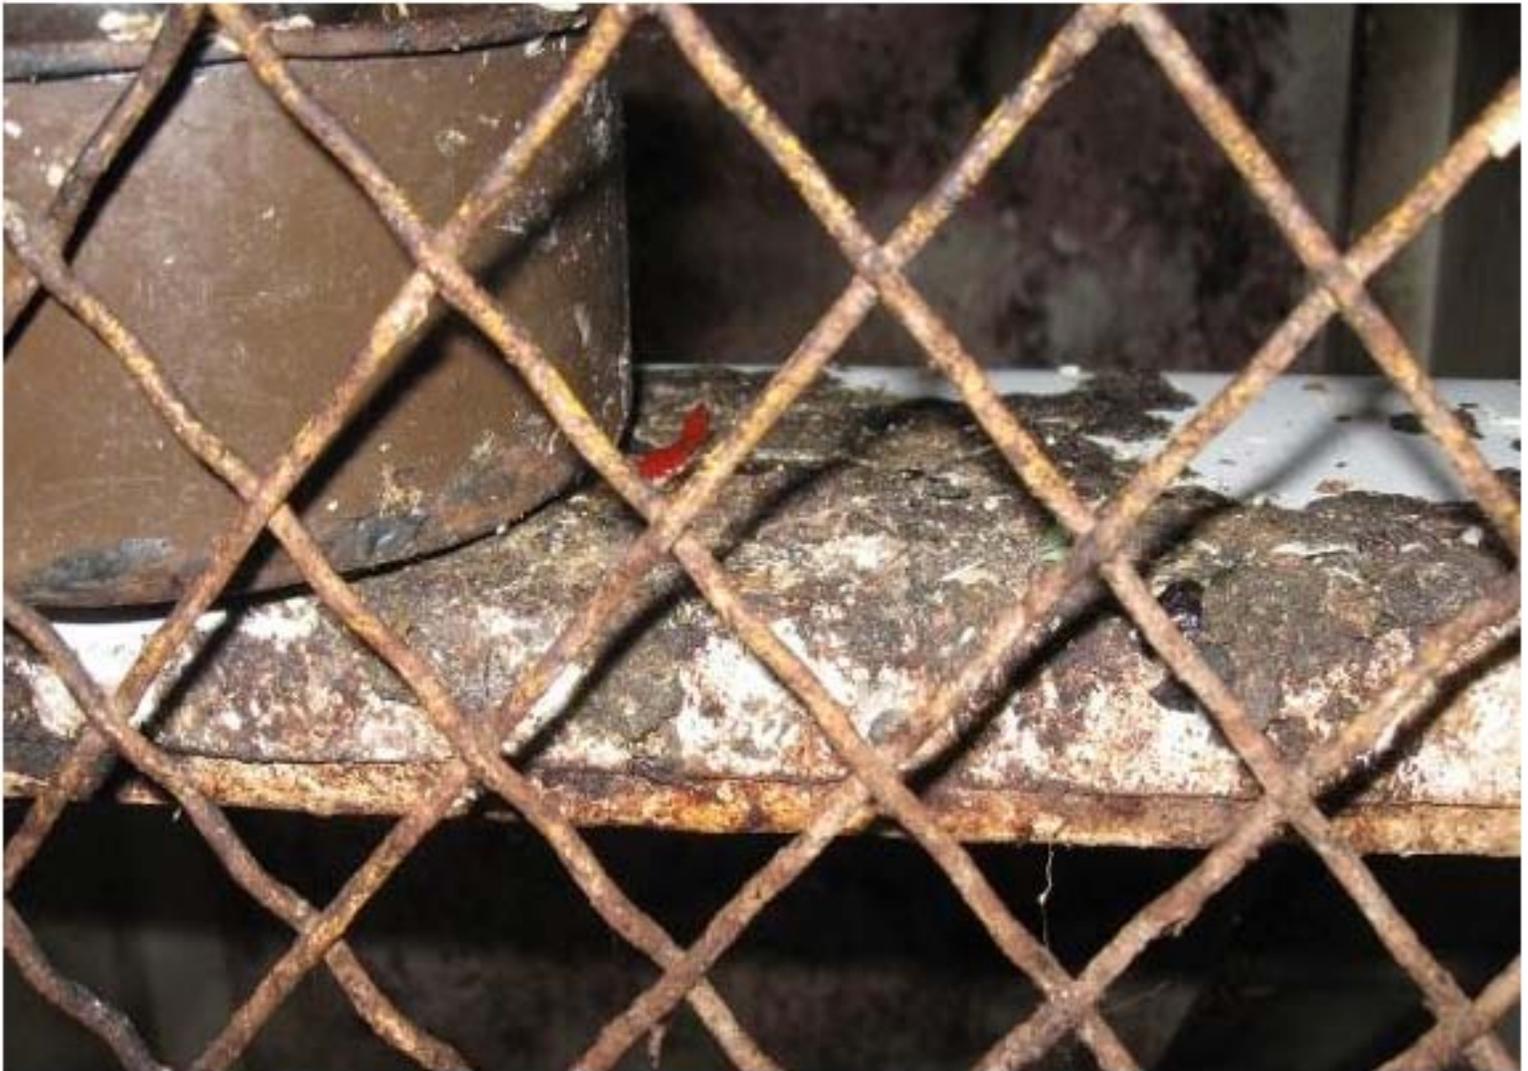
Photographer:	Chad Moore	Legal Name:	Registration:	42-C-0081
Photo Taken:	Wed, Aug 25, '10 Approximately 12:00	JOYCE DE COCK RICHARD DE COCK		
Inspection:	237102249530984			
Description:	Excessive food wastes, feces on shelf in vervet enclosure

CFR: 3.84 (a)

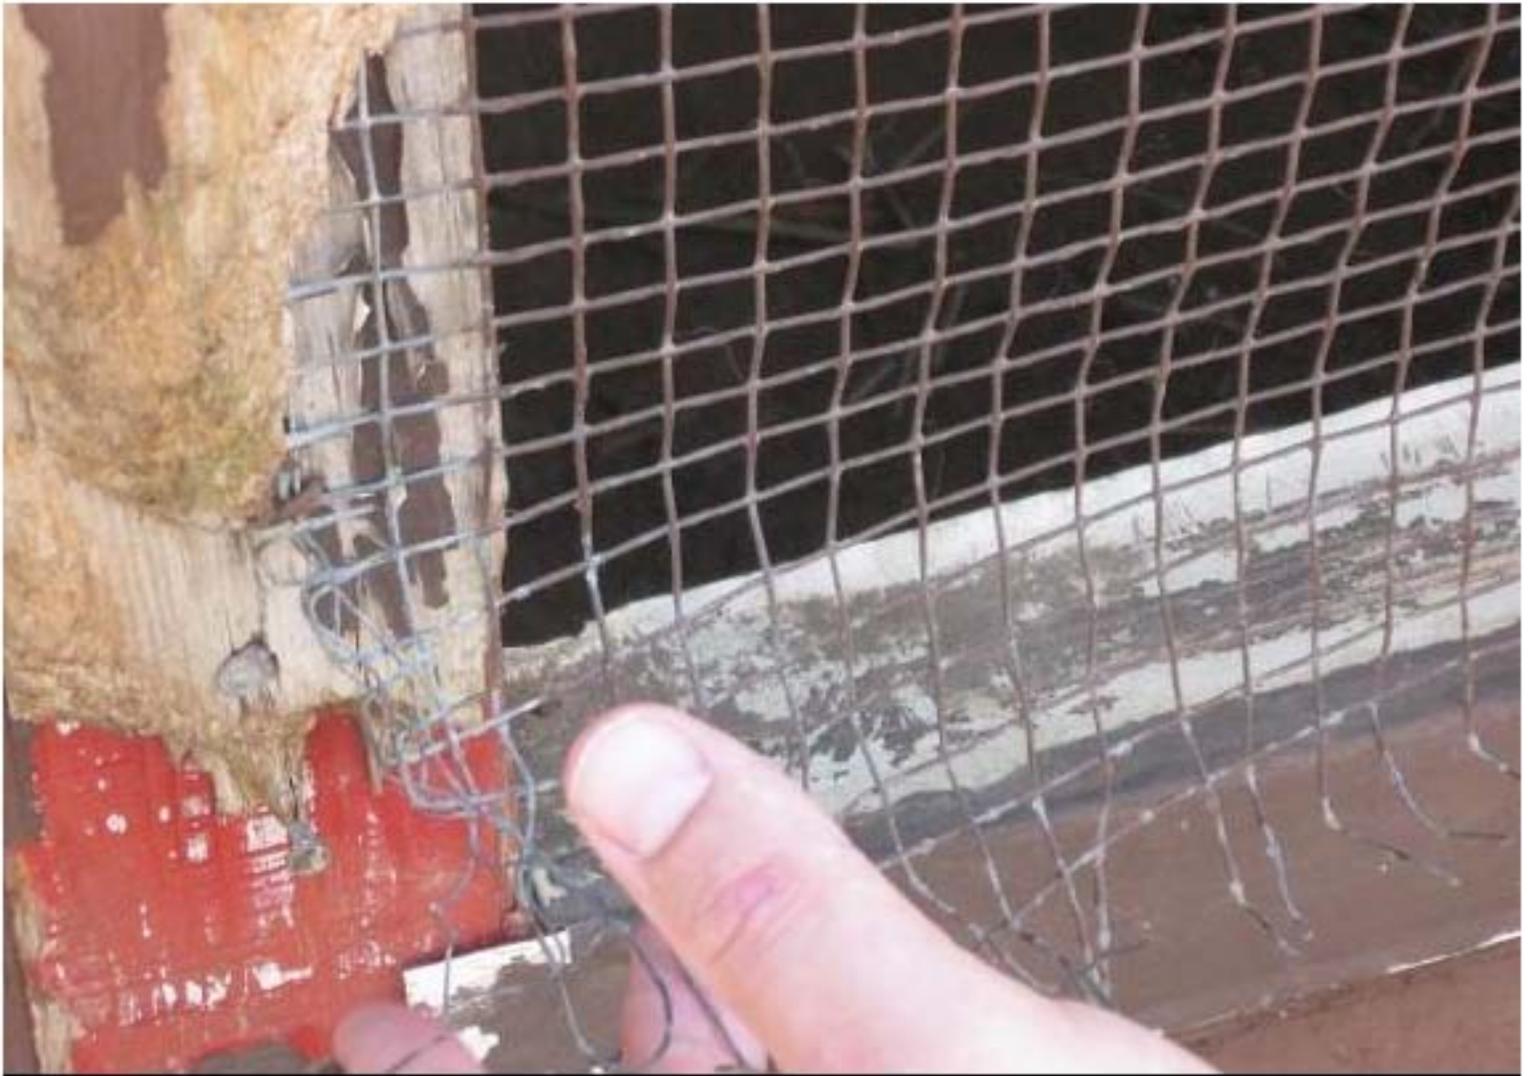
Photographer:	Chad Moore	Legal Name:	Registration:	42-C-0081
Photo Taken:	Wed, Aug 25, '10 Approximately 12:00	JOYCE DE COCK RICHARD DE COCK		
Inspection:	237102249530984			
Description:	Unattached, sharp wire on window of cavy enclosure located in sheep pasture.

CFR: 3.125 (a)

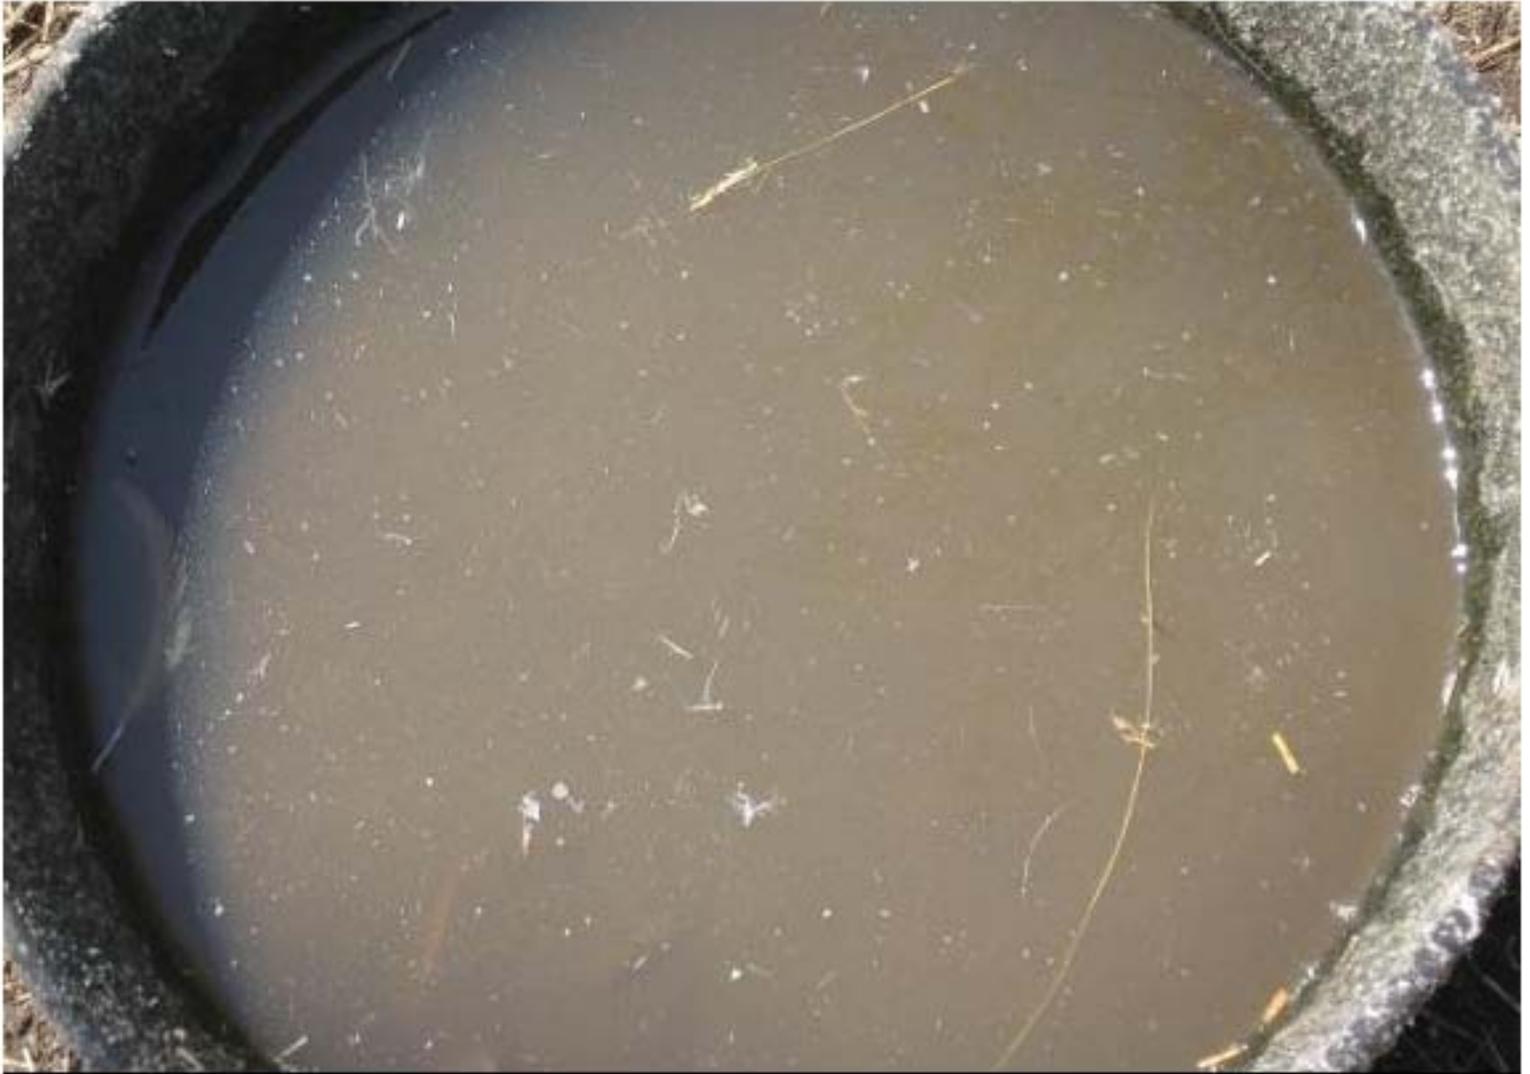
CFR: 3.130

Photographer:	Chad Moore	Legal Name:	Registration:	42-C-0081
Photo Taken:	Wed, Aug 25, '10 Approximately 12:00	JOYCE DE COCK RICHARD DE COCK		
Inspection:	237102249530984			
Description:	Filthy sheep water receptacle

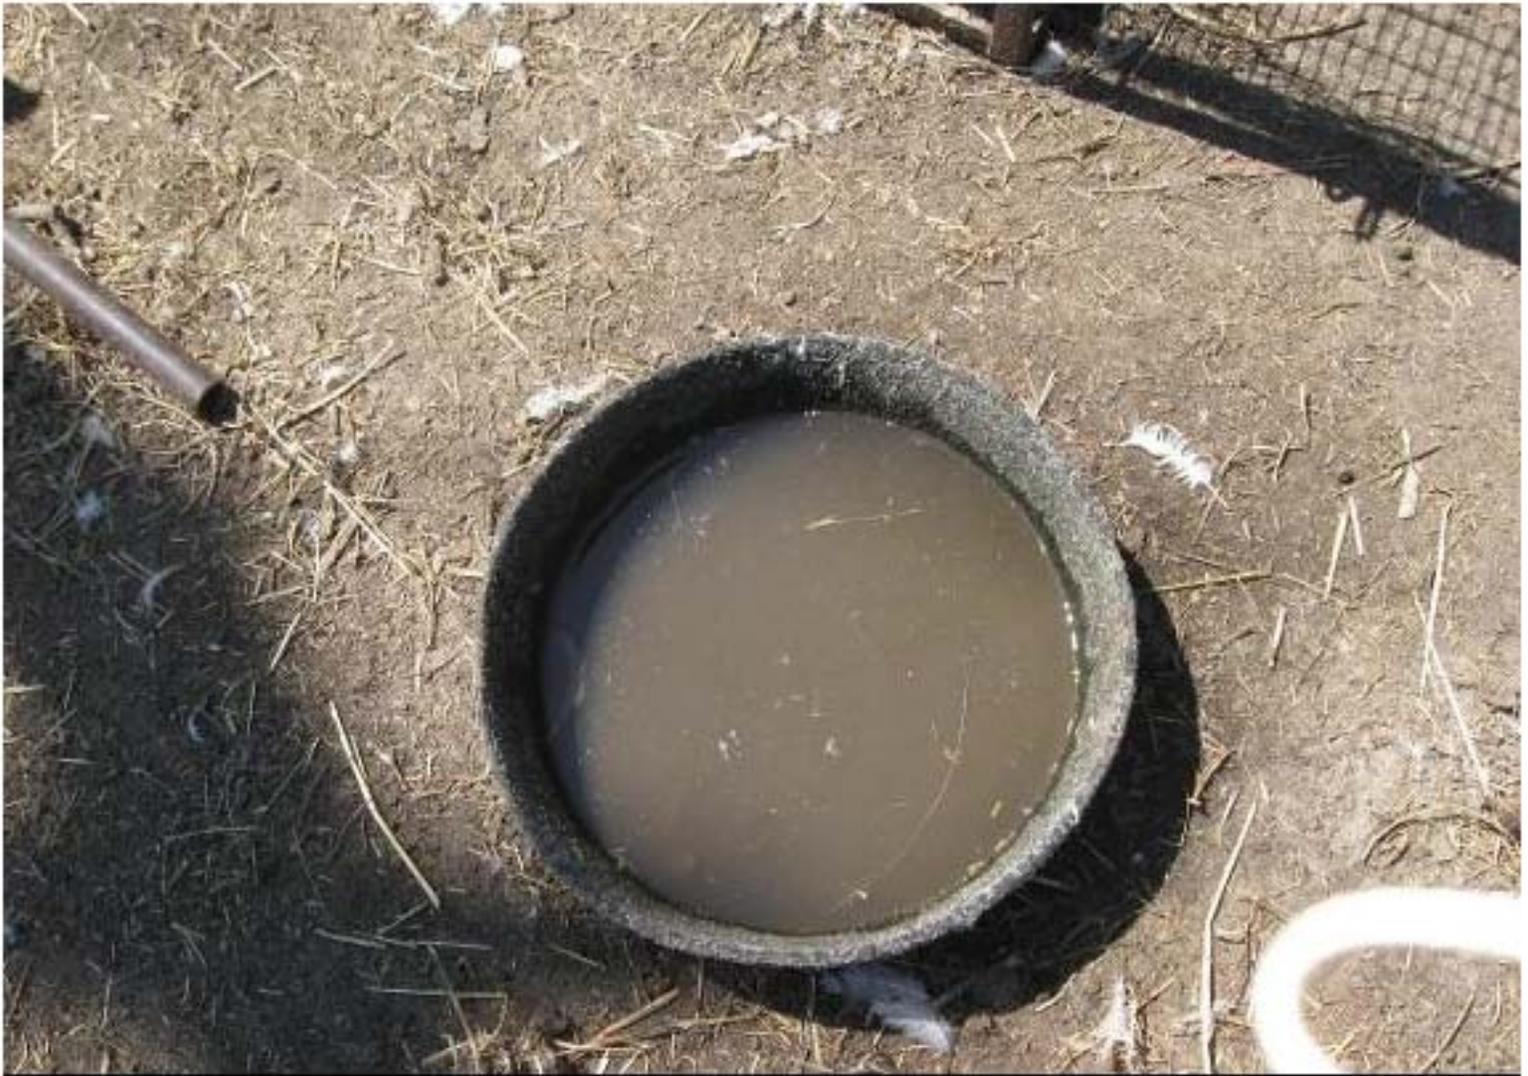
CFR: 3.130

Photographer:	Chad Moore	Legal Name:	Registration:	42-C-0081
Photo Taken:	Wed, Aug 25, '10 Approximately 12:00	JOYCE DE COCK RICHARD DE COCK		
Inspection:	237102249530984			
Description:	Filthy sheep water receptacle

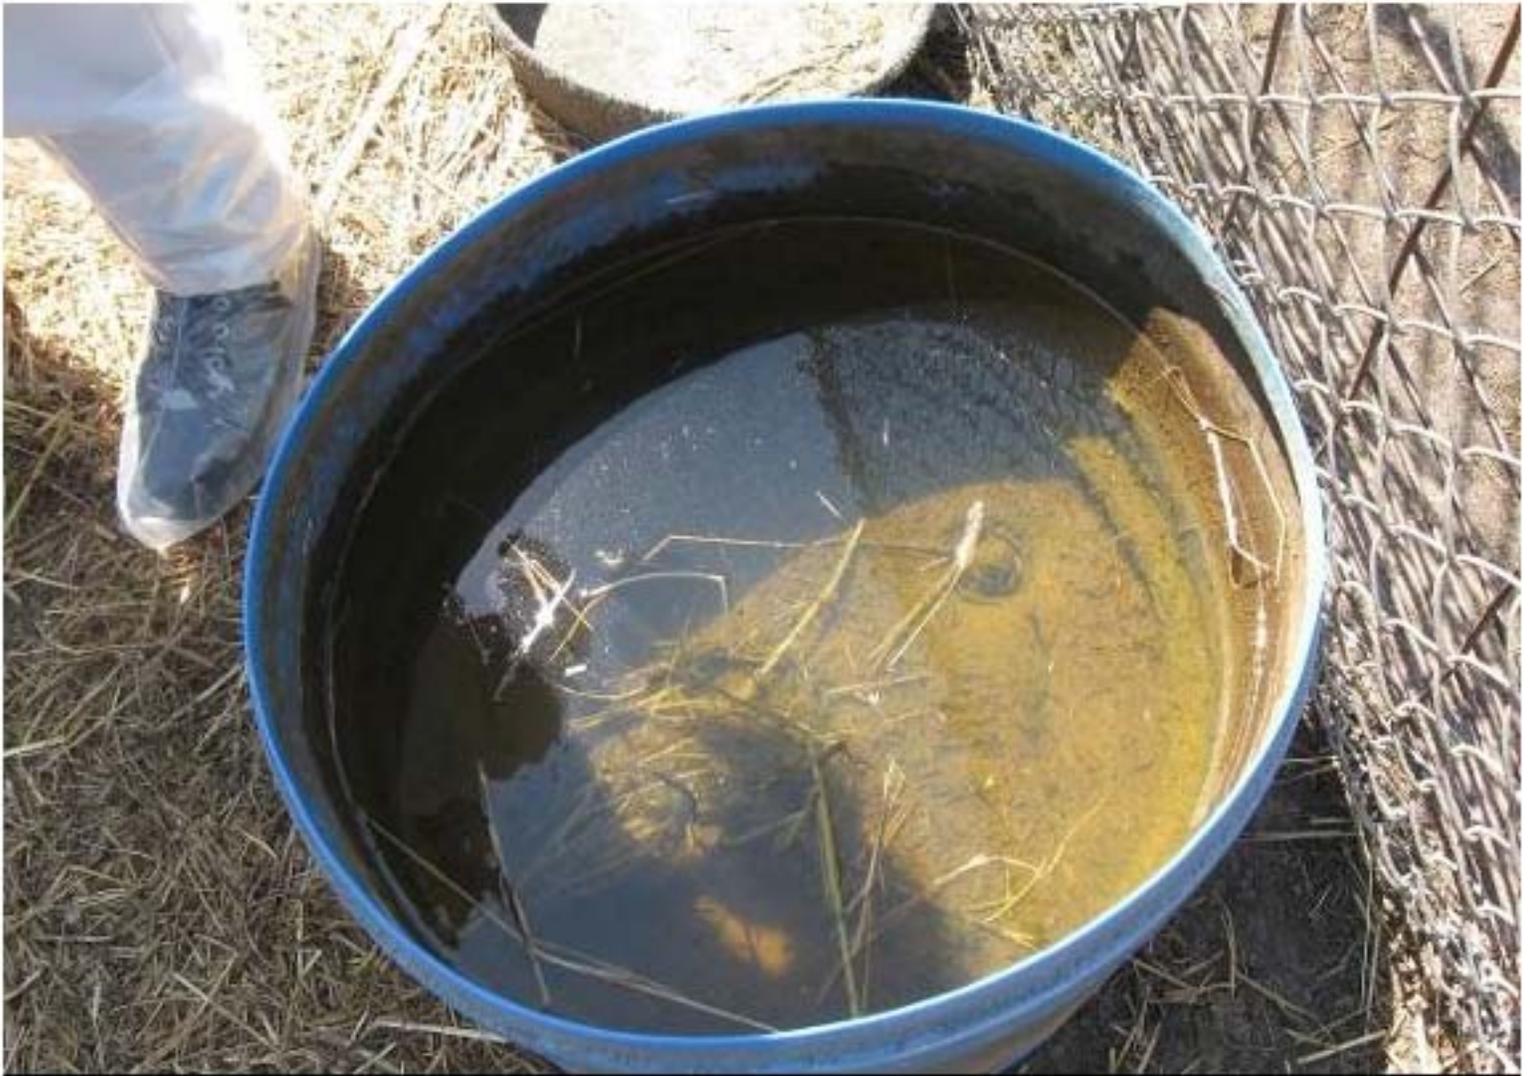
CFR: 3.130

Photographer:	Chad Moore	Legal Name:	Registration:	42-C-0081
Photo Taken:	Wed, Aug 25, '10 Approximately 12:00	JOYCE DE COCK RICHARD DE COCK		
Inspection:	237102249530984			
Description:	Filthy goat water receptacle

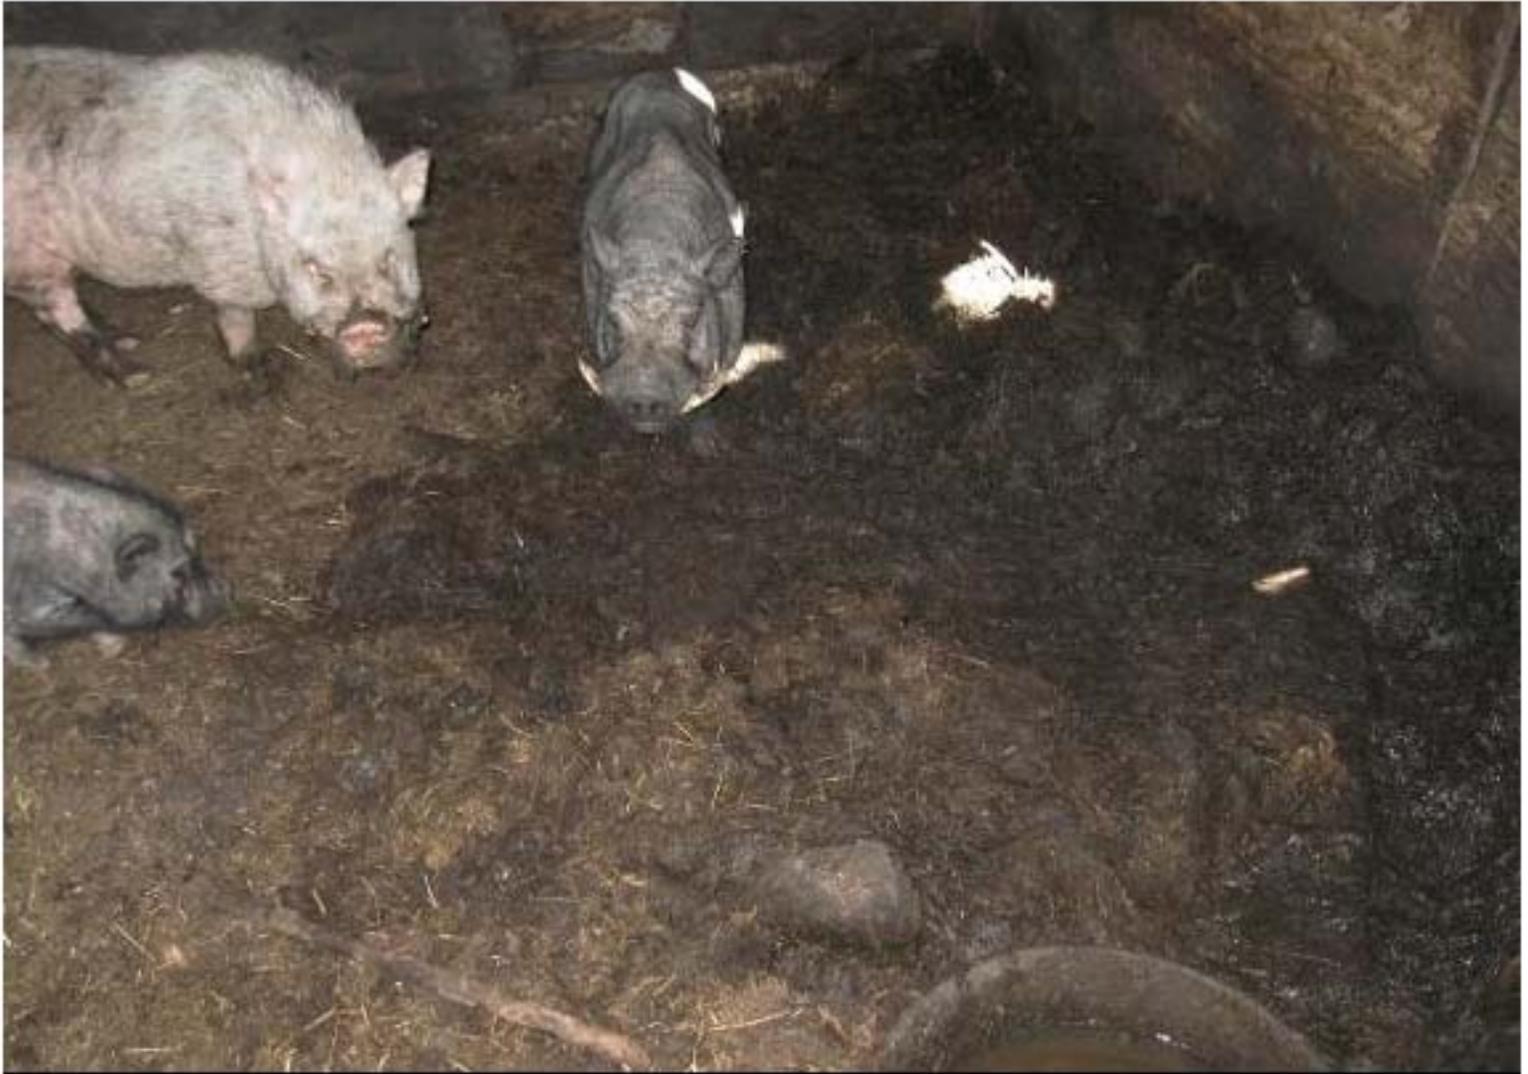
CFR: 3.130, 3.131 (a)

Photographer:	Chad Moore	Legal Name:	Registration:	42-C-0081
Photo Taken:	Wed, Aug 25, '10 Approximately 12:00	JOYCE DE COCK RICHARD DE COCK		
Inspection:	237102249530984			
Description:	Filthy pot bellied pig water receptacle. Feces and mud covered floor of stall/enclosure.

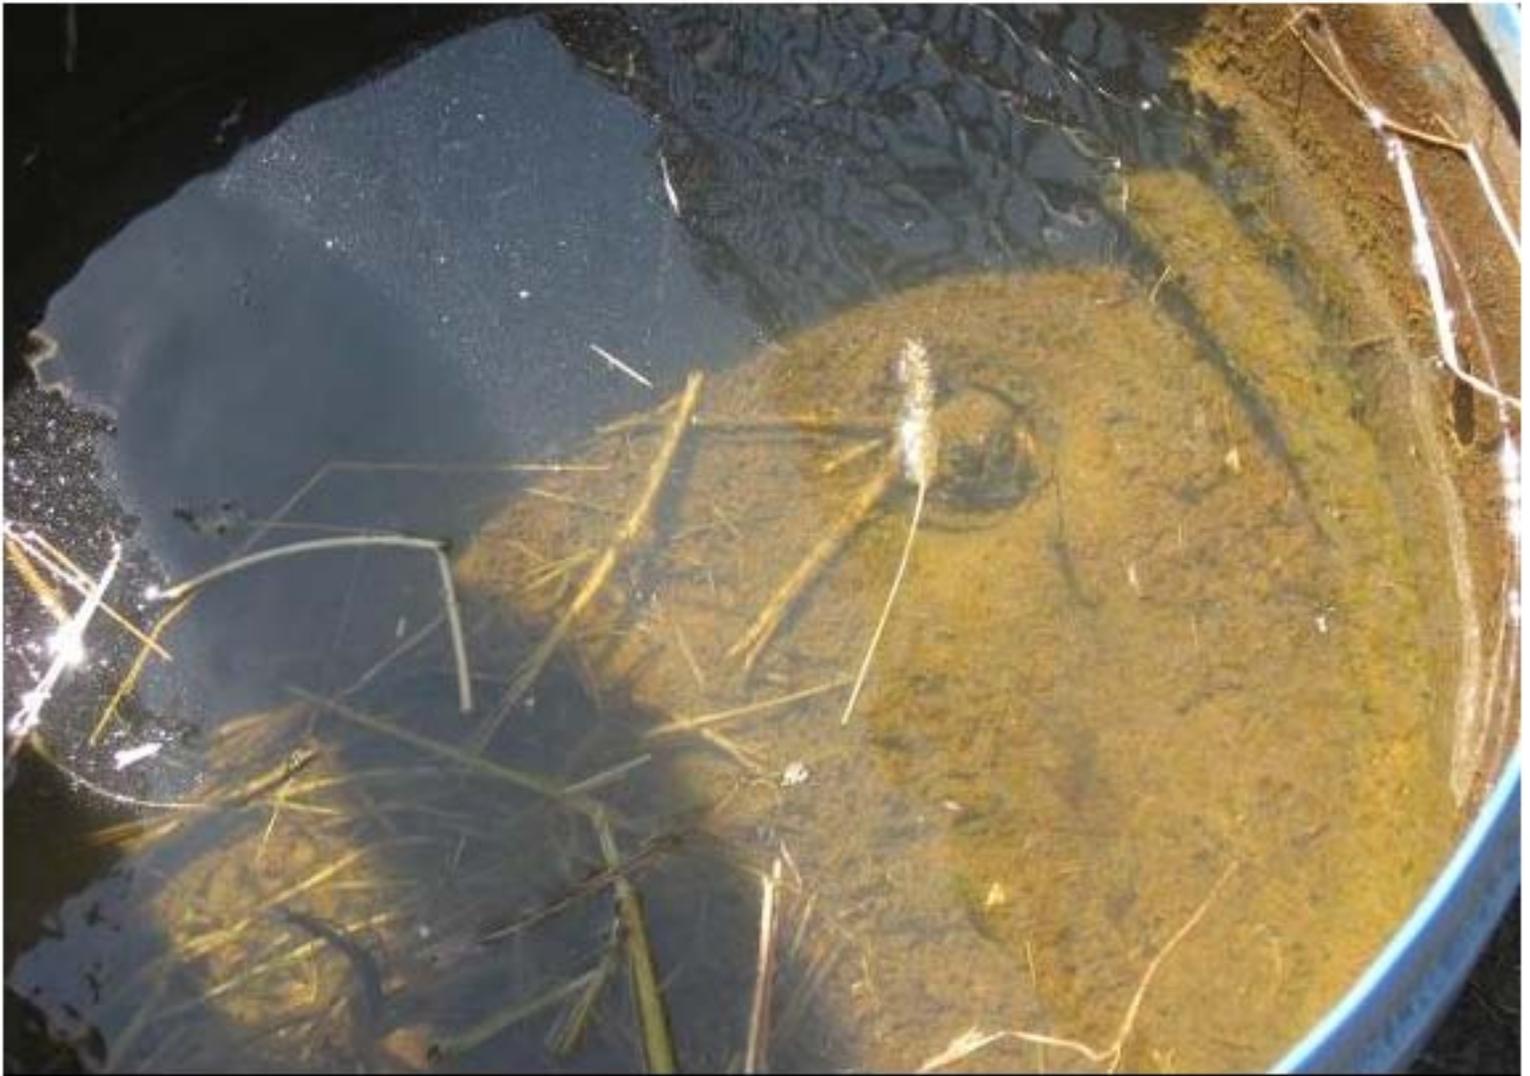
CFR: 3.130

Photographer:	Chad Moore	Legal Name:	Registration:	42-C-0081
Photo Taken:	Wed, Aug 25, '10 Approximately 12:00	JOYCE DE COCK RICHARD DE COCK		
Inspection:	237102249530984			
Description:	Filthy goat water receptacle

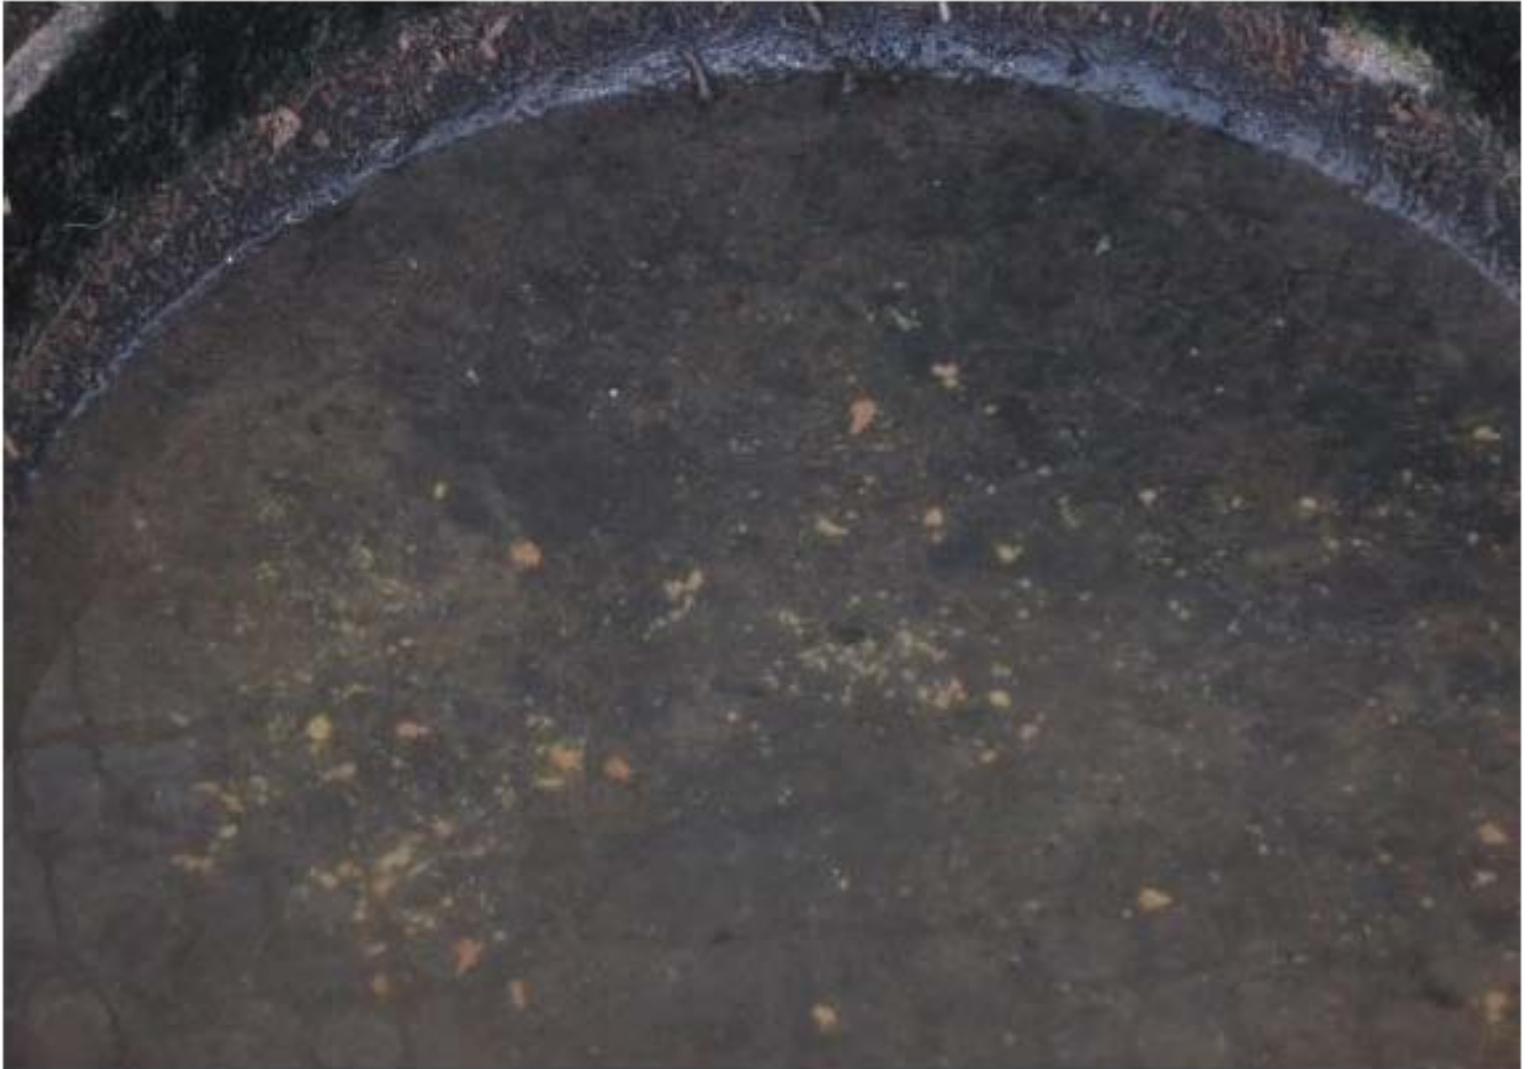
CFR: 3.130

Photographer:	Chad Moore	Legal Name:	Registration:	42-C-0081
Photo Taken:	Wed, Aug 25, '10	Approximately 12:00	JOYCE DE COCK	
Inspection:	237102249530984	RICHARD DE COCK		
Description:	Filthy raccoon water receptacle

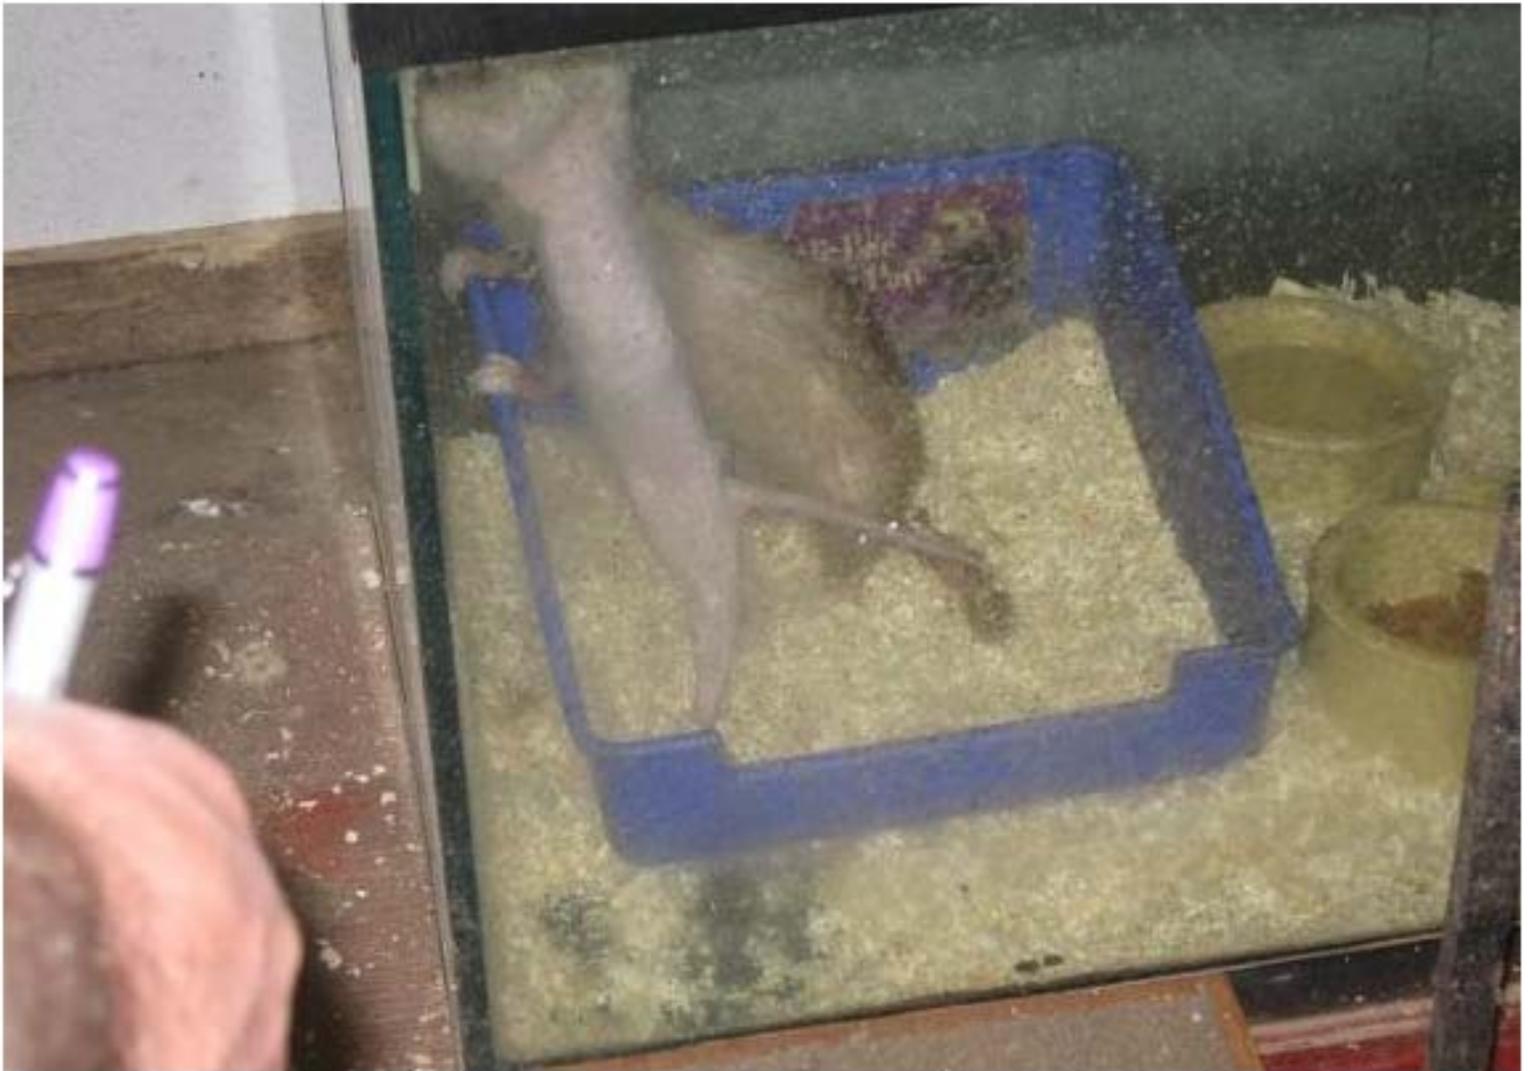
CFR: 3.131 (a)

Photographer:	Chad Moore	Legal Name:	Registration:	42-C-0081
Photo Taken:	Wed, Aug 25, '10	Approximately 12:00	JOYCE DE COCK	
Inspection:	237102249530984	RICHARD DE COCK		
Description:	Ferret aquarium with excessive dirt and grime on glass

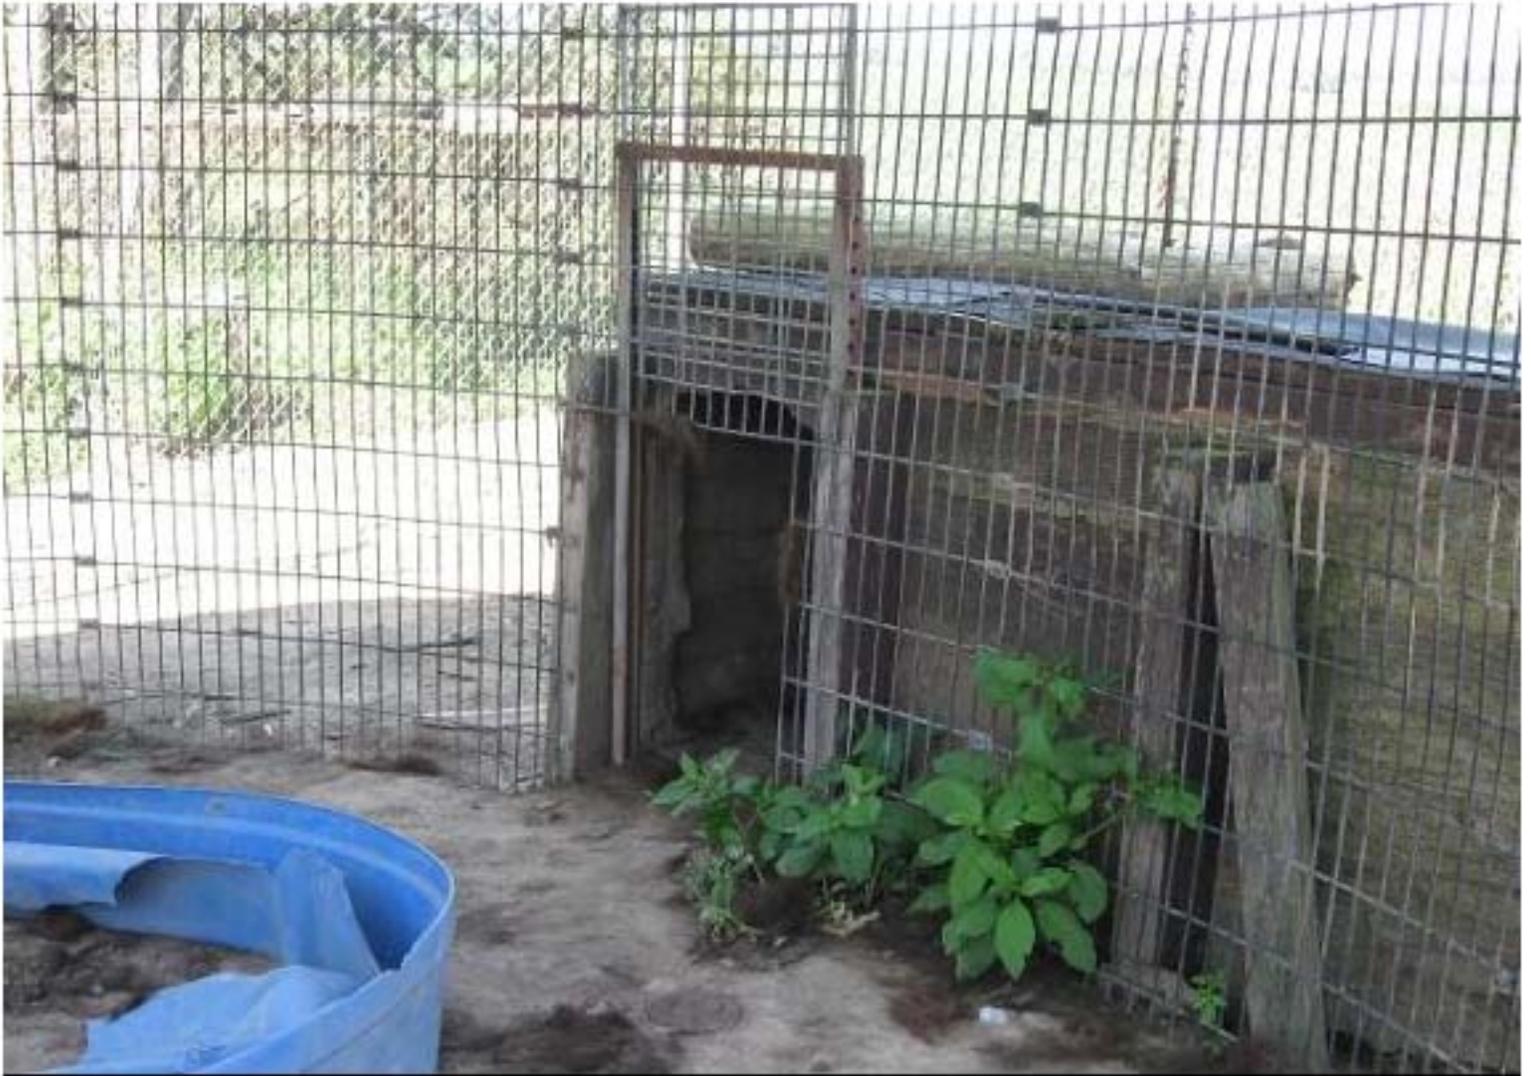
CFR: 3.131 (a)

Photographer:	Chad Moore	Legal Name:	Registration:	42-C-0081
Photo Taken:	Wed, Aug 25, '10 Approximately 12:00	JOYCE DE COCK RICHARD DE COCK		
Inspection:	237102249530984			
Description:	Broken, chewed pool in bear enclosure. Excessive fur and feces in same enclosure

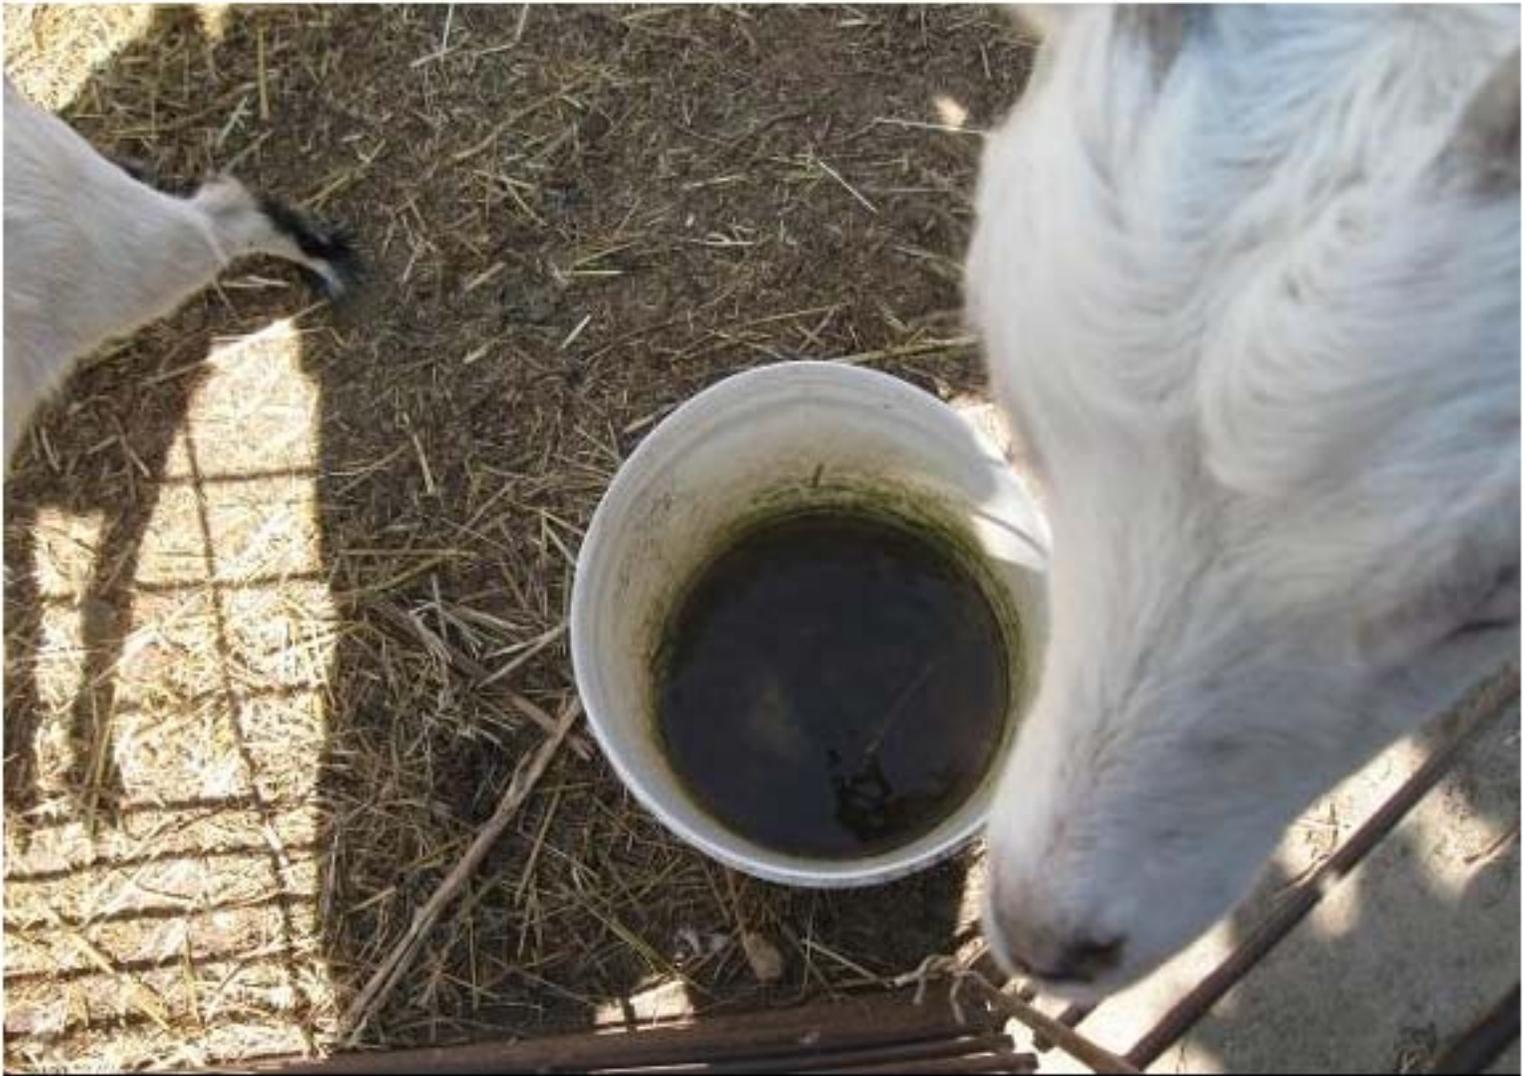
CFR: 3.130

Photographer:	Chad Moore	Legal Name:	Registration:	42-C-0081
Photo Taken:	Wed, Aug 25, '10 Approximately 12:00	JOYCE DE COCK RICHARD DE COCK		
Inspection:	237102249530984			
Description:	Filthy goat water receptacle

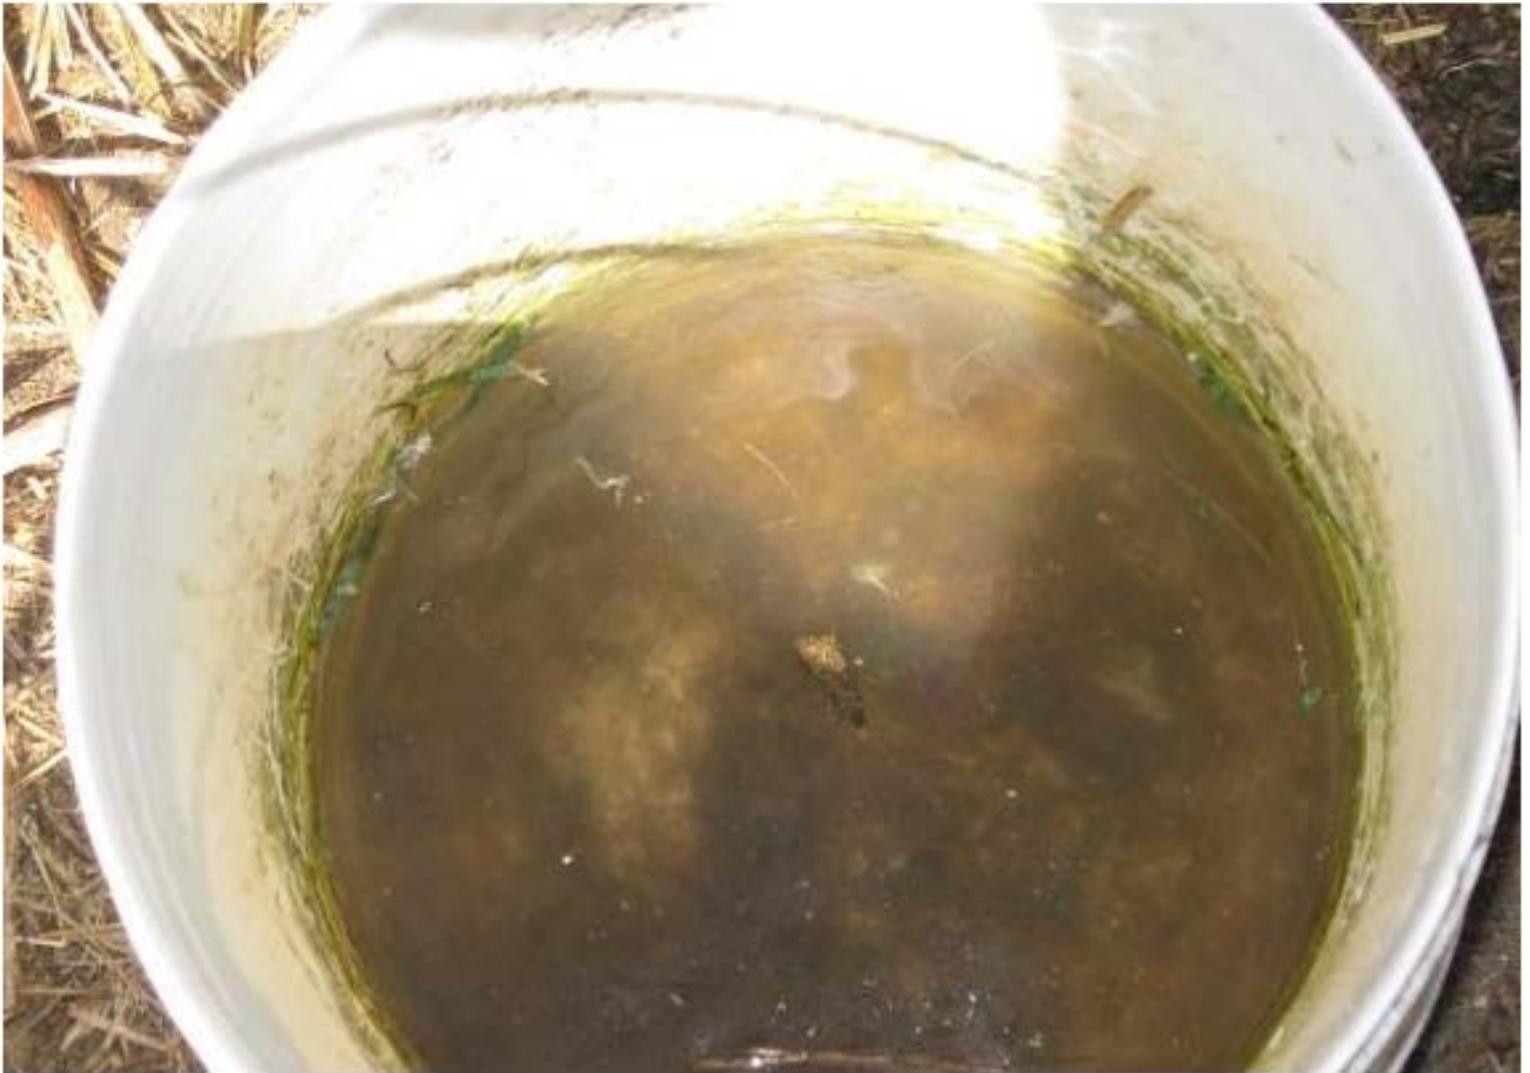
CFR: 3.130

Photographer:	Chad Moore	Legal Name:	Registration:	42-C-0081
Photo Taken:	Wed, Aug 25, '10 Approximately 12:00	JOYCE DE COCK RICHARD DE COCK		
Inspection:	237102249530984			
Description:	Filthy goat water receptacle
