Photographer: Heather Cole, VMO      Legal Name: PAMELA SELLNER      Registration: 42-C-0084  
Photo Taken: Mon, Nov 22, '10 approximately 1100      TOM SELLNER  
Inspection: 326101741280061  
Description:

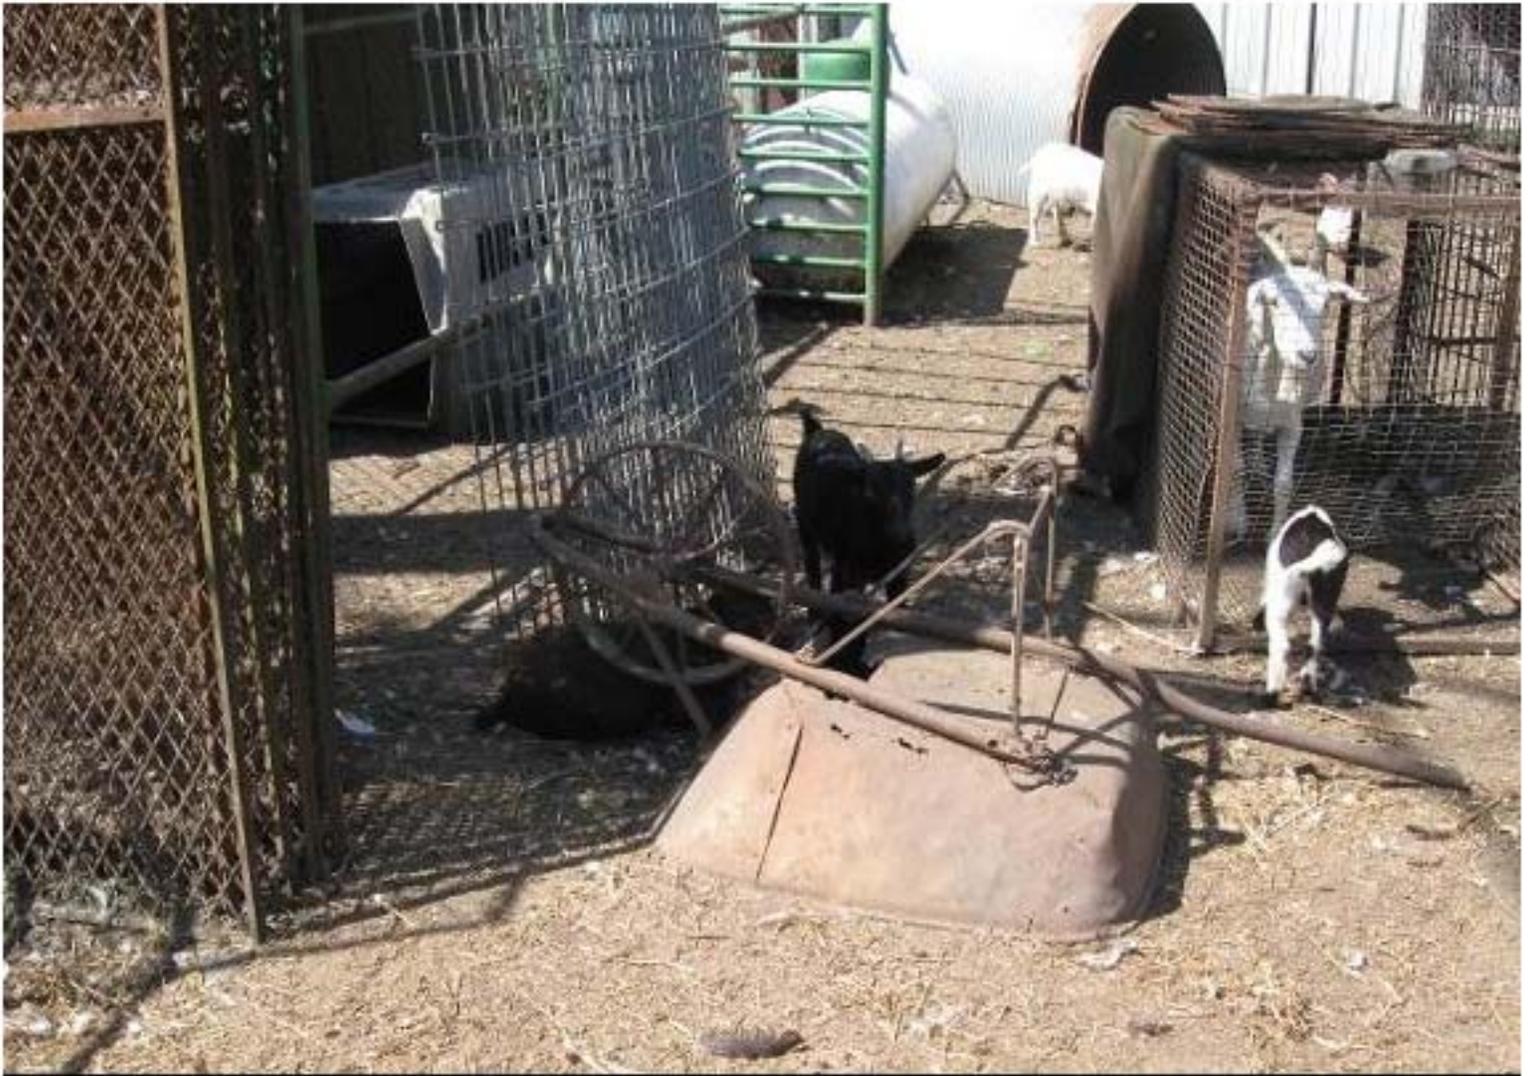
CFR: 3.131 (c)

Photographer:	Chad Moore	Legal Name:	Registration:	42-C-0081
Photo Taken:	Wed, Aug 25, '10 Approximately 12:00	JOYCE DE COCK RICHARD DE COCK		
Inspection:	237102249530984			
Description:	Unused wheelbarrow with rusted jagged edges in goat pasture

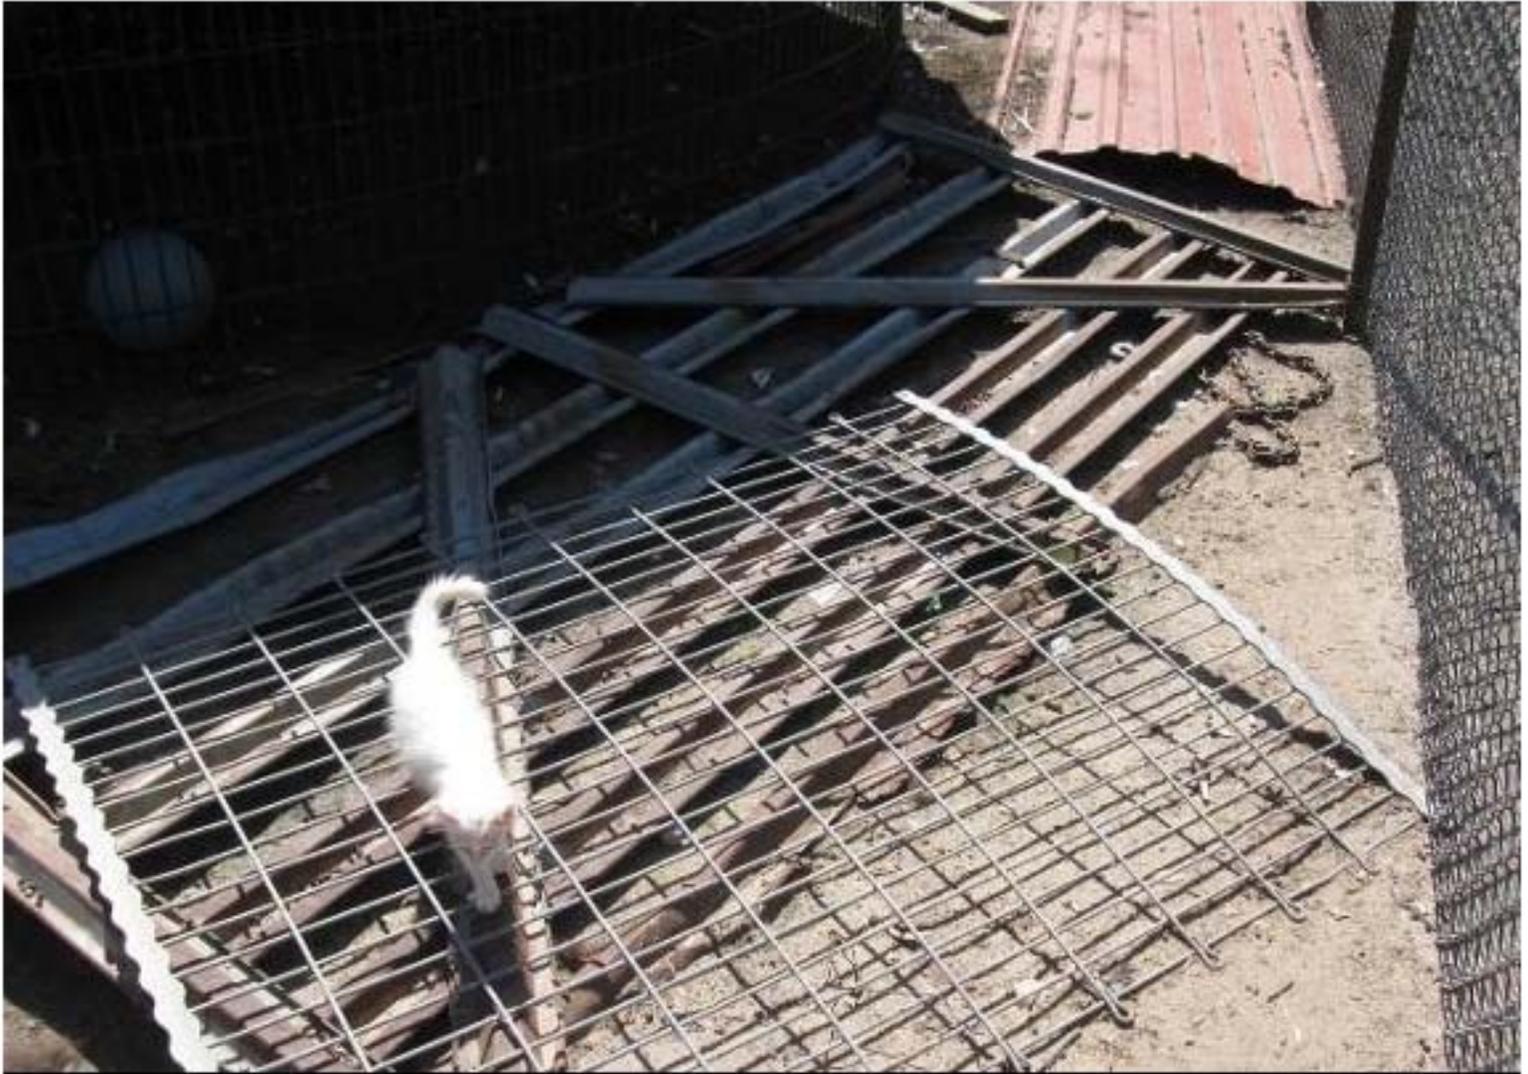
CFR: 3.131 (c)

Photographer:	Chad Moore	Legal Name:	Registration:	42-C-0081
Photo Taken:	Wed, Aug 25, '10	Approximately 12:00	JOYCE DE COCK	
Inspection:	237102249530984	RICHARD DE COCK		
Description:	Unused fencing and metal near bear enclosure in goat pasture

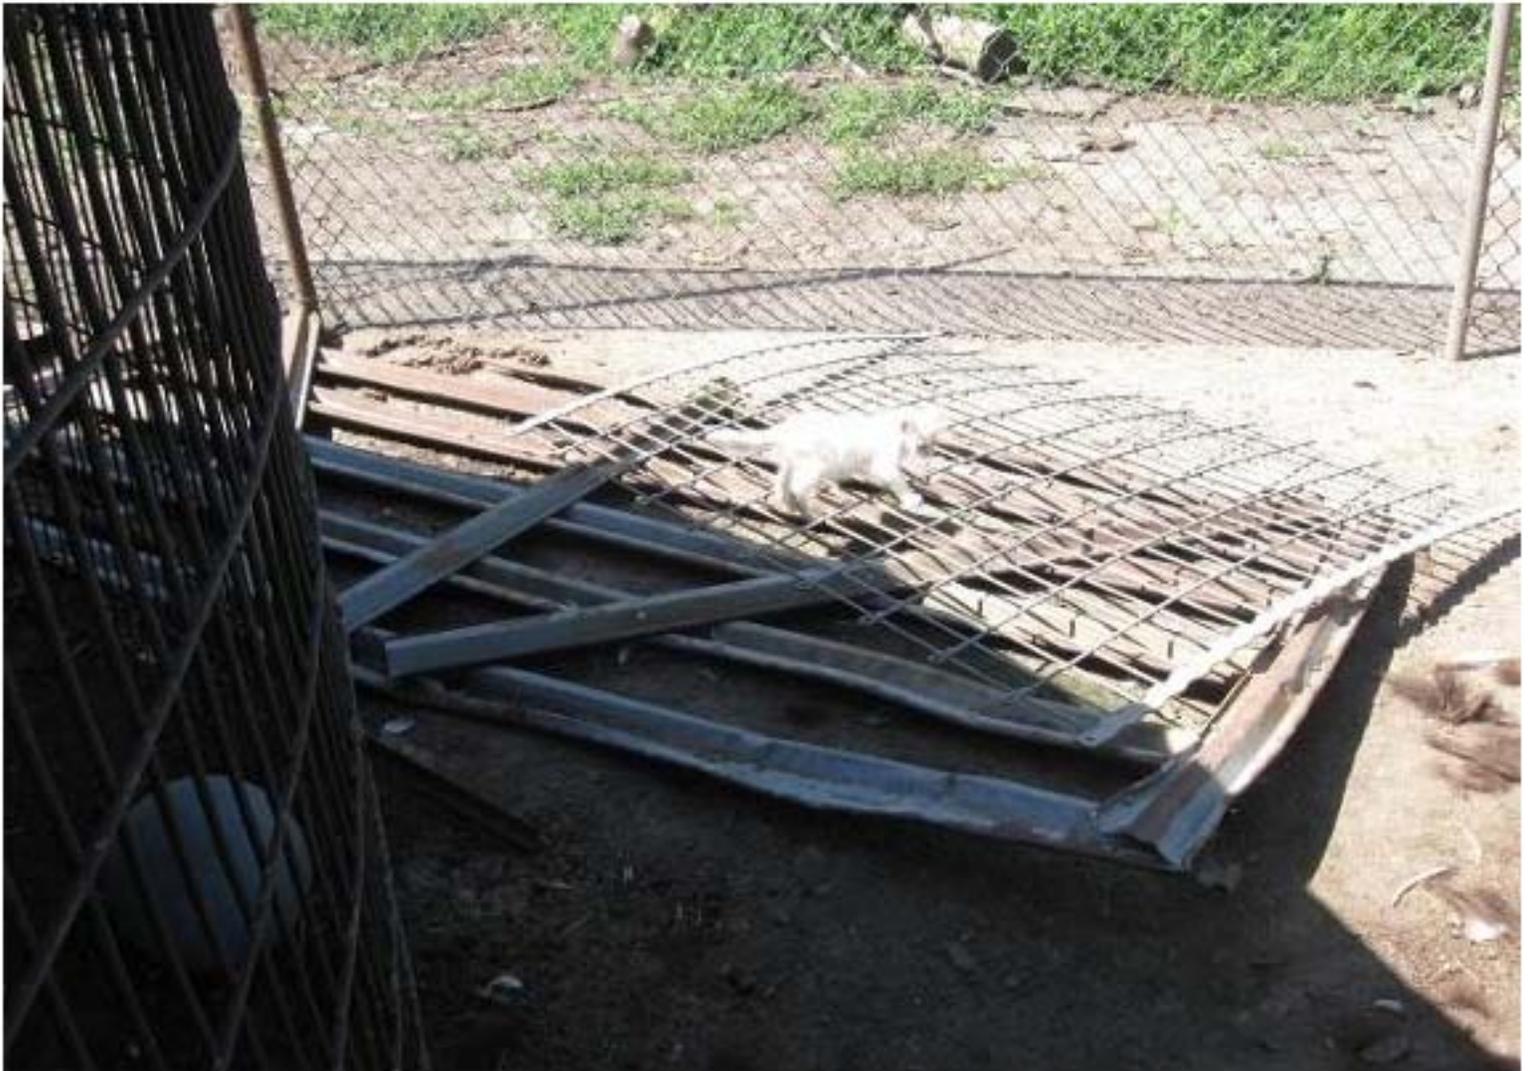
CFR: 3.131 (c)

Photographer:	Chad Moore	Legal Name:	Registration:	42-C-0081
Photo Taken:	Wed, Aug 25, '10	Approximately 12:00	JOYCE DE COCK	
Inspection:	237102249530984	RICHARD DE COCK		
Description:	Unused fencing and metal near bear enclosure in goat pasture

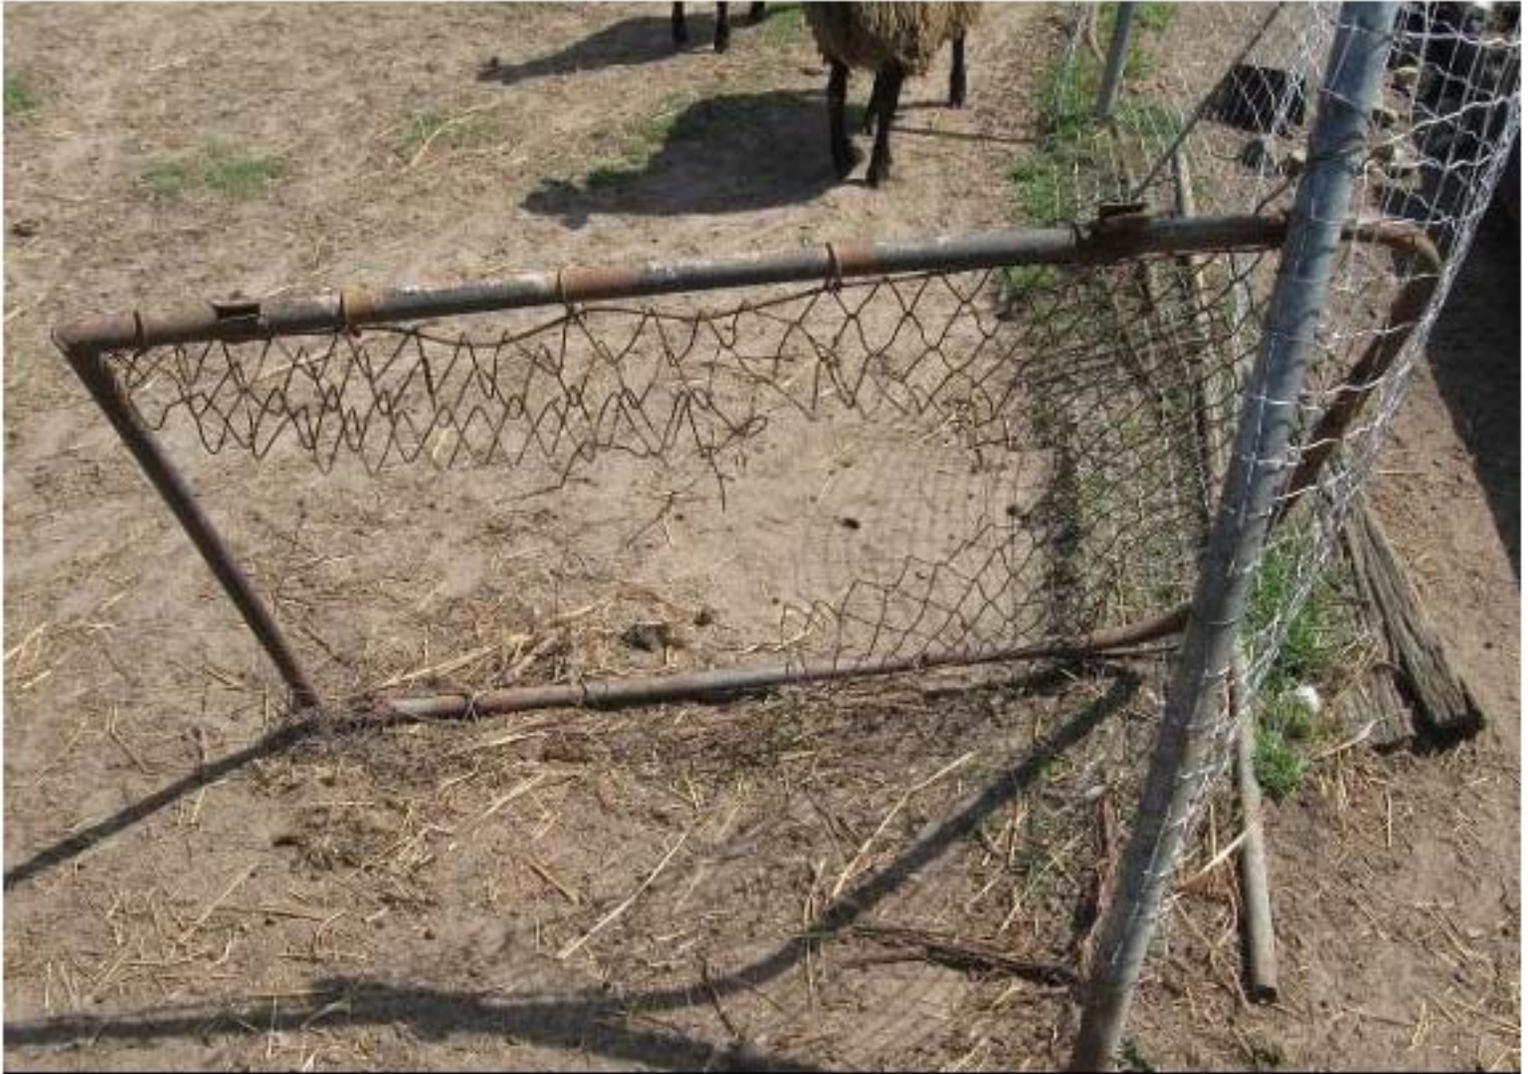
CFR: 3.131 (c)

Photographer:	Chad Moore	Legal Name:	Registration:	42-C-0081
Photo Taken:	Wed, Aug 25, '10 Approximately 12:00	JOYCE DE COCK RICHARD DE COCK		
Inspection:	237102249530984			
Description:	Unattached stray wires from gate fencing in sheep pasture

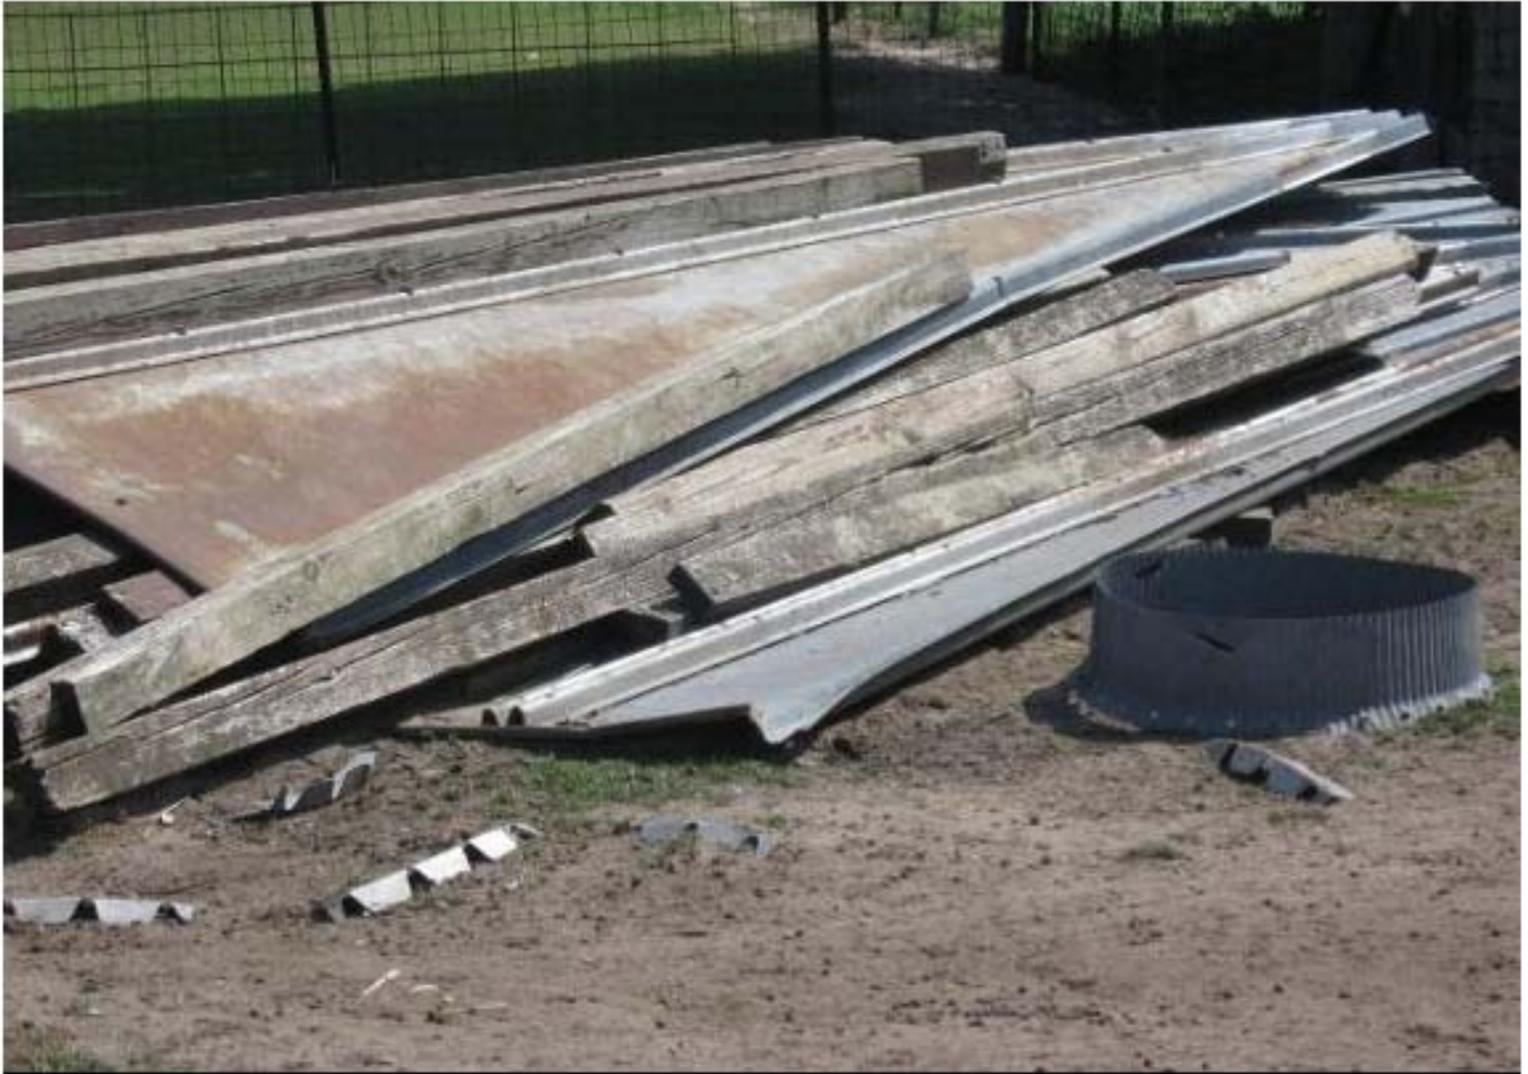
CFR: 3.131 (c)

Photographer:	Chad Moore	Legal Name:	Registration:	42-C-0081
Photo Taken:	Wed, Aug 25, '10	Approximately 12:00	JOYCE DE COCK	
Inspection:	237102249530984	RICHARD DE COCK		
Description:	Unused corn crib building materials in sheep pasture

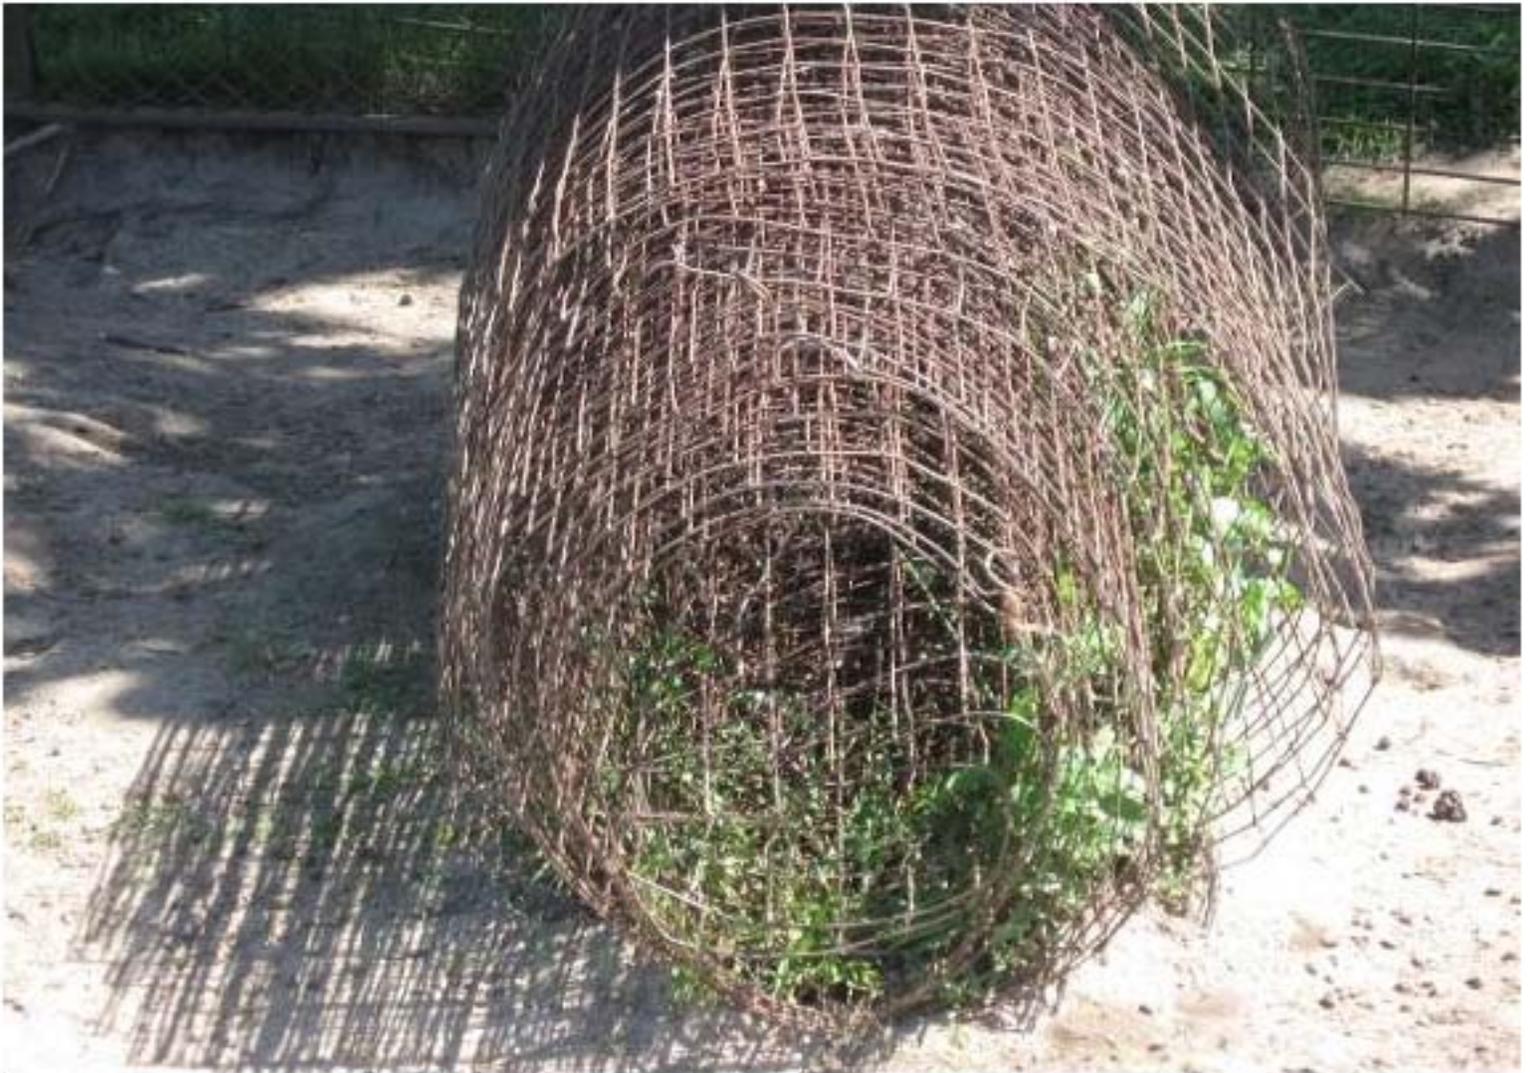
CFR: 3.131 (c)

Photographer:	Chad Moore	Legal Name:	Registration:	42-C-0081
Photo Taken:	Wed, Aug 25, '10	Approximately 12:00	JOYCE DE COCK RICHARD DE COCK	
Inspection:	237102249530984			
Description:	Unused roll of wire fencing in sheep pasture

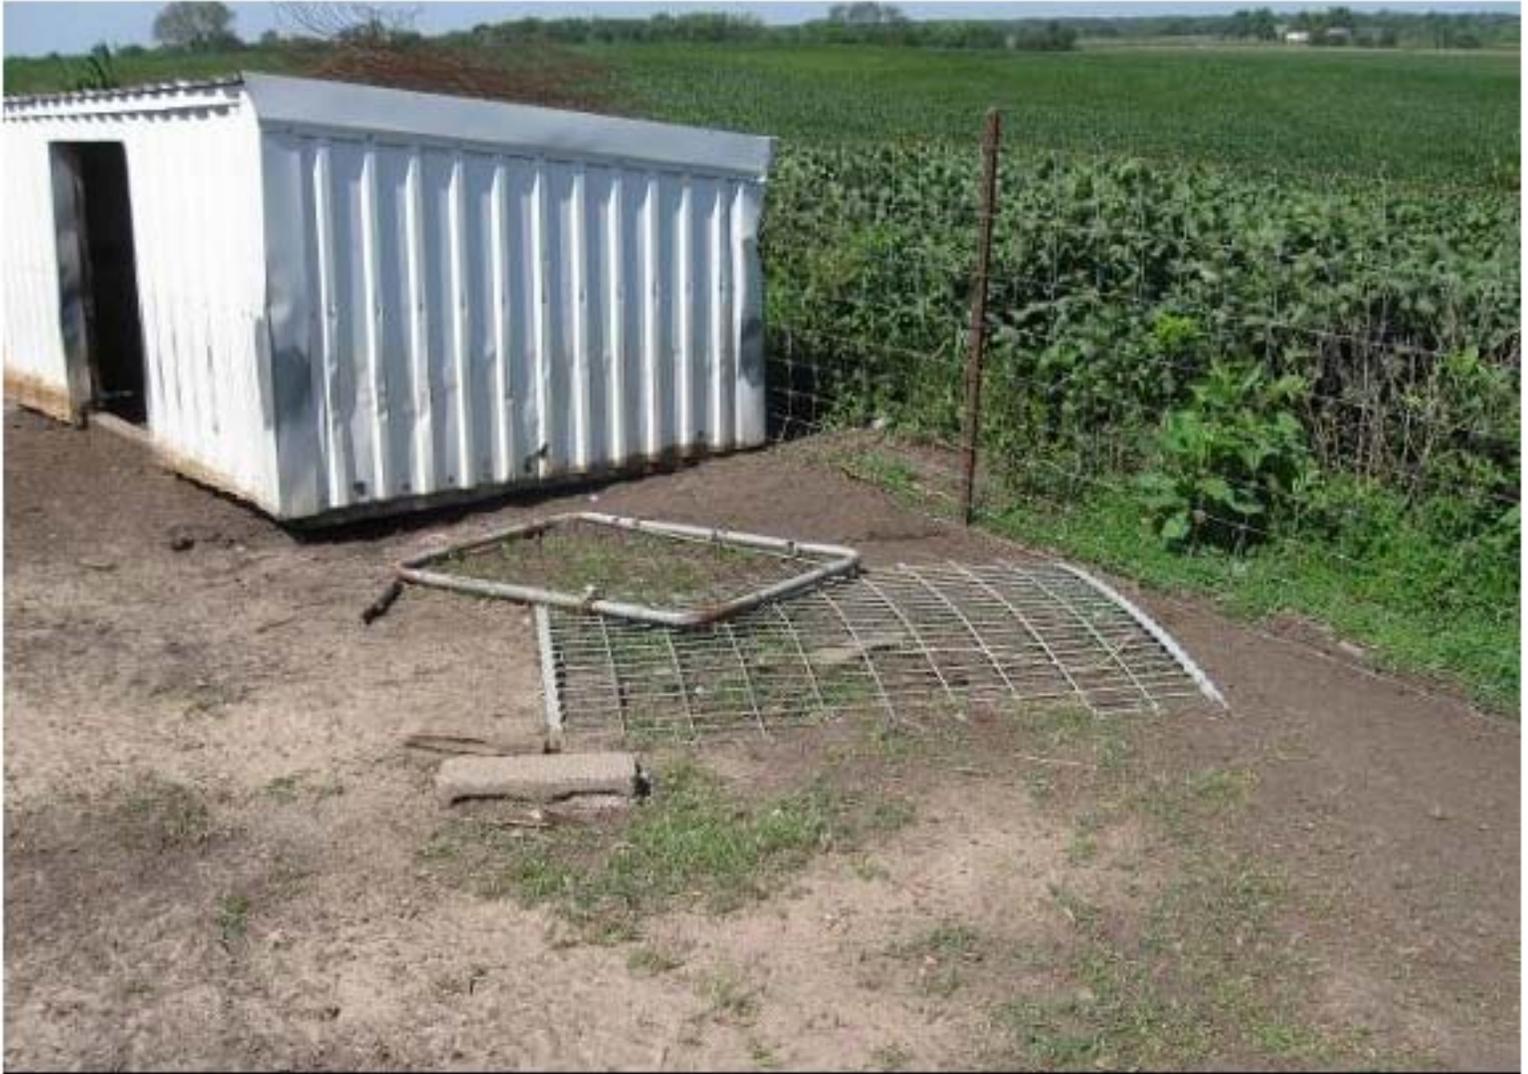
CFR: 3.131 (c)

Photographer:	Chad Moore	Legal Name:	Registration:	42-C-0081
Photo Taken:	Wed, Aug 25, '10 Approximately 12:00	JOYCE DE COCK RICHARD DE COCK		
Inspection:	237102249530984			
Description:	Unused fencing in sheep pasture

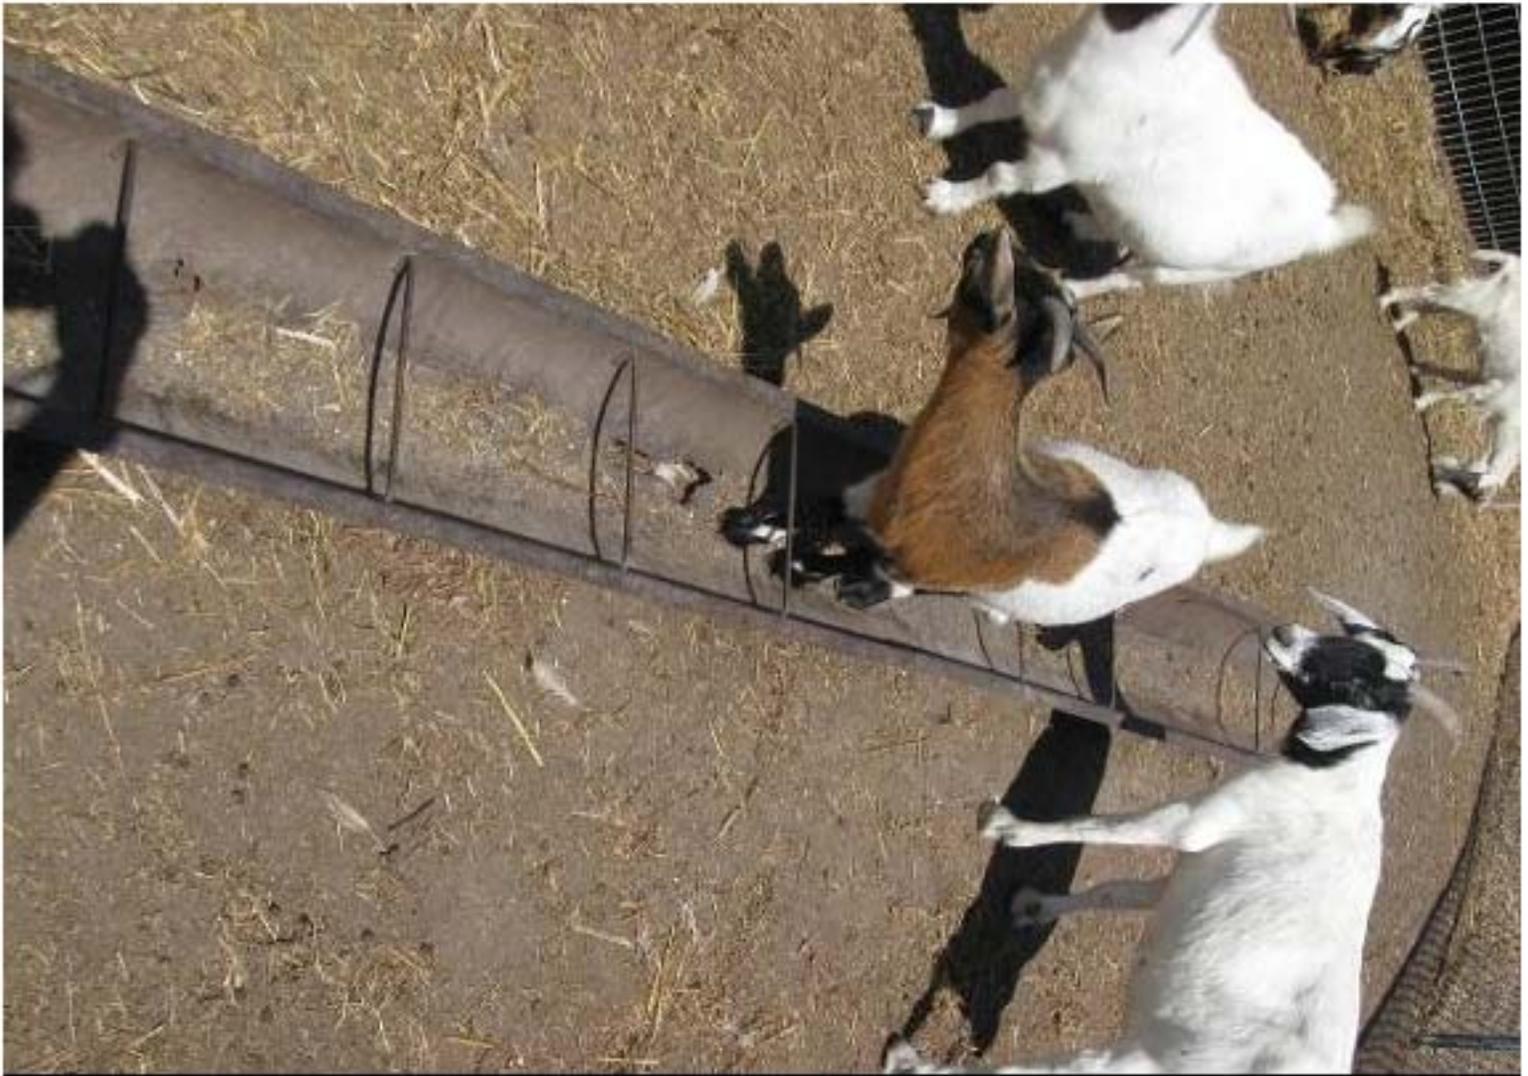
CFR: 3.131 (c)

Photographer:	Chad Moore	Legal Name:	Registration:	42-C-0081
Photo Taken:	Wed, Aug 25, '10 Approximately 12:00	JOYCE DE COCK RICHARD DE COCK		
Inspection:	237102249530984			
Description:	Broken, rusted goat feed trough

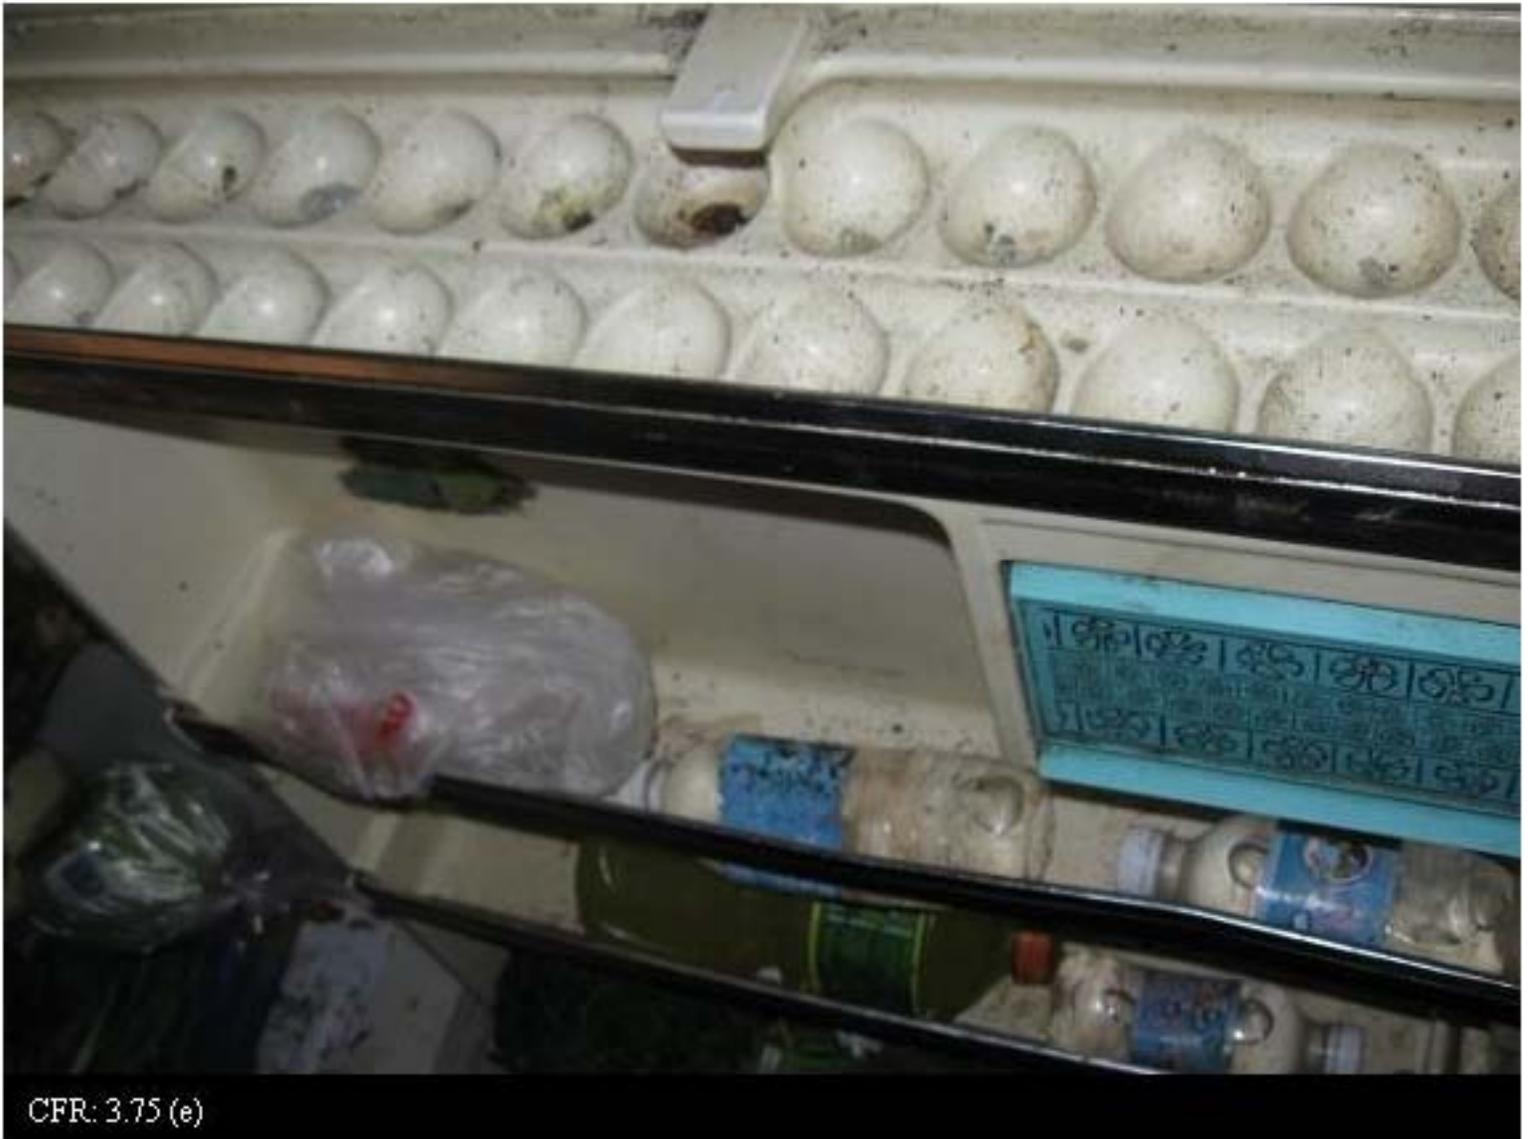
Photographer:	Chad Moore	Legal Name:	Registration:	42-C-0081
Photo Taken:	Thu, May 13, '10	Approximately 12:00	JOYCE DE COCK	
Inspection:	134100903280828	RICHARD DE COCK		
Description:	Dirty refrigerators used to store produce for animals.

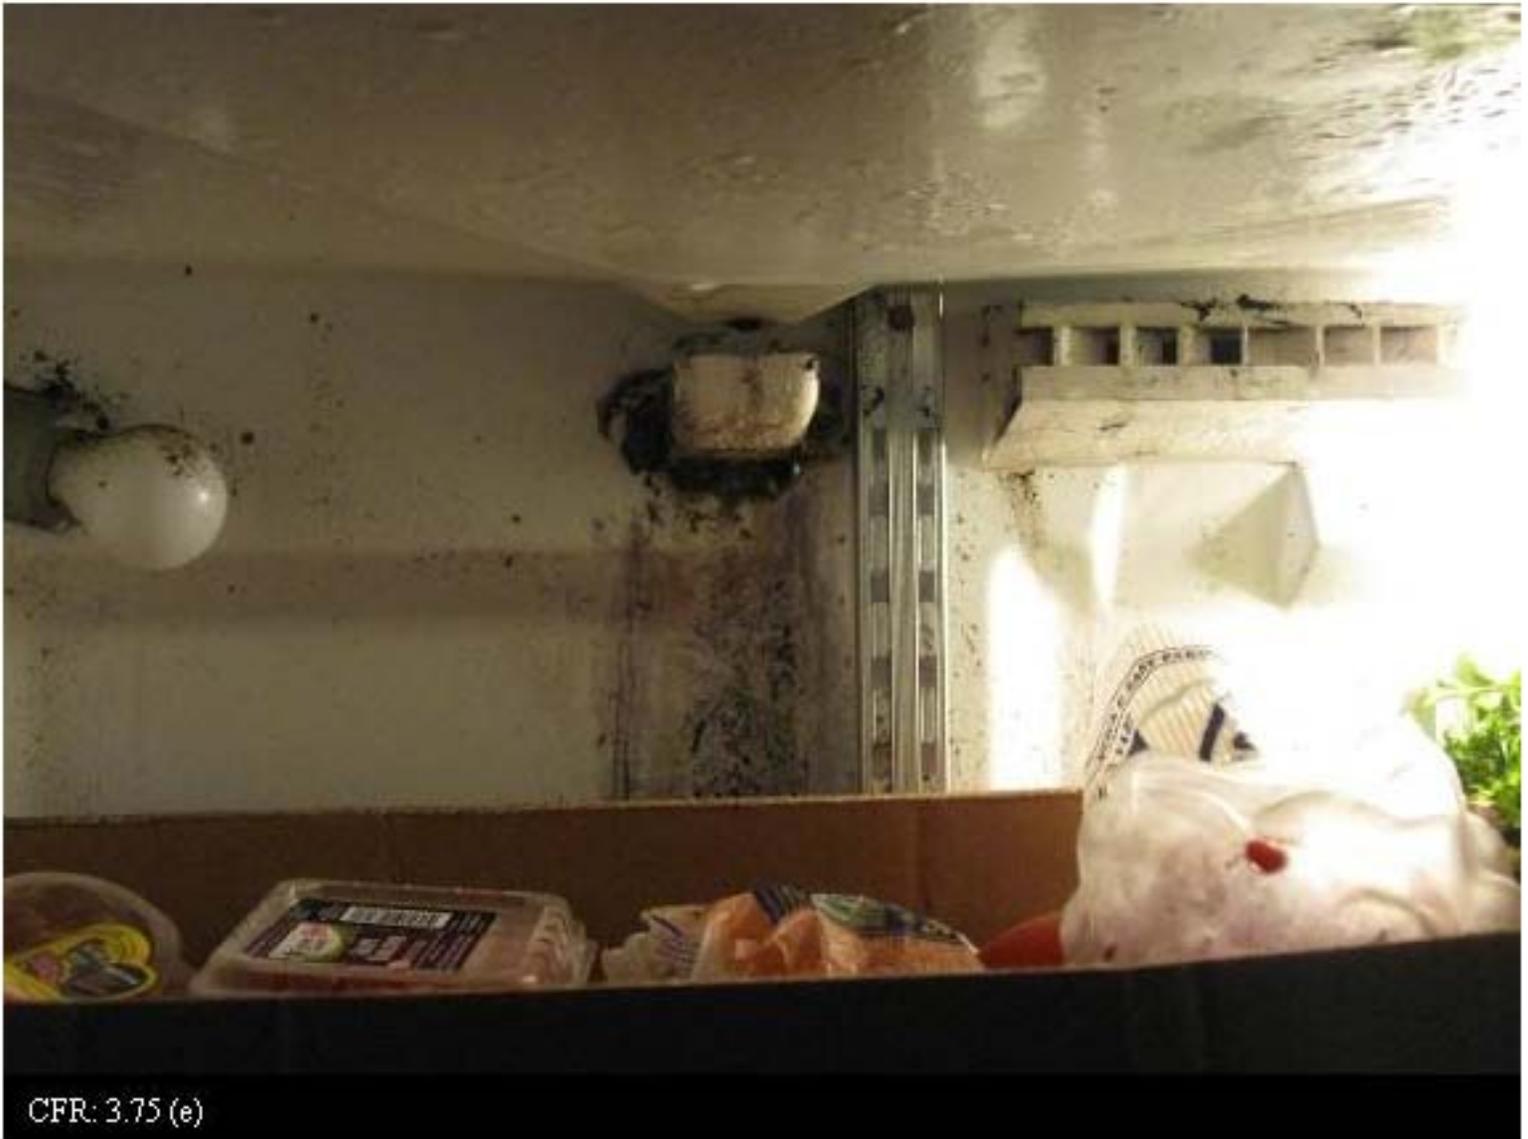
Photographer:	Chad Moore	Legal Name:	Registration:	42-C-0081
Photo Taken:	Thu, May 13, '10	Aproximately 12:00	JOYCE DE COCK	
Inspection:	134100903280828	RICHARD DE COCK		
Description:	Dirty refrigerators used to store produce for animals.

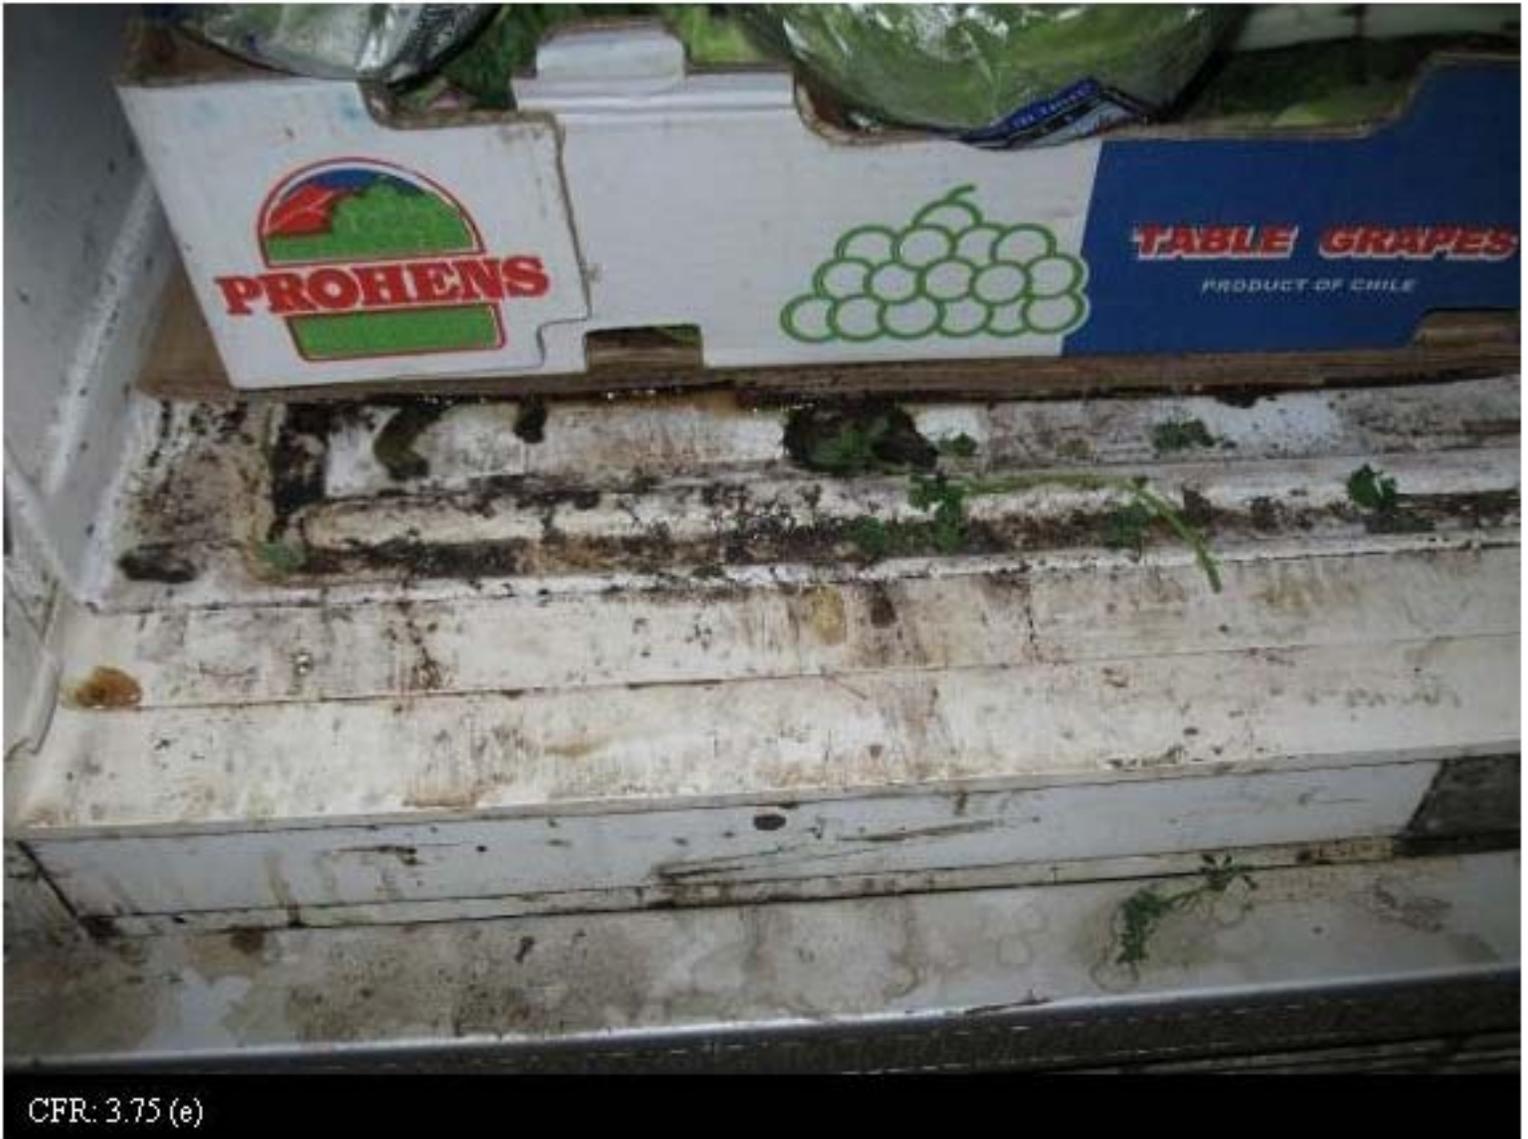
Photographer:	Chad Moore	Legal Name:	Registration:	42-C-0081
Photo Taken:	Thu, May 13, '10	Approximately 12:00	JOYCE DE COCK	
Inspection:	134100903280828	RICHARD DE COCK		
Description:	Dirty refrigerators used to store produce for animals.

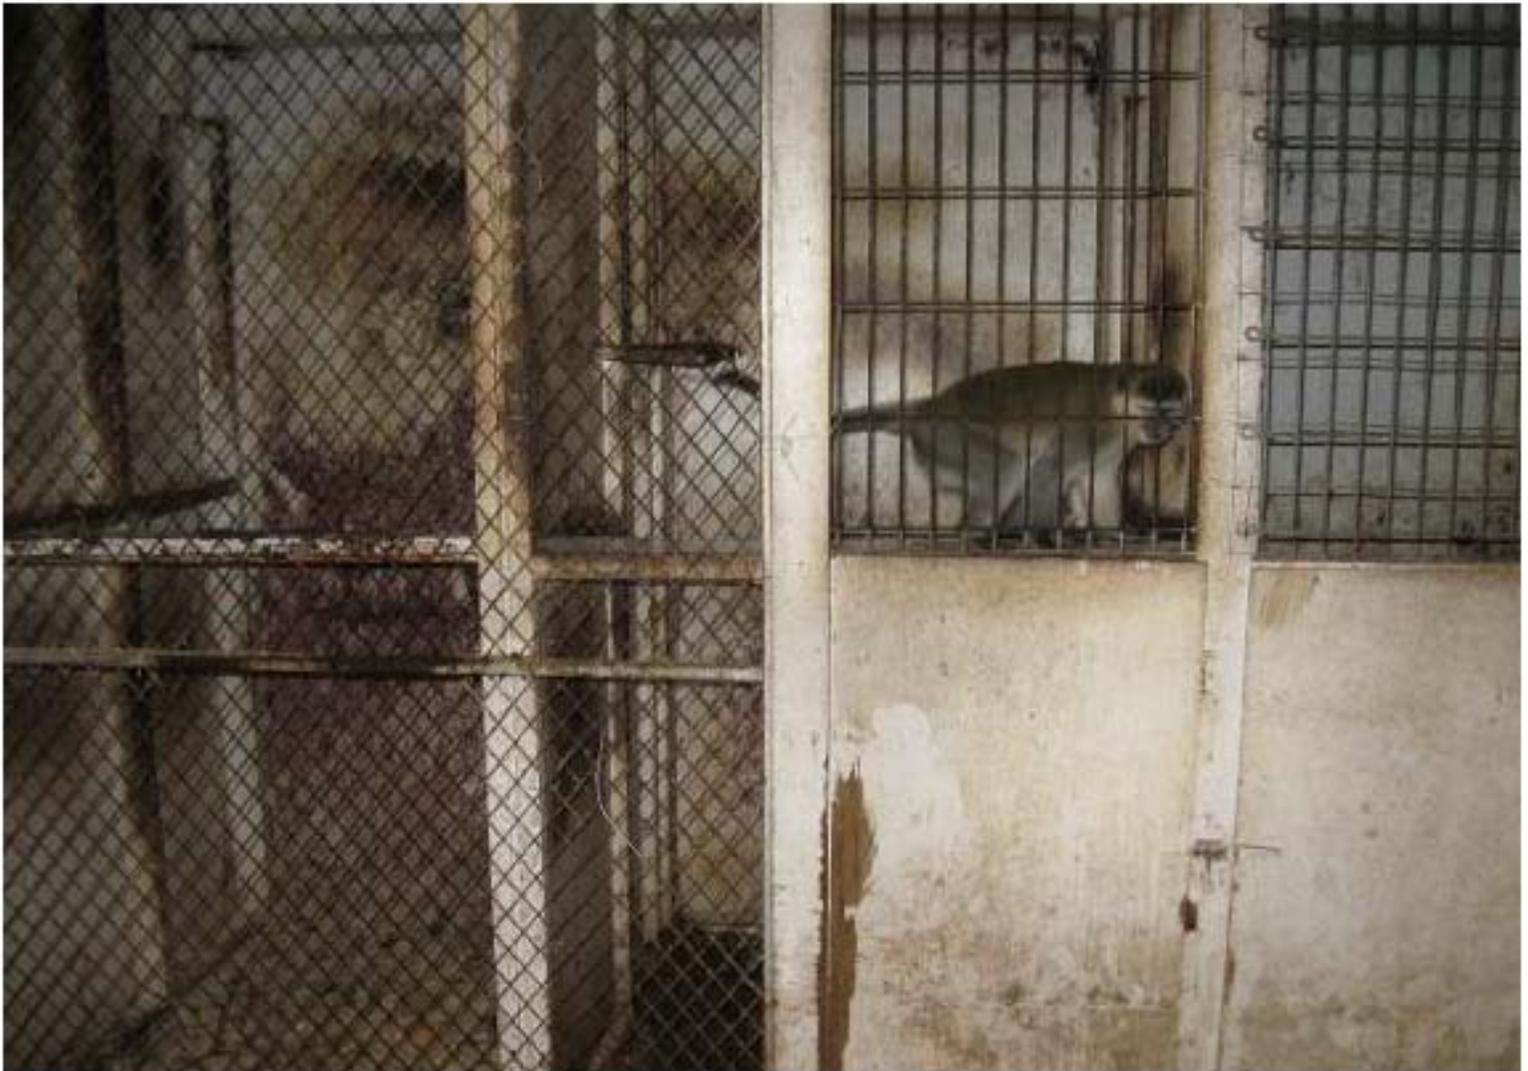
CFR: 3.80 (a)

Photographer:	Chad Moore	Legal Name:	Registration:	42-C-0081
Photo Taken:	Thu, May 13, '10	Approximately 12:00	JOYCE DE COCK	
Inspection:	134100903280828	RICHARD DE COCK		
Description:	Exposed, worn wood surfaces in nonhuman primate enclosures.

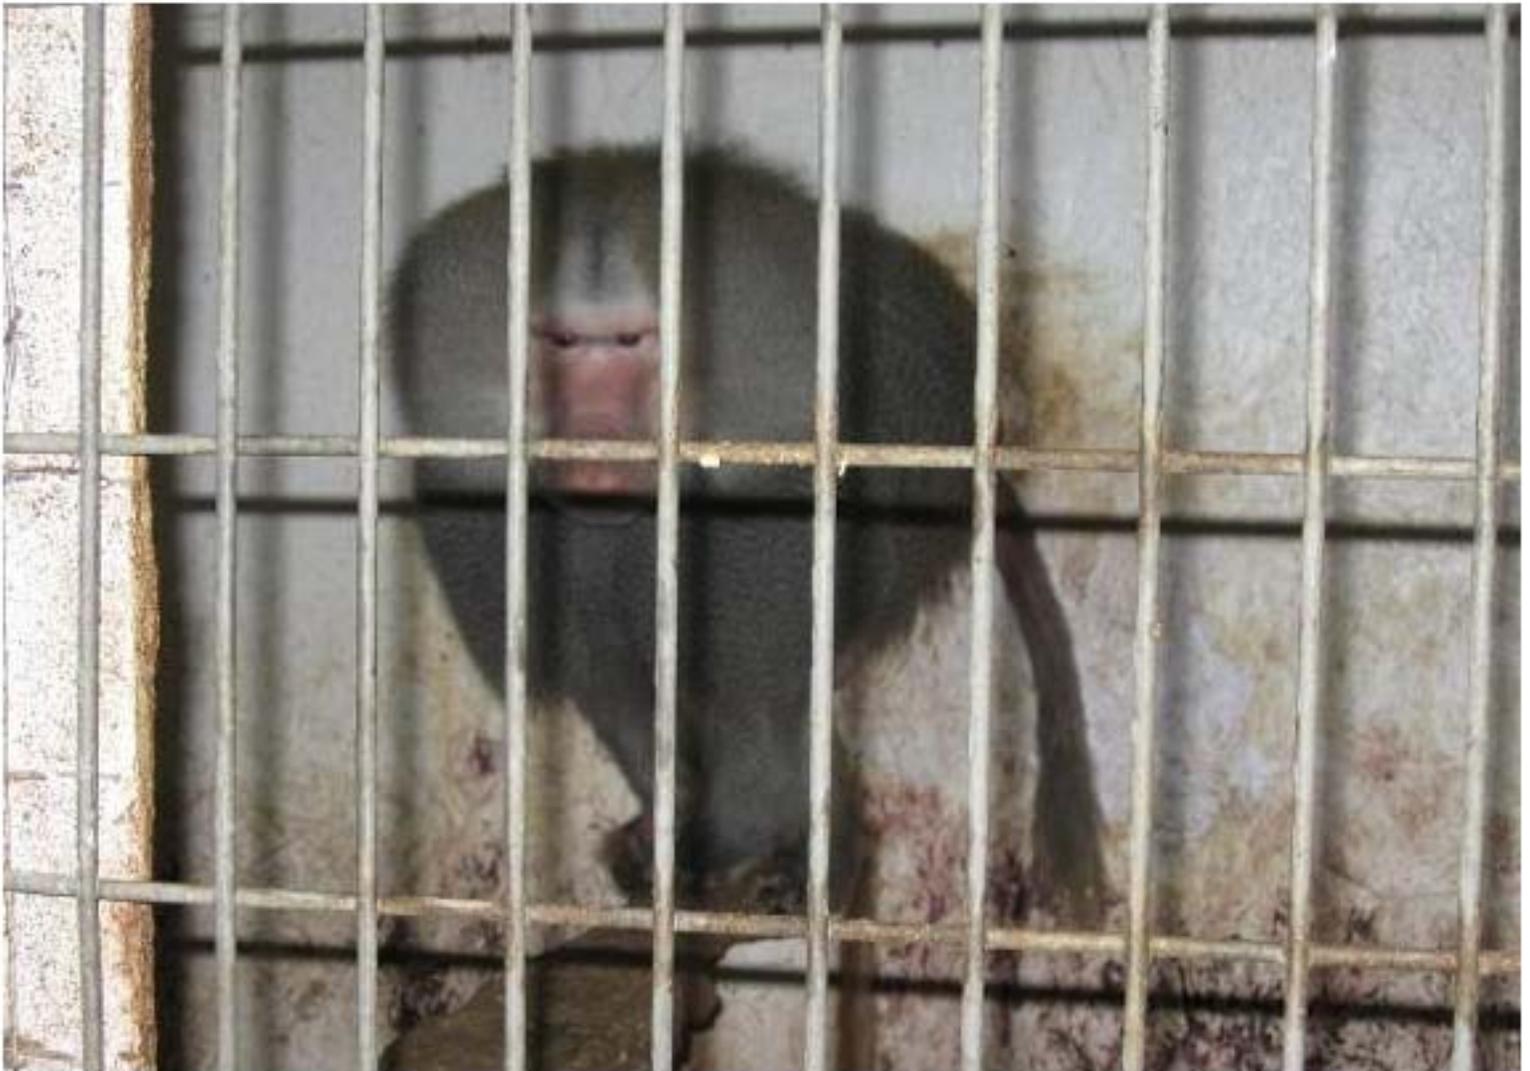
CFR: 3.80 (a)

Photographer:	Chad Moore	Legal Name:	Registration:	42-C-0081
Photo Taken:	Thu, May 13, '10	Approximately 12:00	JOYCE DE COCK	
Inspection:	134100903280828	RICHARD DE COCK		
Description:	Exposed, worn wood surfaces in nonhuman primate enclosures.
