Photographer: Heather Cole, VMO      Legal Name: PAMELA SELLNER      Registration: 42-C-0084  
Photo Taken: Mon, Nov 22, '10 approximately 1100      TOM SELLNER  
Inspection: 326101741280061  
Description:

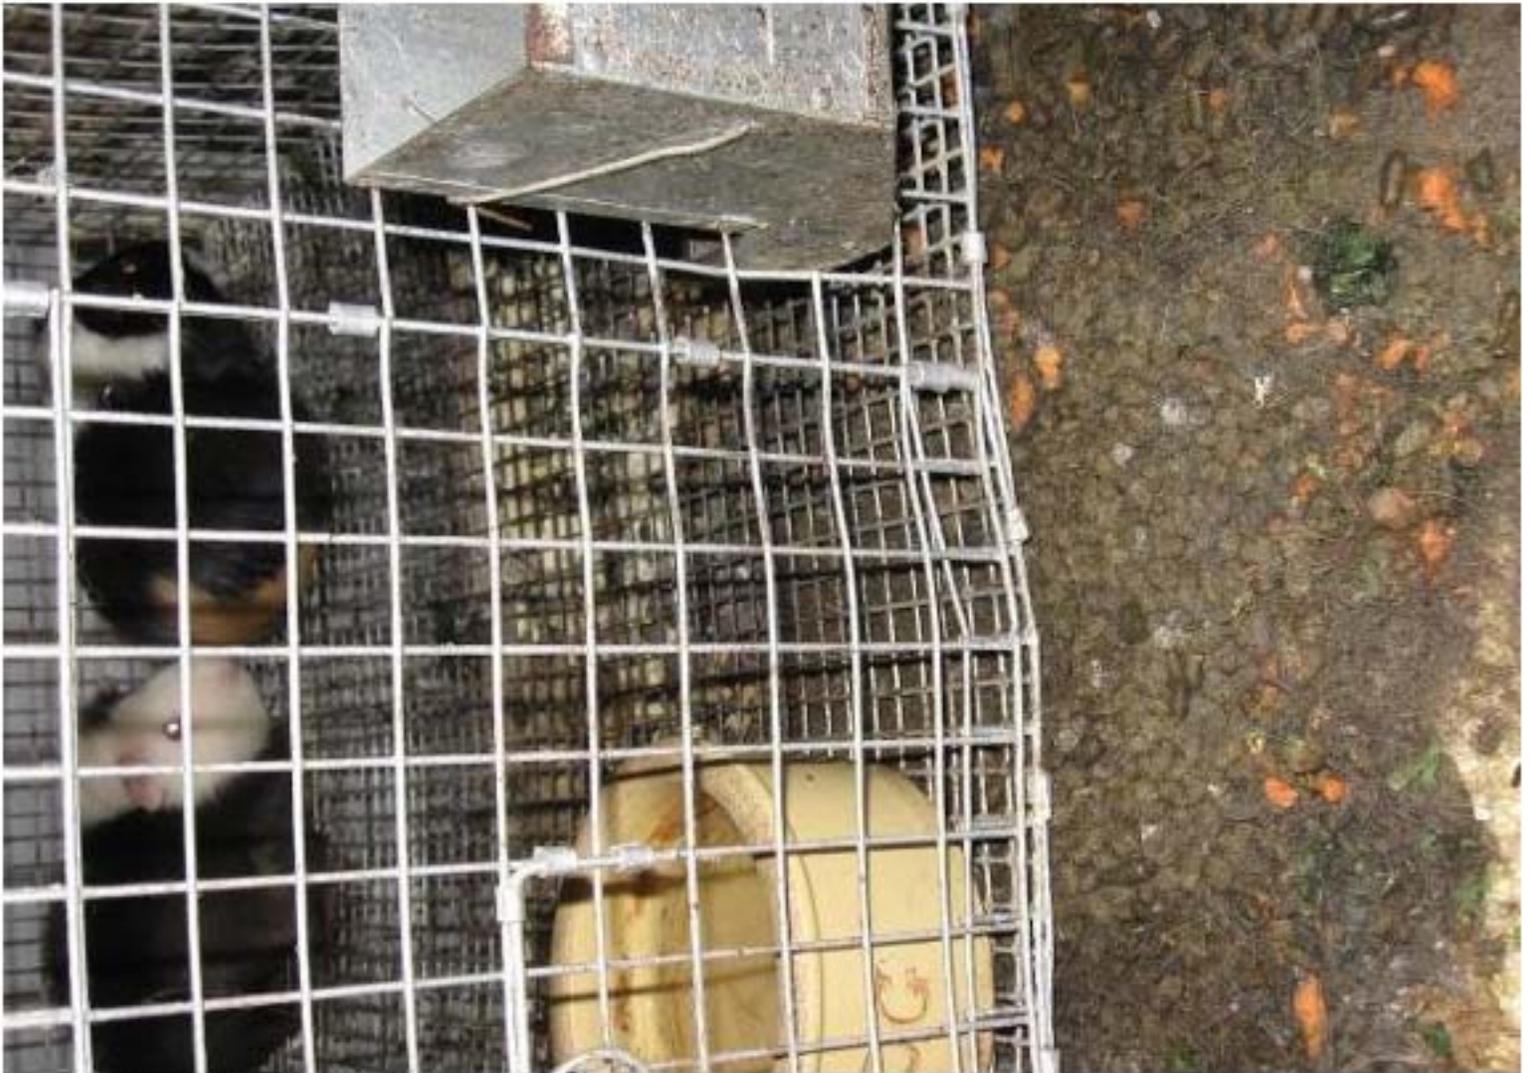
CFR: 3.31 (a) (1)

Photographer:	Chad Moore	Legal Name:	Registration:	42-C-0081
Photo Taken:	Thu, May 13, '10	Approximately 12:00	JOYCE DE COCK	
Inspection:	134100903280828	RICHARD DE COCK		
Description:	Excessive feces in litter pan beneath guinea pig enclosure.

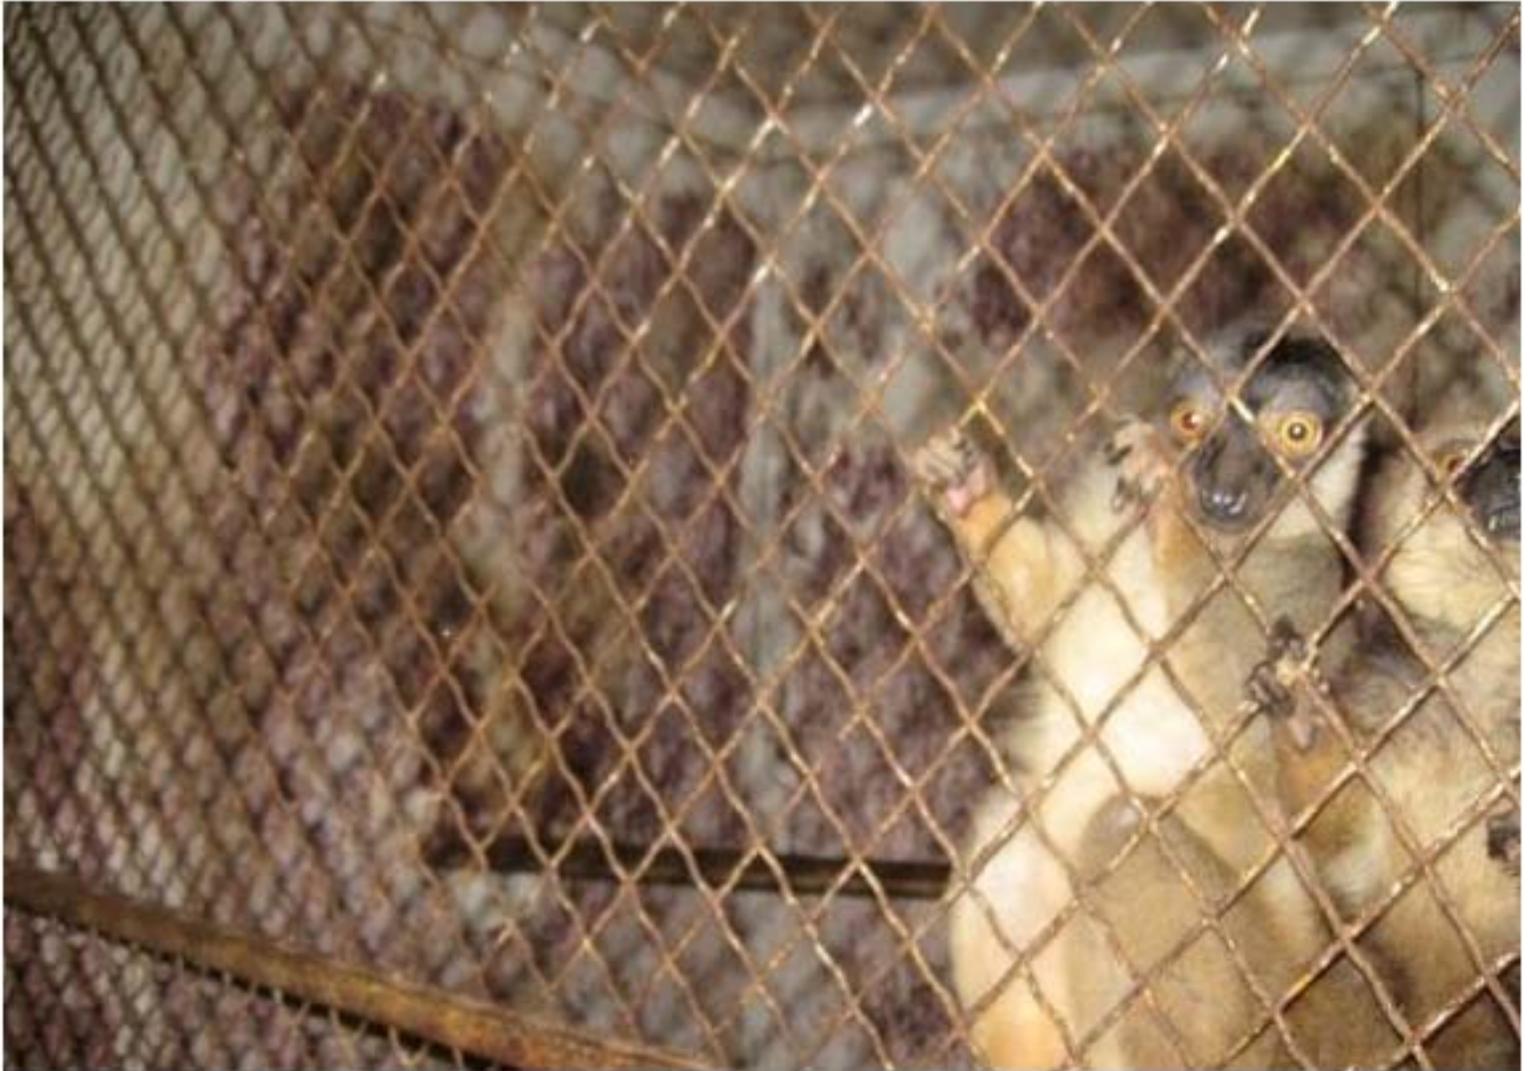
CFR: 3.80 (a)

Photographer:	Chad Moore	Legal Name:	Registration:	42-C-0081
Photo Taken:	Thu, May 13, '10	Approximately 12:00	JOYCE DE COCK	
Inspection:	134100903280828	RICHARD DE COCK		
Description:	Exposed, worn wood surfaces in nonhuman primate enclosures.

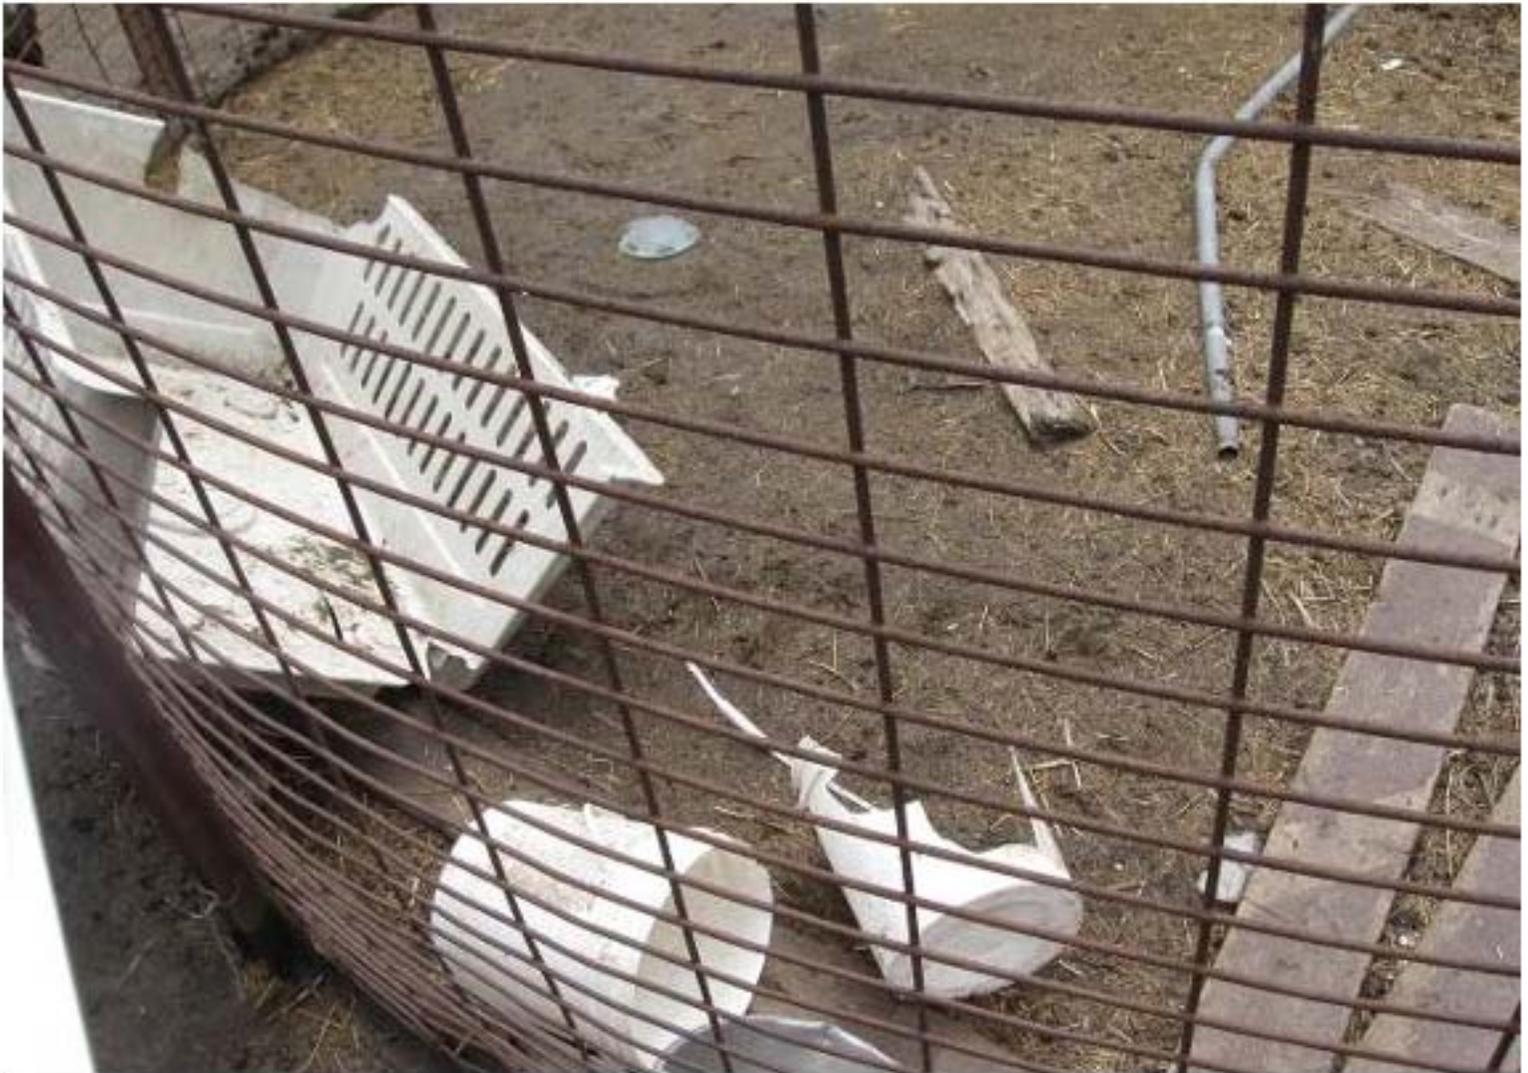
CFR: 3.131 (c)

Photographer:	Chad Moore	Legal Name:	Registration:	42-C-0081
Photo Taken:	Thu, May 13, '10	Approximately 12:00	JOYCE DE COCK	
Inspection:	134100903280828	RICHARD DE COCK		
Description:	Broken plastic dog crate and buckets inside goat pen

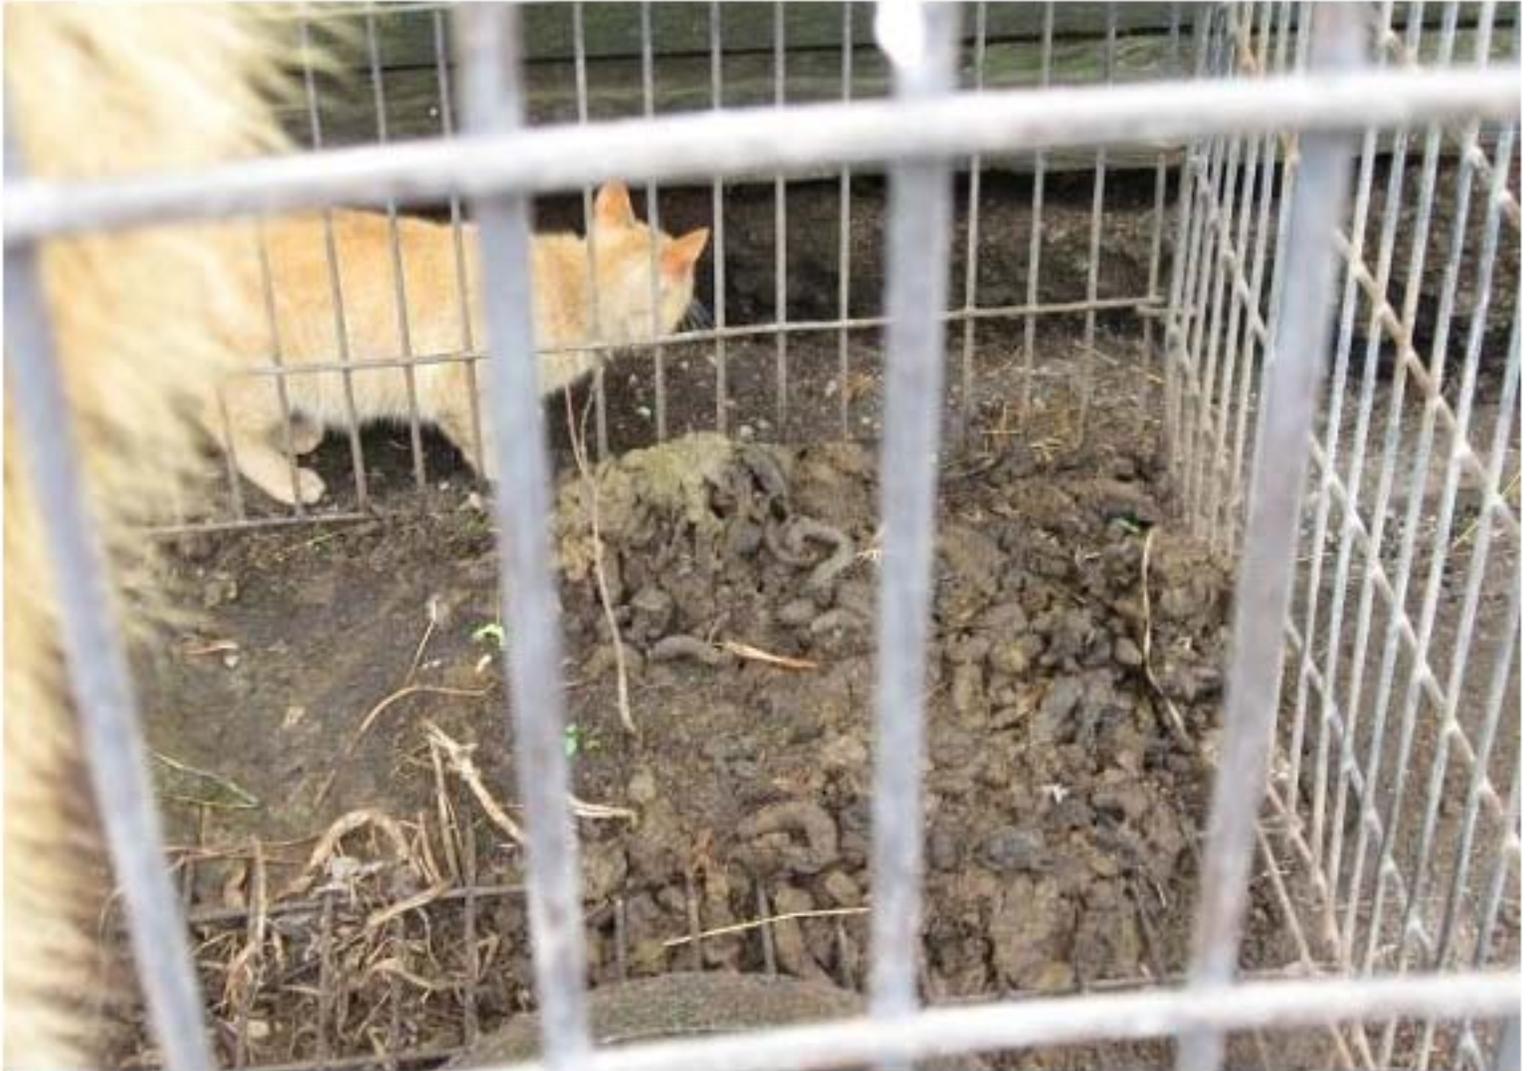
CFR: 3.131 (a)

Photographer:	Chad Moore	Legal Name:	Registration:	42-C-0081
Photo Taken:	Thu, May 13, '10	Approximately 12:00	JOYCE DE COCK	
Inspection:	134100903280828	RICHARD DE COCK		
Description:	Excessive feces in raccoon enclosure.

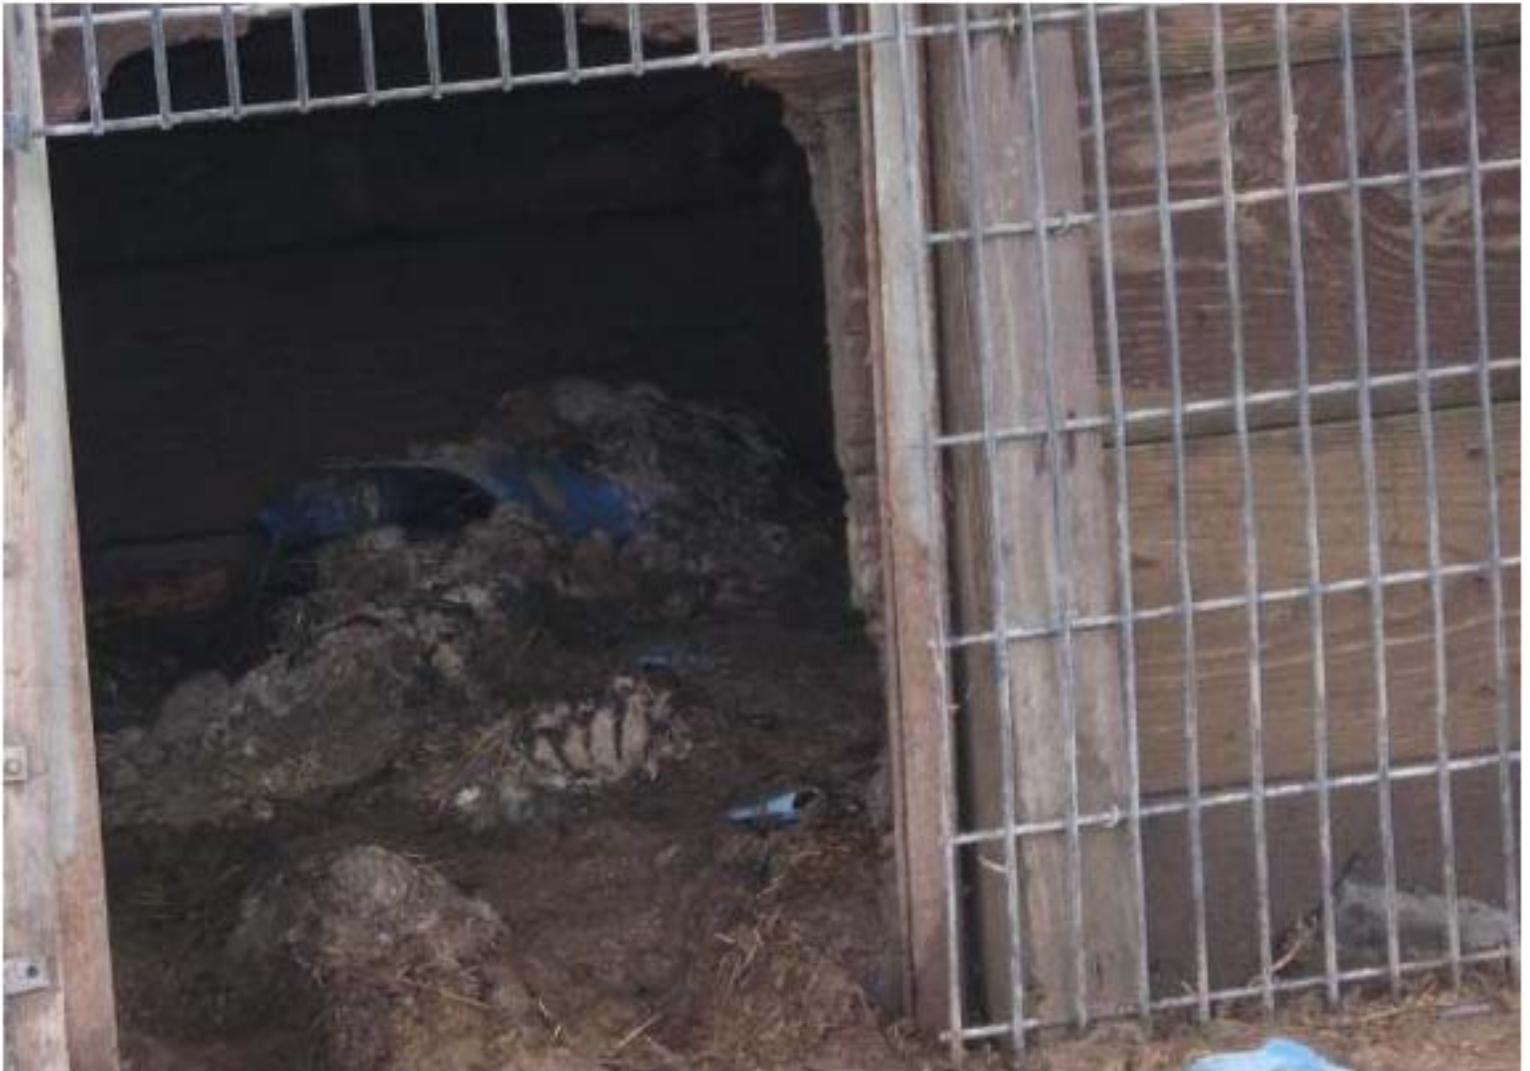
CFR: 3.131 (a)

Photographer:	Chad Moore	Legal Name:	Registration:	42-C-0081
Photo Taken:	Thu, May 13, '10	Approximately 12:00	JOYCE DE COCK	
Inspection:	134100903280828	RICHARD DE COCK		
Description:	Excessive feces in bear den box.

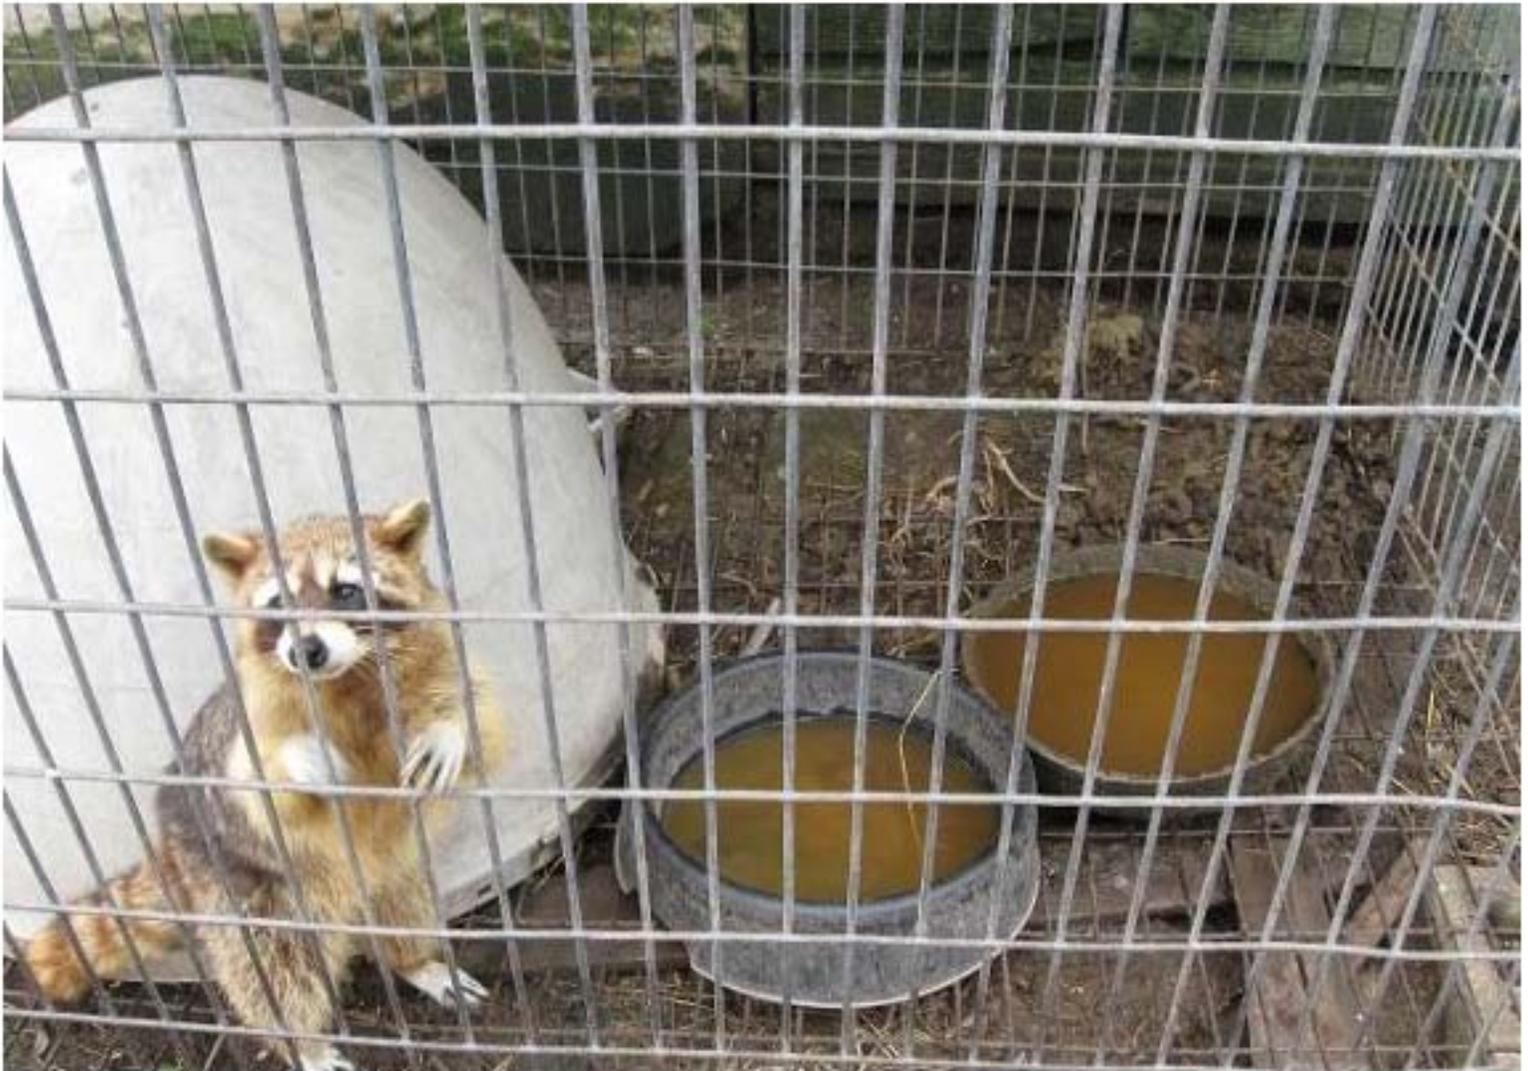
CFR: 3.130

Photographer:	Chad Moore	Legal Name:	Registration:	42-C-0081
Photo Taken:	Thu, May 13, '10	Approximately 12:00	JOYCE DE COCK	
Inspection:	134100903280828	RICHARD DE COCK		
Description:	Excessive feces and unsanitized water dish, nonpotable water.

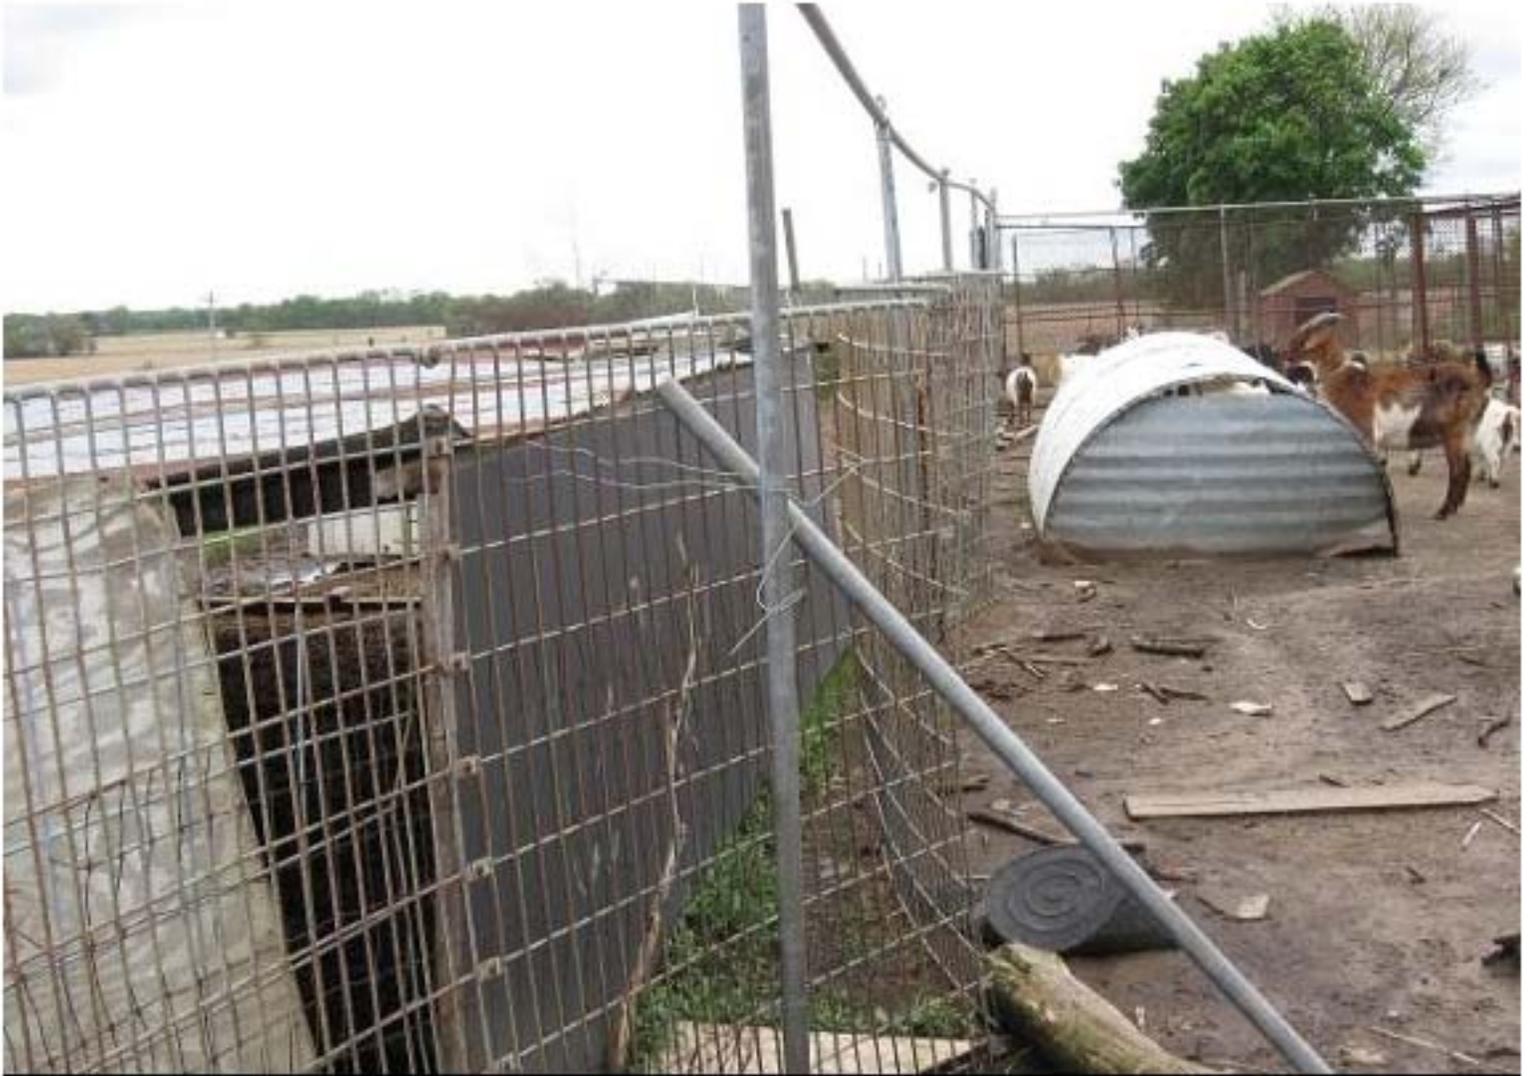
CFR: 3.127 (d)

Photographer:	Chad Moore	Legal Name:	Registration:	42-C-0081
Photo Taken:	Thu, May 13, '10	Approximately 12:00	JOYCE DE COCK	
Inspection:	134100903280828	RICHARD DE COCK		
Description:	North perimeter fence not tall enough

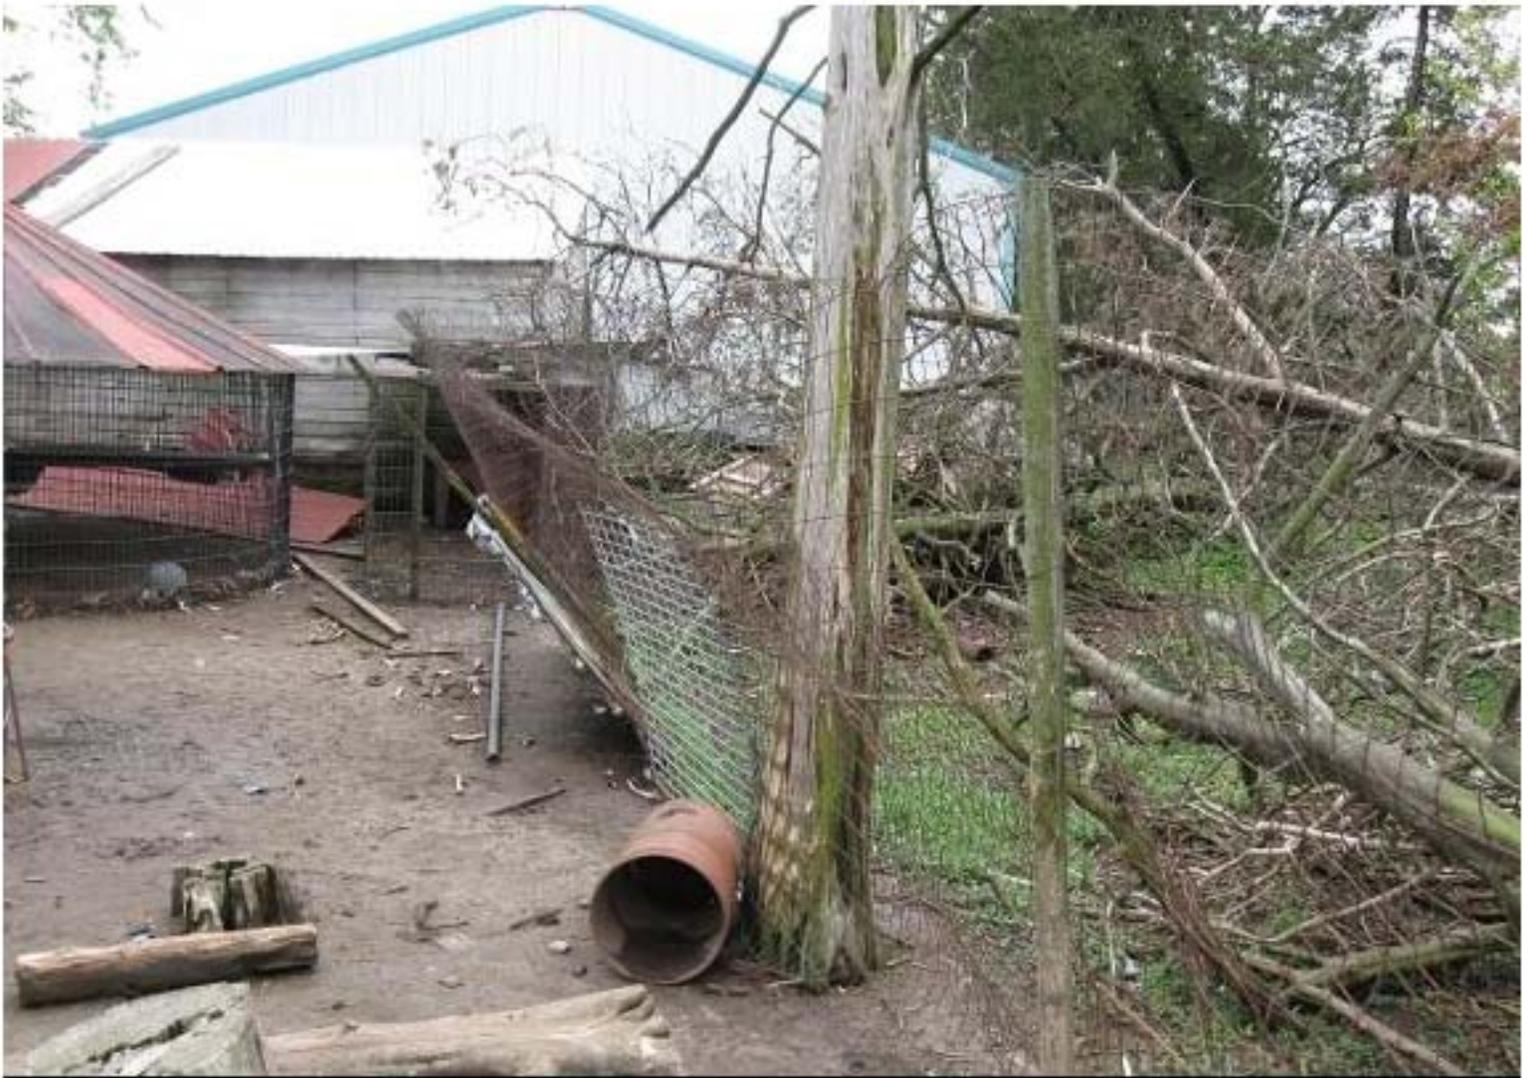
CFR: 3.127 (d)

Photographer:	Chad Moore	Legal Name:	Registration:	42-C-0081
Photo Taken:	Thu, May 13, '10	Approximately 12:00	JOYCE DE COCK	
Inspection:	134100903280828	RICHARD DE COCK		
Description:	West perimeter fence in disrepair

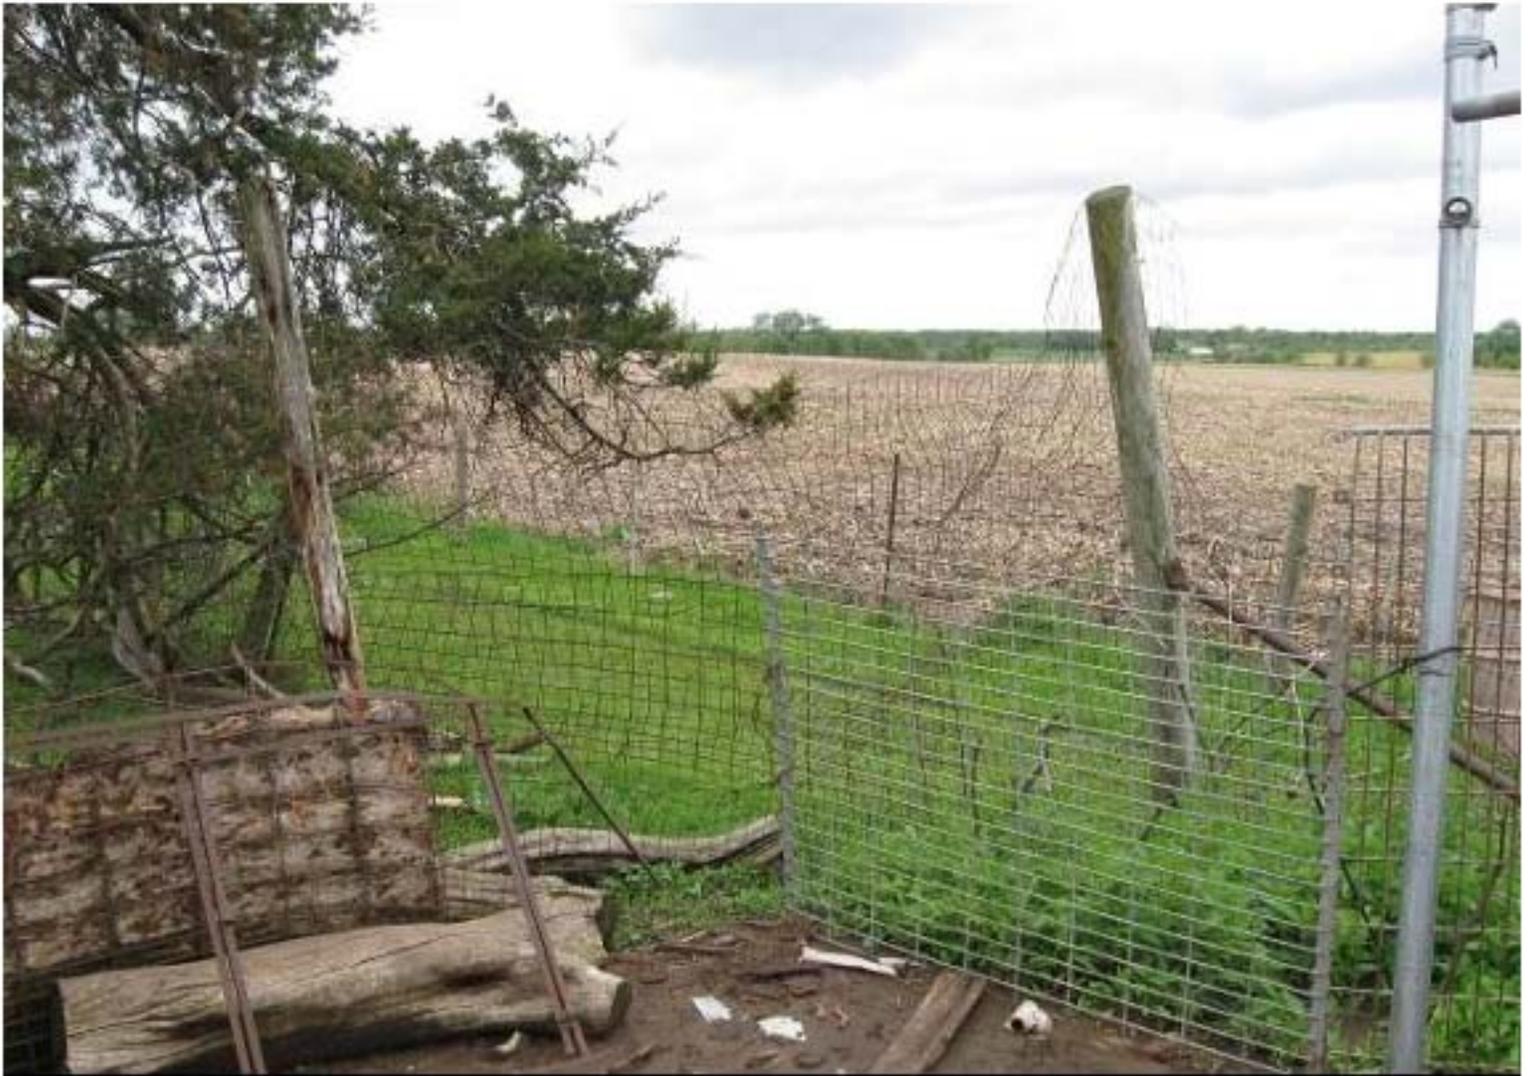
CFR: 3.127 (d)

Photographer:	Chad Moore	Legal Name:	Registration:	42-C-0081
Photo Taken:	Thu, May 13, '10	Approximately 12:00	JOYCE DE COCK	
Inspection:	134100903280828	RICHARD DE COCK		
Description:	North perimeter fence not tall enough

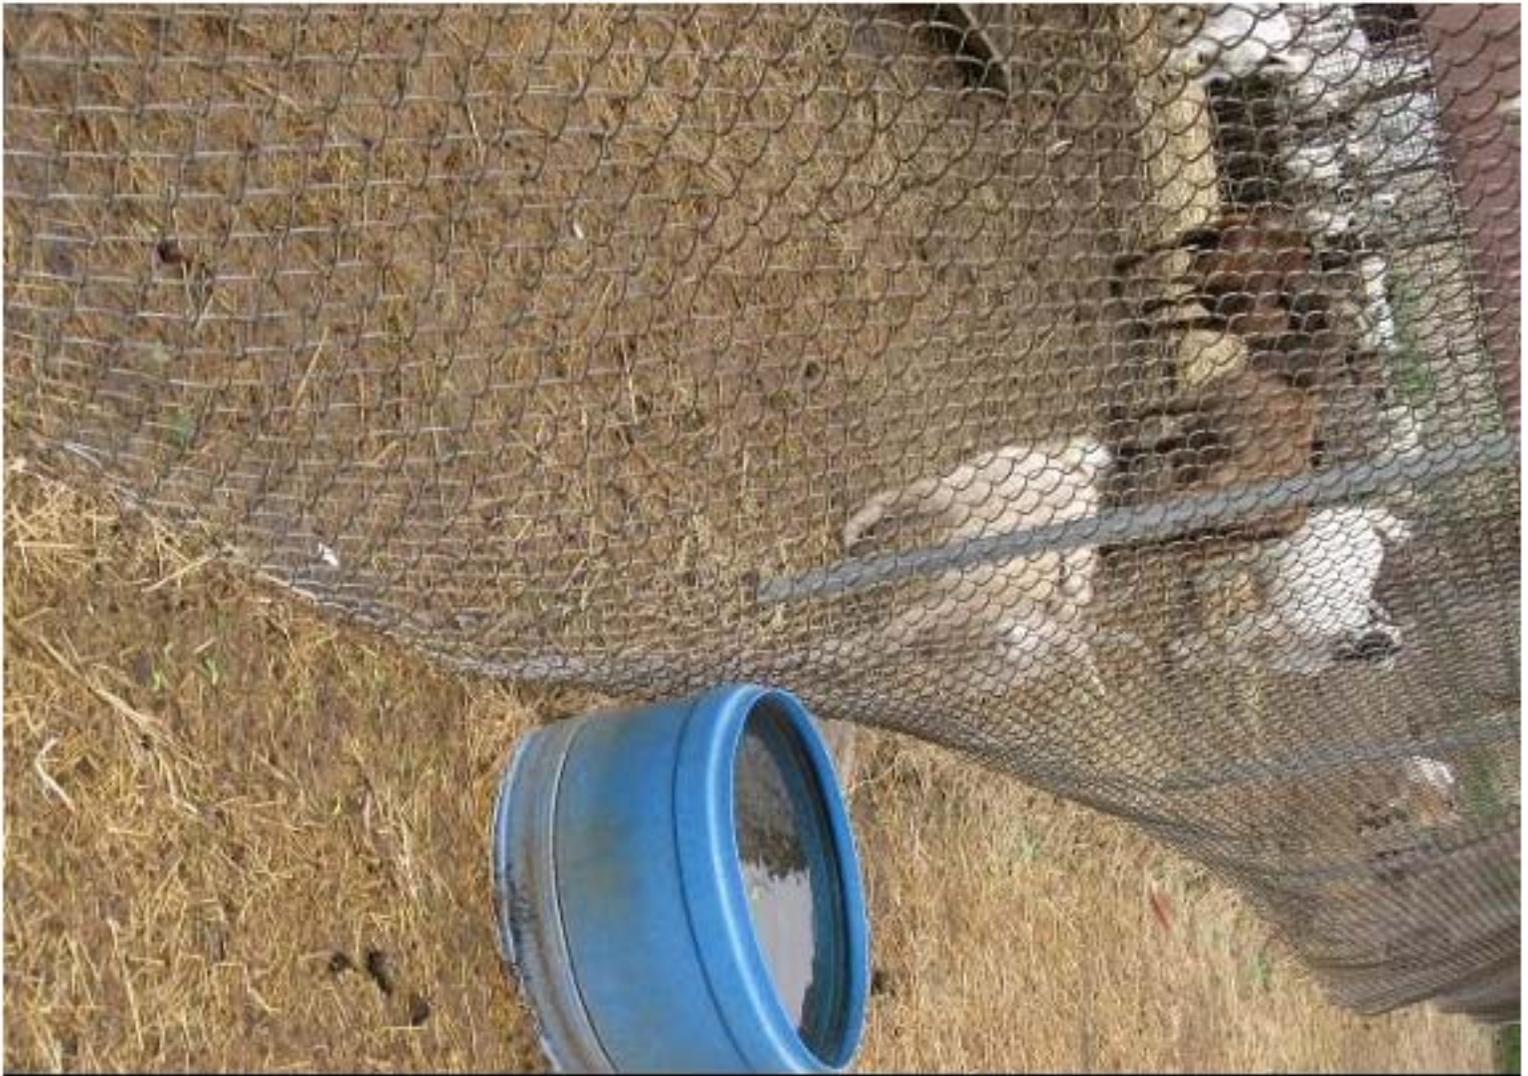
CFR: 3.127 (d)

Photographer:	Chad Moore	Legal Name:	Registration:	42-C-0081
Photo Taken:	Thu, May 13, '10	Approximately 12:00	JOYCE DE COCK	
Inspection:	134100903280828	RICHARD DE COCK		
Description:	East perimeter fence in disrepair

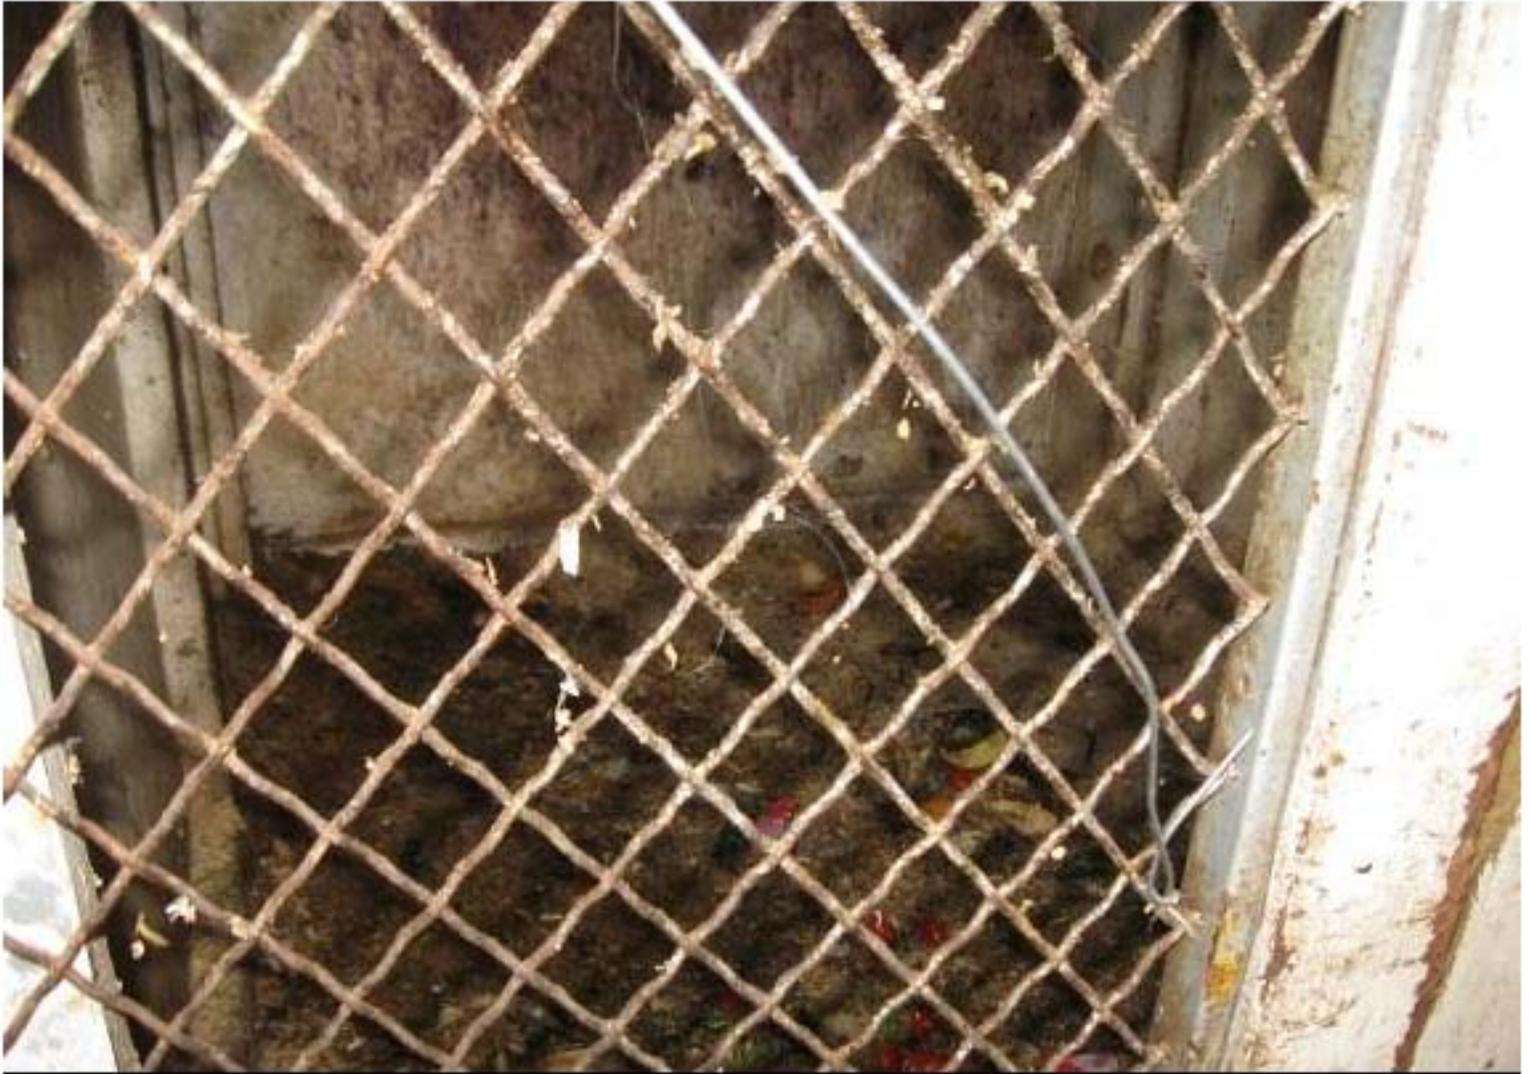
CFR: 3.84 (a)

Photographer:	Chad Moore	Legal Name:	Registration:	42-C-0081
Photo Taken:	Thu, May 13, '10	Approximately 12:00	JOYCE DE COCK	
Inspection:	134100903280828	RICHARD DE COCK		
Description:	Excessive feces and food wastes on floors, walls of nonhuman primate enclosures.

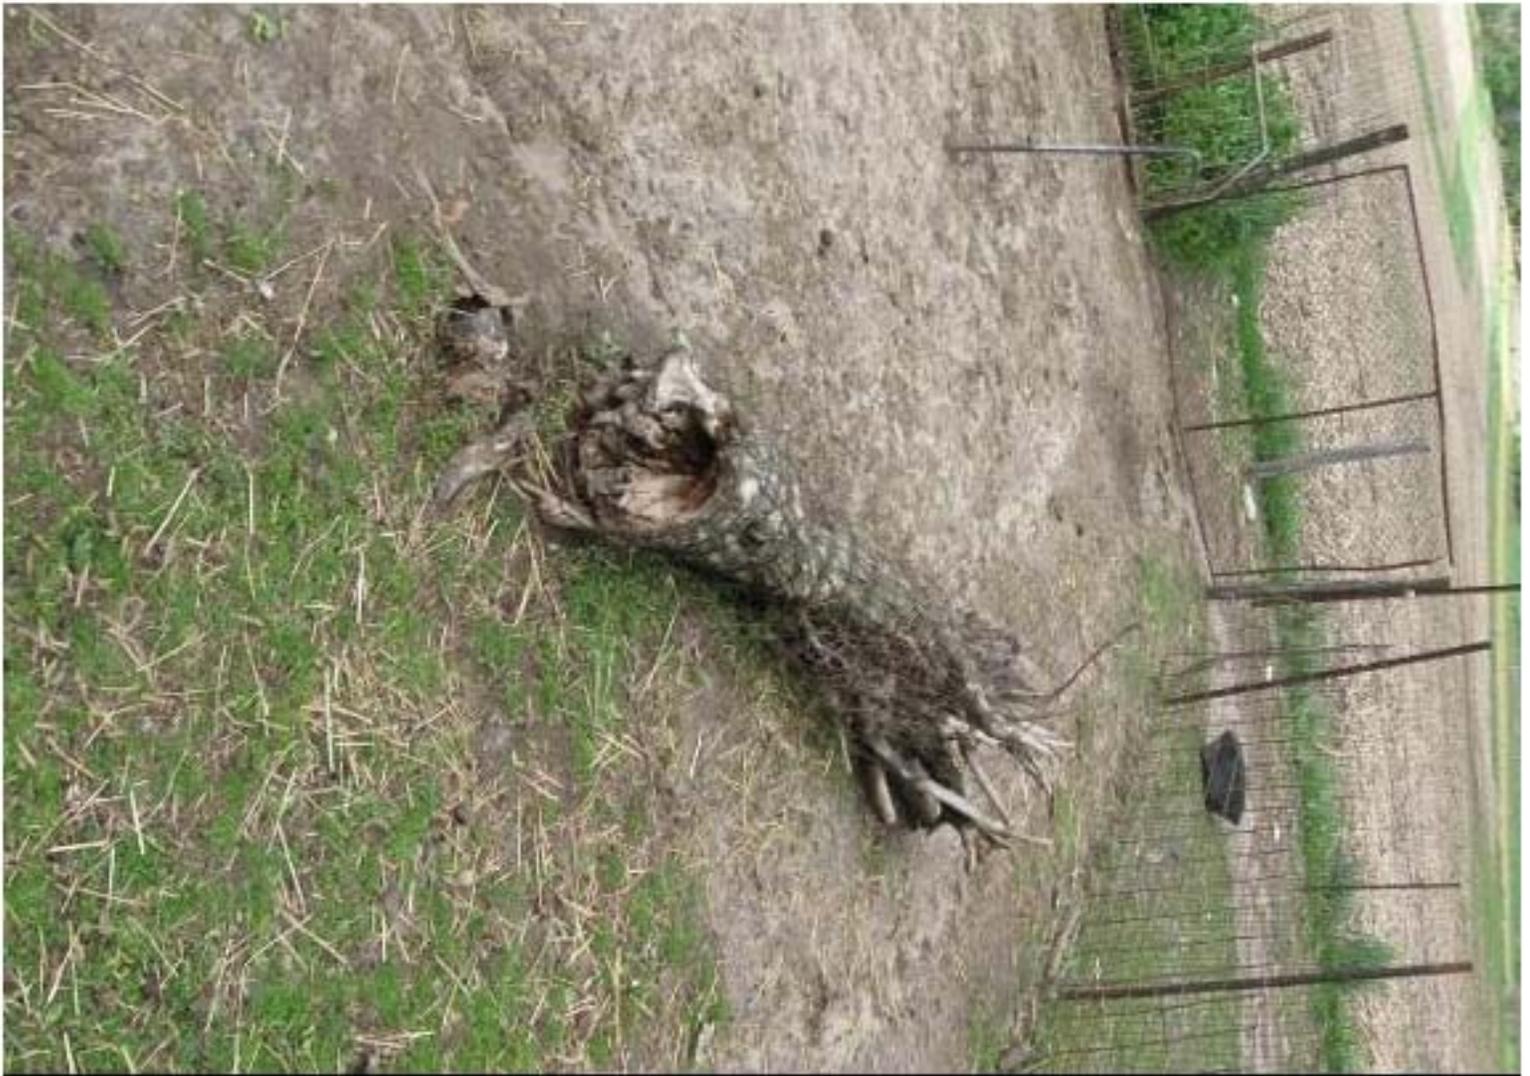
CFR: 3.131 (c)

Photographer:	Chad Moore	Legal Name:	Registration:	42-C-0081
Photo Taken:	Thu, May 13, '10	Approximately 12:00	JOYCE DE COCK	
Inspection:	134100903280828	RICHARD DE COCK		
Description:	Tree with wire (sharp points) wrapped around it in goat pen.

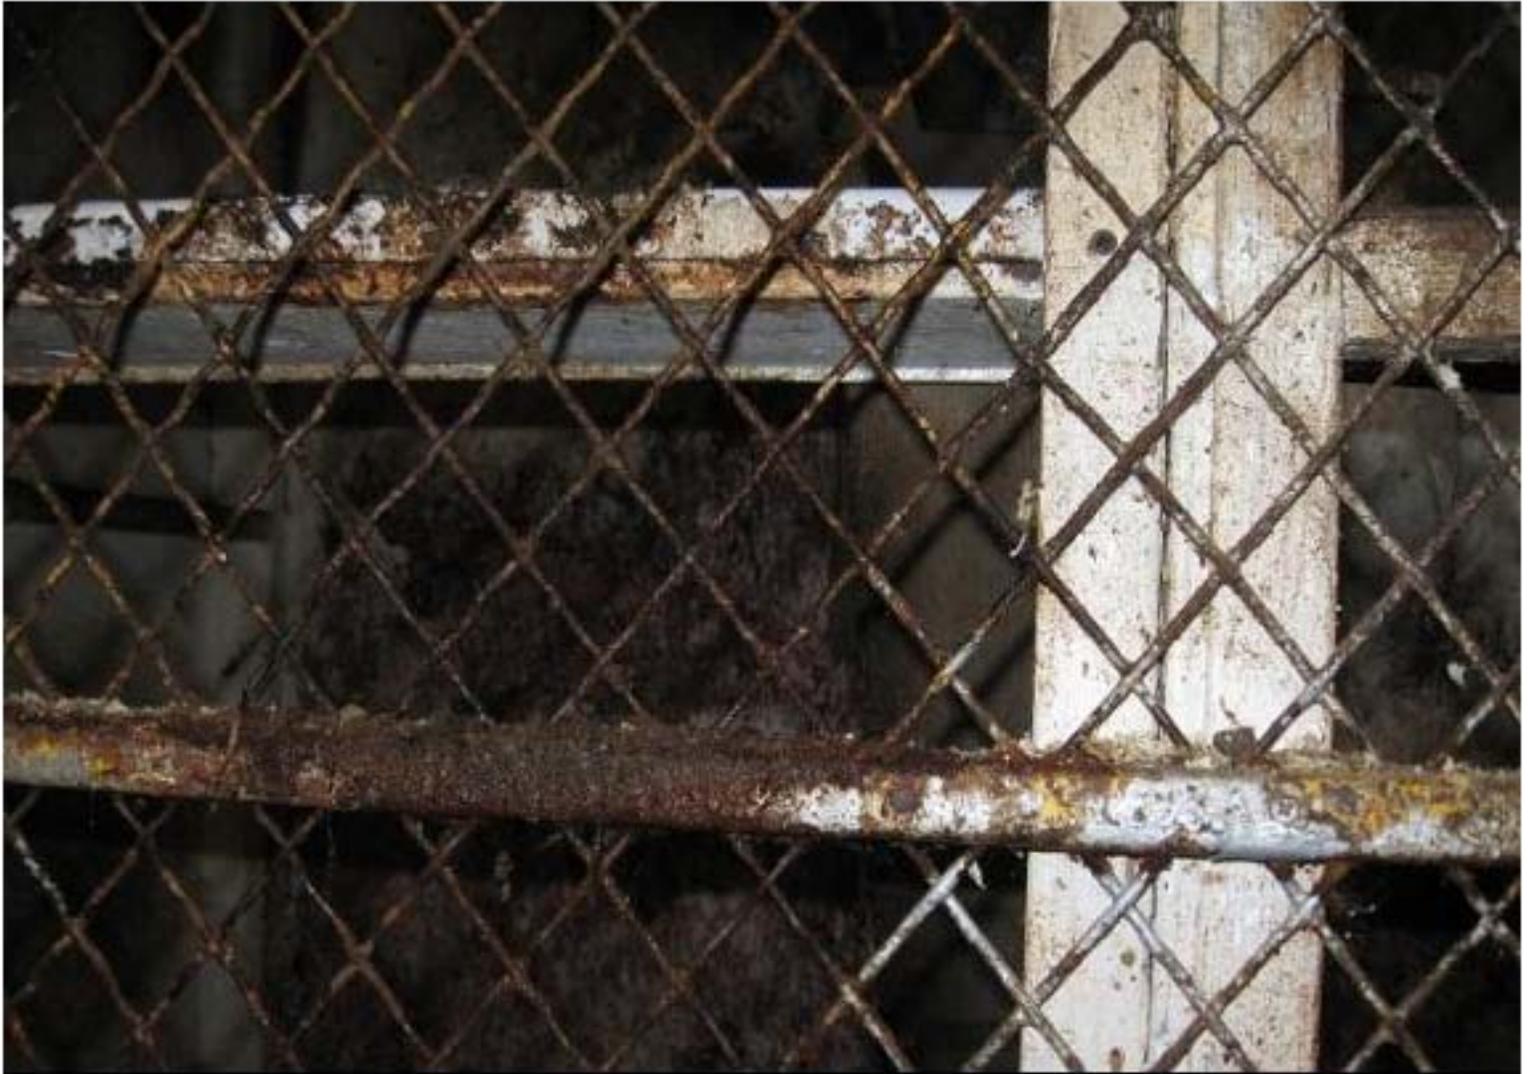
CFR: 3.84 (a)

Photographer:	Chad Moore	Legal Name:	Registration:	42-C-0081
Photo Taken:	Thu, May 13, '10	Approximately 12:00	JOYCE DE COCK	
Inspection:	134100903280828	RICHARD DE COCK		
Description:	Excessive feces and food wastes on floors, walls of nonhuman primate enclosures.
