Photographer: Heather Cole, VMO      Legal Name: PAMELA SELLNER      Registration: 42-C-0084  
Photo Taken: Mon, Nov 22, '10 approximately 1100      TOM SELLNER  
Inspection: 326101741280061  
Description:

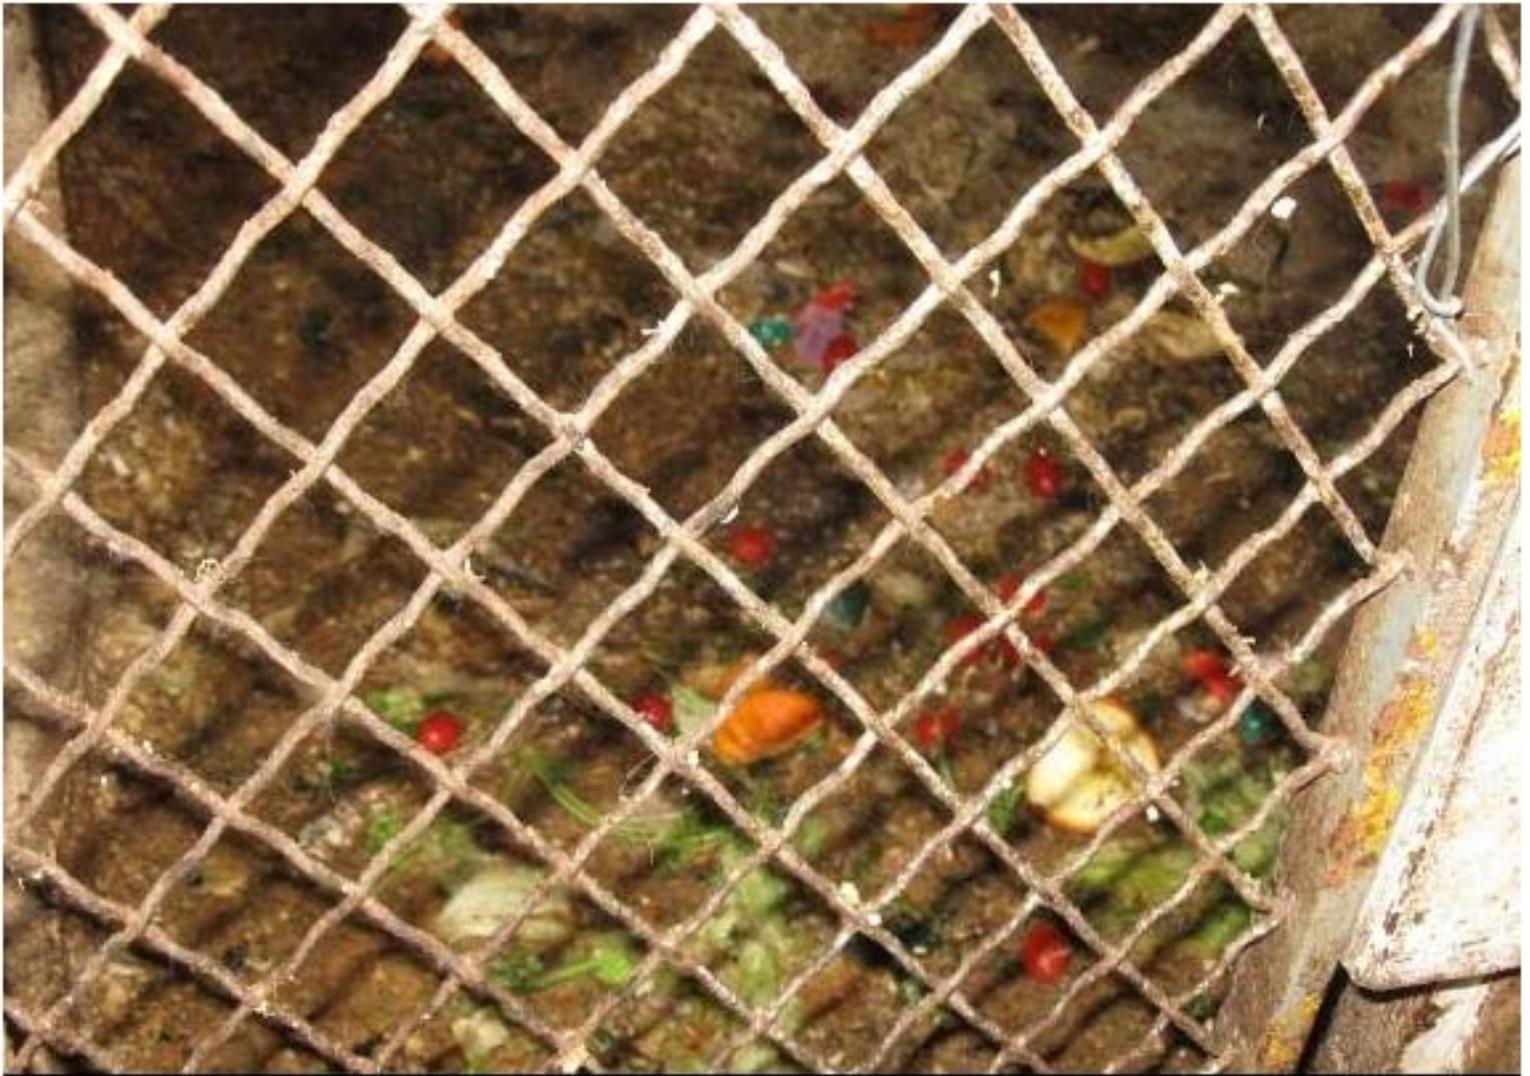
CFR: 3.84 (a)

Photographer:	Chad Moore	Legal Name:	Registration:	42-C-0081
Photo Taken:	Thu, May 13, '10	Approximately 12:00	JOYCE DE COCK	
Inspection:	134100903280828	RICHARD DE COCK		
Description:	Excessive feces and food wastes on floors, walls of nonhuman primate enclosures.

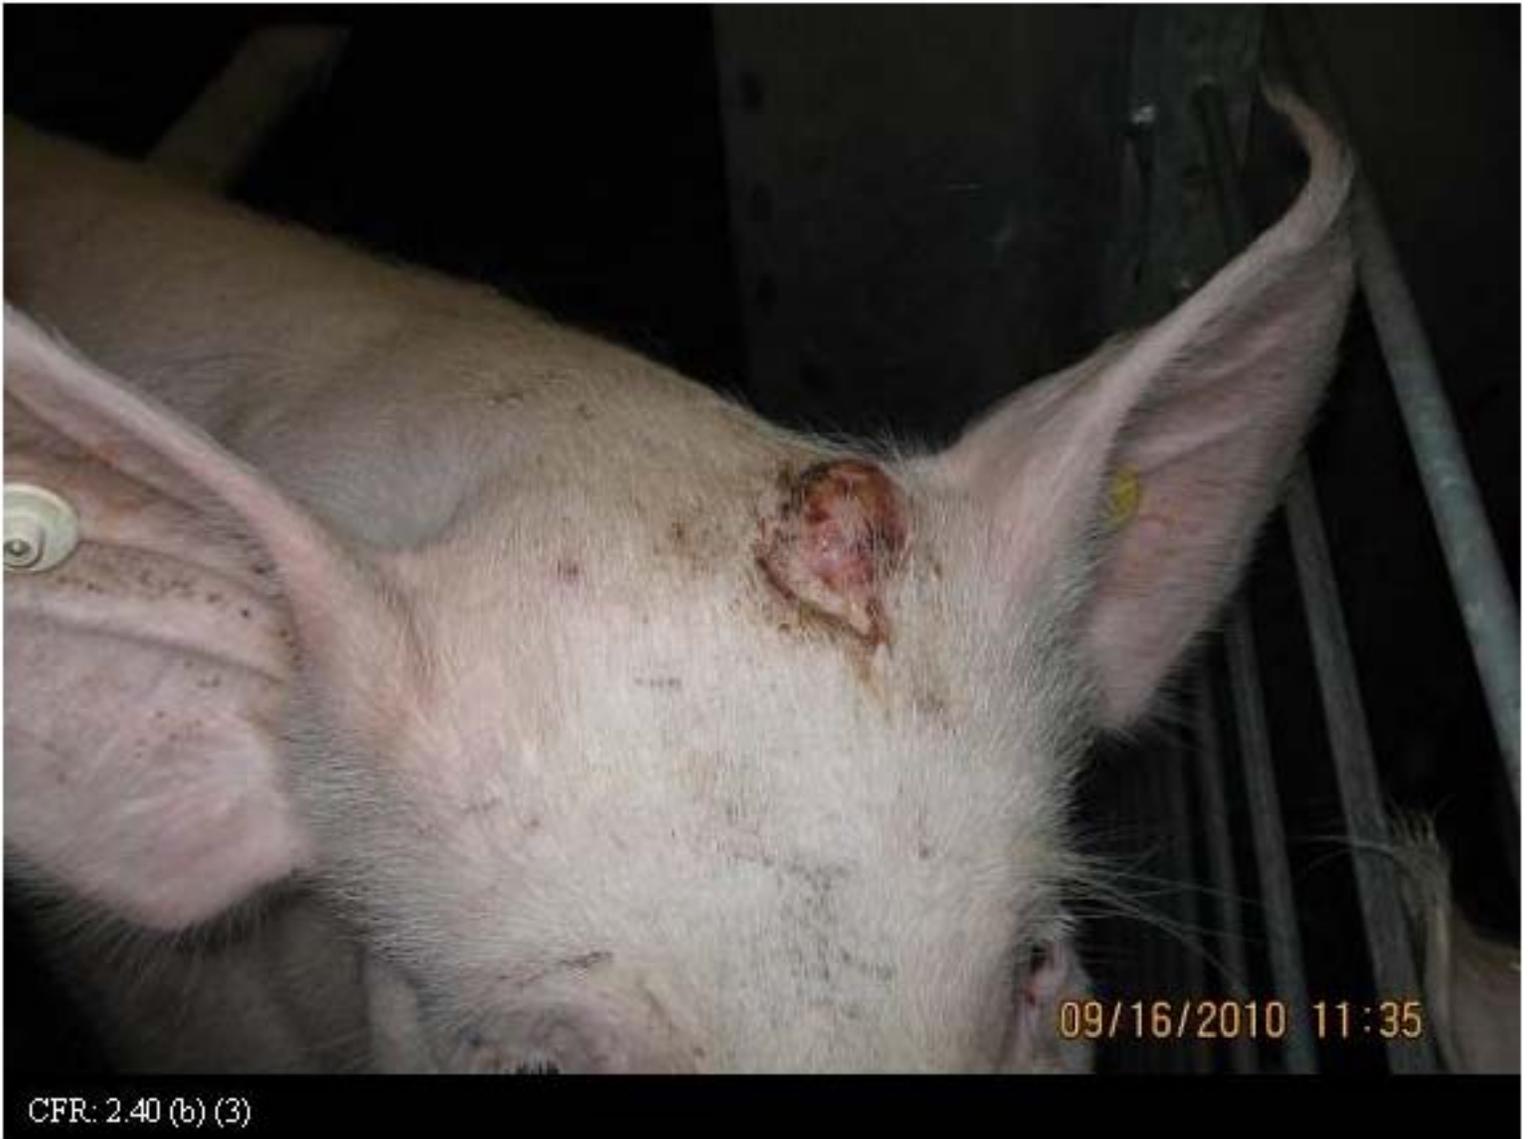
Photographer:	Tracy Thompson	Legal Name:	Registration:	42-B-0270
Photo Taken:	Fri, Sep 17, '10 11:35 AM	EXEMPLAR GENETICS		
Inspection:	260100039360229			
Description:	Sow #920 with raised, reddened purulent nodule on head.

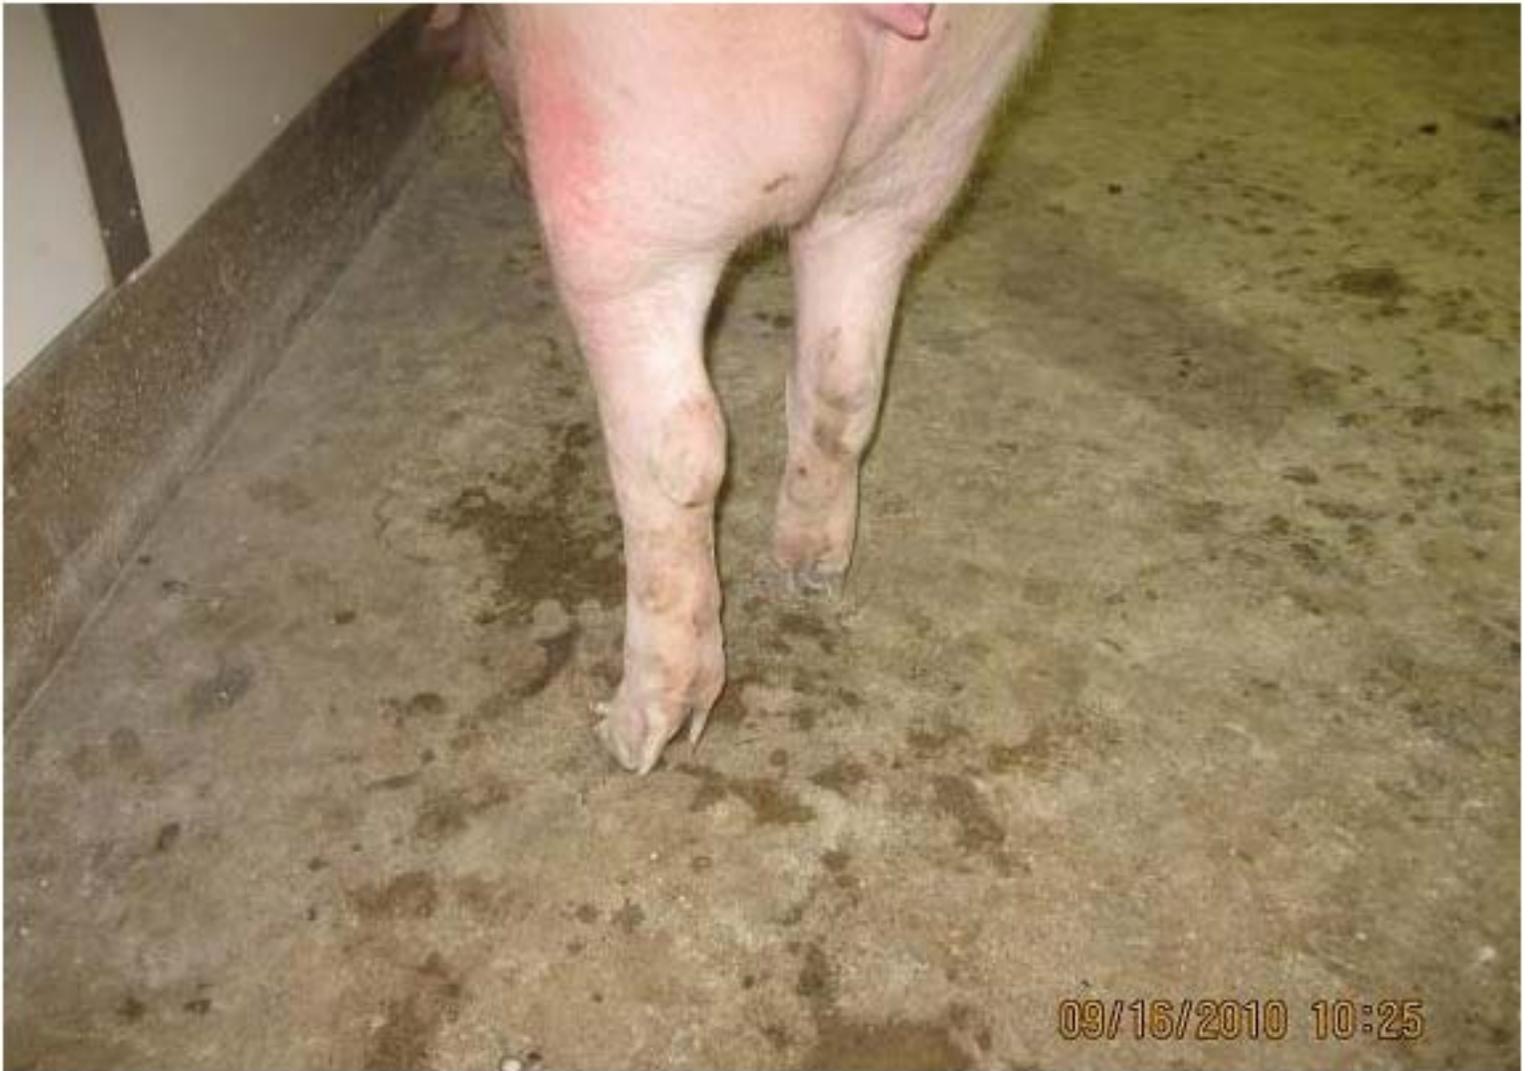
CFR: 2.40 (b) (3)

Photographer:	Tracy Thompson	Legal Name:	Registration:	42-B-0270
Photo Taken:	Fri, Sep 17, '10 10:25 AM	EXEMPLAR GENETICS		
Inspection:	260100039360229			
Description:	Sow #423 with overgrown hooves and lameness that appears to be due to either a swelling or deformity of the left rear foot.

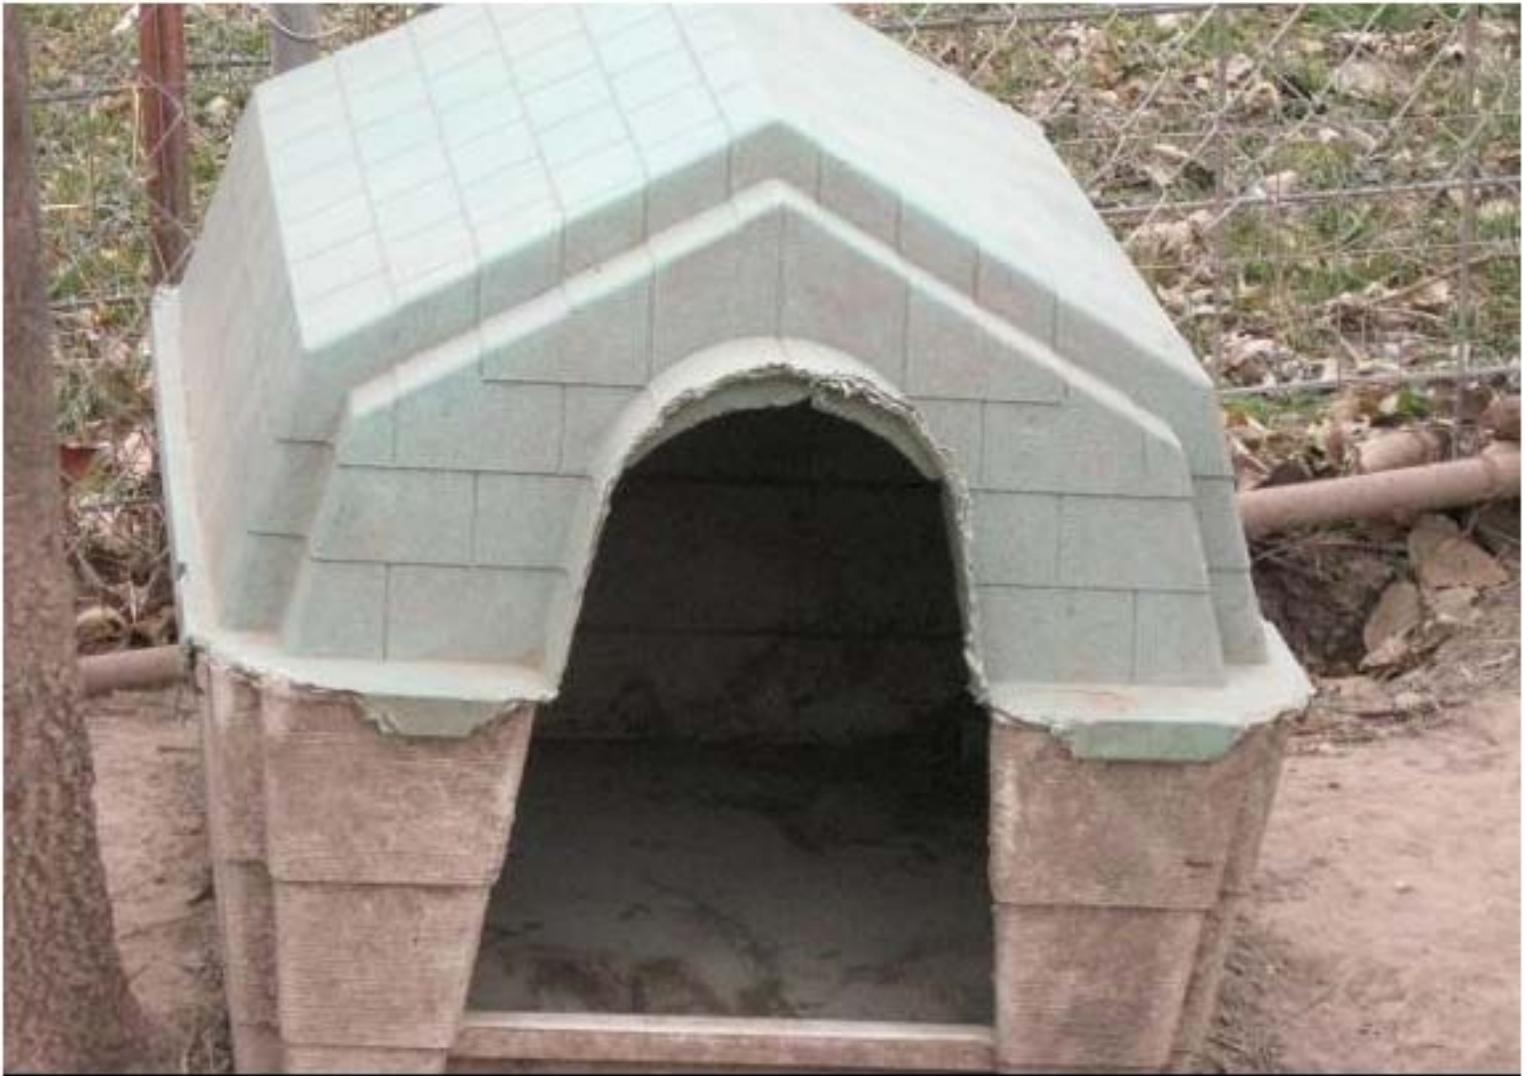
CFR: 3.4 (b) (4), 3.4 (b) (3)

Photographer:	John Lies, ACI	Legal Name:	Registration:	42-B-0242
Photo Taken:	Fri, Dec 3, '10 P.M.	RON WILHARM		
Inspection:	337101839450235			
Description:	3.4 (b)(3) & (4) Outdoor housing : No wind and rain breaks at the entrance. Shelters do not contain bedding.

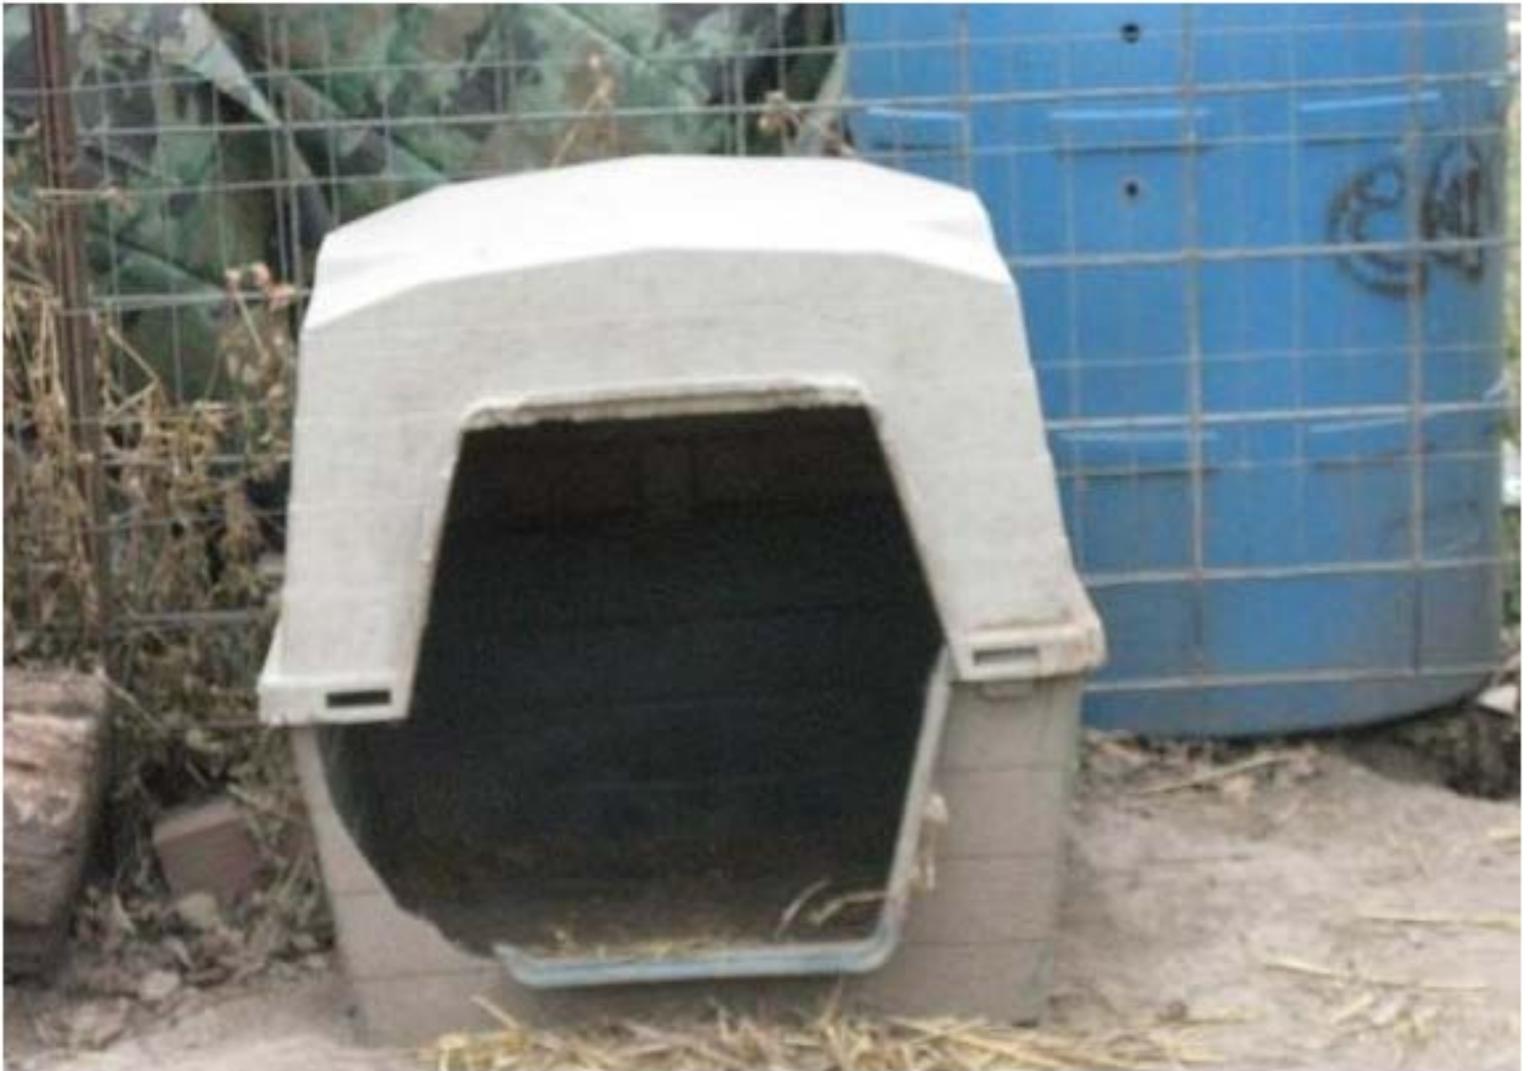
CFR: 3.4 (b) (3), 3.4 (b) (4)

Photographer:	John Lies, ACI	Legal Name:	Registration:	42-B-0242
Photo Taken:	Fri, Dec 3, '10 P.M.	RON WILHARM		
Inspection:	337101839450235			
Description:	3.4 (b)(3) & (4) Outdoor housing : No wind and rain breaks at the entrance. Shelters do not contain bedding.

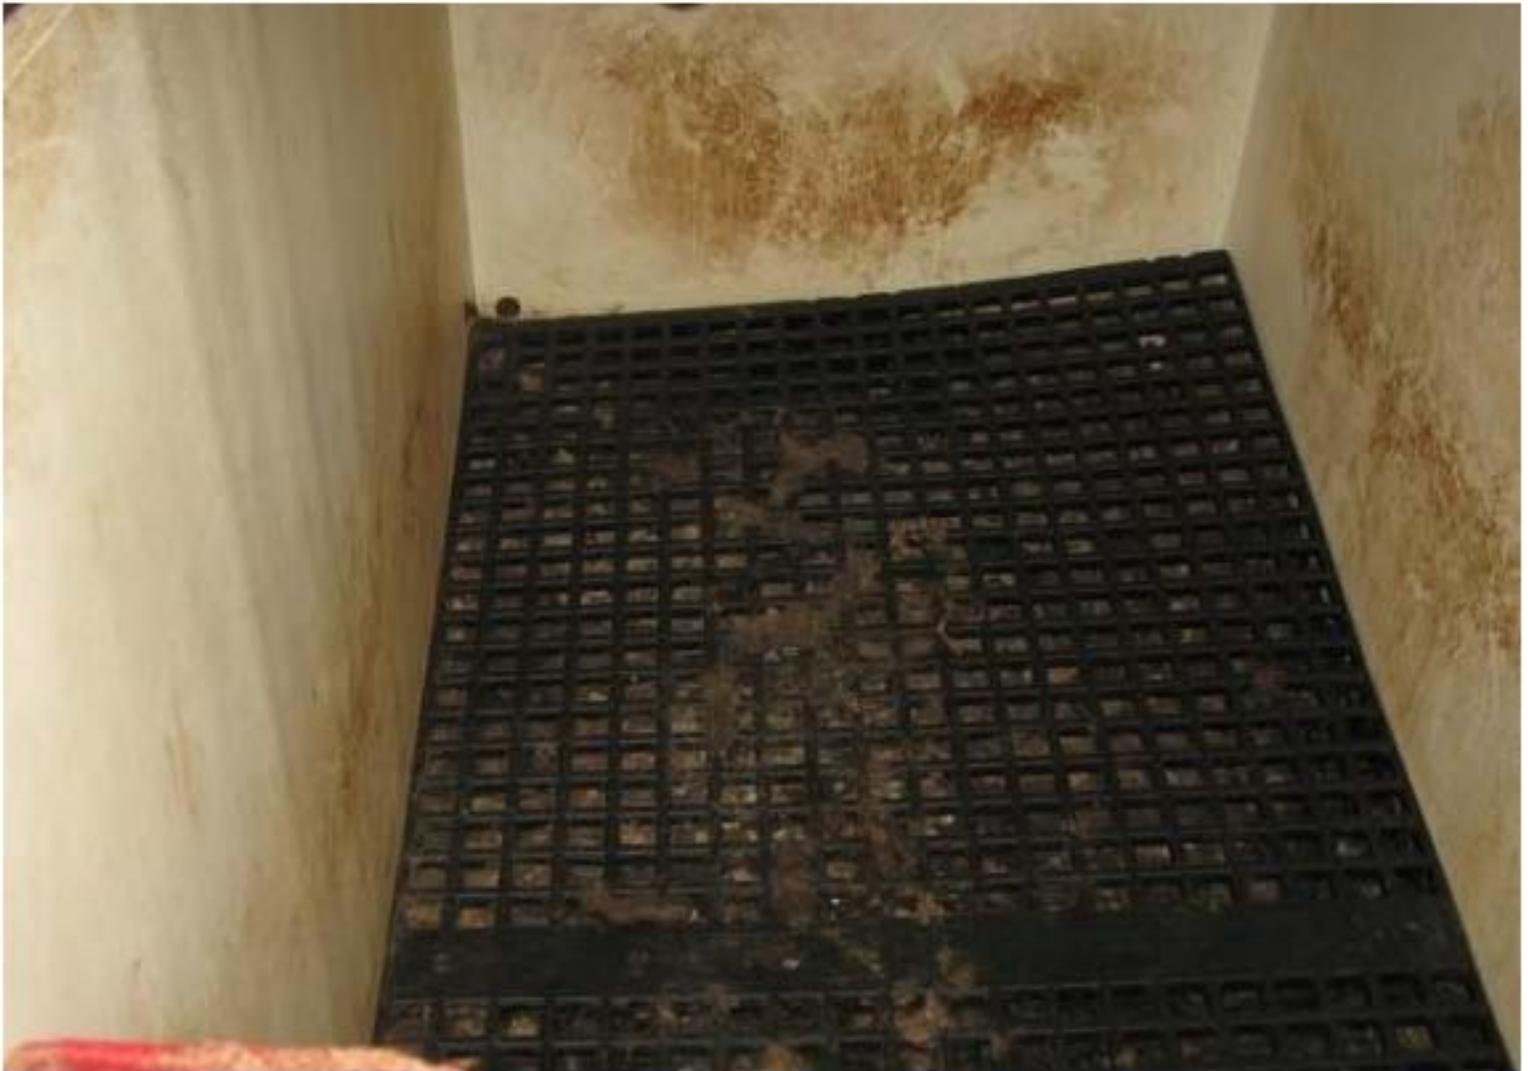
Photographer:	D Watkins	Legal Name:	Registration:	42-B-0168
Photo Taken:	Mon, Sep 13, '10 Afternoon	CAROLYN ARENDS JULIE ARENDS		
Inspection:	256102256060832			
Description:	Primary enclosure wall covered with dirt and fecal material

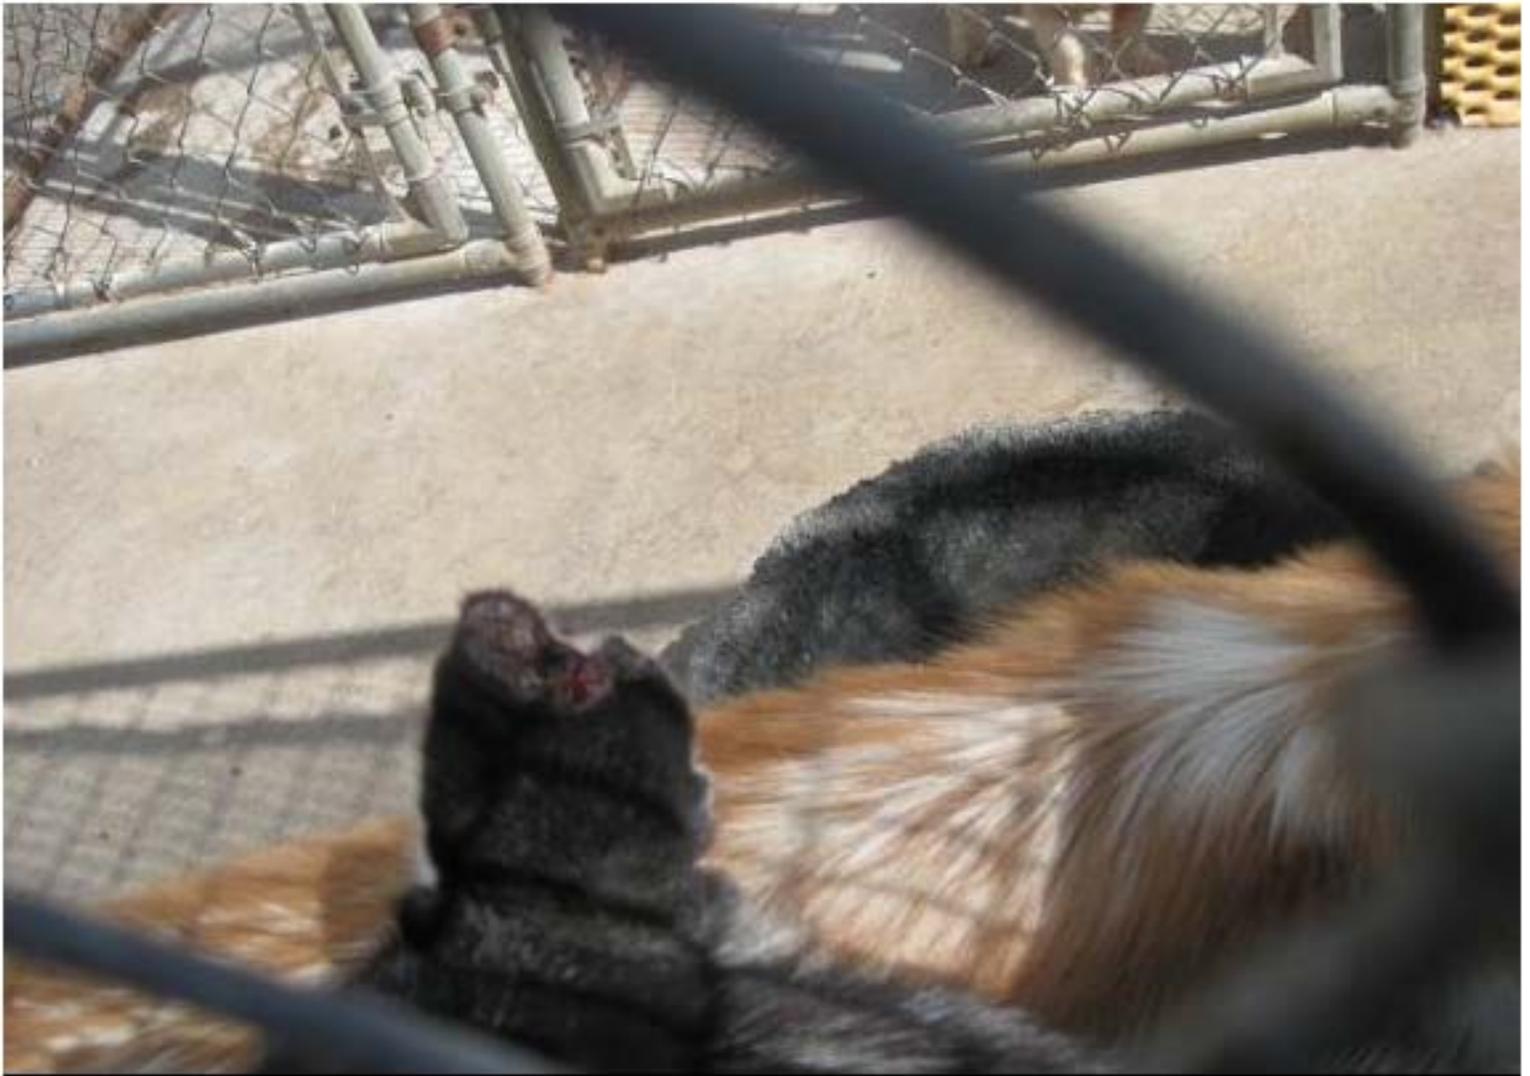
Photographer:	D Watkins	Legal Name:	Registration:	42-B-0168
Photo Taken:	Mon, Sep 13, '10 Afternoon	CAROLYN ARENDS JULIE ARENDS		
Inspection:	256102256060832			
Description:	:Dog with inflamed ear tips from fly bites

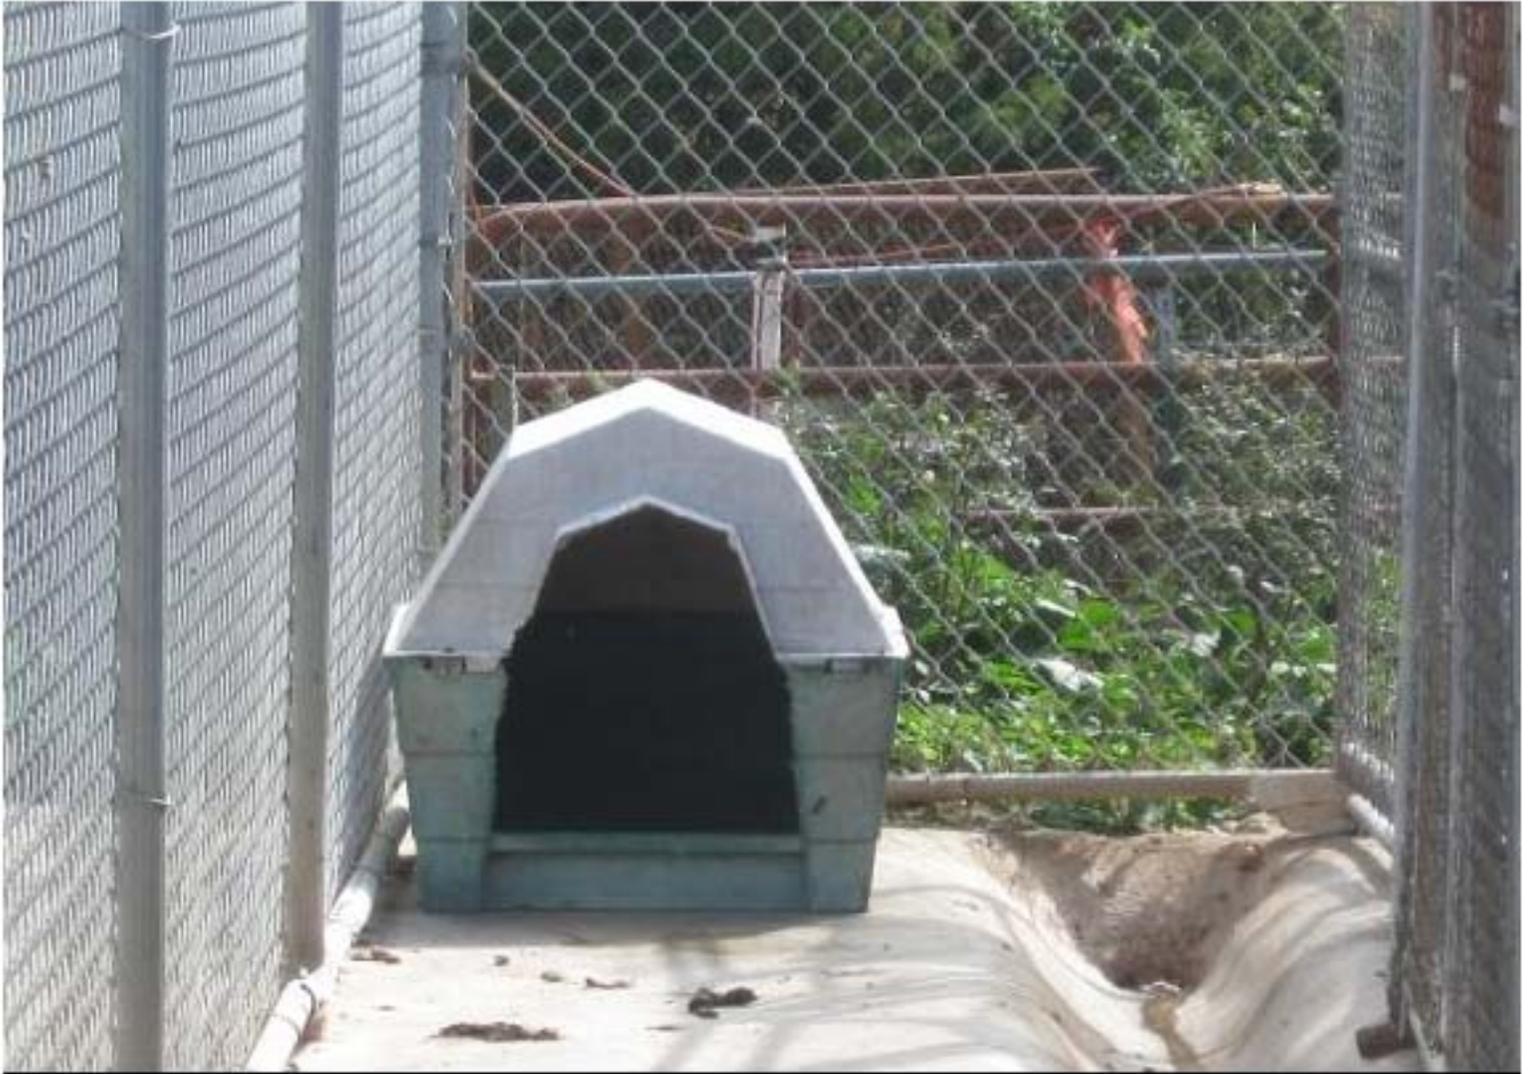
Photographer:	D Watkins	Legal Name:	Registration:	42-B-0168
Photo Taken:	Mon, Sep 13, '10 Afternoon	CAROLYN ARENDS JULIE ARENDS		
Inspection:	256102256060832			
Description:	Three 40-50 pound dogs sharing one shelter that isn't large enough to accommodate these animal. (Shelter is shown in another picture)

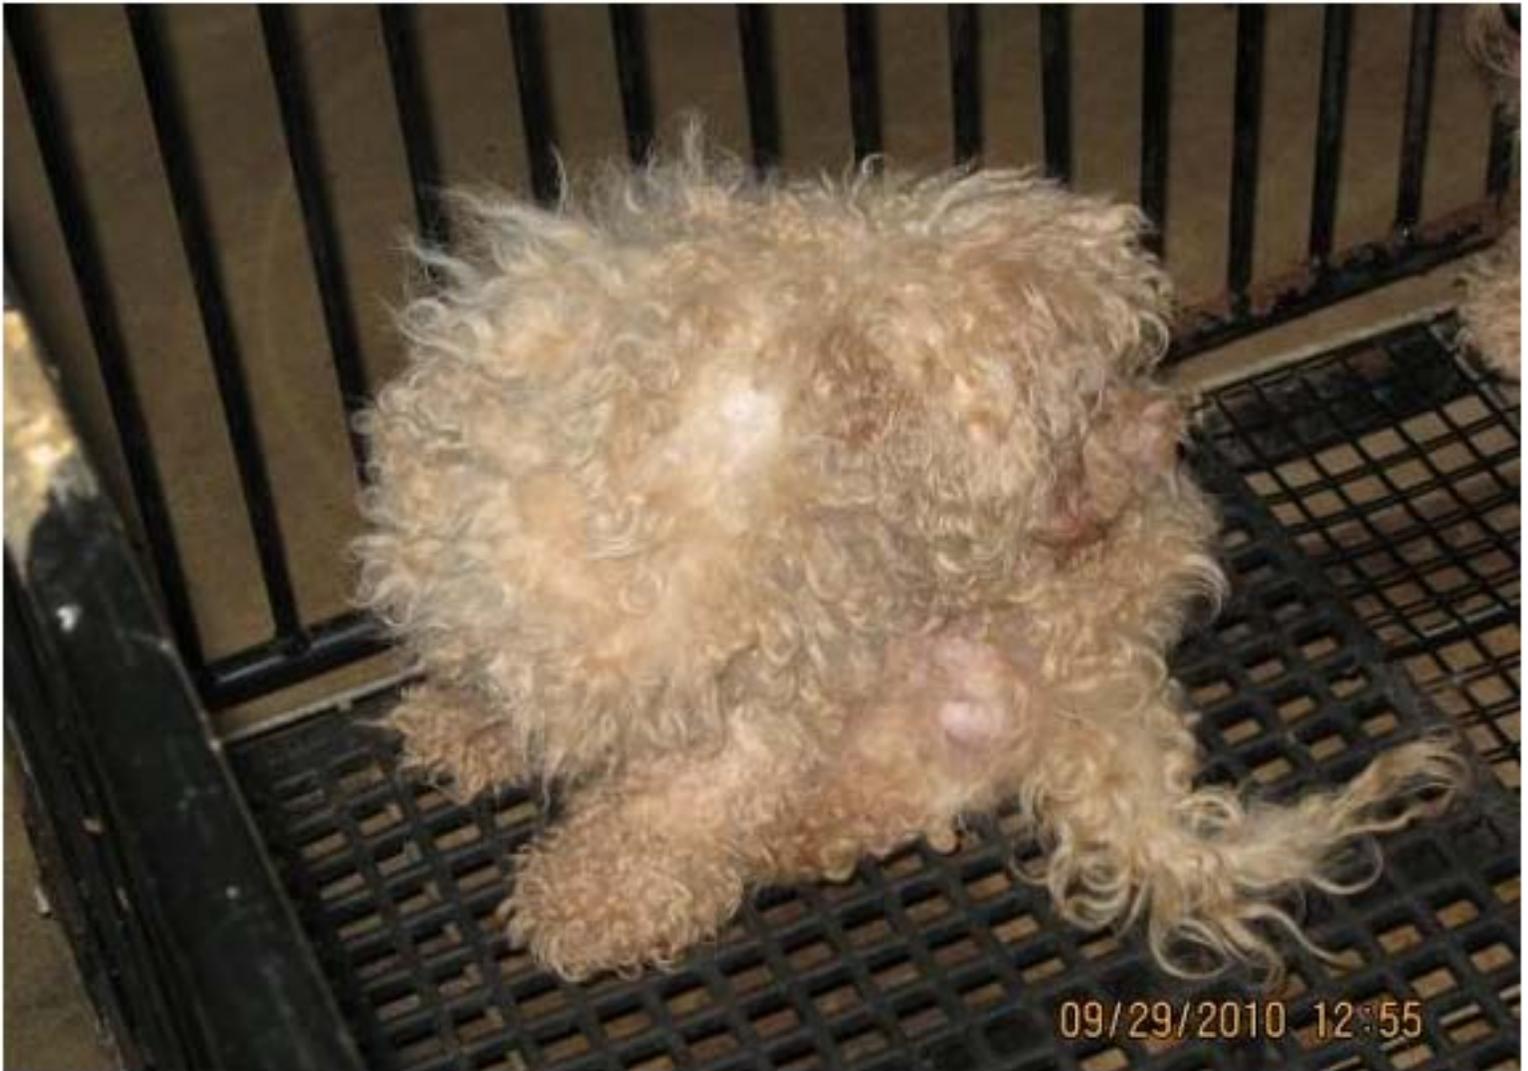
Photographer:	Randall Wagner (ACI)	Legal Name:	Registration:	42-B-0022
Photo Taken:	Wed, Sep 29, '10	RAINBOW KENNELS, INC.		
Inspection:	272101419120582			
Description:	The two dogs with excessive hair and mats.

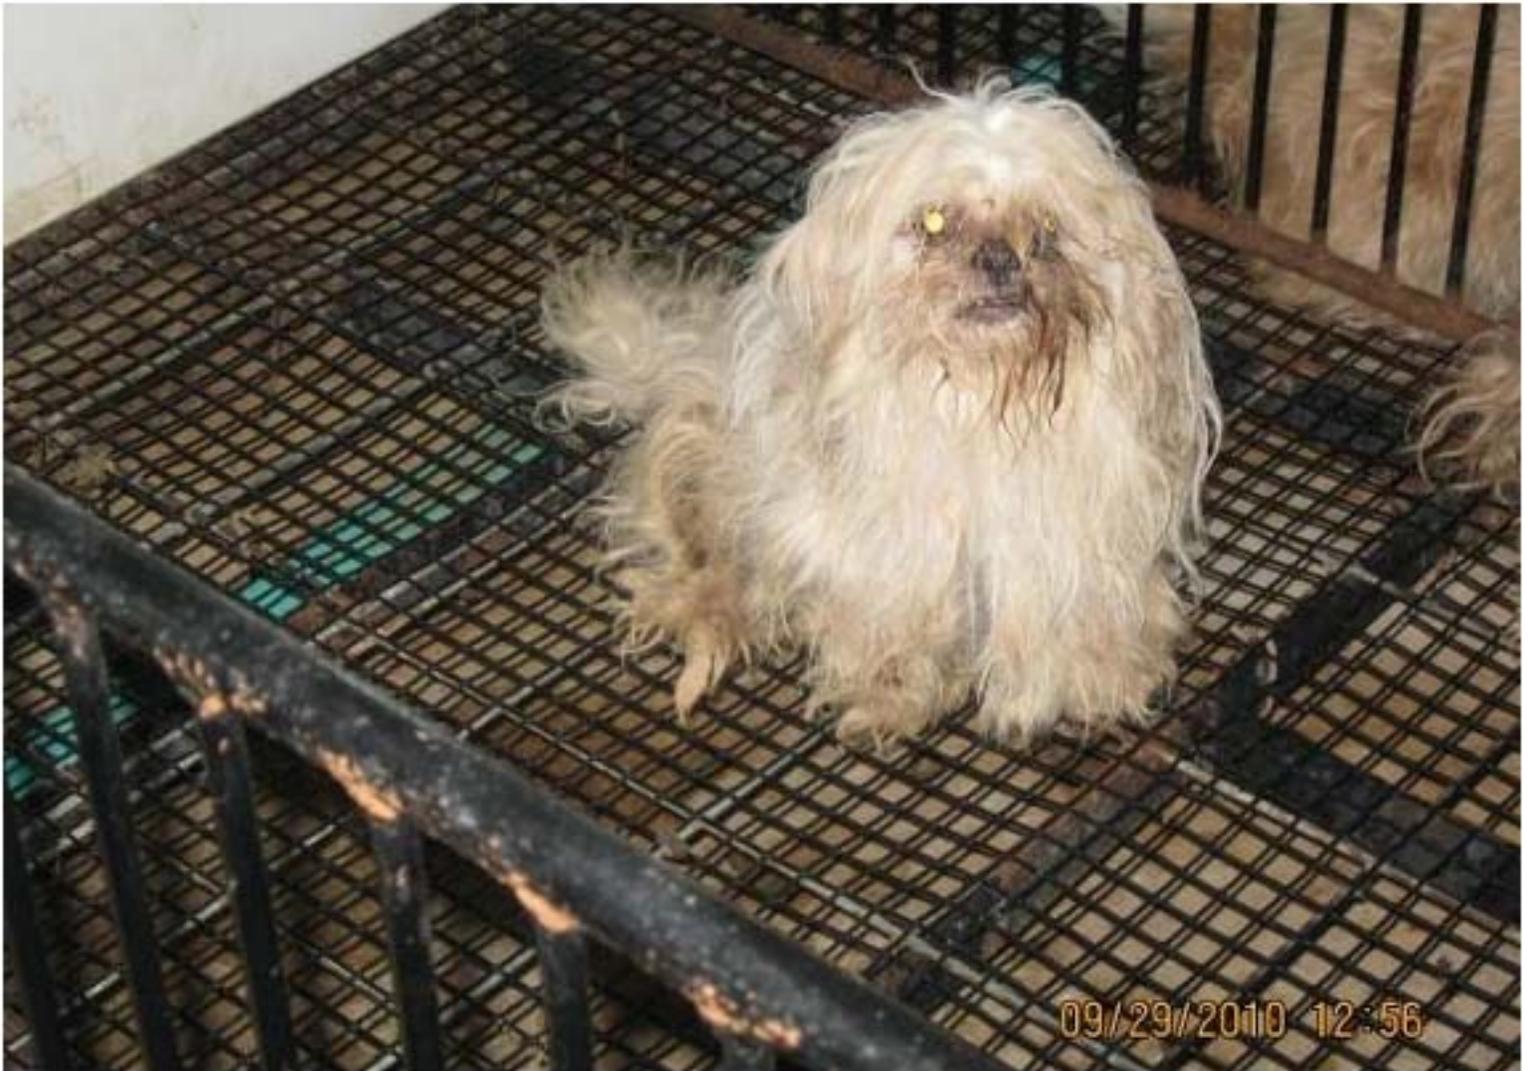
Photographer:	Randall Wagner (ACI)	Legal Name:	Registration:	42-B-0022
Photo Taken:	Wed, Sep 29, '10	RAINBOW KENNELS, INC.		
Inspection:	272101419120582			
Description:	The dog with excessive mats and hair could cause skin disease.

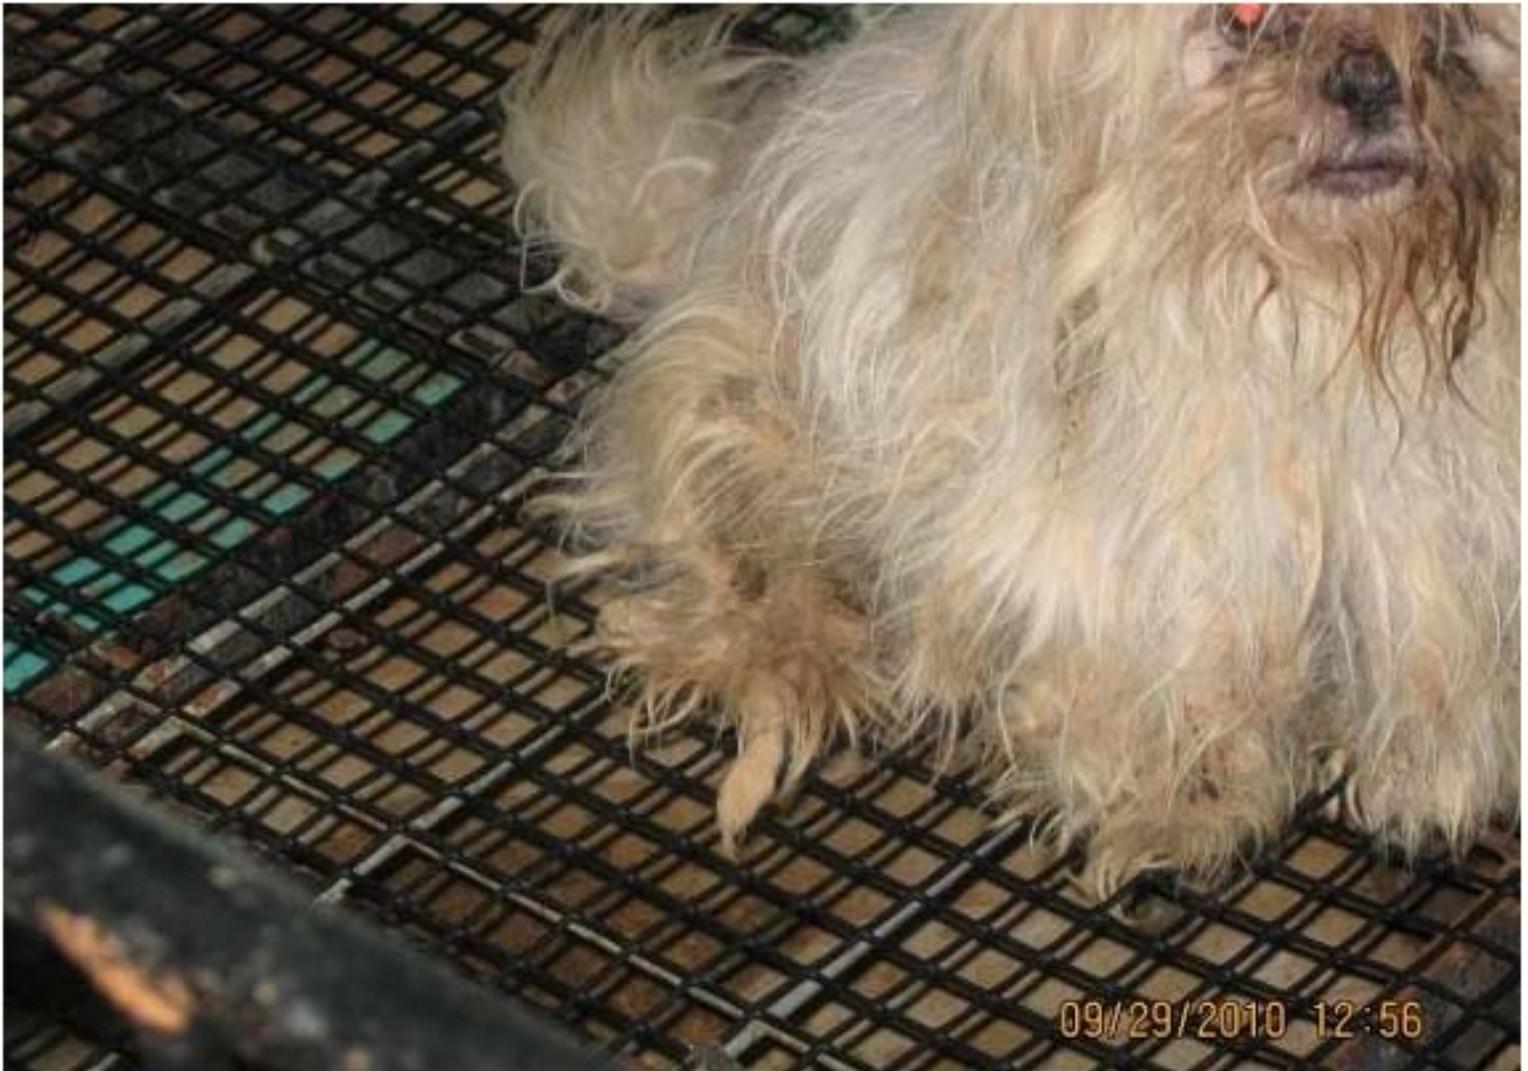
Photographer:	Randall Wagner (ACI)	Legal Name:	Registration:	42-B-0022
Photo Taken:	Wed, Sep 29, '10	RAINBOW KENNELS, INC.		
Inspection:	272101419120582			
Description:	The dog with excessive hair and mats around the paws and lower belly area.

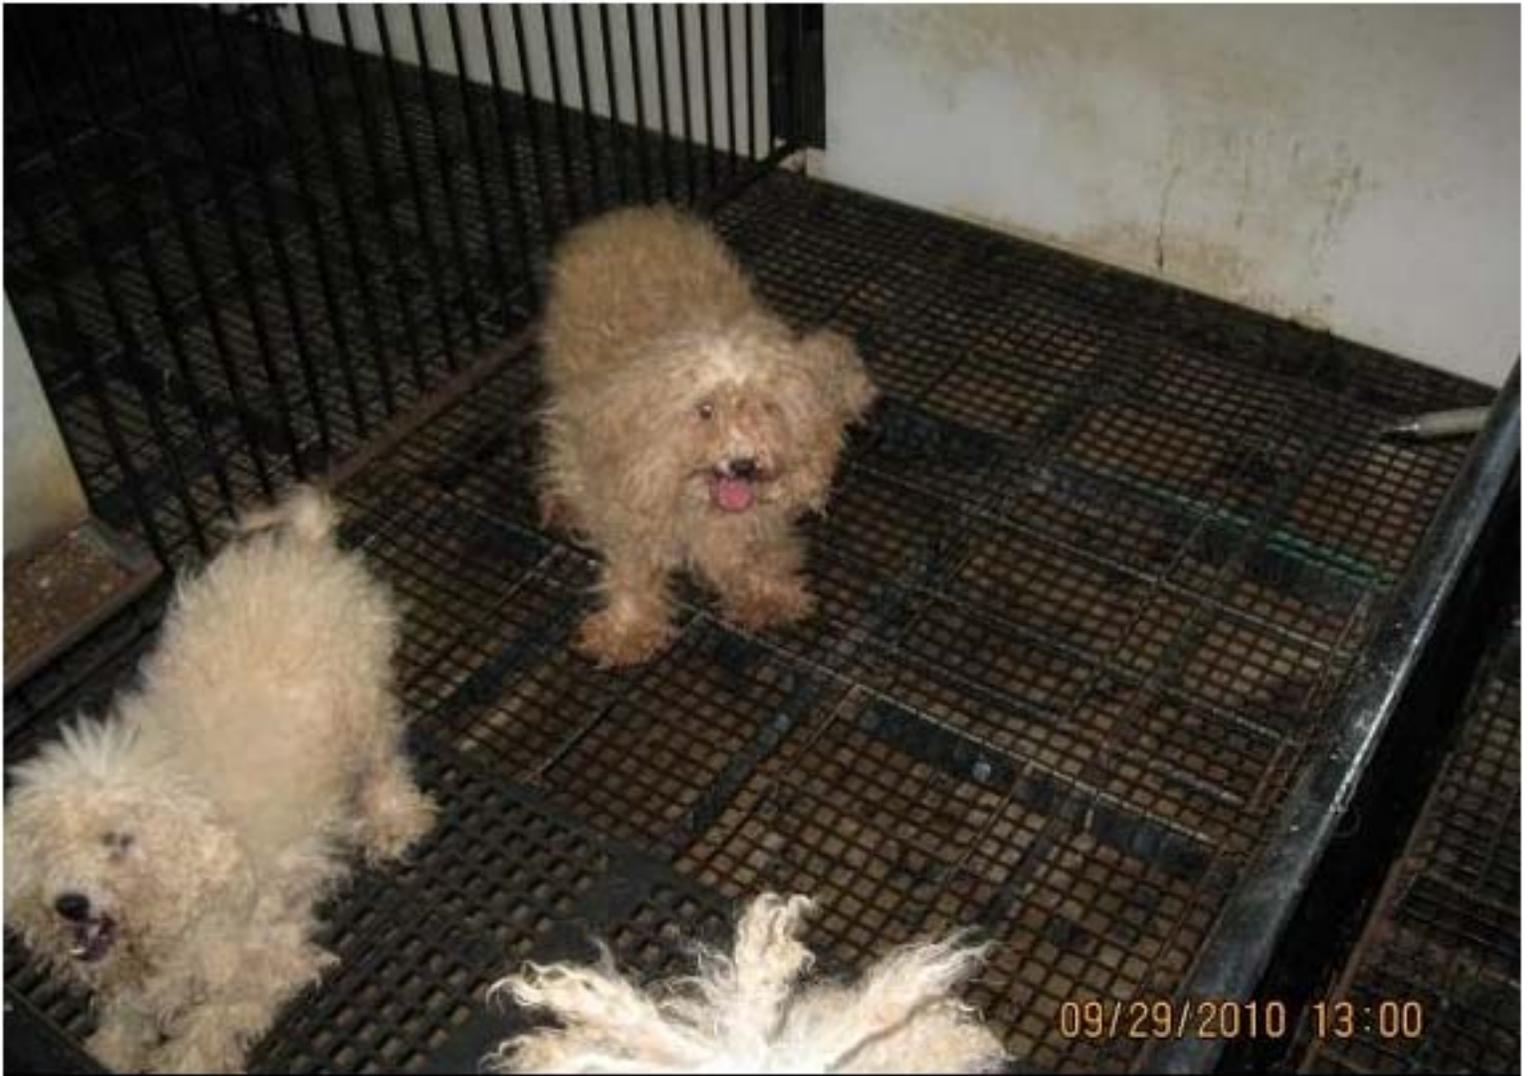
Photographer:	Randall Wagner (ACI)	Legal Name:	Registration:	42-B-0022
Photo Taken:	Wed, Sep 29, '10	RAINBOW KENNELS, INC.		
Inspection:	272101419120582			
Description:	Close in view of the excessive mats and hair around the paws of the animal.

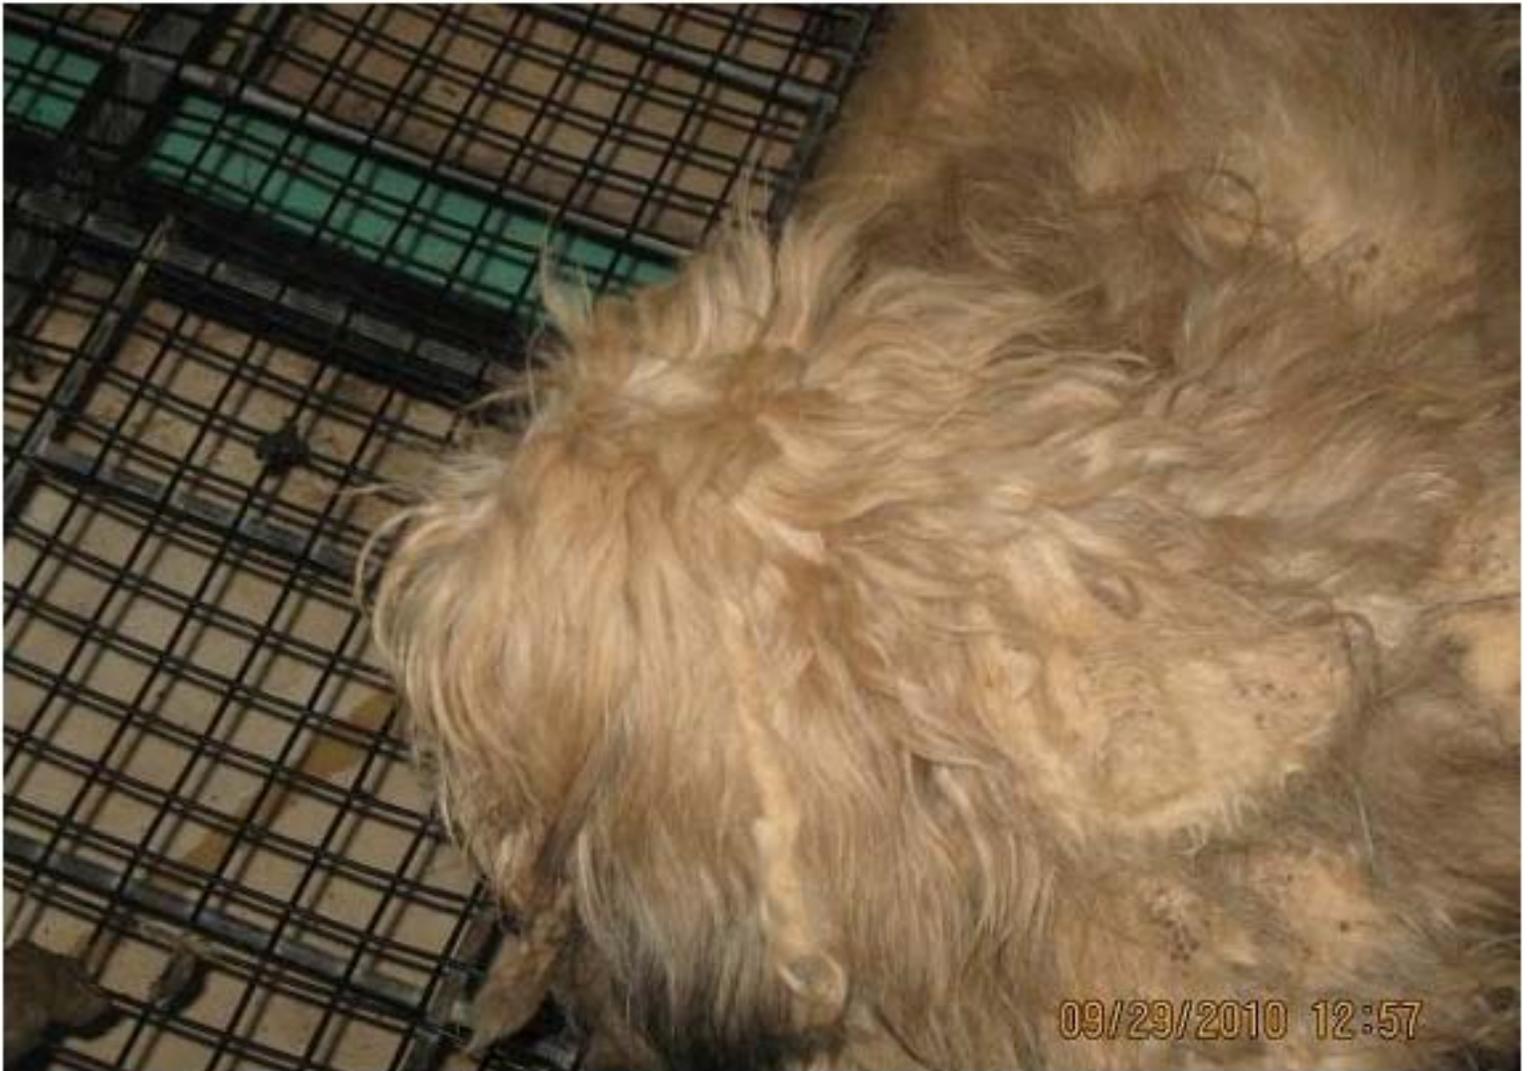
Photographer:	Randall Wagner (ACI)	Legal Name:	Registration:	42-B-0022
Photo Taken:	Wed, Sep 29, '10	RAINBOW KENNELS, INC.		
Inspection:	272101419120582			
Description:	The tow dogs have excessive hair and mats are forming, which can cause skin disease.
