Photographer: Heather Cole, VMO      Legal Name: PAMELA SELLNER      Registration: 42-C-0084  
Photo Taken: Mon, Nov 22, '10 approximately 1100      TOM SELLNER  
Inspection: 326101741280061  
Description:

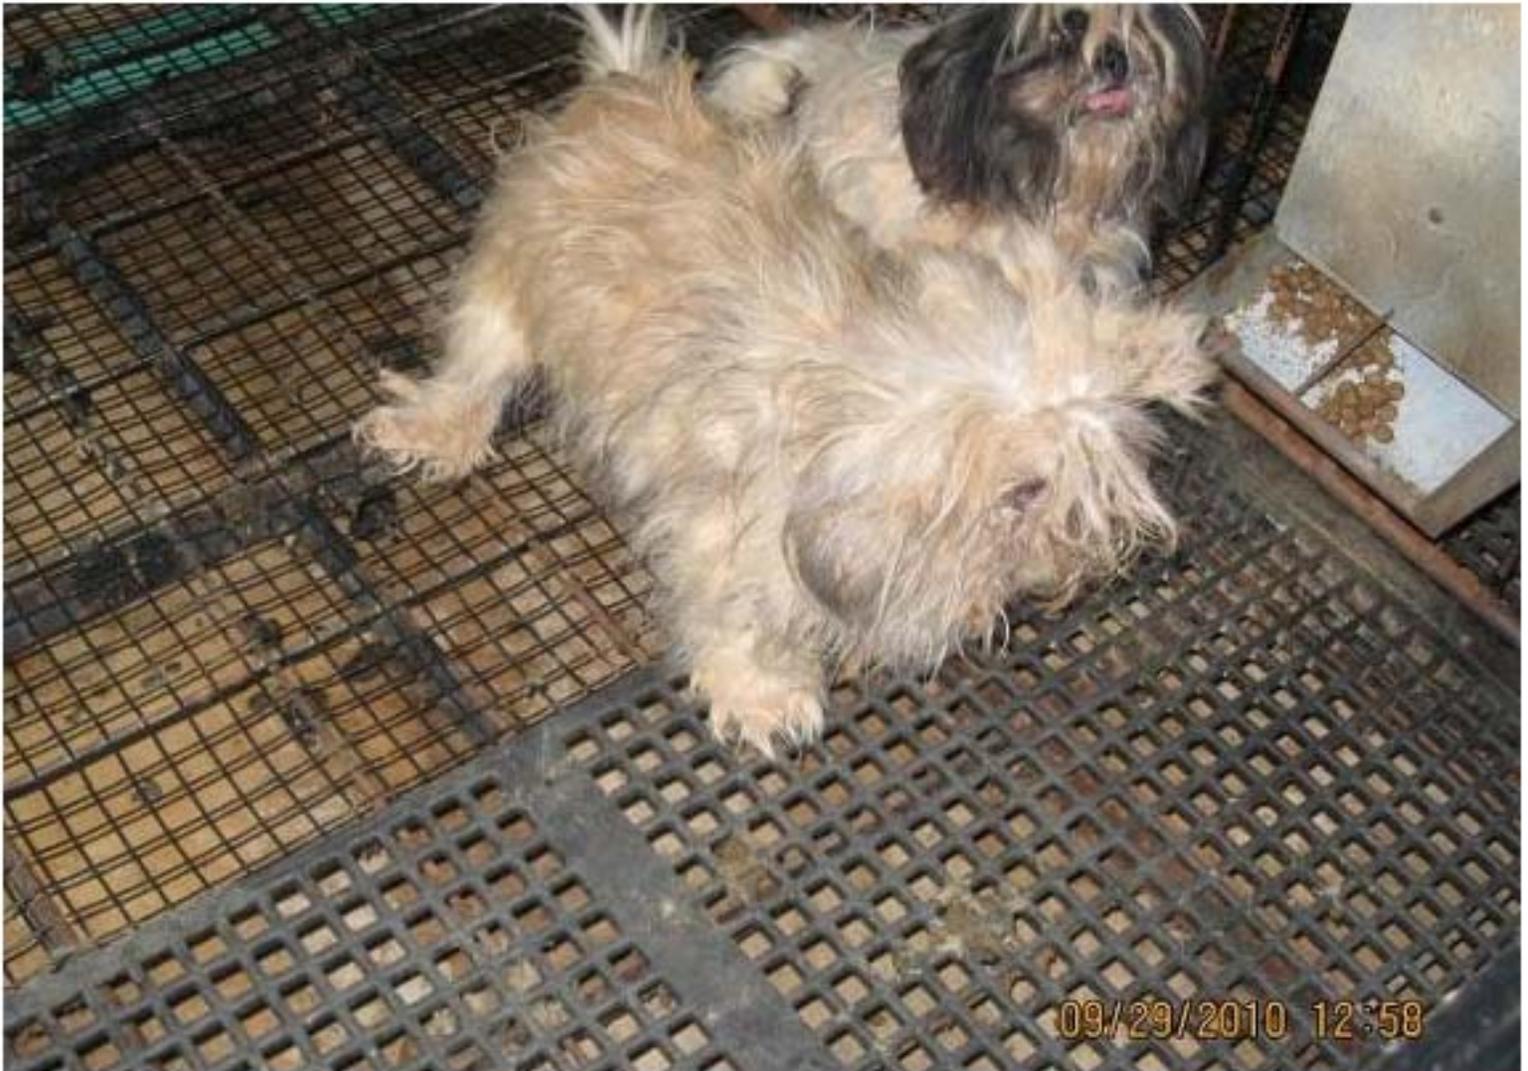
Photographer:	Randall Wagner (ACI)	Legal Name:	Registration:	42-B-0022
Photo Taken:	Wed, Sep 29, '10	RAINBOW KENNELS, INC.		
Inspection:	272101419120582			
Description:	Close in view of a clump or matting on the dogs back/neck.

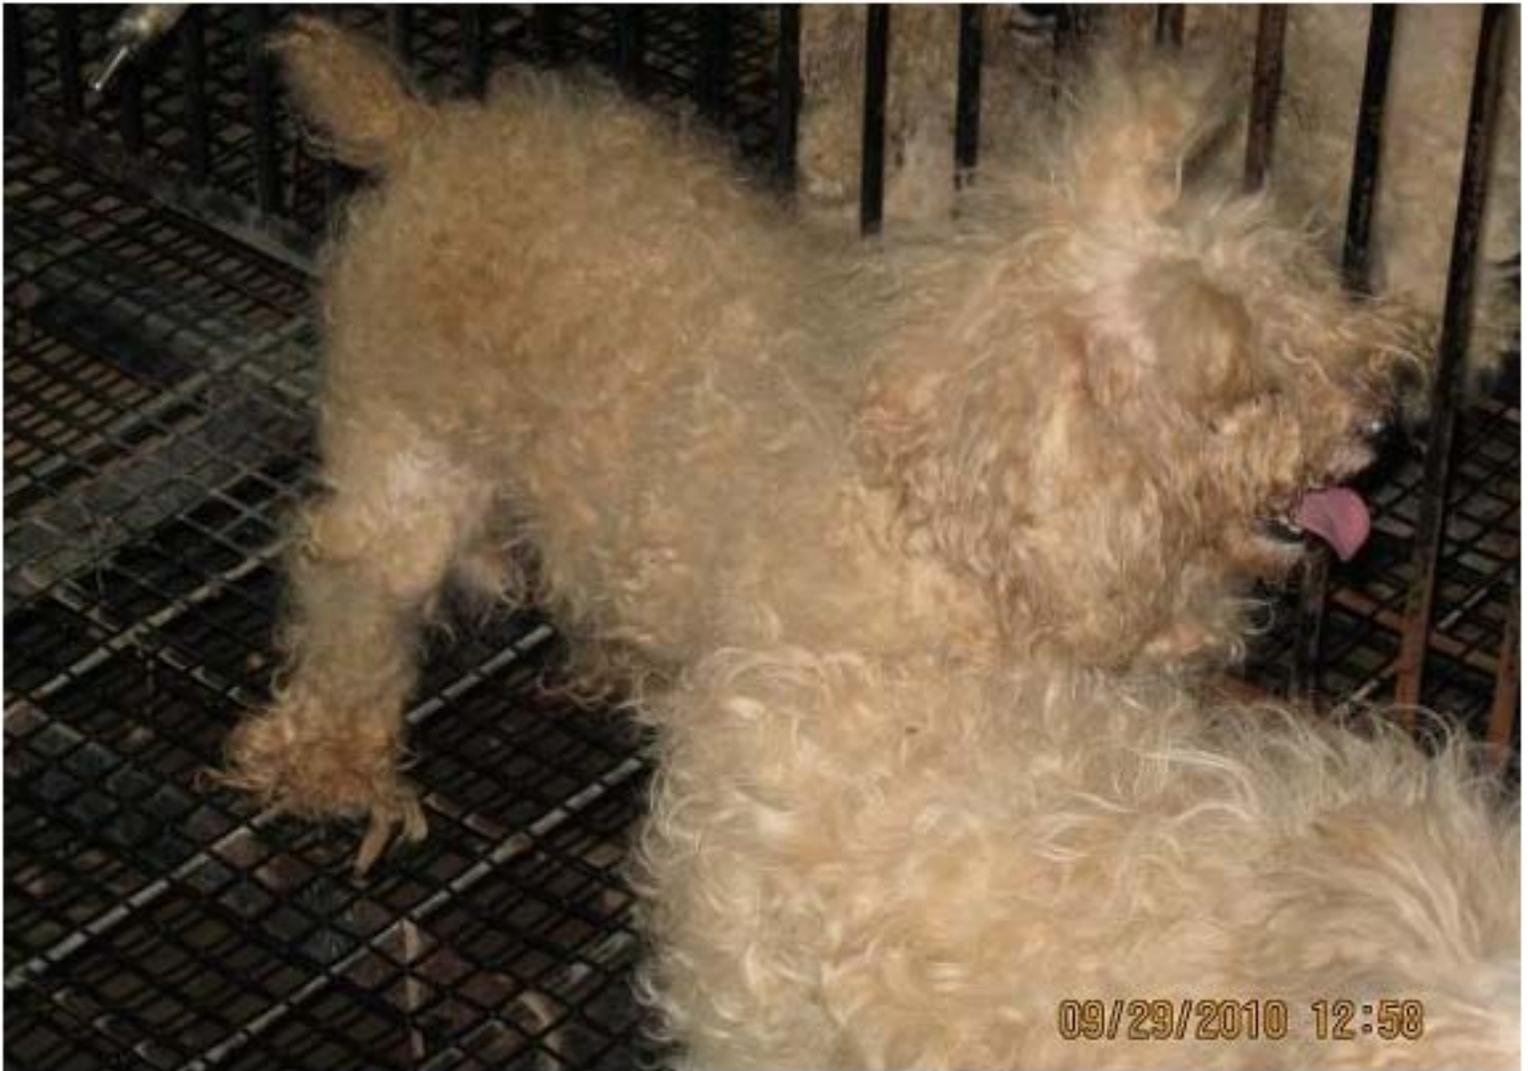
Photographer:	Randall Wagner (ACI)	Legal Name:	Registration:	42-B-0022
Photo Taken:	Wed, Sep 29, '10	RAINBOW KENNELS, INC.		
Inspection:	272101419120582			
Description:	The two dogs with excessive hair and mats in areas on the animal's bodies.

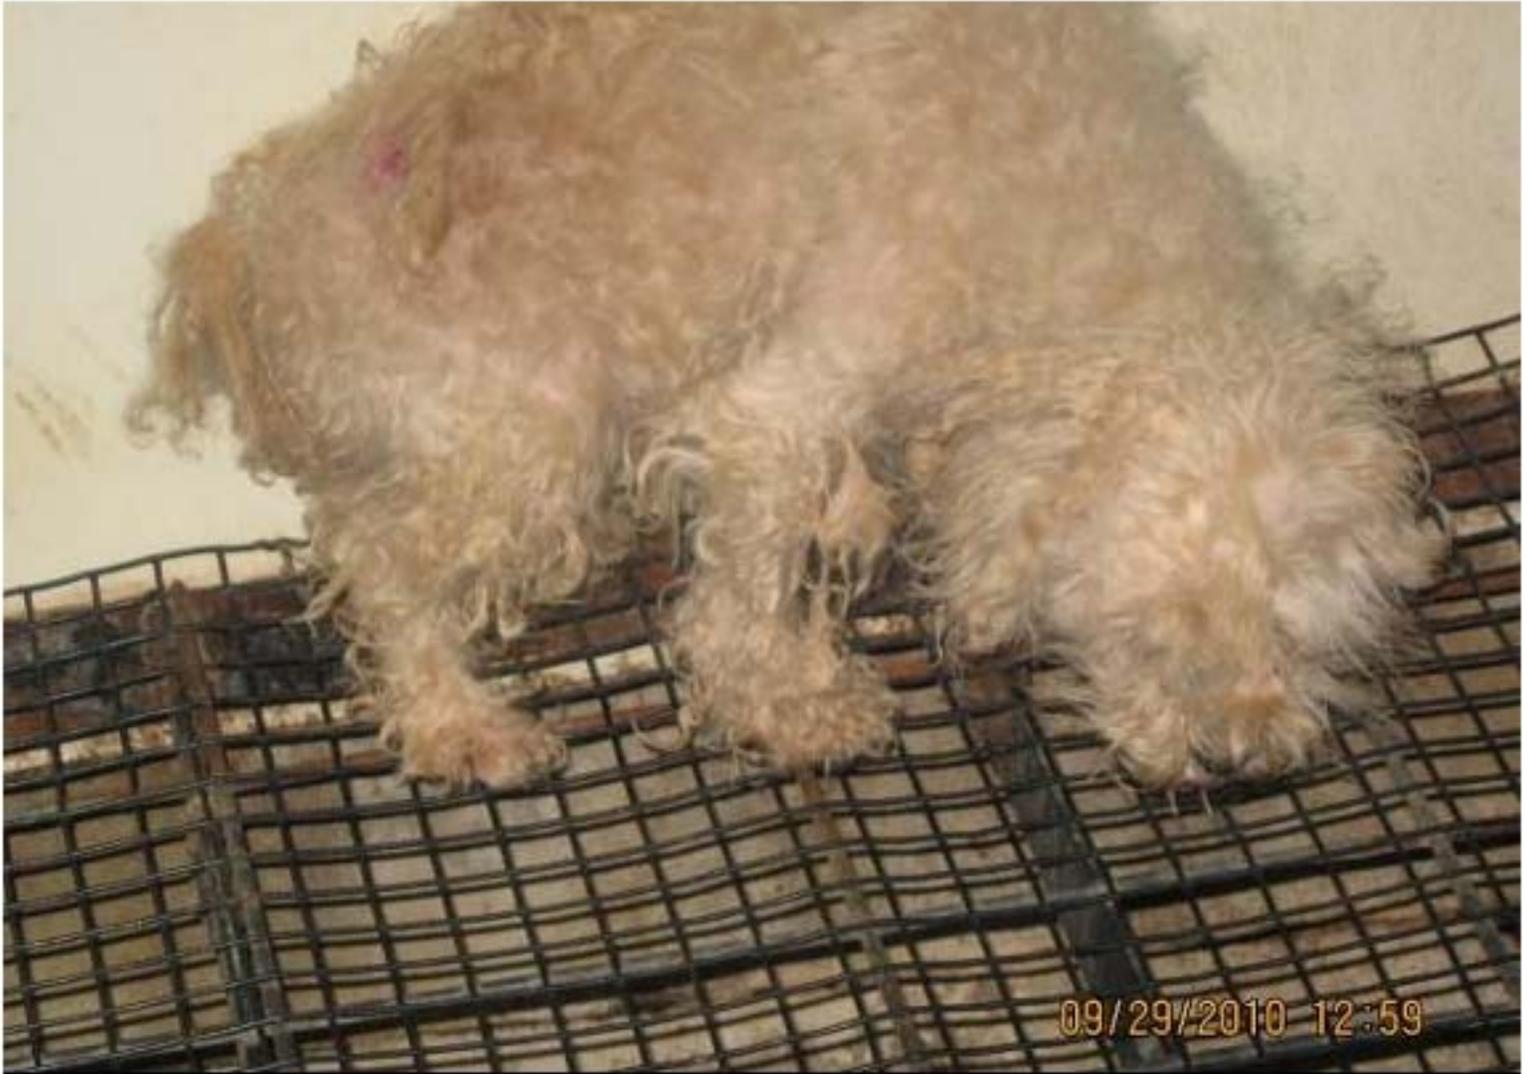
Photographer:	Randall Wagner (ACI)	Legal Name:	Registration:	42-B-0022
Photo Taken:	Wed, Sep 29, '10	RAINBOW KENNELS, INC.		
Inspection:	272101419120582			
Description:	The excessive mats and hair around the dog's face and paw areas.

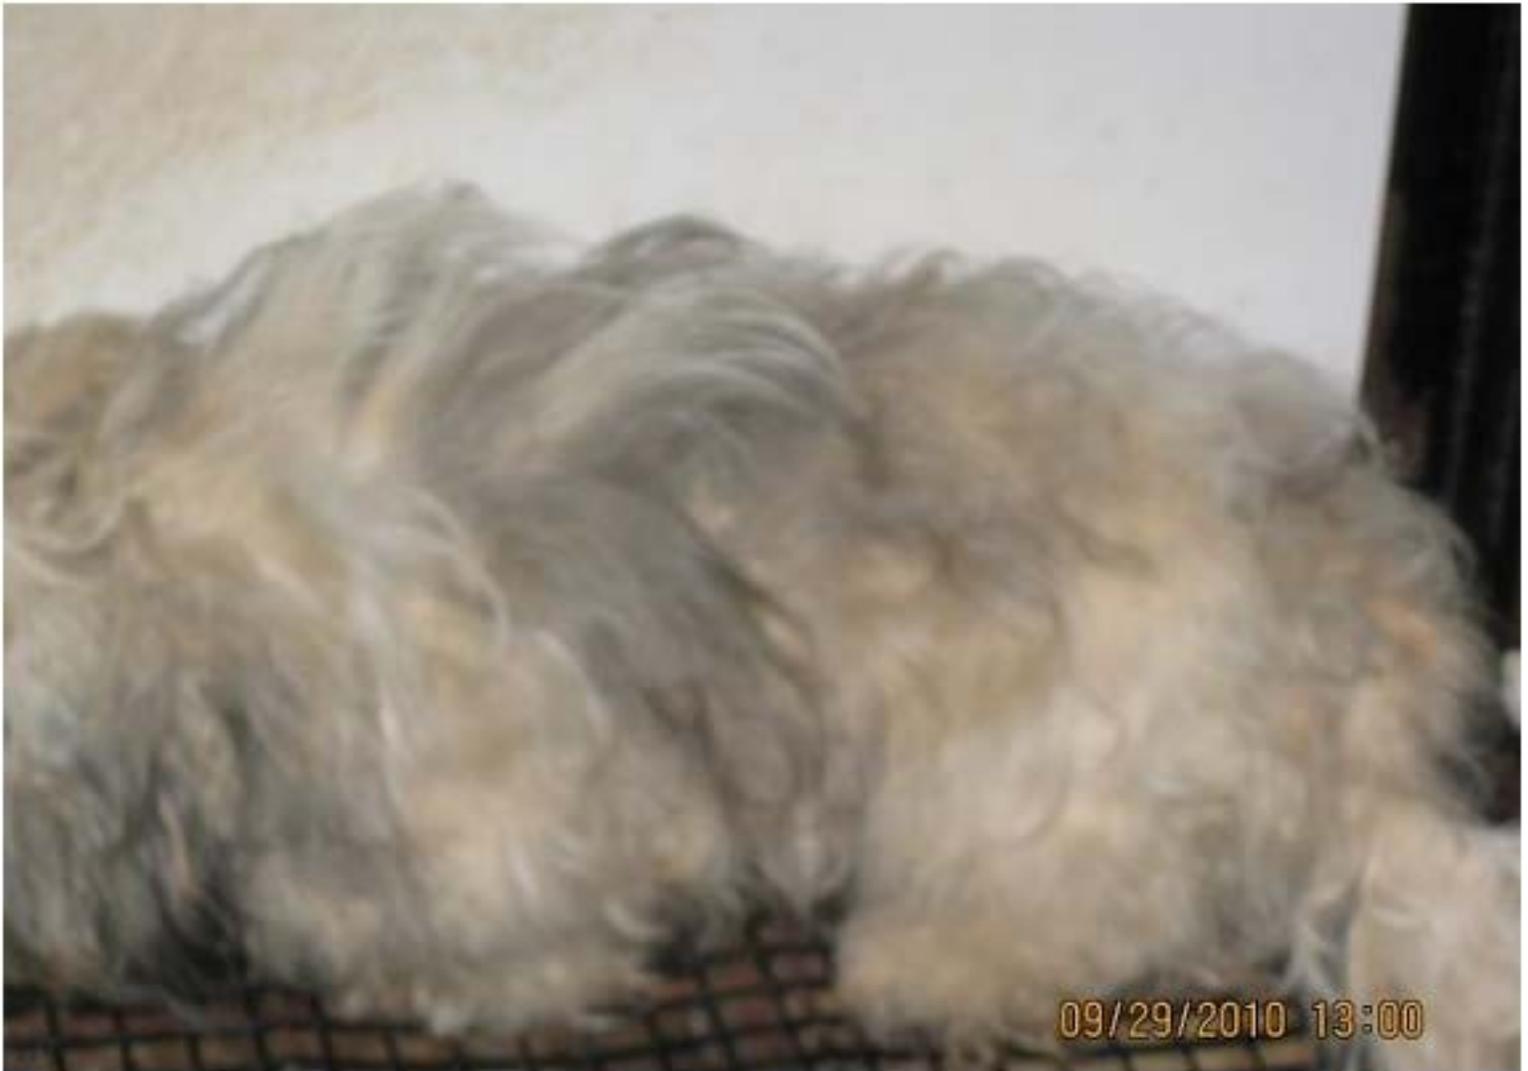
Photographer:	Randall Wagner (ACI)	Legal Name:	Registration:	42-B-0022
Photo Taken:	Wed, Sep 29, '10	RAINBOW KENNELS, INC.		
Inspection:	272101419120582			
Description:	The dog has excessive mats and hair. Also, the mats are dominate on the belly and paws.

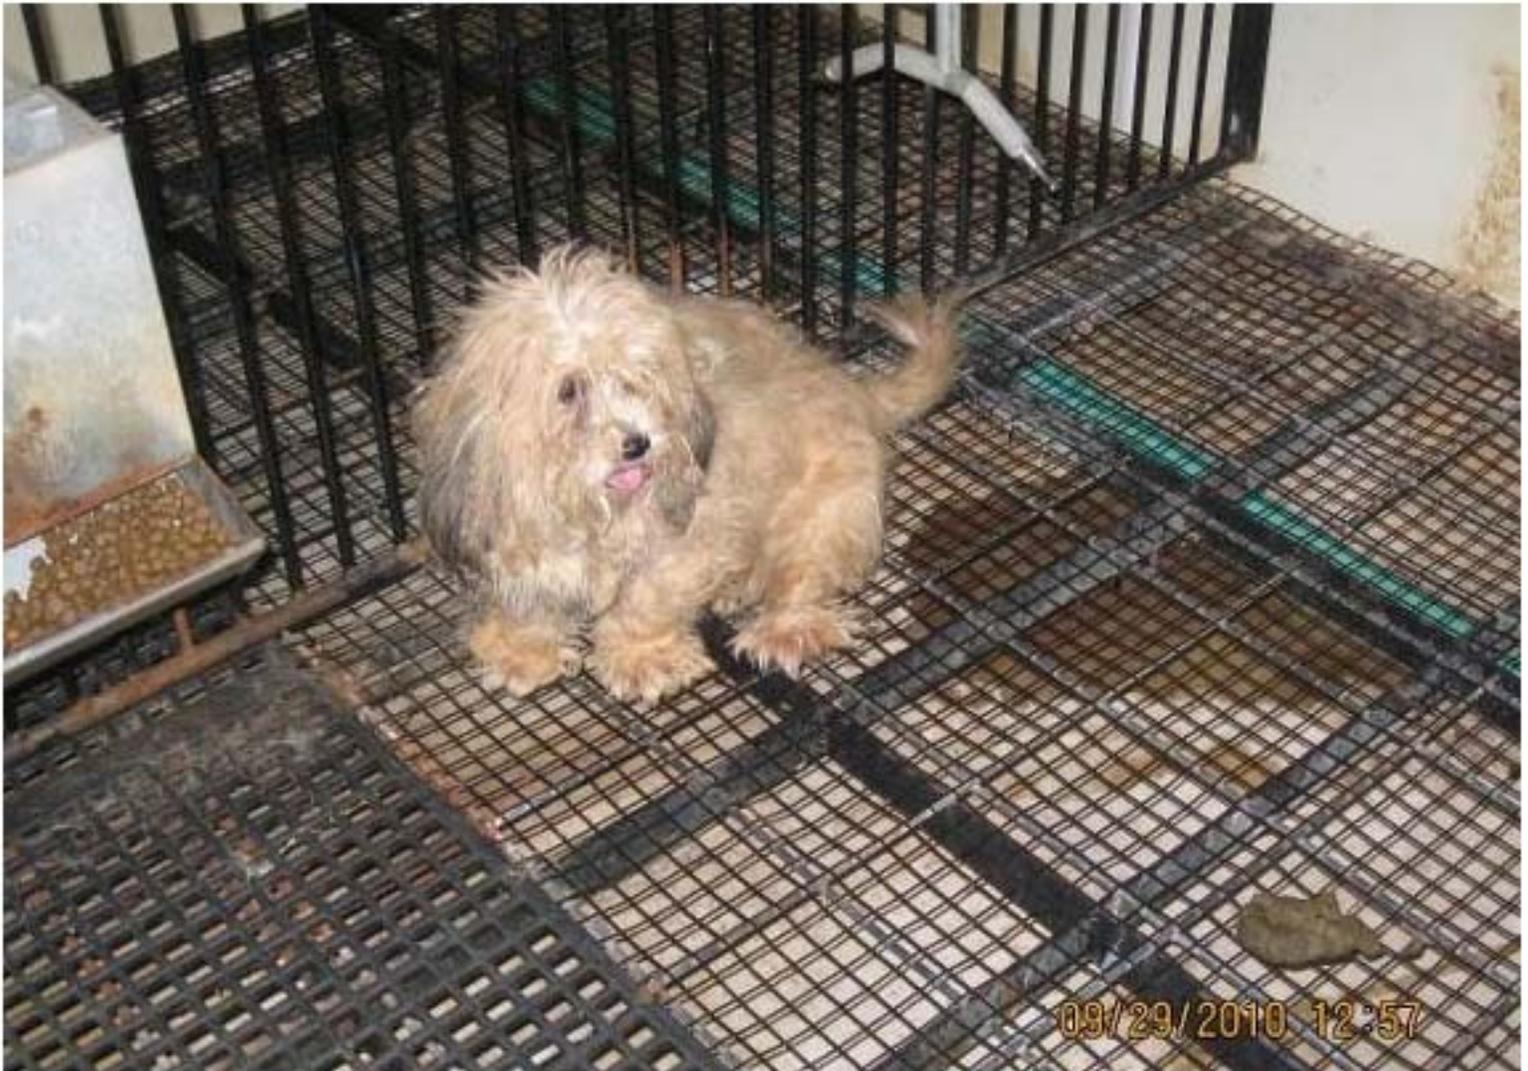
Photographer:	Randall Wagner (ACI)	Legal Name:	Registration:	42-B-0022
Photo Taken:	Wed, Sep 29, '10	RAINBOW KENNELS, INC.		
Inspection:	272101419120582			
Description:	Dog has excessive hair and mats could cause skin disease.

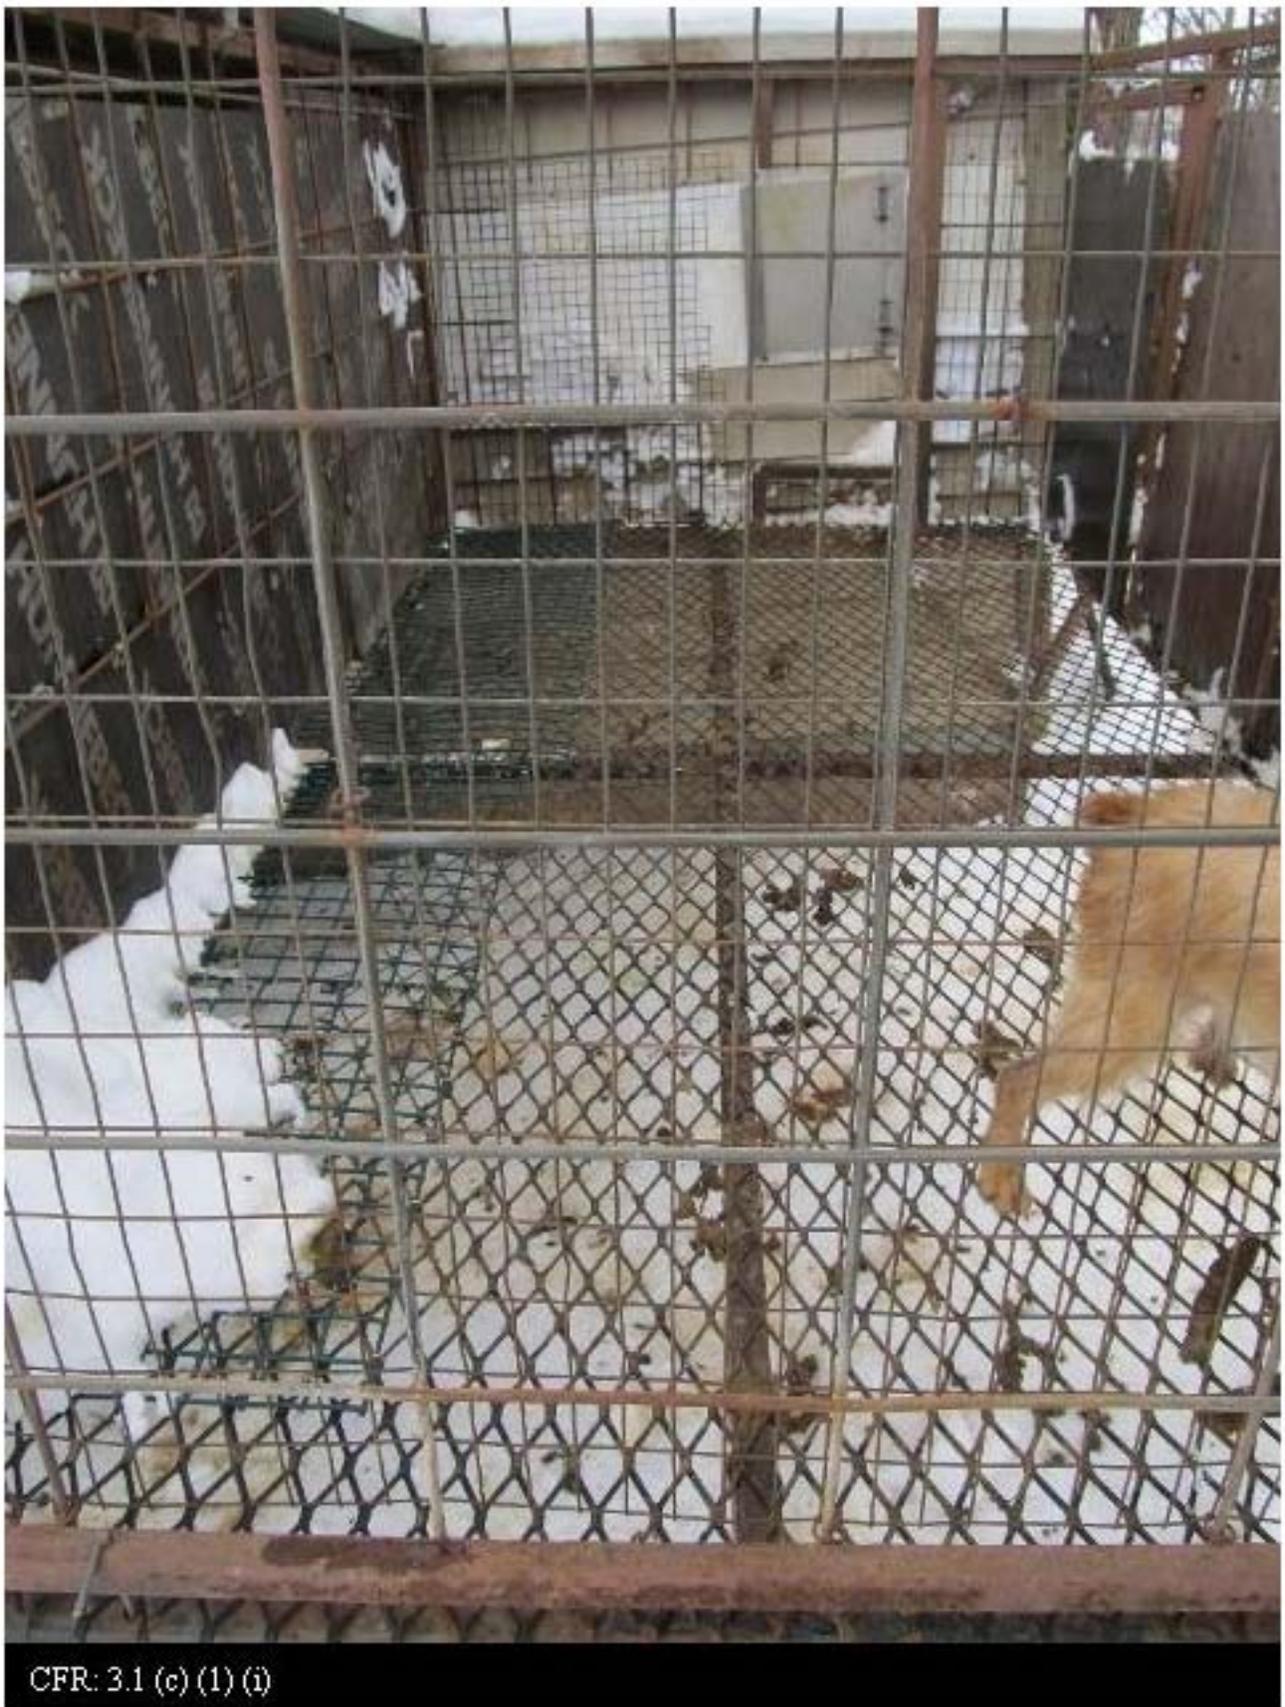
Photographer:	Heather Cole	Legal Name:	Registration:	42-A-1438
Photo Taken:	Wed, Dec 22, '10	Menno Borntreger		
Inspection:	356101519380479	Toby Borntreger		
Description:	Within the sheltered housing building in the South kennel. There is flaking rust on the cage door.

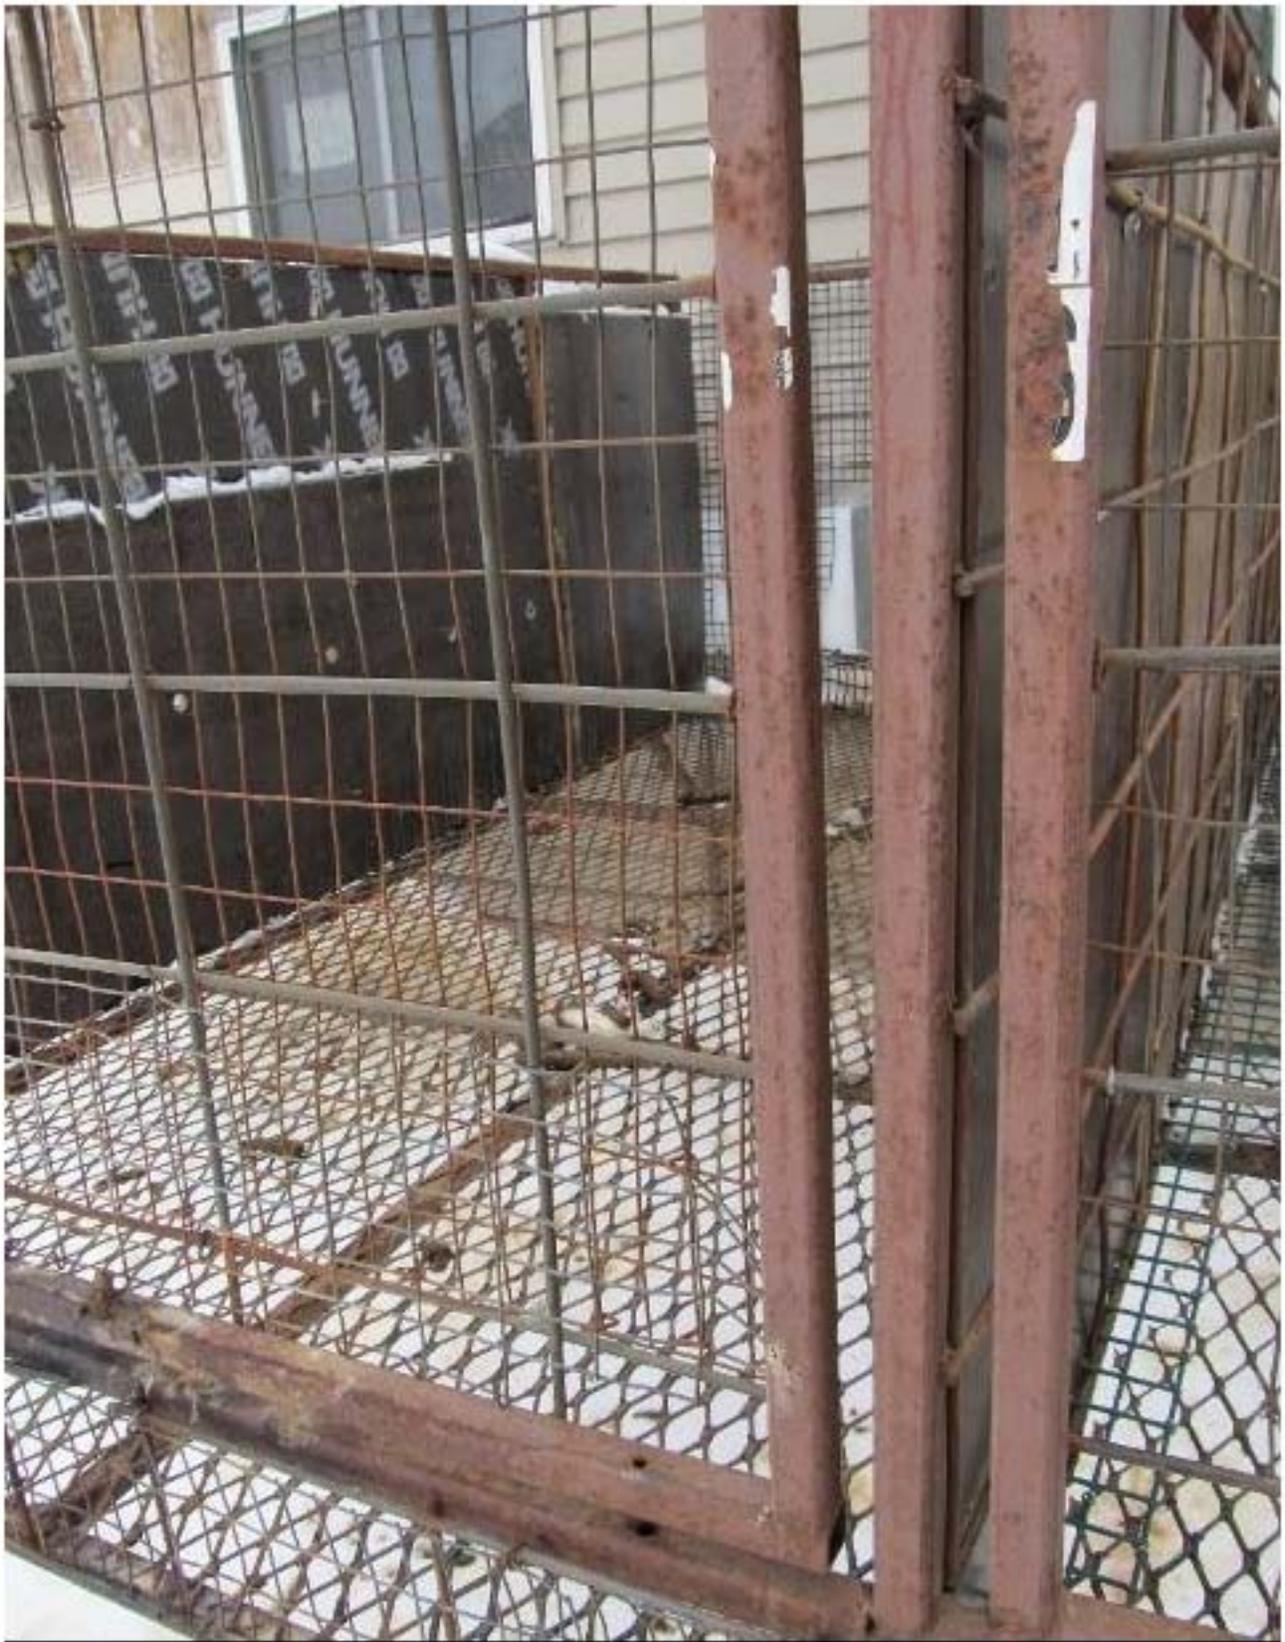
Photographer:	Heather Cole	Legal Name:	Registration:	42-A-1438
Photo Taken:	Wed, Dec 22, '10	Menno Borntreger Toby Borntreger		
Inspection:	356101519380479			
Description:	Distant photo of the front of an outside run of the North kennel. Flaking rust is present on the front of the cage and on the floor of the cage where the wire coating has worn off.

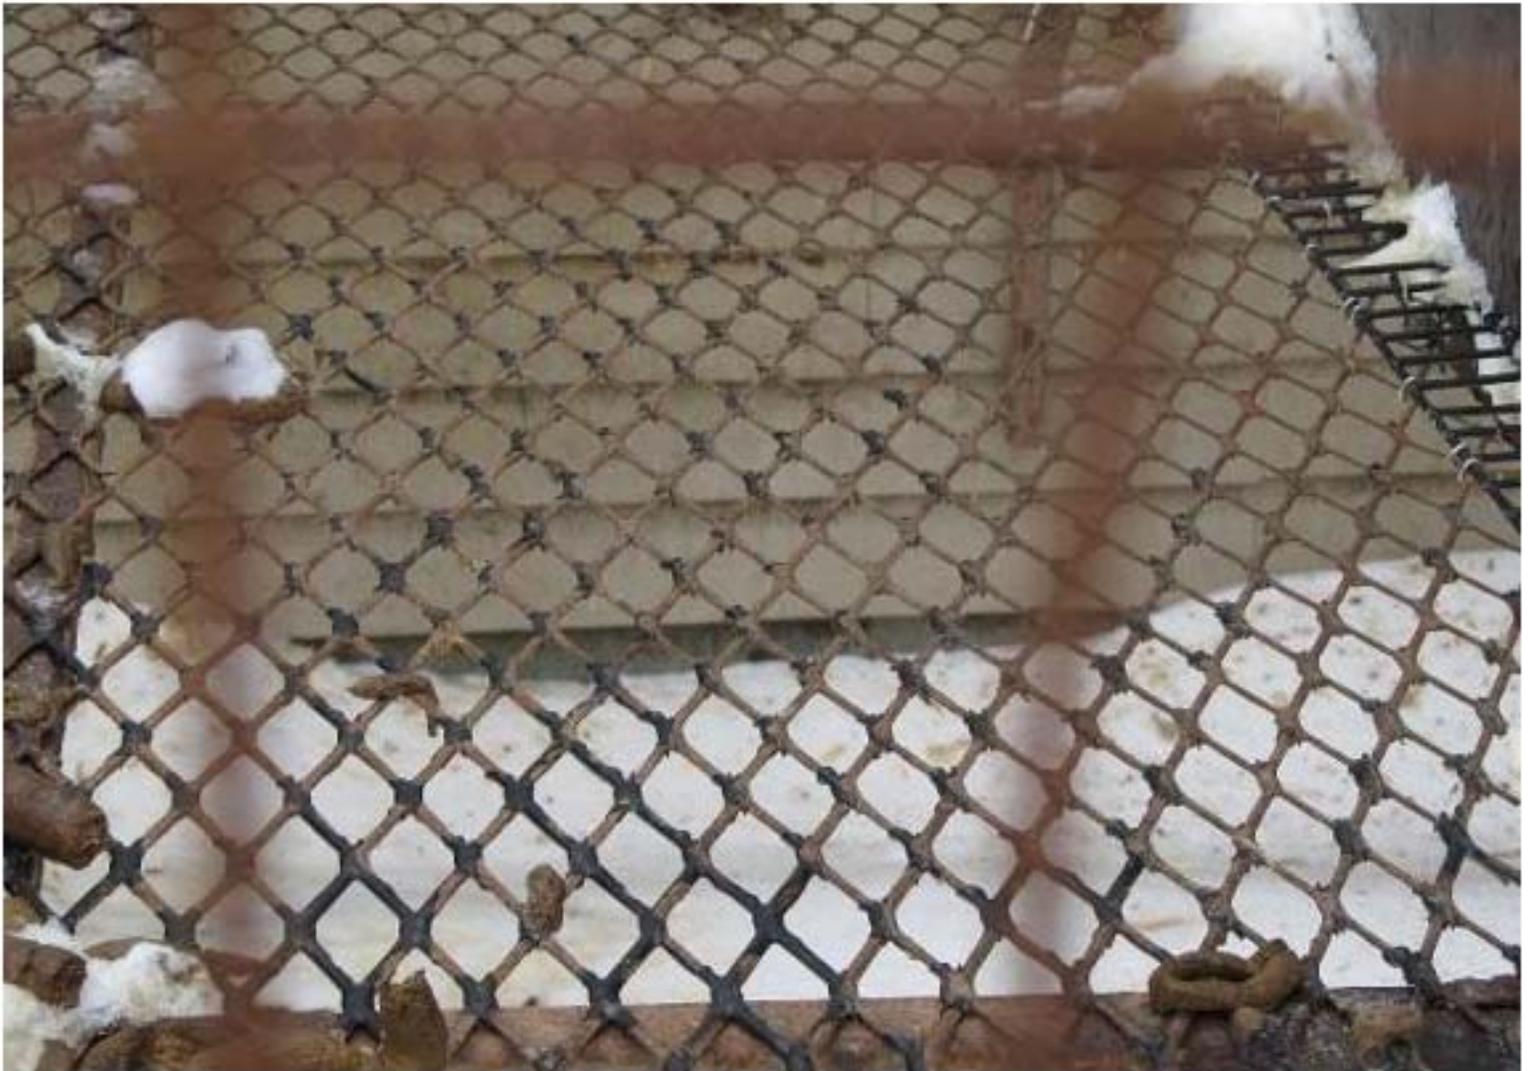
Photographer:	Heather Cole	Legal Name:	Menno Borntreger Toby Borntreger	Registration:	42-A-1438
Photo Taken:	Wed, Dec 22, '10				
Inspection:	356101519380479				
Description:	Distant photo of the front of an outside run of the North kennel. Flaking rust is present on the front of the cage and on the floor of the cage where the wire coating has worn off.				FOIA11-282001031

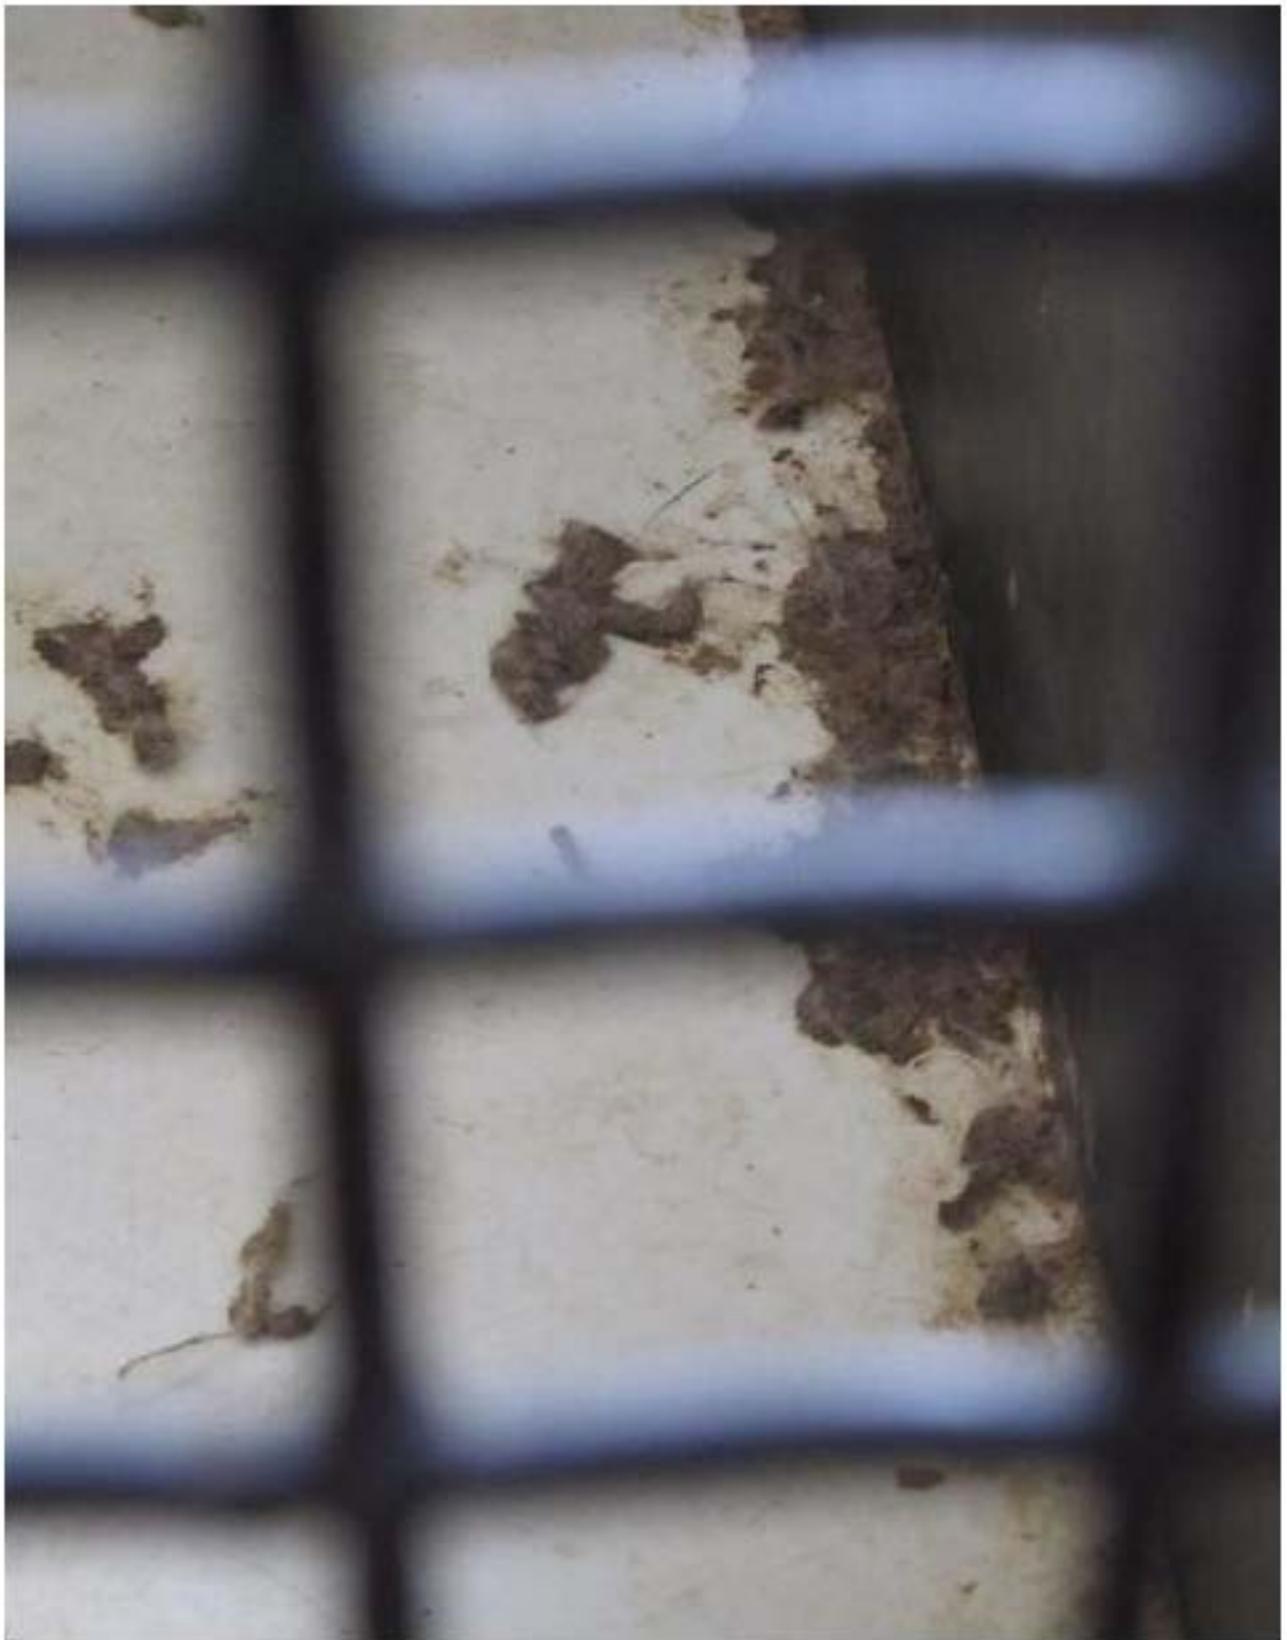
Photographer:	Heather Cole	Legal Name:	Registration:	42-A-1438
Photo Taken:	Wed, Dec 22, '10	Menno Borntreger		
Inspection:	356101519380479	Toby Borntreger		
Description:	Distant photo of the floor of an outside run of the North kennel. Flaking rust is present on the floor of the cage where the wire coating has worn off.

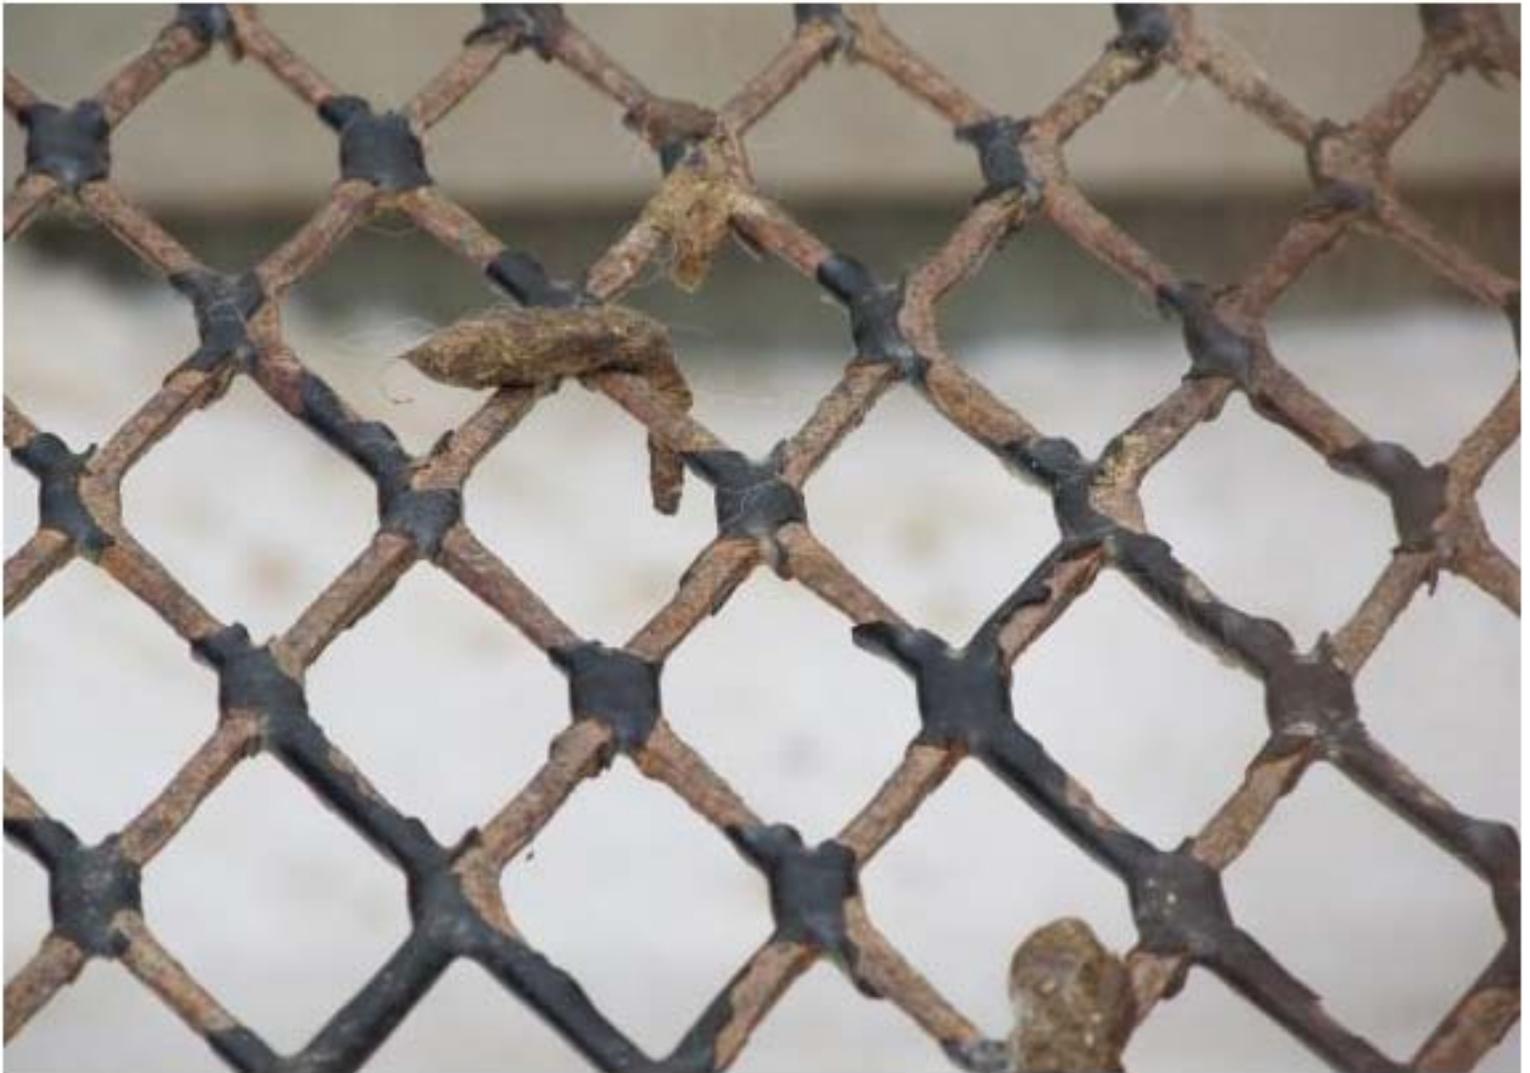
FOIA11-282001033

Photographer:	Heather Cole	Legal Name:	Registration:	42-A-1438
Photo Taken:	Wed, Dec 22, '10	Menno Borntreger Toby Borntreger		
Inspection:	356101519380479			
Description:	Inside the sheltered housing building of the North kennel. There is an accumulation of dried feces, debris, and hair on the floor of the primary enclosure.

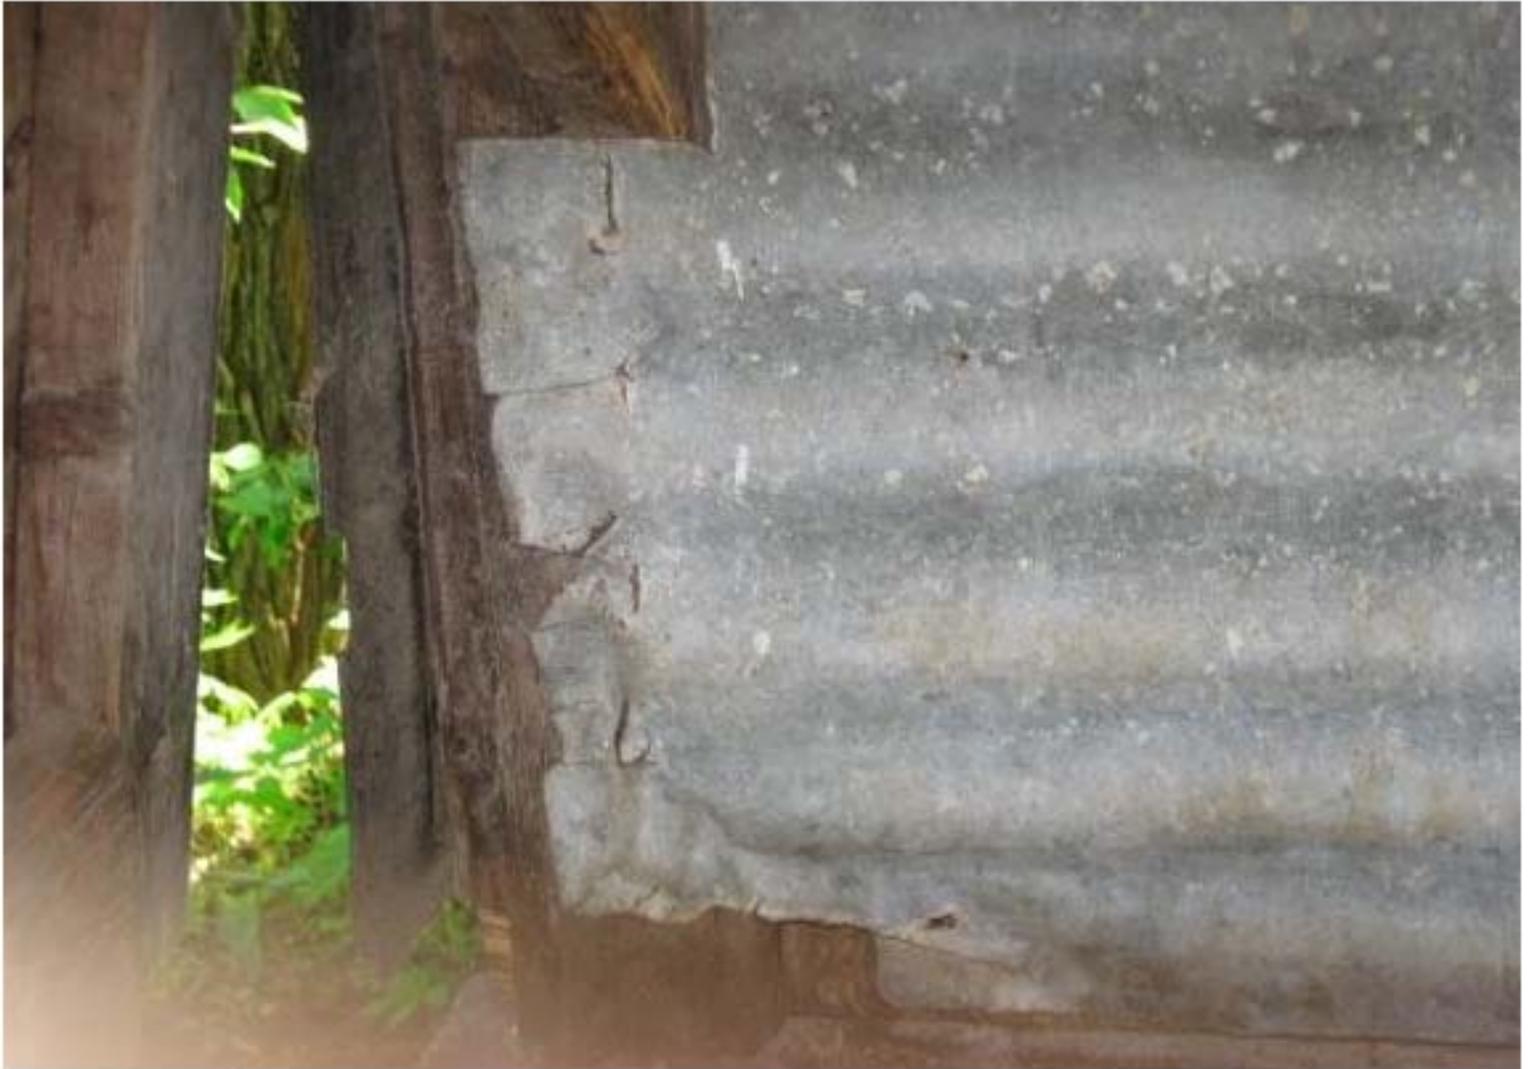
FOIA11-282001042

Photographer:	John J. Lies, ACI	Legal Name:	Registration:	42-A-1431
Photo Taken:	Tue, May 4, '10 A.M.	Ivan Yoder		
Inspection:	124100831140632			
Description:	3.6 (a)(2)(i): Primary enclosures sharp points: Nail inside of an enclosure.

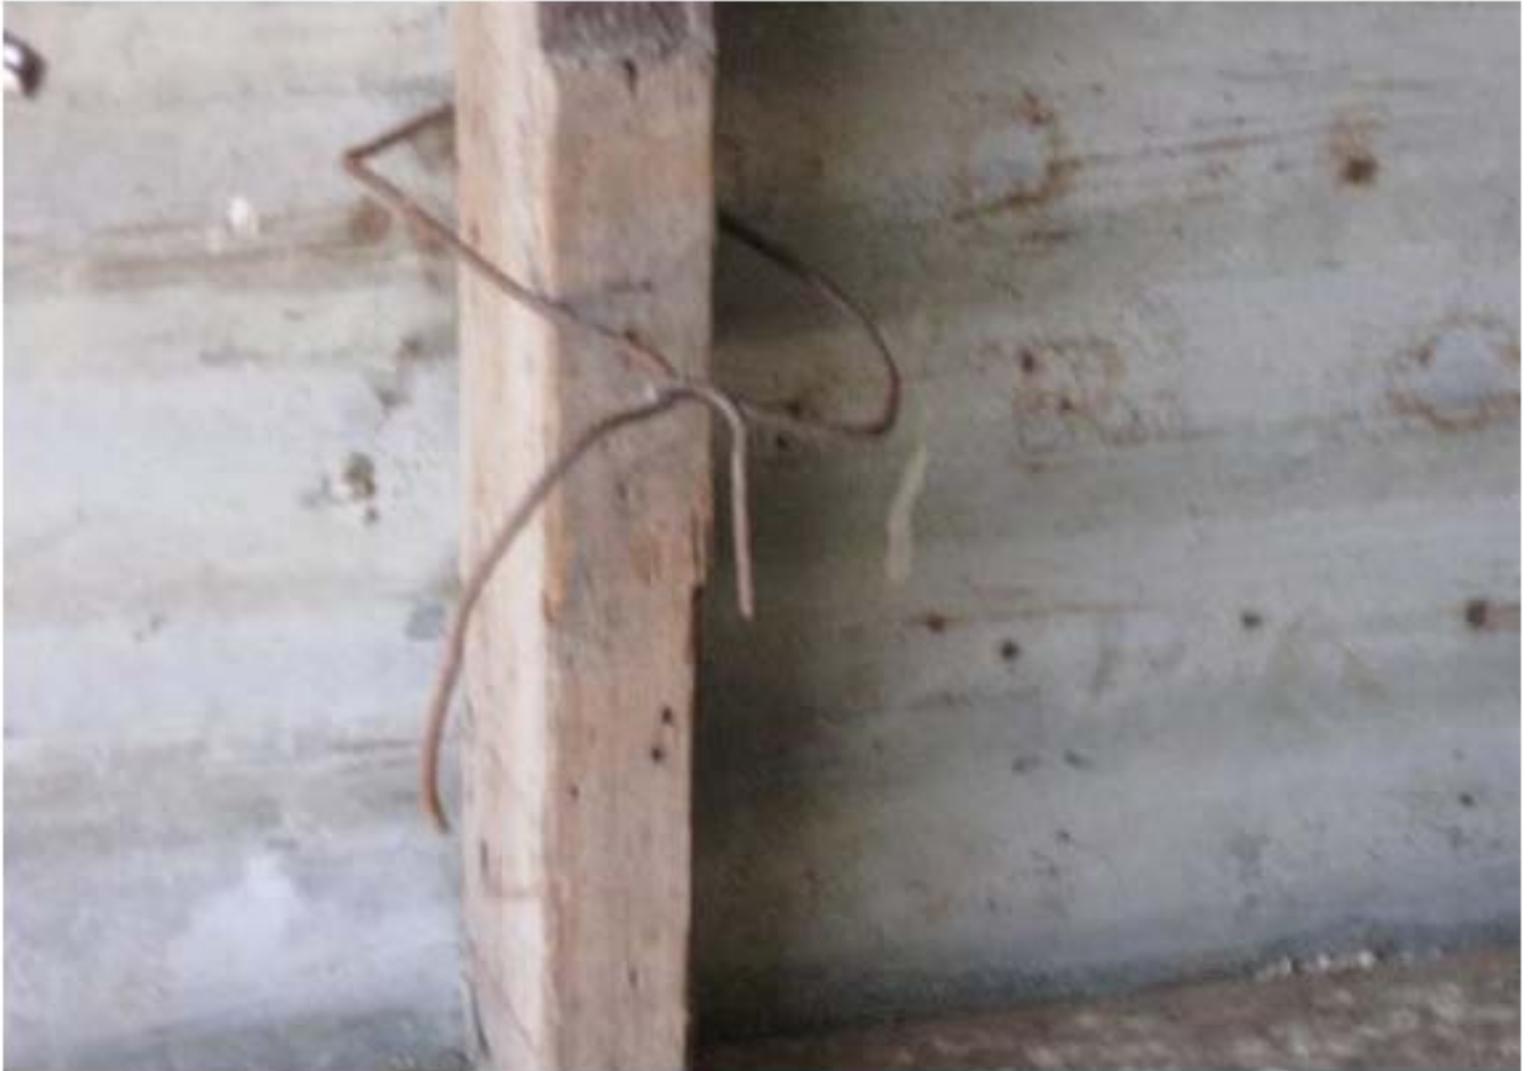
FOIA11-282001043

Photographer:	John J. Lies, ACI	Legal Name:	Registration:	42-A-1431
Photo Taken:	Tue, May 4, '10 A.M.	Ivan Yoder		
Inspection:	124100831140632			
Description:	3.6 (a)(2)(i): Primary enclosures sharp edges: Sharp tin edges inside of an enclosure.
