Photographer: Heather Cole, VMO      Legal Name: PAMELA SELLNER      Registration: 42-C-0084  
Photo Taken: Mon, Nov 22, '10 approximately 1100      TOM SELLNER  
Inspection: 326101741280061  
Description:

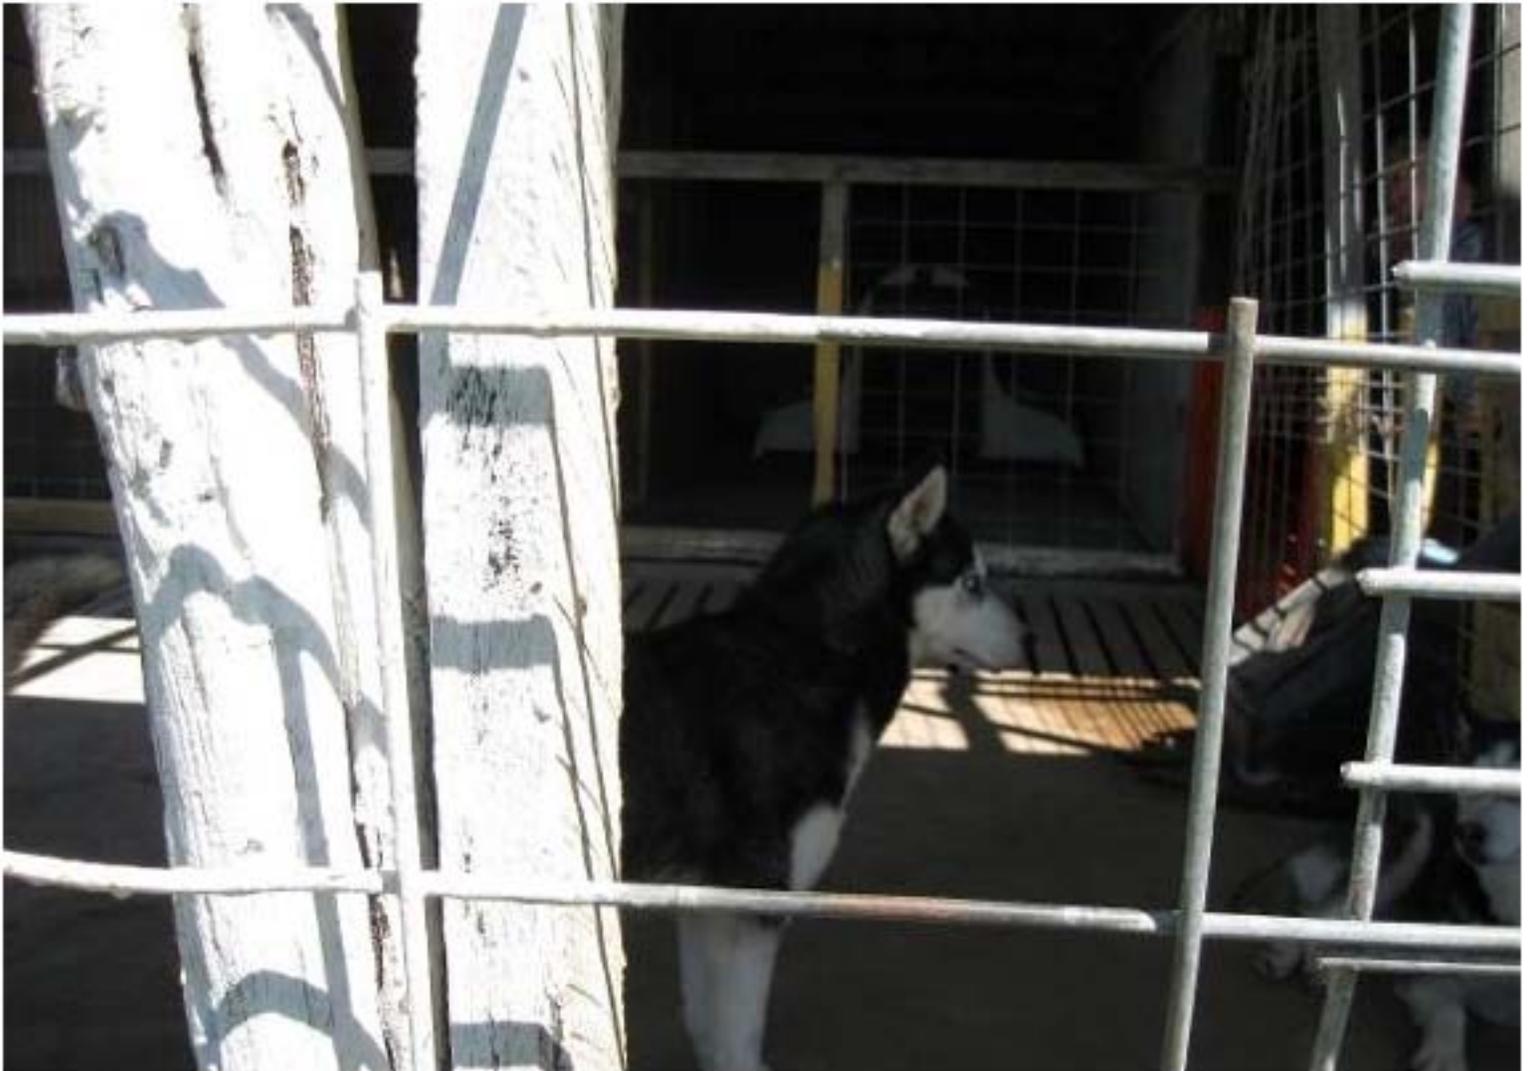
FOIA11-282001044

Photographer:	John J. Lies, ACI	Legal Name:	Registration:	42-A-1431
Photo Taken:	Tue, May 4, '10 A.M.	Ivan Yoder		
Inspection:	124100831140632			
Description:	3.6 (a)(2)(i): Primary enclosures sharp points: Wire points inside of

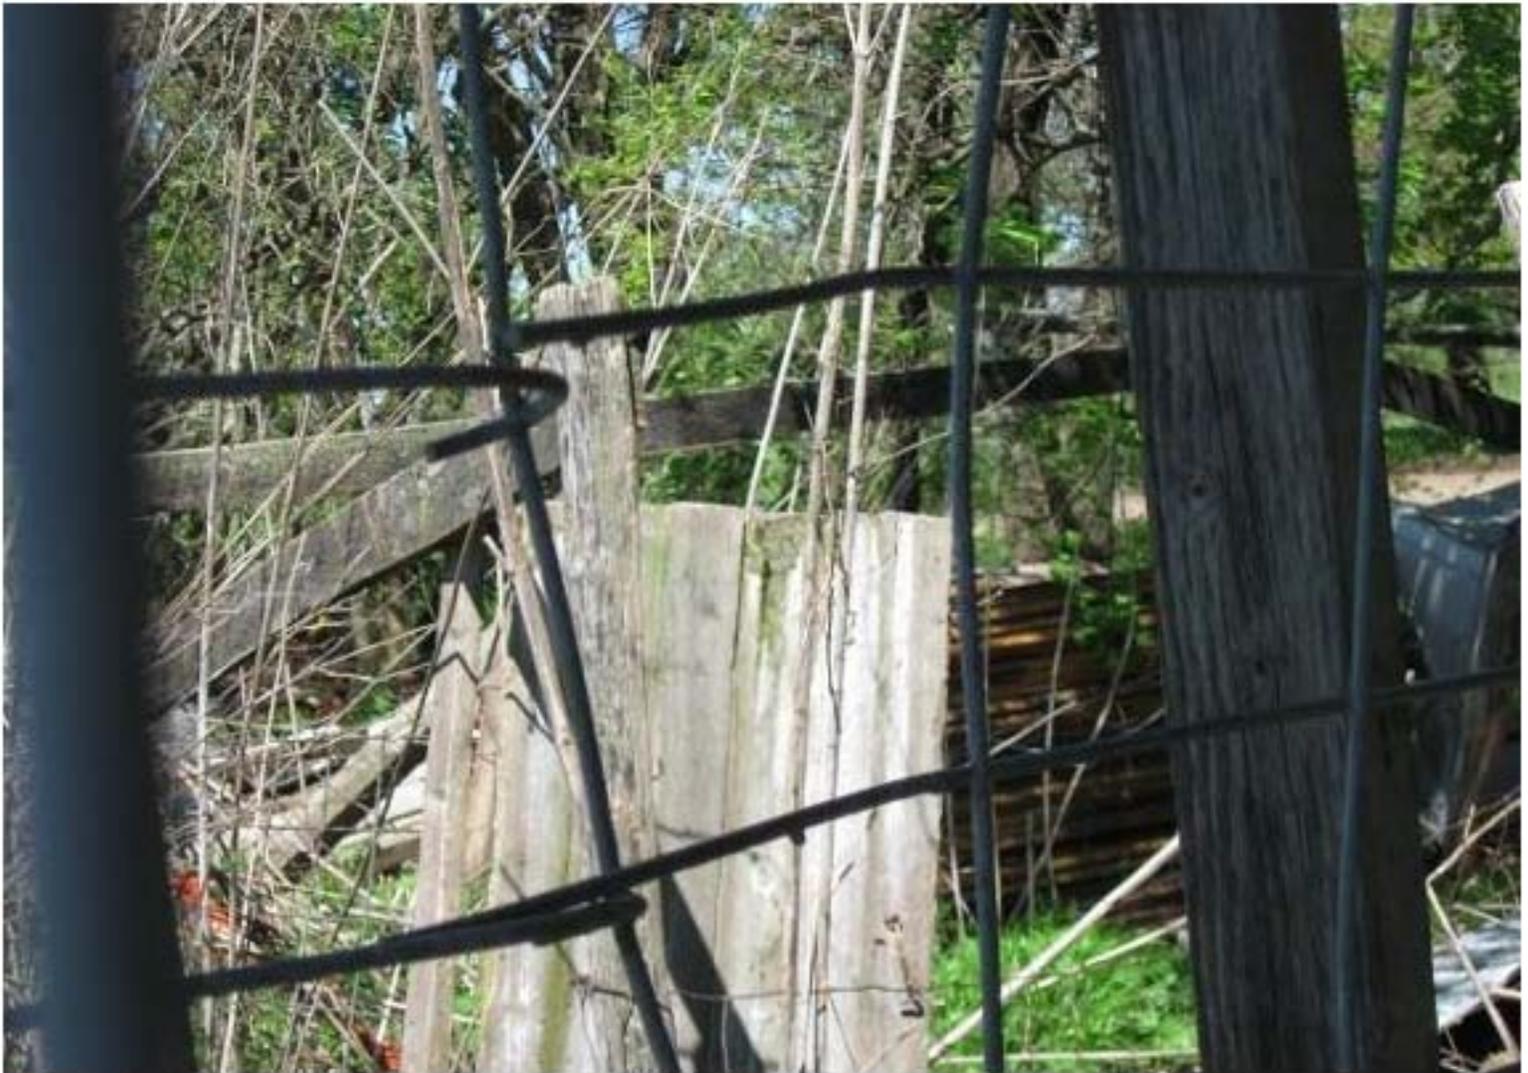
FOIA11-282001045

Photographer:	John J. Lies, ACI	Legal Name:	Registration:	42-A-1431
Photo Taken:	Tue, May 4, '10 A.M.	Ivan Yoder		
Inspection:	124100831140632			
Description:	3.6(a)(2): Primary Enclosures. Contain the dogs Securely:

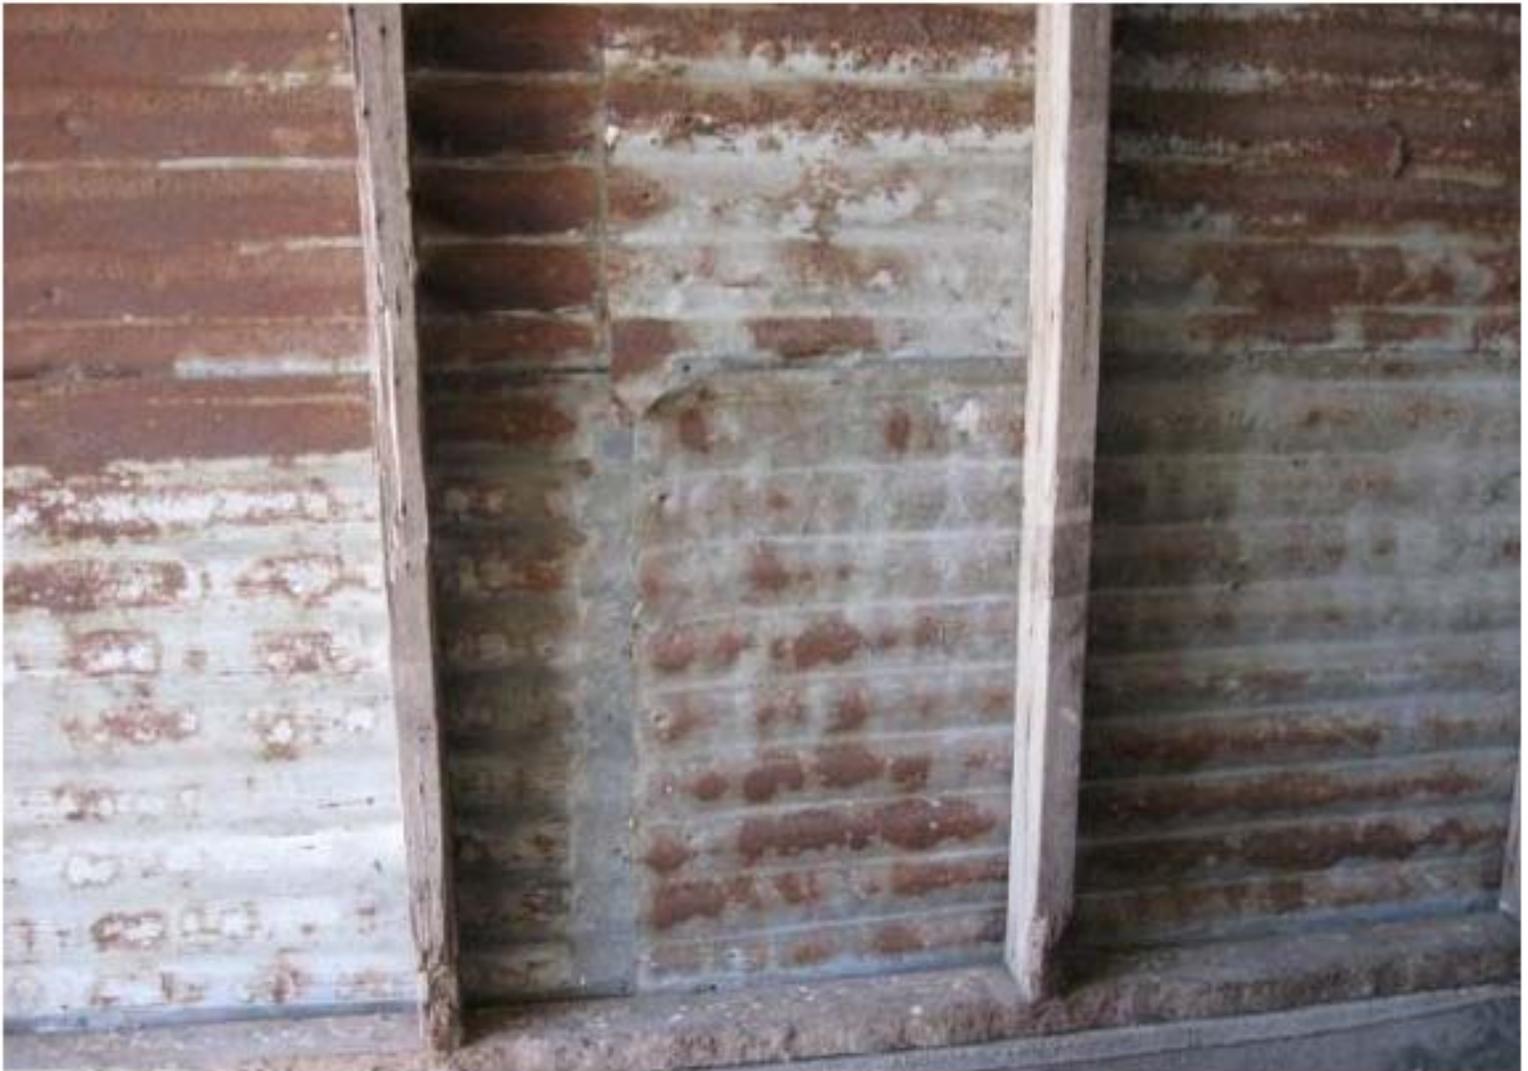
FOIA11-282001046

Photographer:	John J. Lies, ACI	Legal Name:	Registration:	42-A-1431
Photo Taken:	Tue, May 4, '10 A.M.	Ivan Yoder		
Inspection:	124100831140632			
Description:	3.6(a)(2): Primary Enclosures. Contain the dogs Securely:

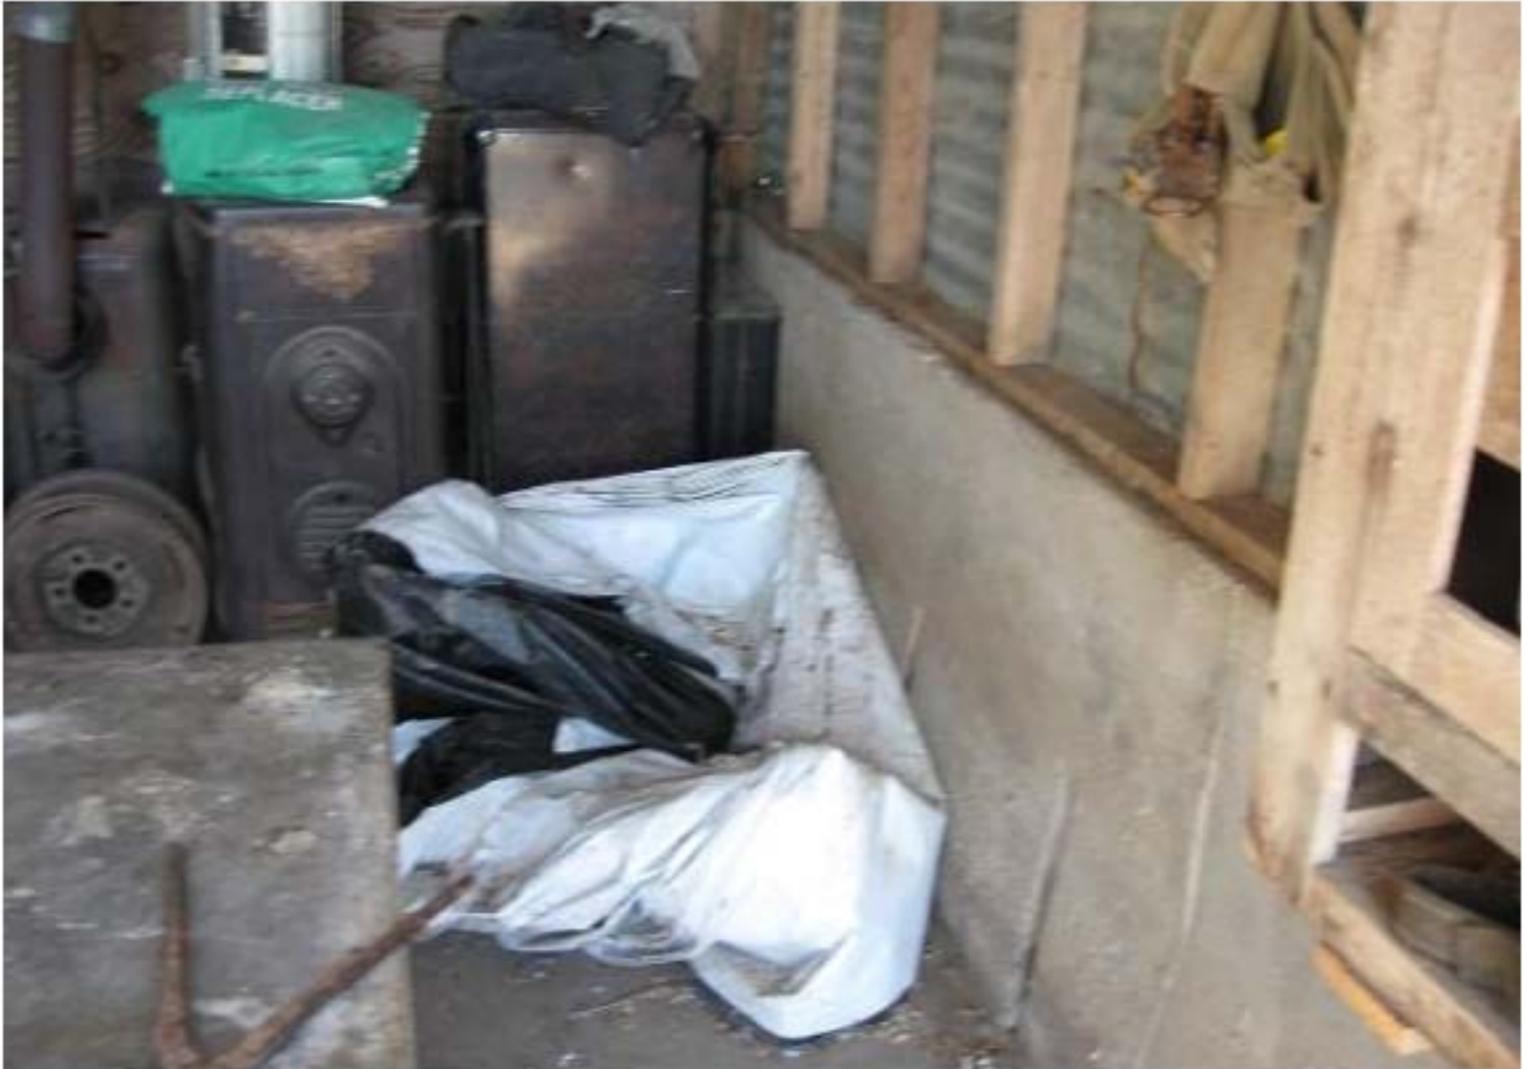
FOIA11-282001050

Photographer:	John J. Lies, ACI	Legal Name:	Registration:	42-A-1431
Photo Taken:	Tue, May 4, '10 A.M.	Ivan Yoder		
Inspection:	124100831140632			
Description:	3.11 (c) Housekeeping: Old lumber, on floor and lid, dirt, debris on ledge in the kennel area.

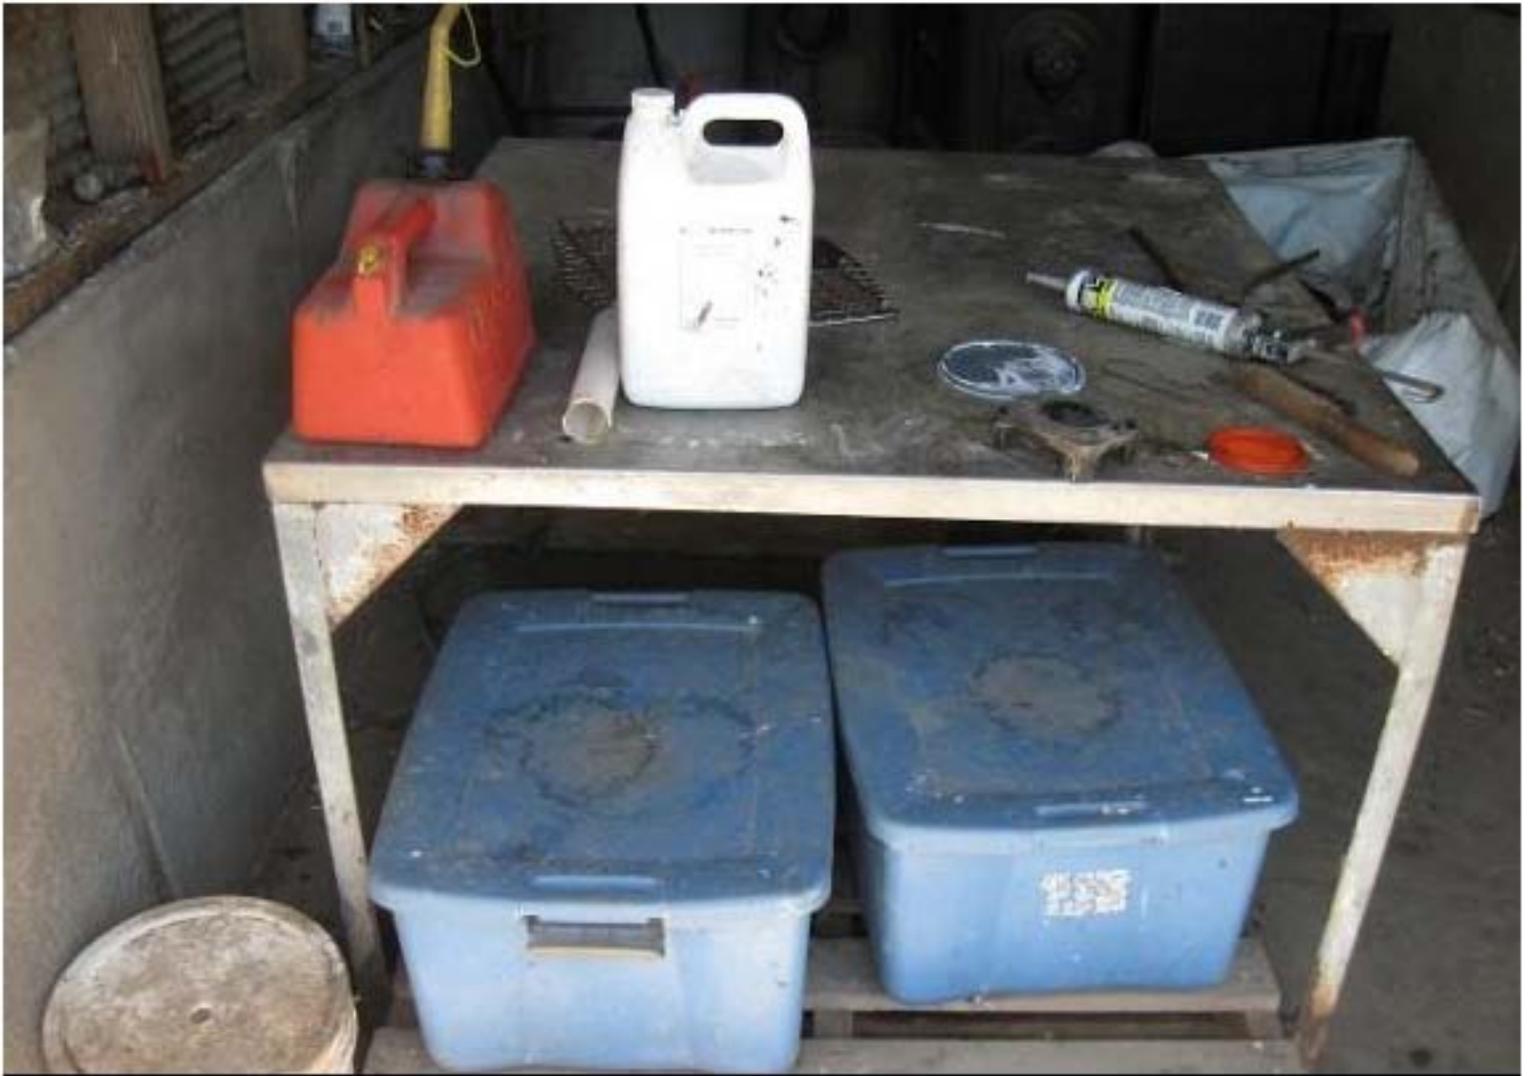
FOIA11-282001051

Photographer:	John J. Lies, ACI	Legal Name:	Registration:	42-A-1431
Photo Taken:	Tue, May 4, '10 A.M.	Ivan Yoder		
Inspection:	124100831140632			
Description:	3.11 (c): Housekeeping: Old tarp, dirt and debris in feed storage area.

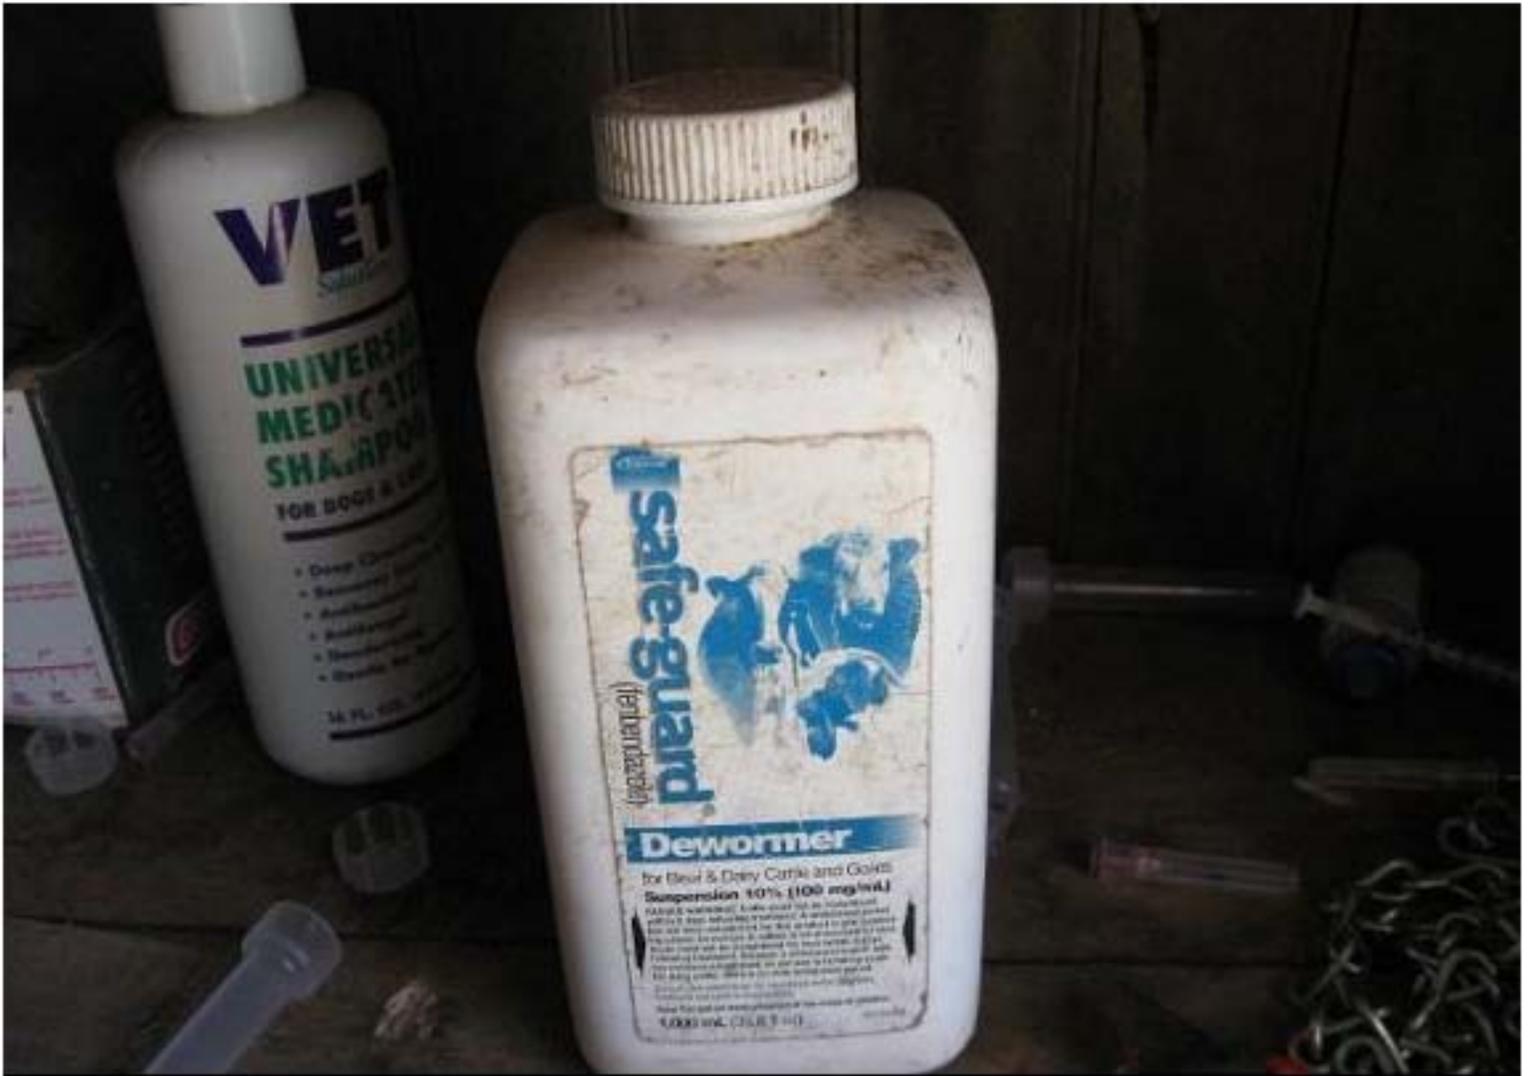
FOIA11-282001054

Photographer:	John J. Lies, ACI	Legal Name:	Registration:	42-A-1431
Photo Taken:	Tue, May 4, '10 A.M.	Ivan Yoder		
Inspection:	124100831140632			
Description:	2.40 (b)(2): Veterinary Care: Medicines not labeled correctly.

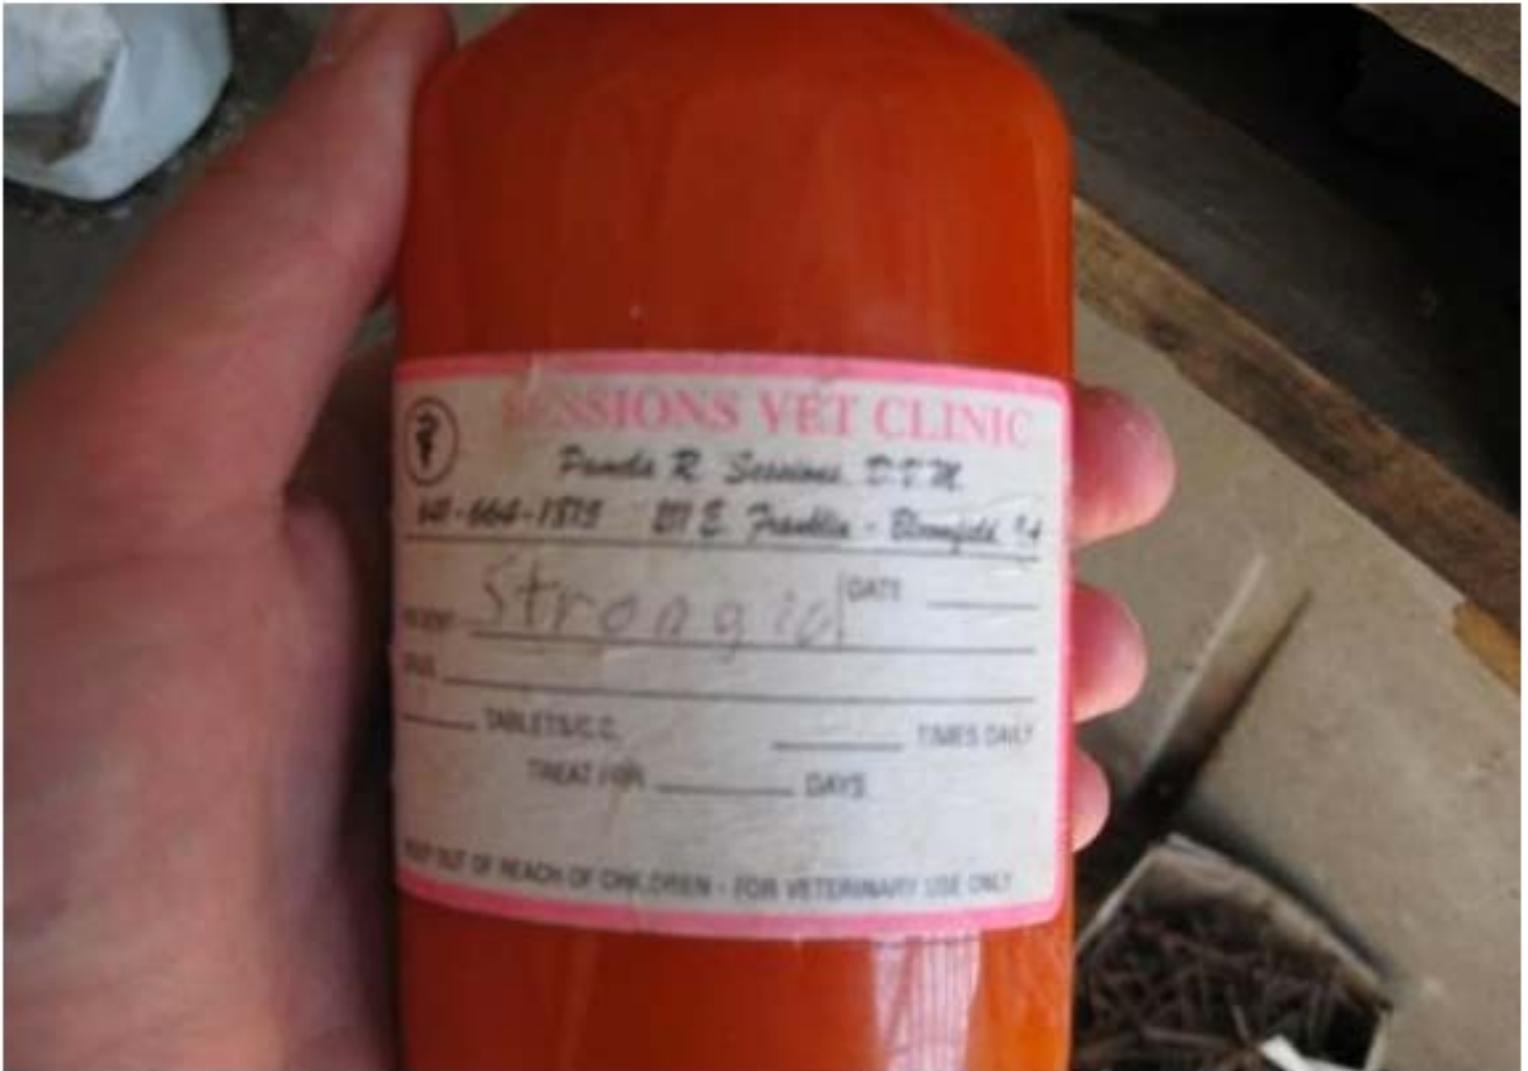
FOIA11-282001055

Photographer:	John J. Lies, ACI	Legal Name:	Registration:	42-A-1431
Photo Taken:	Tue, May 4, '10 A.M.	Ivan Yoder		
Inspection:	124100831140632			
Description:	2.40 (b)(2): Veterinary Care: Medicines not labeled correctly.

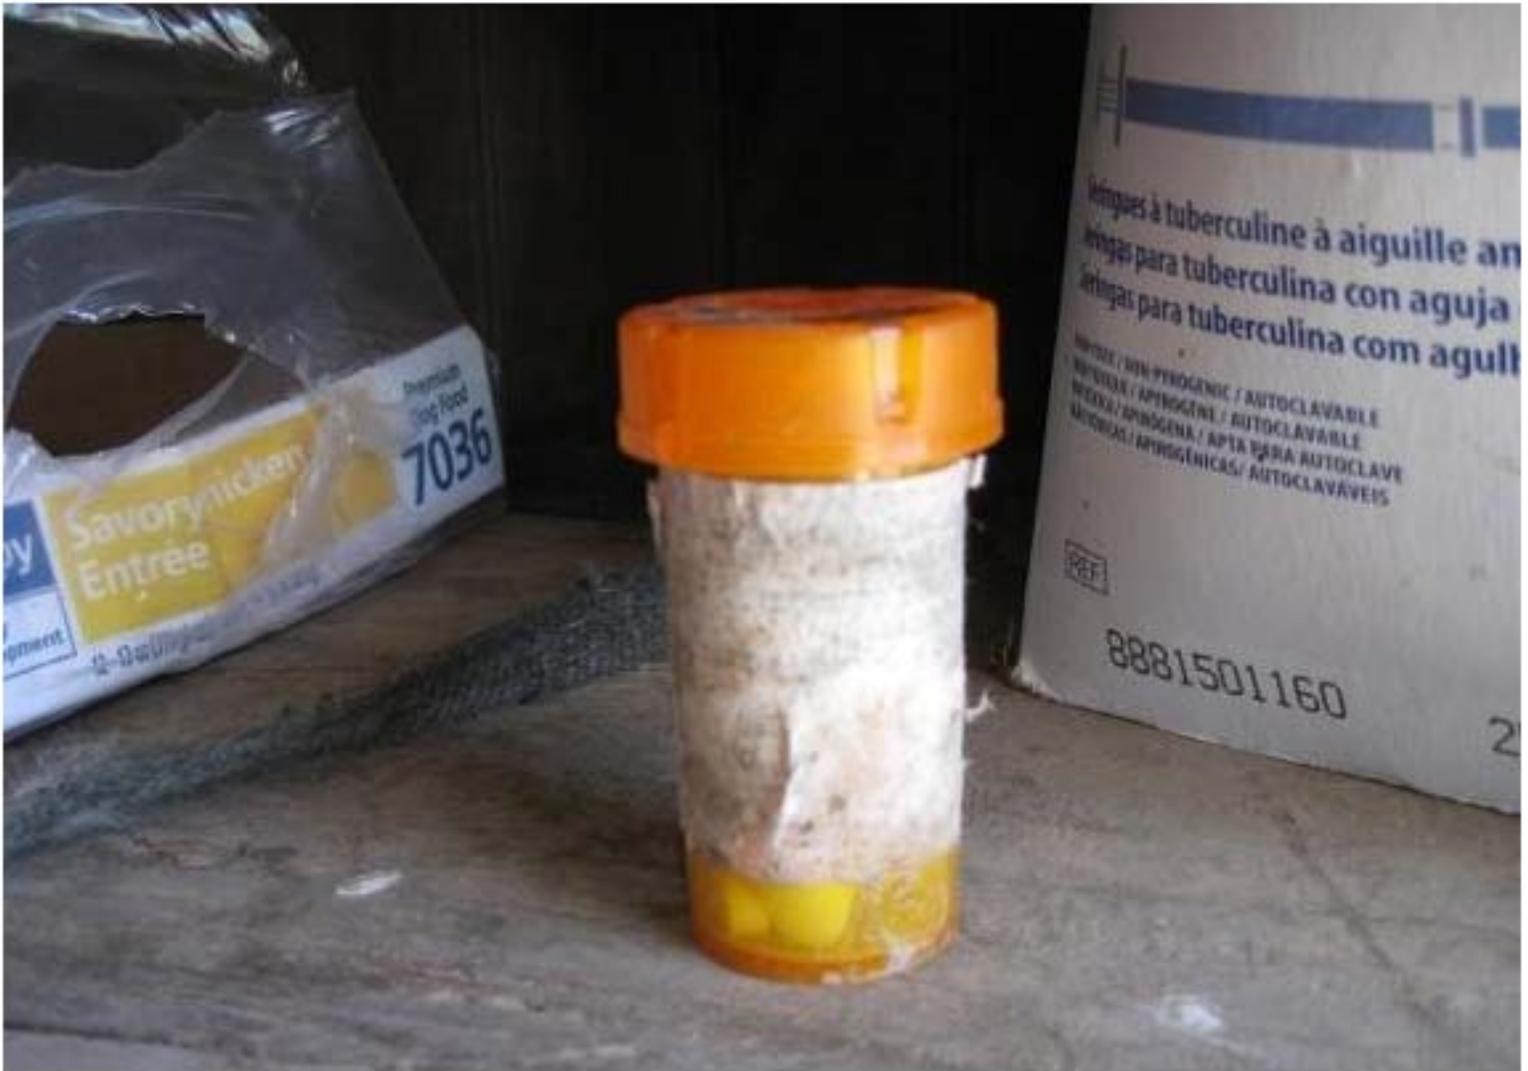
FOIA11-282001056

Photographer:	John J. Lies, ACI	Legal Name:	Registration:	42-A-1431
Photo Taken:	Tue, May 4, '10 A.M.	Ivan Yoder		
Inspection:	124100831140632			
Description:	2.40 (b)(2): Veterinary Care: Medicines not labeled correctly.

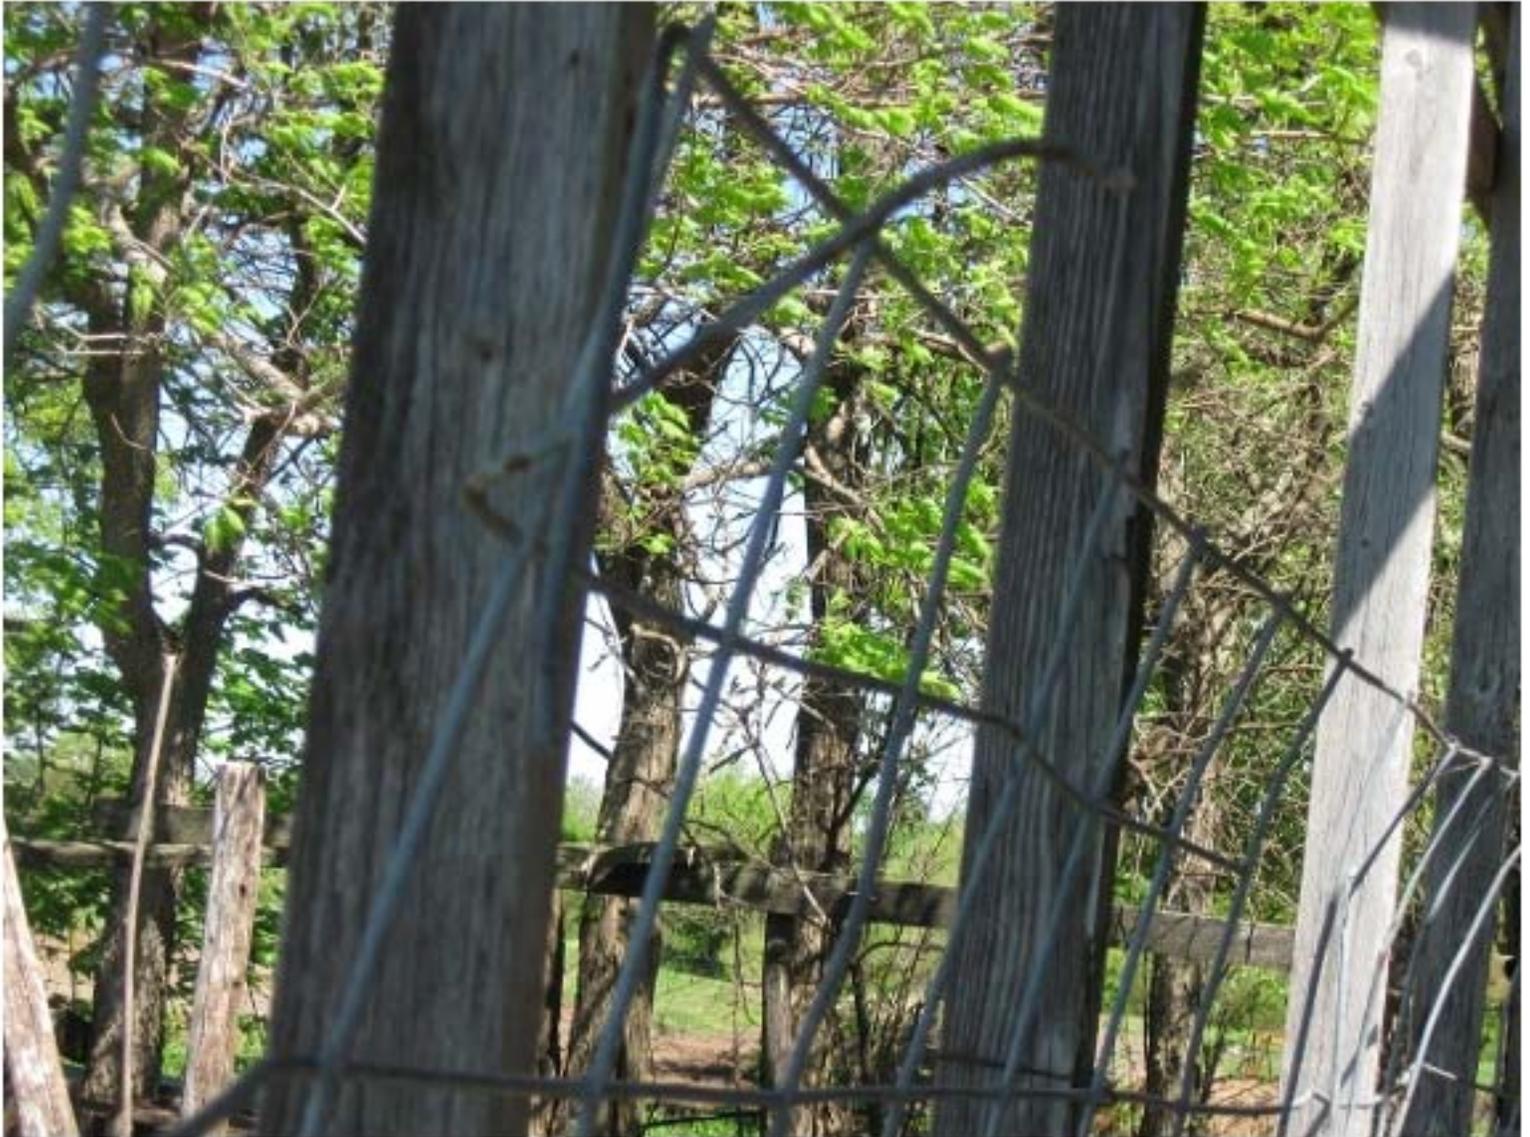
FOIA11-282001058

Photographer:	John J. Lies, ACI	Legal Name:	Registration:	42-A-1431
Photo Taken:	Tue, May 4, '10 A.M.	Ivan Yoder		
Inspection:	124100831140632			
Description:	3.6 (a)(2)(i): Primary enclosures sharp points: Broken cattle panel

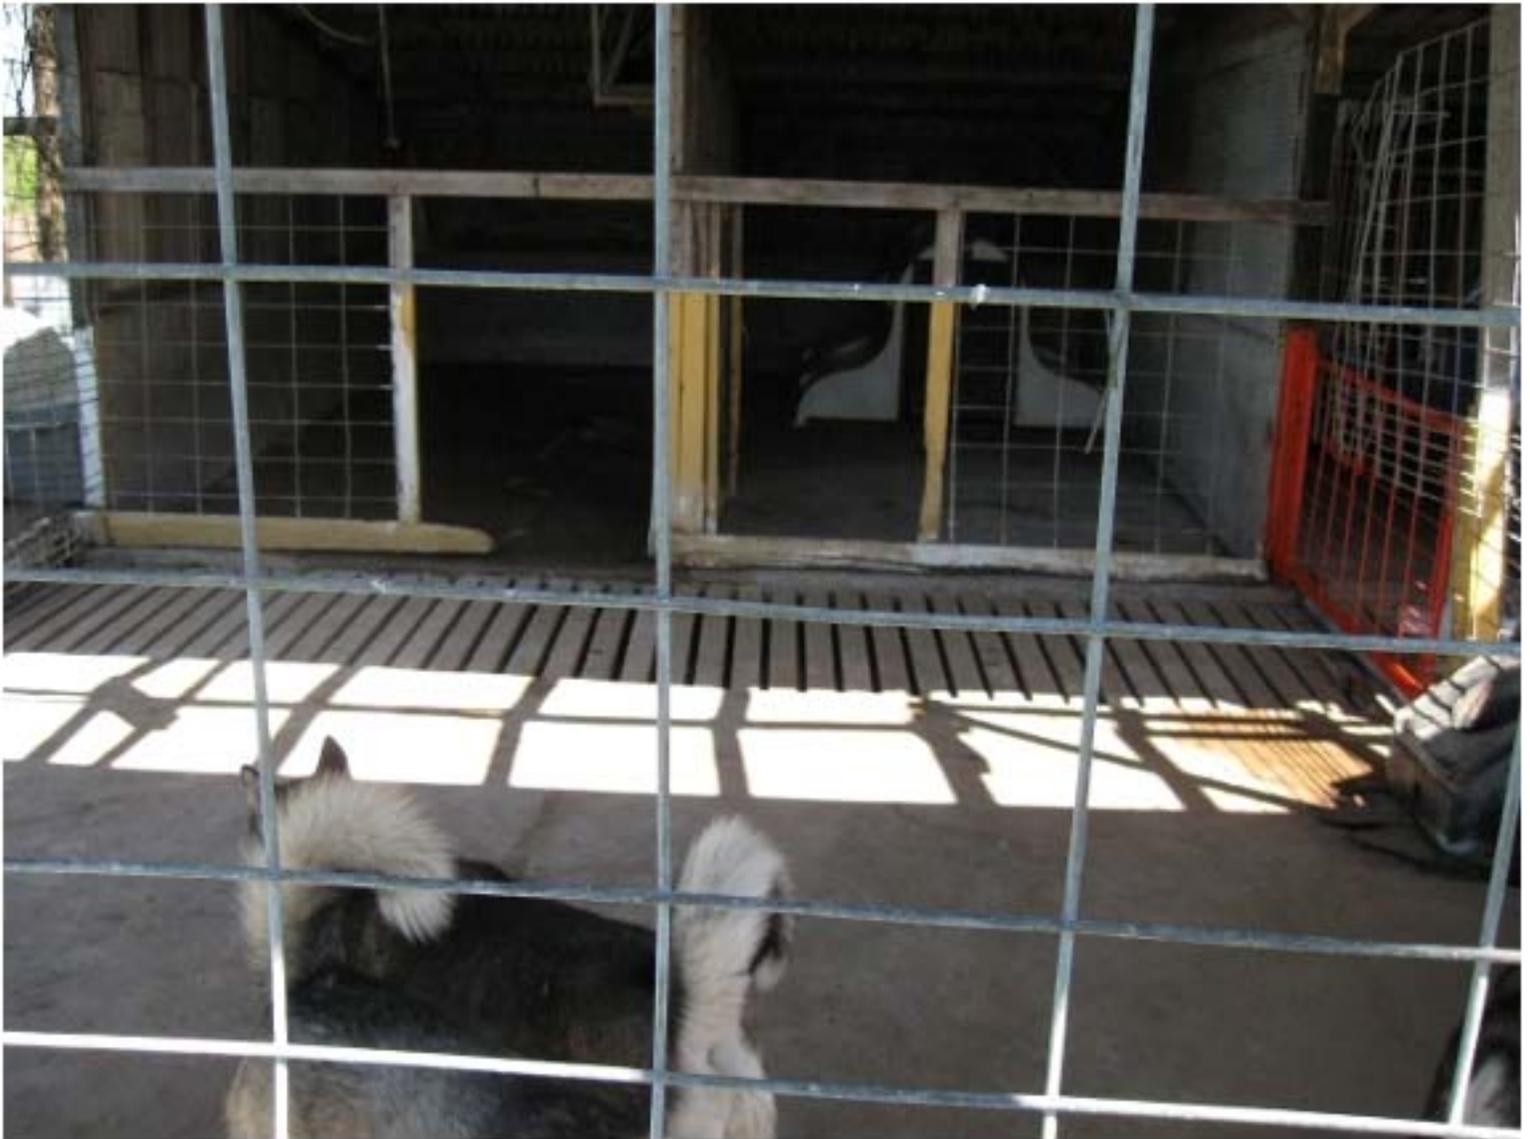
Photographer:	John J. Lies, ACI	Legal Name:	Registration:	42-A-1431
Photo Taken:	Tue, May 4, '10 A.M.	Ivan Yoder		
Inspection:	124100831140632			
Description:	3.6 (a)(2)(i): Primary enclosures sharp points: Broken cattle panel

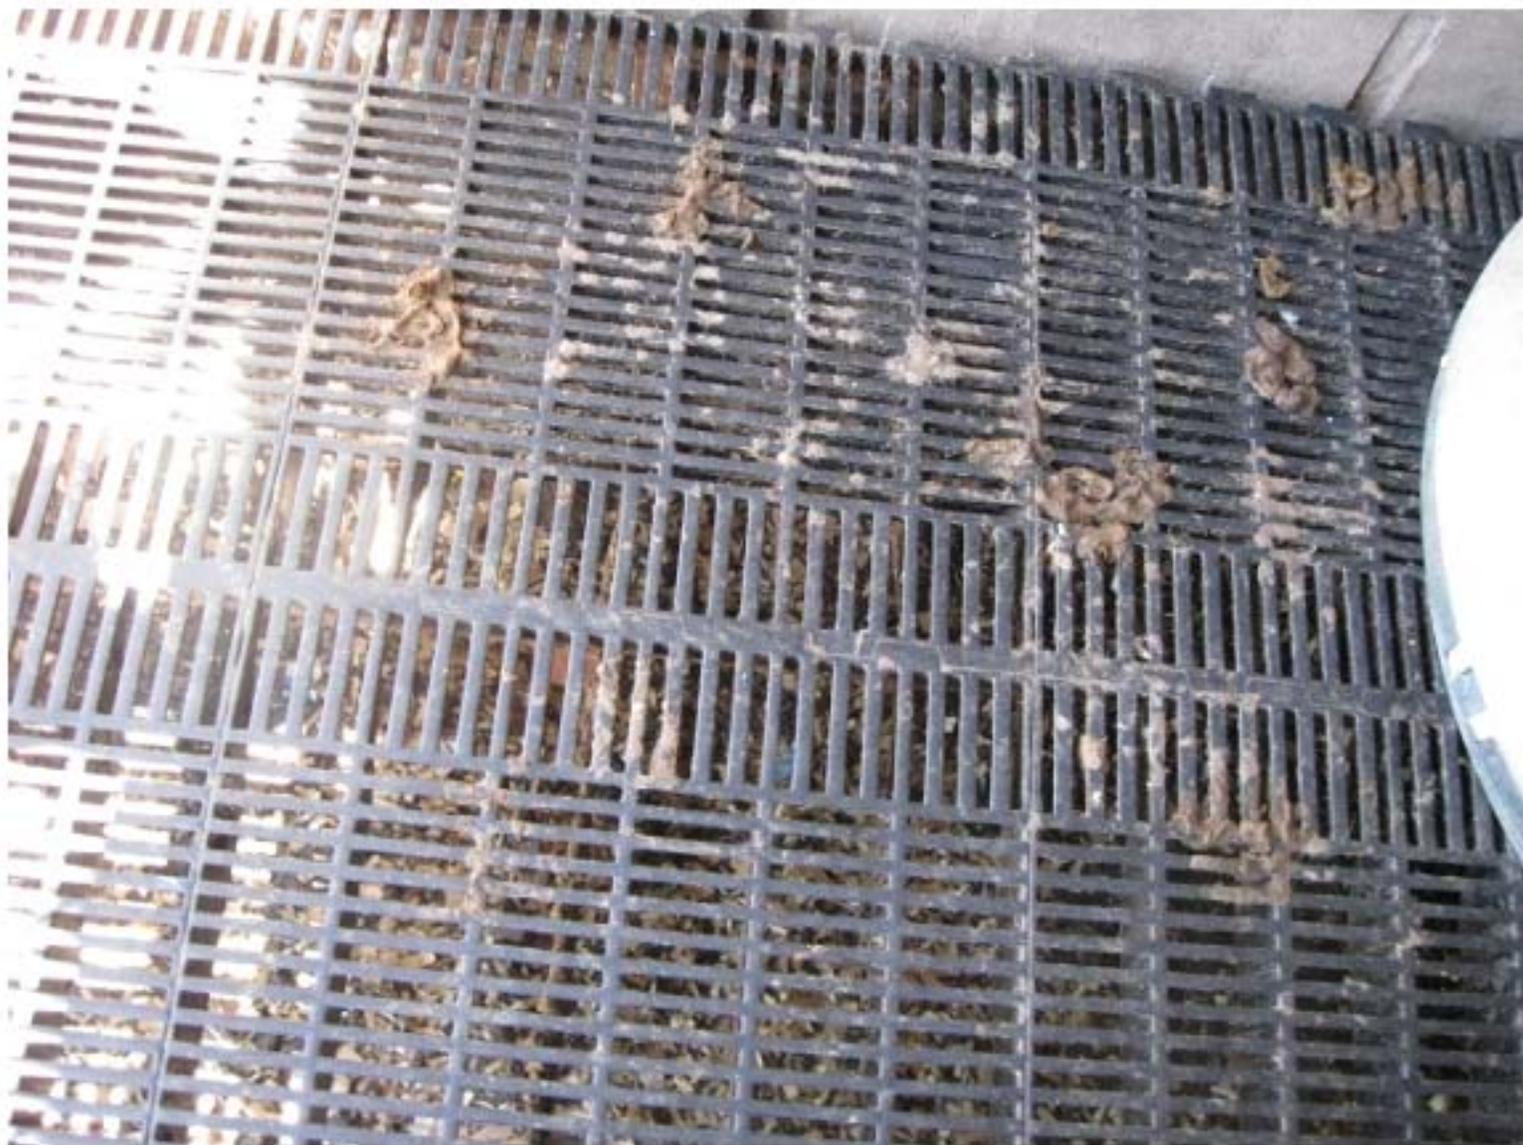
FOIA11-282001061

Photographer:	John J. Lies, ACI	Legal Name:	Registration:	42-A-1431
Photo Taken:	Tue, May 4, '10 A.M.	Ivan Yoder		
Inspection:	124100831140632			
Description:	3.6(a)(2): Primary Enclosures. Contain the dogs Securely:

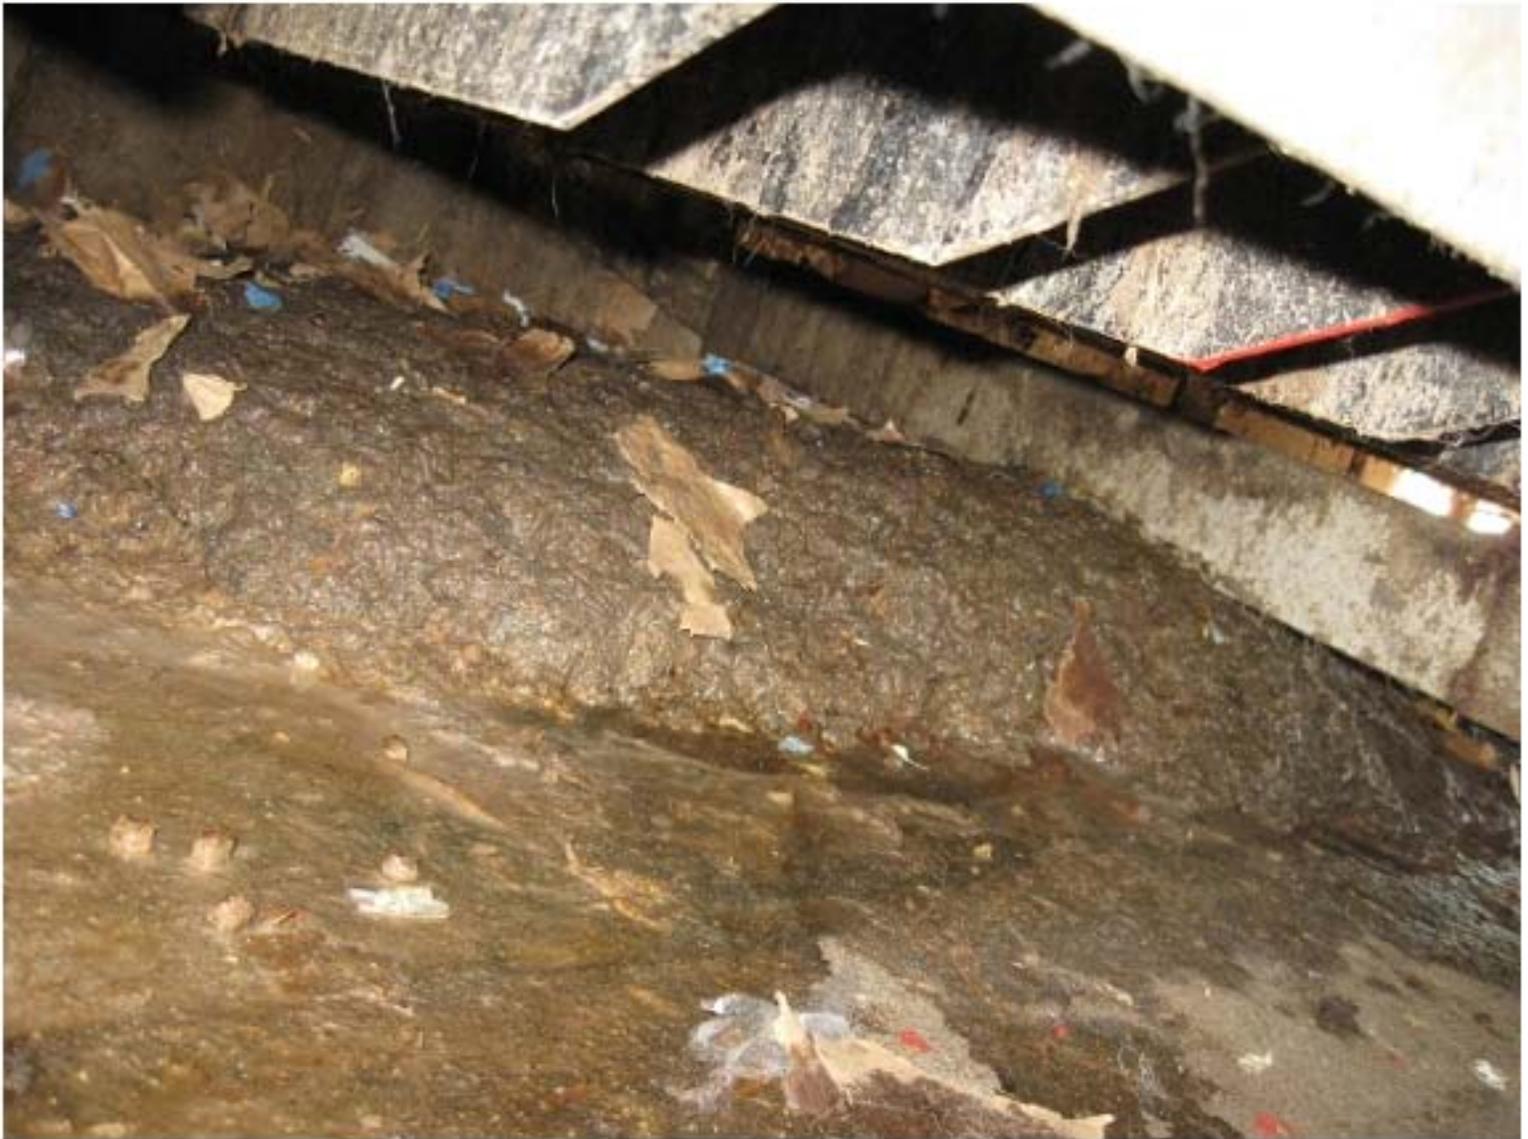
Photographer:	John J. Lies, ACI	Legal Name:	Registration:	42-A-1431
Photo Taken:	Tue, May 4, '10 A.M.	Ivan Yoder		
Inspection:	124100831140632			
Description:	3.1 (c)(3) Cleaning: Feces, on flooring, and residue on flooring and in between slates.

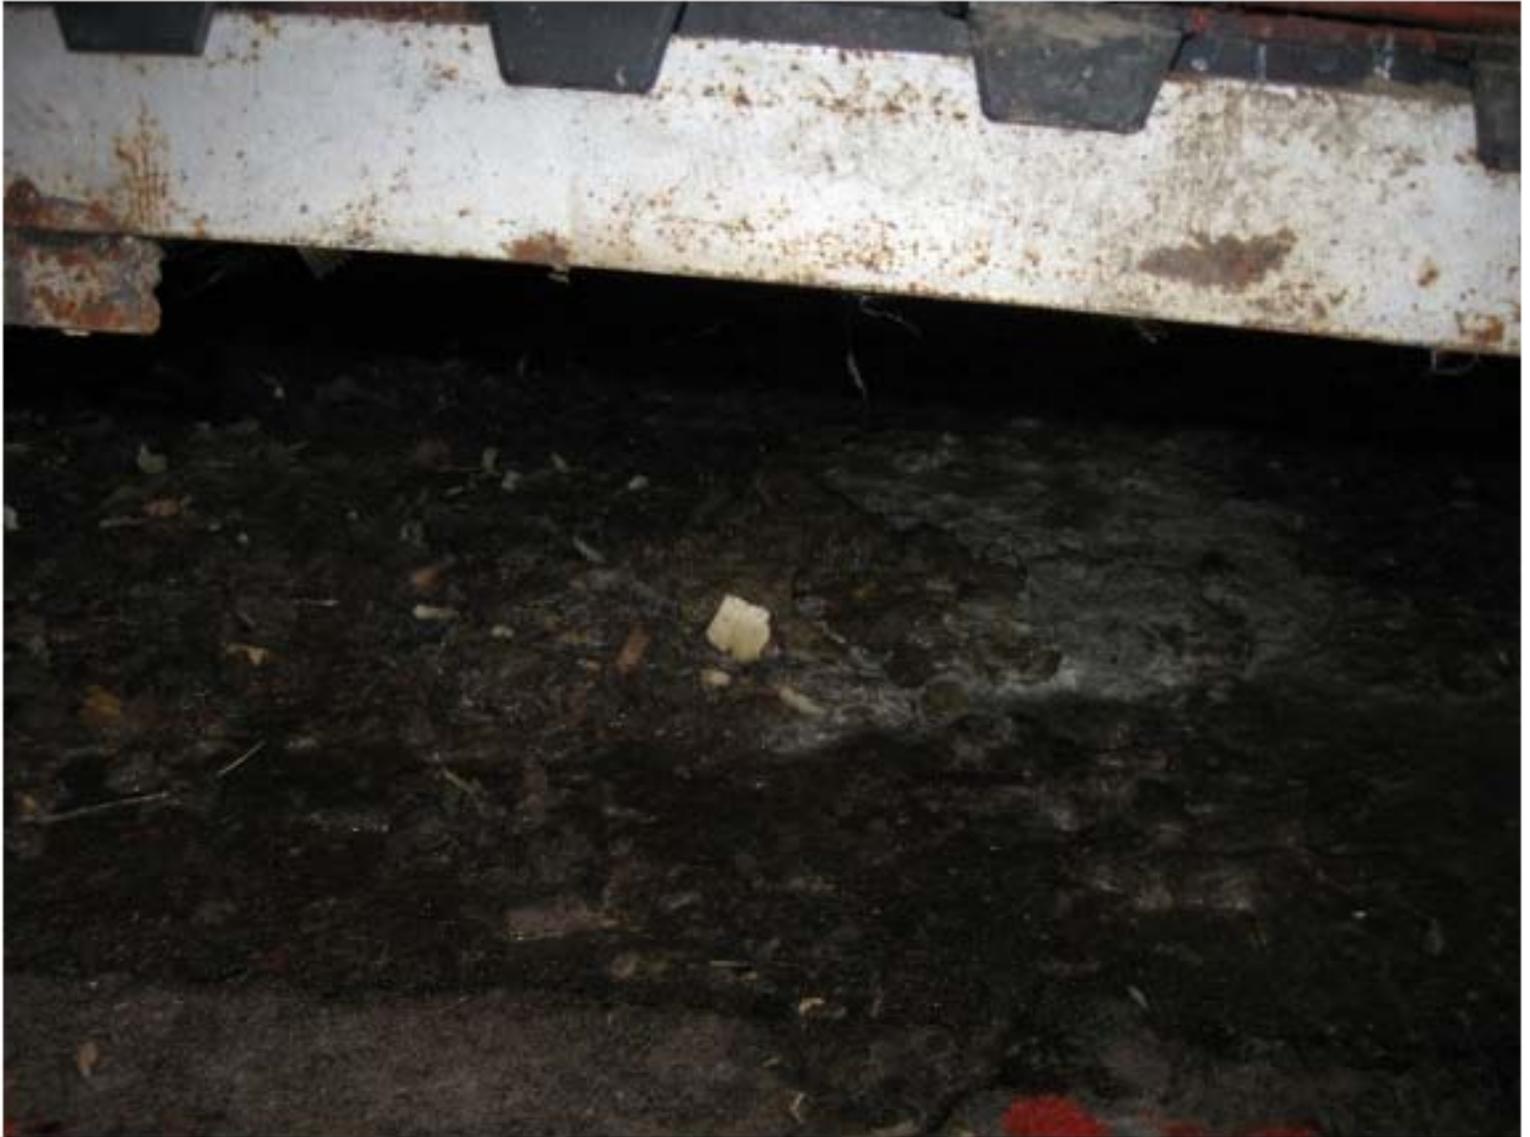
FOIA11-282001064

Photographer:	John J. Lies, ACI	Legal Name:	Registration:	42-A-1431
Photo Taken:	Tue, May 4, '10 A.M.	Ivan Yoder		
Inspection:	124100831140632			
Description:	3.1 (c)(3) Cleaning: Feces, excreta and food waste under elevated run and hair and feces caught on supports.
