Photographer: Heather Cole, VMO      Legal Name: PAMELA SELLNER      Registration: 42-C-0084  
Photo Taken: Mon, Nov 22, '10 approximately 1100      TOM SELLNER  
Inspection: 326101741280061  
Description:

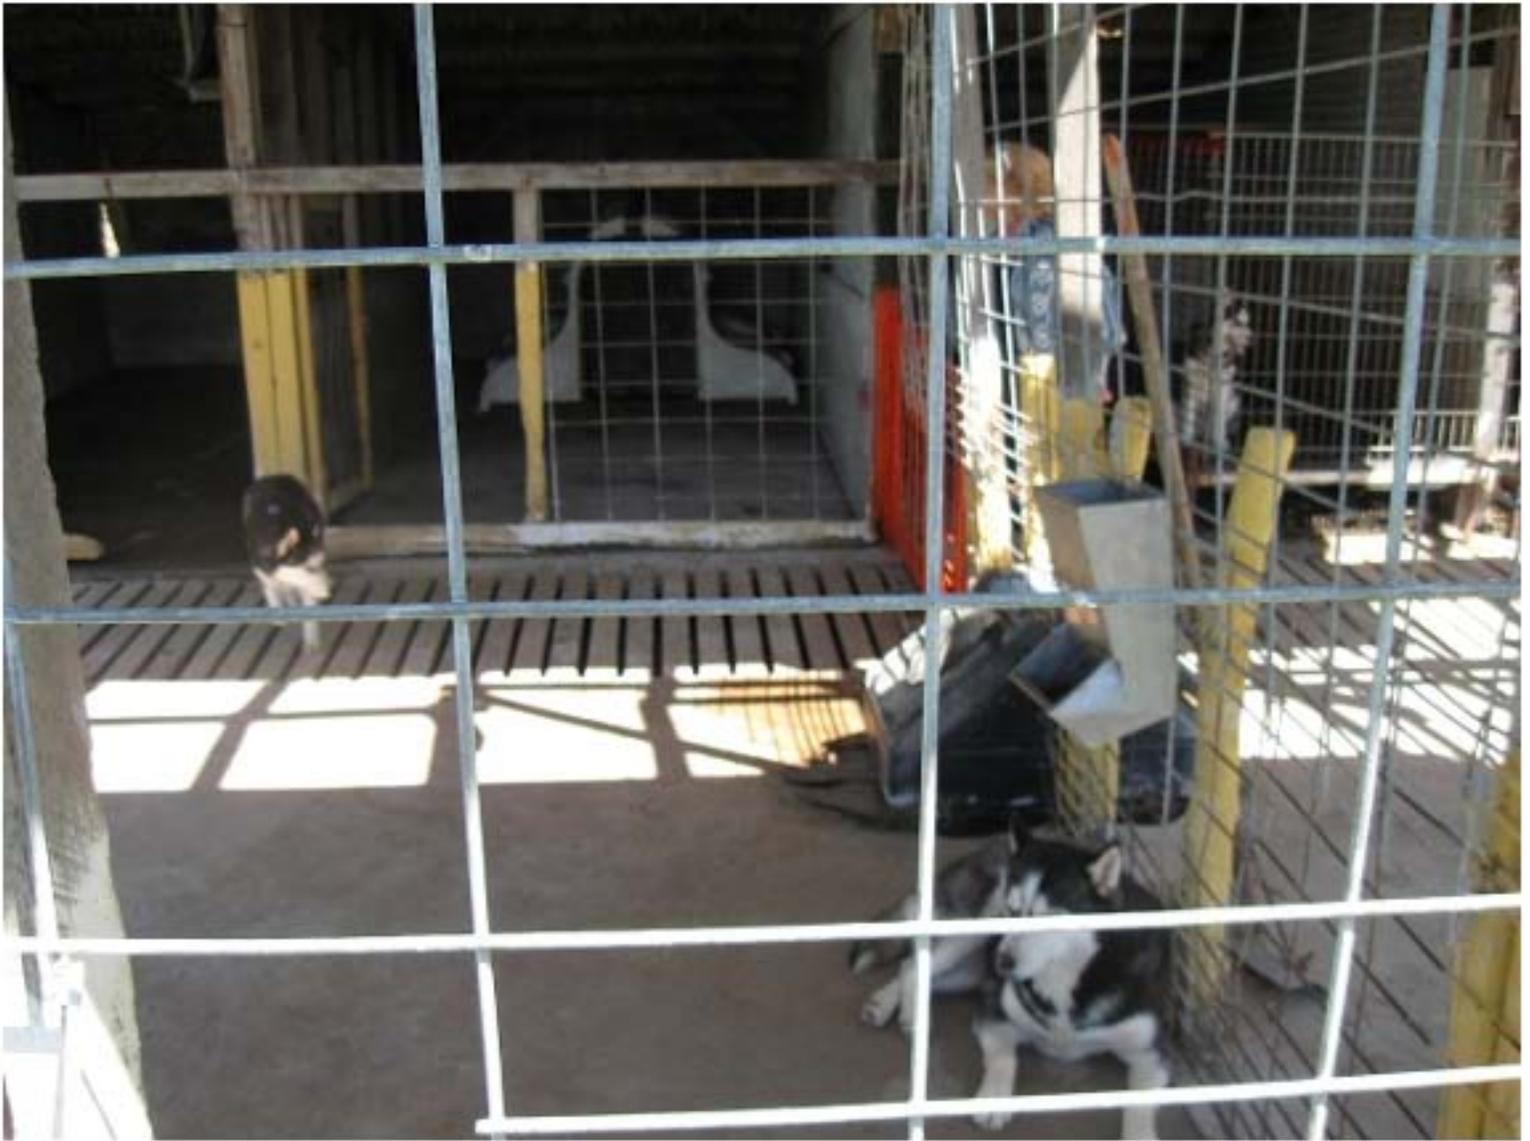
Photographer:	John J. Lies, ACI	Legal Name:	Registration:	42-A-1431
Photo Taken:	Tue, May 4, '10 A.M.	Ivan Yoder		
Inspection:	124100831140632			
Description:	3.1 (c)(3) Cleaning: Feces excreta and food waste under elevated run.
