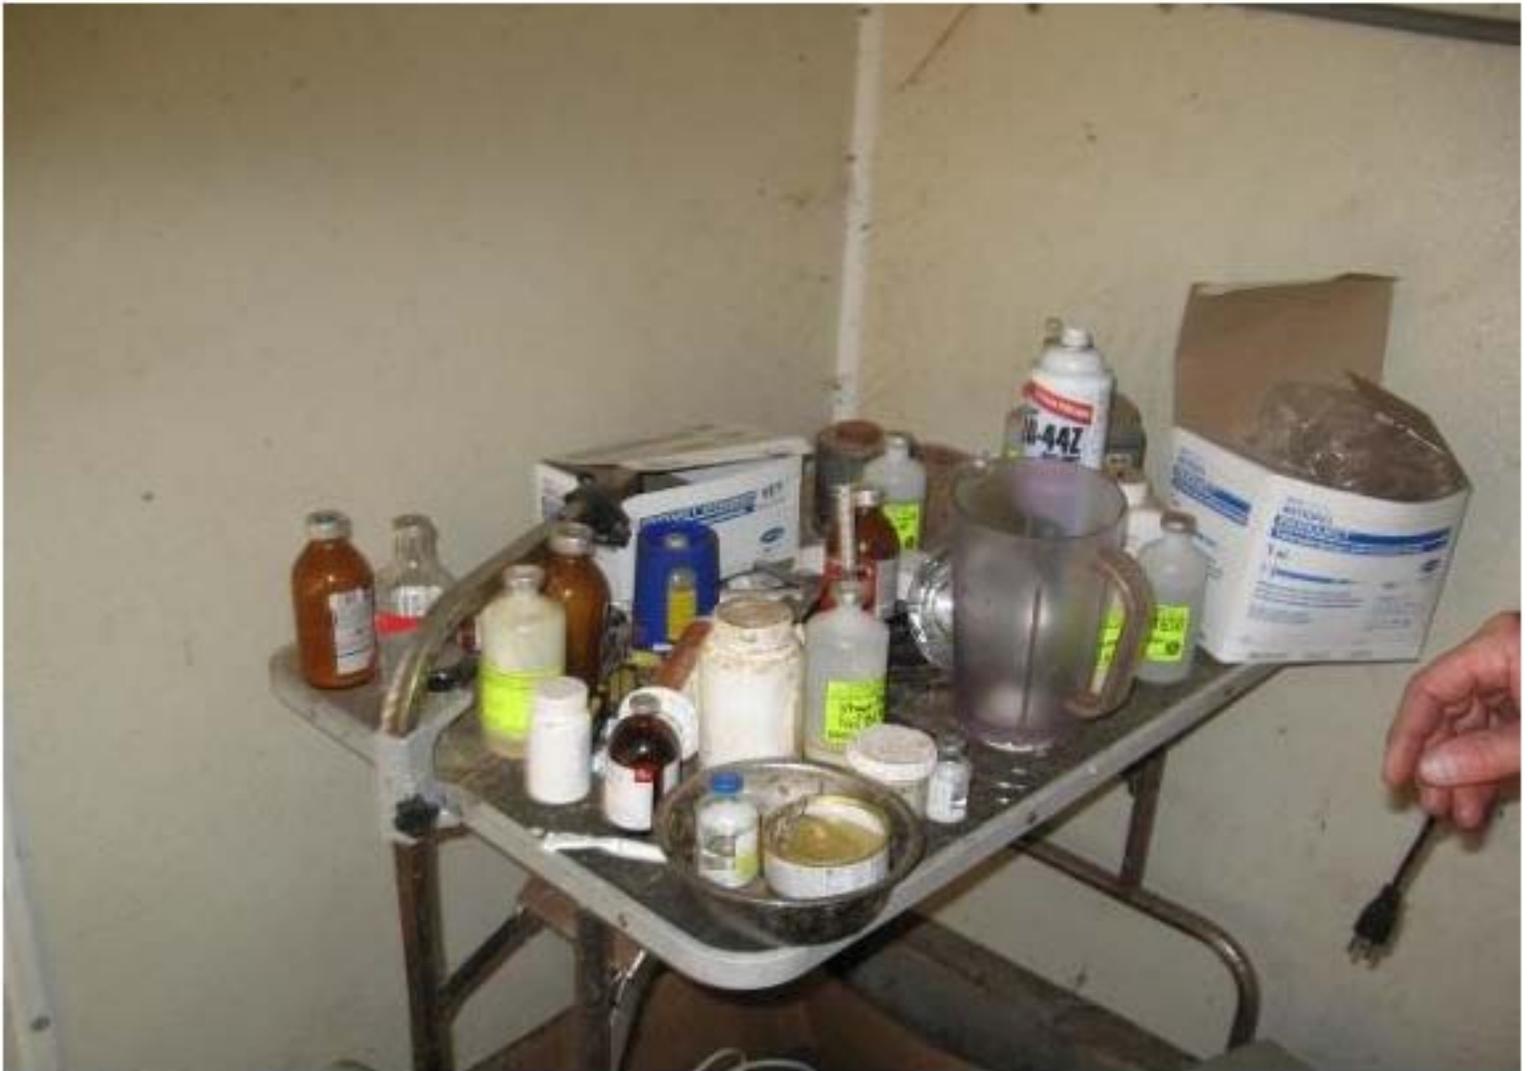
FOIA11-28200003

CFR: 3.11 (c)

Photographer:	Randall Wagner (ACI)	Legal Name:	Registration:	42-A-1401
Photo Taken:	Tue, Sep 21, '10	CALVIN KORTLEVER		
Inspection:	264101747320839			
Description:	The animal husbandry products have excessive dust on them and are not stored properly.

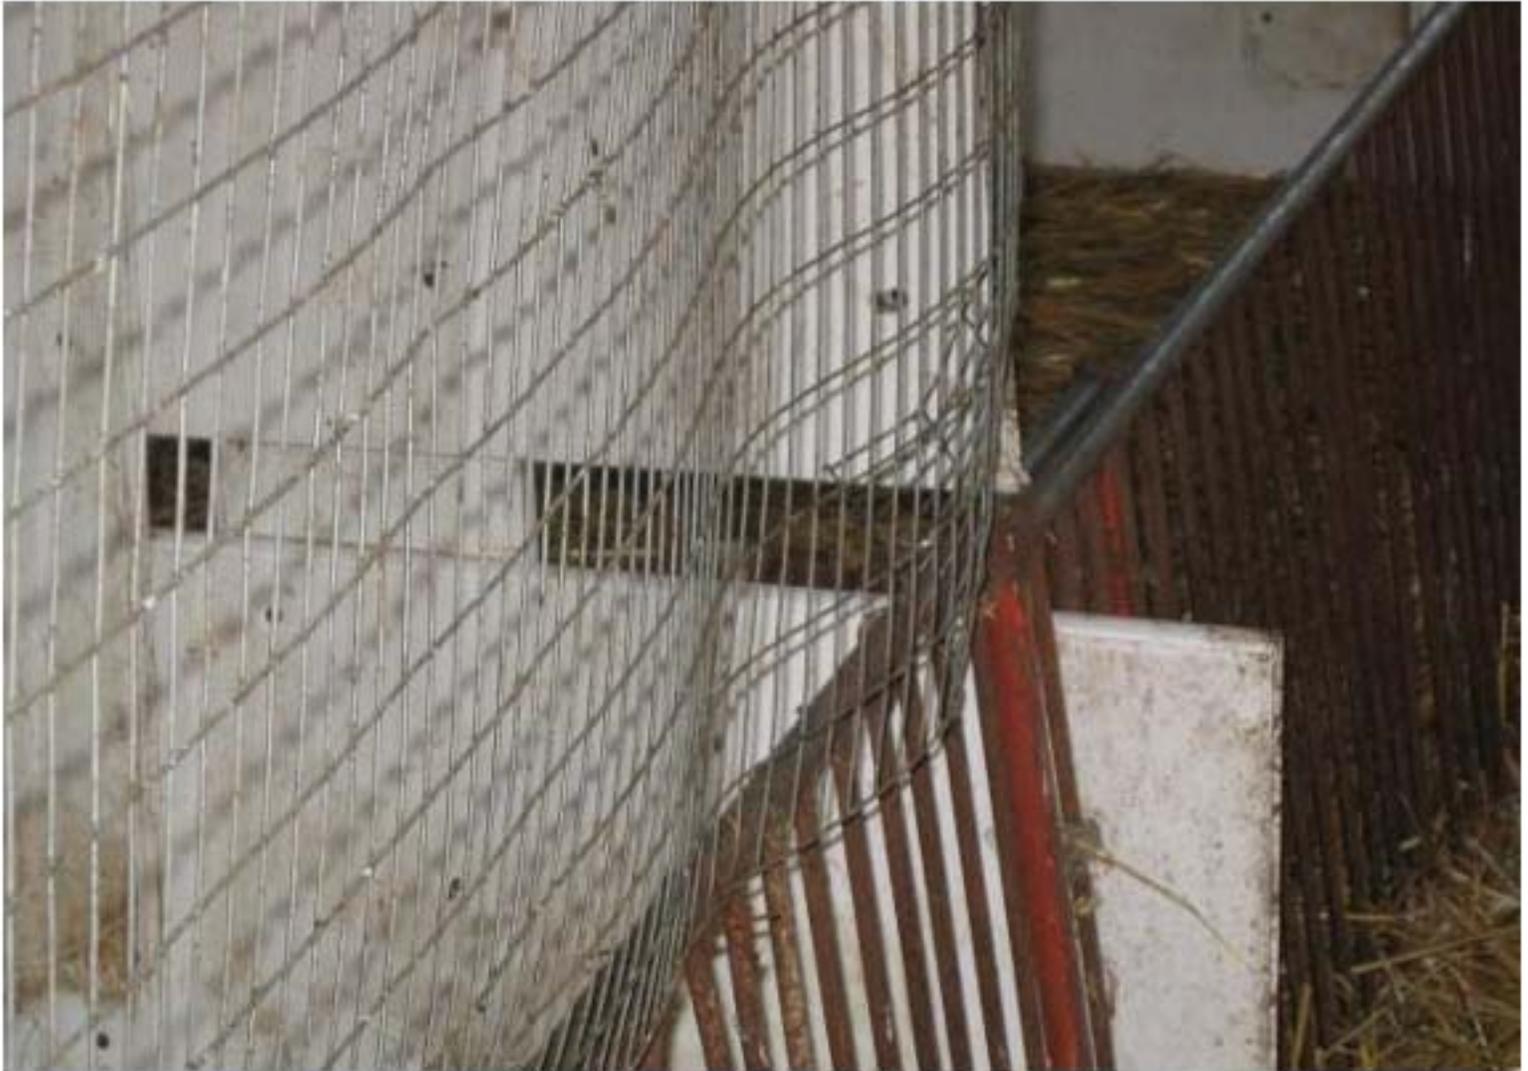
CFR: 3.1 (a)

Photographer:	Randall Wagner (ACI)	Legal Name:	Registration:	42-A-1401
Photo Taken:	Tue, Sep 21, '10	CALVIN KORTLEVER		
Inspection:	264101747320839			
Description:	The 2 X 4 wire is coming loose and bending inward at the corner.

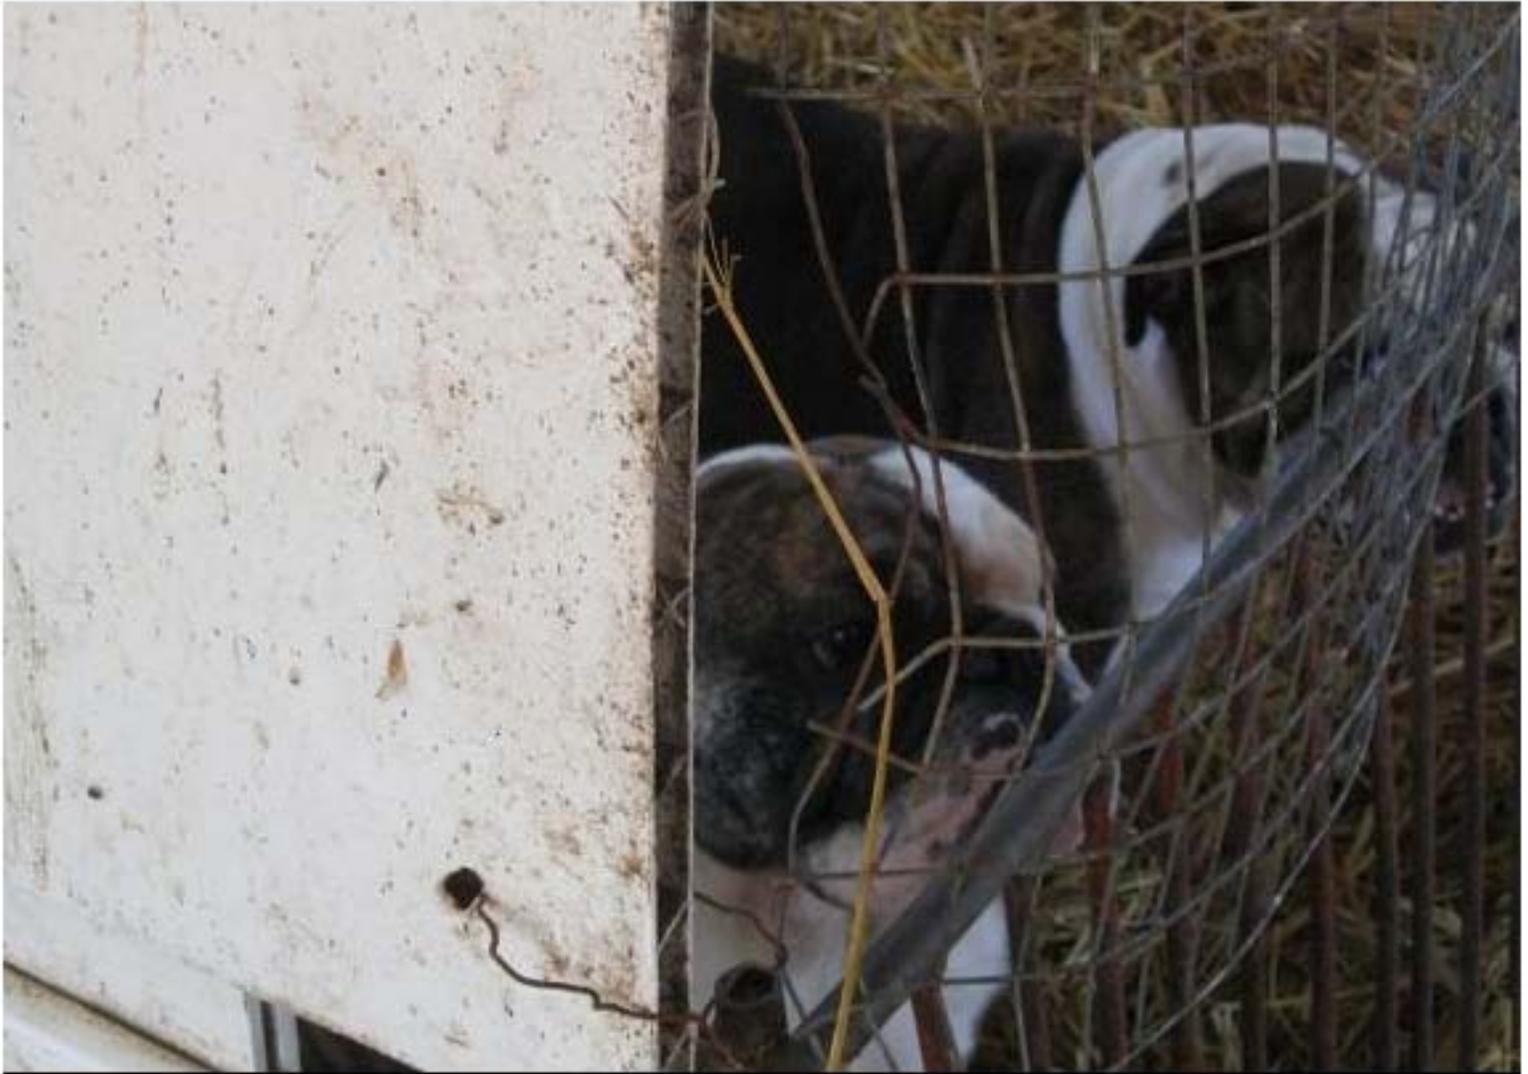
CFR: 3.1 (a)

Photographer:	Randall Wagner (ACI)	Legal Name:	Registration:	42-A-1401
Photo Taken:	Tue, Sep 21, '10	CALVIN KORTLEVER		
Inspection:	264101747320839			
Description:	The broken 2 X 4 wire for the dog enclosure along the side sagging out.

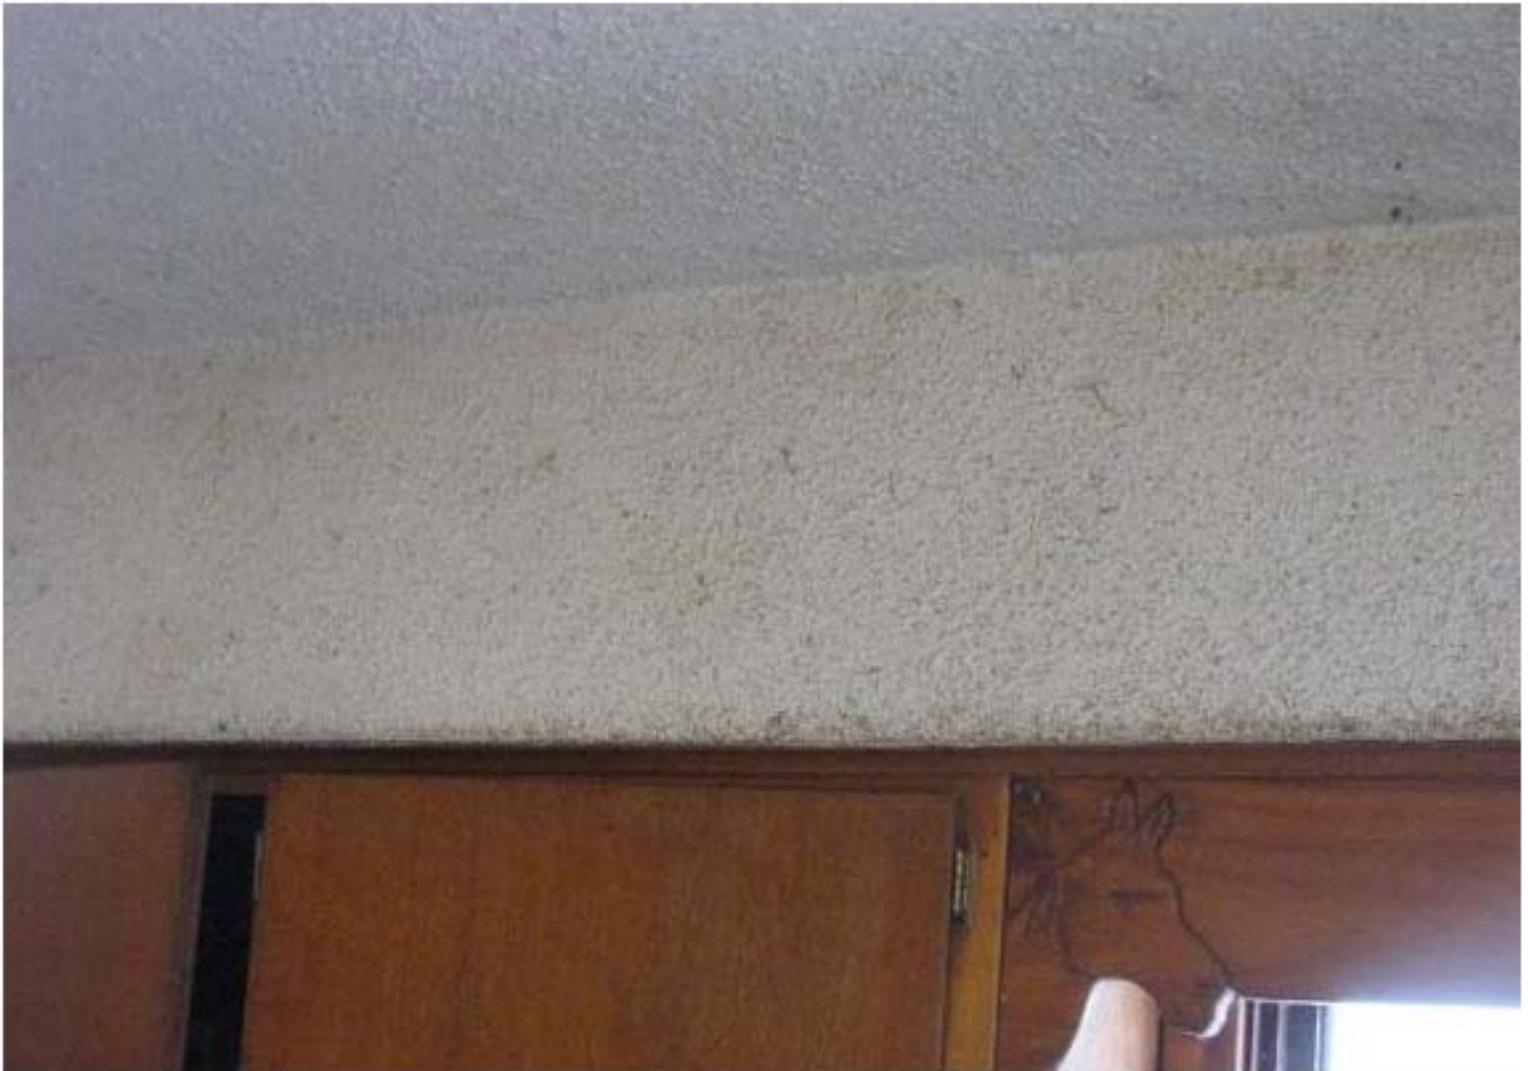
CFR: 3.1 (c) (3), 3.2 (d)

Photographer:	John Lies, ACI	Legal Name:	Registration:	42-A-1399
Photo Taken:	Thu, Dec 22, '11 P.M.	Debra Pratt		
Inspection:	356101302300307			
Description:	3.1(c)(3) General Cleaning: Walls and ceiling need cleaned to remove dirt, hair. 3.2(d) Indoor Surfaces; Walls & Ceiling are not impervious to moisture.

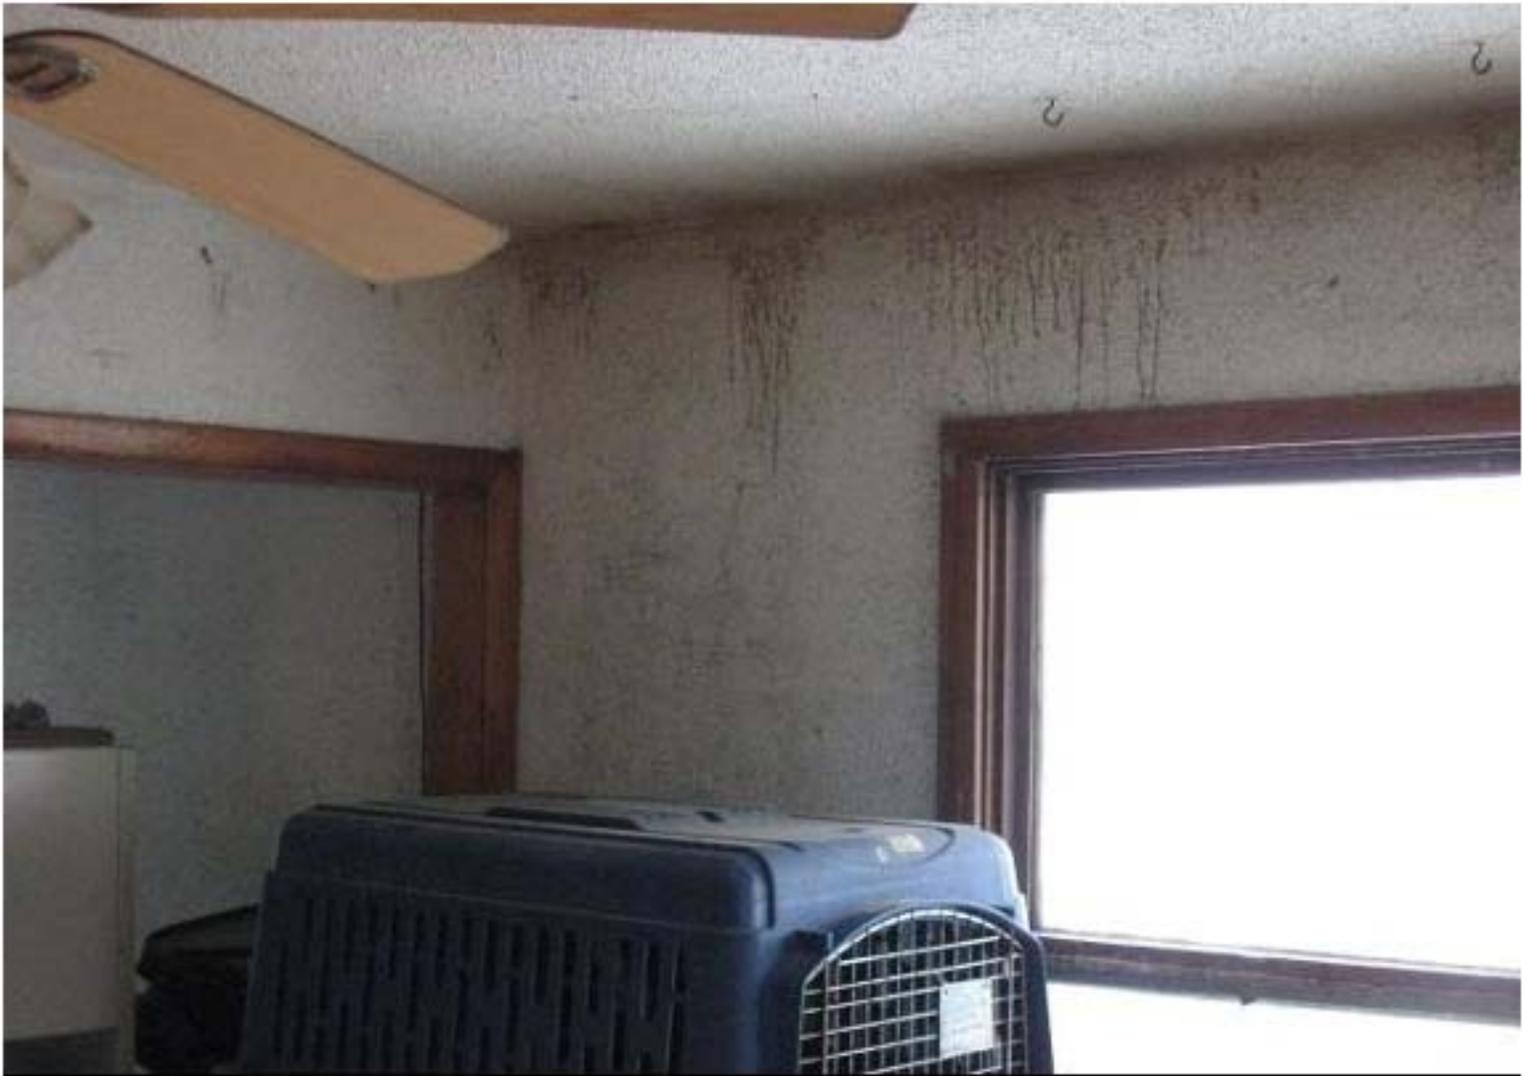
CFR: 3.2 (d), 3.1 (c) (3)

Photographer:	John Lies, ACI	Legal Name:	Registration:	42-A-1399
Photo Taken:	Thu, Dec 22, '11 P.M.	Debra Pratt		
Inspection:	356101302300307			
Description:	3.1(c)(3) General Cleaning: Walls and ceiling need cleaned to remove dirt, hair. 3.2(d) Indoor Surfaces; Walls & Ceiling are not impervious to moisture.

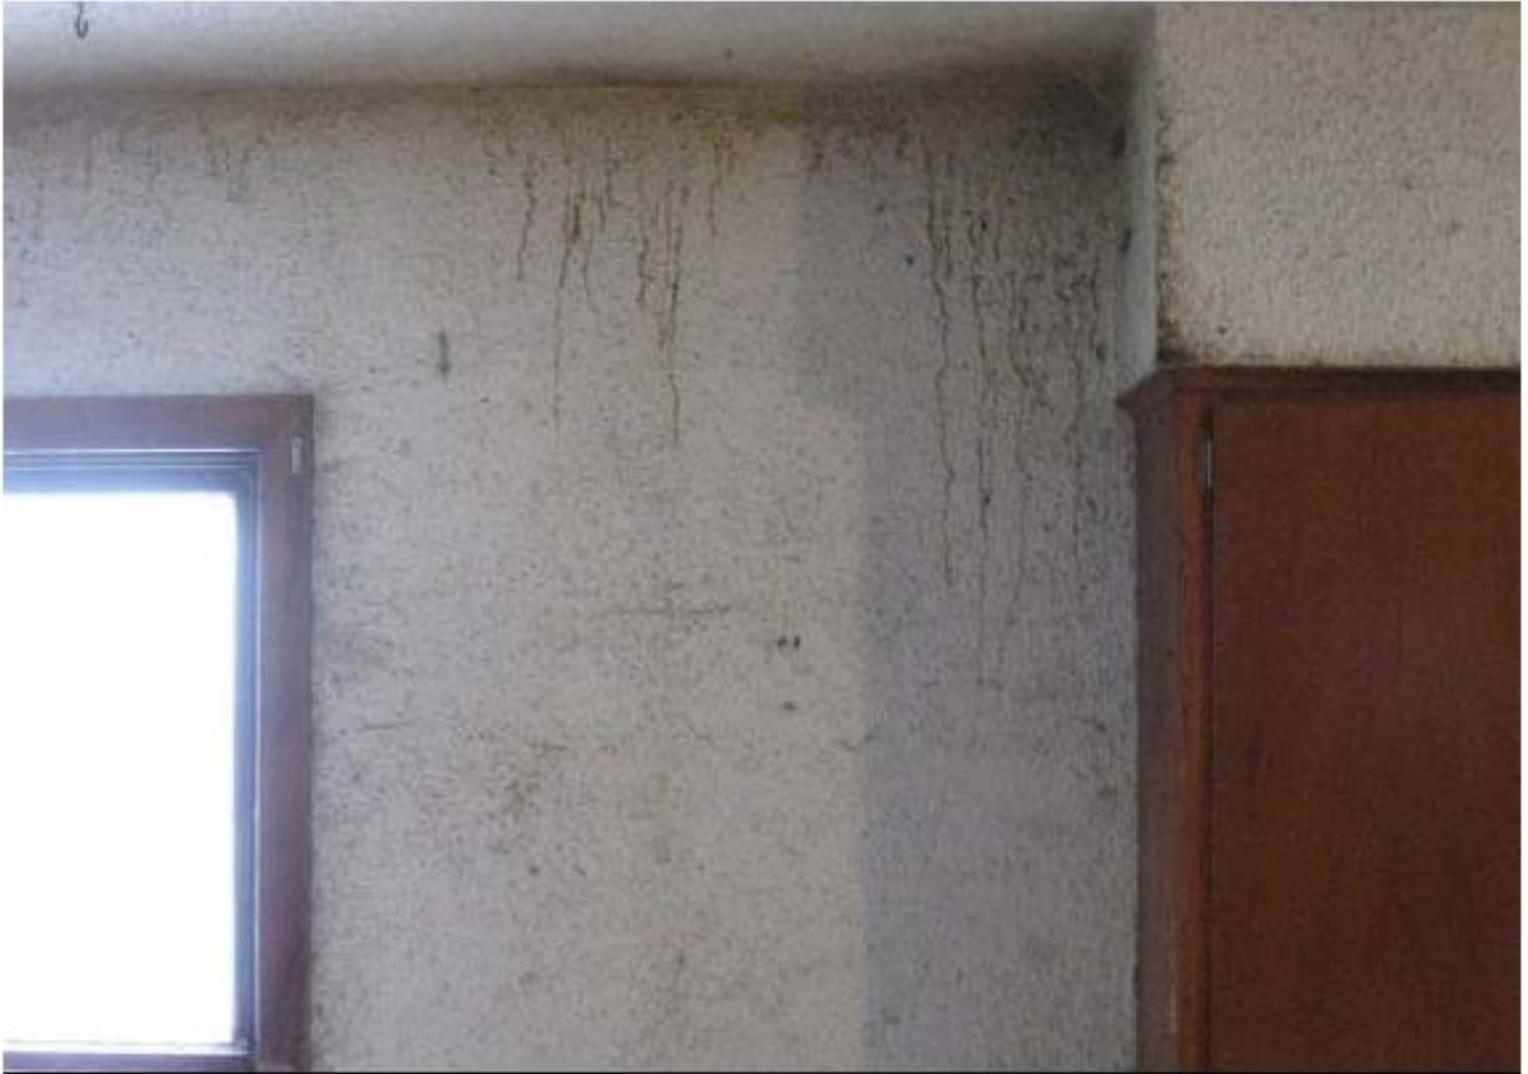
CFR: 3.2 (d), 3.1 (c) (3)

Photographer:	John Lies, ACI	Legal Name:	Registration:	42-A-1399
Photo Taken:	Thu, Dec 22, '11 P.M.	Debra Pratt		
Inspection:	356101302300307			
Description:	3.1(c)(3) General Cleaning: Walls and ceiling need cleaned to remove dirt, hair. 3.2(d) Indoor Surfaces; Walls & Ceiling are not impervious to moisture.

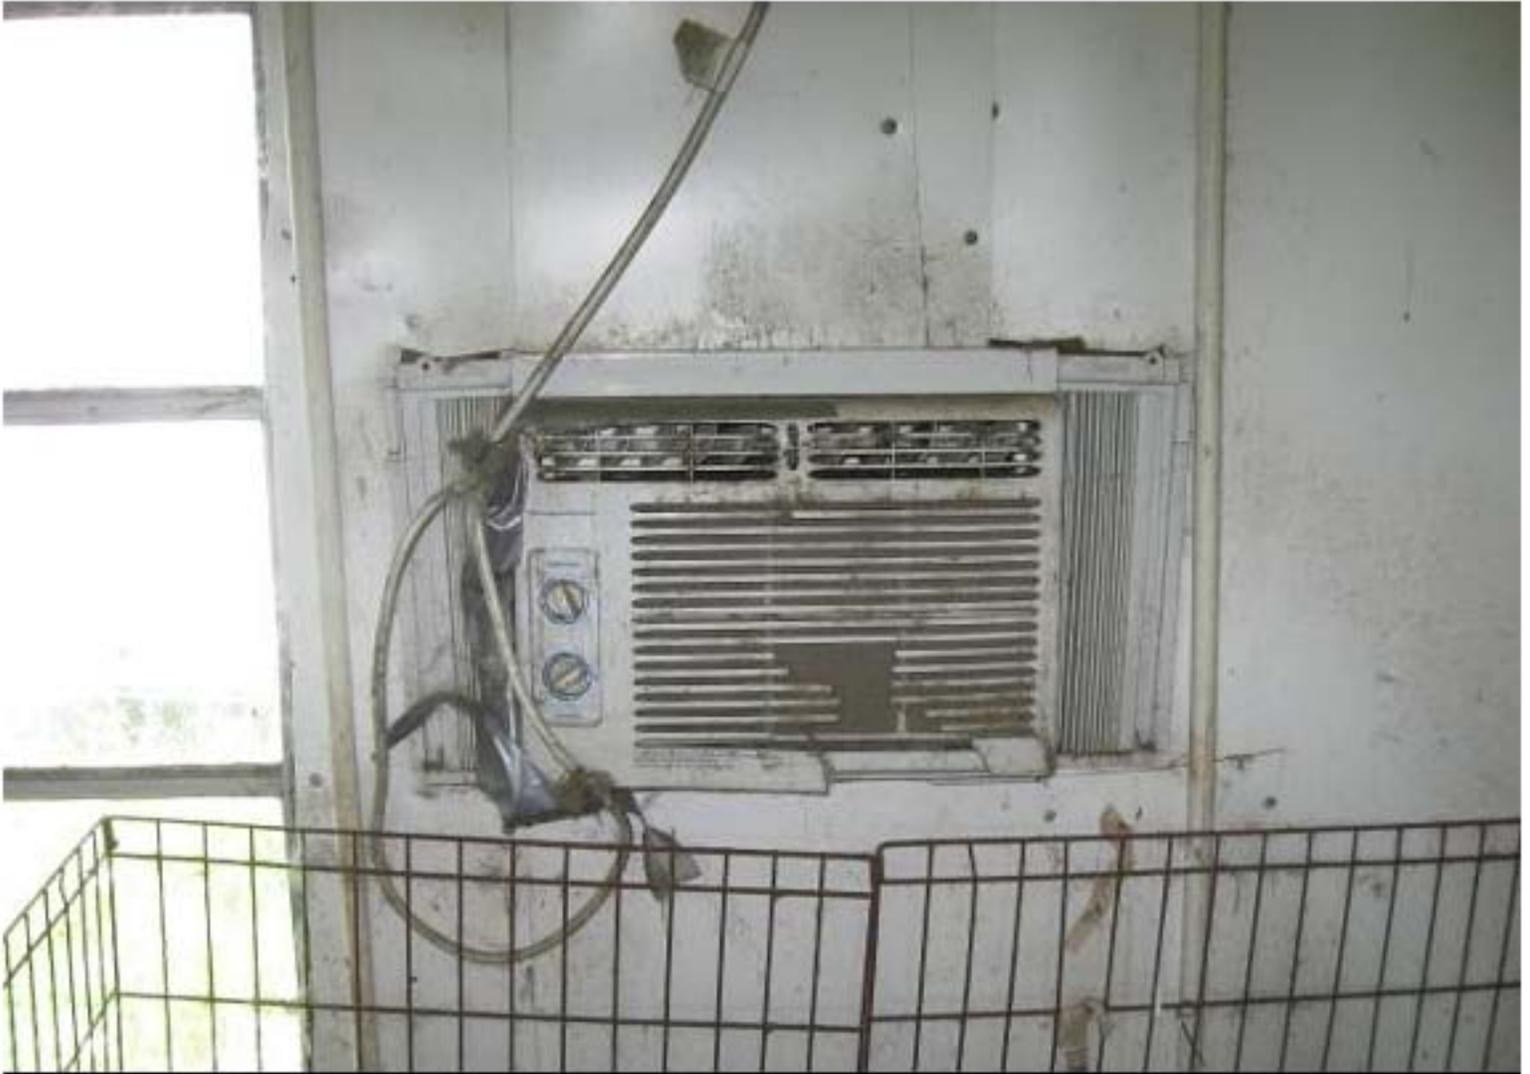
FOIA11-28200009

CFR: 3.1 (c) (3)

Photographer:	John J. Lies, ACI	Legal Name:	Registration:	42-A-1399
Photo Taken:	Tue, Aug 10, '10 P.M.	Debra Pratt		
Inspection:	223101025300653			
Description:	3.1 (c)(3) General Housing Facilities Cleaning: Walls of the facility need to be cleaned to remove dirt, spider webs, etc.

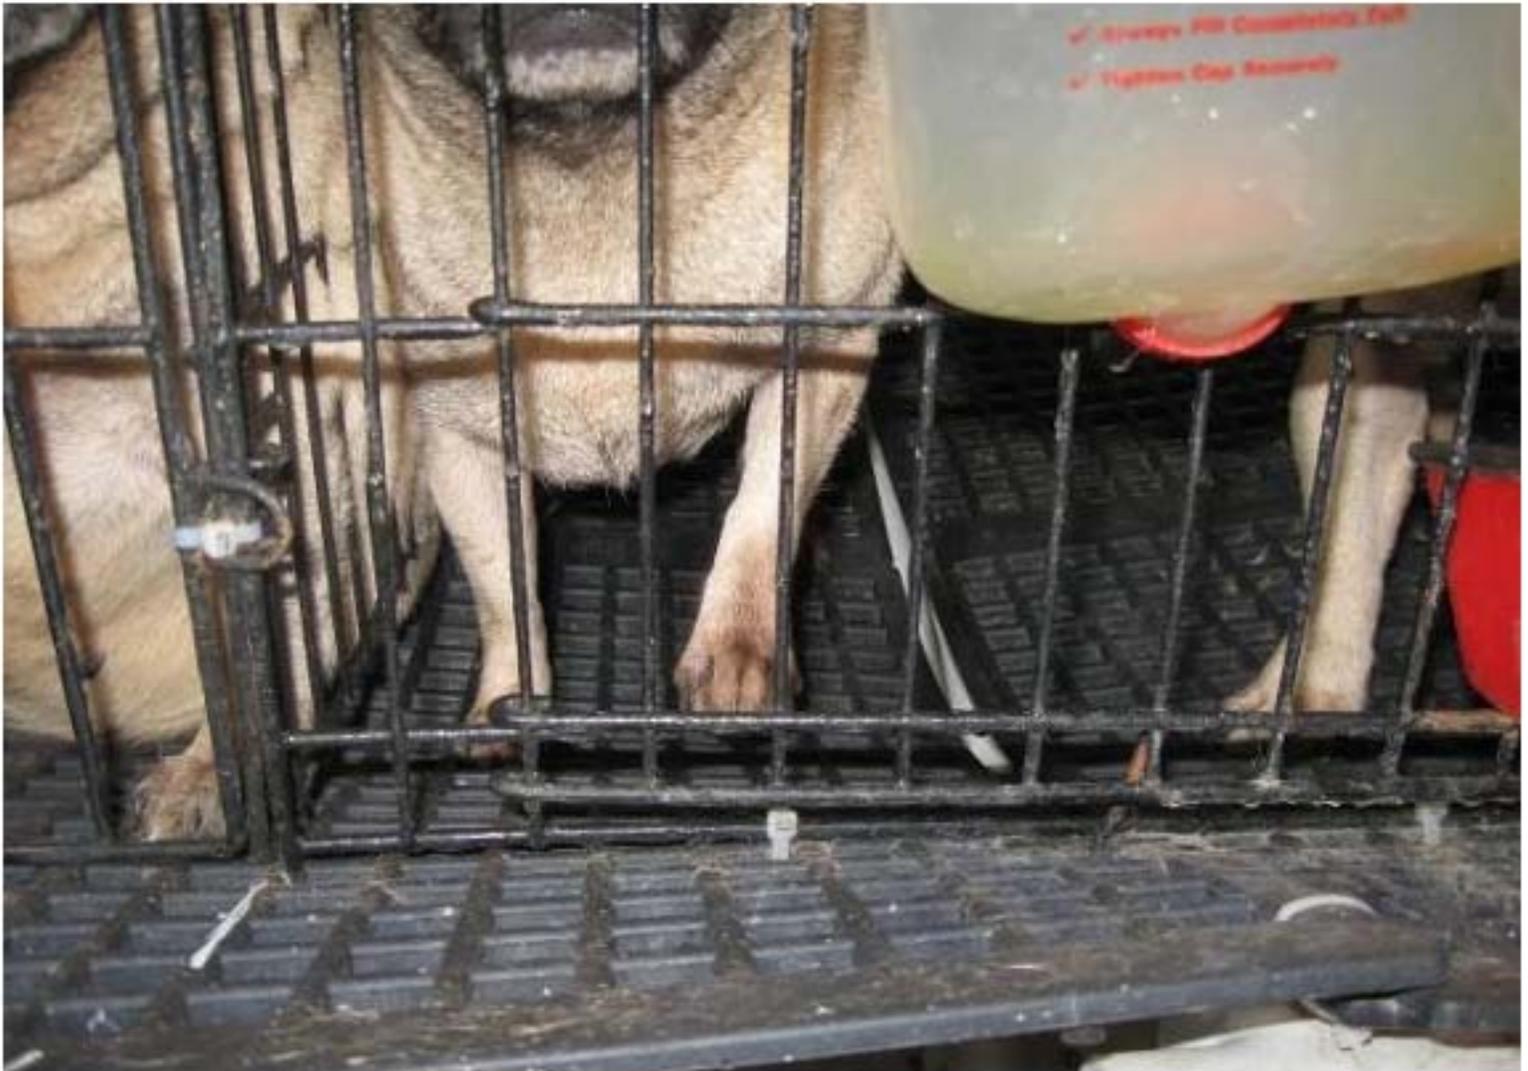
FOIA11-28200010

CFR: 3.6 (a) (2) (xii)

Photographer:	John J. Lies, ACI	Legal Name:	Registration:	42-A-1399
Photo Taken:	Tue, Aug 10, '10 P.M.	Debra Pratt		
Inspection:	223101025300653			
Description:	3.6 (a)(2)(xii) Primary enclosures: Suspended floor sagging between supports.

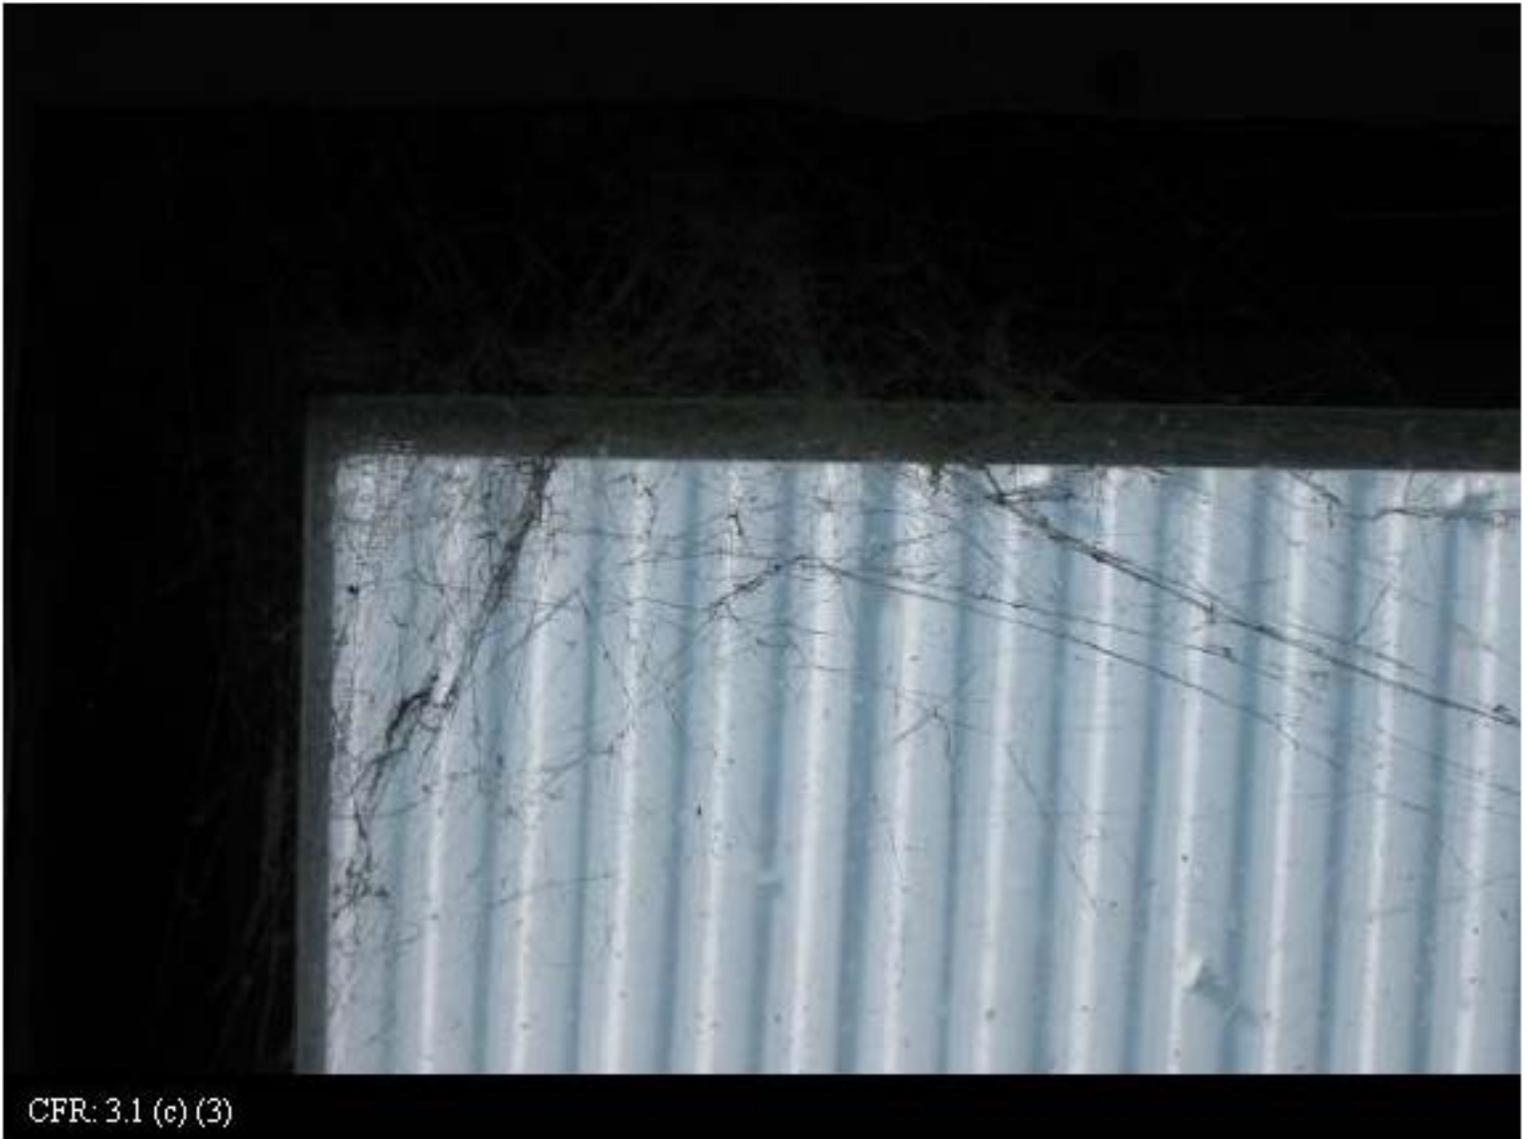
FOIA11-28200011

CFR: 3.1 (c) (3)

Photographer:	John J. Lies, ACI	Legal Name:	Registration:	42-A-1399
Photo Taken:	Tue, Aug 10, '10 P.M.	Debra Pratt		
Inspection:	223101025300653			
Description:	3.1 (c)(3) General Housing Facilities Cleaning: Walls of the facility need to be cleaned to remove dirt, spider webs, etc.

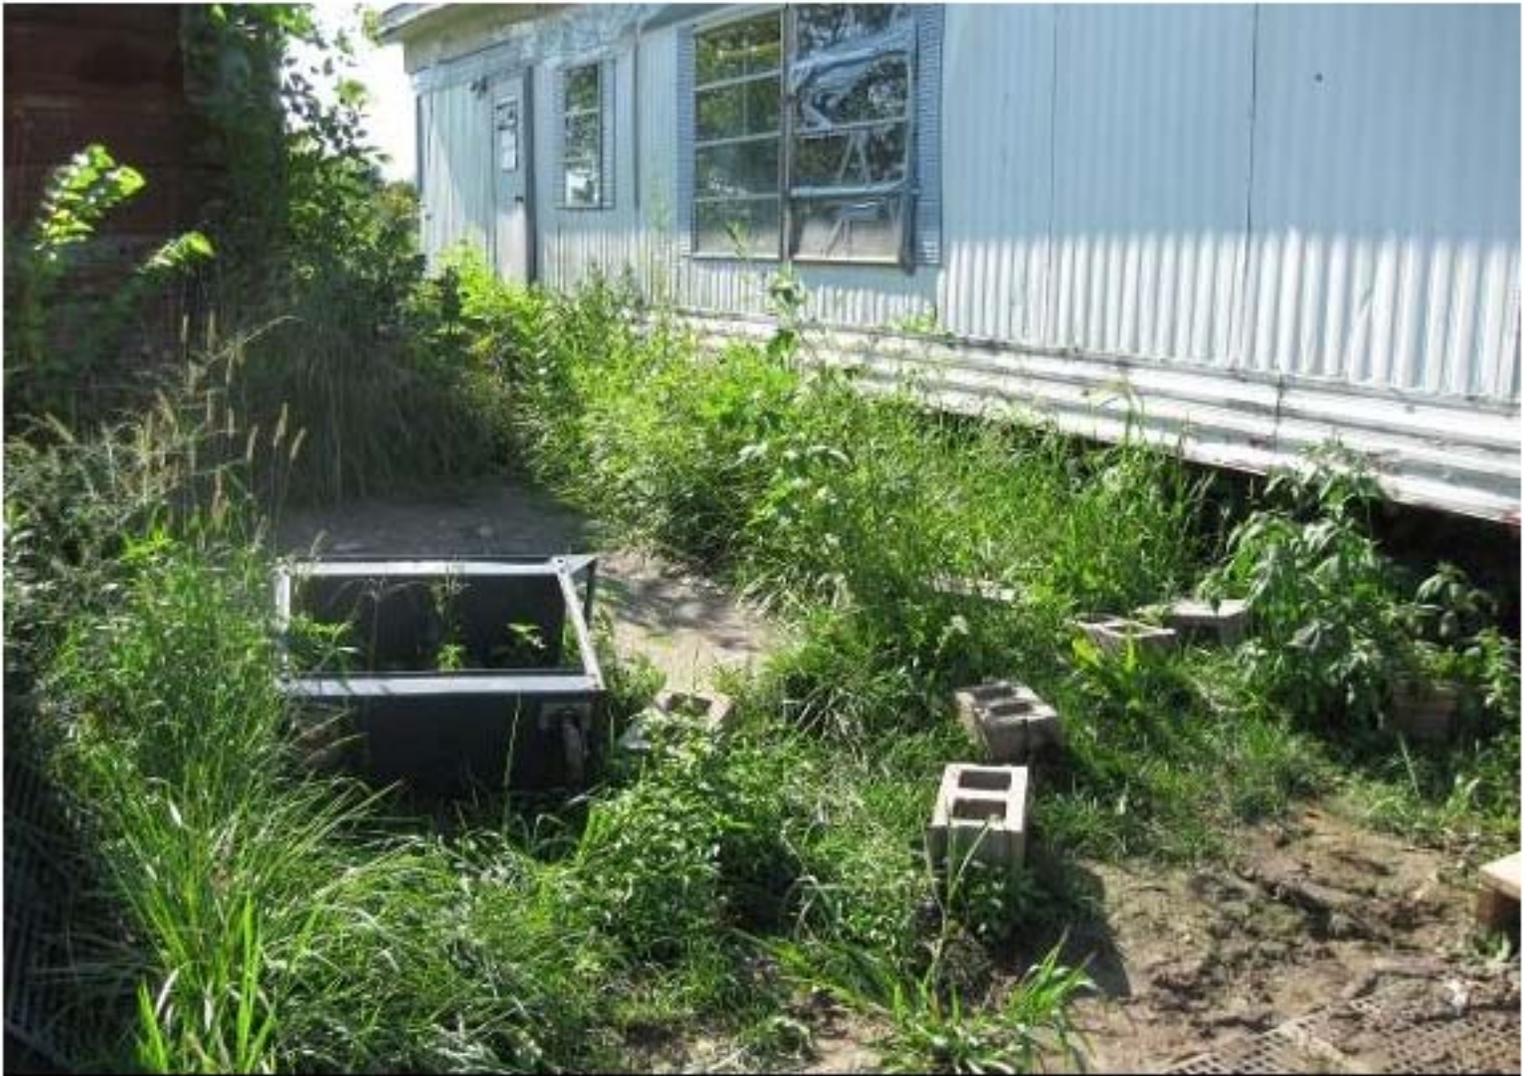
FOIA11-28200012

CFR: 3.11 (c)

Photographer:	John J. Lies, ACI	Legal Name:	Registration:	42-A-1399
Photo Taken:	Tue, Aug 10, '10 P.M.	Debra Pratt		
Inspection:	223101025300653			
Description:	3.11 (c) Housekeeping of premises: Weeds around the facility need to be controlled.

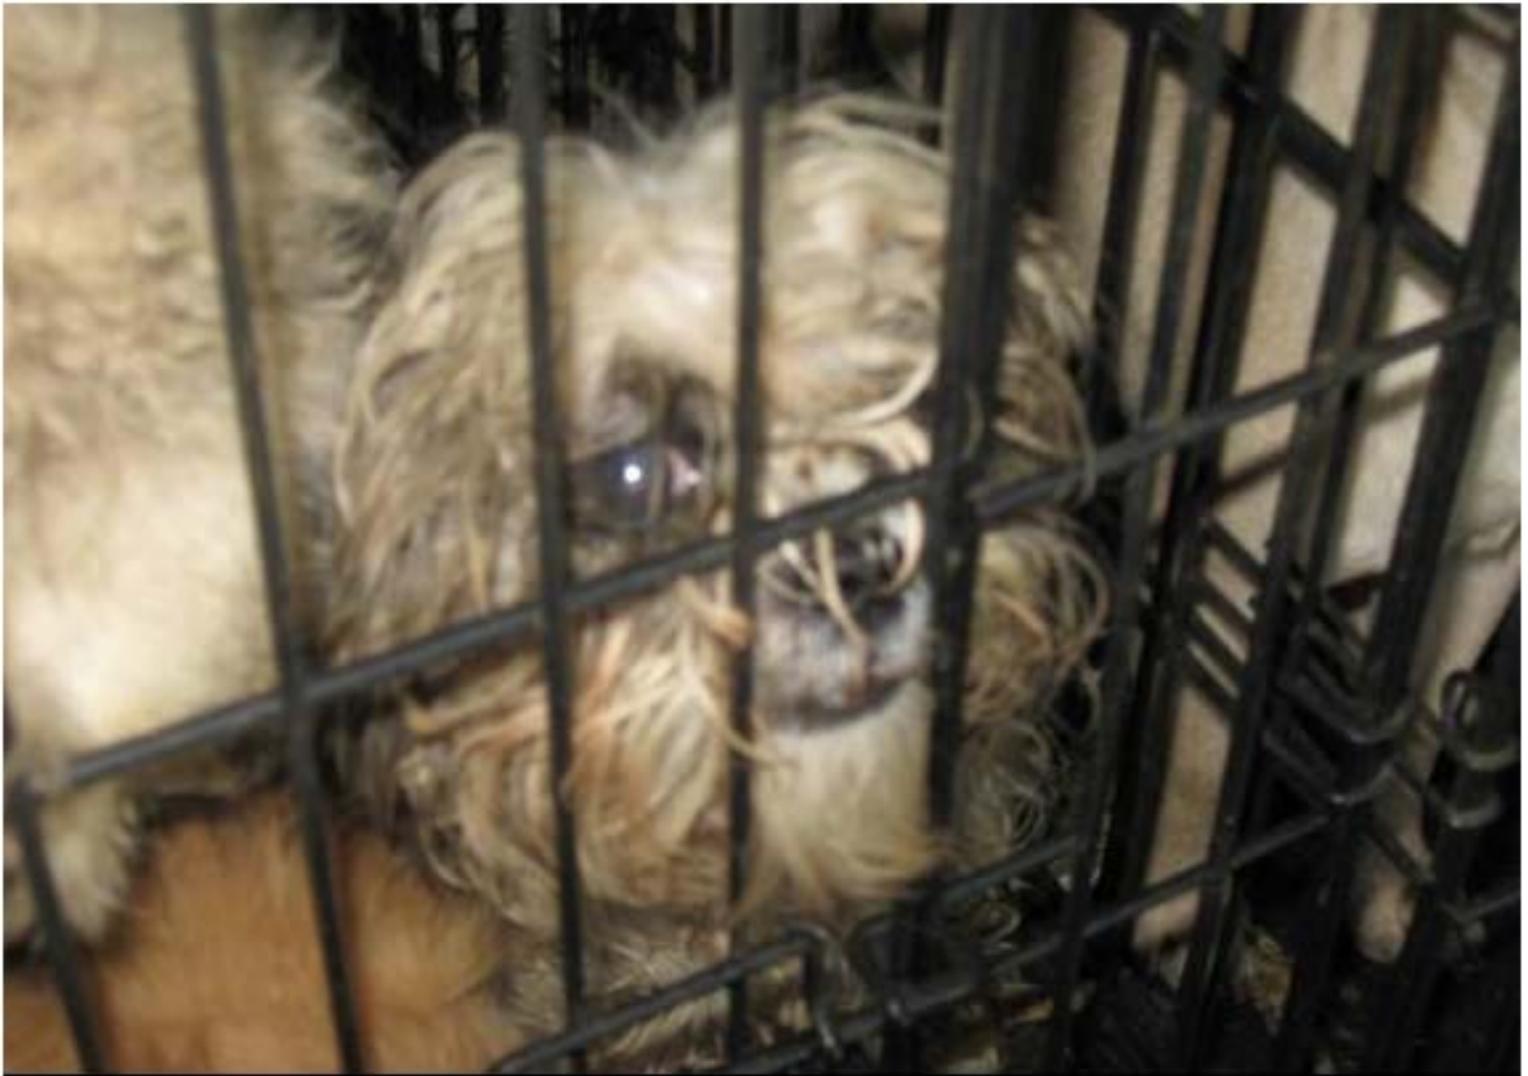
FOIA11-28200013

CFR: 2.40 (b) (2)

Photographer:	John J. Lies, ACI	Legal Name:	Registration:	42-A-1399
Photo Taken:	Tue, Aug 10, '10 P.M.	Debra Pratt		
Inspection:	223101025300653			
Description:	2.40 (b)(2) Veterinary Care: Long haired dog in need of grooming.

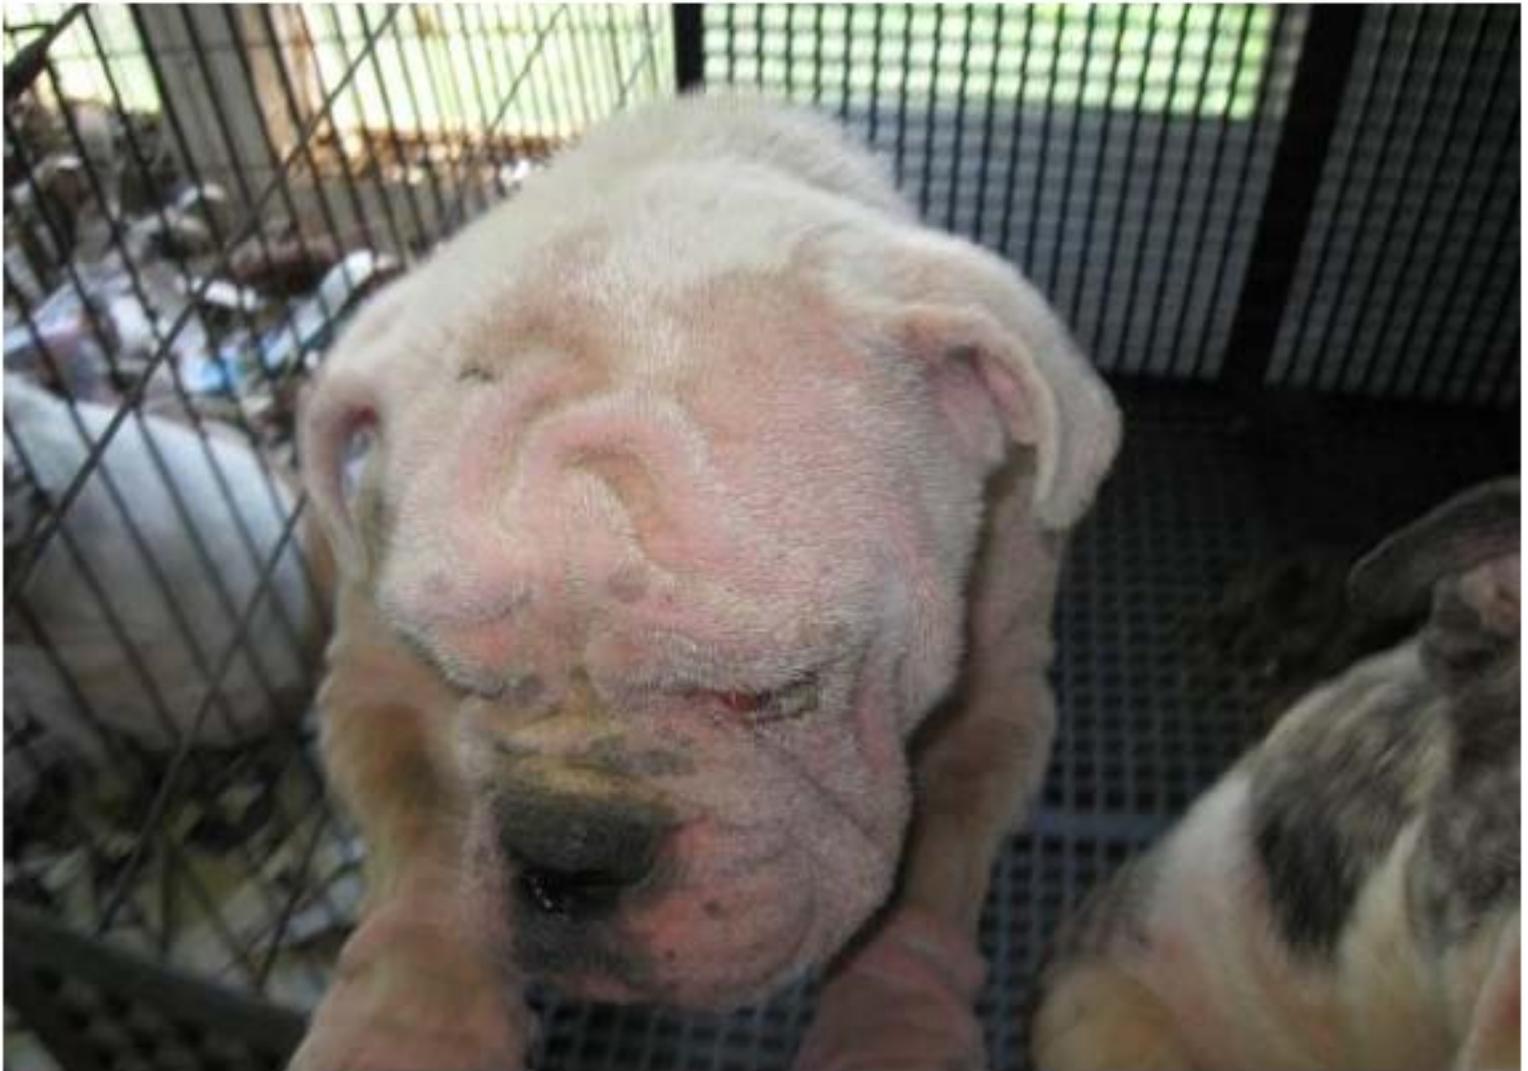
FOIA11-28200014

CFR: 2.40 (b) (2)

Photographer:	John J. Lies, ACI	Legal Name:	Registration:	42-A-1399
Photo Taken:	Tue, Aug 10, '10 P.M.	Debra Pratt		
Inspection:	223101025300653			
Description:	2.40 (b)(2) Veterinary Care: No documentation of diagnosis or treatment for cherry eye and skin irritation.

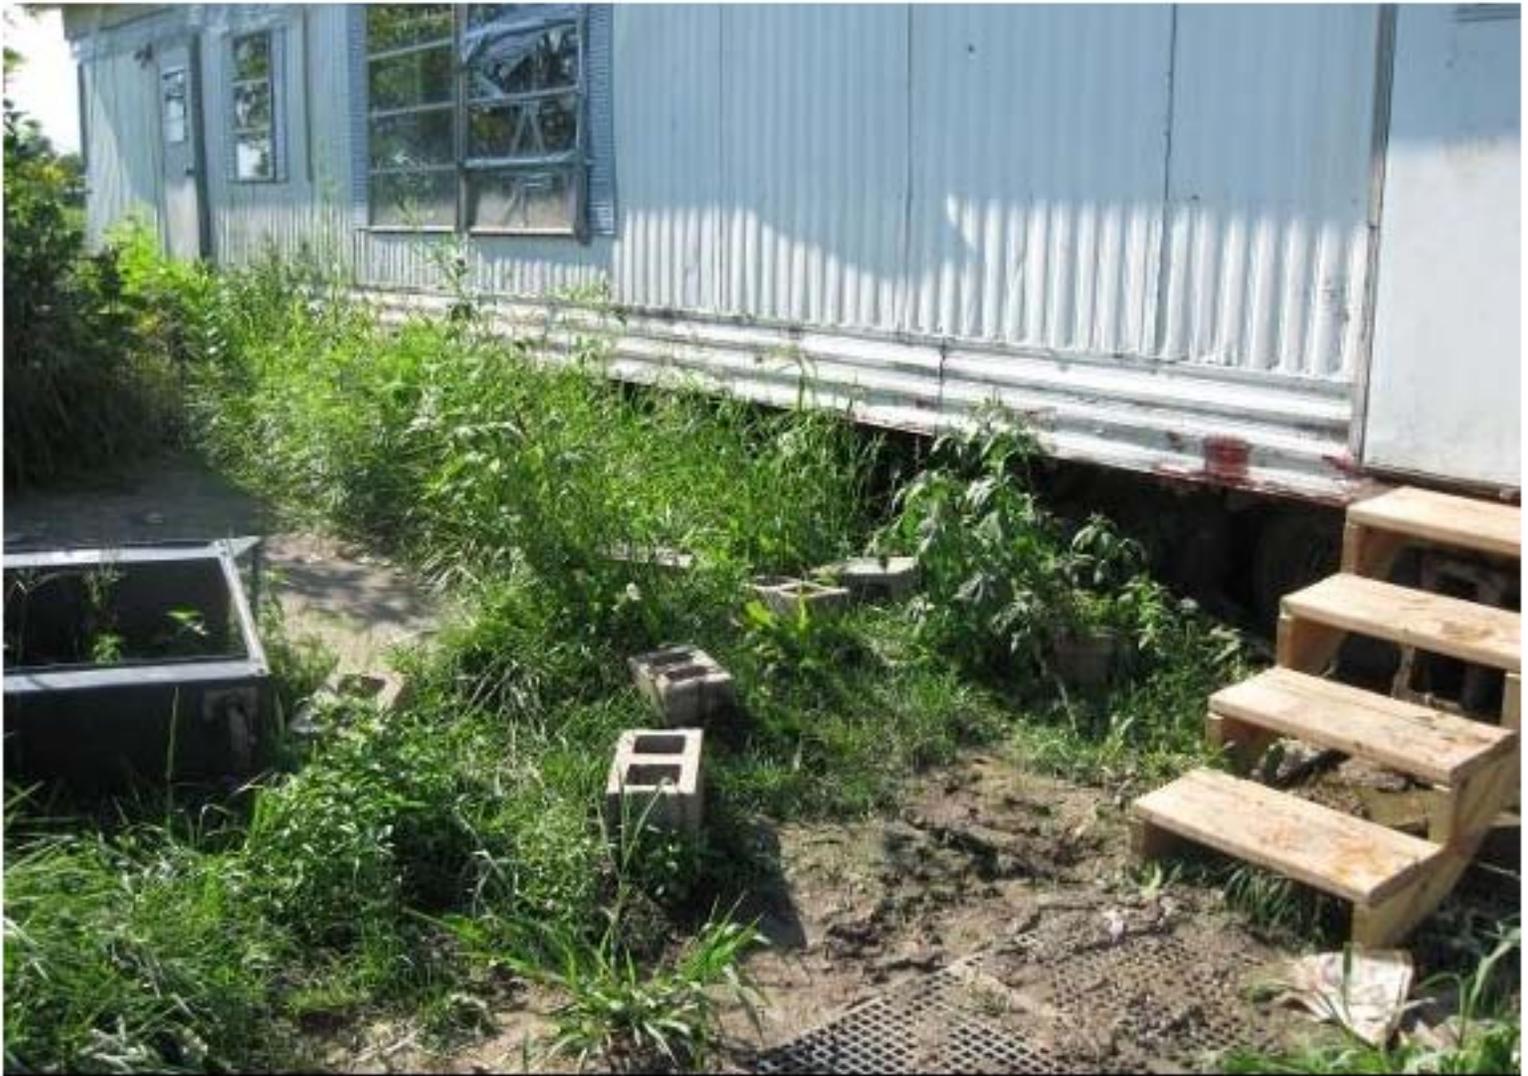
FOIA11-28200015

CFR: 3.11 (c)

Photographer:	John J. Lies, ACI	Legal Name:	Registration:	42-A-1399
Photo Taken:	Tue, Aug 10, '10 P.M.	Debra Pratt		
Inspection:	223101025300653			
Description:	3.11 (c) Housekeeping of premises: Weeds around the facility need to be controlled.
