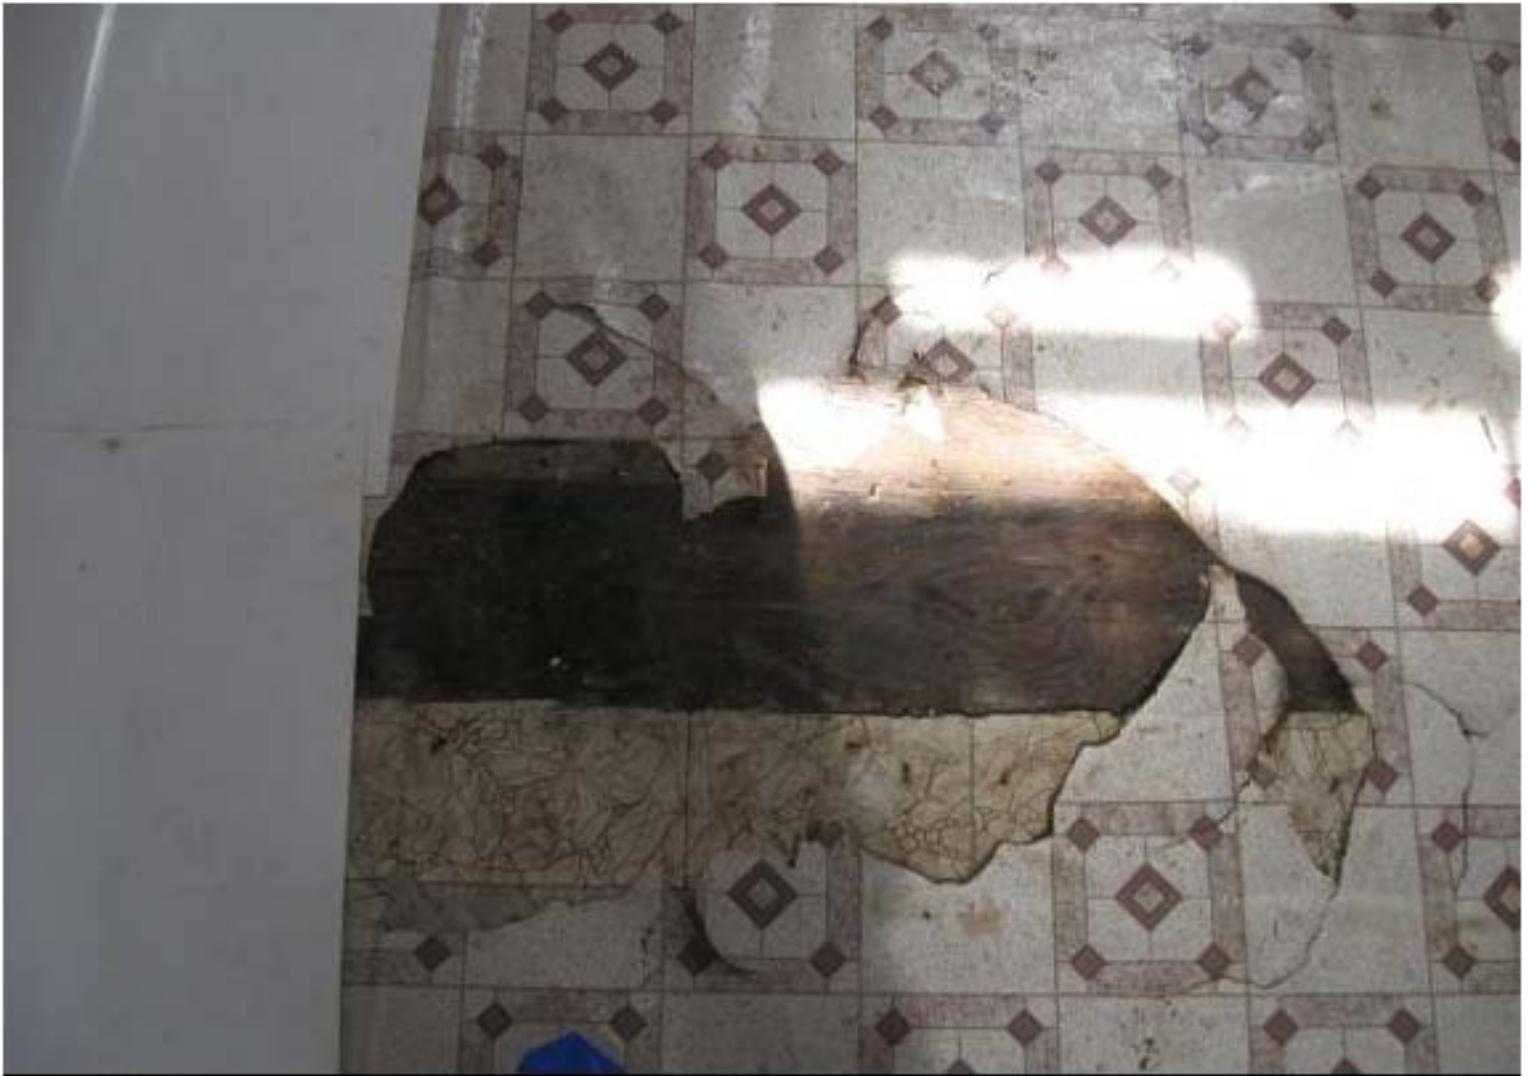
FOIA11-28200016

CFR: 3.2 (b)

Photographer:	John J. Lies, ACI	Legal Name:	Registration:	42-A-1399
Photo Taken:	Tue, Aug 10, '10 P.M.	Debra Pratt		
Inspection:	223101025300653			
Description:	3.2 (d) Indoor Housing Surfaces: Hole in the vinyl flooring exposing bare wood.

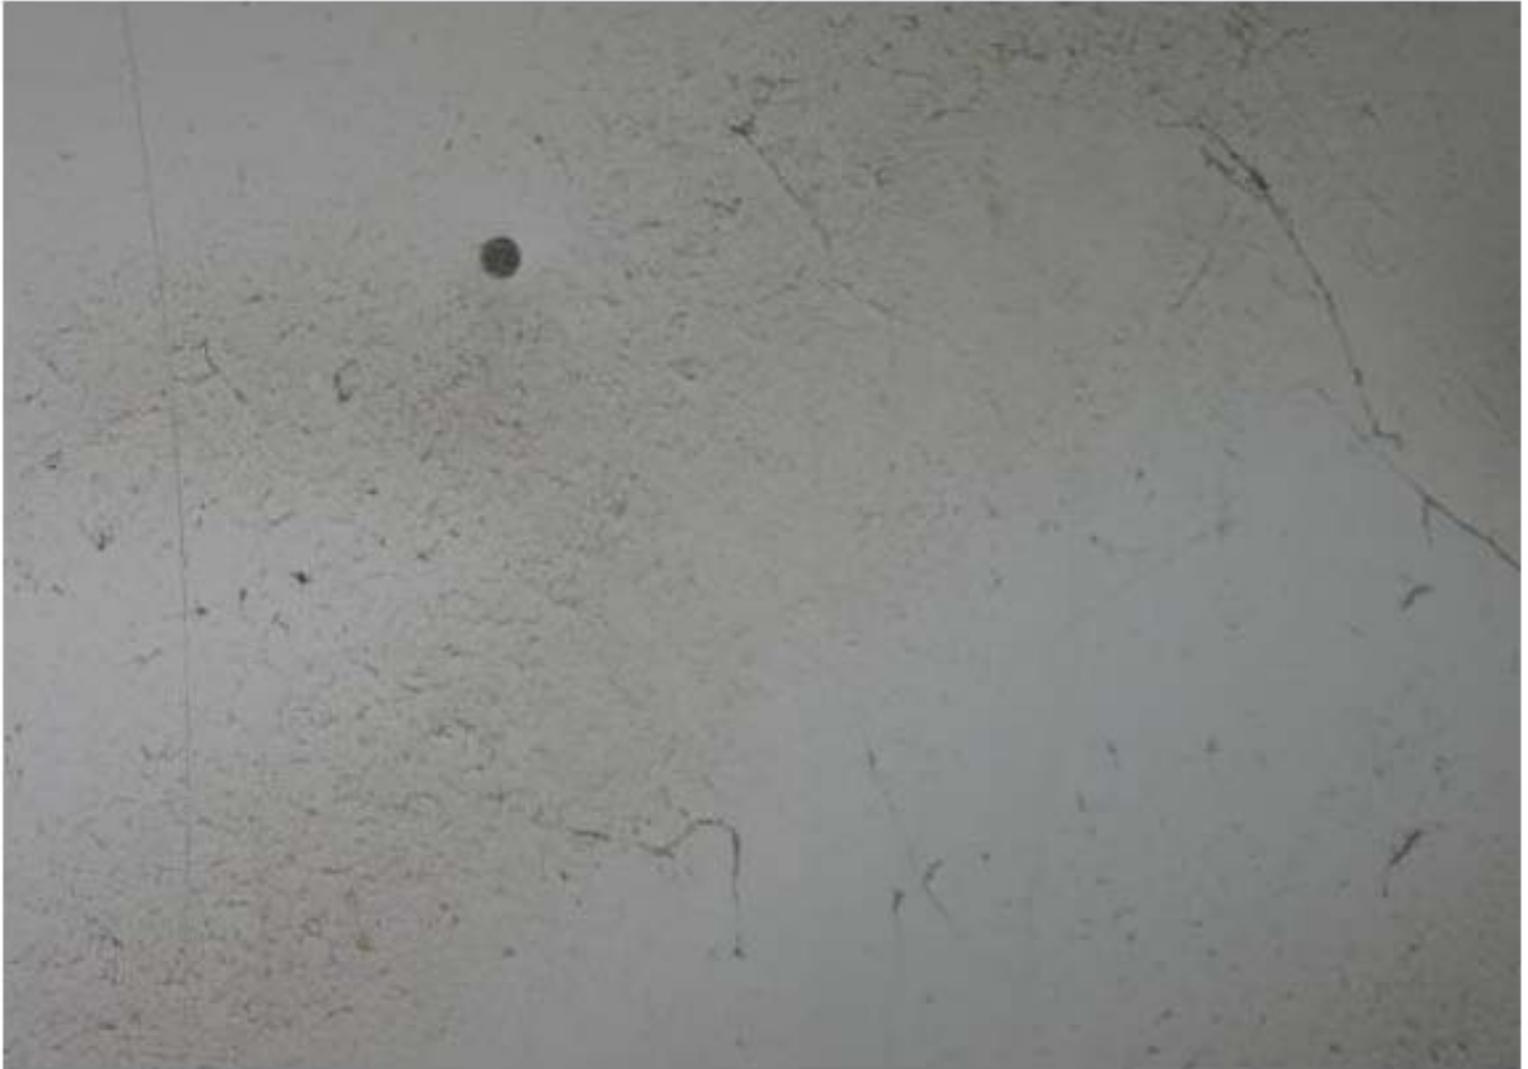
FOIA11-28200017

CFR: 3.1 (c) (3)

Photographer:	John J. Lies, ACI	Legal Name:	Registration:	42-A-1399
Photo Taken:	Tue, Aug 10, '10 P.M.	Debra Pratt		
Inspection:	223101025300653			
Description:	3.1 (c)(3) General Housing Facilities Cleaning: Walls of the facility need to be cleaned to remove dirt, spider webs, etc.

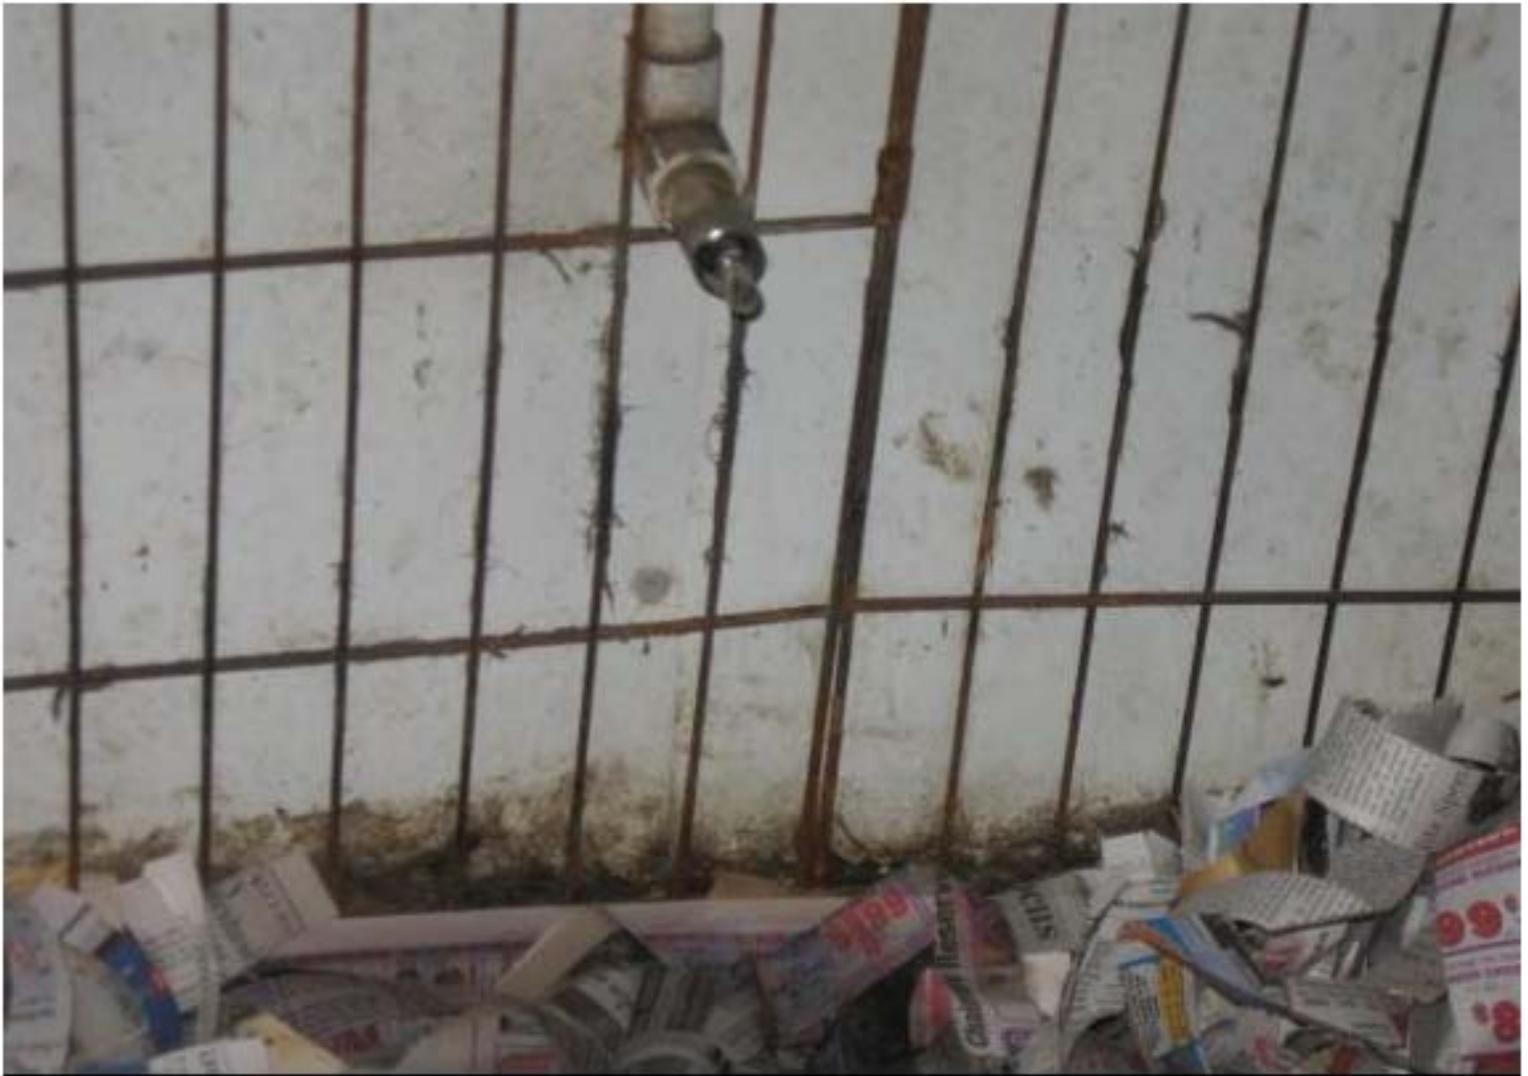
FOIA11-282000018

CFR: 3.1 (c) (3)

Photographer:	John J. Lies, ACI	Legal Name:	Registration:	42-A-1399
Photo Taken:	Tue, Aug 10, '10 P.M.	Debra Pratt		
Inspection:	223101025300653			
Description:	3.1 (c)(3) General Housing Facilities Cleaning: Walls of the facility need to be cleaned to remove dirt, spider webs, etc.

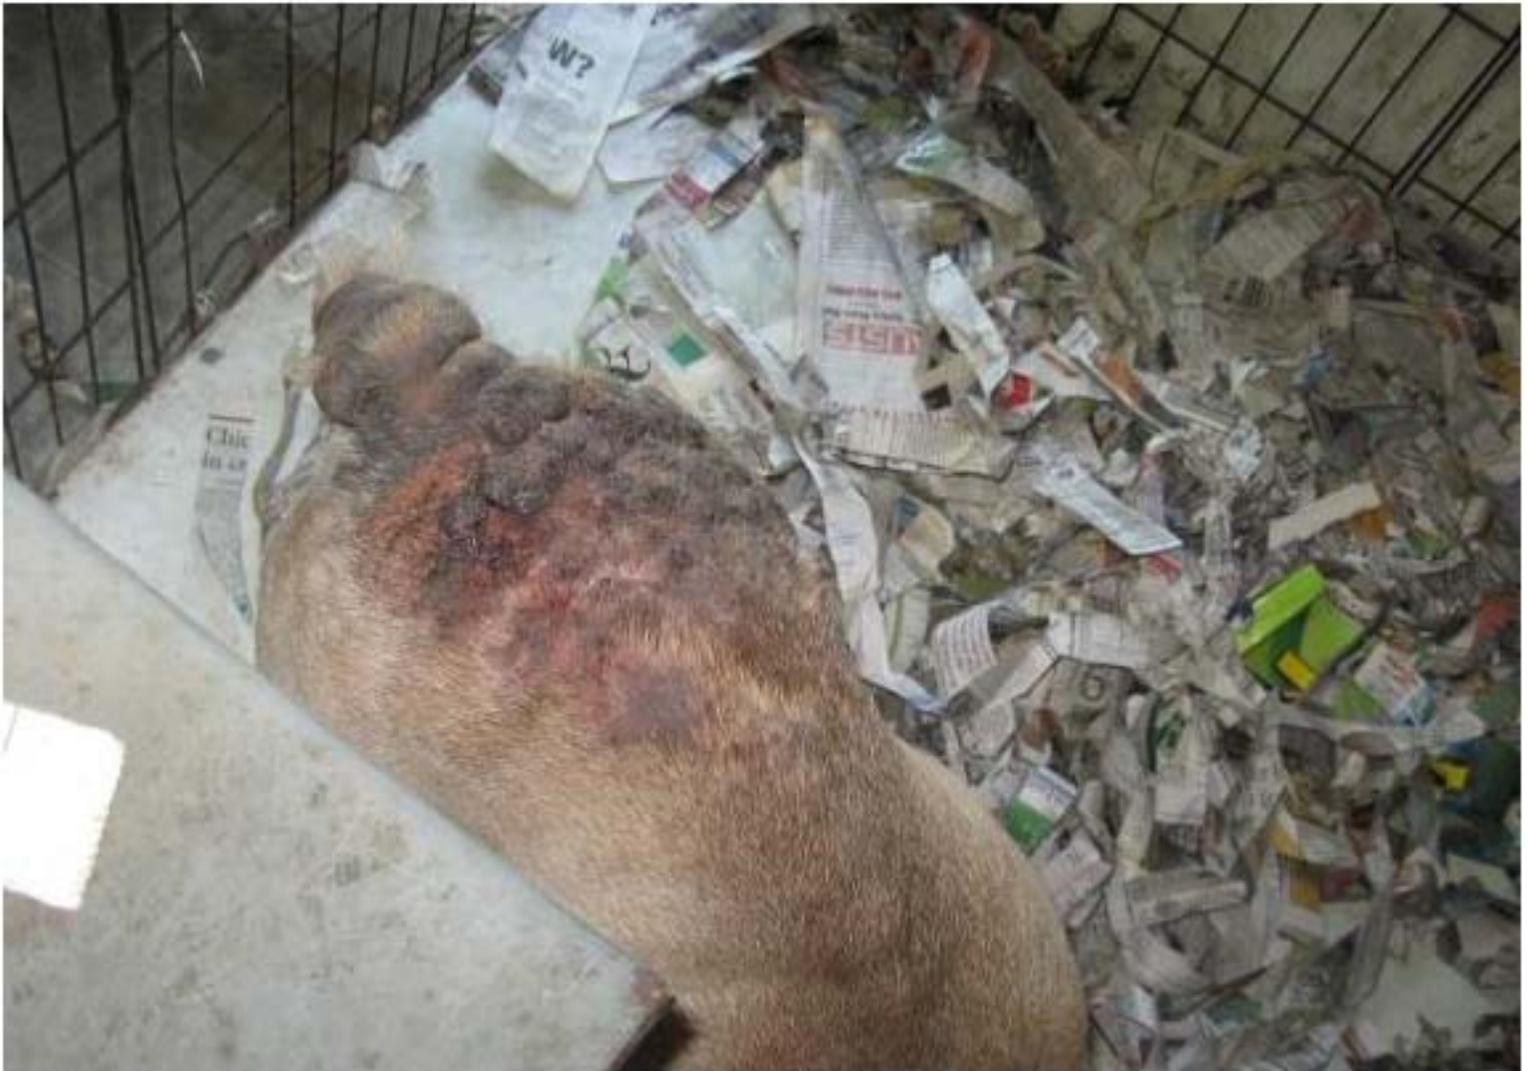
FOIA11-28200019

CFR: 2.40 (b) (2)

Photographer:	John J. Lies, ACI	Legal Name:	Registration:	42-A-1399
Photo Taken:	Tue, Aug 10, '10 P.M.	Debra Pratt		
Inspection:	223101025300653			
Description:	2.40 (b)(2) Veterinary Care: Skin irritation no written documentation of diagnosis and/or treatment.

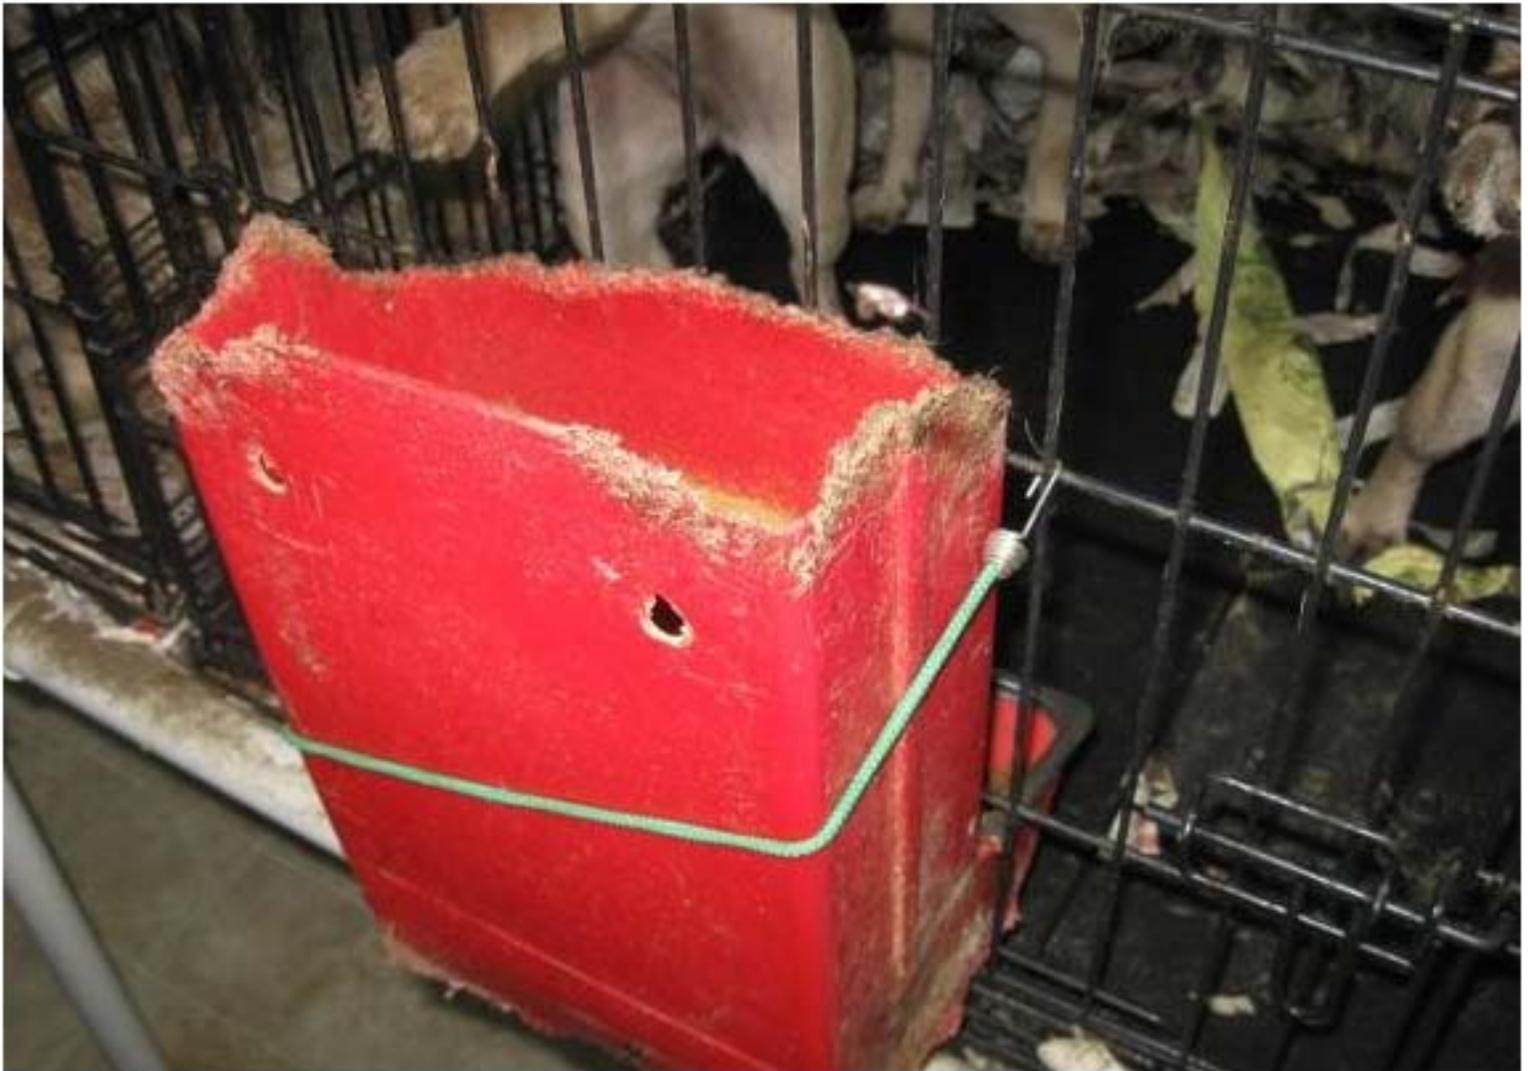
FOIA11-282000020

CFR: 3.8

Photographer:	John J. Lies, ACI	Legal Name:	Registration:	42-A-1399
Photo Taken:	Tue, Aug 10, '10 P.M.	Debra Pratt		
Inspection:	223101025300653			
Description:	3.8 Feeding: Feeders are chewed and can not be properly cleaned or feeders need to be cleaned and sanitized.

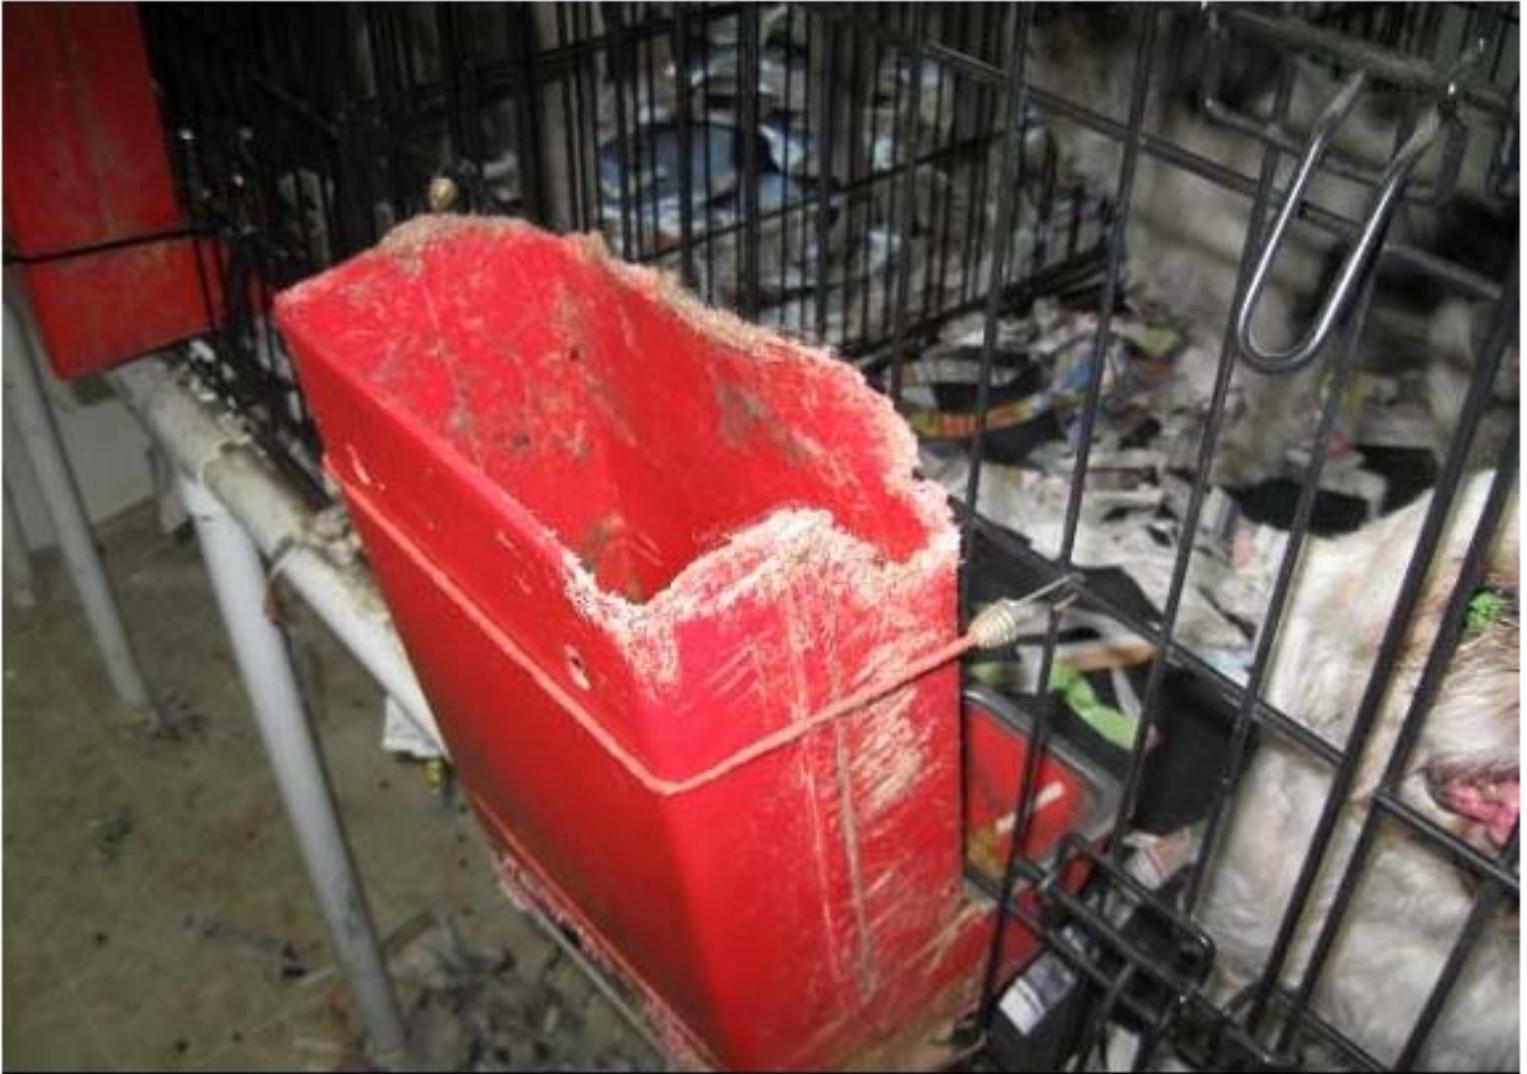
FOIA11-28200021

CFR: 3.8

Photographer:	John J. Lies, ACI	Legal Name:	Registration:	42-A-1399
Photo Taken:	Tue, Aug 10, '10 P.M.	Debra Pratt		
Inspection:	223101025300653			
Description:	3.8 Feeding: feeders have chewed edges that can not be properly cleaned or feeders need to be cleaned and sanitized.

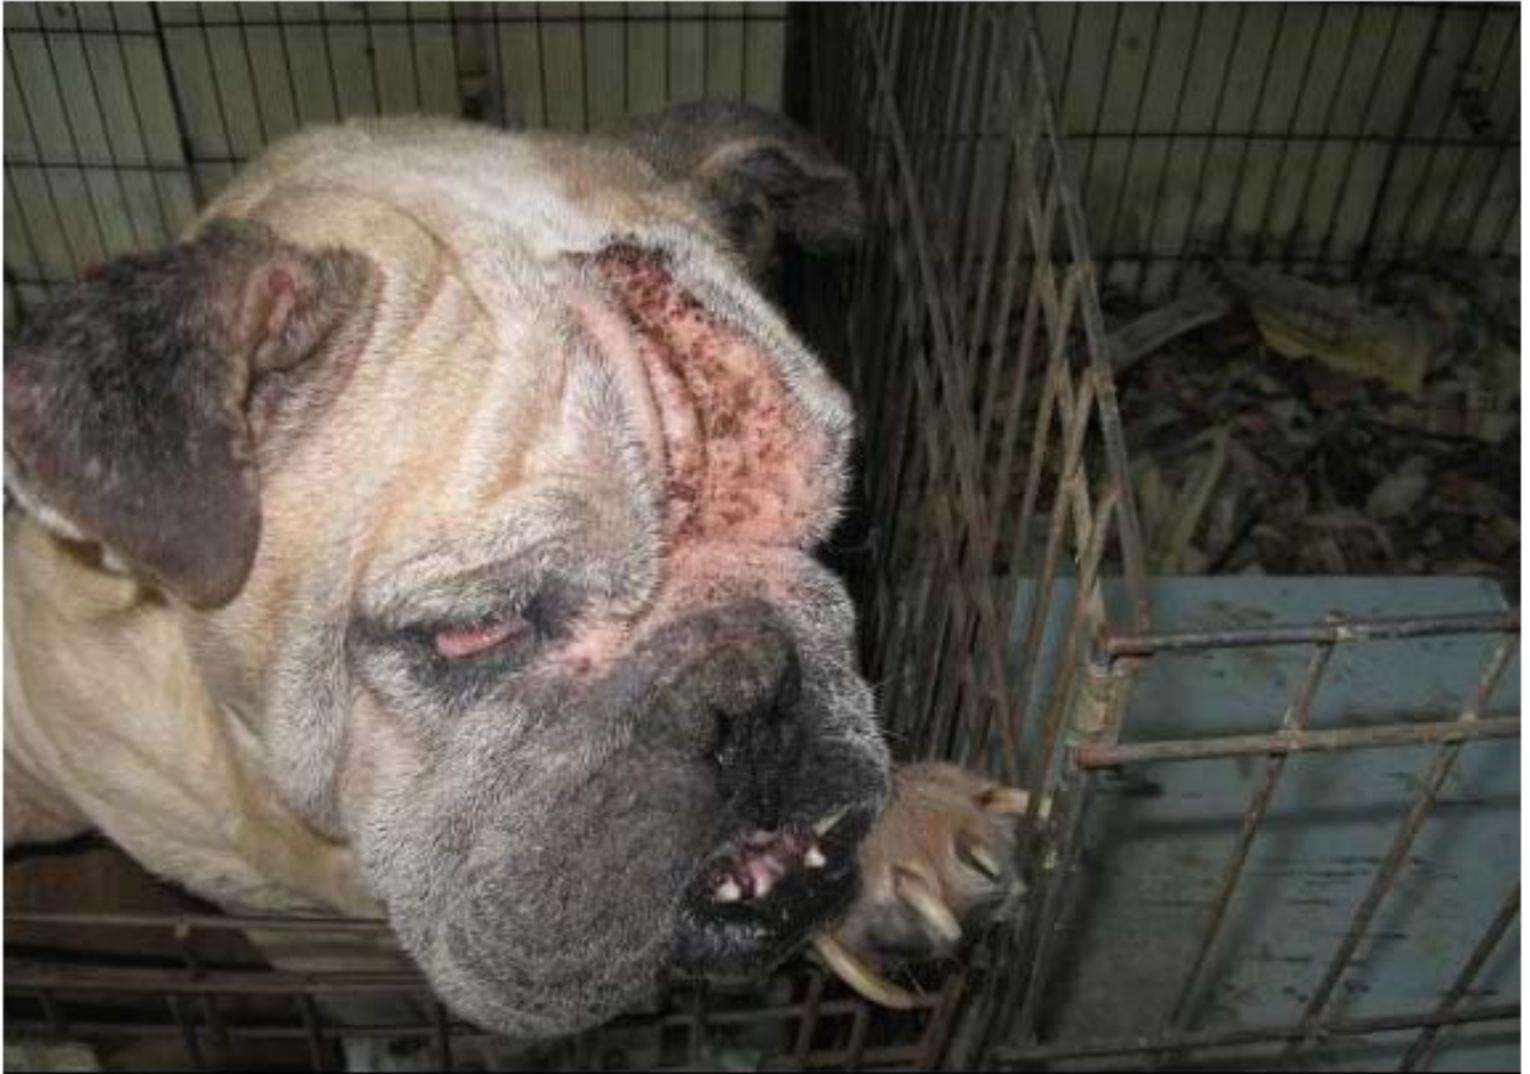
FOIA11-28200022

CFR: 2.40 (b) (2)

Photographer:	John J. Lies, ACI	Legal Name:	Registration:	42-A-1399
Photo Taken:	Tue, Aug 10, '10 P.M.	Debra Pratt		
Inspection:	223101025300653			
Description:	2.40 (b)(2) Veterinary Care: No documentation of diagnosis or treatment for skin irritation.

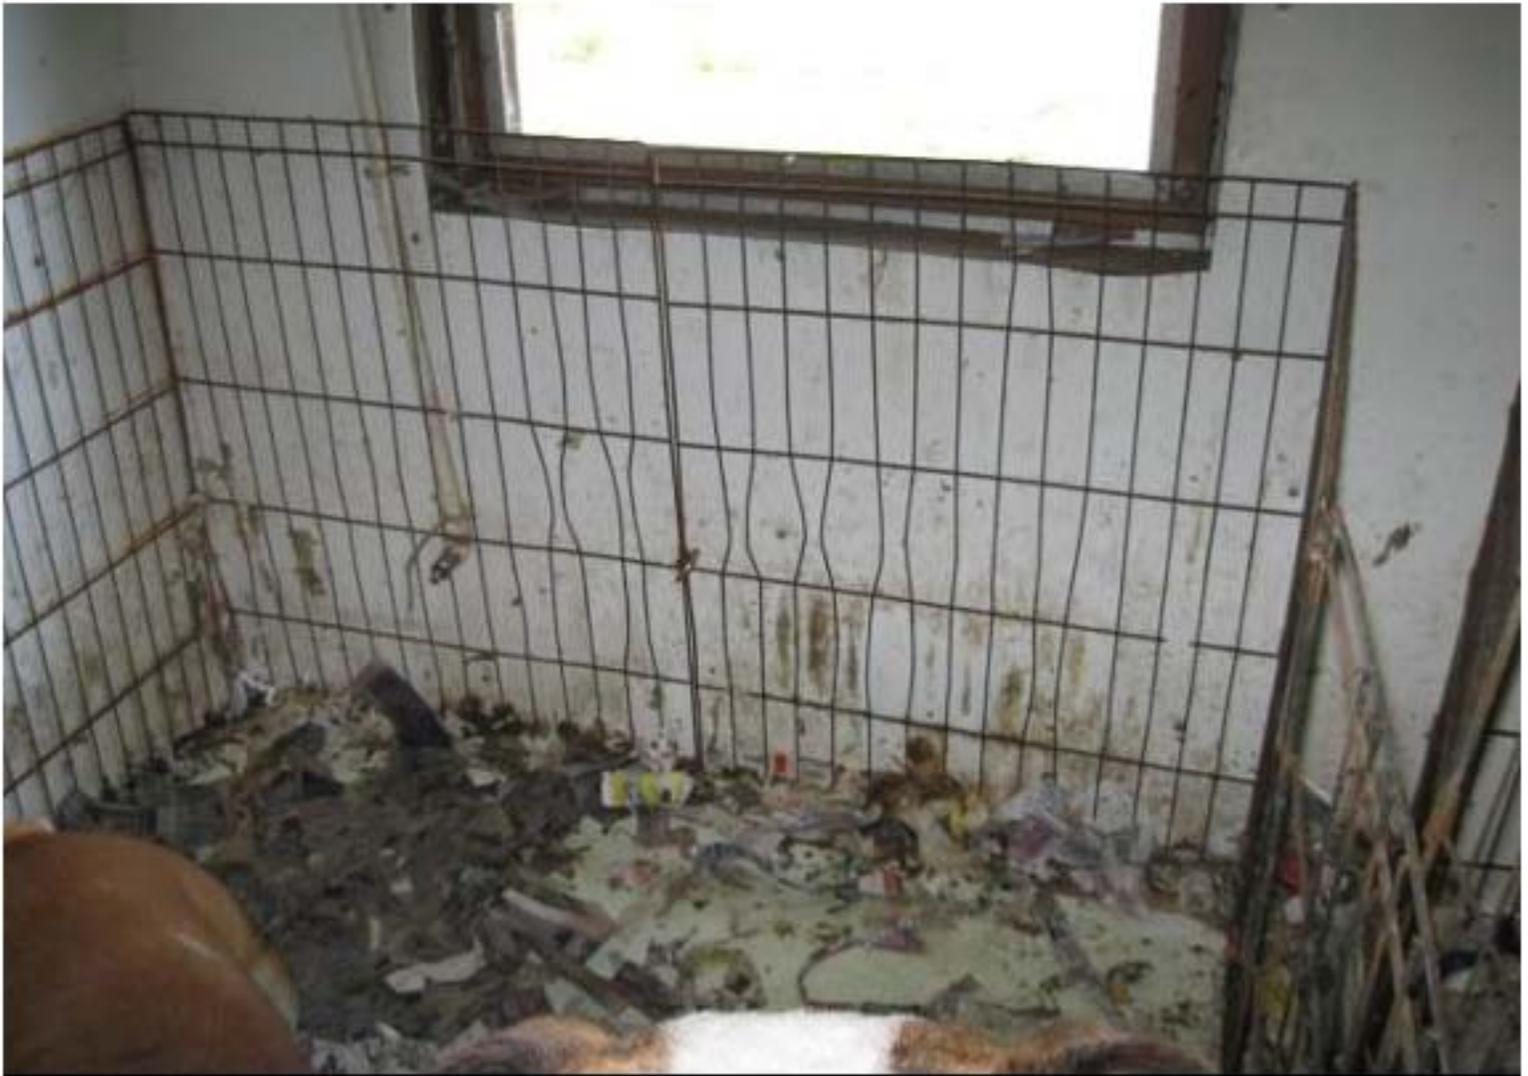
FOIA11-282000023

CFR: 3.1 (c) (3)

Photographer:	John J. Lies, ACI	Legal Name:	Registration:	42-A-1399
Photo Taken:	Wed, Aug 11, '10 P.M.	Debra Pratt		
Inspection:	223101025300653			
Description:	3.1 (c)(3) General Housing Facilities Cleaning: Walls of the facility need to be cleaned to remove dirt, spider webs, etc.

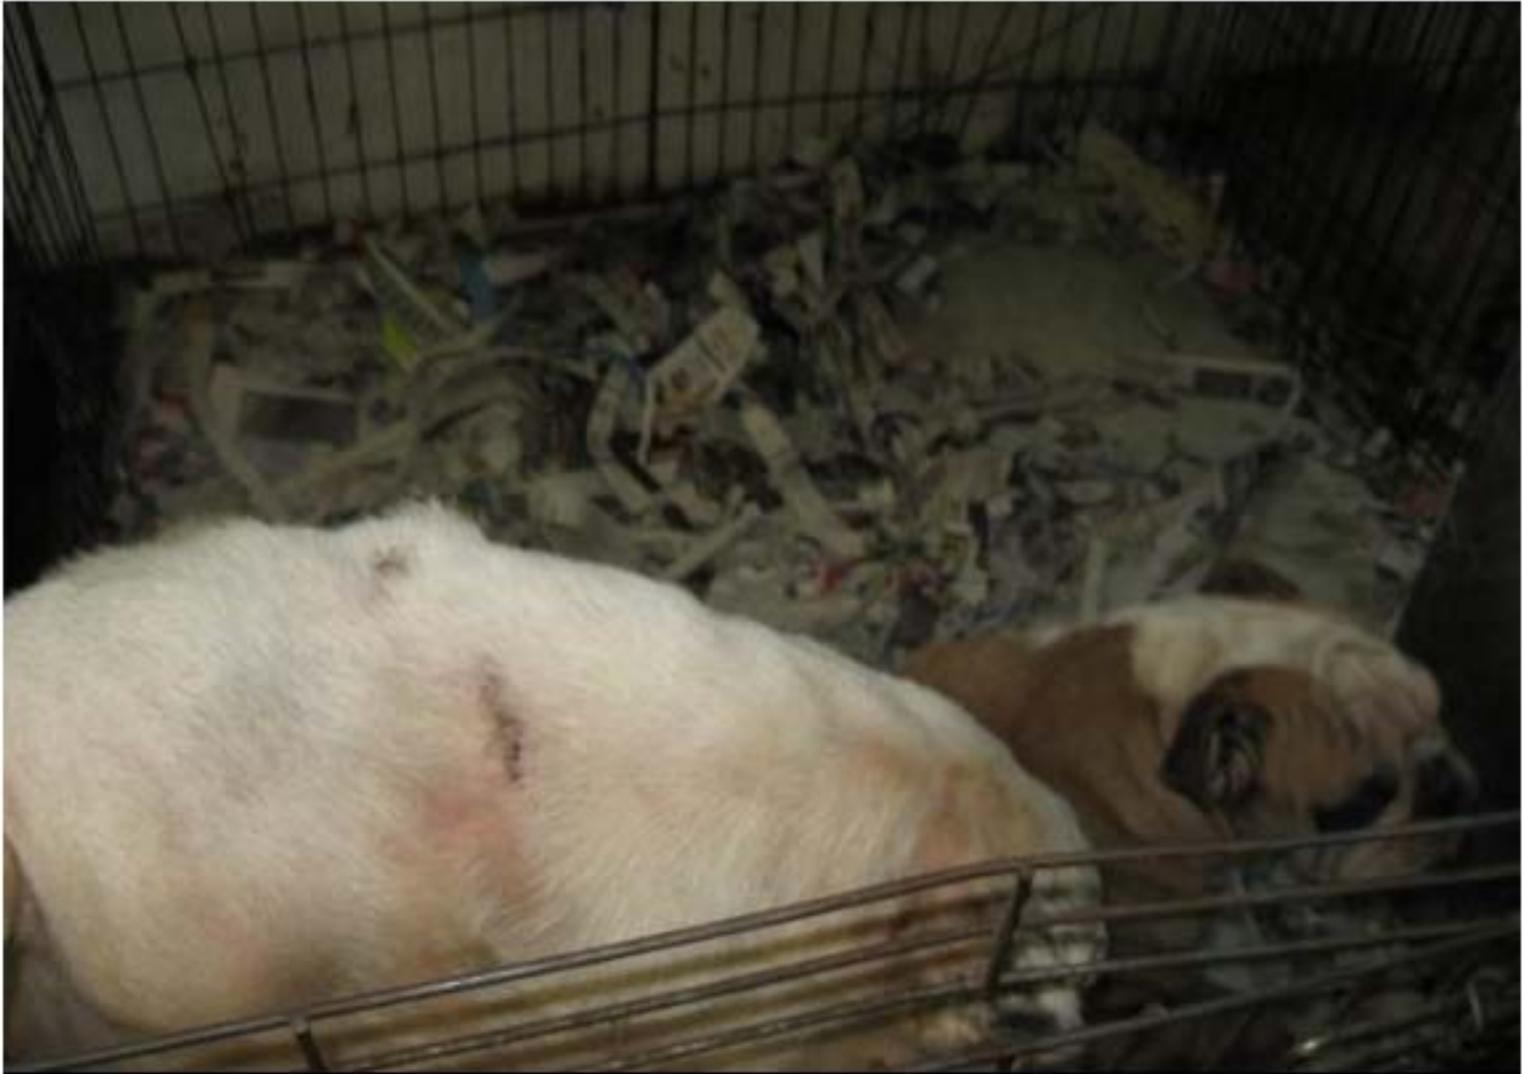
FOIA11-28200024

CFR: 2.40 (b) (2)

Photographer:	John J. Lies, ACI	Legal Name:	Registration:	42-A-1399
Photo Taken:	Tue, Aug 10, '10 P.M.	Debra Pratt		
Inspection:	223101025300653			
Description:	2.40 (b)(2) Veterinary Care: No documentation of diagnosis or treatment for skin irritation.

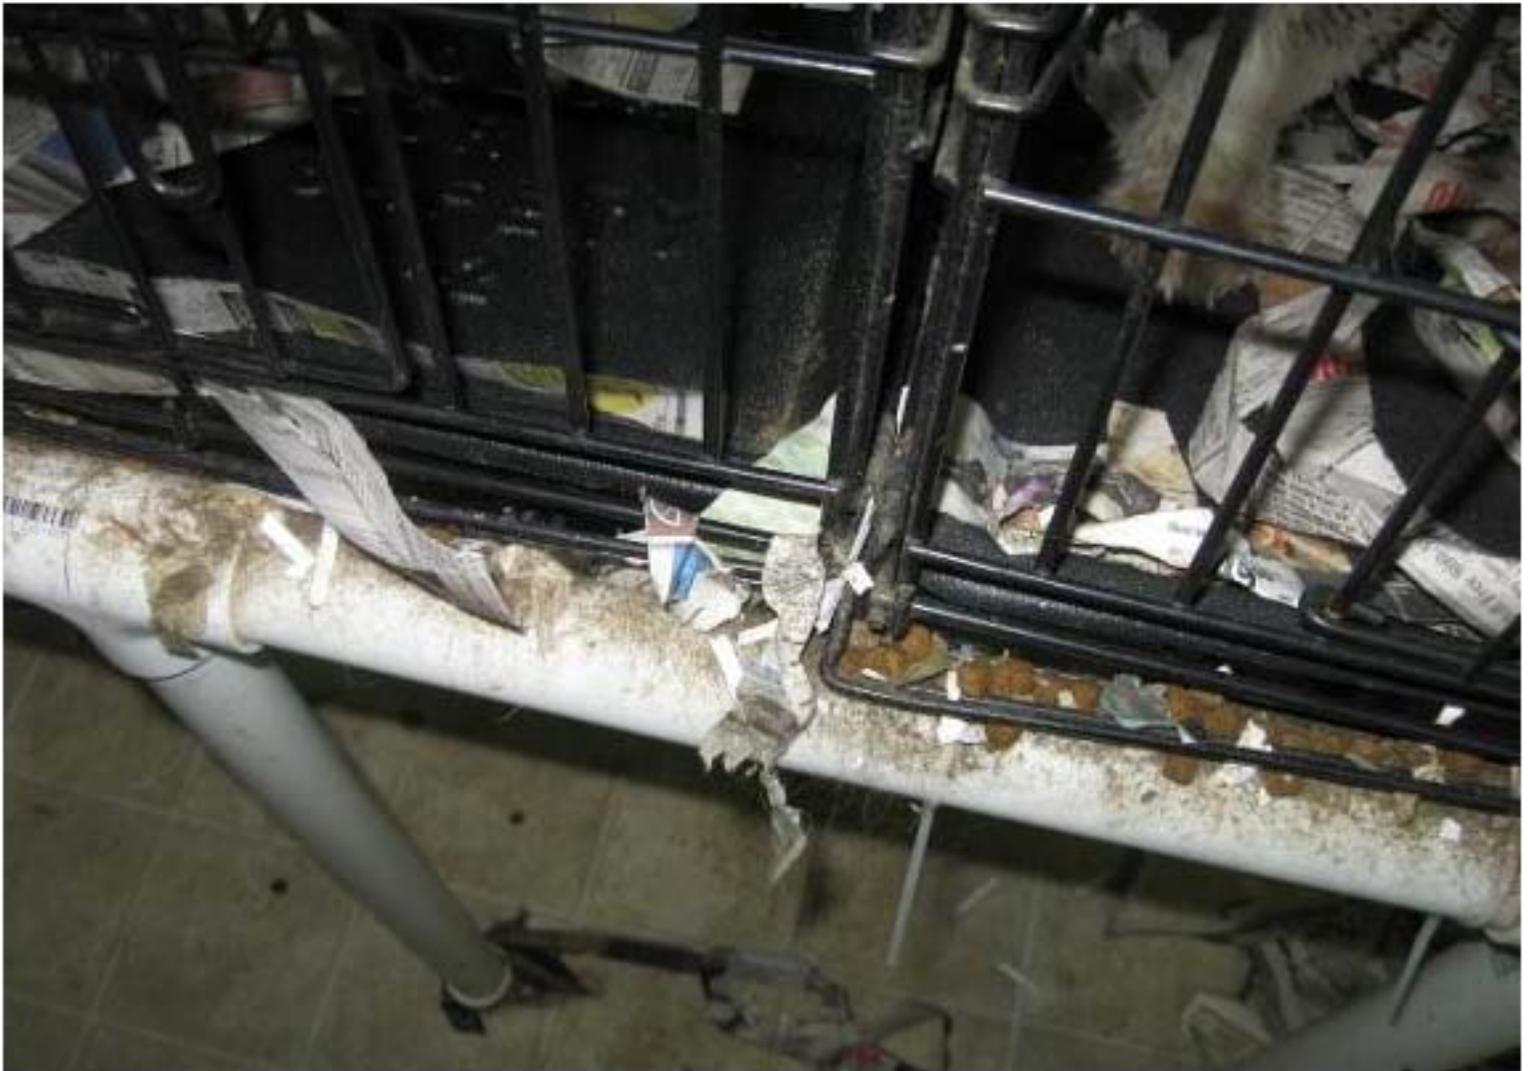
FOIA11-28200025

CFR: 3.1 (c) (3)

Photographer:	John J. Lies, ACI	Legal Name:	Registration:	42-A-1399
Photo Taken:	Tue, Aug 10, '10 P.M.	Debra Pratt		
Inspection:	223101025300653			
Description:	3.1 (c)(3) General Housing Facilities Cleaning: front supports of enclosure need to be cleaned to remove dirt, spilled feed.

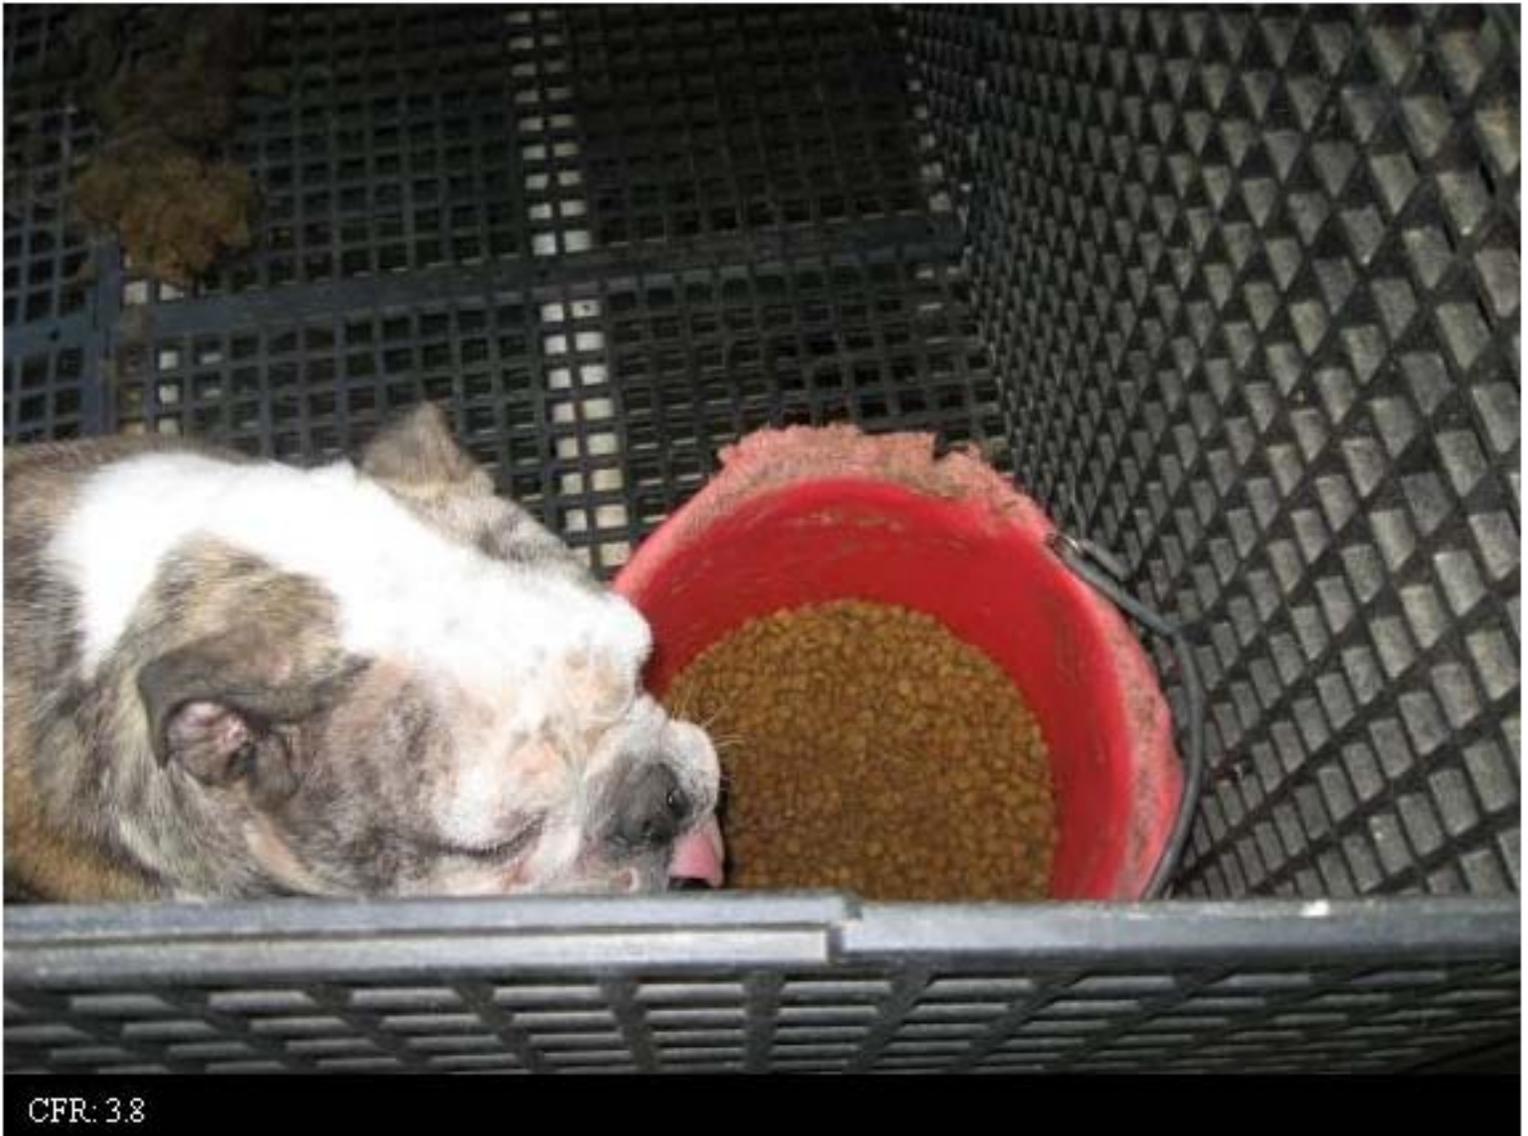
FOIA11-28200026

Photographer:	John J. Lies, ACI	Legal Name:	Registration:	42-A-1399
Photo Taken:	Tue, Aug 10, '10 P.M.	Debra Pratt		
Inspection:	223101025300653			
Description:	3.8 Feeding: feeders have chewed edges that can not be properly cleaned or feeders need to be cleaned and sanitized.

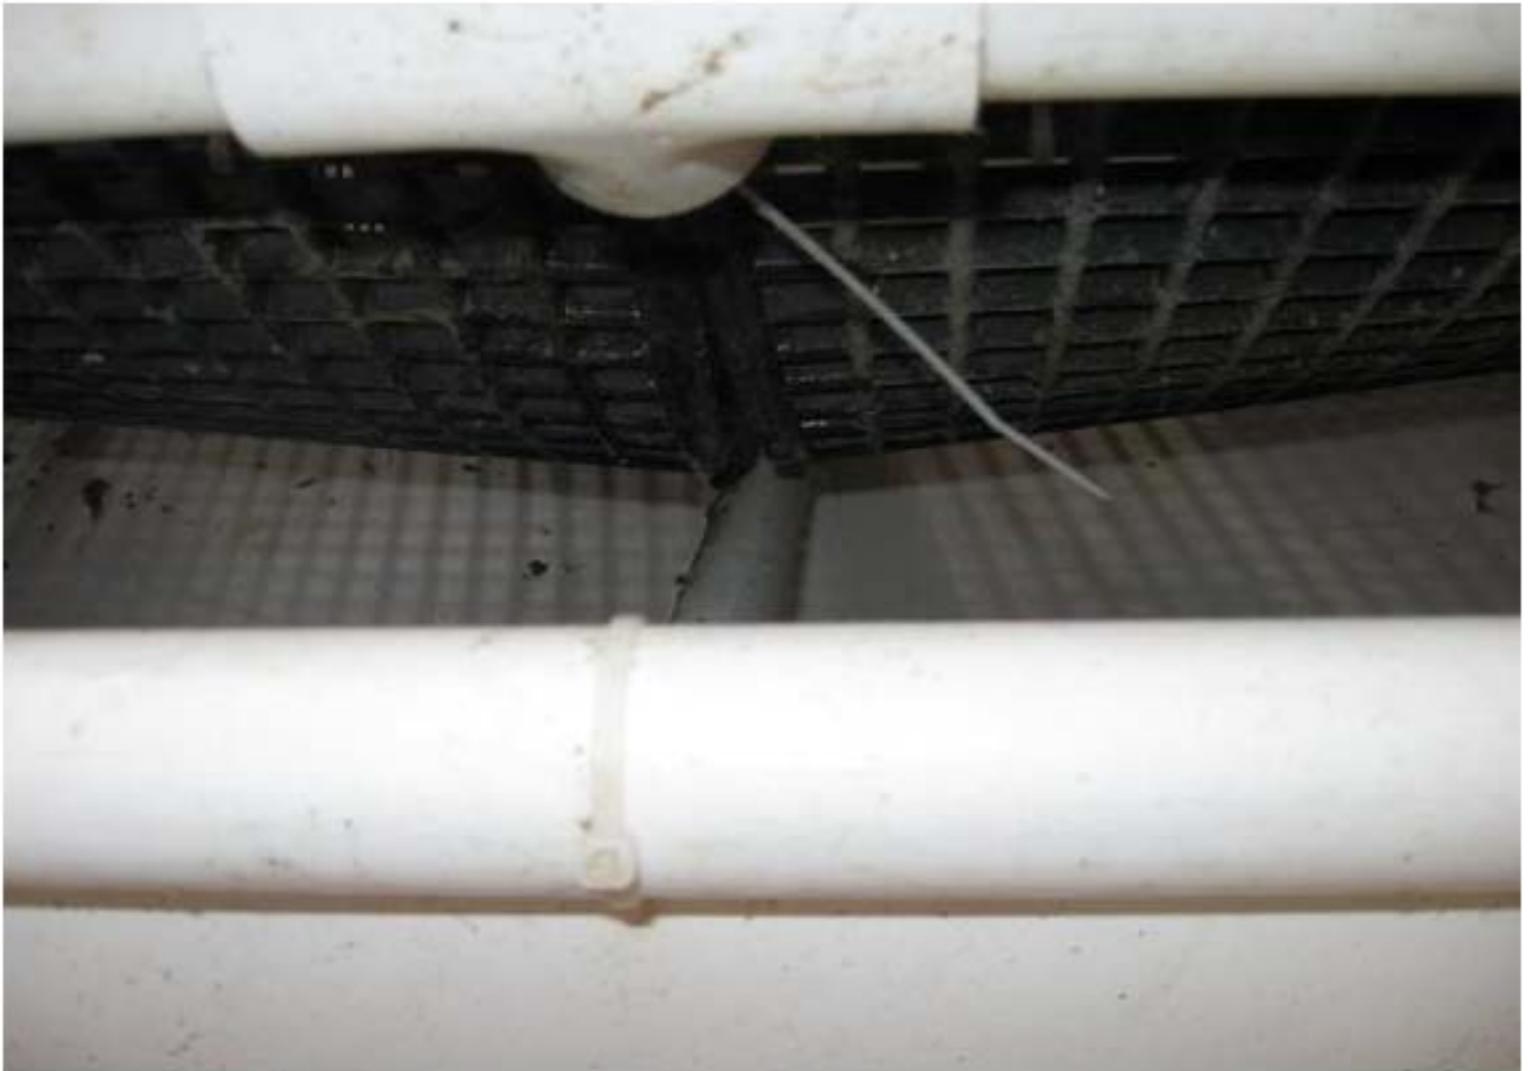
FOIA11-28200027

CFR: 3.6 (a) (2) (xii)

Photographer:	John J. Lies, ACI	Legal Name:	Registration:	42-A-1399
Photo Taken:	Tue, Aug 10, '10 P.M.	Debra Pratt		
Inspection:	223101025300653			
Description:	3.6 (a)(2)(xii) Primary enclosures: Suspended floor sagging between supports.

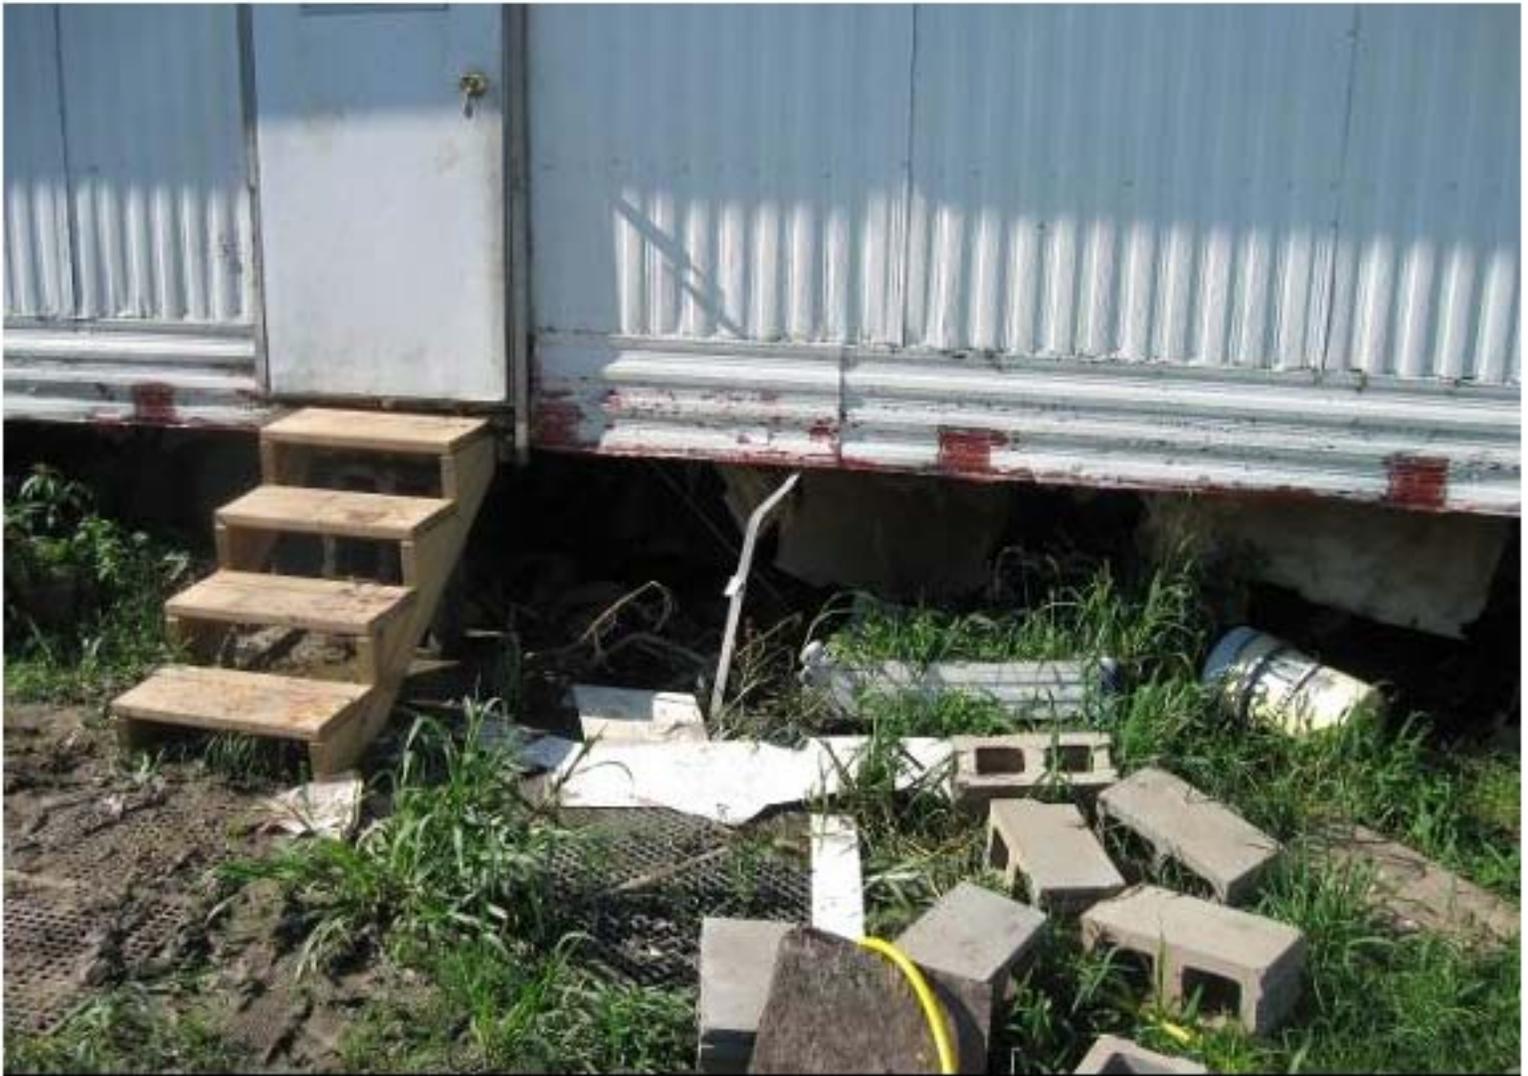
FOIA11-28200028

CFR: 3.11 (d)

Photographer:	John J. Lies, ACI	Legal Name:	Registration:	42-A-1399
Photo Taken:	Tue, Aug 10, '10 P.M.	Debra Pratt		
Inspection:	223101025300653			
Description:	3.11 (c) Housekeeping of premises; Weeds need to be controlled.
