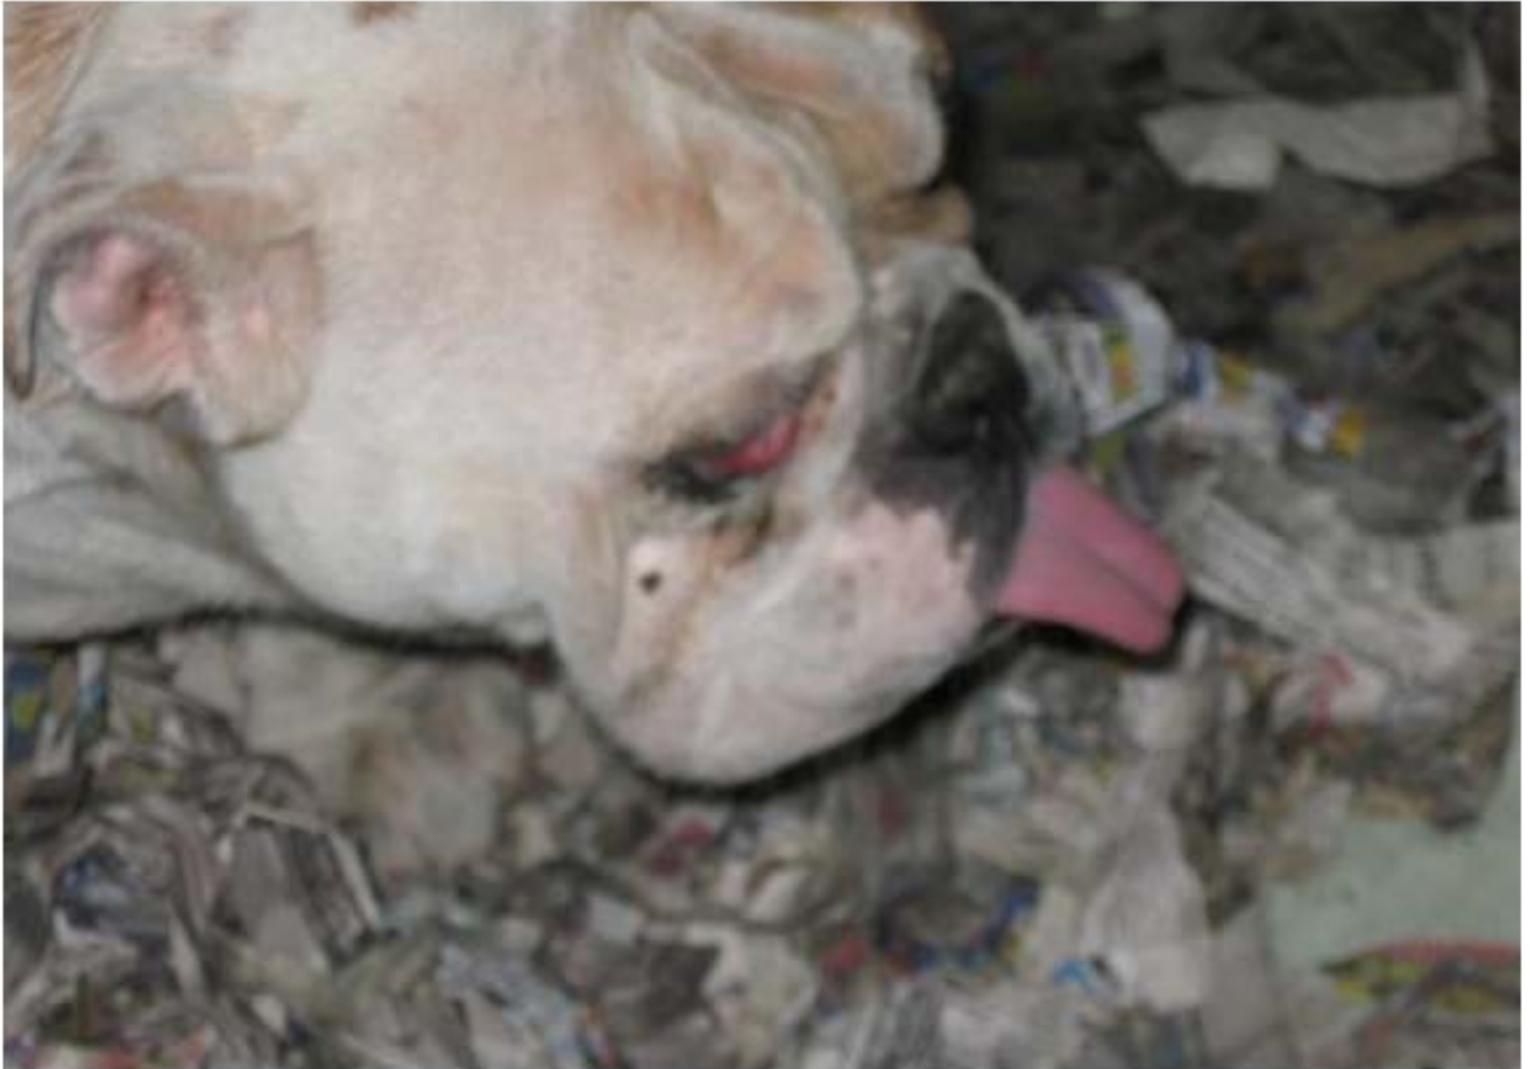
FOIA11-282000030

CFR: 2.40 (b) (2)

Photographer:	John J. Lies, ACI	Legal Name:	Registration:	42-A-1399
Photo Taken:	Tue, Aug 10, '10 P.M.	Debra Pratt		
Inspection:	223101025300653			
Description:	2.40 (b)(2) Veterinary Care: No documentation of diagnosis or treatment for cherry eye.

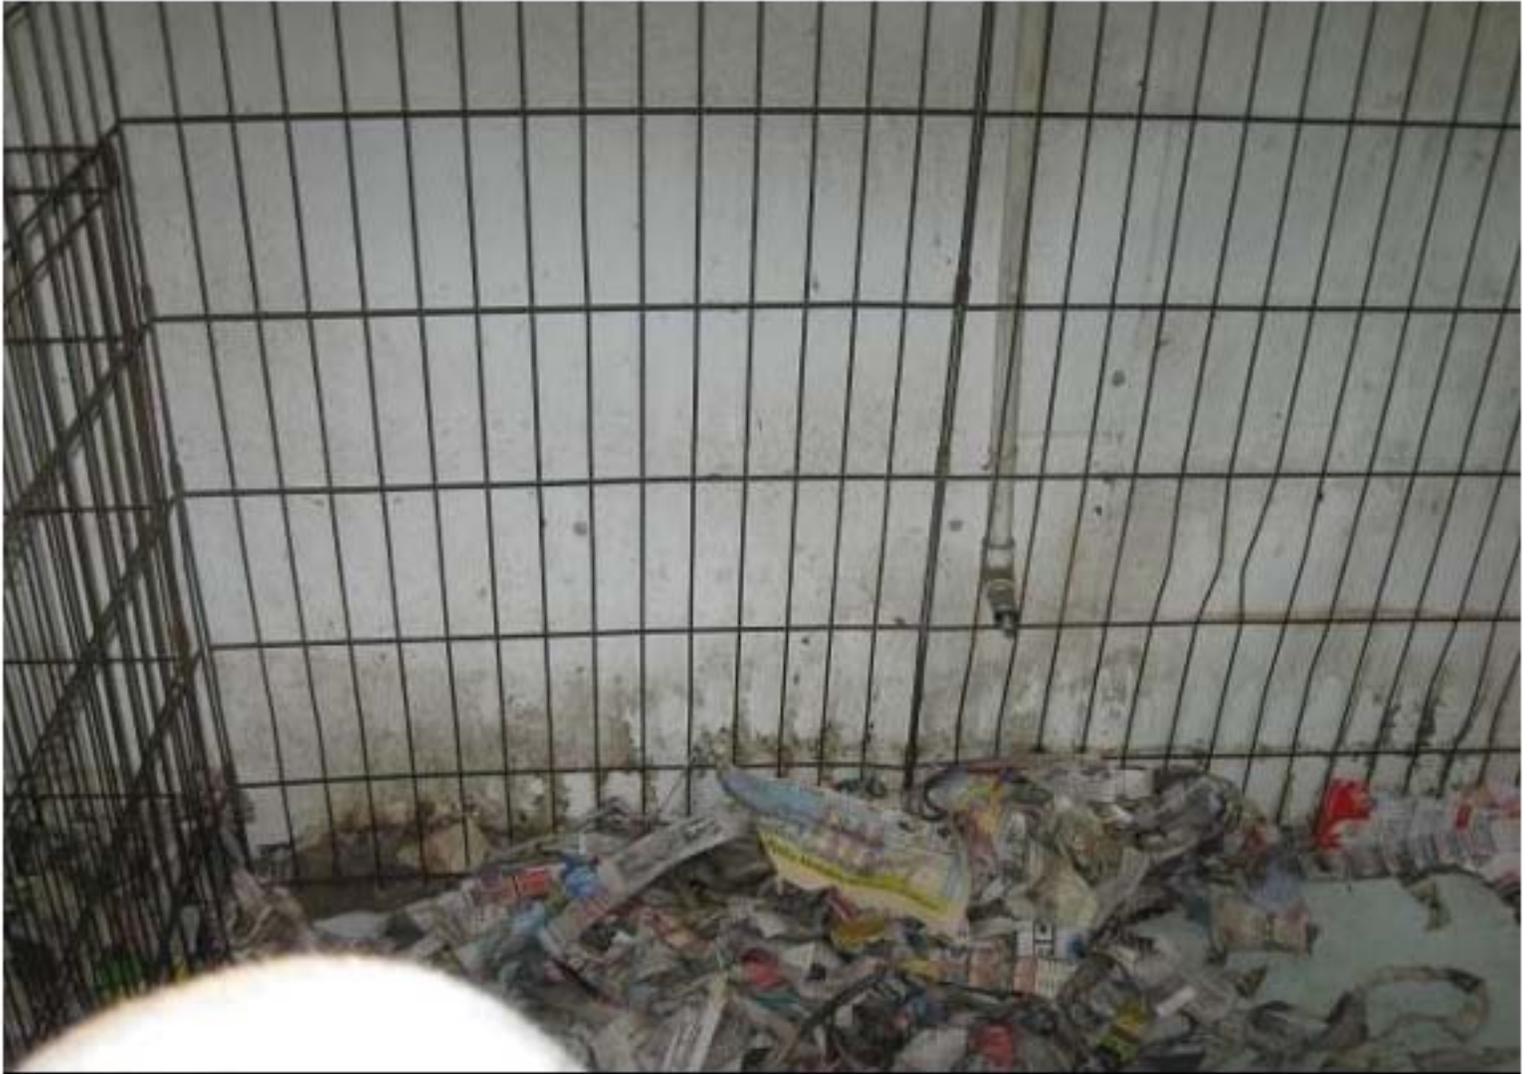
FOIA11-28200031

CFR: 3.1 (c) (3)

Photographer:	John J. Lies, ACI	Legal Name:	Registration:	42-A-1399
Photo Taken:	Tue, Aug 10, '10 P.M.	Debra Pratt		
Inspection:	223101025300653			
Description:	3.1 (c)(3) General Housing Facilities Cleaning: Walls of the facility need to be cleaned to remove dirt, spider webs, etc.

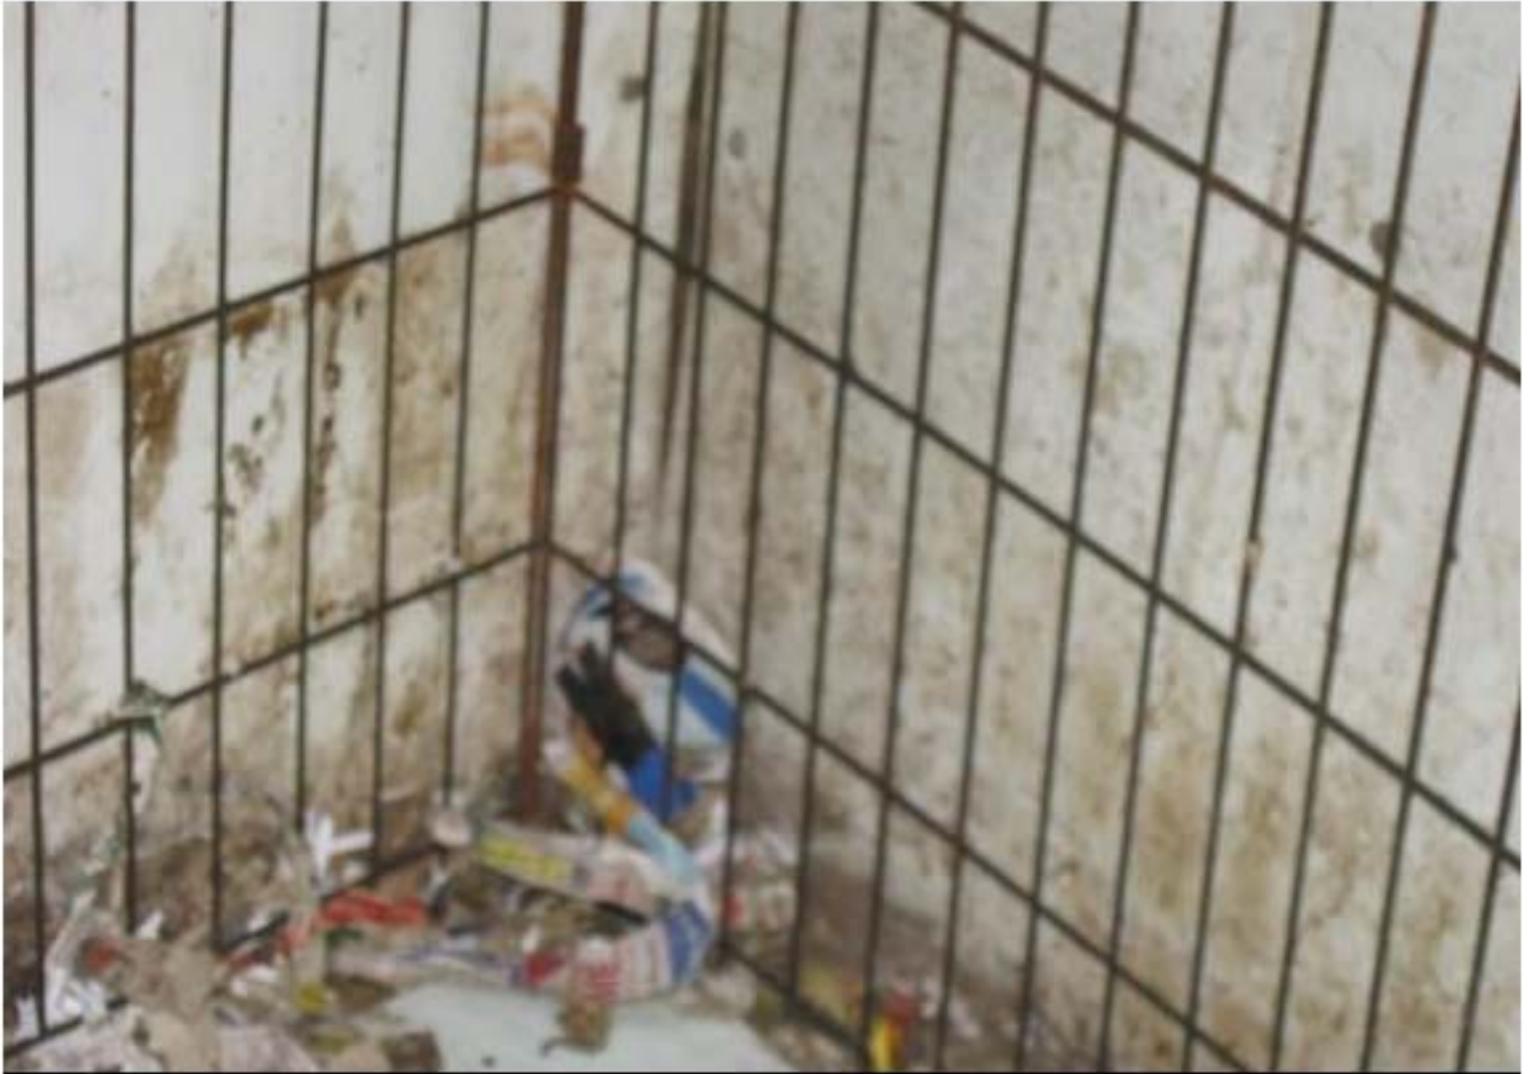
FOIA11-28200032

CFR: 3.1 (c) (3)

Photographer:	John J. Lies, ACI	Legal Name:	Registration:	42-A-1399
Photo Taken:	Tue, Aug 10, '10 P.M.	Debra Pratt		
Inspection:	223101025300653			
Description:	3.1 (c)(3) General Housing Facilities Cleaning: Walls of the facility need to be cleaned to remove dirt, spider webs, etc. and build up between the wall and enclosure.

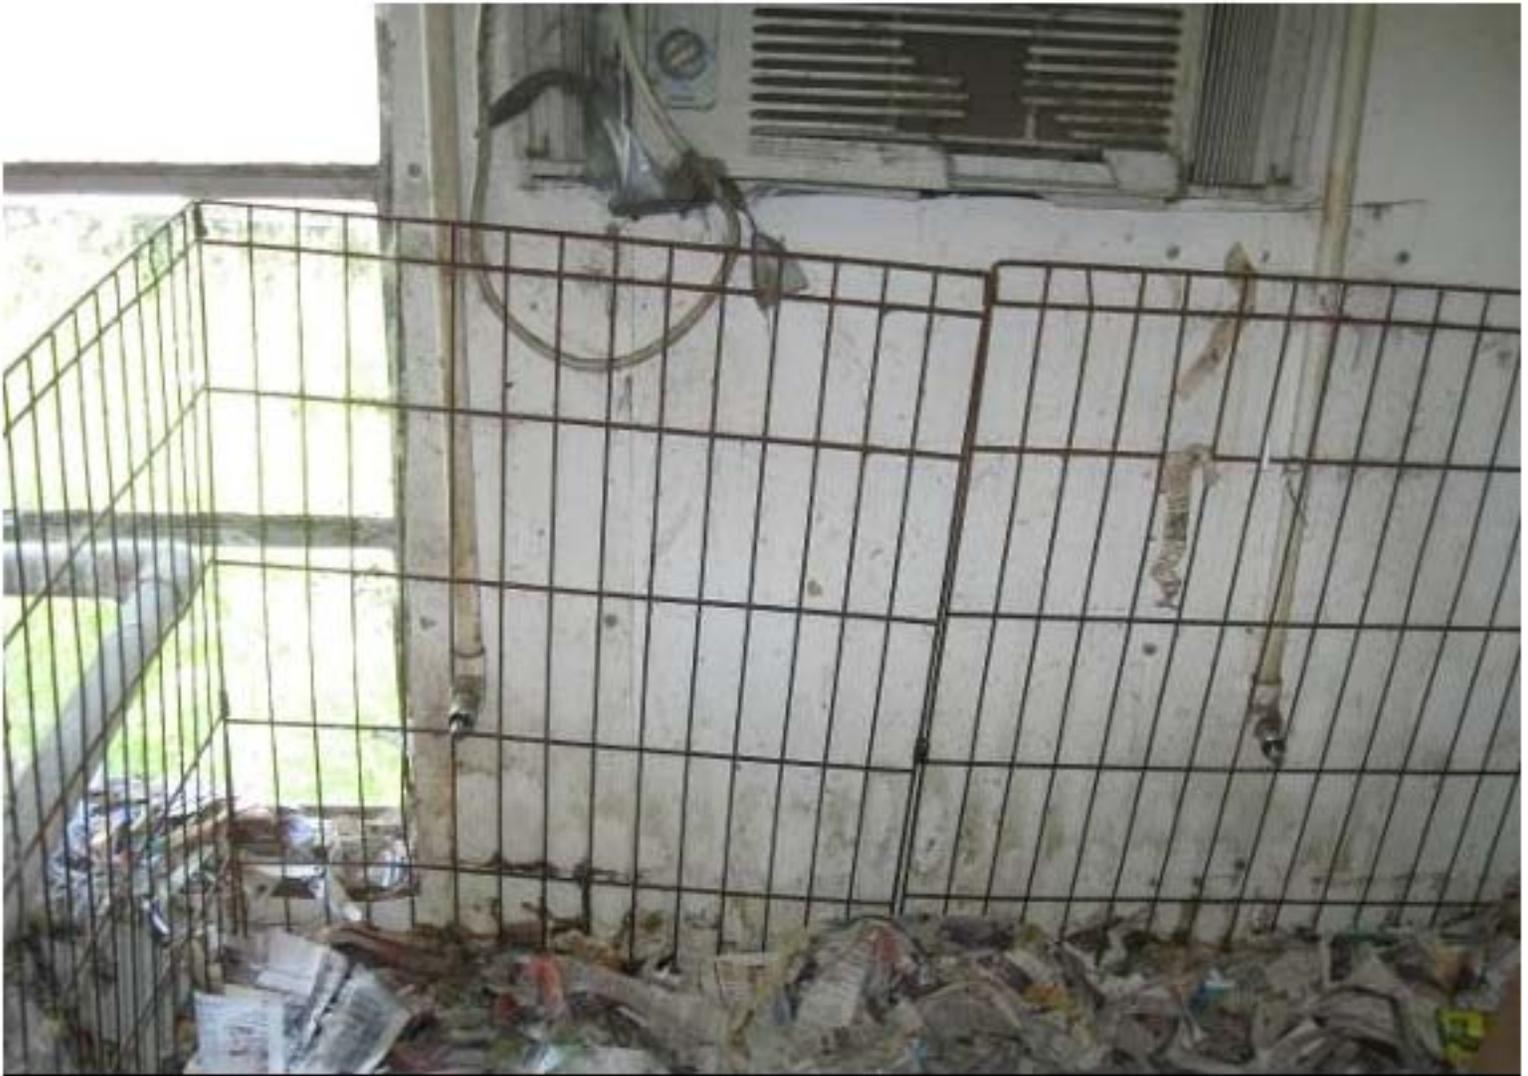
FOIA11-28200033

CFR: 3.1 (c) (3)

Photographer:	John J. Lies, ACI	Legal Name:	Registration:	42-A-1399
Photo Taken:	Tue, Aug 10, '10 P.M.	Debra Pratt		
Inspection:	223101025300653			
Description:	3.1 (c)(3) General Housing Facilities Cleaning: Walls of the facility need to be cleaned to remove dirt, spider webs, etc. and build up between the wall and enclosure.

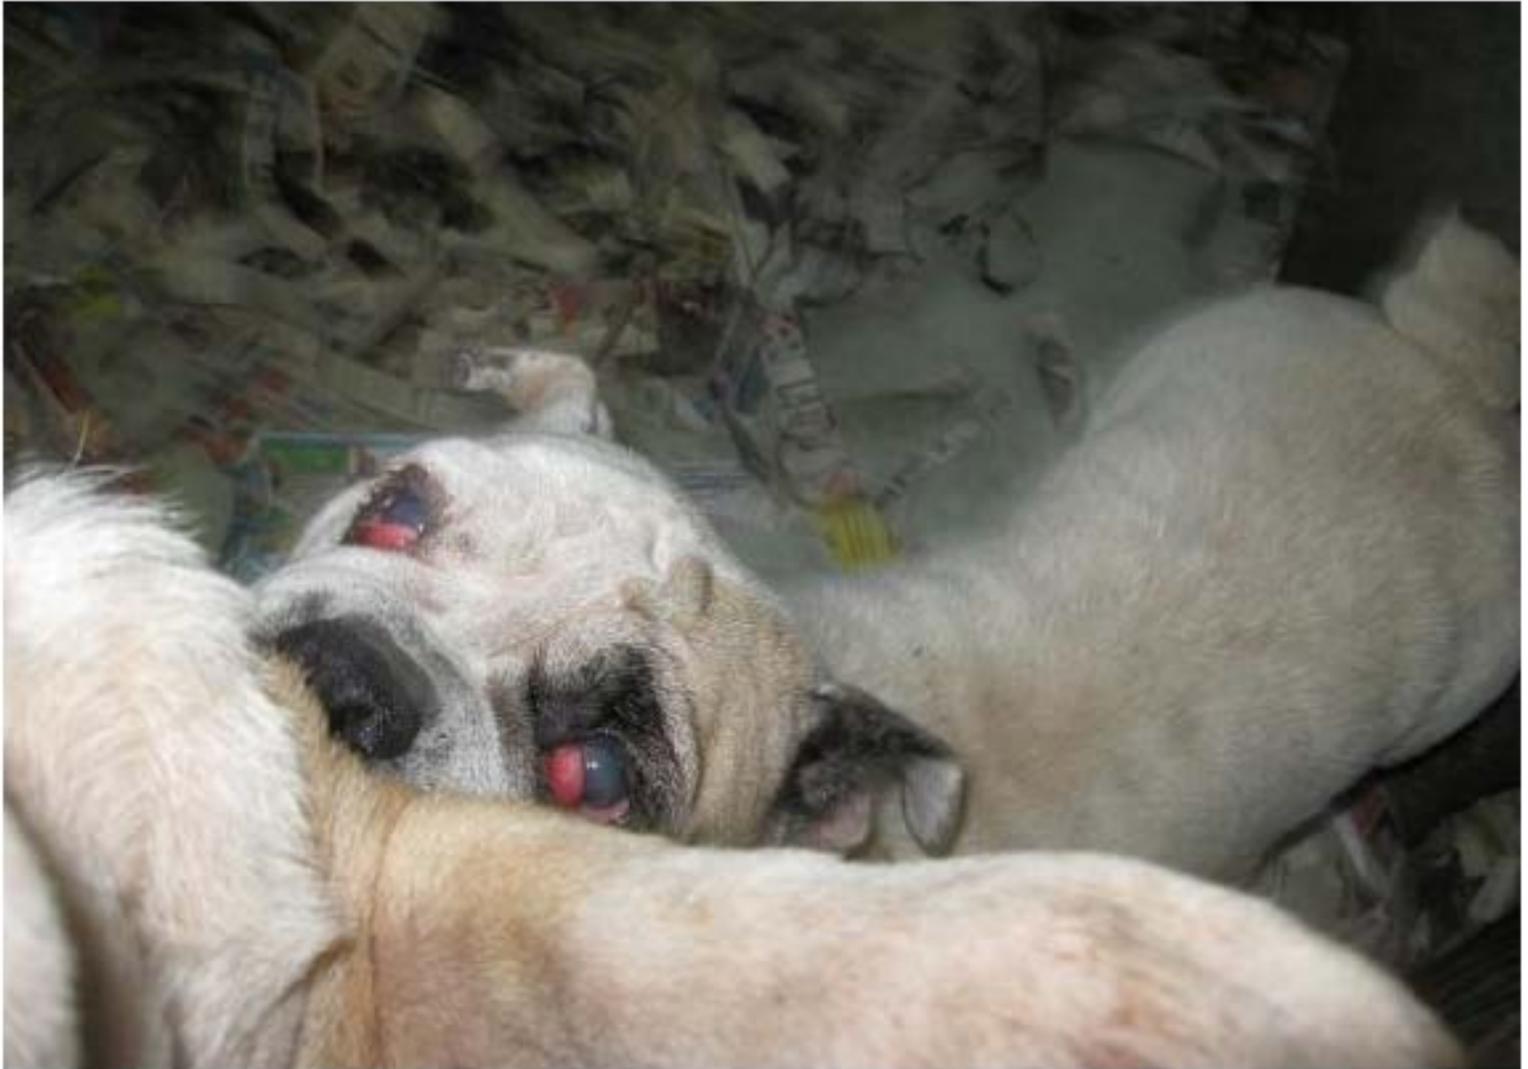
FOIA11-28200034

CFR: 2.40 (b) (2)

Photographer:	John J. Lies, ACI	Legal Name:	Registration:	42-A-1399
Photo Taken:	Tue, Aug 10, '10 P.M.	Debra Pratt		
Inspection:	223101025300653			
Description:	2.40 (b)(2) Veterinary Care: No documentation of diagnosis or treatment for cherry.

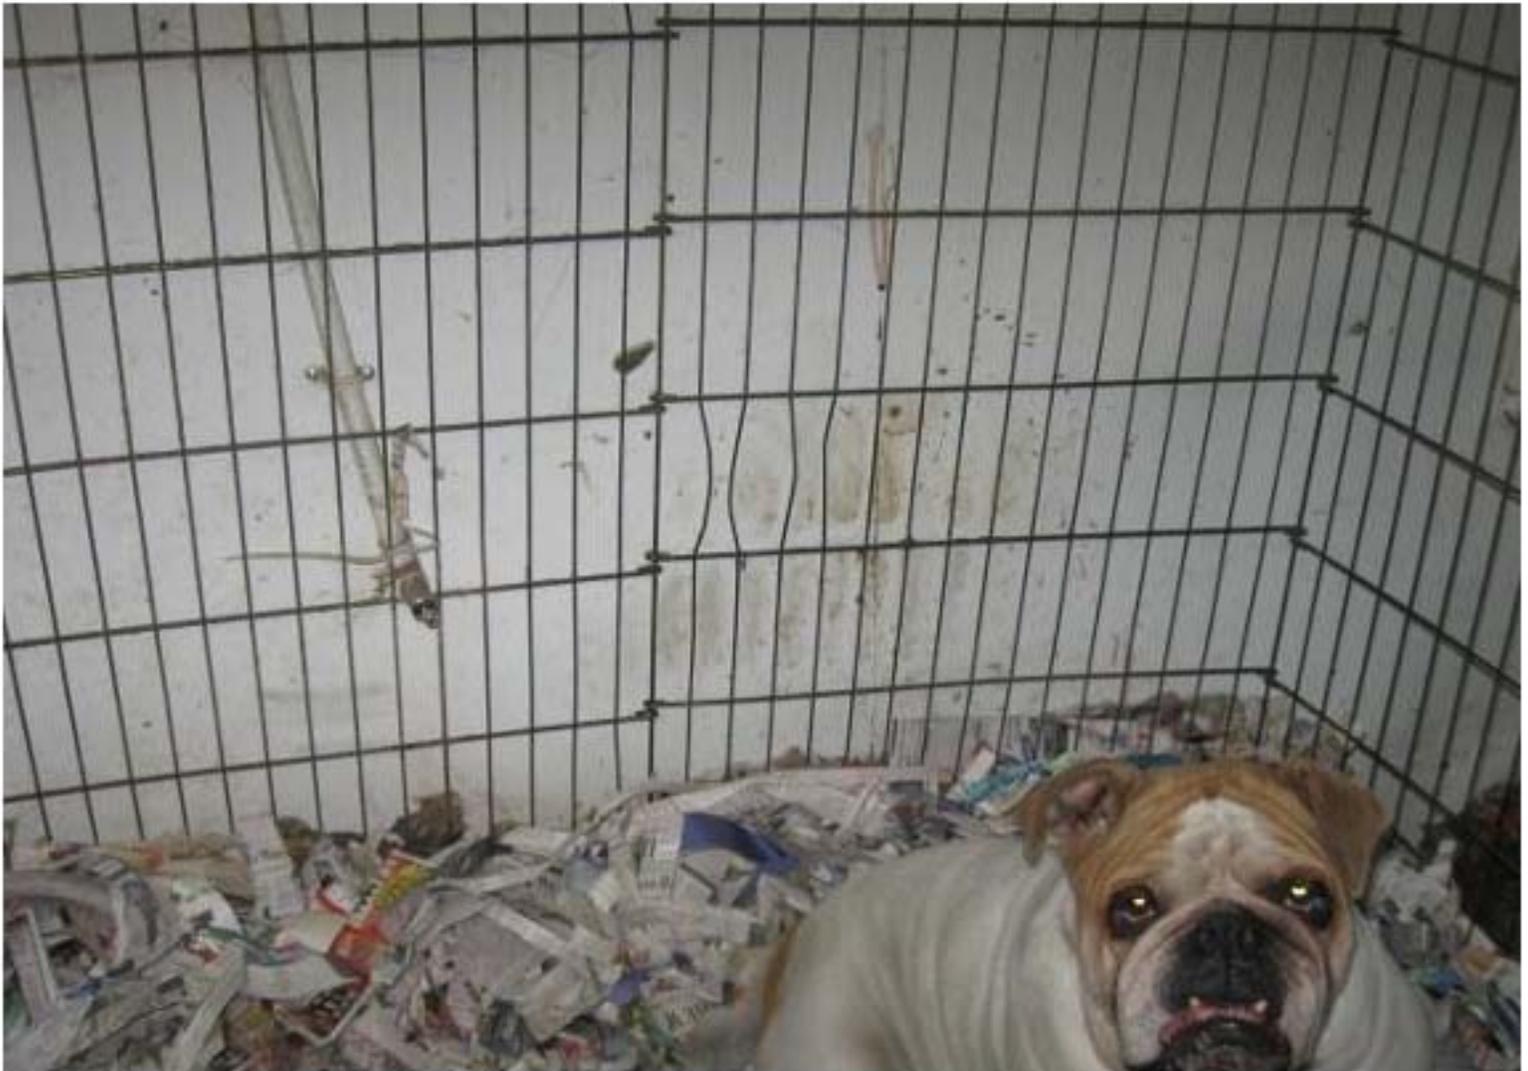
FOIA11-282000035

CFR: 3.1 (c) (3)

Photographer:	John J. Lies, ACI	Legal Name:	Registration:	42-A-1399
Photo Taken:	Tue, Aug 10, '10 P.M.	Debra Pratt		
Inspection:	223101025300653			
Description:	3.1 (c)(3) General Housing Facilities Cleaning: Walls of the facility need to be cleaned to remove dirt, spider webs, etc.

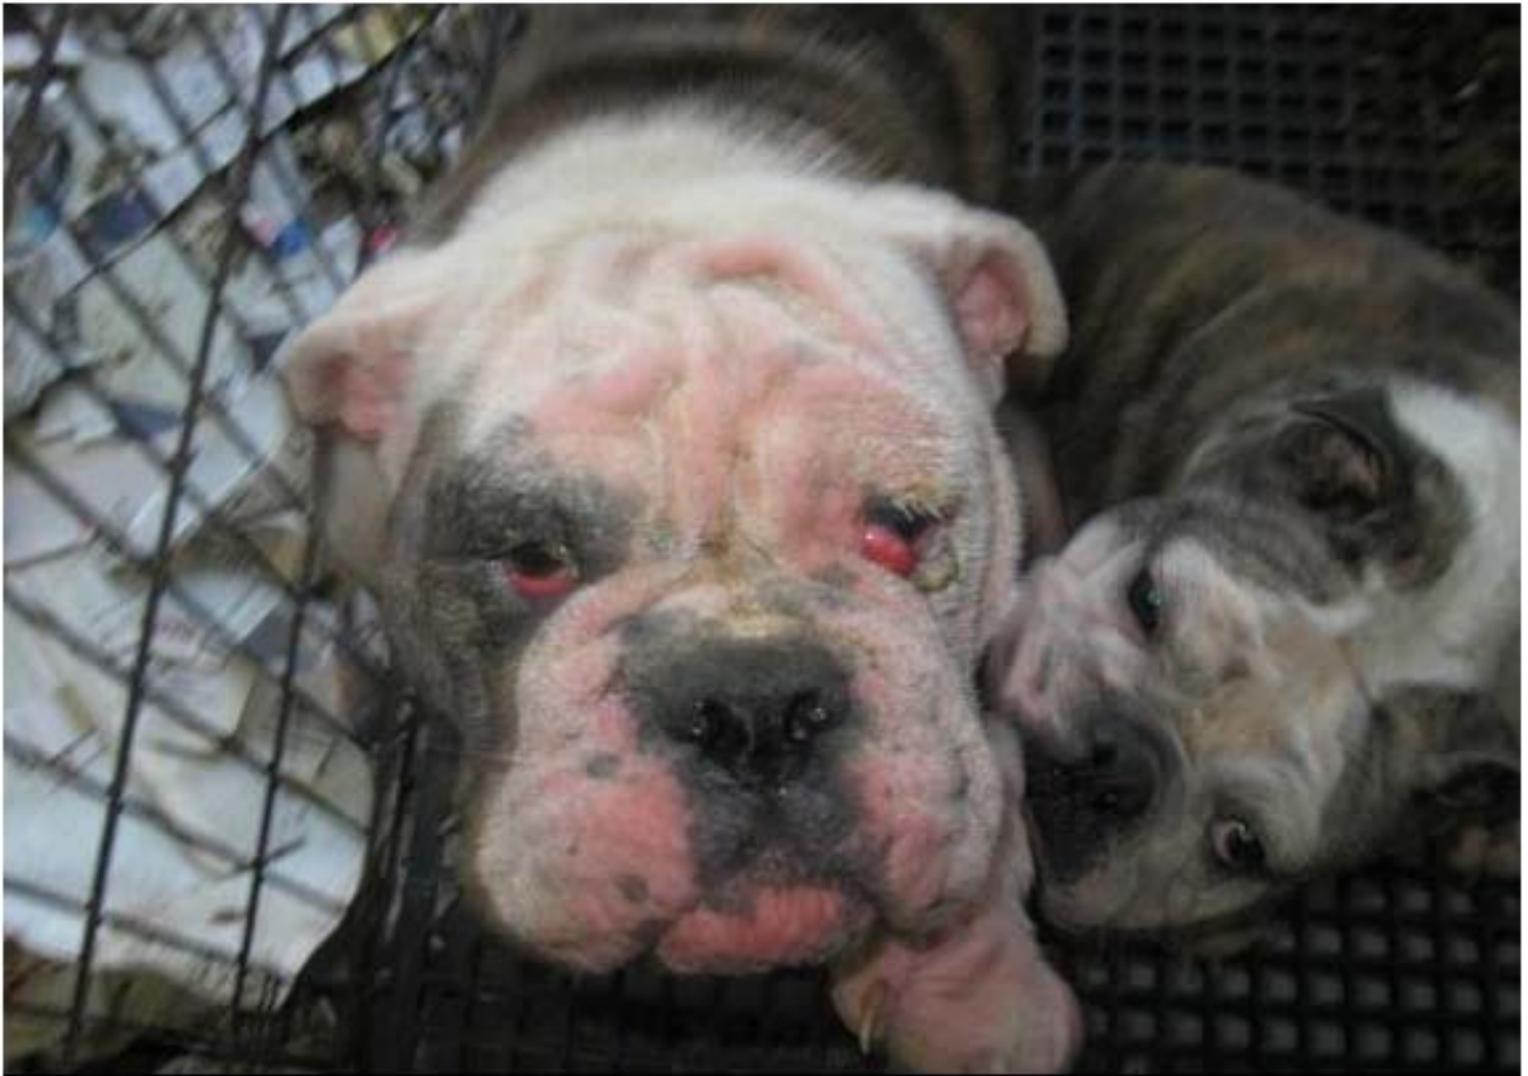
FOIA11-282000036

CFR: 2.40 (b) (2)

Photographer:	John J. Lies, ACI	Legal Name:	Registration:	42-A-1399
Photo Taken:	Tue, Aug 10, '10 P.M.	Debra Pratt		
Inspection:	223101025300653			
Description:	2.40 (b)(2) Veterinary Care: No documentation of diagnosis or treatment for cherry eye and skin irritation.

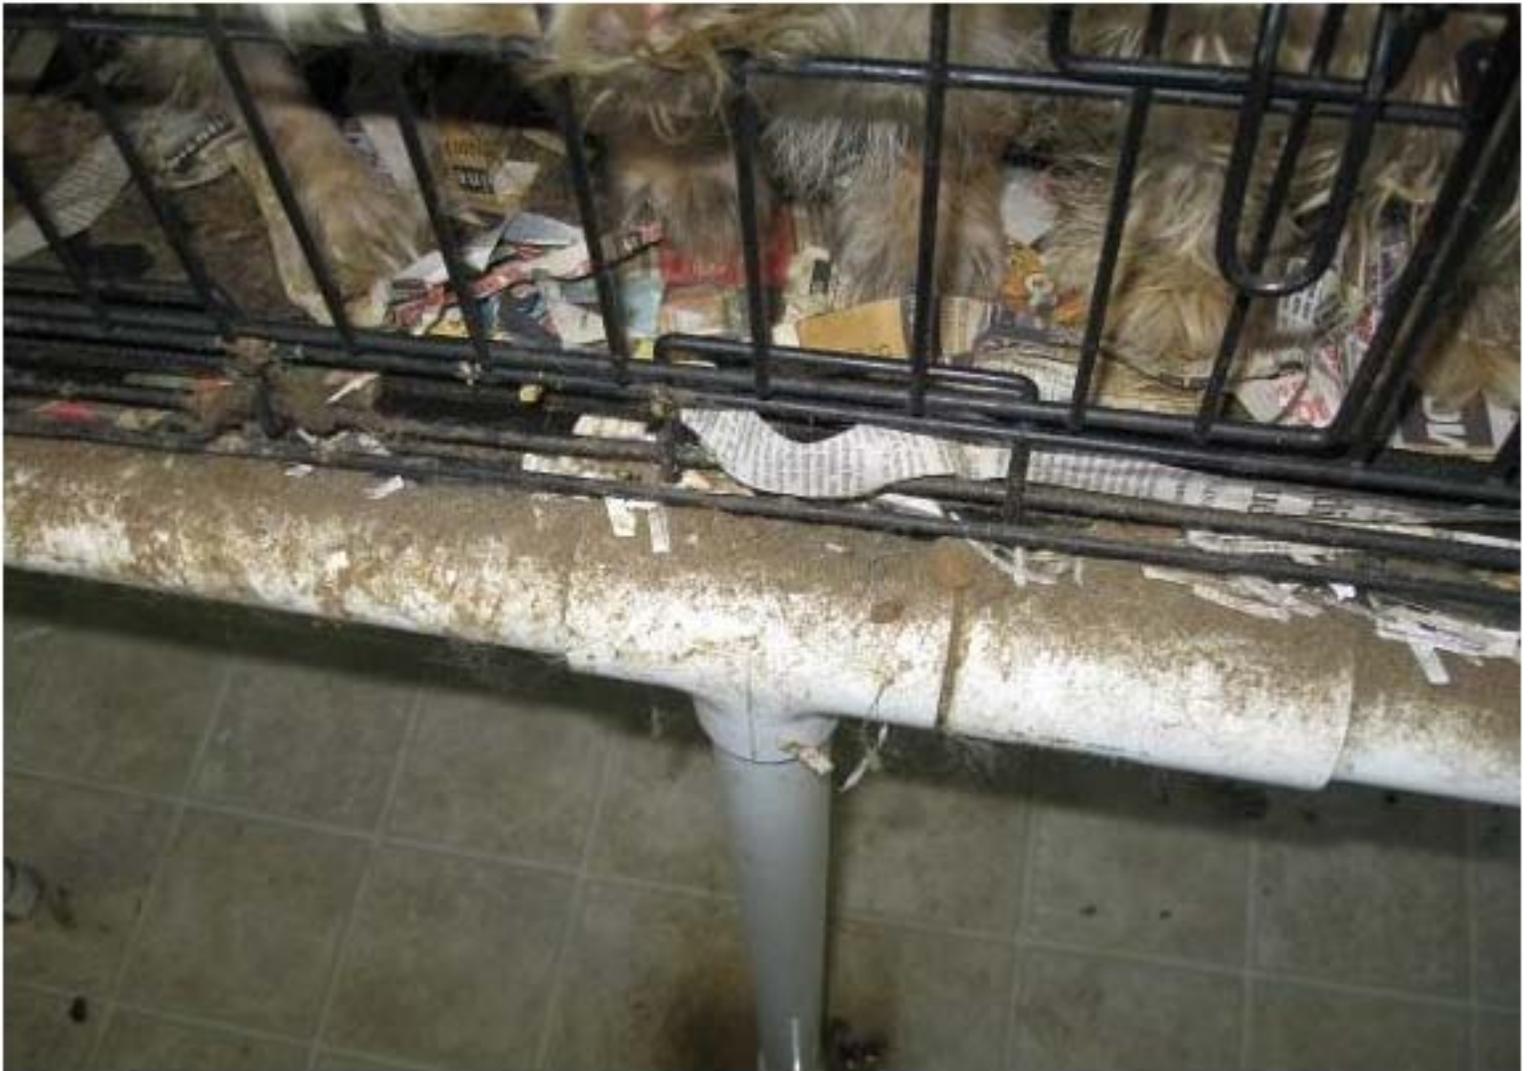
FOIA11-28200037

CFR: 3.1 (c) (3)

Photographer:	John J. Lies, ACI	Legal Name:	Registration:	42-A-1399
Photo Taken:	Tue, Aug 10, '10 P.M.	Debra Pratt		
Inspection:	223101025300653			
Description:	3.1 (c)(3) General Housing Facilities Cleaning: Front supports of enclosure need to be cleaned to remove dirt, feed, etc...

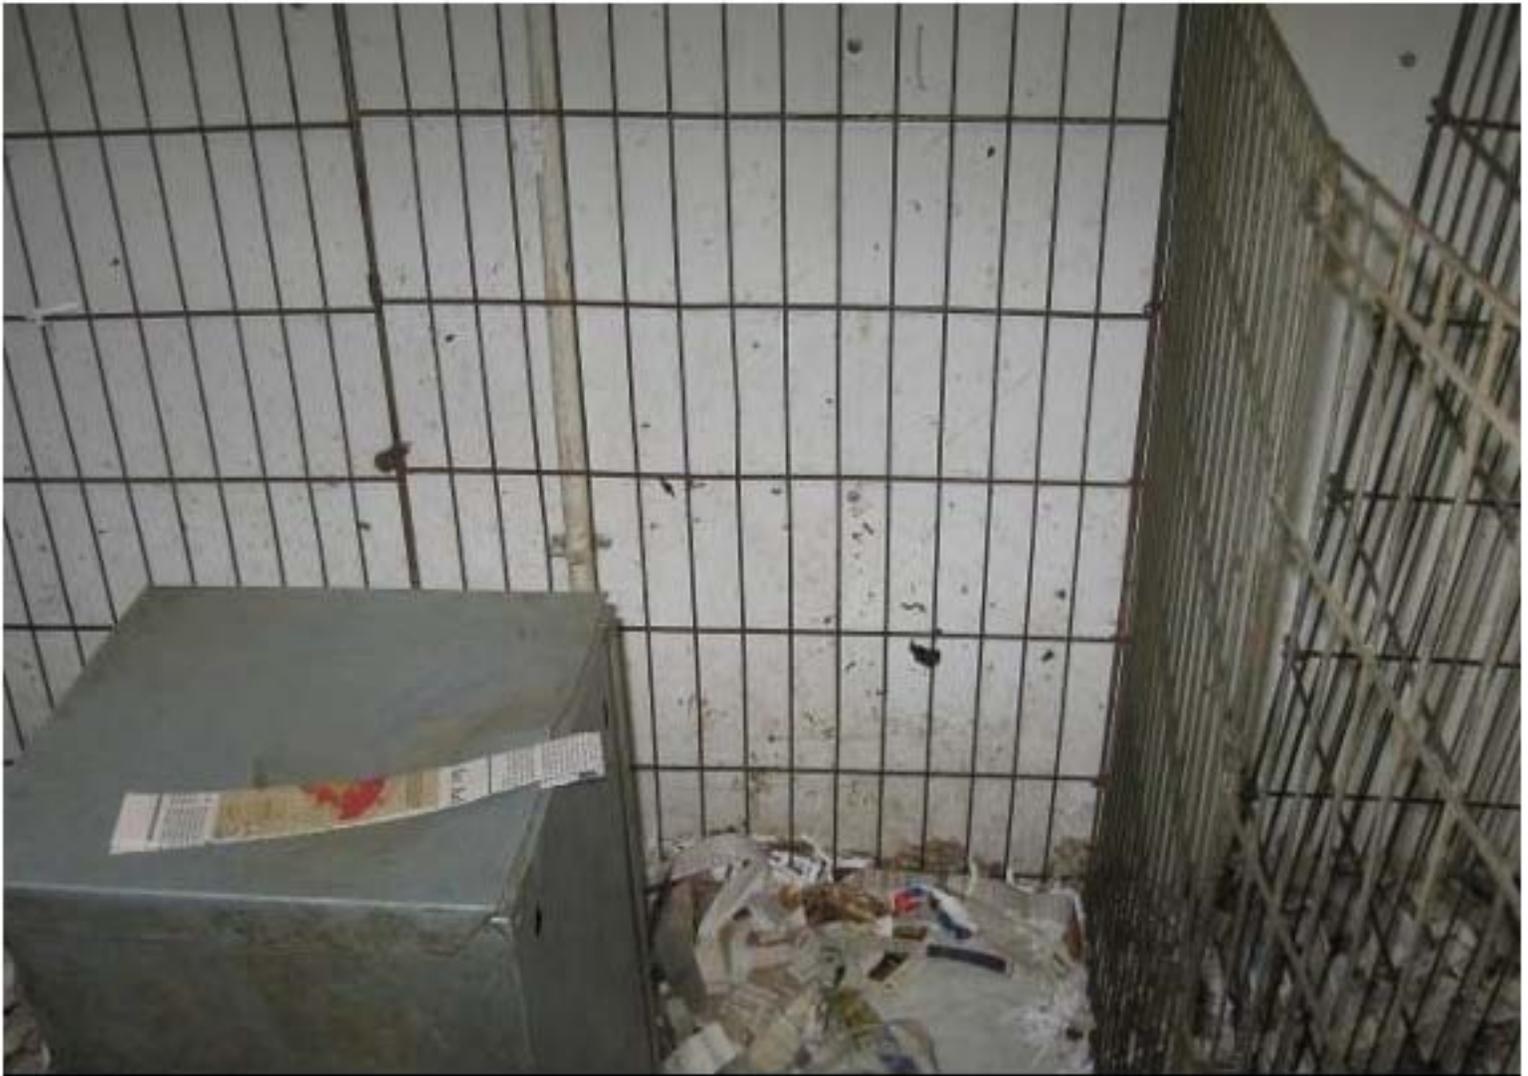
FOIA11-28200038

CFR: 3.1 (c) (3)

Photographer:	John J. Lies, ACI	Legal Name:	Registration:	42-A-1399
Photo Taken:	Tue, Aug 10, '10 P.M.	Debra Pratt		
Inspection:	223101025300653			
Description:	3.1 (c)(3) General Housing Facilities Cleaning: Walls of the facility need to be cleaned to remove dirt, spider webs, etc.

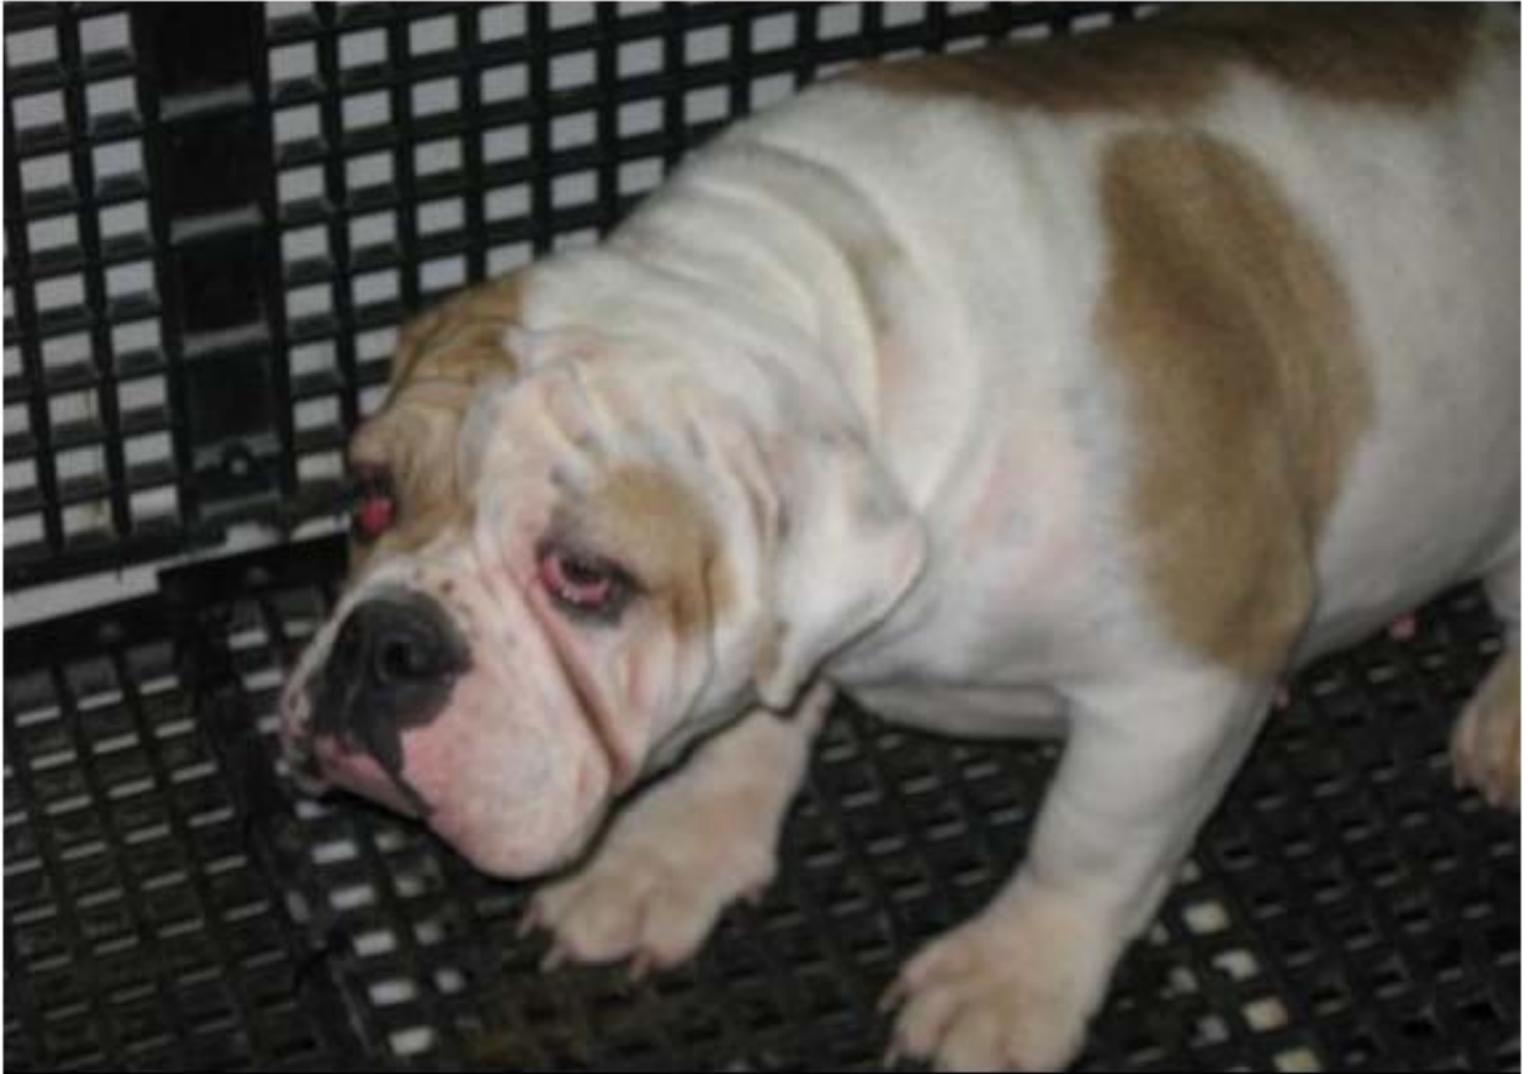
FOIA11-28200039

CFR: 2.40 (b) (2)

Photographer:	John J. Lies, ACI	Legal Name:	Registration:	42-A-1399
Photo Taken:	Tue, Aug 10, '10 P.M.	Debra Pratt		
Inspection:	223101025300653			
Description:	2.40 (b)(2) Veterinary Care: No documentation of diagnosis or treatment for cherry.

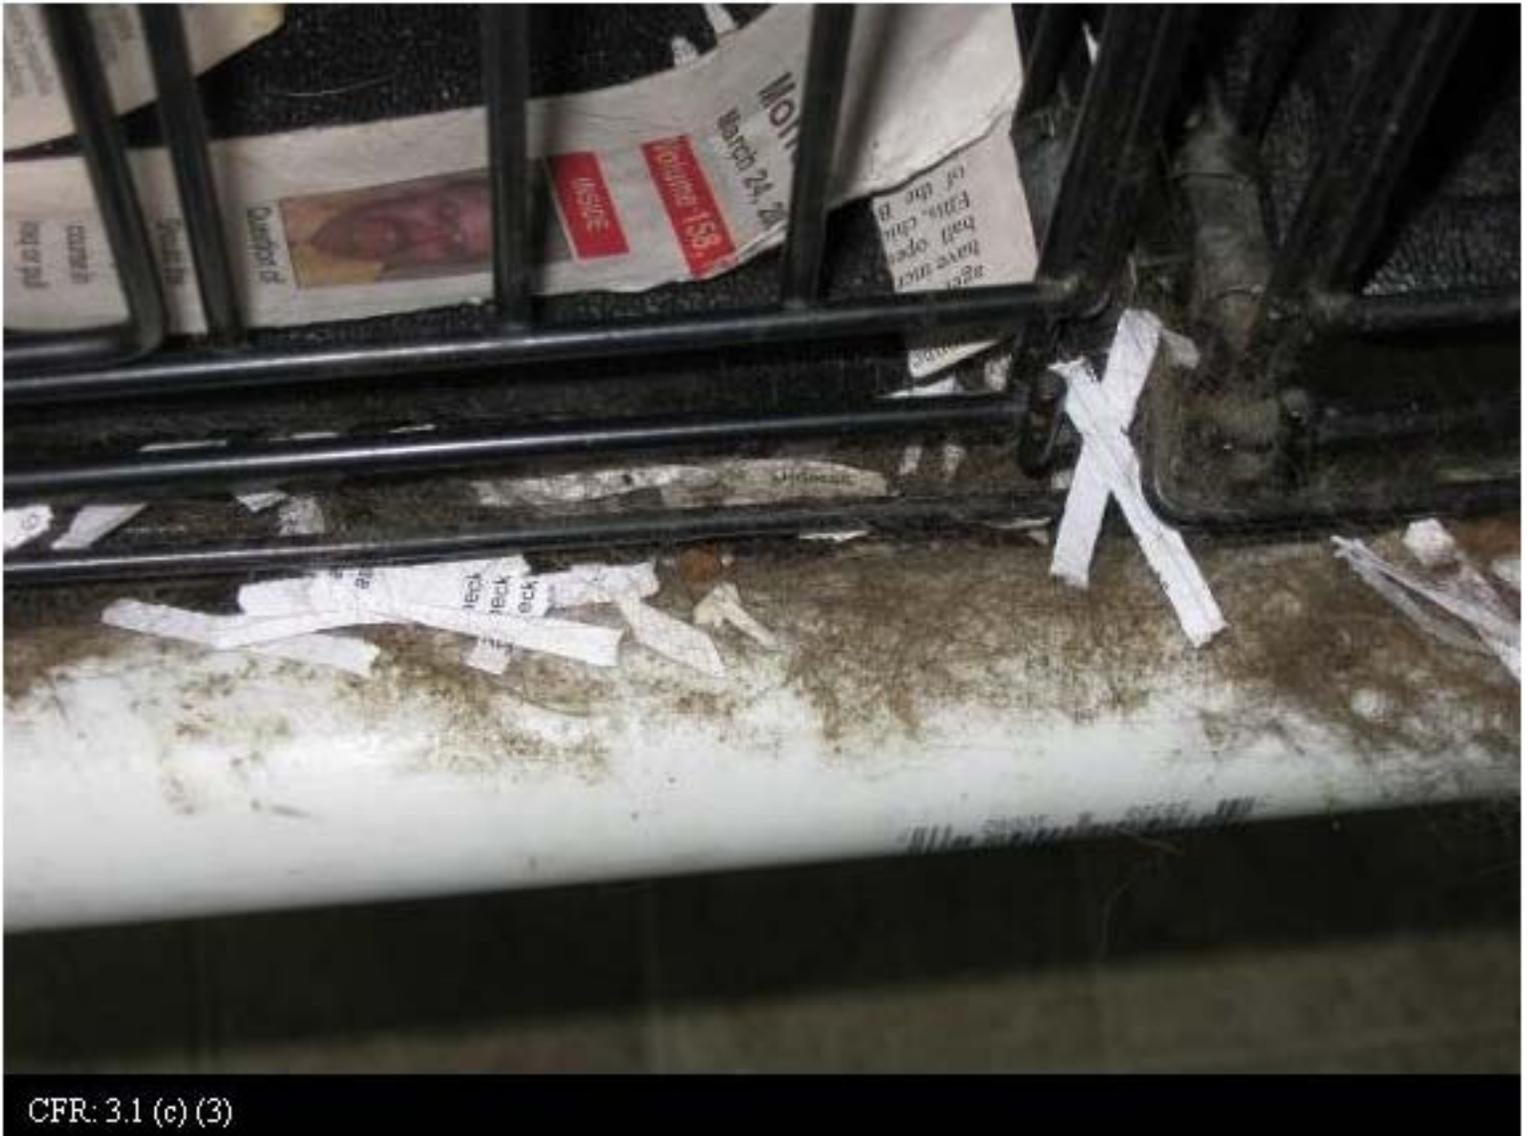
FOIA11-282000040

CFR: 3.1 (c) (3)

Photographer:	John J. Lies, ACI	Legal Name:	Registration:	42-A-1399
Photo Taken:	Tue, Aug 10, '10 P.M.	Debra Pratt		
Inspection:	223101025300653			
Description:	3.1 (c)(3) General Housing Facilities Cleaning: front supports of enclosure need to be cleaned to remove dirt.

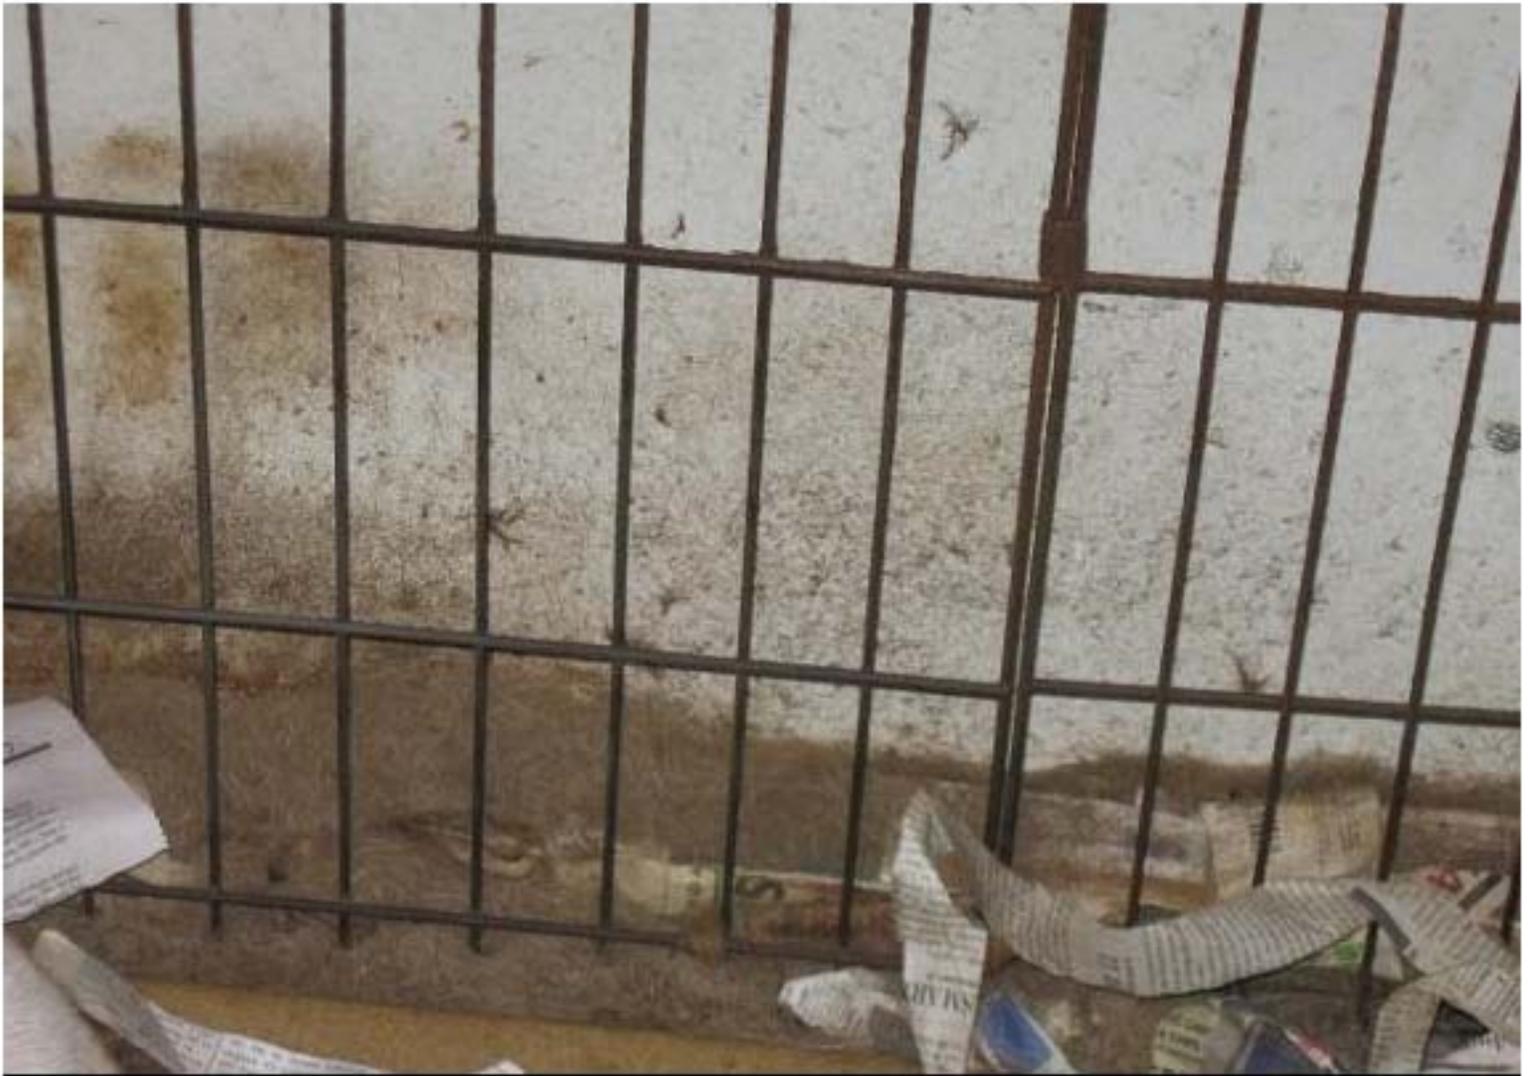
FOIA11-28200041

CFR: 3.1 (c) (3)

Photographer:	John J. Lies, ACI	Legal Name:	Registration:	42-A-1399
Photo Taken:	Tue, Aug 10, '10 P.M.	Debra Pratt		
Inspection:	223101025300653			
Description:	3.1 (c)(3) General Housing Facilities Cleaning: Walls of the facility need to be cleaned to remove dirt, spider webs, etc. and build up between the wall and enclosure.

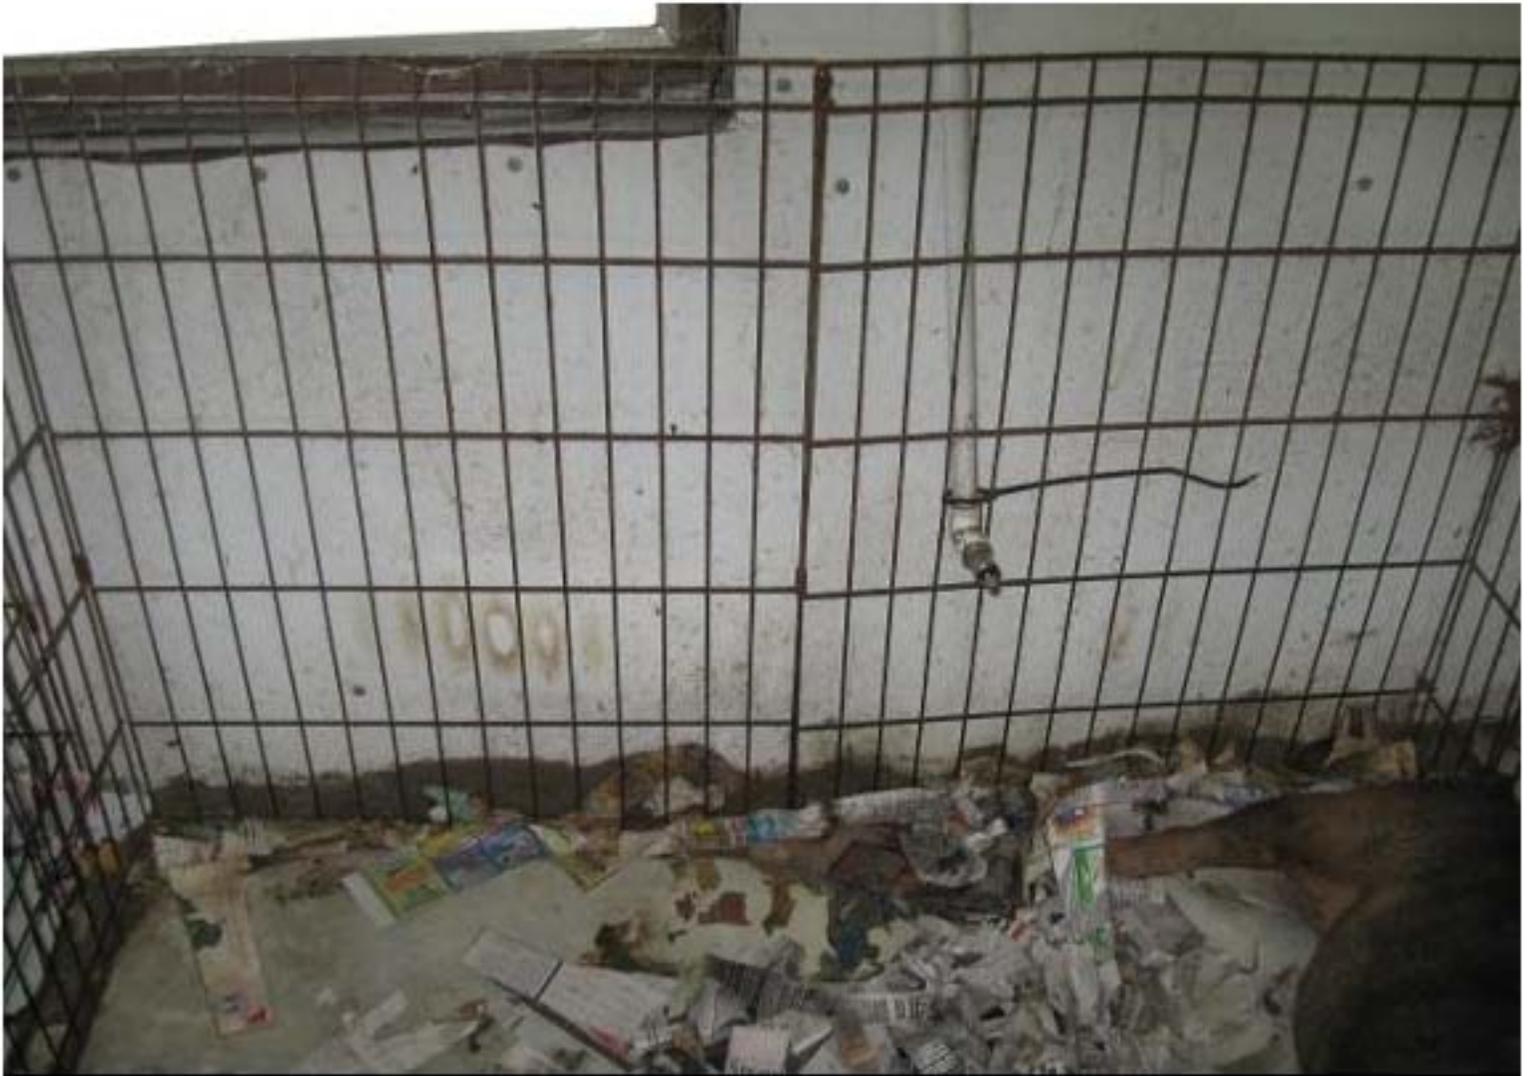
CFR: 3.1 (c) (3)

Photographer:	John J. Lies, ACI	Legal Name:	Registration:	42-A-1399
Photo Taken:	Tue, Aug 10, '10 P.M.	Debra Pratt		
Inspection:	223101025300653			
Description:	3.1 (c)(3) General Housing Facilities Cleaning: Walls of the facility need to be cleaned to remove dirt, spider webs, etc. To include accumulation between enclosure and wall.			FOIA11-28200042
