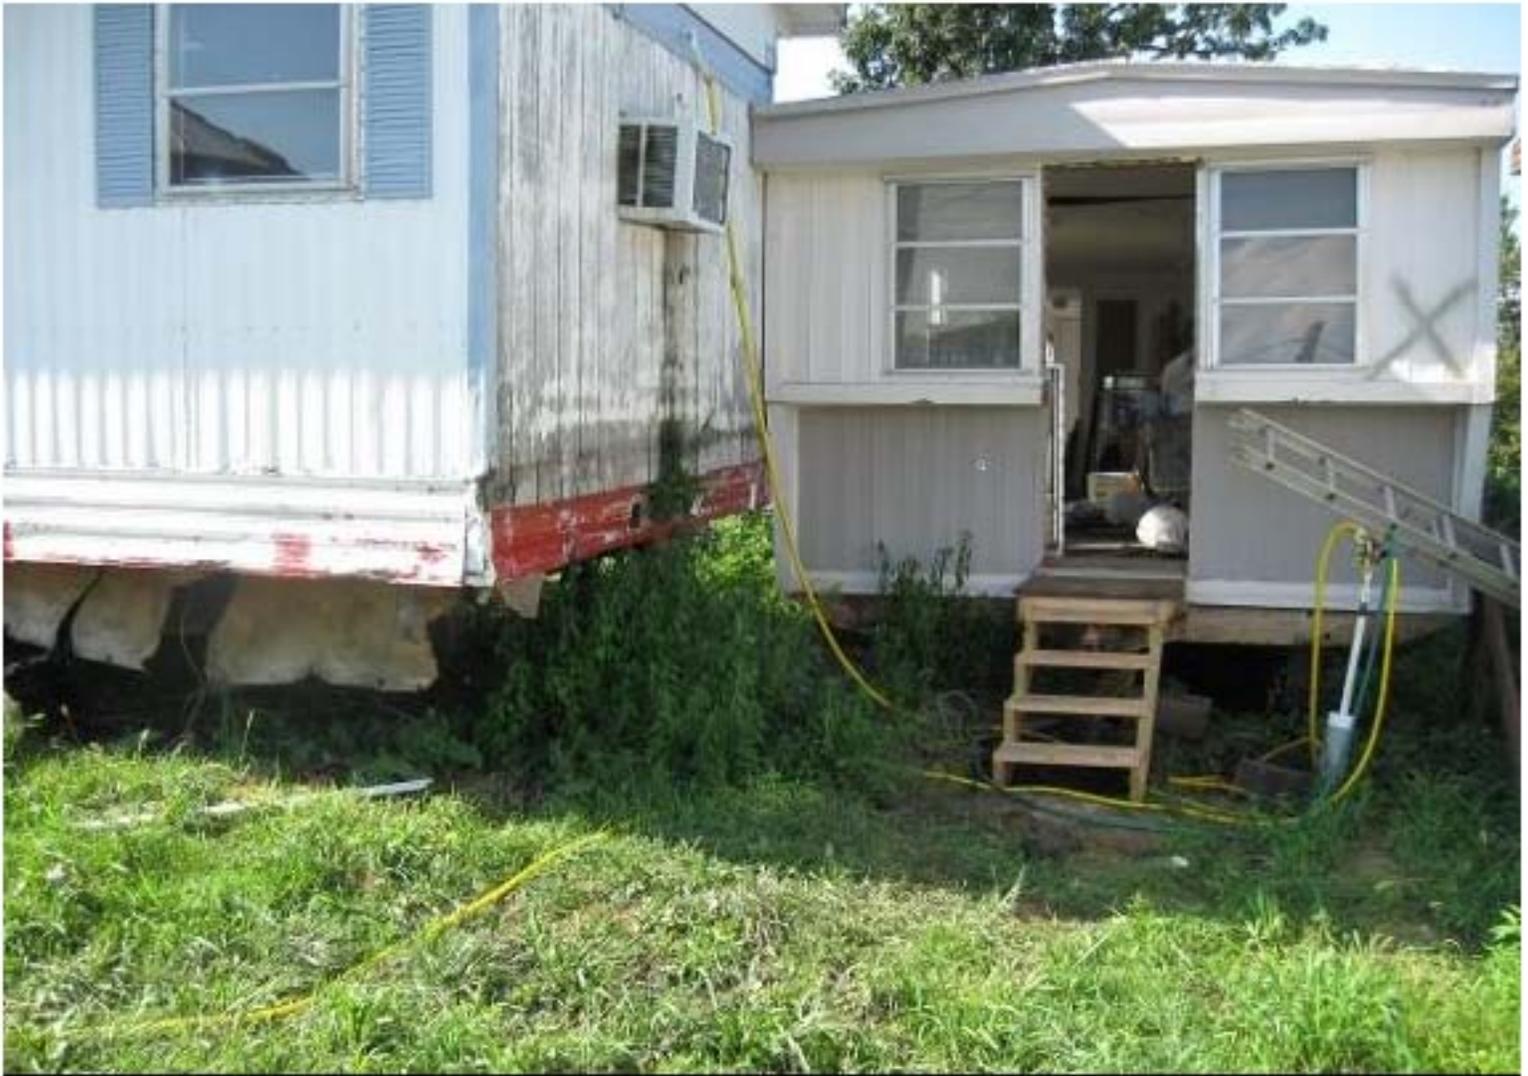
FOIA11-282000043

CFR: 3.11 (c)

Photographer:	John J. Lies, ACI	Legal Name:	Registration:	42-A-1399
Photo Taken:	Tue, Aug 10, '10 P.M.	Debra Pratt		
Inspection:	223101025300653			
Description:	3.11 (c) Housekeeping of premises; Weeds need to be controlled.

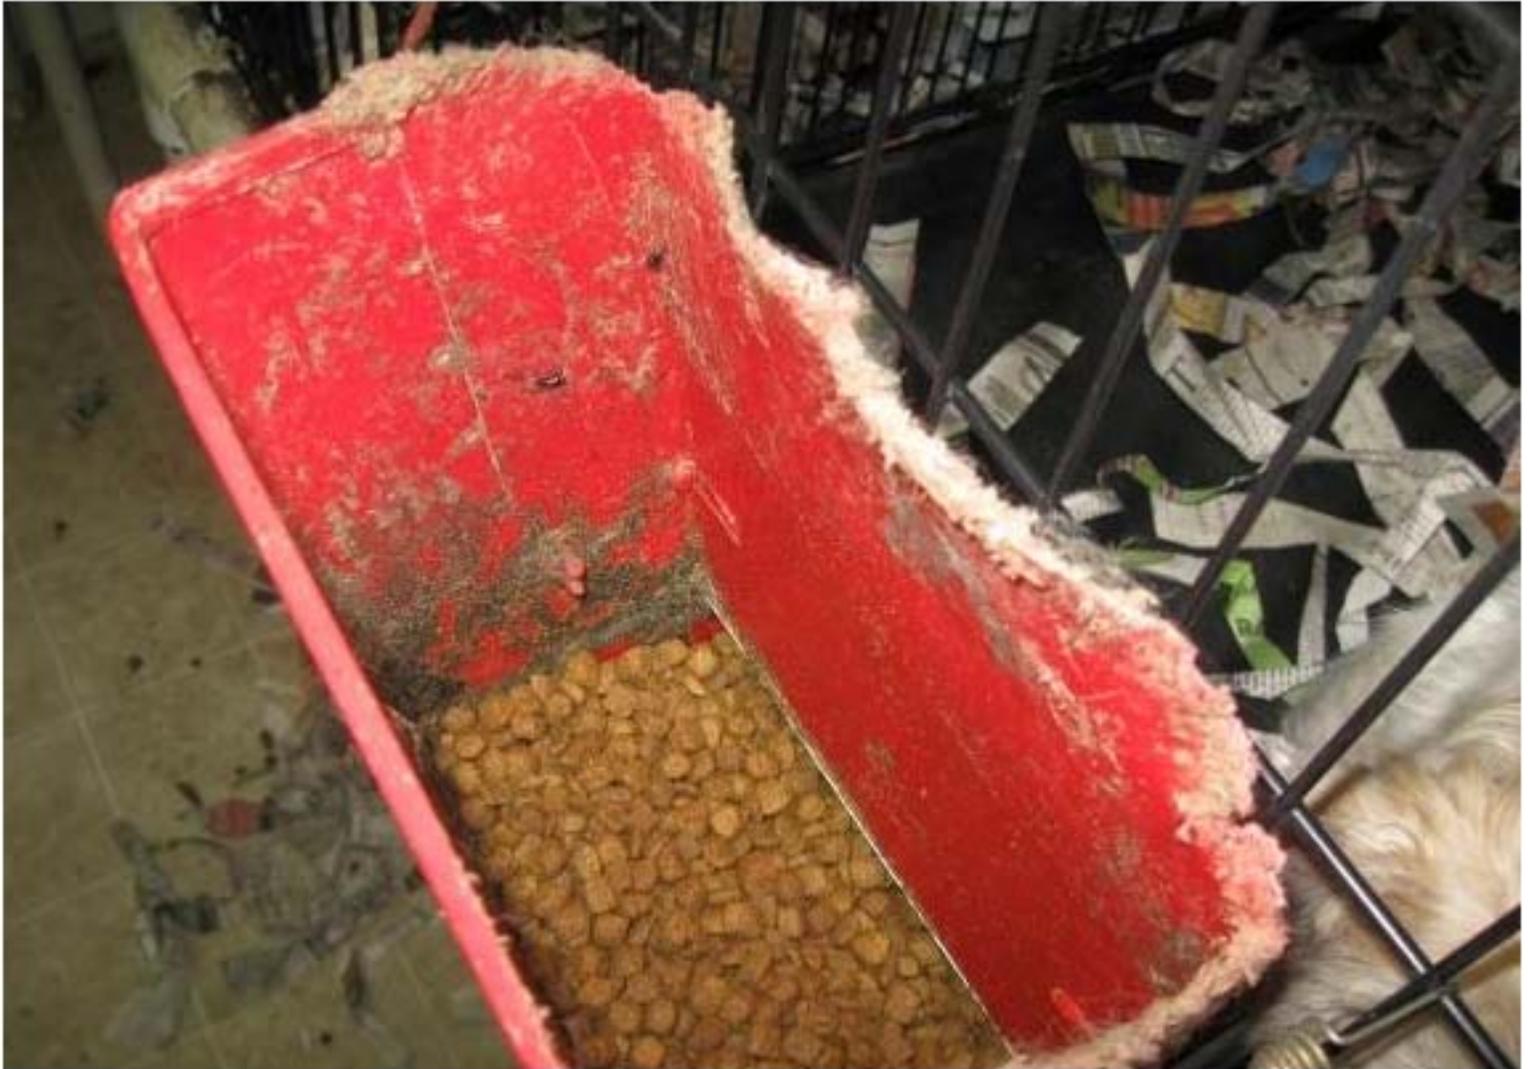
CFR: 3.8

Photographer:	John J. Lies, ACI	Legal Name:	Registration:	42-A-1399
Photo Taken:	Tue, Aug 10, '10 P.M.	Debra Pratt		
Inspection:	223101025300653			
Description:	3.8 Feeding: Feeders are chewed and can not be properly cleaned or feeders need to be cleaned and sanitized.

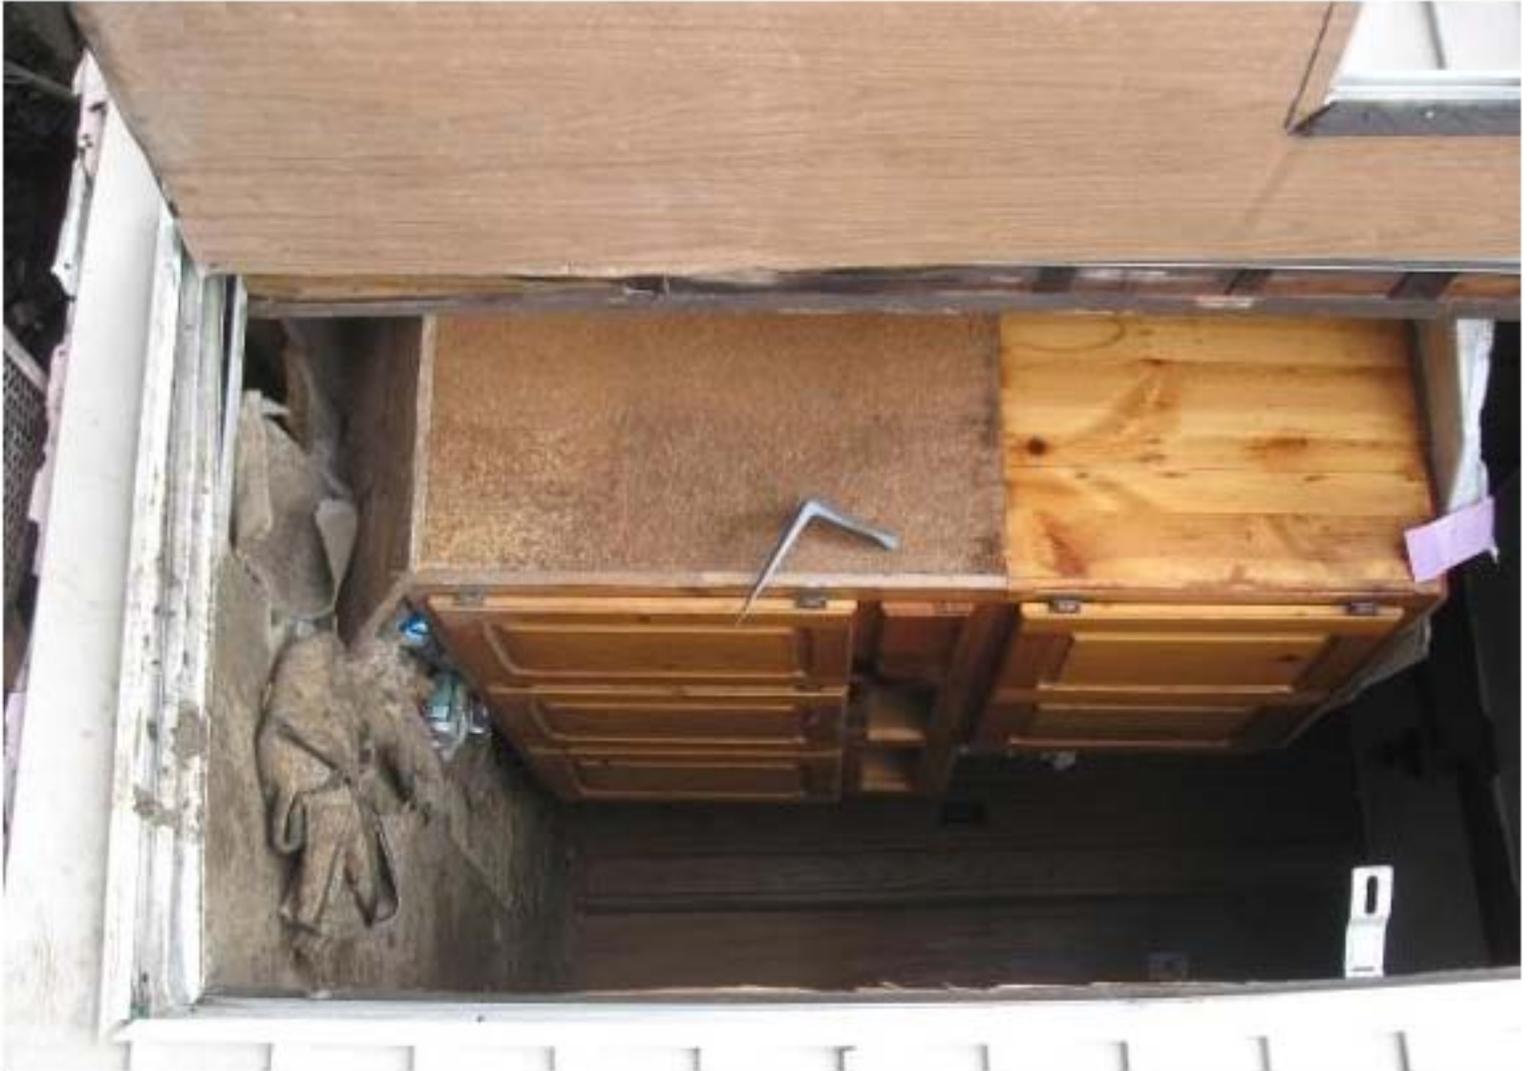
CFR: 3.11 (c)

Photographer:	Cynthia M. Neis	Legal Name:	Registration:	42-A-1398
Photo Taken:	Tue, Nov 16, '10 approximately 1000	Nick Menne Tiffany Menne		
Inspection:	320101251280317			
Description:	Dirty entry way to trailer facility. Accumulation of dirty, debris, and trash.

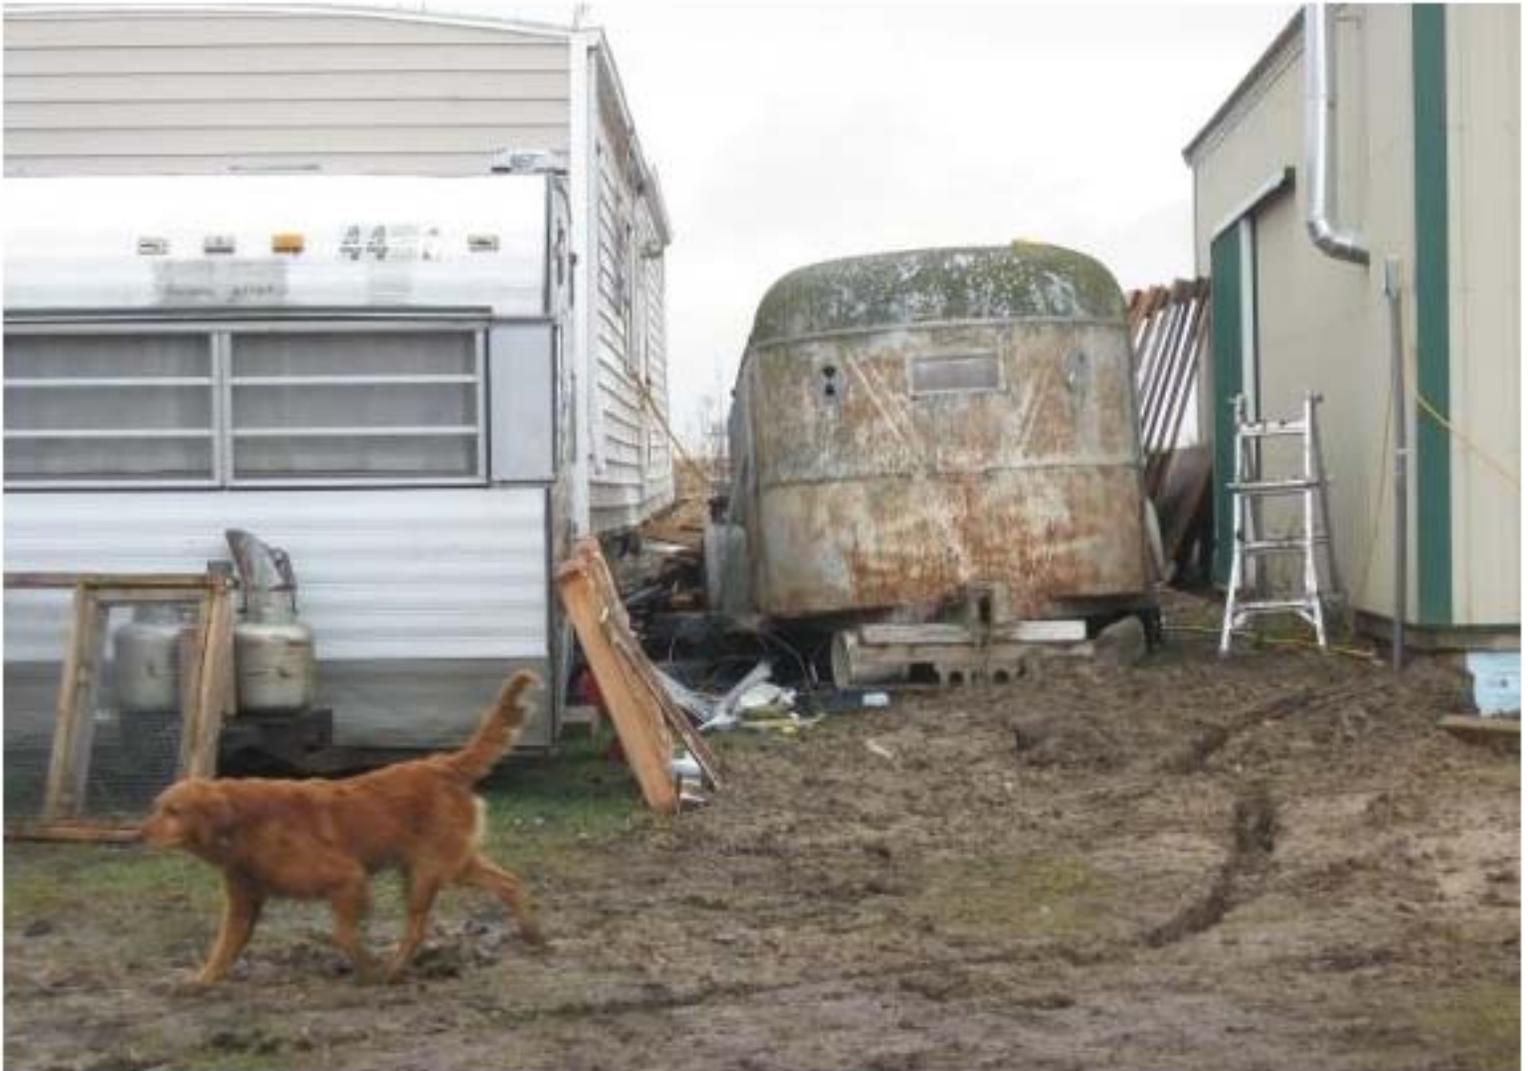
CFR: 3.11 (c)

Photographer:	Cynthia M. Neis	Legal Name:	Registration:	42-A-1398
Photo Taken:	Tue, Nov 16, '10 approximately 1000	Nick Menne		
		Tiffany Menne		
Inspection:	320101251280317			
Description:	Accumulation of discarded materials along between shed facility and trailer facility.

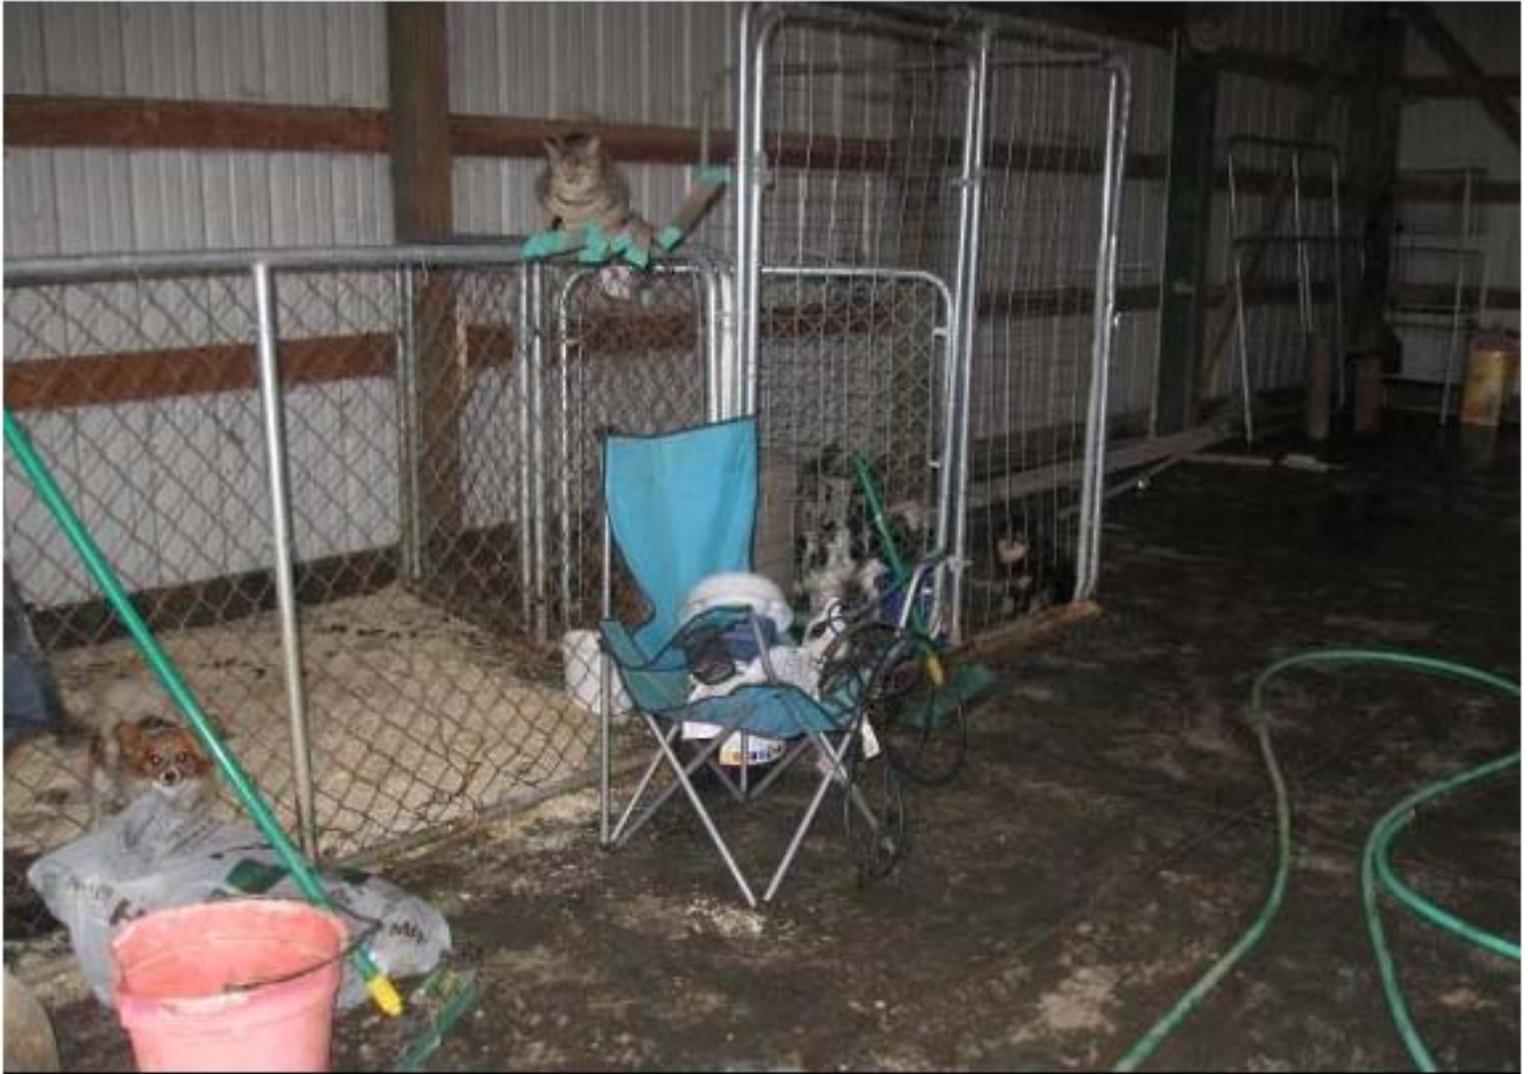
CFR: 3.11 (c)

Photographer:	Cynthia M. Neis	Legal Name:	Registration:	42-A-1398
Photo Taken:	Tue, Nov 16, '10 approximately 1000	Nick Menne Tiffany Menne		
Inspection:	320101251280317			
Description:	Accumulation of unnecessary materials next to enclosures in shed facility.

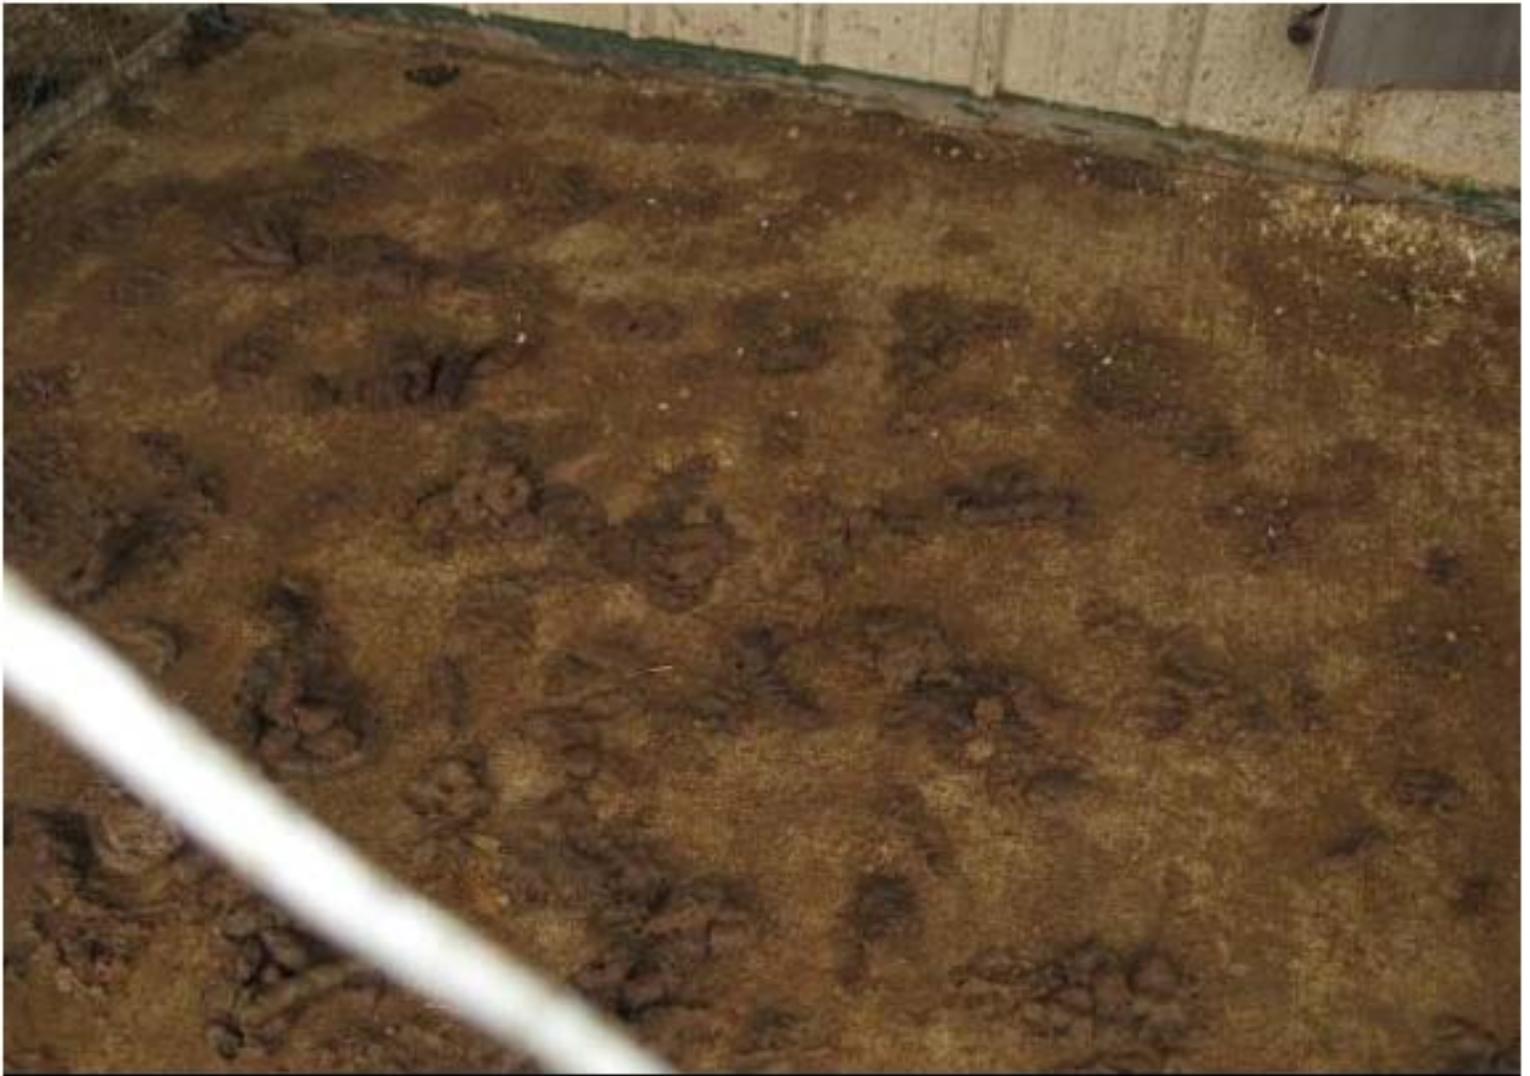
CFR: 3.11 (a)

Photographer:	Cynthia M. Neis	Legal Name:	Registration:	42-A-1398
Photo Taken:	Tue, Nov 16, '10 approximately 1000	Nick Menne Tiffany Menne		
Inspection:	320101251280317			
Description:	Excessive accumulation of dog waste.

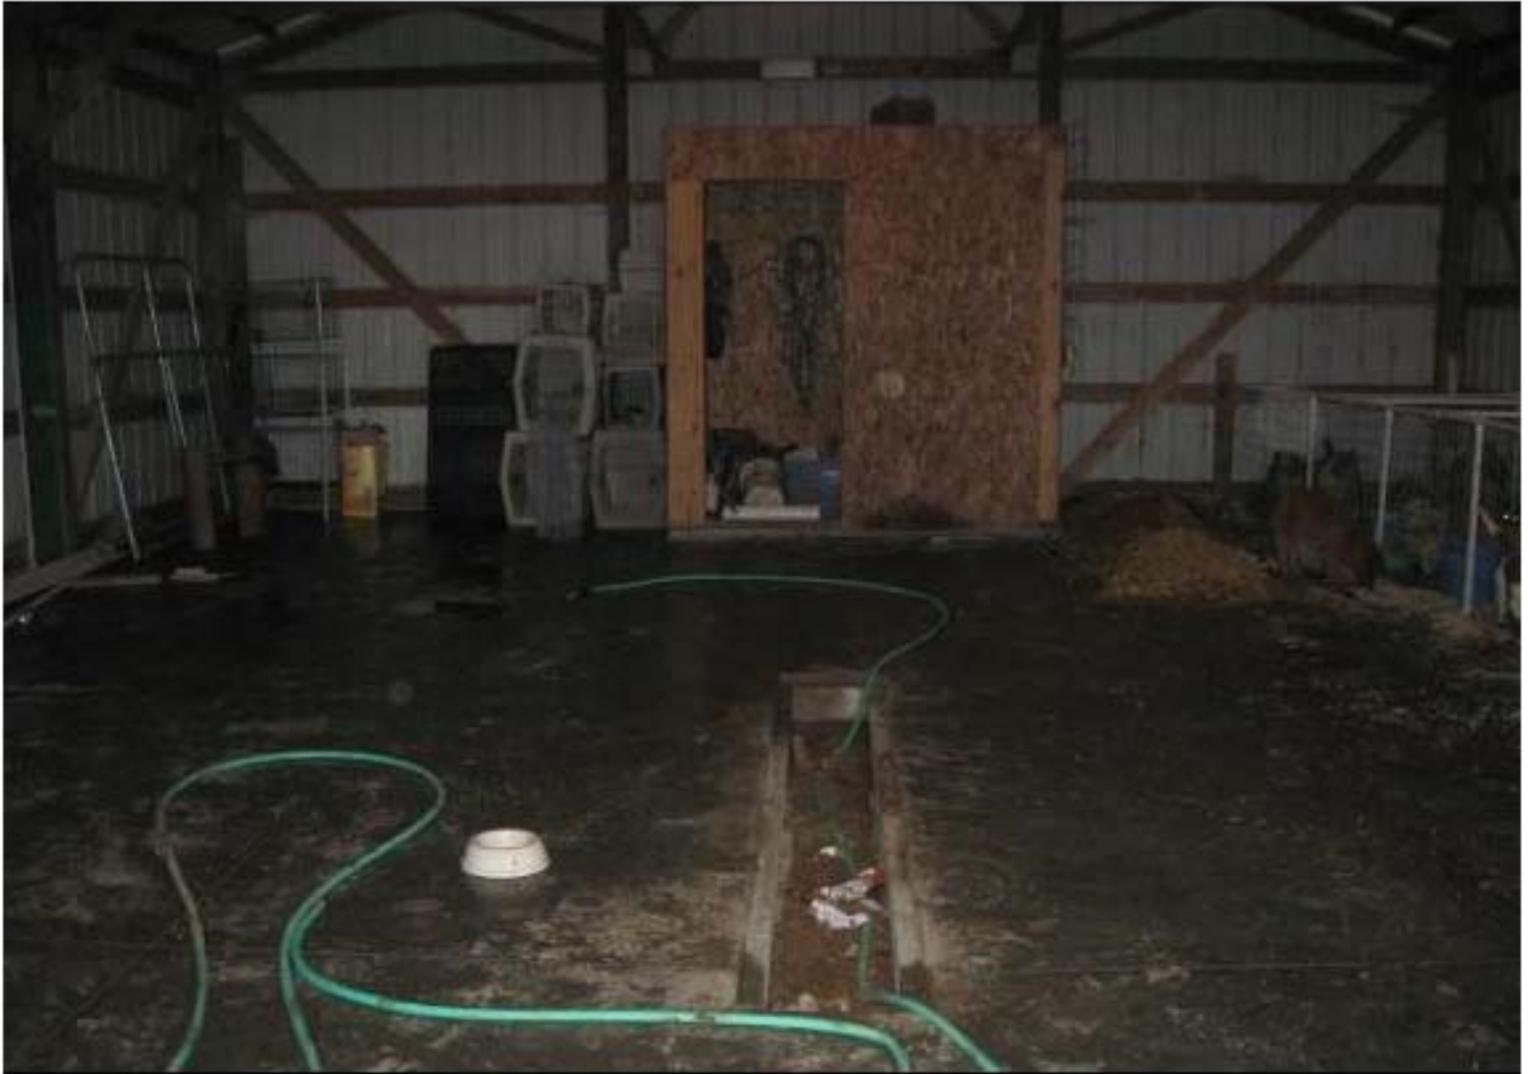
CFR: 3.11 (c)

Photographer:	Cynthia M. Neis	Legal Name:	Registration:	42-A-1398
Photo Taken:	Tue, Nov 16, '10 approximately 1000	Nick Menne Tiffany Menne		
Inspection:	320101251280317			
Description:	Accumulation of storage items in shed facility. For example: pet carriers, enclosures, caging supplies, and discarded bedding.

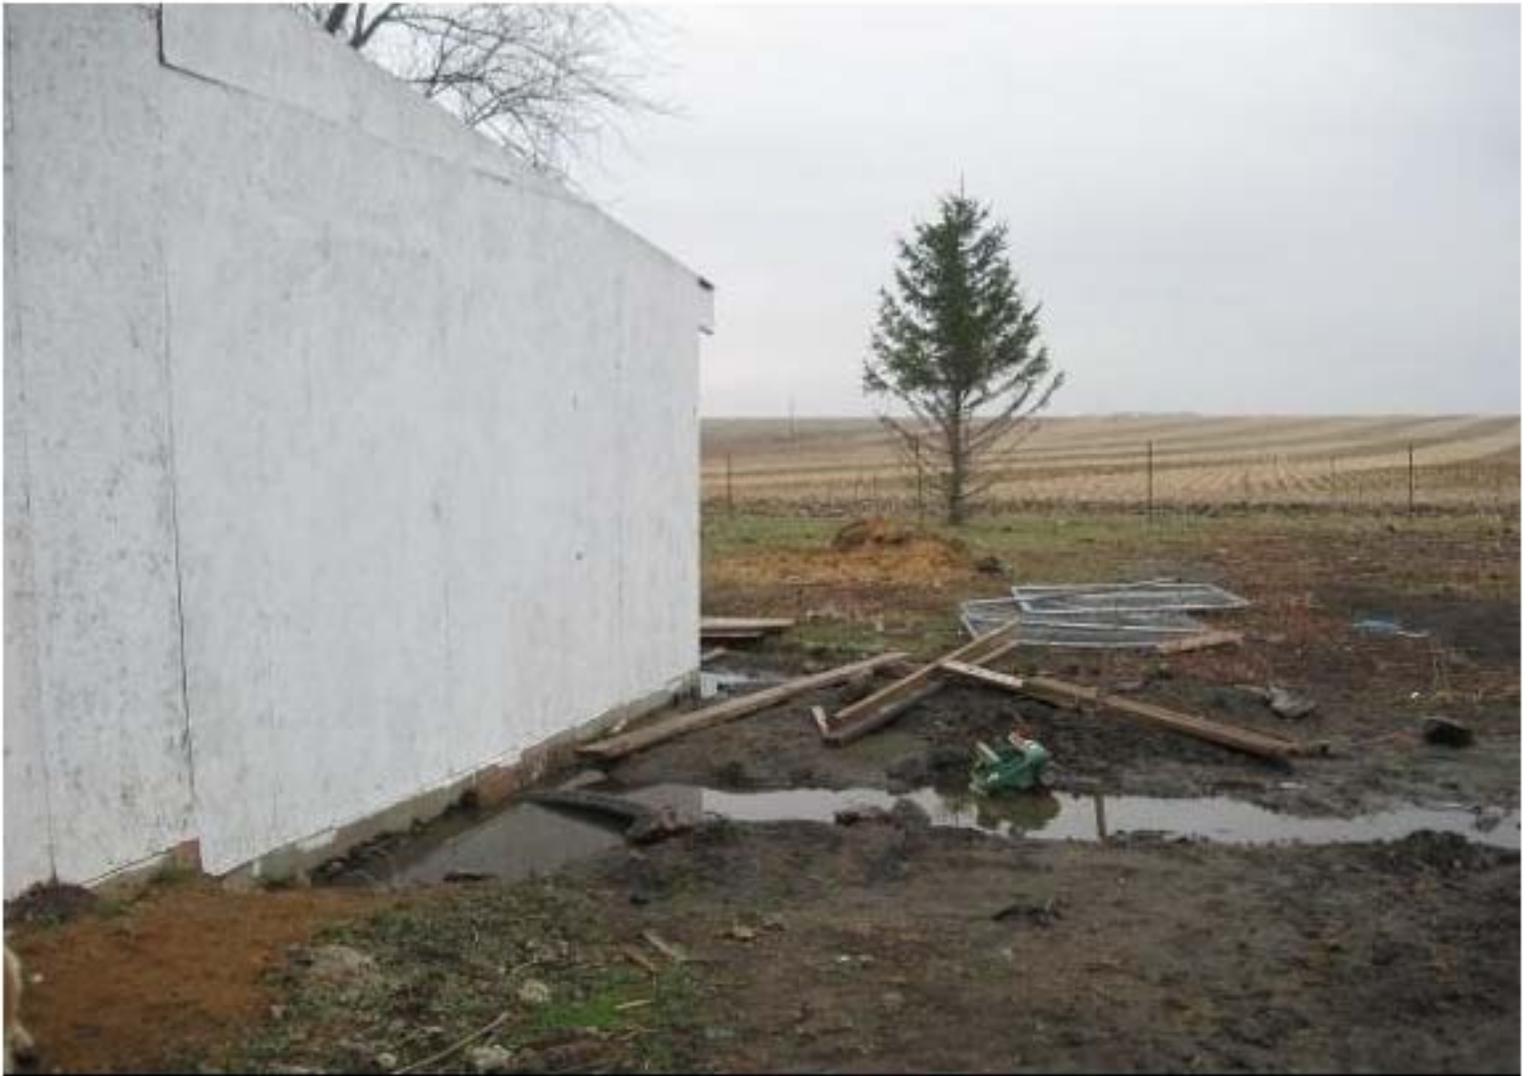
CFR: 3.11 (c)

Photographer:	Cynthia M. Neis	Legal Name:	Registration:	42-A-1398
Photo Taken:	Tue, Nov 16, '10 approximately 1000	Nick Menne Tiffany Menne		
Inspection:	320101251280317			
Description:	Accumulation of materials outside of whelping facility.

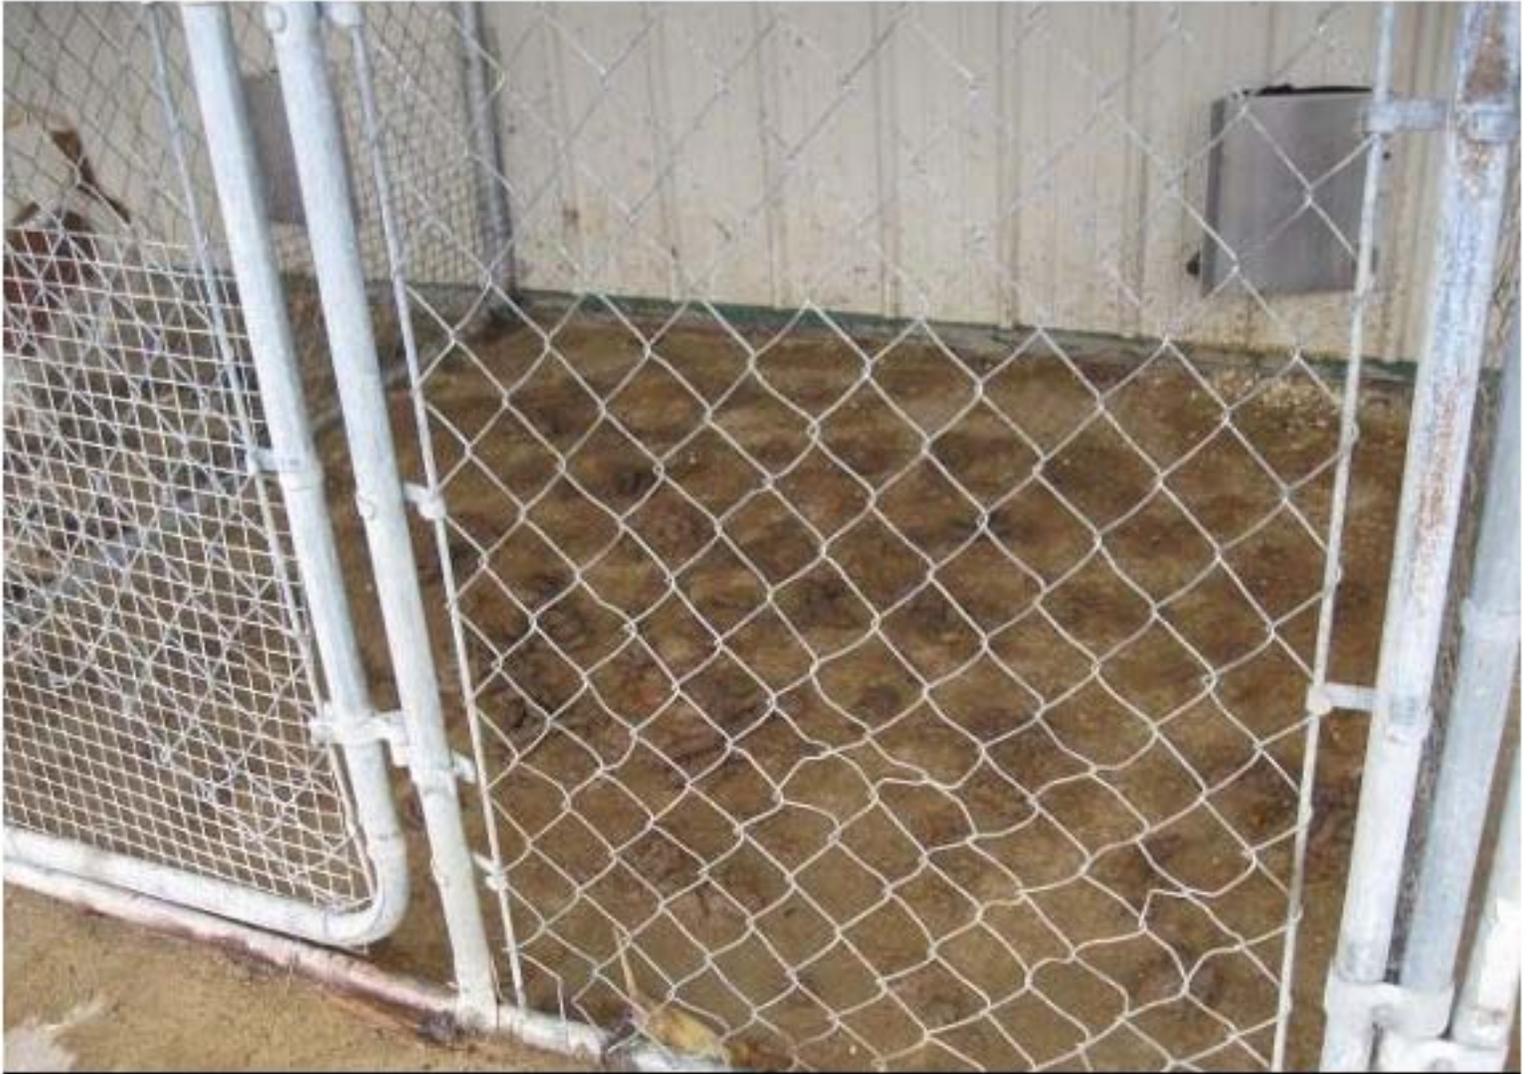
CFR: 3.11 (a)

Photographer:	Cynthia M. Neis	Legal Name:	Registration:	42-A-1398
Photo Taken:	Tue, Nov 16, '10 approximately 1000	Nick Menne Tiffany Menne		
Inspection:	320101251280317			
Description:	Excessive accumulation of dog waste.

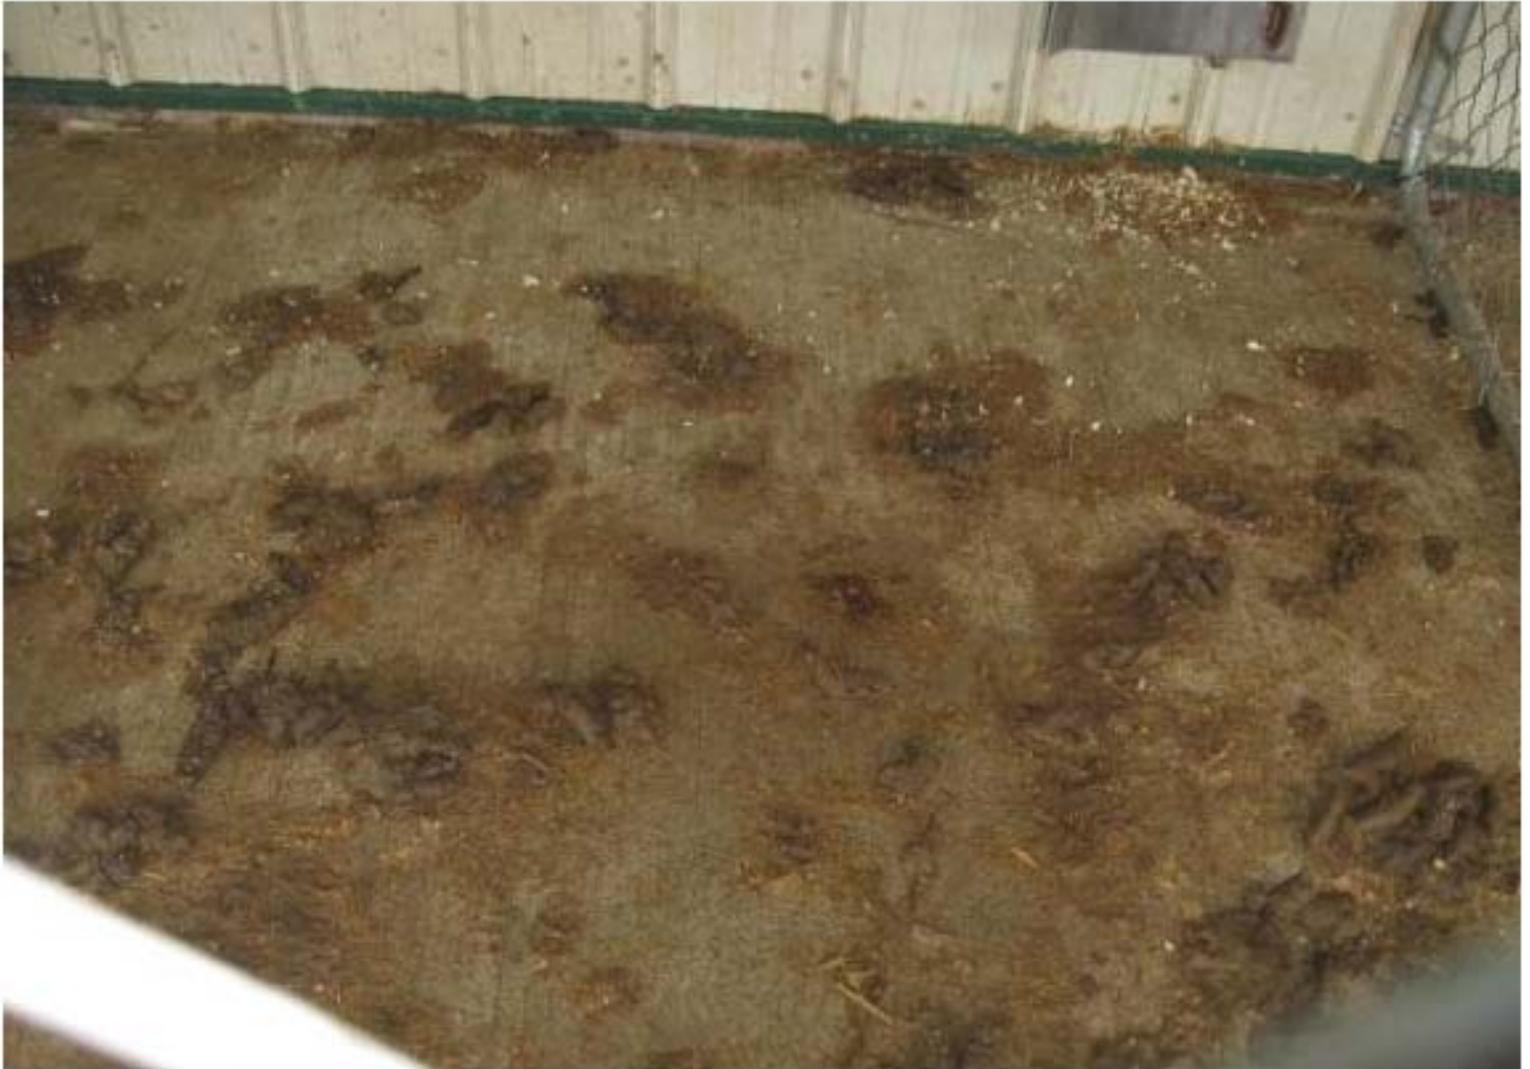
CFR: 3.11 (a)

Photographer:	Cynthia M. Neis	Legal Name:	Registration:	42-A-1398
Photo Taken:	Tue, Nov 16, '10 approximately 1000	Nick Menne		
Inspection:	320101251280317	Tiffany Menne		
Description:	Excessive accumulation of dog waste.

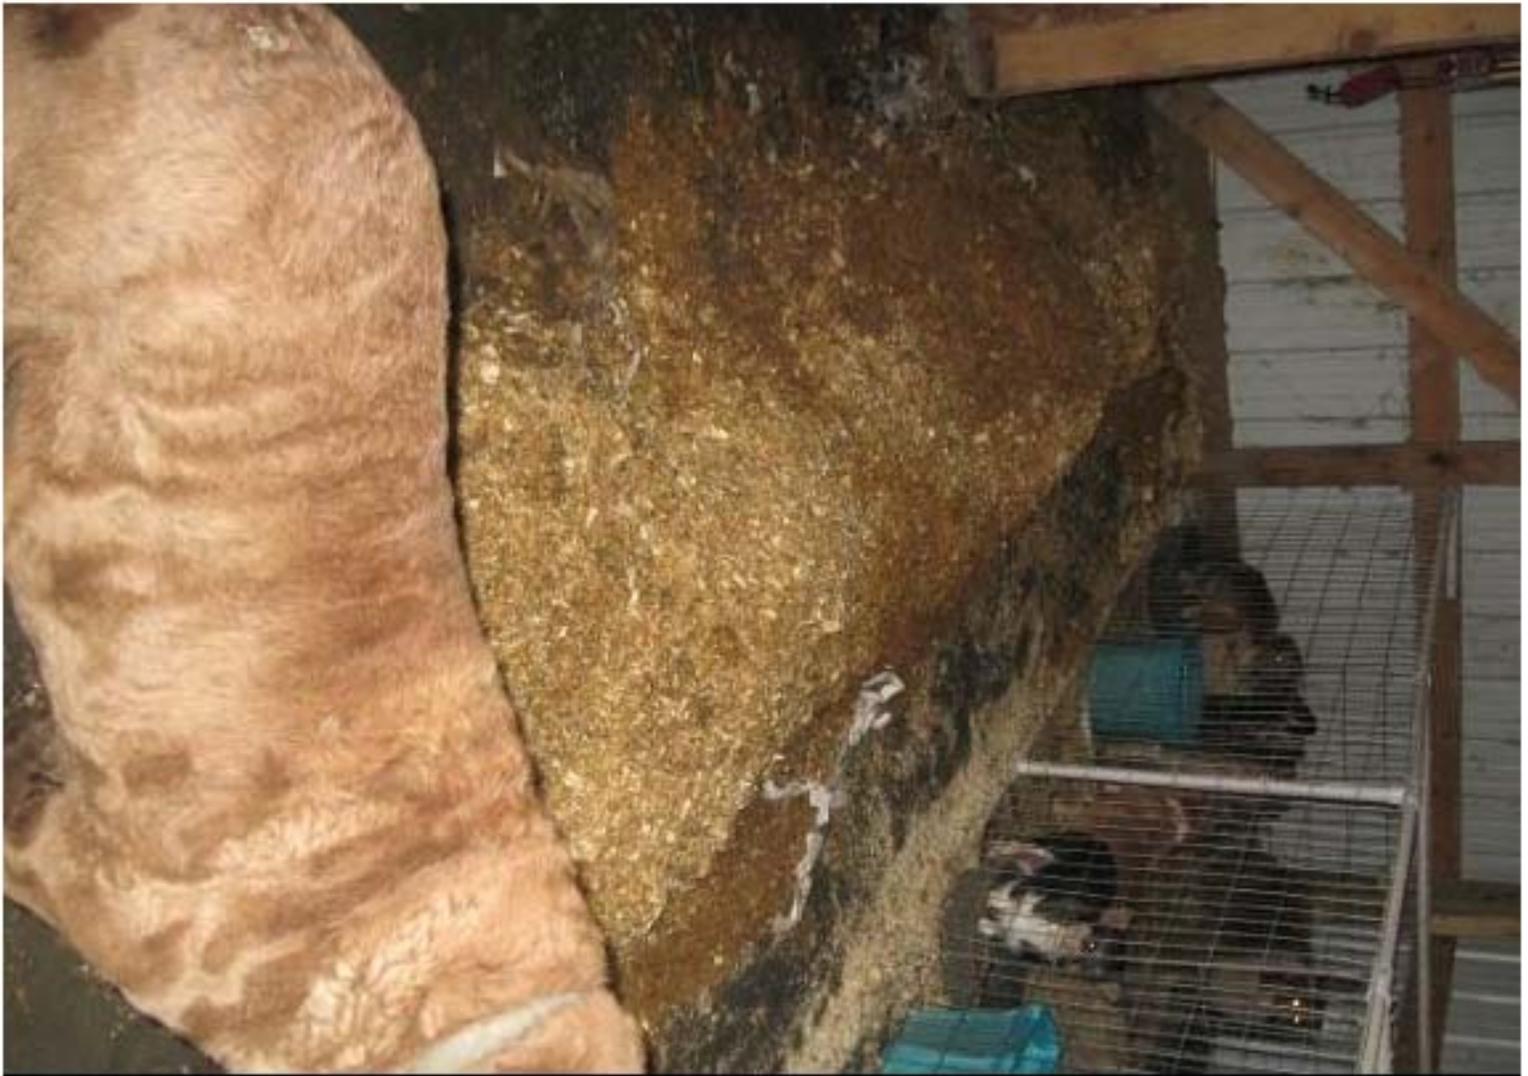
CFR: 3.11 (c)

Photographer:	Cynthia M. Neis	Legal Name:	Registration:	42-A-1398
Photo Taken:	Tue, Nov 16, '10 approximately 1000	Nick Menne Tiffany Menne		
Inspection:	320101251280317			
Description:	Discarded bedding stored immediately outside of dog in enclosures in shed facility.

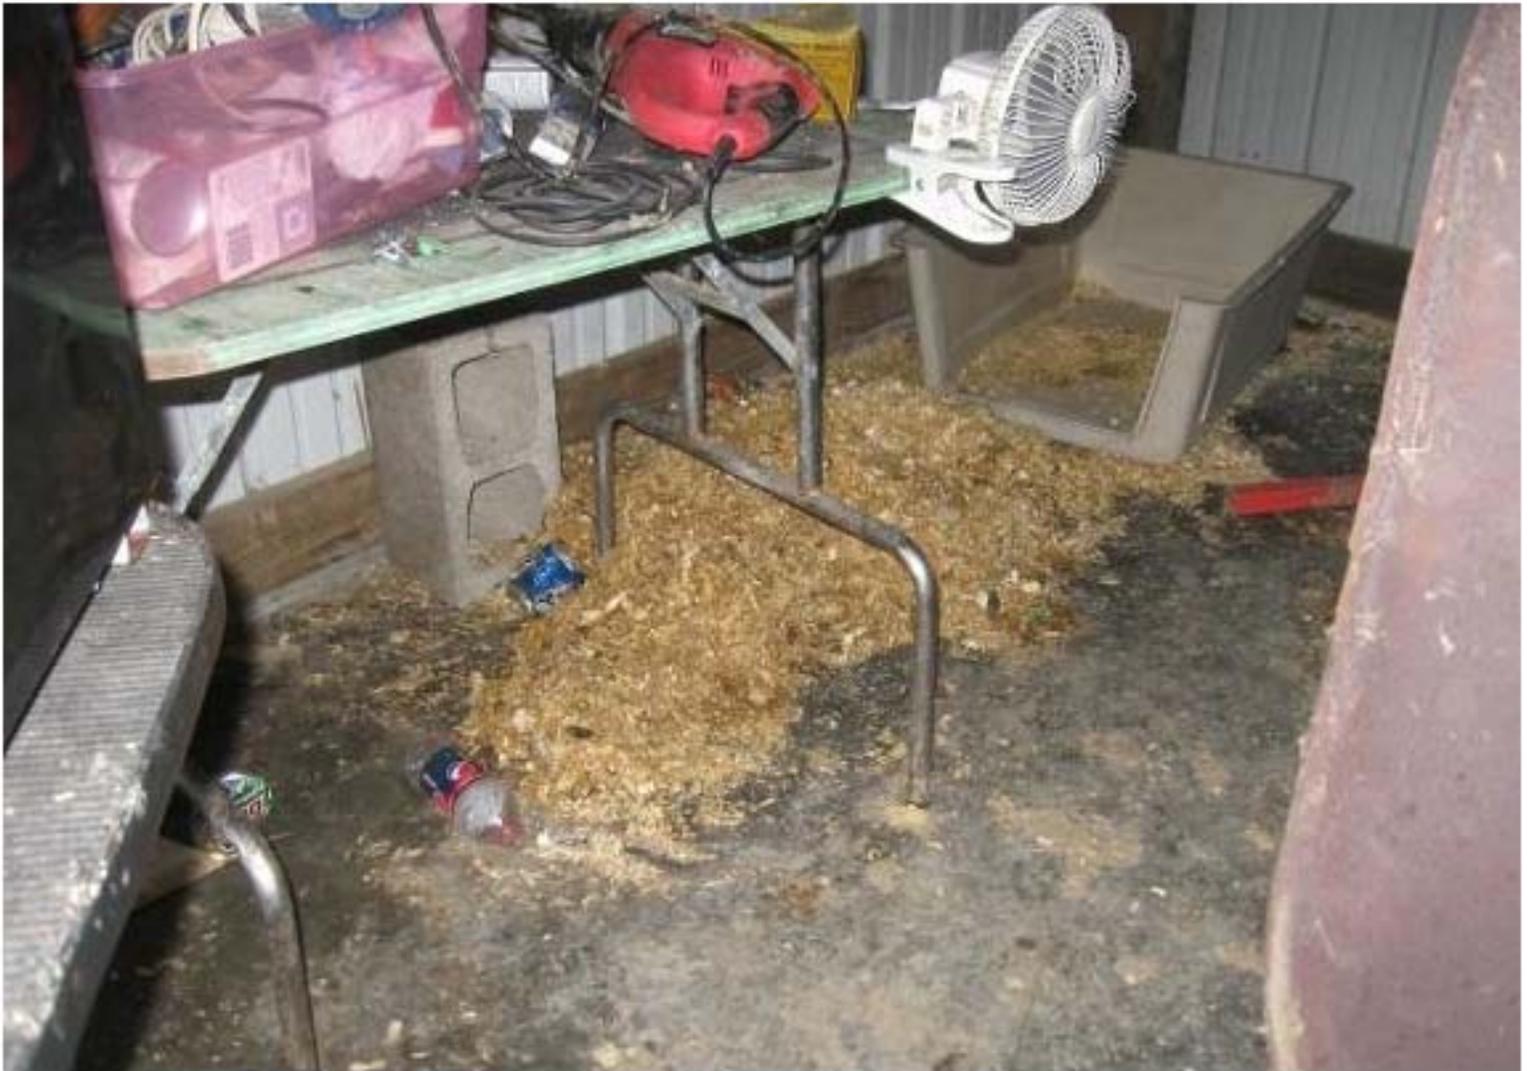
CFR: 3.11 (c)

Photographer:	Cynthia M. Neis	Legal Name:	Registration:	42-A-1398
Photo Taken:	Tue, Nov 16, '10 approximately 1000	Nick Menne Tiffany Menne		
Inspection:	320101251280317			
Description:	Accumulation of discarded bedding and building supplies.

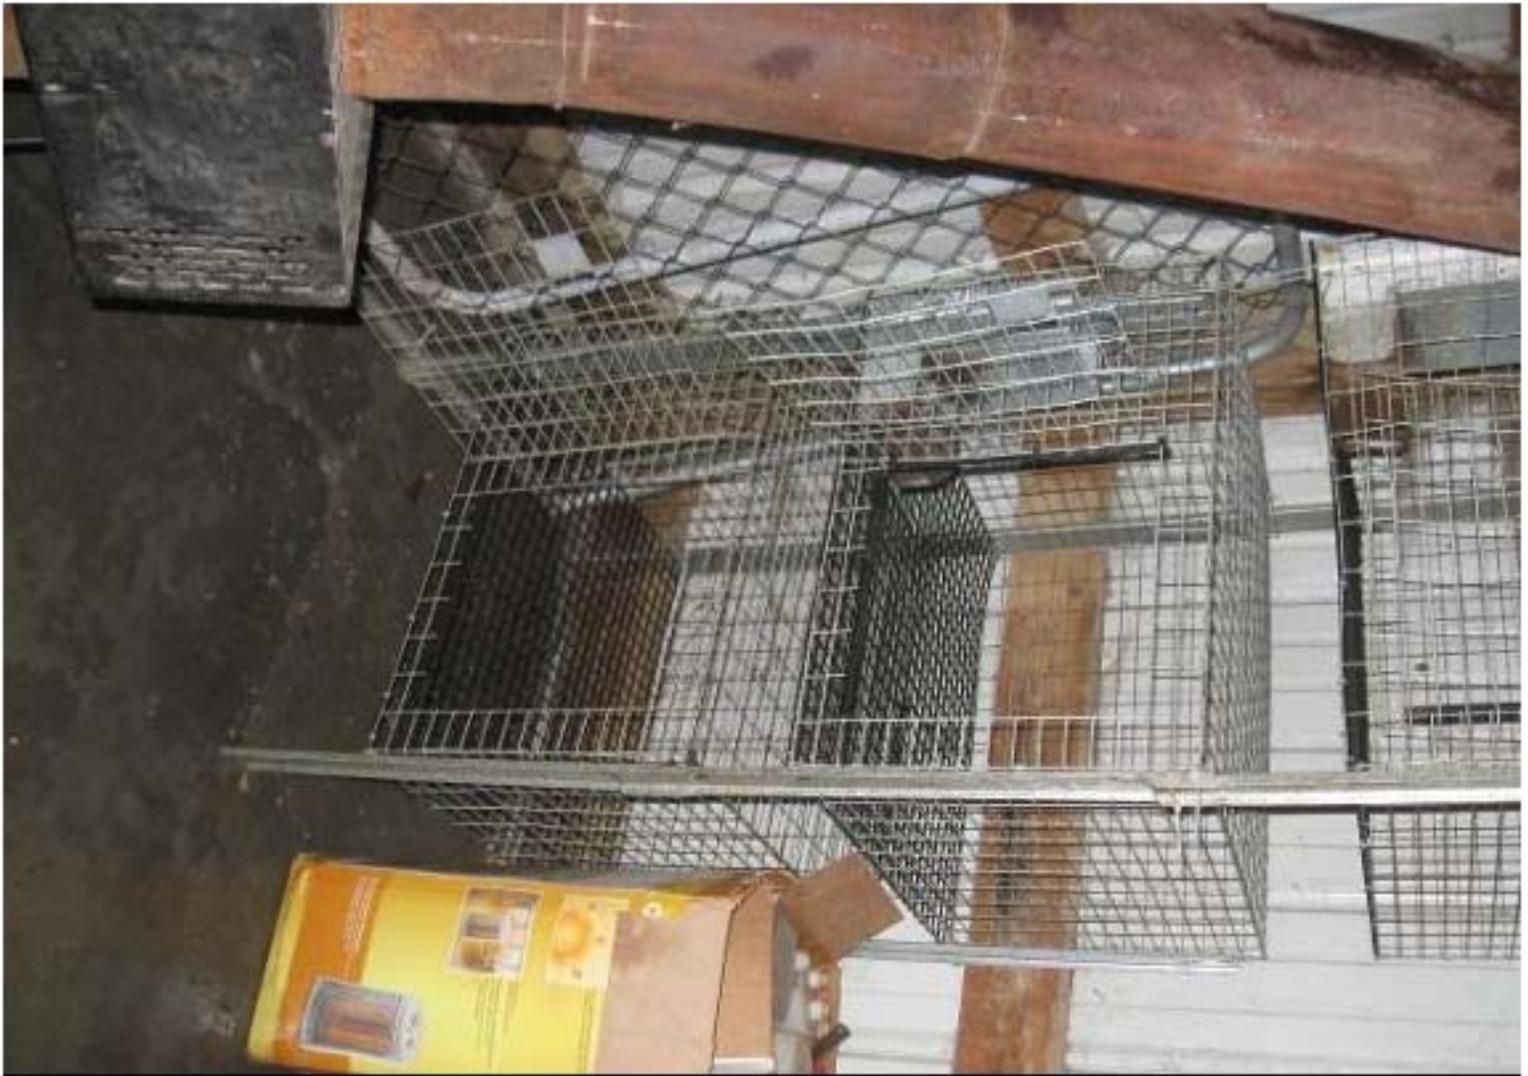
CFR: 3.11 (c)

Photographer:	Cynthia M. Neis	Legal Name:	Registration:	42-A-1398
Photo Taken:	Tue, Nov 16, '10 approximately 1000	Nick Menne Tiffany Menne		
Inspection:	320101251280317			
Description:	Storage of caging material in shed facility.
