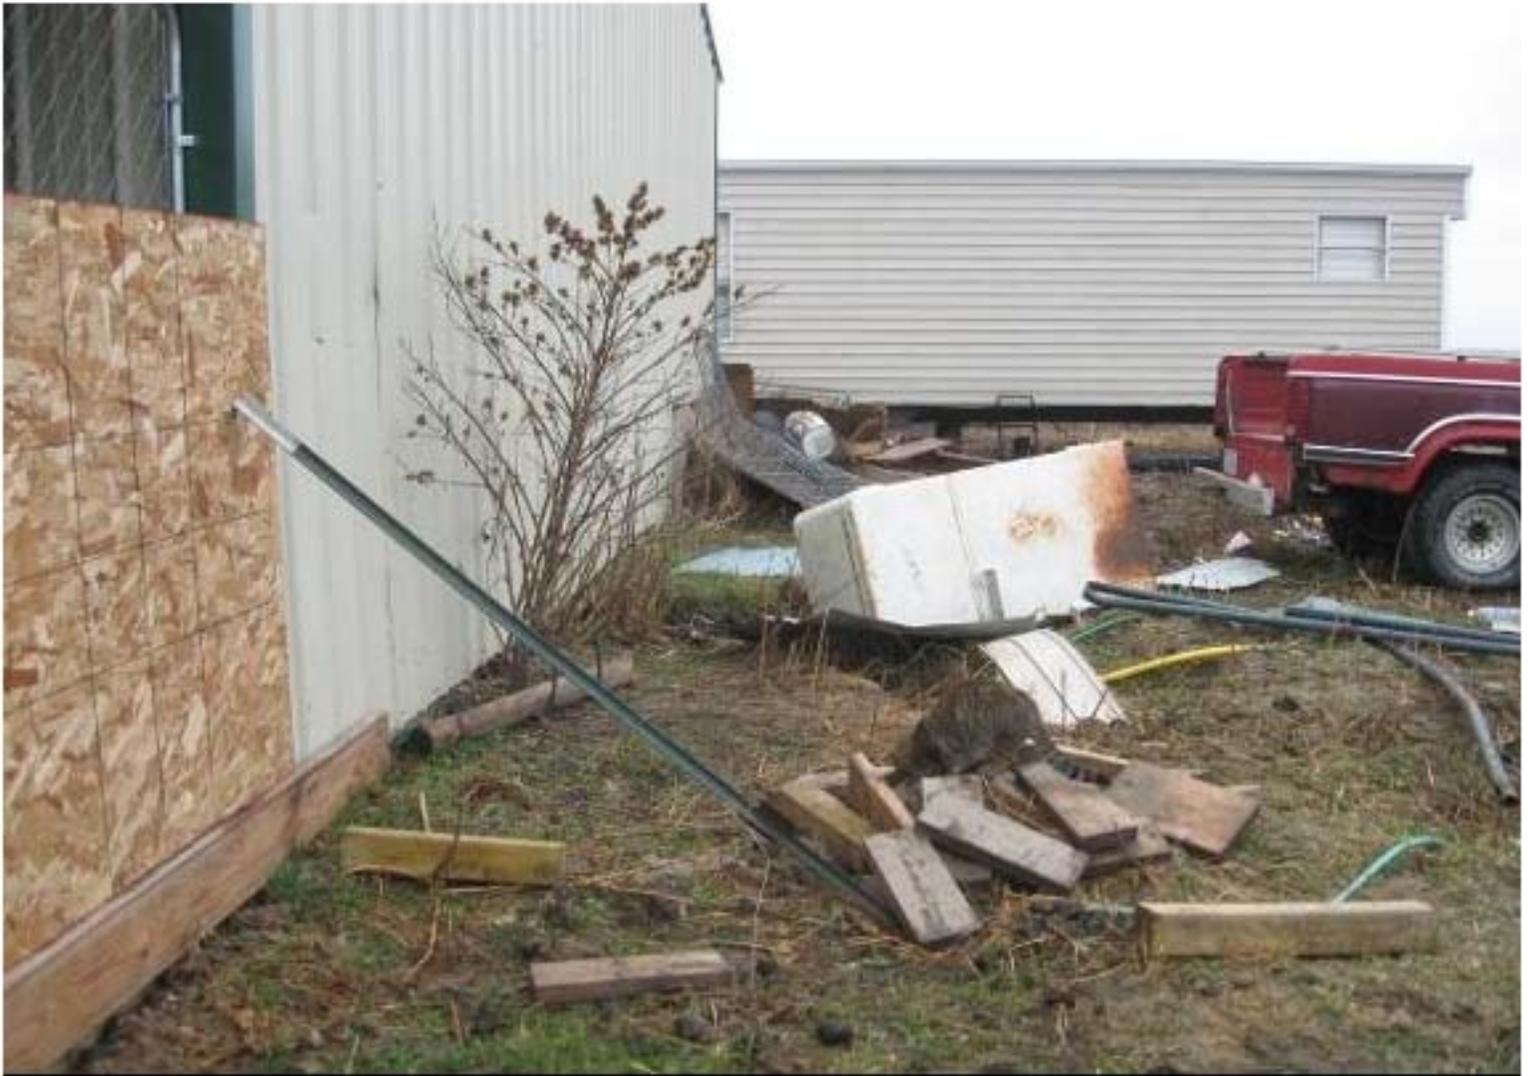
CFR: 3.11 (c)

Photographer:	Cynthia M. Neis	Legal Name:	Registration:	42-A-1398
Photo Taken:	Tue, Nov 16, '10 approximately 1000	Nick Menne Tiffany Menne		
Inspection:	320101251280317			
Description:	Accumulation of discarded materials along back of shed facility.

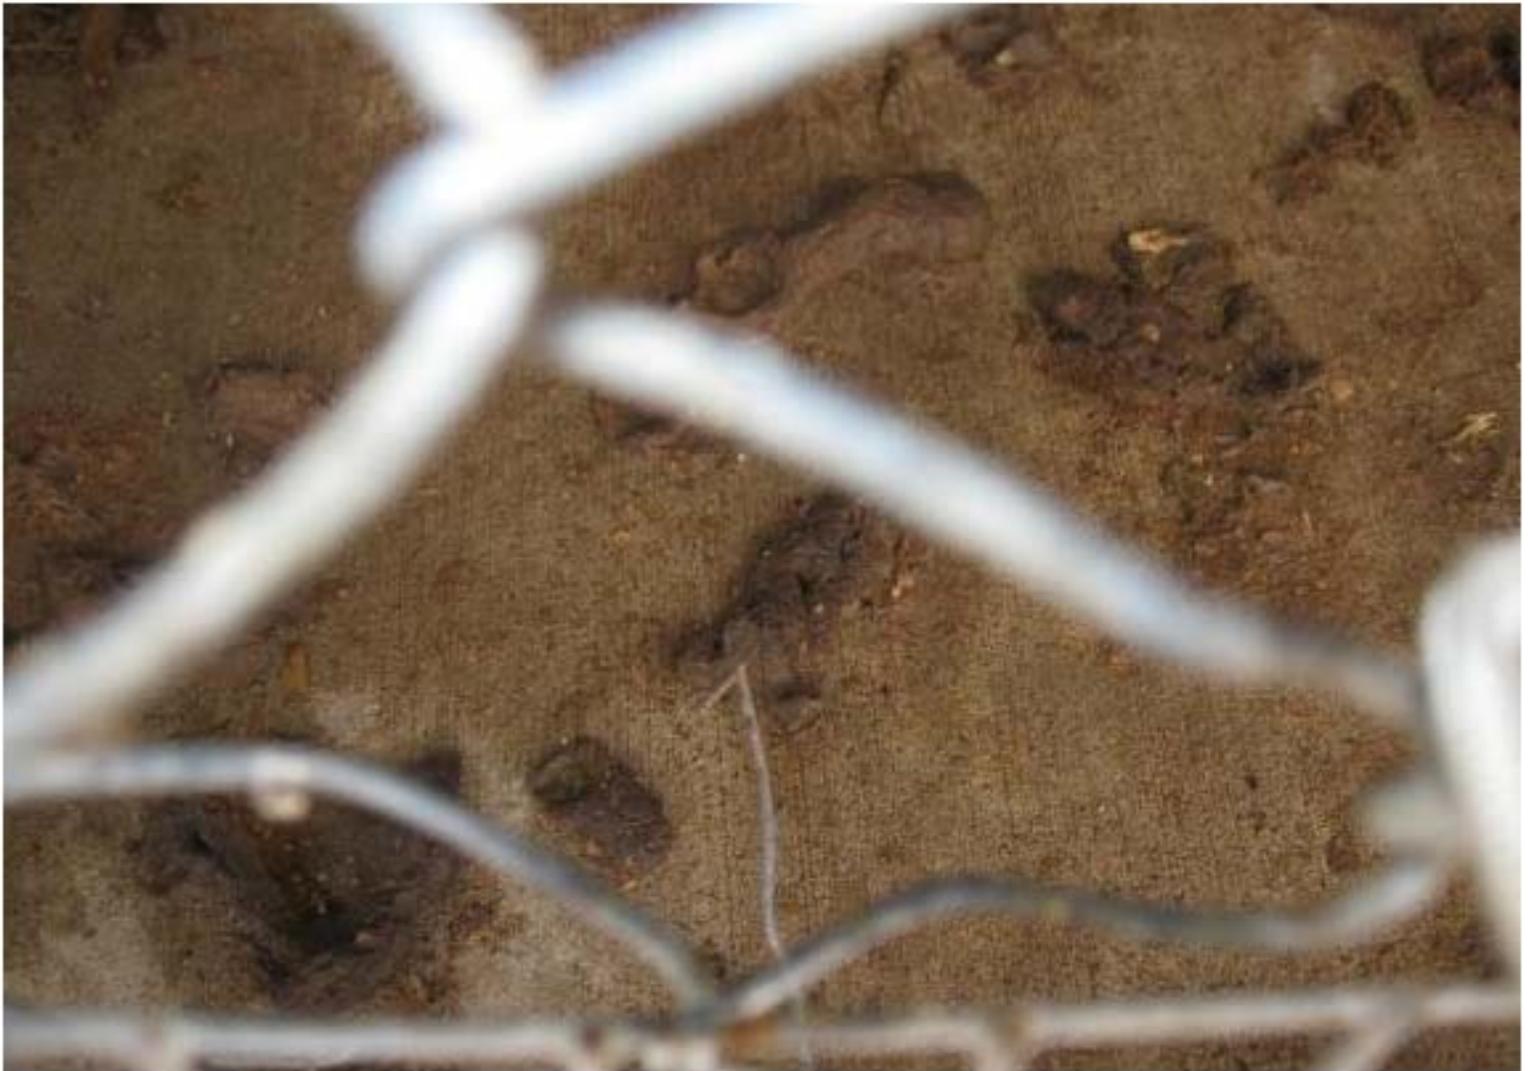
CFR: 3.6 (a) (2) (i), 3.11 (a)

Photographer:	Cynthia M. Neis	Legal Name:	Registration:	42-A-1398
Photo Taken:	Tue, Nov 16, '10 approximately 1000	Nick Menne Tiffany Menne		
Inspection:	320101251280317			
Description:	Excessive accumulation of dog waste. Wire protruding into enclosure.

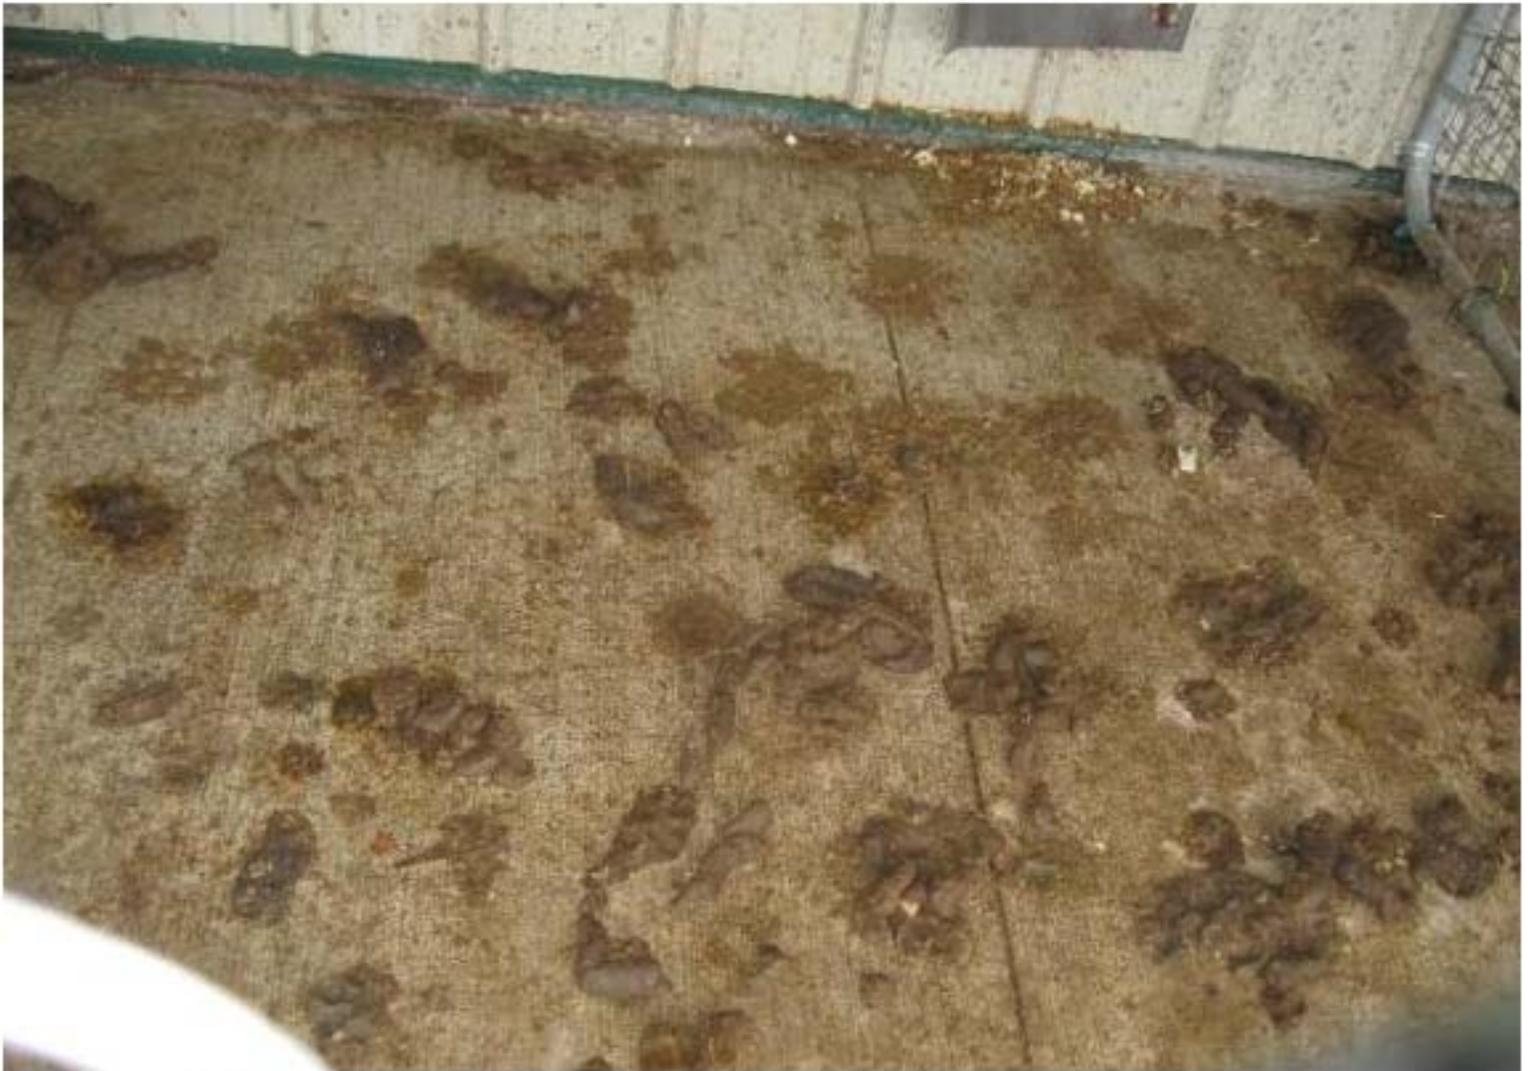
CFR: 3.11 (a)

Photographer:	Cynthia M. Neis	Legal Name:	Registration:	42-A-1398
Photo Taken:	Tue, Nov 16, '10 approximately 1000	Nick Menne Tiffany Menne		
Inspection:	320101251280317			
Description:	Excessive accumulation of dog waste.

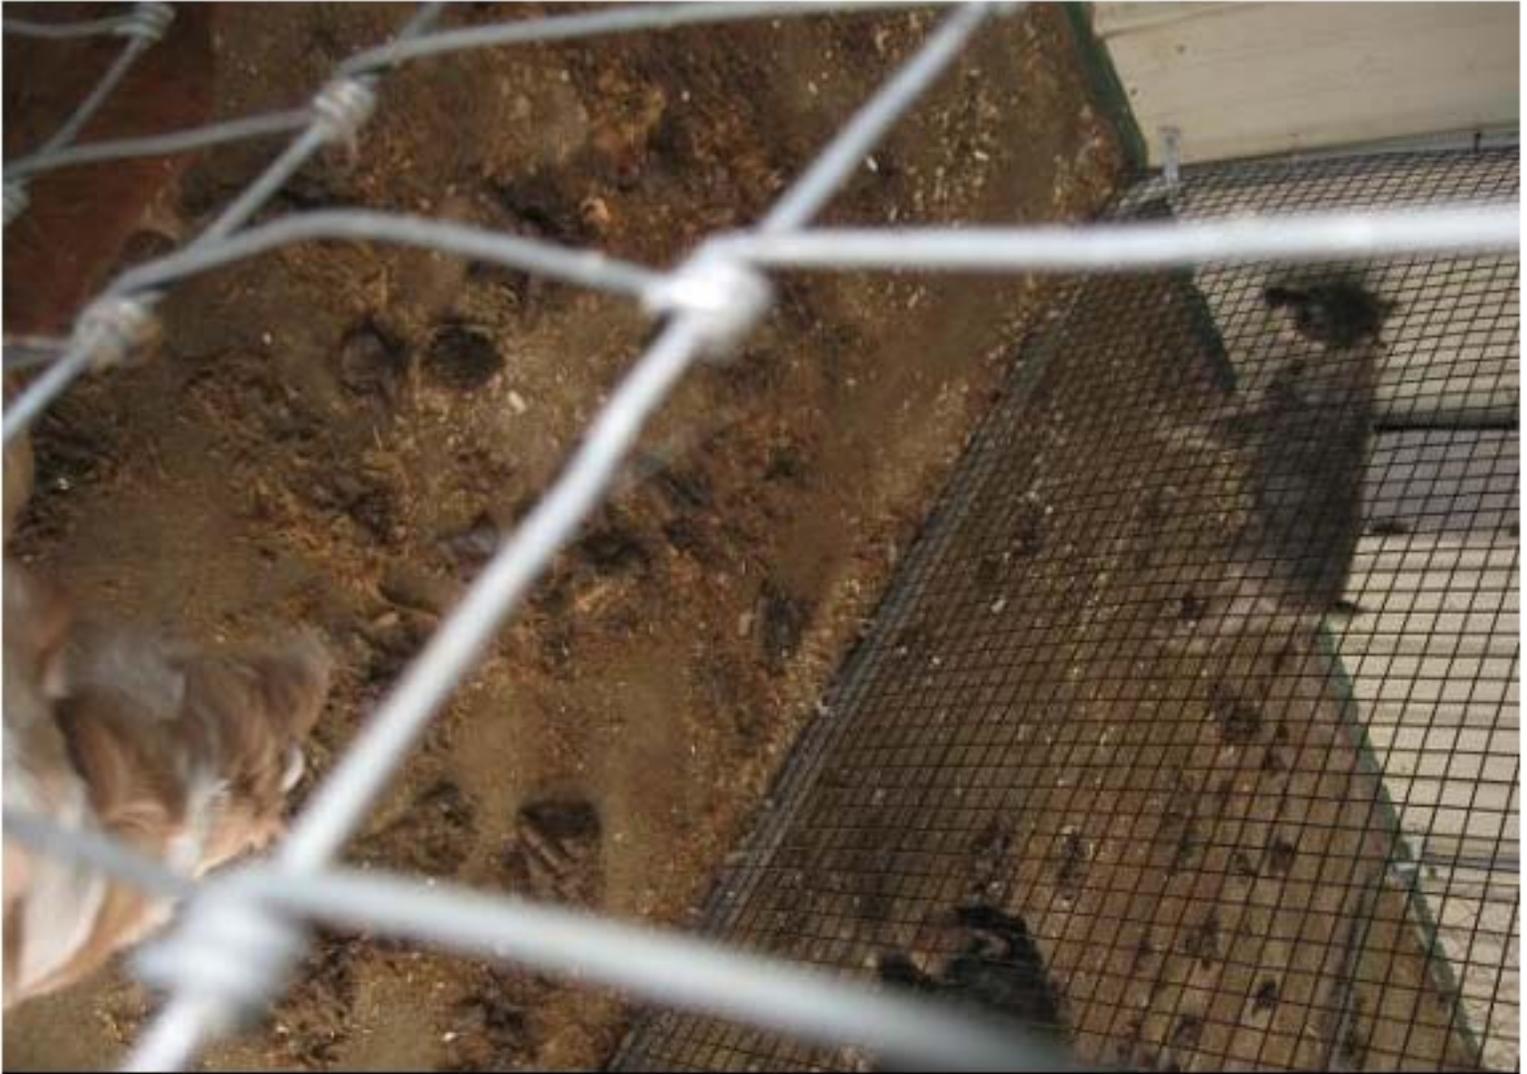
CFR: 3.11 (a)

Photographer:	Cynthia M. Neis	Legal Name:	Registration:	42-A-1398
Photo Taken:	Tue, Nov 16, '10 approximately 1000	Nick Menne Tiffany Menne		
Inspection:	320101251280317			
Description:	Excessive accumulation of dog waste.

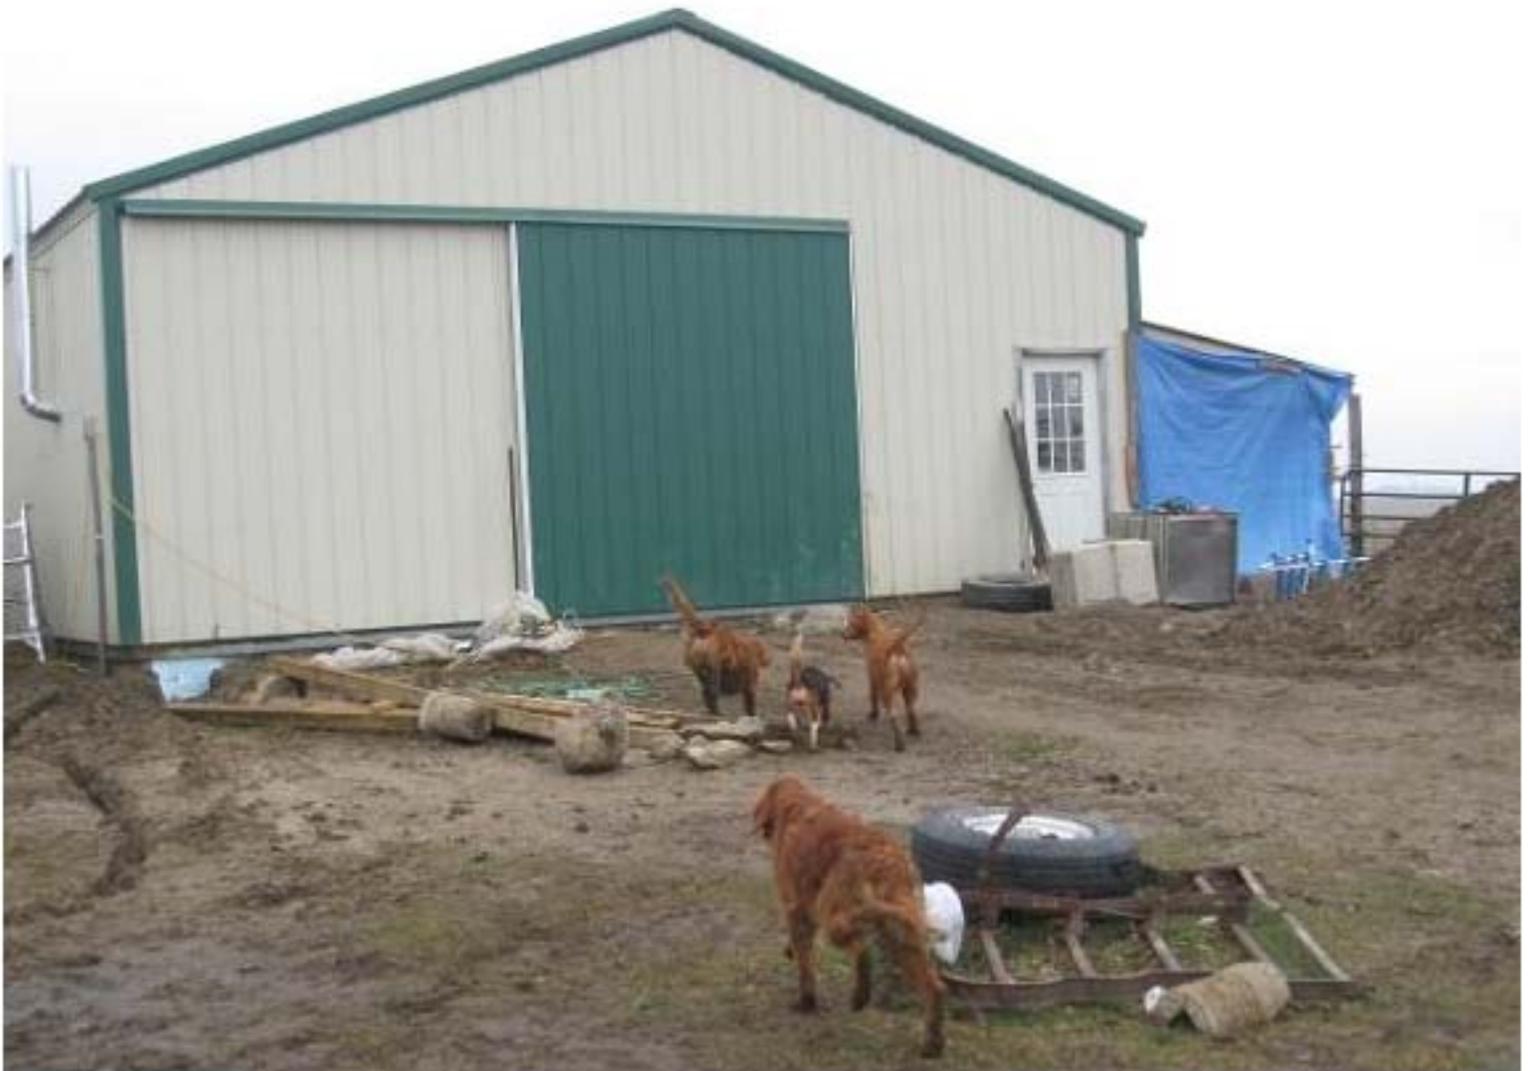
CFR: 3.11 (c)

Photographer:	Cynthia M. Neis	Legal Name:	Registration:	42-A-1398
Photo Taken:	Tue, Nov 16, '10 approximately 1000	Nick Menne Tiffany Menne		
Inspection:	320101251280317			
Description:	Accumulation of materials outside of dog facility. For example: poles, pet carriers, and cages.

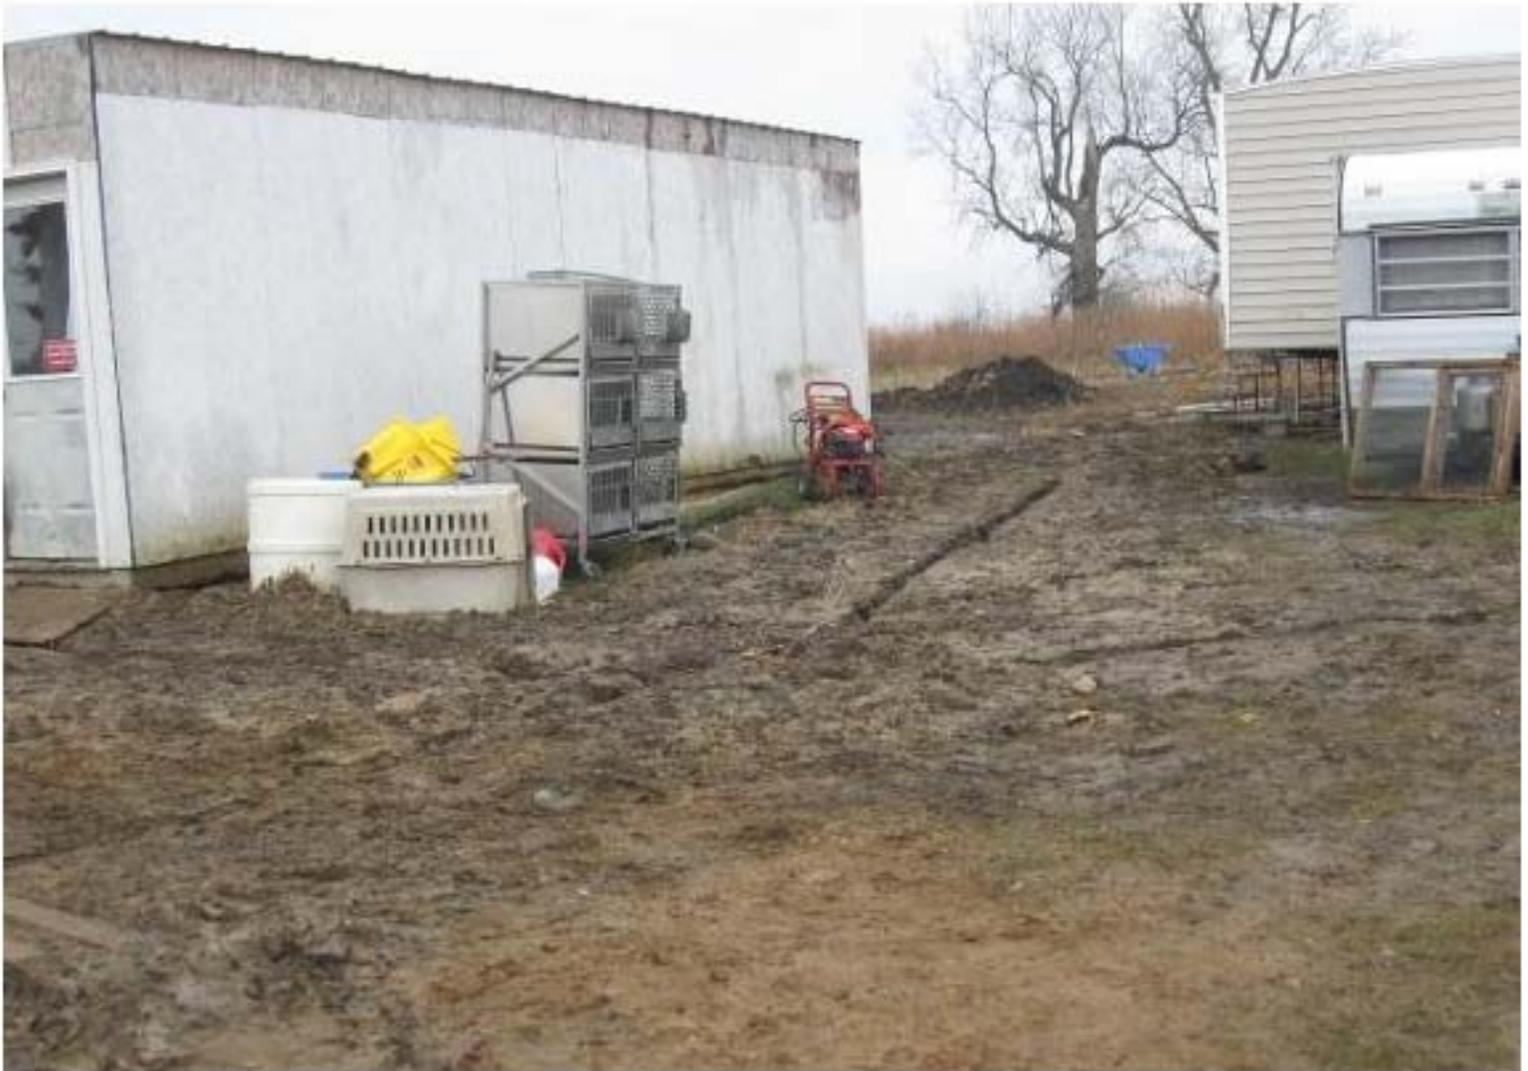
CFR: 3.11 (c)

Photographer:	Cynthia M. Neis	Legal Name:	Registration:	42-A-1398
Photo Taken:	Tue, Nov 16, '10 approximately 1000	Nick Menne Tiffany Menne		
Inspection:	320101251280317			
Description:	Accumulation of materials outside of dog facility. For example: barrels, pet carrier, stainless steel stacker cages, and a power washer.

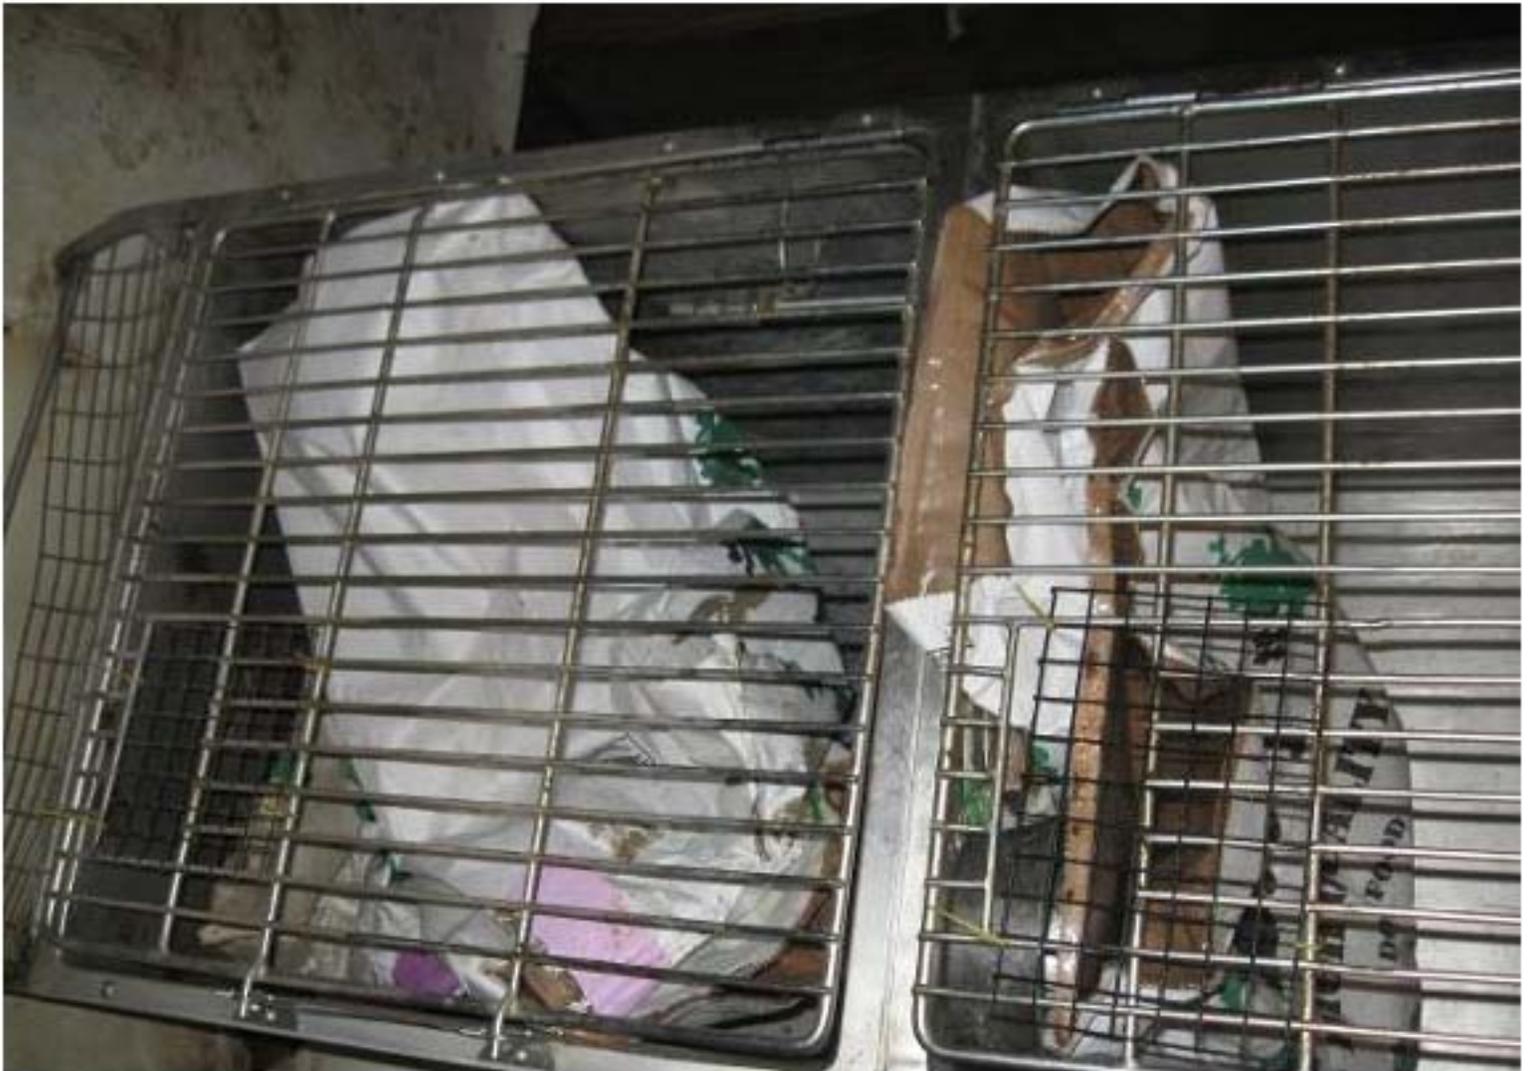
CFR: 3.11 (c)

Photographer:	Cynthia M. Neis	Legal Name:	Registration:	42-A-1398
Photo Taken:	Tue, Nov 16, '10 approximately 1000	Nick Menne		
Inspection:	320101251280317	Tiffany Menne		
Description:	Discarded bags stored in unused cages.

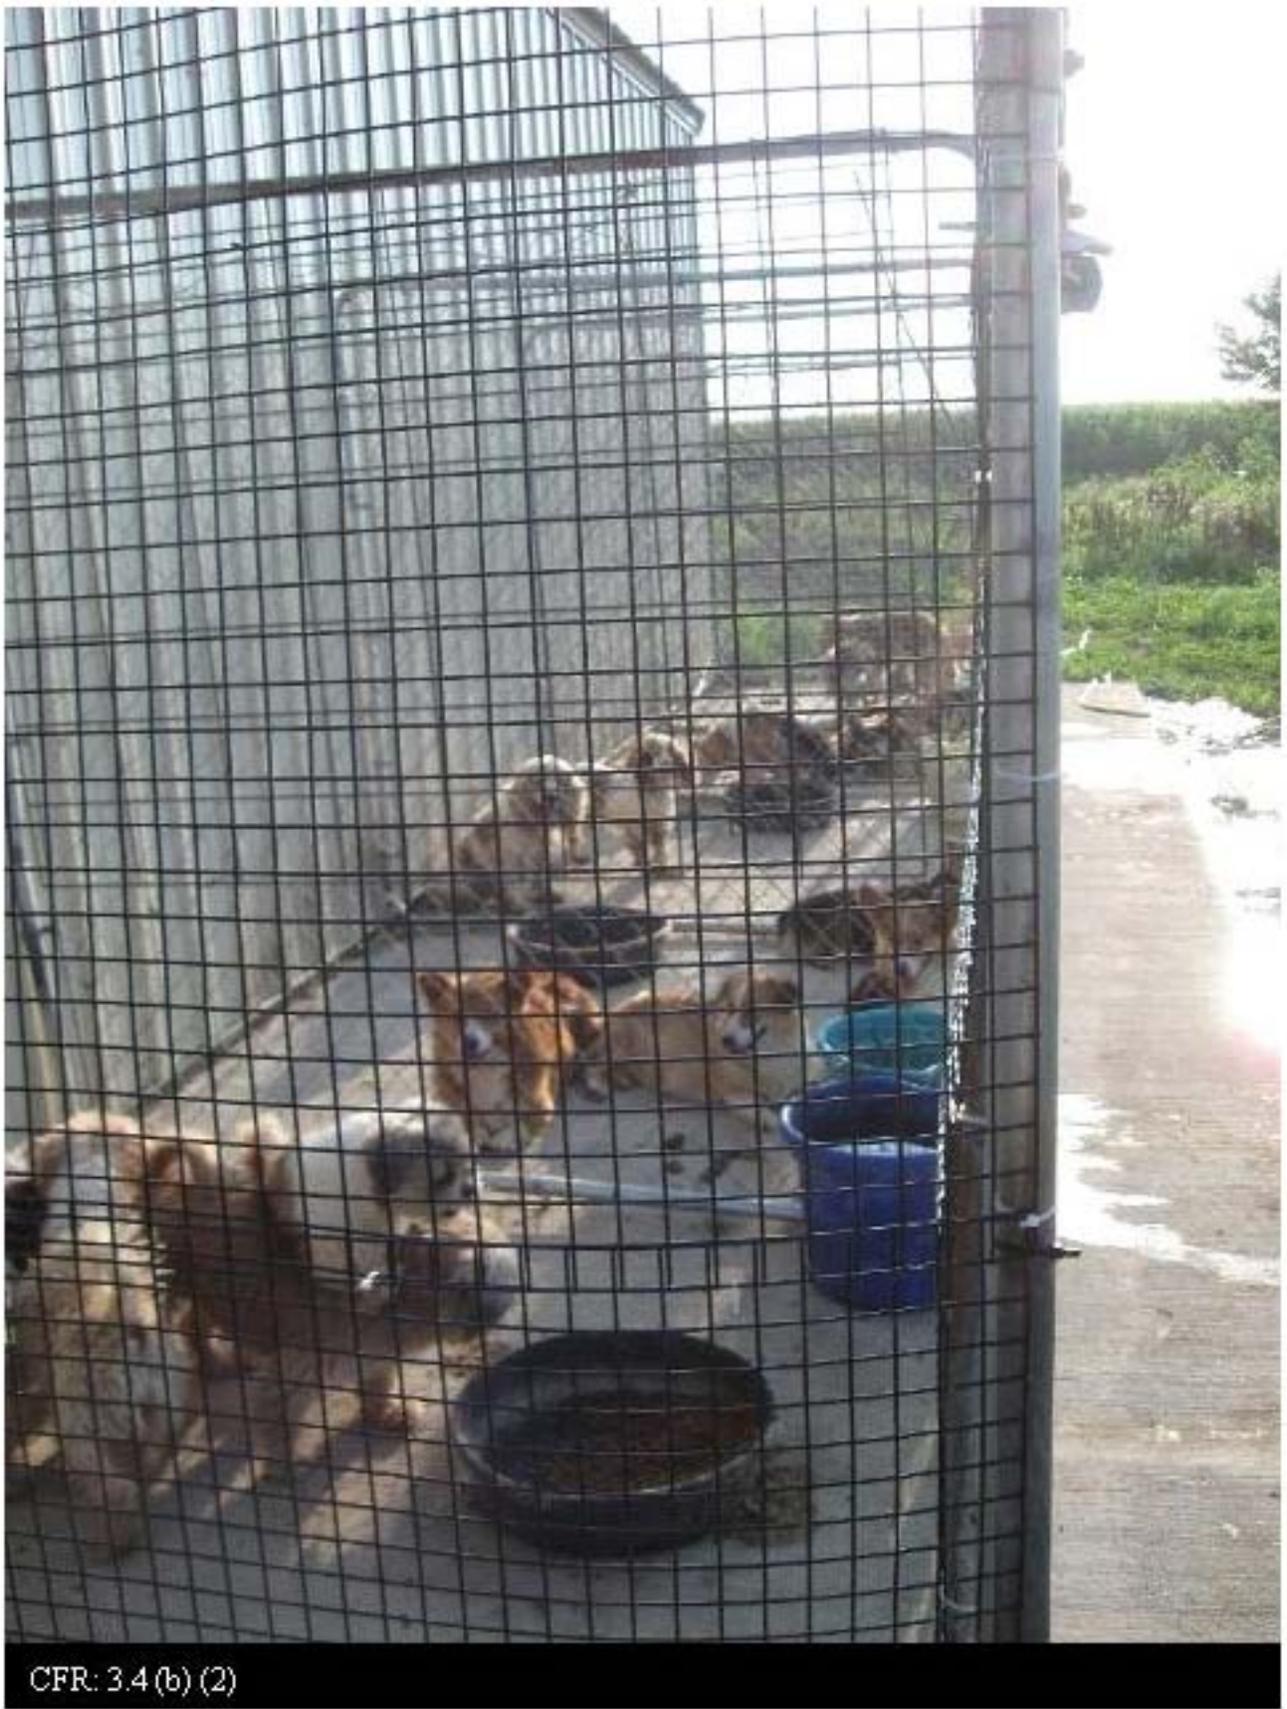
CFR: 3.4 (b) (2)

Photographer:	Cynthia M. Neis	Legal Name:	Registration:	42-A-1398
Photo Taken:	Wed, Aug 4, '10 approximately 1845	Nick Menne Tiffany Menne		
Inspection:	216102302590812			
Description:	Dogs in outdoor enclosures with no shelters.

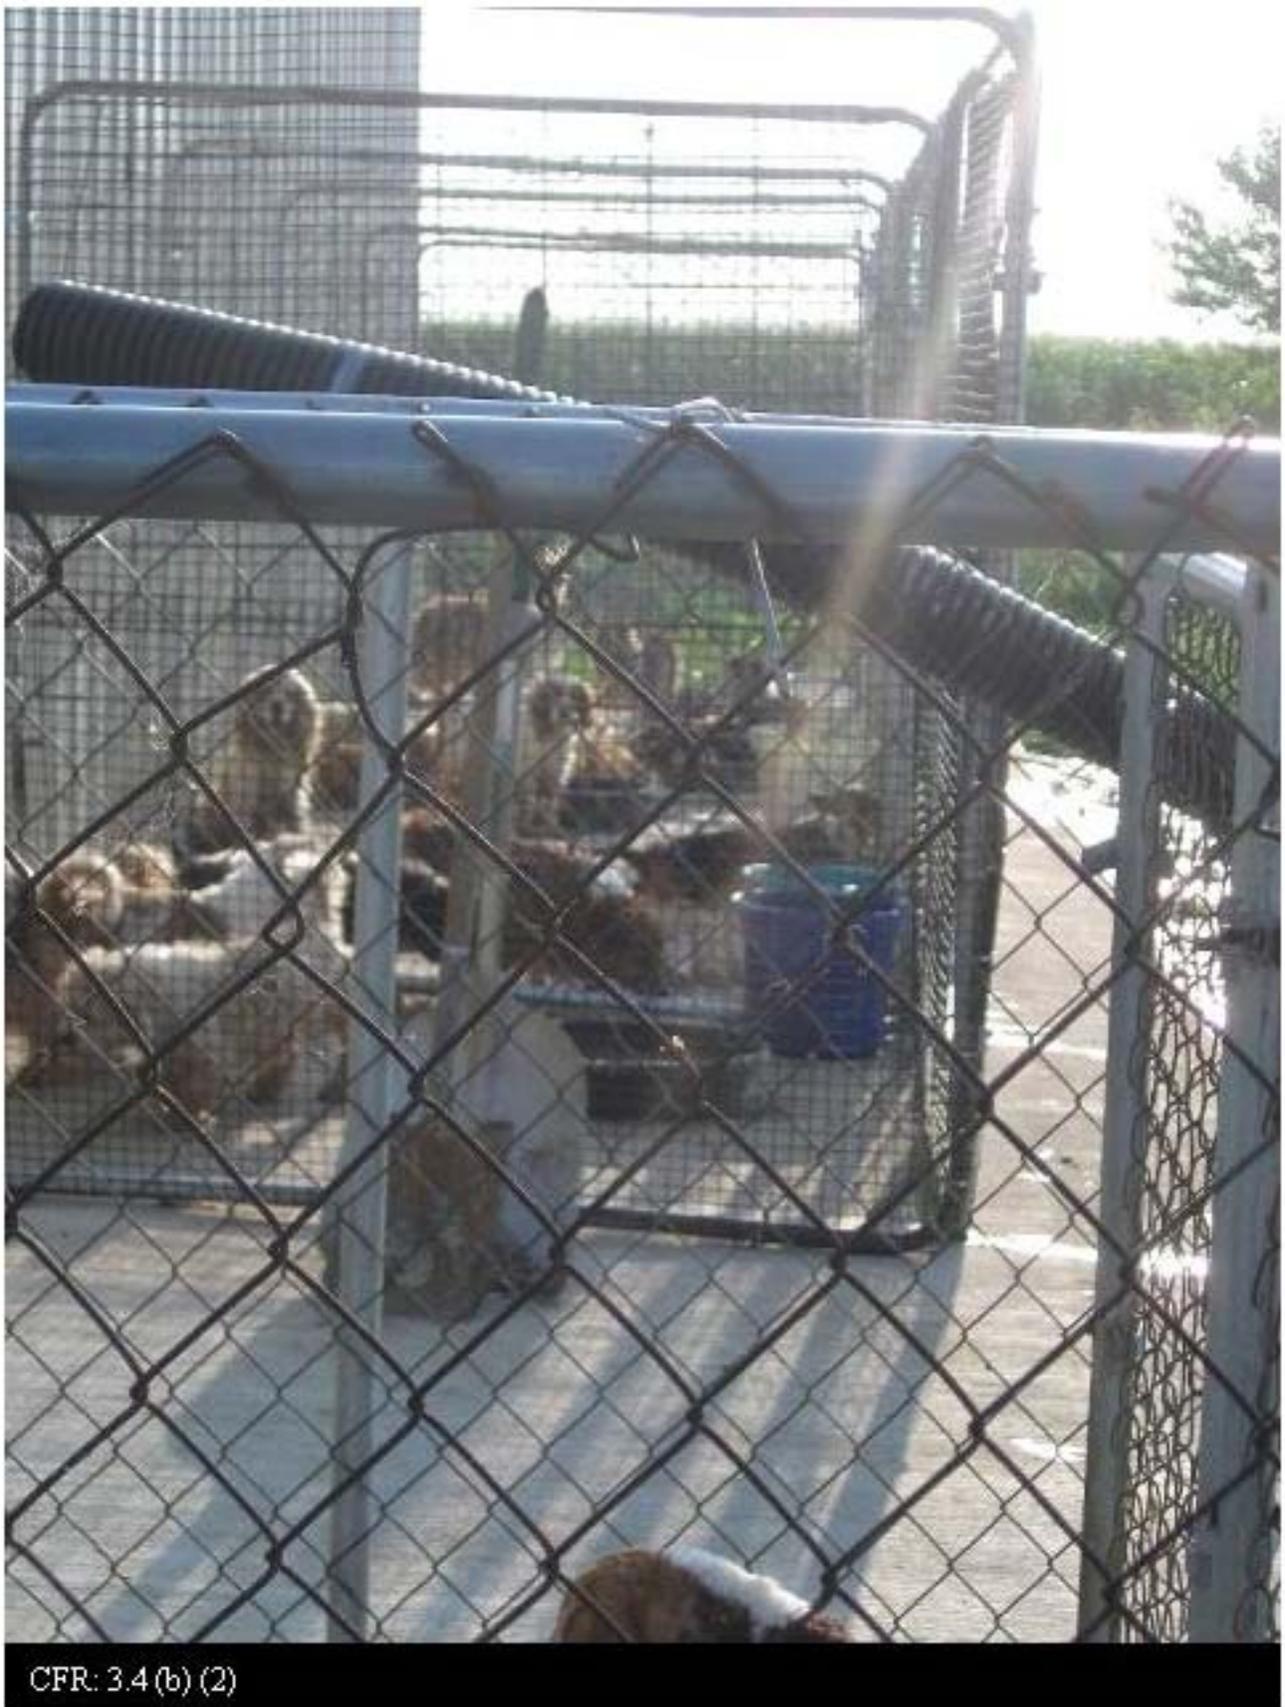
CFR: 3.4 (b) (2)

Photographer:	Cynthia M. Neis	Legal Name:	Nick Menne Tiffany Menne	Registration:	42-A-1398
Photo Taken:	Wed, Aug 4, '10 approximately 1845				
Inspection:	216102302590812				
Description:	Dogs in outdoor enclosures with no shelters.

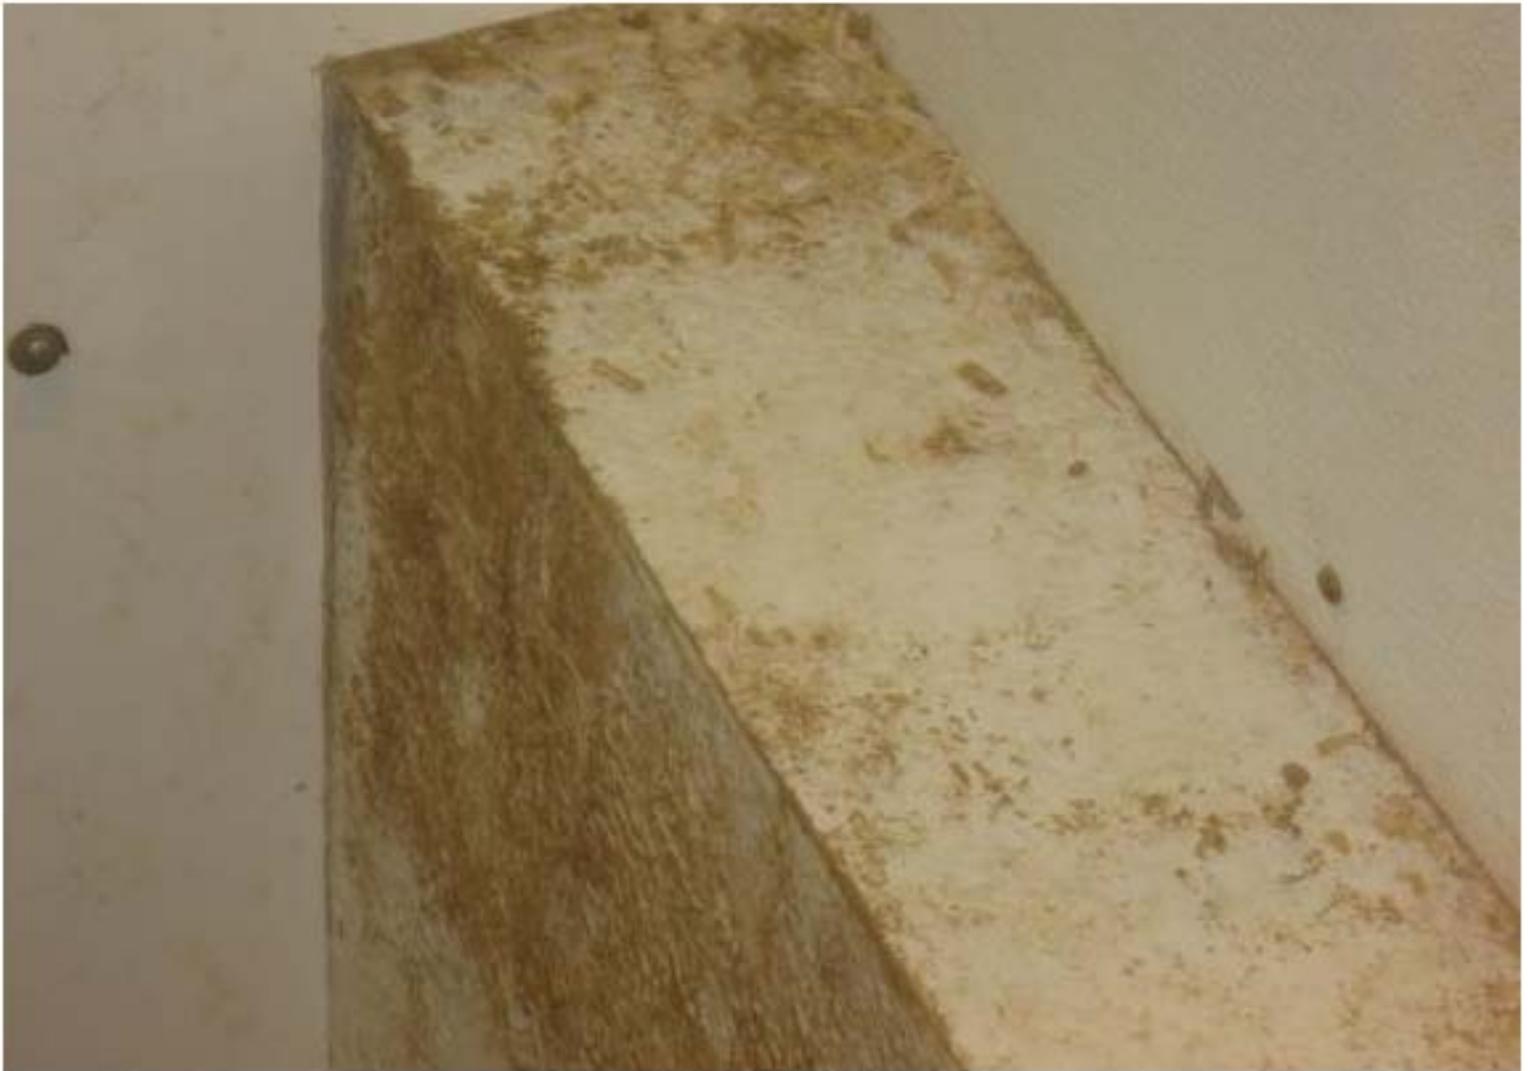
CFR: 3.1 (c) (3)

Photographer:	Dr. Watkins	Legal Name:	Registration:	42-A-1387
Photo Taken:	Tue, Feb 16, '10 1pm	Curtis Wordes		
Inspection:	47100933420873			
Description:	Walls in New Nursery

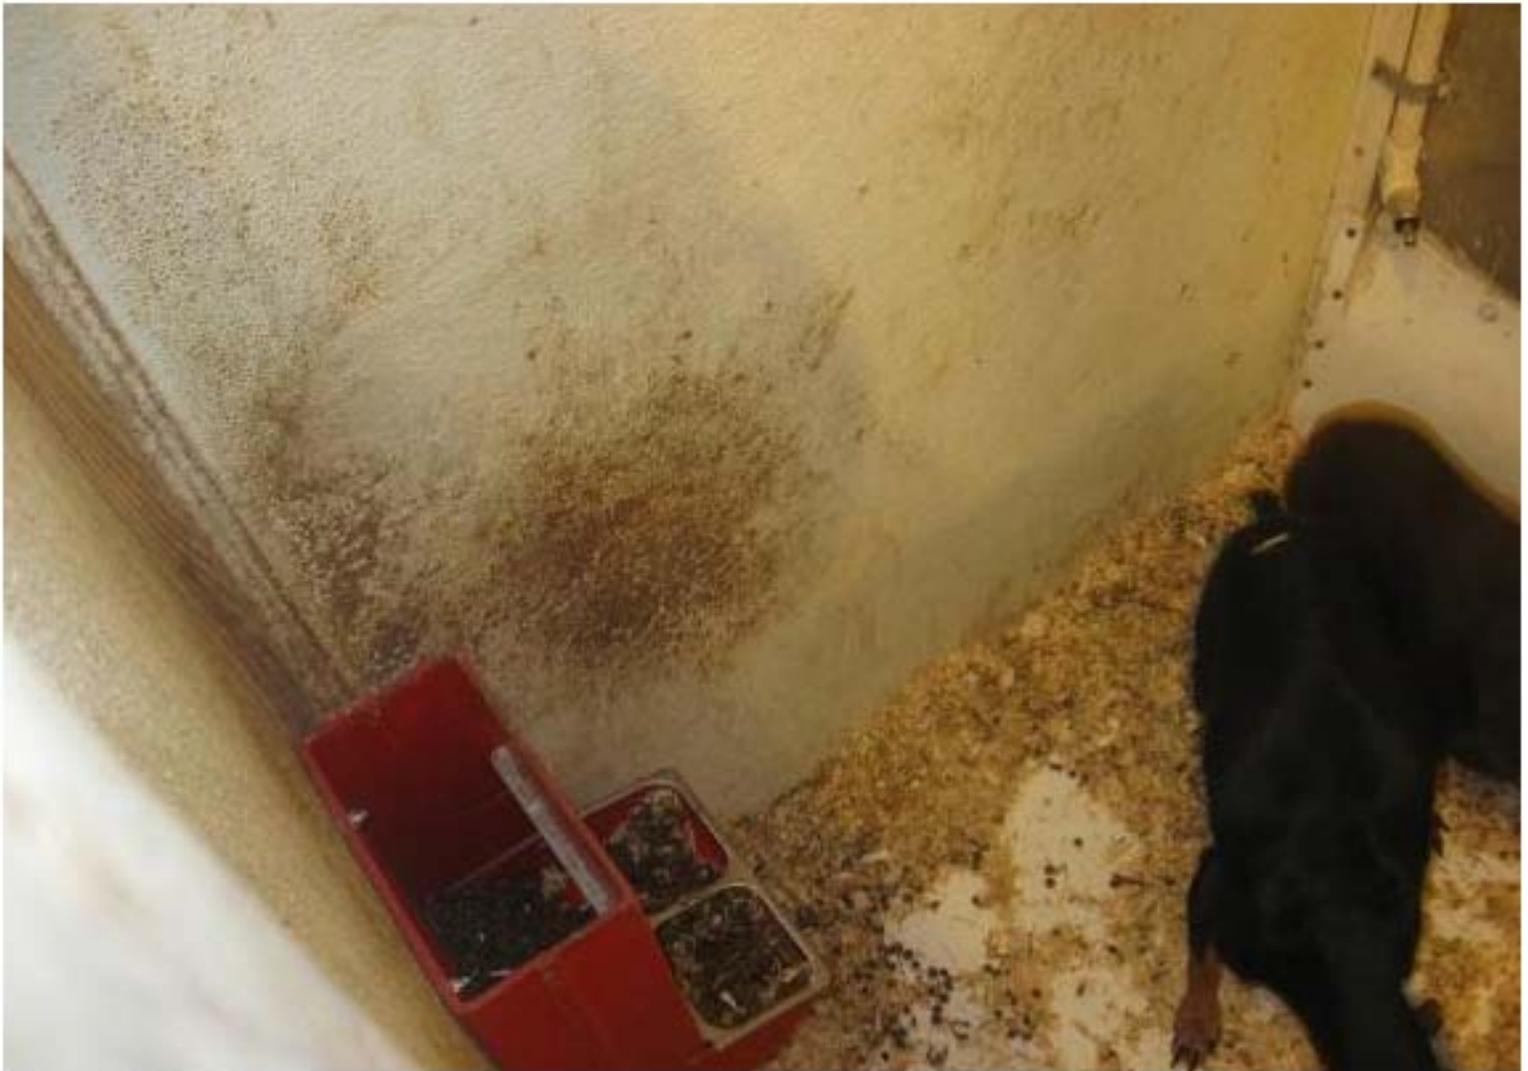
CFR: 3.1 (c) (3)

Photographer:	Dr. Watkins	Legal Name:	Registration:	42-A-1387
Photo Taken:	Wed, Feb 10, '10	Curtis Wordes		
Inspection:	47100933420873			
Description:	Walls on new nursery

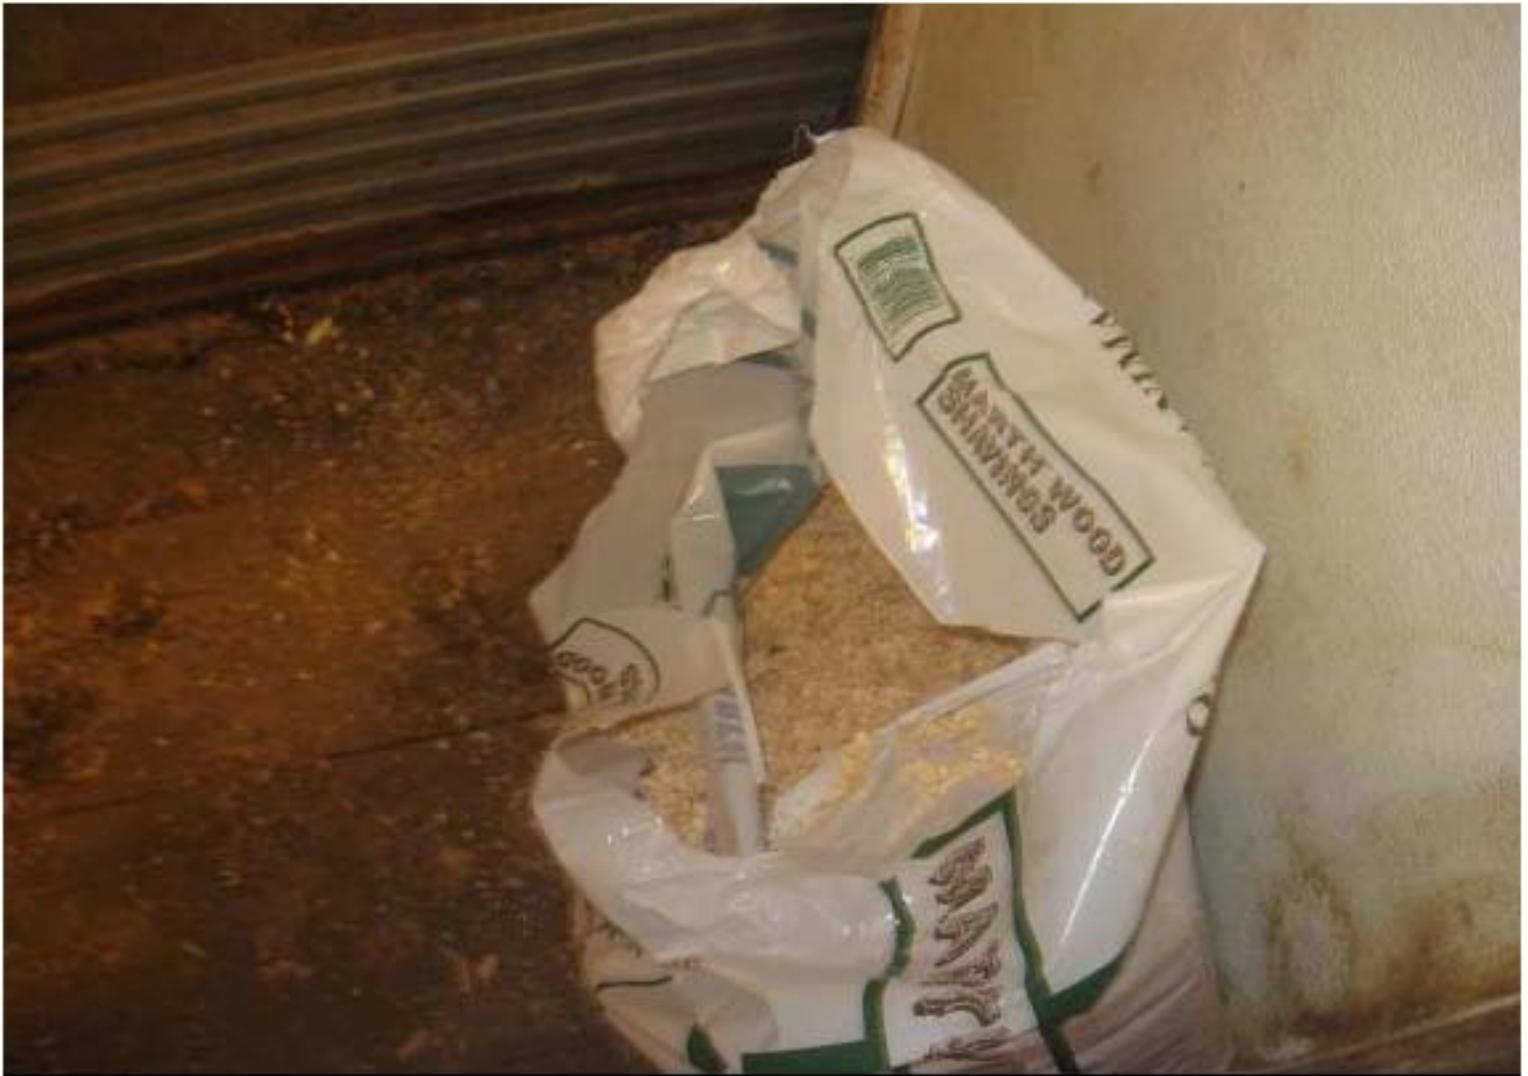
CFR: 3.1 (e)

Photographer:	Dr. Watkins	Legal Name:	Registration:	42-A-1387
Photo Taken:	Wed, Feb 10, '10	Curtis Wordes		
Inspection:	47100933420873			
Description:	Bedding on floor and open

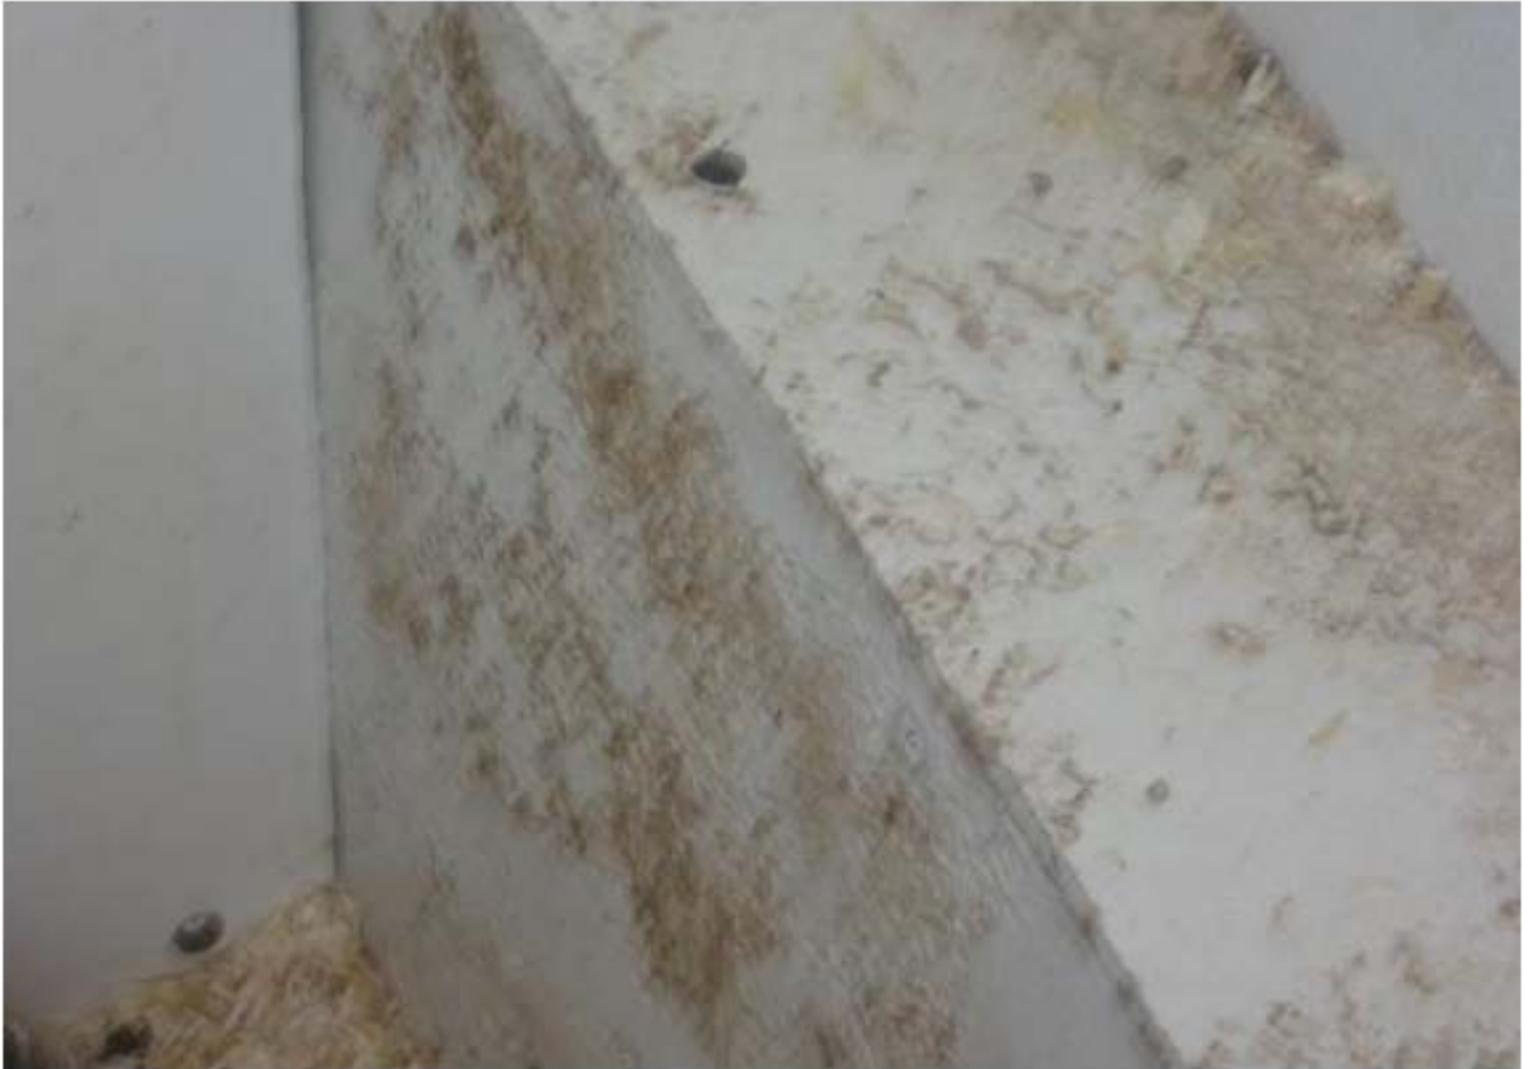
CFR: 3.1 (c) (3)

Photographer:	Dr. Watkins	Legal Name:	Registration:	42-A-1387
Photo Taken:	Wed, Feb 10, '10	Curtis Wordes		
Inspection:	47100933420873			
Description:	Nursery Walls
