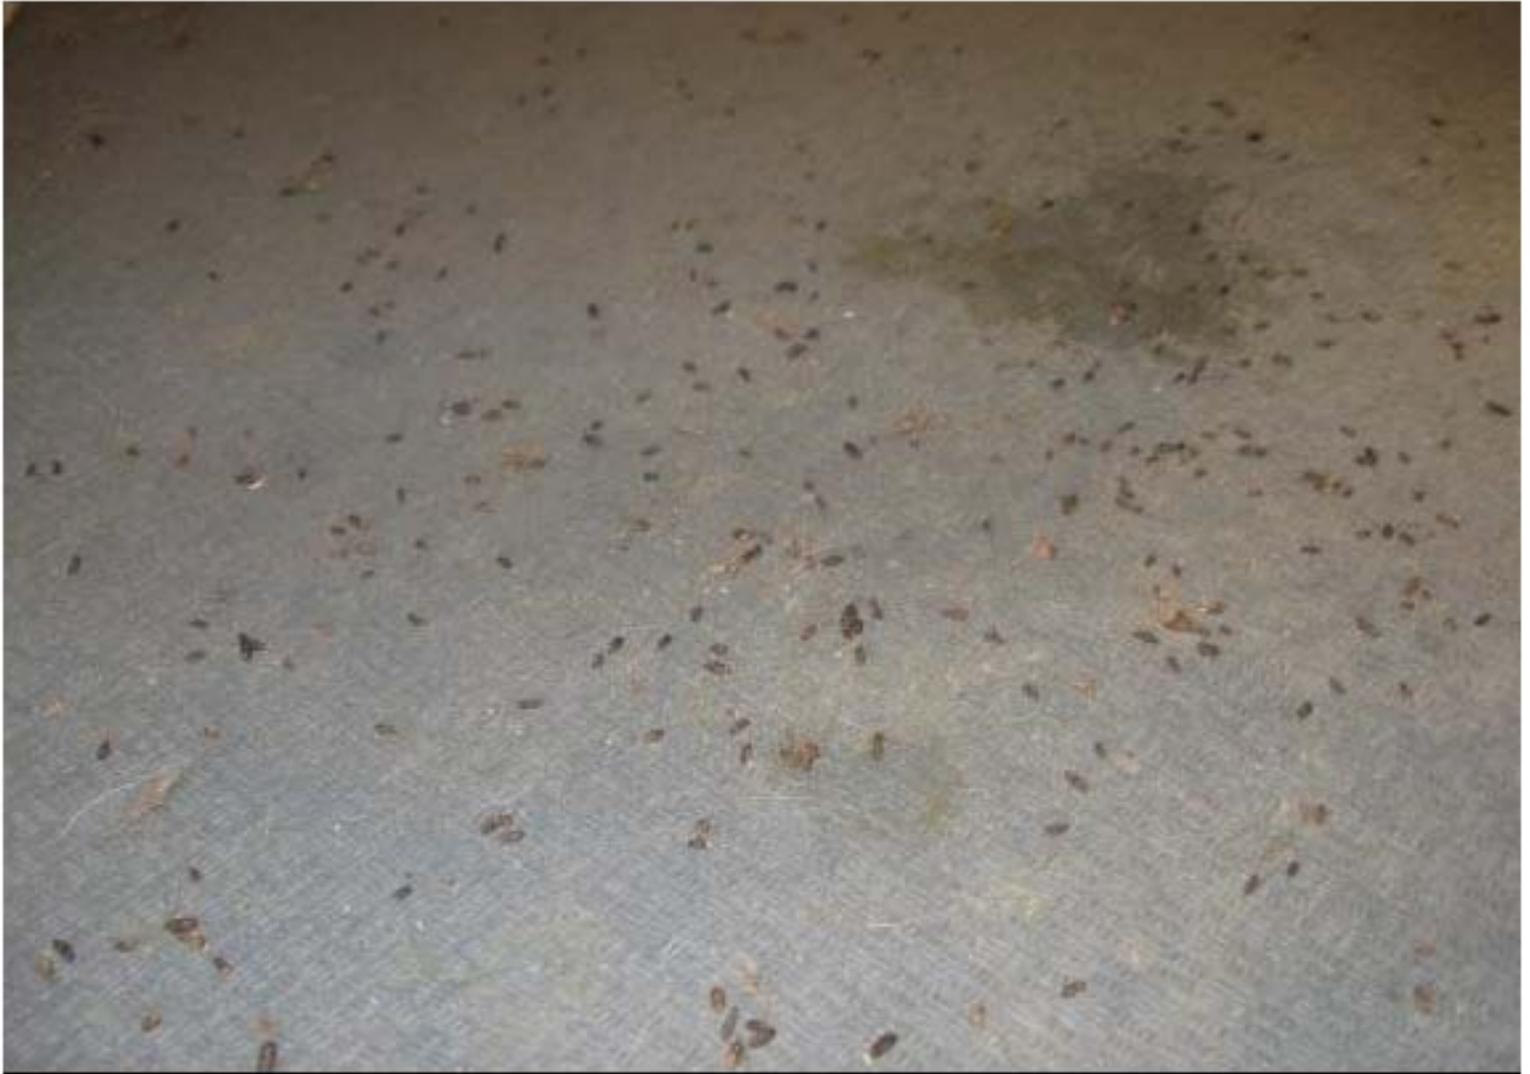
CFR: 3.11 (d) (4)

Photographer:	Dr. Watkins	Legal Name:	Registration:	42-A-1387
Photo Taken:	Wed, Feb 10, '10	Curtis Wordes		
Inspection:	47100933420873			
Description:	Rodent droppings

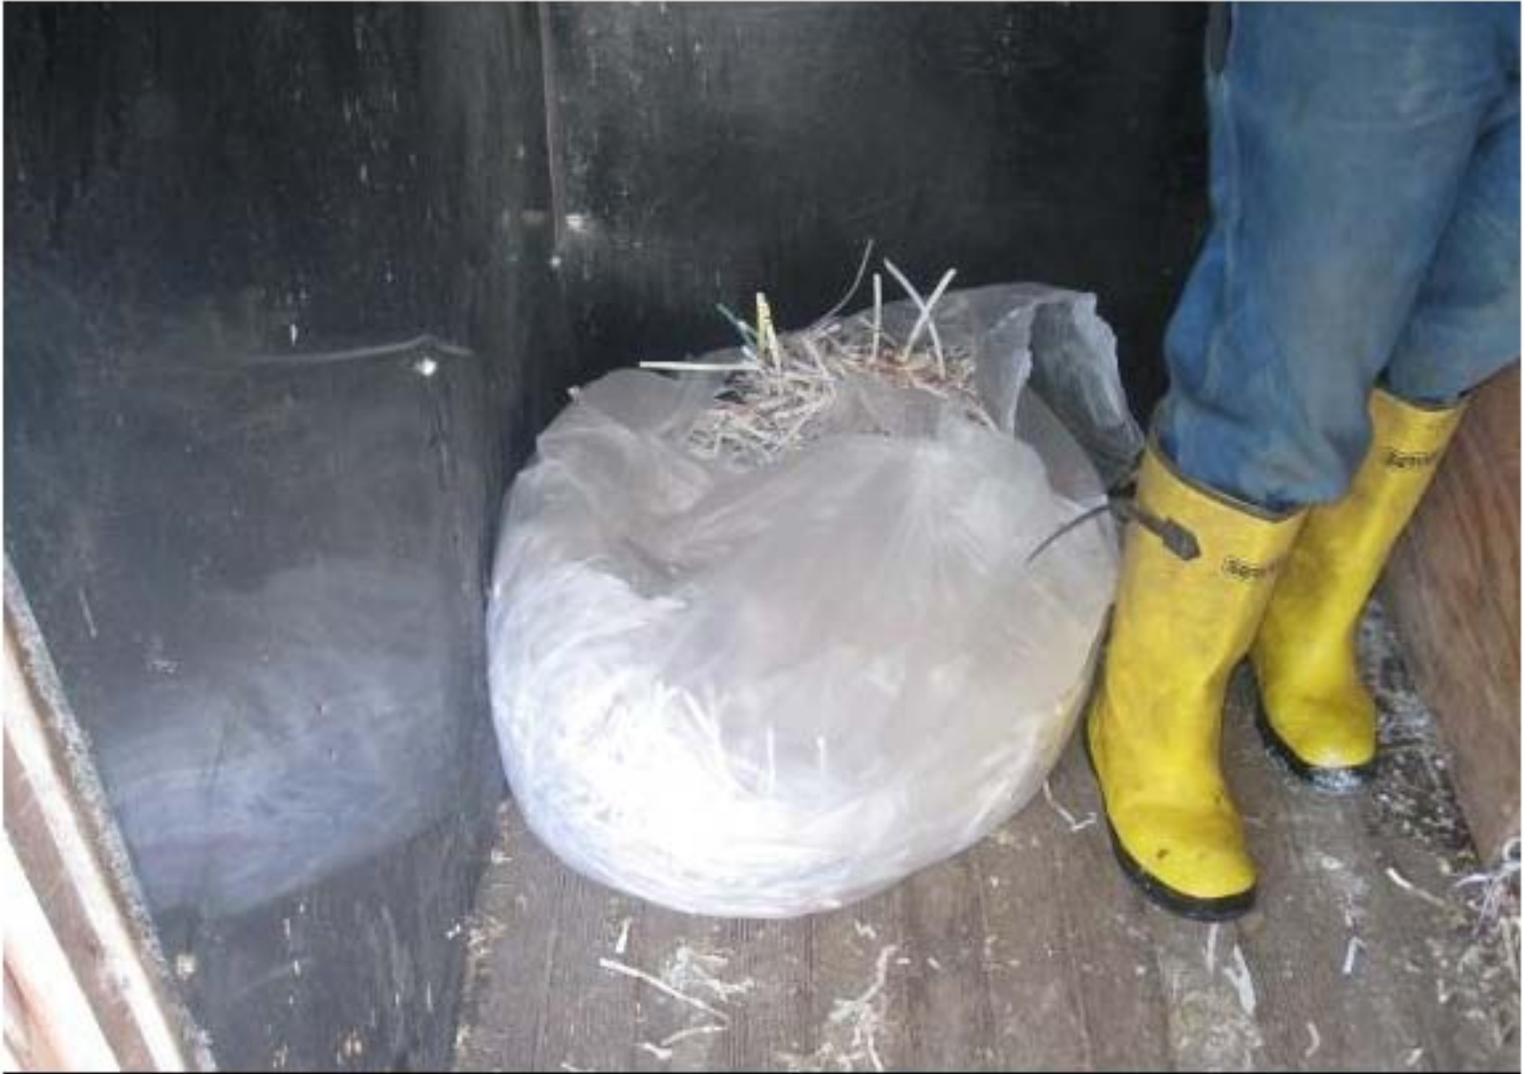
CFR: 3.1 (e)

Photographer:	Dr. Watkins	Legal Name:	Registration:	42-A-1387
Photo Taken:	Wed, Feb 10, '10	Curtis Wordes		
Inspection:	47100933420873			
Description:	Open bedding on floor

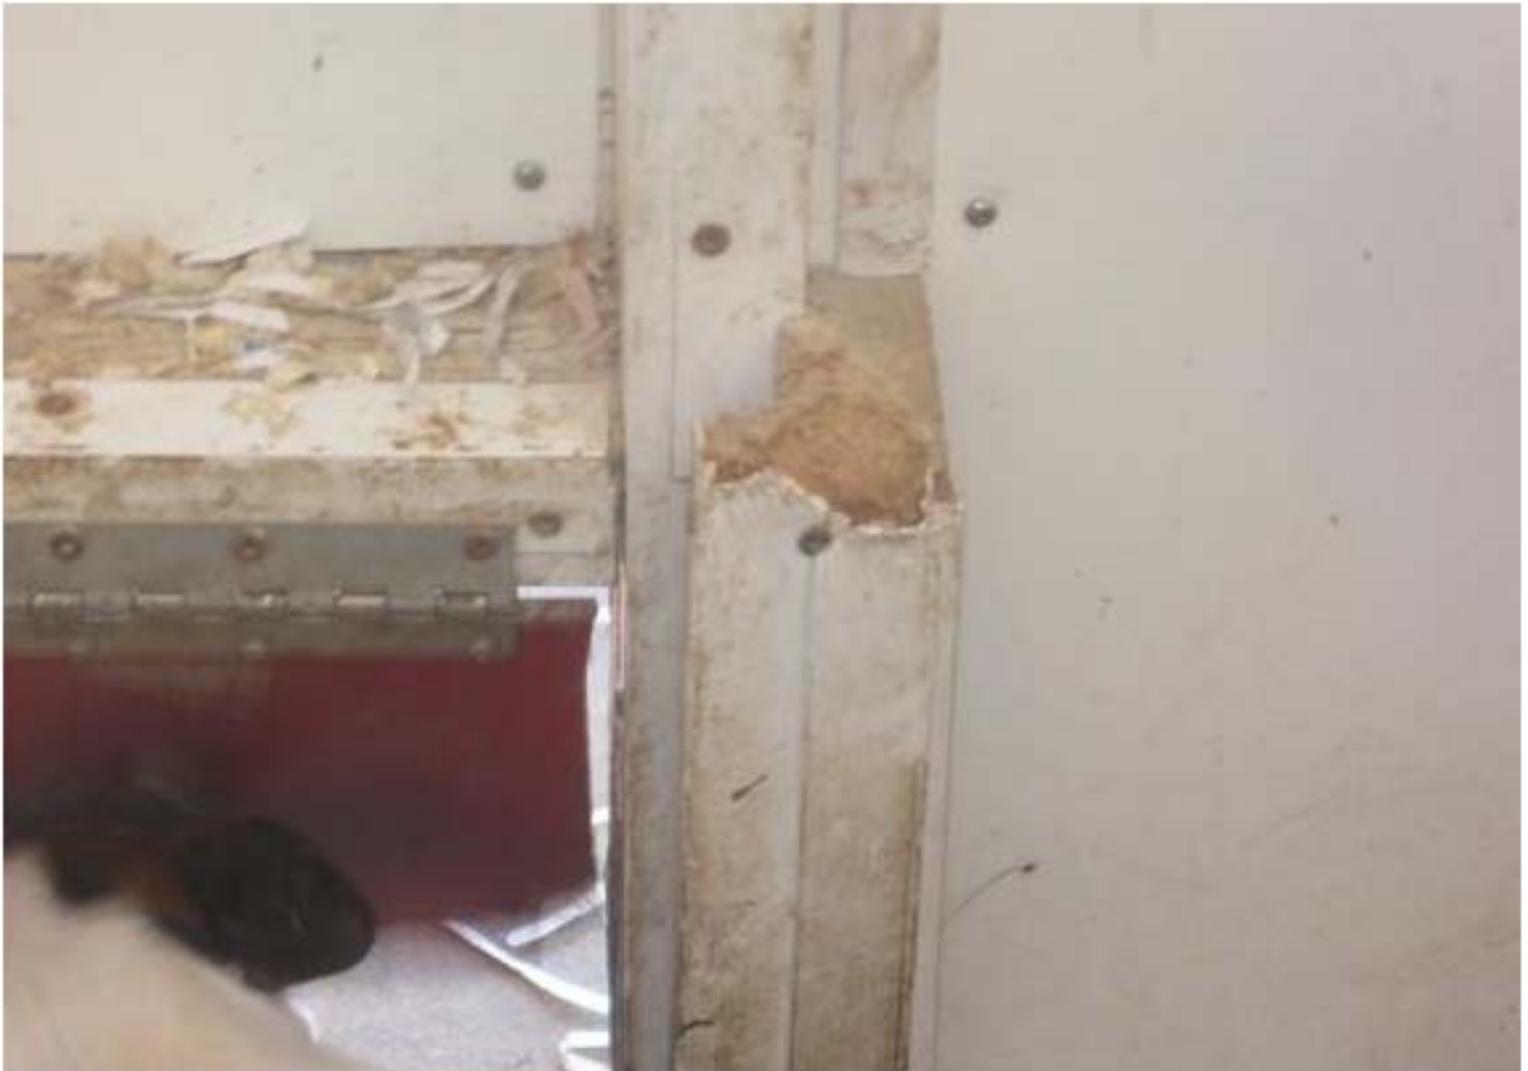
CFR: 3.1 (a)

Photographer:	Dr. Watkins	Legal Name:	Registration:	42-A-1387
Photo Taken:	Wed, Feb 10, '10	Curtis Wordes		
Inspection:	47100933420873			
Description:	Chewed plastic and wood

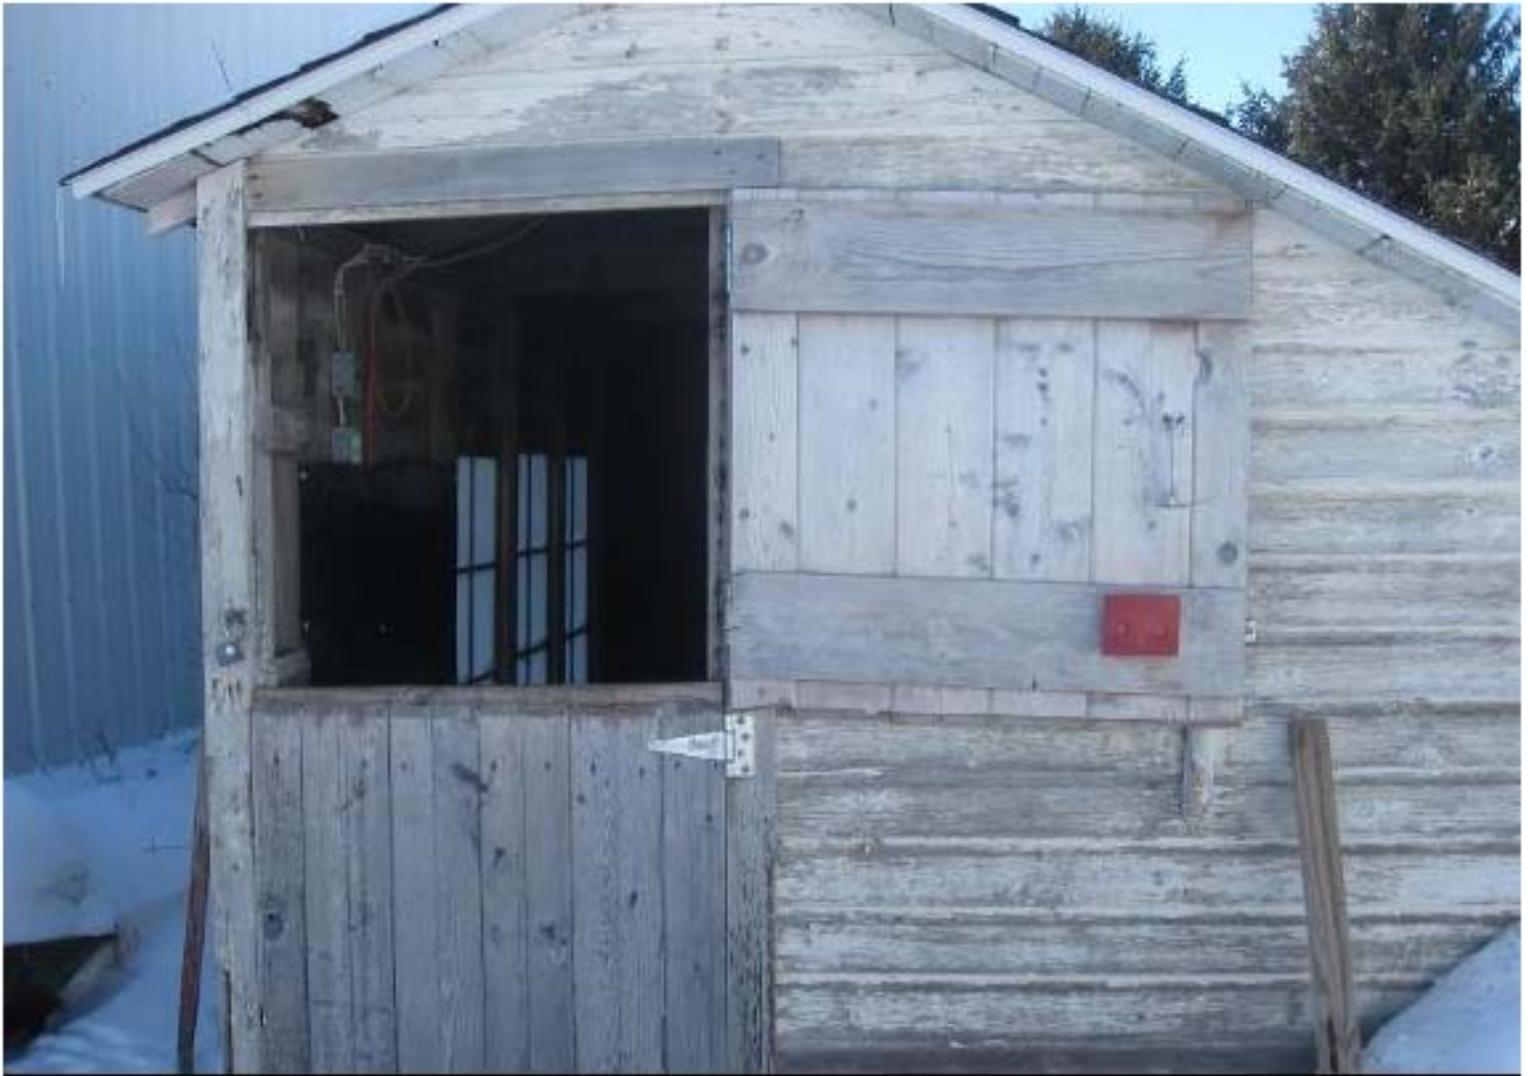
CFR: 3.2 (d)

Photographer:	Dr. Watkins	Legal Name:	Registration:	42-A-1387
Photo Taken:	Wed, Feb 10, '10	Curtis Wordes		
Inspection:	47100933420873			
Description:	Indoor housing facility/wooden building

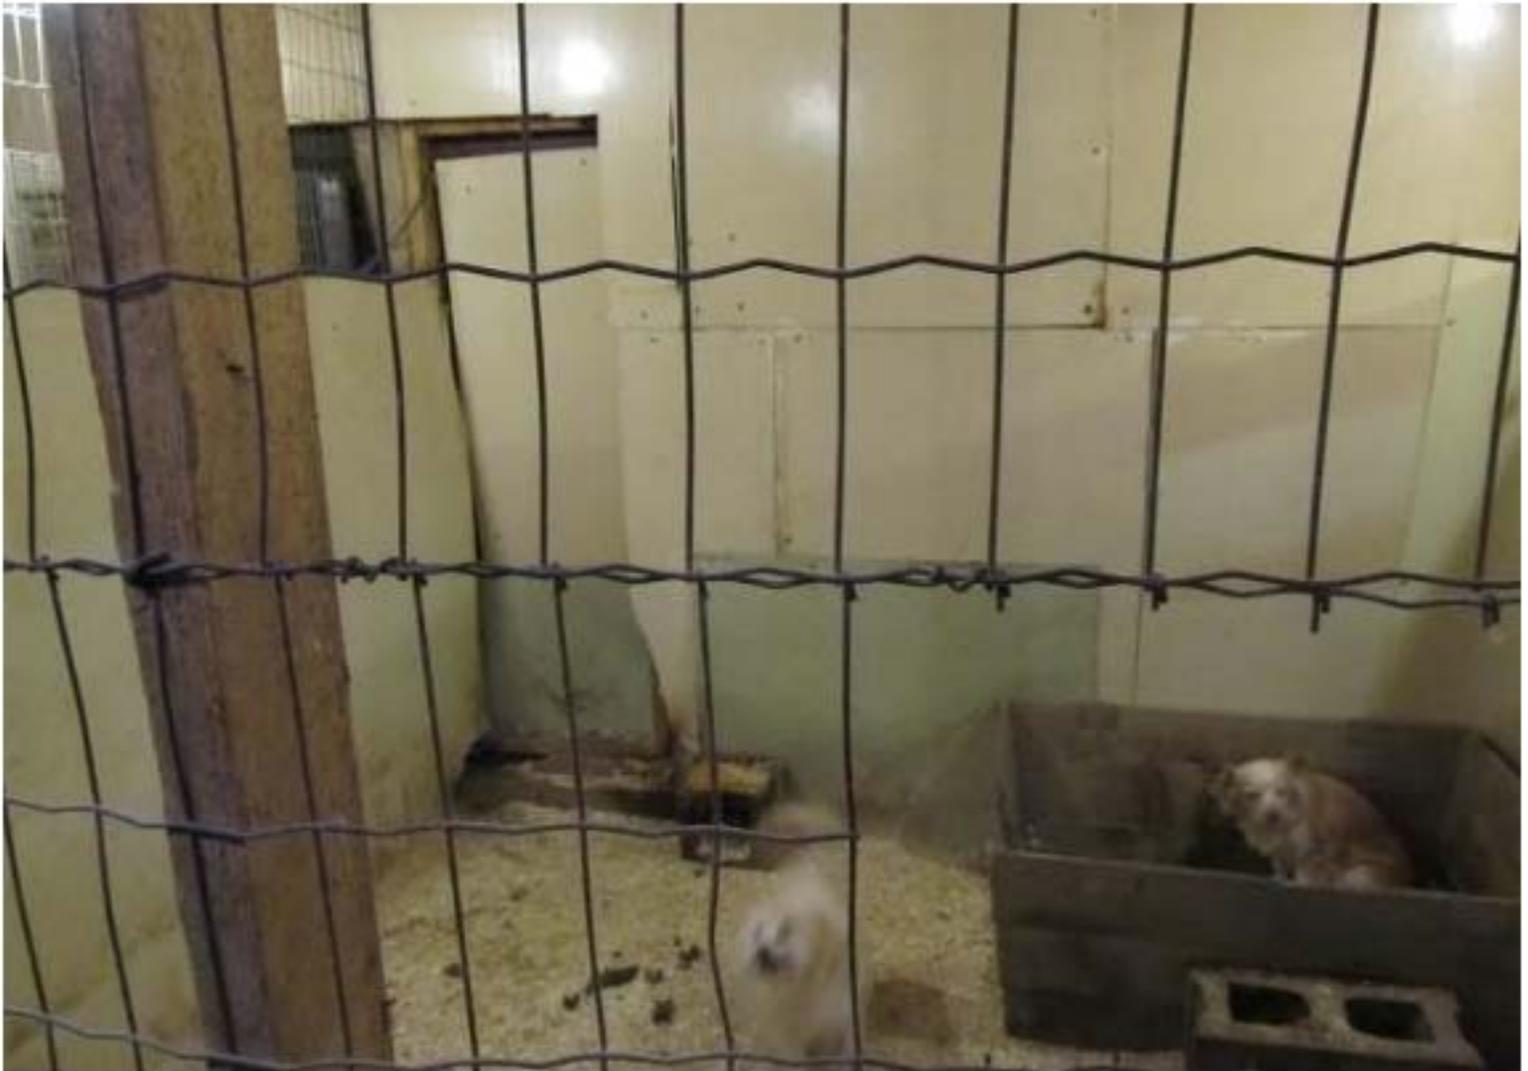
CFR: 3.1 (c) (2)

Photographer:	Brenda Pietrosante	Legal Name:	Registration:	42-A-1366
Photo Taken:	Wed, Jan 26, '11	PAT MC GURK		
Inspection:	28111547020799			
Description:	The plastic boards covering and surrounding the old doorway in the back of the pen are chewed and worn. The edges of the plastic bedding box are also chewed. First large pen on left in whelping bldg.

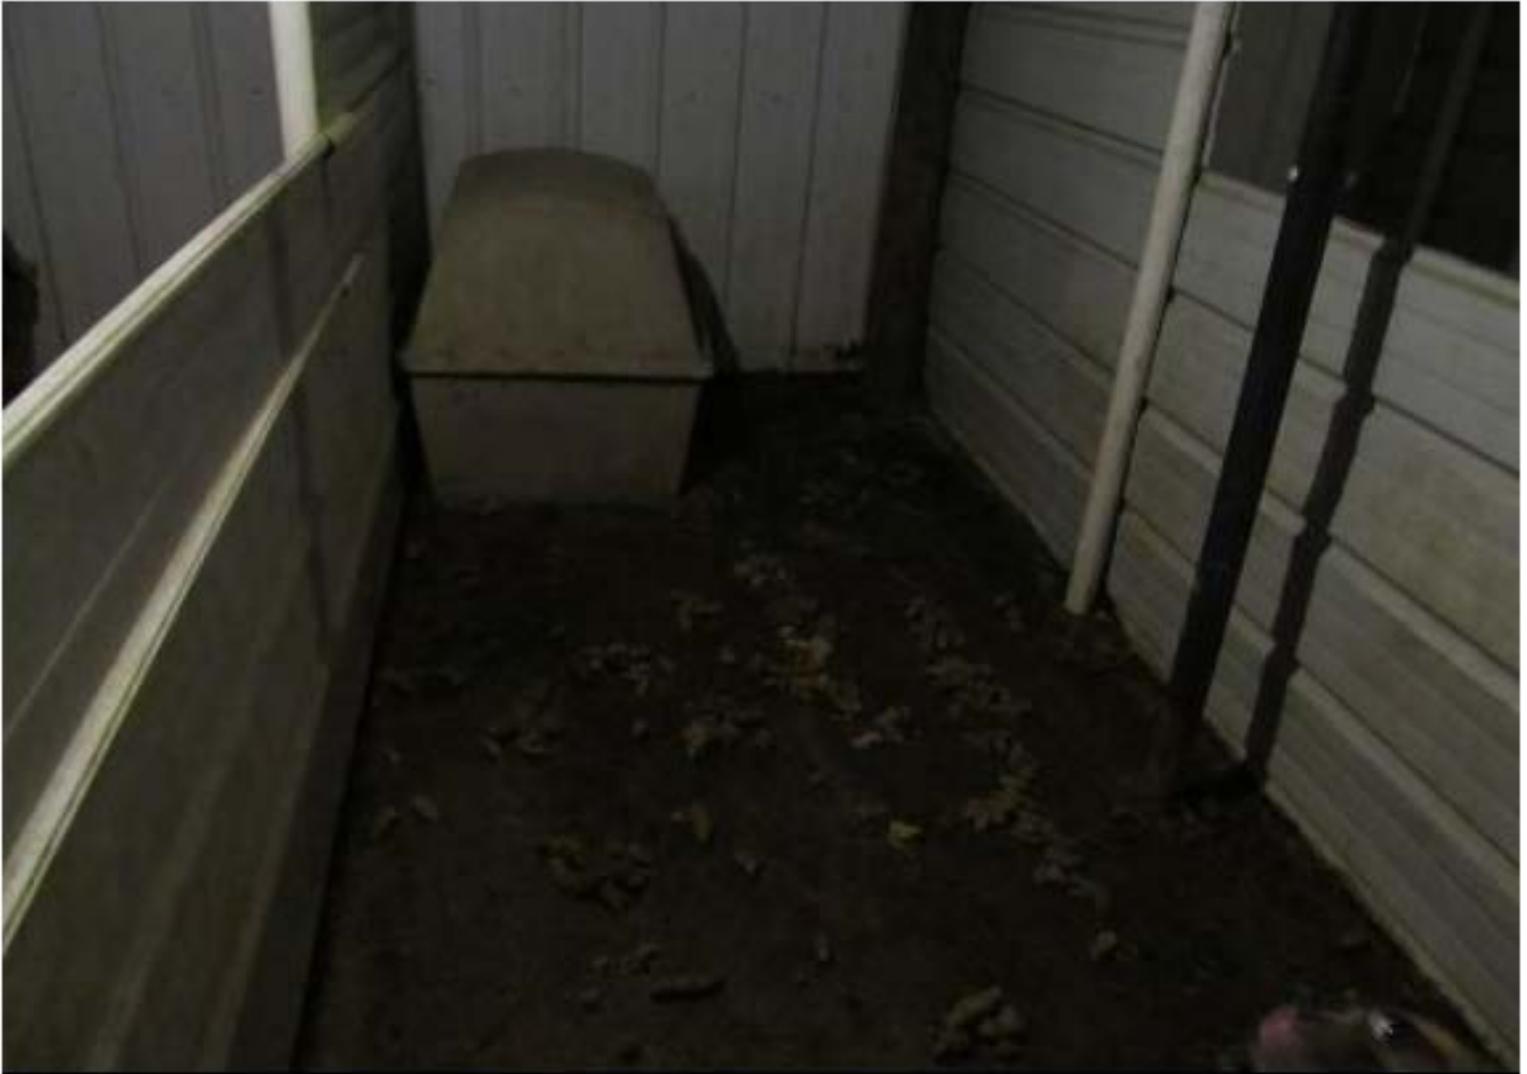
CFR: 3.11 (b) (2)

Photographer:	Brenda Pietrosante	Legal Name:	Registration:	42-A-1366
Photo Taken:	Wed, Jan 26, '11	PAT MC GURK		
Inspection:	28111547020799			
Description:	An accumulation of feces and urine covering a large portion of the cement floor in one run in the "long" outdoor kennel.

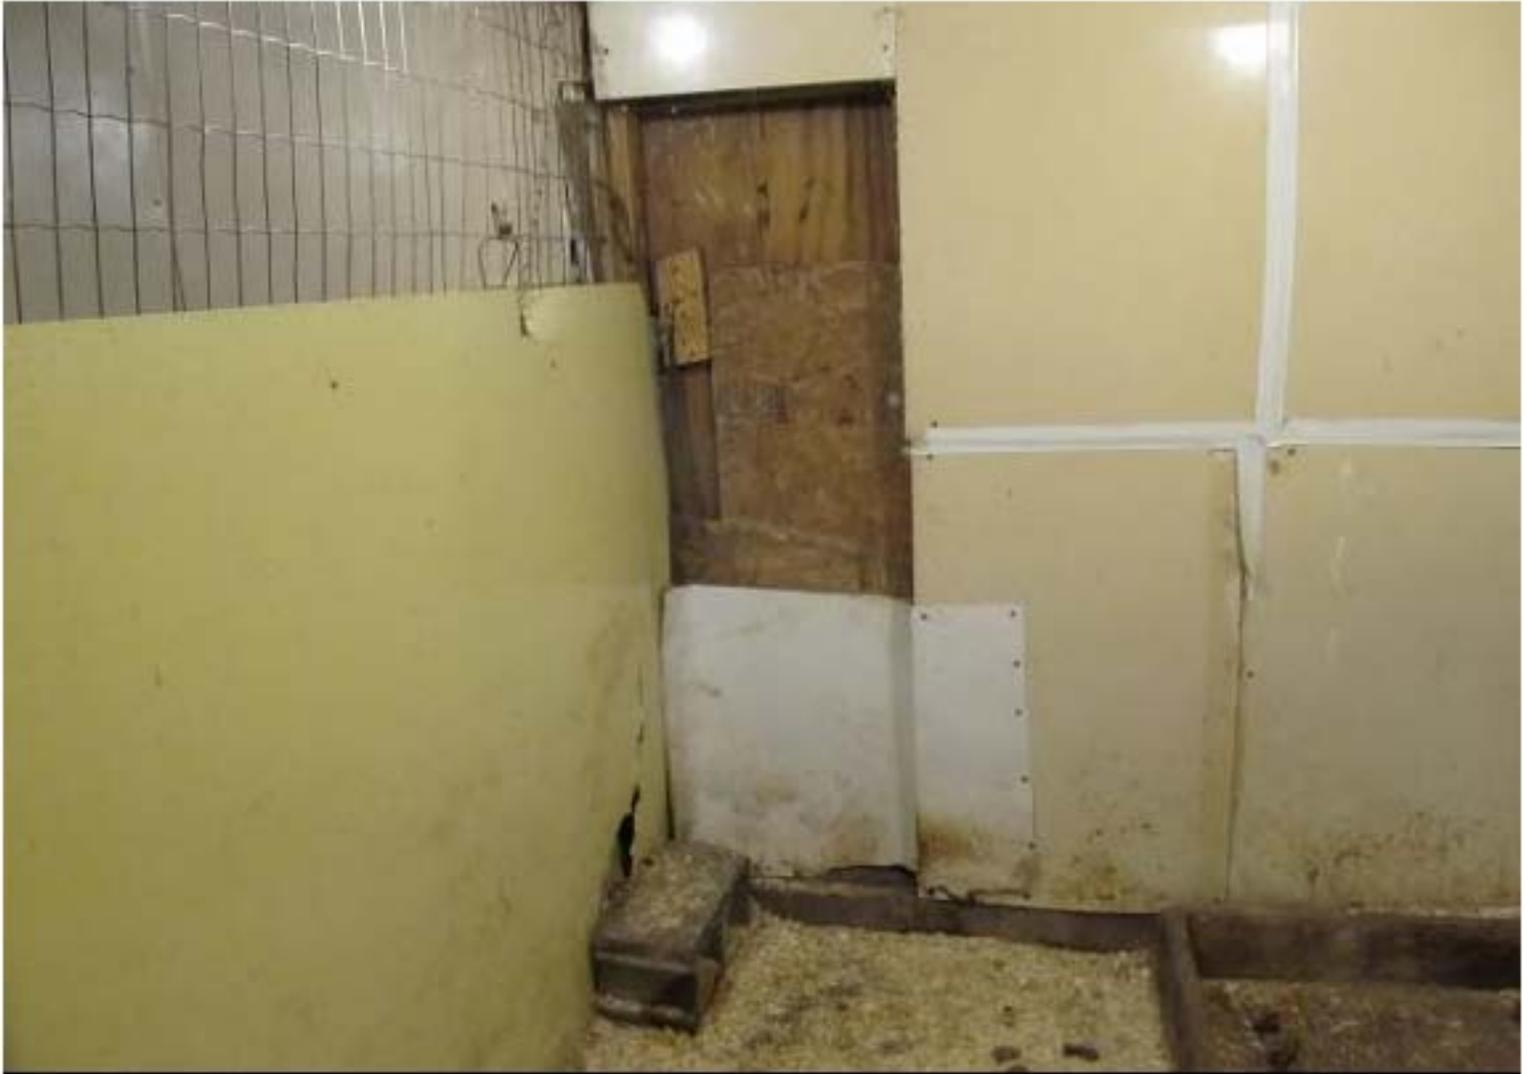
CFR: 3.1 (c) (2)

Photographer:	Brenda Pietrosante	Legal Name:	Registration:	42-A-1366
Photo Taken:	Wed, Jan 26, '11	PAT MC GURK		
Inspection:	28111547020799			
Description:	Large holes chewed in the left side wall of the pen and at the bottom of the plastic covering the old doorway at the back of the pen. Second large pen on left in whelping building. FOIA11-282000099

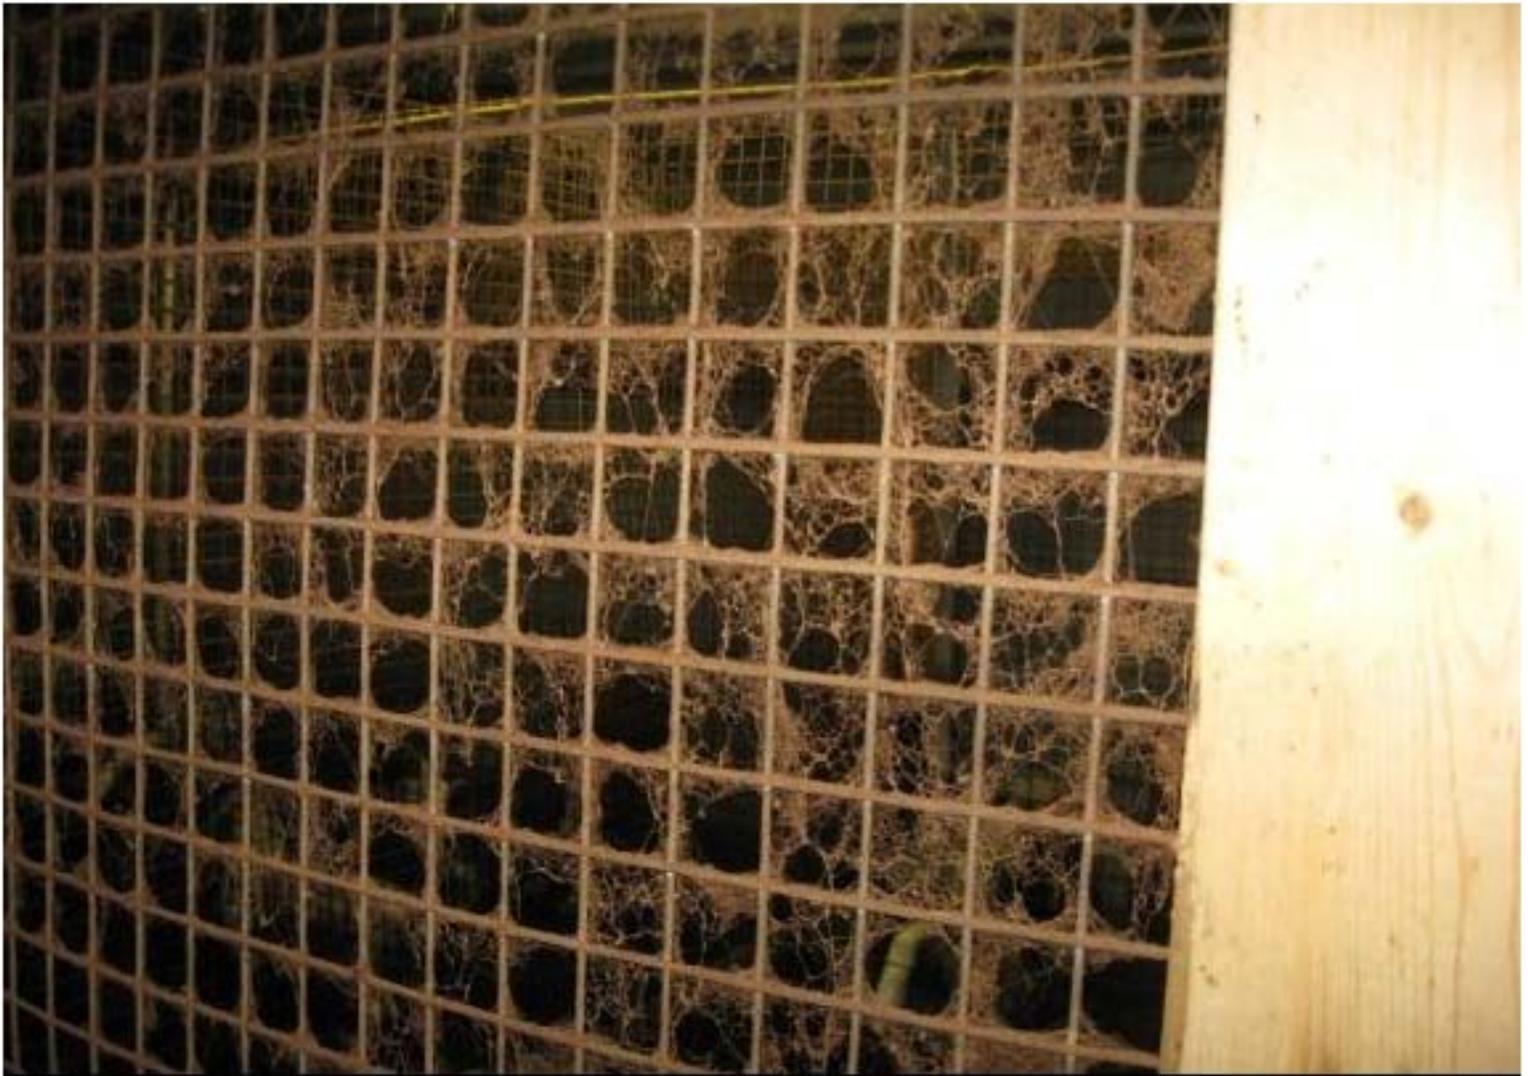
CFR: 3.11 (c)

Photographer:	John J. Lies, ACI	Legal Name:	Registration:	42-A-1354
Photo Taken:	Wed, Jan 12, '11 P.M.	BOB MEHMERT		
Inspection:	12111344160875			
Description:	3.11(c) Housekeeping Spider webs, hair dirt of lights and wire enclosures.

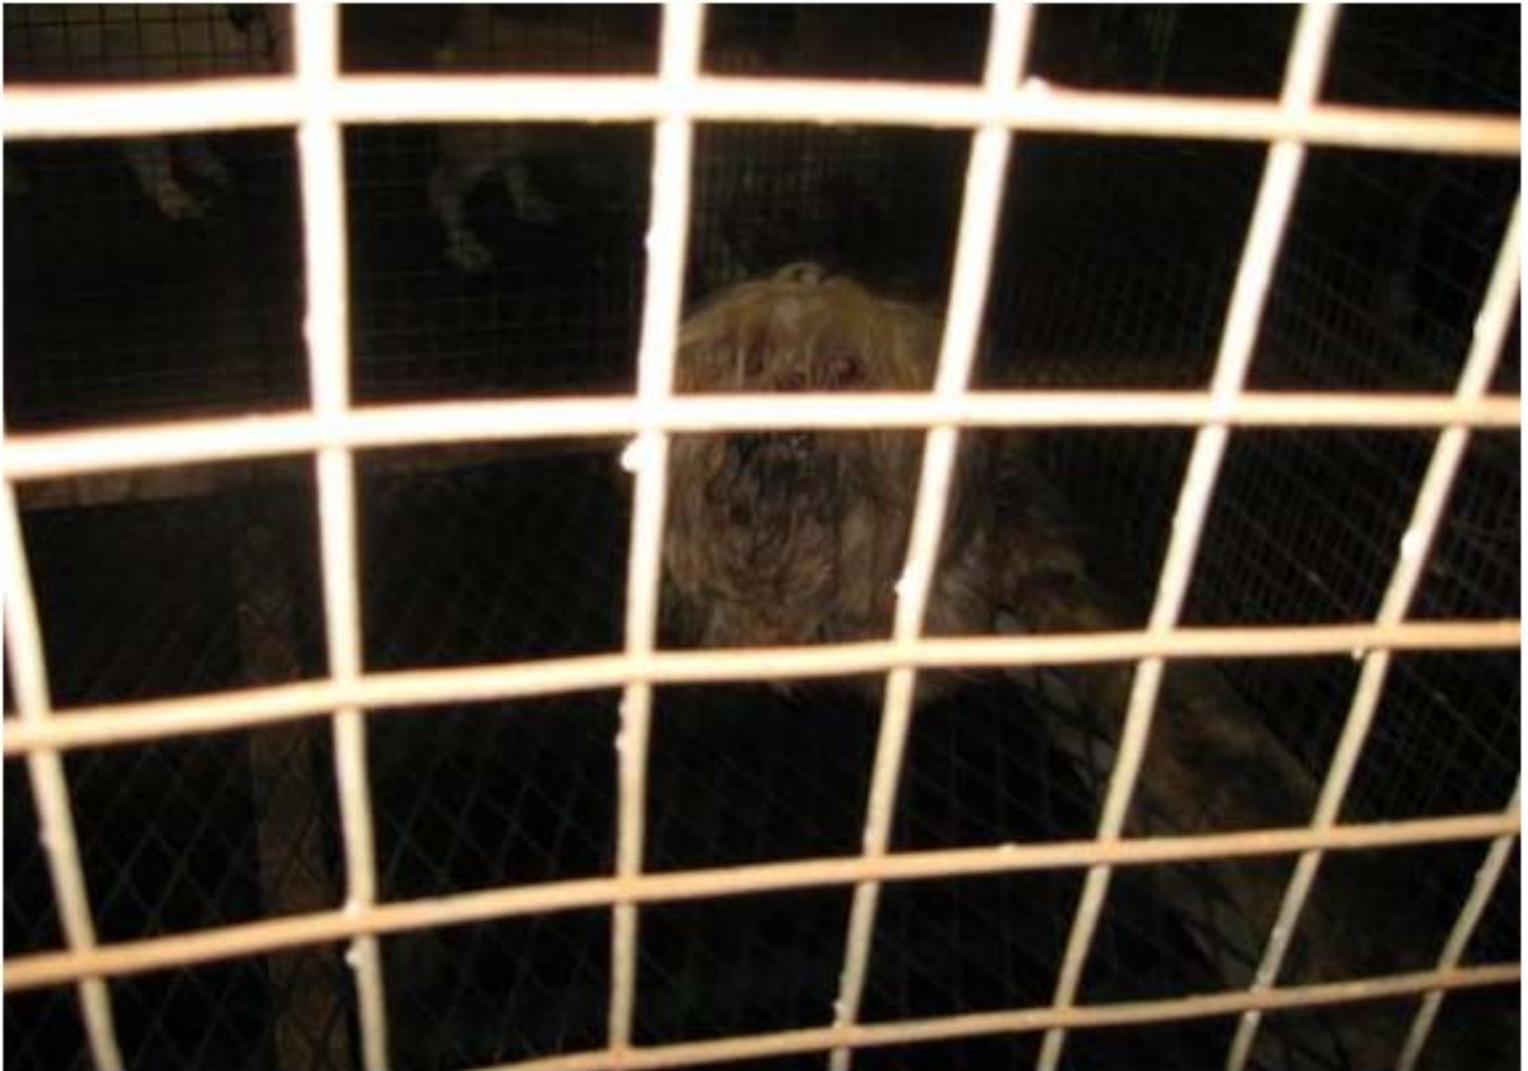
FOIA11-282000106

CFR: 2.40 (b) (2)

Photographer:	John J. Lies, ACI	Legal Name:	Registration:	42-A-1354
Photo Taken:	Wed, Jan 12, '11 P.M.	BOB MEHMERT		
Inspection:	12111344160875			
Description:	2.40 (b)(2) Veterinary Care dogs need to be groomed to remove long and/or matted hair.

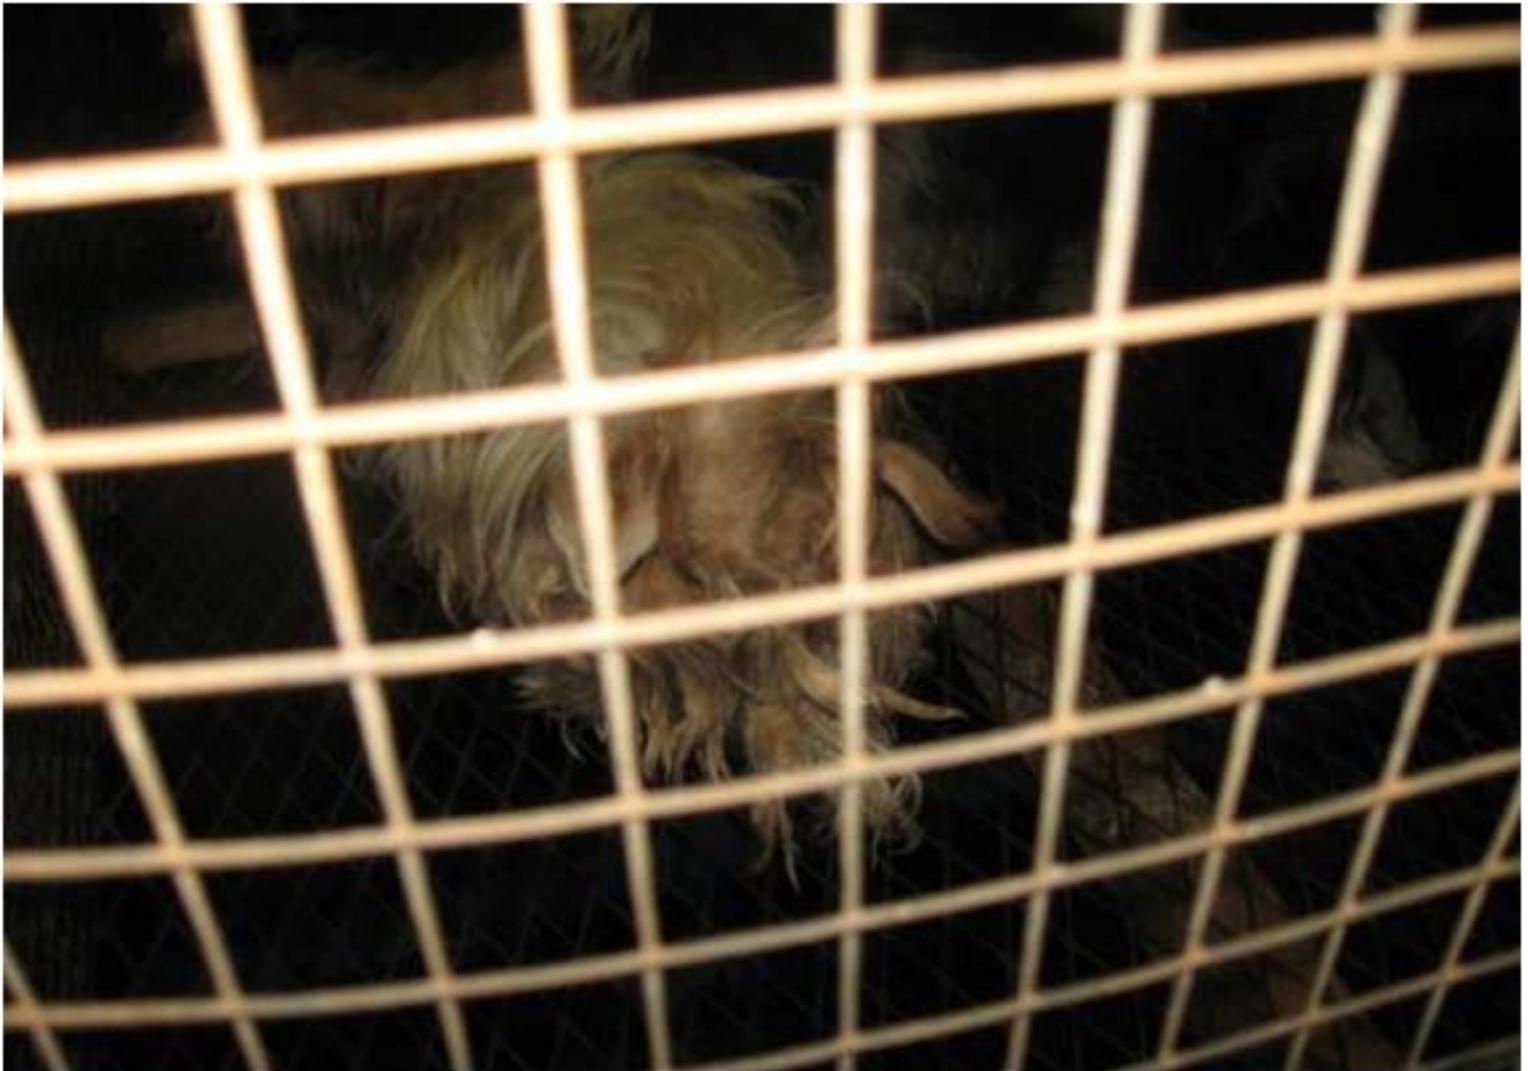
FOIA11-282000107

CFR: 2.40 (b) (2)

Photographer:	John J. Lies, ACI	Legal Name:	Registration:	42-A-1354
Photo Taken:	Wed, Jan 12, '11 P.M.	BOB MEHMERT		
Inspection:	12111344160875			
Description:	2.40 (b)(2) Veterinary Care dogs need to be groomed to remove long and/or matted hair.

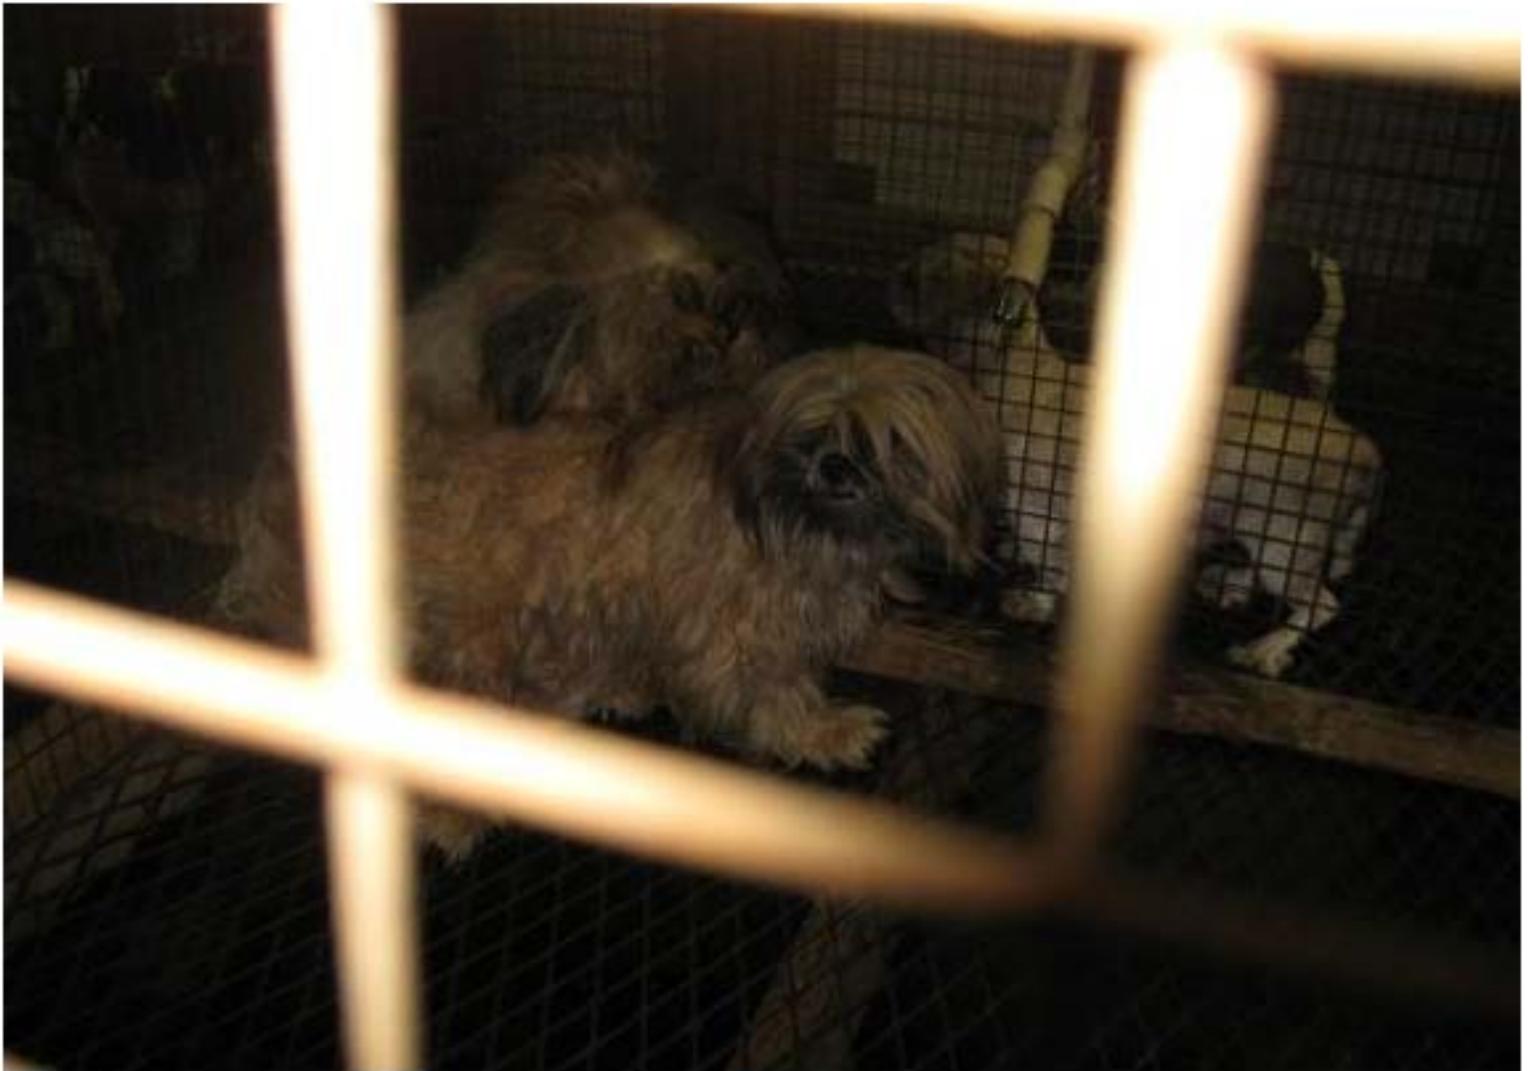
FOIA11-282000109

CFR: 2.40 (b) (2)

Photographer:	John J. Lies, ACI	Legal Name:	Registration:	42-A-1354
Photo Taken:	Wed, Jan 12, '11 P.M.	BOB MEHMERT		
Inspection:	12111344160875			
Description:	2.40 (b)(2) Veterinary Care dogs need to be groomed to remove long and/or matted hair.

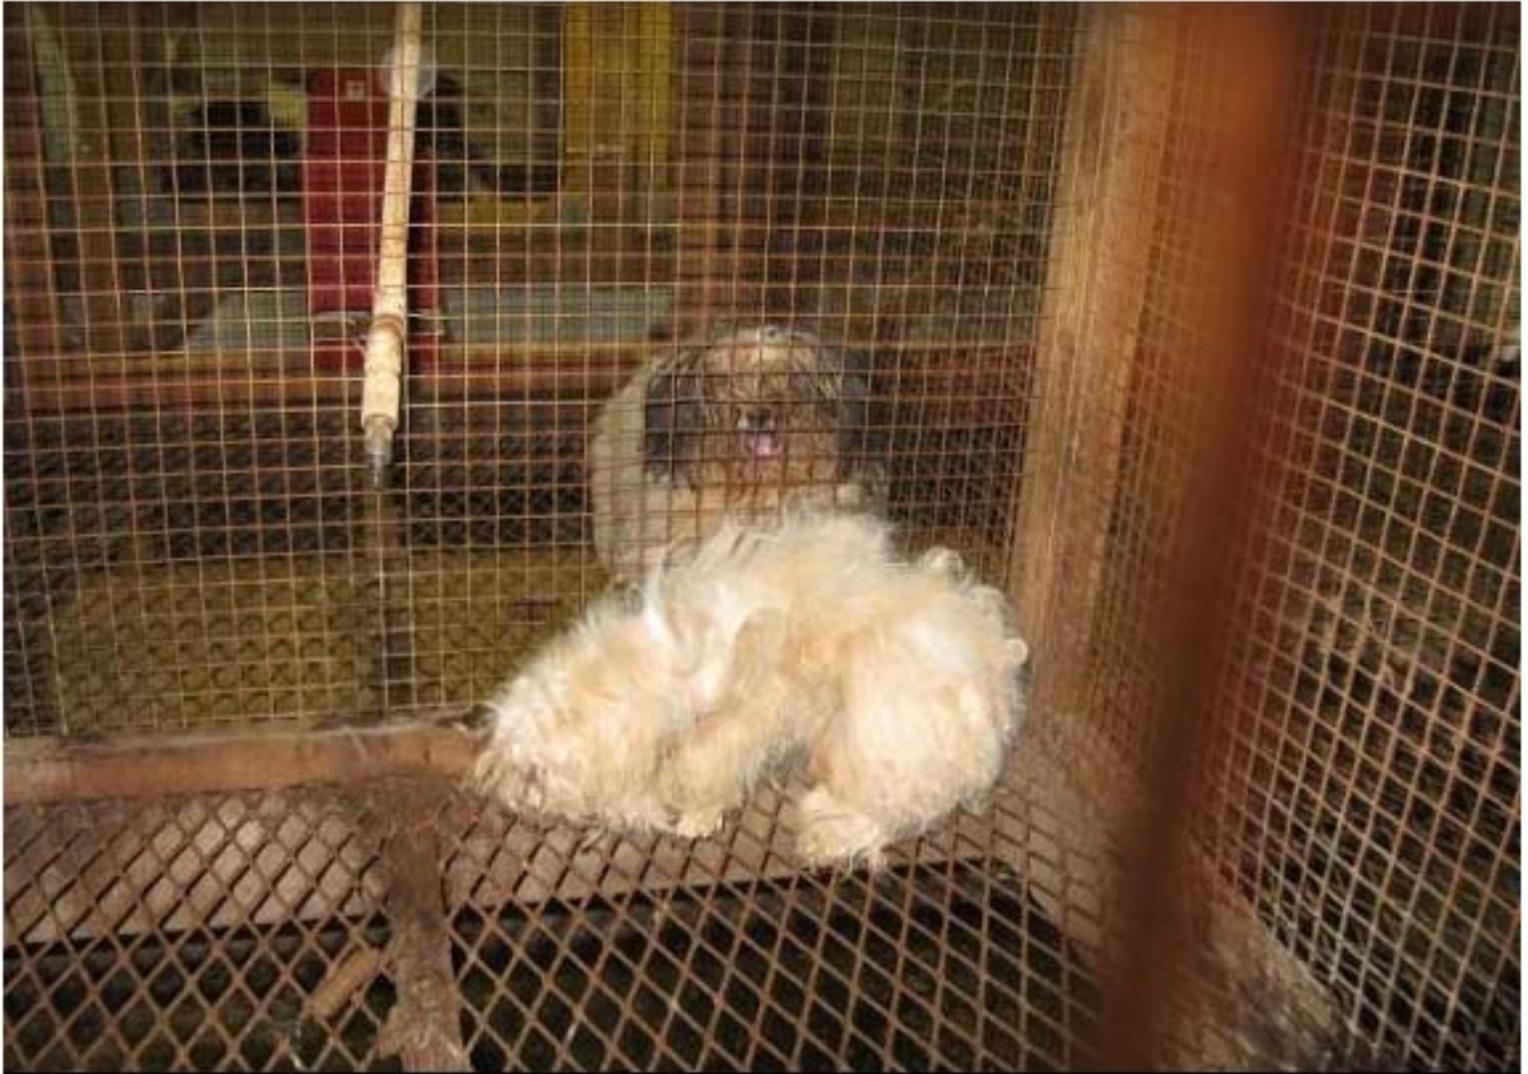
FOIA11-282000110

CFR: 2.40 (b) (2)

Photographer:	John J. Lies, ACI	Legal Name:	Registration:	42-A-1354
Photo Taken:	Wed, Jan 12, '11 P.M.	BOB MEHMERT		
Inspection:	12111344160875			
Description:	2.40 (b)(2) Veterinary Care dogs need to be groomed to remove long and/or matted hair.

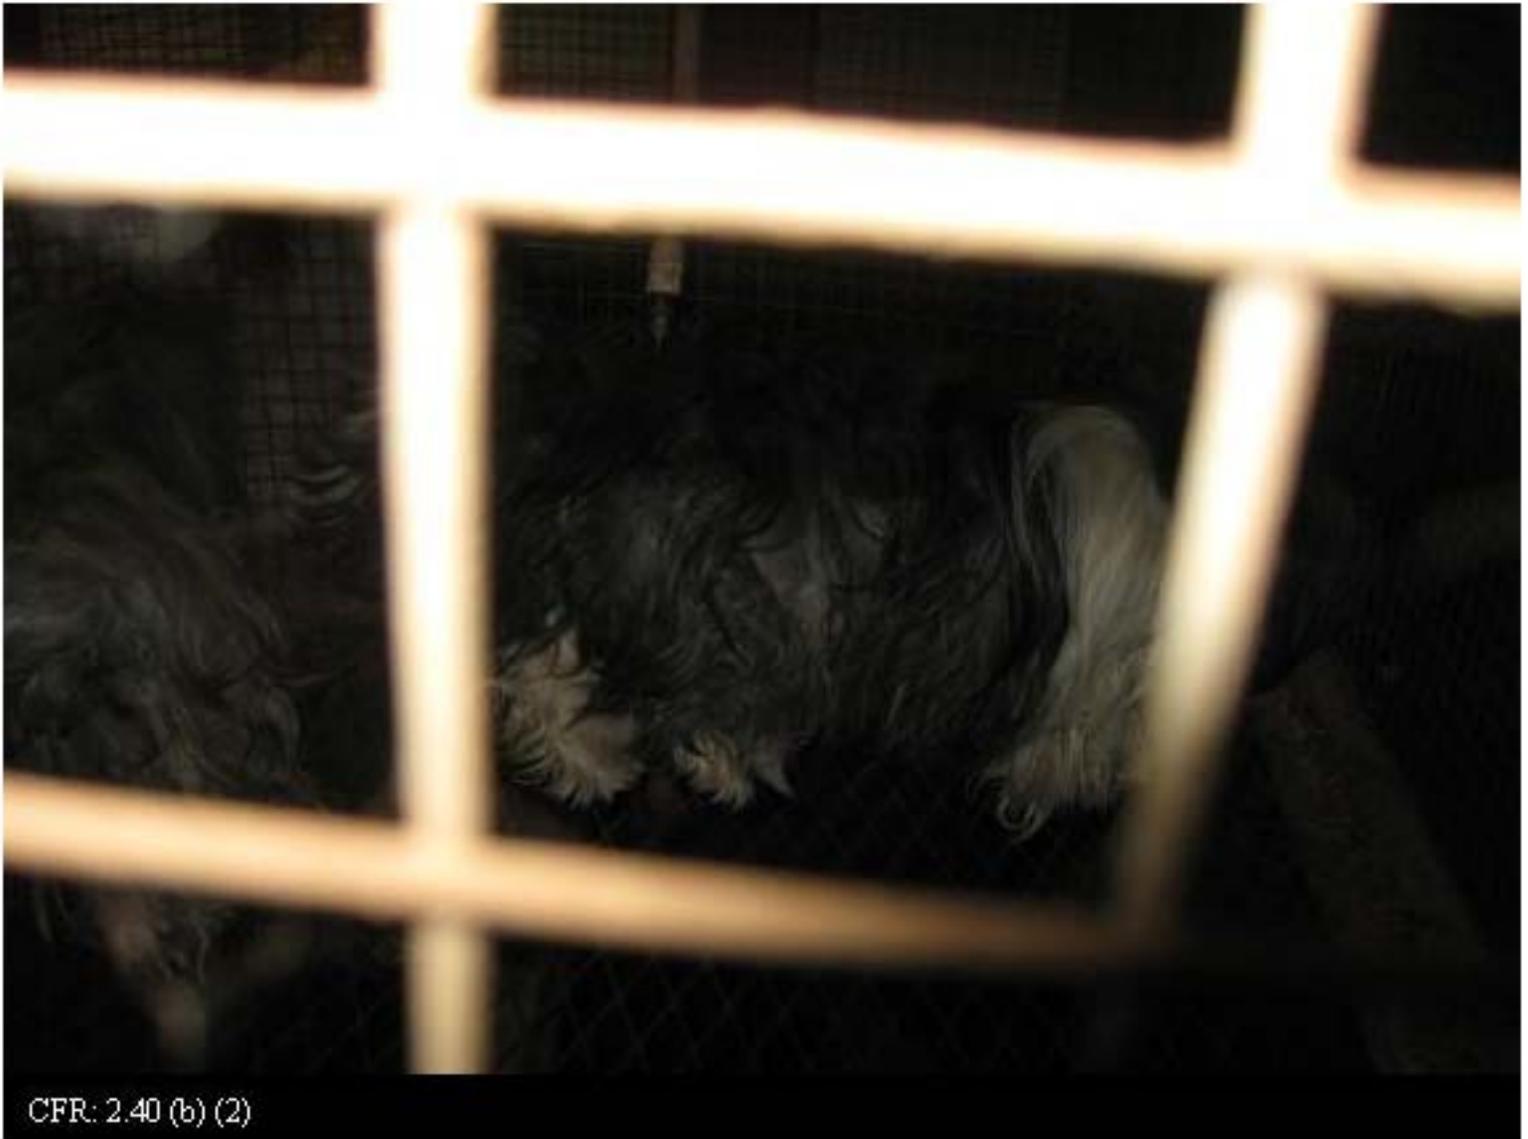
FOIA11-282000111

CFR: 2.40 (b) (2)

Photographer:	John J. Lies, ACI	Legal Name:	Registration:	42-A-1354
Photo Taken:	Wed, Jan 12, '11 P.M.	BOB MEHMERT		
Inspection:	12111344160875			
Description:	2.40 (b)(2) Veterinary Care dogs need to be groomed to remove long and/or matted hair.
