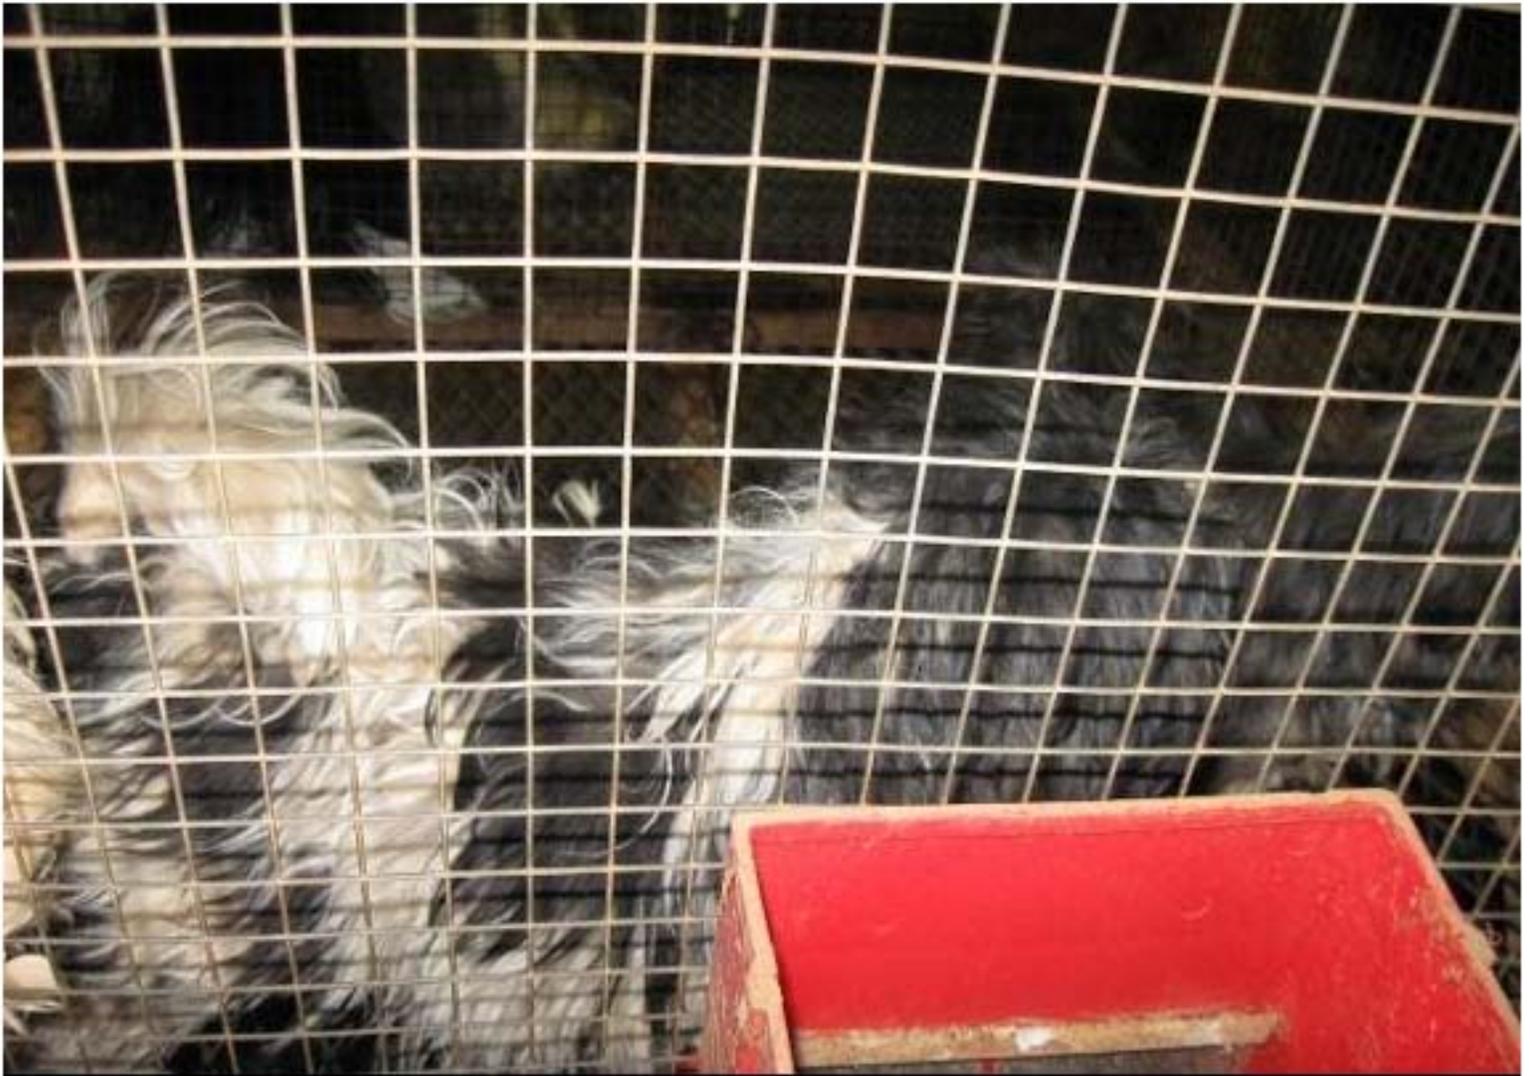
FOIA11-282000113

CFR: 2.40 (b) (2)

Photographer:	John J. Lies, ACI	Legal Name:	Registration:	42-A-1354
Photo Taken:	Wed, Jan 12, '11 P.M.	BOB MEHMERT		
Inspection:	12111344160875			
Description:	2.40 (b)(2) Veterinary Care dogs need to be groomed to remove long and/or matted hair.

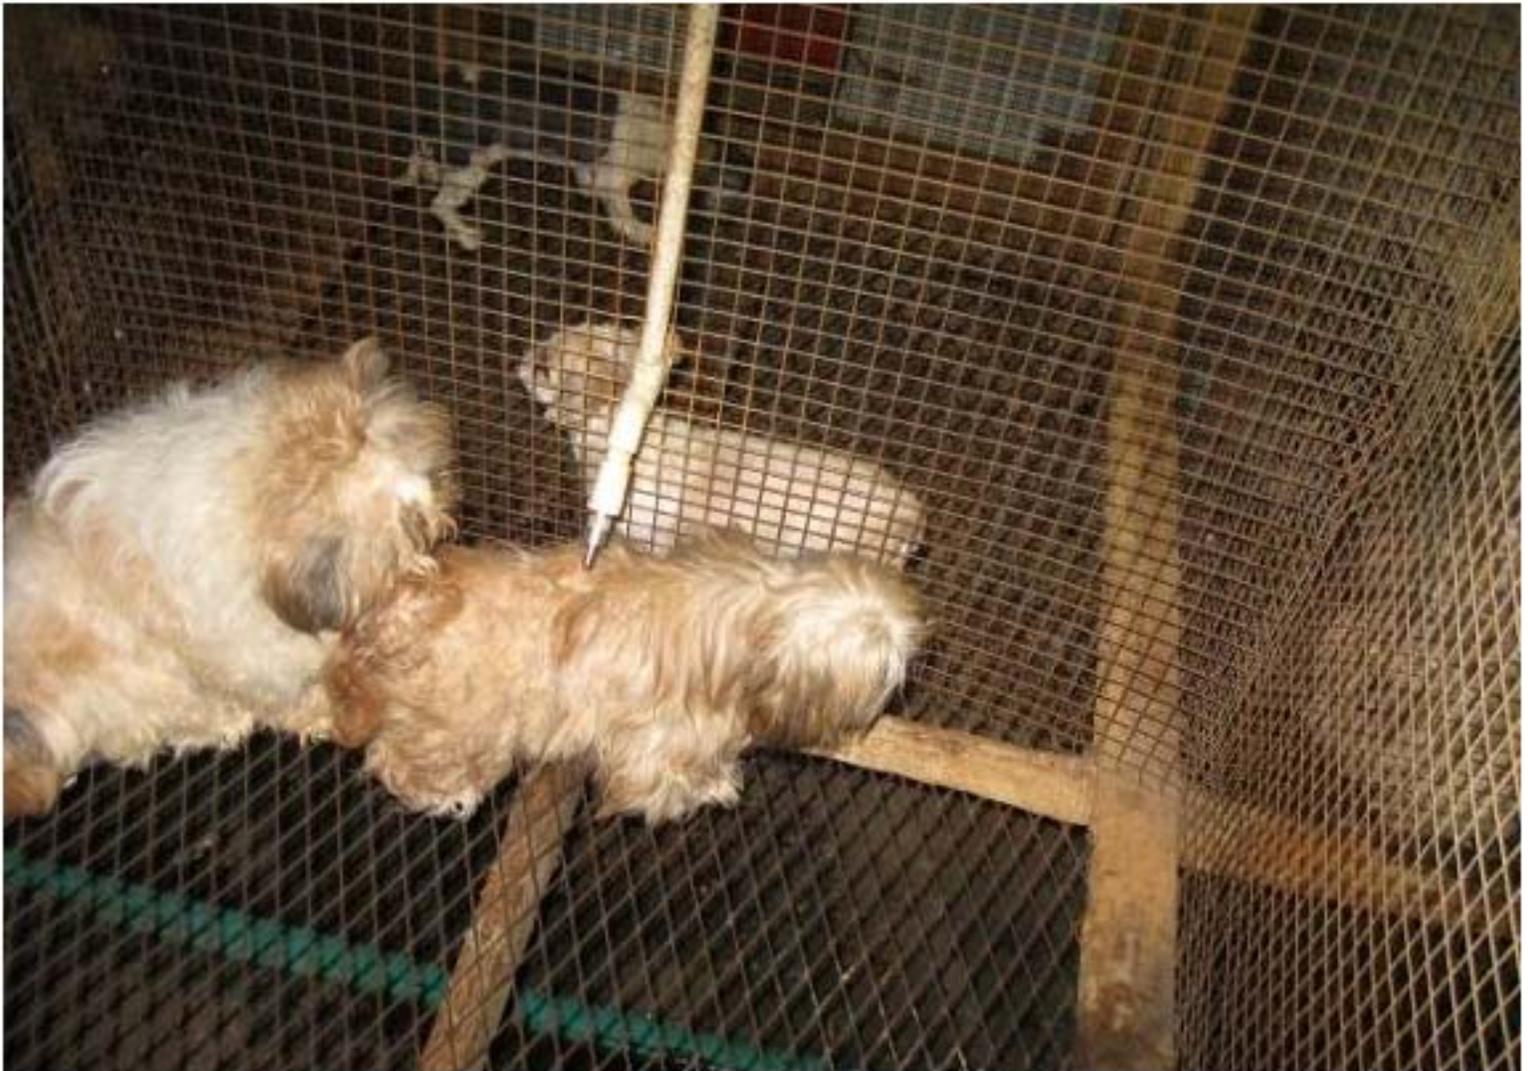
CFR: 2.40 (b) (2)

Photographer:	John J. Lies, ACI	Legal Name:	Registration:	42-A-1354
Photo Taken:	Wed, Jan 12, '11 P.M.	BOB MEHMERT		
Inspection:	12111344160875			
Description:	2.40 (b)(2) Veterinary Care dogs need to be groomed to remove long and/or matted hair. 3.2(d) Indoor surfaces wood supports worn and no longer impervious to moisture.

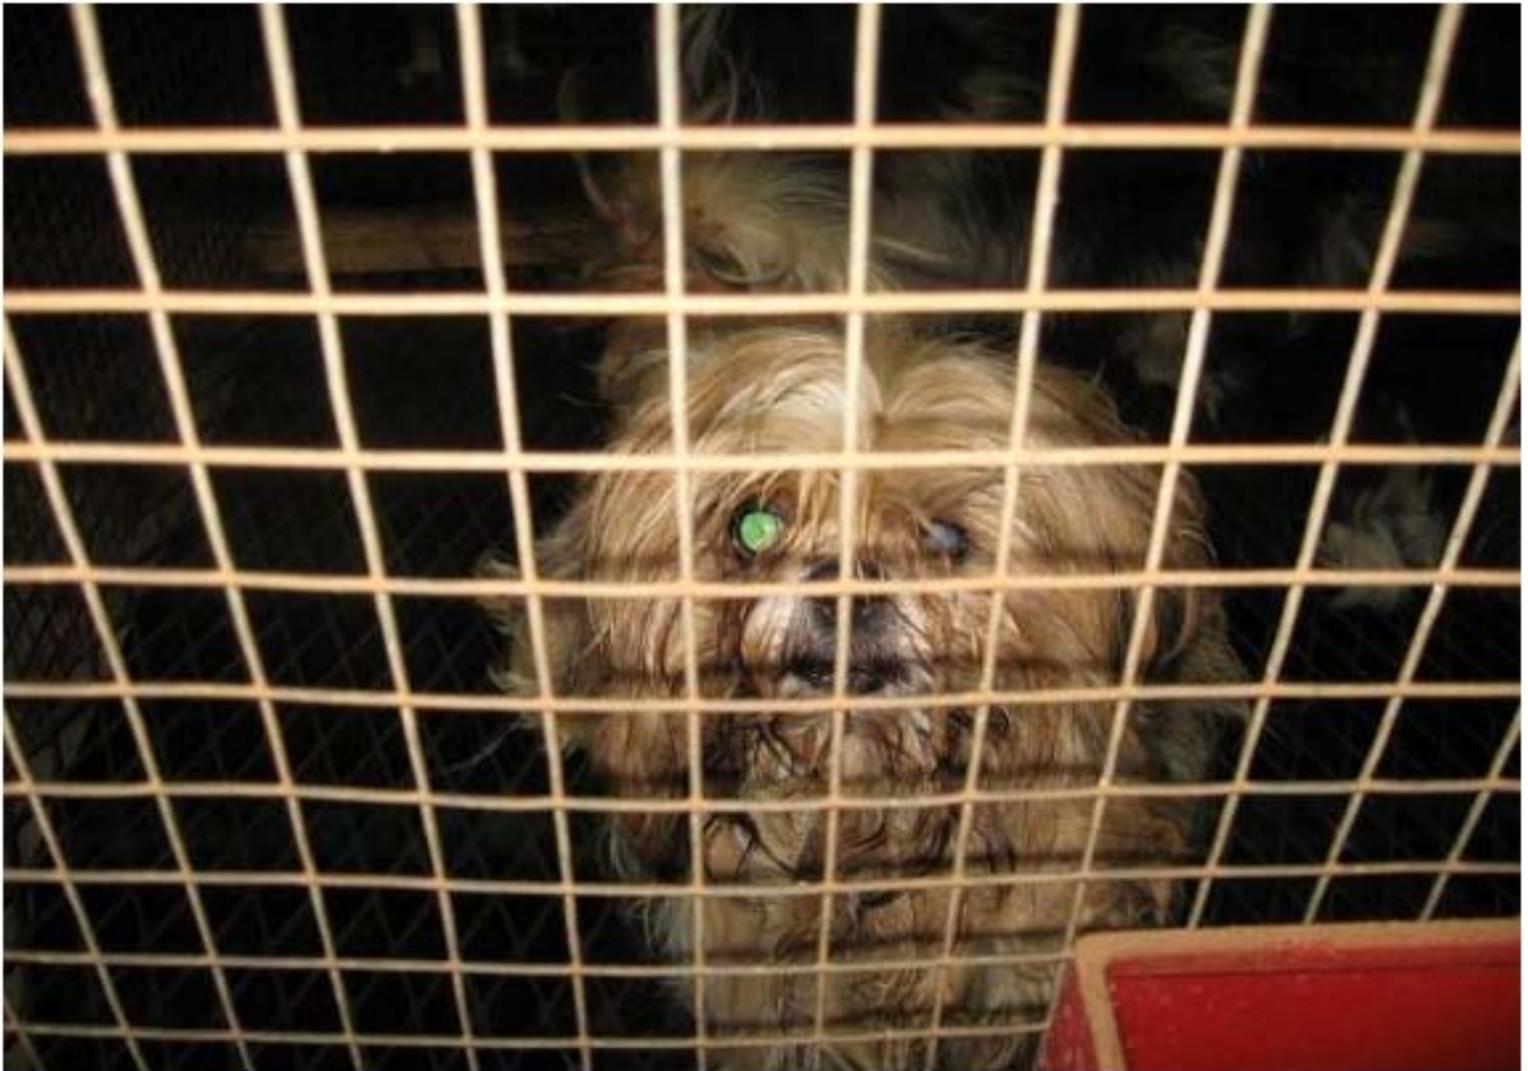
CFR: 2.40 (b) (2)

Photographer:	John J. Lies, ACI	Legal Name:	Registration:	42-A-1354
Photo Taken:	Wed, Jan 12, '11 P.M.	BOB MEHMERT		
Inspection:	12111344160875			
Description:	2.40 (b)(2) Veterinary Care dogs need to be groomed to remove long and/or matted hair. Cloudy eye.

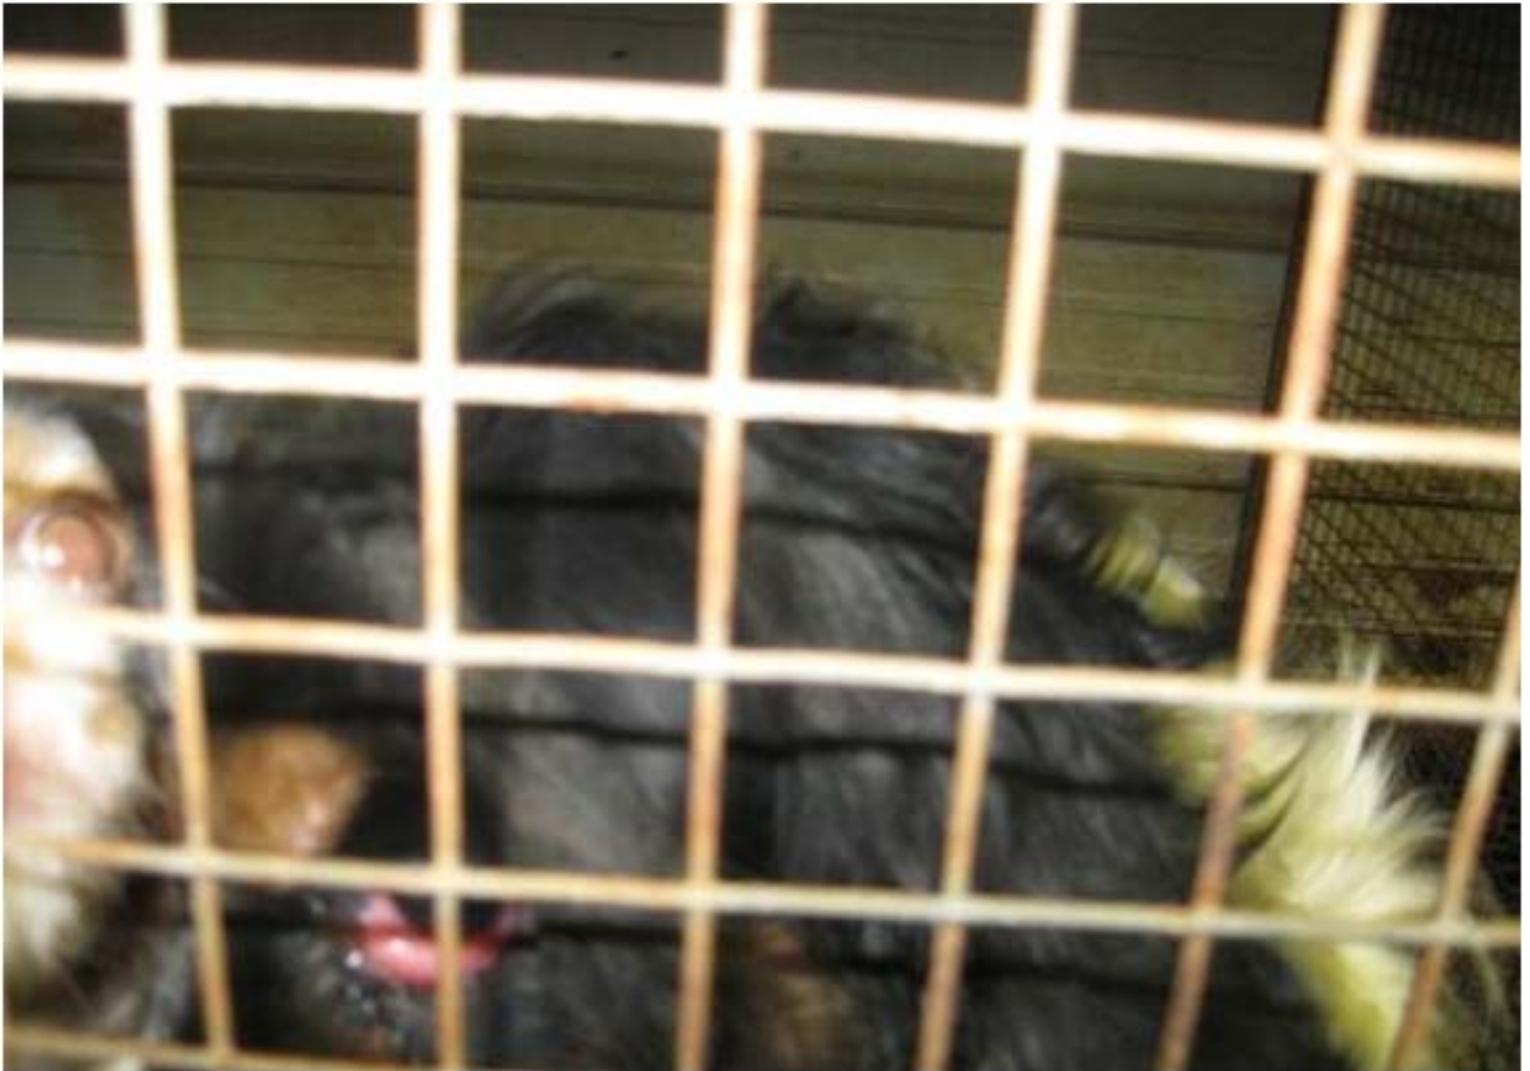
CFR: 2.40 (b) (2)

Photographer:	John J. Lies, ACI	Legal Name:	Registration:	42-A-1354
Photo Taken:	Wed, Jan 12, '11 P.M.	BOB MEHMERT		
Inspection:	12111344160875			
Description:	2.40 (b)(2) Veterinary Care: Cherry eye.

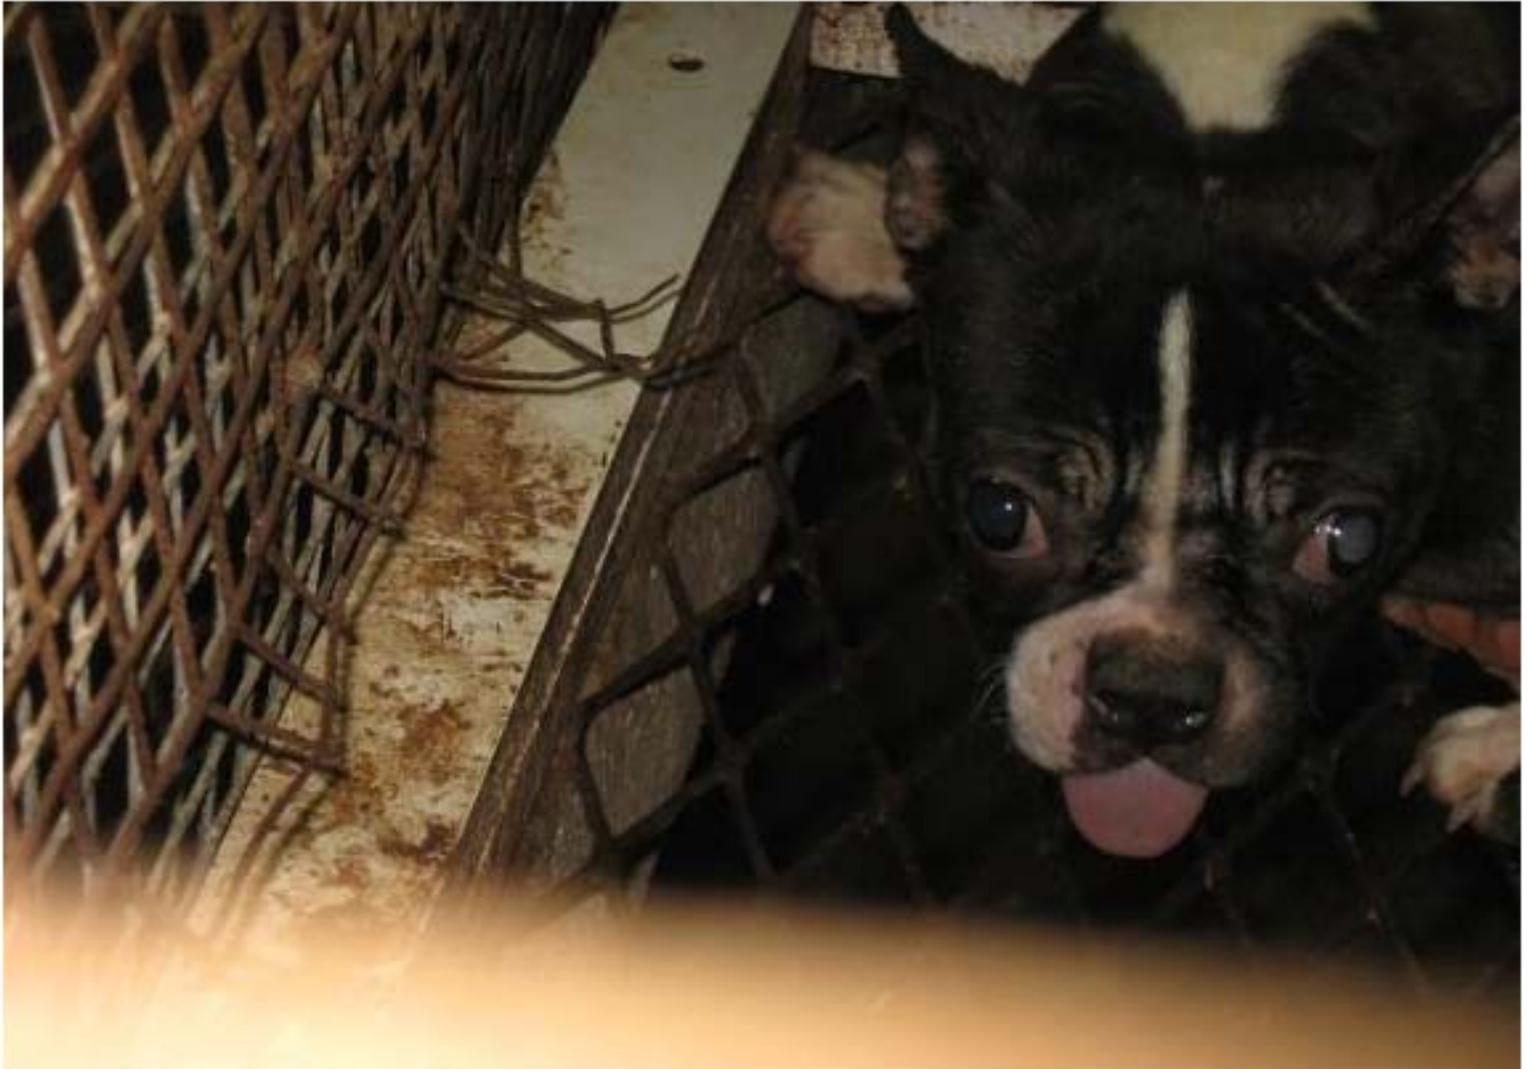
CFR: 3.1 (c) (1) (i), 3.1 (c) (1) (ii)

Photographer:	John J. Lies, ACI	Legal Name:	Registration:	42-A-1354
Photo Taken:	Wed, Jan 12, '11 P.M.	BOB MEHMERT		
Inspection:	12111344160875			
Description:	3.1(c)(1)(i) & (ii) Housing General Surfaces: Rusted broken wire, sharp points inside of enclosure.

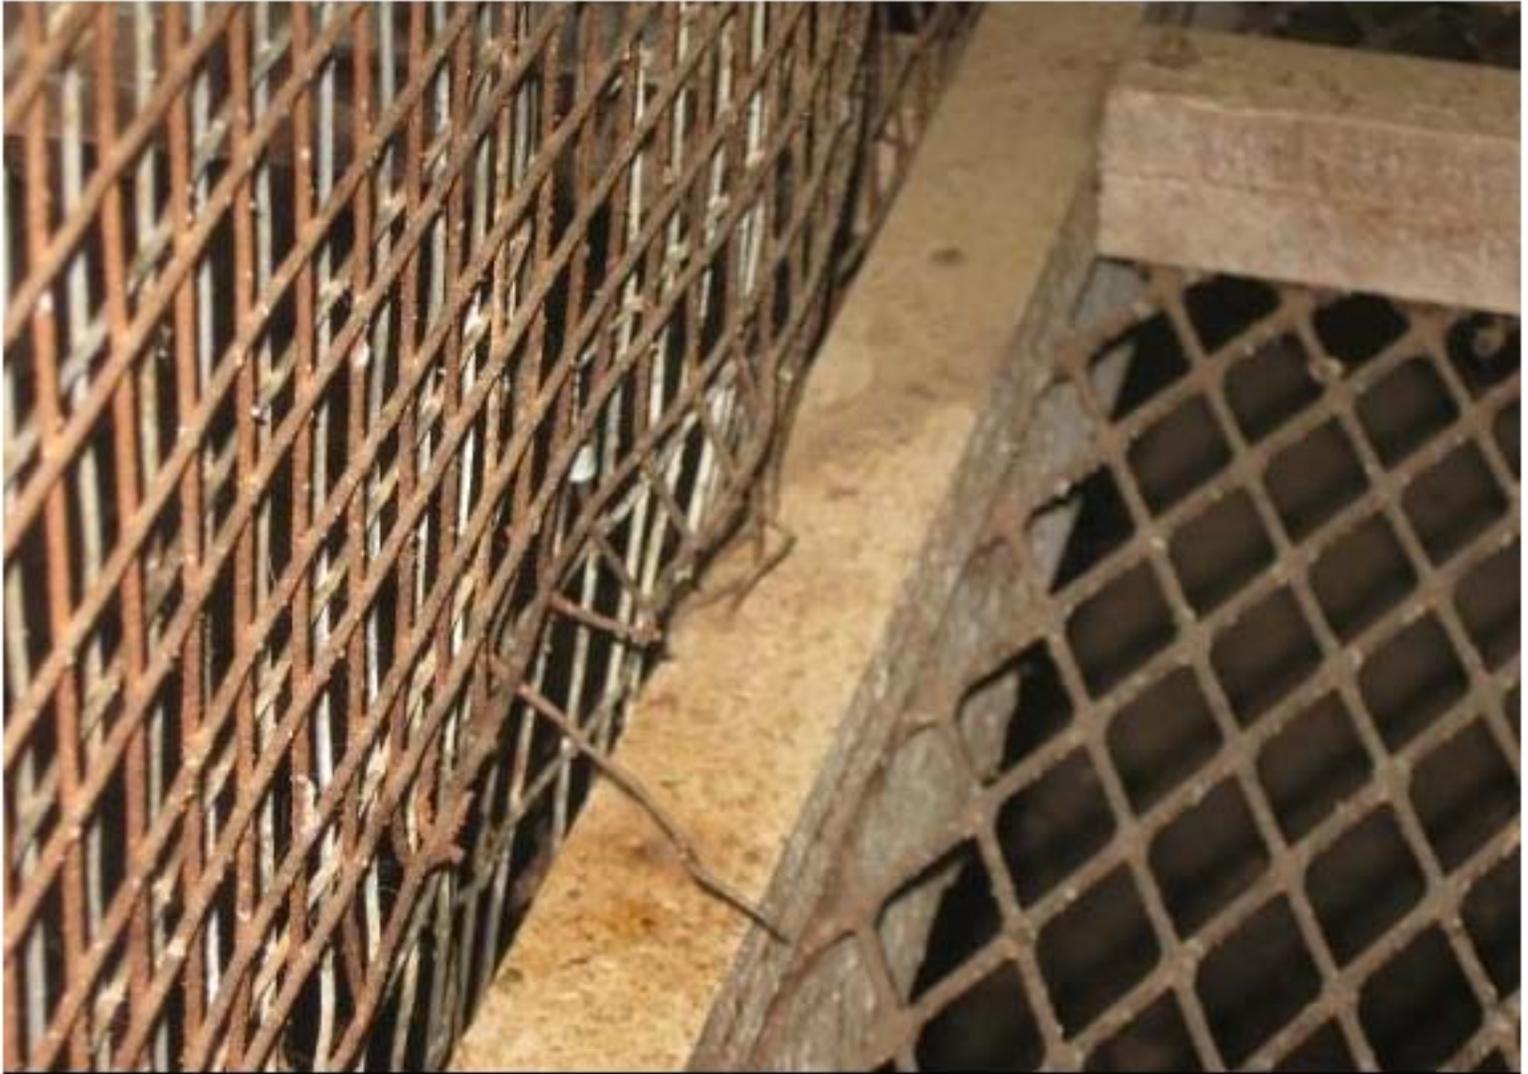
CFR: 3.1 (c) (1) (i), 3.1 (c) (1) (ii)

Photographer:	John J. Lies, ACI	Legal Name:	Registration:	42-A-1354
Photo Taken:	Wed, Jan 12, '11 P.M.	BOB MEHMERT		
Inspection:	12111344160875			
Description:	3.1(c)(1)(i) & (ii) Housing General Surfaces: Rusted broken wire, sharp points inside of enclosure.

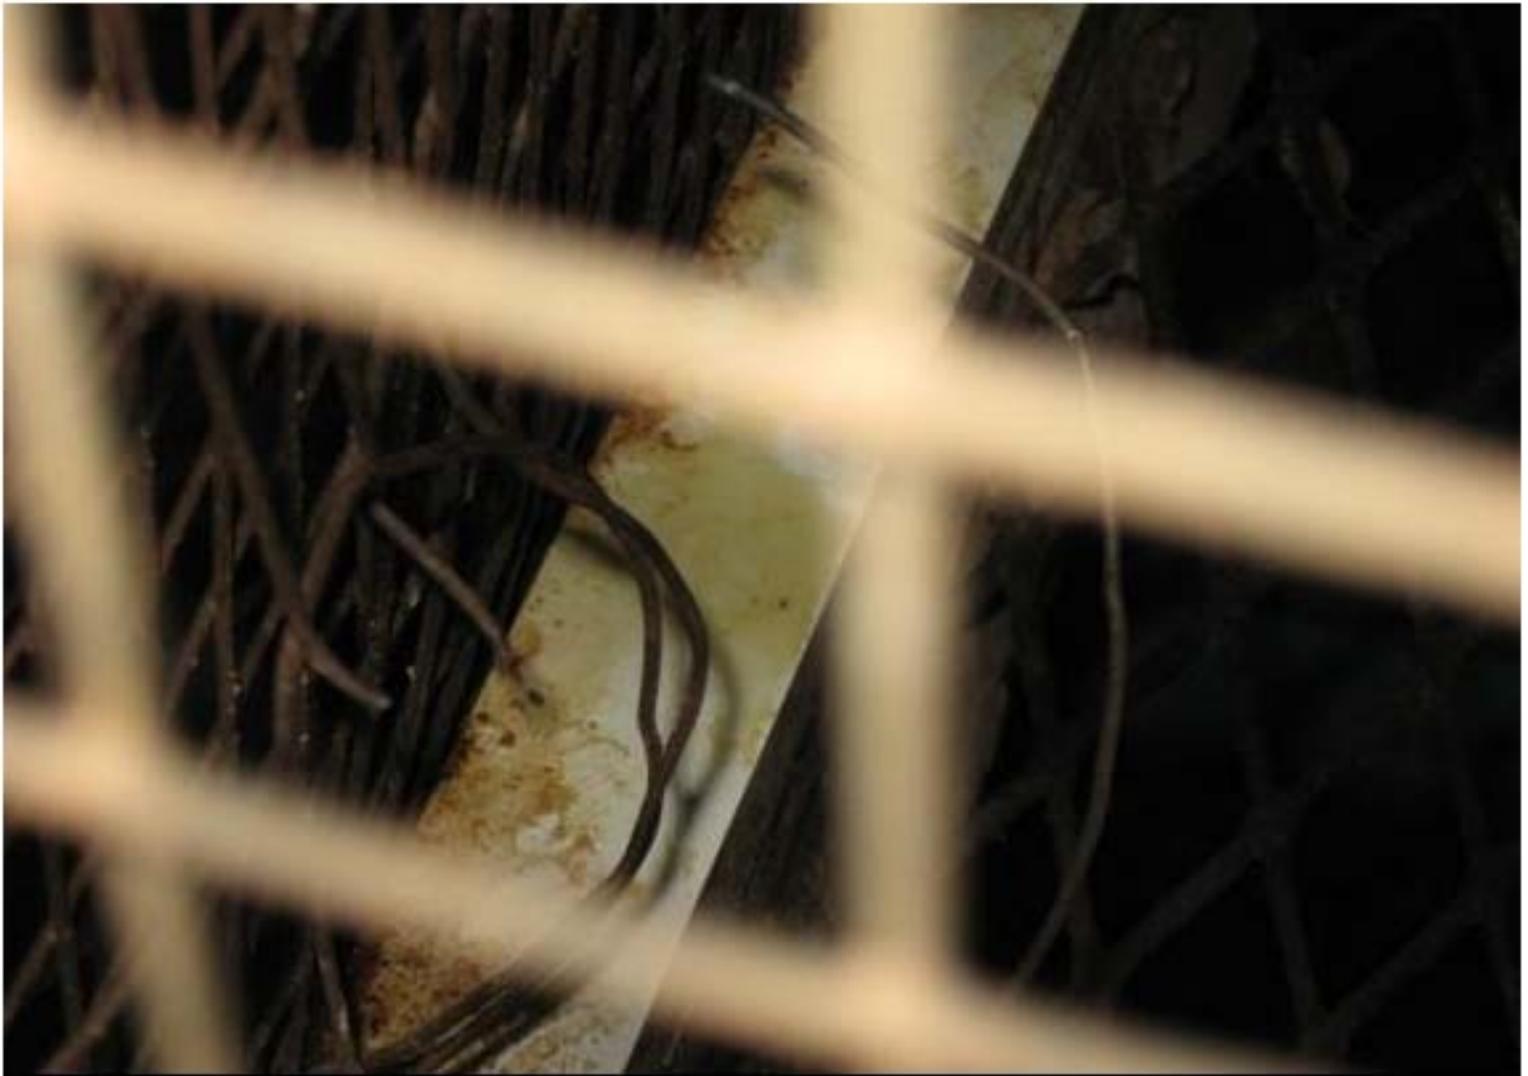
CFR: 3.1 (c) (1) (i), 3.1 (c) (1) (ii)

Photographer:	John J. Lies, ACI	Legal Name:	Registration:	42-A-1354
Photo Taken:	Wed, Jan 12, '11 P.M.	BOB MEHMERT		
Inspection:	12111344160875			
Description:	3.1(c)(1)(i) & (ii) Housing General Surfaces: Rusted broken wire, sharp points inside of enclosure.

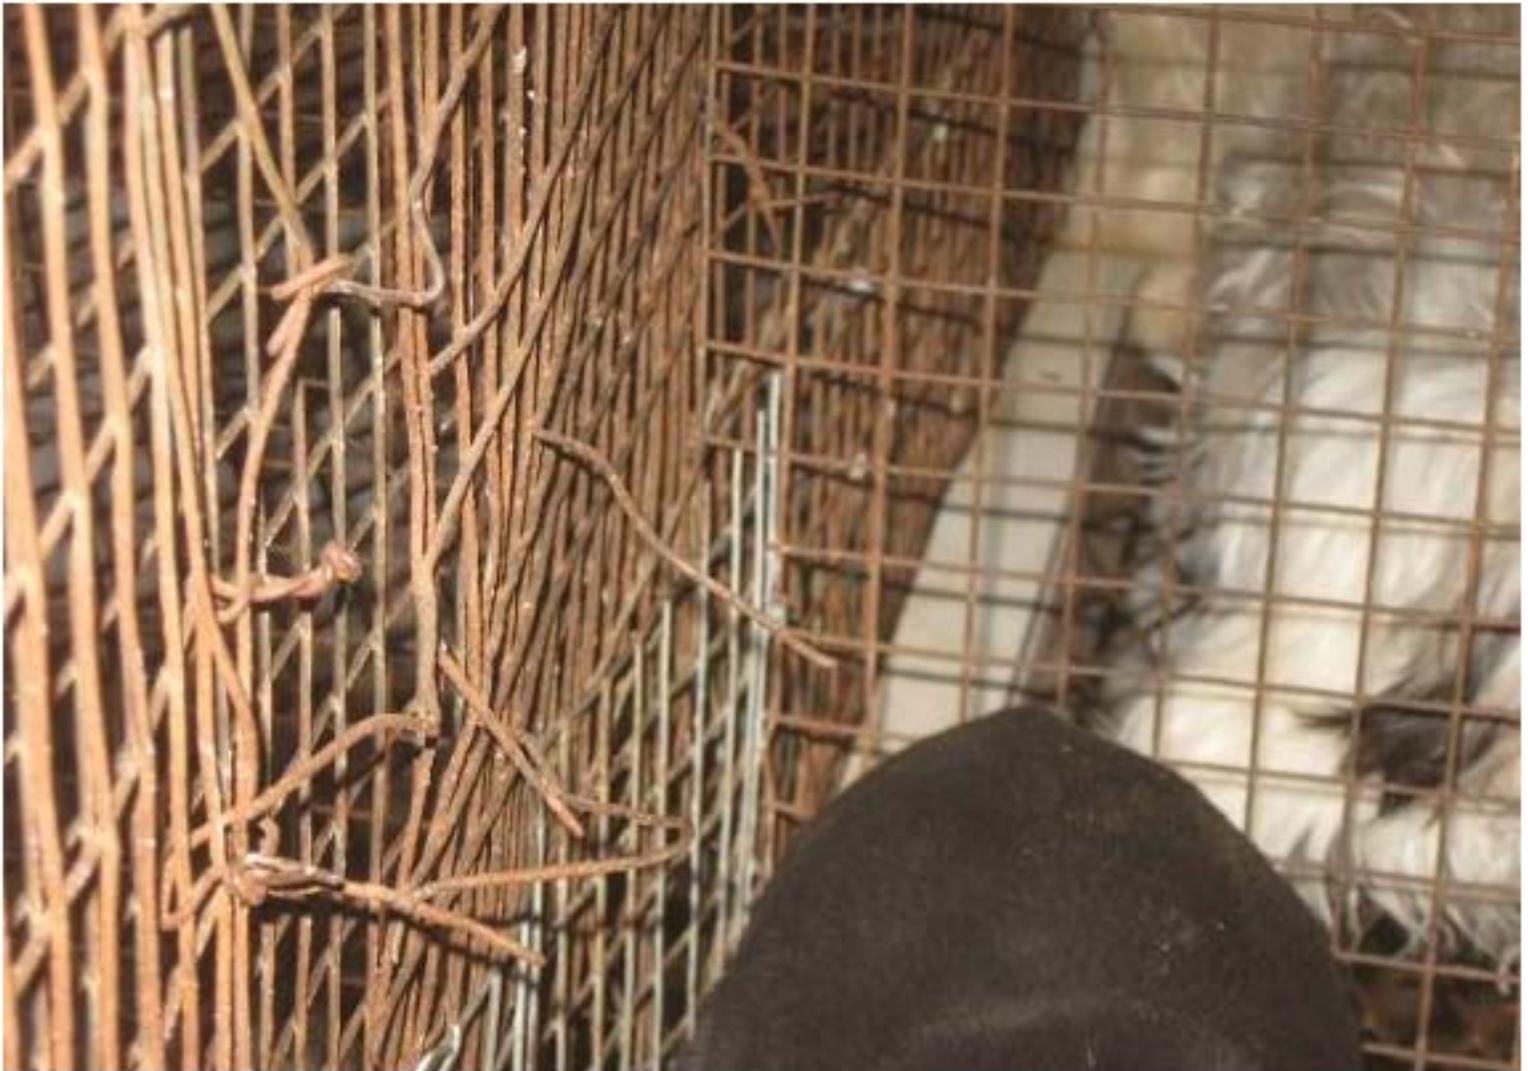
CFR: 3.1 (c) (1) (i), 3.1 (c) (1) (ii)

Photographer:	John J. Lies, ACI	Legal Name:	Registration:	42-A-1354
Photo Taken:	Wed, Jan 12, '11 P.M.	BOB MEHMERT		
Inspection:	12111344160875			
Description:	3.1(c)(1)(i) & (ii) Housing General Surfaces: Rusted broken wire, sharp points inside of enclosure.

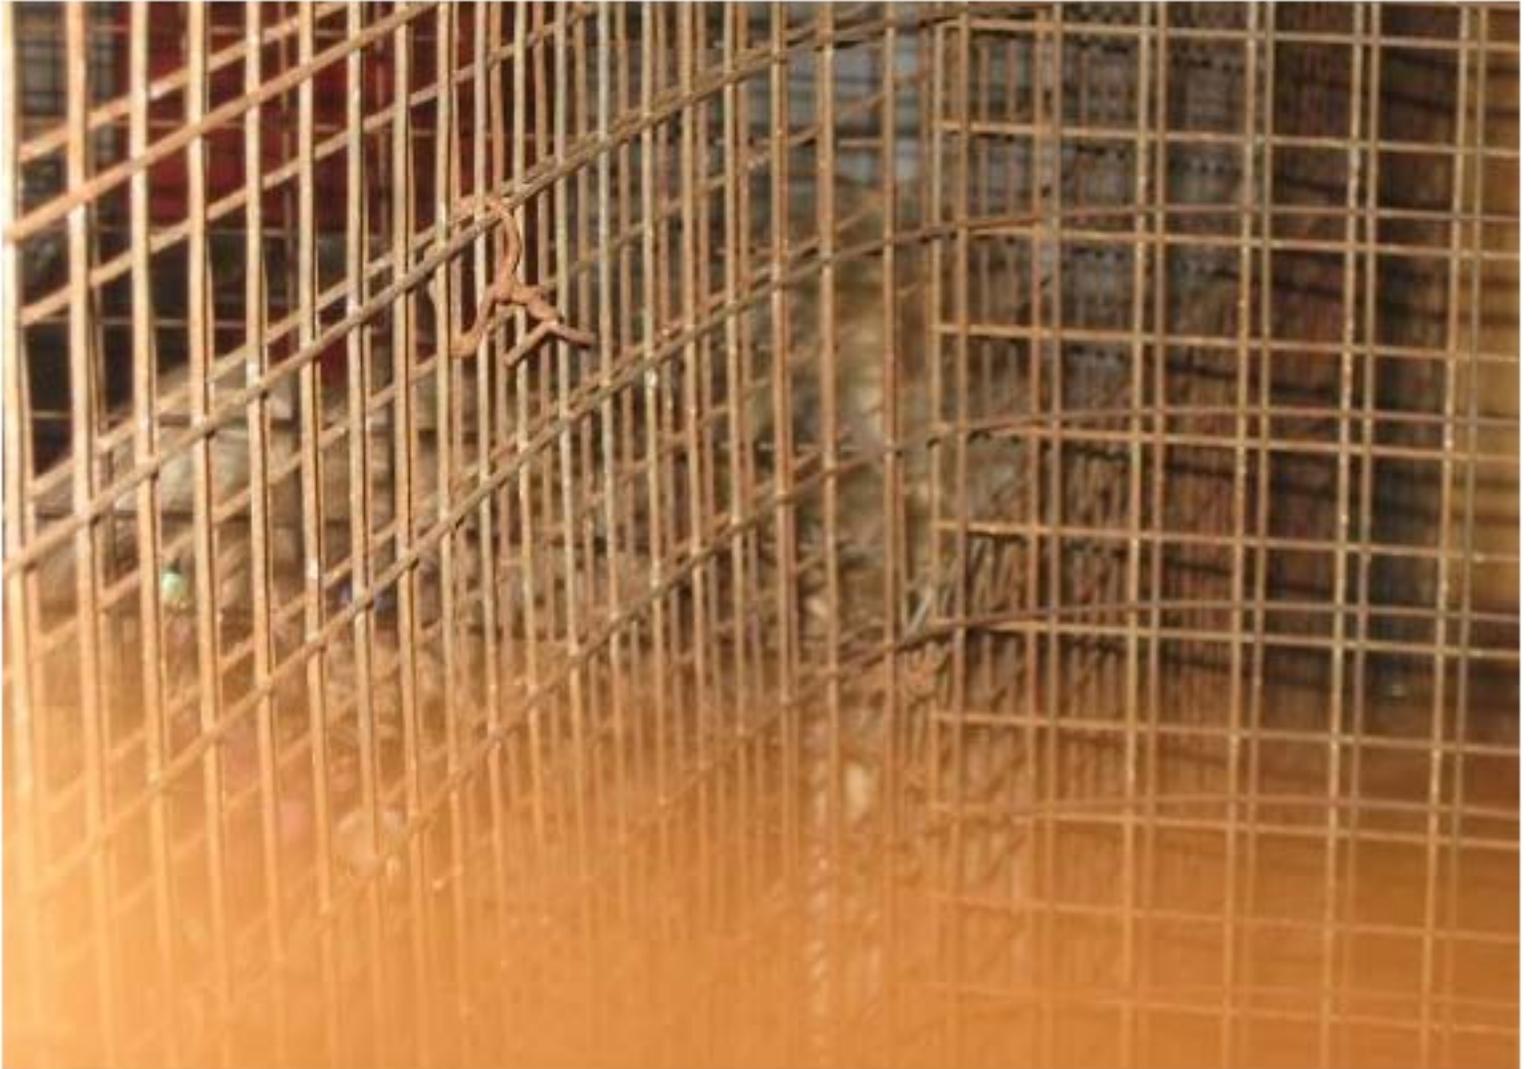
CFR: 3.1 (c) (1) (i), 3.1 (c) (1) (ii)

Photographer:	John J. Lies, ACI	Legal Name:	Registration:	42-A-1354
Photo Taken:	Wed, Jan 12, '11 P.M.	BOB MEHMERT		
Inspection:	12111344160875			
Description:	3.1(c)(1)(i) & (ii) Housing General Surfaces: Rusted broken wire, sharp points inside of enclosure.

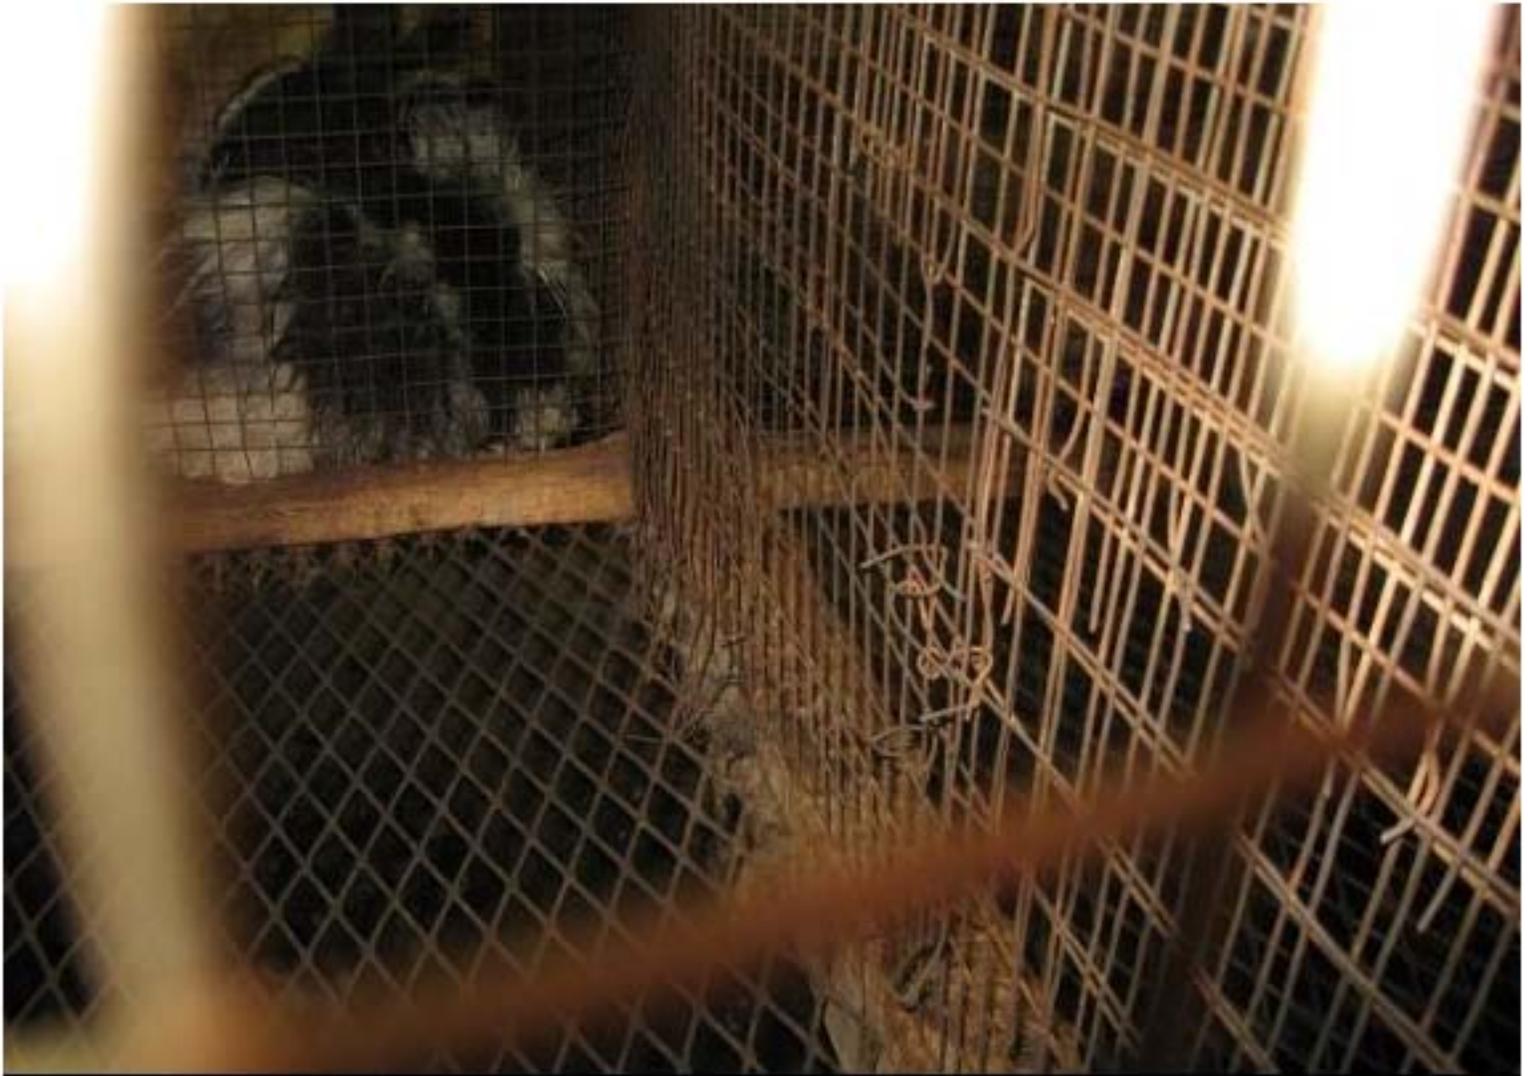
CFR: 3.1 (c) (1) (i), 3.1 (c) (1) (ii)

Photographer:	John J. Lies, ACI	Legal Name:	Registration:	42-A-1354
Photo Taken:	Wed, Jan 12, '11 P.M.	BOB MEHMERT		
Inspection:	12111344160875			
Description:	3.1(c)(1)(i) & (ii) Housing General Surfaces: Rusted broken wire, sharp points inside of enclosure.

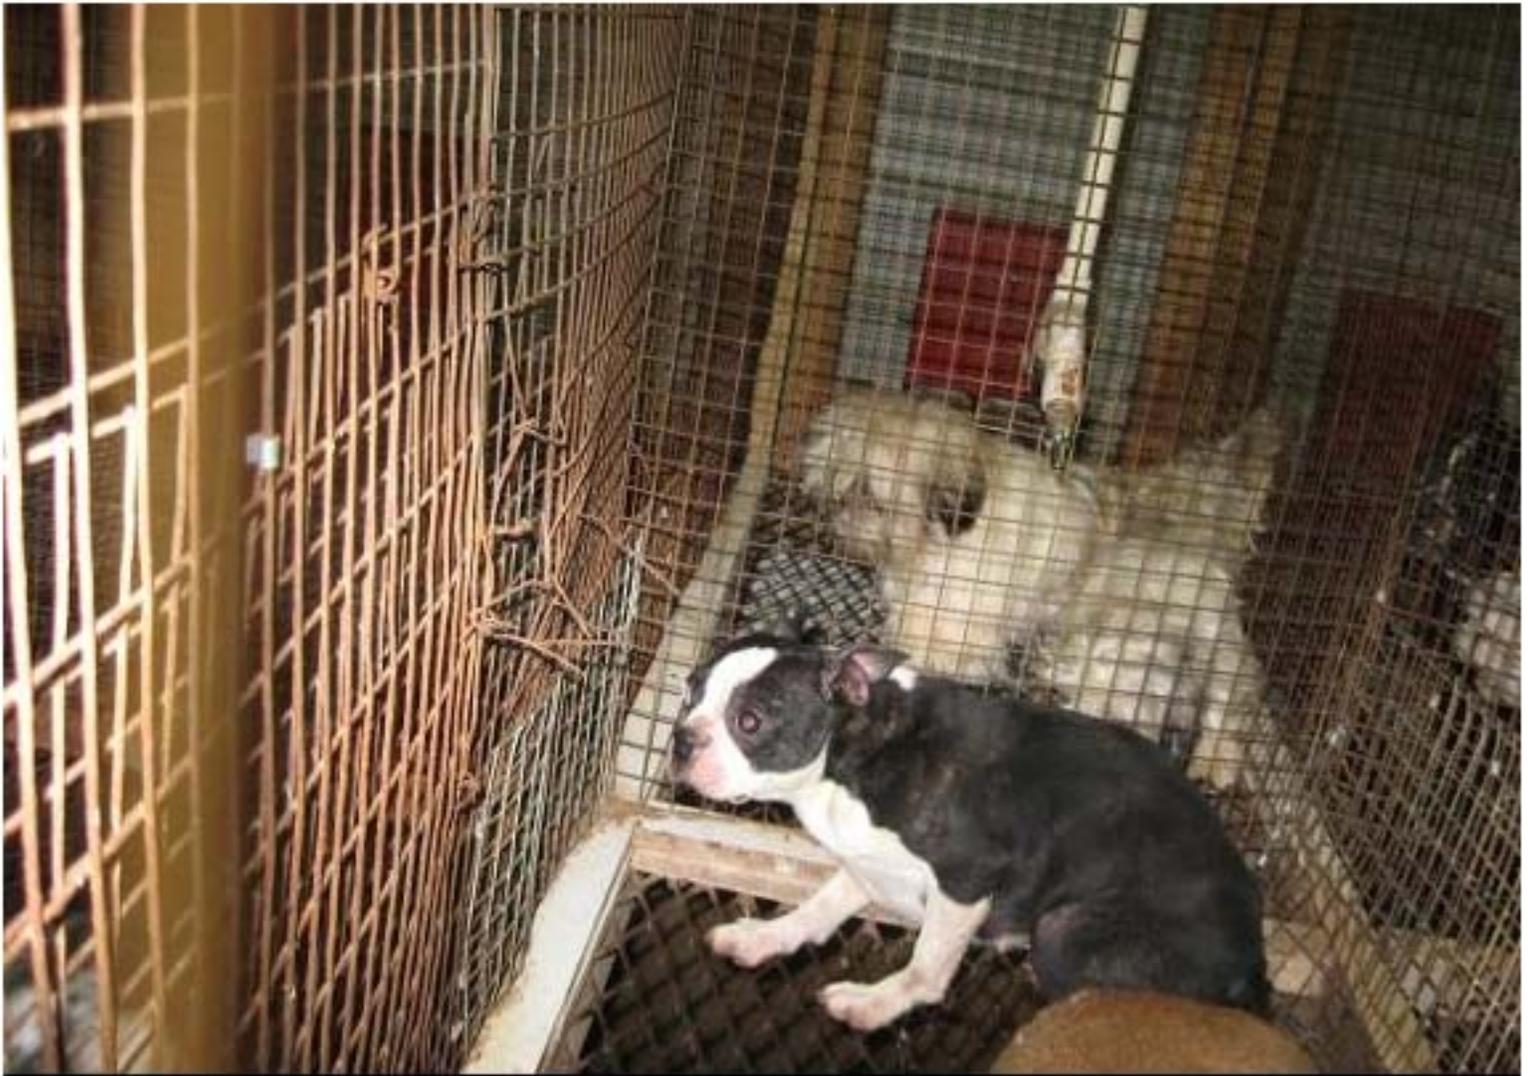
CFR: 3.1 (c) (1) (i), 3.1 (c) (1) (ii)

Photographer:	John J. Lies, ACI	Legal Name:	Registration:	42-A-1354
Photo Taken:	Wed, Jan 12, '11 P.M.	BOB MEHMERT		
Inspection:	12111344160875			
Description:	3.1(c)(1)(i) & (ii) Housing General Surfaces: Rusted broken wire, sharp points inside of enclosure.

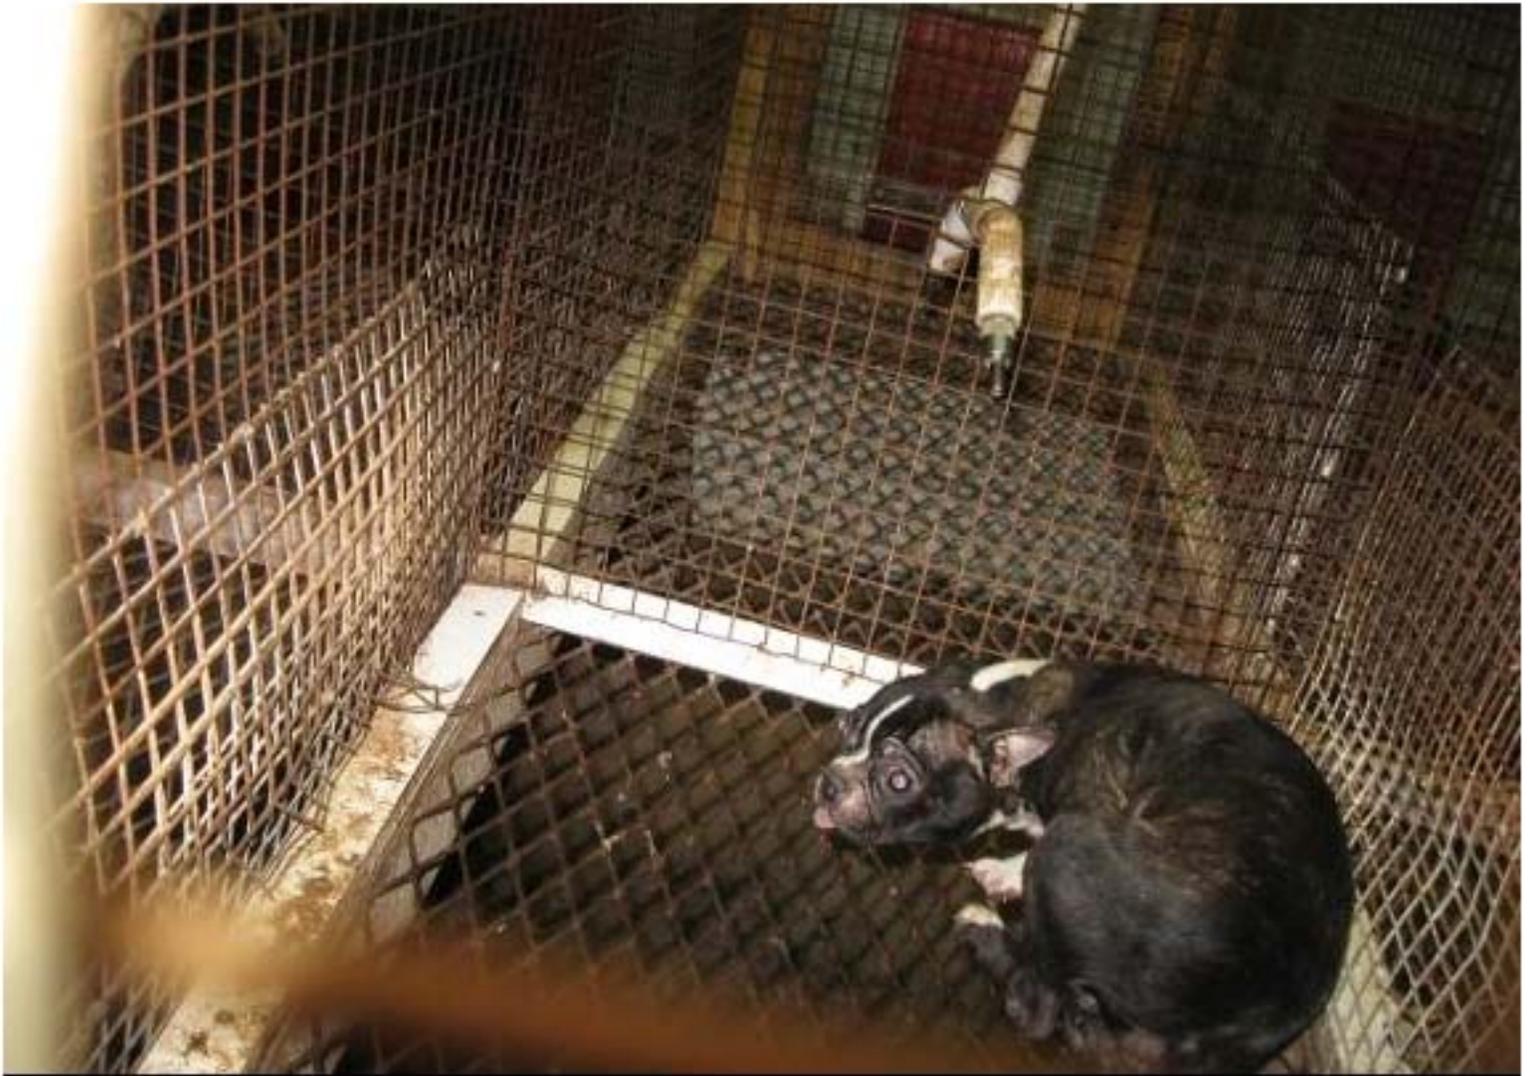
CFR: 3.1 (c) (1) (i), 3.1 (c) (1) (ii)

Photographer:	John J. Lies, ACI	Legal Name:	Registration:	42-A-1354
Photo Taken:	Wed, Jan 12, '11 P.M.	BOB MEHMERT		
Inspection:	12111344160875			
Description:	3.1(c)(1)(i) & (ii) Housing General Surfaces: Rusted broken wire, sharp points inside of enclosure.

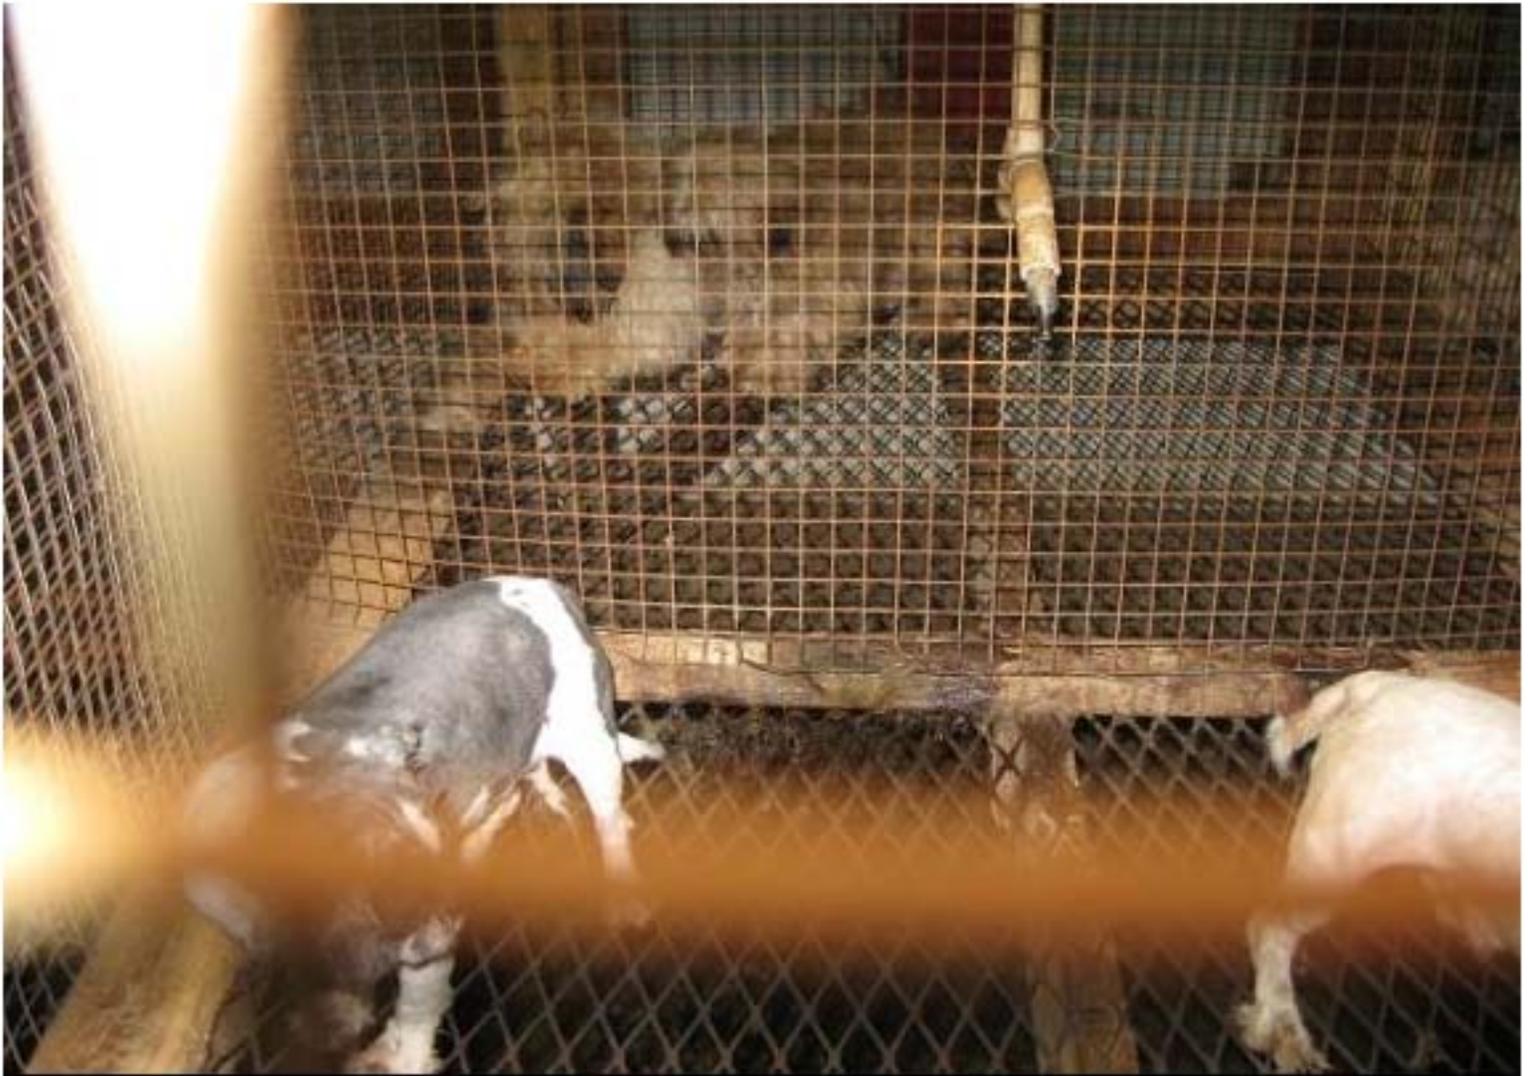
CFR: 3.2 (d)

Photographer:	John J. Lies, ACI	Legal Name:	Registration:	42-A-1354
Photo Taken:	Wed, Jan 12, '11 P.M.	BOB MEHMERT		
Inspection:	12111344160875			
Description:	3.2 (d) Indoor Housing Surfaces: Wood supports worn and no longer impervious to moisture.
