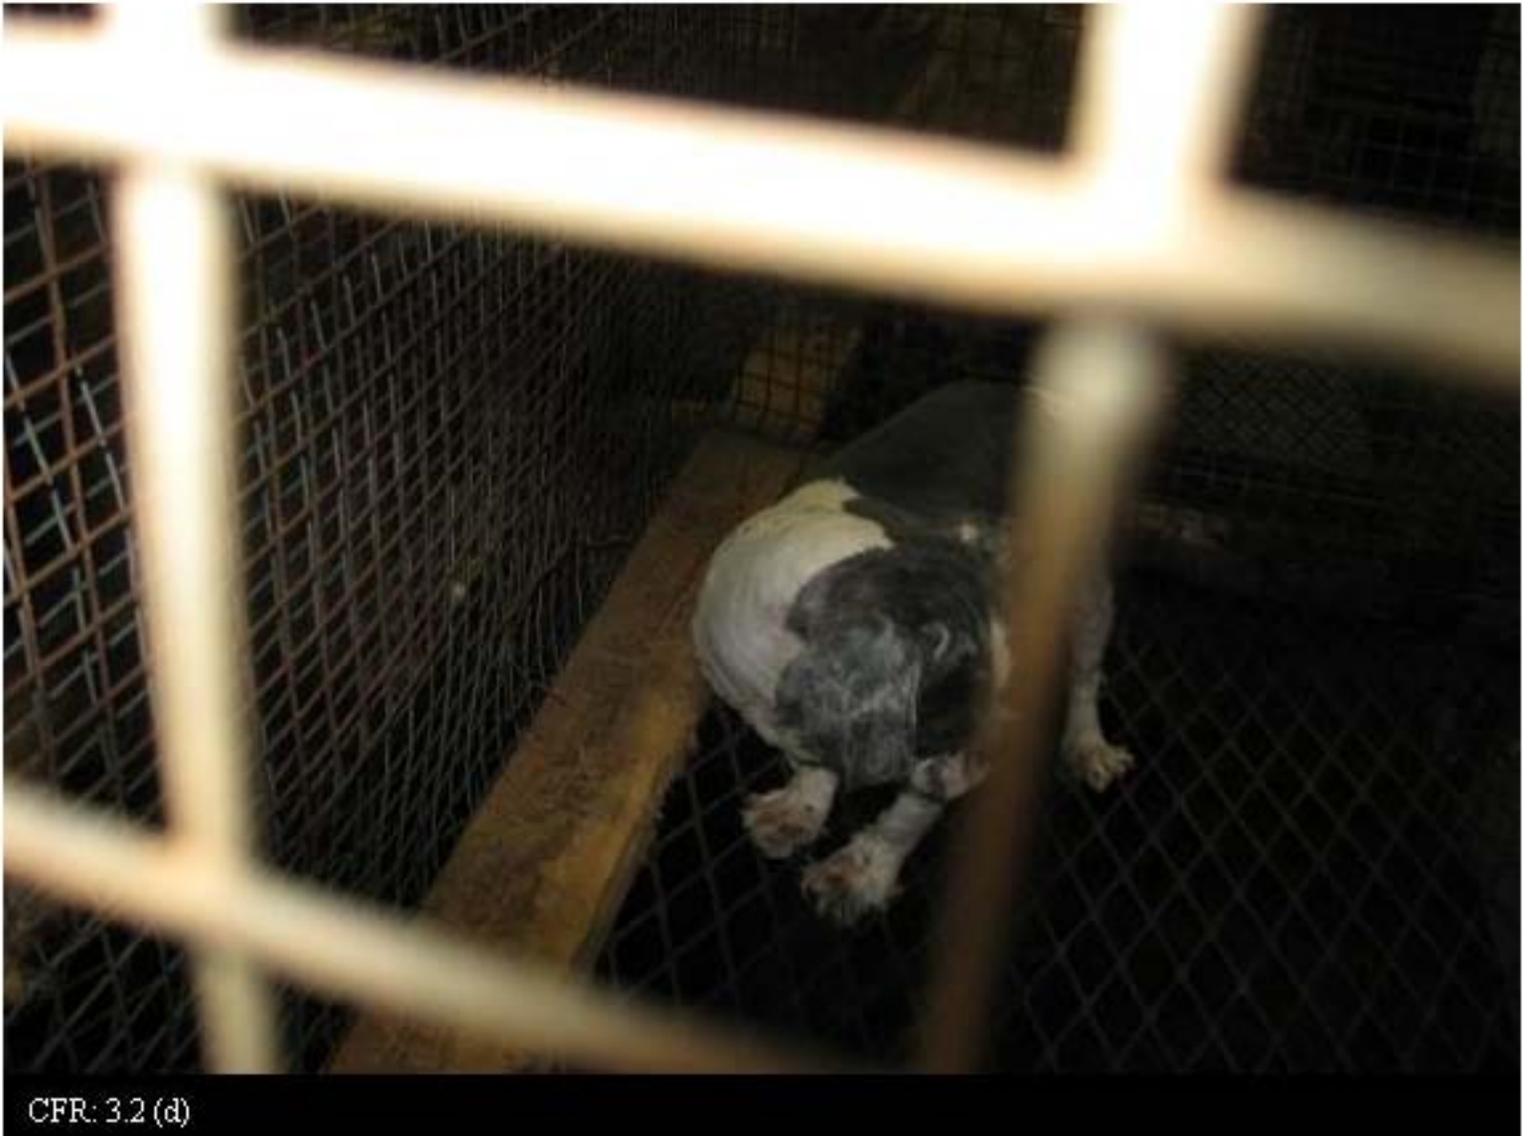
Photographer:	John J. Lies, ACI	Legal Name:	Registration:	42-A-1354
Photo Taken:	Wed, Jan 12, '11 P.M.	BOB MEHMERT		
Inspection:	12111344160875			
Description:	3.2 (d) Indoor Housing Surfaces: Wood supports worn and no longer impervious to moisture.

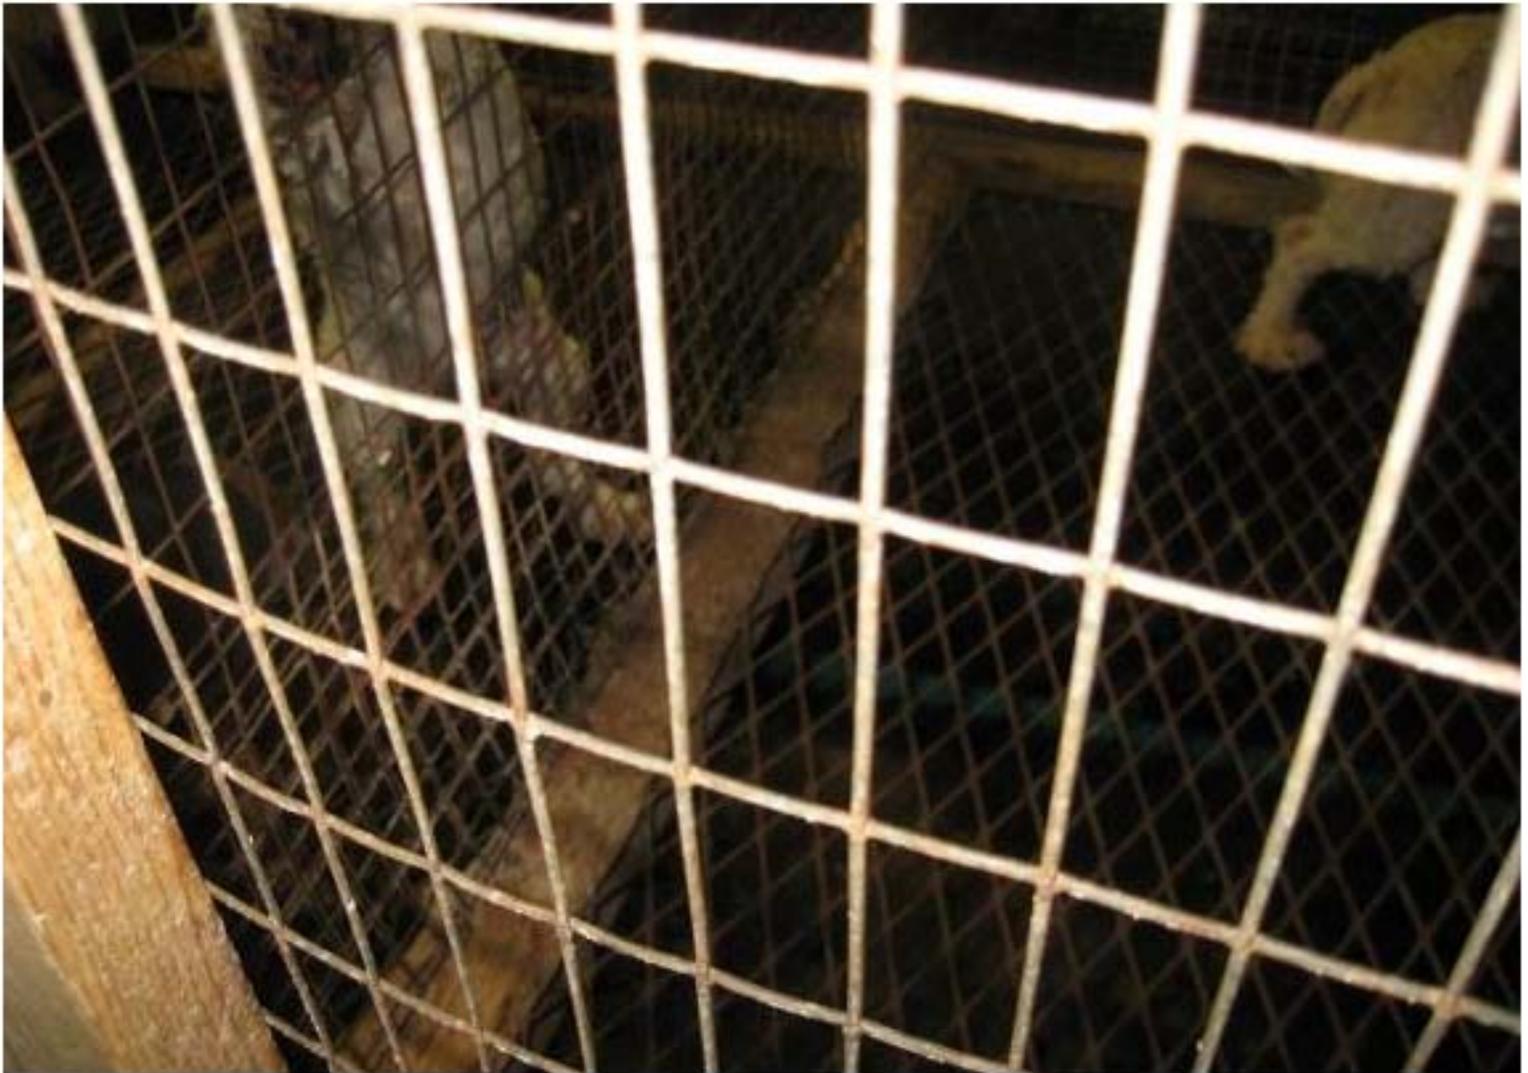
CFR: 3.2 (d)

Photographer:	John J. Lies, ACI	Legal Name:	Registration:	42-A-1354
Photo Taken:	Wed, Jan 12, '11 P.M.	BOB MEHMERT		
Inspection:	12111344160875			
Description:	3.2 (d) Indoor Housing Surfaces: Wood supports worn and no longer impervious to moisture.

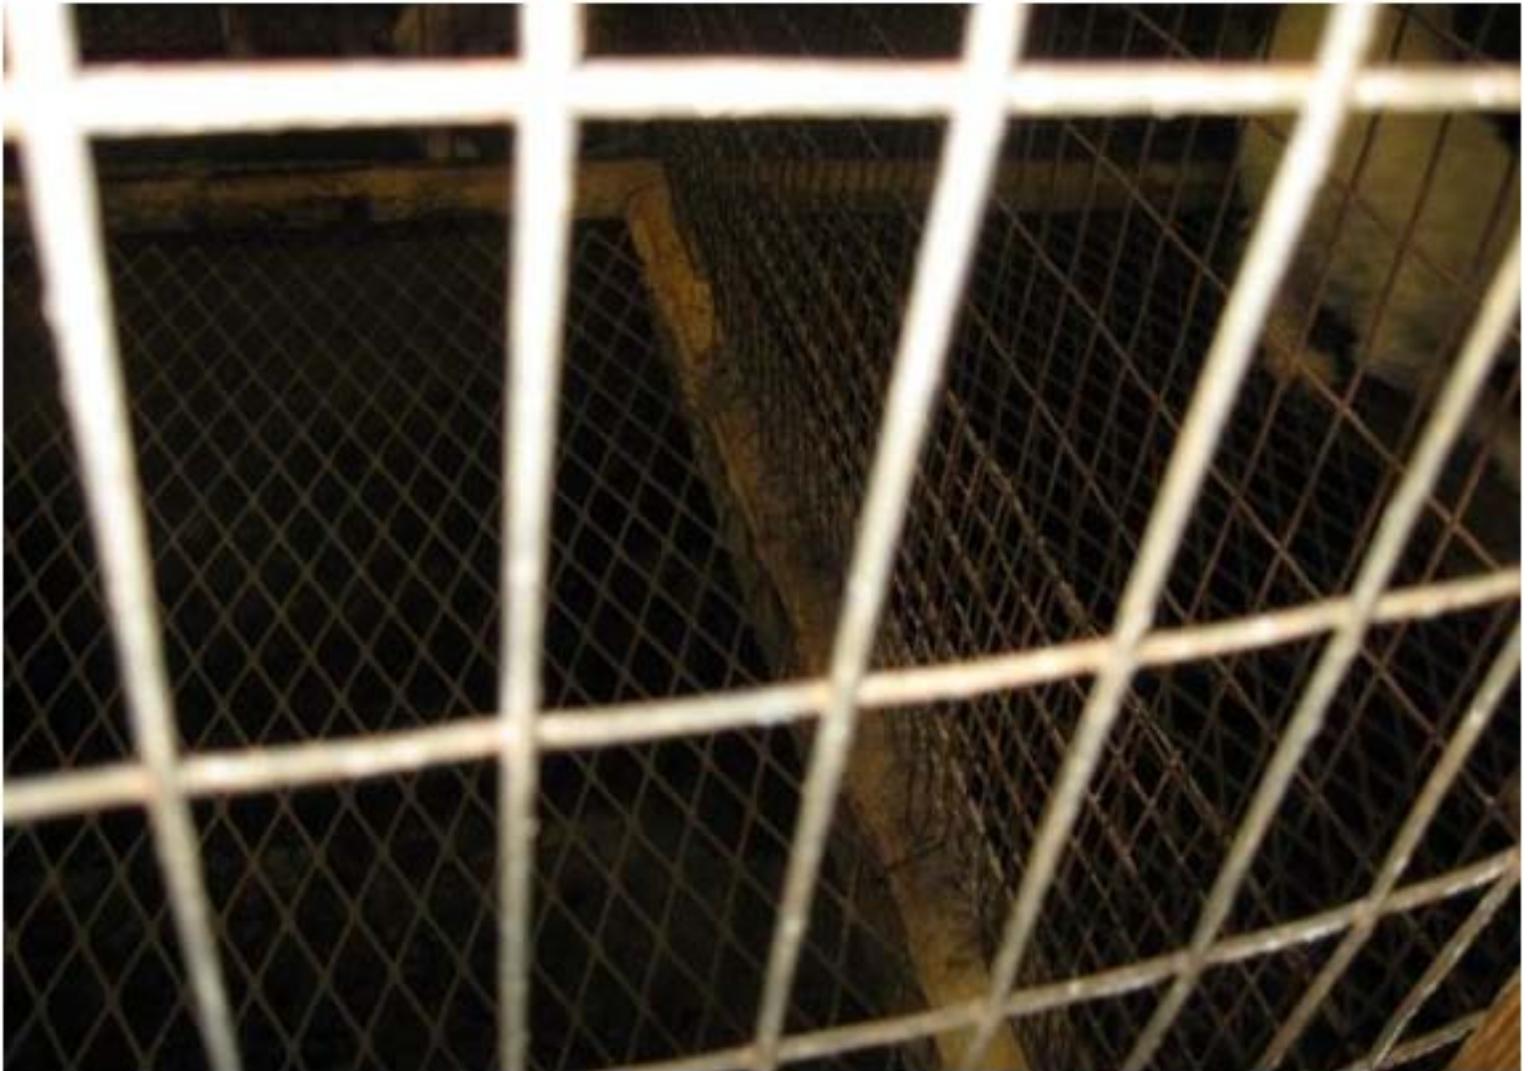
CFR: 3.2 (d)

Photographer:	John J. Lies, ACI	Legal Name:	Registration:	42-A-1354
Photo Taken:	Wed, Jan 12, '11 P.M.	BOB MEHMERT		
Inspection:	12111344160875			
Description:	3.2 (d) Indoor Housing Surfaces: Wood supports worn and no longer impervious to moisture.

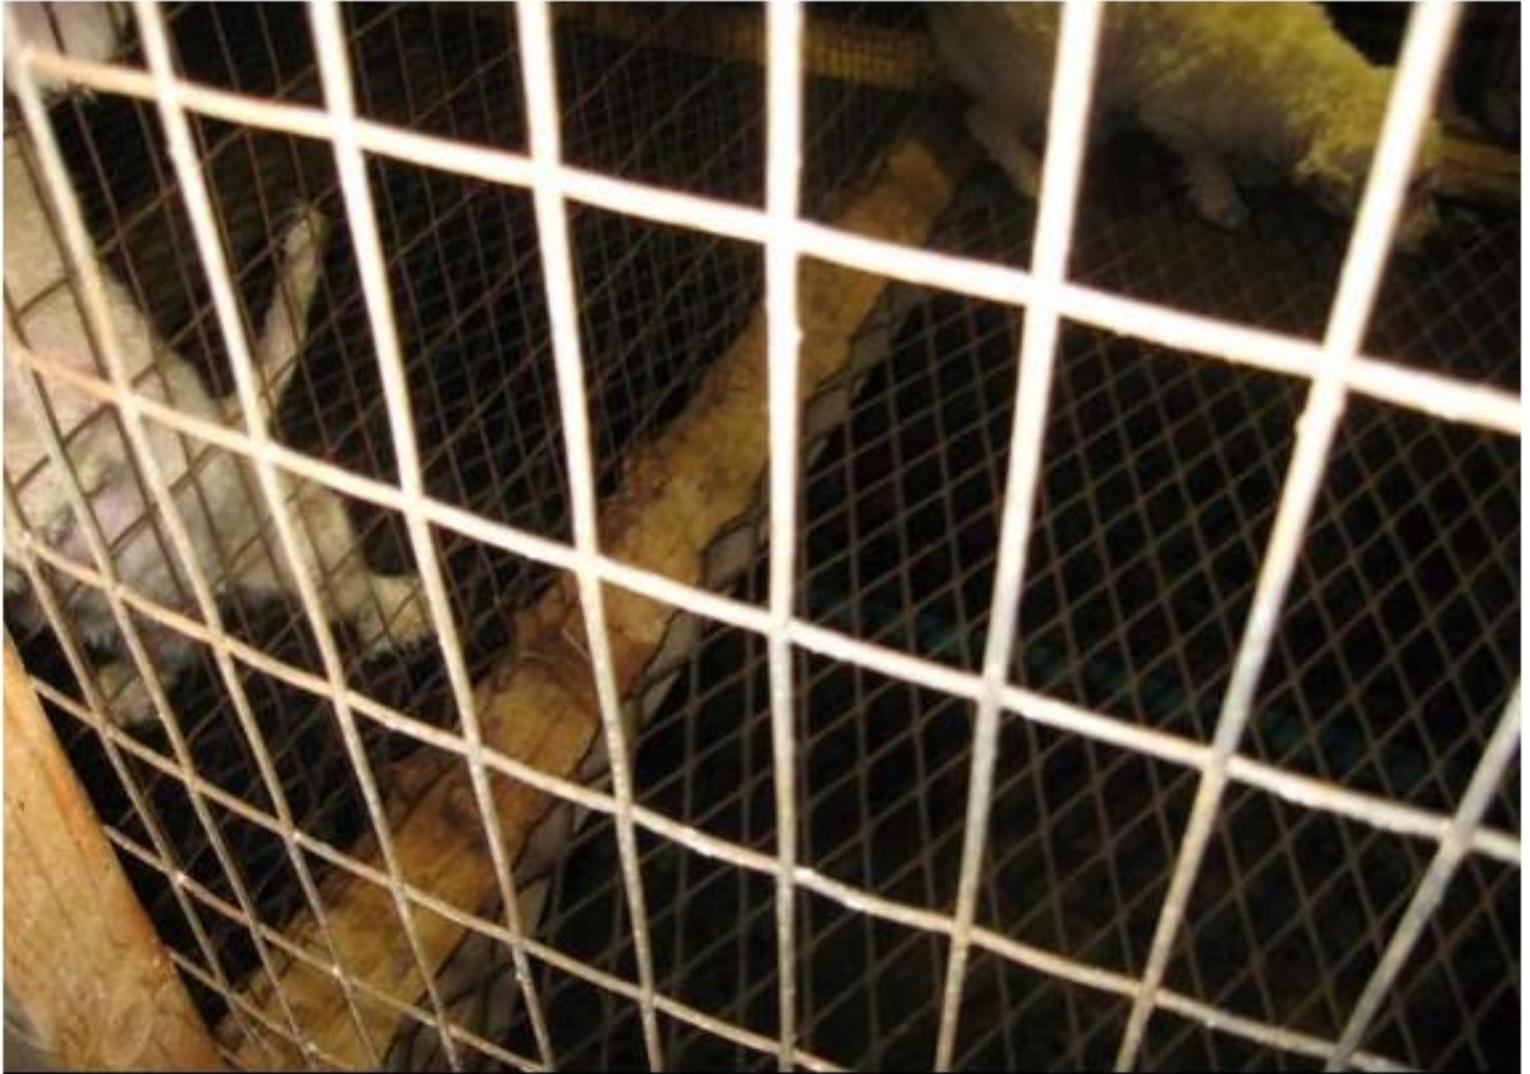
CFR: 3.2 (d)

Photographer:	John J. Lies, ACI	Legal Name:	Registration:	42-A-1354
Photo Taken:	Wed, Jan 12, '11 P.M.	BOB MEHMERT		
Inspection:	12111344160875			
Description:	3.2 (d) Indoor Housing Surfaces: Wood supports worn and no longer impervious to moisture.

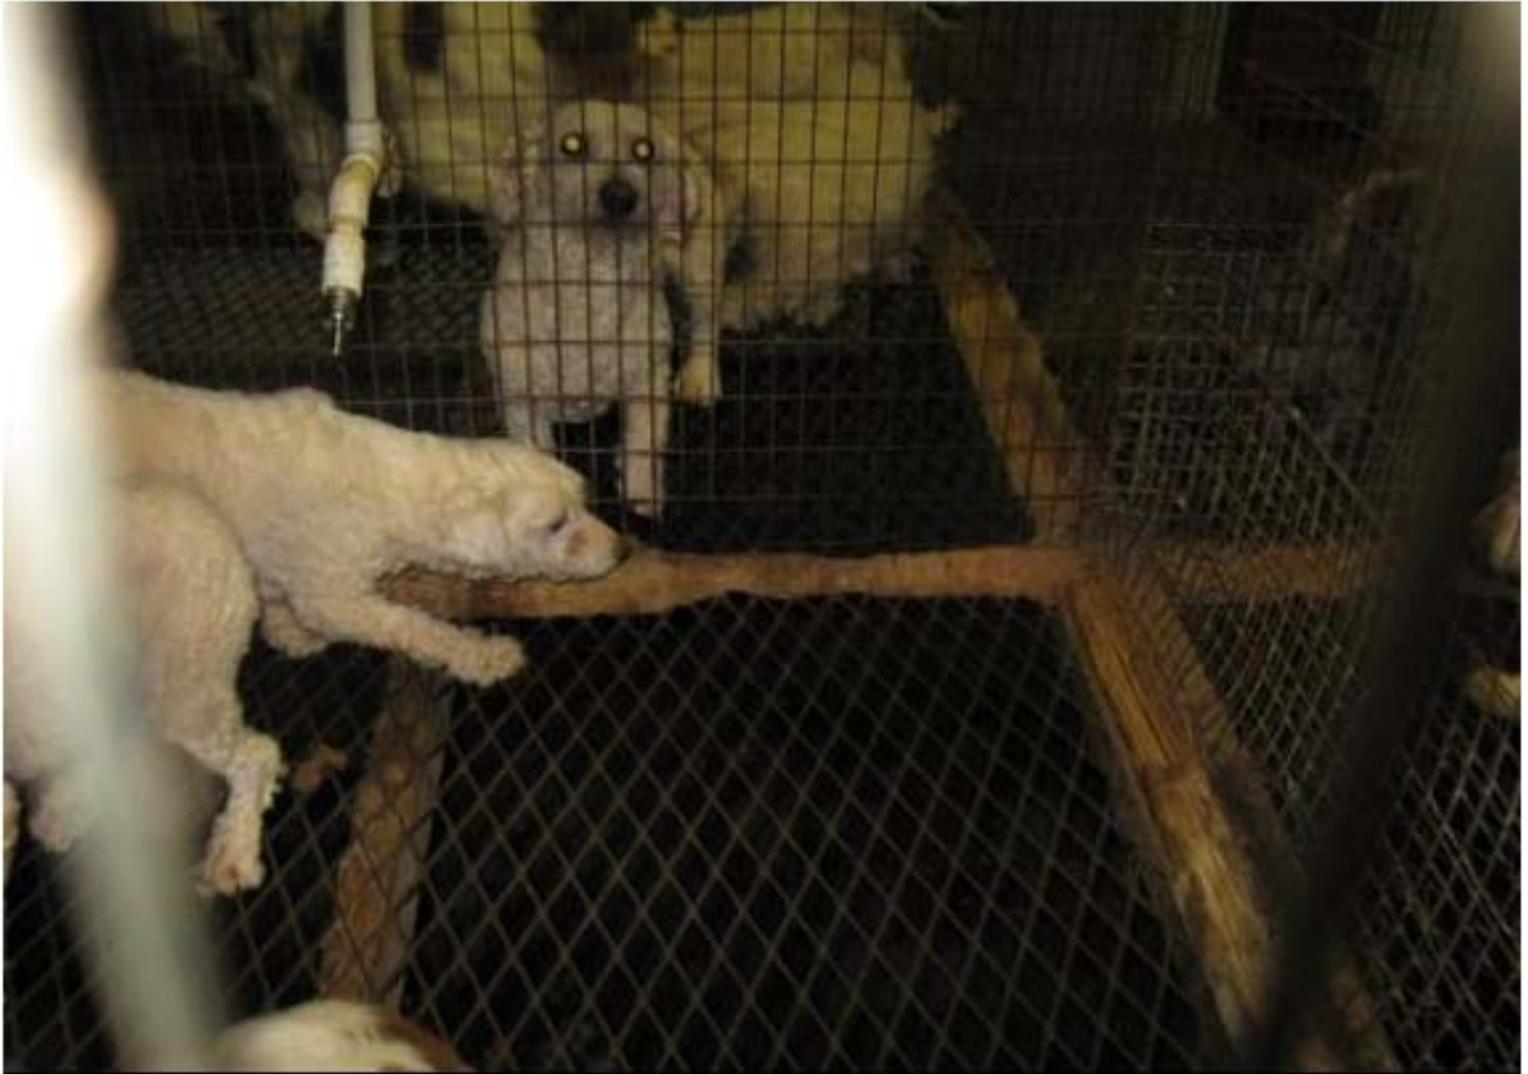
CFR: 3.2 (d)

Photographer:	John J. Lies, ACI	Legal Name:	Registration:	42-A-1354
Photo Taken:	Wed, Jan 12, '11 P.M.	BOB MEHMERT		
Inspection:	12111344160875			
Description:	3.2 (d) Indoor Housing Surfaces: Wood supports worn and no longer impervious to moisture.

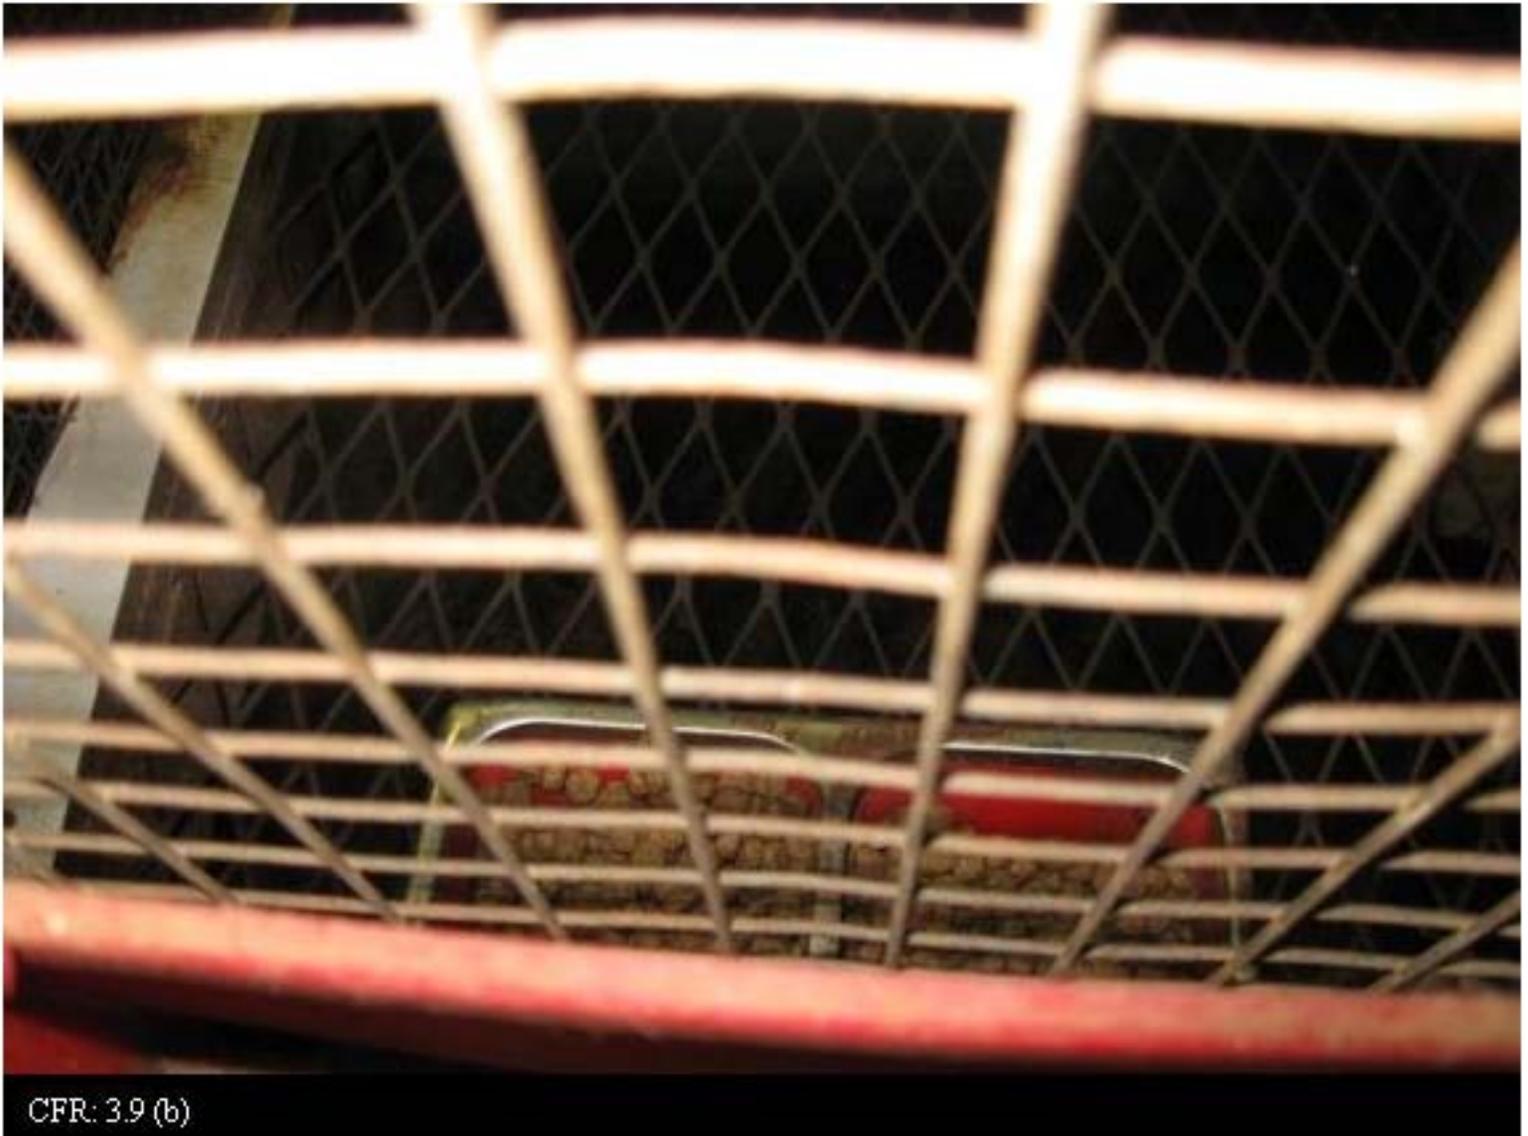
FOIA11-282000133

Photographer:	John J. Lies, ACI	Legal Name:	Registration:	42-A-1354
Photo Taken:	Wed, Jan 12, '11 P.M.	BOB MEHMERT		
Inspection:	12111344160875			
Description:	3.9 (b) Feeding, Self feeders need to be cleaned.

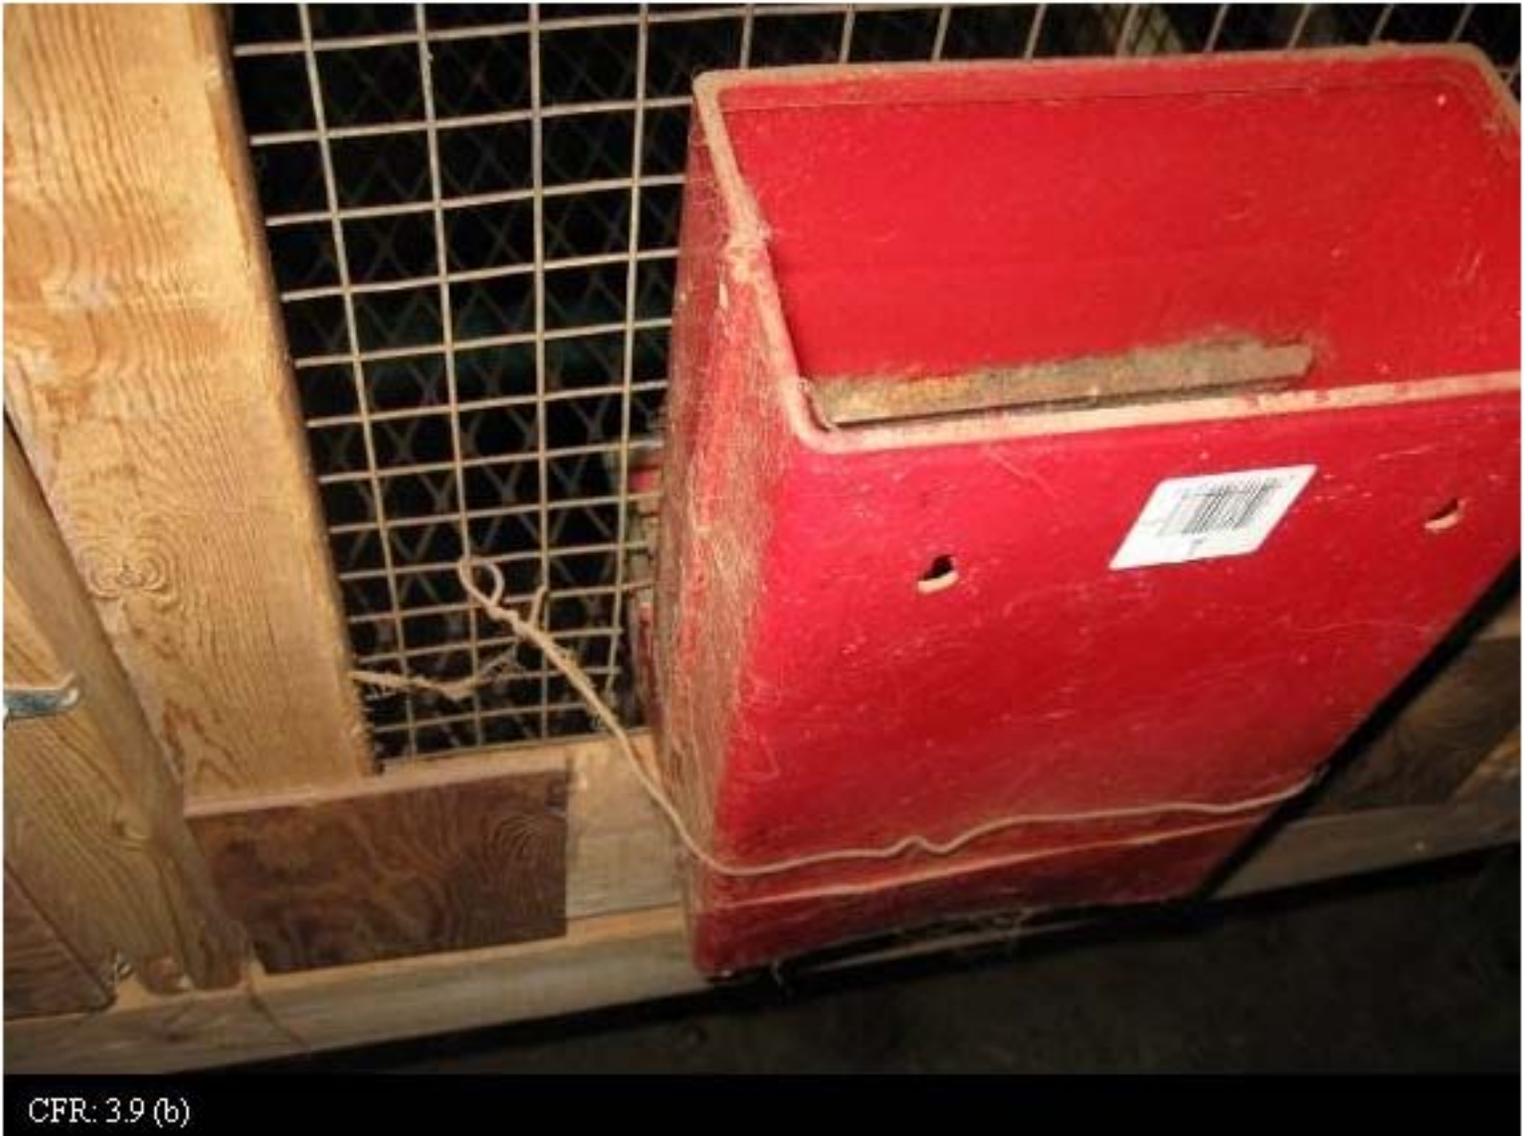
FOIA11-282000134

Photographer:	John J. Lies, ACI	Legal Name:	Registration:	42-A-1354
Photo Taken:	Wed, Jan 12, '11 P.M.	BOB MEHMERT		
Inspection:	12111344160875			
Description:	3.9 (b) Feeding, Self feeders need to be cleaned.

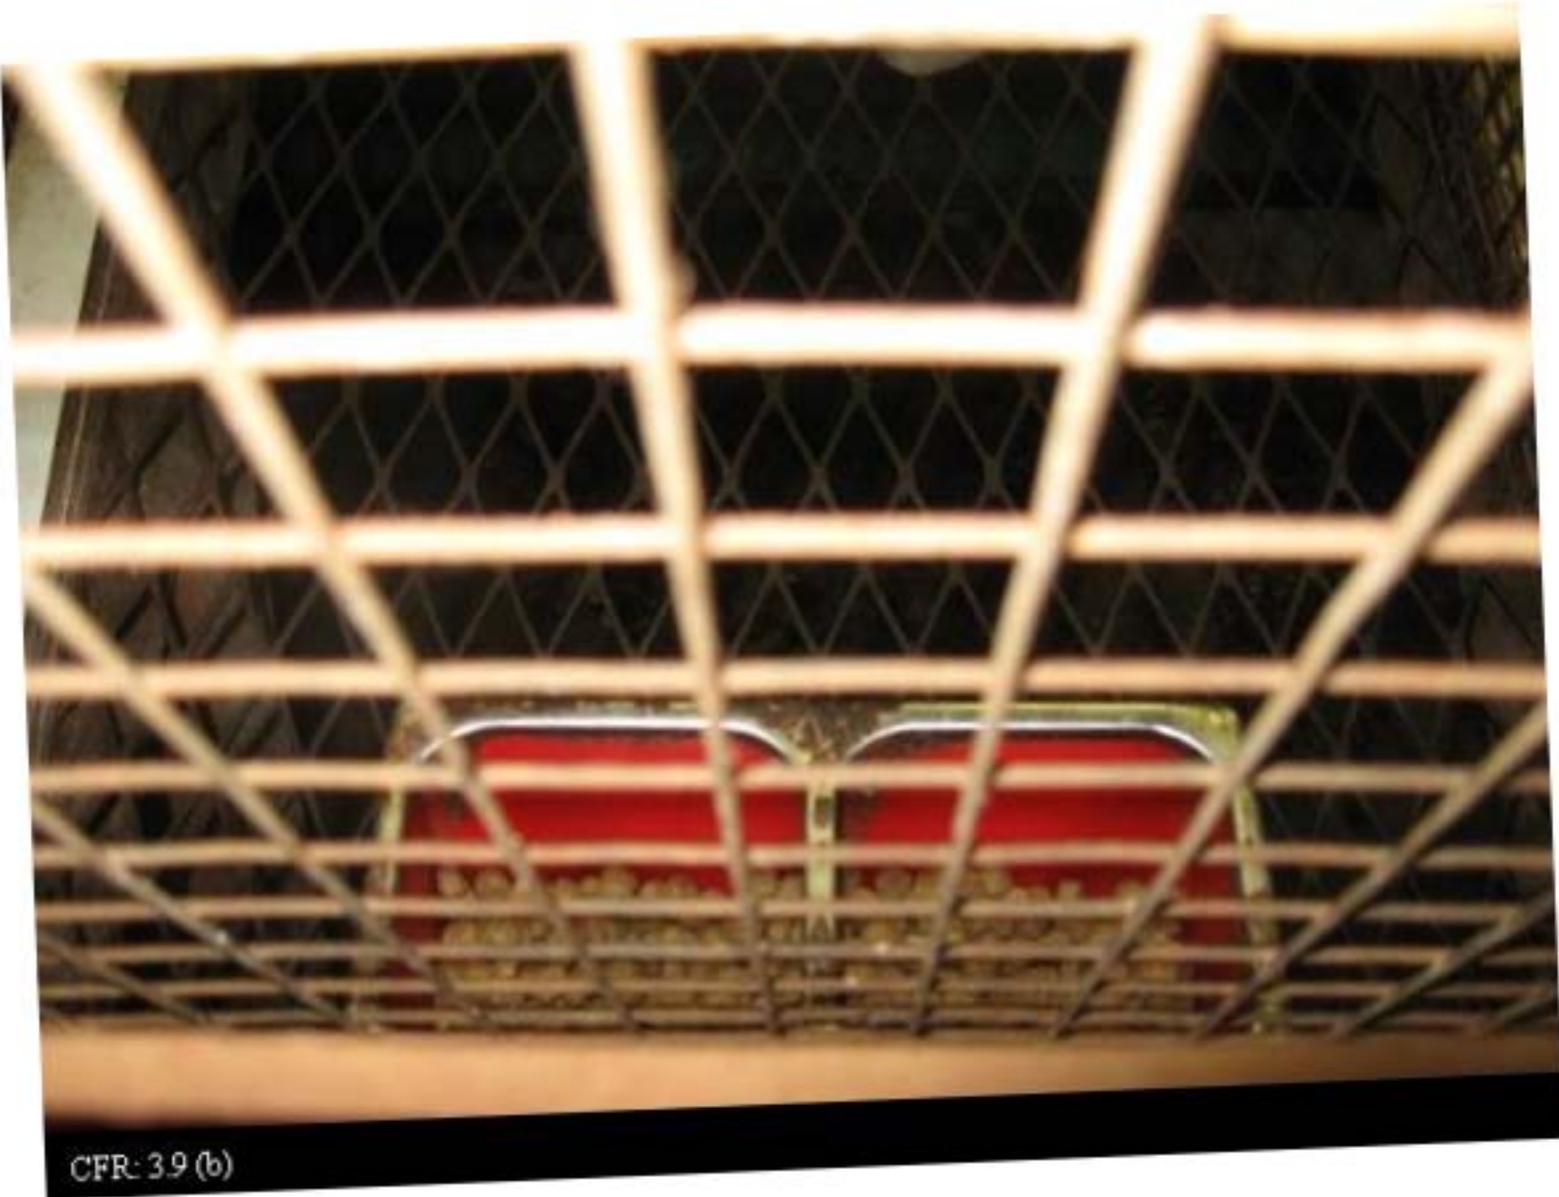
Photographer: John J. Lies, ACI Legal Name: Registration: 42-A-1354
Photo Taken: Wed, Jan 12, '11 P.M. BOB MEHMERT
Inspection: 12111344160875
Description: 3.9 (b) Feeding, Self feeders need to be cleaned.

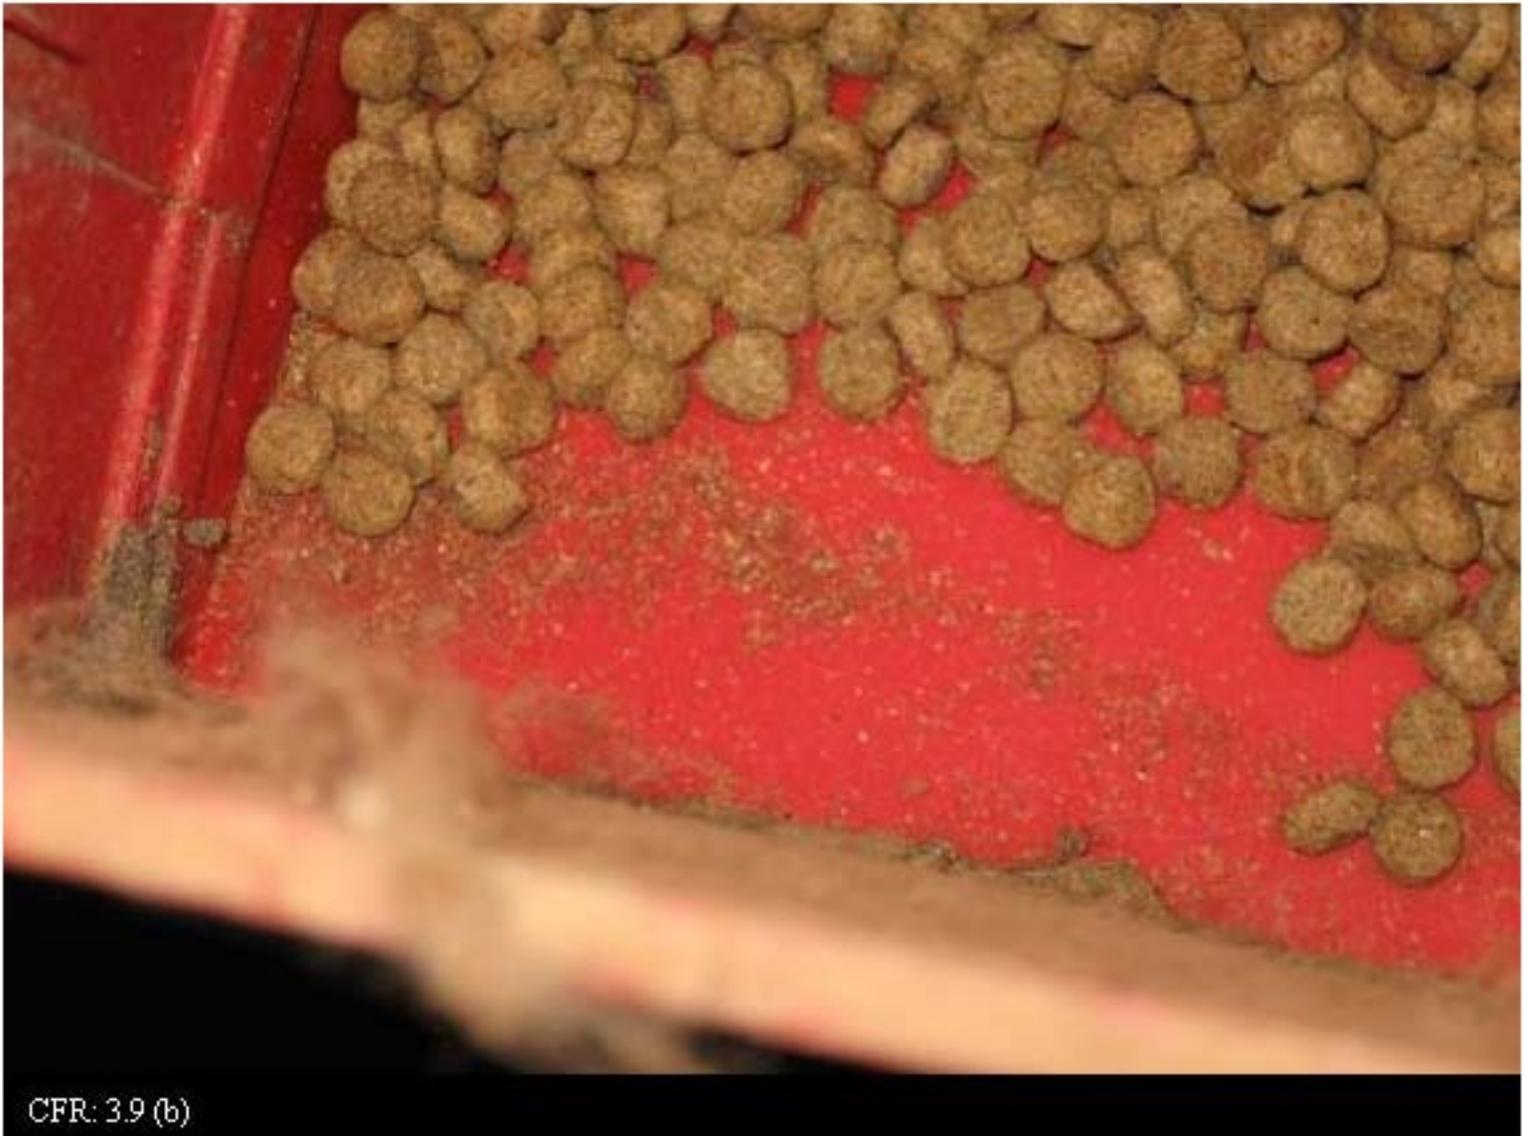
FOIA11-282000136

Photographer:	John J. Lies, ACI	Legal Name:	Registration:	42-A-1354
Photo Taken:	Wed, Jan 12, '11 P.M.	BOB MEHMERT		
Inspection:	12111344160875			
Description:	3.9 (b) Feeding, Self feeders need to be cleaned.

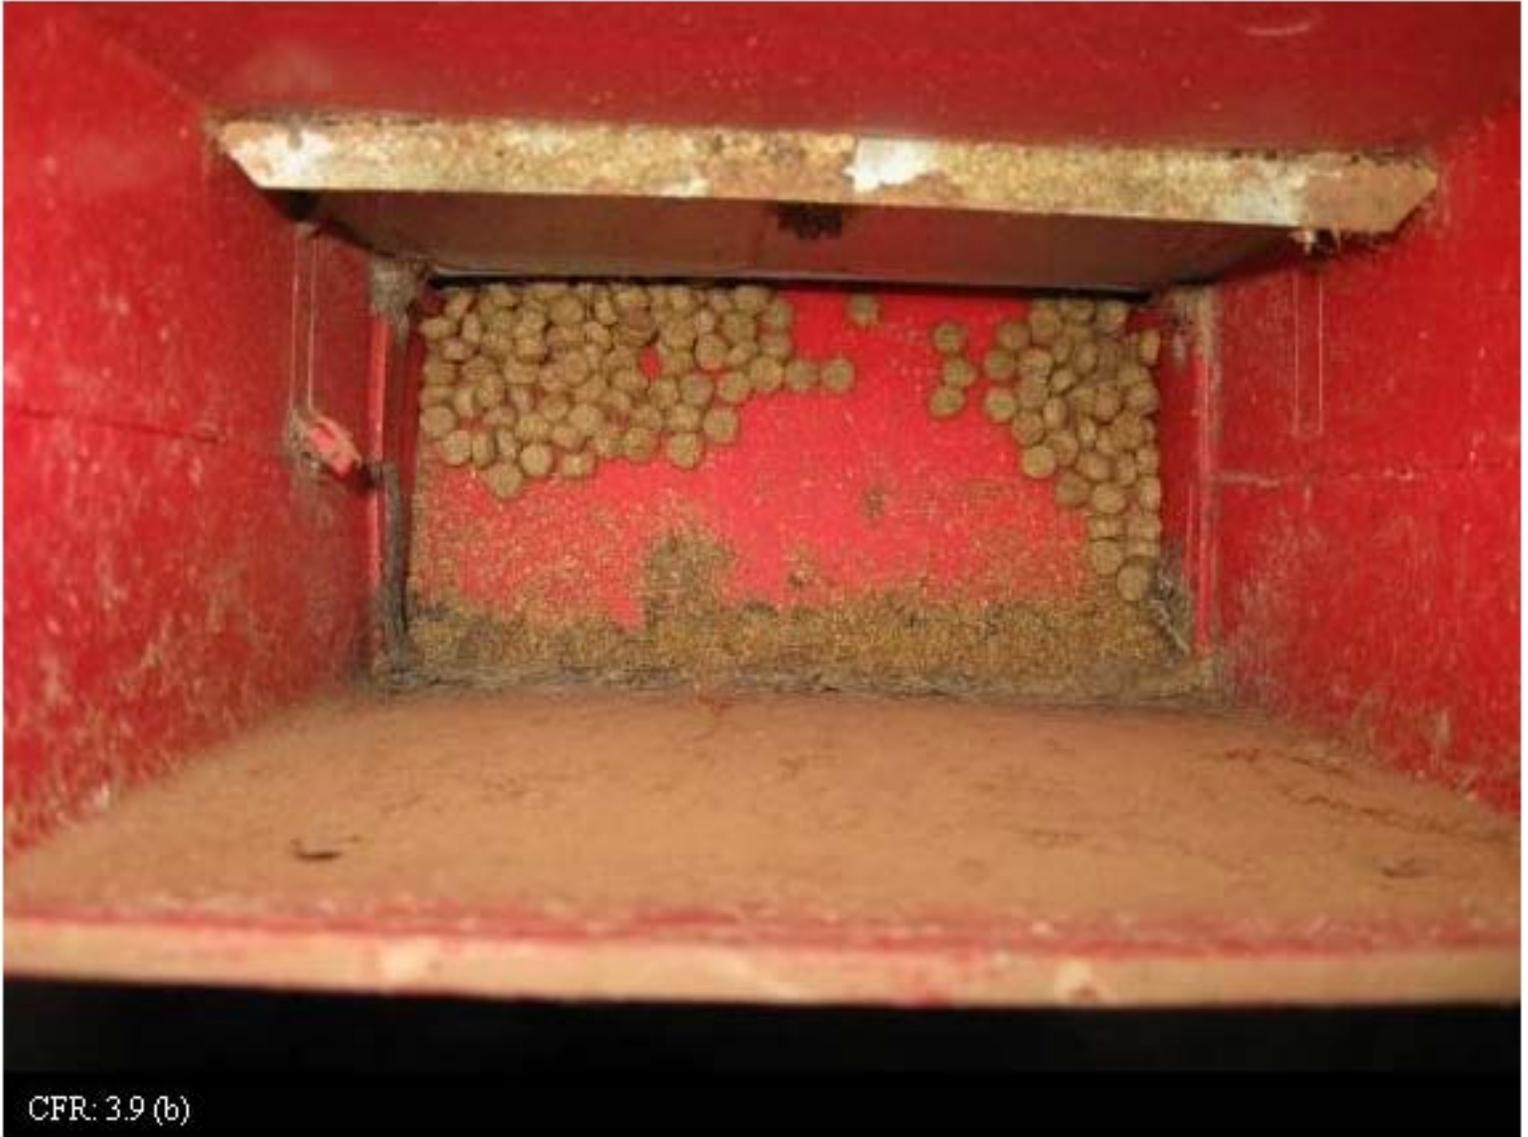
Photographer:	John J. Lies, ACI	Legal Name:	Registration:	42-A-1354
Photo Taken:	Wed, Jan 12, '11 P.M.	BOB MEHMERT		
Inspection:	12111344160875			
Description:	3.9 (b) Feeding, Self feeders need to be cleaned.

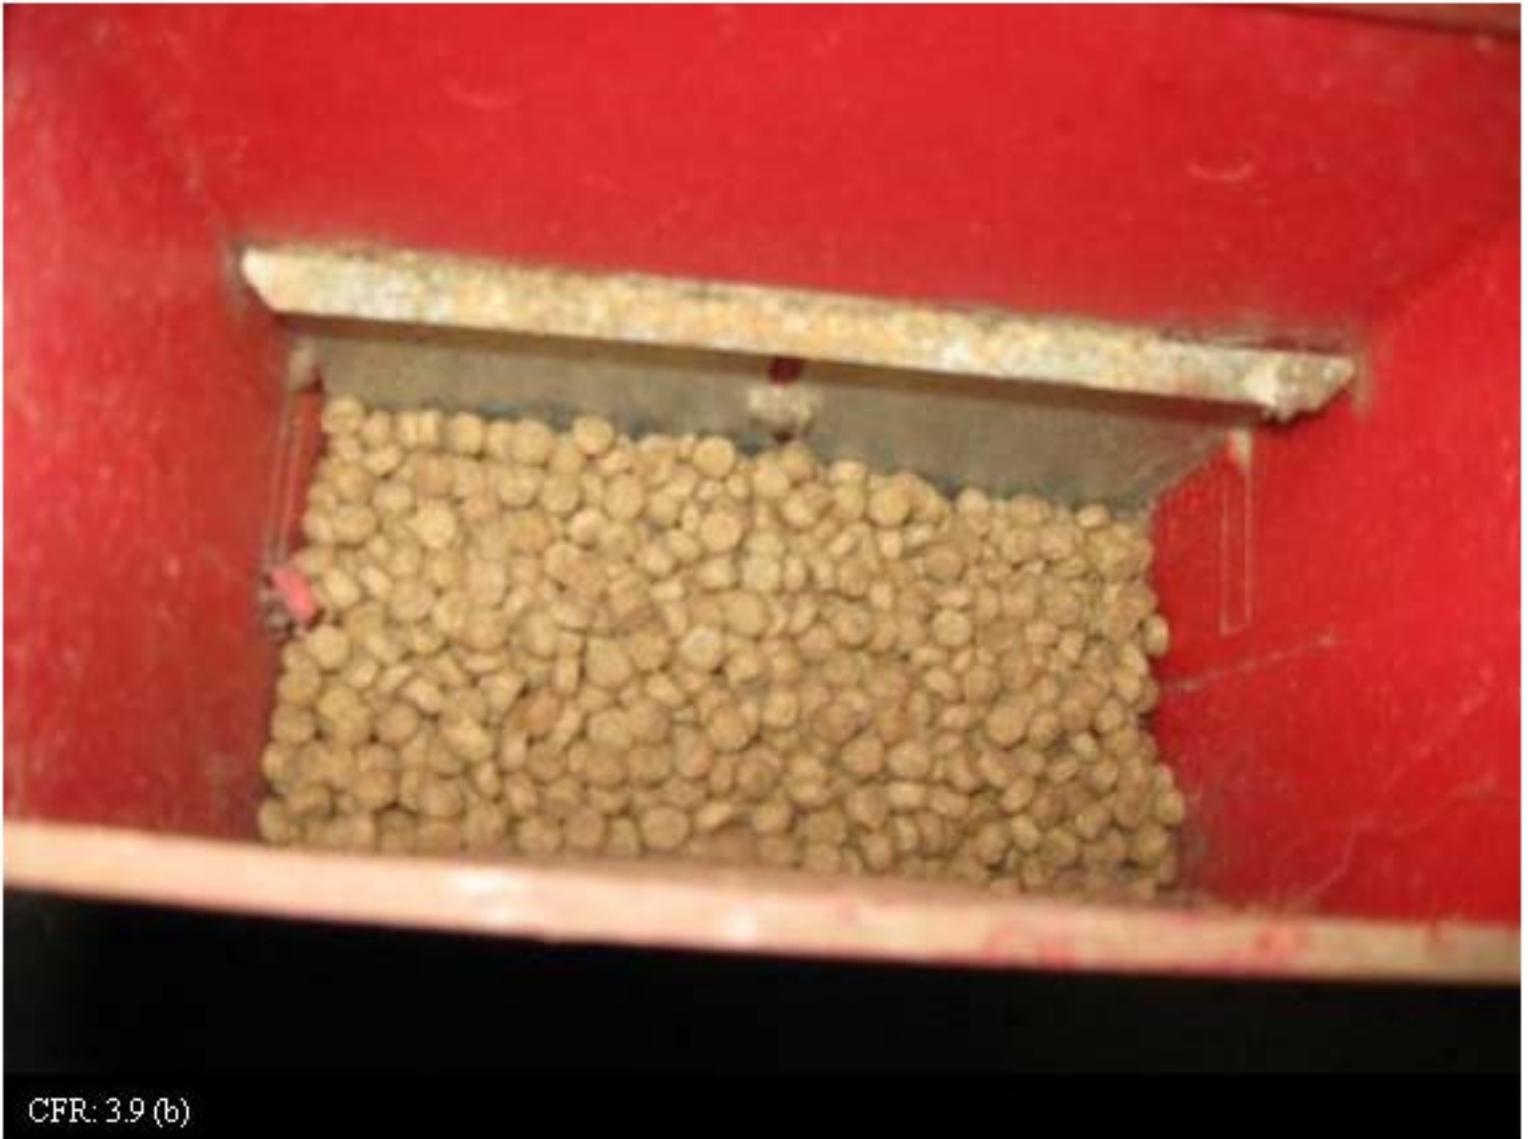
FOIA11-282000138

Photographer:	John J. Lies, ACI	Legal Name:	Registration:	42-A-1354
Photo Taken:	Wed, Jan 12, '11 P.M.	BOB MEHMERT		
Inspection:	12111344160875			
Description:	3.9 (b) Feeding, Self feeders need to be cleaned.

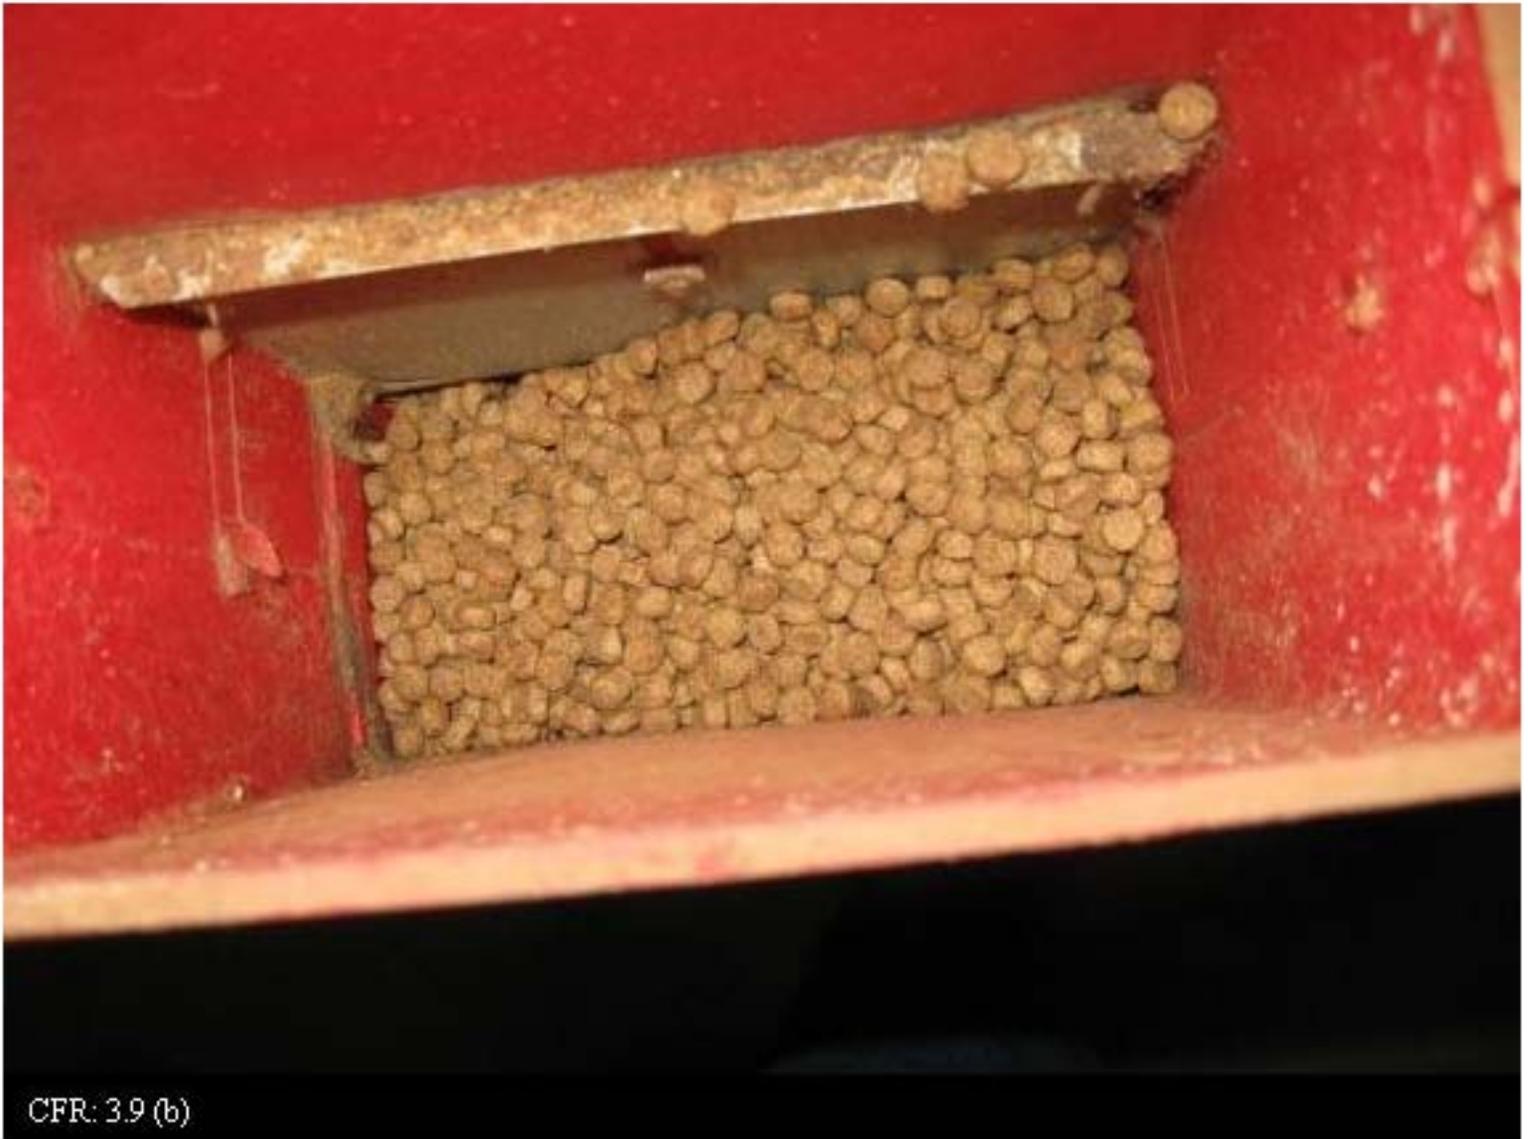
FOIA11-282000139

Photographer:	John J. Lies, ACI	Legal Name:	Registration:	42-A-1354
Photo Taken:	Wed, Jan 12, '11 P.M.	BOB MEHMERT		
Inspection:	12111344160875			
Description:	3.9 (b) Feeding, Self feeders need to be cleaned.

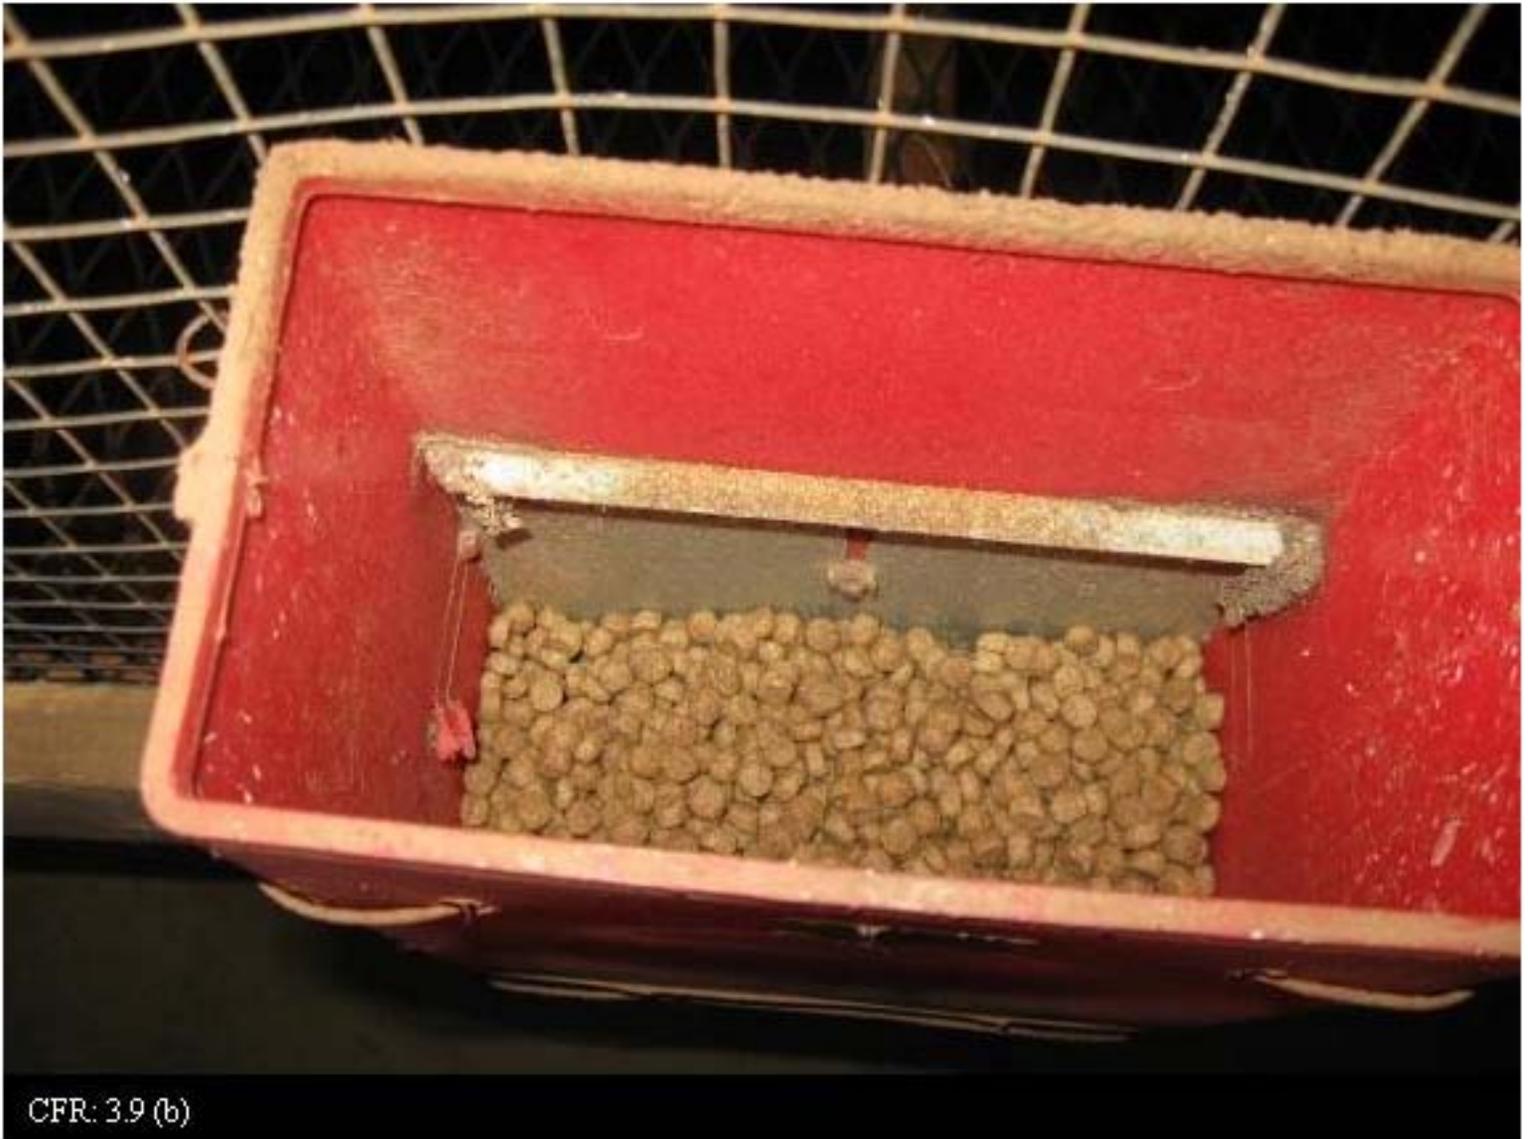
FOIA11-282000140

Photographer:	John J. Lies, ACI	Legal Name:	Registration:	42-A-1354
Photo Taken:	Wed, Jan 12, '11 P.M.	BOB MEHMERT		
Inspection:	12111344160875			
Description:	3.9 (b) Feeding, Self feeders need to be cleaned.
