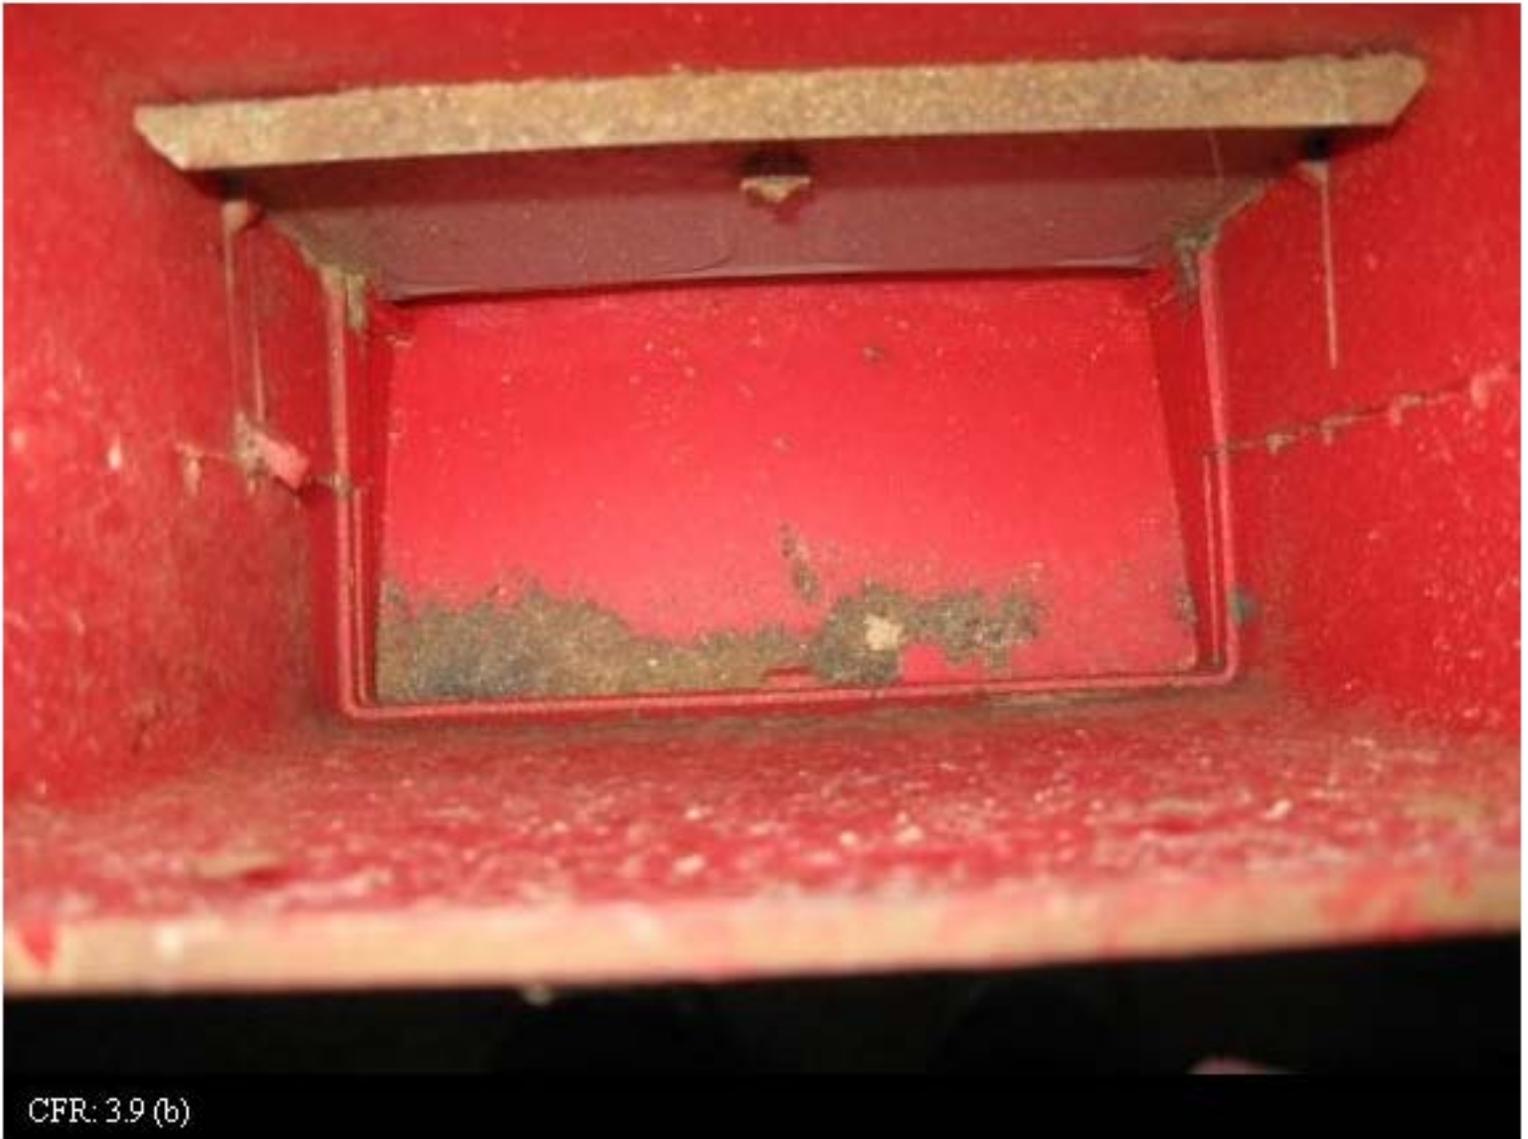
Photographer:	John J. Lies, ACI	Legal Name:	Registration:	42-A-1354
Photo Taken:	Wed, Jan 12, '11 P.M.	BOB MEHMERT		
Inspection:	12111344160875			
Description:	3.9 (b) Feeding, Self feeders need to be cleaned.

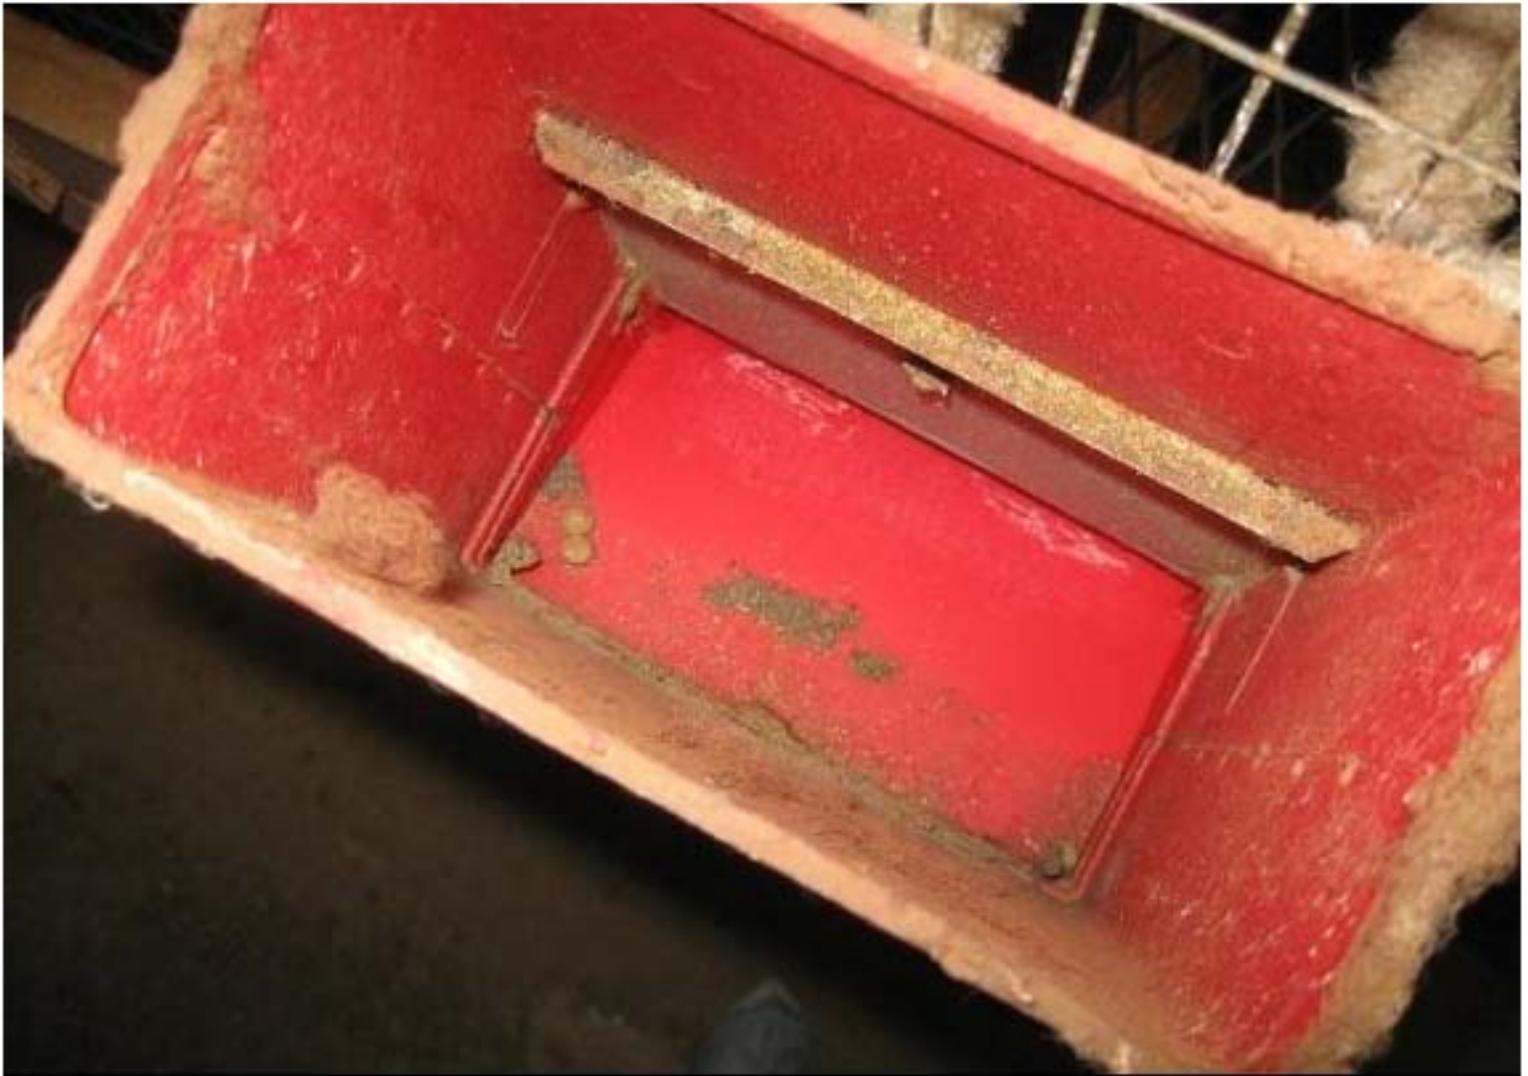
FOIA11-282000142

CFR: 3.9 (b)

Photographer:	John J. Lies, ACI	Legal Name:	Registration:	42-A-1354
Photo Taken:	Wed, Jan 12, '11 P.M.	BOB MEHMERT		
Inspection:	12111344160875			
Description:	3.9 (b) Feeding, Self feeders need to be cleaned.

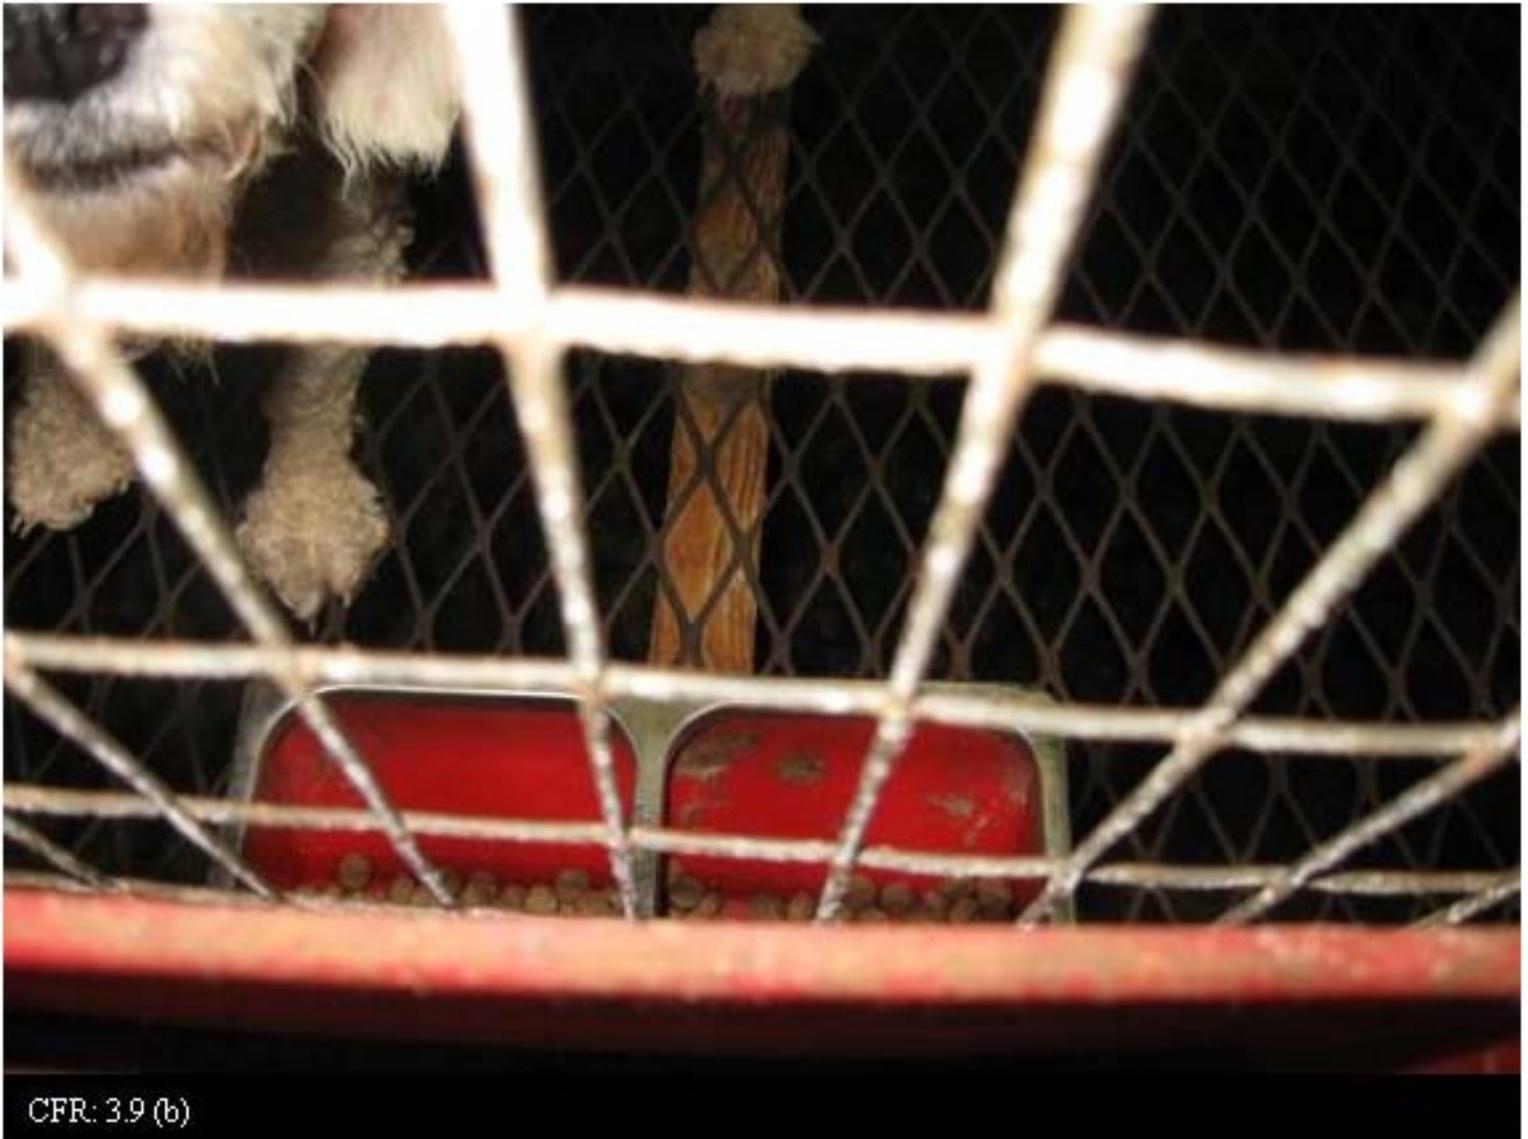
Photographer:	John J. Lies, ACI	Legal Name:	Registration:	42-A-1354
Photo Taken:	Wed, Jan 12, '11 P.M.	BOB MEHMERT		
Inspection:	12111344160875			
Description:	3.9 (b) Feeding, Self feeders need to be cleaned.

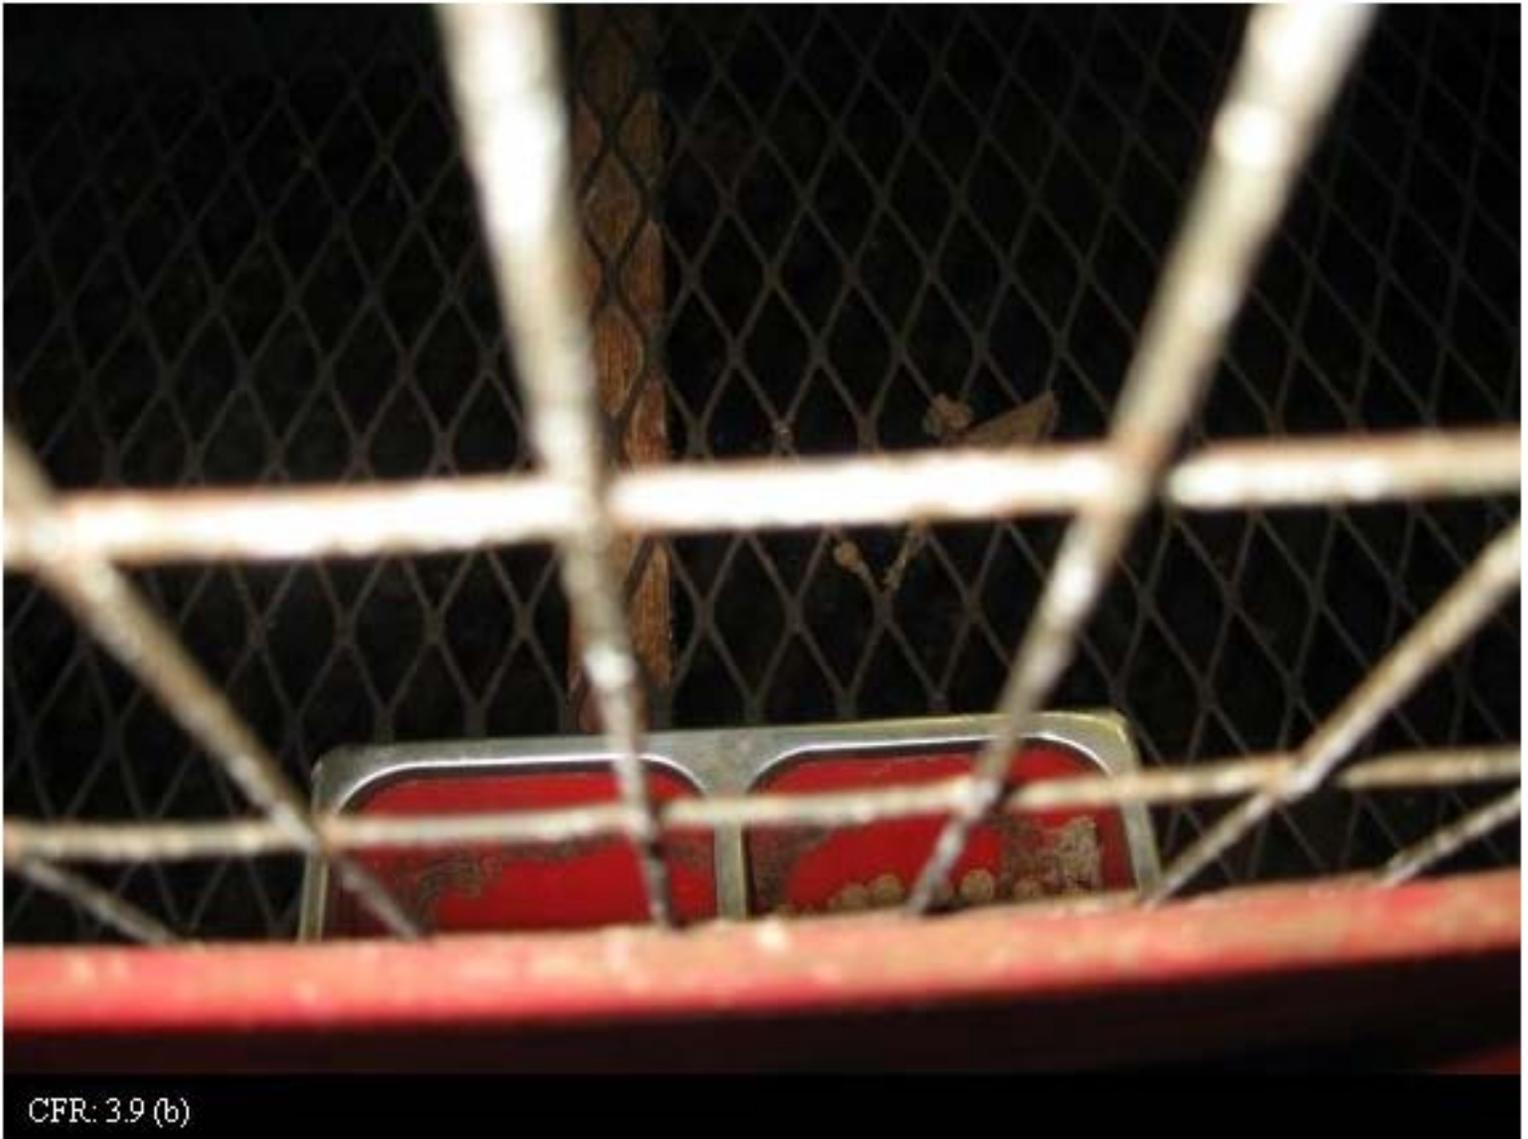
FOIA11-282000144

Photographer:	John J. Lies, ACI	Legal Name:	Registration:	42-A-1354
Photo Taken:	Wed, Jan 12, '11 P.M.	BOB MEHMERT		
Inspection:	12111344160875			
Description:	3.9 (b) Feeding, Self feeders need to be cleaned.

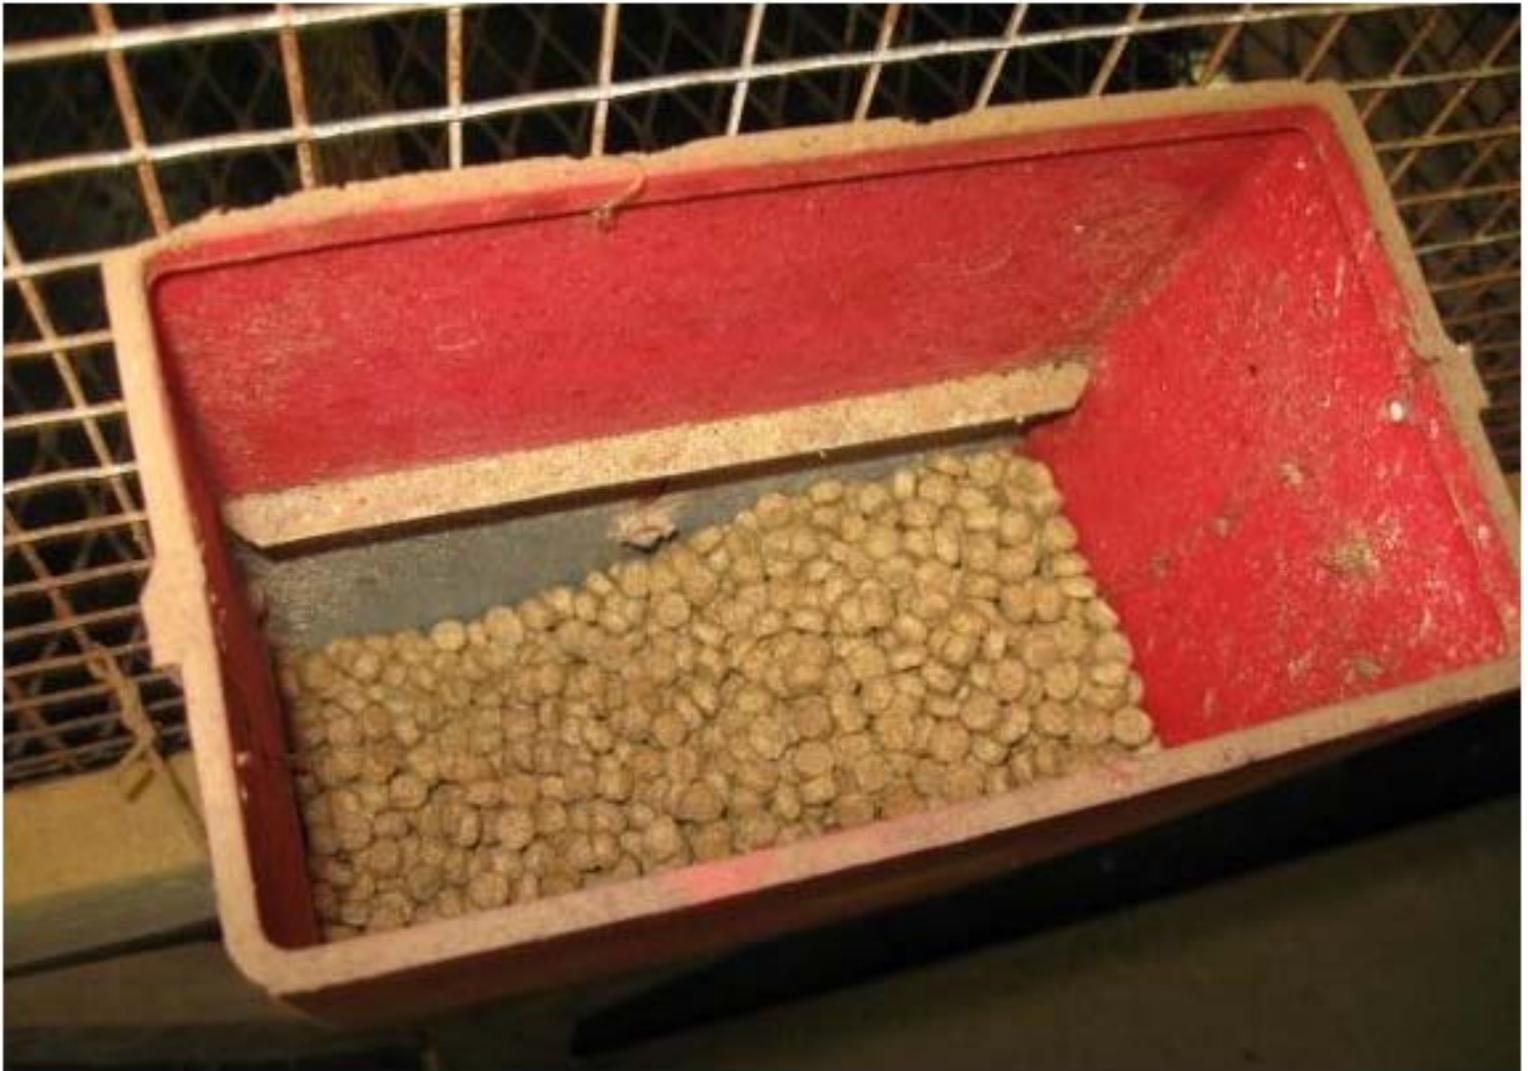
FOIA11-282000145

CFR: 3.9 (b)

Photographer:	John J. Lies, ACI	Legal Name:	Registration:	42-A-1354
Photo Taken:	Wed, Jan 12, '11 P.M.	BOB MEHMERT		
Inspection:	12111344160875			
Description:	3.9 (b) Feeding, Self feeders need to be cleaned.

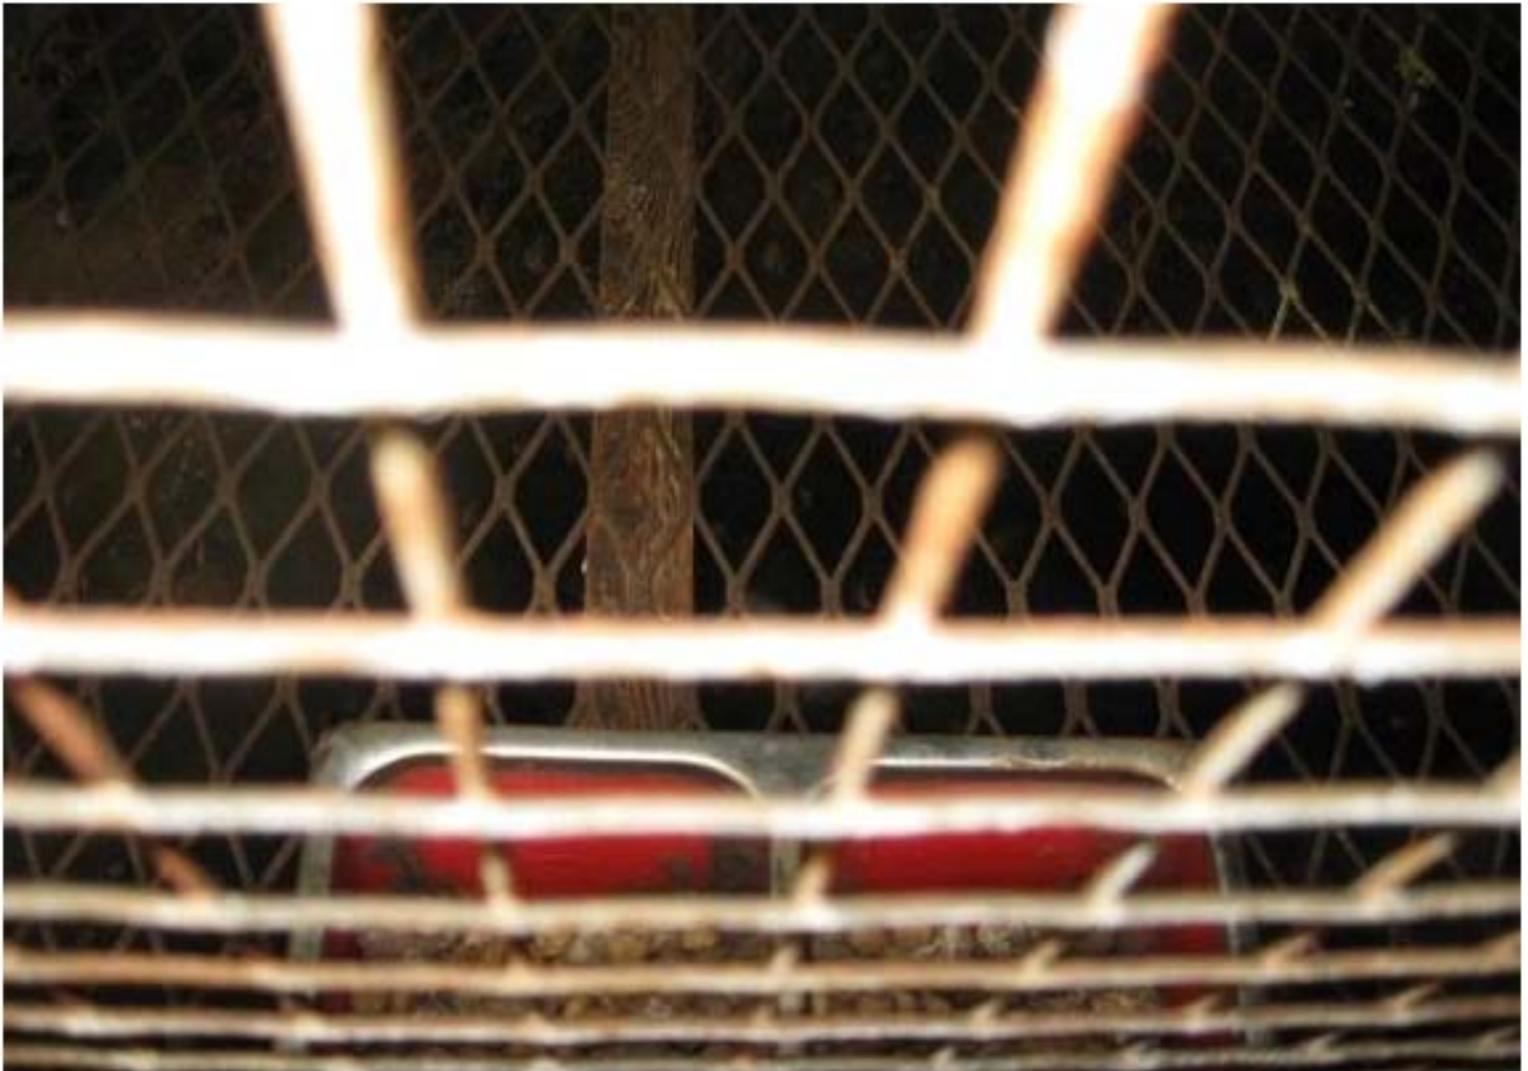
CFR: 3.9 (b)

Photographer:	John J. Lies, ACI	Legal Name:	Registration:	42-A-1354
Photo Taken:	Wed, Jan 12, '11 P.M.	BOB MEHMERT		
Inspection:	12111344160875			
Description:	3.9 (b) Feeding, Self feeders need to be cleaned.

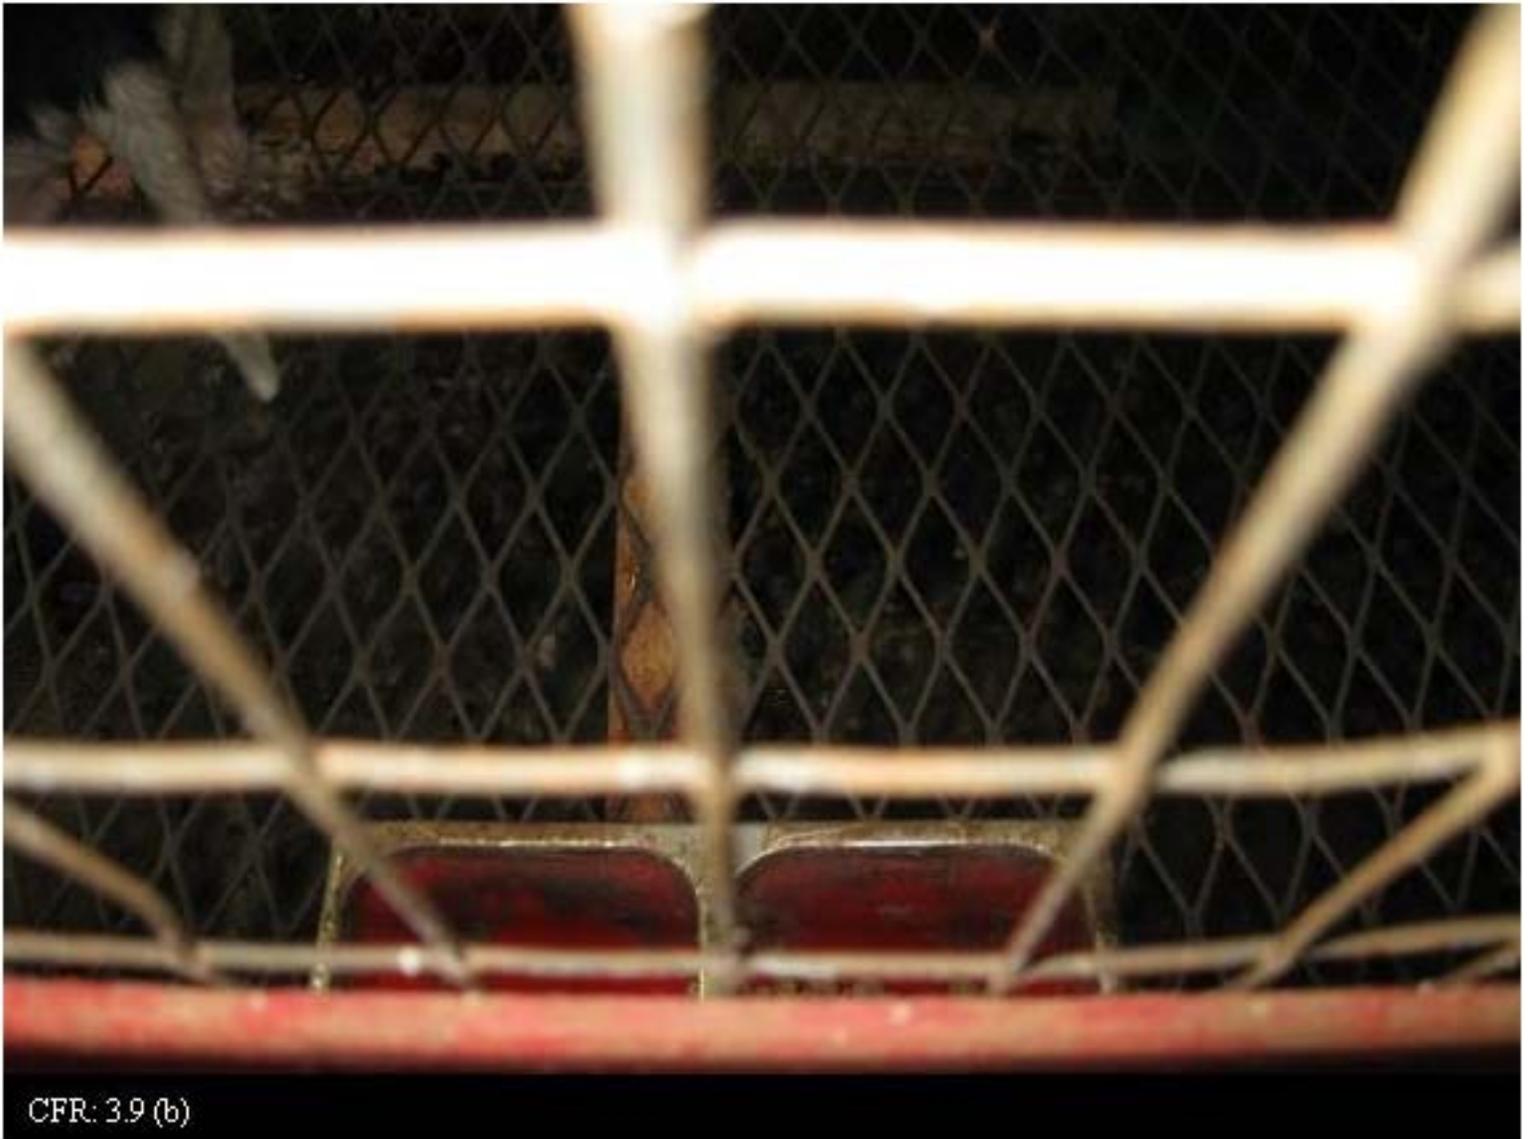
Photographer:	John J. Lies, ACI	Legal Name:	Registration:	42-A-1354
Photo Taken:	Wed, Jan 12, '11 P.M.	BOB MEHMERT		
Inspection:	12111344160875			
Description:	3.9 (b) Feeding, Self feeders need to be cleaned.

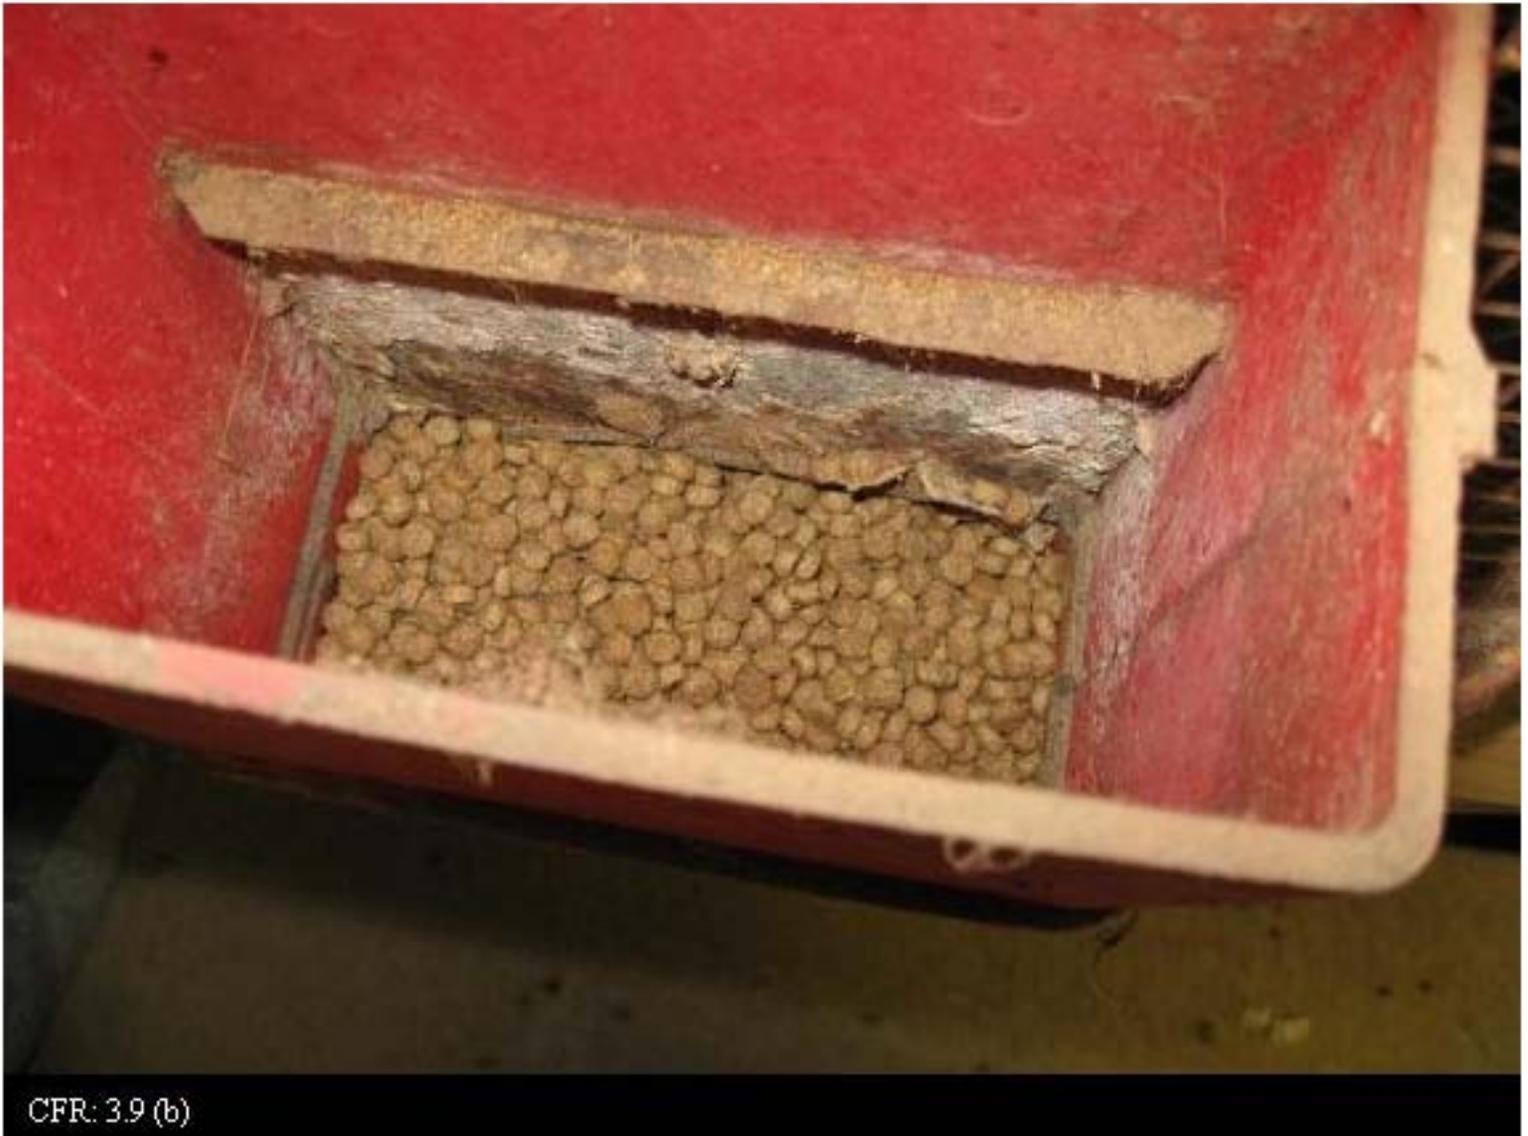
FOIA11-282000148

Photographer:	John J. Lies, ACI	Legal Name:	Registration:	42-A-1354
Photo Taken:	Wed, Jan 12, '11 P.M.	BOB MEHMERT		
Inspection:	12111344160875			
Description:	3.9 (b) Feeding, Self feeders need to be cleaned.

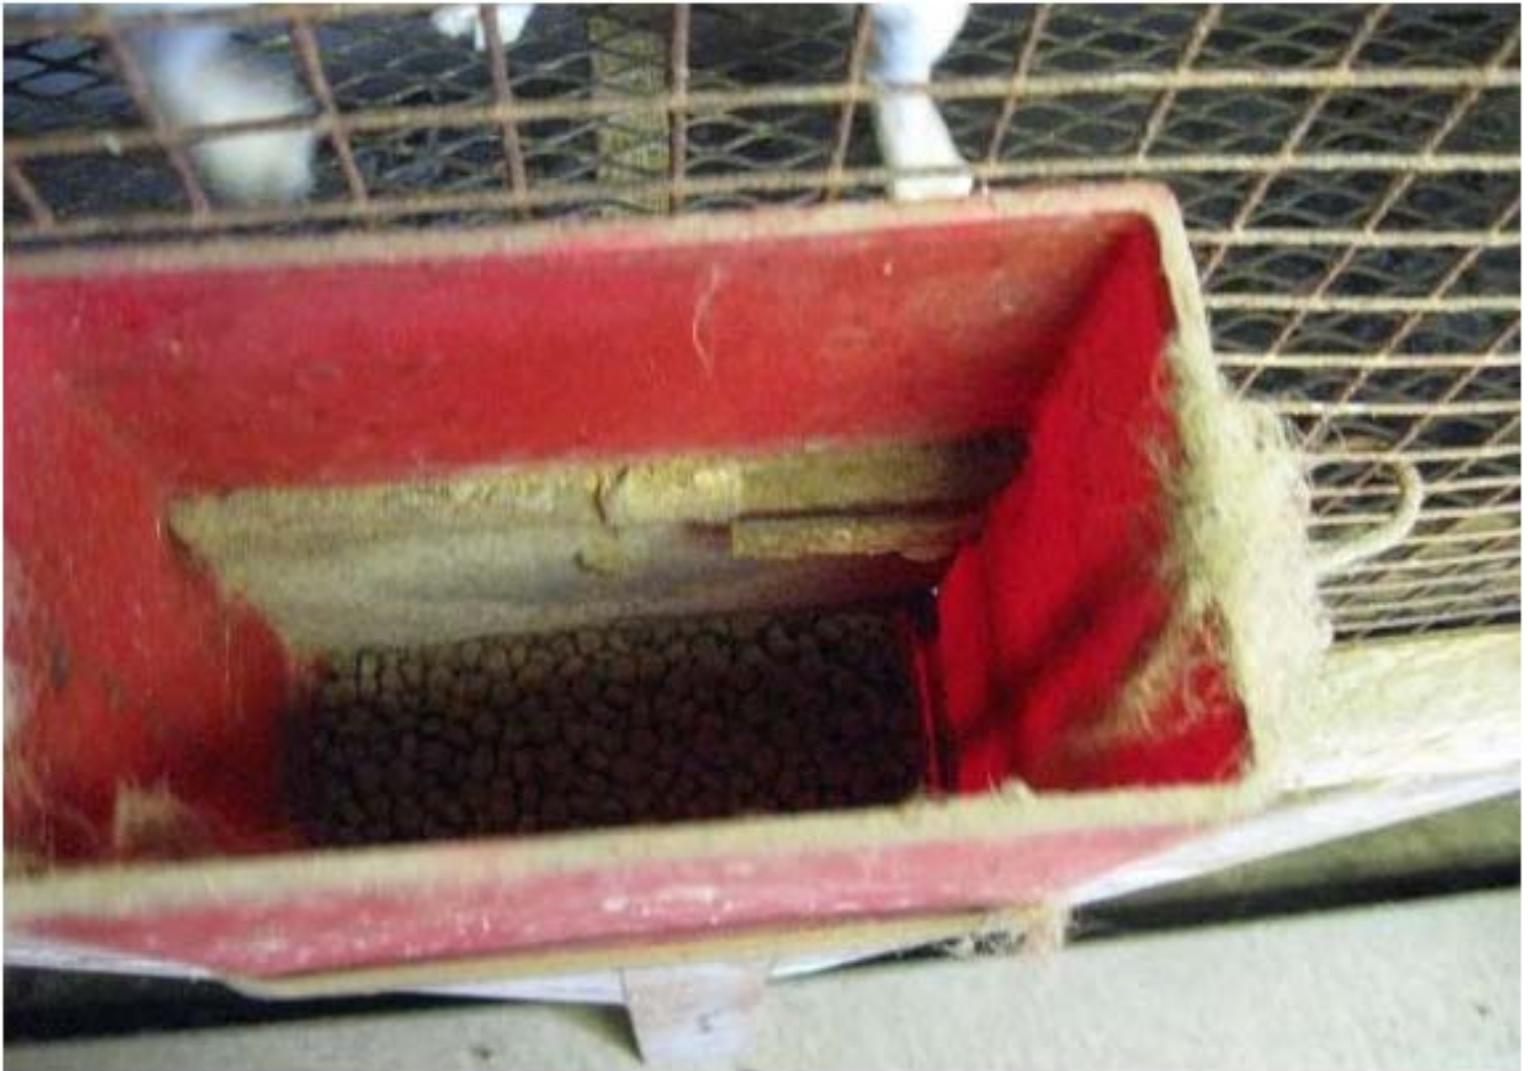
FOIA11-282000149

CFR: 3.9 (b)

Photographer:	John J. Lies, ACI	Legal Name:	Registration:	42-A-1354
Photo Taken:	Wed, Jan 12, '11 P.M.	BOB MEHMERT		
Inspection:	12111344160875			
Description:	3.9 (b) Feeding, Self feeders need to be cleaned.

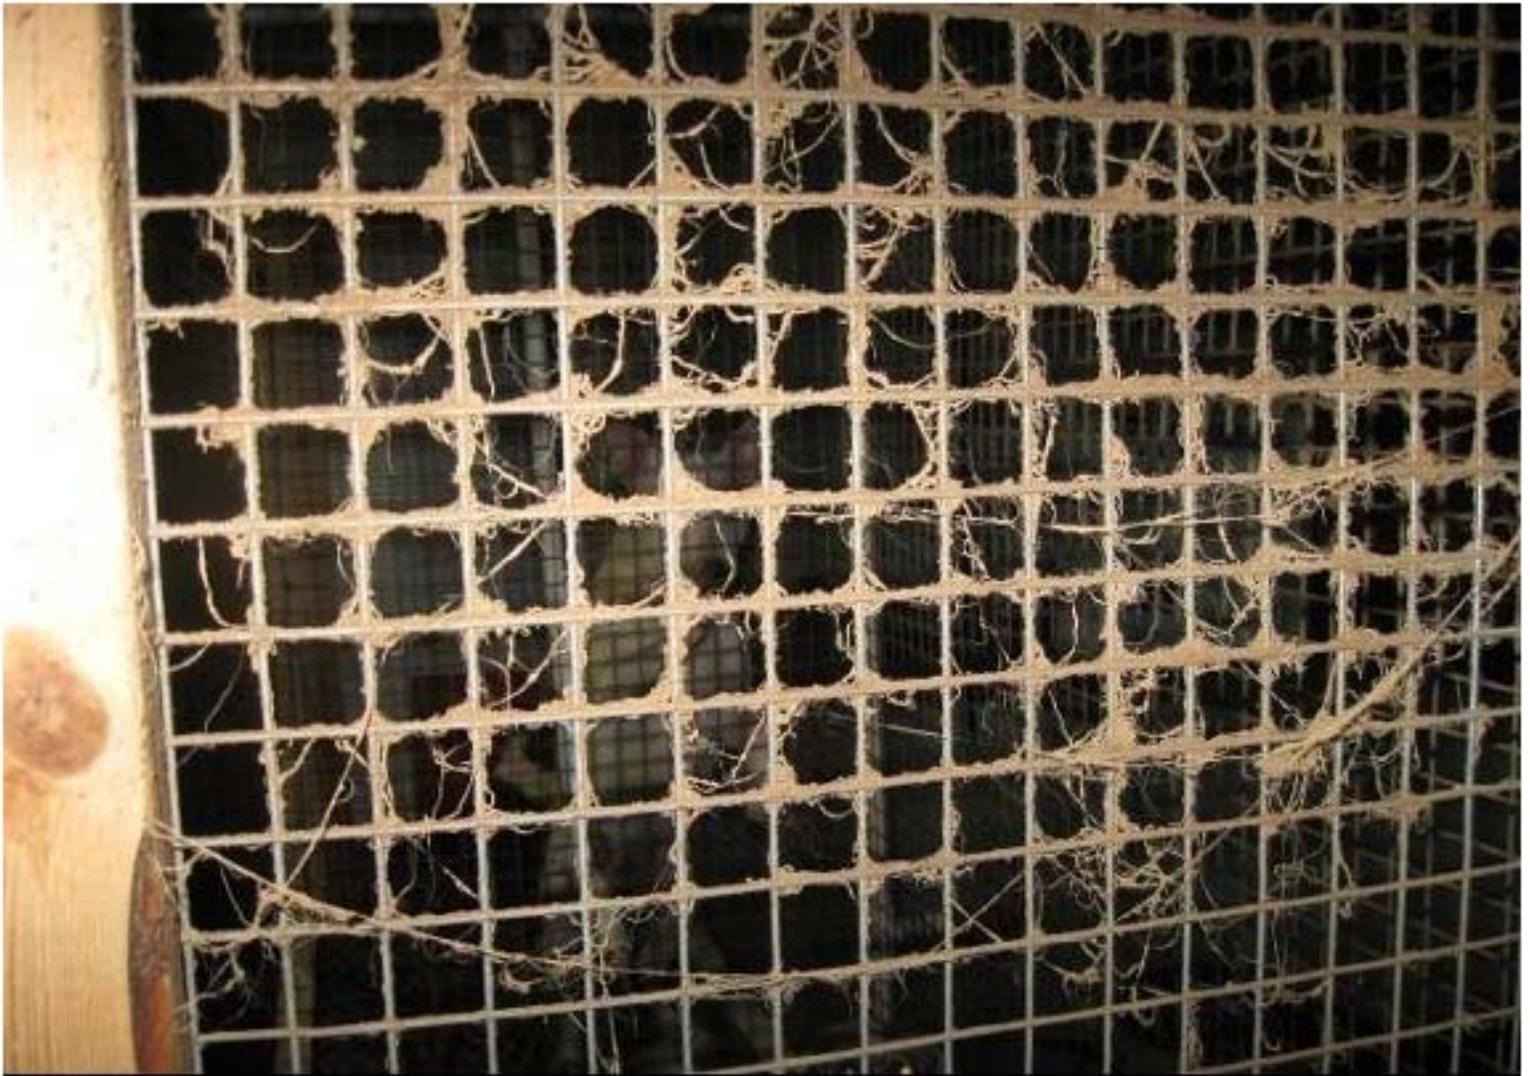
FOIA11-282000150

CFR: 3.11 (c)

Photographer:	John J. Lies, ACI	Legal Name:	Registration:	42-A-1354
Photo Taken:	Wed, Jan 12, '11 P.M.	BOB MEHMERT		
Inspection:	12111344160875			
Description:	3.11(c) Housekeeping Spider webs, hair dirt of lights and wire enclosures.

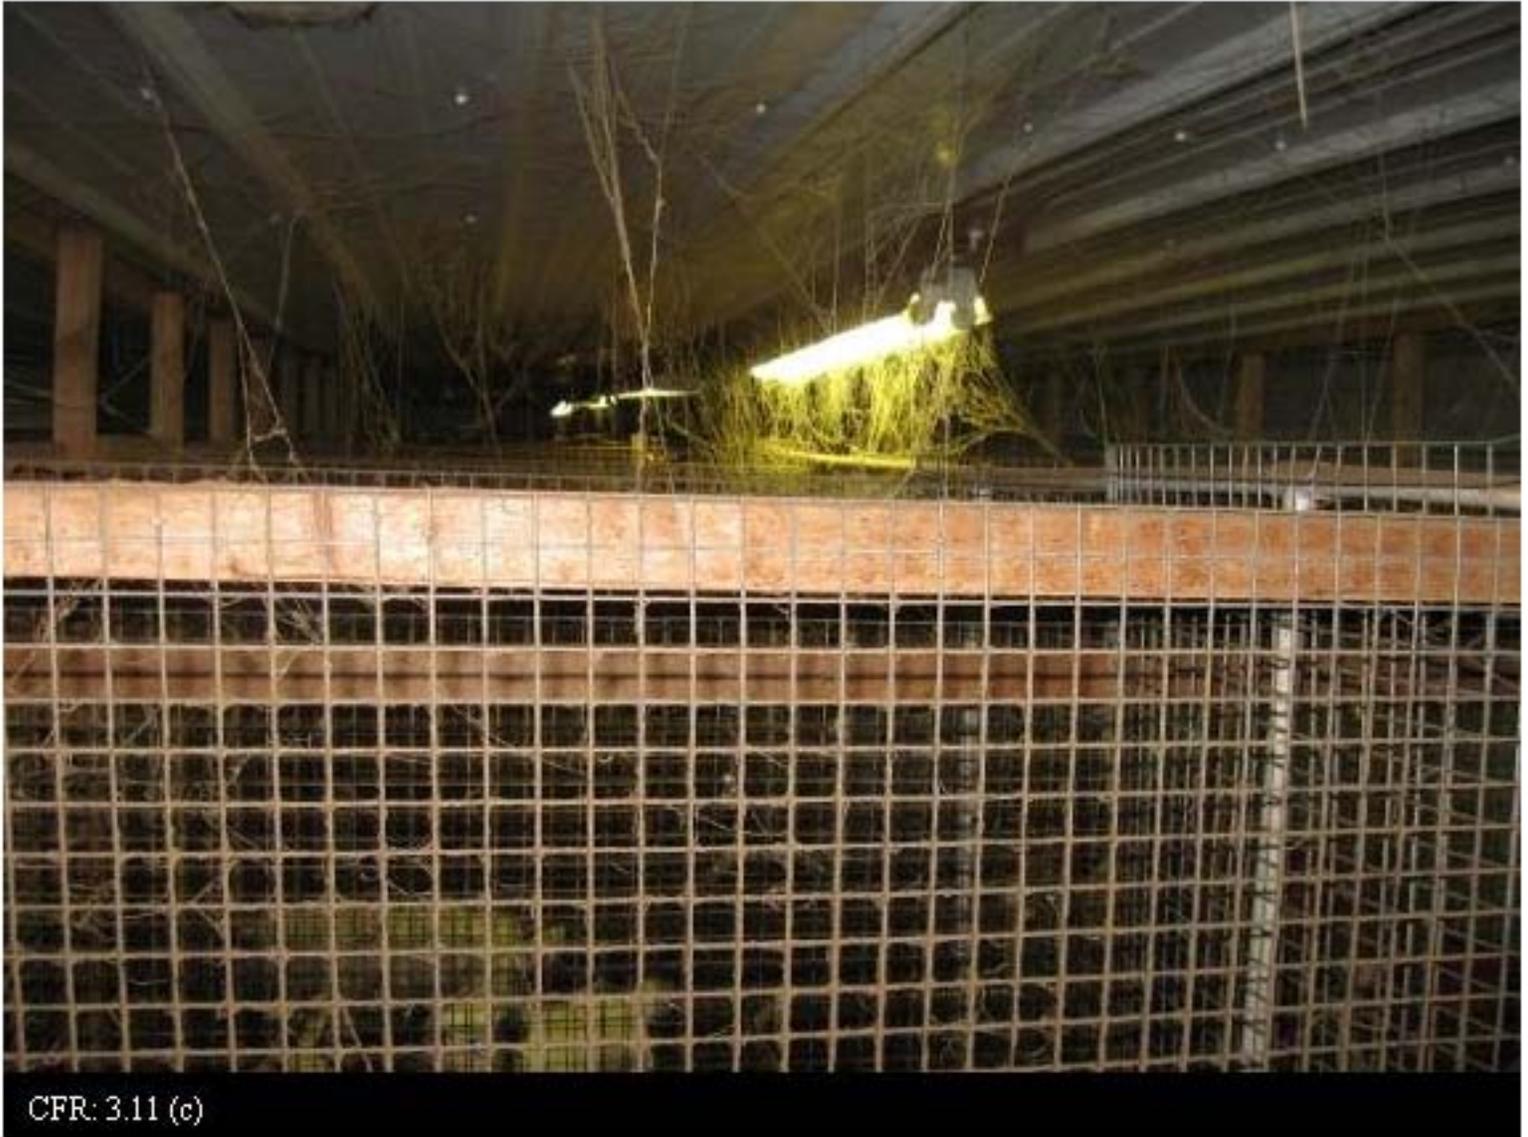
Photographer:	John J. Lies, ACI	Legal Name:	Registration:	42-A-1354
Photo Taken:	Wed, Jan 12, '11 P.M.	BOB MEHMERT		
Inspection:	12111344160875			
Description:	3.11(c) Housekeeping Spider webs, hair dirt of lights and wire enclosures.

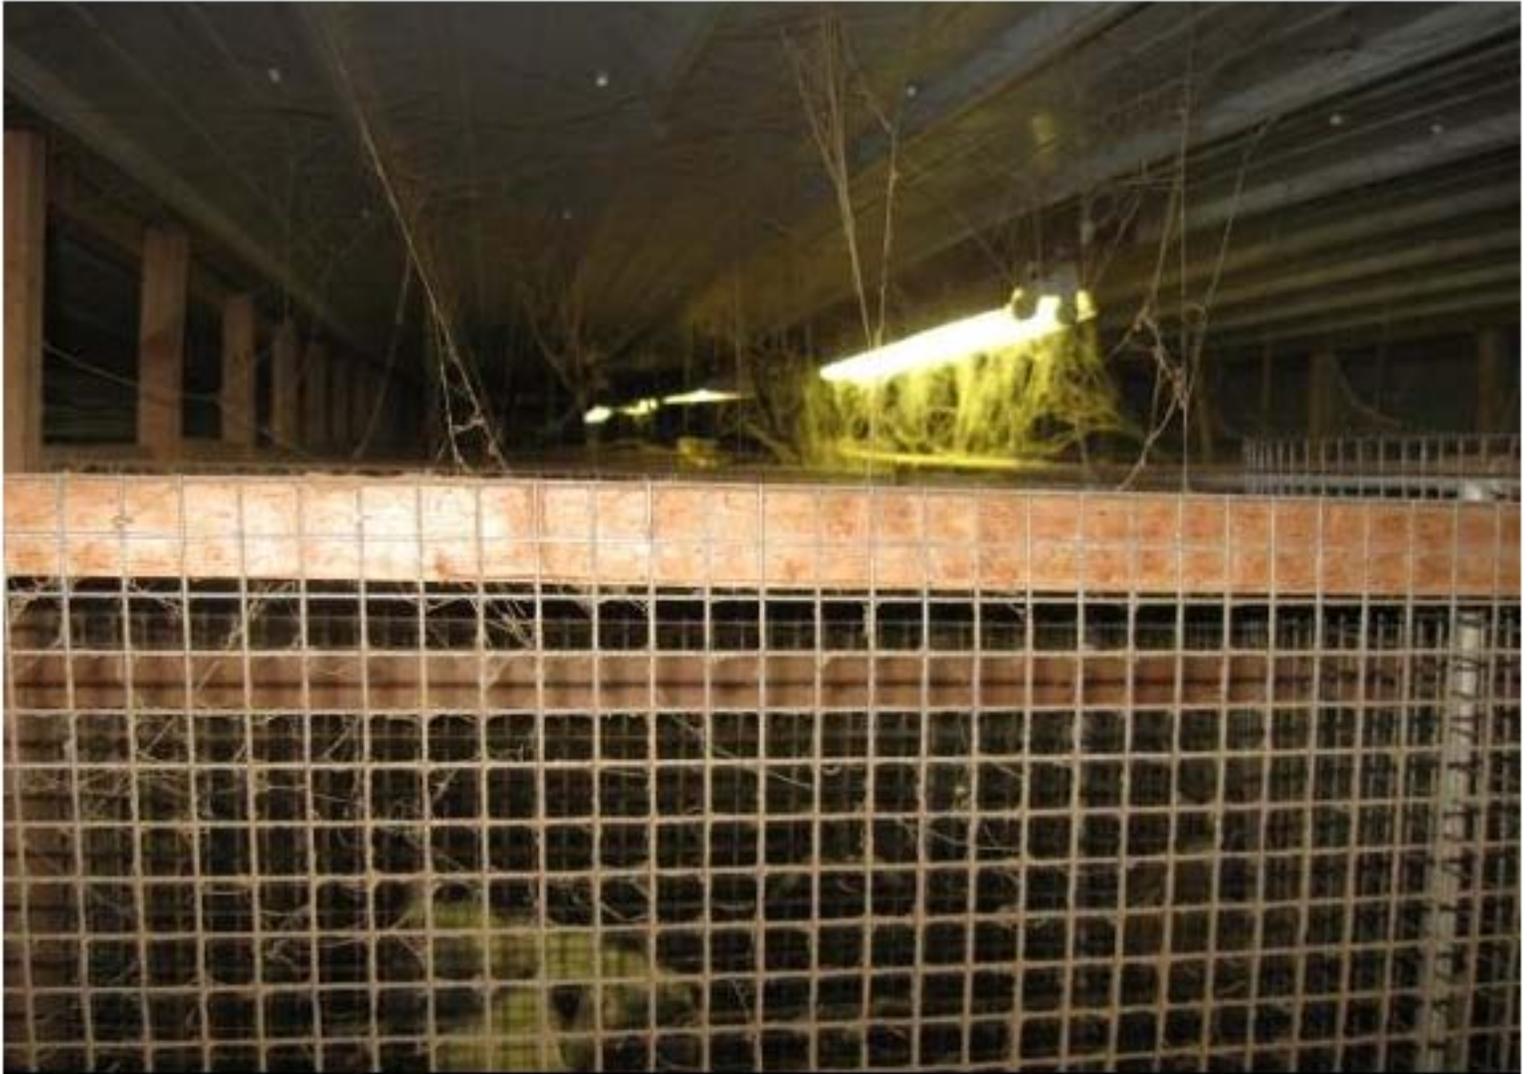
FOIA11-282000152

CFR: 3.11 (c)

Photographer:	John J. Lies, ACI	Legal Name:	Registration:	42-A-1354
Photo Taken:	Wed, Jan 12, '11 P.M.	BOB MEHMERT		
Inspection:	12111344160875			
Description:	3.11(c) Housekeeping Spider webs, hair dirt of lights and wire enclosures.

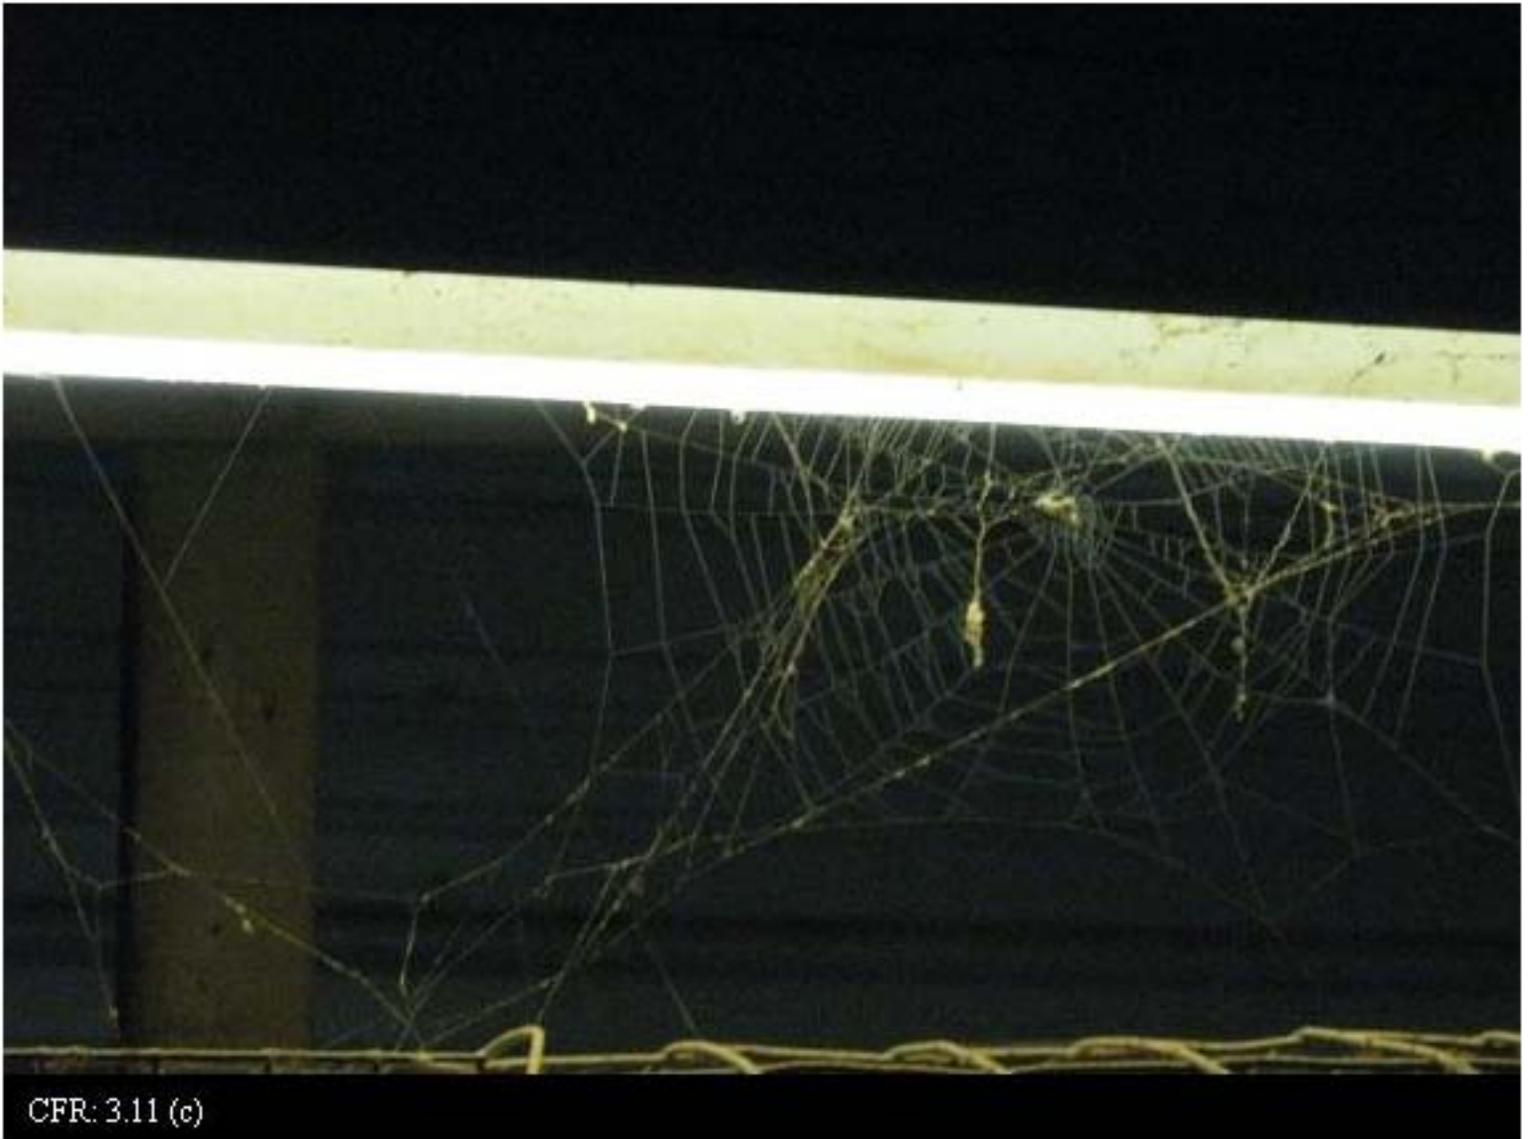
FOIA11-282000153

Photographer:	John J. Lies, ACI	Legal Name:	Registration:	42-A-1354
Photo Taken:	Wed, Jan 12, '11 P.M.	BOB MEHMERT		
Inspection:	12111344160875			
Description:	3.11(c) Housekeeping Spider webs, hair dirt of lights and wire enclosures.
