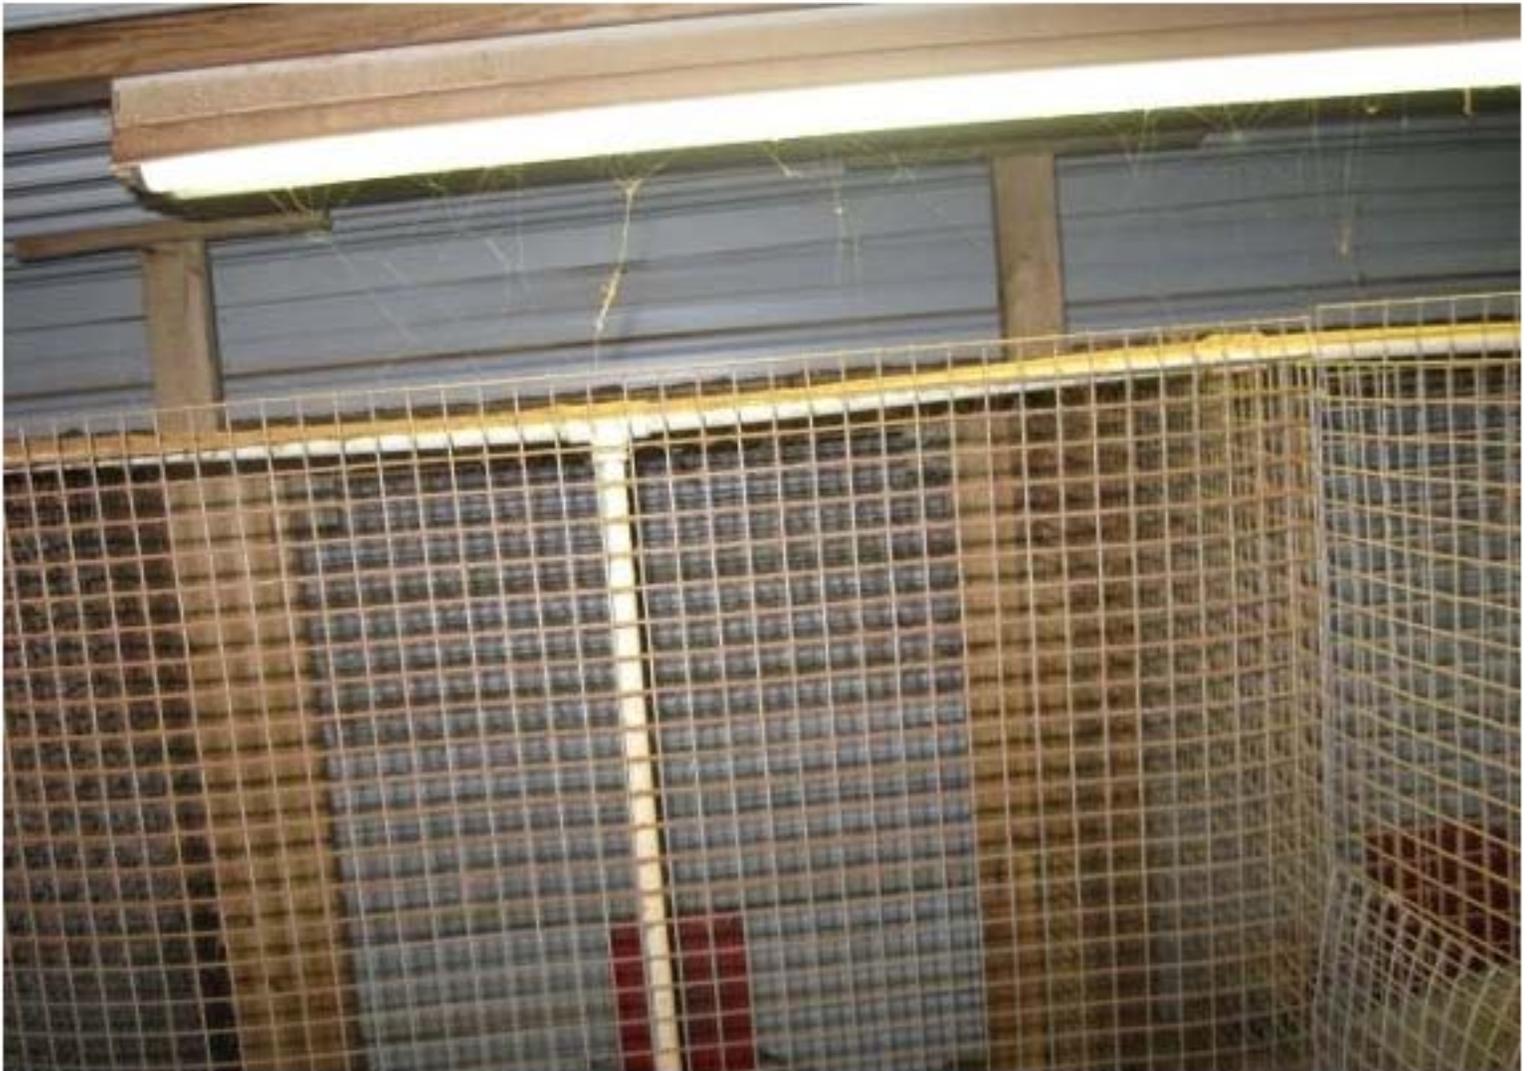
FOIA11-282000154

CFR: 3.11 (c)

Photographer:	John J. Lies, ACI	Legal Name:	Registration:	42-A-1354
Photo Taken:	Wed, Jan 12, '11 P.M.	BOB MEHMERT		
Inspection:	12111344160875			
Description:	3.11(c) Housekeeping Spider webs, hair dirt of lights and wire enclosures.

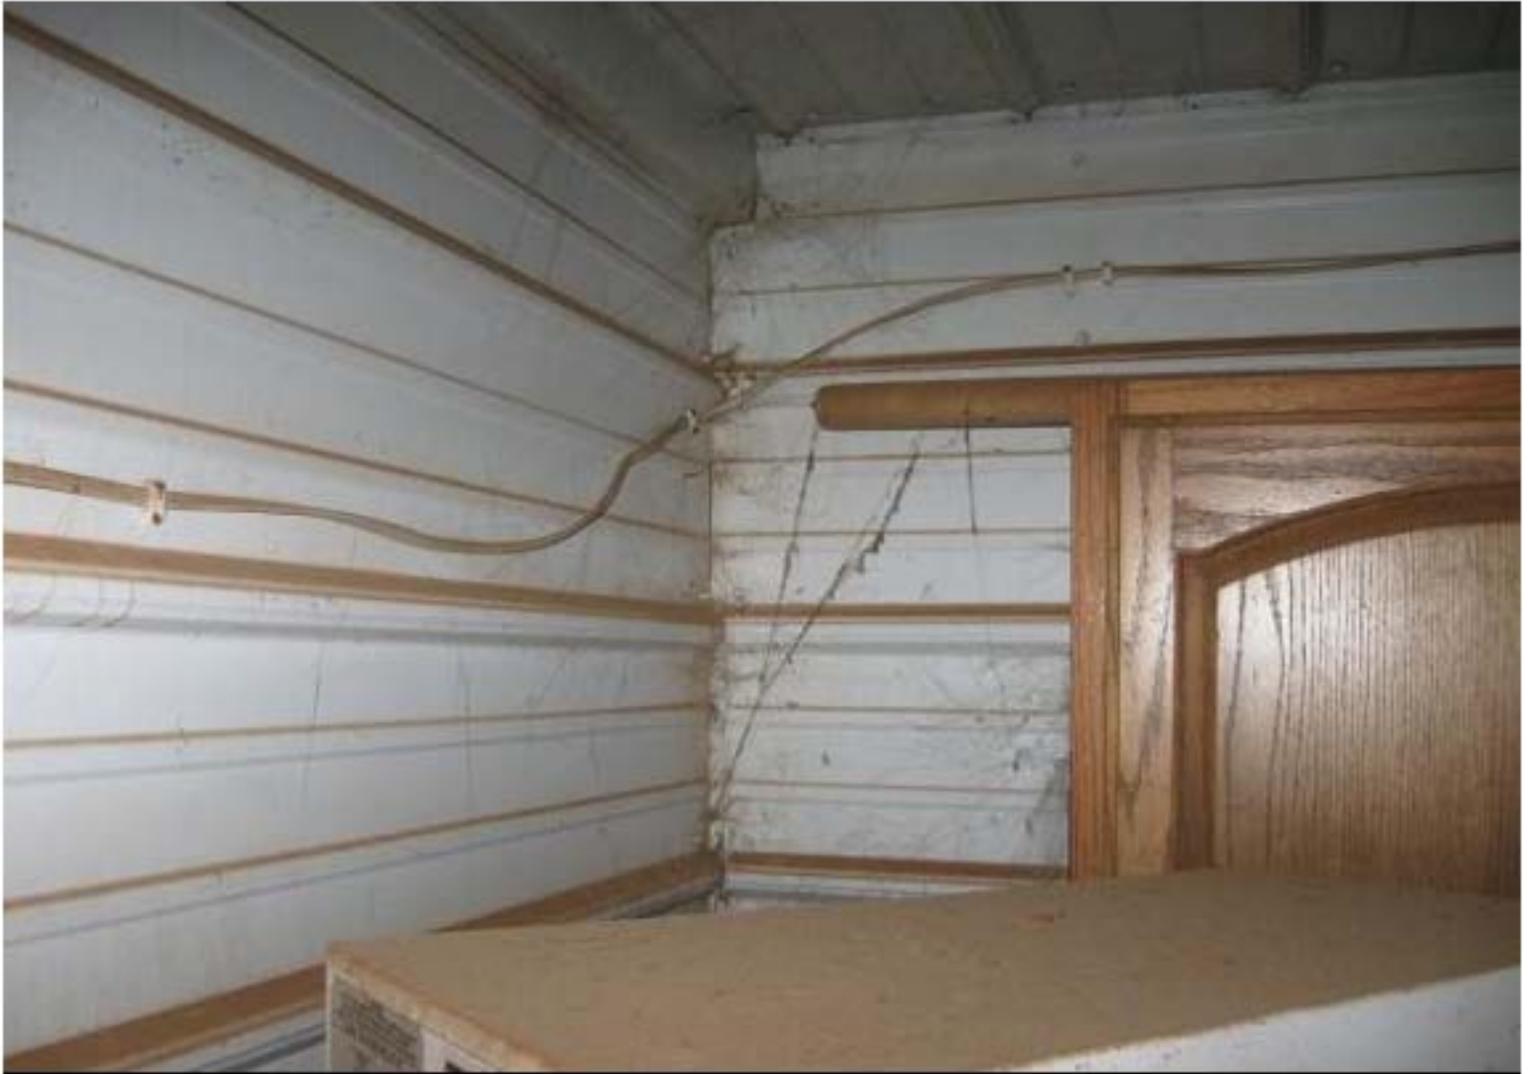
FOIA11-282000155

CFR: 3.11 (c)

Photographer:	John J. Lies, ACI	Legal Name:	Registration:	42-A-1354
Photo Taken:	Wed, Jan 12, '11 P.M.	BOB MEHMERT		
Inspection:	12111344160875			
Description:	3.11(c) Housekeeping Spider webs, hair dirt of lights and wire enclosures.

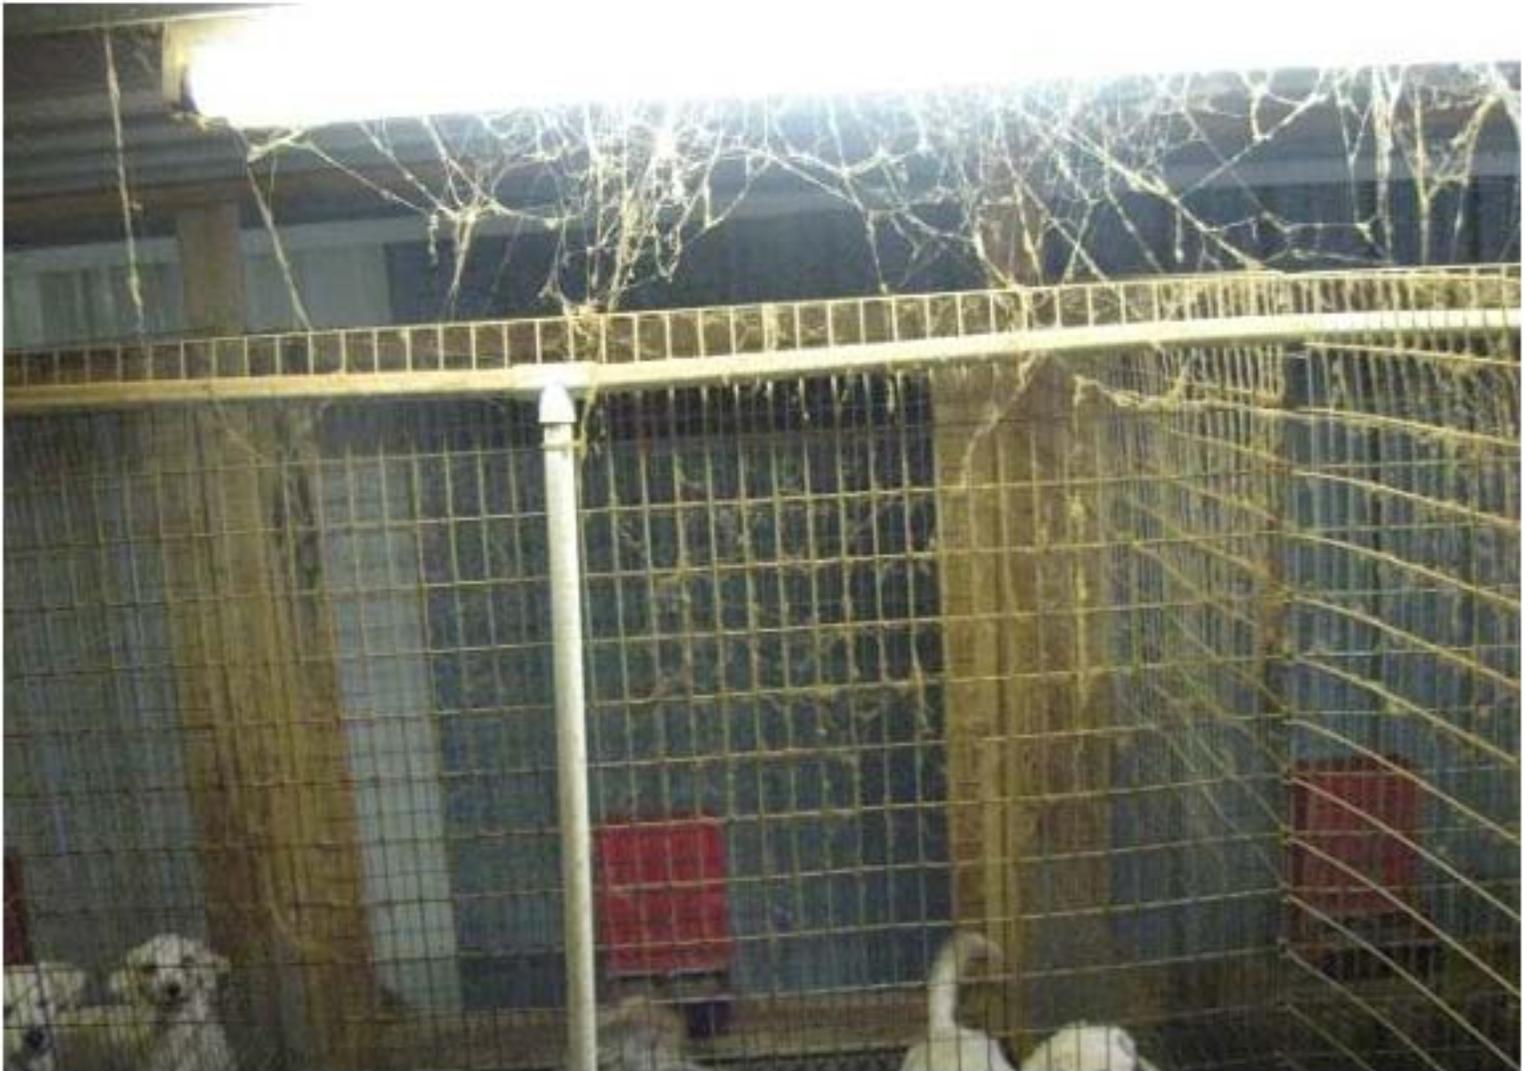
FOIA11-282000156

CFR: 3.11 (c)

Photographer:	John J. Lies, ACI	Legal Name:	Registration:	42-A-1354
Photo Taken:	Wed, Jan 12, '11 P.M.	BOB MEHMERT		
Inspection:	12111344160875			
Description:	3.11(c) Housekeeping Spider webs, hair dirt of lights and wire enclosures.

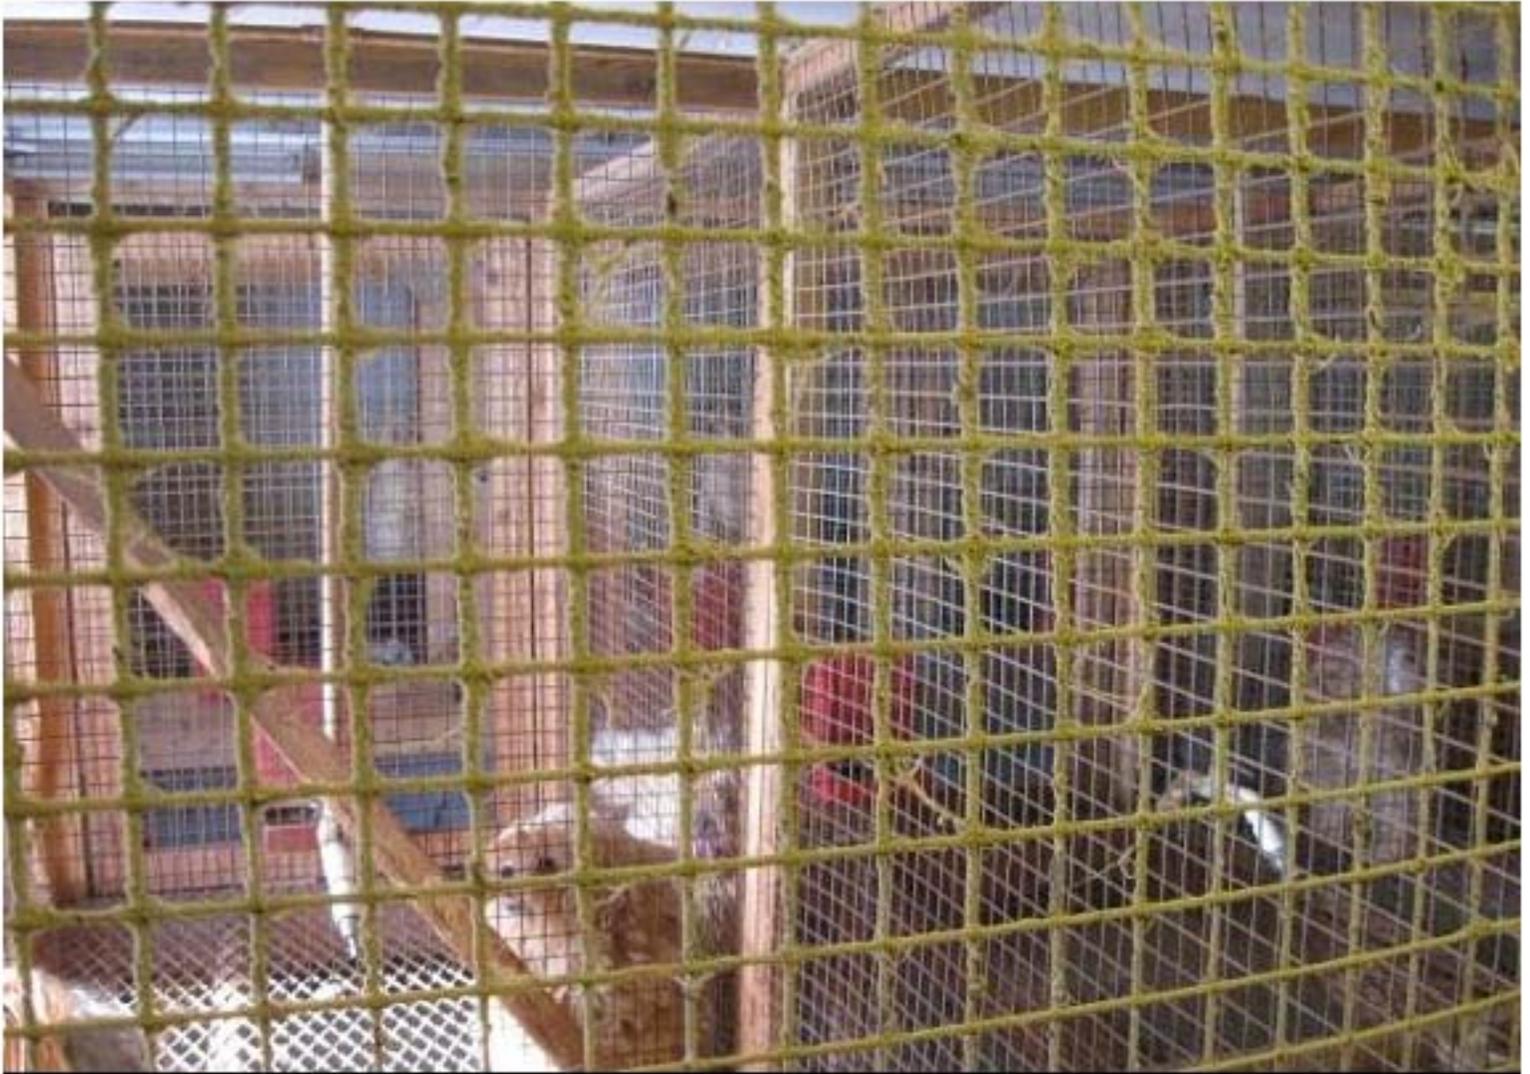
FOIA11-282000157

CFR: 3.11 (c)

Photographer:	John J. Lies, ACI	Legal Name:	Registration:	42-A-1354
Photo Taken:	Wed, Jan 12, '11 P.M.	BOB MEHMERT		
Inspection:	12111344160875			
Description:	3.11(c) Housekeeping Spider webs, hair dirt of lights and wire enclosures.

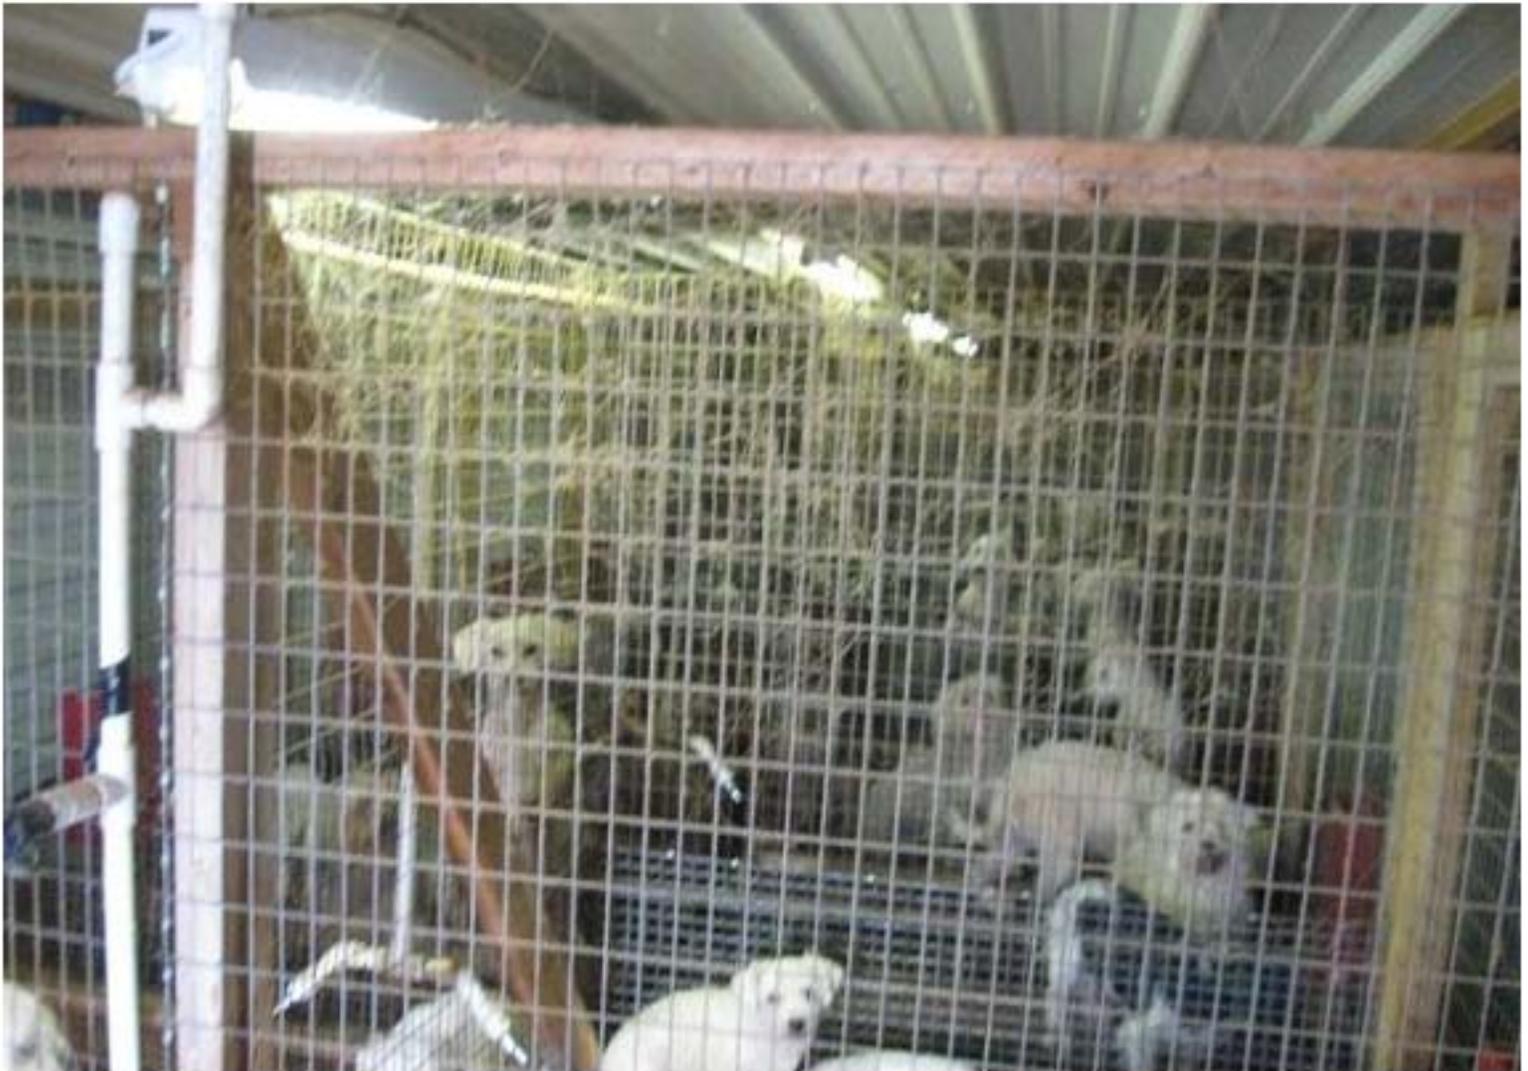
FOIA11-282000158

CFR: 3.11 (c)

Photographer:	John J. Lies, ACI	Legal Name:	Registration:	42-A-1354
Photo Taken:	Wed, Jan 12, '11 P.M.	BOB MEHMERT		
Inspection:	12111344160875			
Description:	3.11(c) Housekeeping Spider webs, hair dirt of lights and wire enclosures.

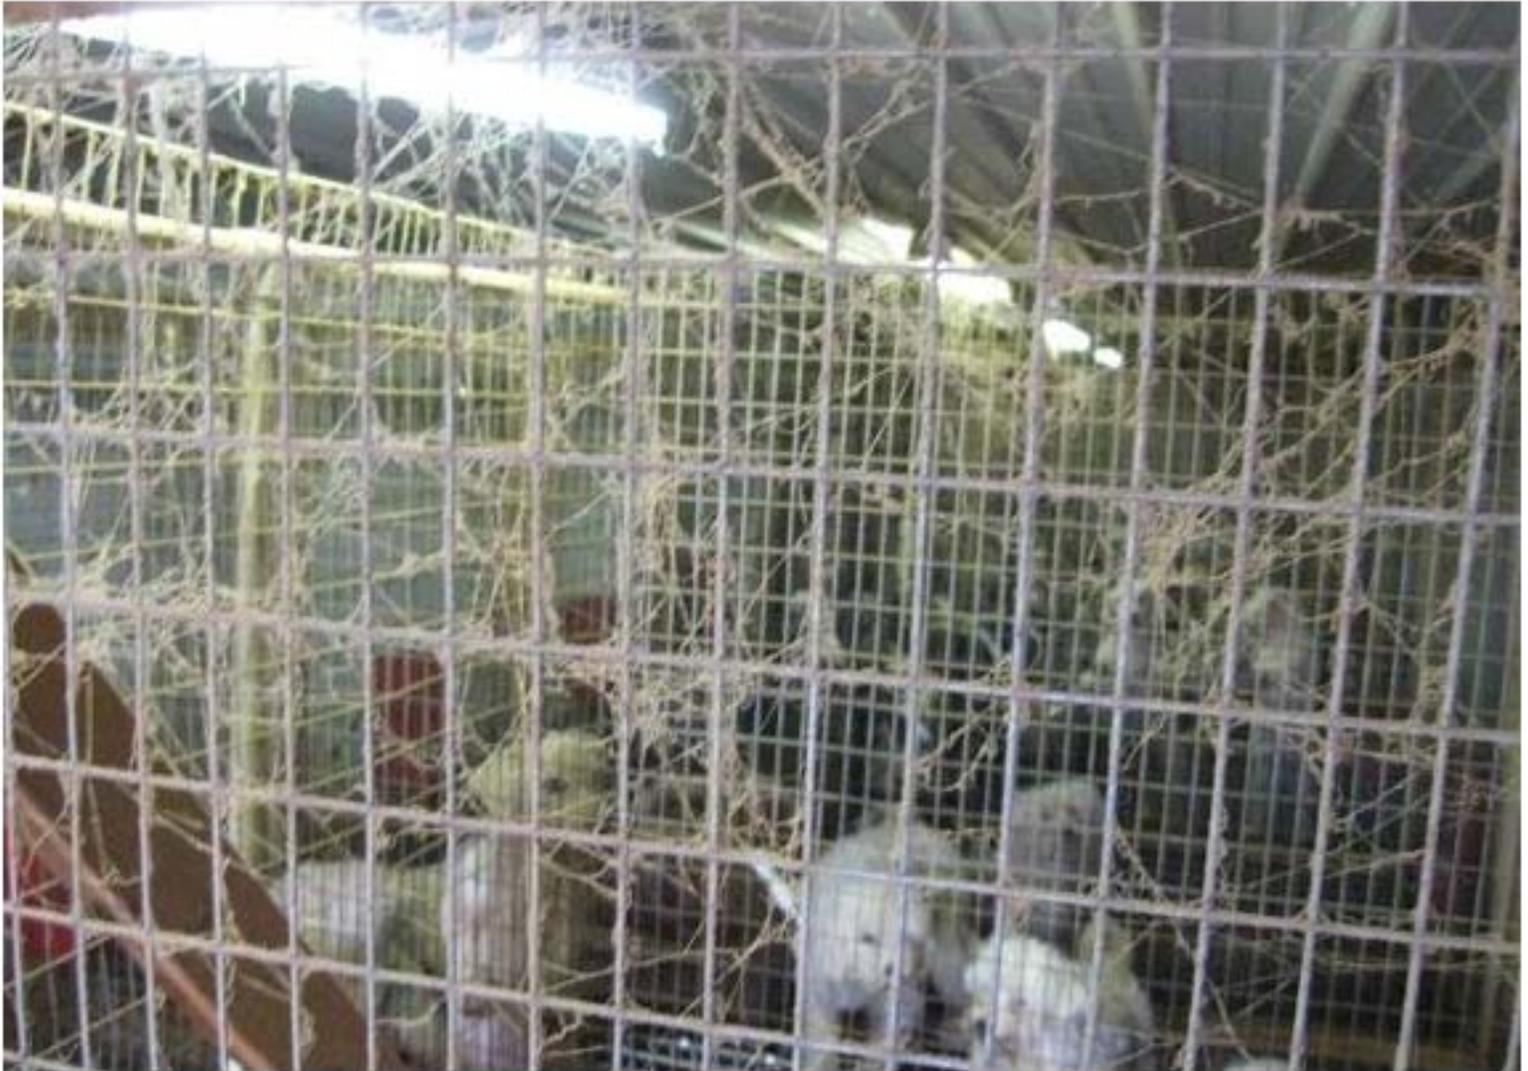
FOIA11-282000159

CFR: 3.11 (c)

Photographer:	John J. Lies, ACI	Legal Name:	Registration:	42-A-1354
Photo Taken:	Wed, Jan 12, '11 P.M.	BOB MEHMERT		
Inspection:	12111344160875			
Description:	3.11(c) Housekeeping Spider webs, hair dirt of lights and wire enclosures.

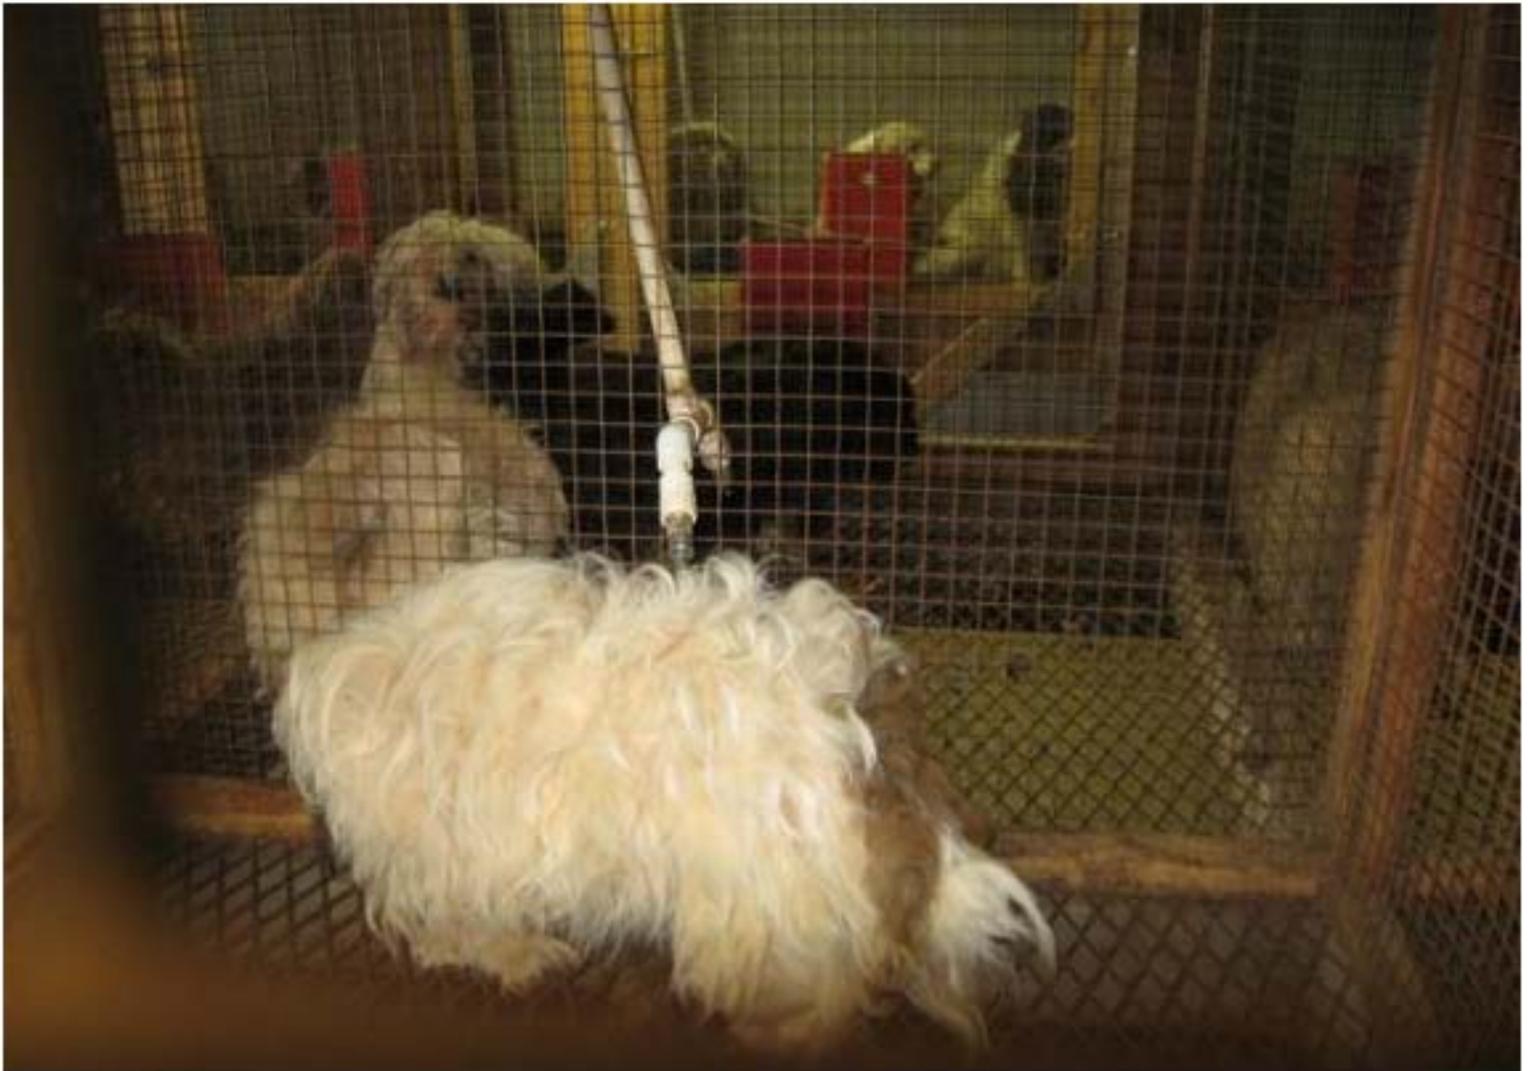
FOIA11-282000160

CFR: 2.40 (b) (2)

Photographer:	John J. Lies, ACI	Legal Name:	Registration:	42-A-1354
Photo Taken:	Wed, Jan 12, '11 P.M.	BOB MEHMERT		
Inspection:	12111344160875			
Description:	2.40 (b)(2) Veterinary Care dogs need to be groomed to remove long and/or matted hair.

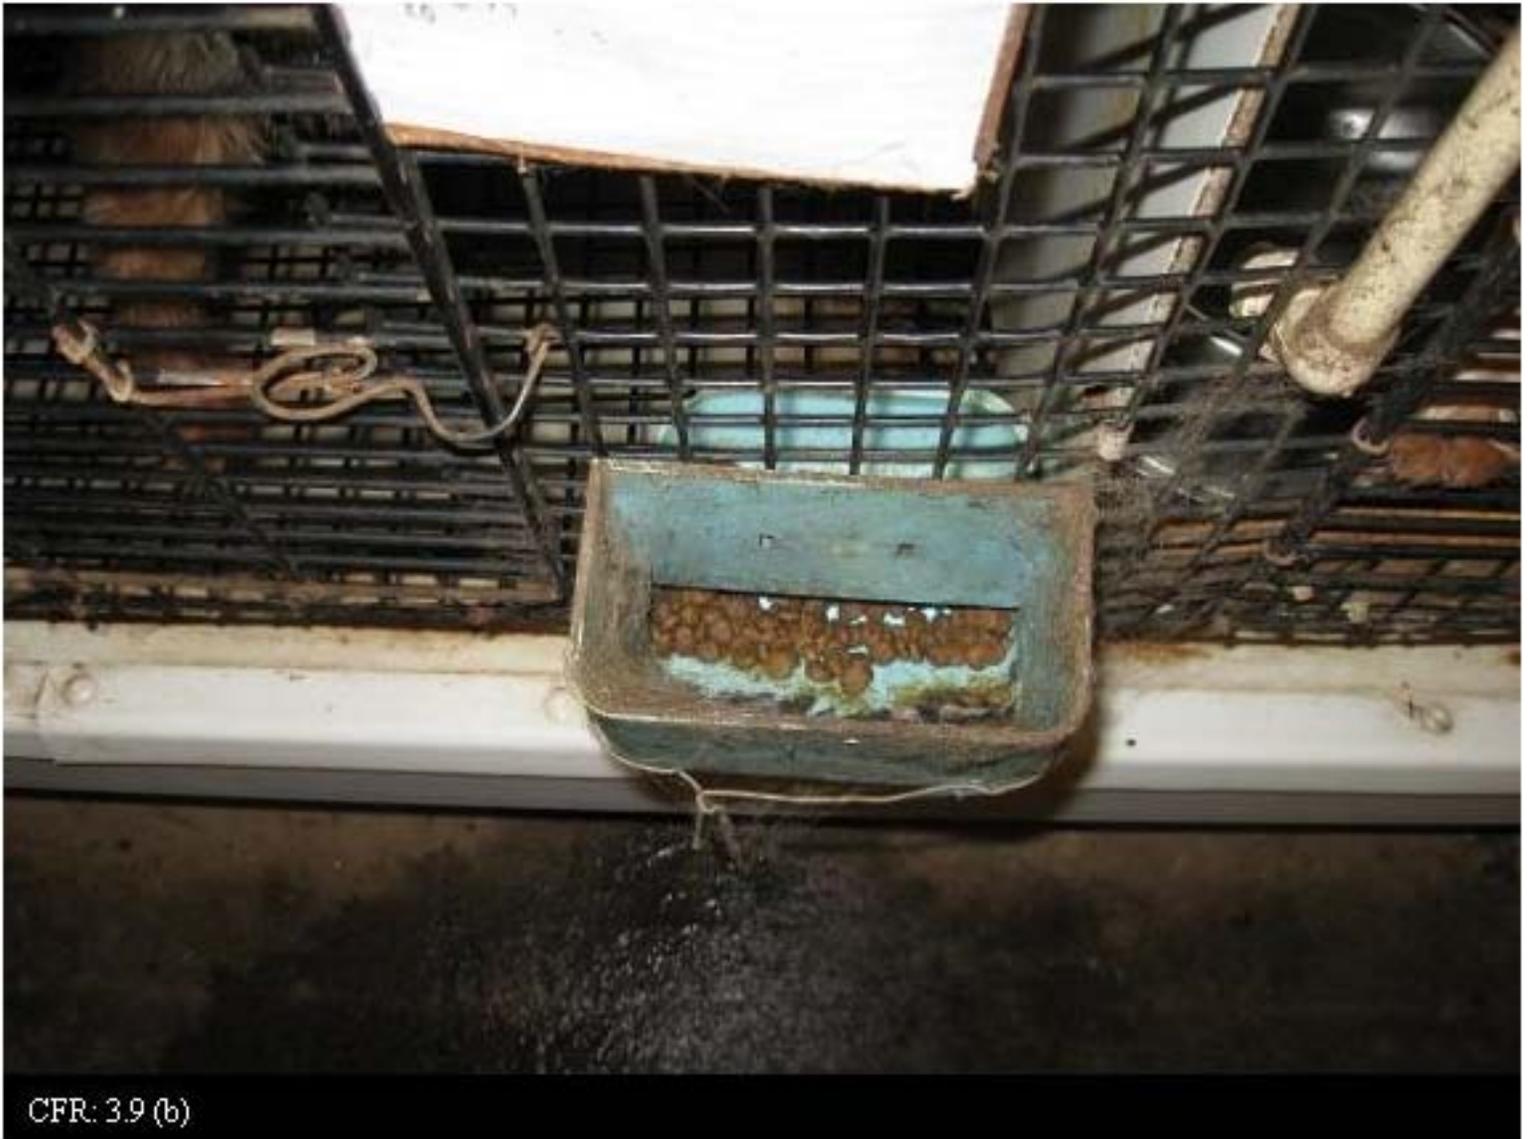
Photographer:	John J. Lies	Legal Name:	Registration:	42-A-1329
Photo Taken:	Wed, Sep 22, '10 P.M.	HENRY SOMMERS		
Inspection:	267101246130491			
Description:	3.9 (b) Feeding: Self feeders need to be cleaned and sanitized to remove grime.

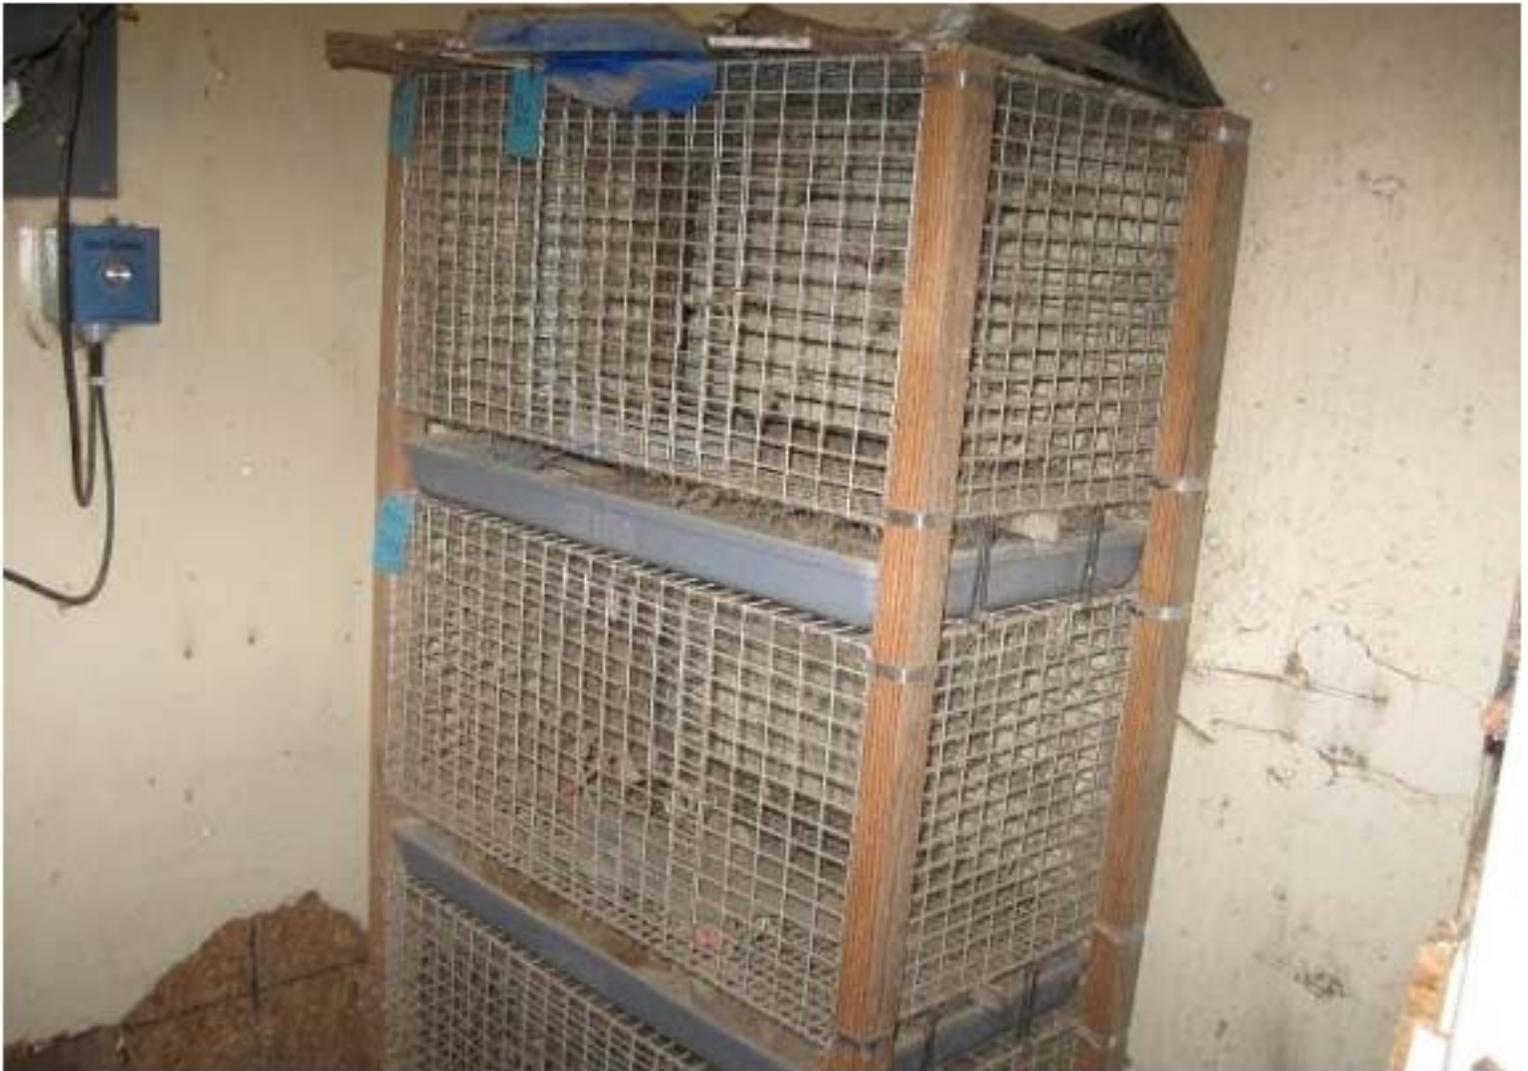
FOIA11-282000162

CFR: 3.1 (b)

Photographer:	John J. Lies	Legal Name:	Registration:	42-A-1329
Photo Taken:	Wed, Sep 22, '10 P.M.	HENRY SOMMERS		
Inspection:	267101246130491			
Description:	3.1 (b) Condition & Site: Facility in need of a general cleaning to remove dirt, hair, grime and/or clutter.

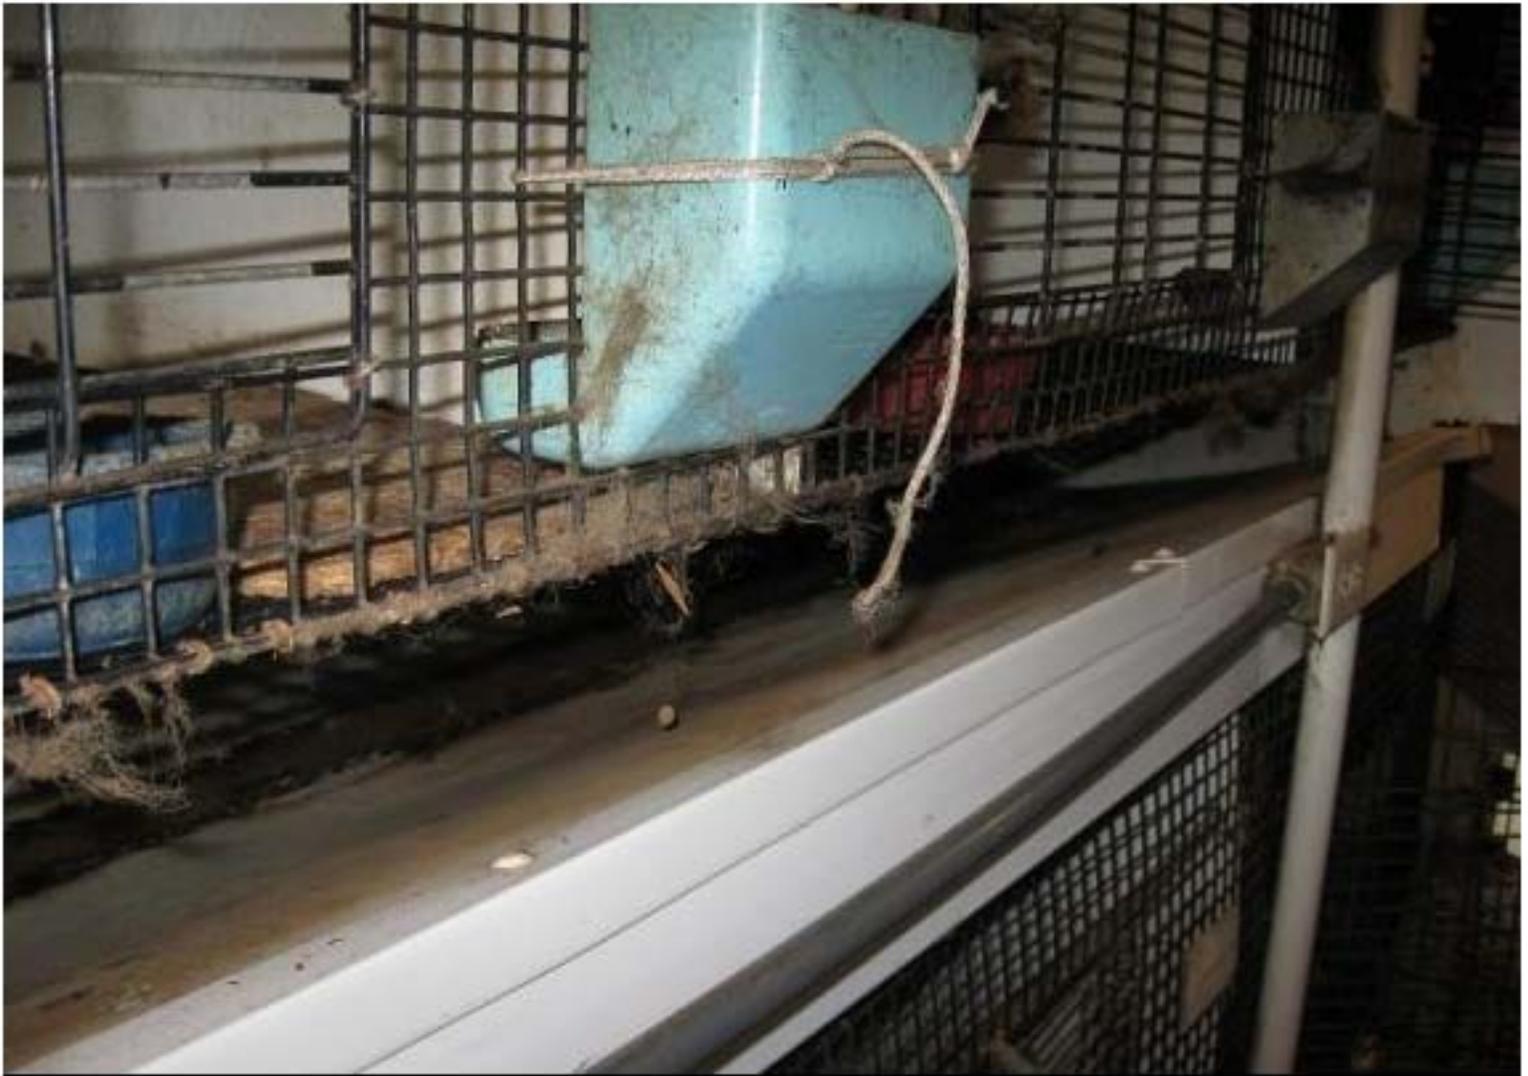
CFR: 3.1 (b), 3.9 (b)

Photographer:	John J. Lies	Legal Name:	Registration:	42-A-1329
Photo Taken:	Wed, Sep 22, '10 P.M.	HENRY SOMMERS		
Inspection:	267101246130491			
Description:	3.1 (b) Condition & Site: Facility in need of a general cleaning to remove dirt, hair, grime and/or clutter. 3.9 (b) Feeding: Self feeders need to be cleaned and sanitized to remove grime. FOIA11-282000163

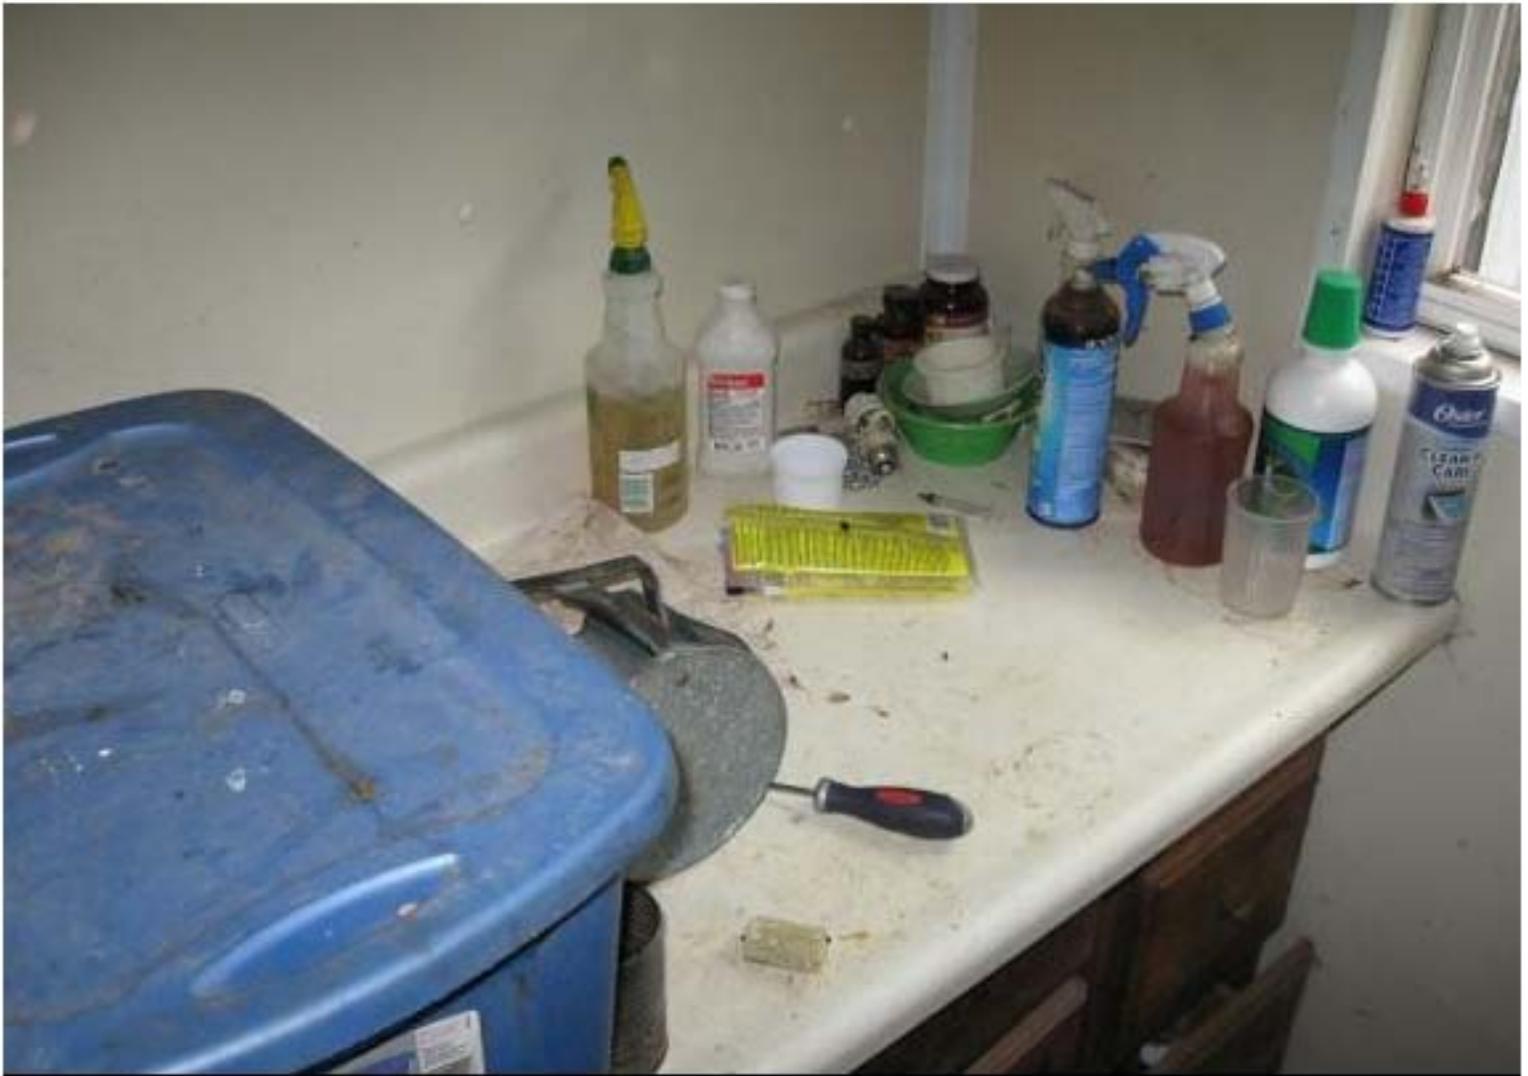
FOIA11-282000164

CFR: 3.1 (b)

Photographer:	John J. Lies	Legal Name:	Registration:	42-A-1329
Photo Taken:	Wed, Sep 22, '10 P.M.	HENRY SOMMERS		
Inspection:	267101246130491			
Description:	3.1 (b) Condition & Site: Facility in need of a general cleaning to remove dirt, hair, grime and/or clutter.

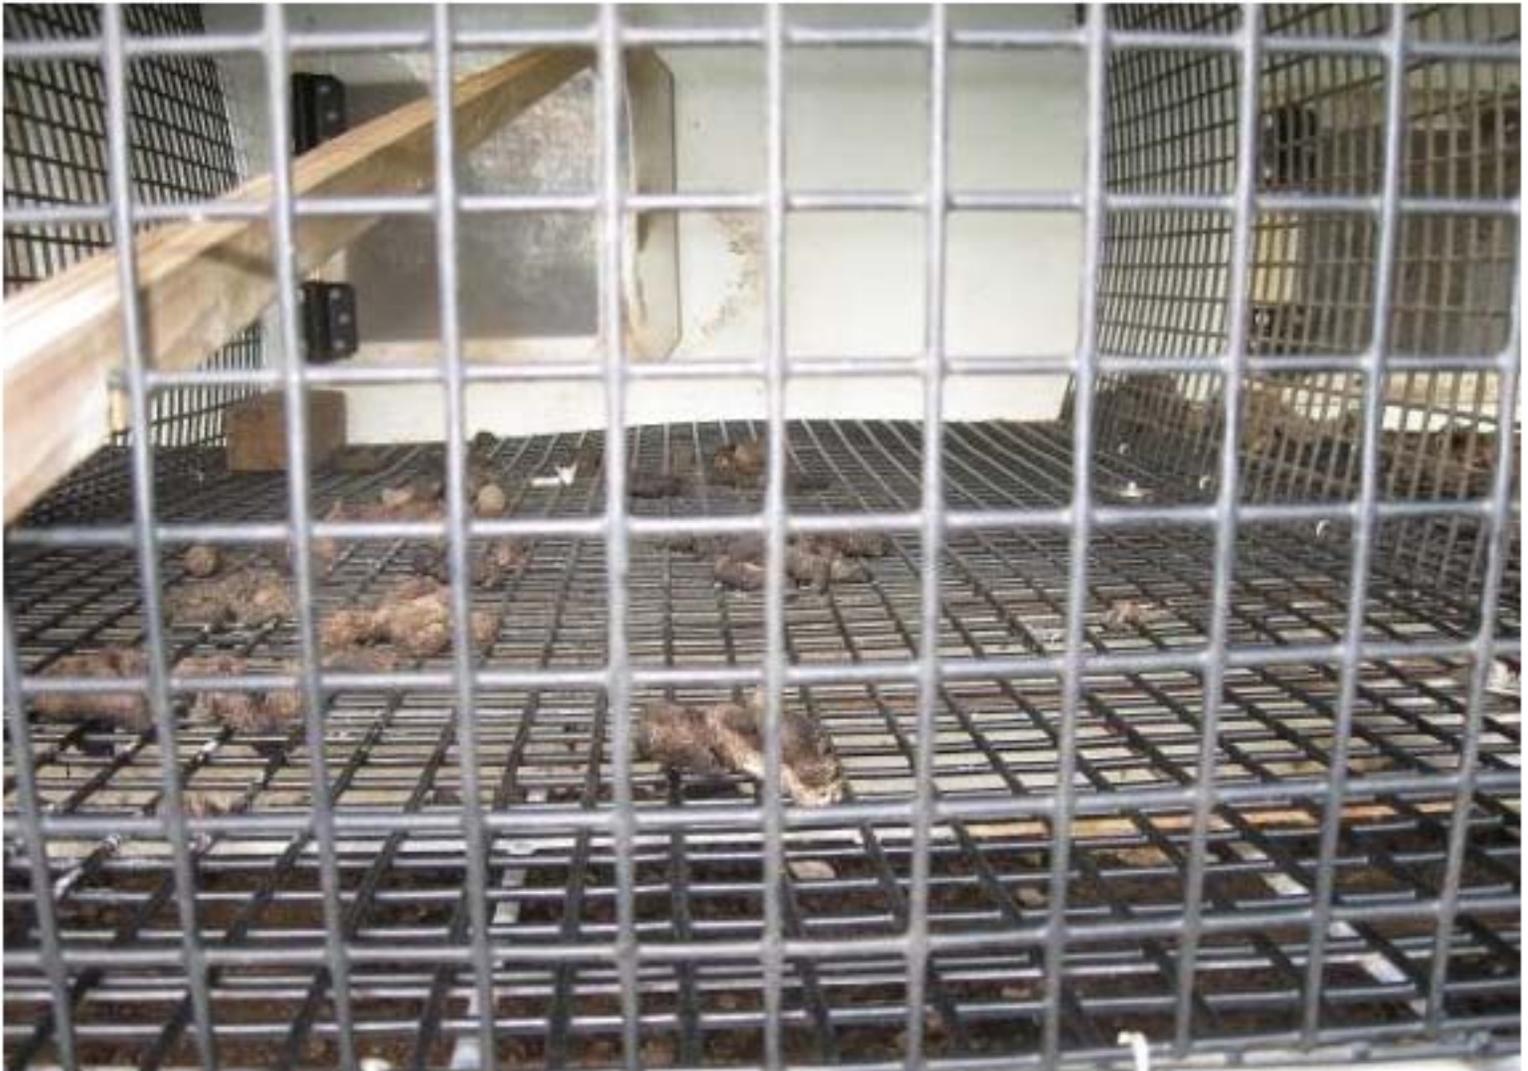
FOIA11-282000165

CFR: 3.11 (a), 3.11 (b)

Photographer:	John J. Lies	Legal Name:	Registration:	42-A-1329
Photo Taken:	Wed, Sep 22, '10 P.M.	HENRY SOMMERS		
Inspection:	267101246130491			
Description:	3.11 (a) & (b) Cleaning and Sanitizing; Feces needs to be removed and back wall needs to be sanitized to remove grime.

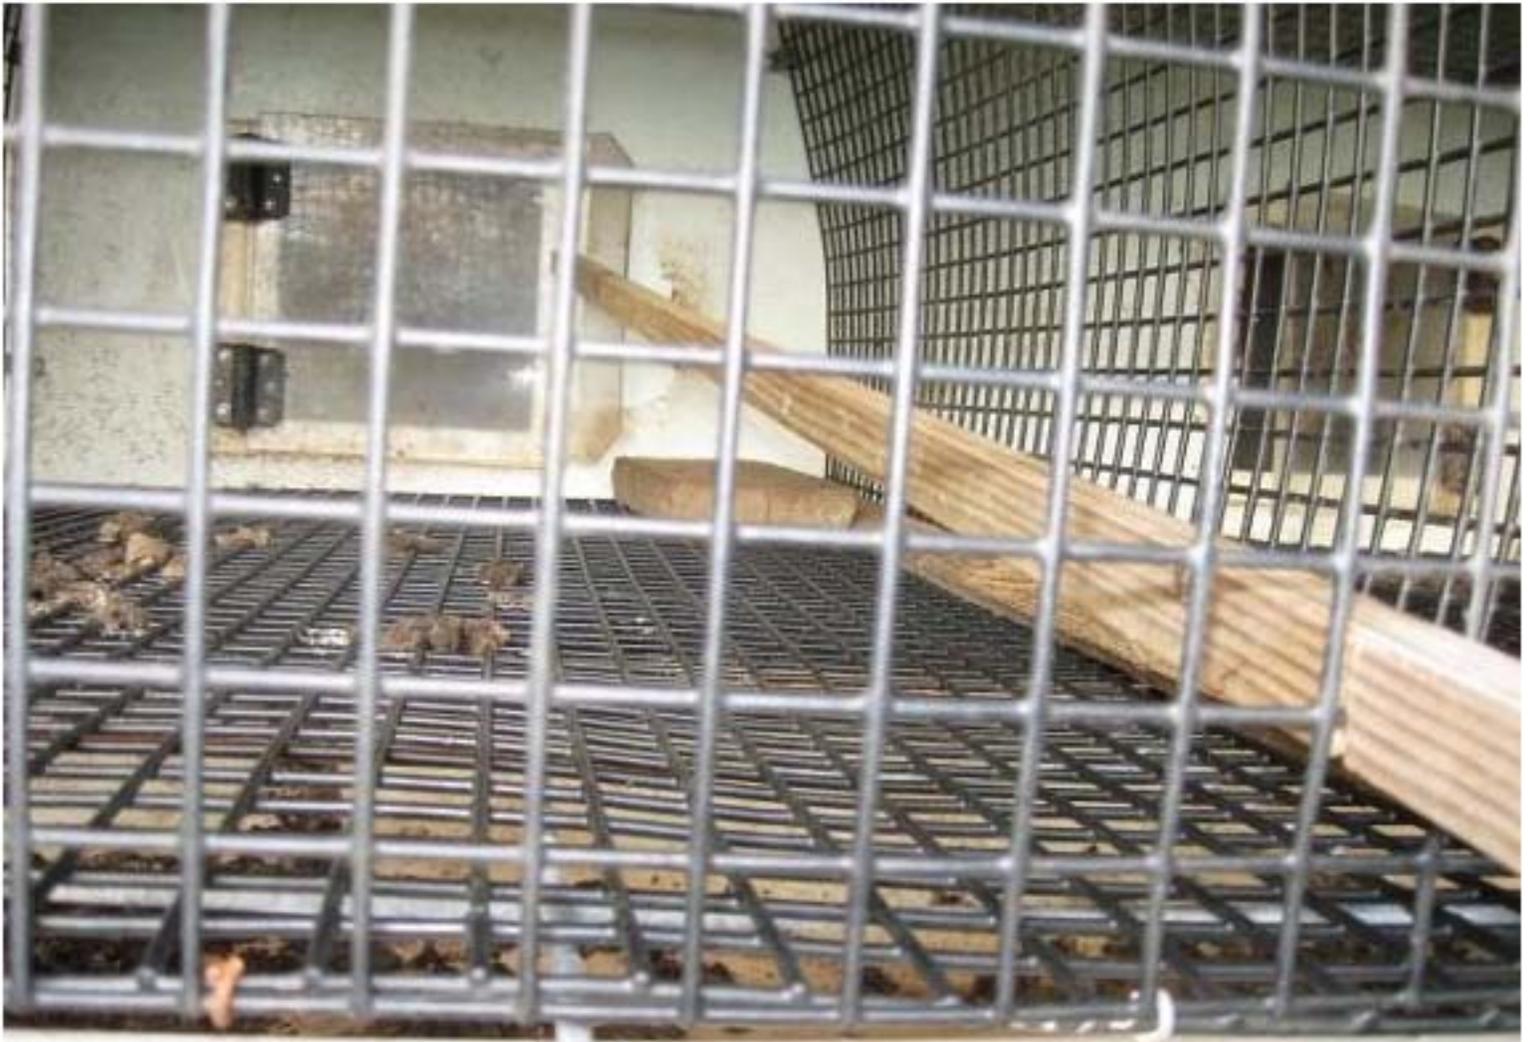
FOIA11-282000166

CFR: 3.11 (a), 3.11 (b)

Photographer:	John J. Lies	Legal Name:	Registration:	42-A-1329
Photo Taken:	Wed, Sep 22, '10 P.M.	HENRY SOMMERS		
Inspection:	267101246130491			
Description:	3.11 (a) & (b) Cleaning and Sanitizing; Feces needs to be removed and back wall needs to be sanitized to remove grime.
