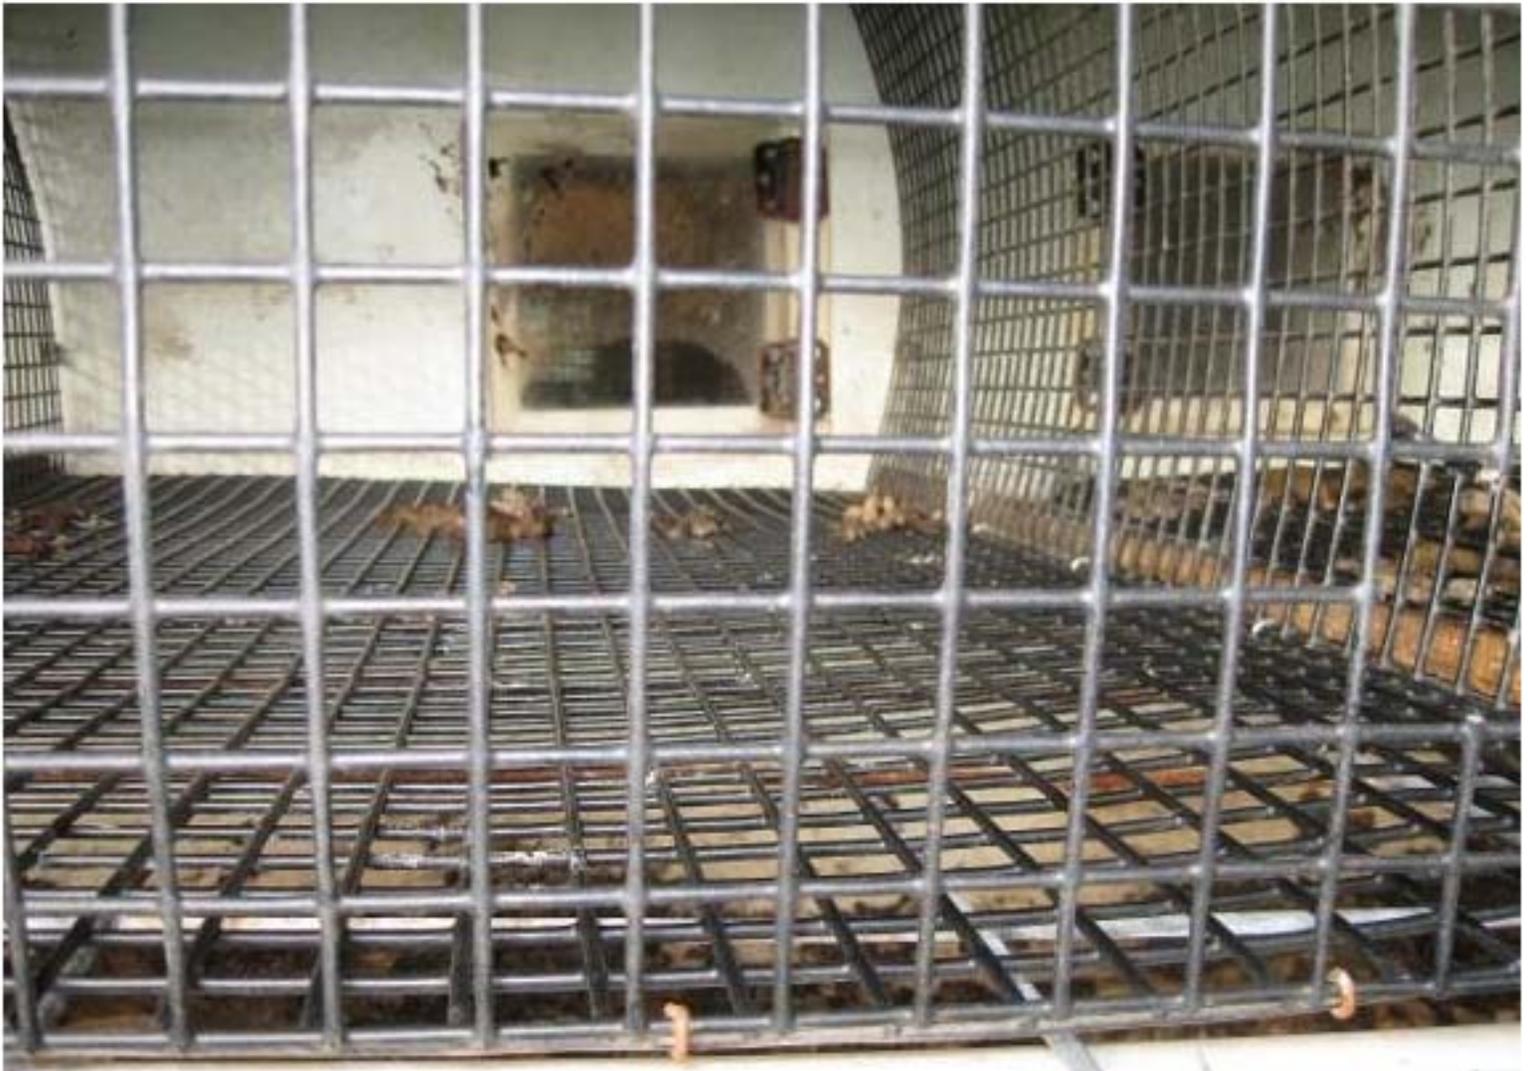
FOIA11-282000167

CFR: 3.11 (a), 3.11 (b)

Photographer:	John J. Lies	Legal Name:	Registration:	42-A-1329
Photo Taken:	Wed, Sep 22, '10 P.M.	HENRY SOMMERS		
Inspection:	267101246130491			
Description:	3.11 (a) & (b) Cleaning and Sanitizing; Feces needs to be removed and back wall needs to be sanitized to remove grime.

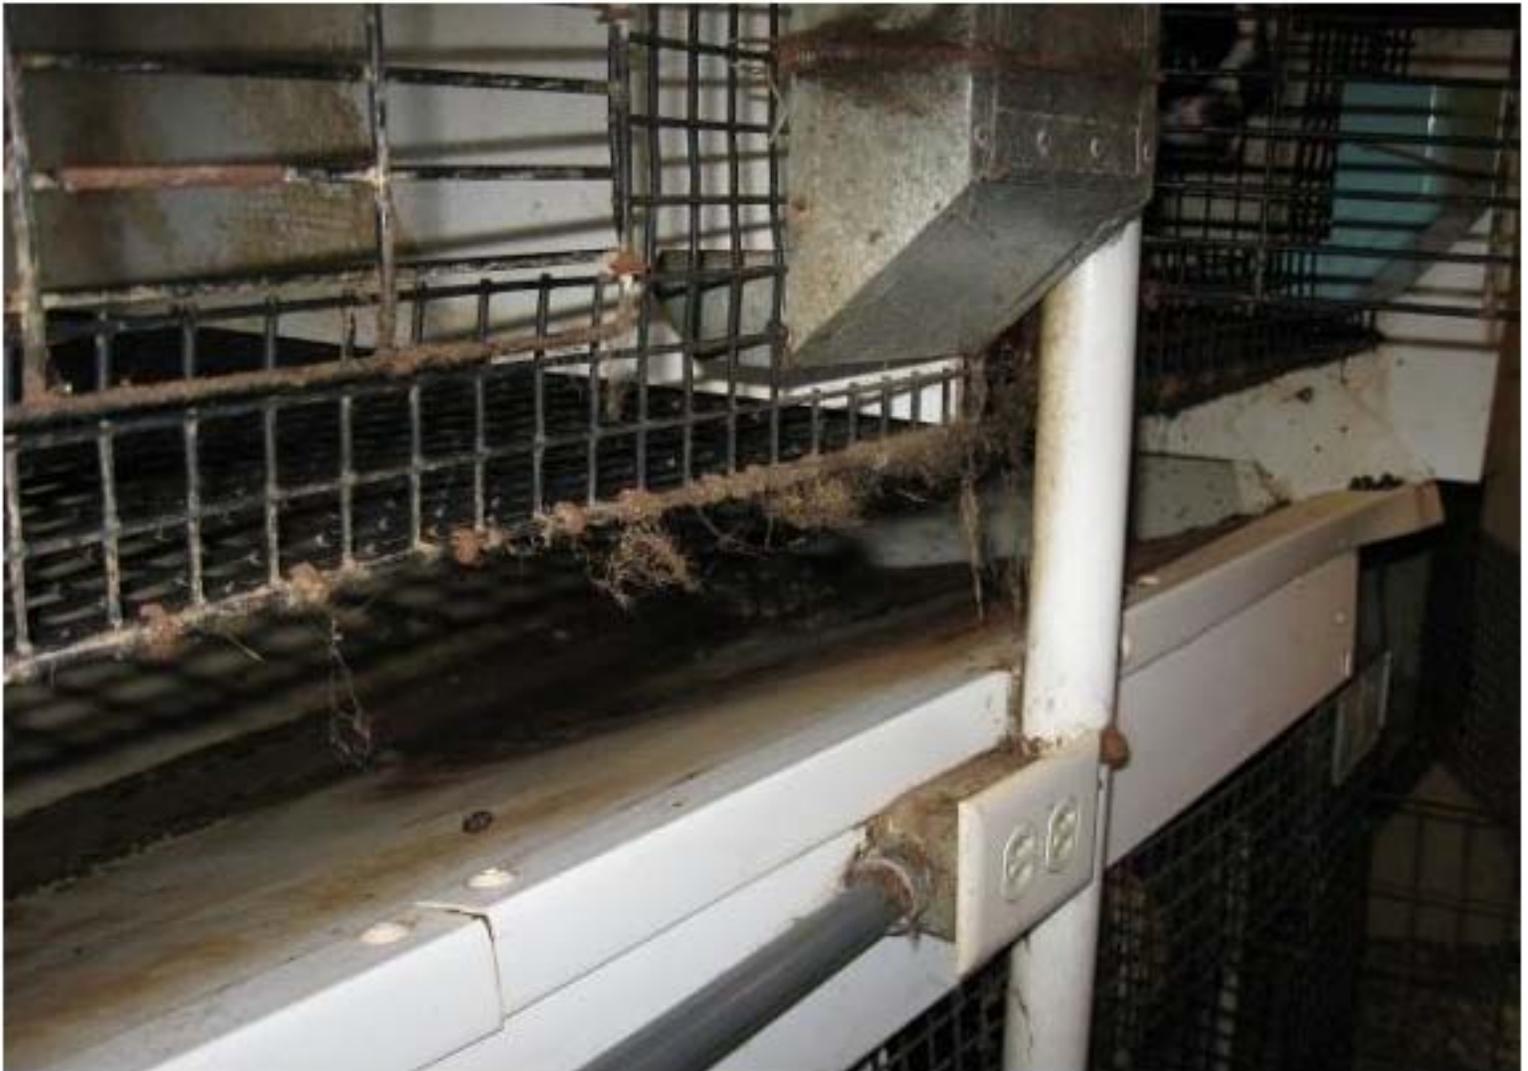
FOIA11-282000168

CFR: 3.1 (b)

Photographer:	John J. Lies	Legal Name:	Registration:	42-A-1329
Photo Taken:	Wed, Sep 22, '10 P.M.	HENRY SOMMERS		
Inspection:	267101246130491			
Description:	3.1 (b) Condition & Site: Facility in need of a general cleaning to remove dirt, hair, grime and/or clutter.

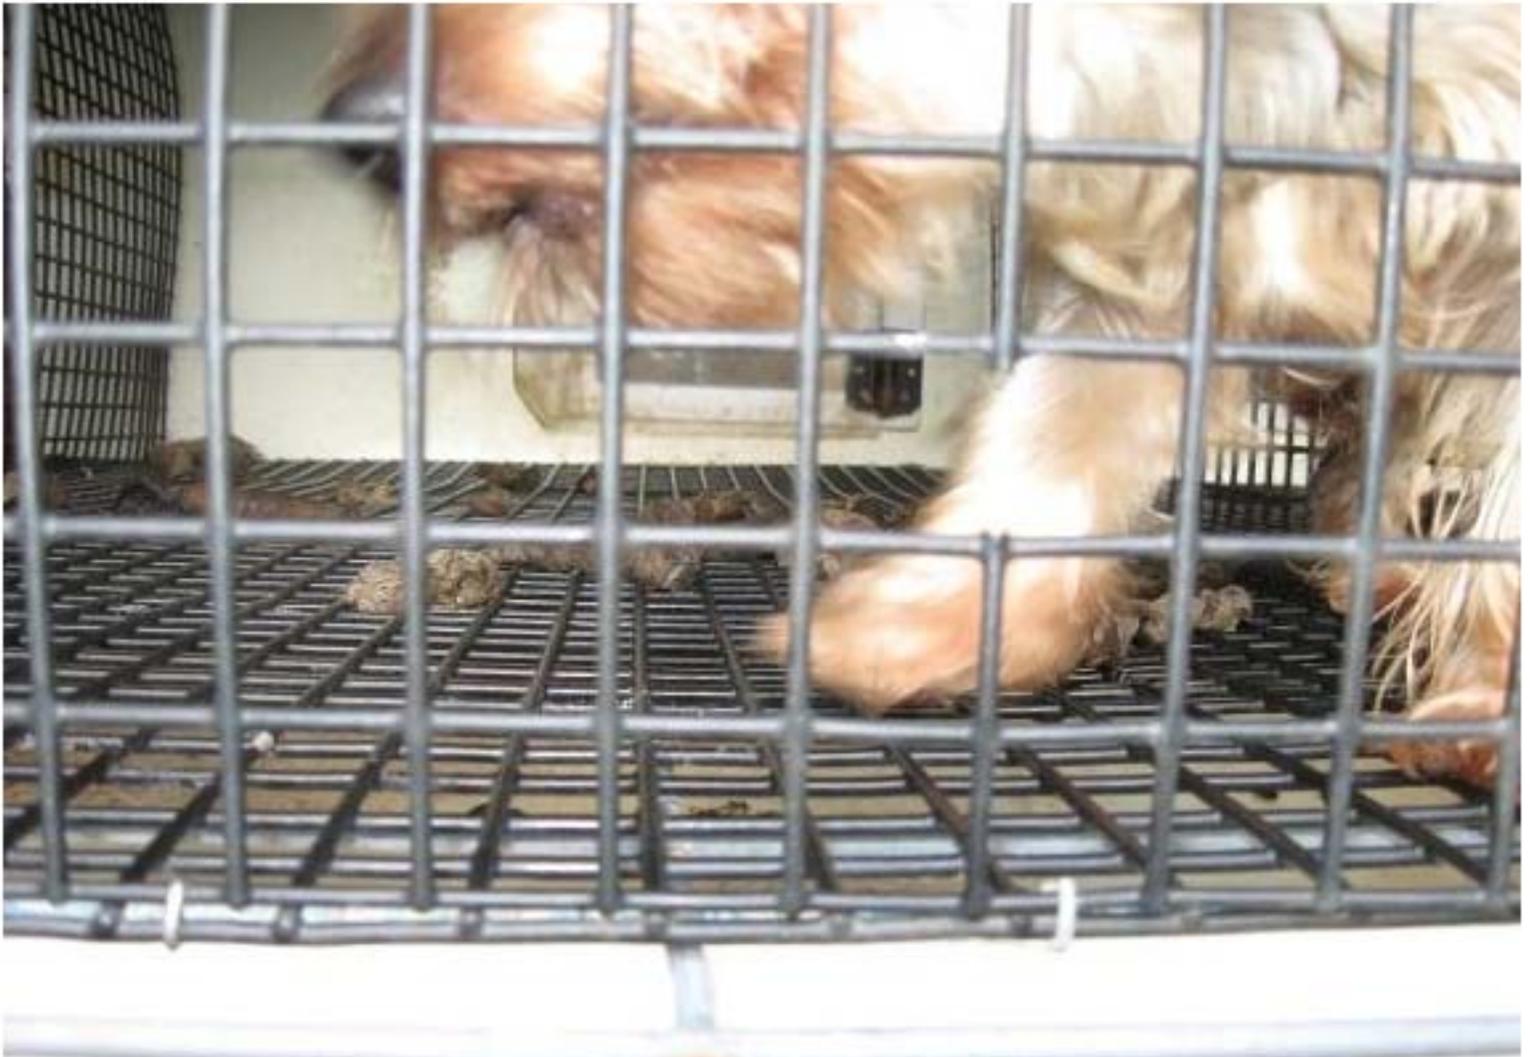
FOIA11-282000169

CFR: 3.11 (a)

Photographer:	John J. Lies	Legal Name:	Registration:	42-A-1329
Photo Taken:	Wed, Sep 22, '10 P.M.	HENRY SOMMERS		
Inspection:	267101246130491			
Description:	3.11 (a) Cleaning Feces needs to be removed from enclosure.

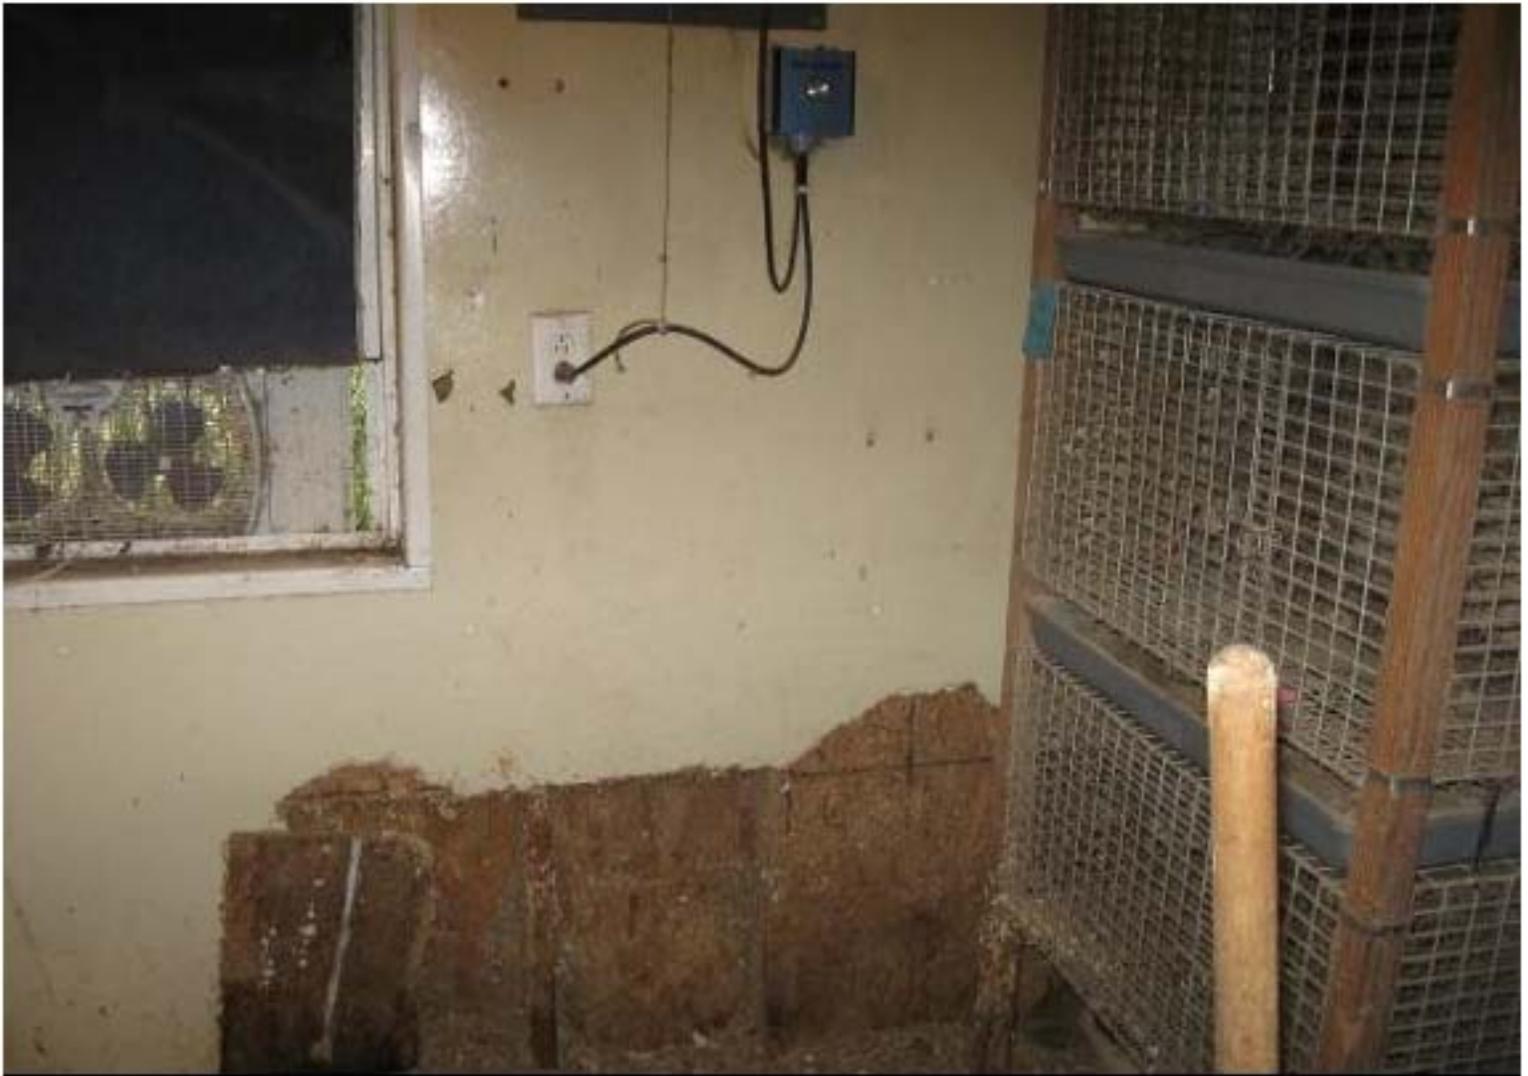
CFR: 3.1 (a), 3.3 (e) (1) (iii)

Photographer:	John J. Lies	Legal Name:	Registration:	42-A-1329
Photo Taken:	Wed, Sep 22, '10 P.M.	HENRY SOMMERS		
Inspection:	267101246130491			
Description:	3.1 (a) Housing Facility Structure: Hole in the wall needs to be repaired. 3.3 (e)(iii) Sheltered Surfaces: Bare wood not impervious to moisture exposed to the dogs in the

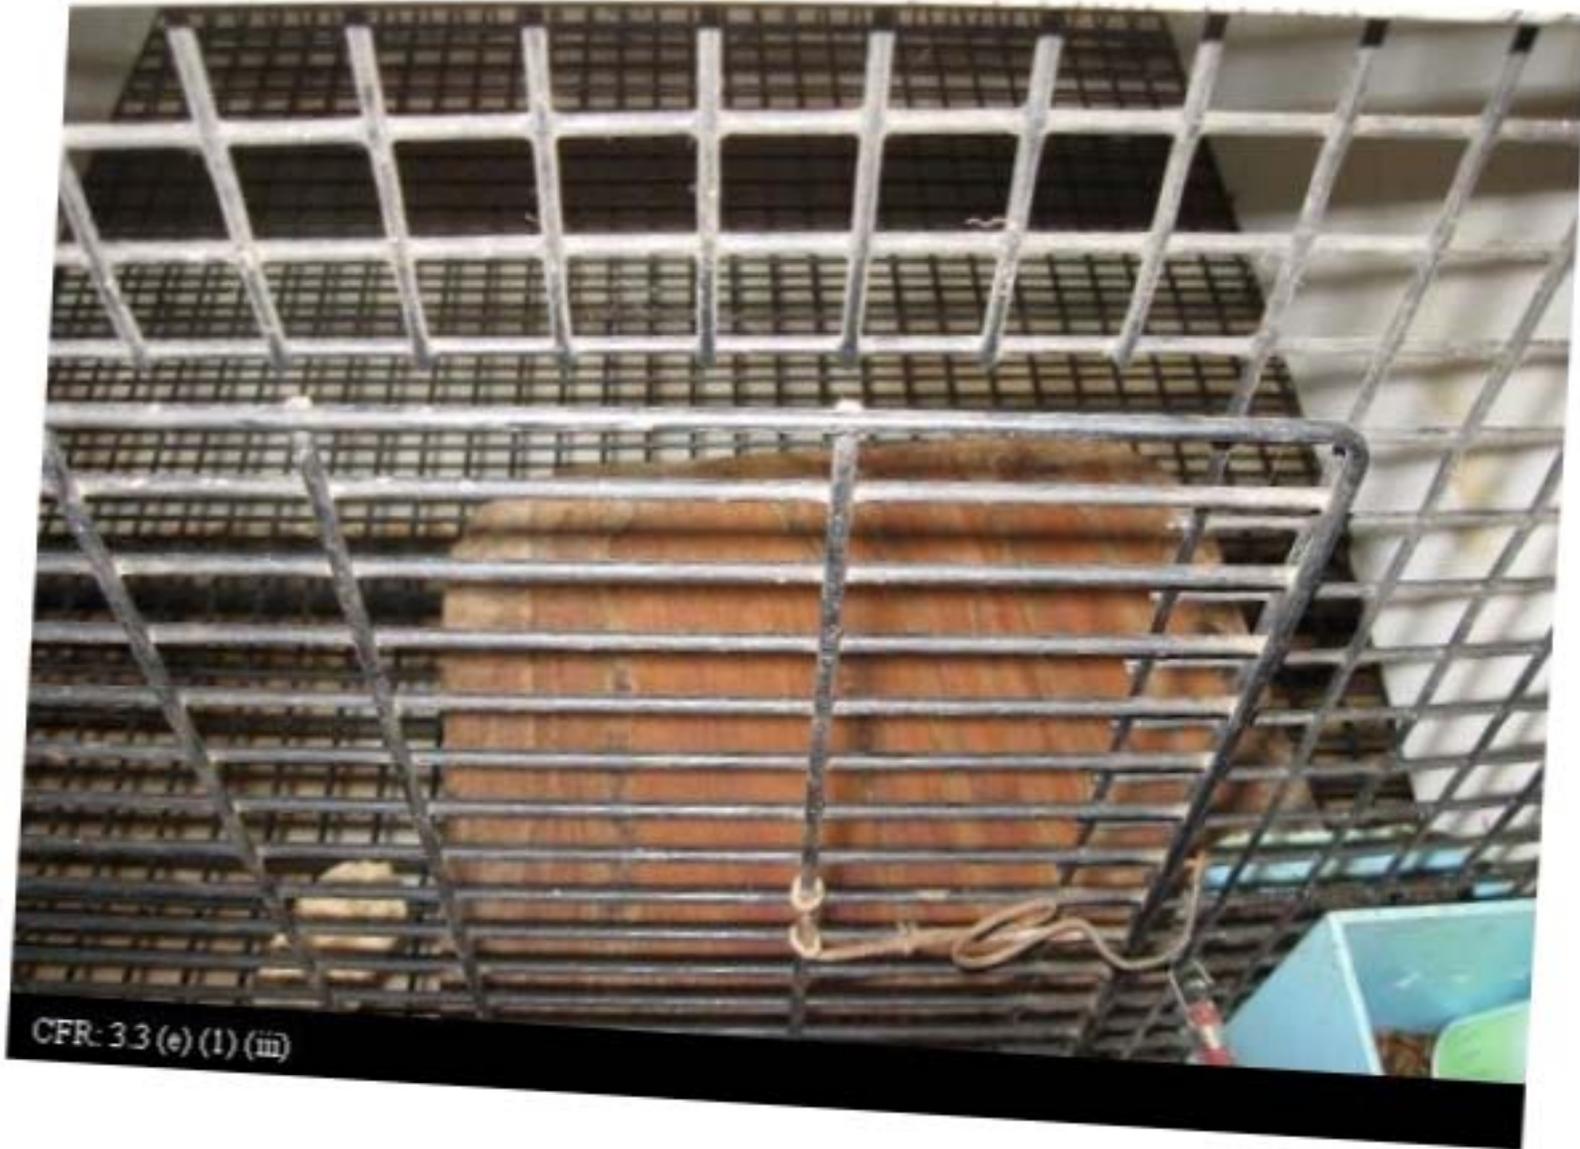
Description: 3.3 (e)(iii) Sheltered Surfaces: Wood resting board worn and no longer impervious to moisture.

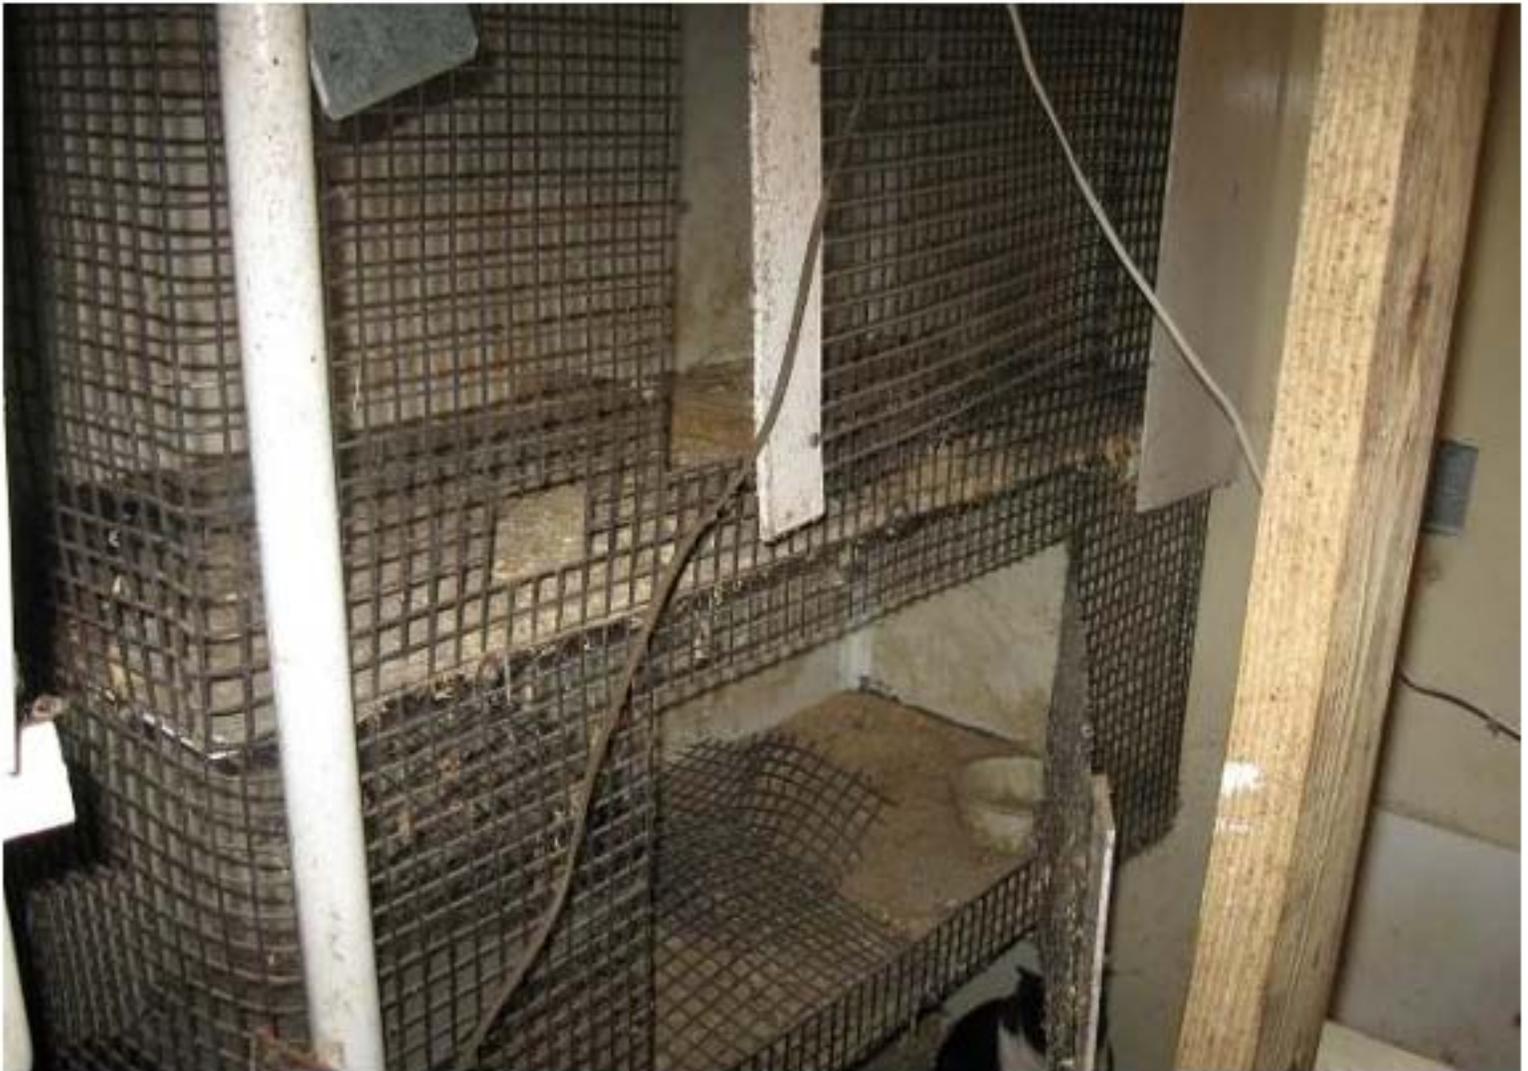
FOIA11-282000172

CFR: 3.1 (b)

Photographer:	John J. Lies	Legal Name:	Registration:	42-A-1329
Photo Taken:	Wed, Sep 22, '10 P.M.	HENRY SOMMERS		
Inspection:	267101246130491			
Description:	3.1 (b) Condition & Site: Facility in need of a general cleaning to remove dirt, hair, grime and/or clutter.

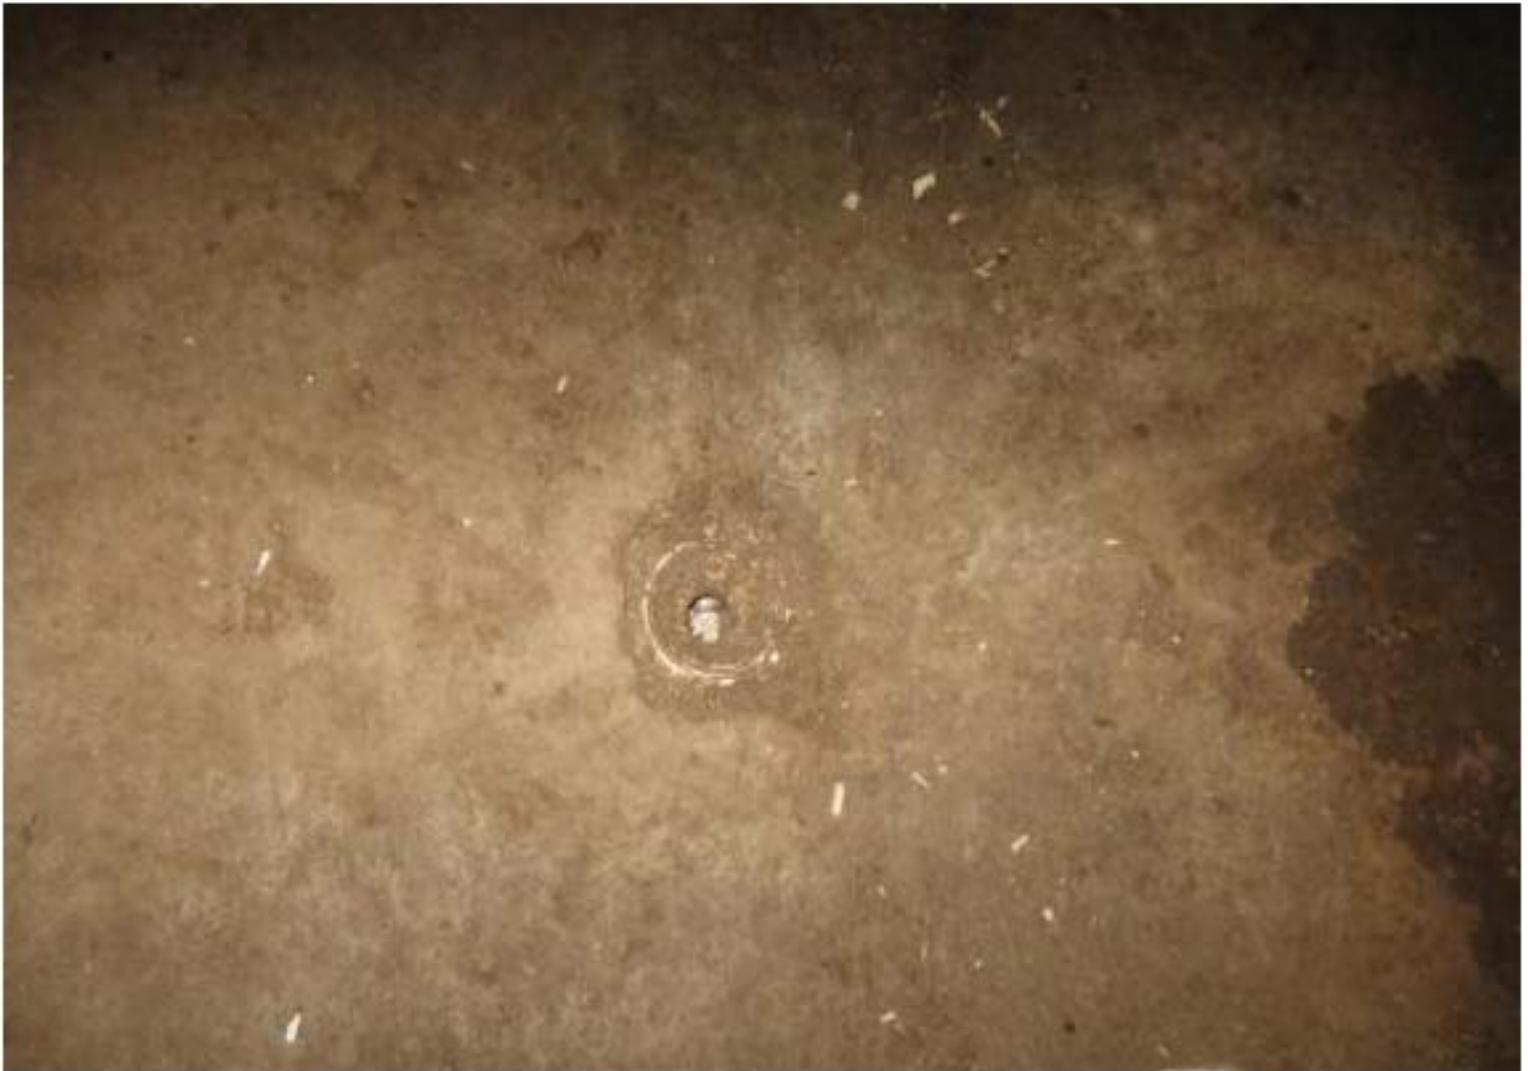
FOIA11-282000173

CFR: 3.1 (b)

Photographer:	John J. Lies	Legal Name:	Registration:	42-A-1329
Photo Taken:	Wed, Sep 22, '10 P.M.	HENRY SOMMERS		
Inspection:	267101246130491			
Description:	3.1 (b) Condition & Site: Facility in need of a general cleaning to remove dirt, hair, grime and/or clutter.

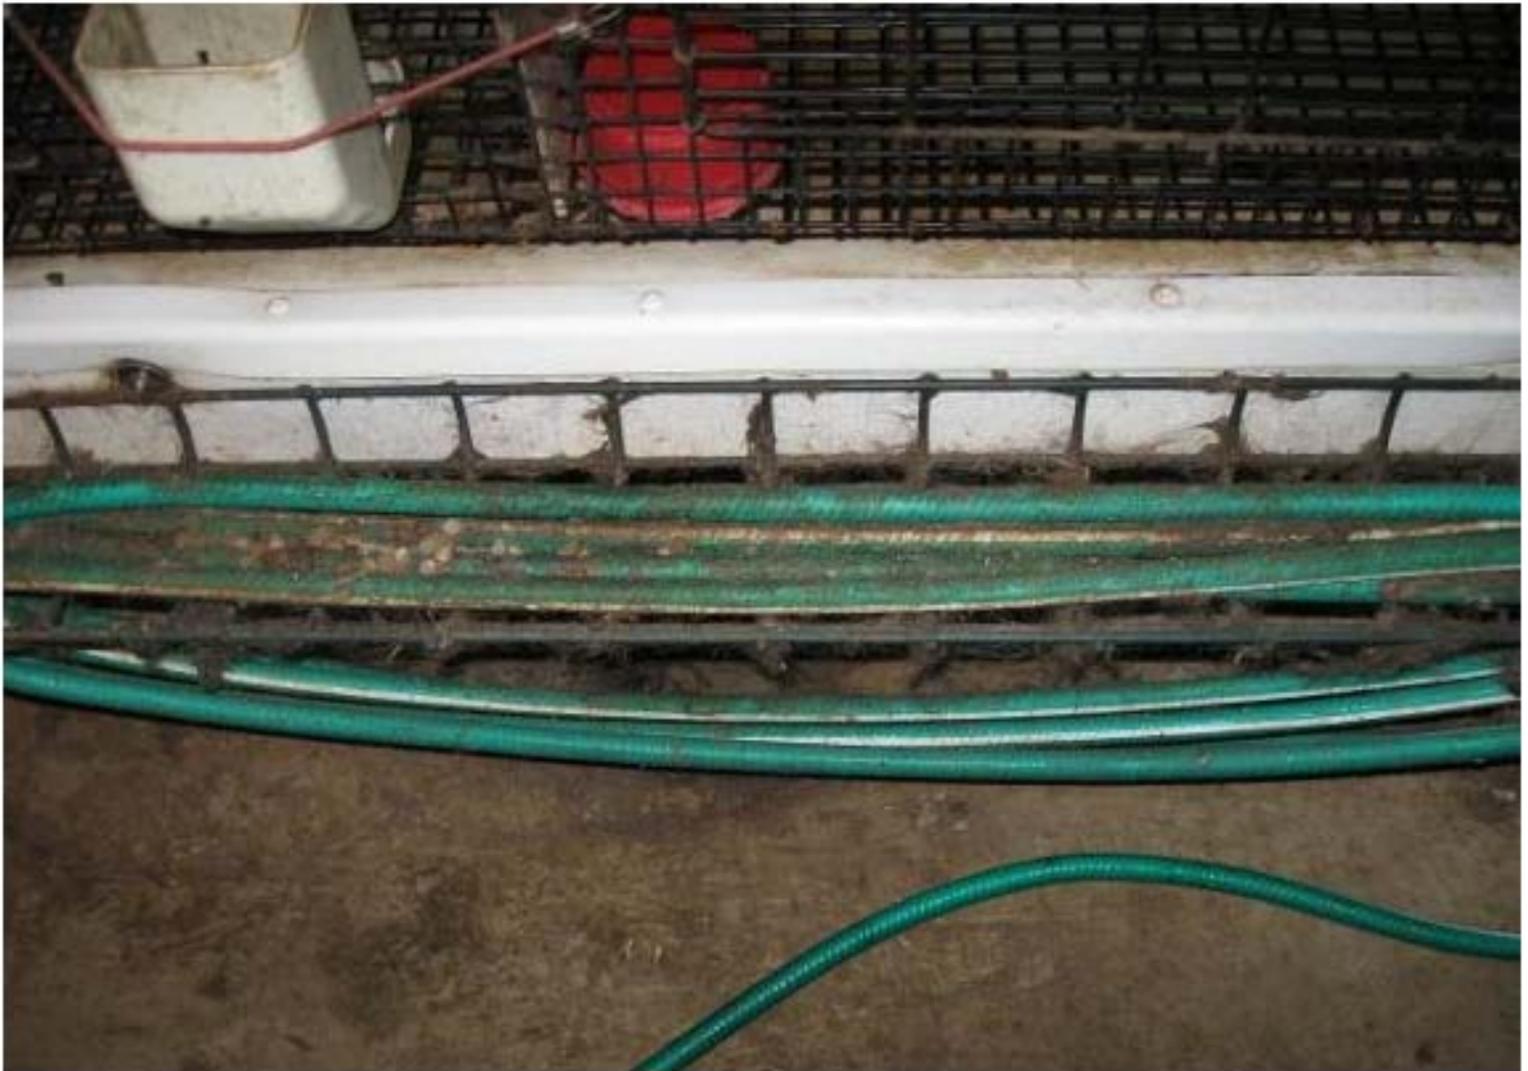
FOIA11-282000174

CFR: 3.1 (b)

Photographer:	John J. Lies	Legal Name:	Registration:	42-A-1329
Photo Taken:	Wed, Sep 22, '10 P.M.	HENRY SOMMERS		
Inspection:	267101246130491			
Description:	3.1 (b) Condition & Site: Facility in need of a general cleaning to remove dirt, hair, grime and/or clutter.

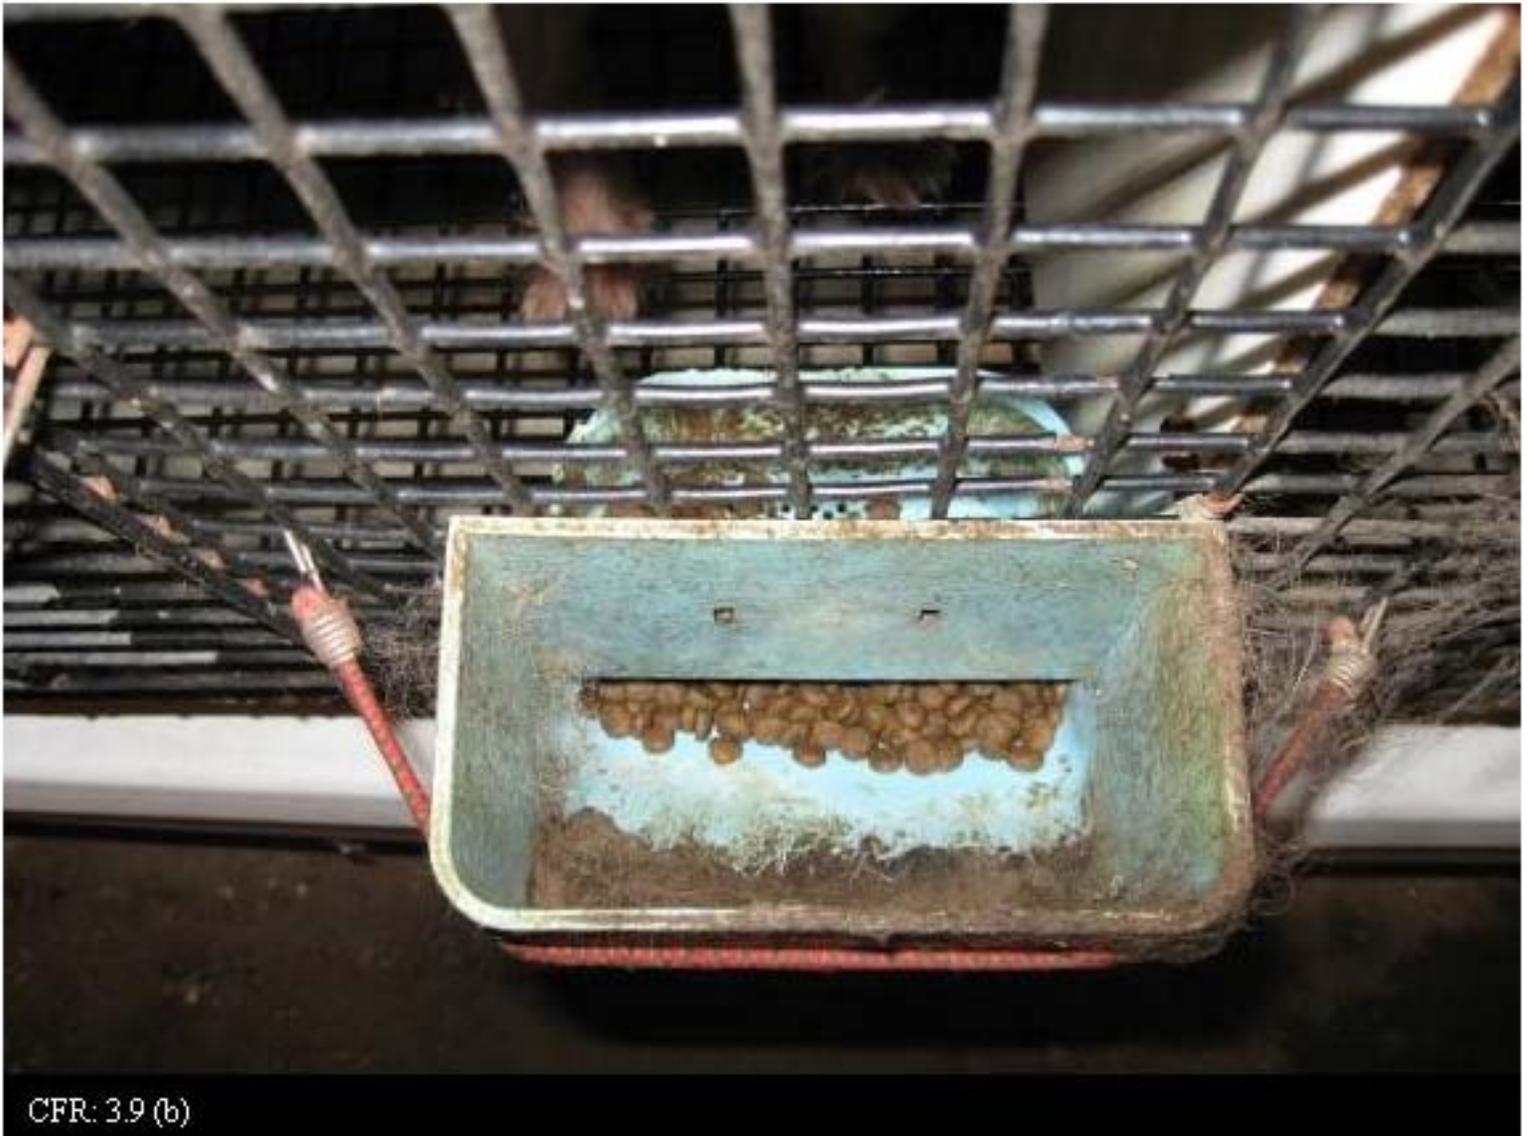
FOIA11-282000175

Photographer:	John J. Lies	Legal Name:	Registration:	42-A-1329
Photo Taken:	Wed, Sep 22, '10 P.M.	HENRY SOMMERS		
Inspection:	267101246130491			
Description:	3.9 (b) Feeding: Self feeders need to be cleaned and sanitized to remove grime.

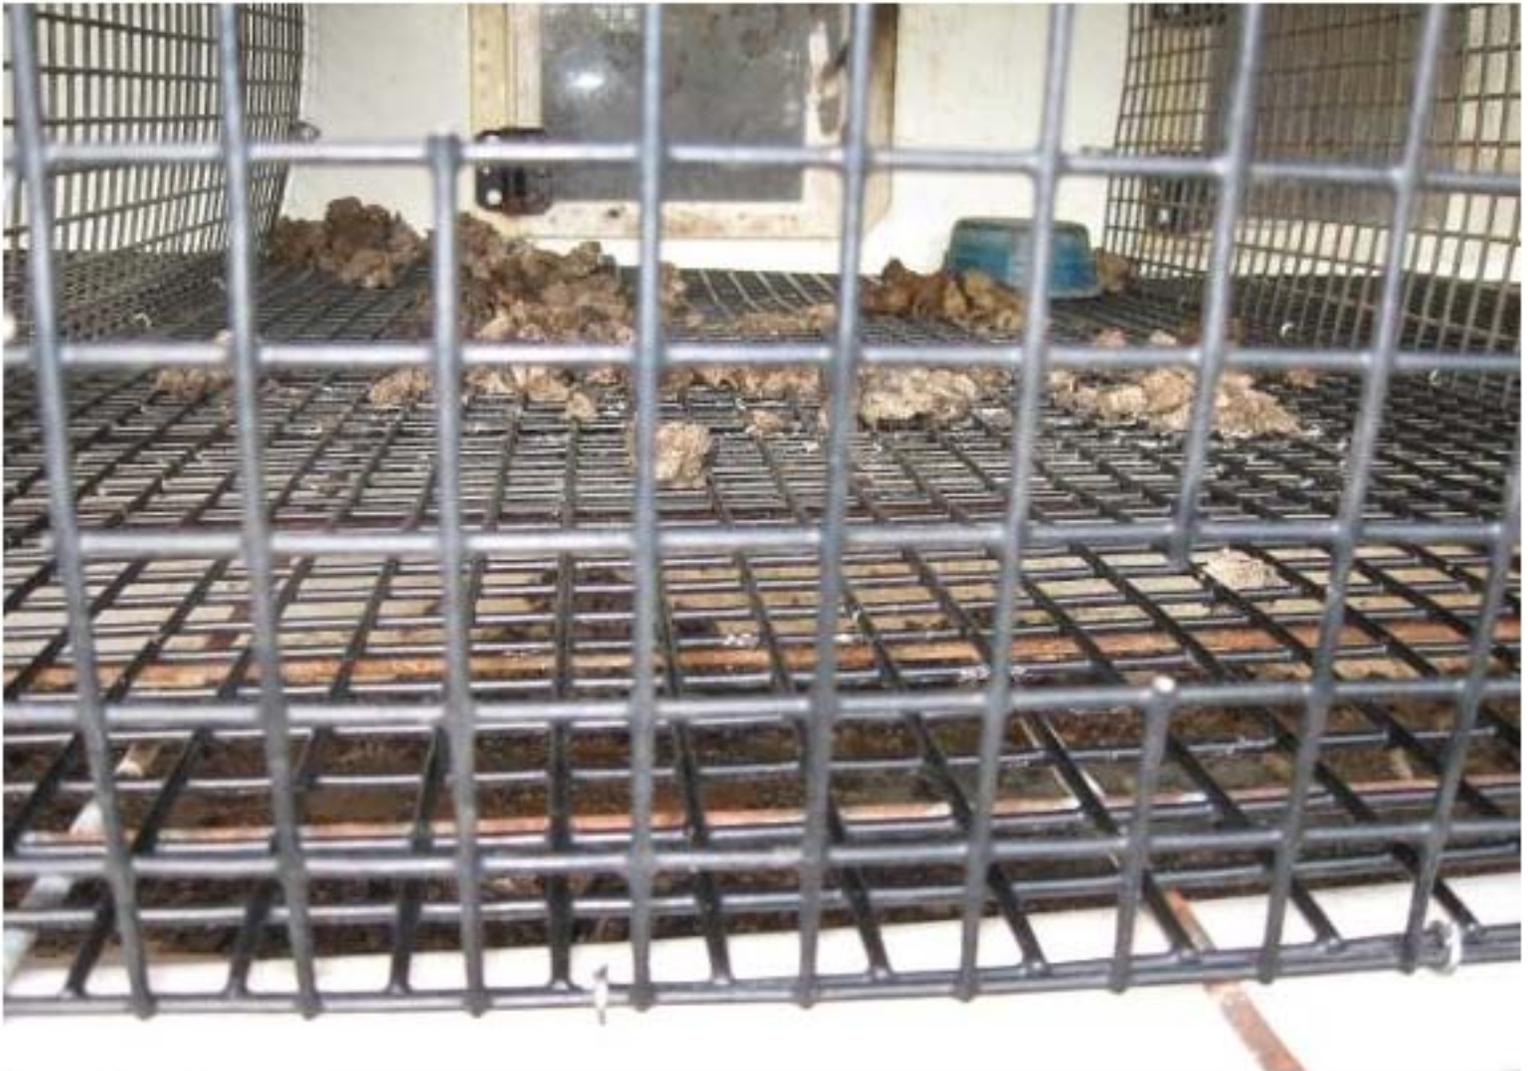
FOIA11-282000176

CFR: 3.11 (a), 3.11 (b)

Photographer:	John J. Lies	Legal Name:	Registration:	42-A-1329
Photo Taken:	Wed, Sep 22, '10 P.M.	HENRY SOMMERS		
Inspection:	267101246130491			
Description:	3.11 (a) & (b) Cleaning and Sanitizing; Feces needs to be removed and back wall needs to be sanitized to remove grime.

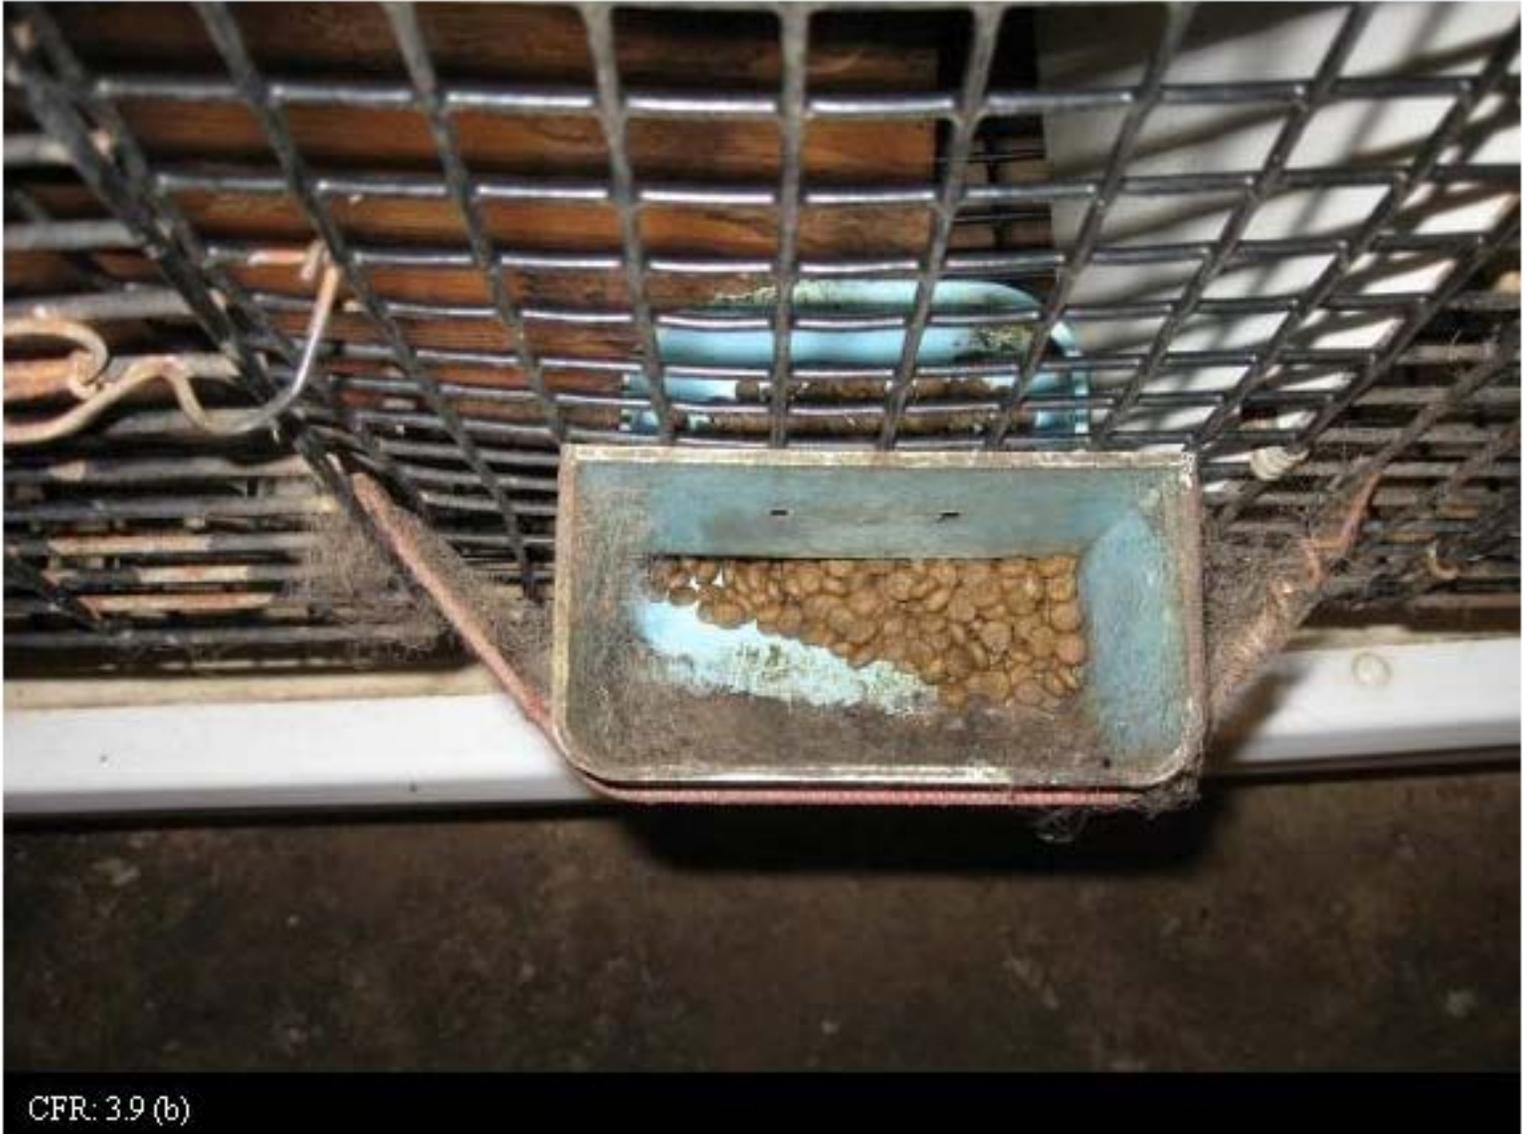
FOIA11-282000177

Photographer:	John J. Lies	Legal Name:	Registration:	42-A-1329
Photo Taken:	Wed, Sep 22, '10 P.M.	HENRY SOMMERS		
Inspection:	267101246130491			
Description:	3.9 (b) Feeding: Self feeder needs to be cleaned and sanitized.

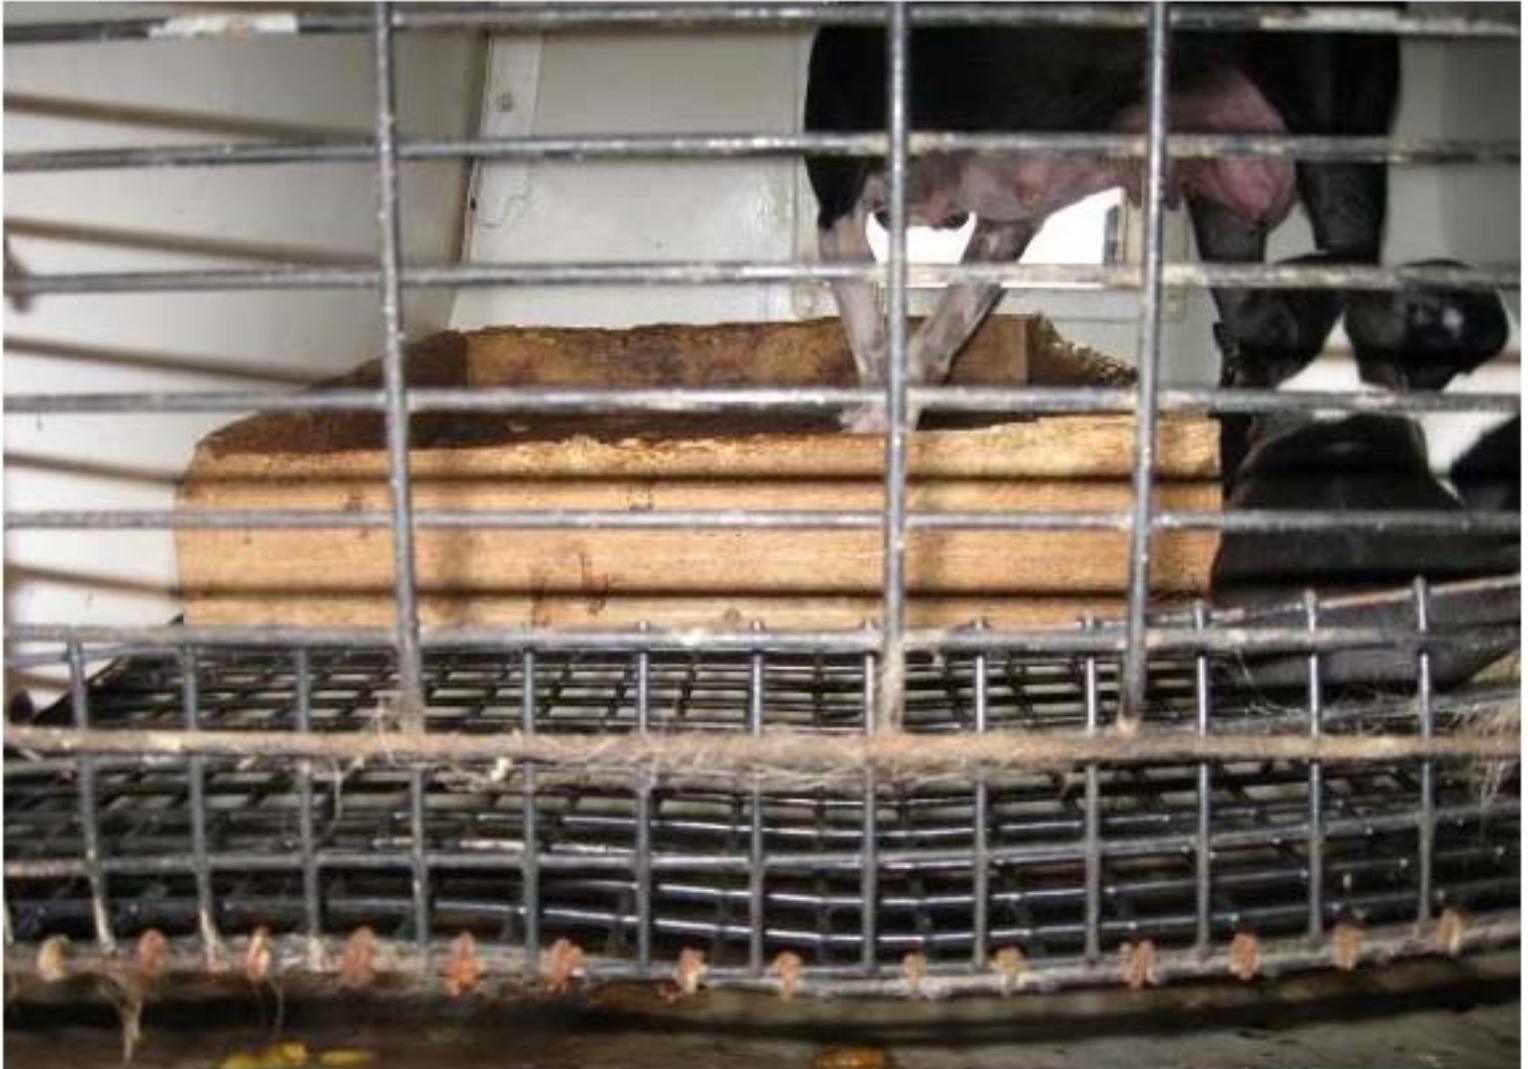
FOIA11-282000178

CFR: 3.3 (e) (1) (iii)

Photographer:	John J. Lies	Legal Name:	Registration:	42-A-1329
Photo Taken:	Wed, Sep 22, '10 P.M.	HENRY SOMMERS		
Inspection:	267101246130491			
Description:	3.3 (e)(iii) Sheltered Surfaces: The wood whelping box is worn and no longer impervious to moisture.

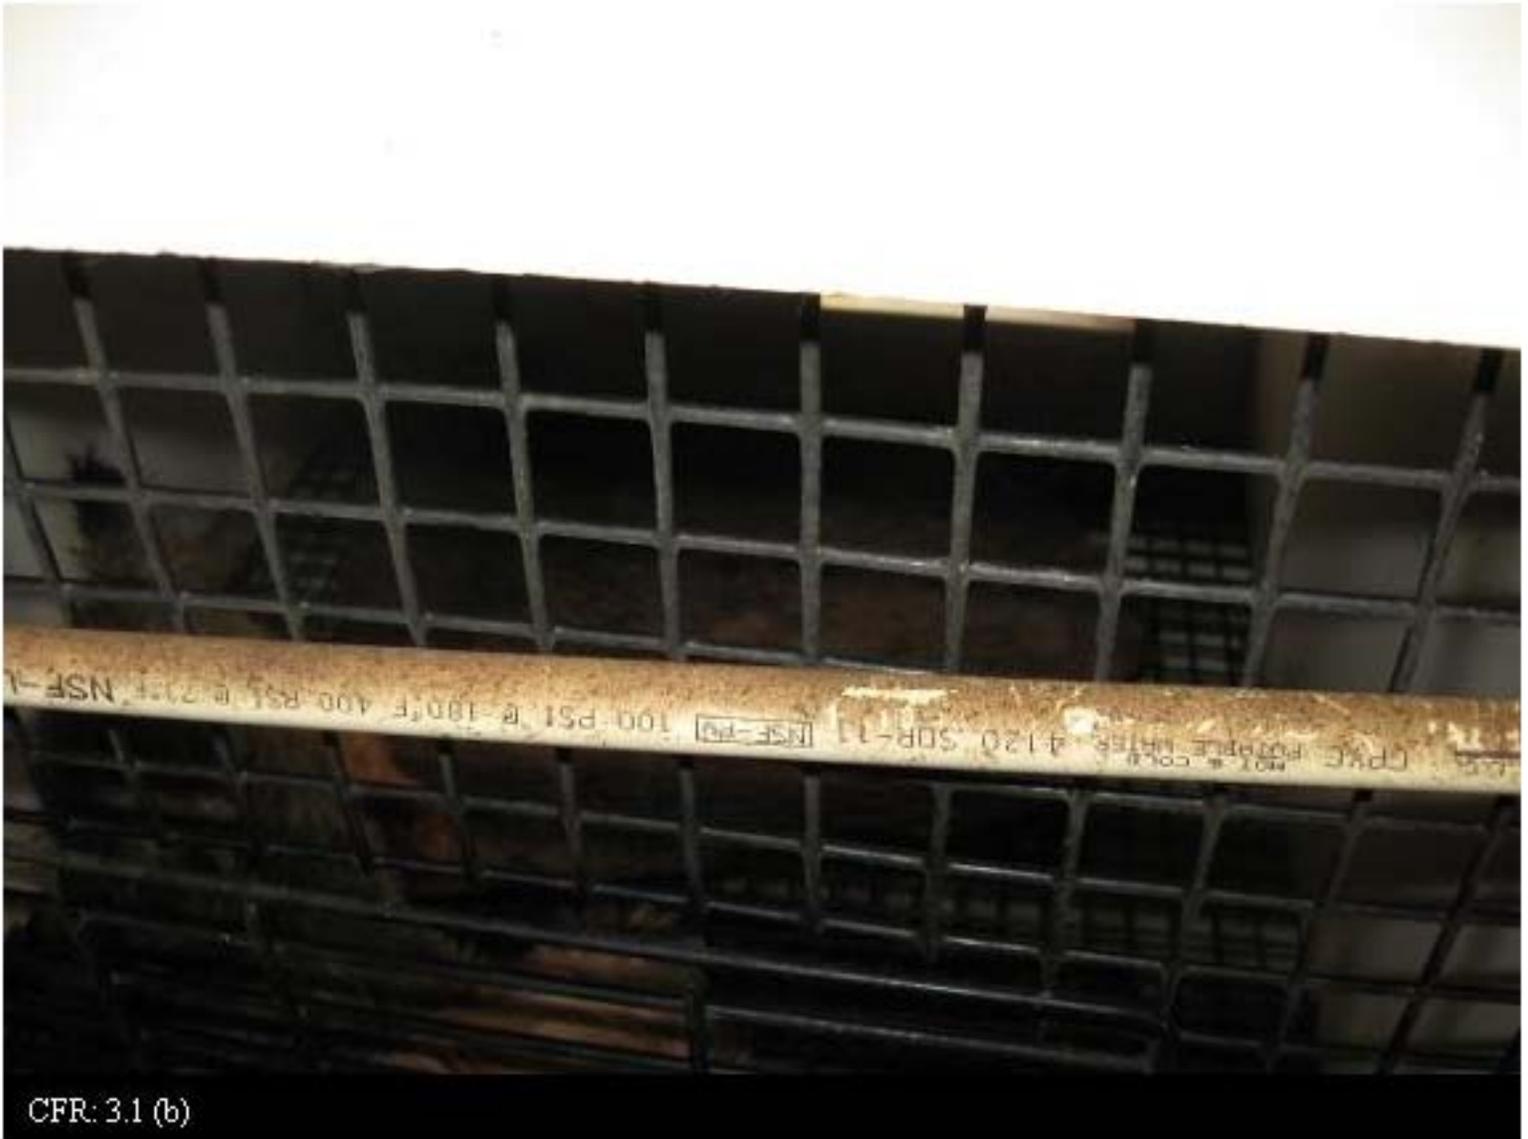
CFR: 3.1 (b)

Photographer:	John J. Lies	Legal Name:	Registration:	42-A-1329
Photo Taken:	Wed, Sep 22, '10 P.M.	HENRY SOMMERS		
Inspection:	267101246130491			
Description:	3.1 (b) Condition & Site: Facility in need of a general cleaning to remove dirt, hair, grime and/or clutter.
