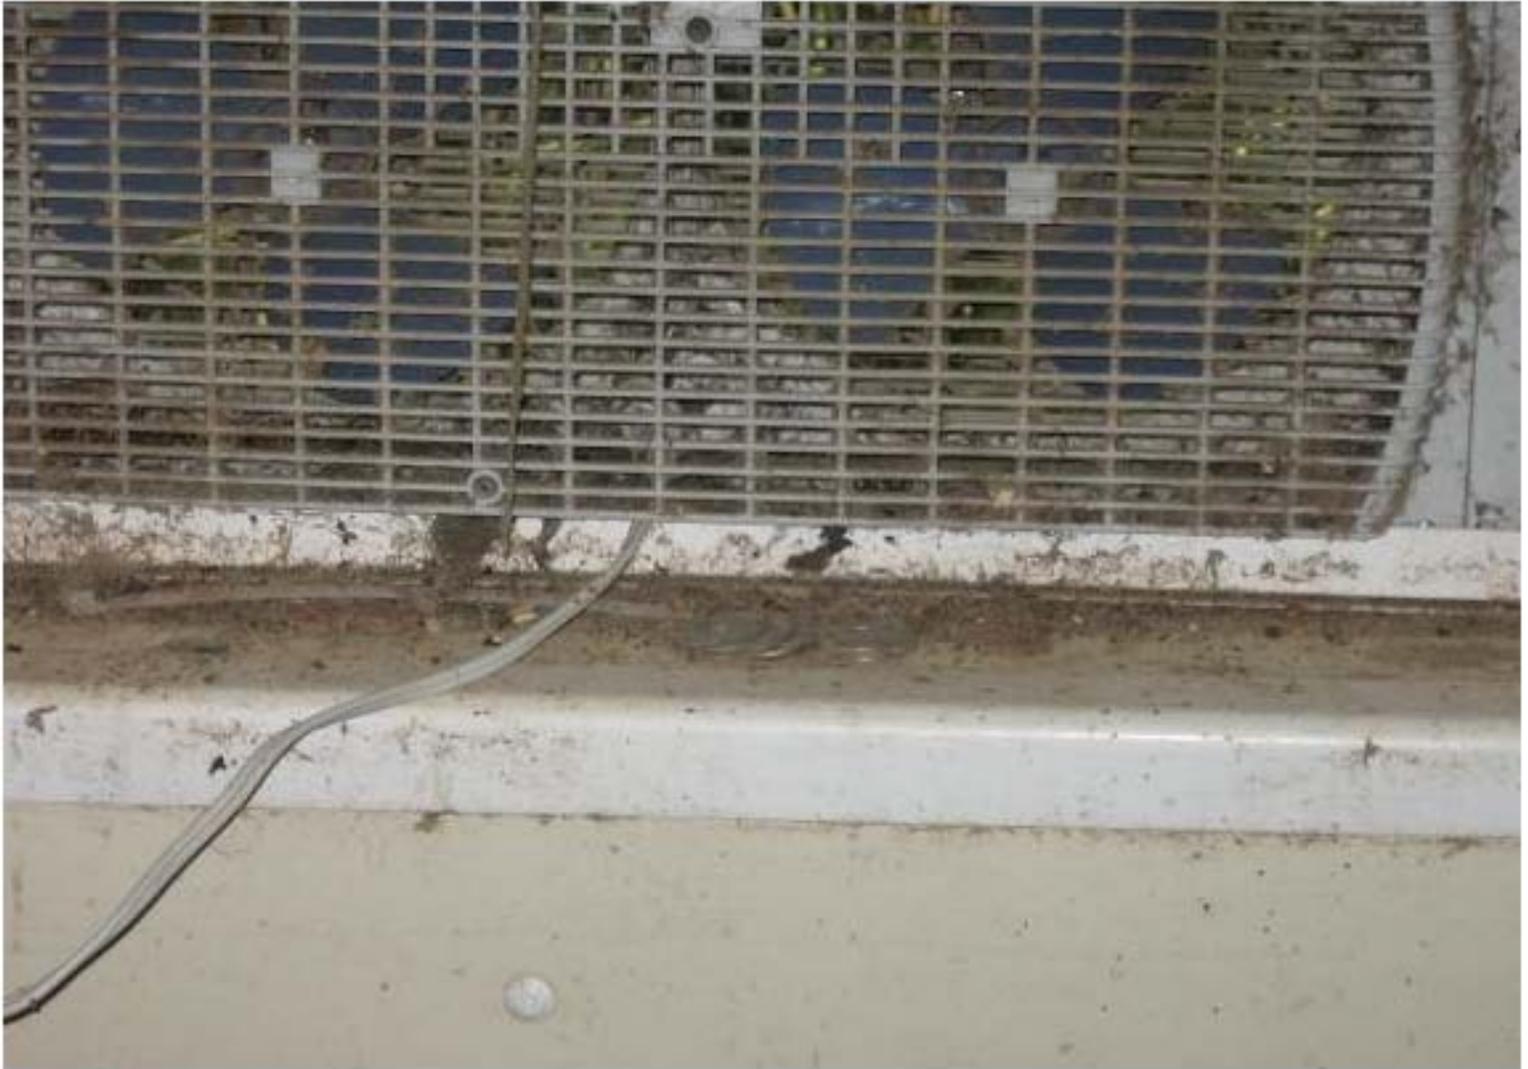
FOIA11-282000180

CFR: 3.1 (b)

Photographer:	John J. Lies	Legal Name:	Registration:	42-A-1329
Photo Taken:	Wed, Sep 22, '10 P.M.	HENRY SOMMERS		
Inspection:	267101246130491			
Description:	3.1 (b) Condition & Site: Facility in need of a general cleaning to remove dirt, hair, grime and/or clutter.

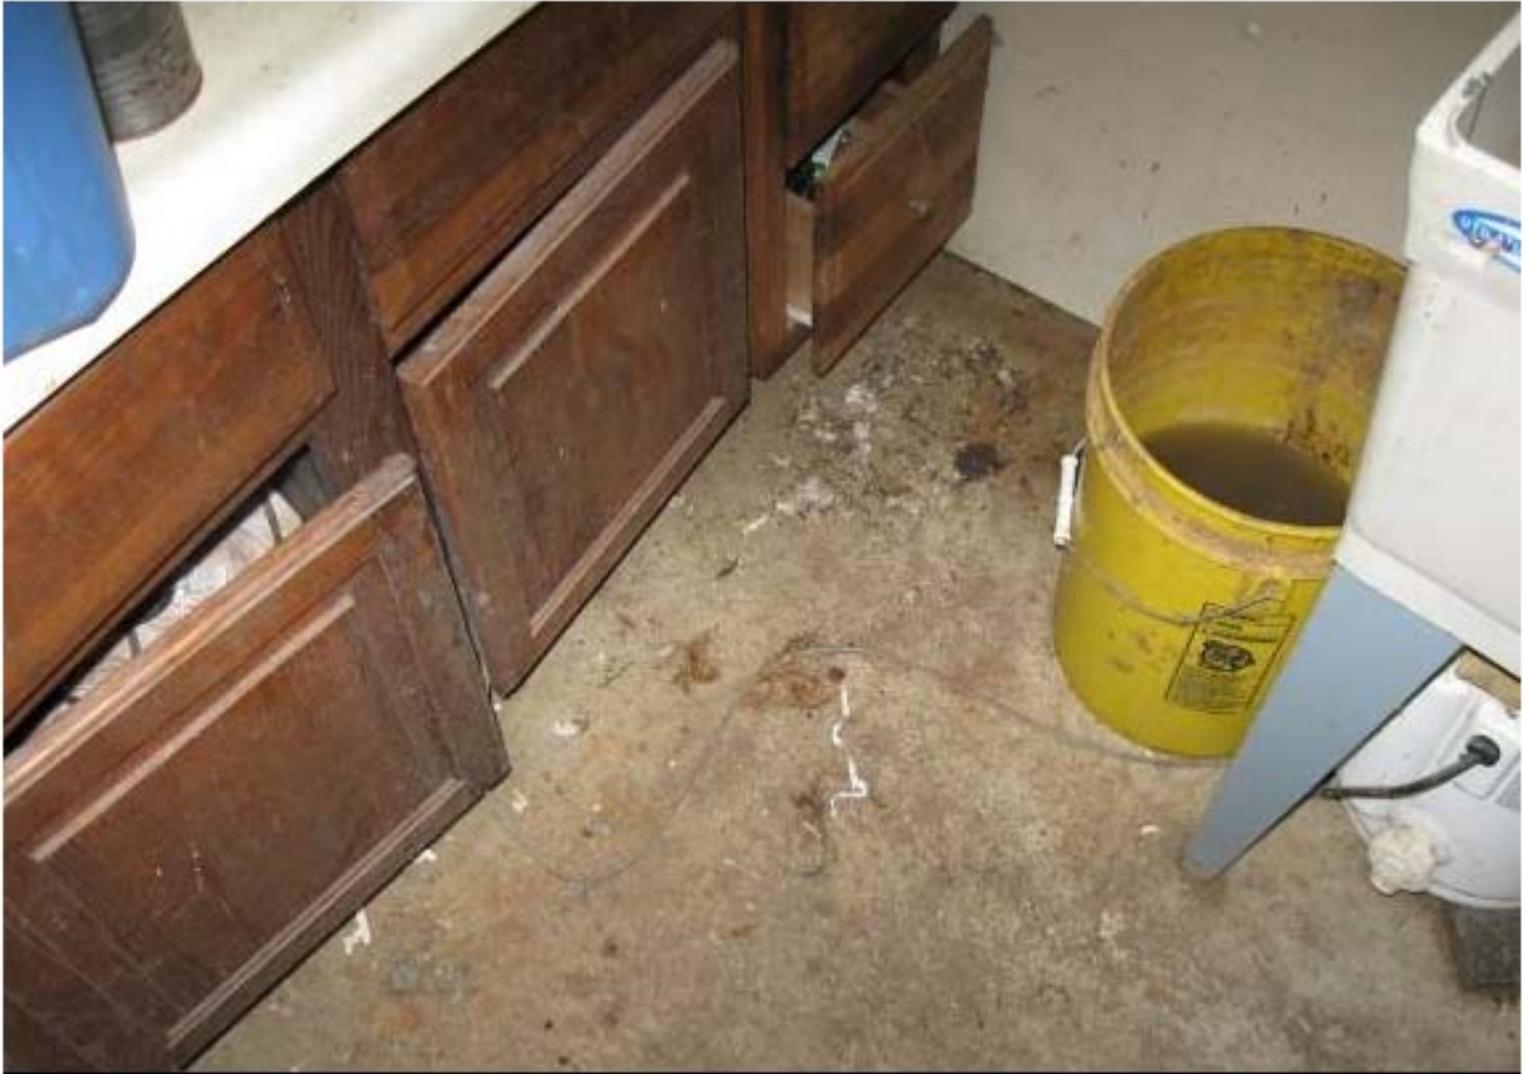
FOIA11-282000181

CFR: 3.1 (b)

Photographer:	John J. Lies	Legal Name:	Registration:	42-A-1329
Photo Taken:	Wed, Sep 22, '10 P.M.	HENRY SOMMERS		
Inspection:	267101246130491			
Description:	3.1 (b) Condition & Site: Facility in need of a general cleaning to remove dirt, hair, grime and/or clutter.

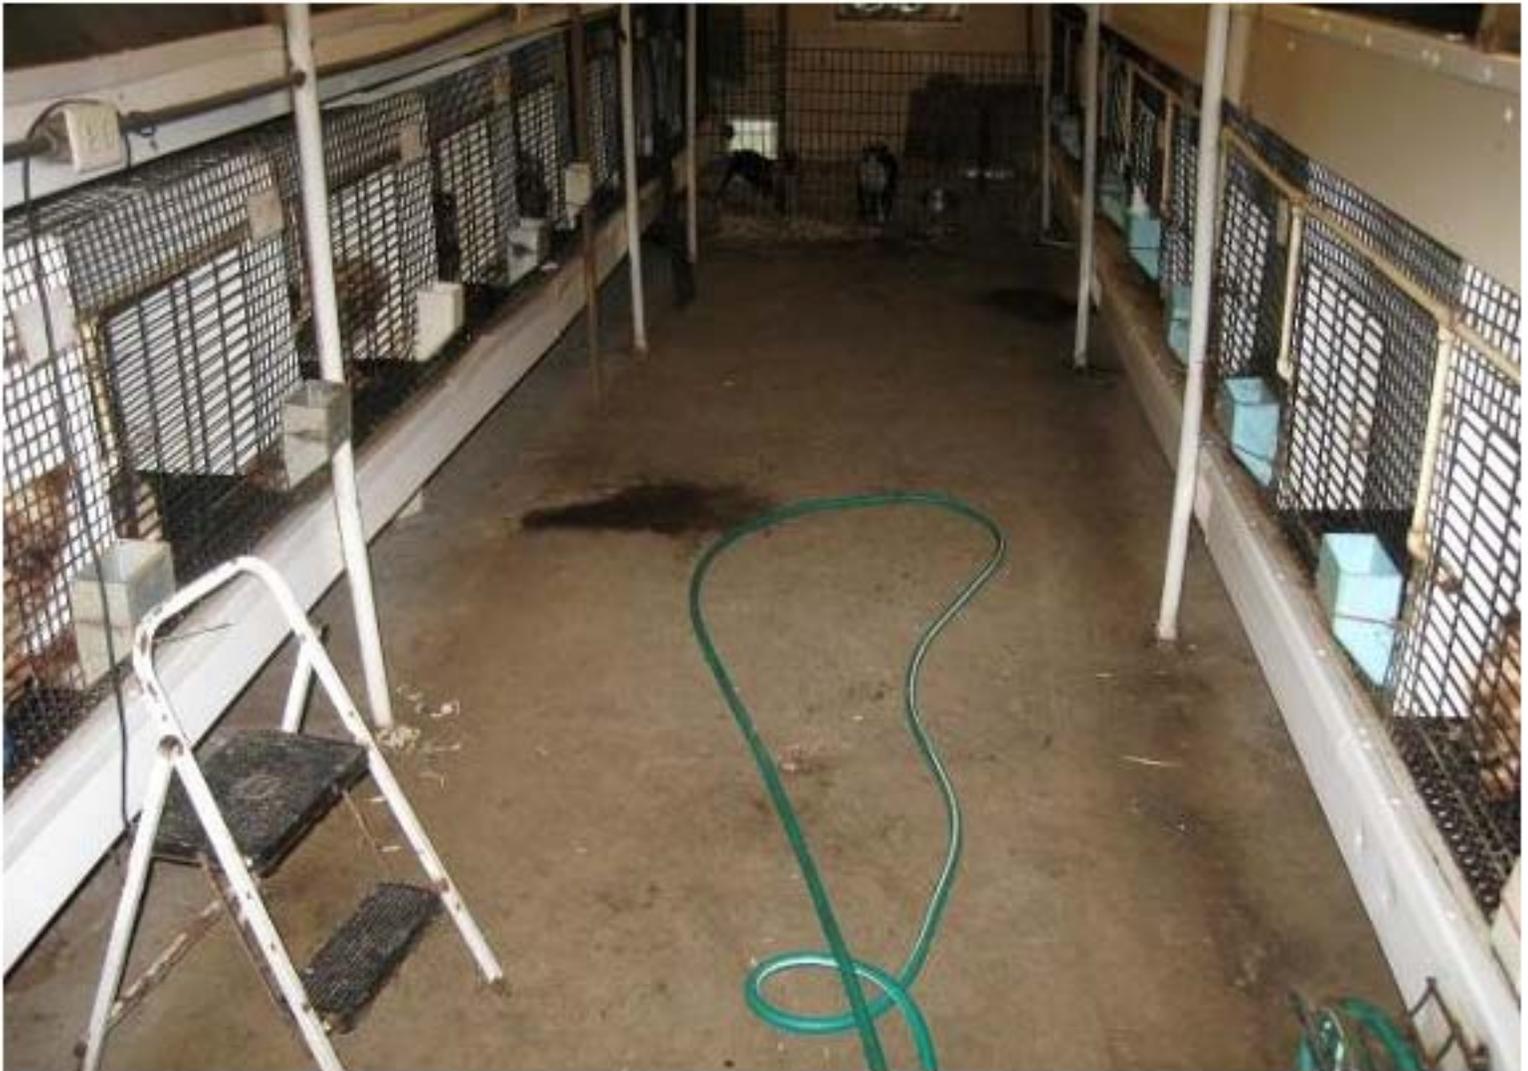
FOIA11-282000182

CFR: 3.1 (b)

Photographer:	John J. Lies	Legal Name:	Registration:	42-A-1329
Photo Taken:	Wed, Sep 22, '10 P.M.	HENRY SOMMERS		
Inspection:	267101246130491			
Description:	3.1 (b) Condition & Site: Facility in need of a general cleaning to remove dirt, hair, grime and/or clutter.

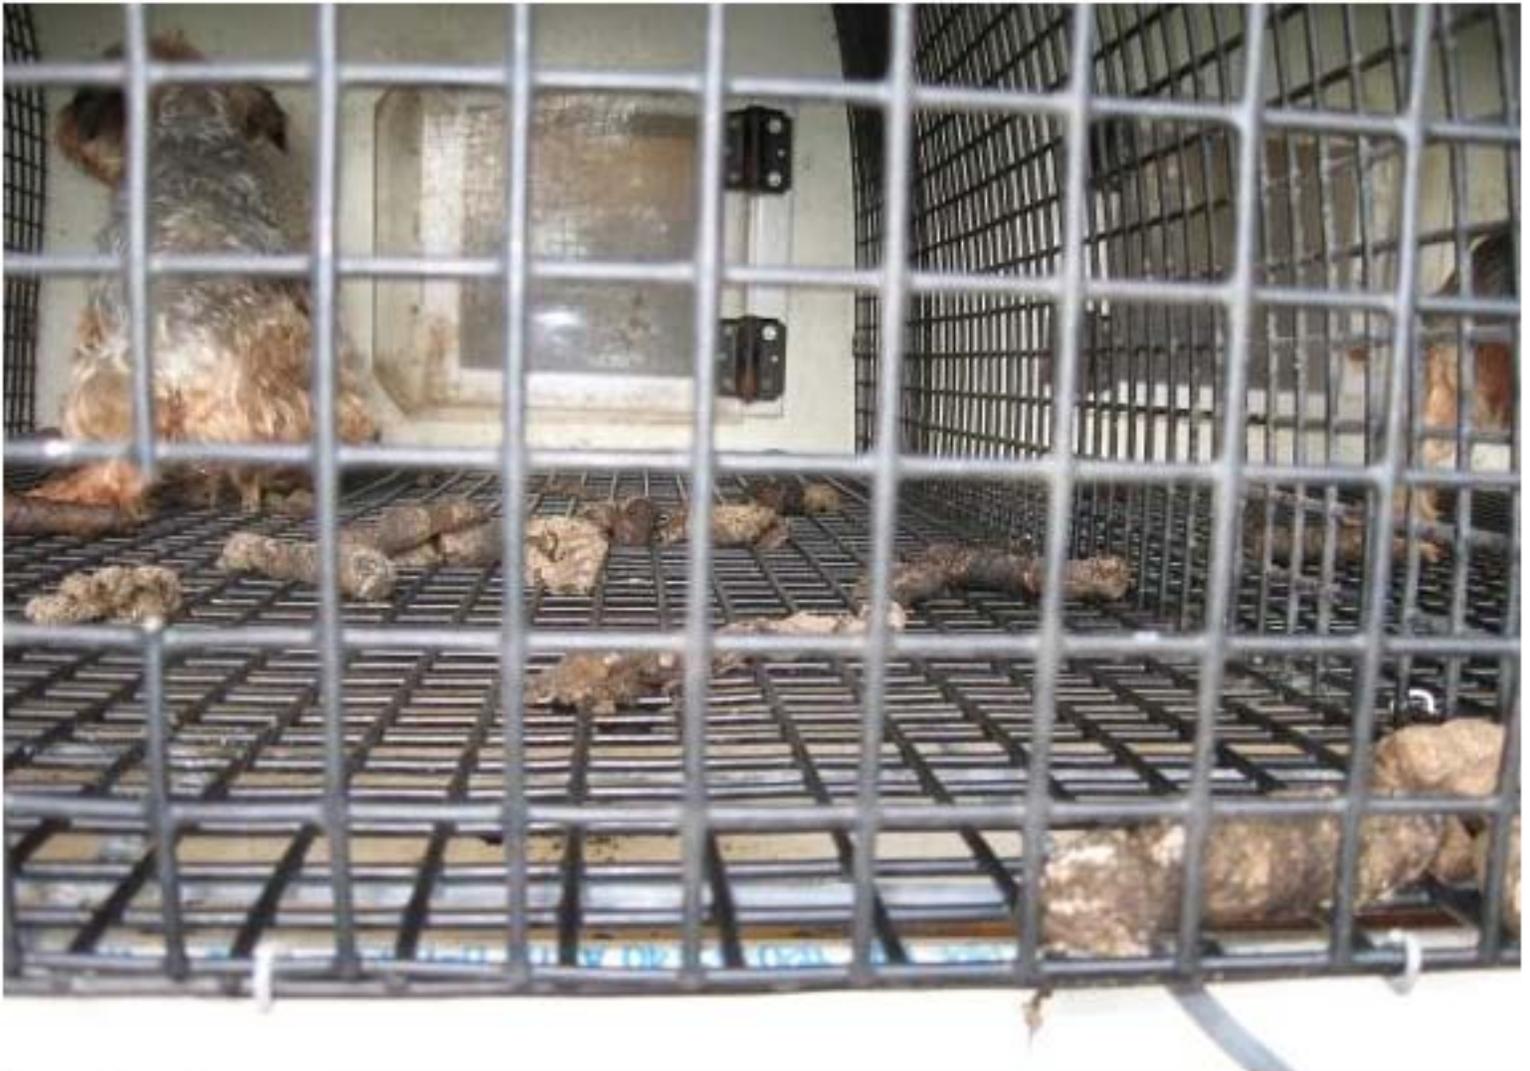
FOIA11-282000183

CFR: 3.11 (a), 3.11 (b)

Photographer:	John J. Lies	Legal Name:	Registration:	42-A-1329
Photo Taken:	Wed, Sep 22, '10 P.M.	HENRY SOMMERS		
Inspection:	267101246130491			
Description:	3.11 (a) & (b) Cleaning and Sanitizing; Feces needs to be removed and back wall needs to be sanitized to remove grime.

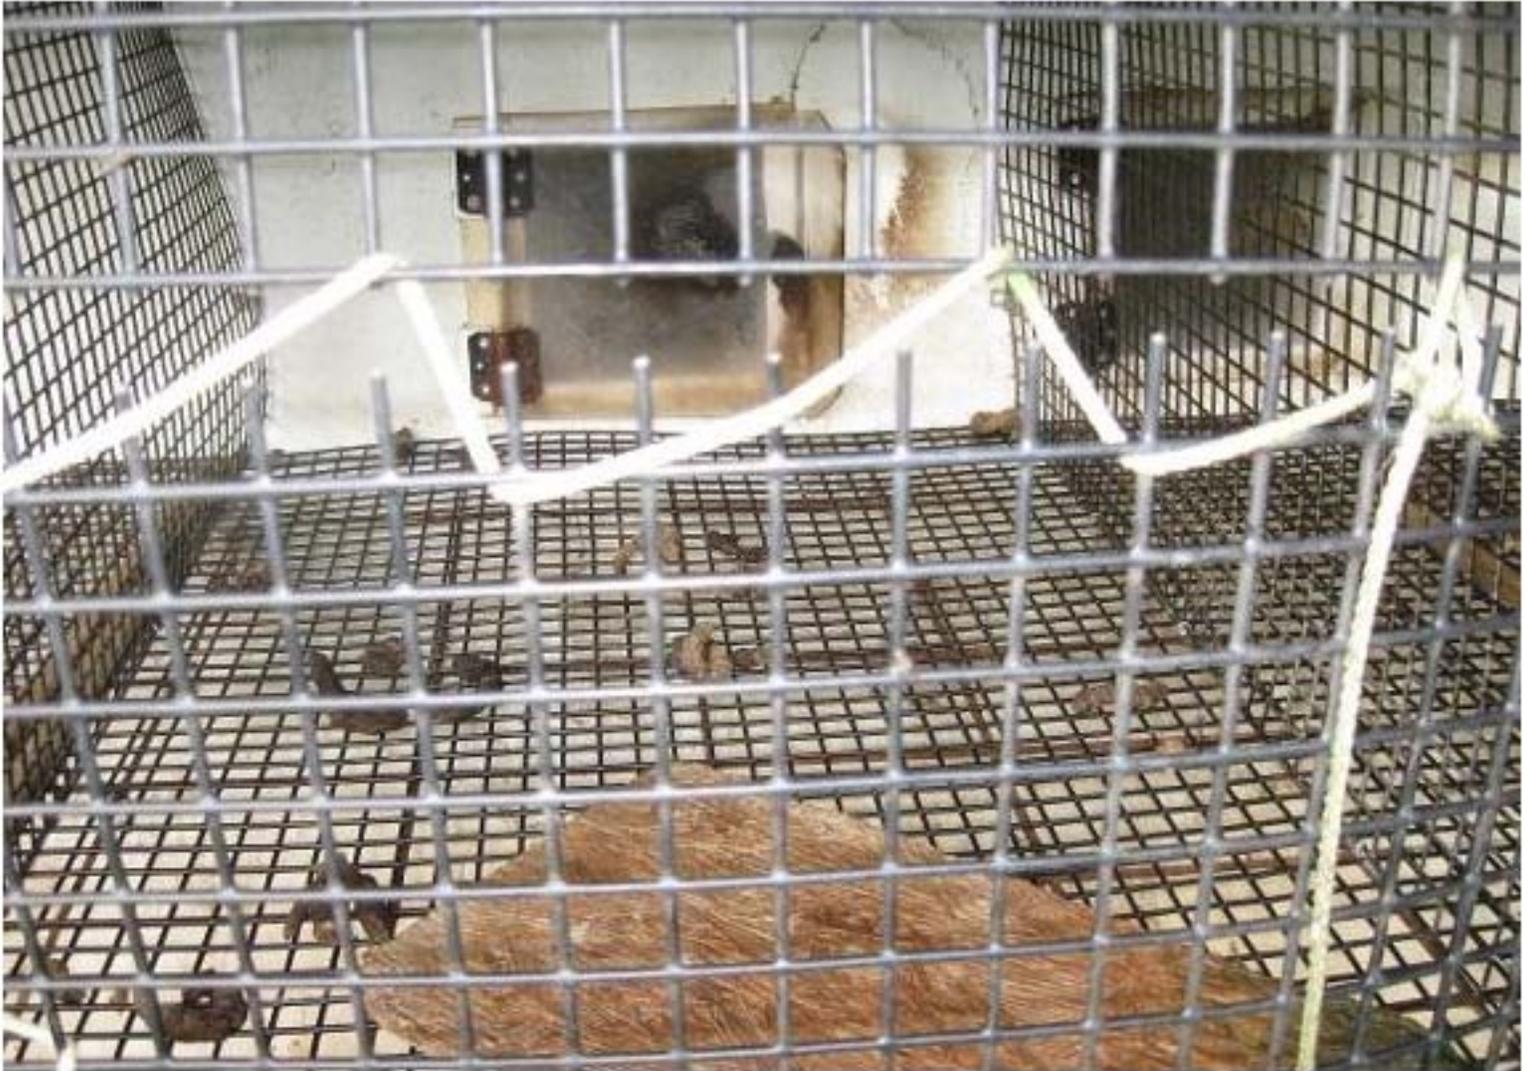
FOIA11-282000184

CFR: 3.11 (a), 3.11 (b)

Photographer:	John J. Lies	Legal Name:	Registration:	42-A-1329
Photo Taken:	Wed, Sep 22, '10 P.M.	HENRY SOMMERS		
Inspection:	267101246130491			
Description:	3.11 (a) & (b) Cleaning and Sanitizing; Feces needs to be removed and back wall needs to be sanitized to remove grime.

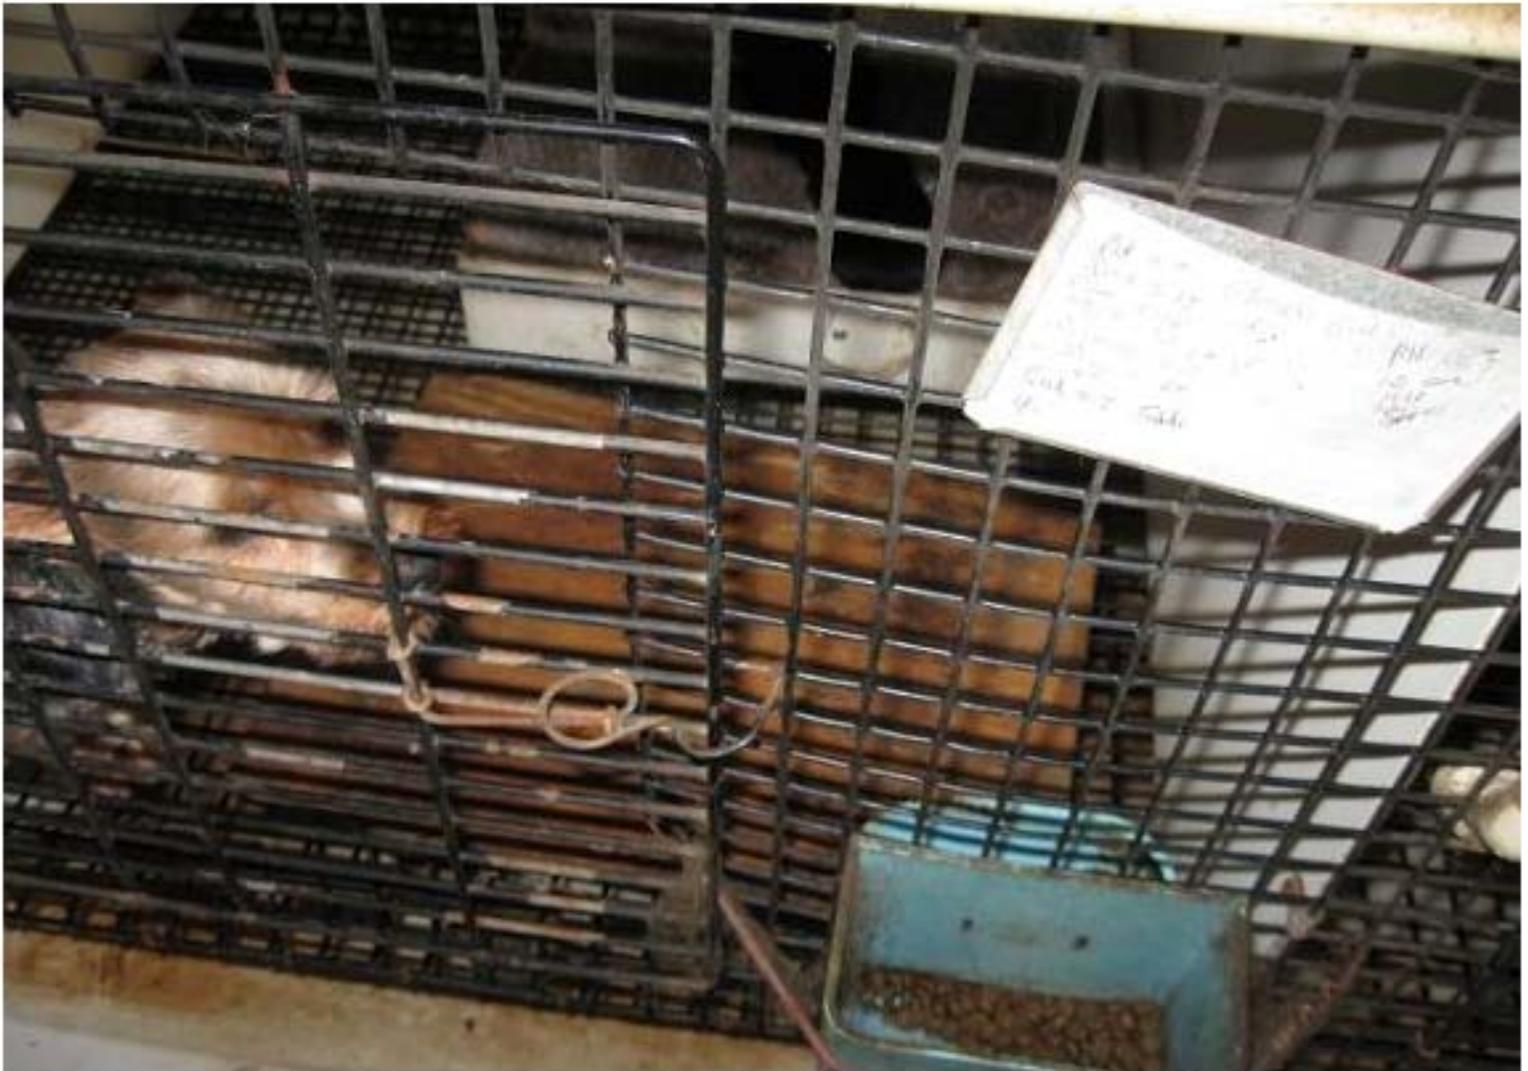
CFR: 3.9 (b), 3.3 (e) (1) (iii)

Photographer:	John J. Lies	Legal Name:	Registration:	42-A-1329
Photo Taken:	Wed, Sep 22, '10 P.M.	HENRY SOMMERS		
Inspection:	267101246130491			
Description:	3.9 (b) Feeding: Self feeders need to be cleaned and sanitized to remove grime. 3.3 (e)(iii) Sheltered Facility Surfaces: Wood surface worn & no longer impervious to moisture.

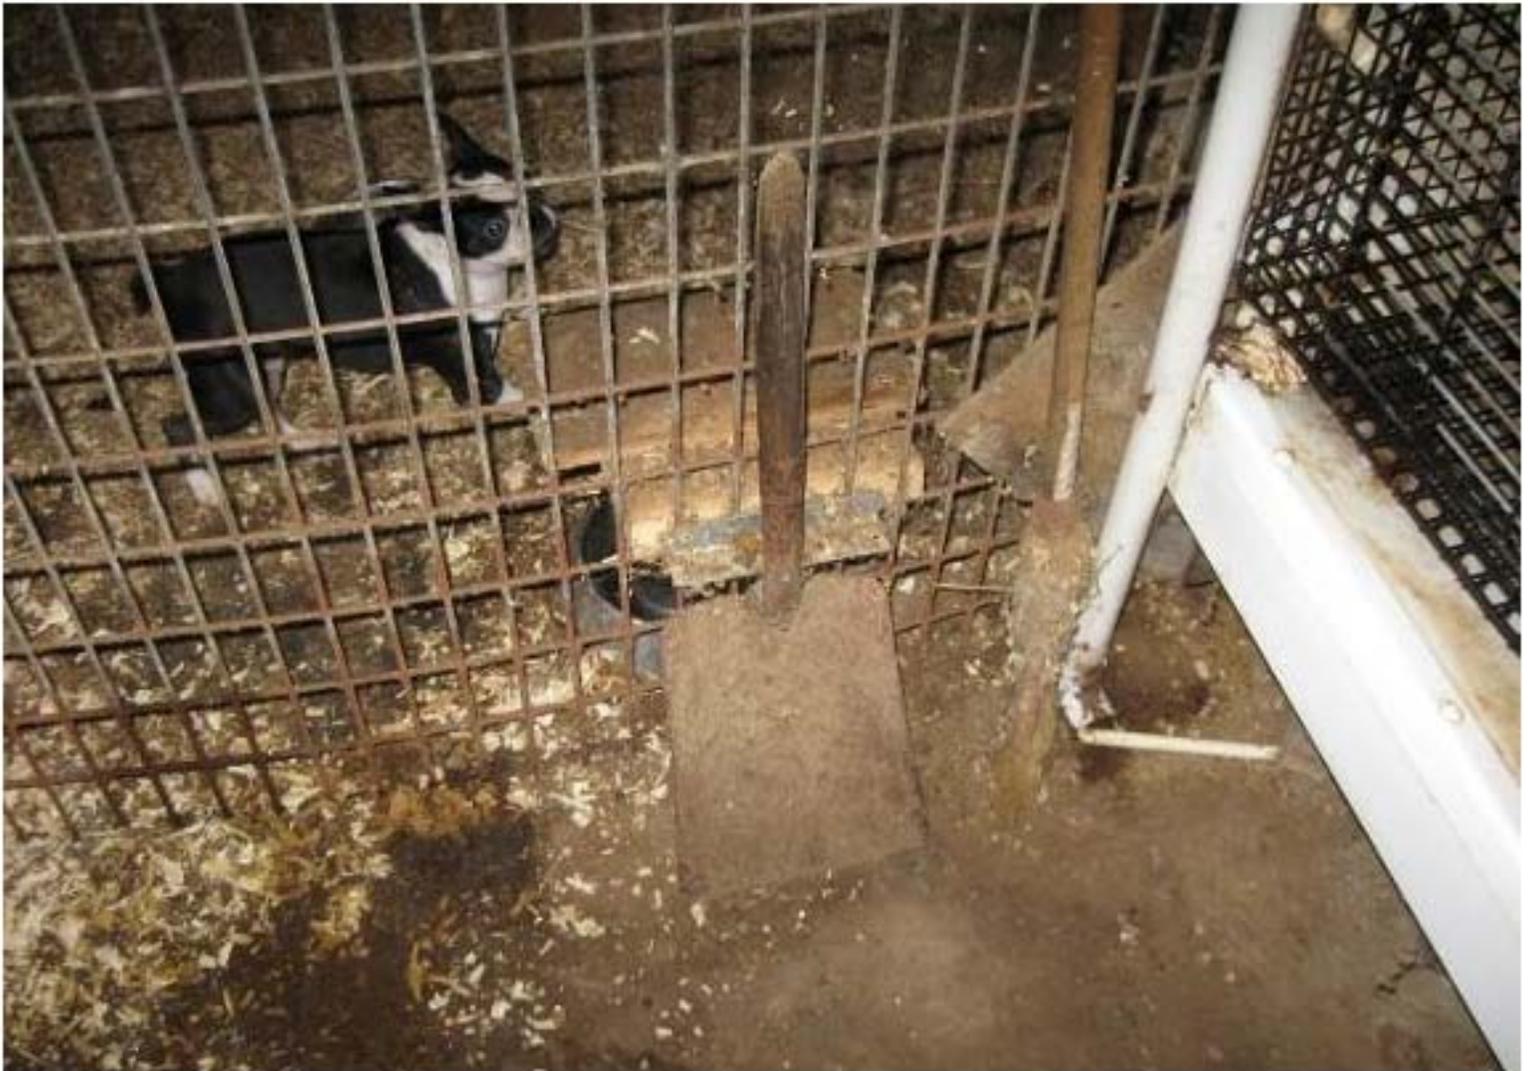
FOIA11-282000186

CFR: 3.1 (b)

Photographer:	John J. Lies	Legal Name:	Registration:	42-A-1329
Photo Taken:	Wed, Sep 22, '10 P.M.	HENRY SOMMERS		
Inspection:	267101246130491			
Description:	3.1 (b) Condition & Site: Facility in need of a general cleaning to remove dirt, hair, grime and/or clutter.

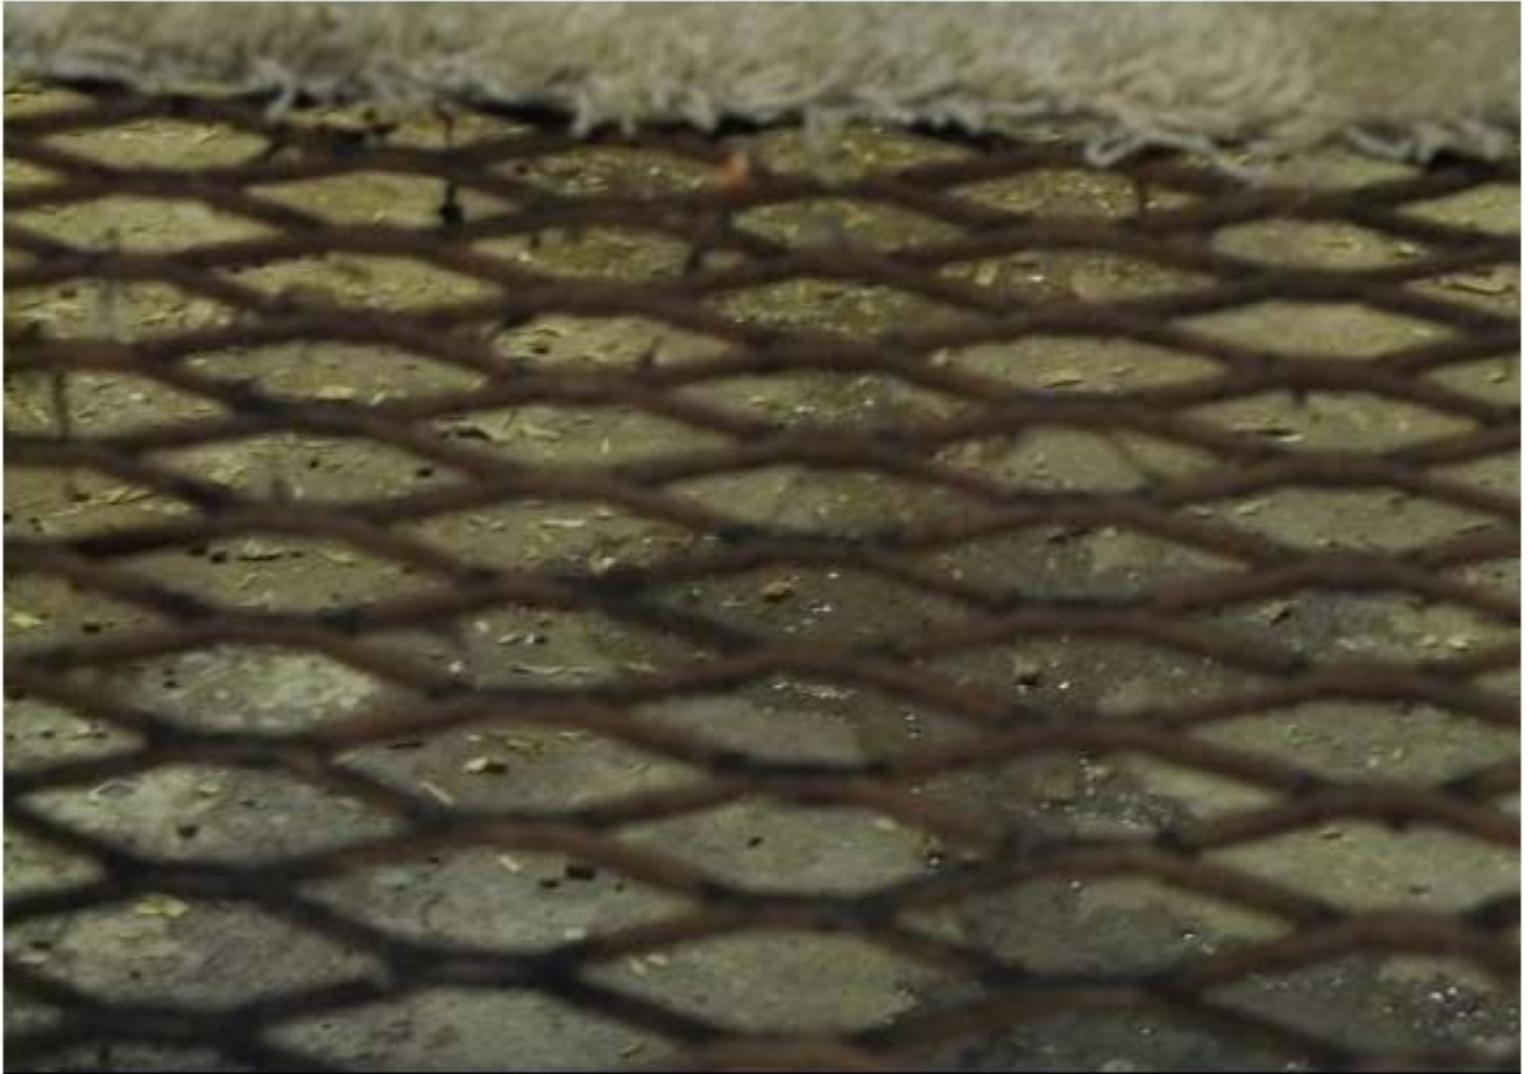
CFR: 3.1 (c) (1) (i)

Photographer:	Heather Cole	Legal Name:	Registration:	42-A-1312
Photo Taken:	Tue, Jan 4, '11 1:15 pm	PHYLLIS DISQUE		
Inspection:	4111614200479			
Description:	Close-up view of a cage floor. The metal wire mesh is rusted where the plastic coating has worn off.

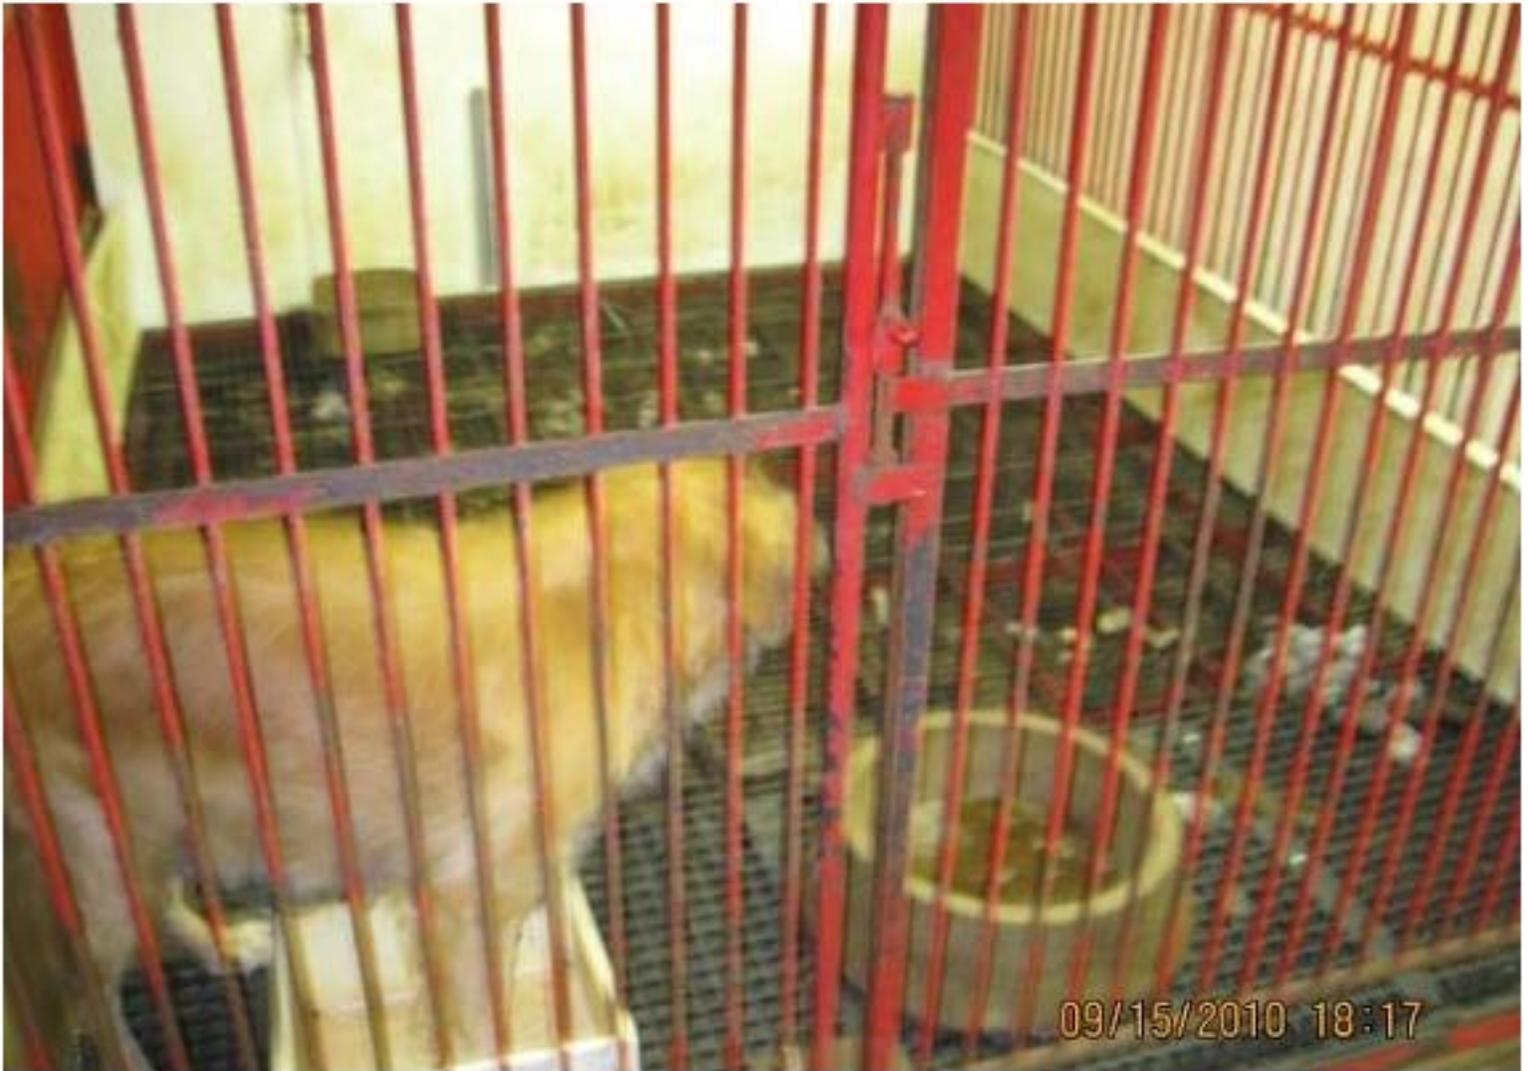
FOIA11-282000192

CFR: 3.1 (c) (3)

Photographer:	Randall Wagner (ACI)	Legal Name:	Registration:	42-A-1286
Photo Taken:	Wed, Sep 15, '10	BOB CLEVERINGA		
Inspection:	258101959550156	DEE ANN CLEVERINGA		
Description:	The accumulation white piles of fecal waste on the hog flooring indicate daily spot-cleaning is not taking place.

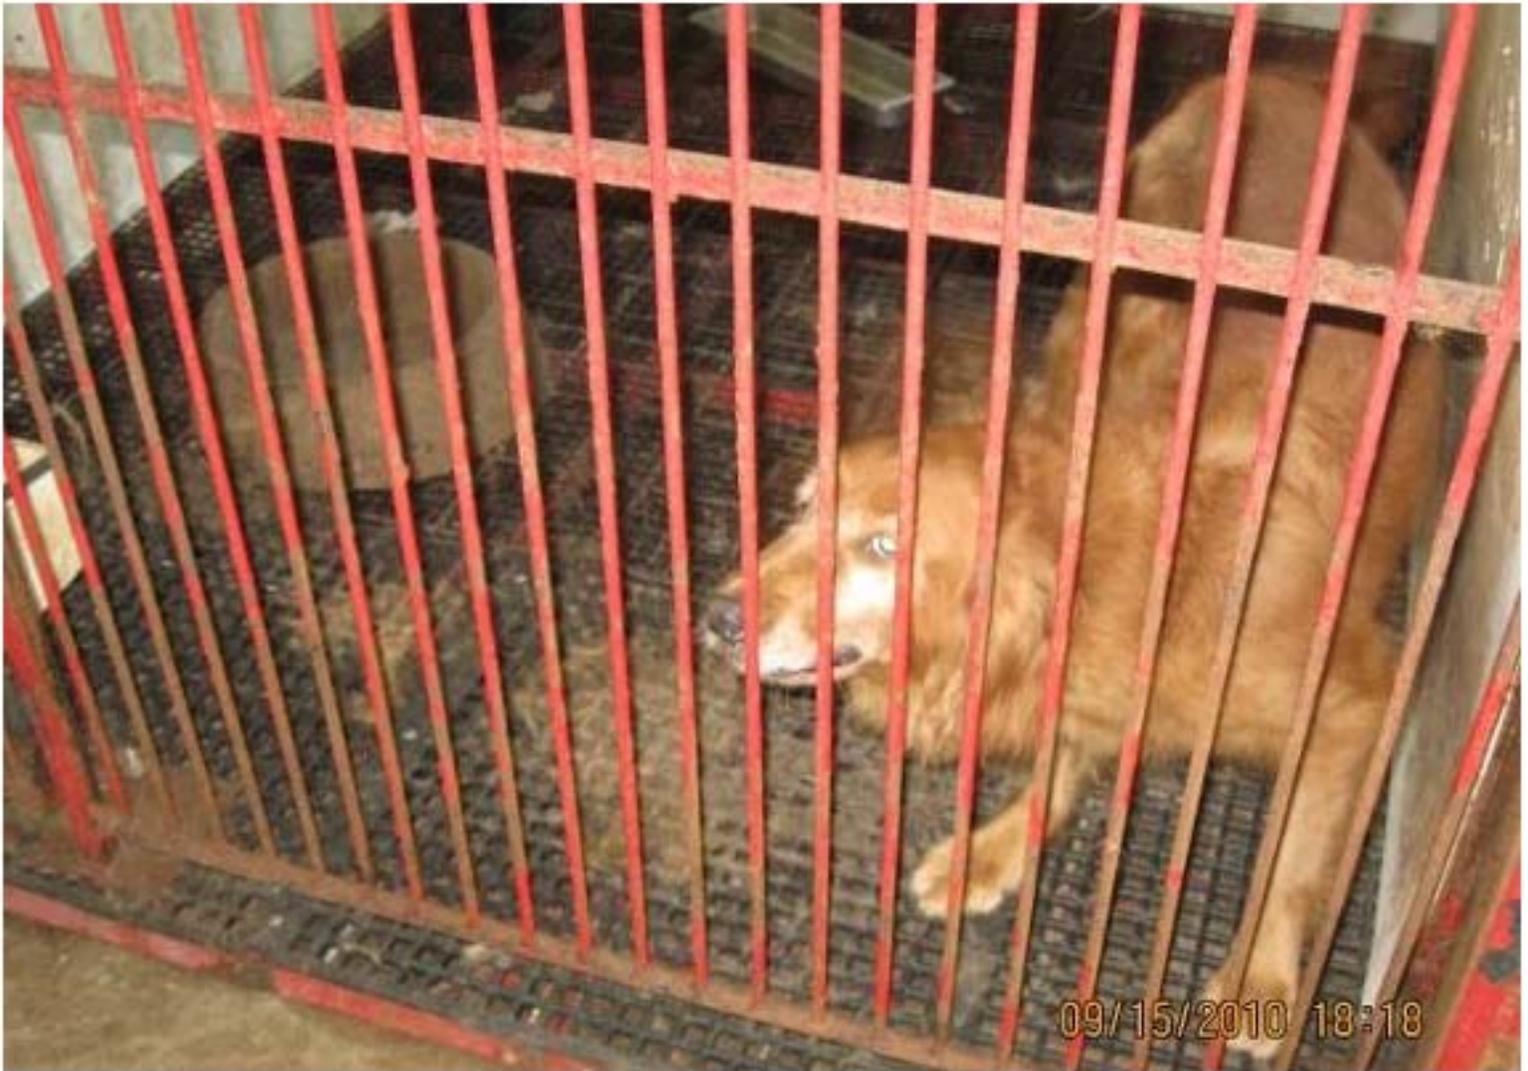
FOIA11-282000193

CFR: 3.1 (c) (3)

Photographer:	Randall Wagner (ACI)	Legal Name:	Registration:	42-A-1286
Photo Taken:	Wed, Sep 15, '10	BOB CLEVERINGA		
Inspection:	258101959550156	DEE ANN CLEVERINGA		
Description:	The Excessive accumulation of brown fecal waste stuck in the hog flooring indicates daily spot-cleaning is not taking place.

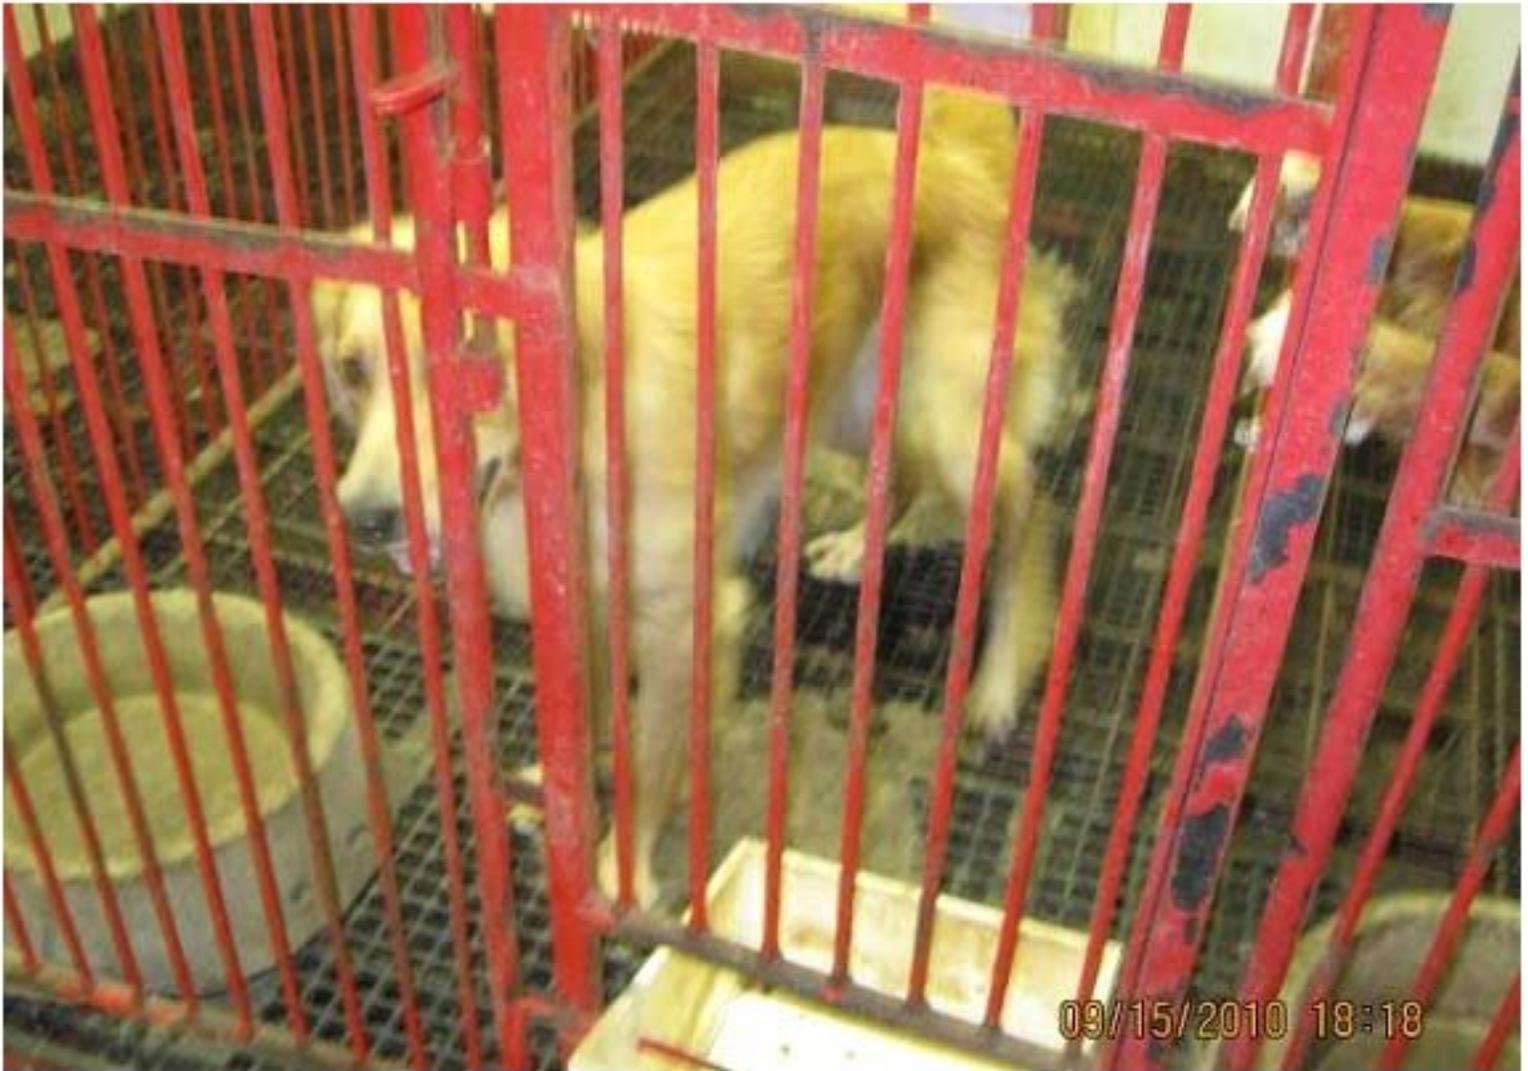
CFR: 3.1 (c) (3)

Photographer:	Randall Wagner (ACI)	Legal Name:	Registration:	42-A-1286
Photo Taken:	Wed, Sep 15, '10	BOB CLEVERINGA		
Inspection:	258101959550156	DEE ANN CLEVERINGA		
Description:	The large accumulation of fecal waste in brown piles indicates daily spot-cleaning is not taking place.

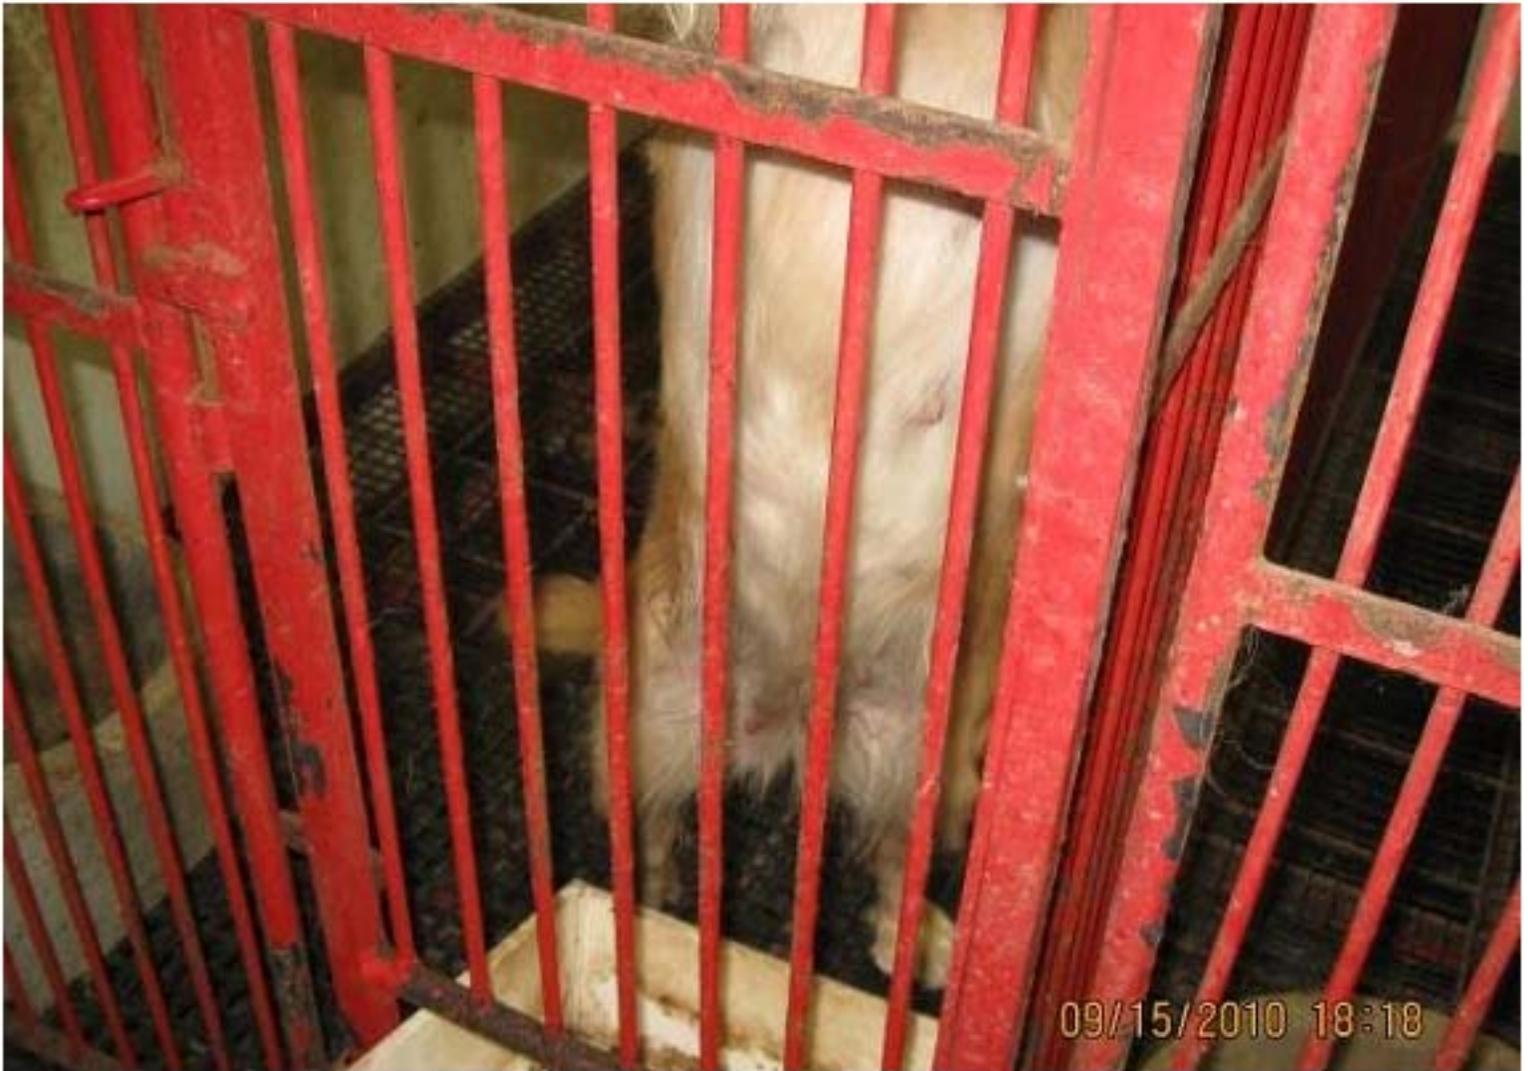
CFR: 3.1 (c) (1) (i)

Photographer:	Randall Wagner (ACI)	Legal Name:	Registration:	42-A-1286
Photo Taken:	Wed, Sep 15, '10	BOB CLEVERINGA		
Inspection:	258101959550156	DEE ANN CLEVERINGA		
Description:	The bottom metal bars are excessively rusting and pitting on the surface.

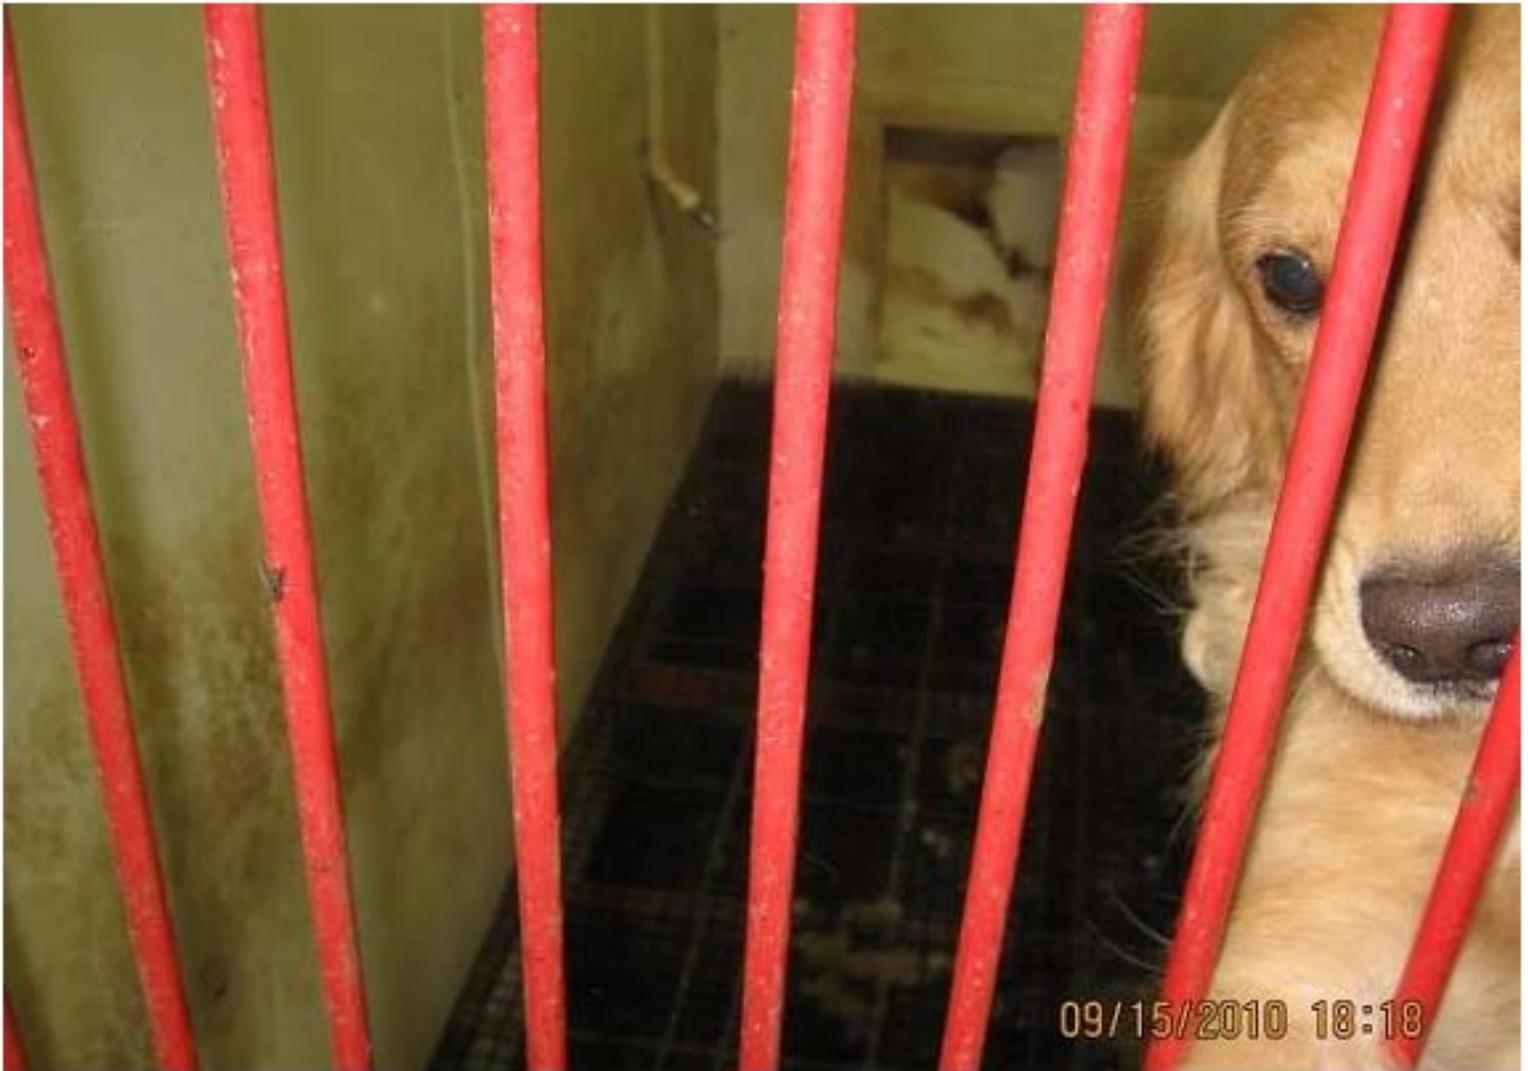
FOIA11-282000196

CFR: 3.1 (c) (3)

Photographer:	Randall Wagner (ACI)	Legal Name:	Registration:	42-A-1286
Photo Taken:	Wed, Sep 15, '10	BOB CLEVERINGA		
Inspection:	258101959550156	DEE ANN CLEVERINGA		
Description:	The white plastic walls have an accumulation of brown excrement smeared onto the surface indicates daily spot-cleaning is not happening.
