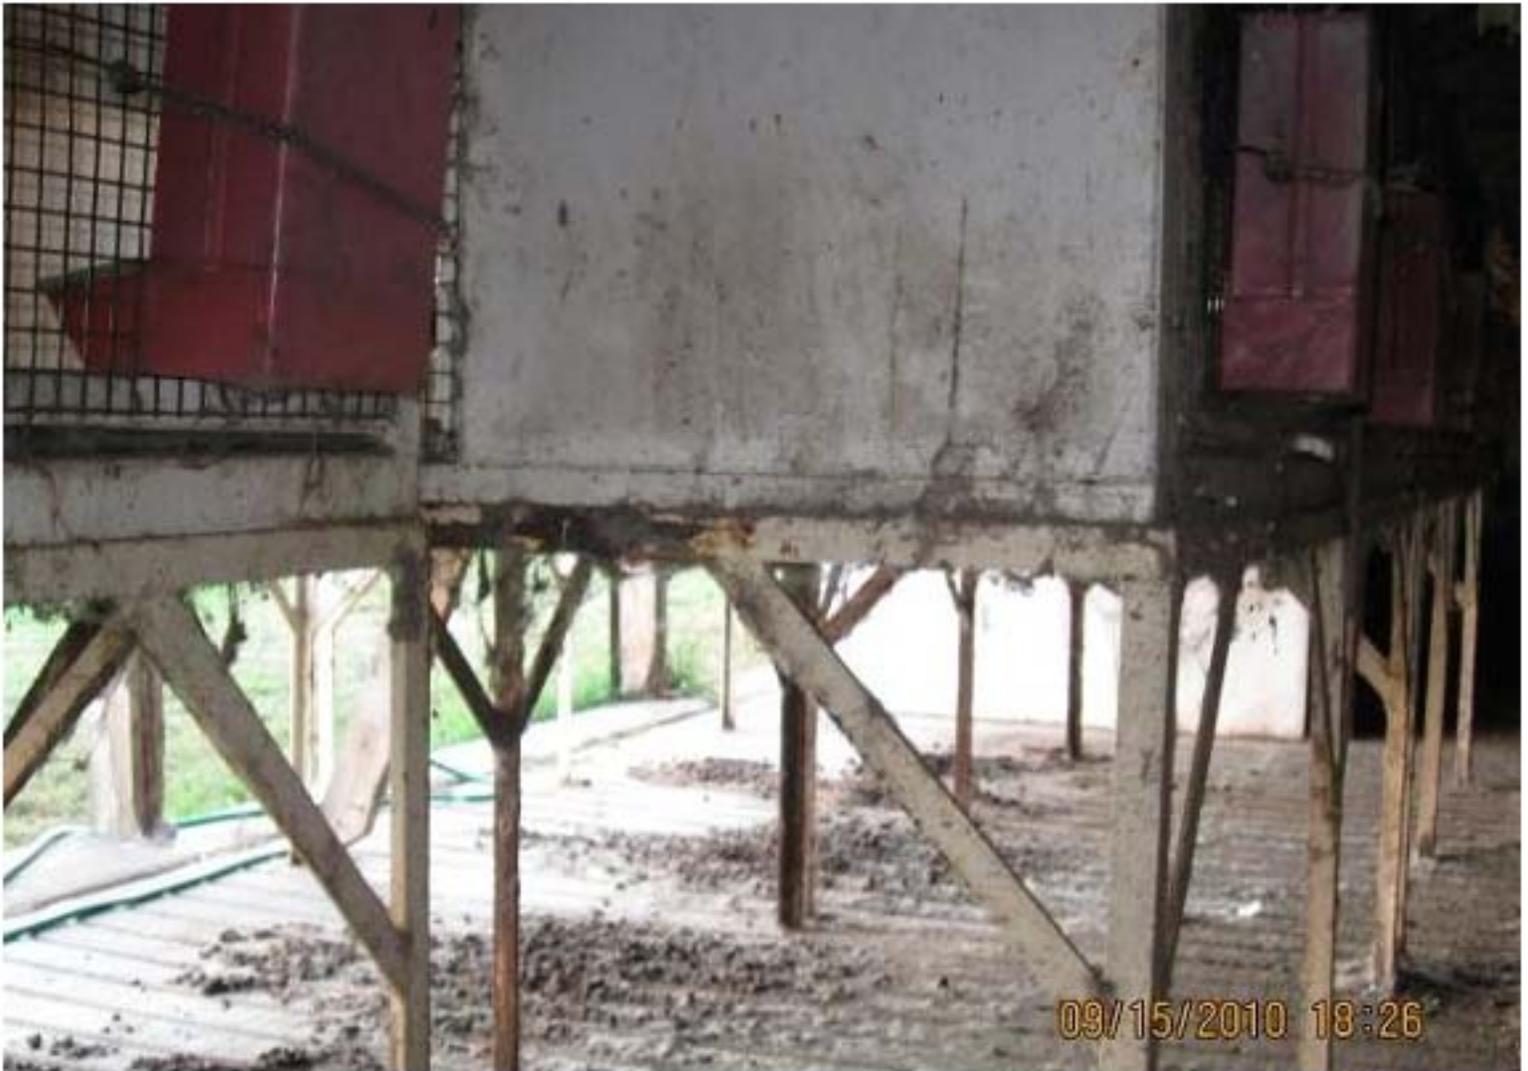
CFR: 3.11 (a)

Photographer:	Randall Wagner (ACI)	Legal Name:	Registration:	42-A-1286
Photo Taken:	Wed, Sep 15, '10	BOB CLEVERINGA		
Inspection:	258101959550156	DEE ANN CLEVERINGA		
Description:	The accumulation of fecal waste under neath the raised runs and dog hair hanging from the flooring indicates the area is not cleaned as necessary.

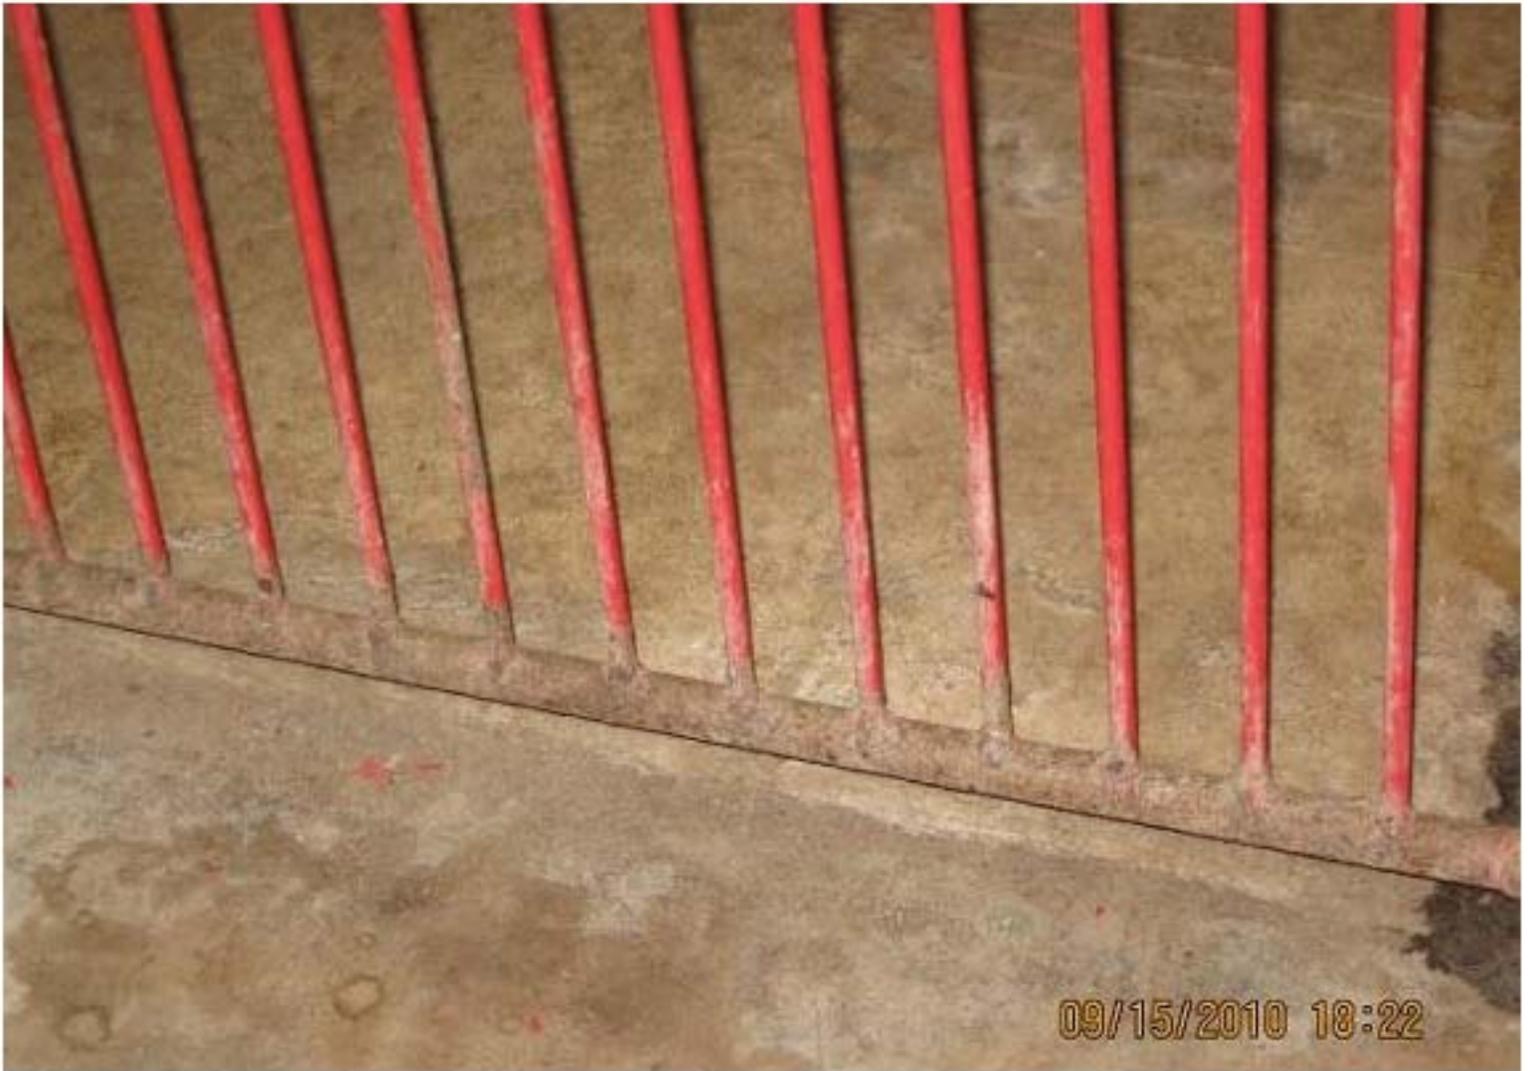
CFR: 3.1 (c) (1) (i)

Photographer:	Randall Wagner (ACI)	Legal Name:	Registration:	42-A-1286
Photo Taken:	Wed, Sep 15, '10	BOB CLEVERINGA		
Inspection:	258101959550156	DEE ANN CLEVERINGA		
Description:	The bottom portion of the metal gate surface is rusting and flaking excessively.

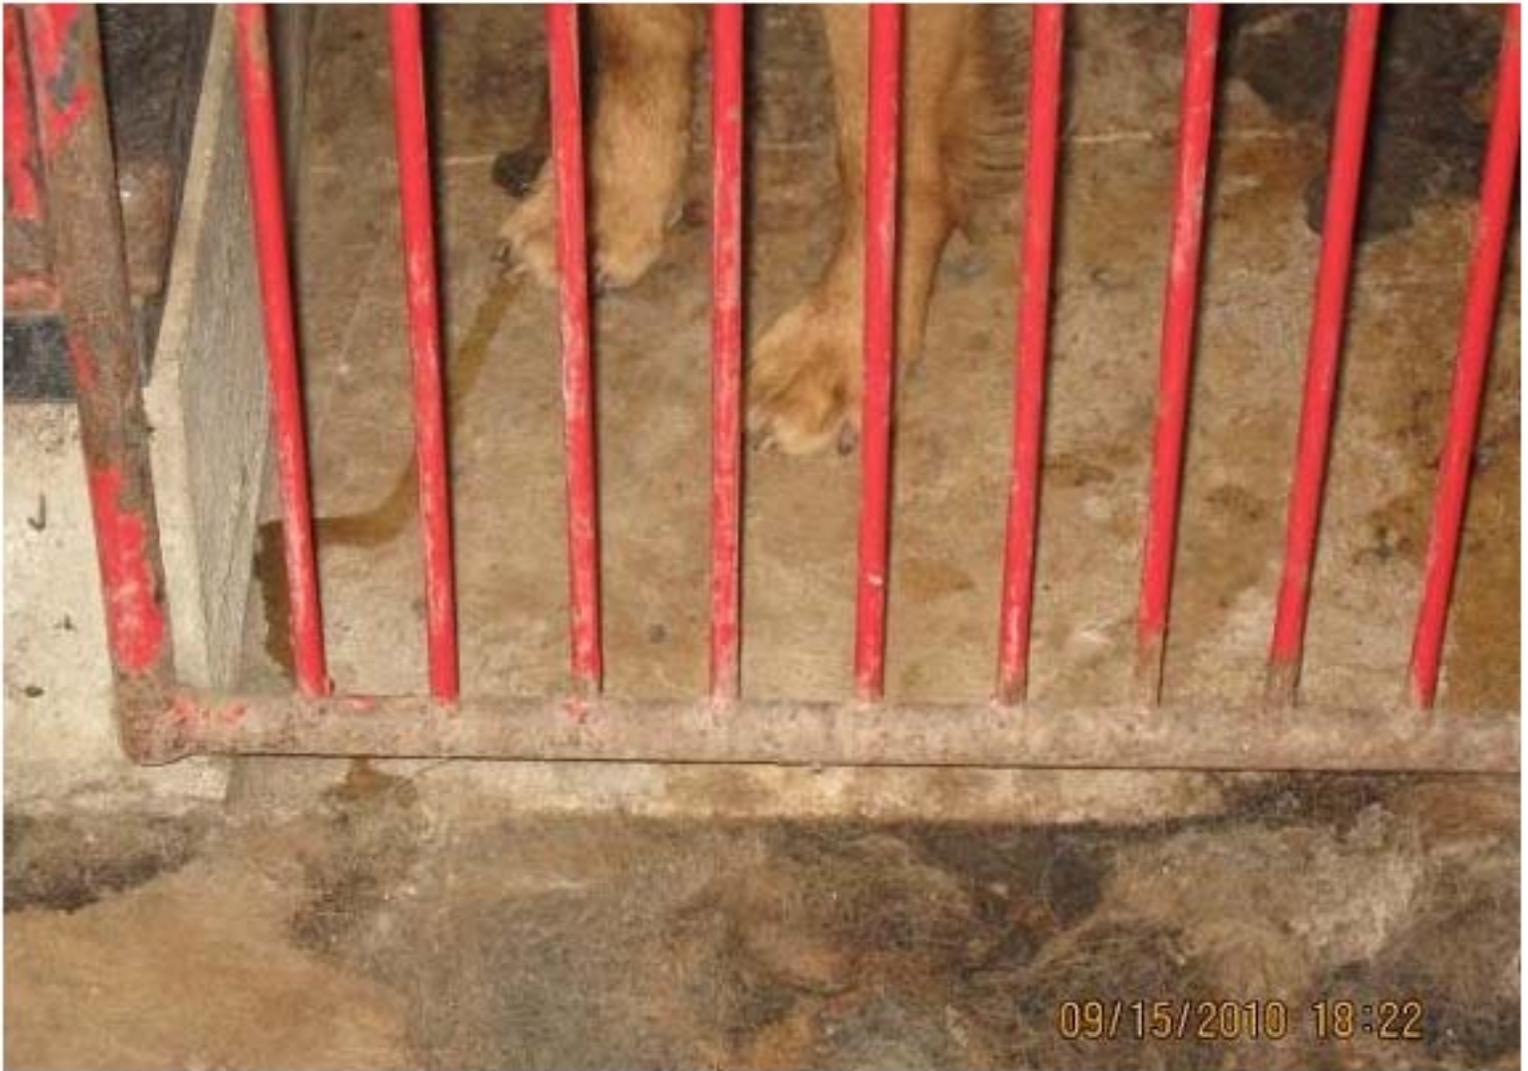
FOIA11-282000199

CFR: 3.1 (c) (3)

Photographer:	Randall Wagner (ACI)	Legal Name:	Registration:	42-A-1286
Photo Taken:	Wed, Sep 15, '10	BOB CLEVERINGA		
Inspection:	258101959550156	DEE ANN CLEVERINGA		
Description:	The accumulation of black excrement/dog hair smeared onto the cement surface indicates daily spot-cleaning is not taking place.

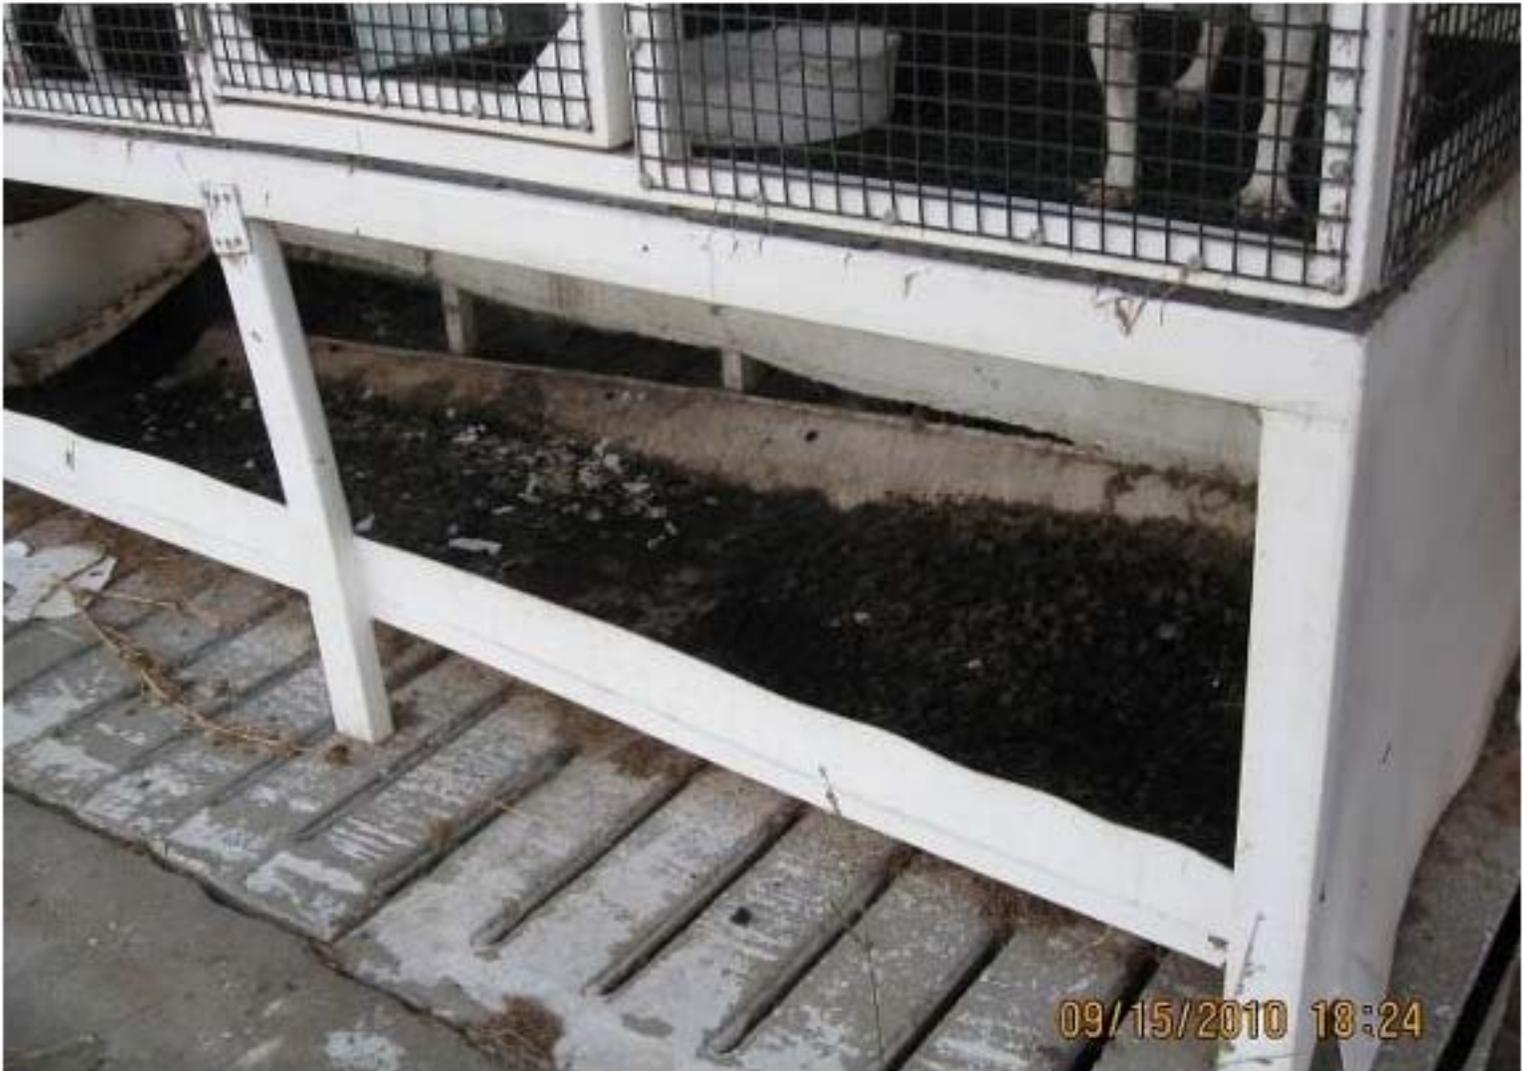
FOIA11-282000200

CFR: 3.11 (a)

Photographer:	Randall Wagner (ACI)	Legal Name:	Registration:	42-A-1286
Photo Taken:	Wed, Sep 15, '10	BOB CLEVERINGA		
Inspection:	258101959550156	DEE ANN CLEVERINGA		
Description:	The wash down has excessive accumulation of fecal waste white to black in color. This indicates the wash down is not cleaned regularly.

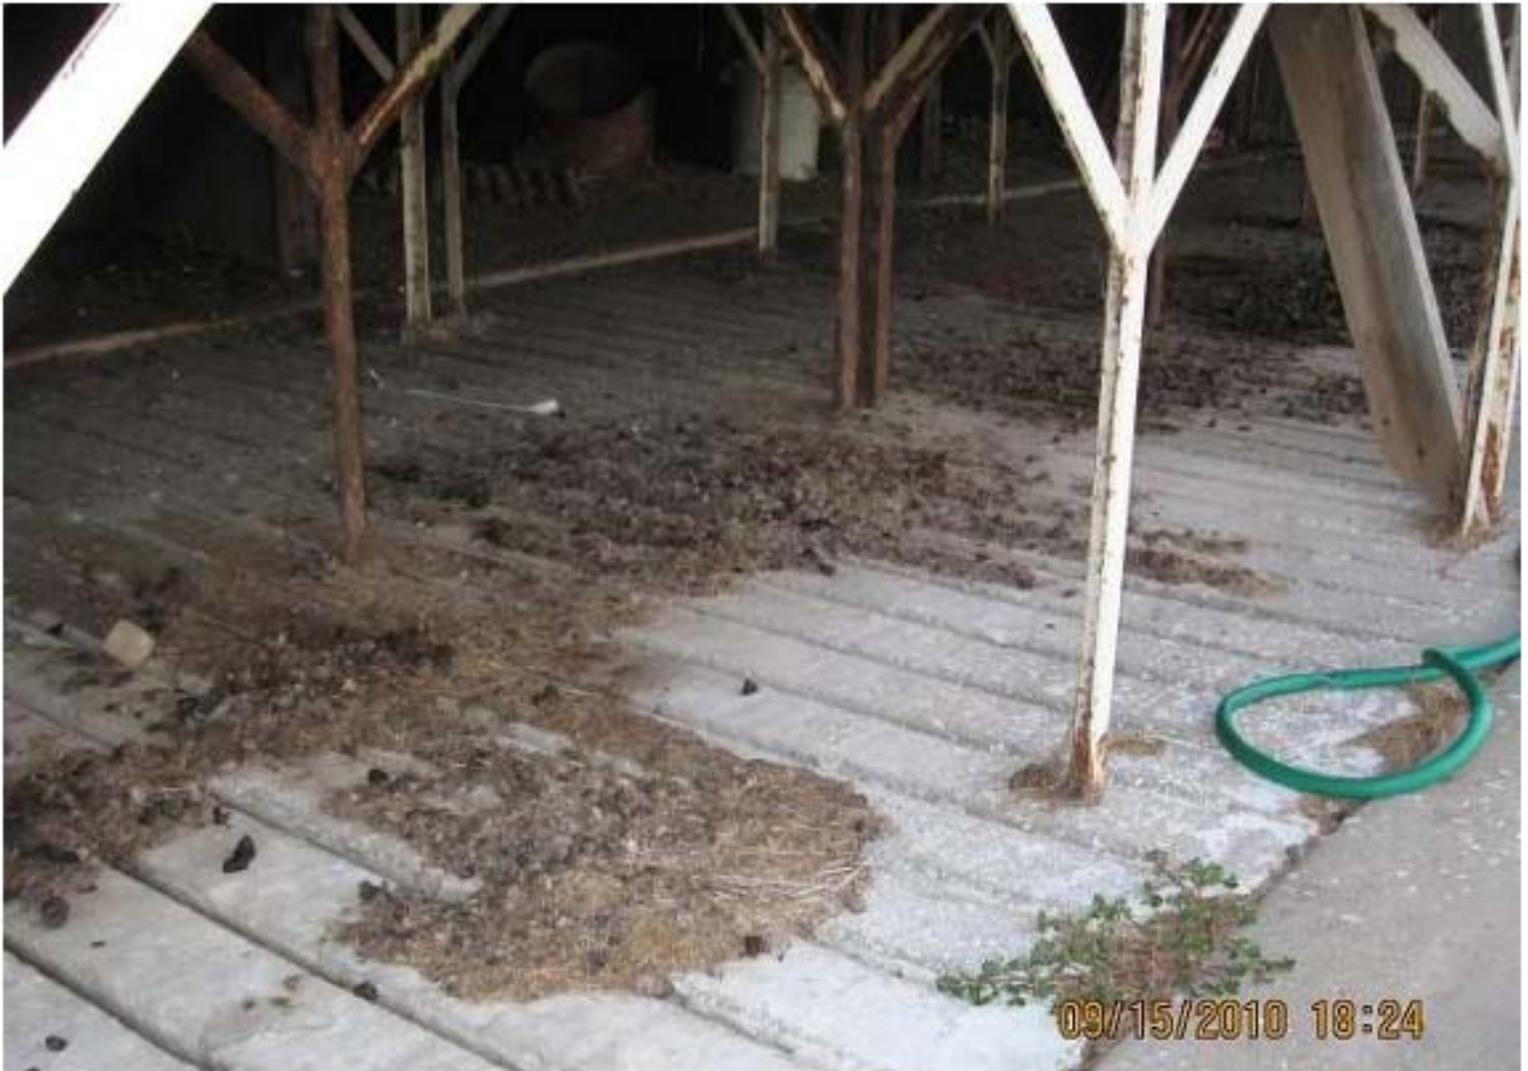
FOIA11-282000201

CFR: 3.11 (a)

Photographer:	Randall Wagner (ACI)	Legal Name:	Registration:	42-A-1286
Photo Taken:	Wed, Sep 15, '10	BOB CLEVERINGA		
Inspection:	258101959550156	DEE ANN CLEVERINGA		
Description:	The under neath area of the raised runs has excessive accumulation of fecal waste, indicates not being cleaned as often as necessary.

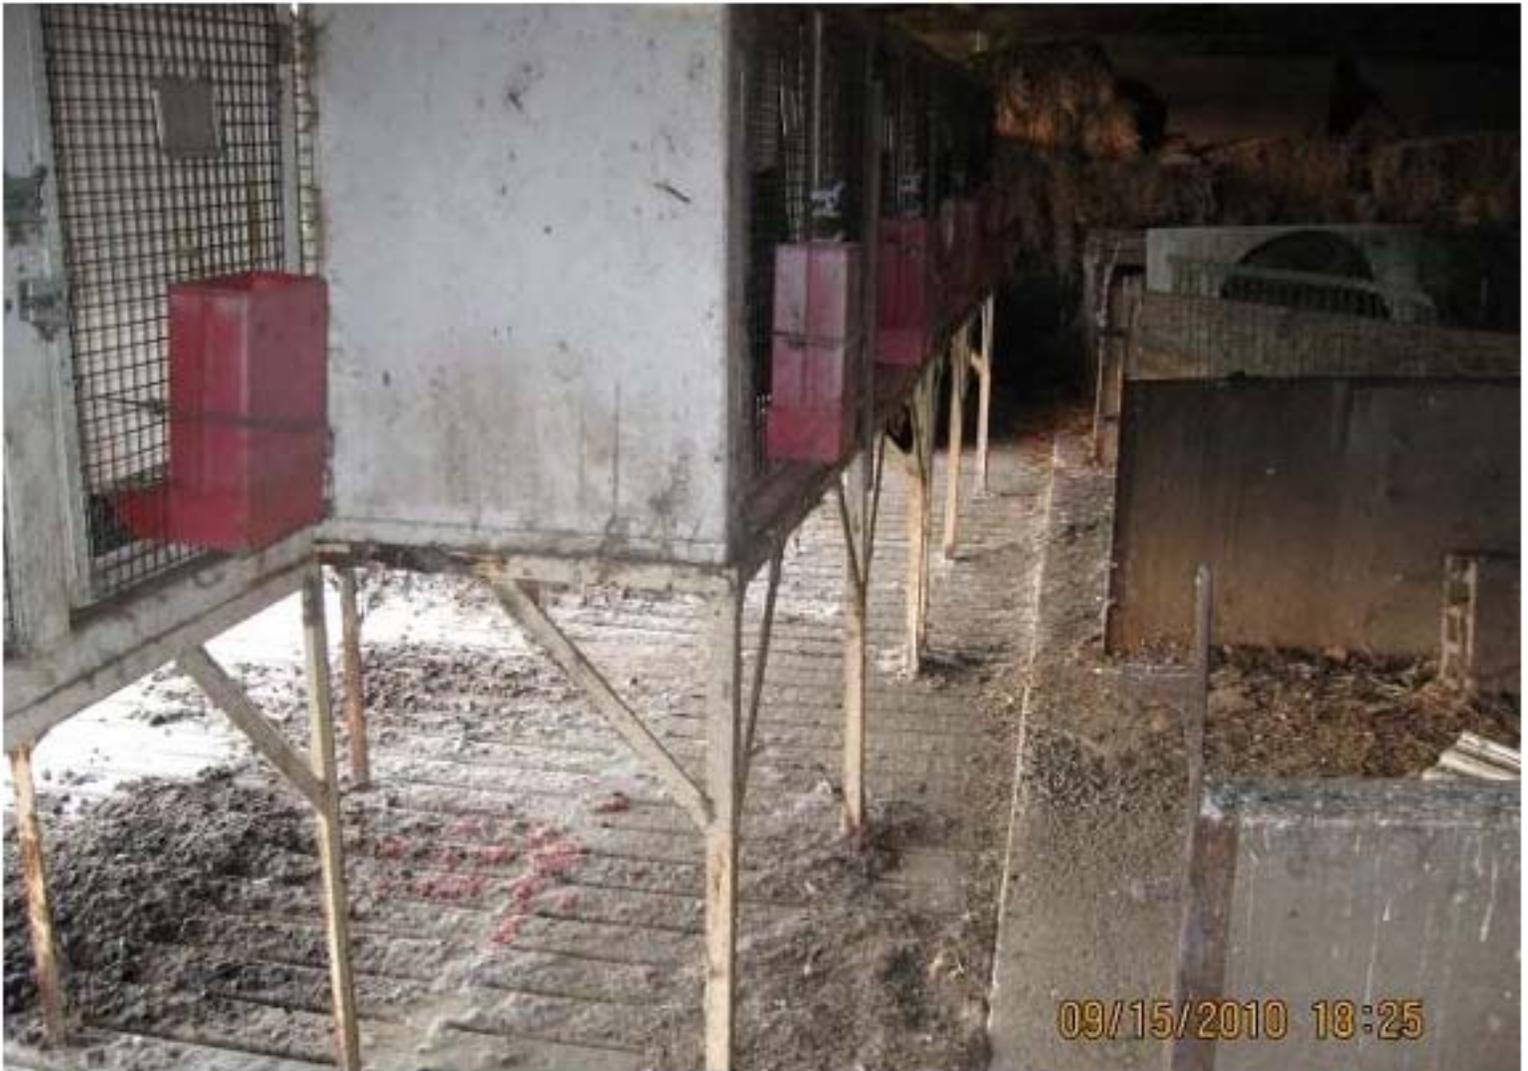
FOIA11-282000202

CFR: 3.11 (a)

Photographer:	Randall Wagner (ACI)	Legal Name:	Registration:	42-A-1286
Photo Taken:	Wed, Sep 15, '10	BOB CLEVERINGA		
Inspection:	258101959550156	DEE ANN CLEVERINGA		
Description:	The under neath areas of the raised kennels have excessive fecal waste. The accumulation of waste is not being removed regularly.

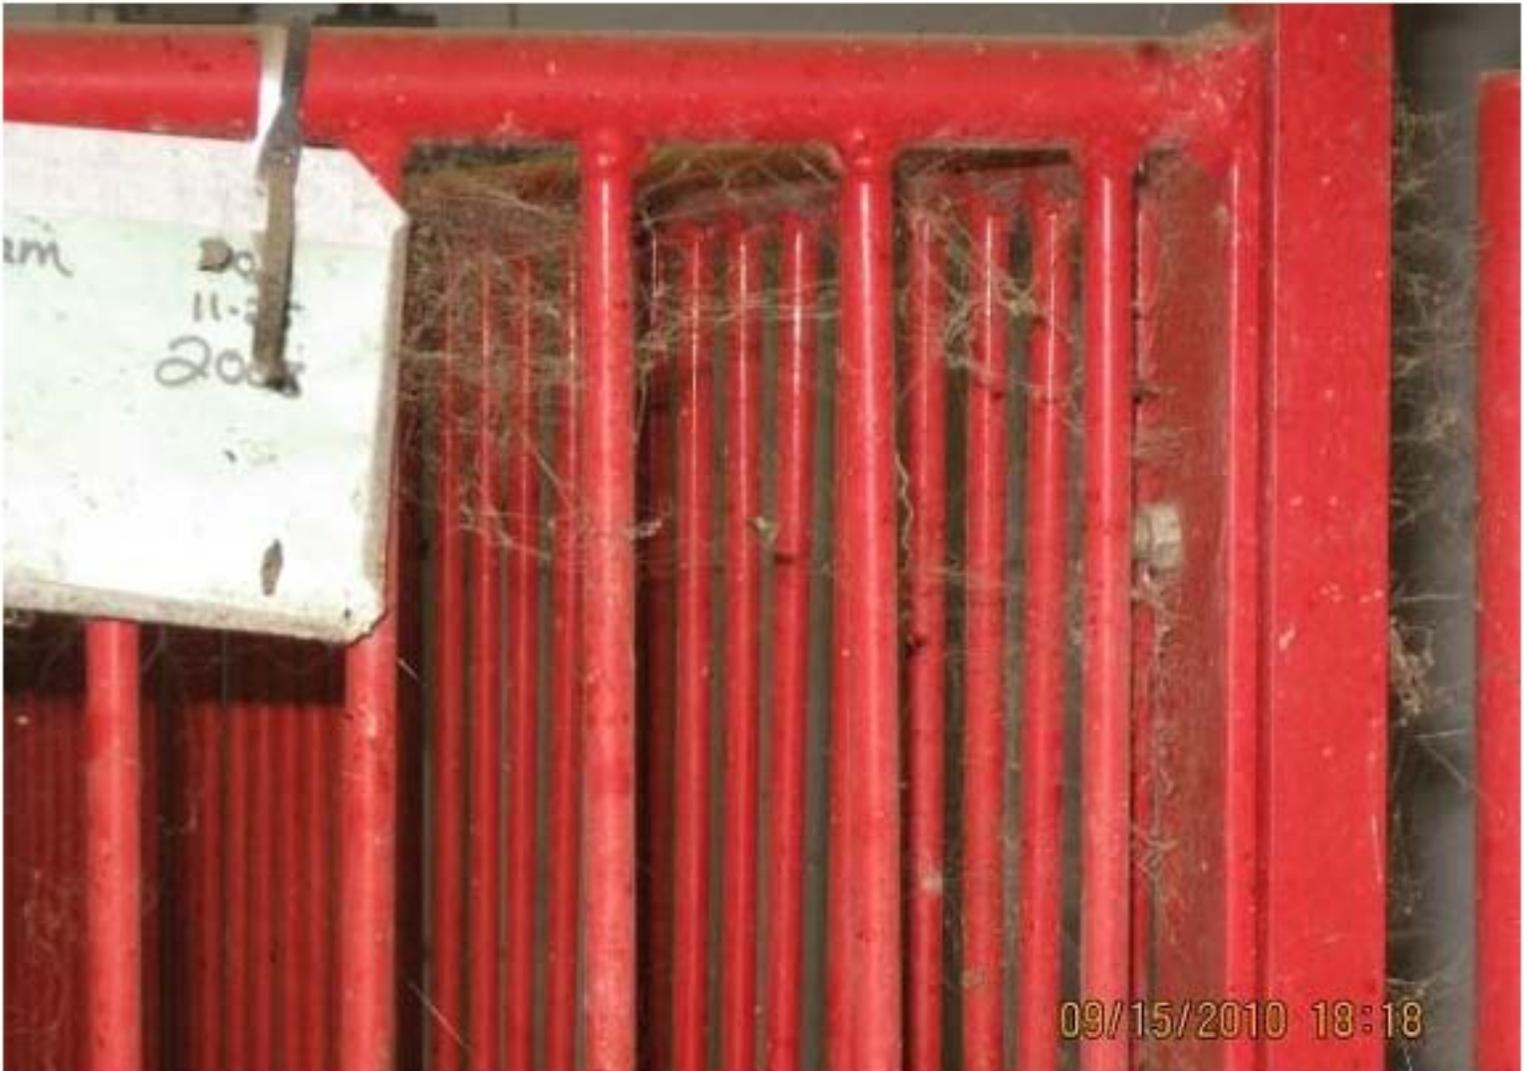
FOIA11-282000203

CFR: 3.1 (c) (3)

Photographer:	Randall Wagner (ACI)	Legal Name:	Registration:	42-A-1286
Photo Taken:	Wed, Sep 15, '10	BOB CLEVERINGA		
Inspection:	258101959550156	DEE ANN CLEVERINGA		
Description:	The excessive cob webs on the enclosure metal bars indicate daily spot-cleaning/sanitization is not taking place.

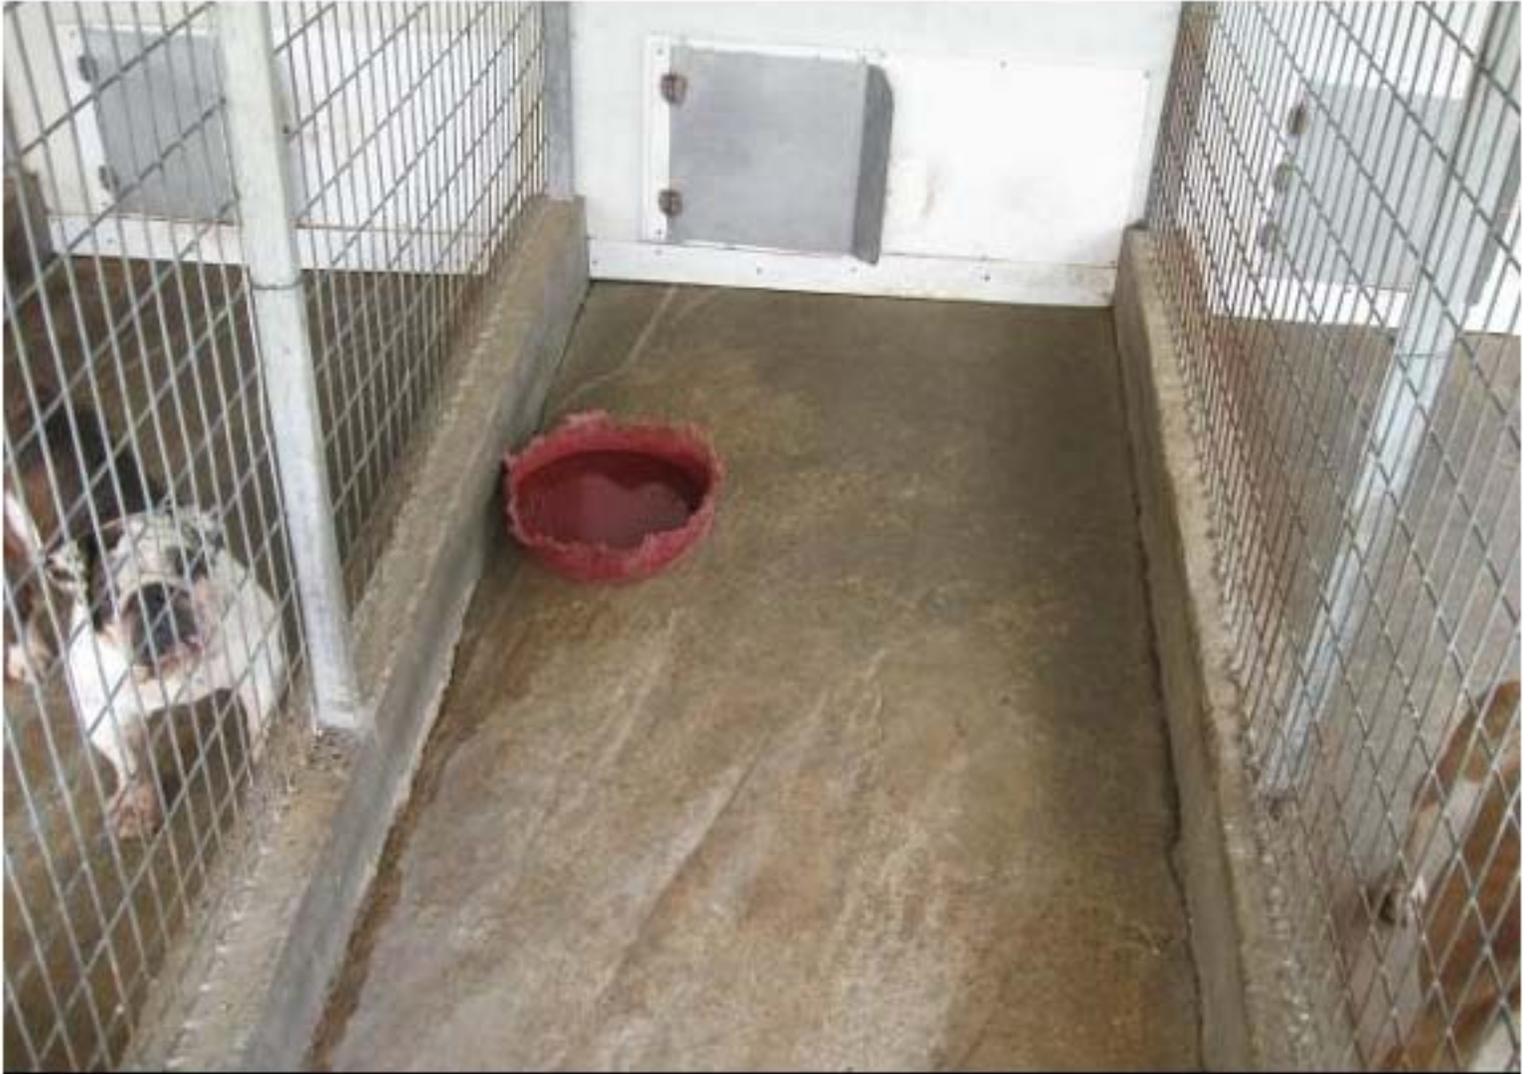
CFR: 3.1 (c) (1)

Photographer:	John J. Lies, ACI	Legal Name:	Registration:	42-A-1263
Photo Taken:	Mon, Aug 2, '10 P.M.	CARLA JONES		
Inspection:	214101528590936			
Description:	3.1 (c)(1) Surfaces: Chewed edges on water bowl can not be properly cleaned.

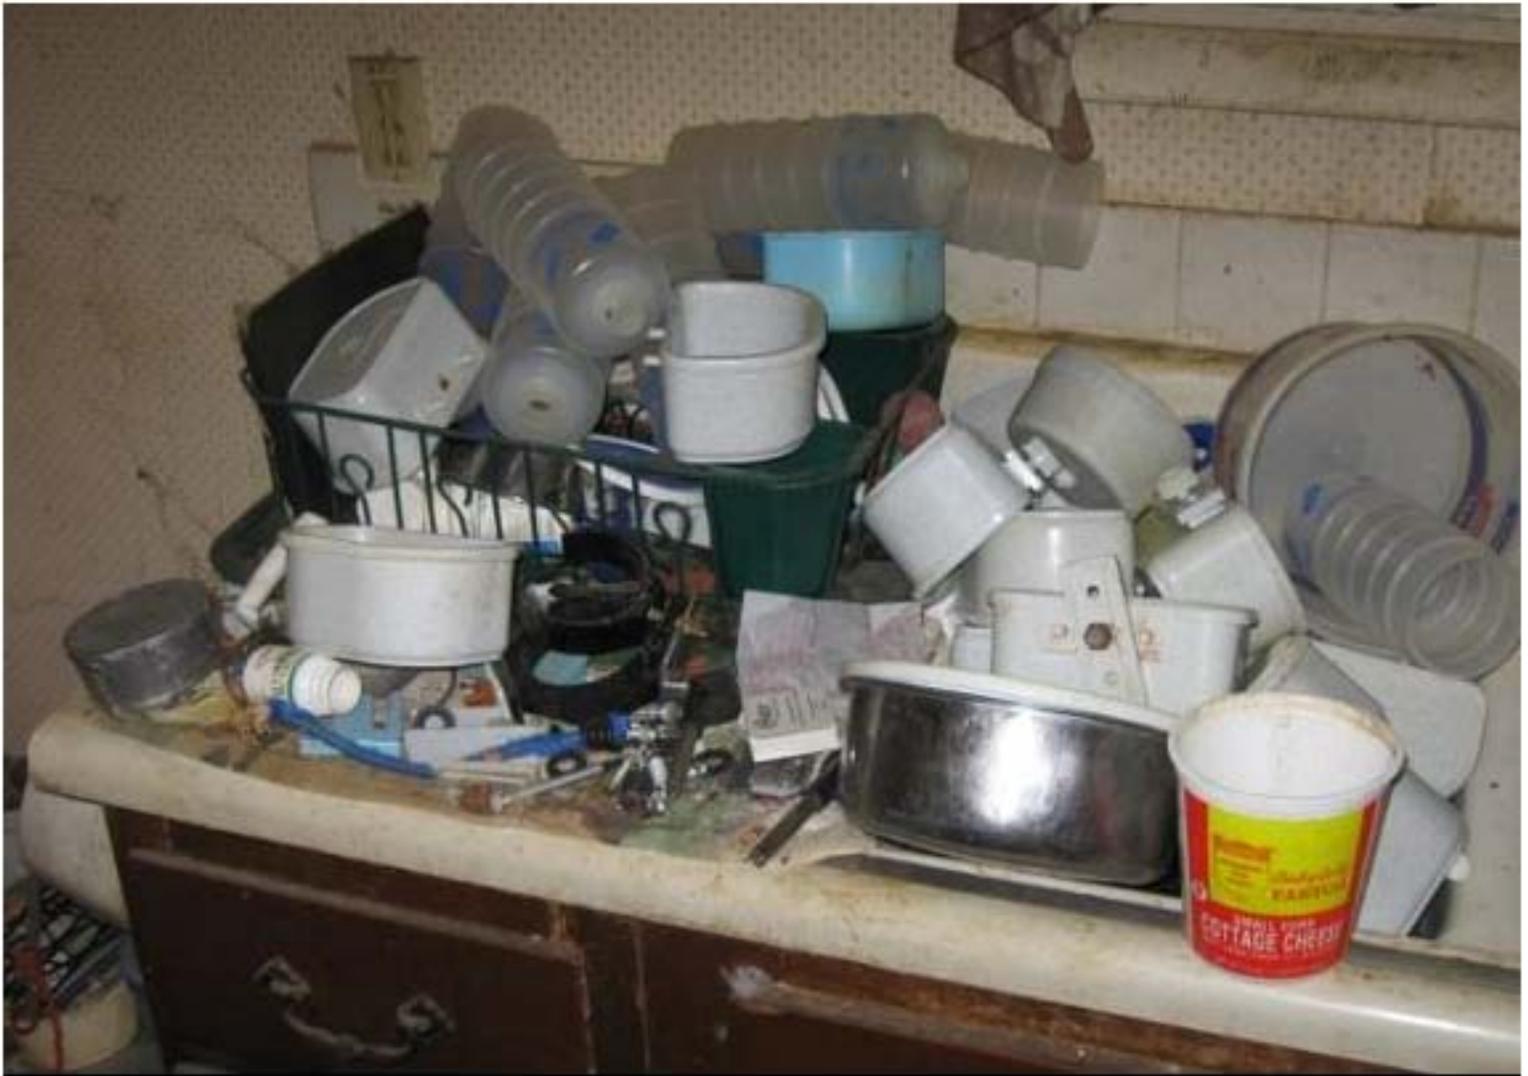
CFR: 3.1 (b)

Photographer:	John J. Lies, ACI	Legal Name:	Registration:	42-A-1263
Photo Taken:	Mon, Aug 2, '10 P.M.	CARLA JONES		
Inspection:	214101528590936			
Description:	3.1 (b) Condition and site: Clutter on the counter in the facility.

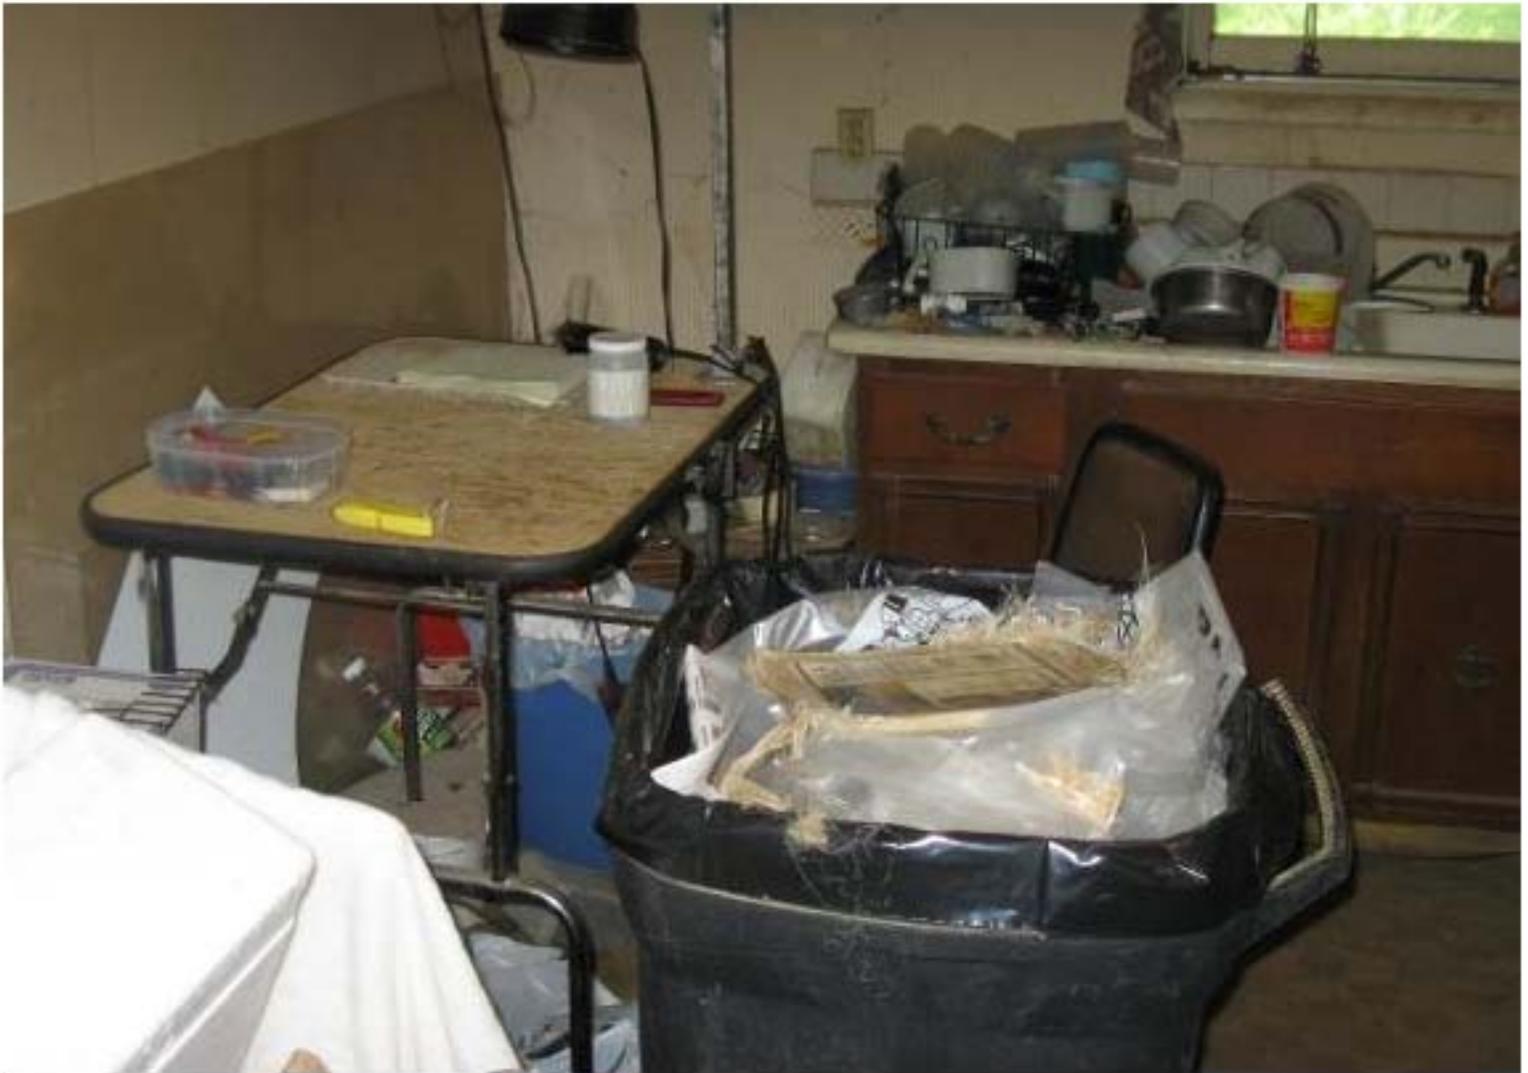
Photographer:	John J. Lies, ACI	Legal Name:	Registration:	42-A-1263
Photo Taken:	Mon, Aug 2, '10 P.M.	CARLA JONES		
Inspection:	214101528590936			
Description:	3.1 (b) Condition and site: Clutter in the facility. 3.1 (f) Waste disposal: Trash can with out a tight fitting lid and full.

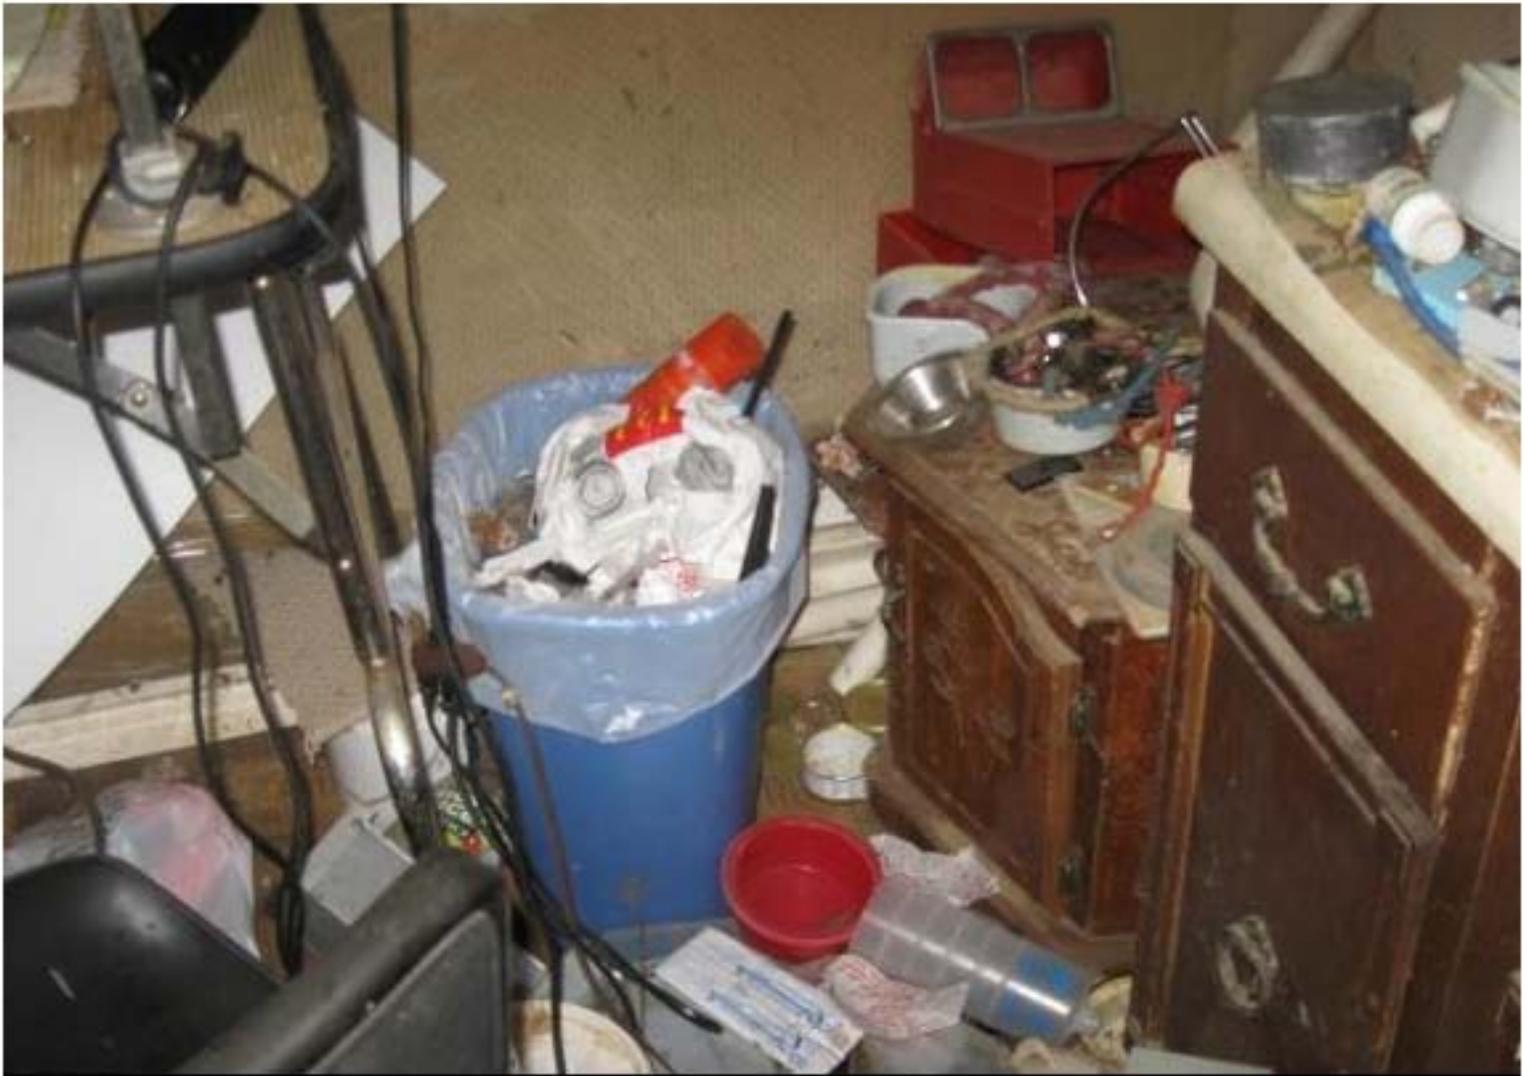
Photographer:	John J. Lies, ACI	Legal Name:	Registration:	42-A-1263
Photo Taken:	Mon, Aug 2, '10 P.M.	CARLA JONES		
Inspection:	214101528590936			
Description:	3.1 (b) Condition and site: Clutter in the facility. 3.1 (f) Waste disposal: Trash can with out a tight fitting lid and full.

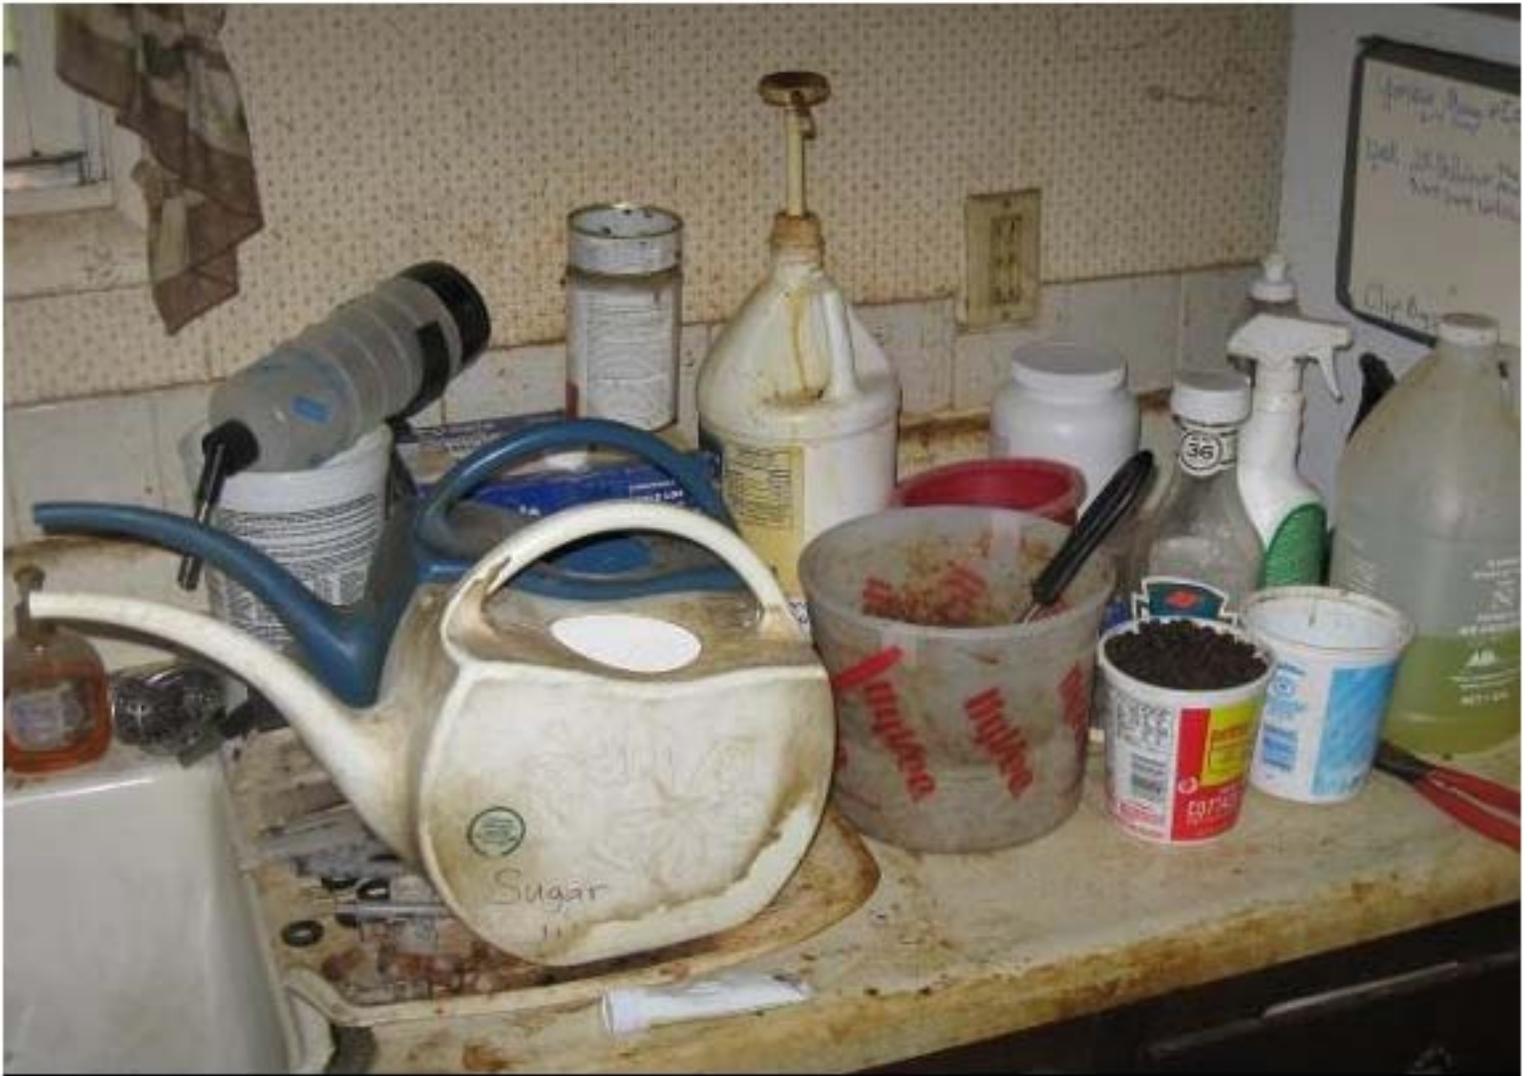
Photographer:	John J. Lies, ACI	Legal Name:	Registration:	42-A-1263
Photo Taken:	Mon, Aug 2, '10 P.M.	CARLA JONES		
Inspection:	214101528590936			
Description:	3.1 (b) Condition and site: Clutter on the counter in the facility.

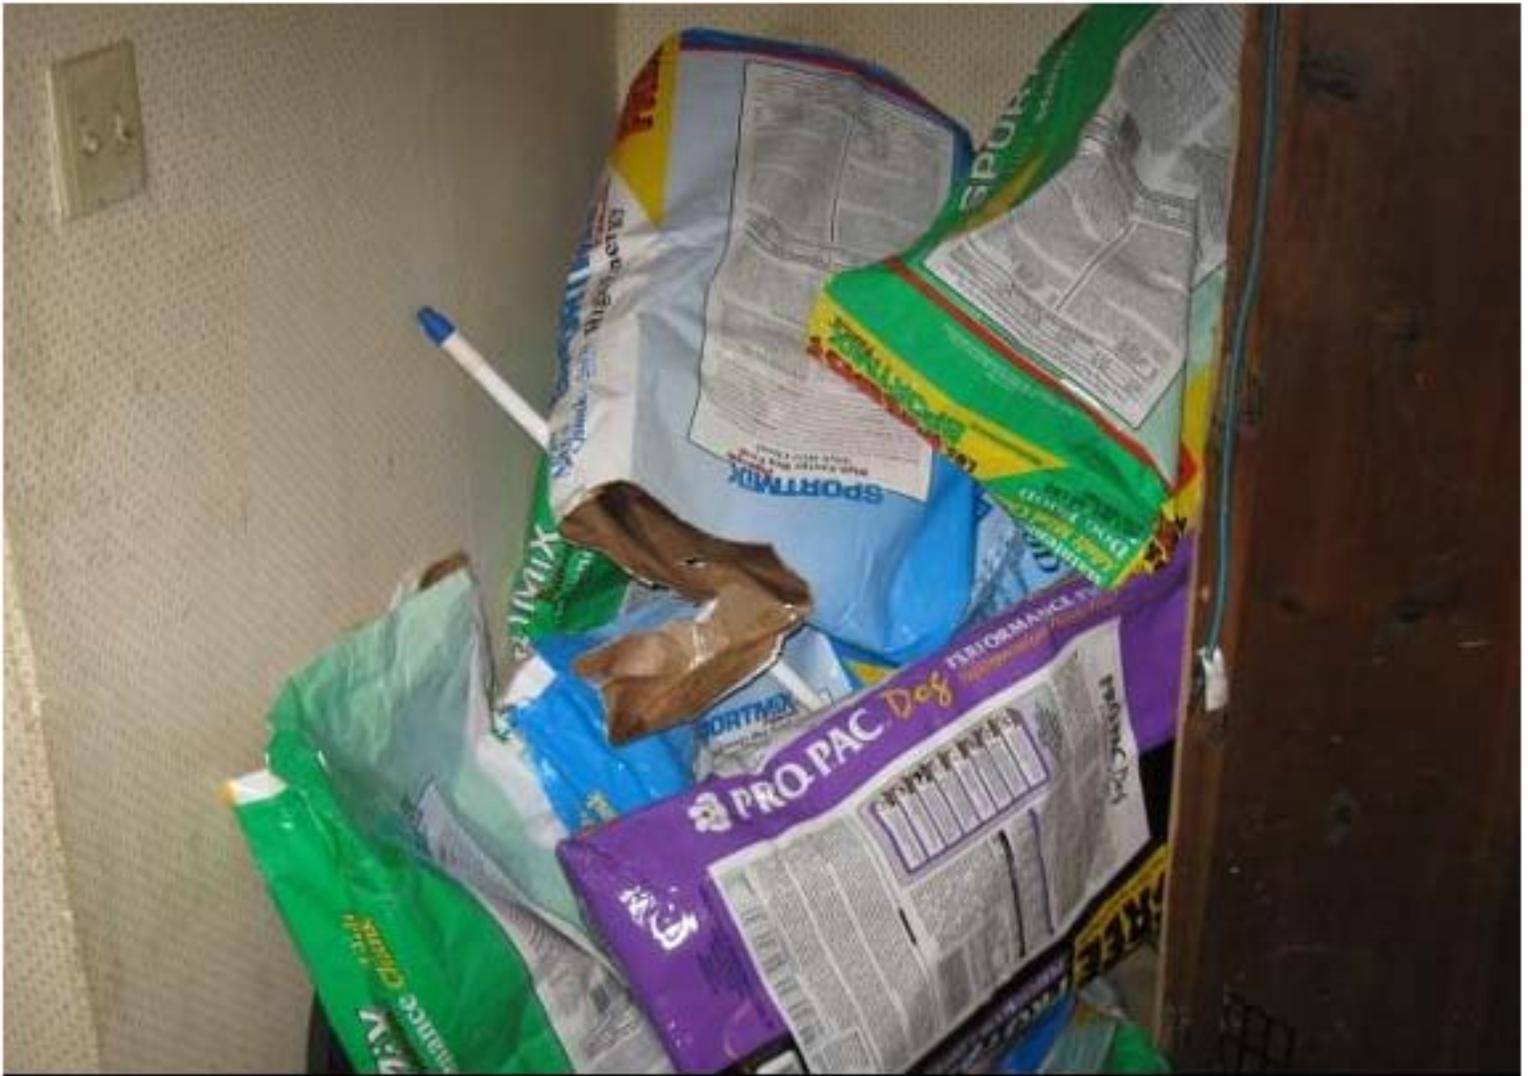
Photographer:	John J. Lies, ACI	Legal Name:	Registration:	42-A-1263
Photo Taken:	Mon, Aug 2, '10 P.M.	CARLA JONES		
Inspection:	214101528590936			
Description:	3.1 (b) Condition and site: empty feed sacks in facility.
