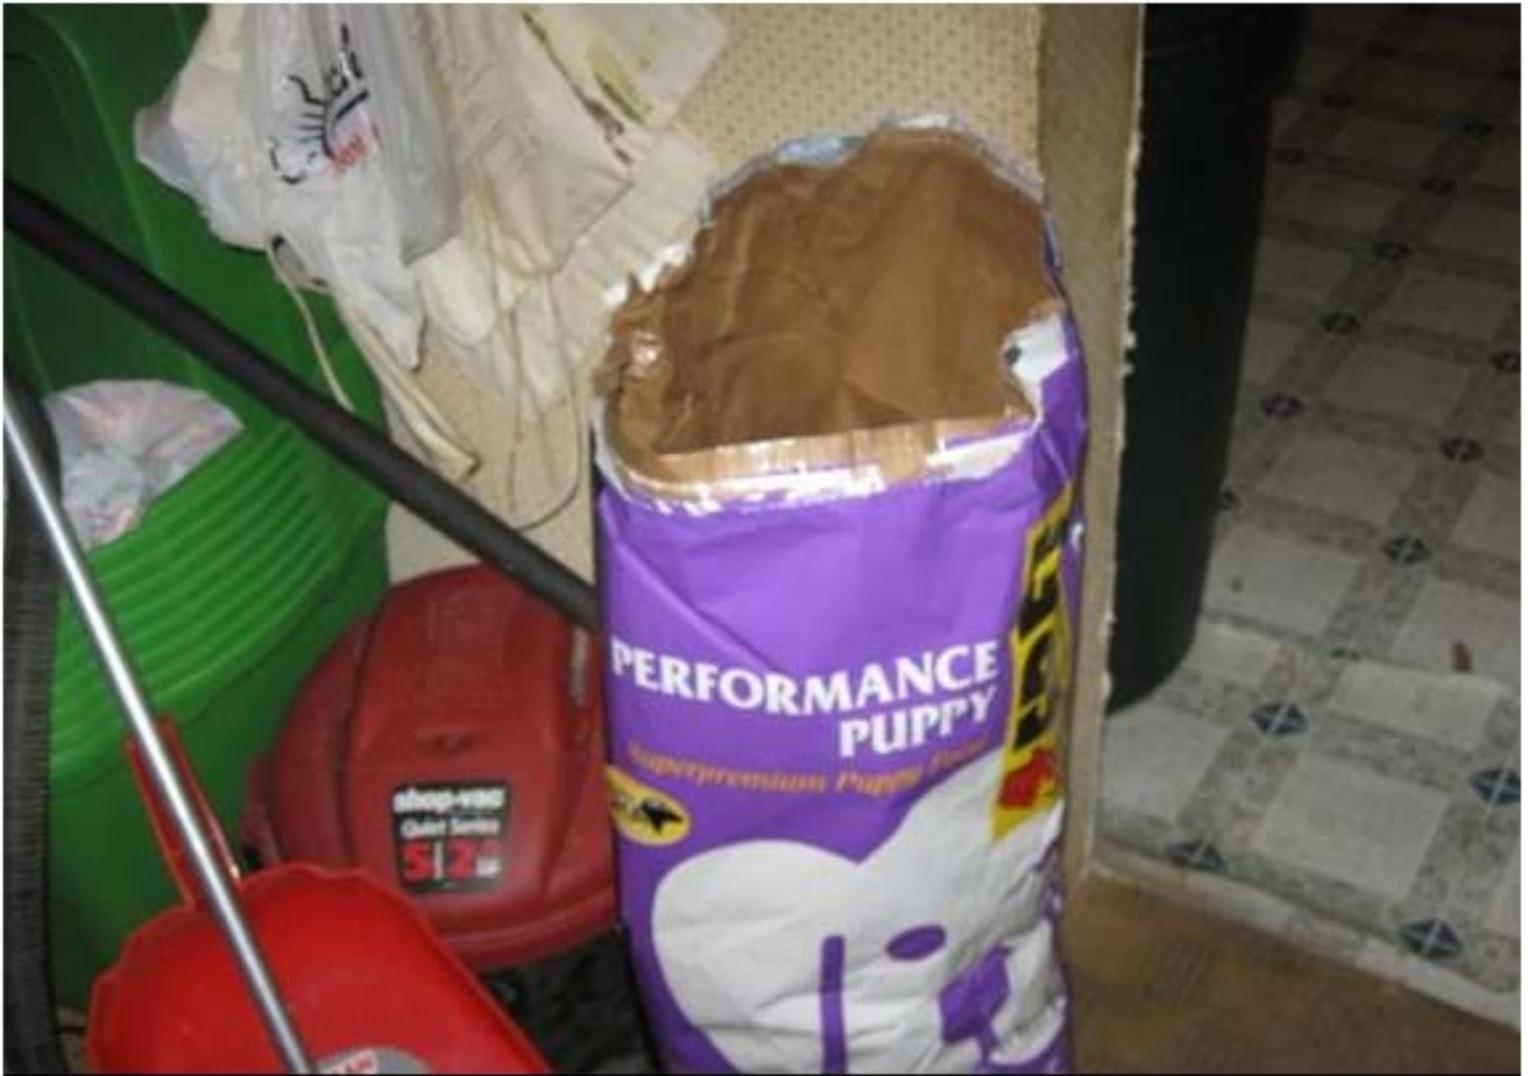
Photographer:	John J. Lies, ACI	Legal Name:	Registration:	42-A-1263
Photo Taken:	Mon, Aug 2, '10 P.M.	CARLA JONES		
Inspection:	214101528590936			
Description:	3.1 (e) Storage: Open feed stored on the floor.

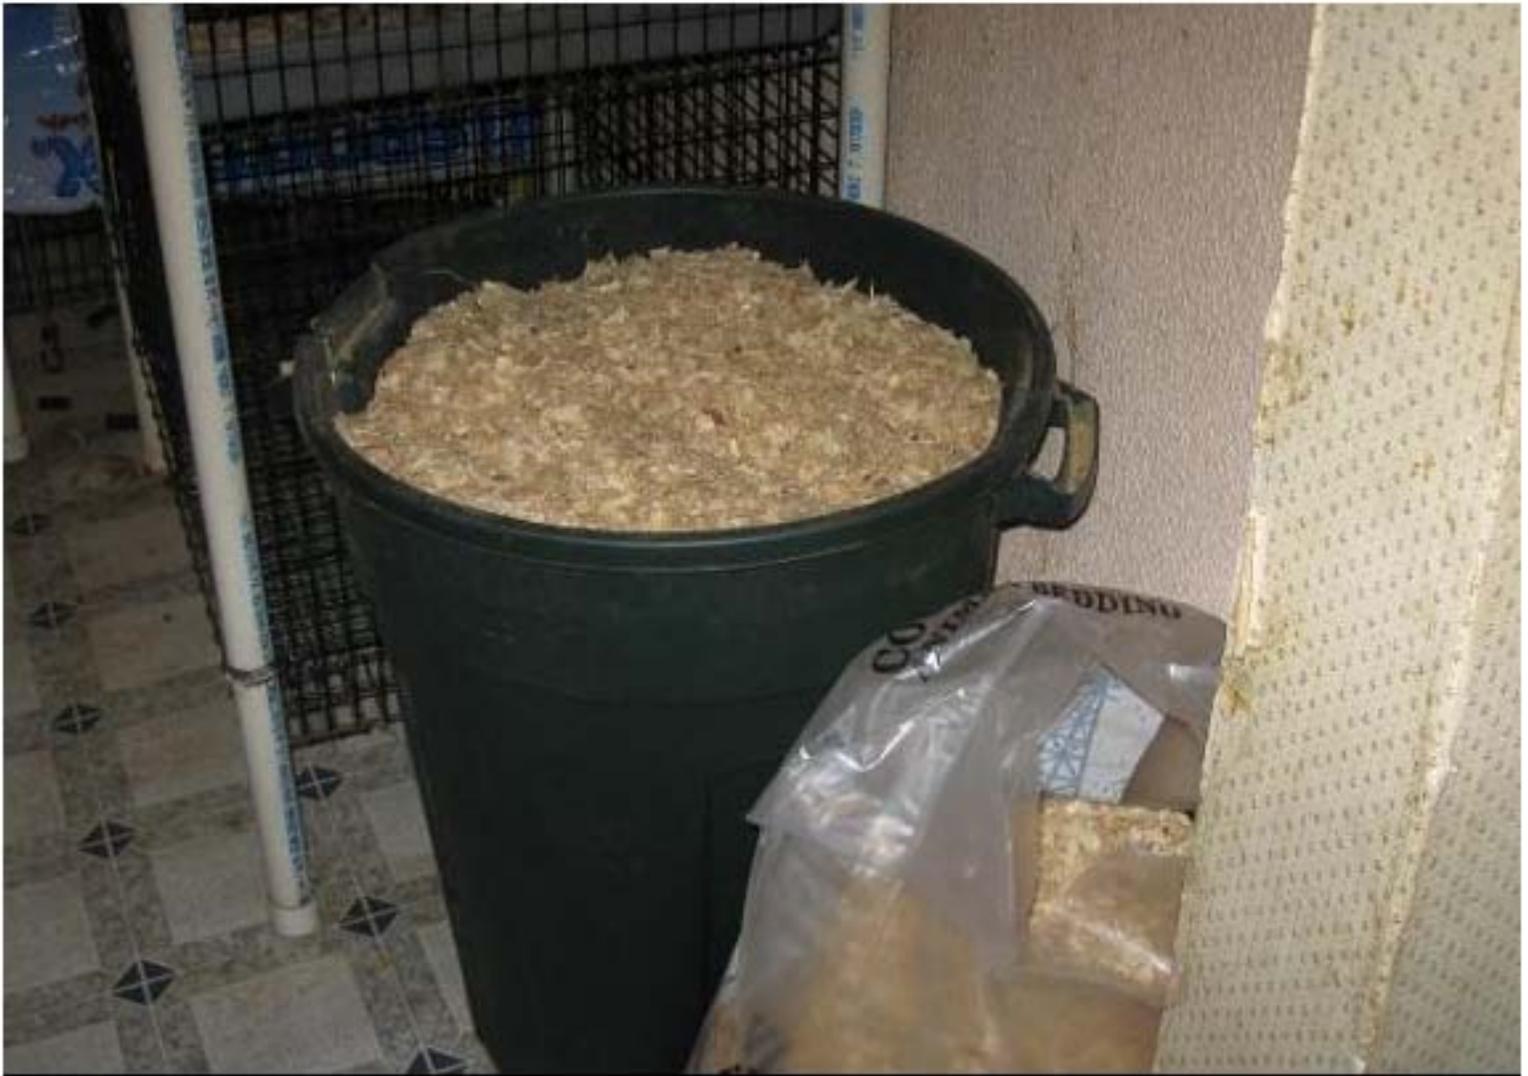
Photographer:	John J. Lies, ACI	Legal Name:	Registration:	42-A-1263
Photo Taken:	Mon, Aug 2, '10 P.M.	CARLA JONES		
Inspection:	214101528590936			
Description:	3.1 (e) Storage: Open bedding stored on the floor. 3.1 (f) Waste disposal: Trash can with out a tight fitting lid and full.

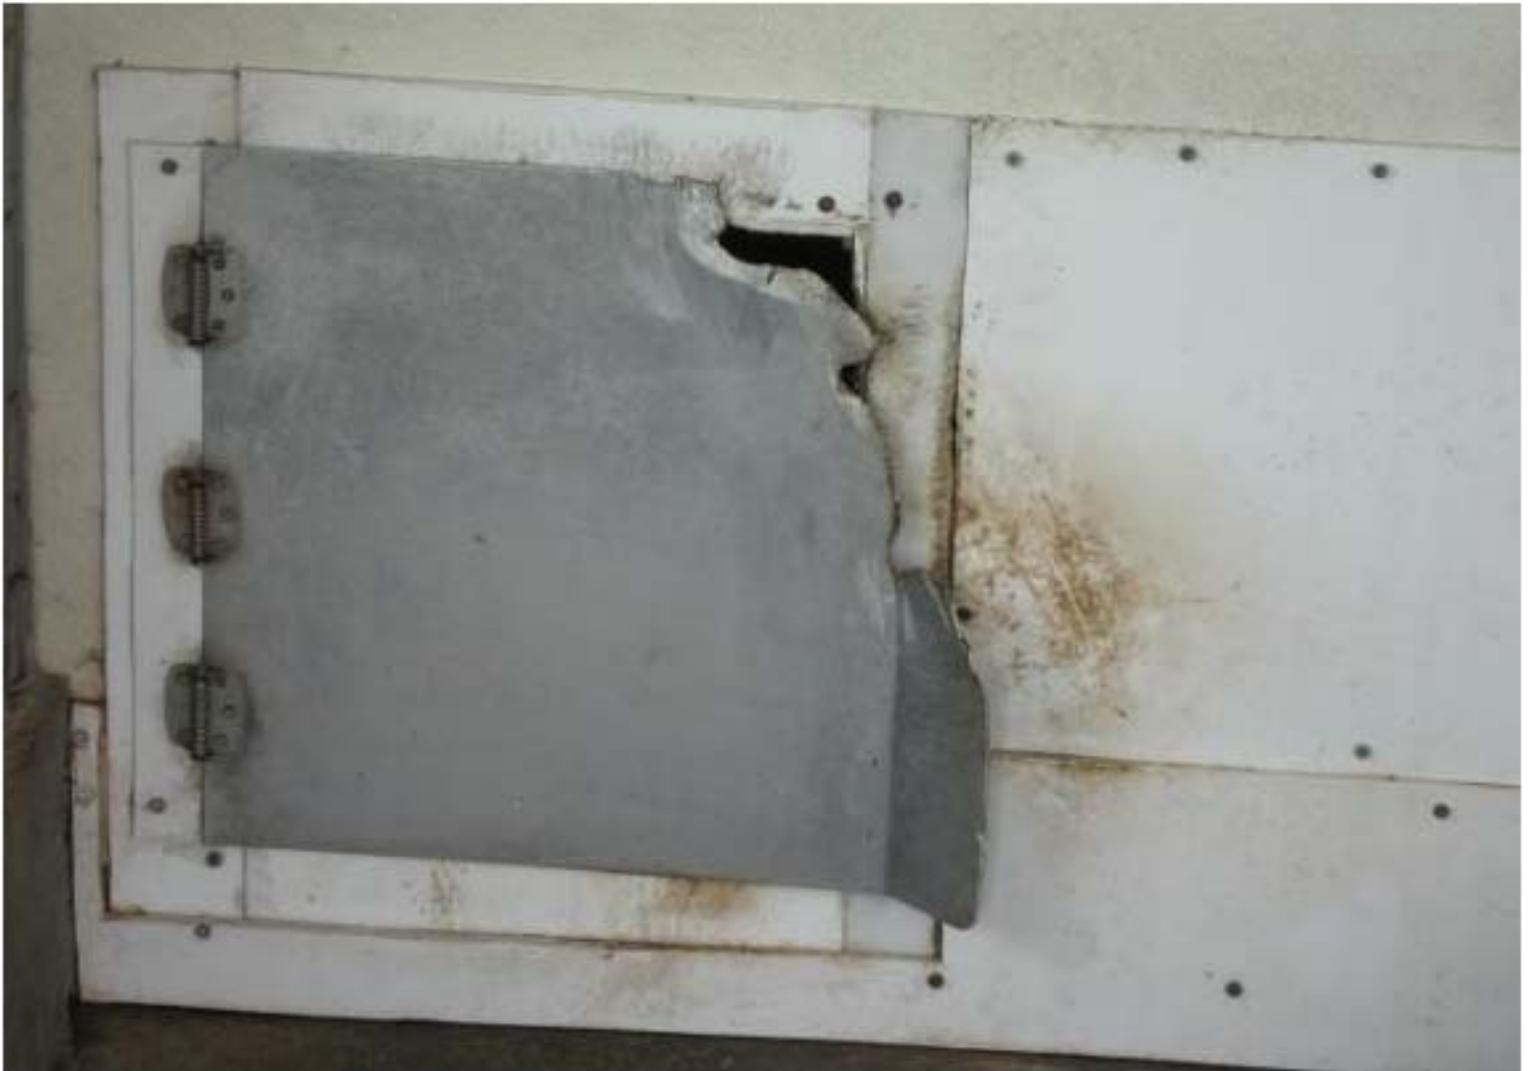
Photographer:	John J. Lies, ACI	Legal Name:	Registration:	42-A-1263
Photo Taken:	Mon, Aug 2, '10 P.M.	CARLA JONES		
Inspection:	214101528590936			
Description:	3.6 (a)(2) Primary Enclosures: Sharp edges on dog door.

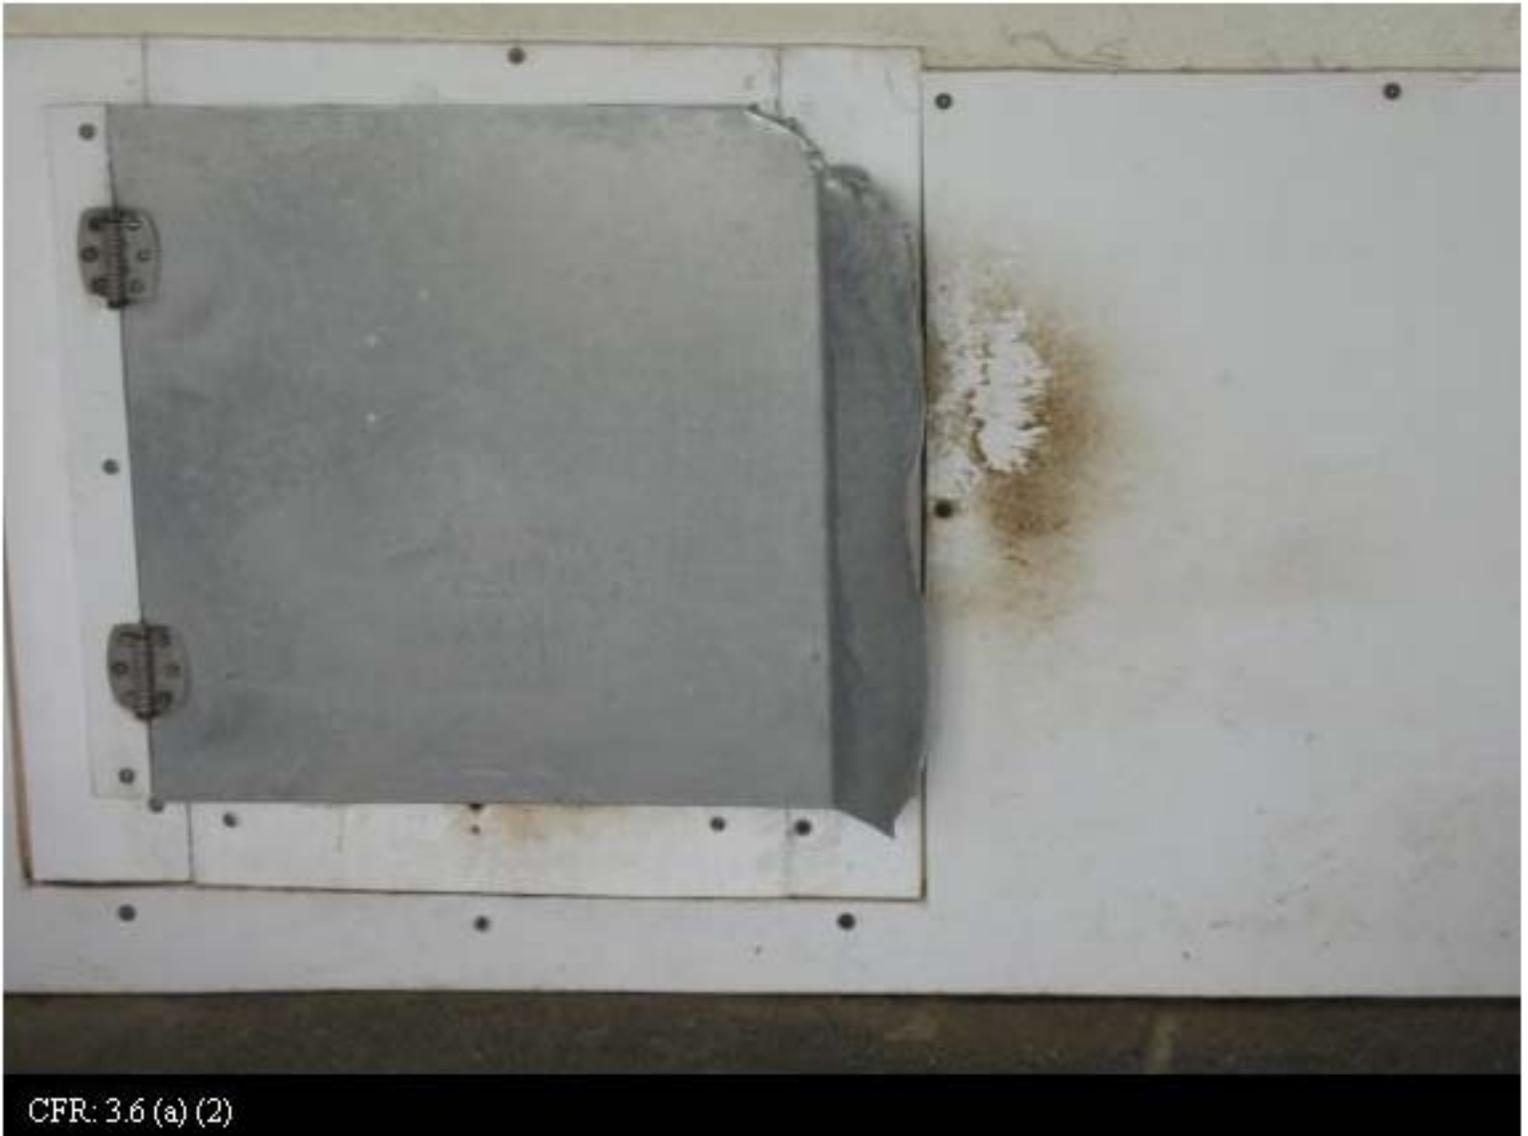
Photographer:	John J. Lies, ACI	Legal Name:	Registration:	42-A-1263
Photo Taken:	Mon, Aug 2, '10 P.M.	CARLA JONES		
Inspection:	214101528590936			
Description:	3.6 (a)(2) Primary Enclosures: Sharp edges on dog door.

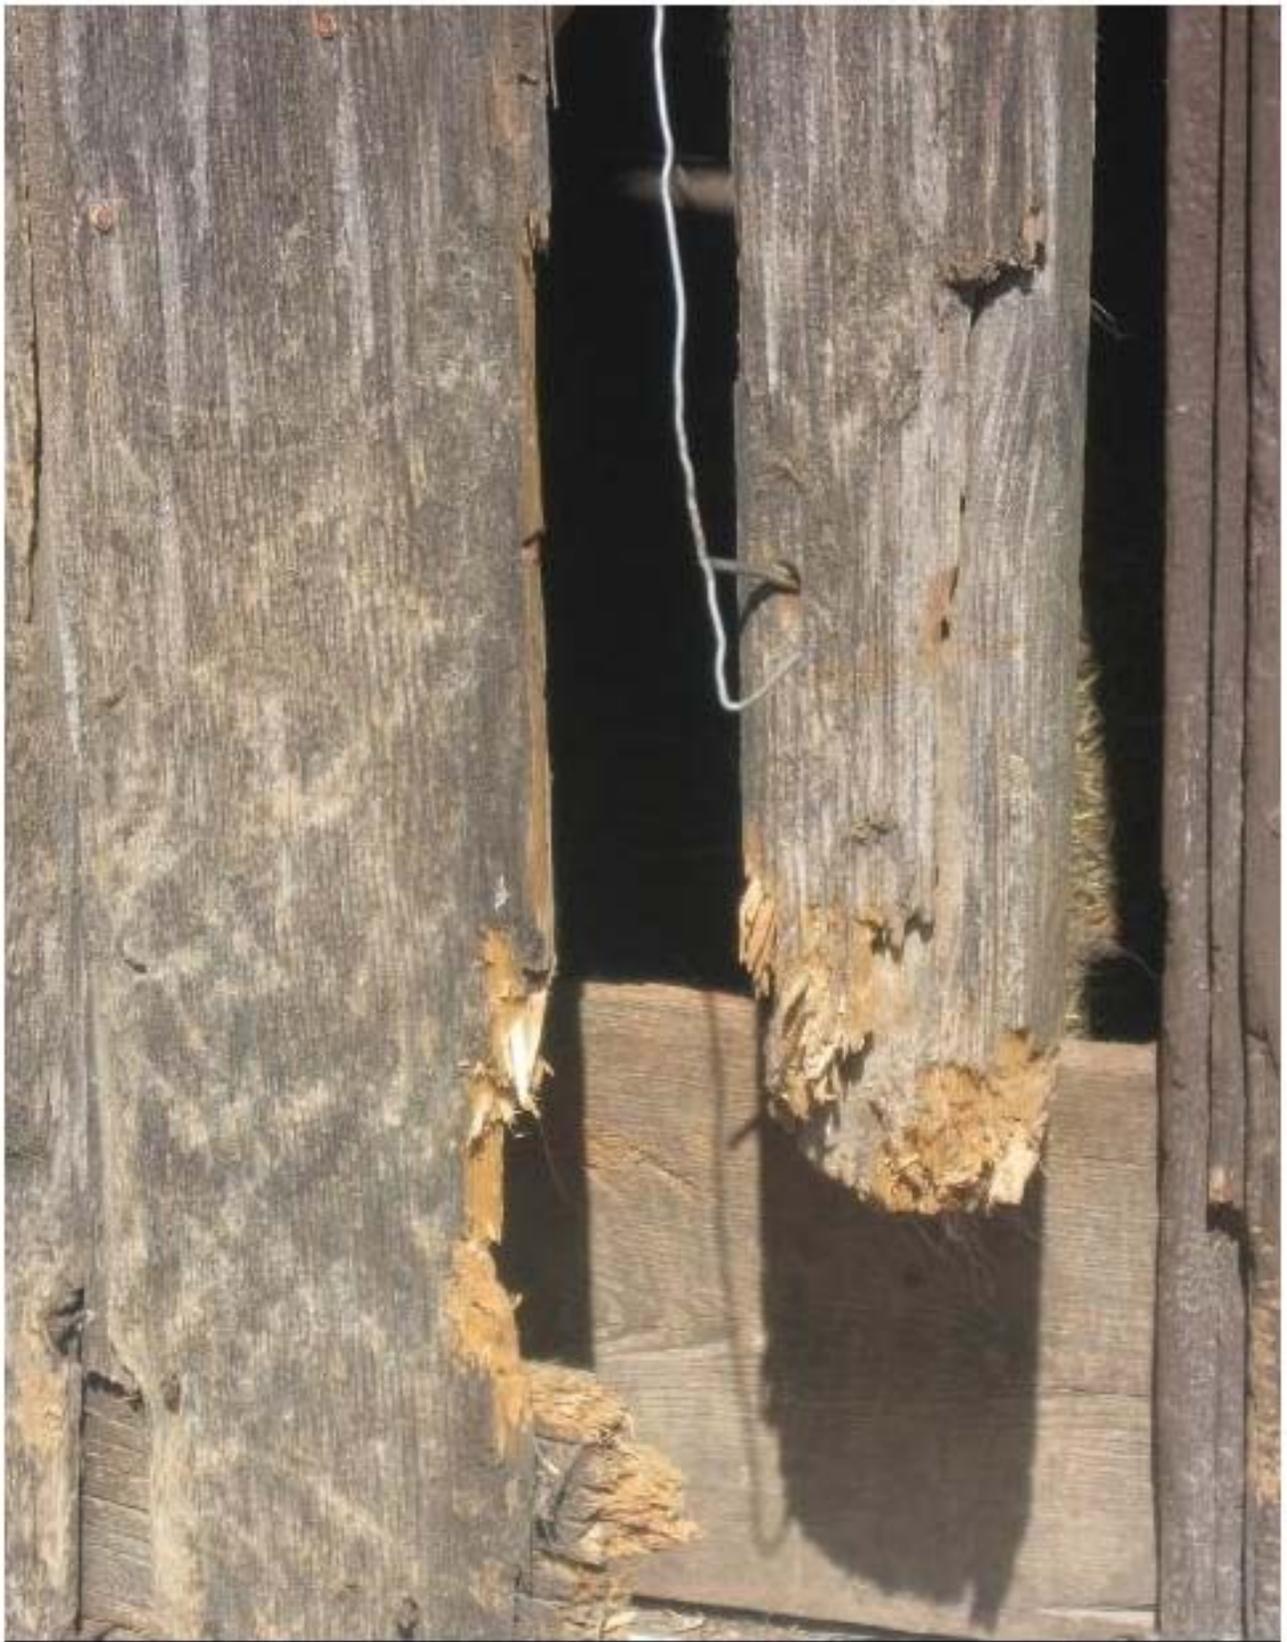
Description: Chewed wood, jagged wire

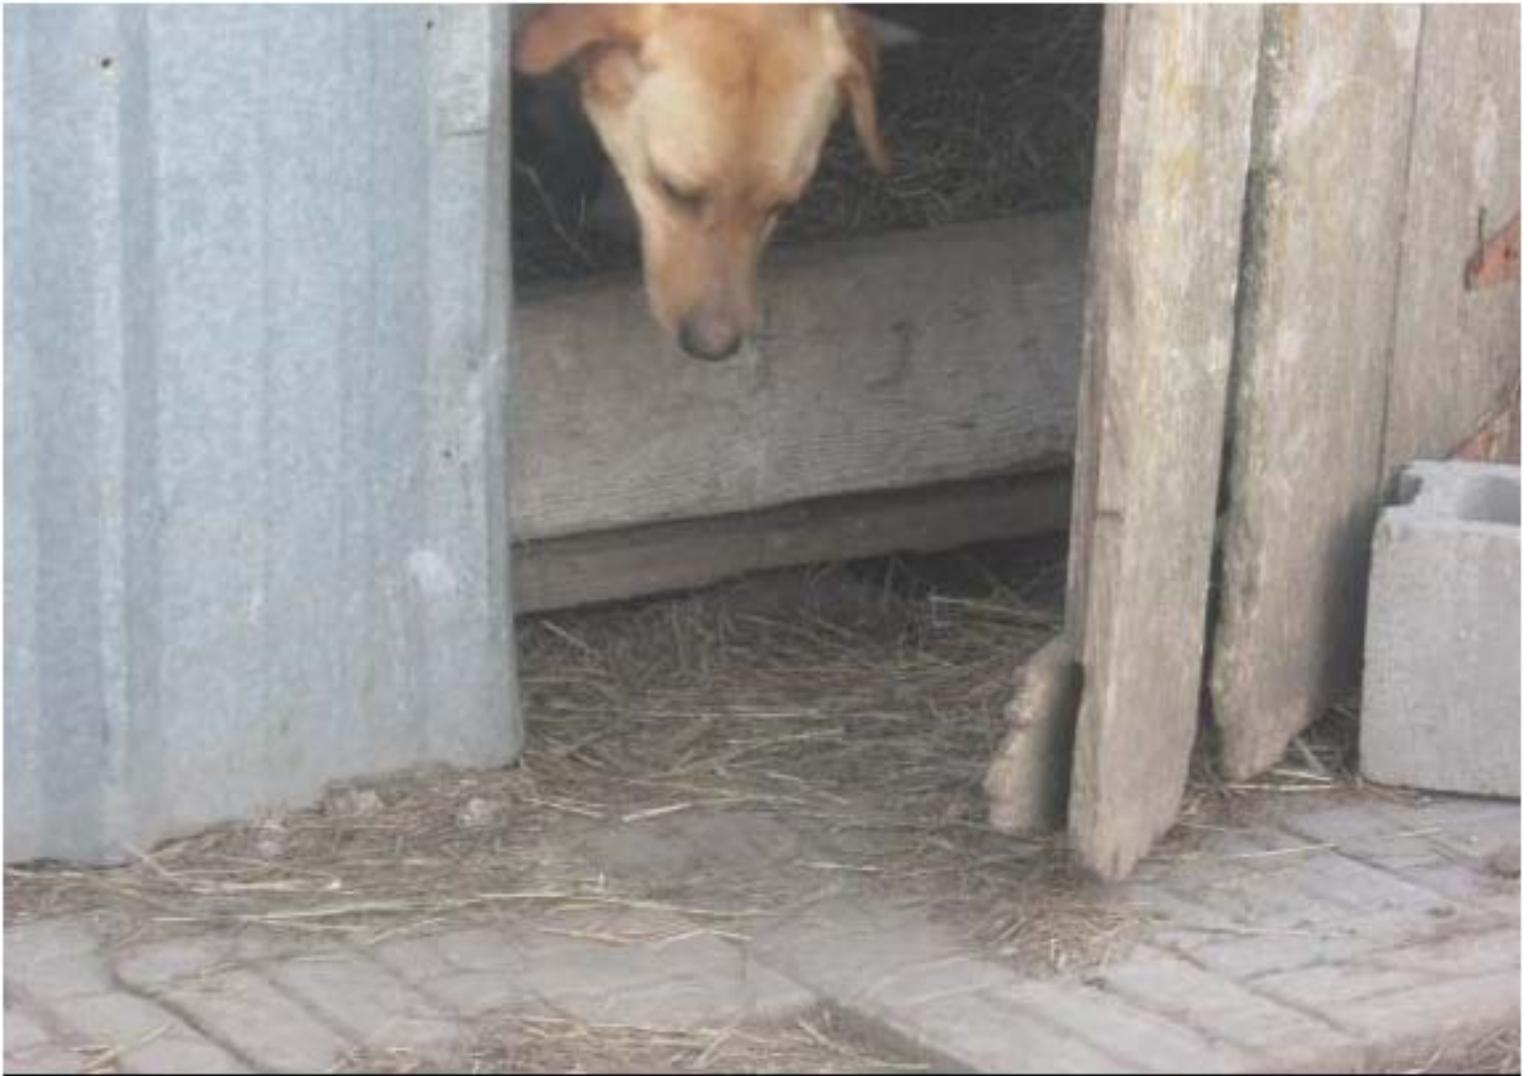
Photographer:	Dr. Richard Watkins	Legal Name:	Registration:	42-A-1256
Photo Taken:	Thu, Apr 1, '10	BETTY PORTER		
Inspection:	95102052350433			
Description:	wood door, not impervious to moisture, housing for mother dog with pups

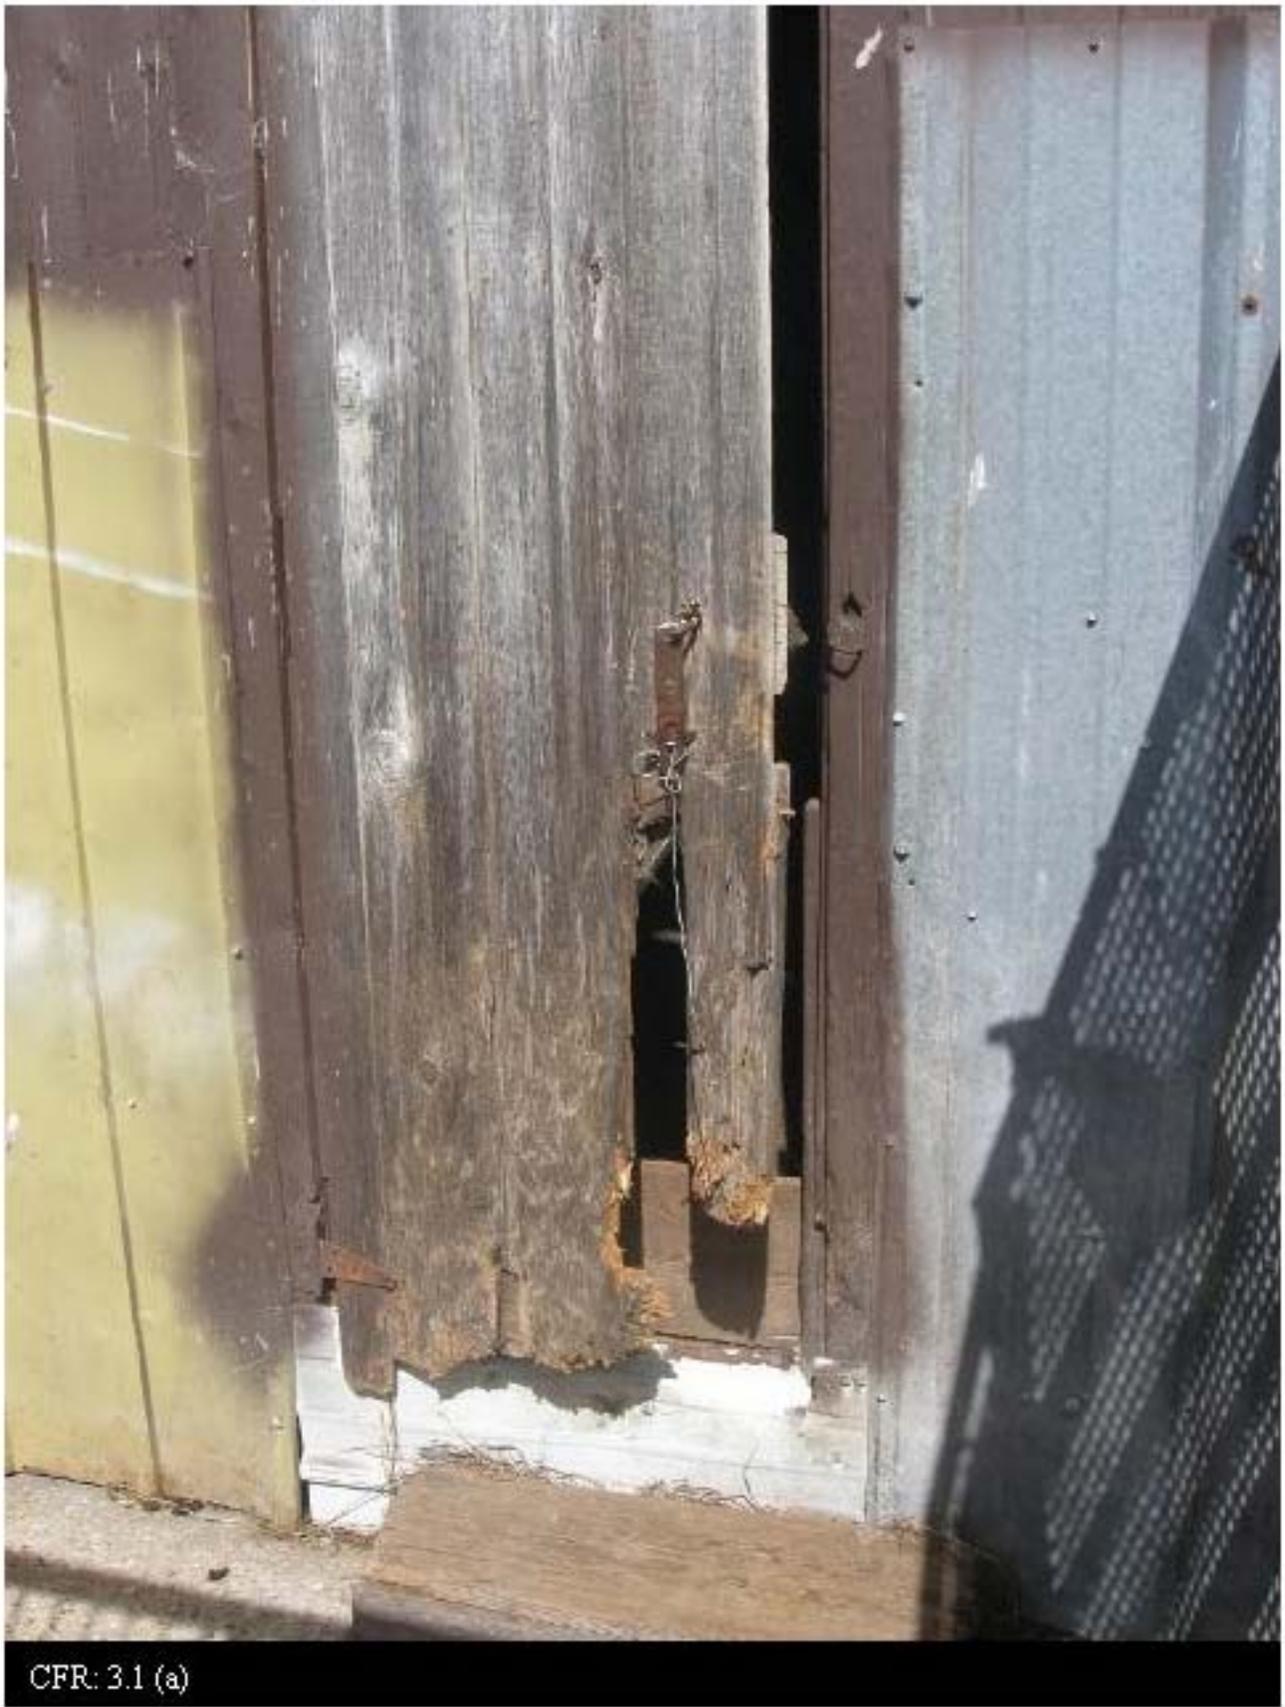
CFR: 3.1 (a)

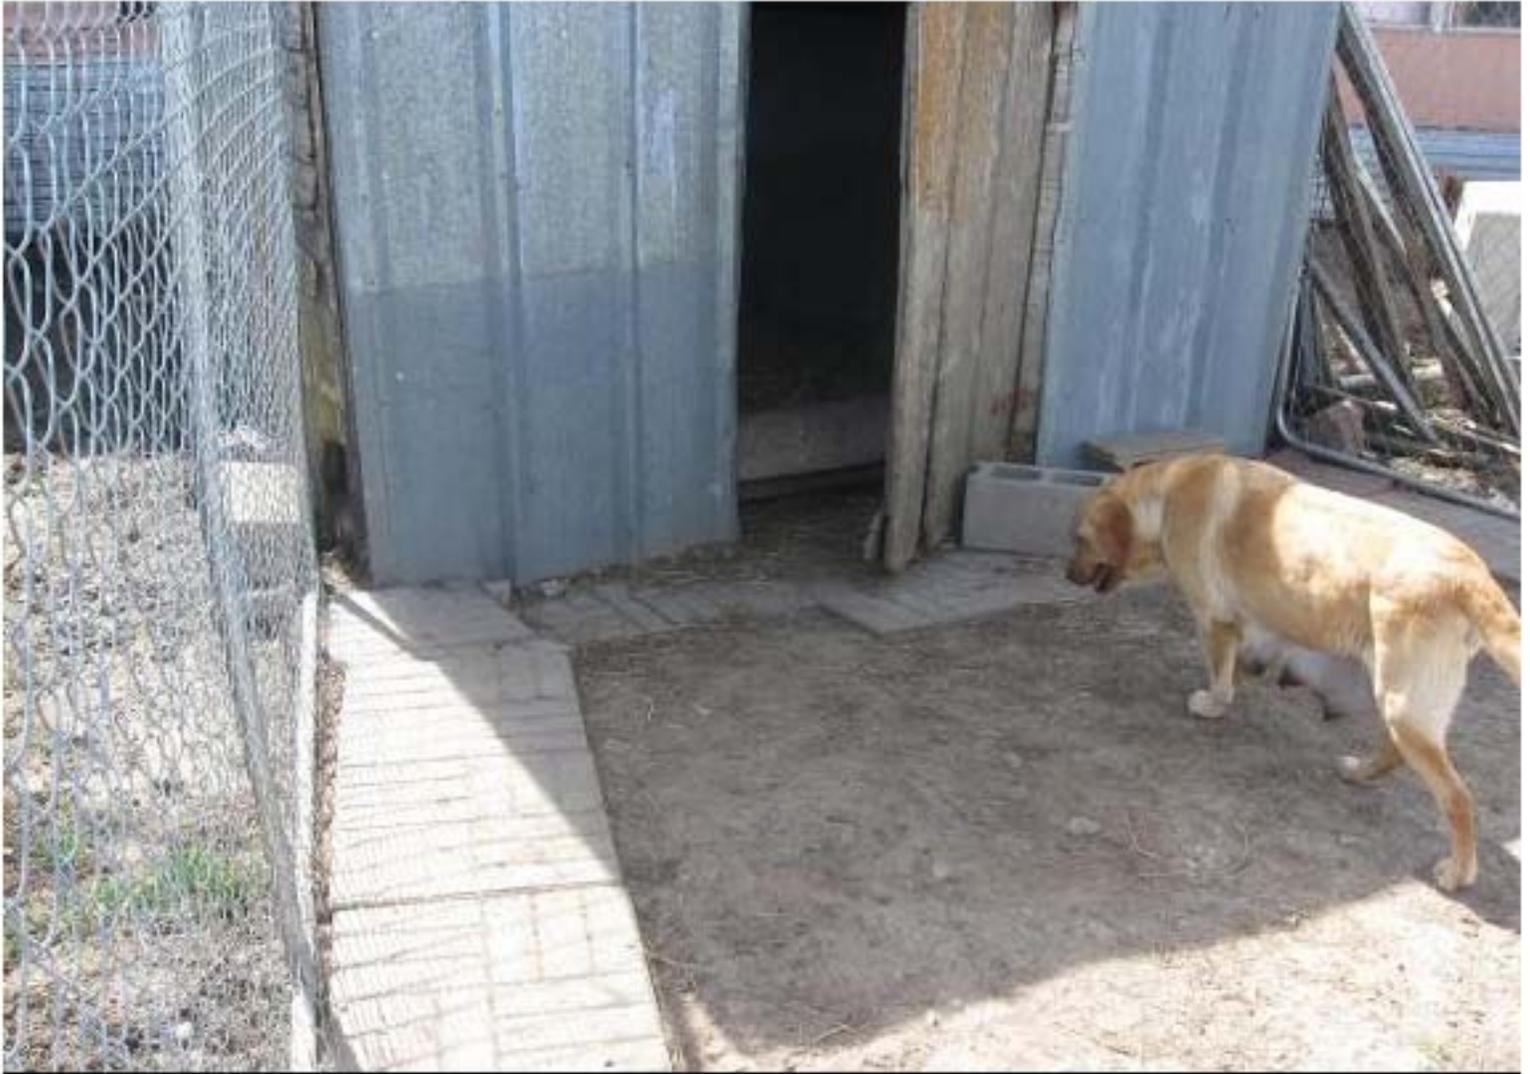
Photographer:	Dr. Richard Watkins	Legal Name:	Registration:	42-A-1256
Photo Taken:	Thu, Apr 1, '10	BETTY PORTER		
Inspection:	95102052350433			
Description:	mother dog with pups in shed/wire fence does not meet flush with shed/ some wiring is loose and sharp.

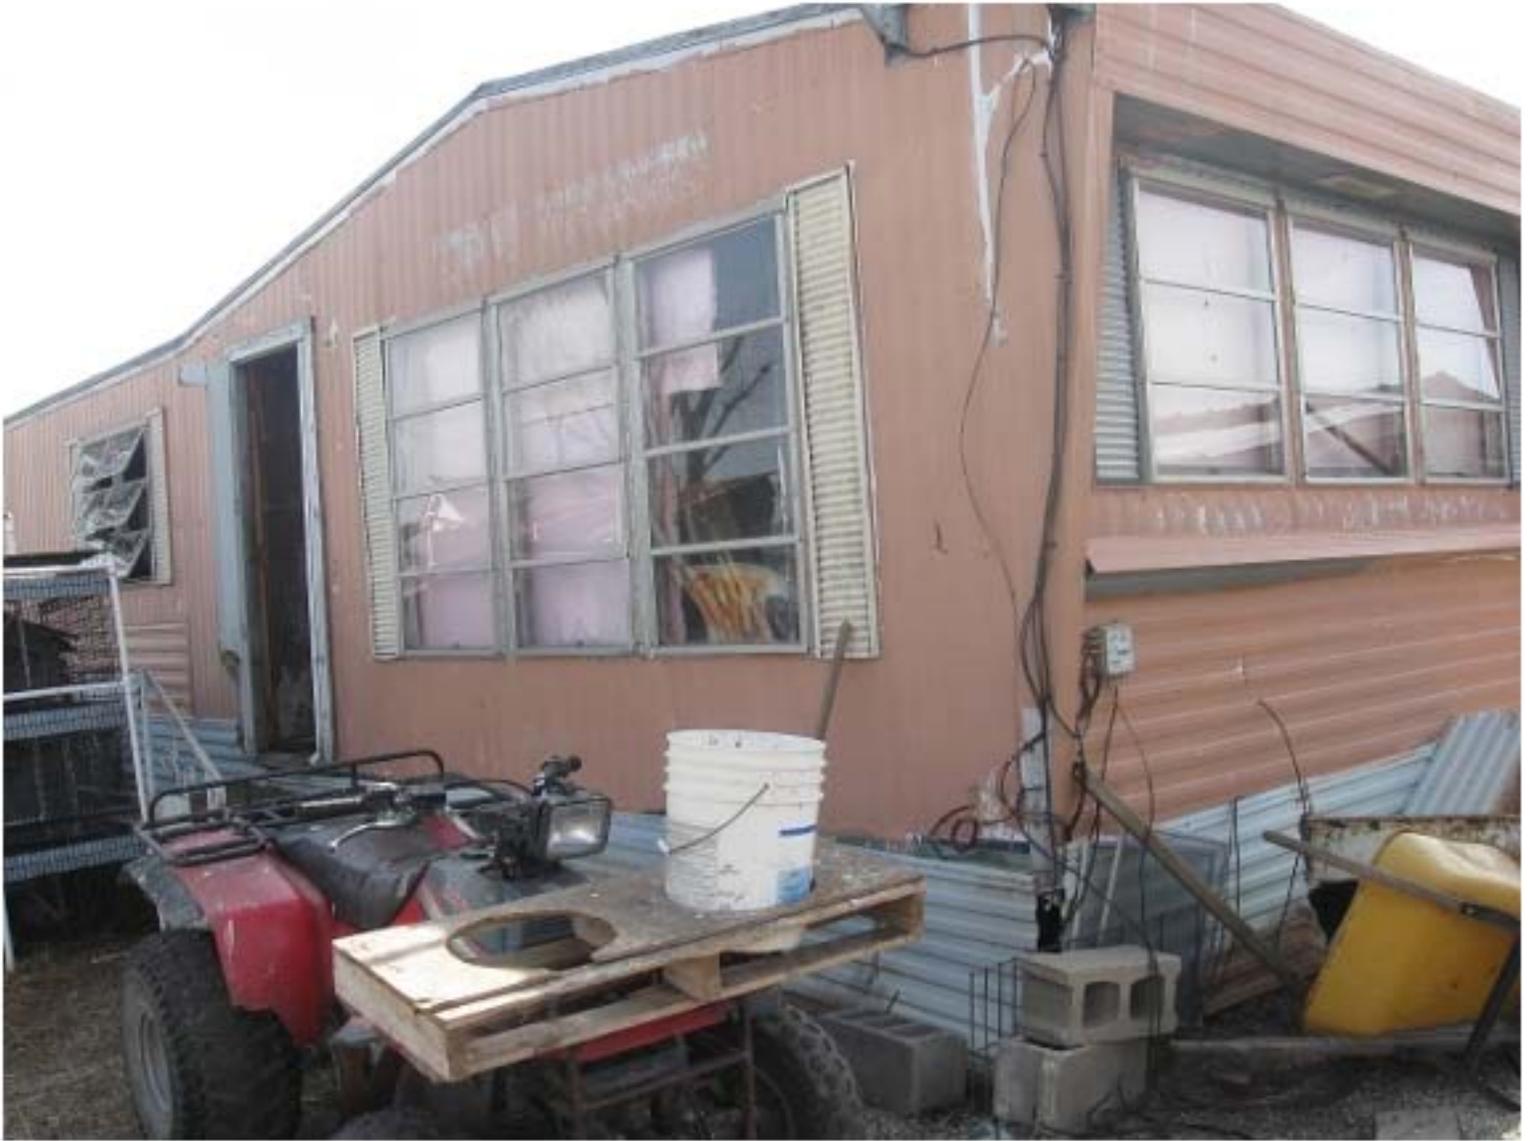
Photographer:	Dr. Richard Watkins	Legal Name:	Registration:	42-A-1256
Photo Taken:	Thu, Apr 1, '10	BETTY PORTER		
Inspection:	95102052350433			
Description:	Whelping trailer with debris all around it.

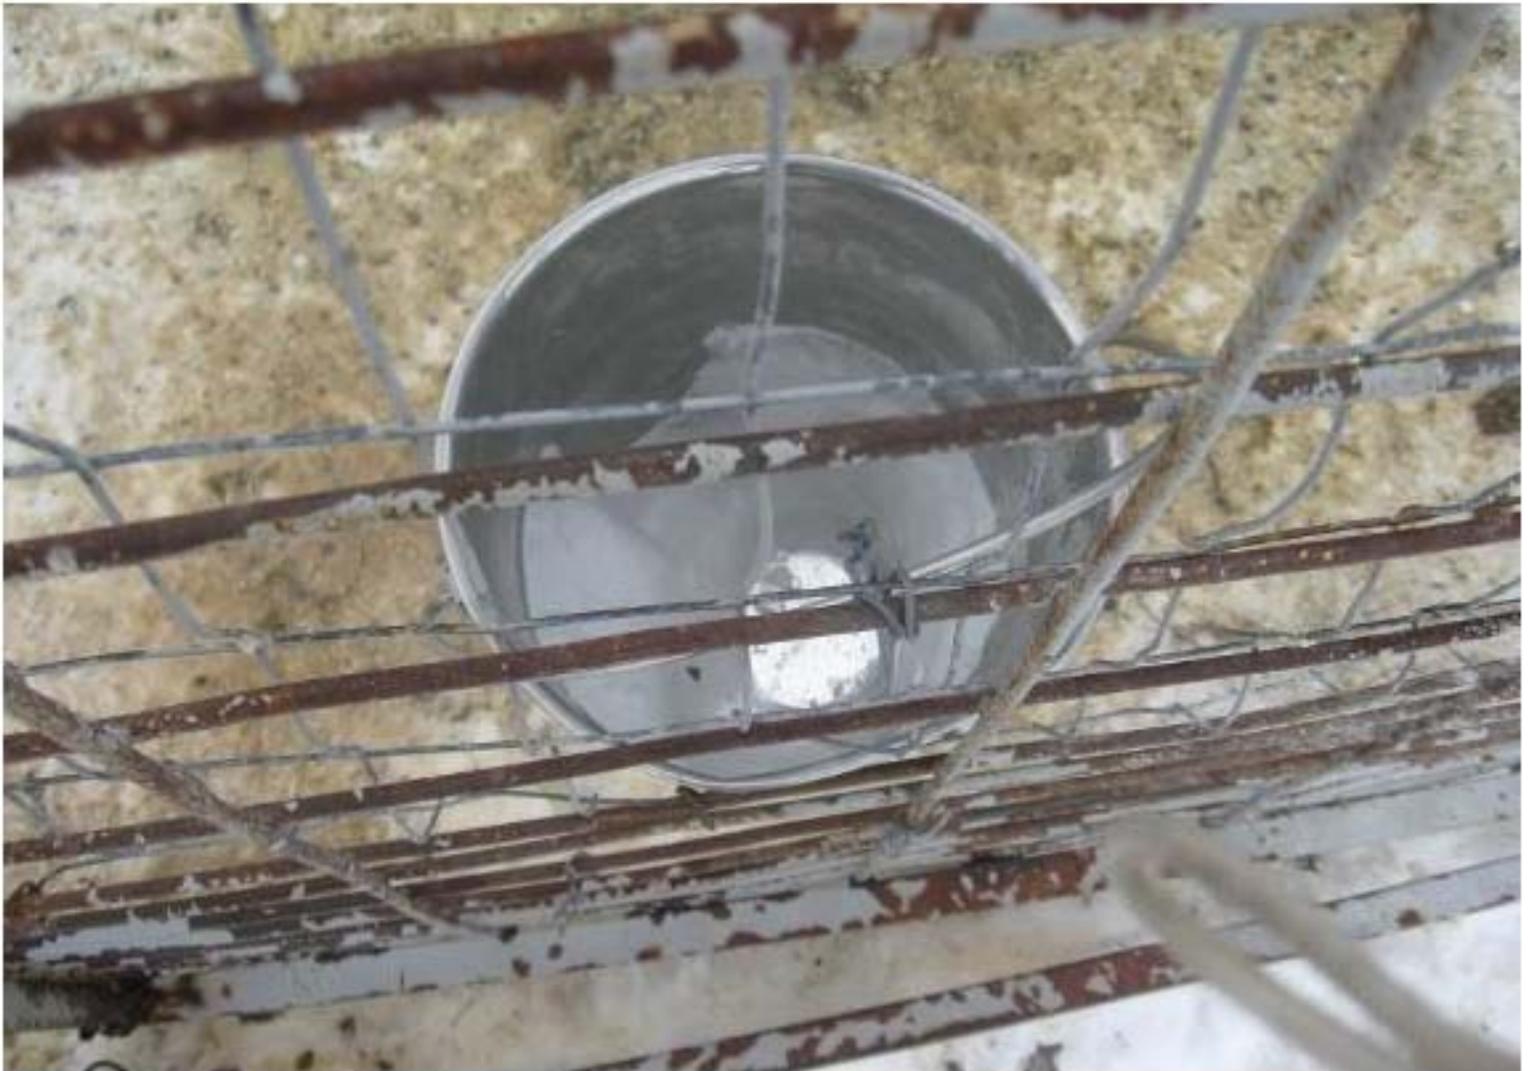
Photographer:	Dr. Watkins	Legal Name:	Registration:	42-A-1256
Photo Taken:	Thu, Feb 11, '10	BETTY PORTER		
Inspection:	53101231270064			
Description:	Frozen water in outdoor, as well as sheltered kennels.

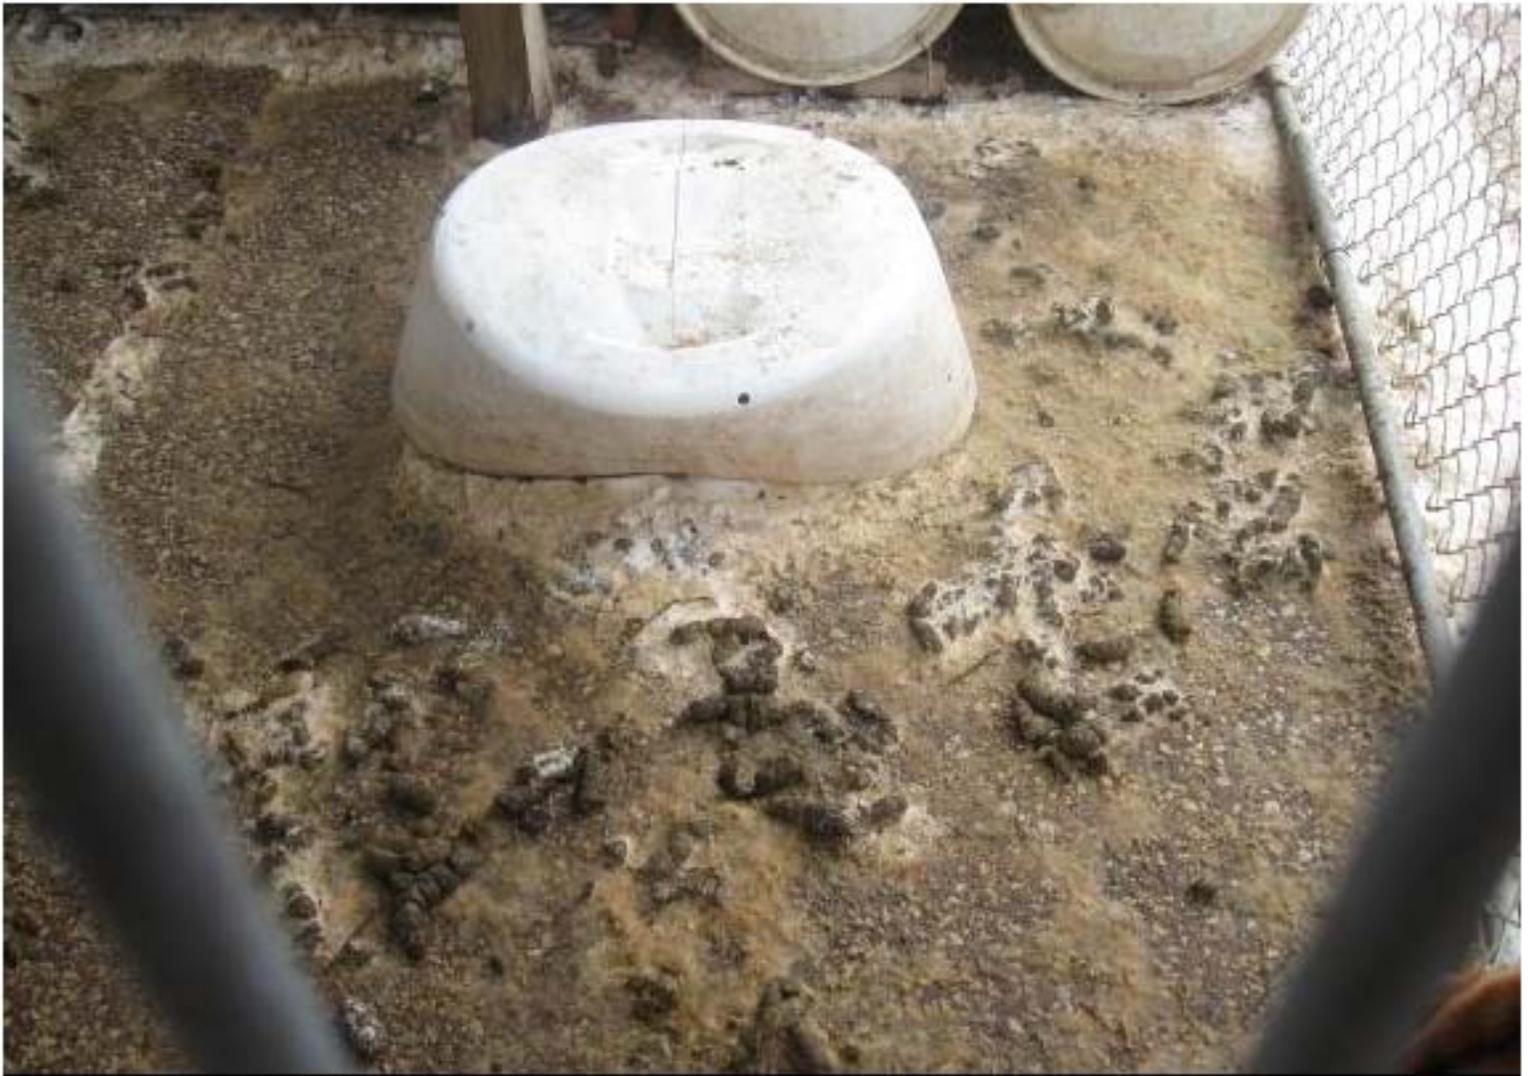
Photographer:	Dr. Watkins	Legal Name:	Registration:	42-A-1256
Photo Taken:	Thu, Feb 11, '10	BETTY PORTER		
Inspection:	53101231270064			
Description:	Excreta Accumulation in kennels

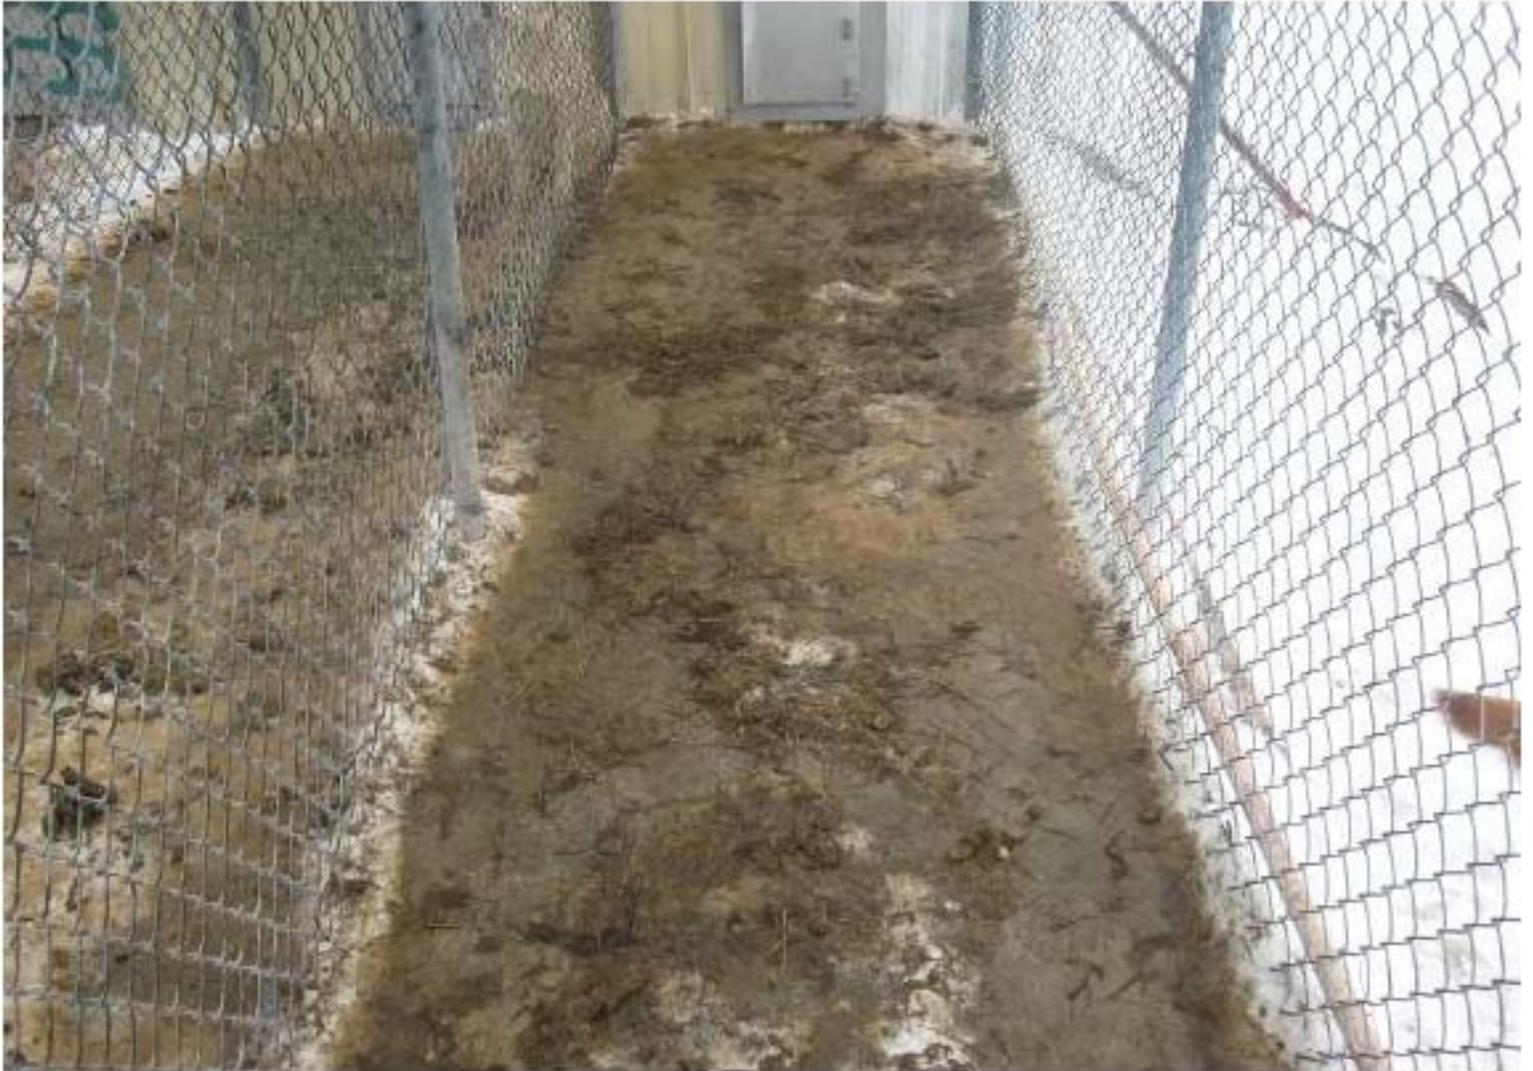
Photographer:	Dr. Watkins	Legal Name:	Registration:	42-A-1256
Photo Taken:	Thu, Feb 11, '10	BETTY PORTER		
Inspection:	53101231270064			
Description:	Excessive feces in kennel

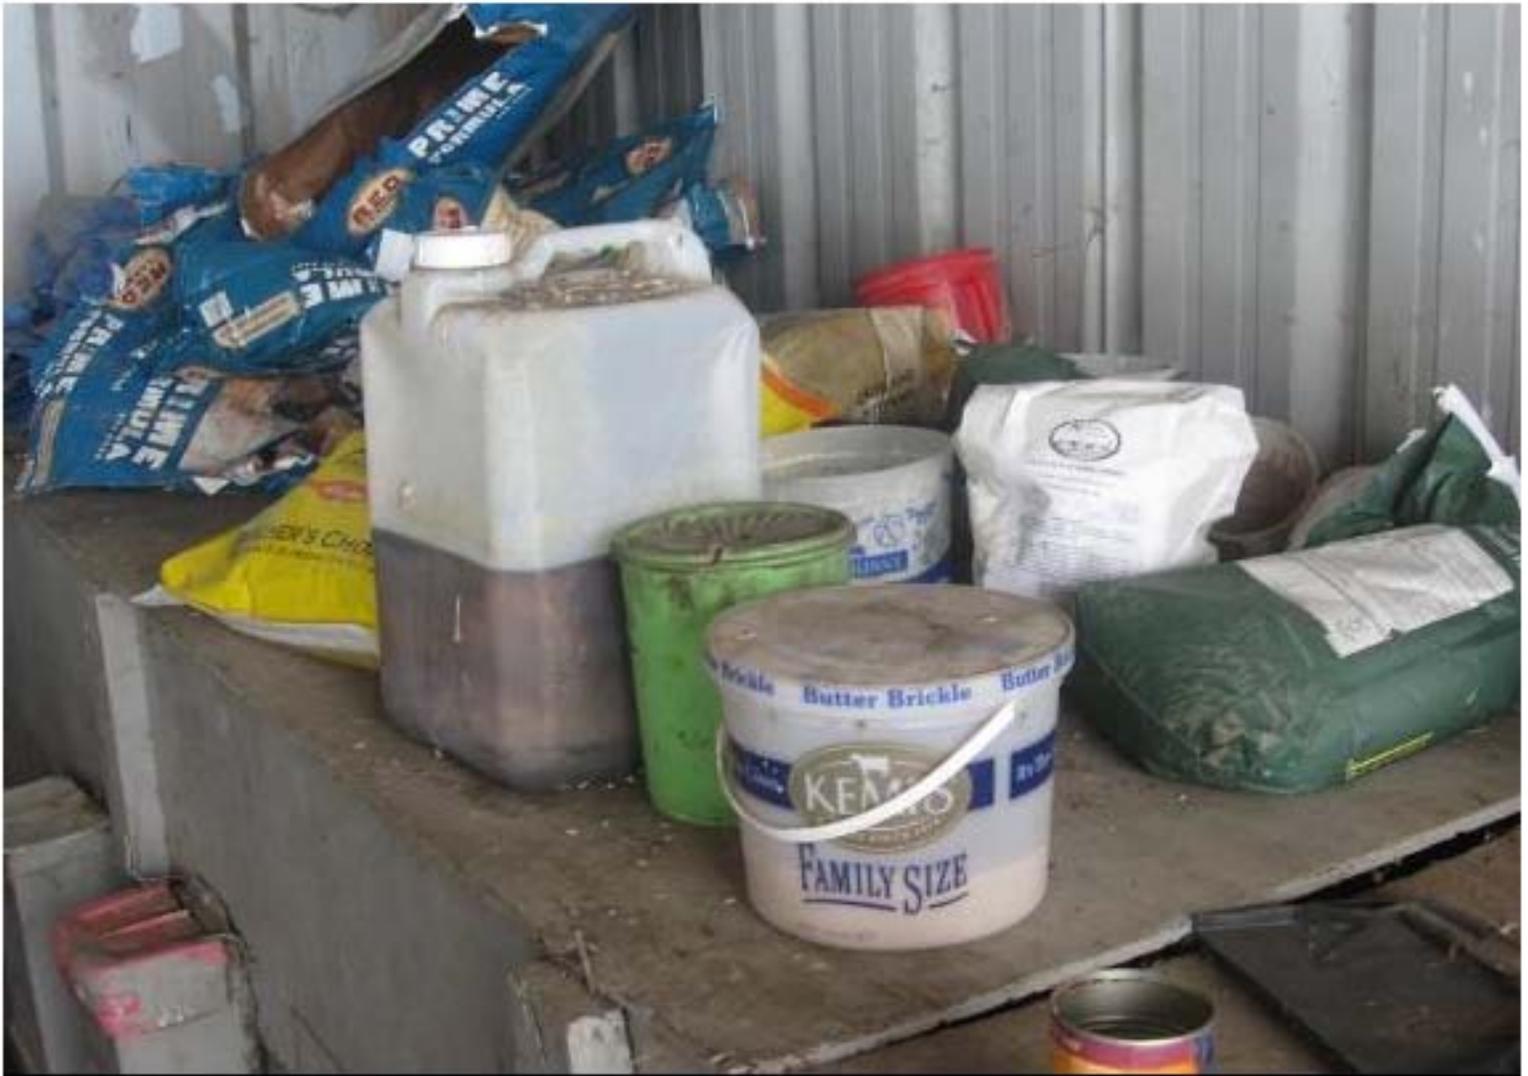
Photographer:	Dr. Watkins	Legal Name:	Registration:	42-A-1256
Photo Taken:	Thu, Feb 11, '10	BETTY PORTER		
Inspection:	53101231270064			
Description:	Debris and accumulated clutter on top of sheltered housing, including large container of oil.
